Evaluation of Household Water Quality in Nelson County, Virginia NOVEMBER 2010 VIRGINIA HOUSEHOLD WATER QUALITY PROGRAM

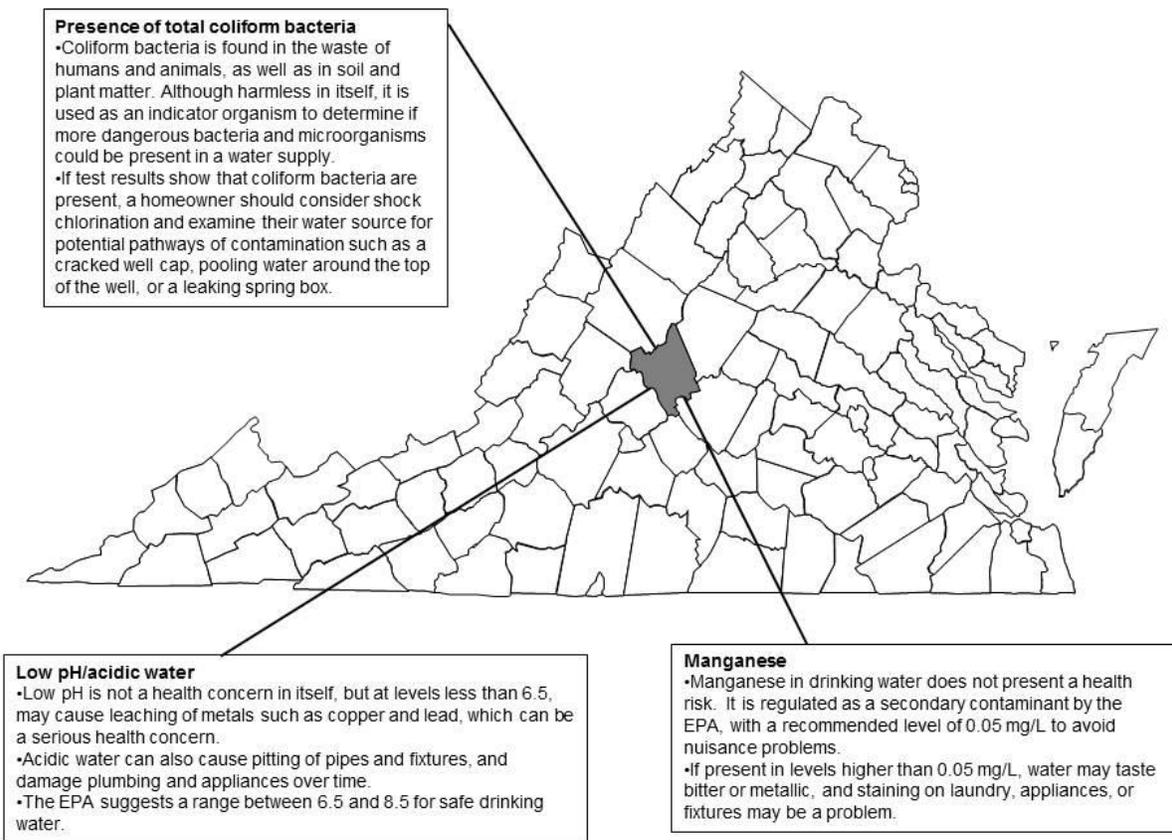
Figure 1. The most common household water quality issues found in the 29 Nelson clinic participant samples were high levels of manganese, low pH, and the presence of total coliform bacteria

Of the 29 samples collected, 41% tested positive (present) for total coliform bacteria. Subsequent *E. coli* analyses for all of these samples showed that 3% of the samples tested positive for *E. coli* bacteria.

pH is a measure of the acidity or alkalinity of a substance. The EPA suggests the pH for public drinking water be between 6.5 and 8.5. Of the 29 Nelson County clinic samples, 79% were below the recommended pH of 6.5, indicating acidic water. Although not a health concern in itself, acidic water may be corrosive and can potentially leach metals like copper and lead from plumbing components. An option for dealing with low pH water is to install an acid neutralizing filter, which raises pH by passing the water through a medium of calcite and/or magnesium oxide.

Seven percent of clinic samples tested above 0.05mg/L. Treatment options for manganese include a water softener, reverse osmosis or distillation.
