Effectiveness, Cost, and Implications of Forest Haul Road Stream Crossing Structures  
and Best Management Practices in Virginia

Brian Christopher Morris

Dissertation submitted to the faculty of the Virginia Polytechnic Institute and State  
University in partial fulfillment of the requirements for the degree of

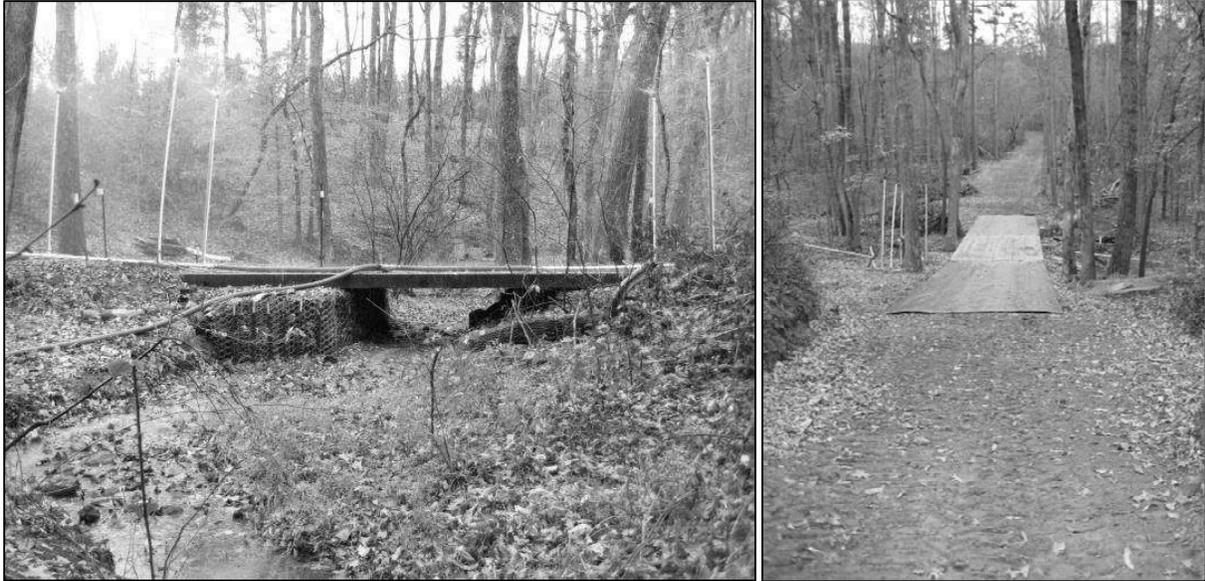
Figure 1: Left, bridge during rainfall simulation on BMP+ treatment with gabion basket as an abutment (left of stream) and the road running surface and bare soil rocked. Right, bridge prior to application of rock over the geo-textile on the running surface of the road (BMP), picture shows geo-textile prior to rock application which completed the BMP treatment, rock was applied over the geo-textile.

The original legacy ford stream crossing consisted of steep approaches with poor alignment. The poor alignment required vehicles to negotiate a curve while entering and exiting the stream channel. These difficult travel conditions often required four-wheel drive and resulted in substantial channel disturbance. In order to improve trafficability and reduce maintenance and risk of erosion from the road network, a wood panel bridge was installed. The bridge consisted of three white oak (*Quercus alba*) panels; 7.3 m long, 1.2 m wide and 0.2 m thick. The panels were combined to form a bridge 7.3 m in length and 3.6 m wide (Figure 1). The bridge spans a distance of 2.8 m with approximately 2.25 m of bridge extending beyond the abutments on each side. The eastern abutment for the bridge was constructed using two gabion baskets (0.9 m x 0.9 m x 3.6 m) that were placed along the edge of the stream channel. Approximately 0.6 m of fill was required behind the gabion baskets to allow for the desired grade on the bridge approach. The eastern abutment utilized a near vertical stream bank that was stabilized by the roots from surrounding trees. Geo-textile was applied on both abutments. Approximately 5 cm of Virginia Department of Transportation (VDOT) #5 (1.25 – 5 cm stone) drain rock was applied on the geotextile to aid drainage and increase the longevity of the permanent bridge.

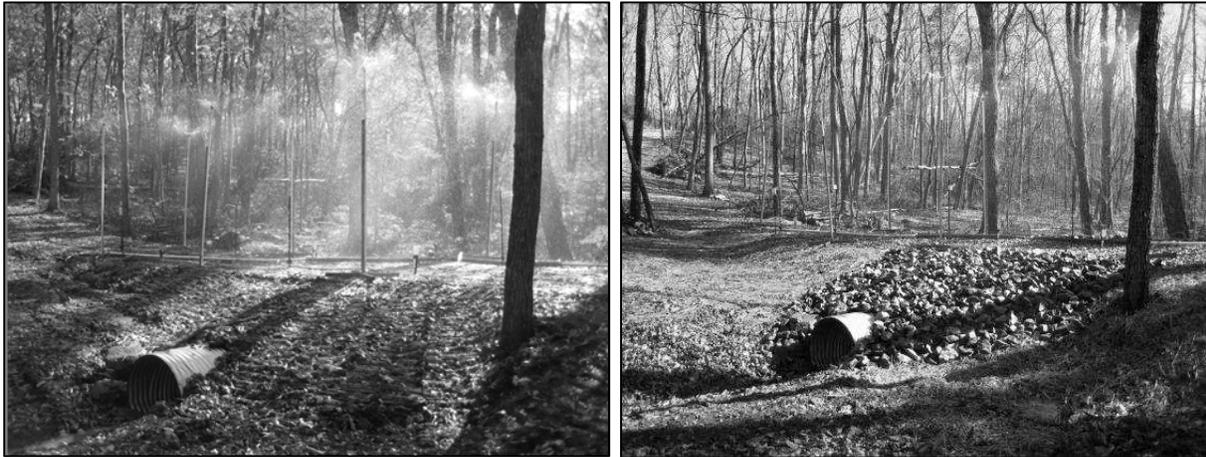
Figure 2: Culvert after installation and during BMP- rainfall simulation (Left), Culvert prior to BMP+ rainfall simulation with rocked running surface and fill slopes and seed and mulch on bare soil (Right).

For the culvert stream crossing, the initial rainfall simulations were conducted on the BMP- treatment, which consisted of the fully constructed culvert with bare soil on the road surface and fill slopes. The second series of rainfall simulations were applied to the BMP treatment, which consisted of the application of #357 rock to the road running surface on top of Geo-textile. The final treatment that received rainfall simulation, BMP+, consisted of applying

rip-rap to the fill slopes as well as the application of grass seed and straw mulch to the bare soil near the road surface and fill slopes (Figure 2).

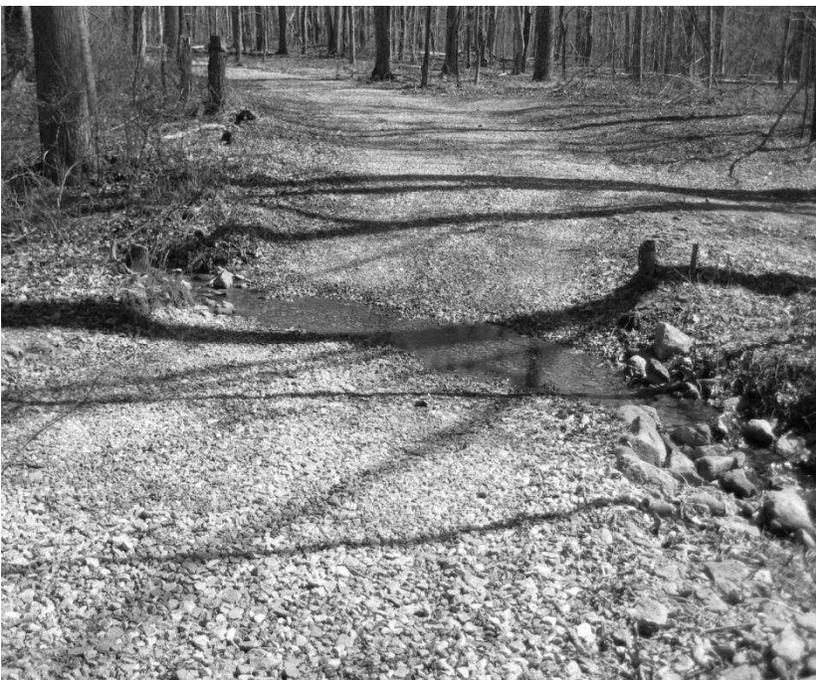
Figure 3: Ford crossing with BMP+ treatment including rocked running surface and Geo-Web in the channel.

For the ford crossing, the beginning rainfall simulations commenced with the BMP- treatment. For BMP- the stream banks were angled and smoothed with the backhoe to allow for easier travel through the crossing and approaches were graded with a bulldozer. BMP- resulted in approximately 50% bare soil due to the native rock fragment. The second series of rainfall simulations were conducted on the BMP treatment. BMP treatment did not improve the stream-bed; however #357 rock was applied to the running surface of the approaches. The final series rainfall simulations were conducted on the BMP+ treatment in which Geo-Web and rock were applied to the stream channel and all bare soil near the crossing was covered with native stone or gravel (Figure 3).

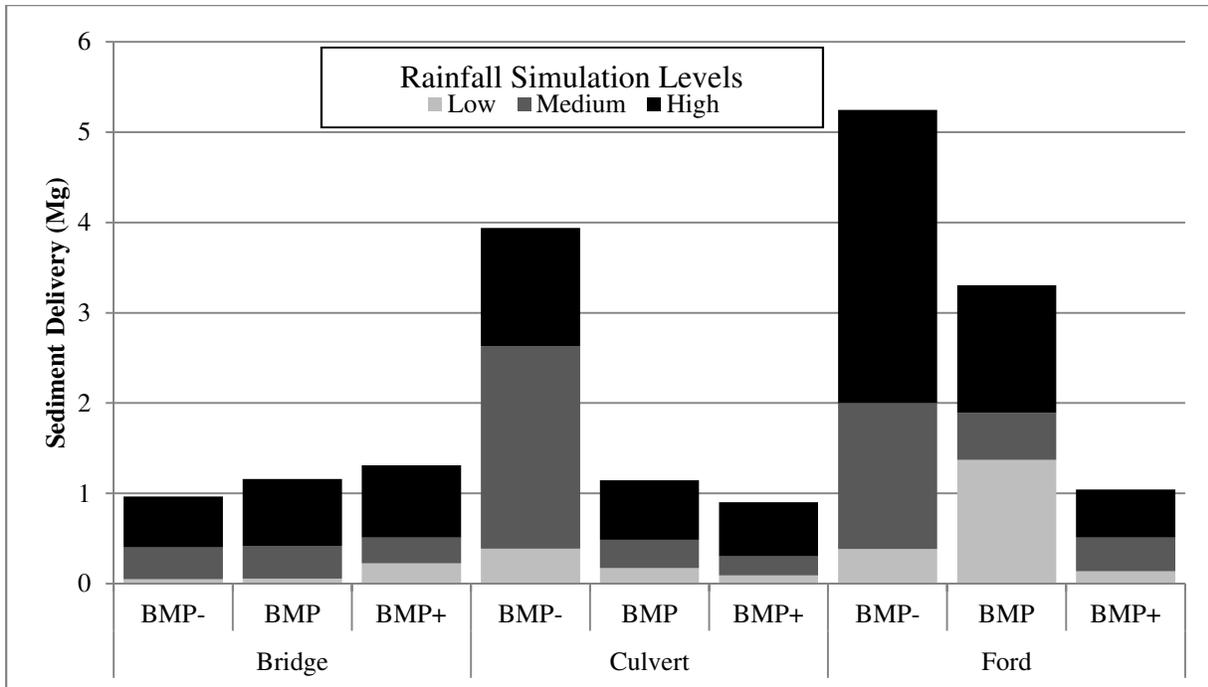
Figure 4: Total sediment delivery (Mg) during the 50 minute period beginning with initiation of the 30 minute rainfall simulation and for 20 minutes after completion of rainfall simulation by crossing and BMP level.

Sediment concentration of each crossing was influenced by the intensity and duration of the rainfall simulation. Sediment concentrations start with low sediment levels at the initiation of rainfall and peak approximately 15 to 30 minutes into the rainfall simulations and again decrease to the baseline levels. Ford and culvert crossings showed a decrease in total sediment delivery with increasing levels of BMPs (i.e. BMP- to BMP to BMP+) while the bridge showed little change through all levels of BMPs (Figure 4).

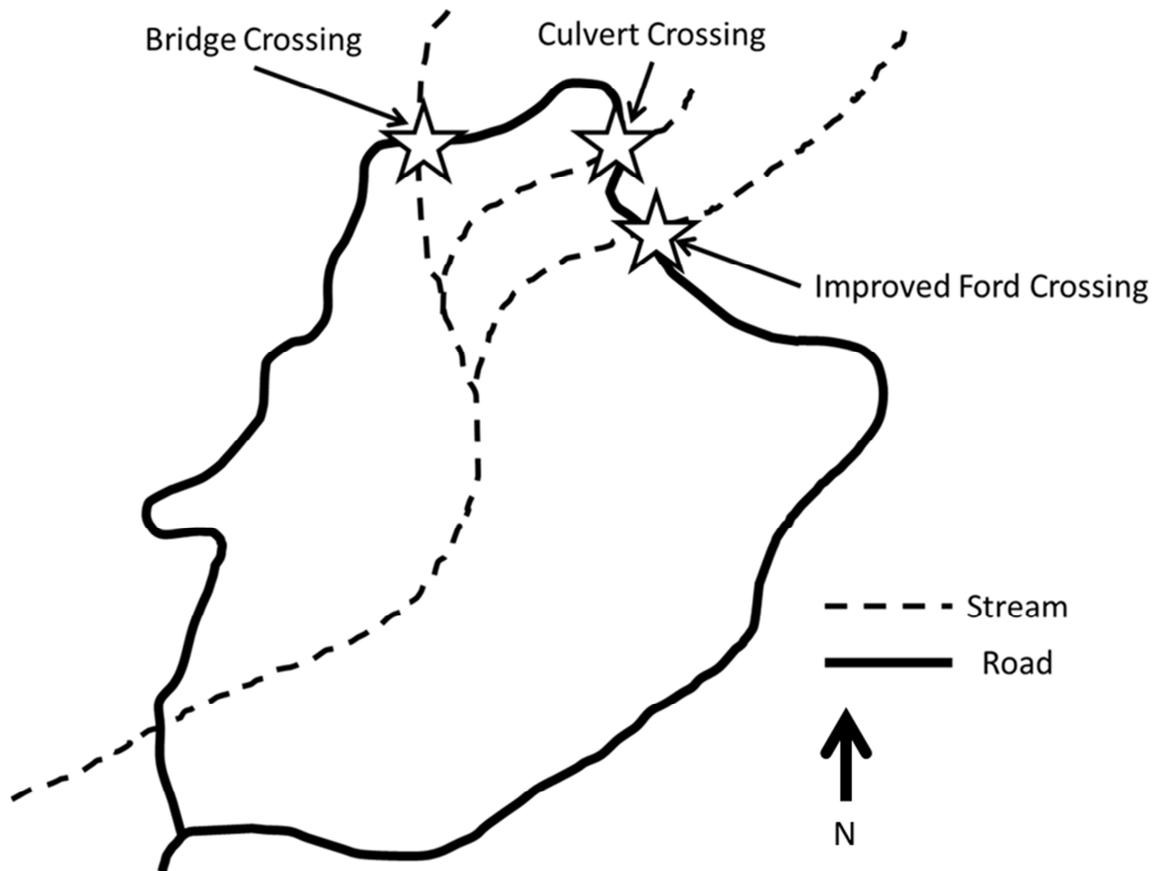
Figure 5: The legacy forest road crosses three separate streams above the stream confluence and again below the confluence of the three streams. Original stream crossings for the bridge, culvert and ford crossings were unimproved legacy ford stream crossings. The fourth stream crossing (below stream confluence) was upgraded with a concrete and culvert pipe low water crossing prior to this project. (Not to scale)

Data collection was conducted in the Piedmont physiographic region of Virginia at the Reynolds Homestead Forest Resources Research Center in Patrick County, VA (36°38'N 80°8'W). Forest management and harvesting in the area includes loblolly pine (*Pinus taeda*) plantations, natural Virginia pine stands (*Pinus virginiana*), and mature mixed hardwood forests. At the site, stream crossings along a legacy road (>100 years old) with minimal BMPs were improved on three perennial streams (Figure 5). The legacy road is used as an access road for forest operations as well as teaching and research activities. The three crossings were identified and the most appropriate crossing type was chosen based upon crossing characteristics including road approach elevation, stream alignment, and stream width. The watershed area above each crossing consists of mixed hardwood forest cover and ranged from 17.0 to 40.4 ha in size. Stream slope was approximately 2% for all three streams and sand and gravel made up the largest portions of bed material (Table 8).

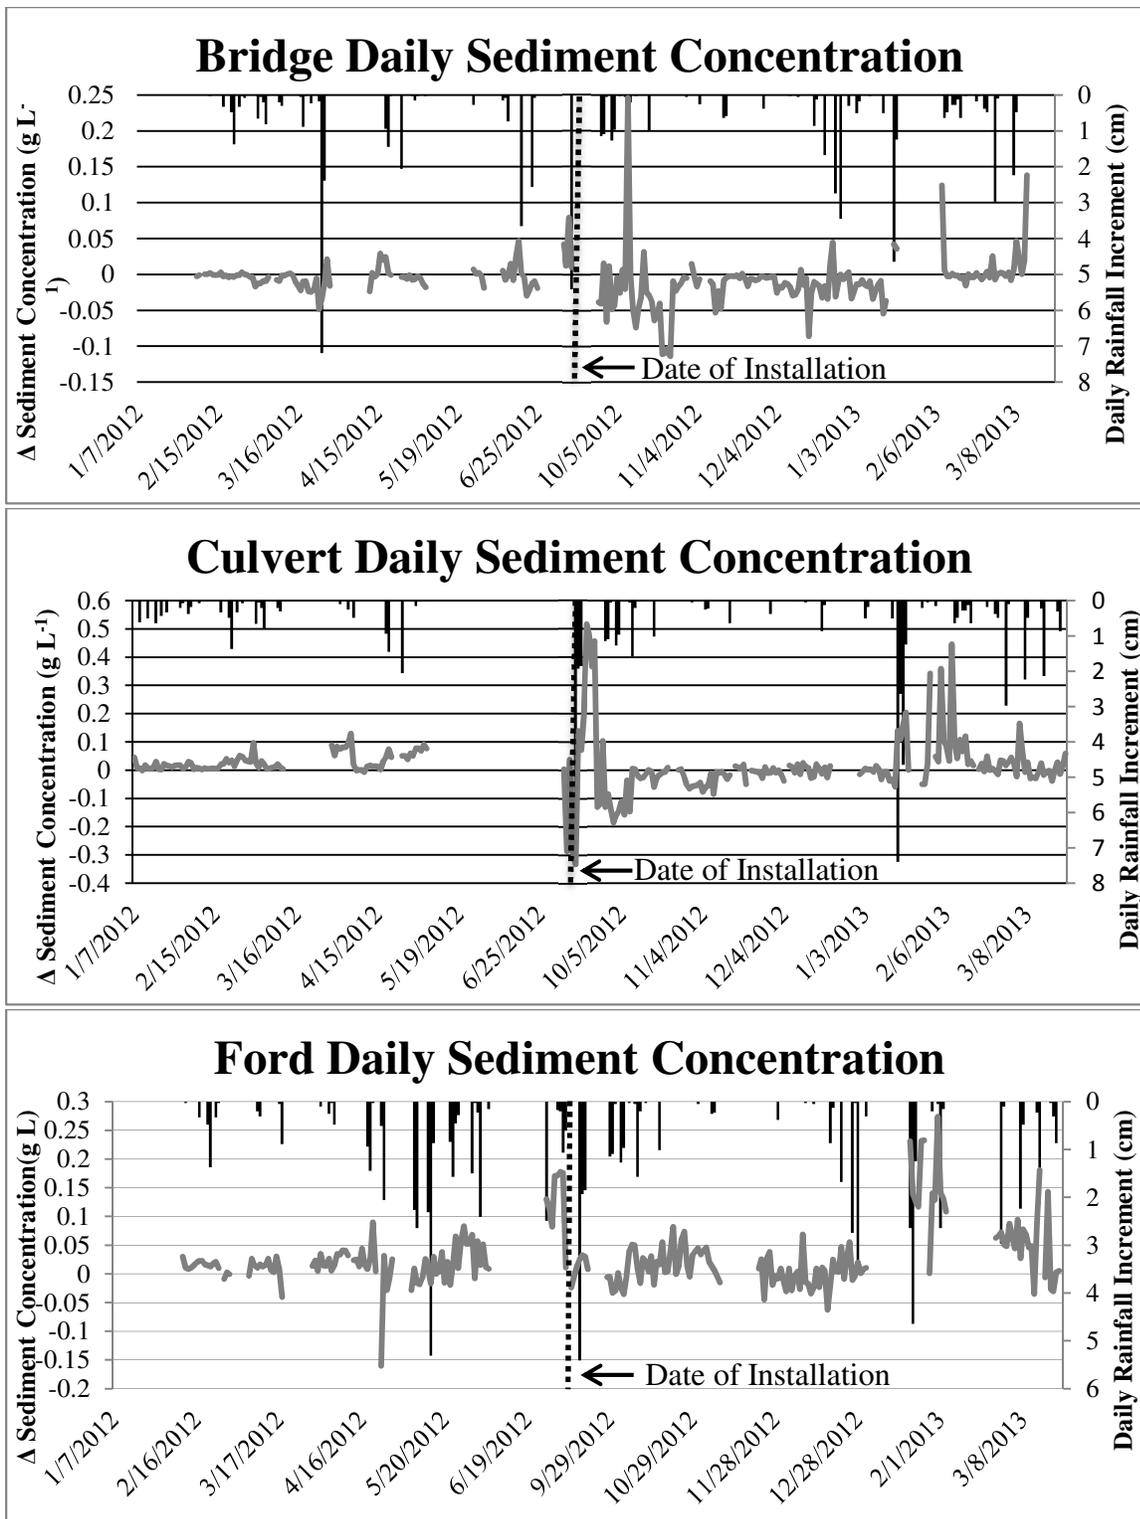
Figure 6: Bridge (top), Culvert (middle), and Ford (bottom) crossing daily  $\Delta$  sediment concentration ( $\text{g mL}^{-1}$ ) and rainfall ( $\text{mm day}^{-1}$ ) calculated as downstream TSS – upstream TSS.

The bridge crossing showed a  $\Delta$  sediment concentration near the zero line prior to the crossing installation (Figure 6). On March 25, 2012 the  $\Delta$  sediment concentration showed minimal response to a  $>70$  mm rain event. Following the bridge installation  $\Delta$  sediment concentration showed a mean and median level less than the pre installation period. The mean and median were both below zero in the post improvement time period. The difference between the pre and post installation phases for the culvert crossing was found to be statistically significant ( $p < 0.0001$ ). The mean and median sediment concentrations decreased in the post improvement time period. In early January 2013 and into February 2013 there were several larger rain storms ( $>4$  cm day<sup>-1</sup>). These storms resulted in increased sediment levels. The increased sediment levels following these rain events may be due to natural variability in the system or the minimal time since disturbance. The ford treatment did not show a statistically significant difference in  $\Delta$  sediment concentration. Following crossing improvement, the sediment levels decreased; however, storm events greatly increased sediment (Figure 8).

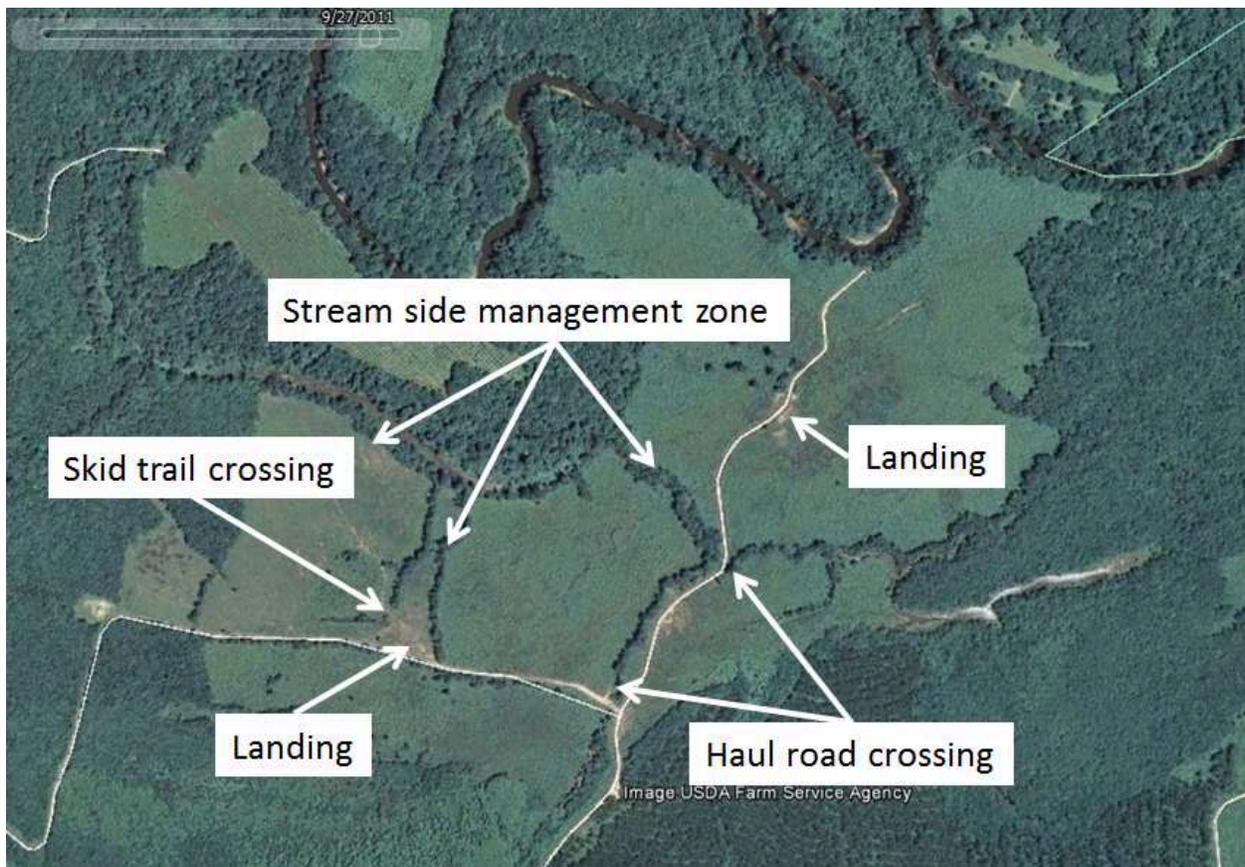
Figure 7: Google Earth image of harvest site with two haul road stream crossings and one skid trail stream crossing. Crossings, stream side management zones and log landings are marked on the pine clear cut harvest.

location of potential stream crossings. In addition to the presence of stream crossings, data were collected on the haul road length (measured with the built in path length measuring tool in the Google Earth software), harvest type (clear cut, partial harvest, mixed), and species composition (hardwood or pine). Figure 7 is an example of a clear cut pine harvest with one skid trail and two haul road stream crossings.
