**RENEWAL ENGINEERING TECHNOLOGIES FOR DRINKING WATER AND
WASTEWATER PIPELINE SYSTEMS – A STATE OF THE ART LITERATURE
AND PRACTICE REVIEW**

Thesis submitted to the faculty of the
Virginia Polytechnic Institute and State University
in partial fulfillment of the requirements for the degree of

Civil Engineering

May 1st, 2012

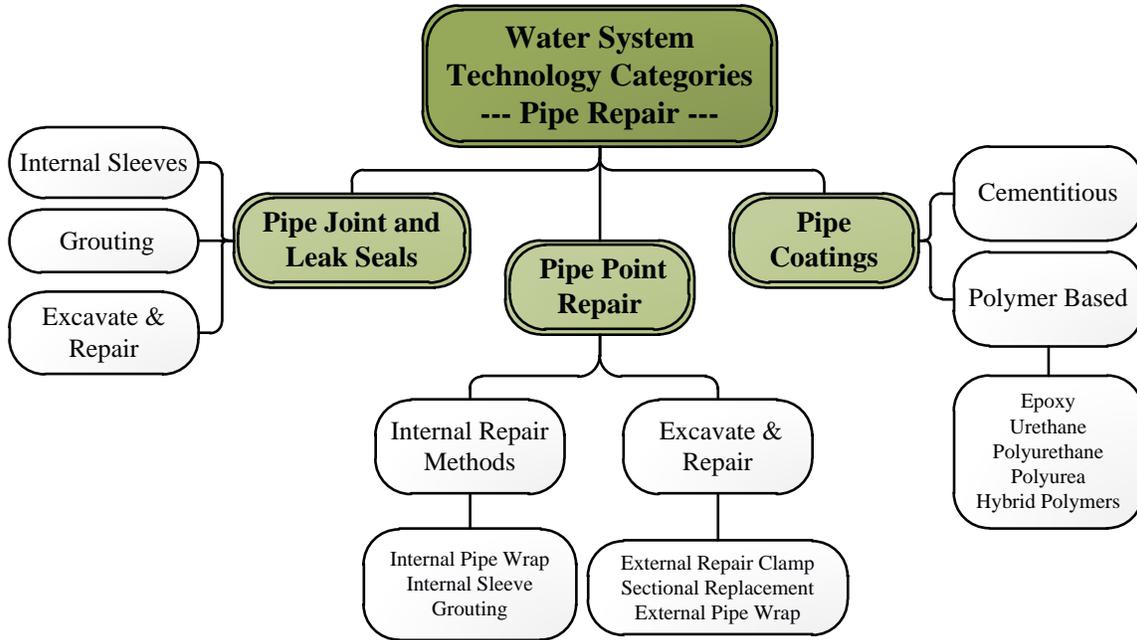
Figure 2-1. Water Pipe Repair Technology Categories

Water and wastewater pipeline repair technologies are used to restore normal pipeline operating conditions or repair small, localized leaks along the pipeline. The technologies are typically used where the defect is not severe enough to require renewal of the entire pipe segment or where deterioration is contained to a small area. Repair technologies can be used to enhance structural stability of the host pipe, but the repair mechanism still relies on the host pipe for structural soundness (EPA, 2010). As shown in Figures 2-1 and 2-2 below for water and wastewater systems respectively, pipe repair technologies have been broken into three major technology classes: (1) pipe joint and leak seals, (2) pipe point repairs, and (3) pipe coatings.

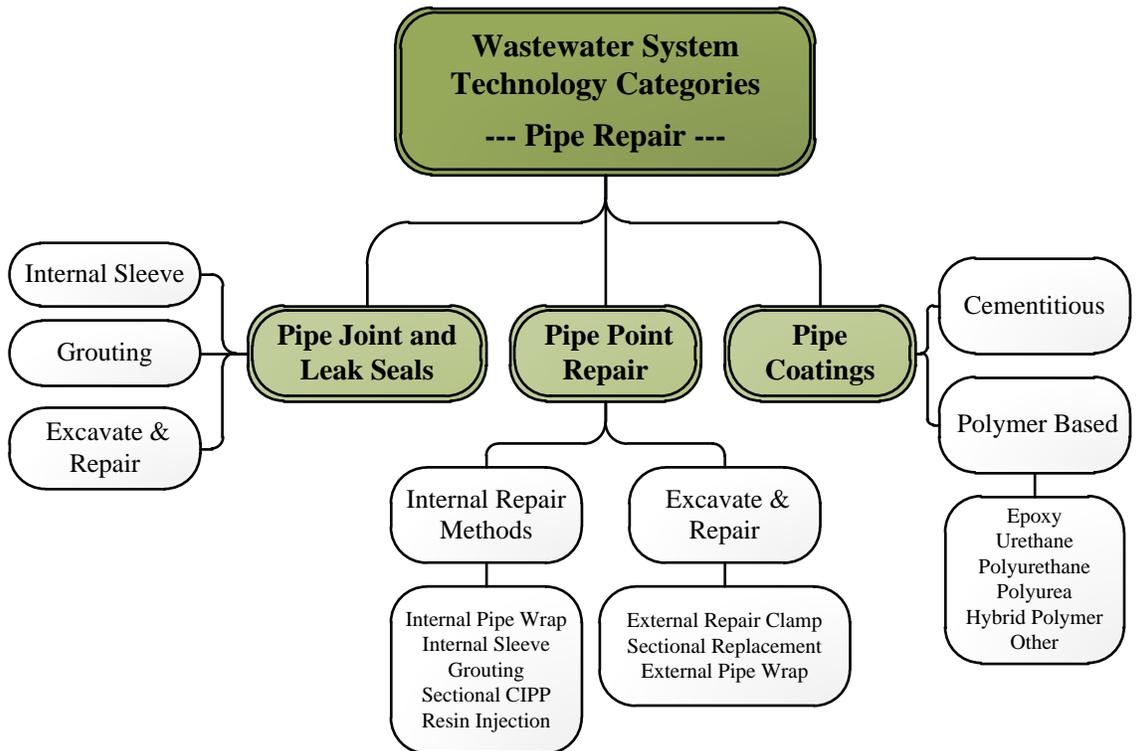
Figure 2-2. Wastewater Pipe Repair Technology Categories

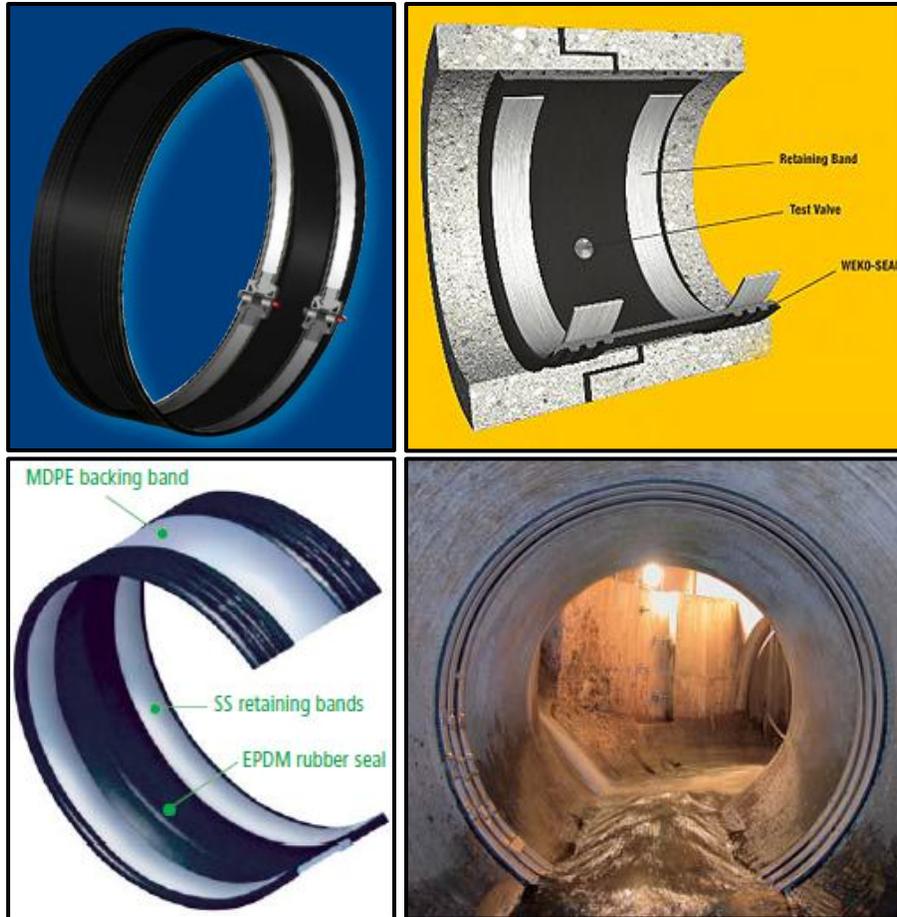
Internal mechanical sleeves are typically made of an ethylene propylene diene M-class (EPDM) rubber with two stainless steel compression rings, one on each edge of the rubber seal (Robert Morrison, March 2010). The rubber seal is placed over the leaking joint or at the transition point between two different pipe materials, and the steel retaining bands are expanded to fit tightly against the pipe wall, sealing off the leaking joint. Before applying the internal sleeve it is important to make sure the surface of the pipeline has been adequately cleaned to ensure that a proper seal can be established between the rubber seal and the host pipe. Dirt and other debris can prevent a tight leak seal from being established and prevent the repair technology from adequately sealing the joint or cause failure. Examples of typical internal joint sleeves are shown below in Figure 2-3.

Figure 2-3. Internal Joint Seals: NPC Internal Joint Seal (top left) (Trelleborg, 2009), Weko Seal (top right) (Sancon Engineering, Inc., 2008), AMEX-10 Seal (bottom left) and AMEX-10 Installed in Potable Water Pipe (bottom right) (AMEX GmbH, 2006)

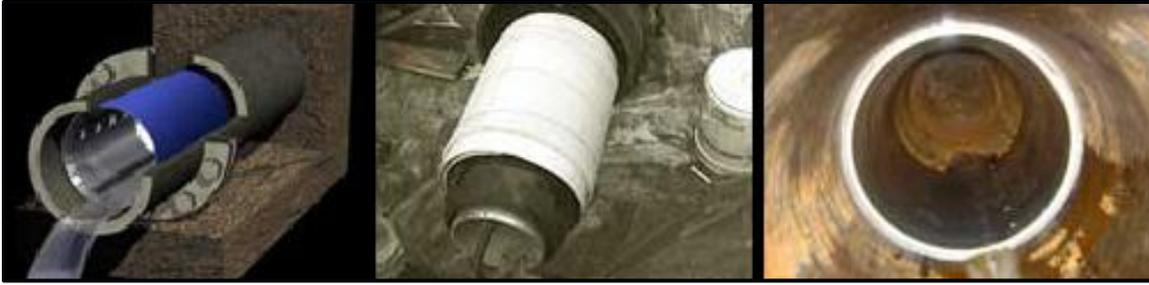
A second type of internal joint and leak sealing sleeve uses a resin saturated felt liner wrapped around a polyethylene foam layer and stainless steel core. Adequate cleaning is also an essential part of successful installation for this type of internal joint seal. The assembled components are carried into position within the pipeline on an inflatable rubber plug, and a CCTV camera is used to help the installer adjust the position of the repair sleeve within the pipeline. Once in position, the plug is pressurized, causing the sleeve to expand and lock into place when the full installation pressure is reached. The resin begins curing when the sleeve locks at which point air pressure can be released and the equipment removed. There is no need to maintain pressure on the sleeve as it cures, as the mechanical lock in the steel sleeve keeps the resin in place as it cures (Link-Pipe, 2010). Figure 2-4 below shows examples of this type of internal sleeve for both water and wastewater applications.

Figure 2-4. Mechanical Sleeve (left), Cured in Place Internal Sleeve (center), and Installed Sleeve (right) (Link-Pipe, 2010)

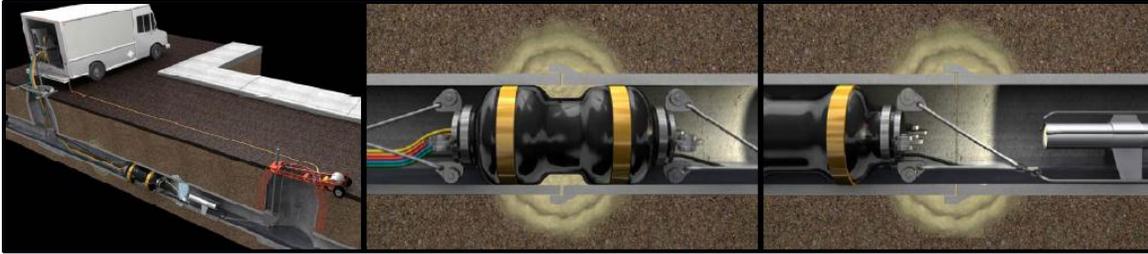
For non-potable applications, grout packers, as shown in Figure 5 below, are often used to seal leaking joints. Packer systems work by isolating the joint from the rest of the pipeline and injecting a liquid resin and activator simultaneously into the defects. This technology essentially creates a waterproofing grout-collar external to the sewerline that seals the defect and all surrounding soil voids (Robert S. Amick, 2000). A CCTV camera is attached to the front of the inflatable packer to help the installer guide the packer into position centered over the leaking joint. The packer is then inflated to isolate the leaking joint from the rest of the sewerline, and the two grout components are pumped through the joint connection to form a rapid setting, hard gel and sand mass around the outside of the pipe joint. The resin and activator are pumped into the packer through separate tubes so that mixing occurs just before injection, preventing the grout from curing before it is allowed to infiltrate all the external voids. The grout packer is then deflated and pulled from the pipeline, and any excess grout is scraped off of the interior pipe wall to leave a smooth finish.

Figure 2-5. Joint Sealing with Grout Packer (C. Vipulanandan, October 2004)

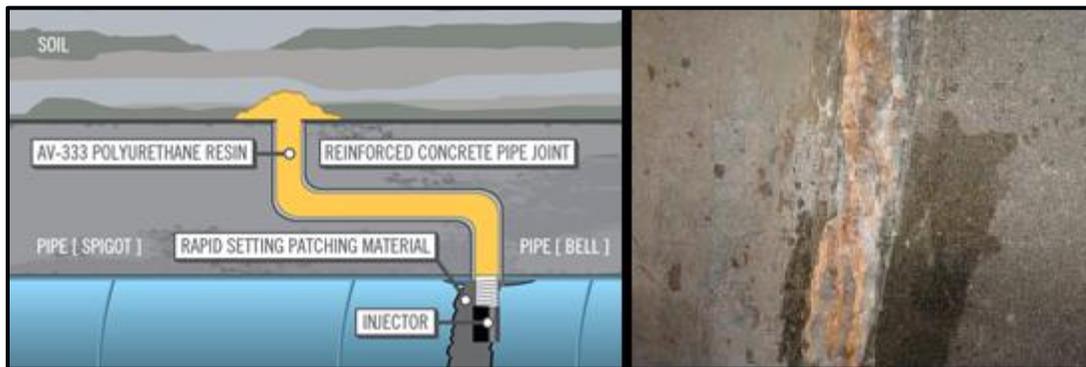
Where the joints are cracked or opened in excess of 1-inch, repairs can be made through re-gasketing of the joint. One method makes use of special packing fibers that are saturated with a water-activated resin which are activated in a water bath packed into the joint cracks. The joints must be sprayed with water in preparation for packing so as to further activate the resin-saturated fibers once they are in place. With the new gasket in place, the top 1-inch of the crack is patched with rapid setting grout and smoothed to match the existing surface. As an alternate method, a rapid setting grout material can be applied and injection tubes encapsulated in the grout around the circumference of the joint. An elastomeric, water-activated resin is then injected into the tubes until the entirety of the open joint is filled. The rapid setting grout material originally applied acts to keep the injected resin within the bounds of the open joint until it is completely filled, at which point resin will begin seeping out of the top-most injection tubes. Figure 2-6 provides a snapshot of this grouting method. The two methods described above can be used in potable water applications, provided the materials are NSF 61 approved for such use.

Figure 2-6. Pipe Joint Crack Repair Diagrams (left) (Avanti International, 2009) and Post-Joint Repair (right) (Prime Practices, 2010)

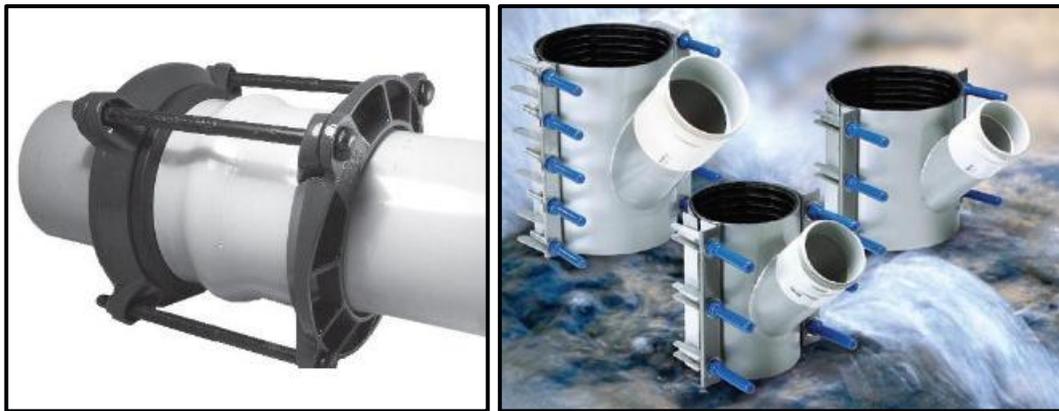
repair clamp. The clamps are specifically designed for different pipe materials, joint types, and pressure ratings. Many of the available repair clamps made specifically for joints are specified for bell joints and can be used on ductile iron, cast iron, certain types of PVC, and rubber ring and caulk joints. The working pressure allowance is dependent on the diameter of the pipeline and decreases as pipe diameter increases. Most of the external joint seals available are geared toward the repair of gravity pipe joints, but bell joint repair clamps are available for working pressures of up to around 150 – 200 psi. Clamps are also available for leaking joints at junctions and service connections. The use of pipe joint repair clamps is limited in pressure system applications to pipelines with diameters less than 15-inches. An example of a bell joint and junction repair clamp is shown in Figure 2-7 below.

Figure 2-7. Bell-Joint Leak Clamp for up to 150 psi (left) (Smith-Blair, 2011) and for Joints at Pipe Junctions (right) (Tyco Water, 2011)

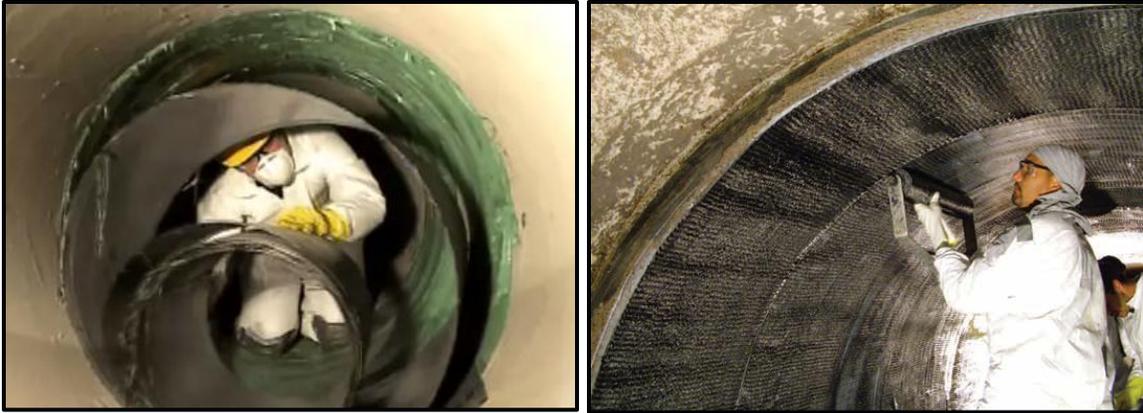
Another type of commonly used pipe wrap is fiber reinforced wrap that is applied with a wet lay-up method. An example of this is also shown in Figure 2-8 below. This type of pipe wrap also requires that the surface around the defect be properly prepared, meaning it needs to be meticulously cleaned and the surface repaired to be completely even. A tack coat is applied to the prepared pipe surface once it is completely dry, the resin-saturated fabric applied by hand with a roller, and a final epoxy coat applied over the fabric layer as a sealant. There are NSF 61 certified top-coats for use in potable water systems. (Fyfe Co, LLC, 2009)

Figure 2-8. Fiber Reinforced Internal Pipe Wrap – Pre-Cured Laminate (left) (Pipe Medic, LLC, 2012) and Wet-Lay Up Applied (right) (Fyfe Co, LLC, 2009)

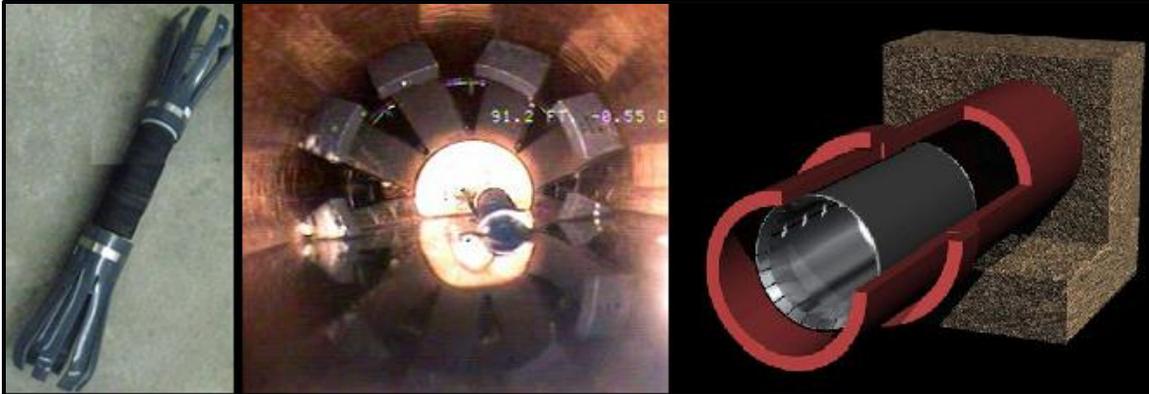
A factory manufactured, mechanical sleeve is used to position and permanently secure a resin-impregnated fabric liner or collar of grout inside of a pipe, again depending on the type of pipeline to which the technology is being applied. The metal or plastic sleeve structurally reinforces the pipe system, while the cured liner or grout provides a seal against leaks. The Mechanical Sleeves can be used to repair longitudinal and circumferential cracks, and can span multiple cracks. The grouting collar is wet-out and wrapped around the sleeve. The sleeve is positioned around an inflatable bladder and then inserted into the host pipe. The Grouting Sleeve is positioned with the help of CCTV equipment at the location of the required point repair. The bladder is inflated and the sleeve radially expands locking out tightly against the host pipe. For experienced maintenance personnel, an internal point repair with a Grouting Sleeve can be accomplished in 20 minutes. The sleeves can be overlapped for lining longer lengths. An example of a typical internal joint sleeve that utilizes grout is shown below in Figure 2-9 and is applicable only to wastewater systems. The mechanical sleeves for potable water applications are the same sleeves as those used to seal leaking joints as was shown previously in Figure 2-4.

Figure 2-9. Internal Mechanical Sleeve (Link-Pipe, 2010)

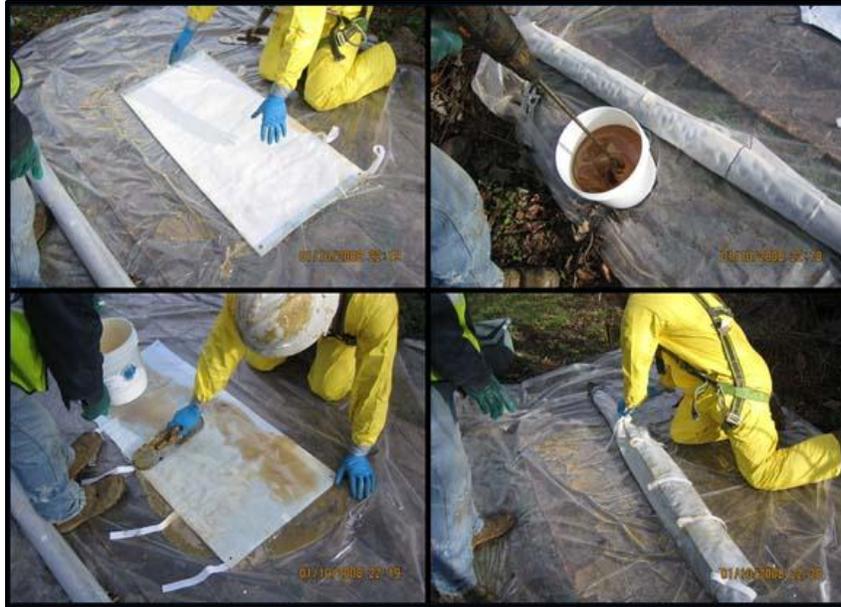
CIPP Liners are one of the oldest forms of pipeline rehabilitation, and a similar technology, often called CIPP sectional or short liners, is available to repair localized defects. CIPP short liners utilize CIPP liners that are attached to a specialized bladder and pulled, rather than inverted, into place within the pipeline. Resin is applied to the CIPP liner before it is attached to the bladder, and once in position, the liner is inflated to fit tightly against the host pipe. Short liners are designed to span only short lengths of pipeline whereas traditional CIPP liners are used to rehabilitate pipe segments from manhole to manhole. If necessary, more than one short liner can be used within the same pipe segment, but typically after about two liners it becomes more reasonable to relin the entire segment. CIPP short liners (shown in Figure 2-10 below) are only used in wastewater applications due to the increased access issues and inconveniences that would be faced with their use in water systems.

Figure 2-10. CIPP Short Liner Material (top left), Mixing of Resins A and B (top right), Resin Application (bottom left), Liner Secured to Carrier Tube (bottom right) (Steiner, 2012)

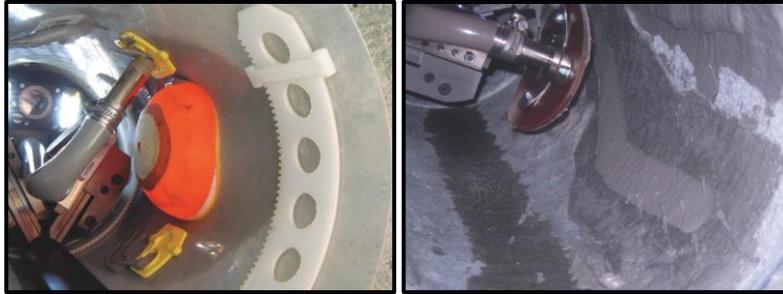
Another injection method requires that a series of holes of specified diameter are drilled along-side the defect, and individual packers are inserted into the drill holes to inject resin into the defect. The installer moves from drill hole to drill hole, injecting resin until the entire crack has been filled. There are two primary types of resins: hydrophilic and hydrophobic. Hydrophilic resins are activated by water whereas hydrophobic resins repel water. (Prime Resins, 2012) An example of a resin injection system is shown in Figure 2-11 below.

Figure 2-11. Resin Injection (Heenan, 2010)

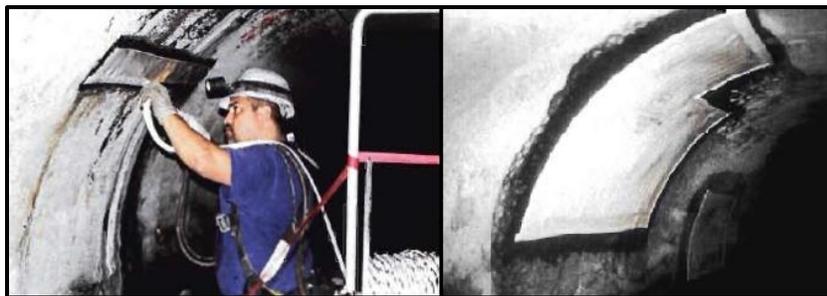
Patch repair methods include those technologies used to perform spot repairs on localized defects by welding a patch of new material over the defect. Typically spot repairs are performed with plastic or metal sheets on pipelines that have been lined with or are composed of the respective material. Plastic liner patches utilize a virgin sheet of PVC that is applied to the PVC-lined pipe surface, and the sheeting is fused to the host pipe lining with welding strips that are backed with a special adhesive of molten material to facilitate hot air welding of the weld strip. The resulting liner is a continuous, impermeable PVC membrane that protects the pipe from the harmful chemicals and abrasive particles that exist in sewage flows. Small repairs of cuts, nail holes, or other minor defects can be repaired with the weld strips alone, but larger defects require a piece of virgin PVC sheeting so that adequate overlap of material, typically about 1-inch, can be made on all sides of the new liner patch (Ameron International, 2005). In a similar manner, patch repair is also an option for steel pipelines. Any existing defects must be repaired and areas of pitting or corrosion removed to create a smooth interior wall surface. A patch of new steel material can then be welded over the defect area using weld strips on each edge of the liner patch to join the host pipe and new steel material. Figure 2-12 below shows examples of a small and large PVC liner patch repair.

**Figure 2-12. Small Patch Repair (left) and Larger Liner Patch Repair (right)
(Project Engineering Consultants, LTD. , August 31, 2005)**

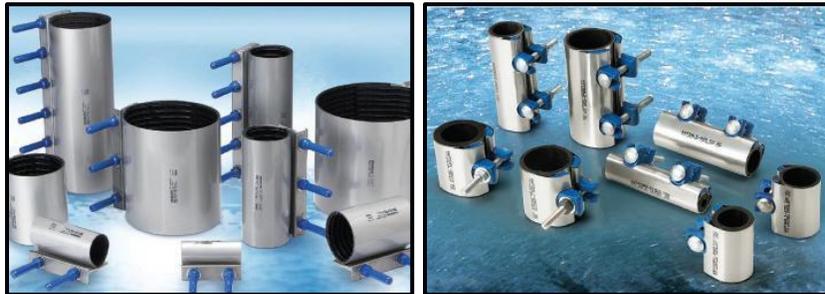
After excavation, the first step to application of the repair clamp is to completely clean the surface of the pipe so that it is free of all soil, mud, scale, etc. A clean surface is imperative to creating a tight seal between the repair clamp and host pipe. Once the pipe surface is cleaned, the repair clamp is held up against the pipeline, and left-end and right-end clamp locator marks are drawn on the pipe. All nuts can then be loosened, but not removed, to the end of their studs, but care should be taken not to flatten or crease the metal bands. Lubricant is applied to the clamp and pipe surface, and the clamp is then wrapped around the prepared host pipe and moved into position between the left and right clamp locator marks. It is important to keep all gaskets and studs free of any dirt, debris, or other foreign material. The repair clamp should be tightened per manufacturer directions, making sure that the gasket mat is not wrinkled or twisted anywhere around the pipe. Studs should be re-tensioned after about 30 minutes to account for tension losses caused by gasket relaxation. Once all components of the repair clamp have been tightened securely and re-tensioned, the excavation pit can be backfilled per specifications and the site restored. Figure 2-13 below shows two different types of repair clamp.

Figure 2-13. Pipe Repair Clamps (left) and Kwik Clamps (right)

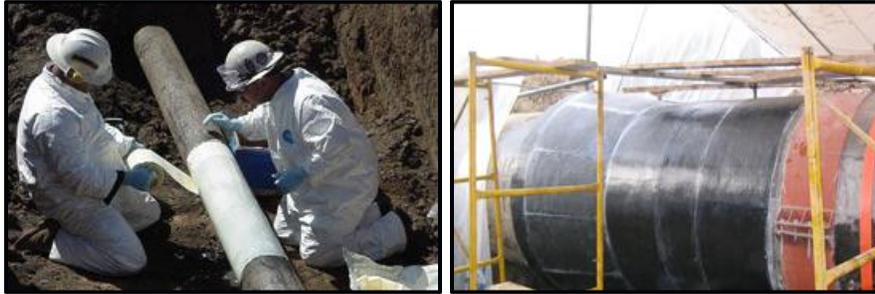
The primary type of pipe wrap externally applied is with a wet lay-up method. The FRP wrap is transported to the job site on spools and can be easily cut to any size in the field. Examples of external pipe wraps for small and large diameter pipelines are shown in Figure 2-14 below. A tack coat is applied to the prepared pipe surface once it is completely dry, the resin-saturated fabric is applied by hand with a roller, and a final epoxy coat is applied over the fabric layer as a sealant. (Fyfe Co, LLC, 2009)

Figure 2-14. External Pipe Wrap Applications on Small Diameter (left) (EA Services, 2011) and large diameter (right) (Fyfe Co, LLC, 2009)

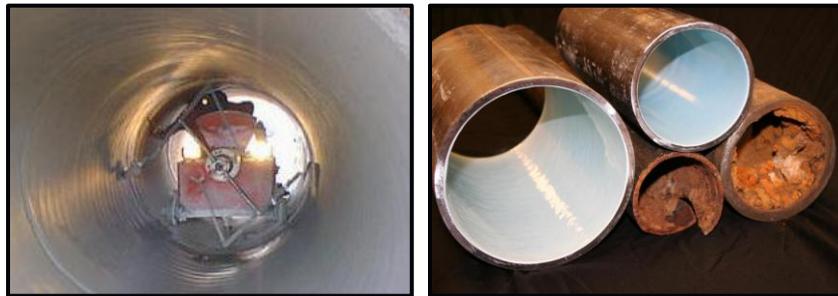
Cement-mortar lining is a mixture of cement, sand, and water that forms a chemically hardened cementitious material installed onto the interior wall of the host pipe. Cement-mortar can be applied by hand with trowels or a spray nozzle or centrifugally cast onto the surface by machine. Cement linings have been used for decades to act as a barrier to corrosion, to increase fluid flow, and in the case of potable water lines to address color and odor issues. Hardened cement mortar does not possess significant tensile strength and therefore cannot provide the host pipe with additional internal pressure capacity or compensate for lost internal pressure capacity due to substantial wall thickness loss (Ed Kampbell, February 2011). Figure 2-15 below shows an example of an applied cementitious coating.

Figure 2-15. Cementitious Coating (left) (Cement Lining Corporation International, 2008) and Epoxy Coating (right) (Craftsman Pipe Lining, Inc., 2012)

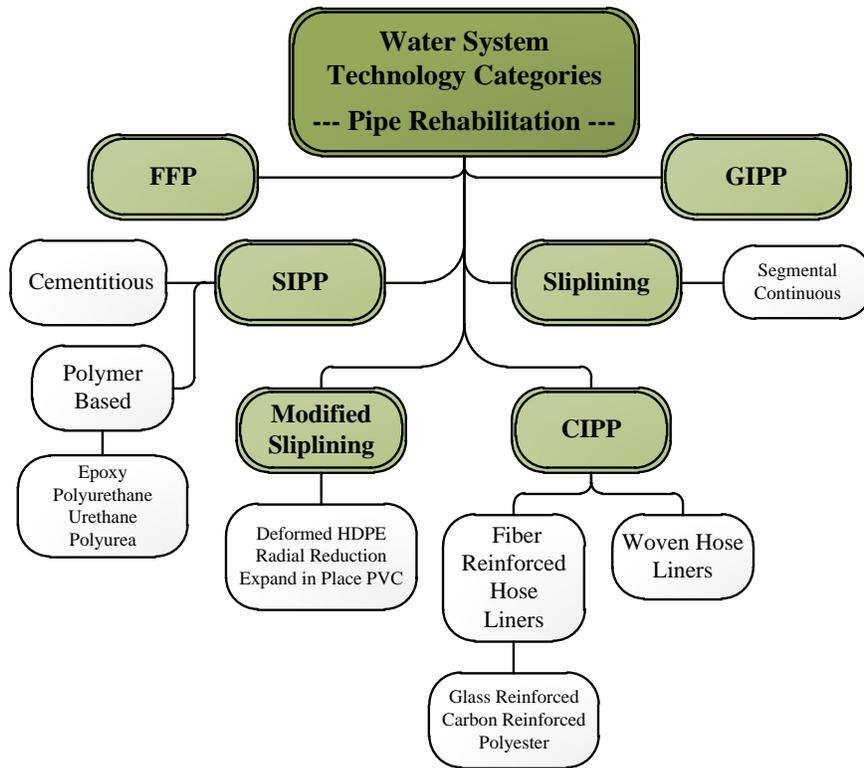
Water and wastewater pipeline rehabilitation technologies are used where the existing host pipe is structurally sound enough to at least partially support the use of the renewal technology. These technologies are aimed at restoring the capacity of a defective pipeline, but slight increases in capacity are sometimes possible, primarily due to reductions in surface friction that results from technology applications. Rehabilitation technologies also restore the structural integrity of the pipeline system, though still may rely on the host pipe for some support, and also extend the life expectancy of the pipeline, typically by at least 50 years. (EPA, 2010) Rehabilitation technologies are used where the defects are too numerous or severe for repair options to be feasible. As shown in Figures 16 and 17 below for water and wastewater systems respectively, pipe rehabilitation technologies have been broken into six major technology classes: (1) Cured-in-Place Pipe (CIPP) Liners, (2) Fold and Form Pipe (FFP) Liners, (3) Grout-in-Place Pipe (GIPP) Liners, (4) Spray-in-Place Pipe (SIPP) Liners, (5) Sliplining, and (6) Modified Sliplining.

Figure 2-16. Broad DW Pipe Rehabilitation Categories

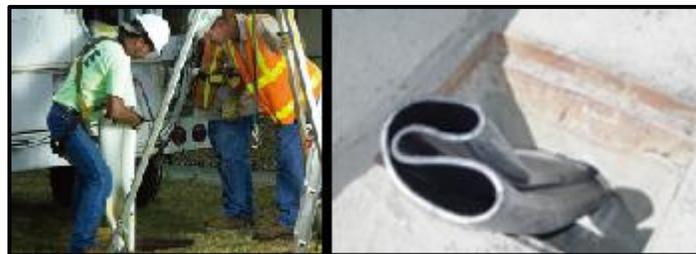
Deformed/Reformed FFP Liners are available for both water and wastewater applications. The liner is composed of some form of Polyethylene (PE) material such as HDPE or FRPE and is folded into a “U” shape at the factory before being coiled onto a spool for transportation to the project site. The liner is winched into place within the host pipe, and heat and pressure are used to reform the liner to its natural shape until it fits tightly against the host pipe. Because it is a tight-fitting liner system, no grouting is required, and services can be reinstated robotically. Figure 2-20 below shows an example of a Deformed/Reformed HDPE Liner.

Figure 2-20. Thermoformed PVC Liner Insertion (left) (Miller Pipeline, 2012) and Deformed/Reformed Liner Exiting Pipeline (right) (HydroTech Inc., 2012)

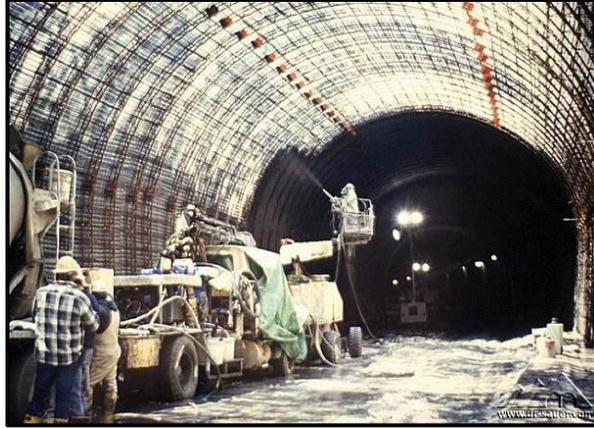
Reinforced Cement lining is the most common form of cementitious SIPP Lining, but it is limited in its structural capabilities due to its lack of adequate tensile strength. At best, metal pipes such as ductile iron or steel have nearly 100 times the tensile strength of concrete, and at the cracks that inevitably occur in the lining over time, the tensile strength is essentially zero. The cementitious material is sometimes reinforced with fibers such as steel for added structural integrity or is sprayed into a metal reinforcing cage-like structure which provides a structural rehabilitation solution. Figure 2-21 below shows an example of a spray applied cementitious material.

Figure 2-21. Shotcrete Application (Dr. Sauer Group, 2012)

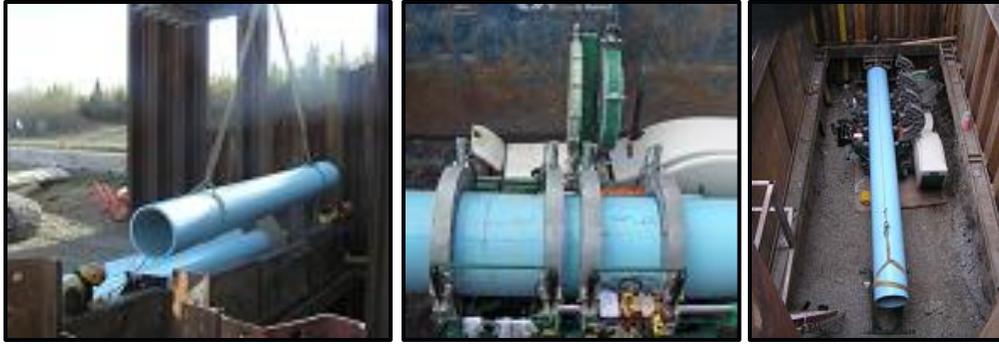
In segmental sliplining, the liner is assembled one pipe segment at a time, each being lowered into alignment at the insertion pit where it is pulled or pushed into the existing pipe nearly all the way, leaving one end exposed for joining to the next segment. The next segment is then lowered into the insertion pit, joined to the previous segment, and pulled or pushed into the existing pipe nearly all the way, leaving one end exposed for joining to the next segment. This process continues until the entire liner is in place within the host pipe. With the liner in place, the annular space between the host pipe and new pipe is grouted. Compared to continuous sliplining, segmental sliplining generally reduces the construction site footprint as well as the size requirements of the insertion pit. Figure 2-22 below shows the various stages of segmental sliplining.

Figure 2-22. Loading of Pipe Segment into Fusion Pit (left), Fusion (center), and Insertion (right) (Underground Solutions, Inc., 2011)

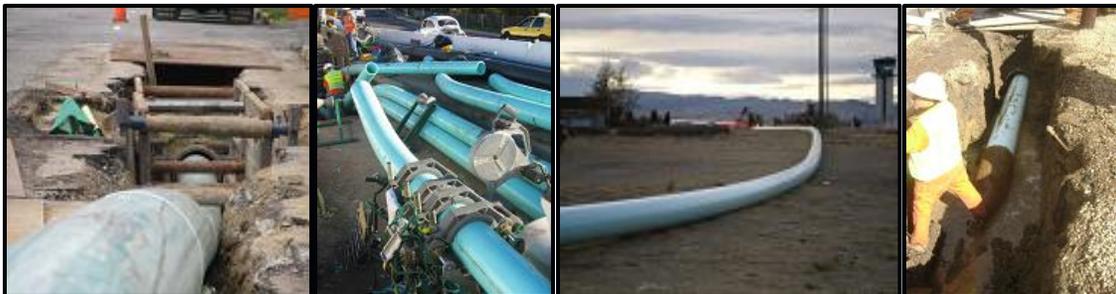
In continuous sliplining, the liner is manufactured as a continuous pipe or is assembled in the field prior to insertion to match the entire length of the existing pipe. Joints can either be fused or restrained type joints. Continuous Sliplining often uses HDPE or fusible PVC pressure pipe. The length of the insertion pit is determined by the allowable radius of curvature of the pipe and is also influenced by host pipe depth. The length of the pipe string can lead to large construction footprints and generate substantial site disruption as compared to many alternative pipe rehabilitation technologies. Figure 2-23 below shows the various steps and components of continuous sliplining.

Figure 2-23. Insertion (left), Fusion (left-center), Lay-Down Area (right-center), Exit Pit (right) (Underground Solutions, Inc., 2011)

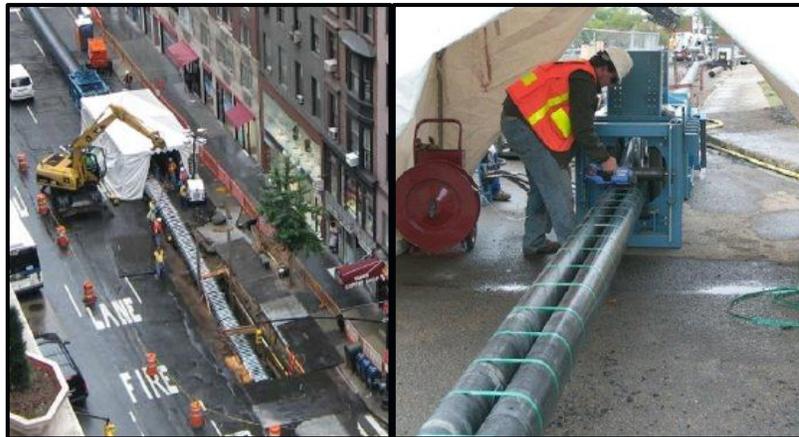
Deformed HDPE Pipe is pulled through a die to deform it into a shape with a cross section small enough to be pulled easily into the host pipe. Deformation can either be performed on-site as shown in Figure 2-24 below, or it can be done by the manufacturer so that it arrives to the project site ready for pull-in. Straps are typically wrapped around the circumference of the deformed pipe to restrain it until it is safely in place within the host pipe. A cable is strung through the host pipe from an access pit or existing manhole and attached to the liner at a second manhole or access pit. The liner is then carefully pulled through the host pipe using sleeves or rollers to protect it from damage. Once in place, the liner is cut and end seals attached that allow for monitoring of pressure and temperature during the reforming and curing processes. An alternate method for reforming the HDPE pipe is to run a rounding device through the deformed pipe to re-round it to its natural shape. Steam is injected into the new liner until it is reformed and fits tightly against the host pipe wall. Once this curing process is complete, the liner is allowed to cool to below 100°F before equipment can be disconnected and service connections reinstated via a robotic cutter device. Once the deformed pipe has been reformed within the host pipe, it becomes a structural pipe within the host pipe. There are Deformed HDPE products available for both water and wastewater applications.

Figure 2-24. On-Site Deformation of Deformed HDPE Pipe Liner Pull-In (left) and Close-Up of Deforming Machine (right) (Insituform Technologies, Inc., 2012)

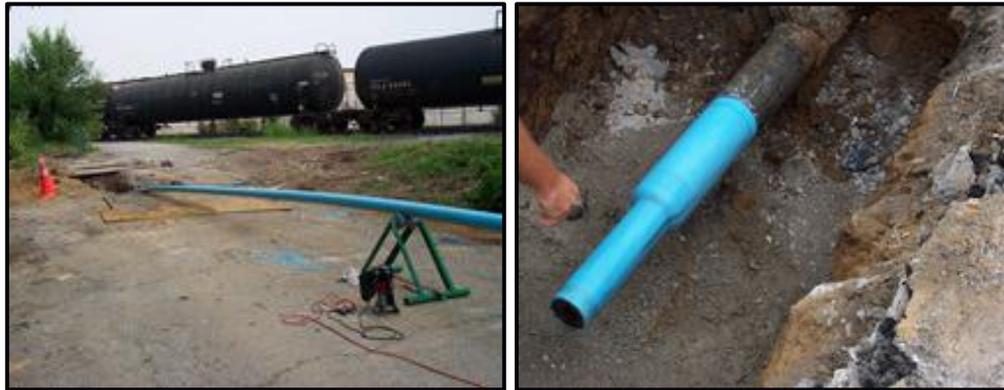
Expand-in-Place PVC liners begin with a diameter smaller than that of the host pipe to facilitate easy insertion. The pipe segments are fused in the field and inserted just as they would be for a continuous sliplining technology. Once in position within the host pipe, the pipeline is heated and pressurized until the new PVC pipe is fully cured and expanded to fit tightly against the host pipe. Once the curing process is complete, the liner provides a fully independent, structural solution. This technology is available for application to both water and wastewater pipelines and is shown in Figure 2-25 below.

Figure 2-25. Expand-in-Place PVC Entering Host Pipe (left) and After Expansion (right)
(Underground Solutions, 2012)

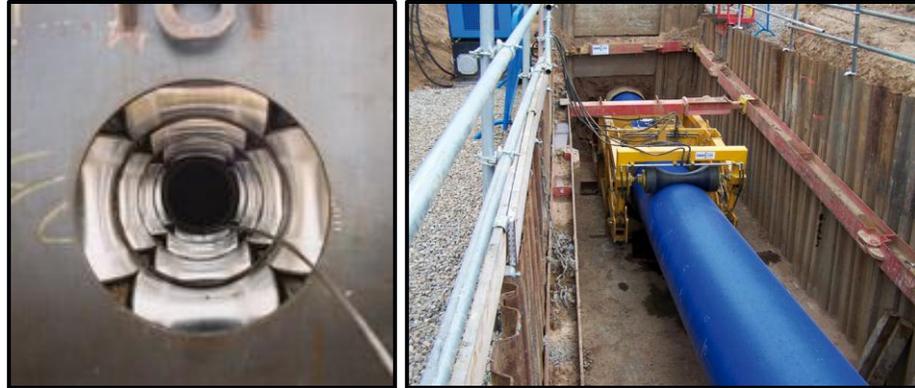
Radial Reduction installations are either mechanically or thermally induced. For mechanically induced reductions, the diameter of the new pipe is reduced by up to 20% after it is put through a machine such as a rolling machine. The pipe is hydraulically pushed through a series of compression rollers to reduce its diameter. With the pipe under compression rather than tension, there is little change in pipe length. There is, however, a corresponding increase in the pipe wall thickness. The pipe diameter does not immediately try to recover its original shape, so pressurization is used to help the pipe recover its original diameter after it has been pulled into place within the host pipe. To mechanically reduce the new pipe diameter by tension, the pipe is pulled through a swage die just before it enters the host pipe as shown in Figure 2-26 below. With the pipe under tension, there is some change in pipe length, so after pull in is completed, the winch is disconnected and the liner allowed to visco-elastically recover towards its original diameter until it fits tightly against the host pipe wall. Technologies that utilize radial reduction are available for both water and wastewater applications.

Figure 2-26. Mechanical Radial Reduction by Compression (left) (Insituform Technologies, Inc., 2012) and Tension (right) (Swagelining, 2011)

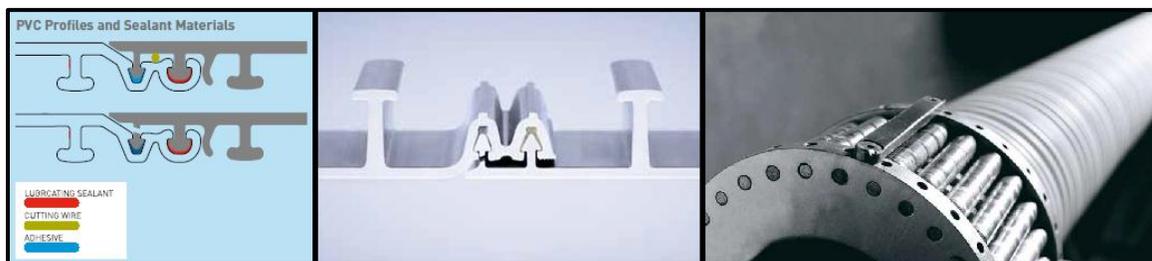
Un-Grouted Spiral Liners are not used very often and are only available for wastewater system applications. Liners are made of HDPE, PVC, or steel reinforced materials based on the unique needs of the individual project. A specially designed spiral winding machine winds the liner into place within the deteriorated host pipe at a diameter smaller than that of the host pipe. A secondary locking mechanism is used to hold the liner at the reduced diameter until it reaches the upstream access point. At this point, the liner is torsionally restrained as the cutting wire is pulled to release the secondary locking mechanism. When the cutting wire is removed, the liner is allowed to expand in place and adjacent profile wraps are joined automatically by the primary lock upon expansion. Once the liner is expanded to fit tightly against the host pipe and the primary locking mechanism has allowed the joining of all profiles, the ends of the liner are cut at the manhole chambers to achieve a perfect fit. The locking mechanisms and wound liner are shown in Figure 2-27 below. The smooth liner can be designed as a fully structural solution, but it is not able to withstand the loadings of a pressurized pipeline.

Figure 2-27. Un-Grouted Spiral Wound Profiles (left and center) and Wound Liner (right) (Sekisui SPR, 2011)

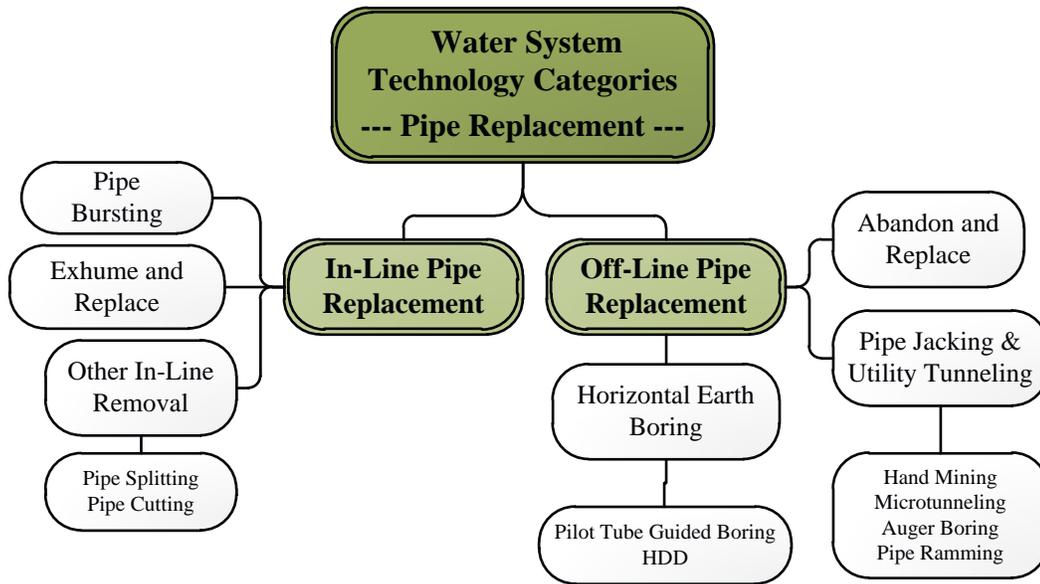
Water and wastewater pipeline replacement technologies are used where the existing host pipe is no longer structurally sound enough to support repair or rehabilitation technologies or where the existing host pipe is severely deteriorated or collapsed. These technologies are designed to completely restore or increase capacity and structural integrity of a defective pipeline, and the old pipe is either abandoned in place or removed in some manner from its existing alignment (EPA, 2010). Replacement technologies restart the life expectancy of the pipeline rather than just extend it, so that the new life expectancy is heavily dependent on the type of pipe chosen for installation. As shown in Figures 2-28 and 2-29 below for water and wastewater systems respectively, pipe replacement technologies have been broken into two major technology categories: (1) In-Line Replacement Methods and (2) Off-Line Replacement Methods.

Figure 2-28. Drinking Water System Technology Categories

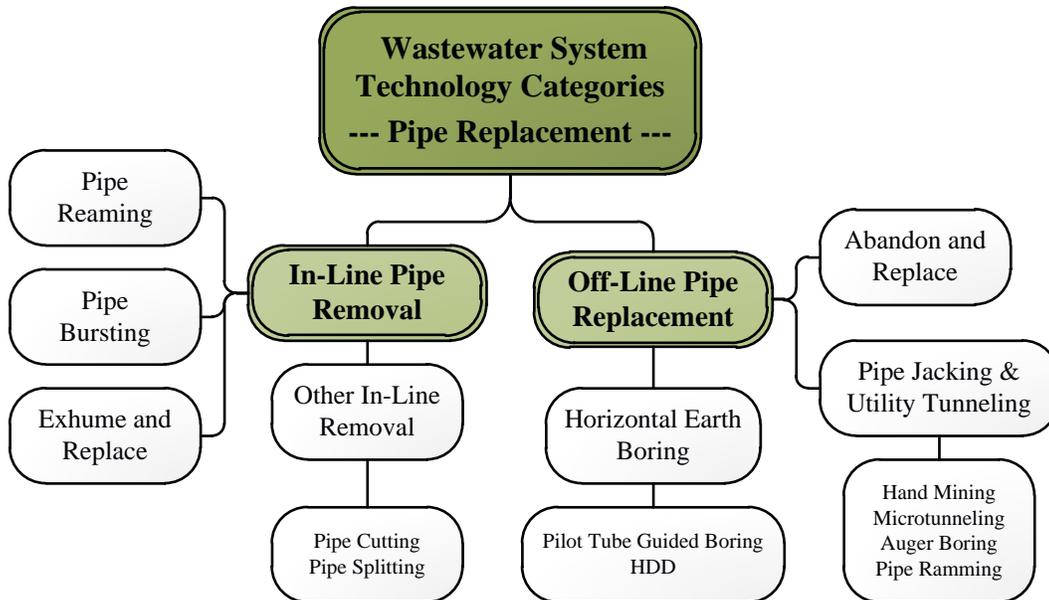
Figure 2-29. Wastewater System Technology Categories

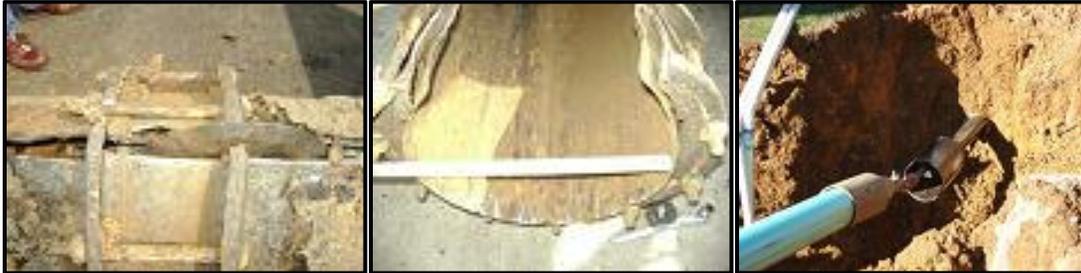
Figure 2-30. Cutter Head at Coupling (left), Expanded Steel Pipe (center), Bursting Head (right) (Underground Solutions, Inc., 2011)

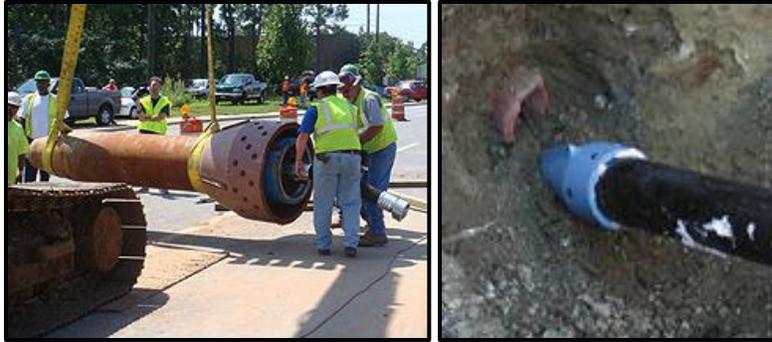
Figure 2-31. Pneumatic Bursting Head (TT Technologies, Inc., 2012)

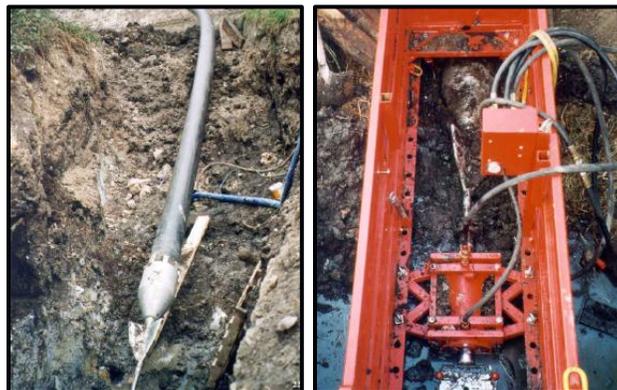
The hydraulic pipe bursting process uses a bullet shaped head driven by a hydraulic power supply. The bursting head is attached to the front of a cable that is used to pull it through the existing host pipe, and the hydraulic power is used to open and close the bursting head, the action of which breaks up the existing pipe. The head, attached to a constant-tension winch cable, is used to break one section of the pipe, and the assembly is then pulled forward to break the next, unbroken section of pipe. The primary function of the winch cable is to prevent the bursting head from shifting off of alignment as it opens and closes. It is not for pulling the cone-shaped head forward to break the pipe. This process repeats itself until the entire pipeline has been replaced. (Jadranka Simicevic, 2001) Figure 2-32 below shows a hydraulic pipe bursting head and winching machine.

Figure 2-32. Hydraulic Bursting Head (left) and Winching Machine (right) (Terra Systems for Trenchless Pipe Installation, 2011)

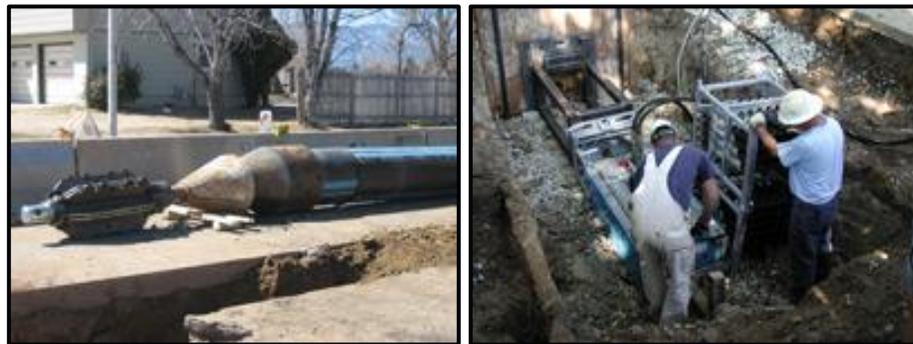
radial force, breaking up the existing pipe and expanding the cavity to a diameter large enough for the new pipe. The individual steel bursting rods are connected and inserted into the existing pipe from the pulling shaft. When the rods reach the insertion shaft, the bursting head is attached, and the new pipe is connected to the rear of the head. The head is then pulled by either a pulling rod assembly (TRS system) or a winch cable, which, like the rods, would also be inserted through the existing pipe and attached to the front of the bursting head. The bursting head and new pipe are pulled by the rods or winching cable, fracturing the existing pipe and pushing the debris into the surrounding soil. The process continues until the bursting head reaches the pulling shaft, where it is separated from the new pipe. If a cable or winch is used instead of a rod assembly, the pulling process continues with minimum interruption, but the force available for the operation is less. Roller blade cutting wheel assemblies allow bursting of pipe types such as steel and ductile iron as well as ductile iron repair clamps which are more difficult to burst. (Jadranka Simicevic, 2001) Figure 2-33 below shows a static pipe bursting head and machine.

Figure 2-33. Static Pipe Bursting Head (left) and Bursting Machine (right) (TT Technologies, Inc., 2012)

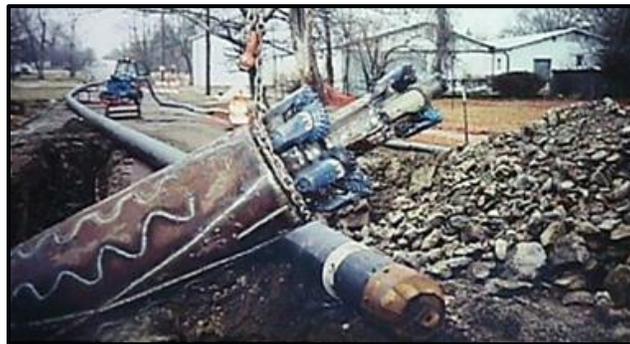
Figure 2-34. Reaming Head Recommended for Use with VCP
(Nowak Pipe Reaming, Inc., 2011)

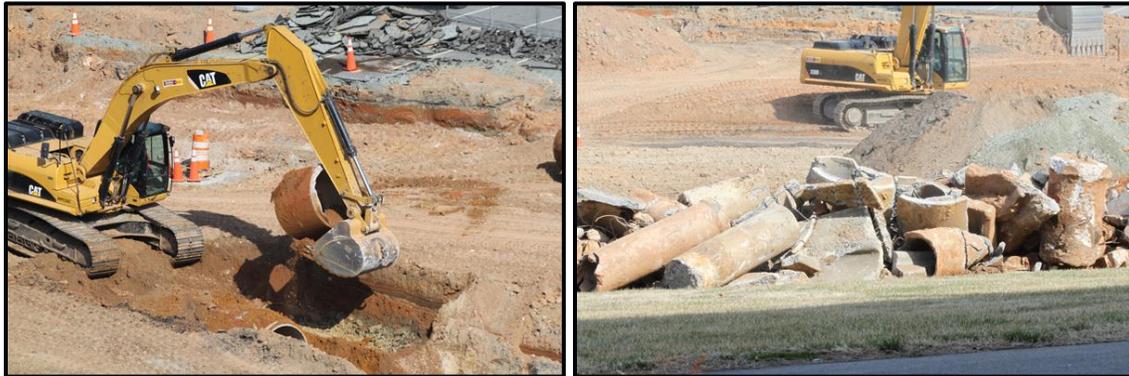
Figure 2-35. Exhume and Replace Pipe Removal (Wake Forest, 2011)

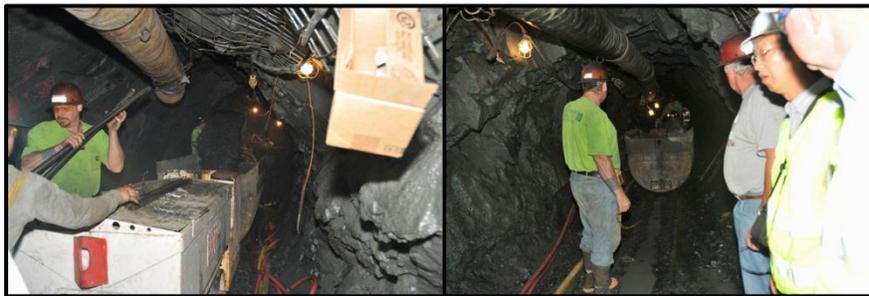
Hand mining is a simple, yet effective method for utility tunneling in many situations, where access issues or soil composition prevents other tunneling techniques. The tunnel opening is advanced by hydraulic jacks or by traditional blasting techniques in predetermined increments, and the tunnel face is cleared of material and debris by hand or with the aid of a small excavator. (NYC Comptroller, 2001) Figure 2-32 shows an example of a tunnel being created by traditional drill and blast where hand mining with rail carts was used to remove blasted rocks and debris.

Figure 2-36. Back Dump Mucker to Remove Debris (left) and Dumping of Spoil into Muck Car (right) (Steiner, Sewer Interceptor Installation Using Traditional Drill and Blast Tunneling Techniques in Howard County, MD, 2012)

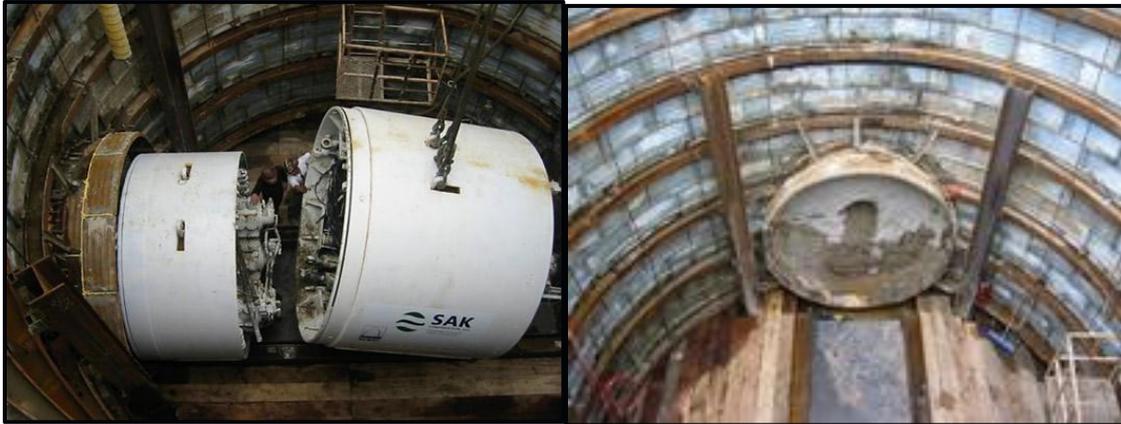
Figure 2-37. Microtunneling Machine (left) and Access Shaft (right) (SAK Construction, 2012)
