**RENEWAL ENGINEERING TECHNOLOGIES FOR DRINKING WATER AND
WASTEWATER PIPELINE SYSTEMS – A STATE OF THE ART LITERATURE
AND PRACTICE REVIEW**

Thesis submitted to the faculty of the
Virginia Polytechnic Institute and State University
in partial fulfillment of the requirements for the degree of

Civil Engineering

May 1st, 2012

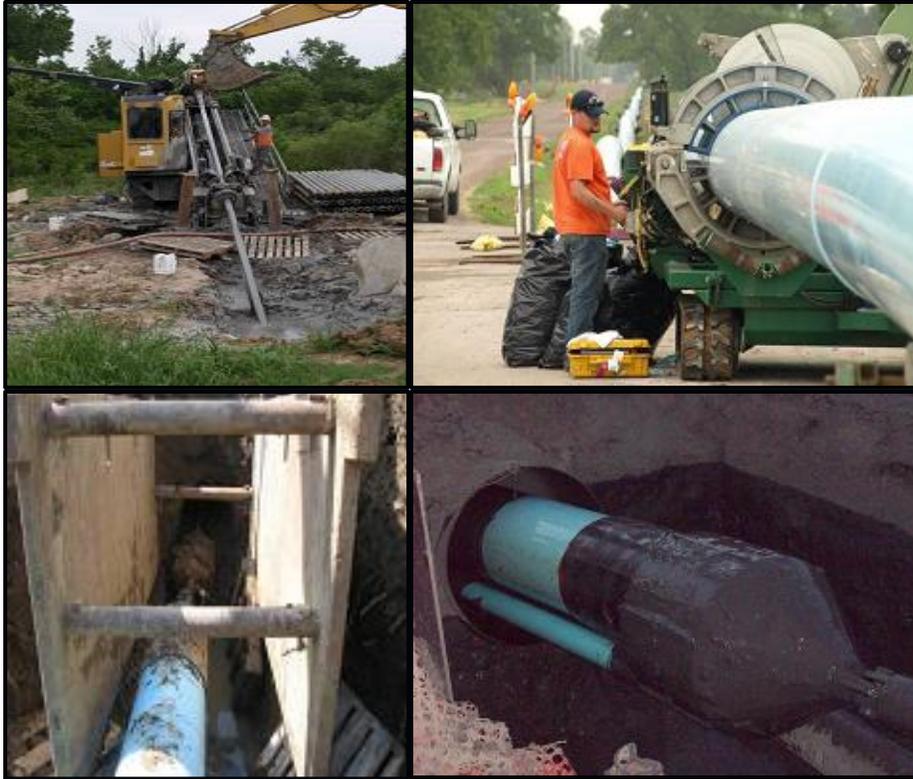
Horizontal Directional Drilling is a form of renewal that allows a water or wastewater pipe to be installed through hard rock or beneath environmental features such as lakes/streams with minimal disturbance. The technique requires two excavation pits, an entrance pit and a receiving pit, and a small diameter pilot hole is first drilled along the proposed pipe alignment. The operator has steering capabilities, though limited, to ensure that the pilot hole is drilled along the correct alignment. A series of back-reamers, progressively larger in size, are then used to expand the pilot hole to the diameter required for host pipe insertion. Once the soil tunnel has been expanded to the proper diameter, the new pipe is pulled back through from the receiving pit to the insertion pit by the reaming machine, and service connections are reinstated robotically or by hand, depending on the pipe type and diameter. Figure 2-38 below shows the various components of the HDD process.

Figure 2-38. Drilling Rods and Rig (top left), Pipe Fusion (top right), Pipe Pull-In (bottom left), Exit Pit (bottom right) (Underground Solutions, Inc., 2011)

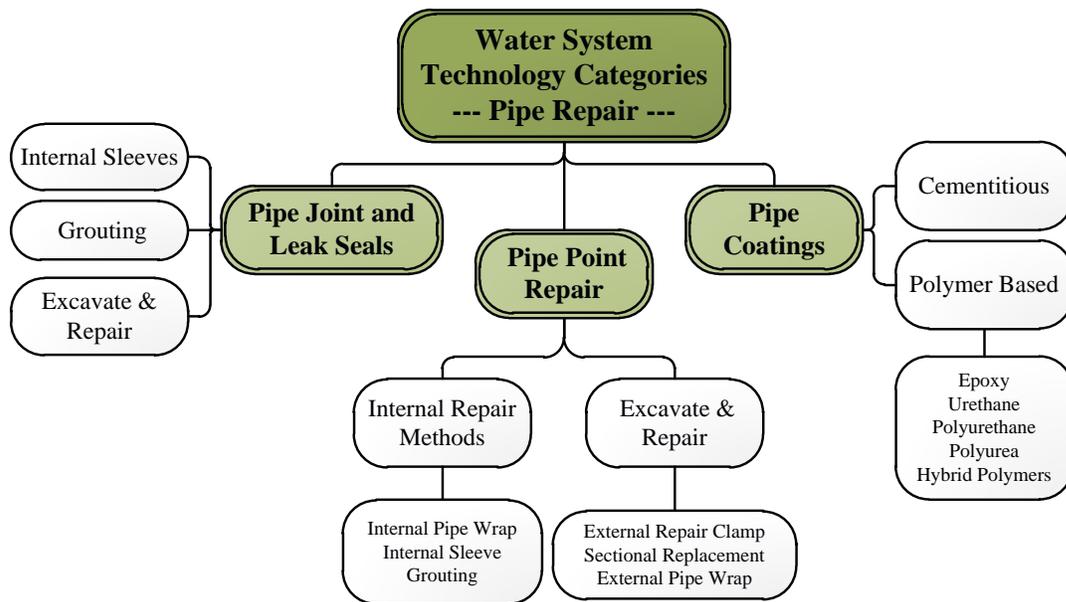
Figure 3-1. Water Pipe Repair Technologies

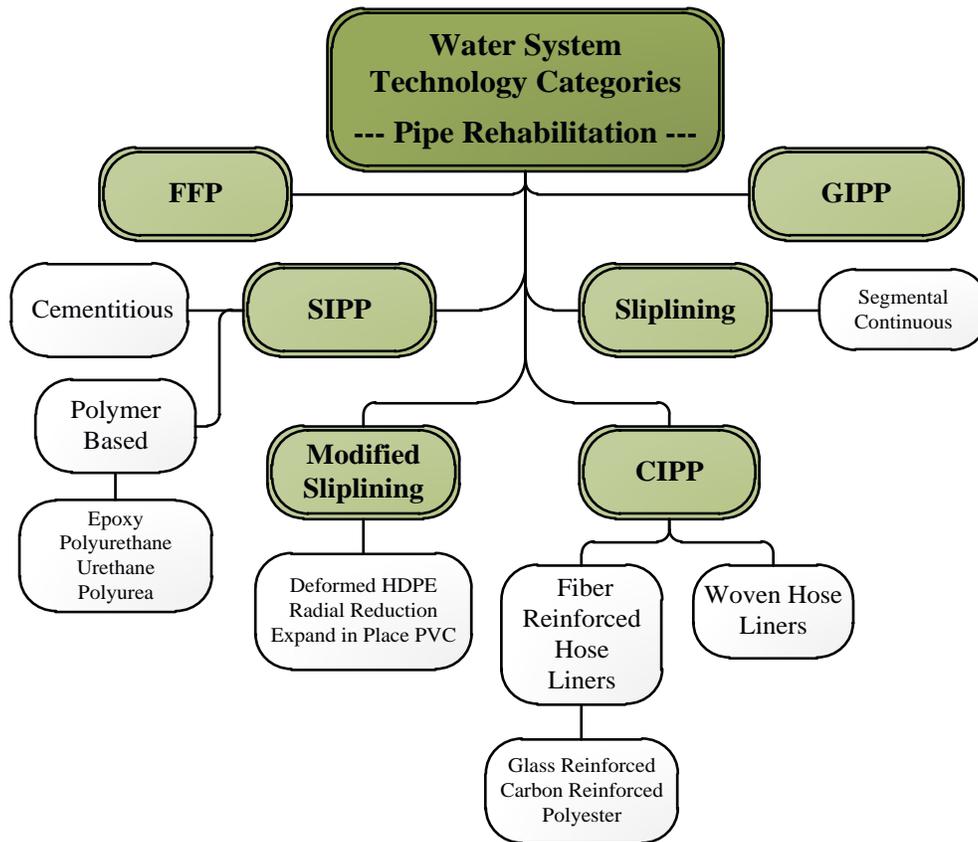
Figure 3-2. Water Pipe Rehabilitation Technologies

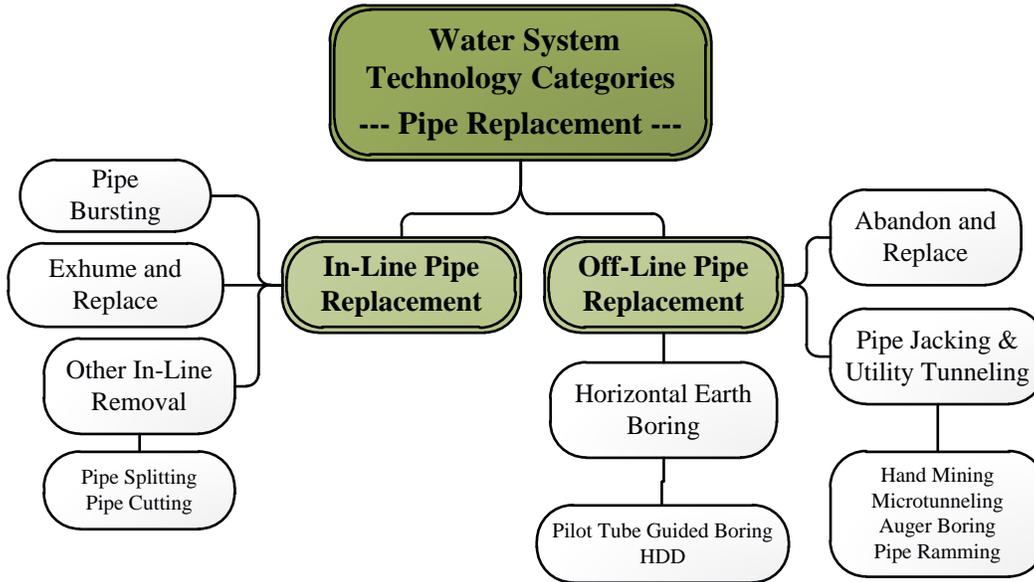
Figure 3-3. Drinking Water Pipe Replacement Technologies

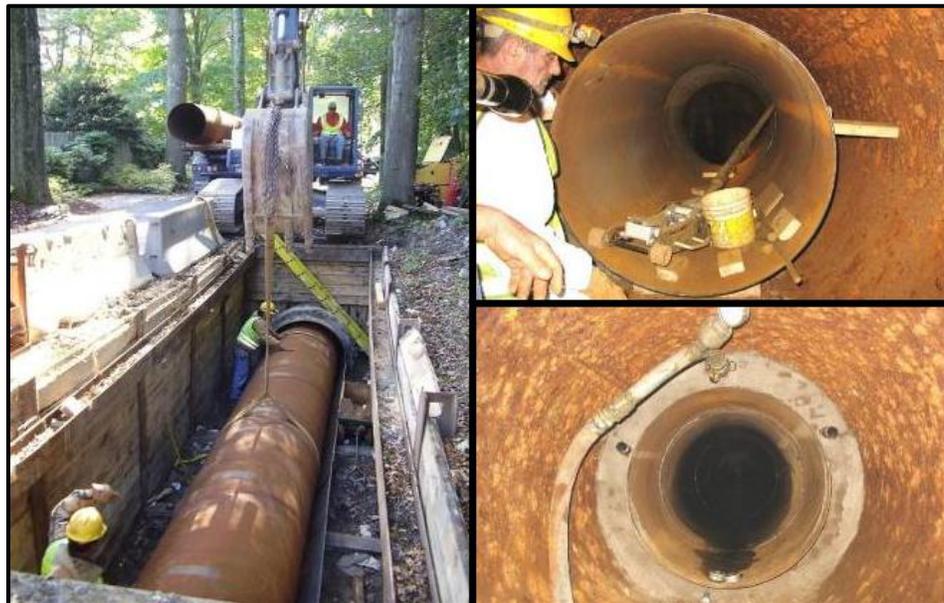
Figure 3-26. Segmental Sliplining Operations (Authority, 2009)

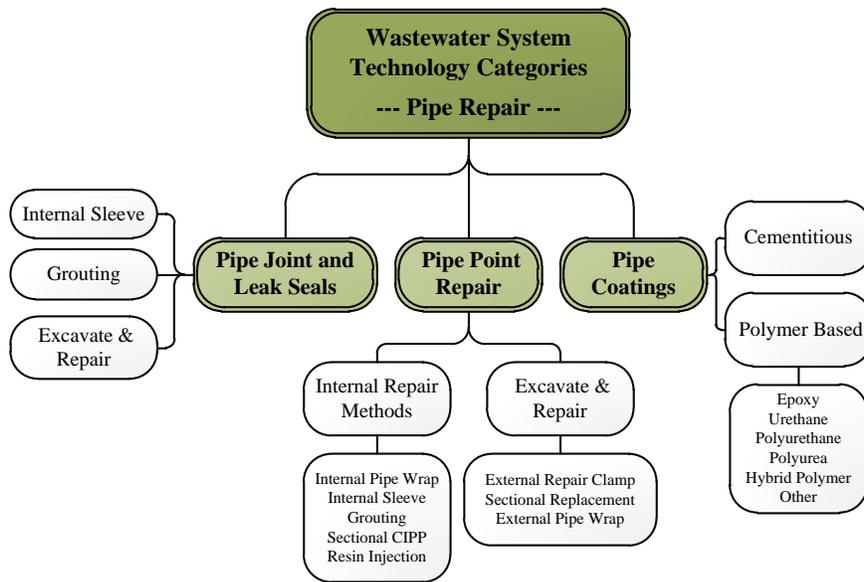
Figure 4-1. Wastewater System Technology Categories

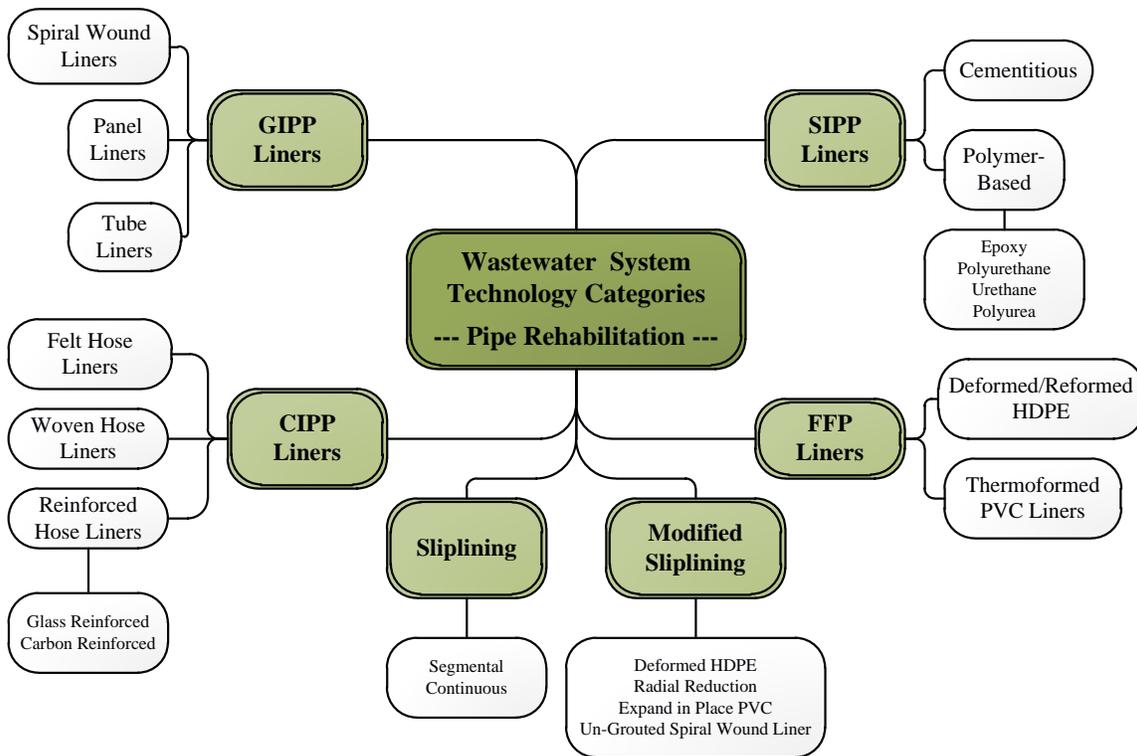
Figure 4-2. Wastewater Pipe Rehabilitation Technologies

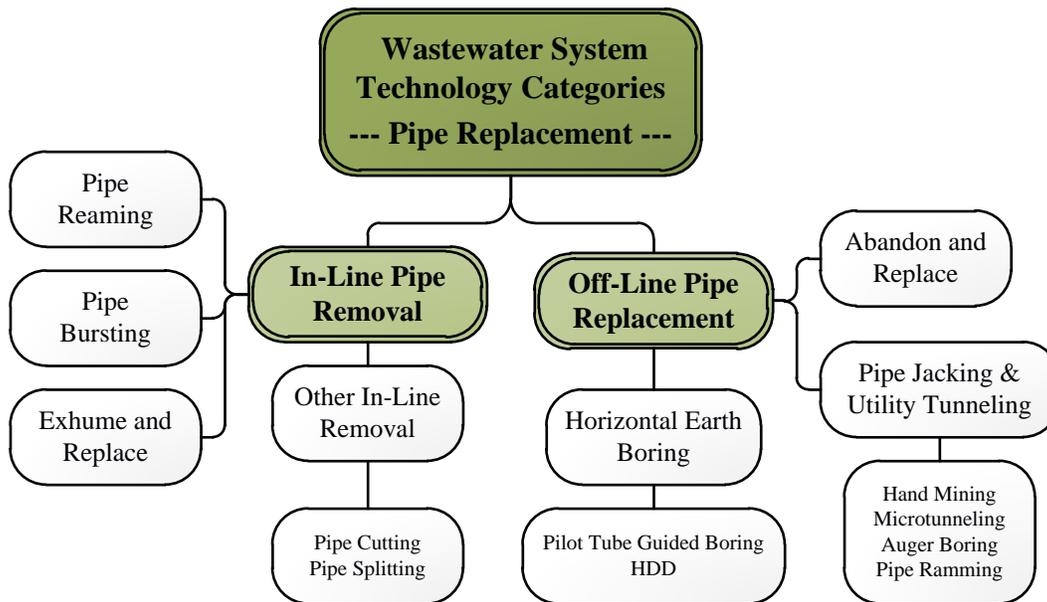
Figure 4-3. Wastewater Pipe Replacement Technologies

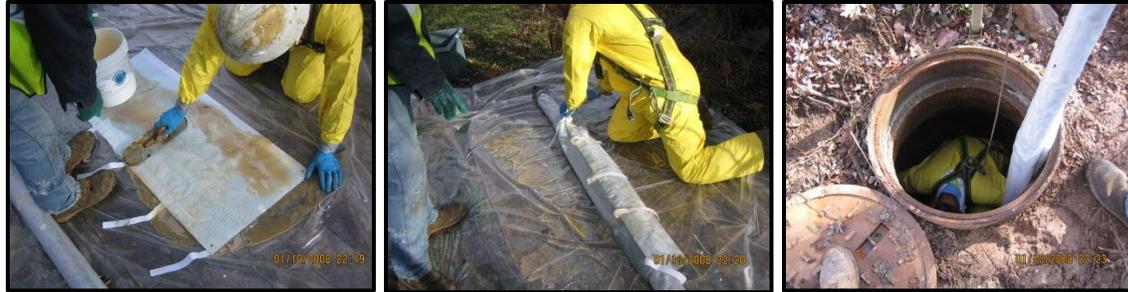
Figure 4-16. Resin Application (left), Wrapping of Liner on Inflatable Device (center), and Insertion of Liner into Manhole (right) (images courtesy of the Metropolitan Sewerage District of Buncombe County, NC)

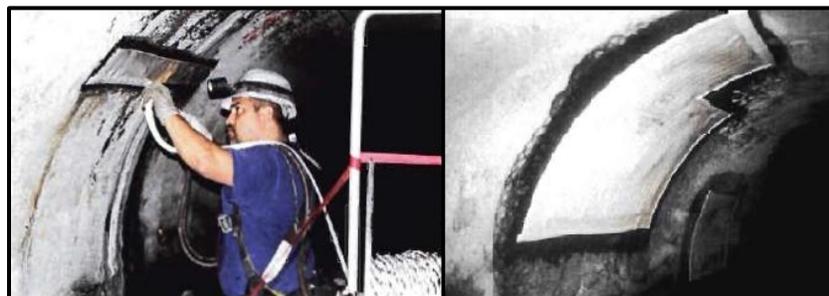
Figure 4-17. Small Patch Repair (left) and Larger Liner Patch Repair (right) (Project Engineering Consultants, LTD. , August 31, 2005)

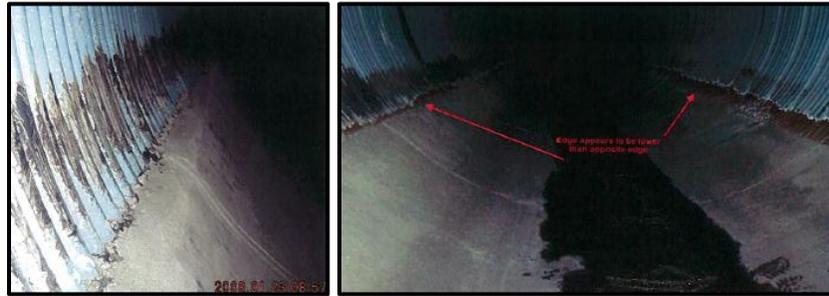
Figure 4-19. 4-inch Thick Cementitious Coating Applied to Pipe Invert (ICON Engineering, Inc., February 2008)

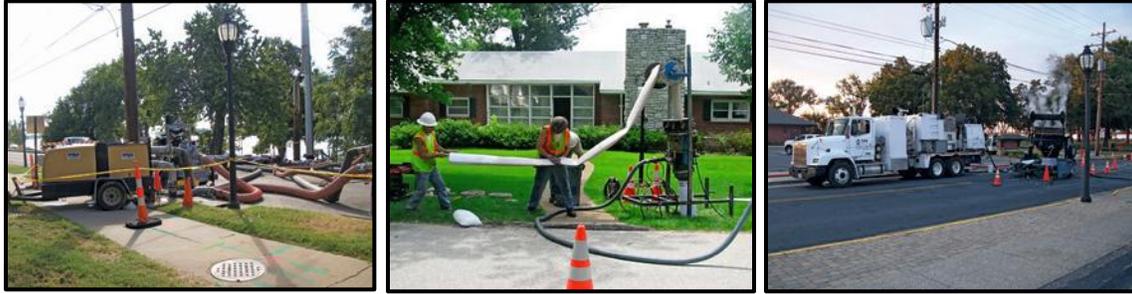
Like Villa Park, Henderson Water Utility used CIPP Liners as the primary rehabilitation method, using it to address issues throughout the system with water tightness and structural integrity. It was used to rehabilitate over 18,700 LF of combined sewers ranging in diameter from 8- to 48-inches, and once rehabilitated, the combined sewers were turned into sewers to carry stormwater only. New pipes were installed to handle wastewater flows. The initiative to separate combined sewers into stormwater sewers and gravity mains is a common initiative throughout the nation since it greatly reduces the flows the system has to handle after rain events, thereby reducing the risk of overflows. Like many other utilities, the City of Henderson initiated their sewer rehabilitation as part of a control plan agreed upon with the EPA. The major challenge faced was the installation of the liners through the historic downtown where surface, traffic, and business disruptions had to be kept to a minimum. The City used steam curing which reduces the cure time to between 8 and 10 hours. A limitation the City experienced was that some of the pipe was not structurally sound enough to support pull-in of the new liner, so exhume and replace methods were required. Figure 4-21 below shows the bypass system and CIPP installation.

Figure 4-21. Temporary Bypass (left) and CIPP Installation in the City of Henderson (center and right) (images courtesy of the City of Henderson)

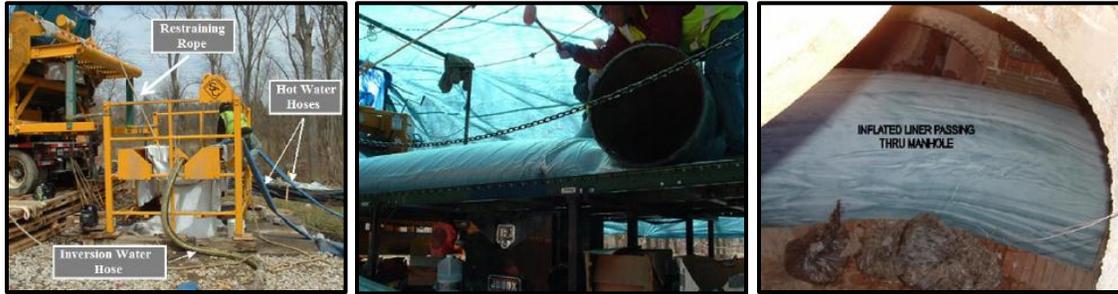
Figure 4-22. Inversion Equipment Setup, Dispersion of Resin after Impregnation, and Inflated Liner Passing through Manhole (images courtesy of Baltimore County)

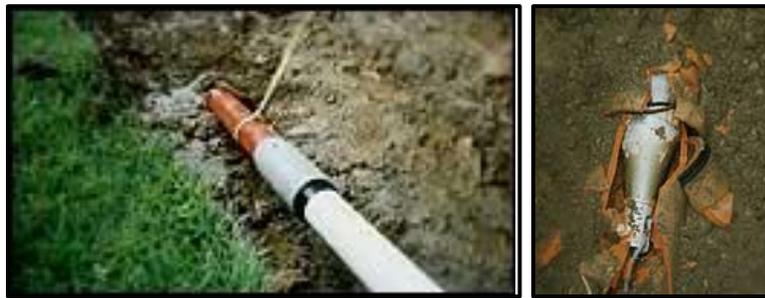
Figure 4-27. Launch Pit and Bursting Head in Benton, AR Pipe Bursting Project (images courtesy of the City of Benton) (TT Technologies, Inc., 2011)

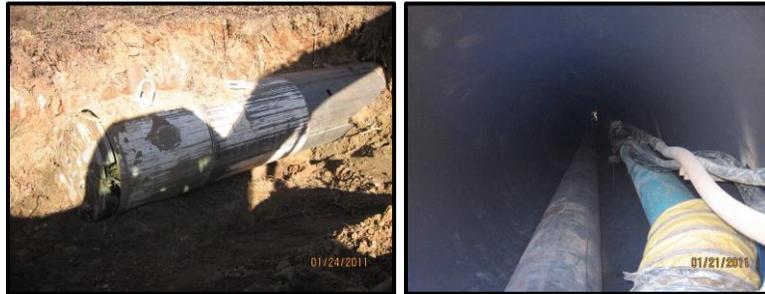
encasement pipe. Figure 4-29 below shows the boring machine at the receiving pit and the carrier pipe as it is pulled into place within the encasement pipe.

Figure 4-29. Auger Boring Machine at Receiving Pit and Installation of Carrier Pipe in Encasement Pipe (images courtesy of the Metropolitan Sewerage District of Buncombe County, NC)

The primary benefits of the auger boring machine was the ability to install pipelines beneath surface obstructions like interstates or railroad tracks, and they can also be used where excessively deep cuts would result in longer pipe runs with much flatter grades. Limitations include the increased costs associated with specialized equipment such as rock bores and the impact that soils and surrounding ground medium characteristics can have on the boring operations. Where multiple soil types are encountered, the bore tends to be pushed off of alignment.

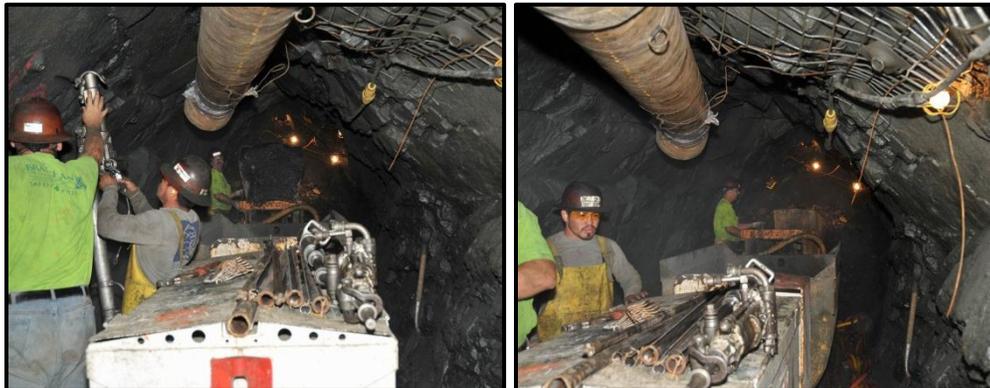
Figure 4-30. Traditional Drill and Blast Utility Tunneling (images courtesy of Howard County Public Utilities)

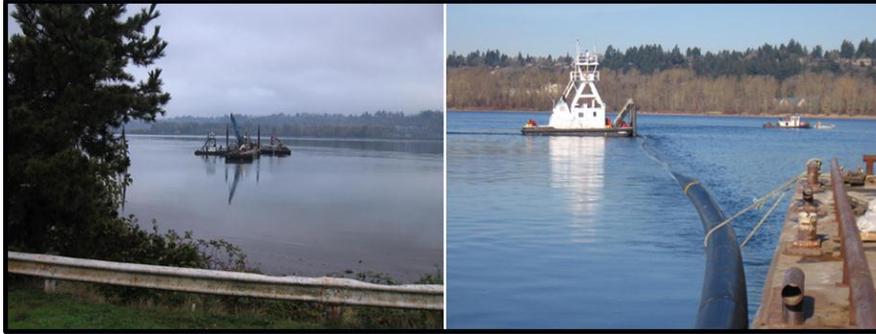
filled with water. Figure 4-31 shows the Barge on the Columbia River and Pull-In of 30-inch HDPE Pipe at the outfall location.

Figure 4-31. Barge on Columbia River (left) and Pull-In of 30” HDPE Pipe at Columbia River Outfall (right) (Kinnan Engineering, Inc., 2009)

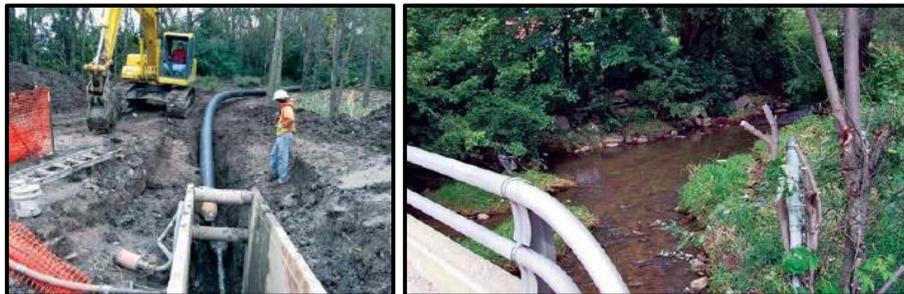
estimate levels of I/I before system rehabilitation, the effectiveness of I/I removal was marked by the 15% and 30% reductions in total inflow for a 1-year and 30-year storm event respectively. An advantage for the City was eliminating the need to excavate within the city where several surface obstructions existed. Figure 4-33 below shows the stream beneath which HDD allowed the installation of the new sewer main.

Figure 4-33. HDD Crossing of Stream in Villa Park, IL
