## **Chapter 3: Experimental Facilities and Instrumentation**

### **3.1 Wind Tunnel Facility**

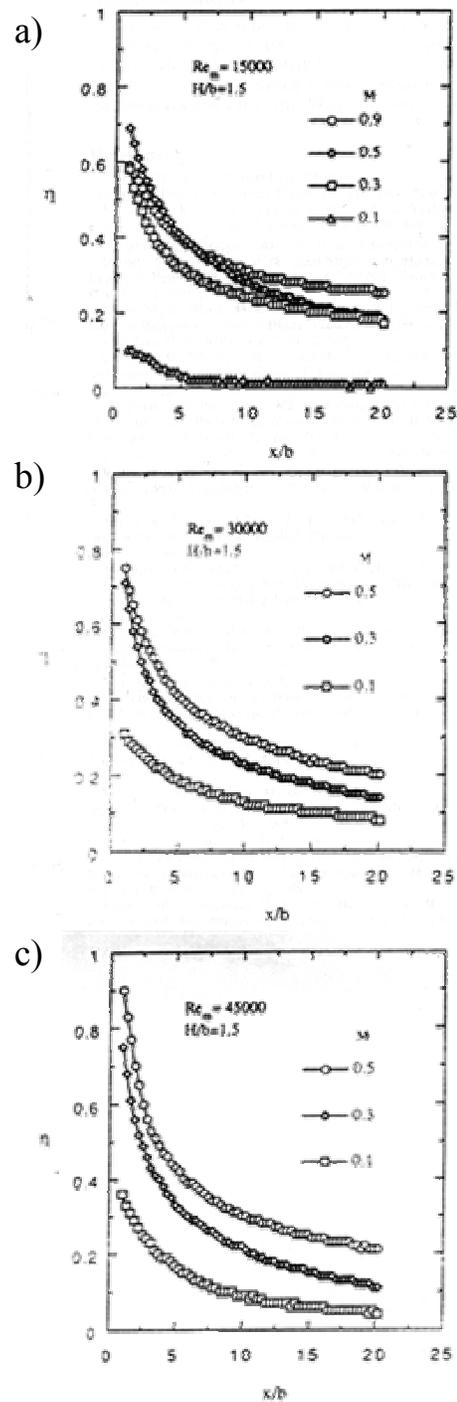
**Figure 2-10** Spanwise averaged effectiveness for a)  $Re = 15,000$  at four blowing ratios, b)  $Re = 30,000$  at three blowing ratios, and c)  $Re = 45,000$  at three blowing ratios (Kim and Metzger, 1995).

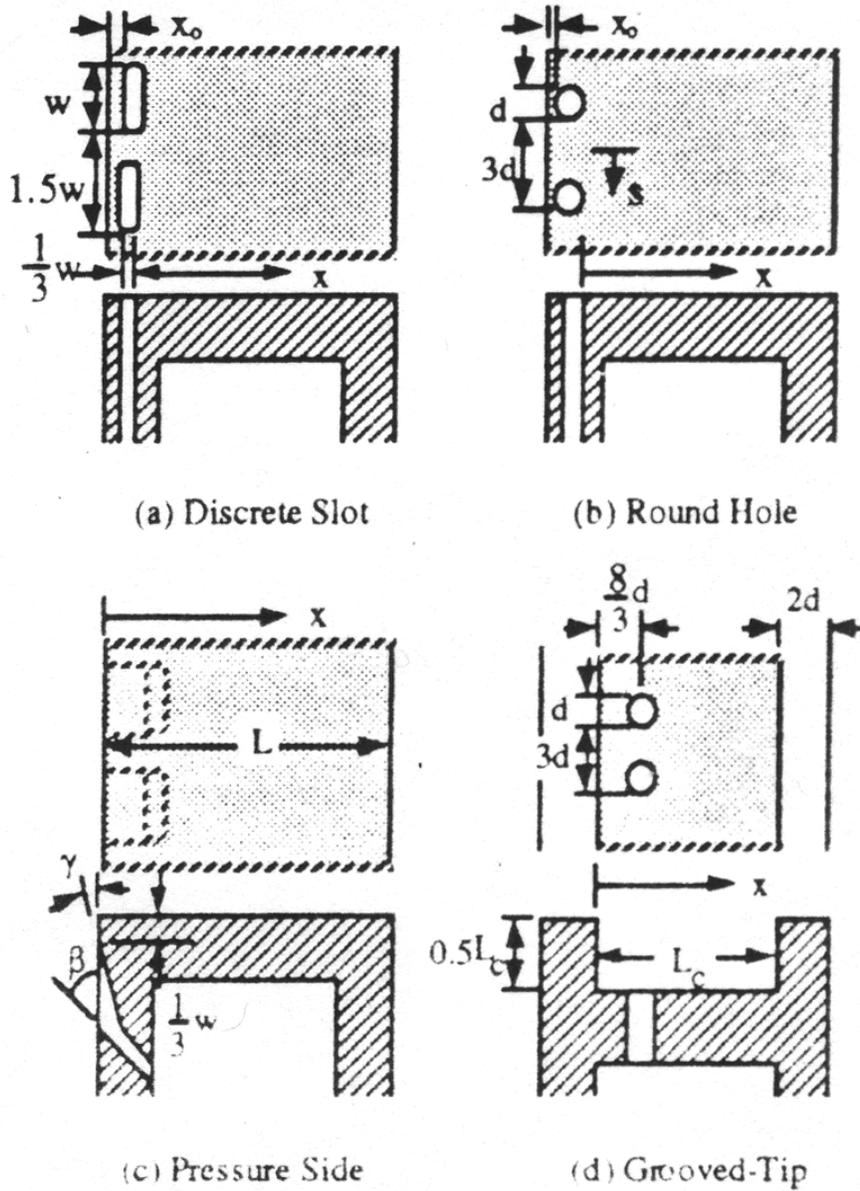
Configuration	Dimensions (cm)
Discrete Slot	$x_0=0.25, w=0.95$
Round Hole	$x_0=0.25, d=0.48$
Pressure Side	$w=0.95, \gamma=12^\circ, \beta=45^\circ$
Grooved Tip	$d=0.48, L_c=5.08$

**Figure 2-11** Heat transfer coefficients were examined for four different tip geometries including a) discrete slots, b) round holes, c) pressure side injection, and d) grooved tips (Kim et al., 1995).

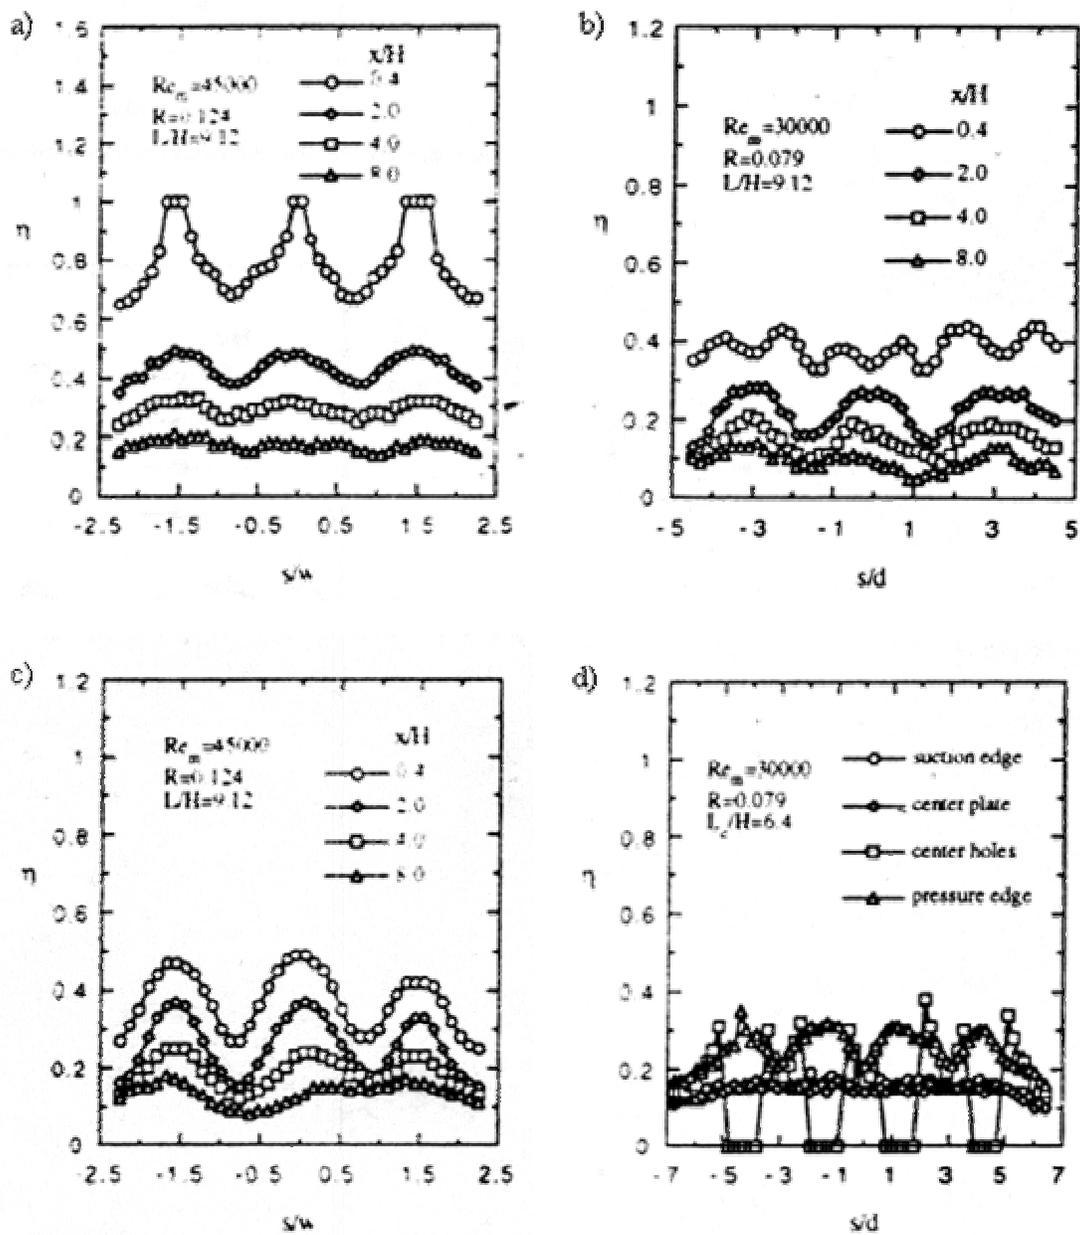
**Figure 2-12** Typical spanwise film cooling effectiveness results at various locations downstream of the cooling ducts for a) discrete slots, b) round holes, c) pressure side injection, and d) grooved tips (Kim et al., 1995).

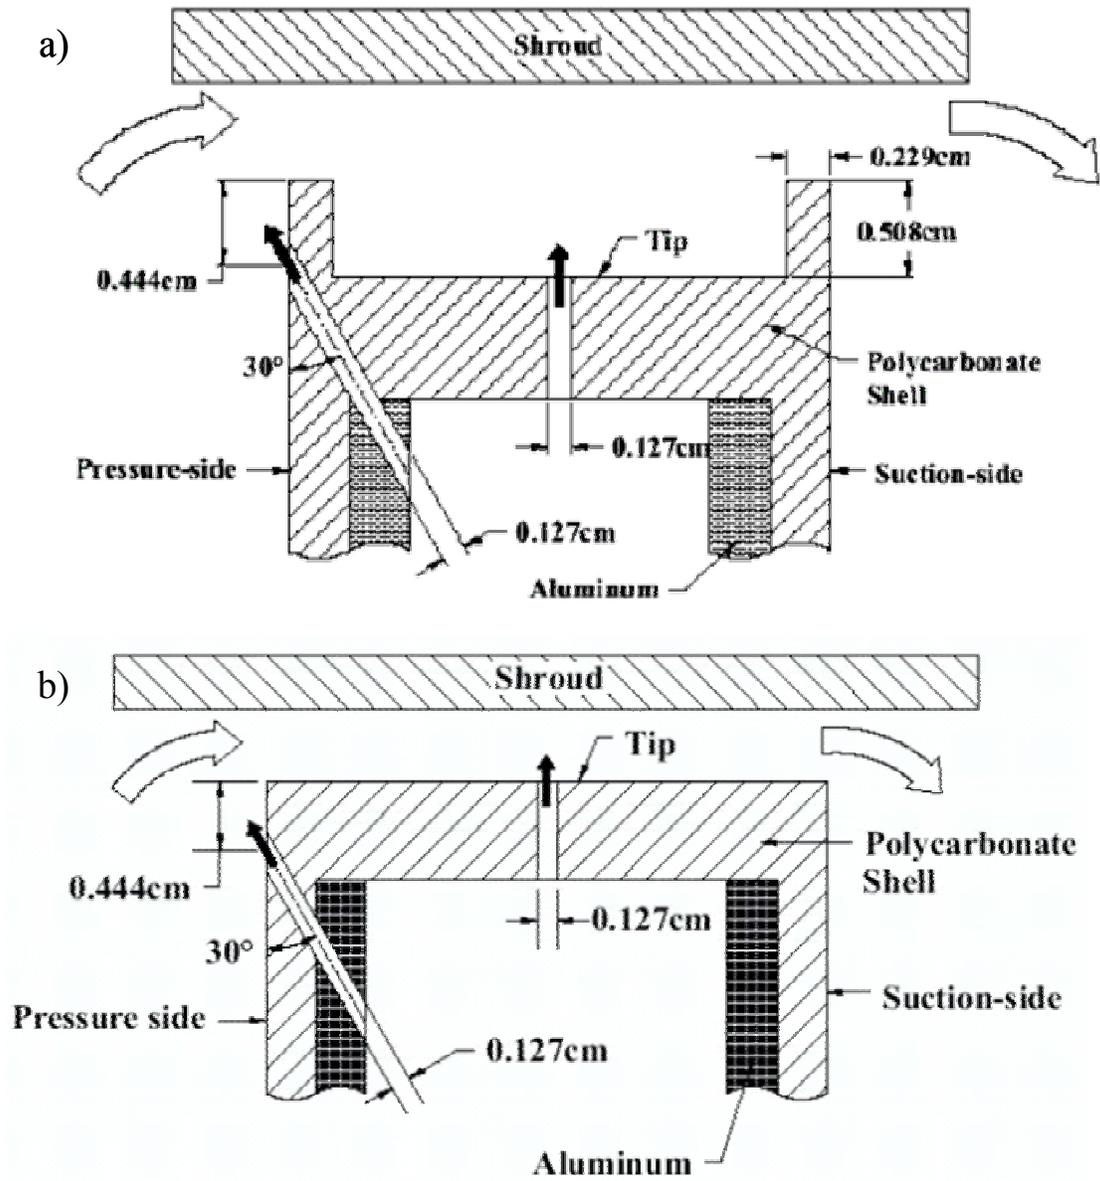
**Figure 2-13** Film-cooling configurations shown a) with a squealer tip (Kwak and Han, 2002b) and b) flat tip (Kwak and Han, 2002a).

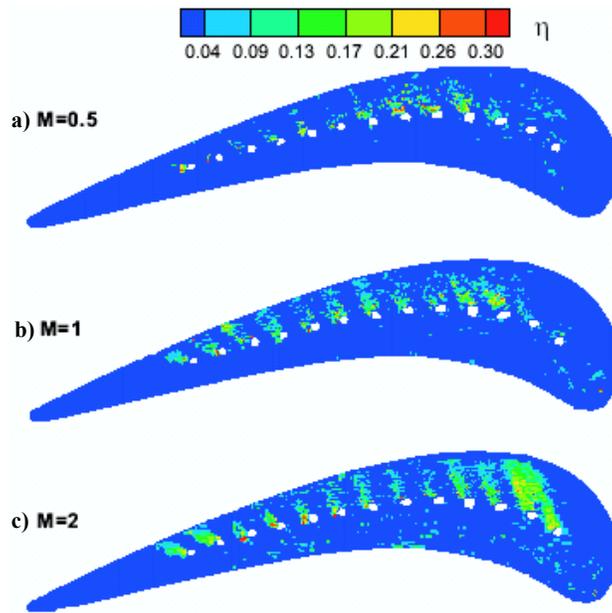
**Figure 2-14** Film-cooling effectiveness contours for tip blowing over a flat tip with gap height at 1.5% of the total blade height and blowing ratios of a)  $M = 0.5$ , b)  $M = 1$ , and c)  $M = 2$  (Kwak and Han, 2002a).

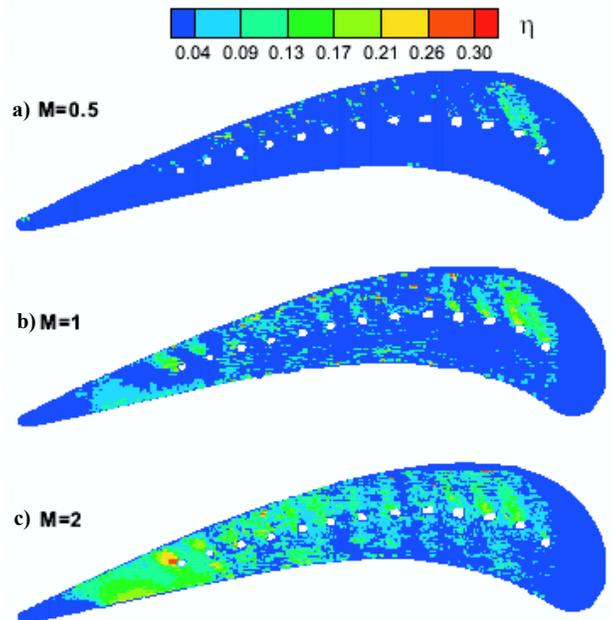
**Figure 2-15** Film-cooling effectiveness contours for tip and pressure side blowing over a flat tip with gap height at 1.5% of the total blade height and blowing ratios of a)  $M = 0.5$ , b)  $M = 1$ , and c)  $M = 2$  (Kwak and Han, 2002a).

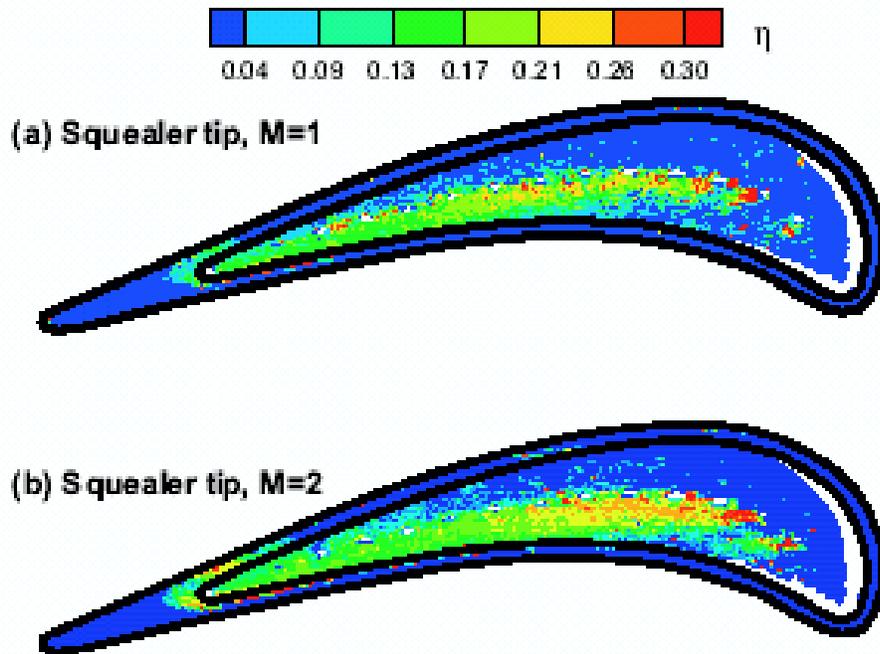
**Figure 2-16** Film-cooling effectiveness contours for tip blowing over a squealer tip with blowing ratios of a)  $M = 1$  and b)  $M = 2$  (Kwak and Han, 2002b).

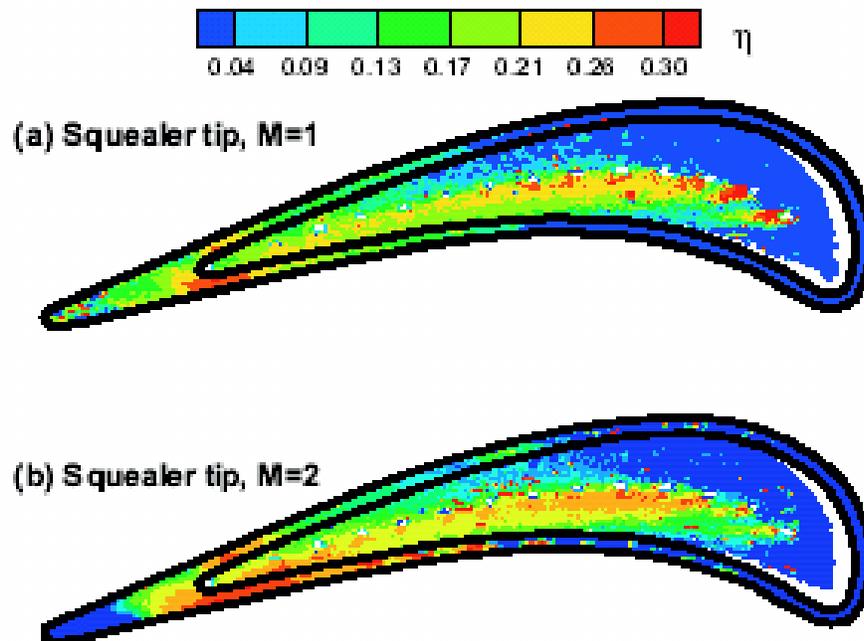
**Figure 2-17** Film-cooling effectiveness contours for tip and pressure side blowing over a squealer tip with blowing ratios of a)  $M = 1$  and b)  $M = 2$  (Kwak and Han, 2002b).

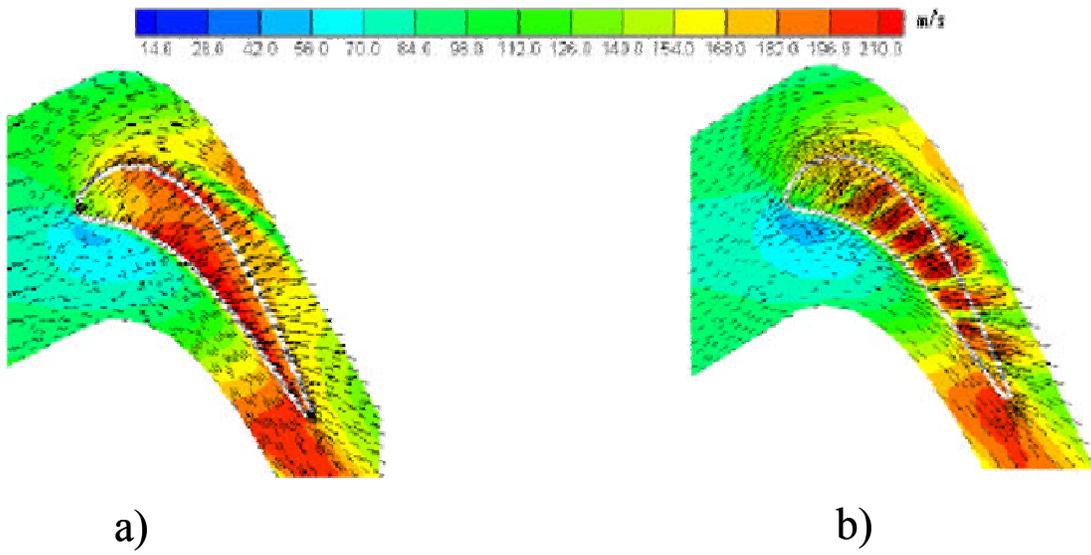
**Figure 2-18** Velocity vectors and magnitudes on the middle plane of tip gap with a gap clearance of 1.5% of the total blade height, turbulence levels of 6.1% for the cases a) without film-cooling and b) with film cooling (Acharya et al., 2002).

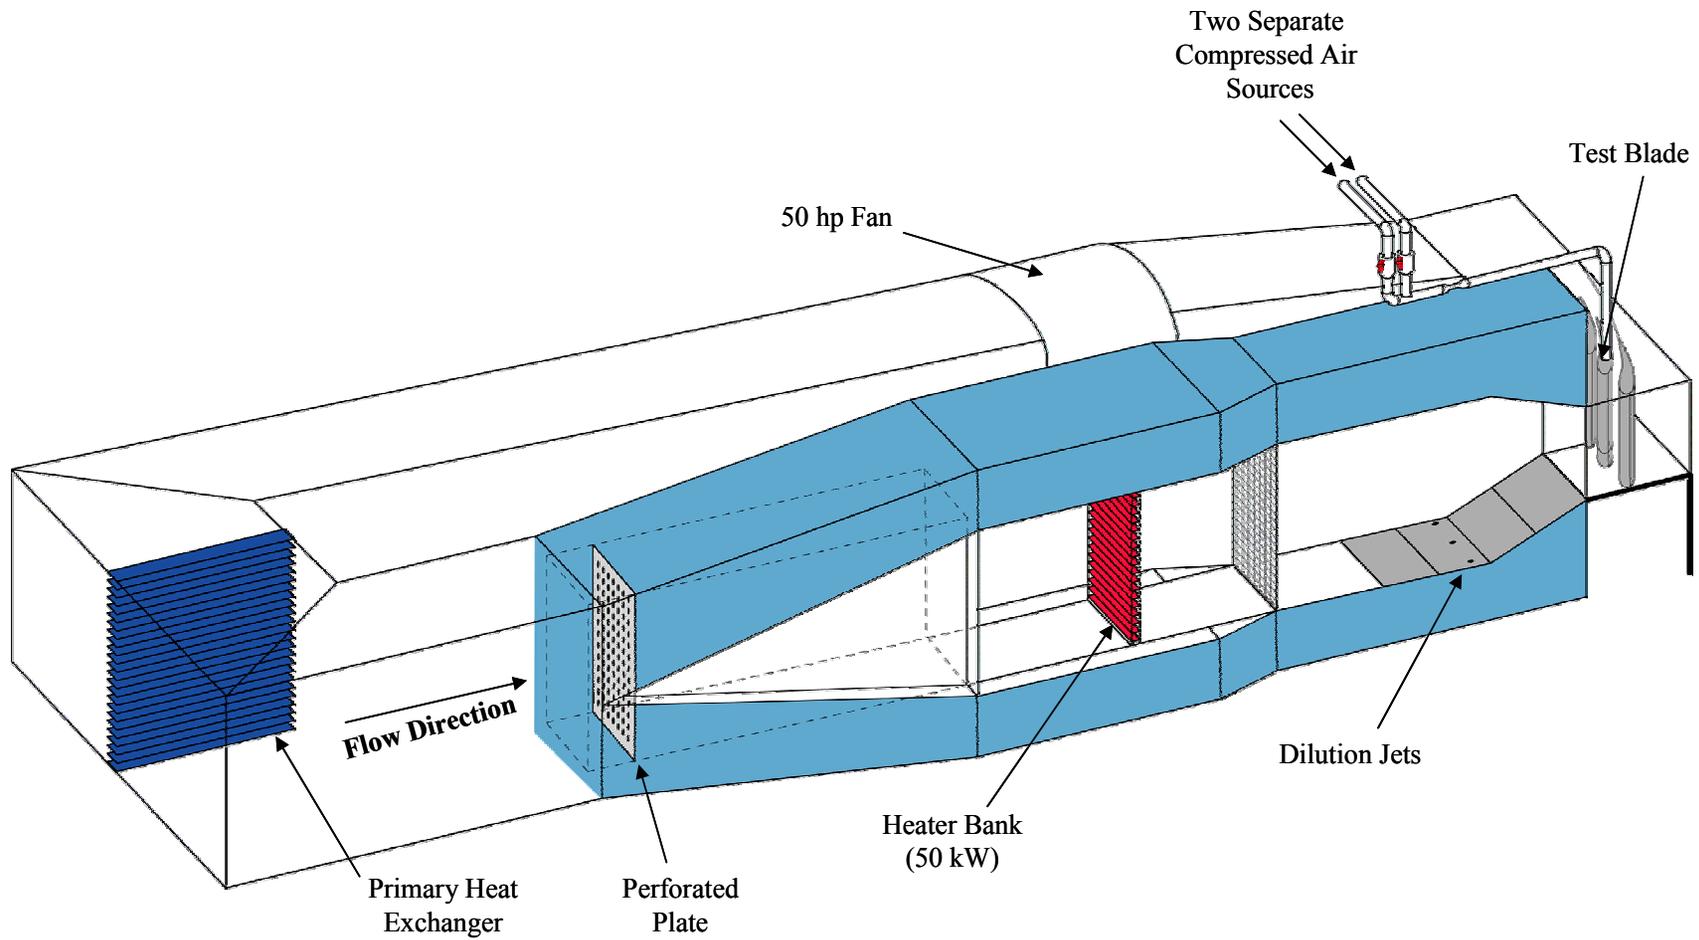
**Figure 3-1** Tests were conducted in a low speed wind tunnel. The shaded area is the combustor simulator.

This section offers a description of the experimental facilities and models used in this study. Tests were conducted in the large scale, low speed wind tunnel depicted in Figure 3-1. The tunnel cycled air around a closed loop with a 50 hp, 0-60 Hz Joy Technologies axial fan. Air exiting the fan was cooled by a primary heat exchanger in which the operating fluid was water cooled by a 38 kW chiller. Using a refrigerant, this chiller circulated water from a reservoir that was maintained at a temperature specified by the user. The heat exchanger could also have used tap water, but the chiller was used so that the water temperature did not vary.

Following the primary heat exchanger, the flow split into three passages in the transition section. A perforated wooden plate, shown in Figure 3-1, was placed over the center passage providing the necessary pressure drop to distribute flow through all three passages. This plate had an open area of  $0.269 \text{ m}^2$  or 24.6% of the main passage area. A 55 kW heater bank heated the center passage flow. The heater bank consisted of a top, middle, and bottom section, so that the power to each section could be independently adjusted through a digital control panel. During these experiments, the same power was allotted to each heater to provide an isothermal flowfield. The outer passages housed secondary heat exchangers, which could operate with chilled water or tap water to cool

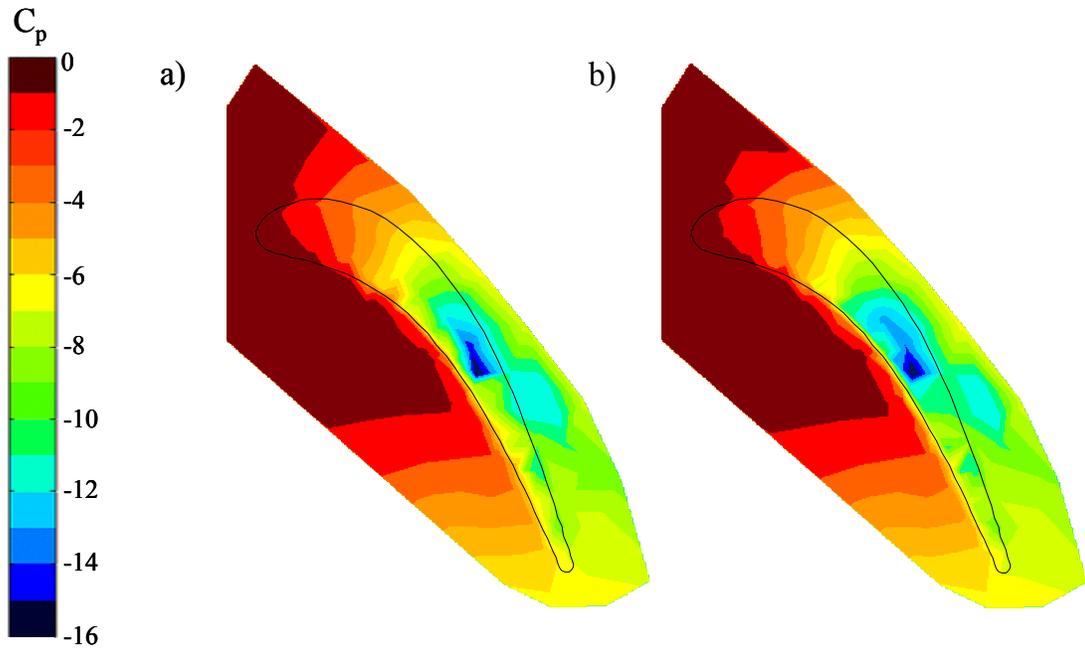
**Figure 3-2** Static pressure distributions on the shroud a) without a trip wire and b) with a trip wire.

Just upstream of the blades, the combustor simulator height contracted at an angle of  $15.4^\circ$  from 98 cm (38.6 in) to 55 cm (21.8 in) while the width remained 112 cm (44 in). Though the dilution flow provided turbulence upstream of the blade, there was concern that the transition from the combustor simulator to the test section inlet would cause a small laminar boundary layer at the tip gap. A 1.6 mm (0.063 in) diameter brass tube was made to run along the floor upstream of the blades to trip this laminar flow and ensure a turbulent boundary layer at the tip gap. Figure 3-2 shows pressure distributions on the shroud indicating that this trip wire had no noticeable effect on the flow field through the tip gap.

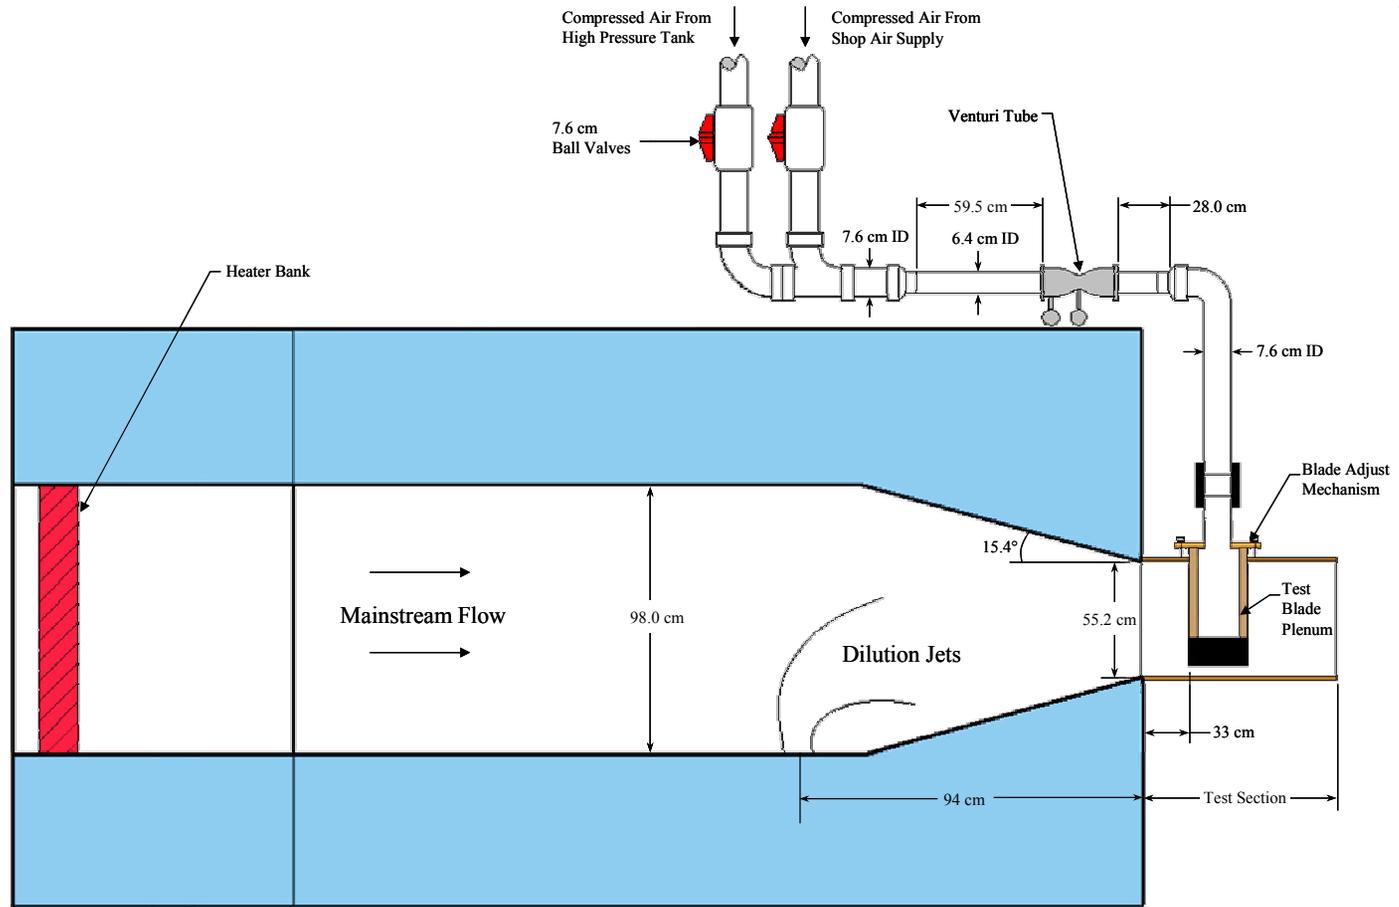
**Figure 3-3** Schematic of route for secondary air to the microcircuit.

**Coolant Supply.** The tip geometries that were tested required a coolant air supply at temperatures below that of the air exiting the combustor simulator. This air was supplied by two external tanks, which were pressurized by compressors. The first tank was located at the Virginia Tech Power Plant (Long, 2002) and was used to provide compressed air to lines throughout the Virginia Tech campus. This tank was automatically recharged at the power plant to maintain a supply pressure of 551.6 kPa (80 psi). The second tank, located in the Aerospace Department of Randolph Hall (Edwards, 2002), was used as a supplementary air supply for cases that required more flow than the first tank alone could provide. This tank was typically pressurized to 14.4 kPa (300 psi). For the highest flow cases, the pressure in the second tank would drop about 50 psi over an hour, and we would activate the compressor to recharge the tank as needed. As a safety precaution, the line from this tank had a regulator at the wind tunnel location that could reduce the supply pressure to as little as 68.9 kPa (10 psi). Dryers removed moisture from both tanks, which supplied air at ambient temperatures. The tanks delivered coolant to the blade tip through the piping circuit illustrated in Figure 3-3. The pipe connectors used were all standard polyvinyl chloride (PVC) pipe components with a 7.6 cm (3.0 in) internal diameter (ID).

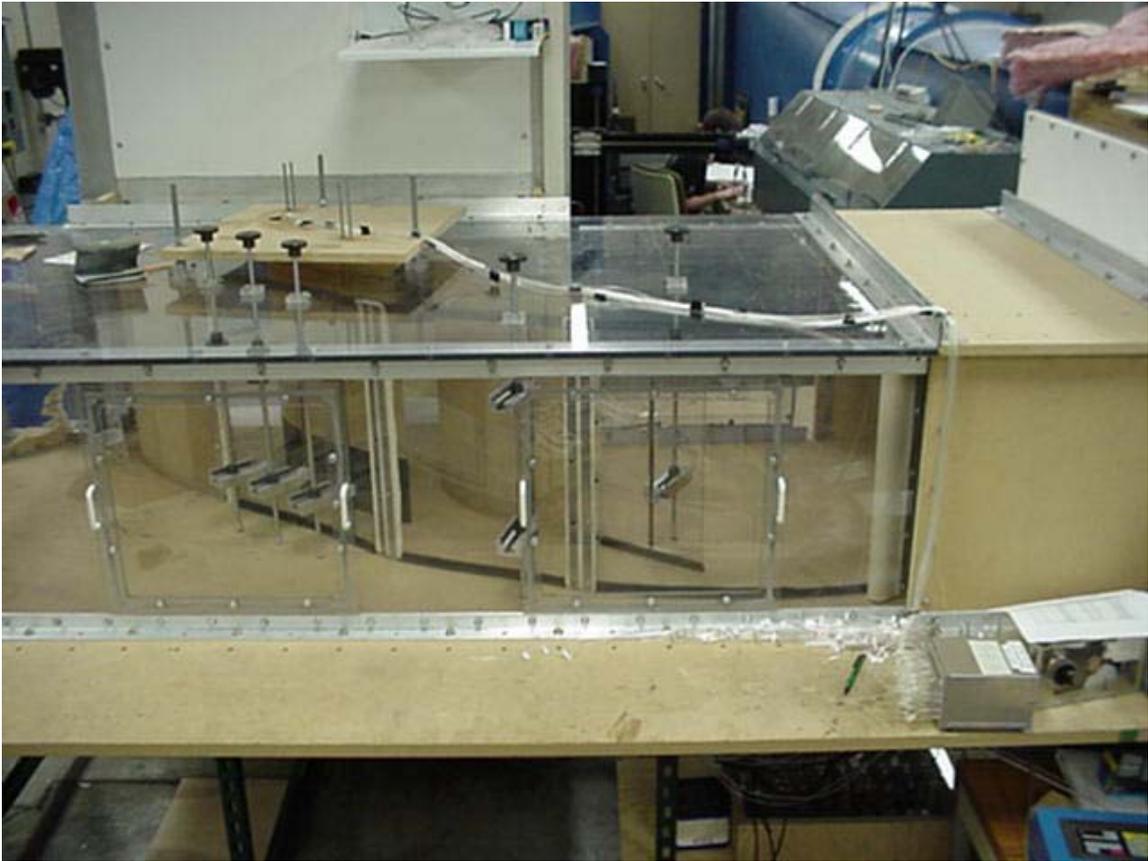
**Figure 3-4** Picture of the completed test section.

**Design of Blade Test Section.** To match the engine flow conditions around the test blade, we constructed a test section, pictured in Figure 3-4, to house three 12X scale blades. The blade layout, shown in Figure 3-5, formed two full air passages with two smaller air bleeds on the far left and right. The floor of the test section was 25.4 mm (1.0 in) thick medium density fiberboard (MDF), and the outside walls were 9.53 mm (0.375 in) thick lexan. The section ceiling was made from 12.7 mm (0.50 in) thick lexan.

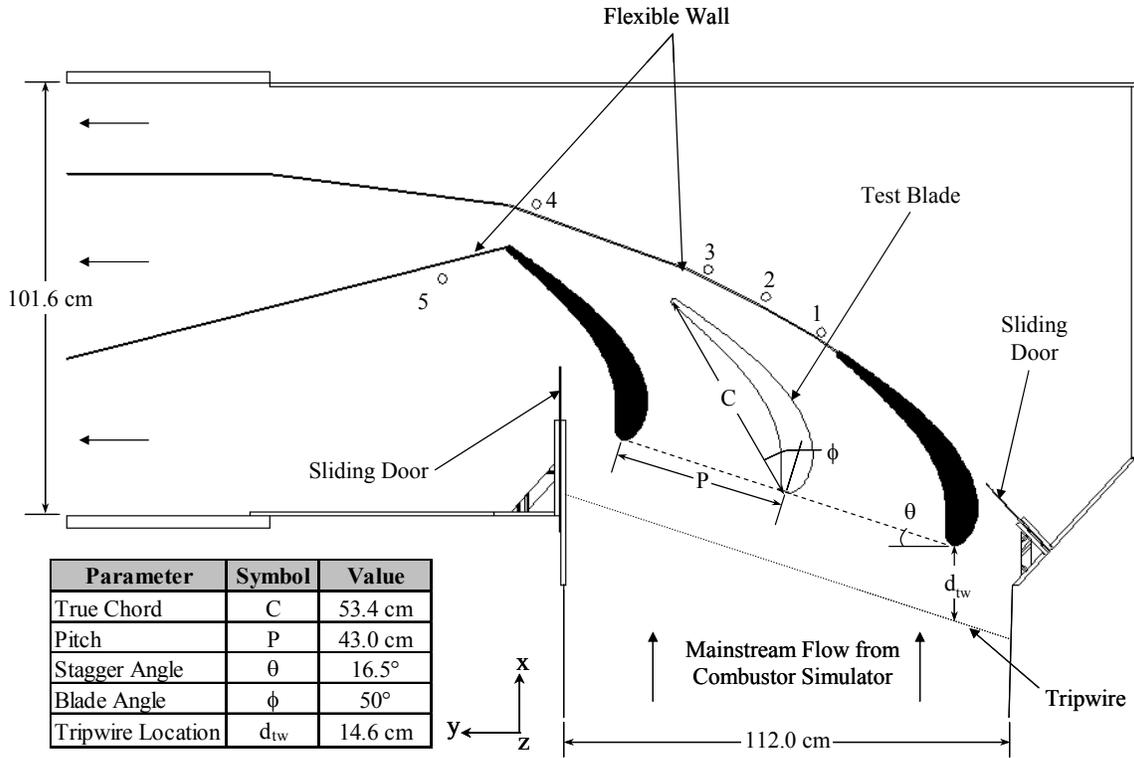
**Figure 3-5** The test section for the wind tunnel houses three blades, which form two full passages. Flexible walls allow the flow to be adjusted around the test blade in the center.

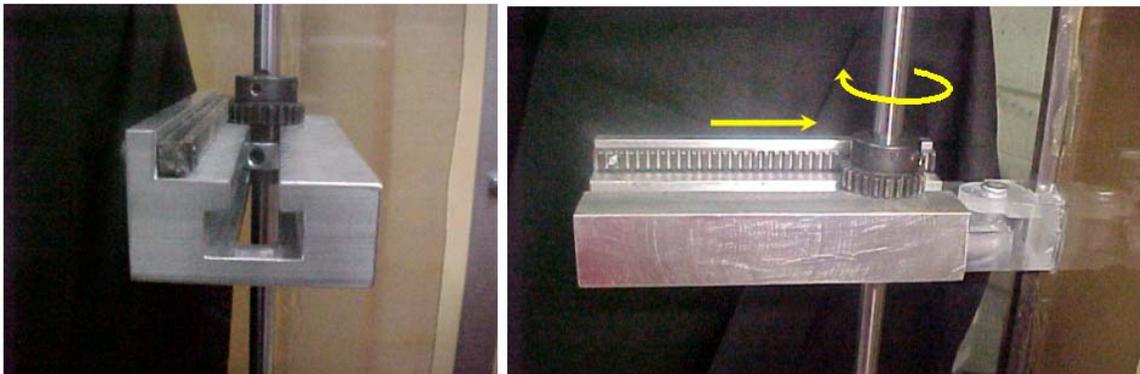
**Figure 3-6** Flexible wall adjustment mechanism (FWAM).

The flow around the center blade, which contained the microcircuit geometry, had to be balanced to meet the midspan pressure distribution that was determined from computational predictions by Hohlfeld [2003]. Details on measuring the midspan pressure distribution are given later in this chapter. To match the predicted pressure distribution, the test section was designed with several flow adjusting components. As shown in Figure 3-5, sliding doors in the outer air bleed passages governed the amount of air that entered the passages on either side of the test blade. A rod with 28 threads per 25.4 mm (1.0 in) actuated the sliding doors, which were mounted on two more smooth rods for stability. Flexible walls of 3.18 mm (0.125 in) Plexiglas extended from the trailing edges of both outer blades. The contours of the walls were adjusted using the gear and rack mechanism shown in Figure 3-6. The block containing the gear and rack was attached to the flexible wall with a hinge joint. The gear rotated on axis with a rod that extended through the tunnel ceiling to a knob where it could be instantaneously adjusted without interfering with the flow. Schematics and parts lists of this flexible wall adjustment mechanism (FWAM) are included in Appendix A. The FWAM locations are indicated on Figure 3-5 with the white circles labeled one through five. The grouping of the FWAMs was more concentrated on the flexible wall immediately downstream of the right blade. FWAMs 1, 2, and 3 served to follow the contour of the trailing edge on the suction side of the center blade. Fine adjustments at this wall were necessary when balancing flow around the center blade to achieve the proper midspan pressure distribution. FWAMs 4 and 5 impacted the overall pressure drop of the test section. As these two opened, the tunnel experienced less flow blockage, and the inlet velocity to the test section increased. The high velocity air through the center passage created a low pressure zone that tended to pull the flexible walls together. To prevent this, the FWAMs

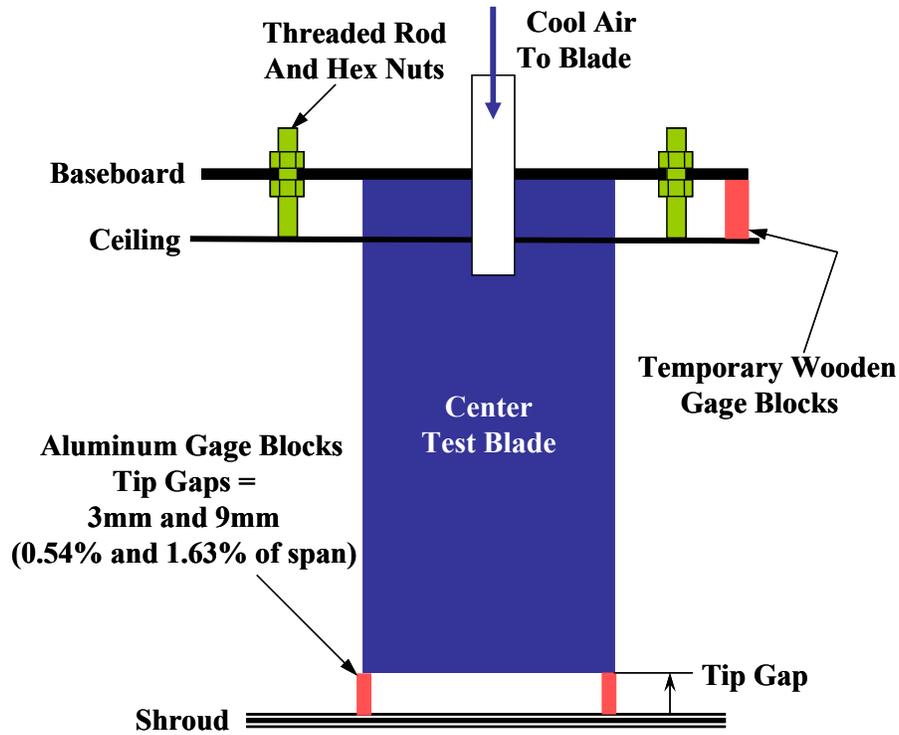
**Figure 3-7** Setting the tip gap. The center blade and baseboard assembly traversed vertically along the threaded rods while gage blocks set the distance for the proper tip gap.

Great care was taken to accurately set the tip gap. Aluminum blocks were machined on an end mill to the thickness of the desired tip gaps within  $\pm 0.025$  mm ( $\pm 0.001$  in), which is 0.8% of the small tip gap height. The blade-baseboard assembly was allowed to rest on these blocks while the hex nuts were tightened into place. The blocks could then be pulled out, so that the tip gap remained. During experimentation, we began to build temporary, wooden gage blocks that set the tip gap by offsetting the distance from the baseboard to the test section ceiling, as labeled on Figure 3-7. After initially setting the tip gap inside the tunnel with the aluminum blocks, we would cut MDF blocks to the size of the distance from the baseboard to the section ceiling. This allowed us to reset the tip gap from outside the flow without turning off the tunnel. On a table saw, the wooden blocks were cut to a snug fit which is within  $\pm 0.064$  mm ( $\pm 0.0025$  in). The total uncertainty from the aluminum block machining and the MDF block machining stacks up to 3% of the small tip gap height.

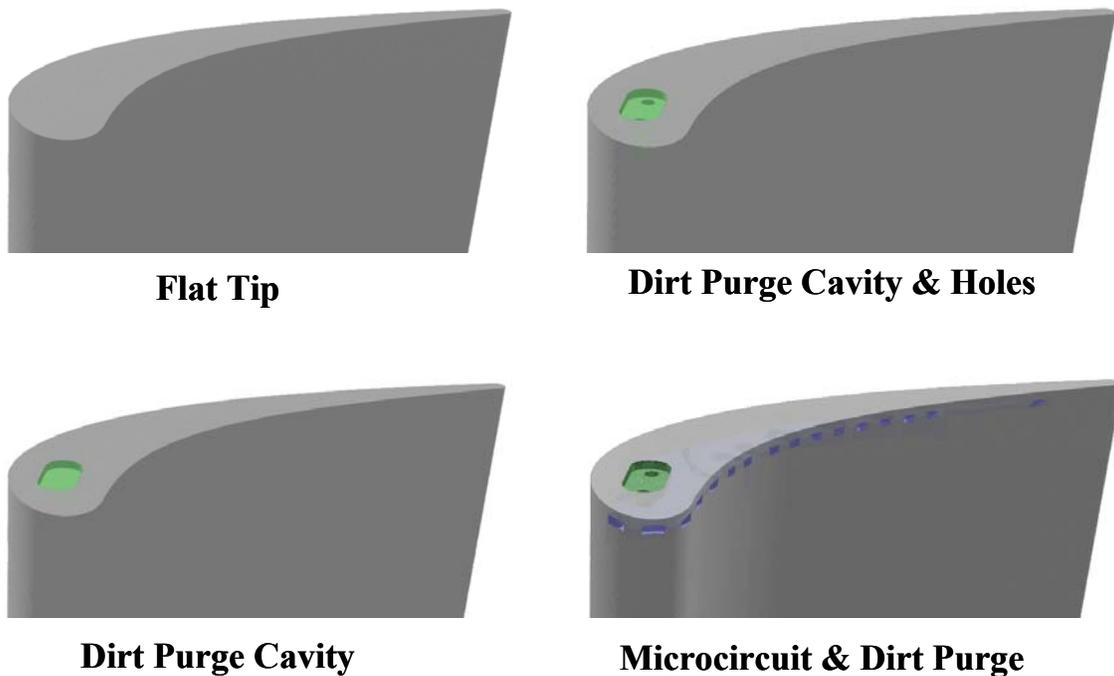
**Figure 3-8** Four different tip geometries (Hohlfeld, 2003).

**Tip Models.** While the two outer blades served to shape the air flow around the center blade, the center blade was the blade of interest. There were four different tip geometries tested in this study. Figure 3-8 shows the flat tip, dirt purge cavity, dirt purge

cavity with holes, and combined dirt purge-microcircuit geometries. The flat tip geometry is a plain blade with characteristics listed in Table 3-1. The coordinates of the blade profile are included in Appendix B. All blade geometries tested in this study are variations on this basic blade shape.

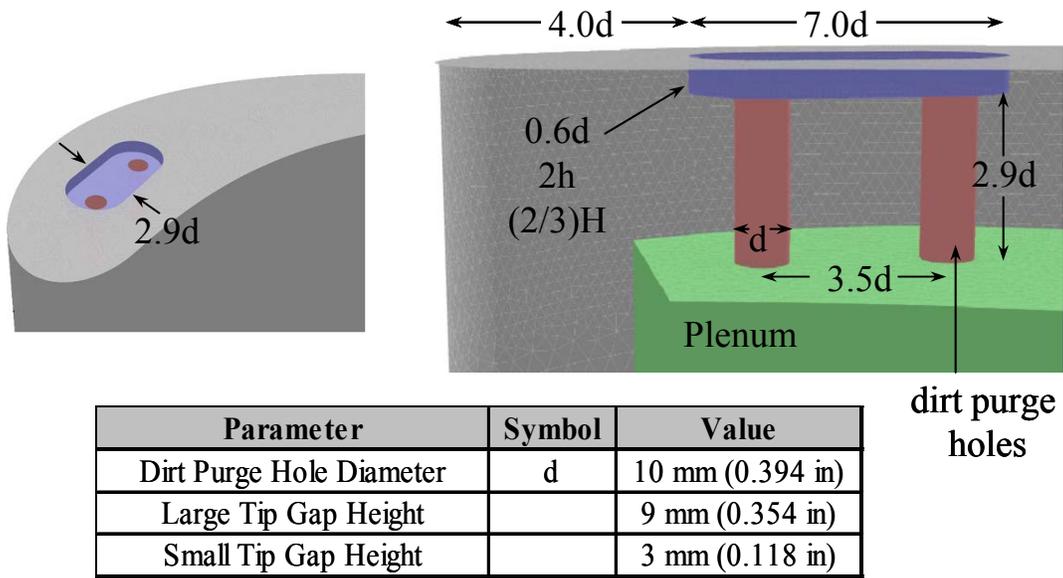
**Figure 3-9** This three-dimensional depiction of the test blade shows the inner components of the dirt purge geometry that was tested in the wind tunnel (Hohlfeld, 2003).

The dirt purge geometry is shown in greater detail in Figure 3-9. The hollow blade plenum fed coolant air through two holes that exited through the blade tip on the leading edge. This geometry is present in actual turbine blades to expel foreign particles from the blade. Centrifugal forces drive dust or dirt through the dirt purge holes preventing it from clogging smaller coolant holes located elsewhere on the blade. Sometimes, during transient engine operation, thermal expansion will cause the blade tip to rub against the shroud, so blade designers added a recess, or cavity, at the dirt purge hole exits that is intended to prevent them from being closed off. Experiments were done on a blade with the dirt purge holes and cavity as well as with the cavity only. For the case with the cavity alone, the dirt purge holes were blocked with a kneaded rubber material that was purchased at a local art supply store. The kneaded rubber created an airtight seal but could still be removed without leaving any excess rubber to obstruct the holes.

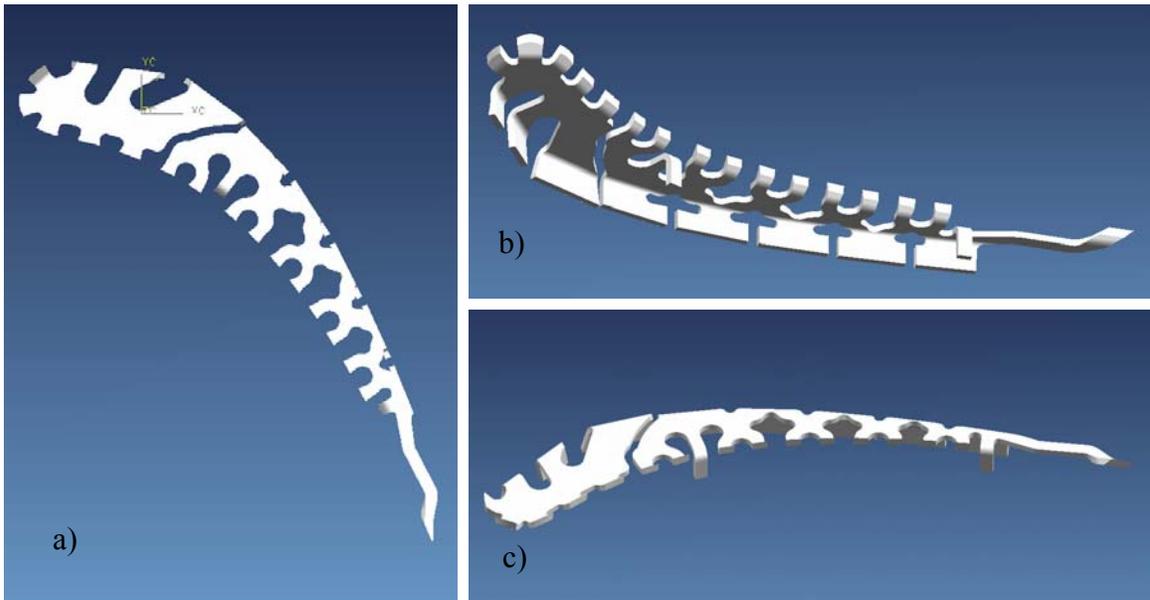
**Figure 3-10** Negative image of the tip microcircuit geometry from a top view and two isometric views looking at the side from above and below the microcircuit (Hohlfeld, 2003).

The fourth geometry studied was the blade tip containing a microcircuit channel geometry. Figure 3-10 shows the negative of the microcircuit—or the air passages without the surrounding blade material. This tip design incorporated a complex series of internal air passages that were fed by the hollow blade plenum and exited along the pressure side near the tip. The plenum supplied air to the microcircuit through ten inlet channels. After passing through the microcircuit, cool air was expelled from holes located 4.5 mm (0.18 in) from the tip. There were sixteen shaped holes, which were all 6.4 mm (0.25 in) in height and had varying widths. They are labeled in Figure 3-11 with a numbering scheme that will be used to reference these exits later in this report. The dirt purge geometry was also present in the microcircuit design and is labeled as holes 17 and 18.

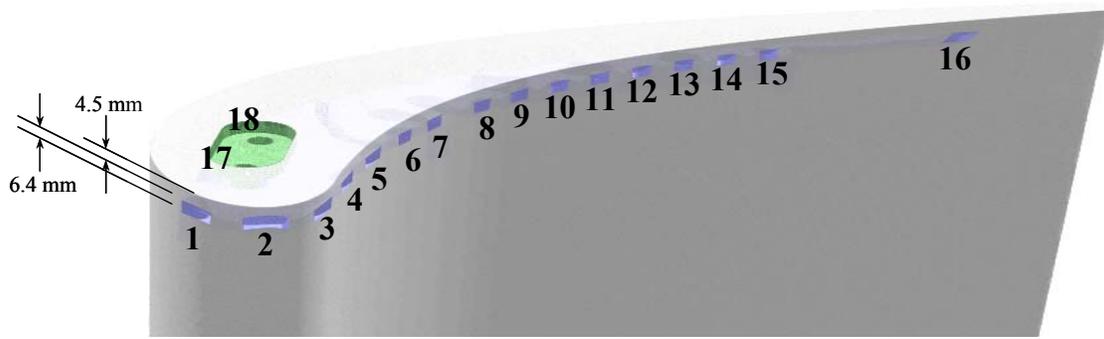
**Figure 3-11** Tip microcircuit numbering scheme for referencing various flow ducts (Hohlfeld, 2003).

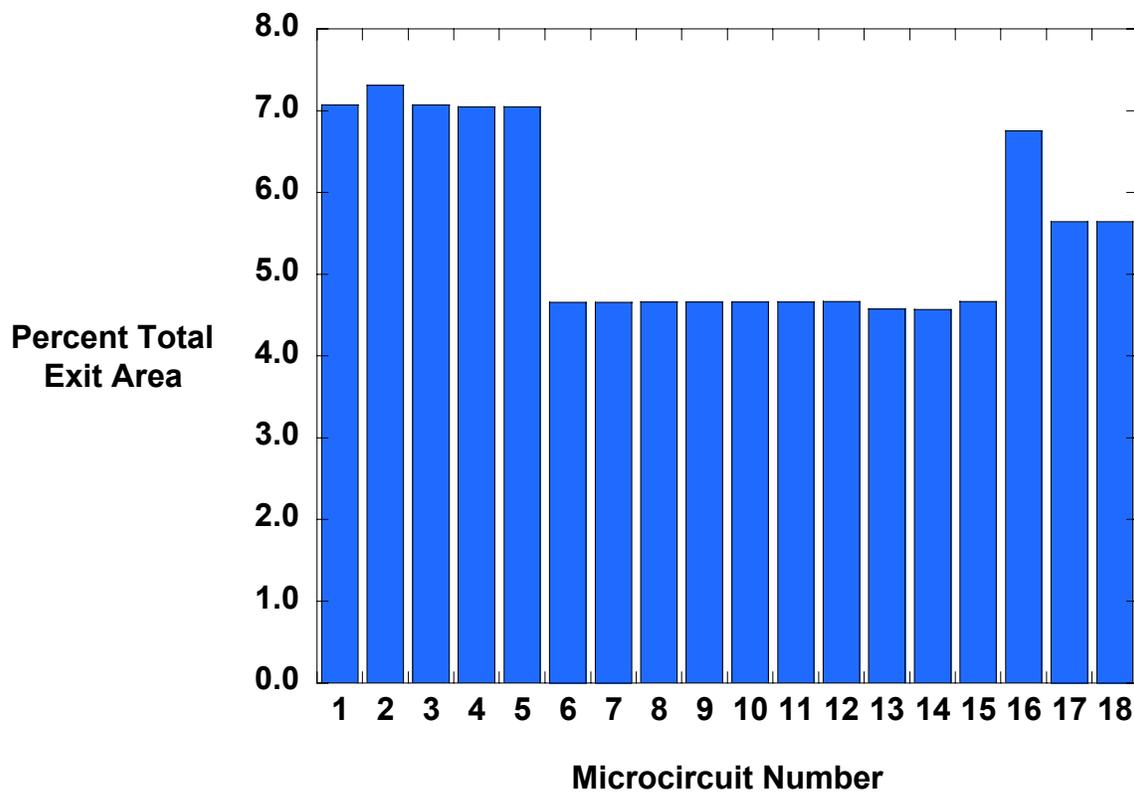
**Figure 3-12** Exit area of each tip microcircuit and dirt purge hole when compared to the entire coolant flow area (Hohlfeld, 2003).

The area of each microcircuit exit and dirt purge hole was calculated by Hohlfeld [2003]. Figure 3-12 charts the area of each exit as a percentage of the entire coolant flow exit area. The microcircuit exits at the leading edge had the largest exit areas followed by

exit number 16 on the trailing edge. The dirt purge holes comprised 11% of the total exit area while the remaining 89% of the area was microcircuit exits. The total exit area was  $13.9 \text{ cm}^2$  ( $2.16 \text{ in}^2$ ). Figure 3-13 shows the predicted coolant flow percentages through each microcircuit exit and dirt purge hole according to Praisner [2002] and Hohlfeld [2003]. Although microcircuit exits 1 through 5 each had larger exit areas, the highest coolant flows exited through the dirt purge holes. The least flow exited the midchord exits, which also have the smallest areas.

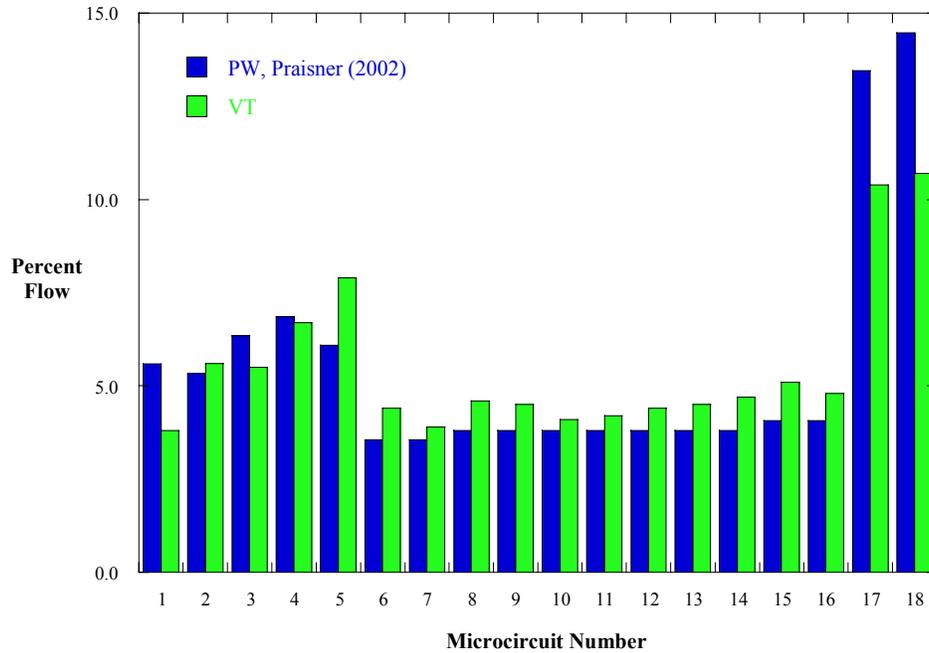
**Figure 3-13** Comparison of flow distribution within the microcircuit. Numbers 1-16 represent the microcircuit holes with 17 and 18 the dirt purge holes (Hohlfeld, 2003).

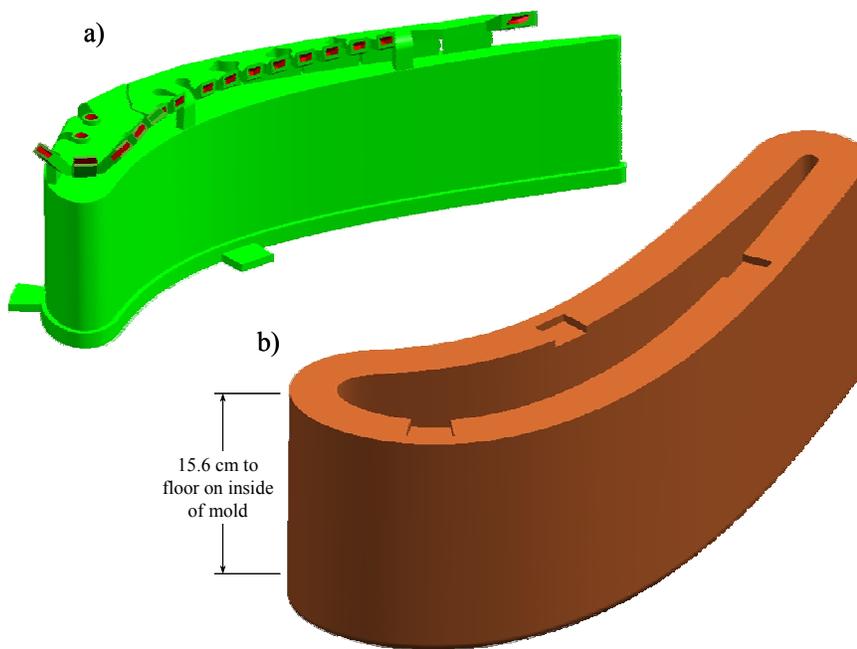
**Figure 3-14** Models of the a) air passage piece and b) outer mold for the blade tip (Santeler, 2002).

The adiabatic tip was built using a foam material manufactured by the Stepan Company. The Turbulence and Turbine Cooling Research Lab at the University of Texas (Bogard, 2002) provided the foam material to Virginia Tech's Experimental Computational Convection Laboratory in two liquid parts. Part A was Stepanfoam AM-9451 (polymeric diisocyanate), and part B was Stepanfoam RM-9137 (polyol). A foam material forms when a one-to-one ratio of A and B is mixed together for 30 seconds and allowed to set. In preliminary tests, the mixture immediately began expanding exothermically for about five minutes until it set leaving the completed foam material. The foam blade was created by pouring the A-B mixture into a mold and allowing the foam to expand around the desired geometry. Two components were necessary for this process: a piece to shape the air passages of the microcircuit and a piece to form the outer shape of the blade. Figure 3-14 shows the air passages and outer mold that were built on a

stereo lithography (SLA) machine at Pratt & Whitney's fabrication lab. The outer mold was pulled away after the foam set, but the piece forming the air passages would become a permanent part of the final product. To prevent foam from leaking into the microcircuit air passages, a 1.6 mm (0.063 in) thick layer of SLA material closed off the microcircuit exits. The SLA layer was included as part of the microcircuit air passage piece provided by the fabrication lab and was removed with a Dremel tool after the mold process was completed. The dirt purge hole exits were plugged with kneaded rubber.
