## **Chapter 3: Experimental Facilities and Instrumentation**

### **3.1 Wind Tunnel Facility**

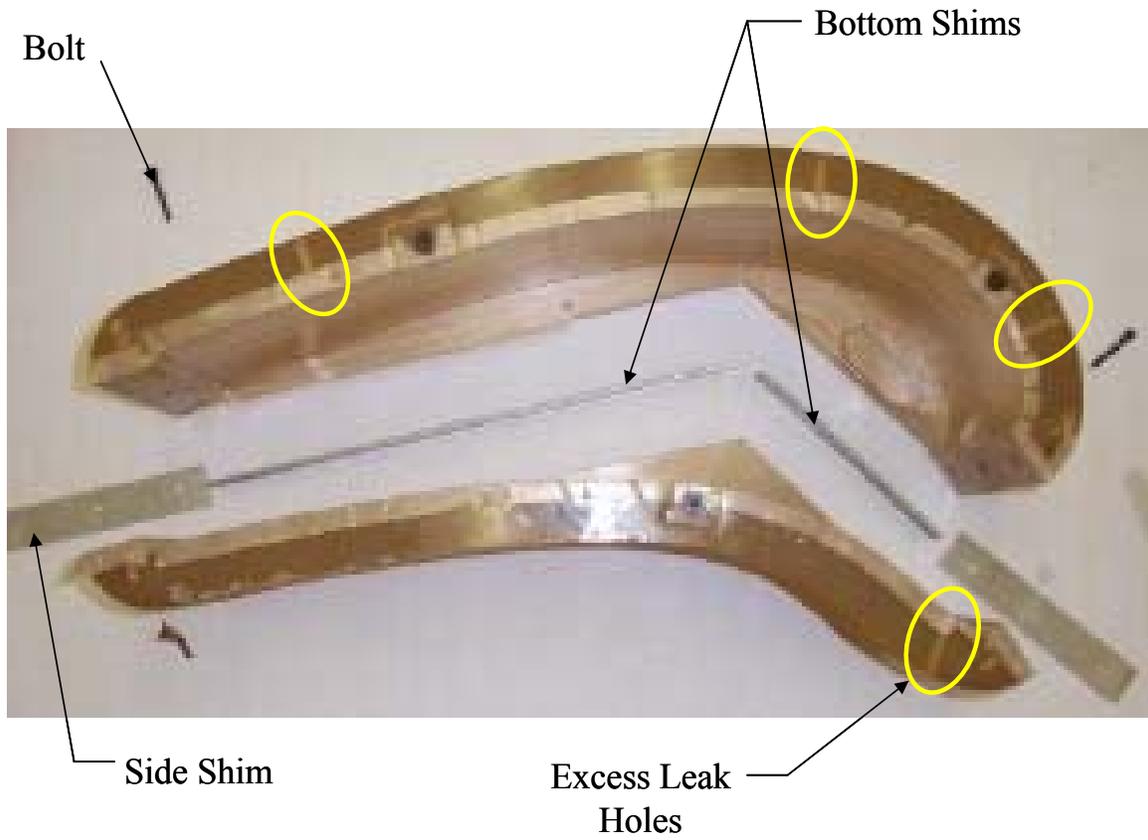
**Figure 3-15** Two part outer mold assembly. Holes that were drilled to leak off excess foam are circled in yellow.

Prior to pouring the foam, the preparation of the mold was critical for good results. The expansion of the foam would cause such great pressure that, afterwards, the blade would not slide out easily. For this reason, the outer mold was cut into two pieces that could be pulled away. Figure 3-15 shows a picture of the two-part outer mold assembly. Metal shim strips filled the gap that remained after the cutting operation, and bolts were used to hold the two pieces together tightly during foam expansion. The air passage piece had tabs that could be bolted to threaded holes in the outer mold. This kept the air passages stationary during foam expansion, and later the tabs could be cut away from the final part. Also indicated on Figure 3-15 are holes that were drilled into the mold to allow excess foam to leak out. This kept the pressure in the mold from becoming so great that the SLA microcircuit passages would collapse.

The foam had a tendency to bond to the SLA material of the outer mold, so we lined all surfaces that would be exposed to foam with Teflon-coated fiberglass tape. The outer mold halves were then bolted together, and all taped surfaces were then coated with Dee-Rax, which is a resin mold release that was purchased at a local art supply store. The mold release is applied over the tape as an added measure to ensure that the foam model pulled from the mold easily after the foam set.

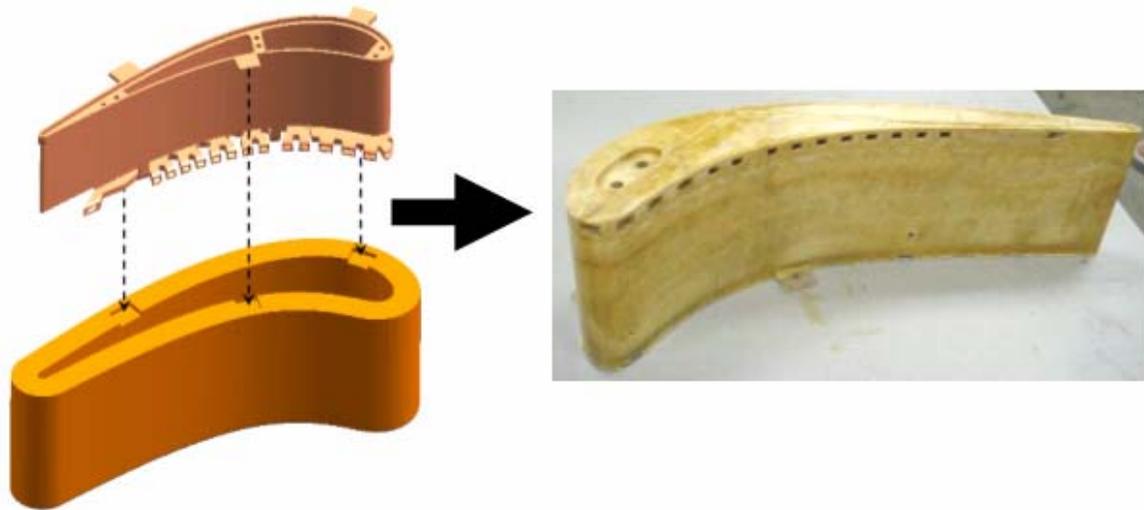
**Figure 3-16** Final product of foam mold process.

a measuring cup. An extra 25% was added to each part to ensure that the entire blade volume was formed. We vigorously mixed the two parts together for 30 seconds until the mixture had a uniform yellow color. The mixture was immediately poured into the outer mold, and the SLA model microcircuit passages were inserted and bolted down. The initial expansion of the foam took only 5 minutes, but the entire hardening process continued for several hours. Therefore, after pouring, a lid was placed on the mold, and the mold was allowed to sit for 24 hours. When the mold hardened, the two outer mold halves were knocked off with a rubber mallet leaving the final blade shown in Figure 3-16.

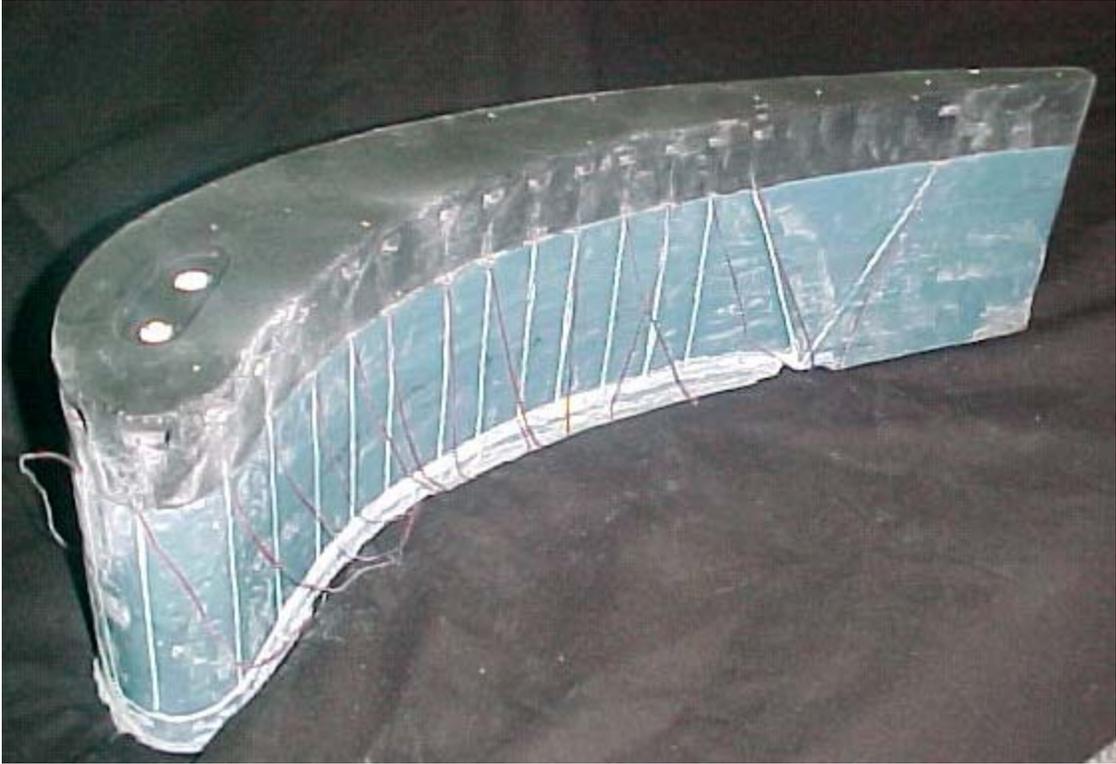
**Figure 3-17** Final alumina tip model.

The second blade tested was made from an alumina oxide ceramic, which had a thermal conductivity of  $1.44 \text{ W / m K}$  ( $10 \text{ BTU in / hr } ^\circ\text{F ft}^2$ ). This material was known as RTC-60 and was distributed by the Cotronics Corporation. Pratt & Whitney provided the alumina blade model though some cracks had to be repaired at Virginia Tech. Broken pieces of the brittle alumina blade were reattached with a general purpose adhesive called Resbond 907GF which is also distributed by Cotronics Corporation. Material properties for RTC-60 and Resbond are included in Appendix C. This adhesive had a thermal conductivity of  $0.58 \text{ W / m K}$  ( $4 \text{ BTU in / hr } ^\circ\text{F ft}^2$ ). Figure 3-17 shows a picture of the alumina blade. The vertical lines are thermocouples that were installed for tests to be completed by Christophel [2003].

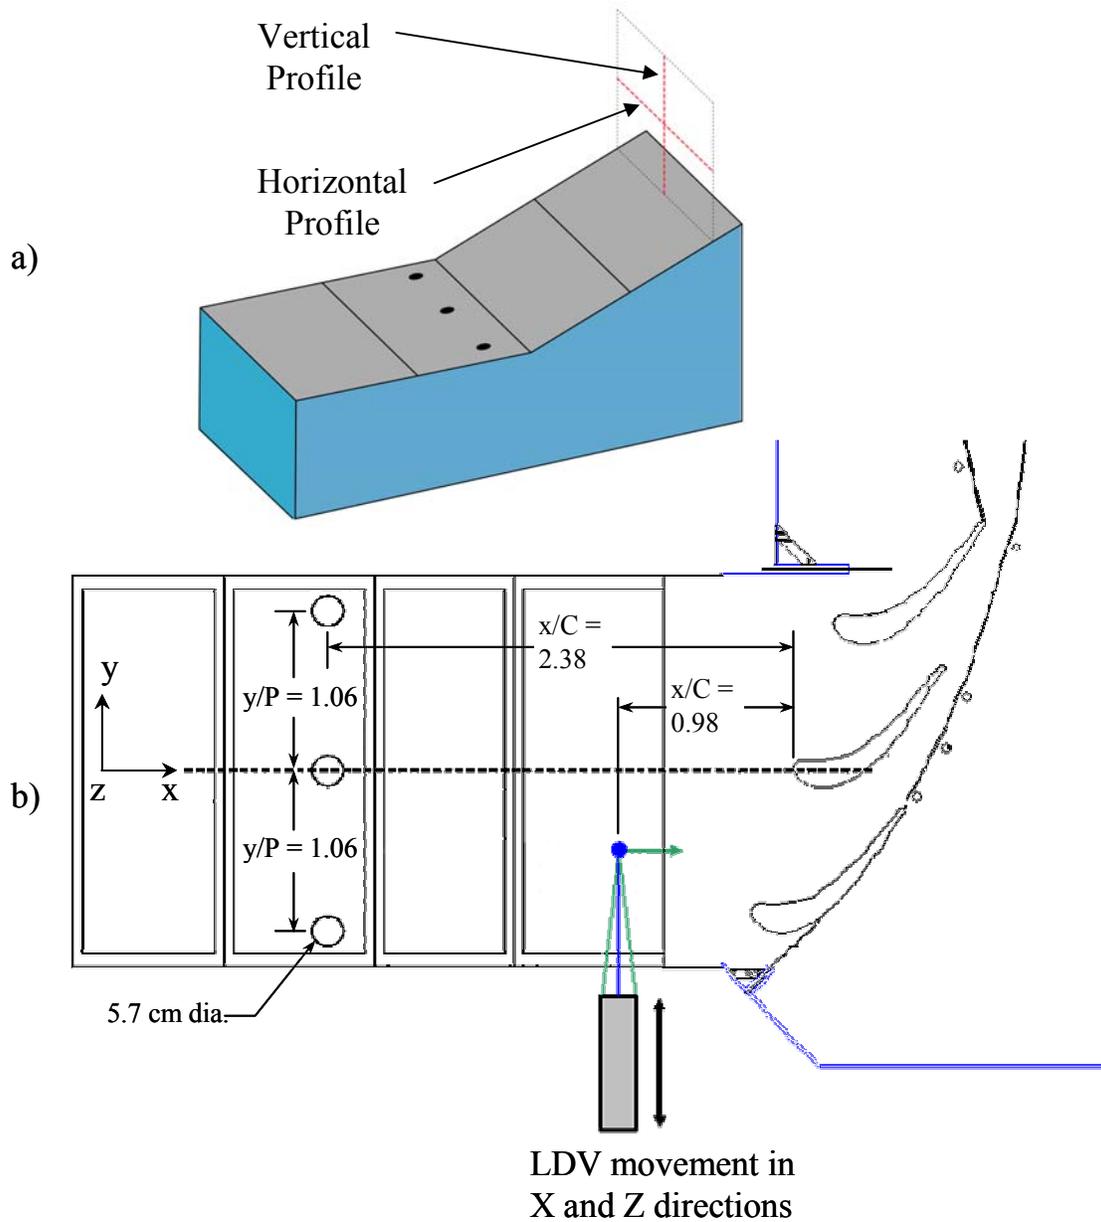
**Figure 3-18** a) Horizontal and vertical velocity profiles measured upstream of the test section. b) Laser Doppler Velocimeter measures the  $z$  and  $x$  components of flow velocity upstream of the test section.

**Flowfield Measurements.** To verify that the tip was exposed to a uniform mean and highly turbulent flow, velocity profiles were measured at  $x/C = 0.98$  upstream of the test blade. Because the apparatus used to measure velocity had to be positioned upstream of the blade inlet, the profiles were measured inside the contracting area of the combustor simulator. These profiles were measured on horizontal and vertical planes that were normal to the flow as shown in Figure 3-18. The distances of the measurement plane and dilution jets relative to the blade stagnation point are normalized by pitch,  $P$ , and true chord,  $C$ .

Measurements were made with a two component, back scatter, fiber optic, laser-Doppler velocimeter (LDV) system. A 5 W laser source provided a beam to a TSI model 9201 Colorburst separator where the beam was separated into a green and a blue beam. The beams were then routed to a probe through fiber optic cables and emitted through a 750 mm focusing lens with a beam expander. Data was processed by a TSI model IFA 755 Digital Burst Correlator which was controlled by TSI's FIND software for Windows.

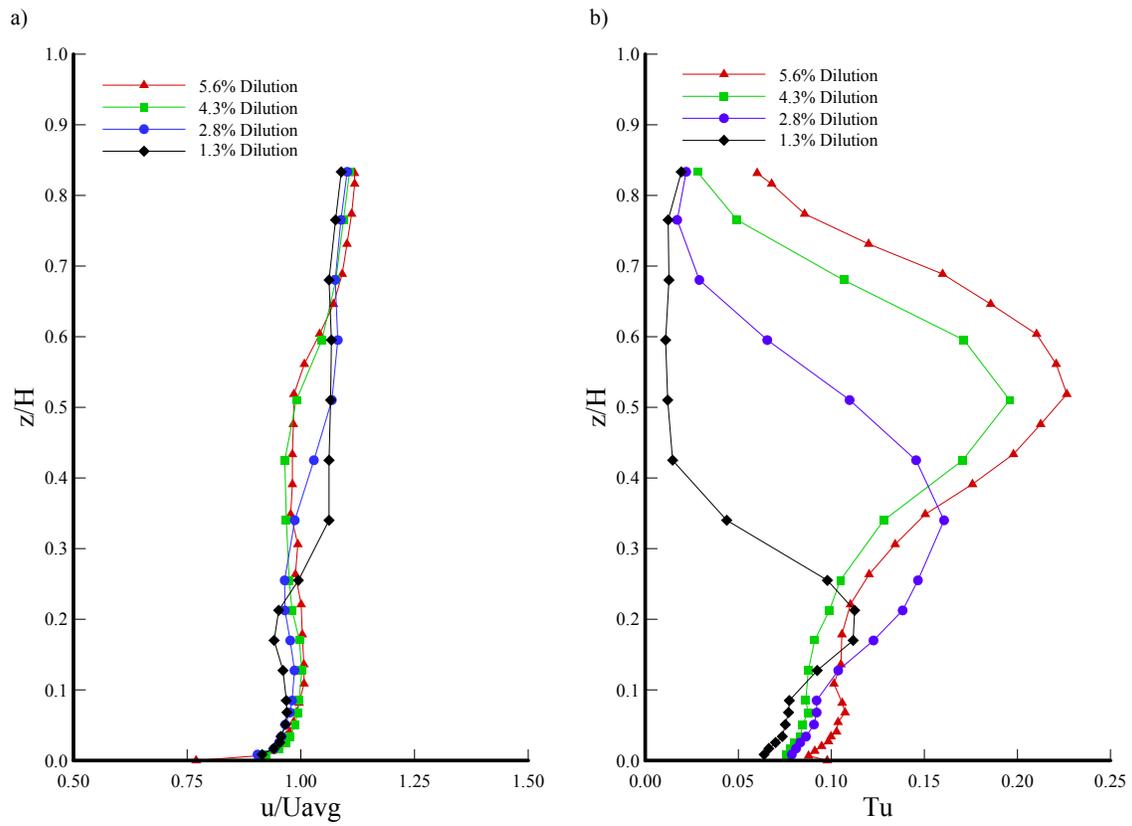
**Figure 3-19** a) Vertical velocity profiles for four different dilution mass flow ratios and b) corresponding turbulence levels.

Figure 3-19 shows the results from the vertical profile readings. The LDV measurements show velocities close the floor were most uniform for the cases with 4.3% and 5.6% of the combustor exit mass flow. Turbulence levels of about 10% best simulate actual combustor turbulence before the turbine, and the 4.3% and 5.6% cases both satisfied this requirement. Because more dilution flow would reduce the freestream temperature and, thus, reduce the overall resolution of the thermal field measurements, we investigated the 4.3% dilution flow setting.

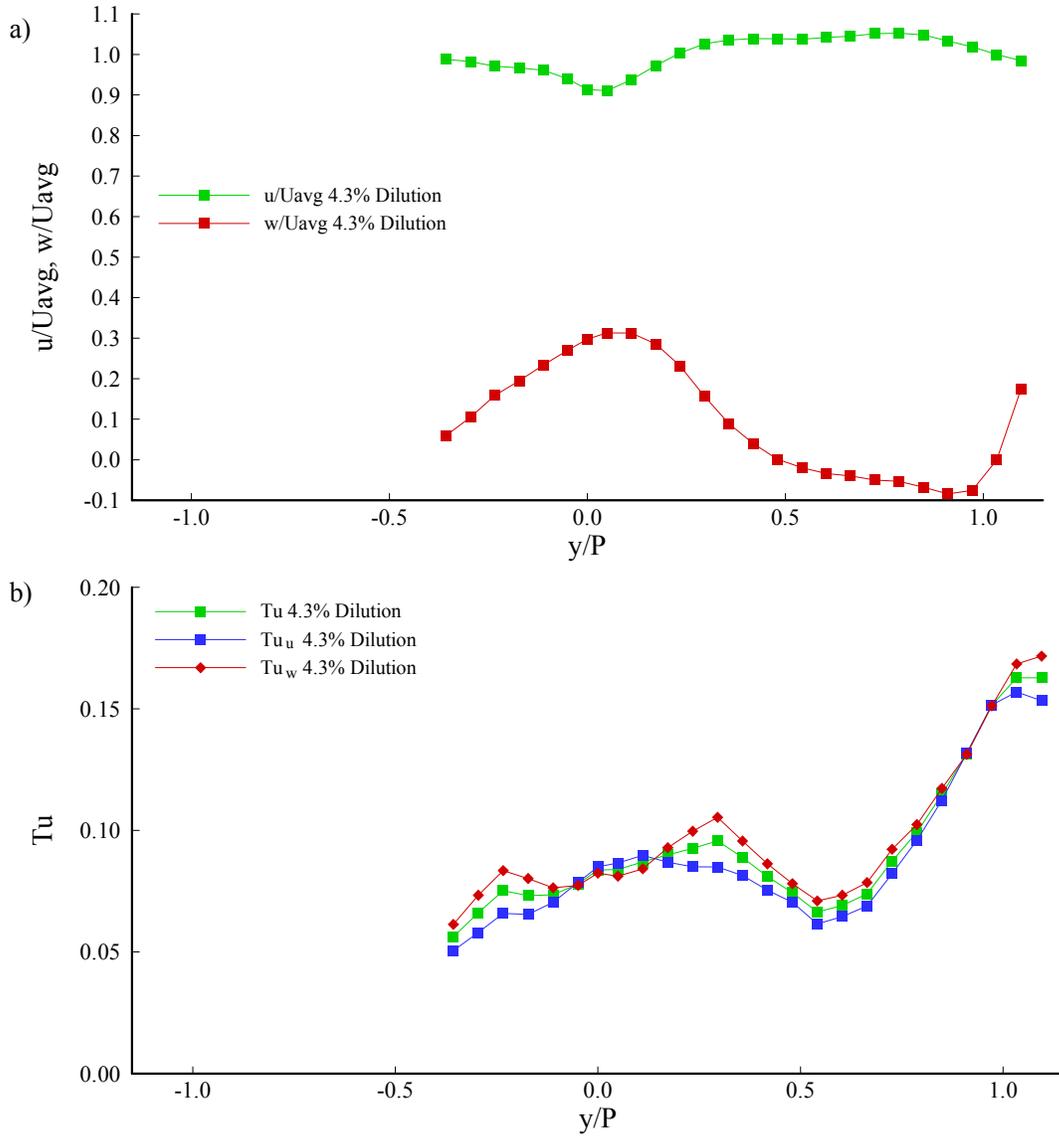
**Figure 3-20** a) Horizontal profile of the cross-stream velocity component normalized by the free-stream mean velocity direction ( $w/U_{avg}$ ) and the free-stream velocity component normalized by the free-stream mean velocity ( $u/U_{avg}$ ) for 4.3% dilution flow. b) Horizontal profile of averaged turbulence levels ( $Tu$ ), turbulence levels based on stream-wise fluctuations ( $Tu_u$ ), and turbulence levels based on cross-stream fluctuations ( $Tu_w$ ) for 4.3% dilution flow.

The horizontal plane results, shown in Figure 3-20, suggest that a symmetric velocity profile is present for this case. The largest variation in velocity across the horizontal plane was 9% of the mean. This suggests that the individual effects of the dilution jets have are mixing out on the horizontal direction. Figure 3-20 also shows the cross-stream component of the flow normalized by the averaged x-velocity. The turbulence levels are based on streamwise fluctuations,  $Tu_u$ , and cross-stream fluctuations,  $Tu_w$  where

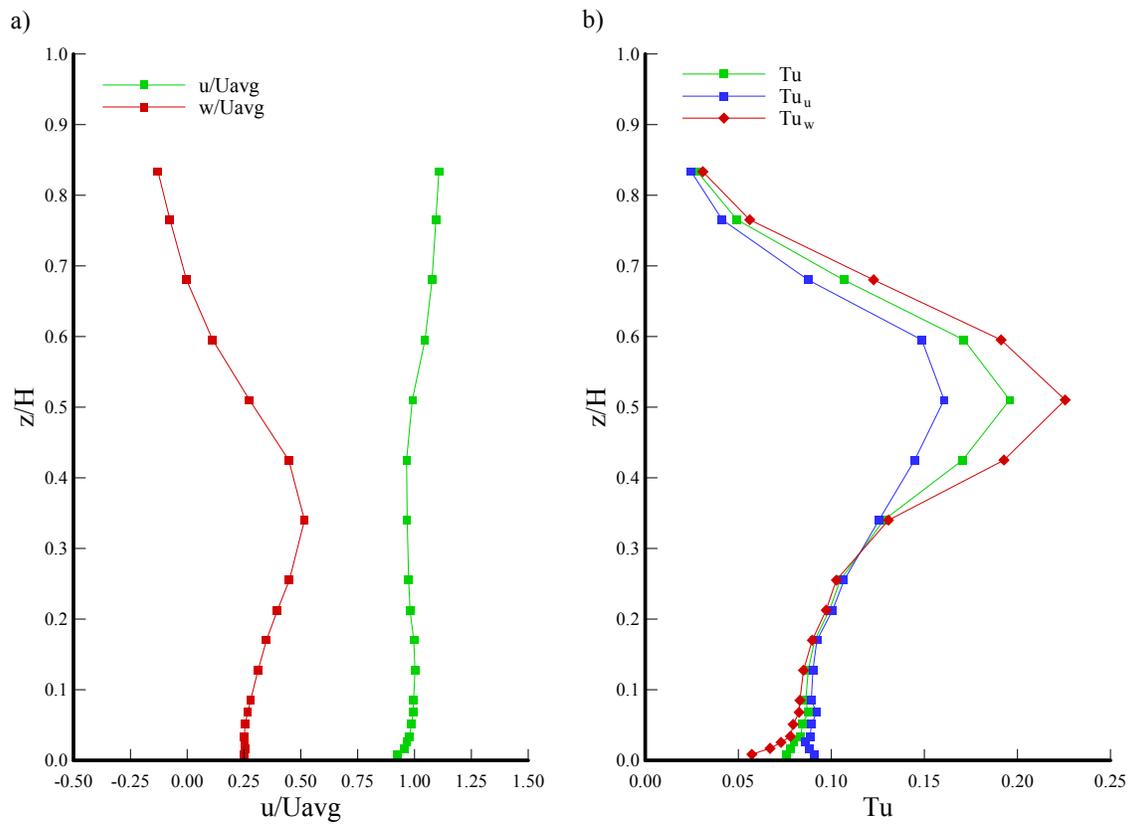
**Figure 3-21** a) Vertical profile of the cross-stream velocity component normalized by the free-stream mean velocity direction ( $w/U_{avg}$ ) and the free-stream velocity component normalized by the free-stream mean velocity ( $u/U_{avg}$ ) for 4.3% dilution flow. b) Vertical profile of averaged turbulence levels ( $Tu$ ), turbulence levels based on stream-wise fluctuations ( $Tu_u$ ), and turbulence levels based on cross-stream fluctuations ( $Tu_w$ ) for 4.3% dilution flow.

Figure 3-21 shows vertical profiles for these same values at the 4.3% dilution flow. At one chord upstream of the test blade, we estimate a boundary layer thickness of 22 mm (0.87 in) or 4.0% of the blade span. This boundary layer is more than twice the size of the large tip gap, which is 9 mm (0.35 in) or 1.63% of the blade span. We decided to run all

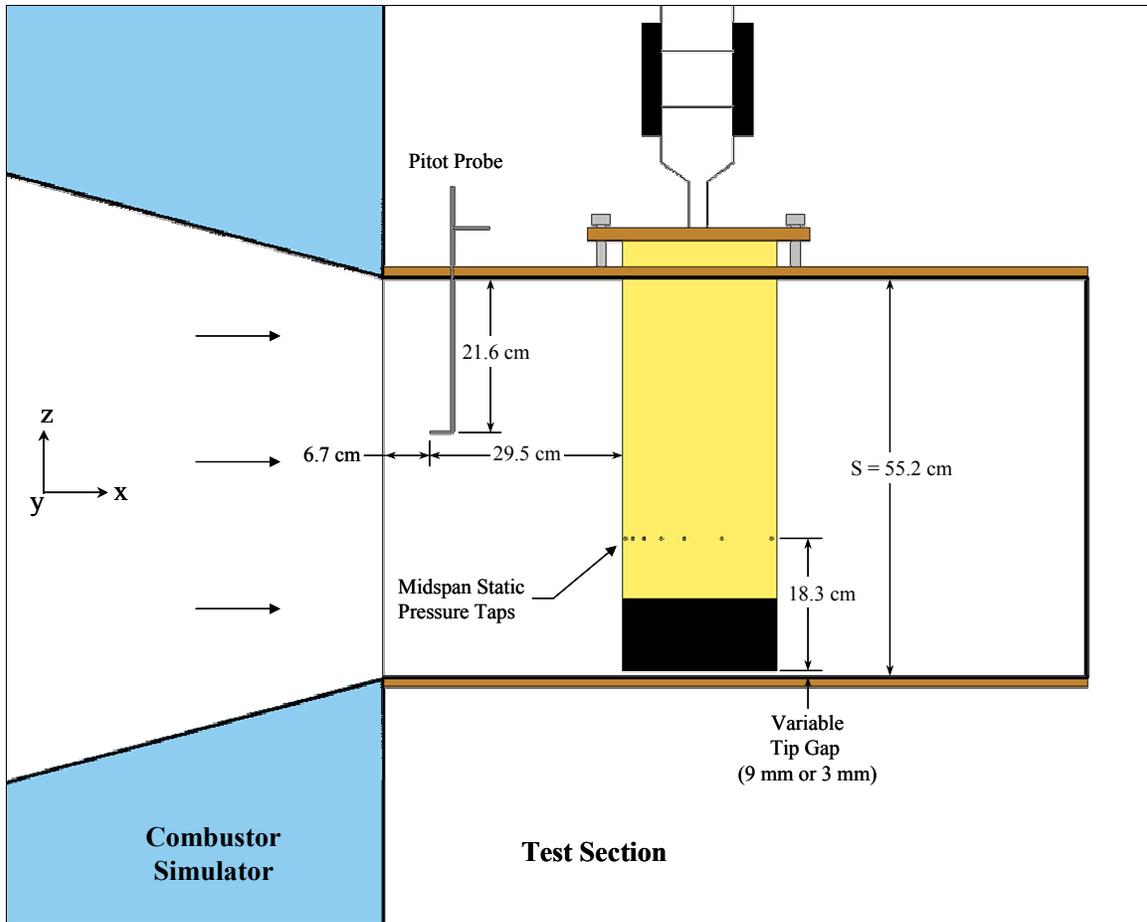
**Figure 3-22** Side view of test section showing pitot probe location used to measure inlet velocity profiles. Dynamic pressure was measured at seven equally spaced locations in the  $y$ -direction.

As a continual check of the uniformity of the test section inlet velocity, dynamic pressure measurements were made along the combustor simulator exit with a pitot probe prior to all data collection. The pitot probe was inserted into the flow through seven ports evenly spaced across the 112.0 cm width of the tunnel. The pressure reading was measured on a 0-125 Pa (0-0.5 inH<sub>2</sub>O) transducer and then converted to a velocity based on the inlet area and the density of air. Figure 3-22 shows the pitot probe location in the z-x plane. The pitot probe extended about 21.6 cm into the tunnel, which was about 39% of the full height of the combustor simulator exit measured from the top. Figure 3-23 shows a sample inlet velocity profile for one of the cases. The local and mean velocities are plotted against the measurement location in the y-direction. Inlet velocities were typically within 5% of the mean. If this were not the case, adjustments were made as necessary to the outer flow gates and FWAM's, so that conditions at the tip region were consistent for all cases.

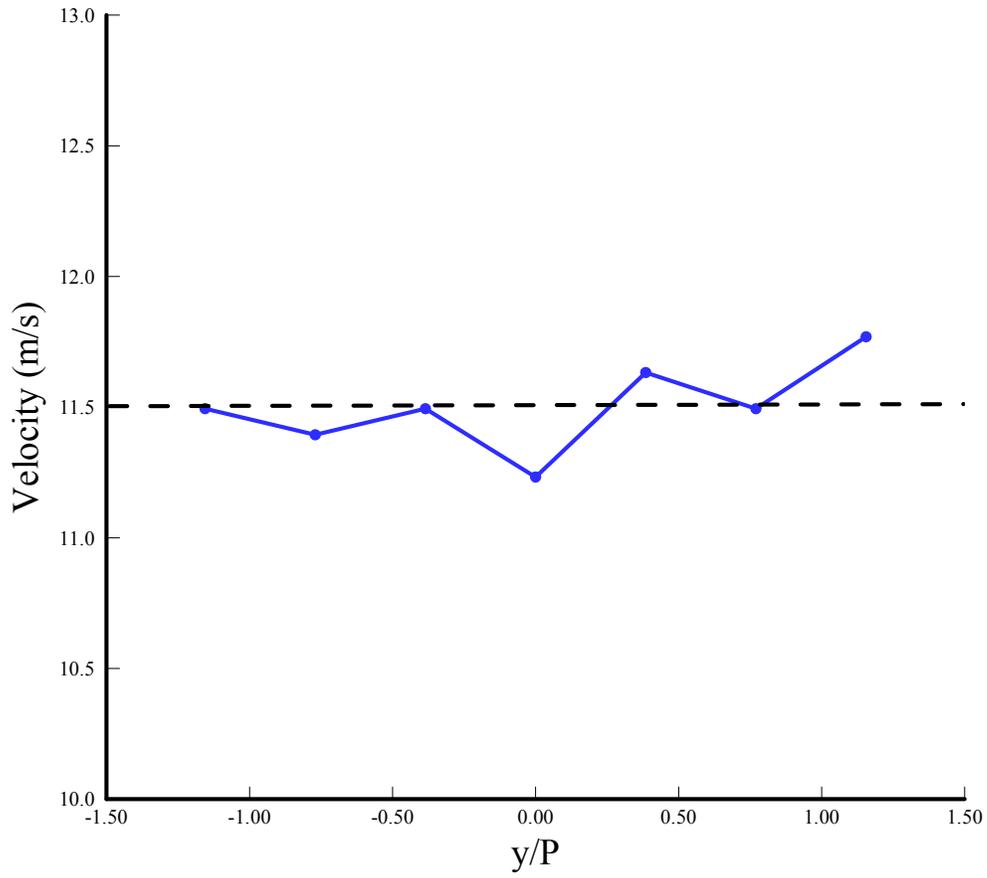
**Figure 3-23** Sample of a horizontal velocity profile at the test section inlet. The dashed line is the mean velocity.

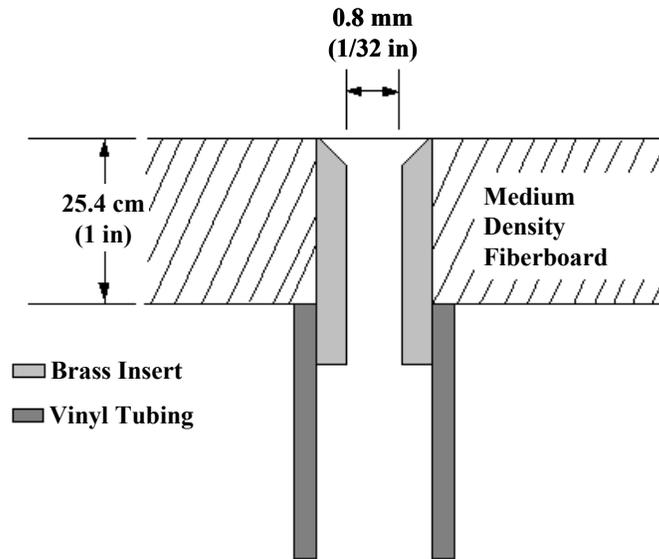
**Figure 3-24** Static pressure tap configuration for pressure measurements on the shroud and midspan pressure measurements on the blade.

**Pressure Measurements.** To better understand the leakage flow across the tip gap, static pressure readings were made along the shroud below the test blade with an array of static pressure taps. Each static pressure tap was installed across the shroud in the configuration shown in Figure 3-24. The location and quantity of taps was determined using computational predictions of the pressure distribution along the shroud with a flat tip. Pressure taps were grouped more tightly where high pressure gradients were predicted. Figure 3-25 shows 112 tap locations overlaying the predicted pressure distribution. Also shown are ten more taps that were installed after our first tests to

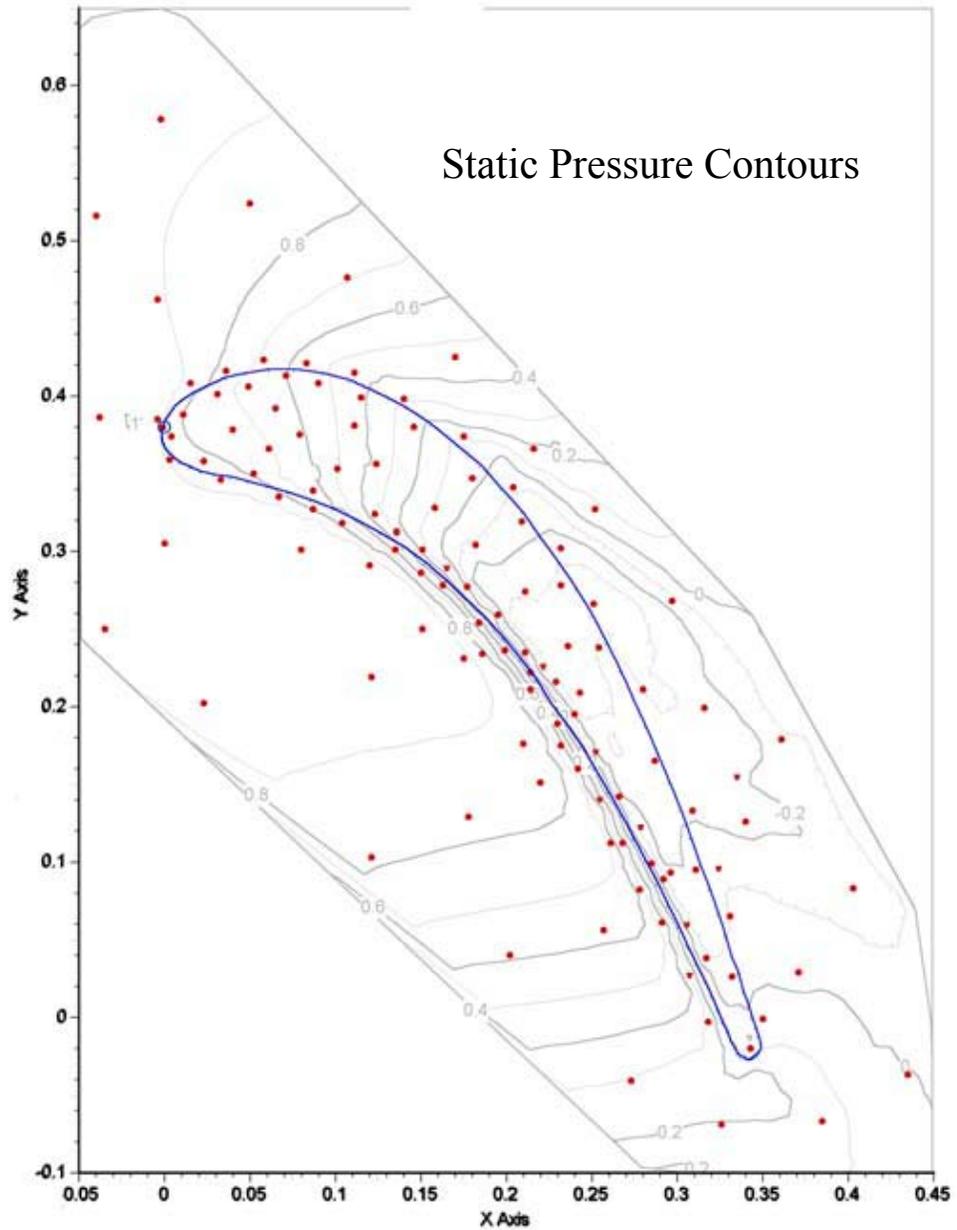
**Figure 3-25** Static pressure tap array on the shroud overlaying shroud static pressure contours. The locations of the taps are indicated with red dots which were grouped around static pressure gradients (Christophel, 2003).

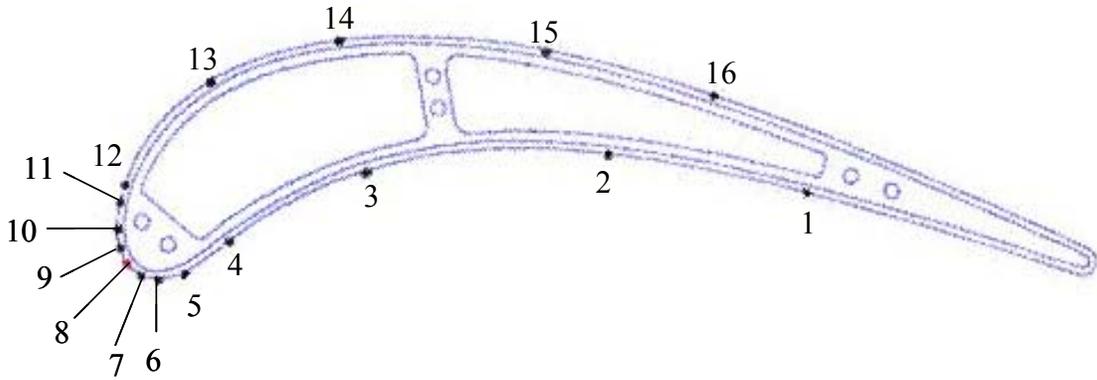
**Figure 3-26** Static pressure tap locations on the blade midspan (Christophel, 2003).

Pressure measurements were also made at the midspan on the test blade to verify that the flow was periodic about the center blade. Sixteen static pressure taps were placed along the center blade at 36% of the blade span above the tip in the same configuration as in Figure 3-24. The locations of the midspan static pressure taps are diagrammed in Figure 3-26, and their locations are listed in Appendix D. Pressure readings from these taps were used to verify that the pressure distribution around the center blade agreed with the distribution computationally predicted by Hohlfeld [2003]. Typically, the adjustable components of the test section could be set to achieve good agreement with computational predictions as shown in the sample midspan pressure distributions in Figure 3-27. The midspan pressure distributions for the highest and lowest blowing ratios are shown for two tip gaps. Values for  $C_p$  are plotted against the normalized surface distance along the blade from stagnation,  $s/s_{max}$ . The pressure side of the blade ranges from  $s/s_{max} = -1$  to 0, and the suction side ranges from  $s/s_{max} = 0$  to 1. For all cases the experimental midspan pressures match closely to the predicted values along the pressure side and around the stagnation location. However, with the large tip gap the experimental  $C_p$  values are higher (smaller negative values) on the suction side than the predicted values. This is likely due to the fact that a periodic boundary condition does not exist at the flexible wall near the suction side of the blade as it does in the computer model. Therefore, the greater leakage flow through the large tip gap contributed to lower pressures on the suction side. The test section flow settings were adjusted to improve agreement with predicted values, but perfect agreement could not always be achieved due to the limited the range of motion of the FWAM's and bleed gates.

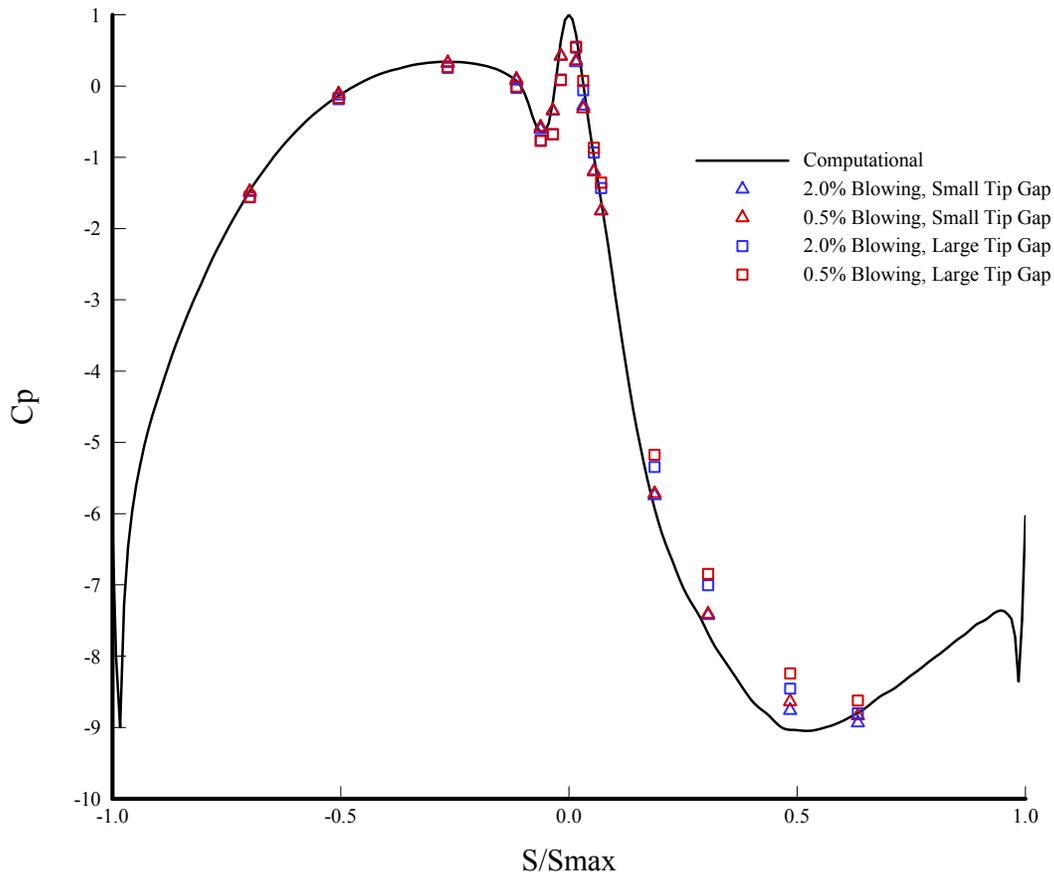
**Figure 3-27** Comparison of experimental midspan pressure distribution to computational predictions.

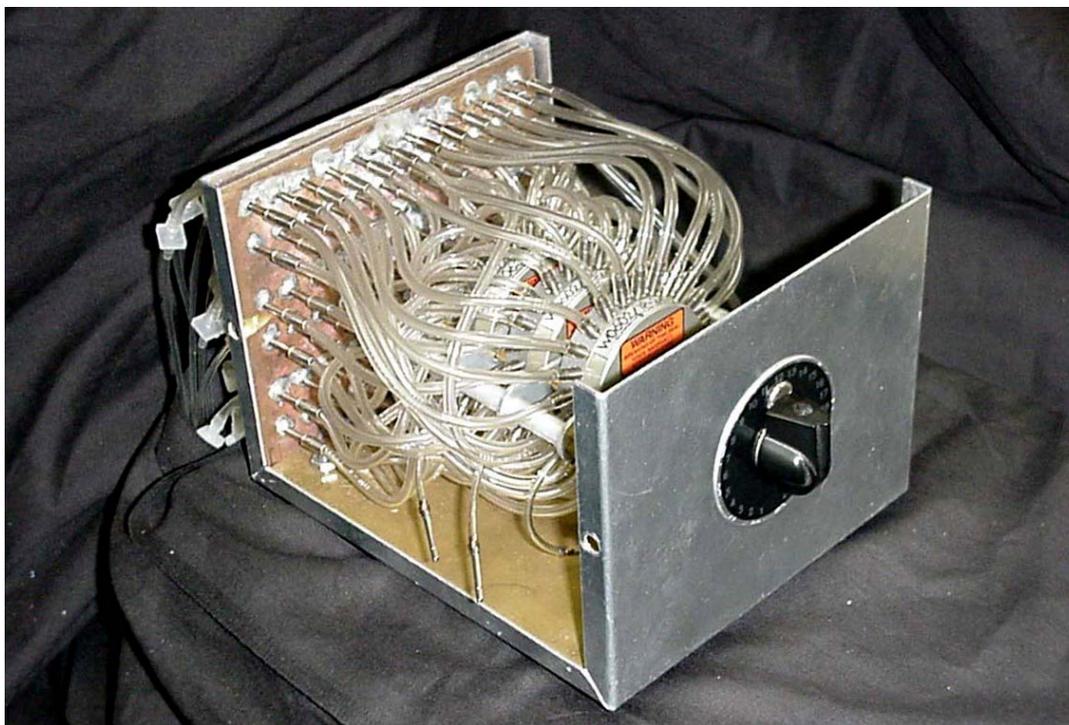
**Figure 3-28** Scanivalve wafer and box (Vakil, 2002).

The midspan and shroud pressure taps were routed to a Scanivalve wafer through 1.6 mm (0.063 in) ID vinyl tubing. This tubing was distributed by the Scanivalve Corporation as part number VINL-063. The Scanivalve wafer shown in Figure 3-28 allows different pressure channels to be read at the turn of a knob. Six Scanivalve wafers with each having 24 different ports served as junctions to the transducer box. The transducer box, shown in Figure 3-29, housed eight transducers that measured pressure differences and expressed them as voltage on a 0 - 5 V range. Table 3-2 lists the pressure

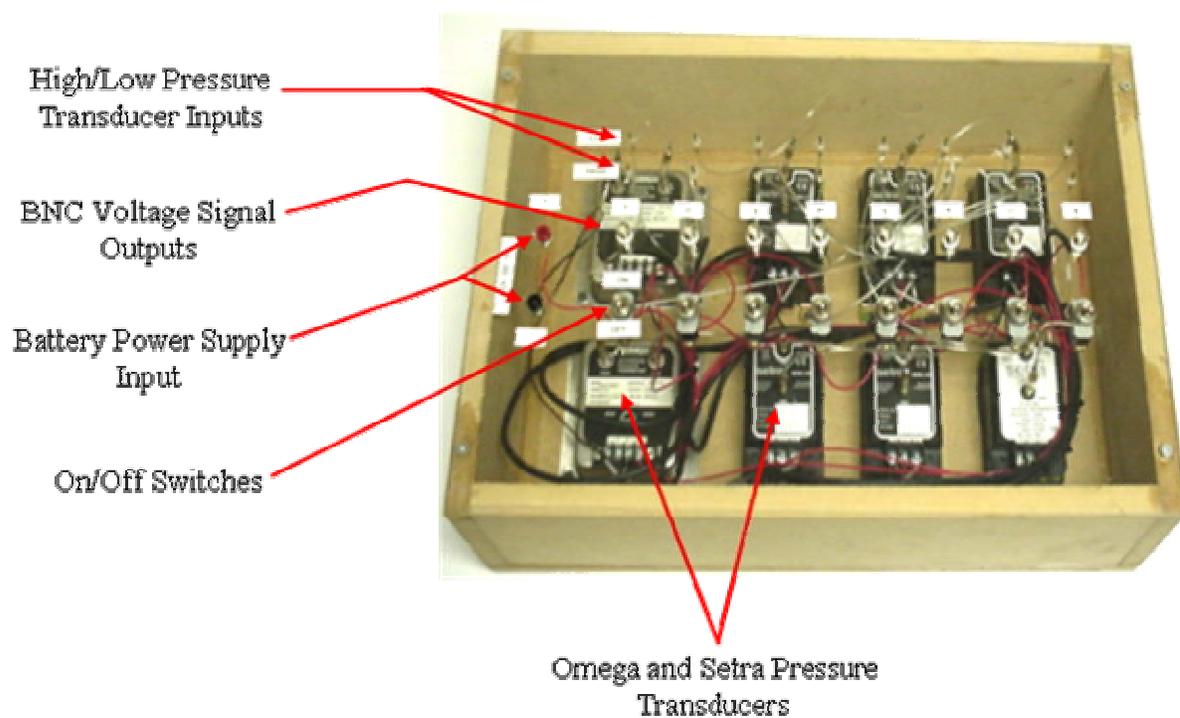
**Figure 3-29** Transducer box. (Vakil, 2002).

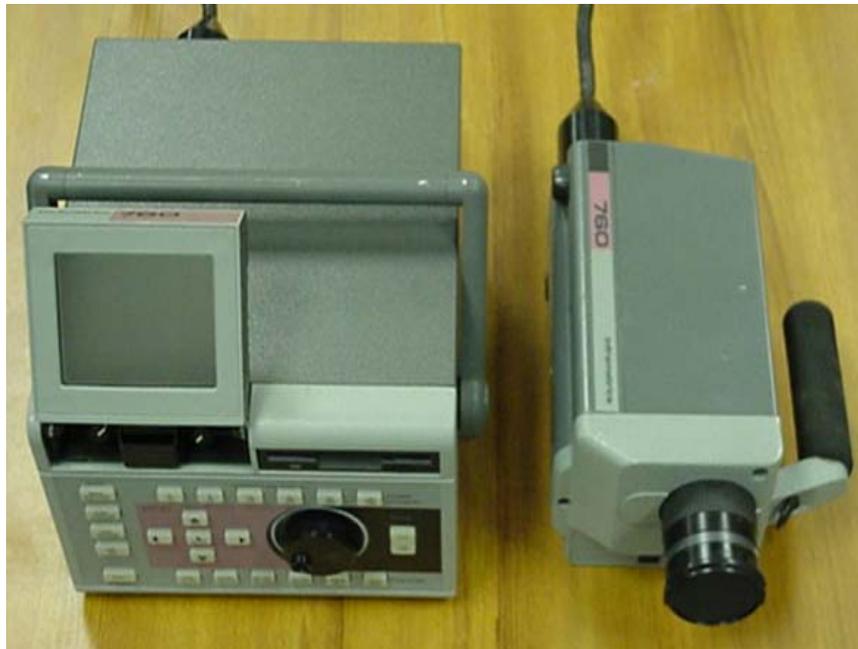
**Figure 3-30** Infrared camera.

**Temperature Measurements.** Surface temperatures on the tip of the blade were measured with the Inframetrics model 760 infrared camera pictured in Figure 3-30. To reduce levels of uncertainty, the camera was set to record images that were averages of sixteen temperature readings. The uncertainties in the infrared camera measurements are discussed in Section 3.4. The camera made tip temperature measurements through a window that passed infrared wavelengths. This window had to be part of the shroud and, thus, be large enough to image the entire tip surface. However, many infrared transmissive materials are so expensive that the cost of such a large window rendered this option infeasible.

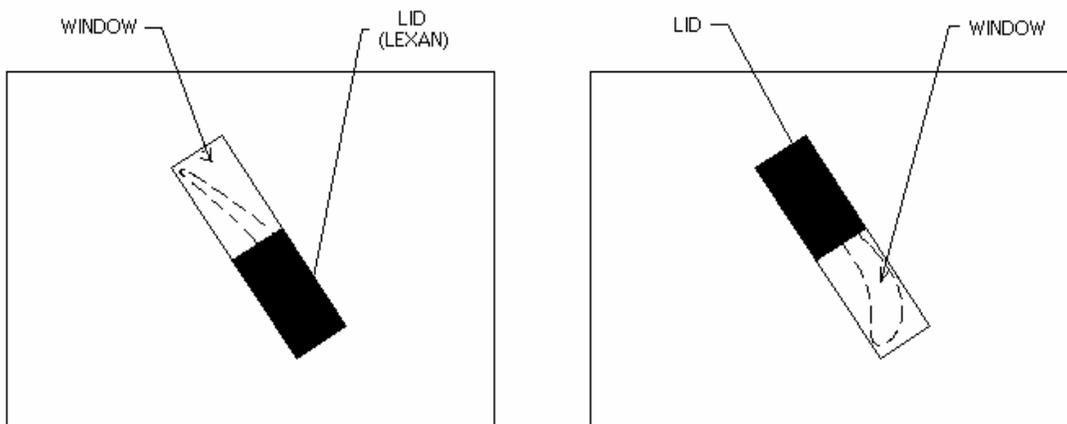
**Figure 3-31** ZnSe window configurations to image blade tip.

A second purchase was made that was less likely to break but offered less transmissivity. The REFLEX Analytical Corporation manufactured a Zinc Selenide (ZnSe) window which passed the 8 to 12  $\mu\text{m}$  wavelength range at about 70% transmissivity. We were able to purchase two 10 mm (0.39 in) thick, 15.2 cm x 15.2 cm (6 in x 6 in) windows that together could cover half of the blade. The two ZnSe windows

were placed inside an aluminum frame to protect them from the stresses caused by the thermal expansion of the lexan shroud during tests.

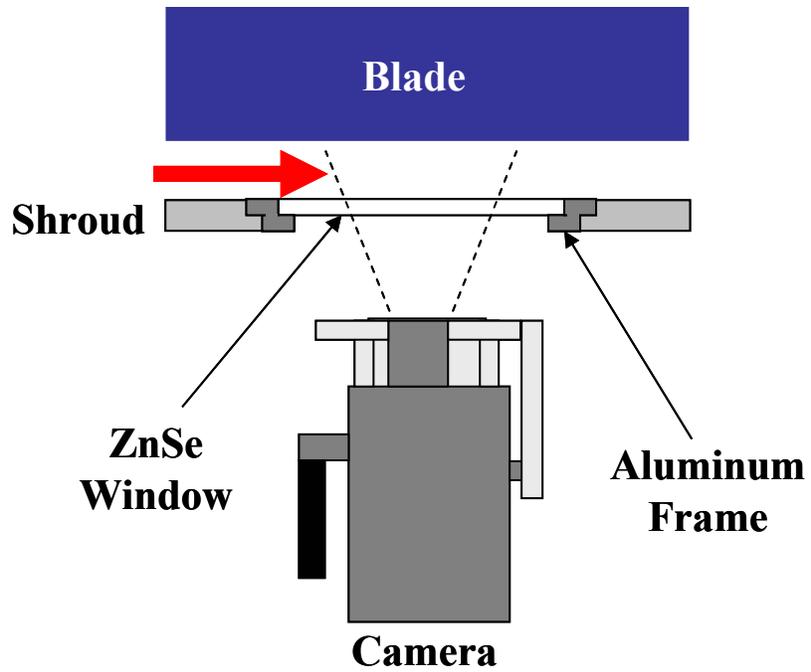
**Figure 3-32** Infrared camera imaging the blade tip.

The camera was positioned under the window as depicted in Figure 3-32. The camera viewing angles of  $20^\circ$  and  $15^\circ$  formed a rectangular viewing area with side lengths determined by

where  $a$  and  $b$  are the lengths of the viewing area sides and  $L$  is the distance from the camera lens to the tip surface. The camera lens was positioned 54.6 cm (21.5 in) from the tip, so that the resultant 19.0 cm x 14.3 cm (7.49 in x 5.63 in) viewing area covered at least a fourth of the blade. The camera recorded this viewing area to disk as a 255 x 206

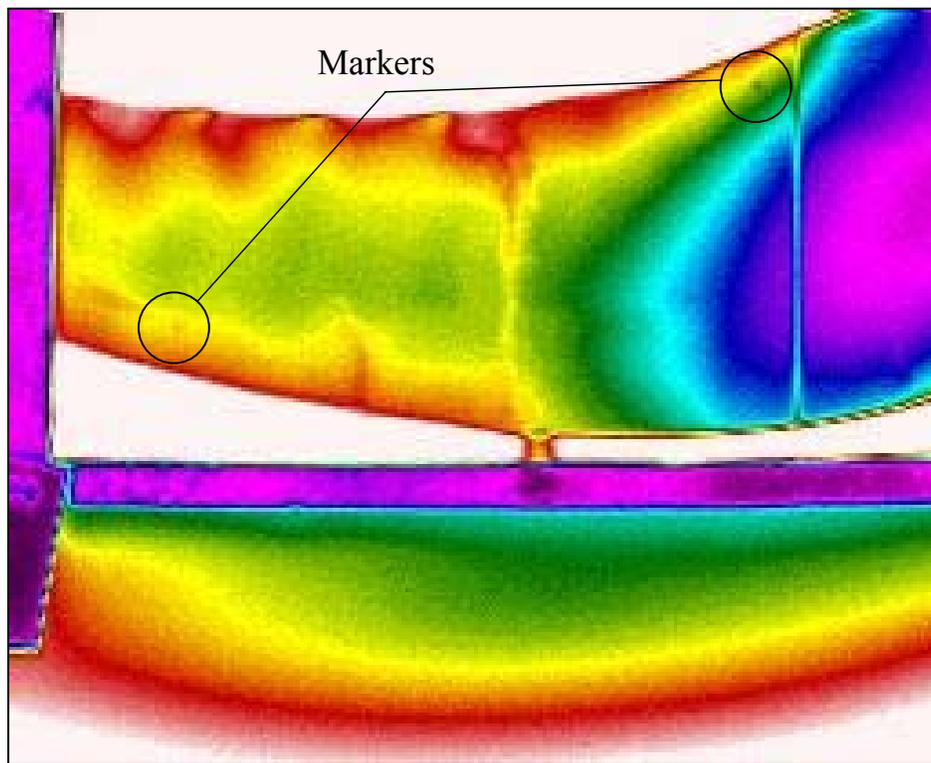
**Figure 3-33** An infrared camera image of the alumina tip before any post processing.

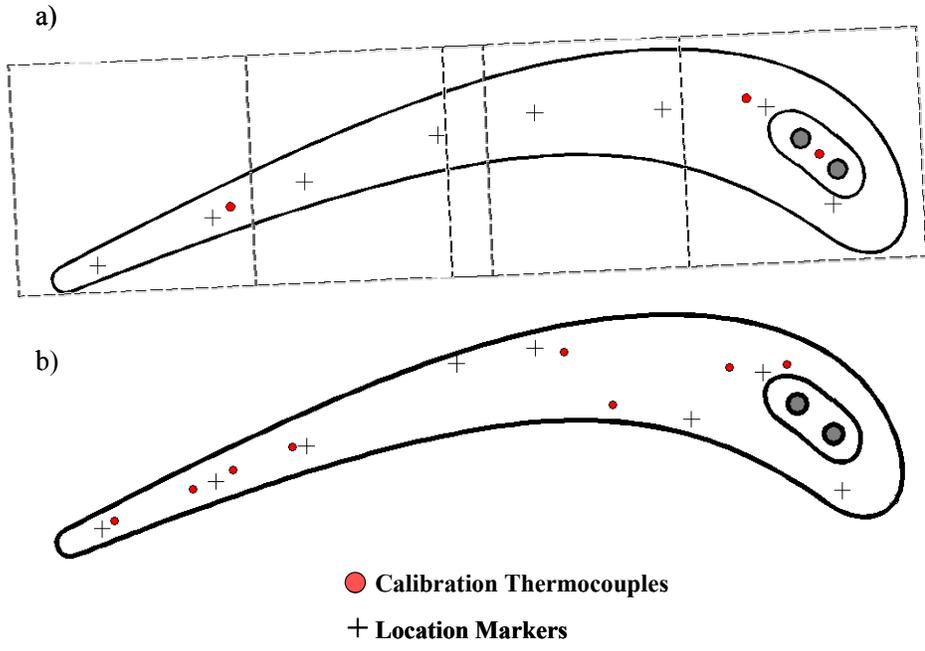
**Figure 3-34** Marker and thermocouple locations for a) foam tip and b) alumina tip. The dashed lines show the areas that are imaged through the ZnSe windows.

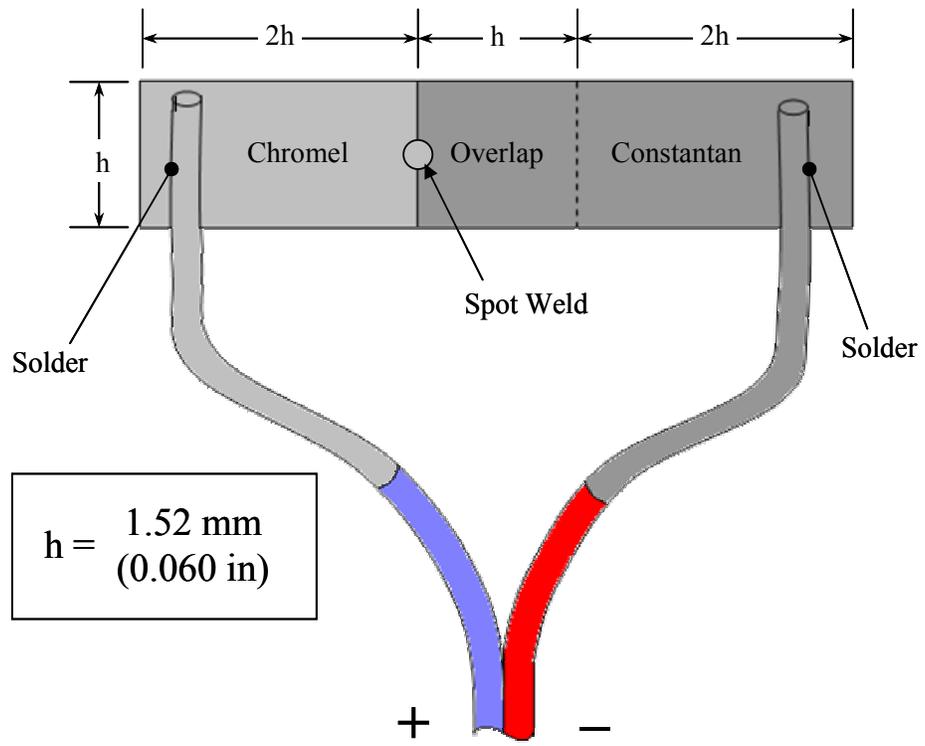
**Figure 3-35** Layout of a thermocouple constructed from flat ribbons of chromel and constantan.

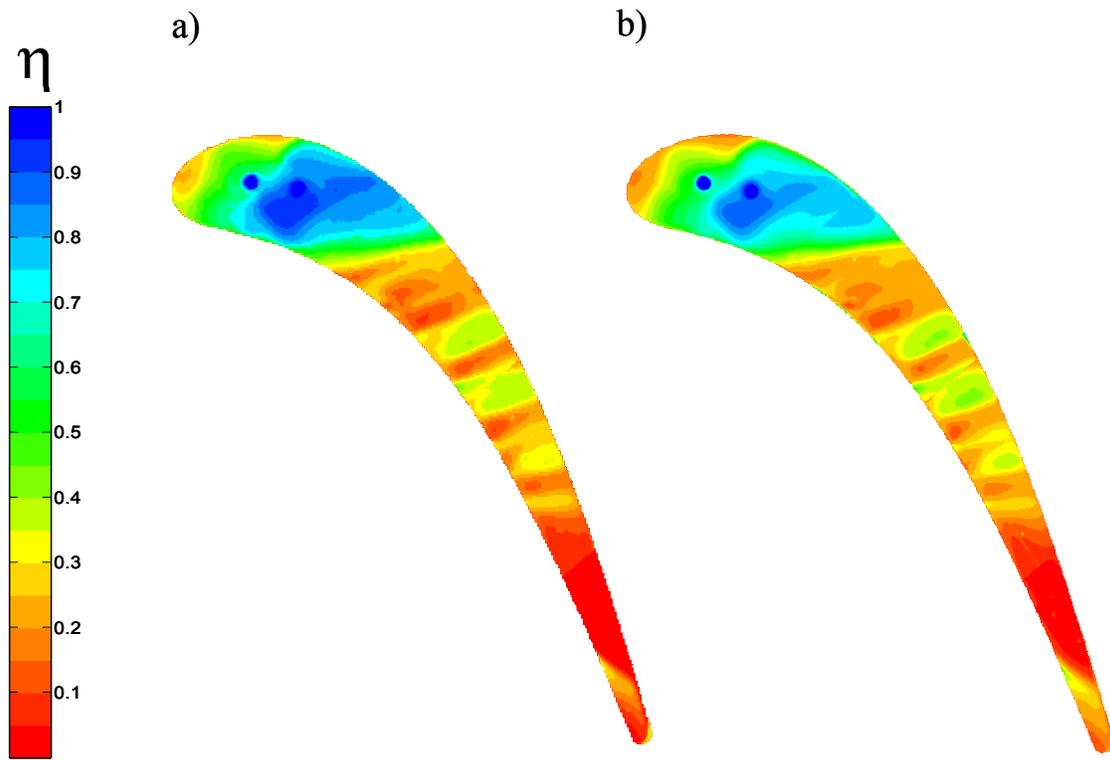
**Figure 3-36** Repeatability results for adiabatic effectiveness. Tests were run with a large tip gap with 1.0% blowing from the microcircuit and dirt purge holes.

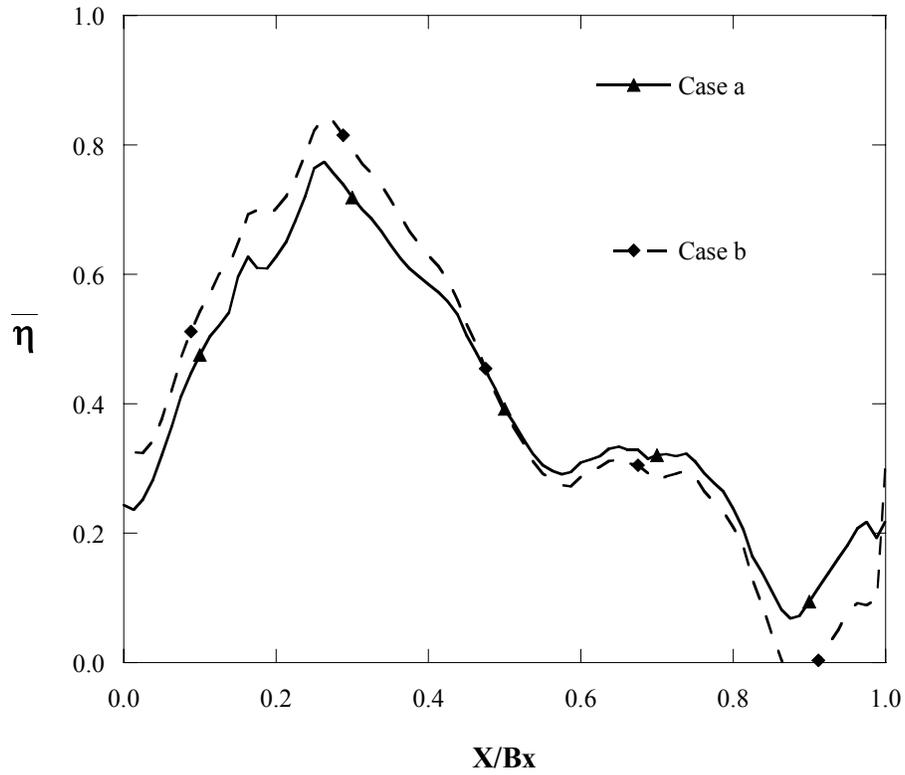
**Figure 3-37** Lateral averages of the repeatability results for adiabatic effectiveness with a large tip gap at 1.0% blowing from the microcircuit and dirt purge holes.
