## **Chapter 3: Experimental Facilities and Instrumentation**

### **3.1 Wind Tunnel Facility**

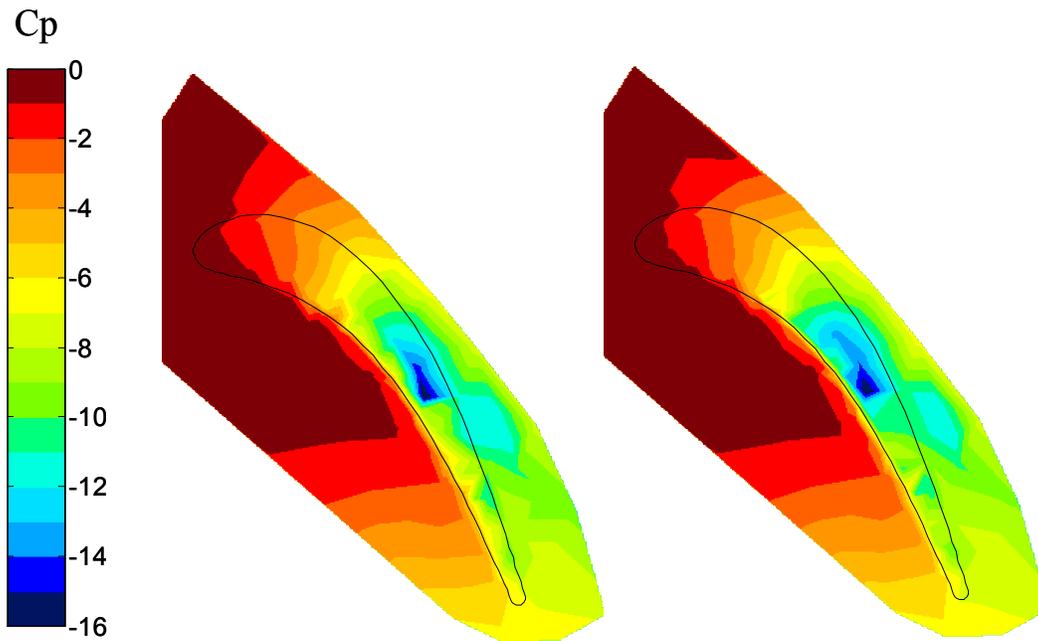
**Figure 3-38** Repeatability results for pressure distribution on the shroud. Tests were run with a large tip gap with no blowing.
