**CORROSION IN NEW CONSTRUCTION: ELEVATED
COPPER, EFFECTS OF ORTHOPHOSPHATE INHIBITORS,
AND FLUX INITIATED MICROBIAL GROWTH**

Thesis submitted to the Faculty of the
Virginia Polytechnic Institute and State University
in partial fulfillment of the requirements for the degree of

Master of Science
in
Environmental Science and Engineering

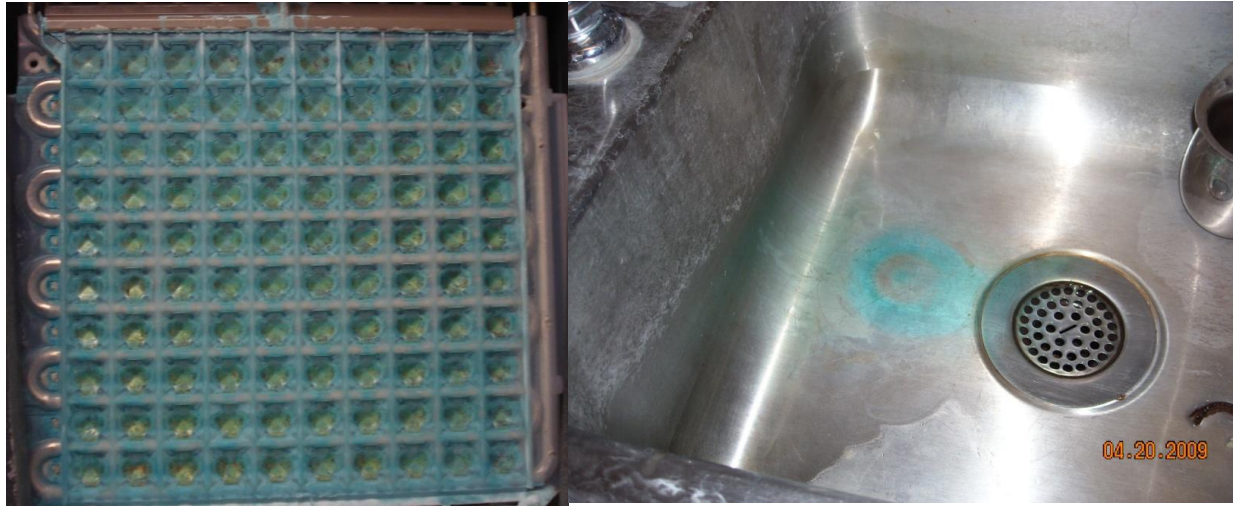
Figure 1-1. Pictures of blue ice cubes from Miami Public School and blue staining in sink.

Virginia Tech was contacted in March, 2009 to assist in resolving a problem with excessive blue water and ice staining in a newly constructed Miami elementary school. The blue water caused aesthetic concerns for parents of students attending the school, faculty, and students themselves. Bottled water had to be purchased by the school which became both a financial and environmental burden. School officials provided pictures of the blue ice cubes and the staining that occurred in the sinks as a result of the blue water (Figure 1-1). There are two newly built schools of similar age within this school/water system and only one is experiencing blue water. The particular school with the problem is 1.5 years old and sits at the end of a 1.5 mile water main of which the school is the only user. School officials initially hypothesized that the problem could be attributed to lightning striking the school or grounding.

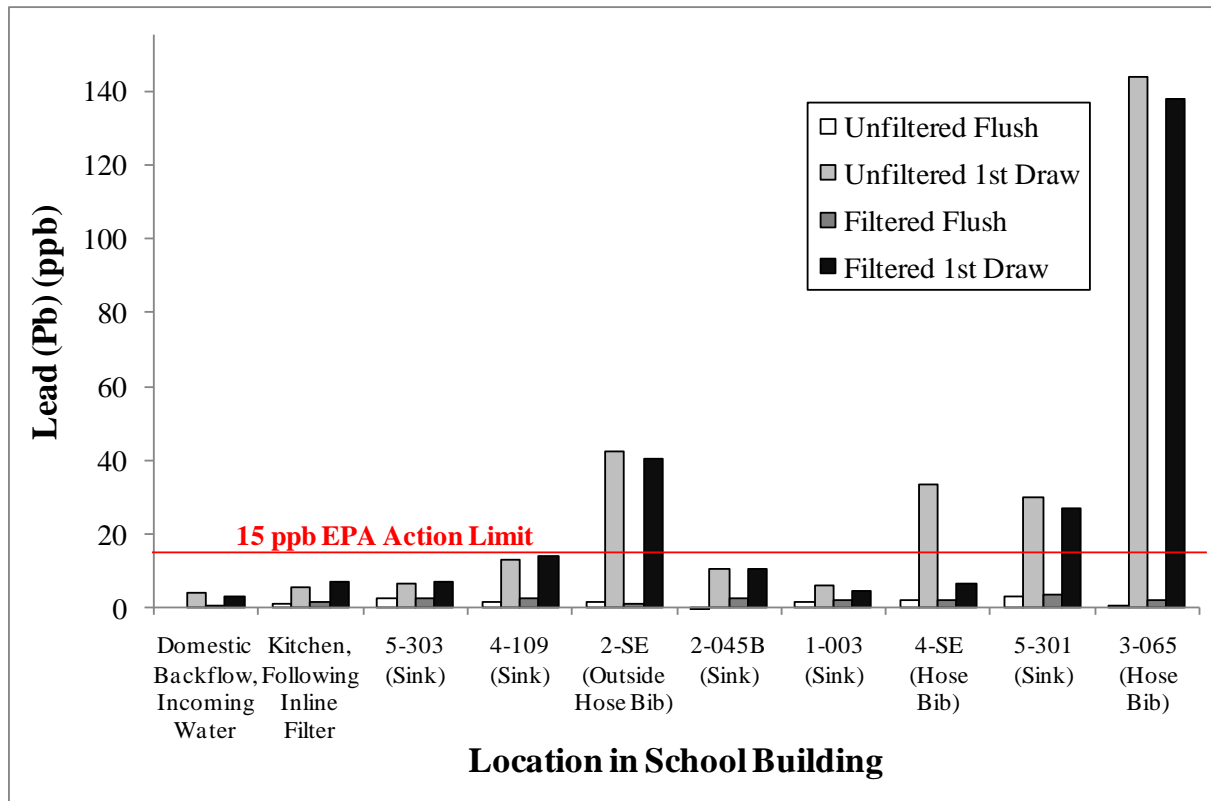
Figure 1-2. Lead Concentration in water from Miami Public School.

A school official took chlorine measurements at 10 different locations throughout the school and sent us the results. The chlorine levels indicated an extremely low level of disinfectant in flushed samples (Figure 1-3). Low chlorine levels are probably due to the fact that the school is located so far from the main distribution line. Microbial monitoring results indicated the presence of SRB and HAB in the water, but overall relatively low microbial activity was found in the school water (Table 1-1) despite the low chlorine concentrations. Lead concentrations were measured and in four of the ten sampling locations the concentrations of lead in the water exceeded EPA's Lead Action Limit of 15 ppb (Figure 1-2).

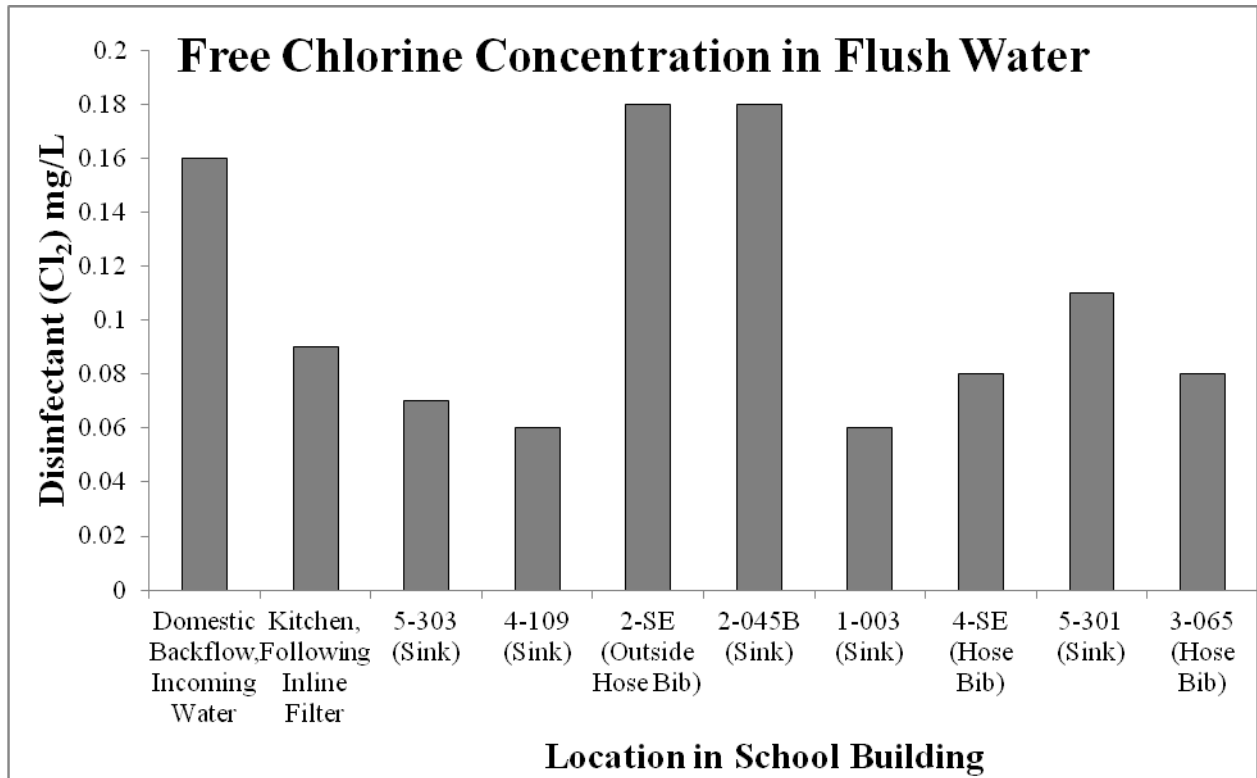
Figure 1-3. Disinfectant (free chlorine) concentration in Miami Public School flush water (water was flushed for 10 minutes).

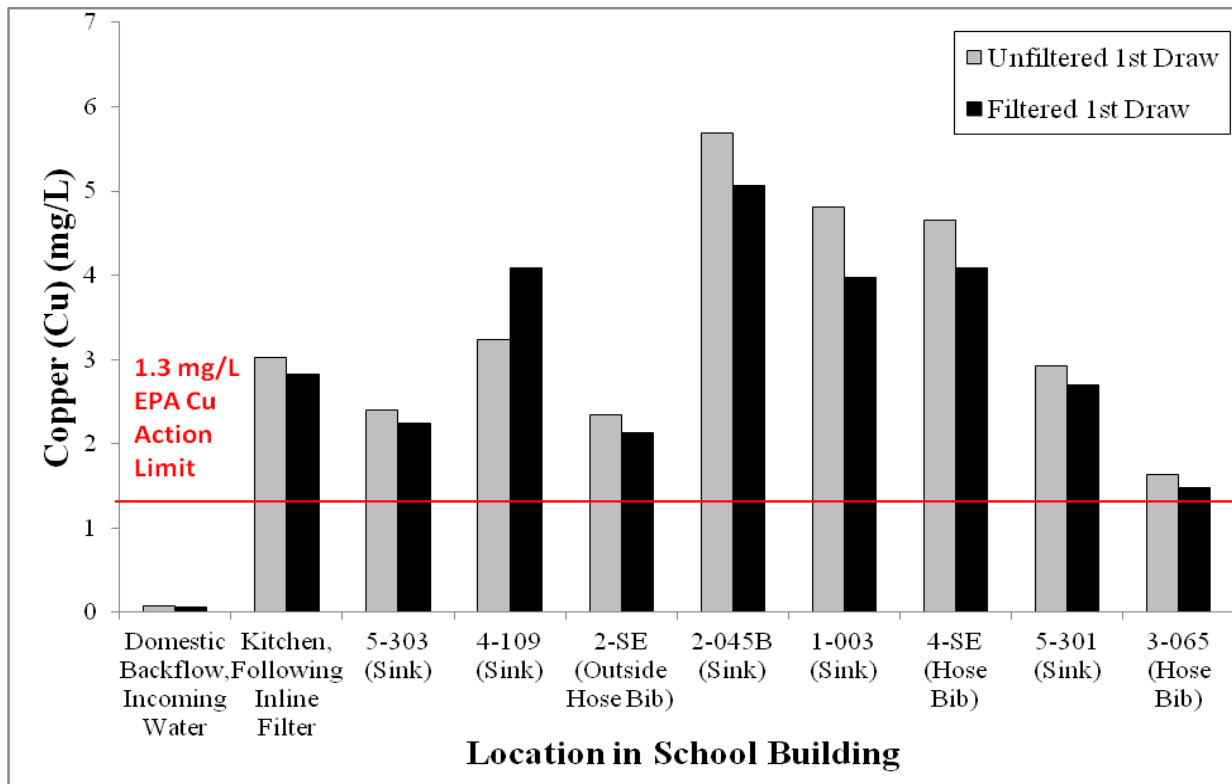
Figure 1-5. Copper concentrations in first draw filtered and unfiltered samples showing copper concentrations exceeded EPA Action Limit in nine out of the ten locations.

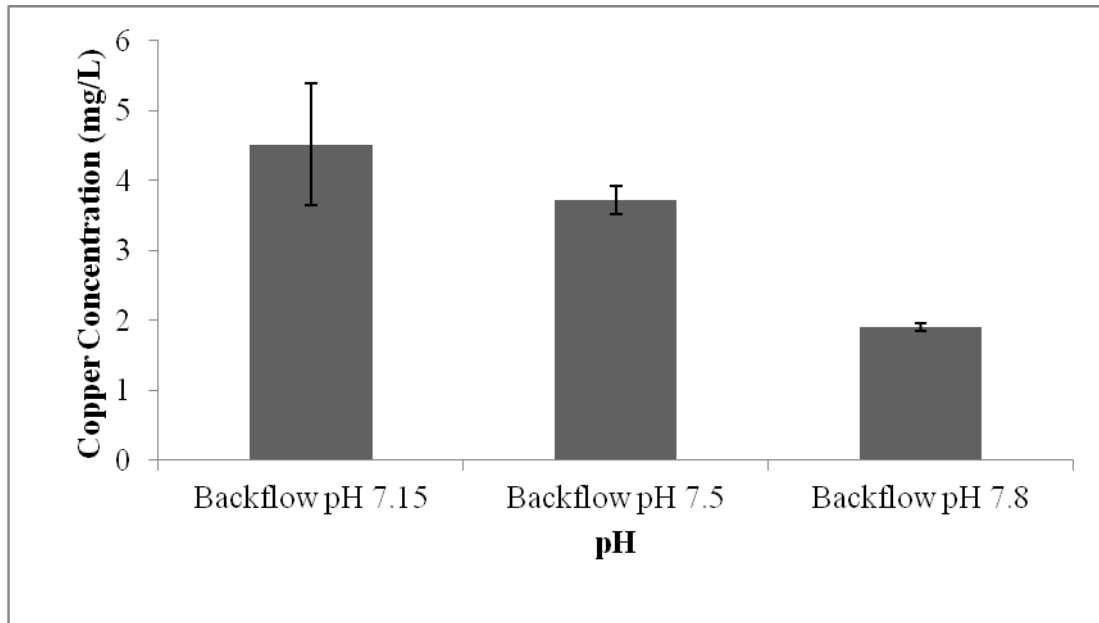
Figure 1-6. Copper release relative to water pH (error bars represent 95% confidence).

A study was conducted to test the hypothesis that increasing the pH would cause a decrease in copper leaching. Three sets of triplicate pipes were used and pH levels of 7.15, 7.5 and 7.8 were tested. These pH levels were used because they fall within the pH range that was observed in the school (Figure 1-4). An average was determined for each set of triplicates and error bars represent the standard deviation within each set (Figure 1-6). The results confirmed that the copper concentration decreased as the pH increased. The pipes with a pH of 7.15 had 2.4

times higher copper concentrations compared to the pipes held at pH 7.8. The pipes with a pH of 7.5 showed a decrease in copper concentration compared to the lower pH of 7.15, but the results were not as dramatic as observed for the pH 7.8 pipes.

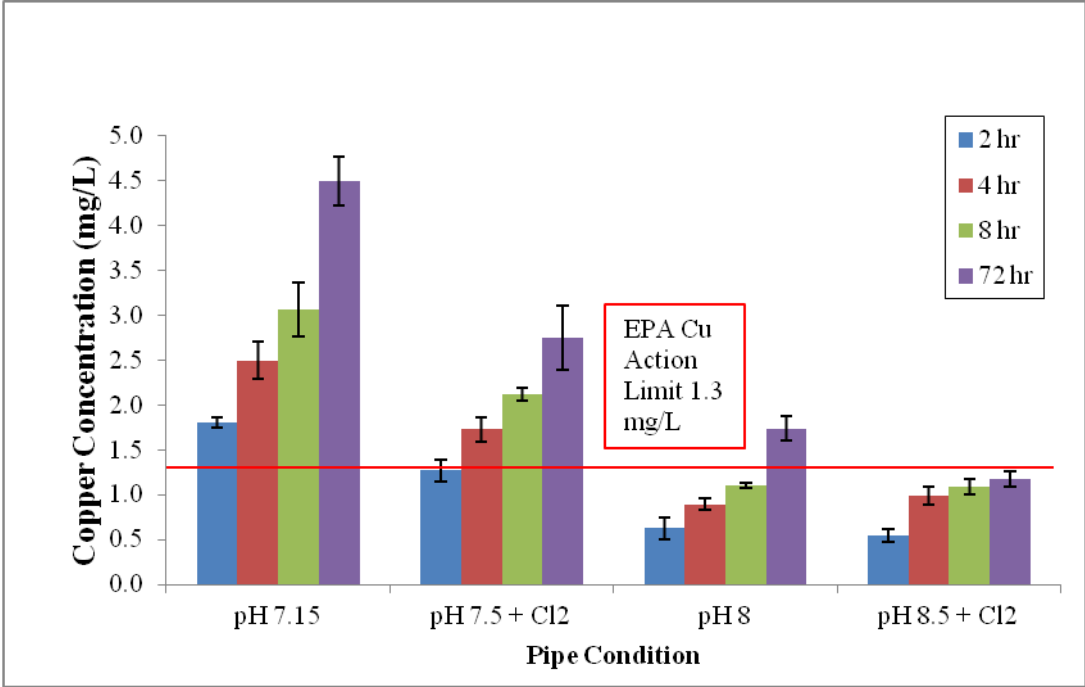
Figure 1-7. Copper release relative to time (error bars represent 95% confidence).

Copper release as a function of time was also considered. Water quality conditions for this experiment were pH 7.15, pH 7.5 + 0.5 mg/L chlorine, pH 8.0, and pH 8.5 + 0.5 mg/L chlorine. These parameters were used in order to examine a wide range of pH levels and to consider the effects that chlorine has under these conditions. After each water change, water samples were taken at 2 hours, 4 hours, 8 hours, and 72 hours for ICP-MS analysis.

A low pH and longer contact time with copper pipe corresponds to higher copper levels in the water (Figure 1-7). The copper levels at 2 hours were below the EPA Copper Action Limit in three of the four conditions. When 72 hours had passed the copper levels had increased by more than a factor of two for all conditions. The copper concentrations exceeded the EPA Copper Action Limit in three out of the four conditions after 72 hours. On the basis of these results it was believed that raising pH to 7.8 would be effective in reducing copper levels below 1.3 mg/L. Unfortunately, when chemical feed was tested to adjust pH to this range, the chemical feed nozzles clogged rapidly due to precipitation of calcite (Figure 1-9 and 1-10), making it desirable to find other remedial strategies.

- Stagnation time has a dramatic effect on the amount of copper that gets released into the water (Figure 1-7). If water is left stagnant in a copper pipe system for a long period of time, the amount of copper that inevitably leaches into the water will also increase. In order to reduce the amount of copper in the school's water, flushing the system is recommended after long periods of stagnation.

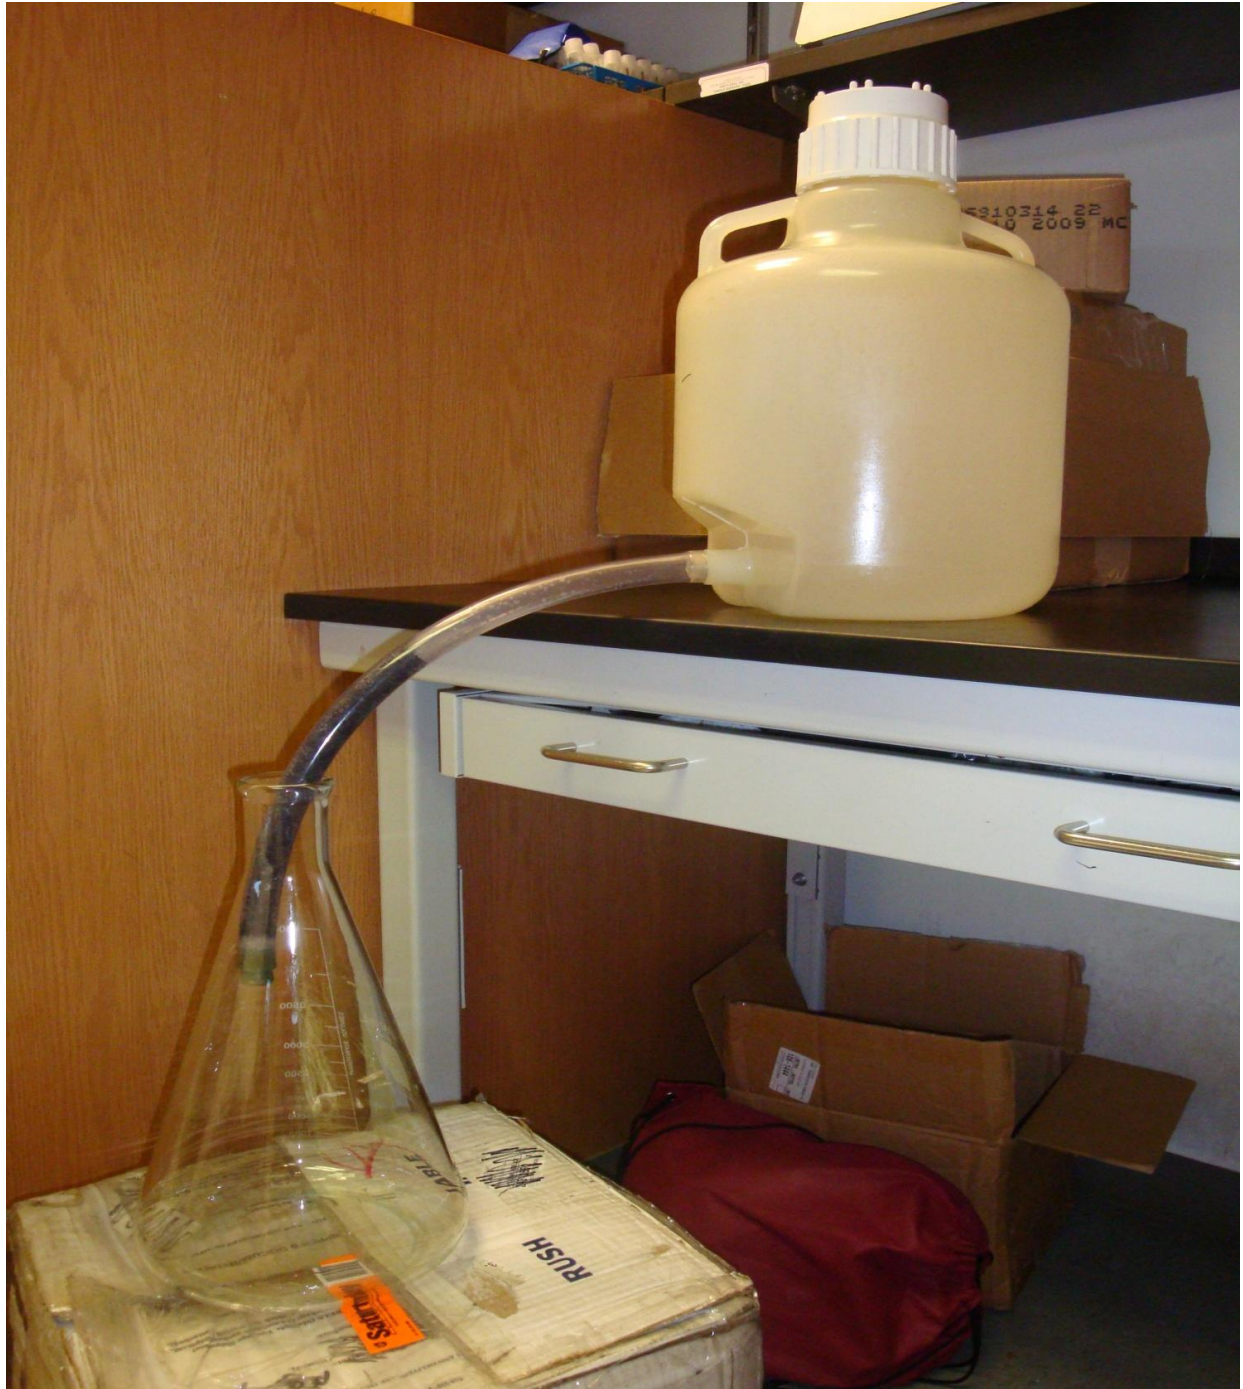
Figure 1-8. Carbon filtered water filter.

A follow up bench-scale experiment was performed comparing the benefits of orthophosphate inhibitor and carbon filtered water in terms of copper leaching. A condition using carbon filtered water was used because the groundwater in question had high TOC, which interferes with aging of copper pipes [3]. A granular activated carbon filter was prepared using a two foot section of tygon tubing. A plastic stopper with a small hole drilled into it sealed the bottom of the tubing, a one inch layer of glass wool was placed above the stopper, and then an eight inch layer of activated carbon was placed above the glass wool (Figure 1-8). The Miami water was filtered through the carbon filter two times and TOC measurements showed that 70% of the carbon and 72% of the UV₂₅₄ was removed from the water.

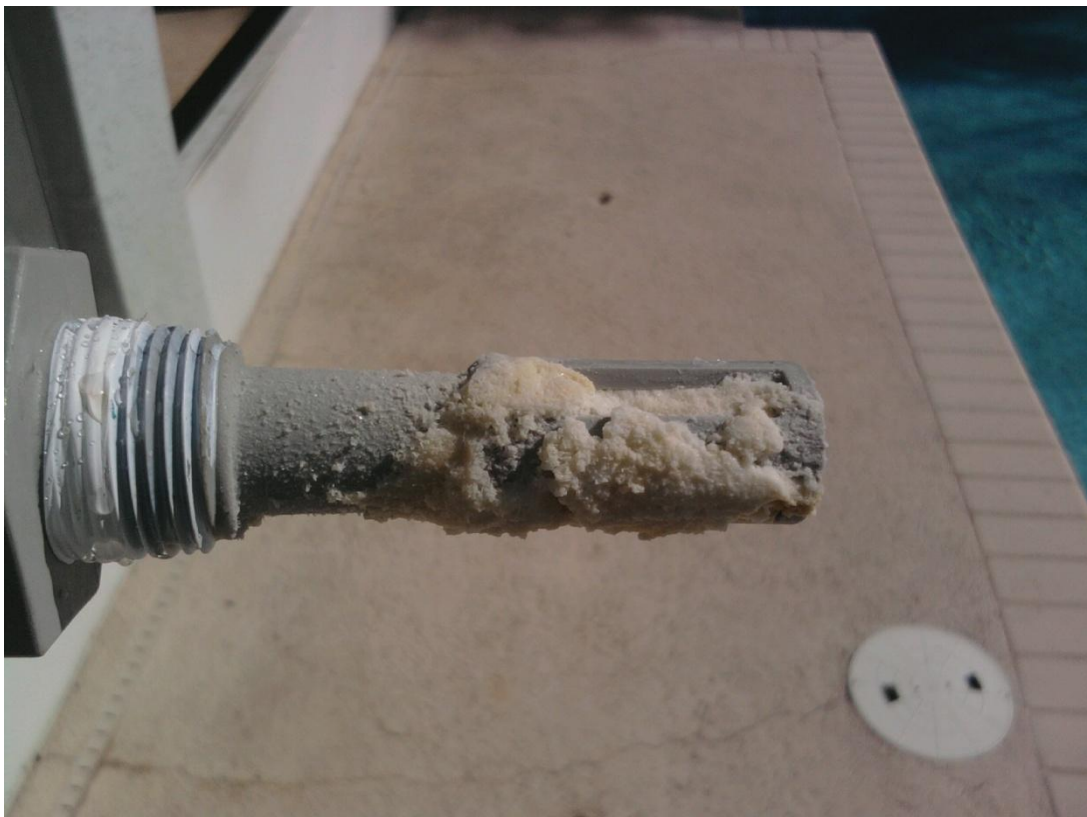
Figure 1-10. Calcite scale in Miami Public School.

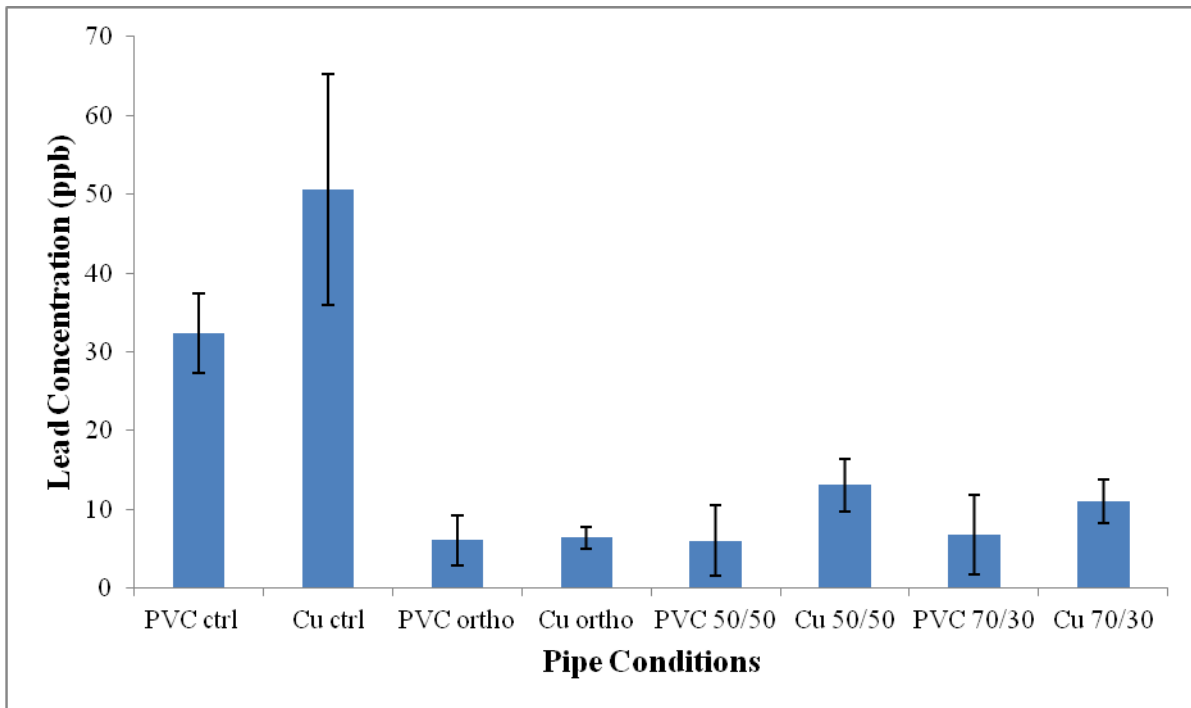
Figure 2-3. Lead release for copper pipe galvanically connected to brass rod (error bars represent 95% confidence).

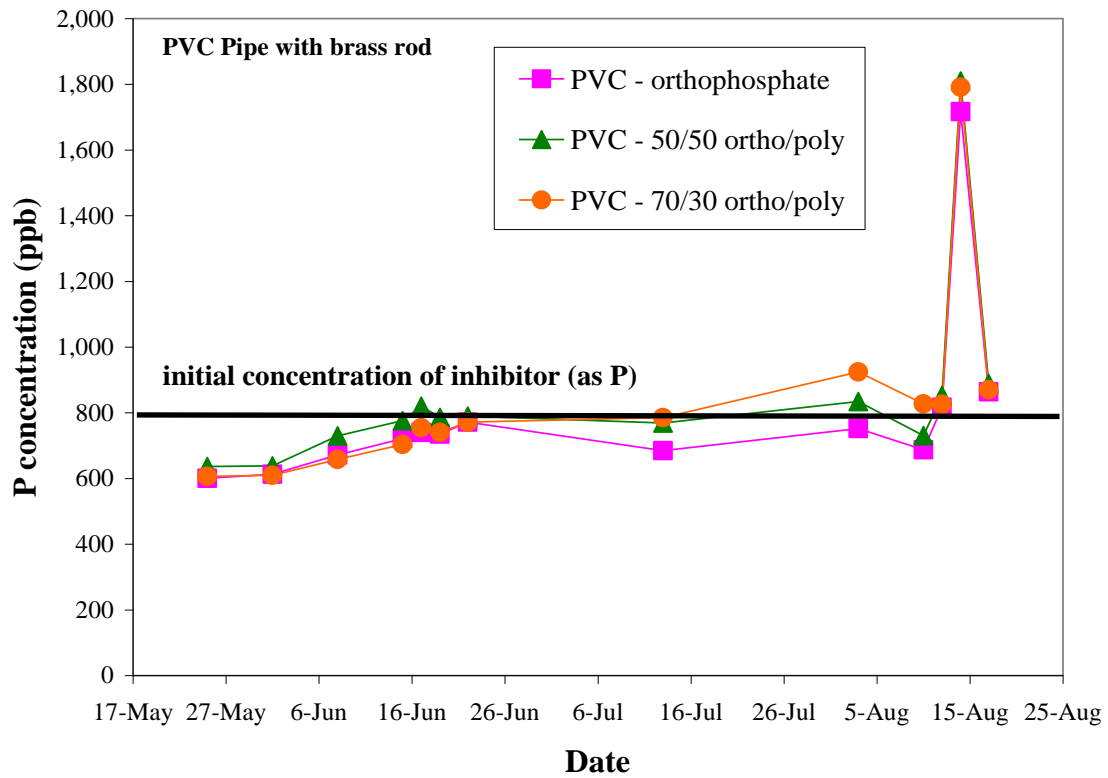
Figure 2-6. Phosphorus concentration as a function of time for PVC pipe with inserted brass rod. There is a little uptake of phosphorus early in the experiment; however, after 3 weeks no further uptake was observed. Spike was caused by improper dosing.

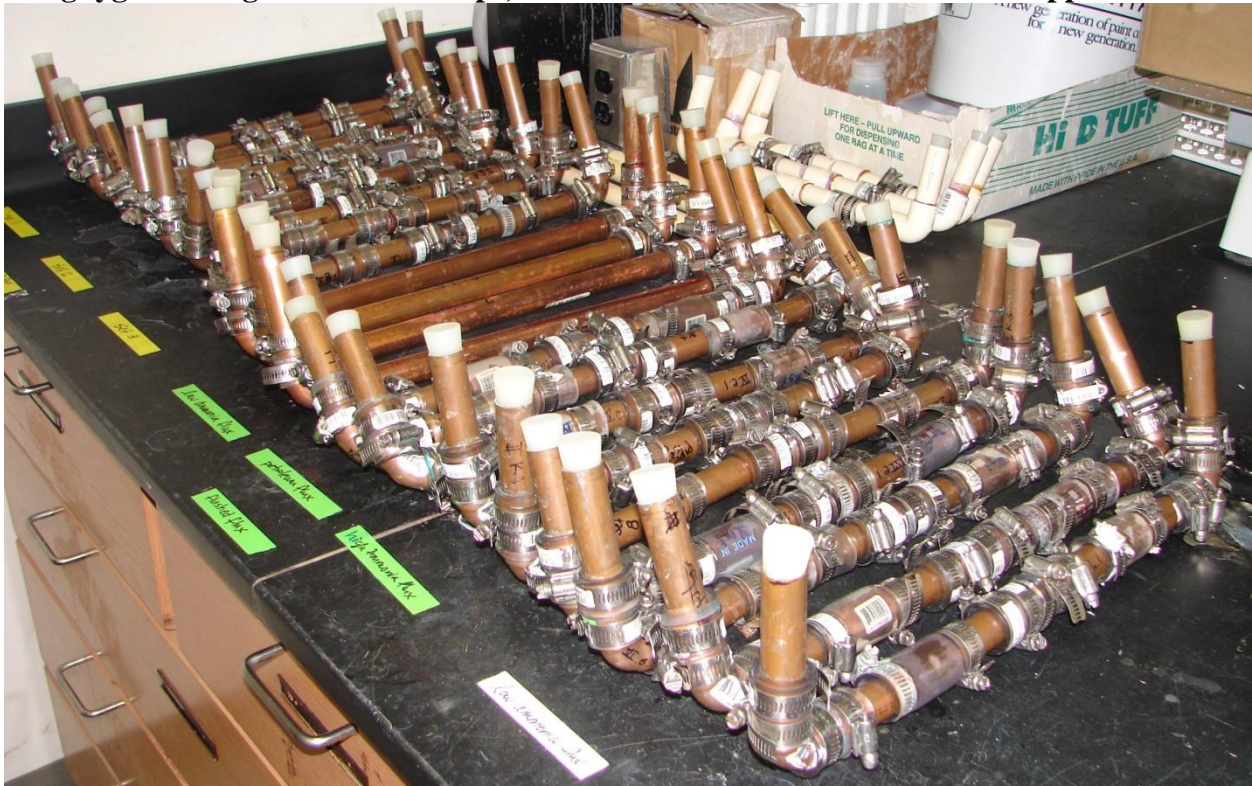
Figure 3-2. Complete set of pipes used in flux experiment.

The three types of flux were tested in pipe rigs in a variety of methods including: 1) very high flux application without any flushing, 2) very high flux application that had been thoroughly flushed for one week, and 3) no flux at all. One gram of flux was used to solder each individual joint together and therefore each copper pipe assembly contained a total of six grams of flux and 200 mL's of water. Triplicate pipes were tested at each condition making 27 tests total (Figure 3-2). A parallel experiment used a set of PVC pipes with joints glued together as an additional control.

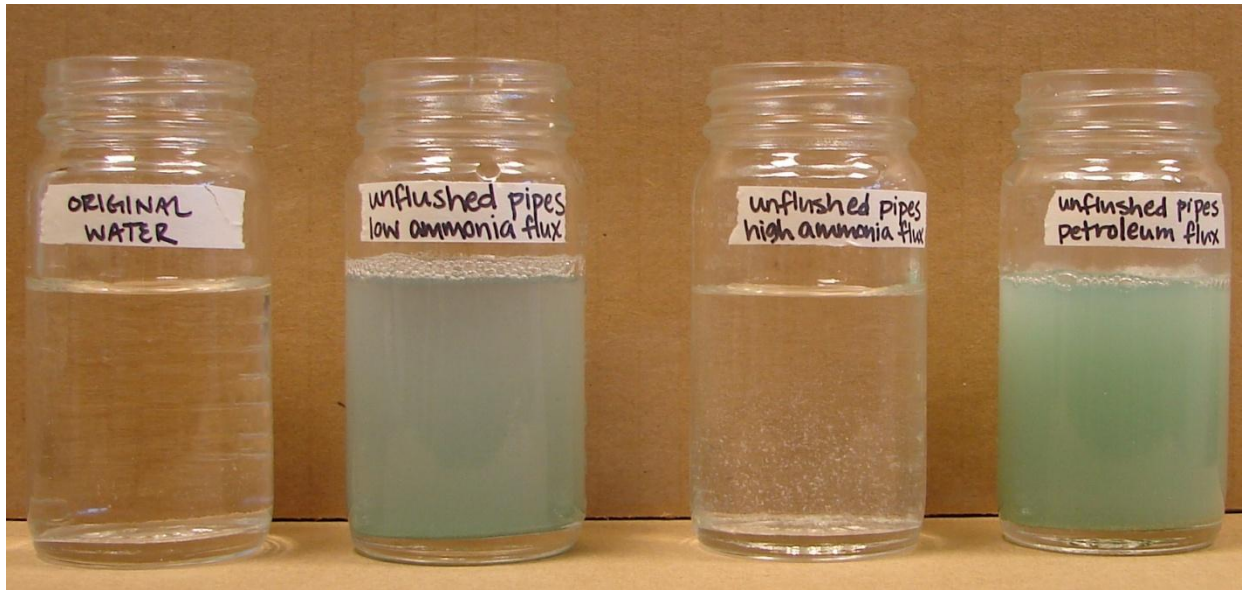
Figure 3-3. Visible effects of flux on water after an initial three week stagnation period in unflushed copper pipes.

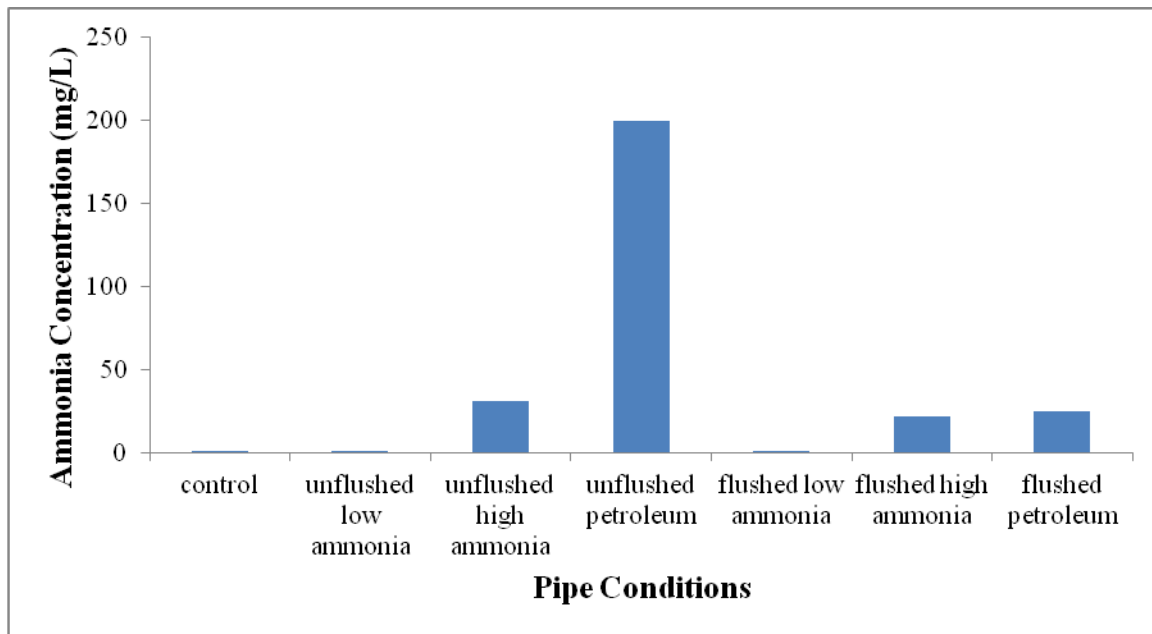
Figure 3-4. Ammonia concentrations in pipe conditions after three week stagnation.

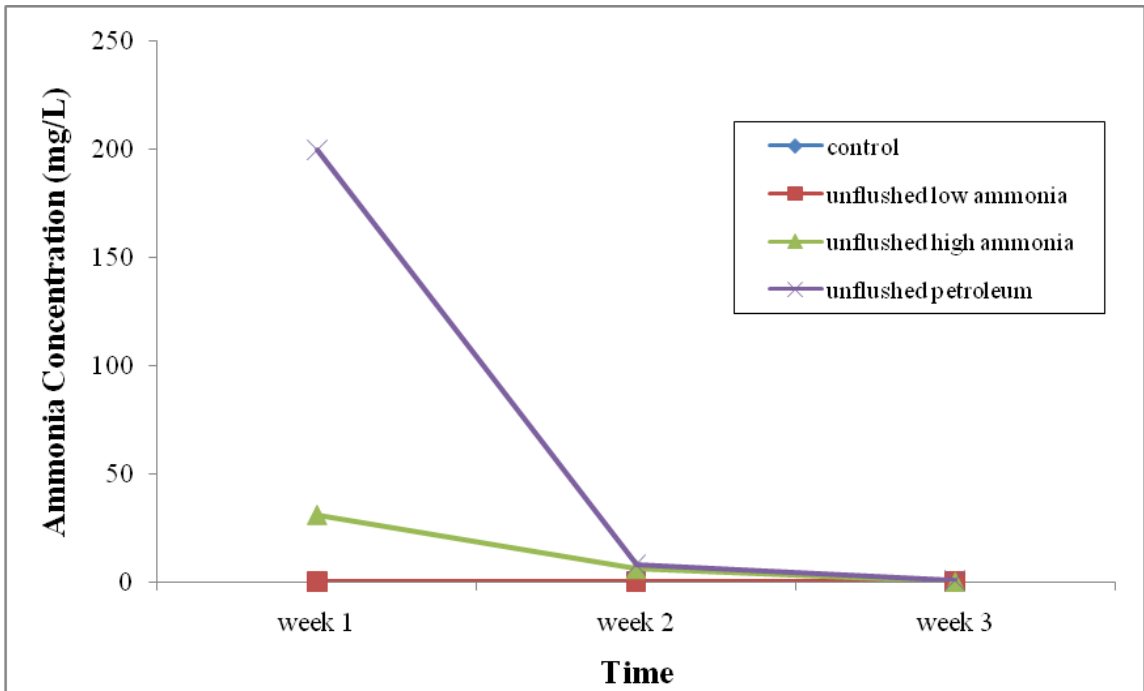
Figure 3-7. Ammonia concentration in unflushed pipes over the first three weeks of water changes during the experiment, after a three week stagnation period.

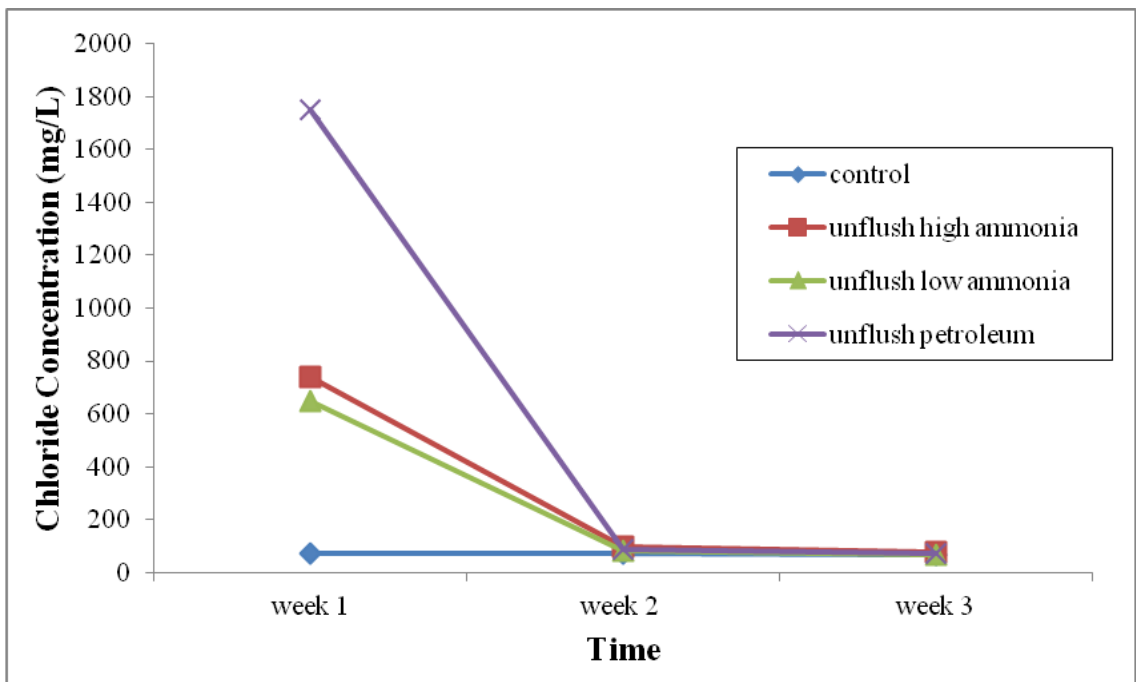
Figure 3-8. Chloride concentration in unflushed pipes over the first three weeks of water changes during the experiment, after a three week stagnation period.

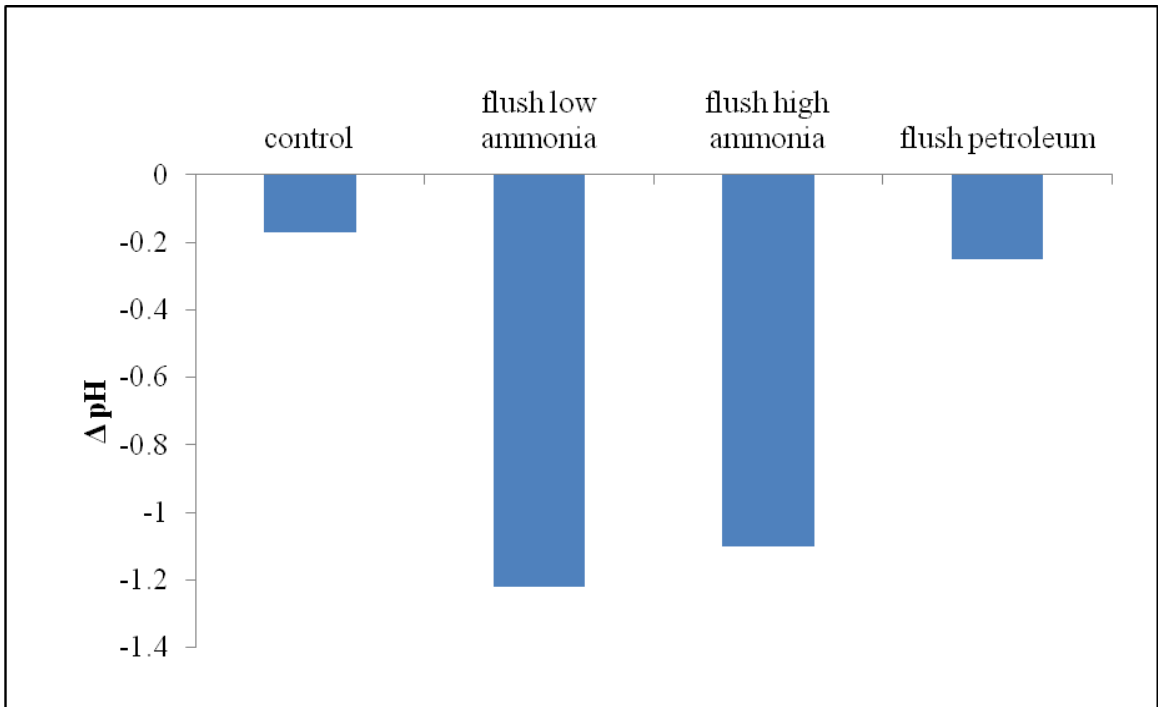
Figure 3-10. Change in pH values in flushed pipe conditions as a means of monitoring nitrification activity.

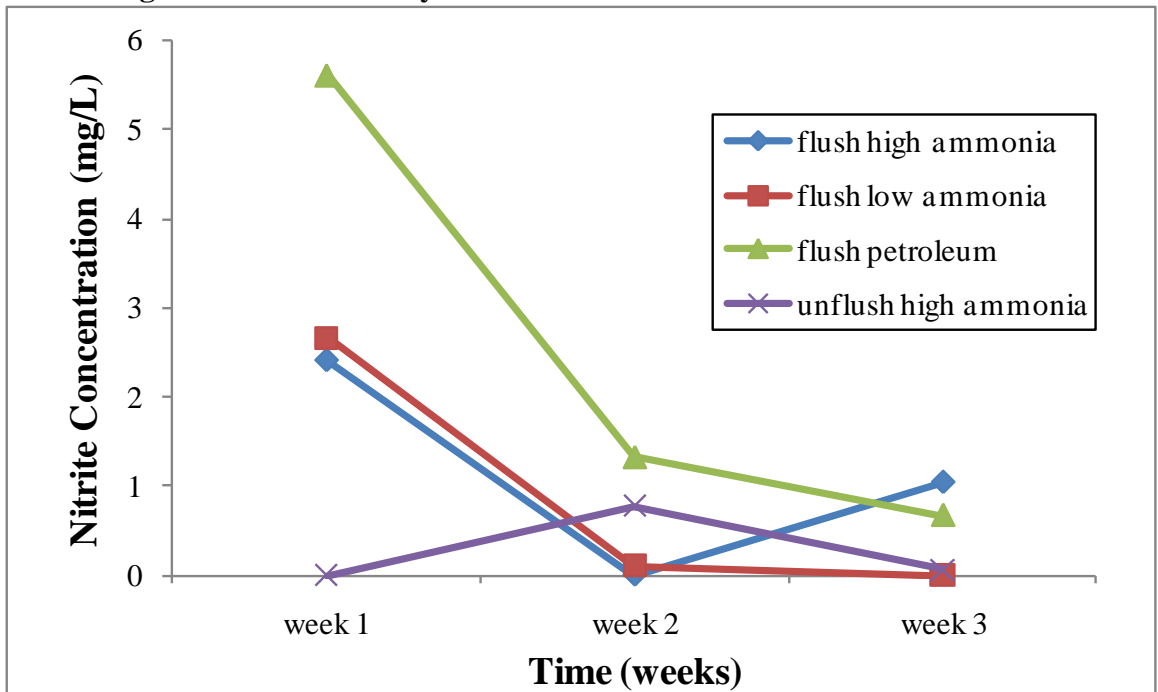
Figure 3-11. Nitrite concentrations in different pipe conditions over the first three weeks of water changes, after a three week stagnation period.

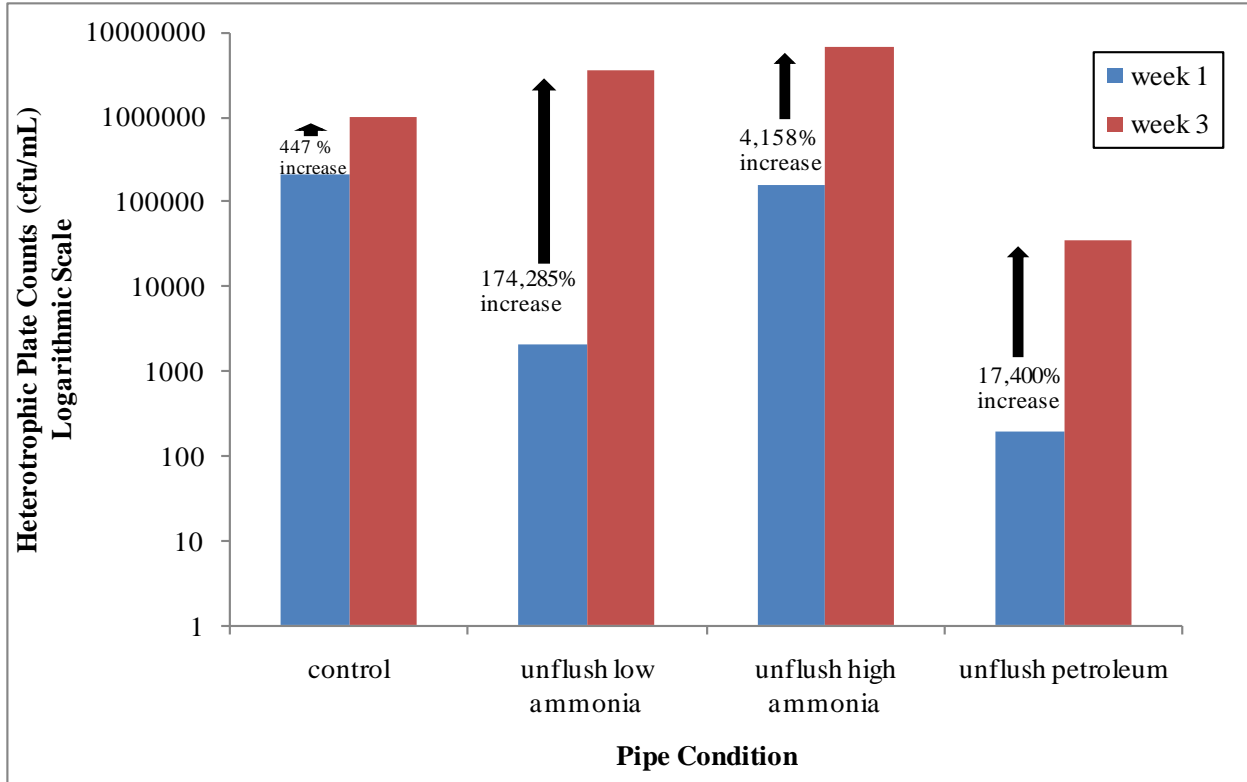
Figure 3-12. HPC's in unflushed copper pipes between week one and week three. The graph is presented using a logarithmic scale.

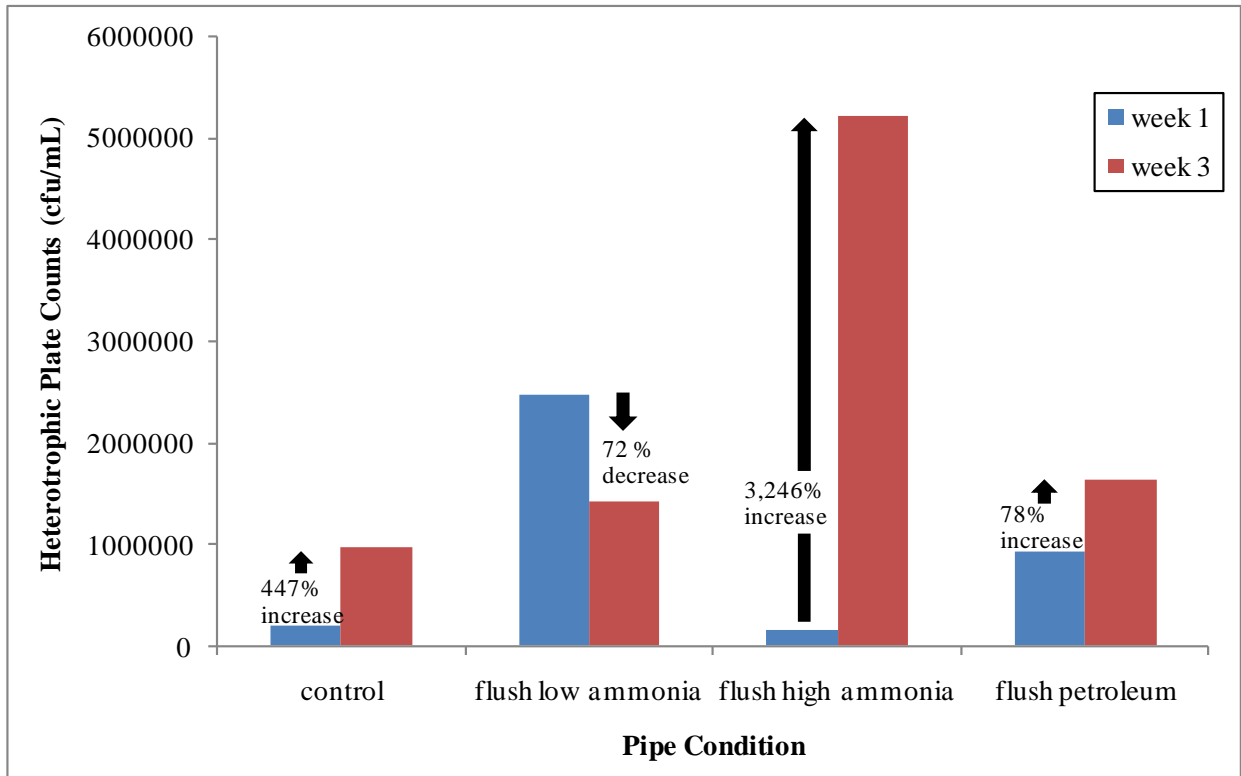
Figure 3-13. HPCs in flushed copper pipes between week 1 and week 3.

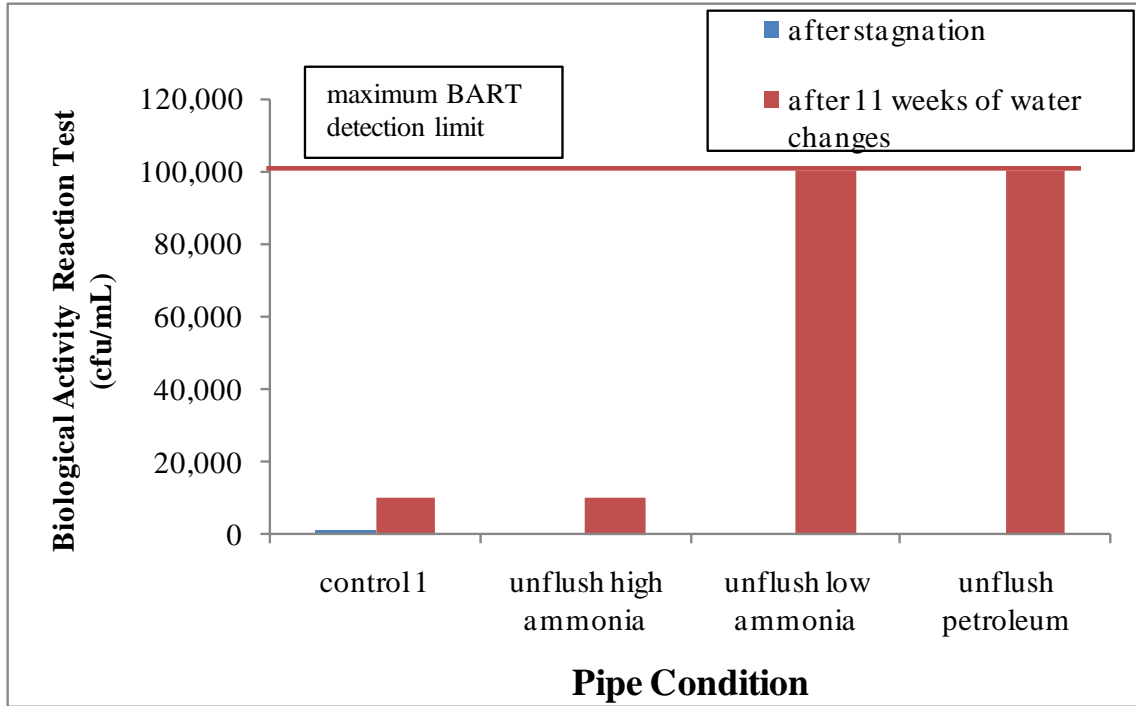
Figure 3-14. Nitrifier-Biological Activity Reaction Test results for unflushed flux pipes at three weeks and eleven weeks.

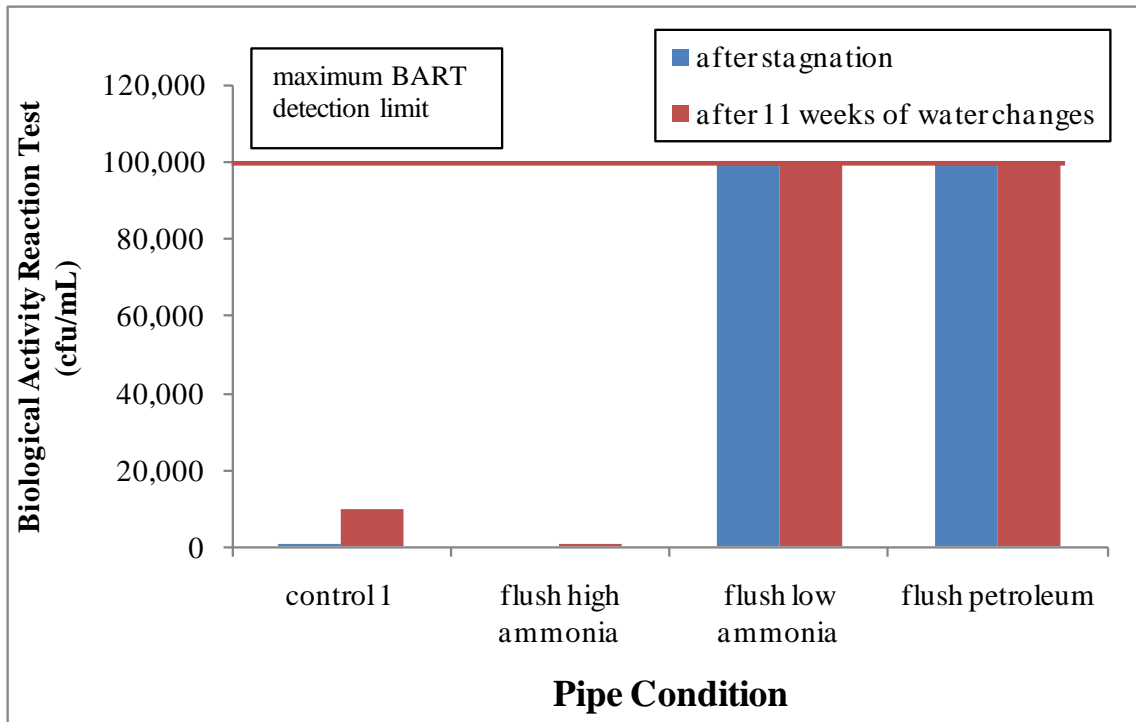
Figure 3-15. Nitrifier-Biological Activity Reaction Test results for flushed flux pipes at three weeks and three months.

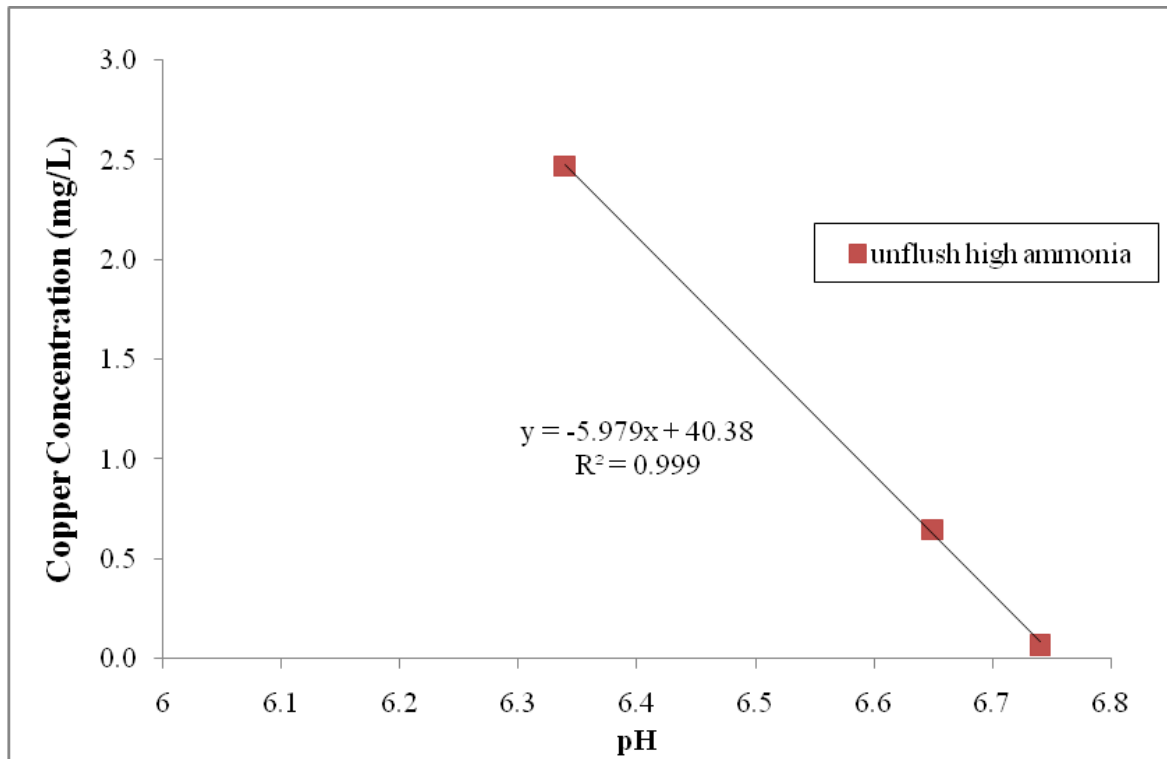
Figure 3-16. Copper concentration in copper pipe with unflushed high ammonia flux as a function of pH.

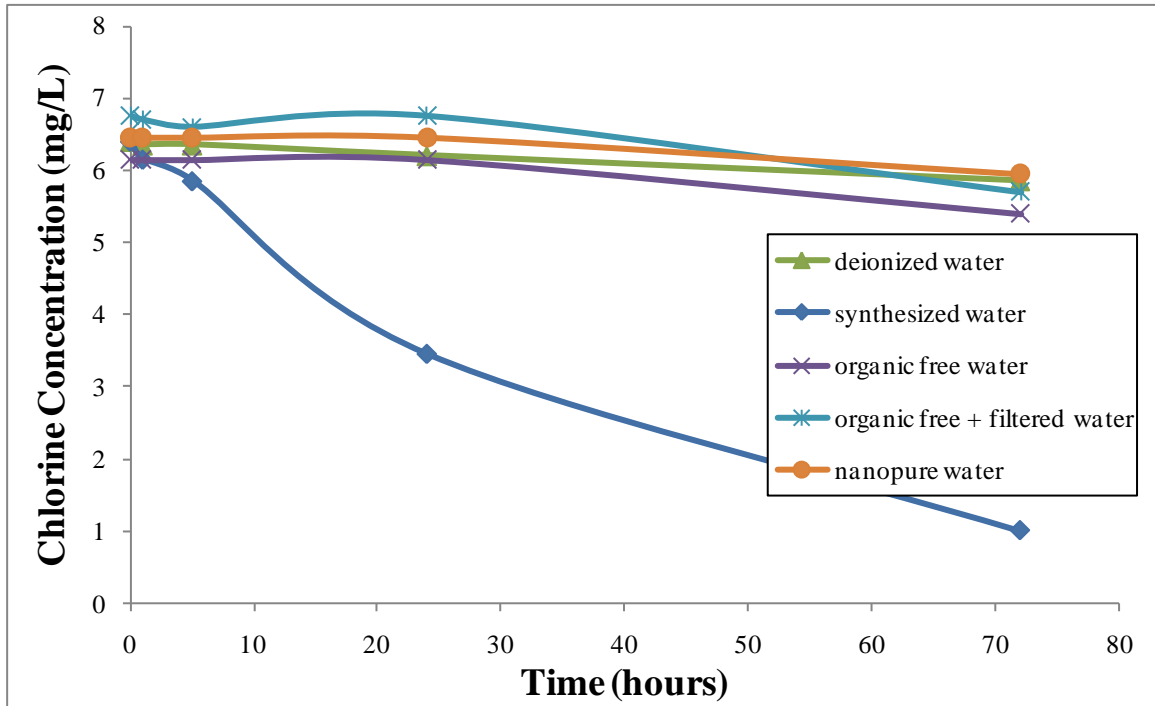
Figure 4-13. Chloramine decay (chlorine concentration) comparing PVC pipes exposed to different waters with 8 mg/L chloramine.
