**Insights into the Liquefaction Hazards in Napier and Hastings Based on the Assessment of Data from the 1931 Hawke's Bay, New Zealand Earthquake**

Thesis submitted to the faculty of the Virginia Polytechnic Institute and State University in partial fulfillment of the requirements for the degree of

Master of Science  
In  
Civil Engineering

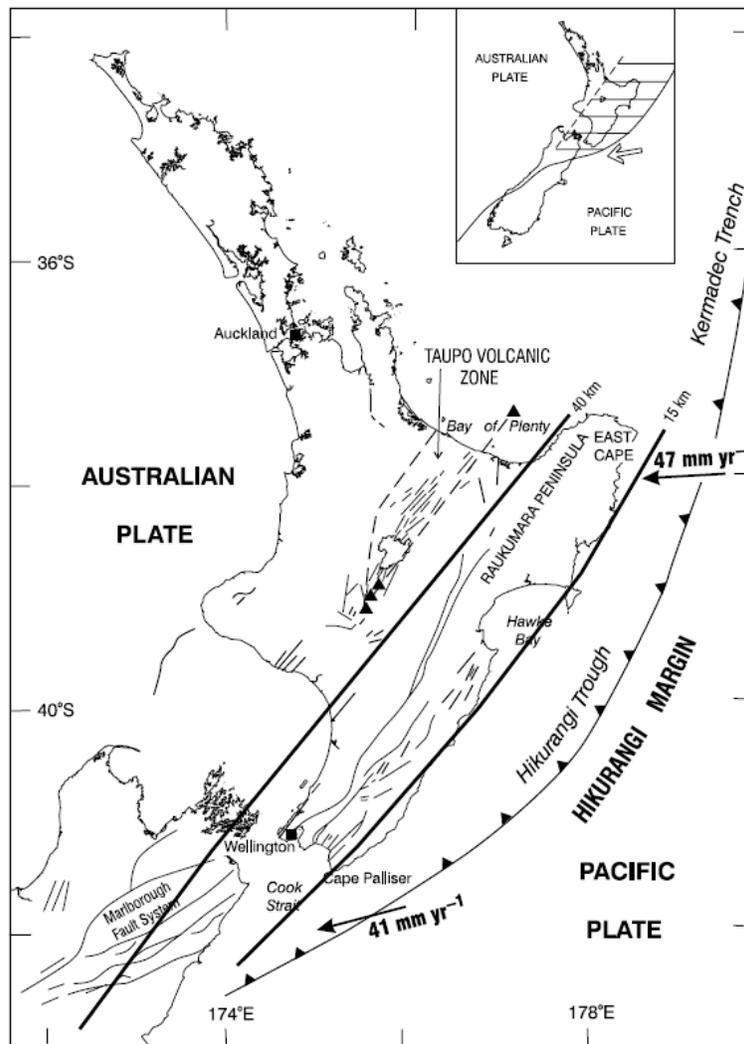
Figure 3: Tectonic setting of Hawke's Bay (from Doser and Webb 2003). Bold lines indicate the depth of the Australian/Pacific plate interface. Triangles are recently active volcanoes.

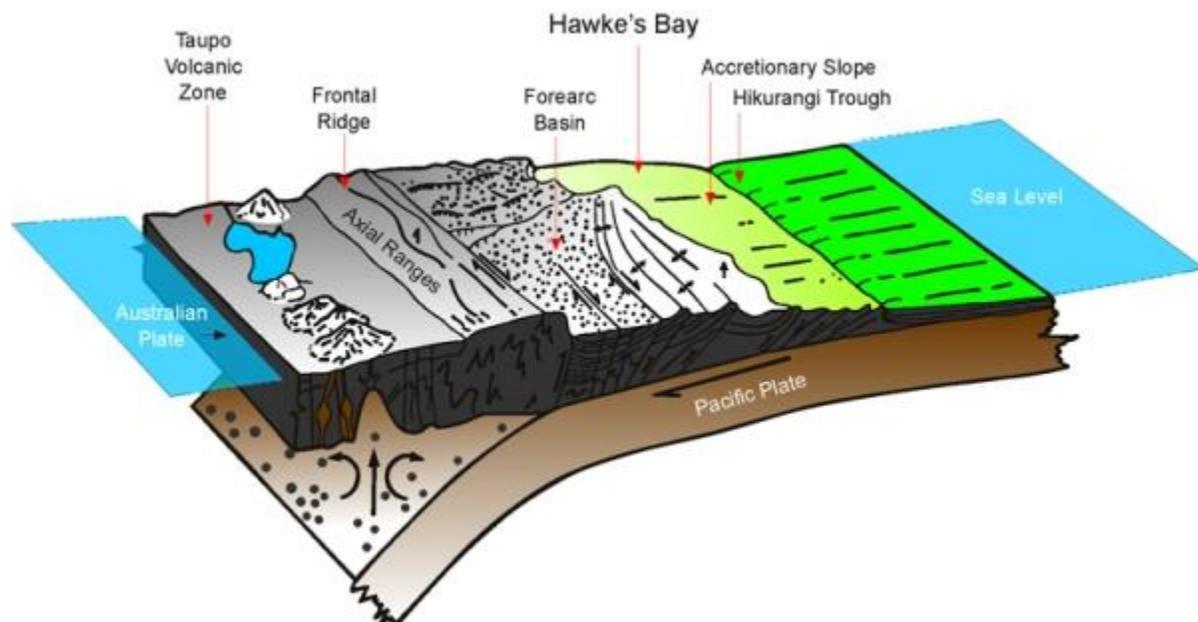
Figure 4: Idealized model of the subduction zone in Hawke's Bay (from *HBRC Emergency Management Portal n.d.*)

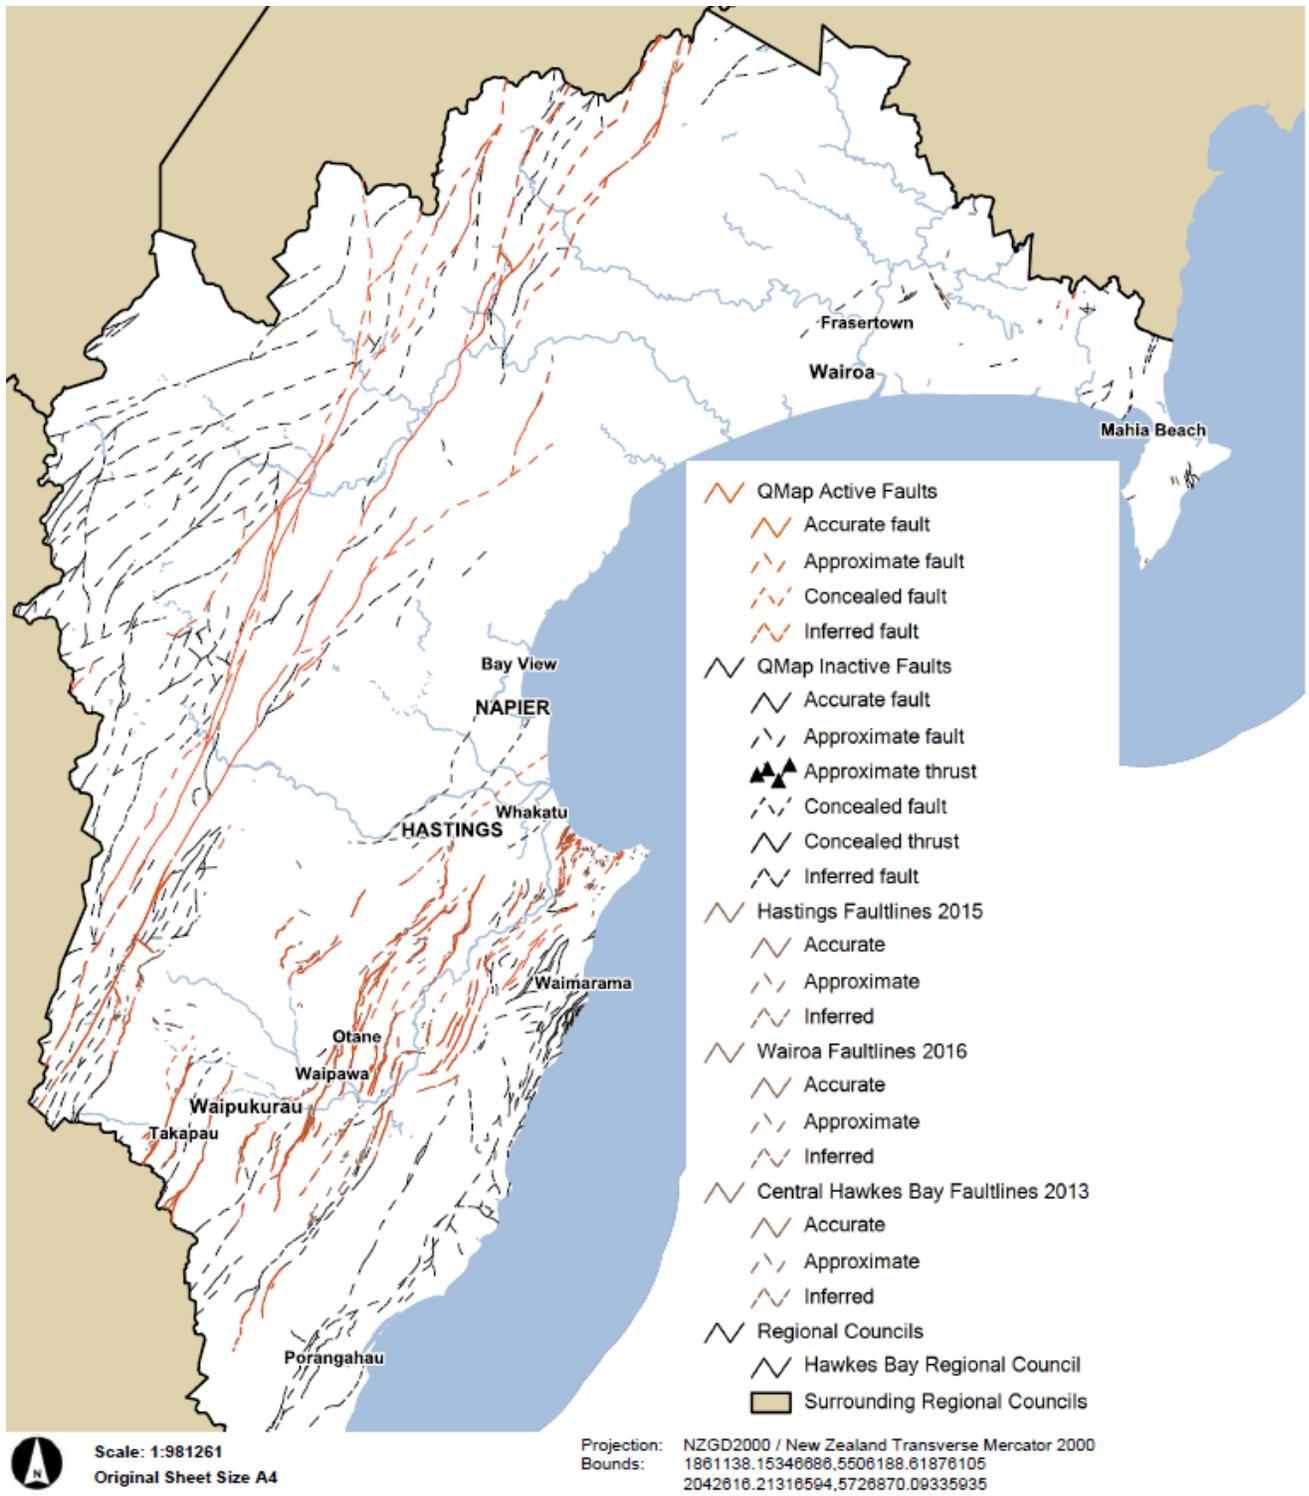
Figure 5: Active and inactive faults in Hawke's Bay (from *HBRC Emergency Management portal n.d.*)

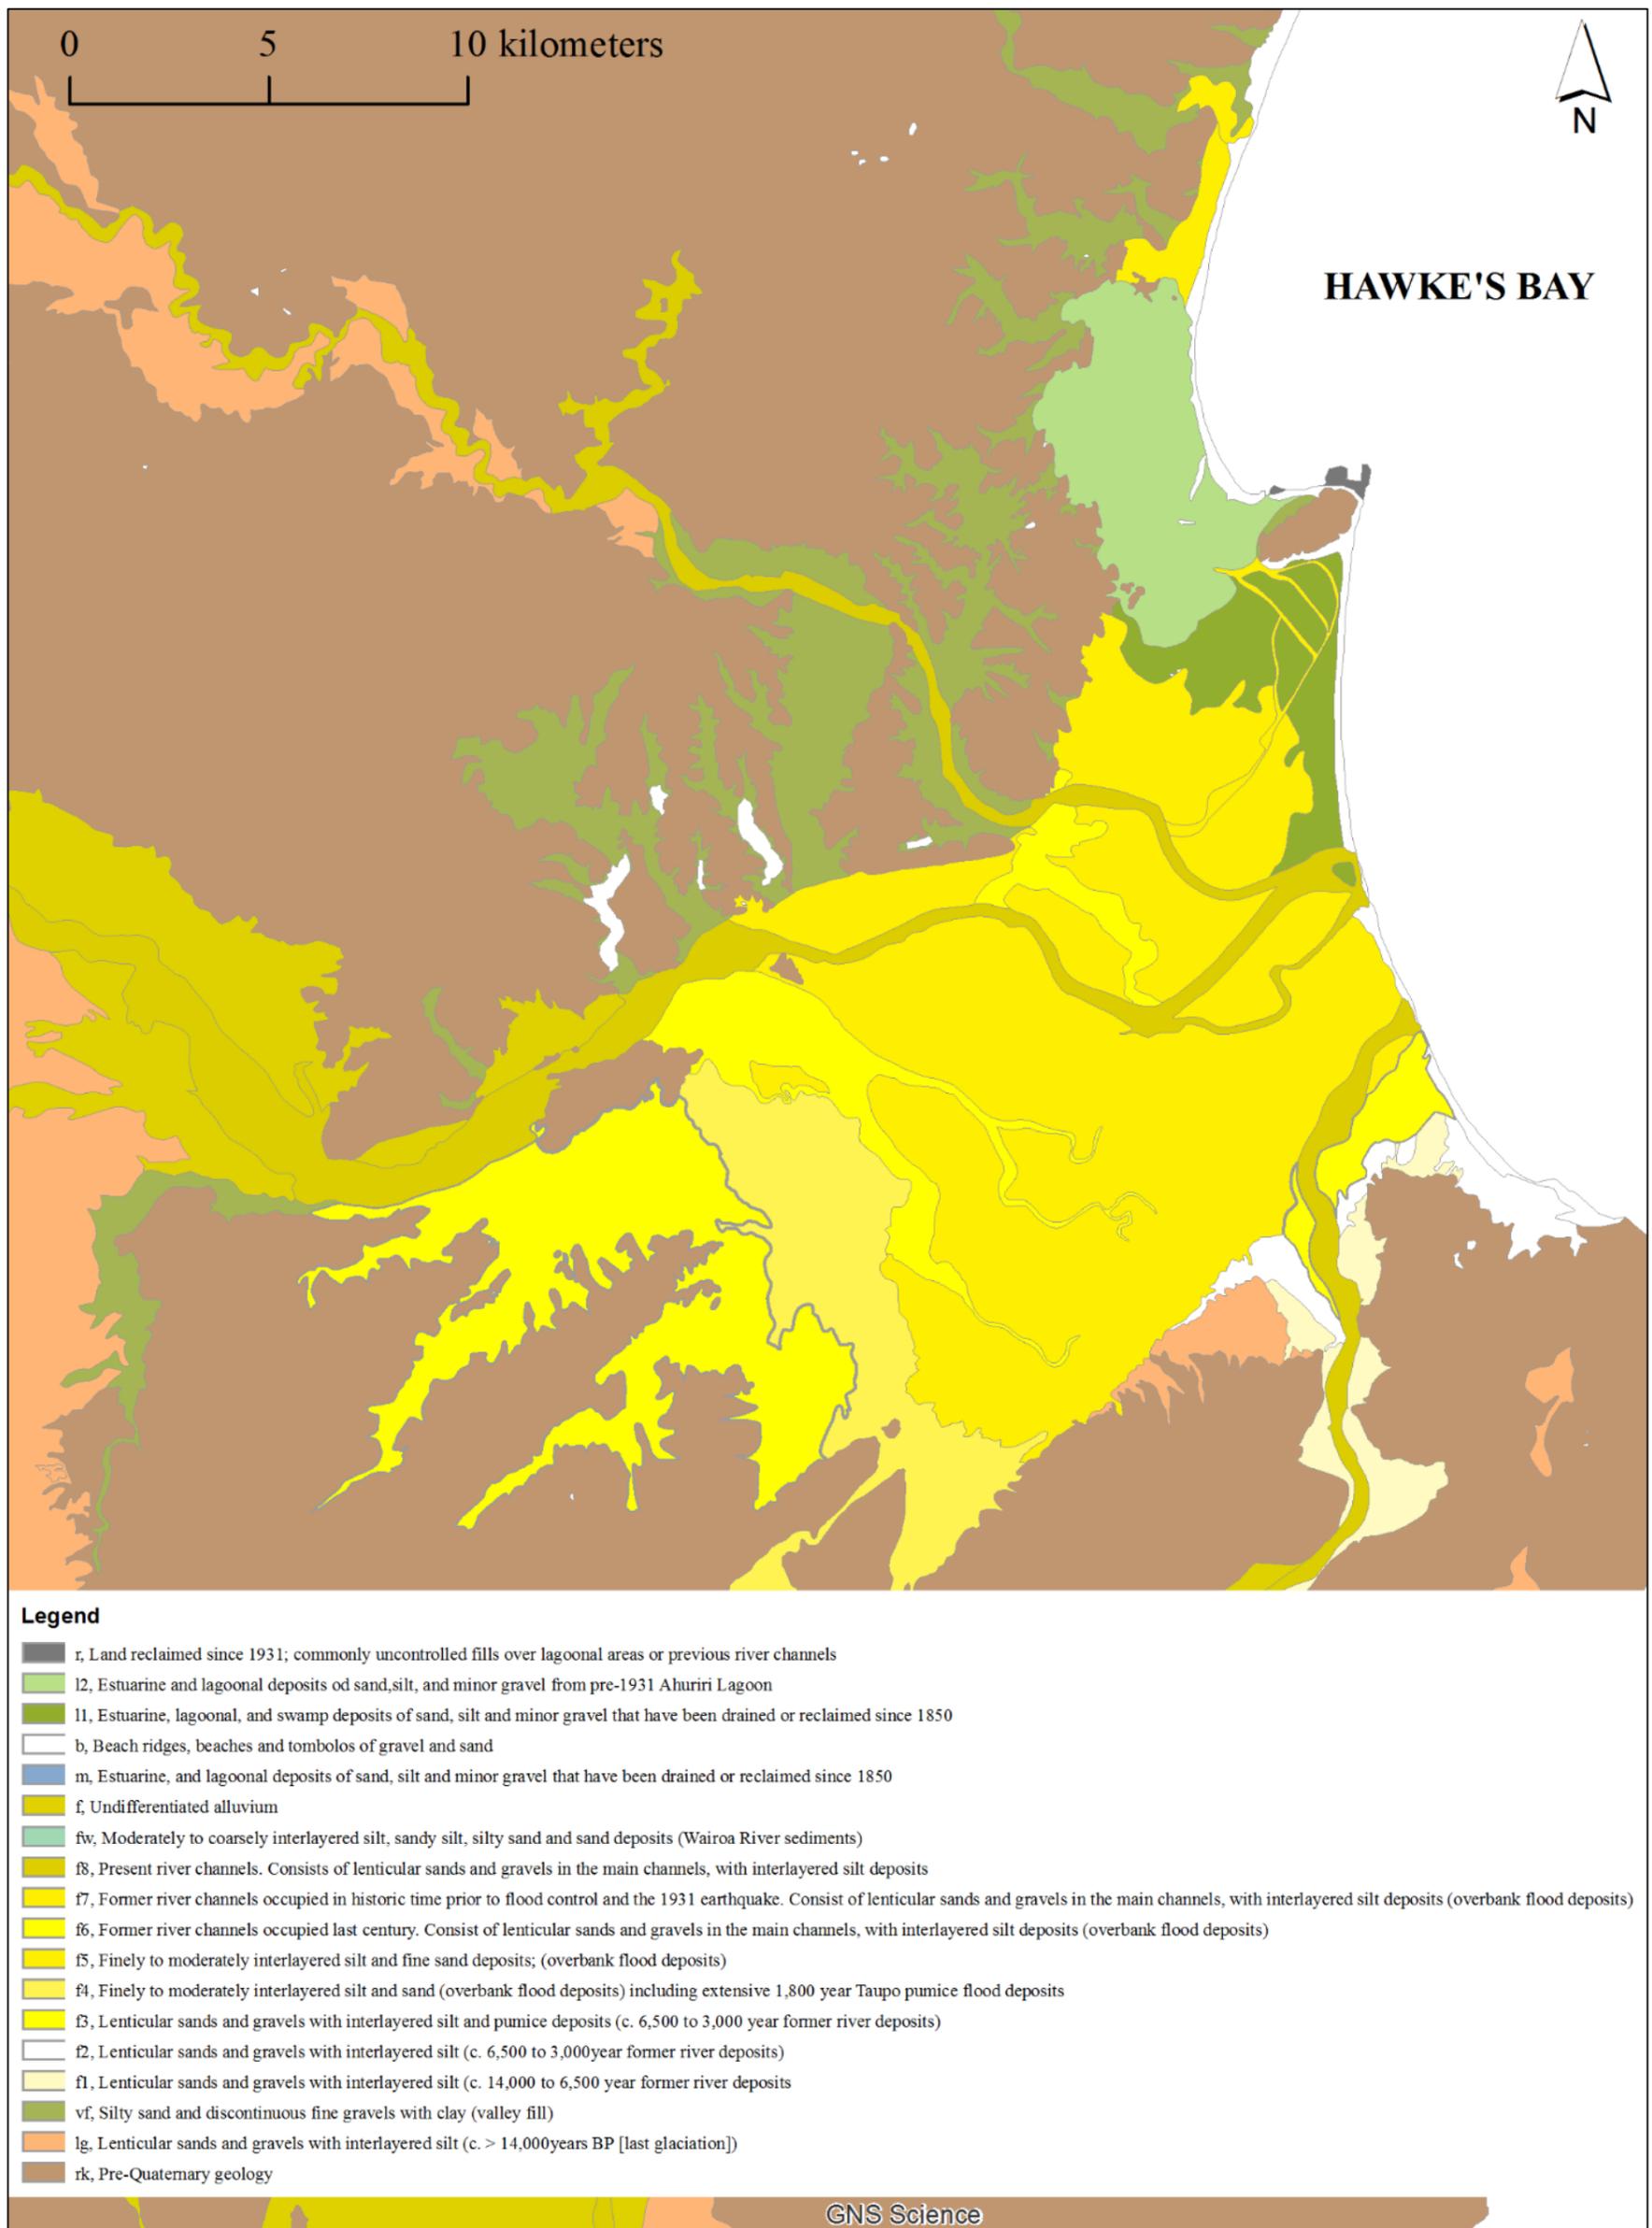
Figure 6: Quaternary geology of the Heretaunga Plains (after Dravid and Brown 1997)

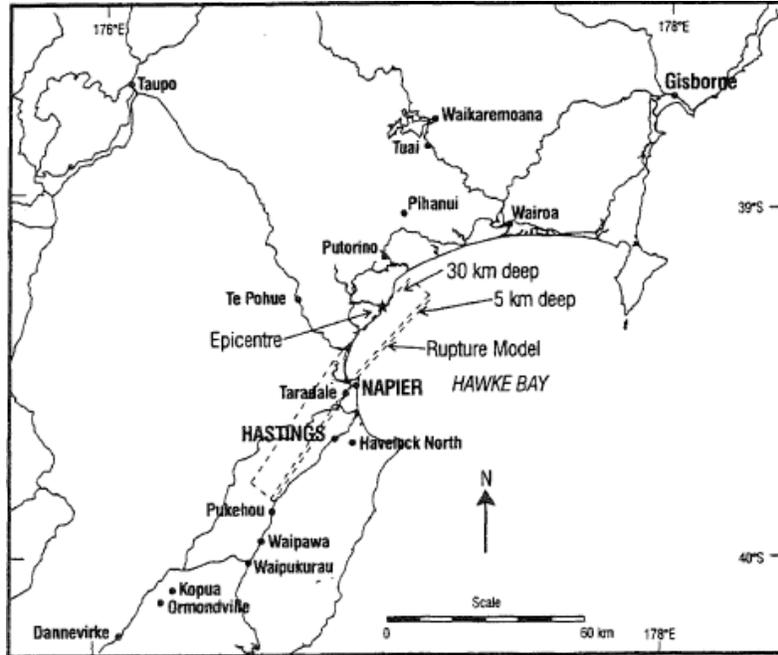
Figure 7: Elastic dislocation model for the main event by Haines & Darby (1987) (from Dowrick 1998)

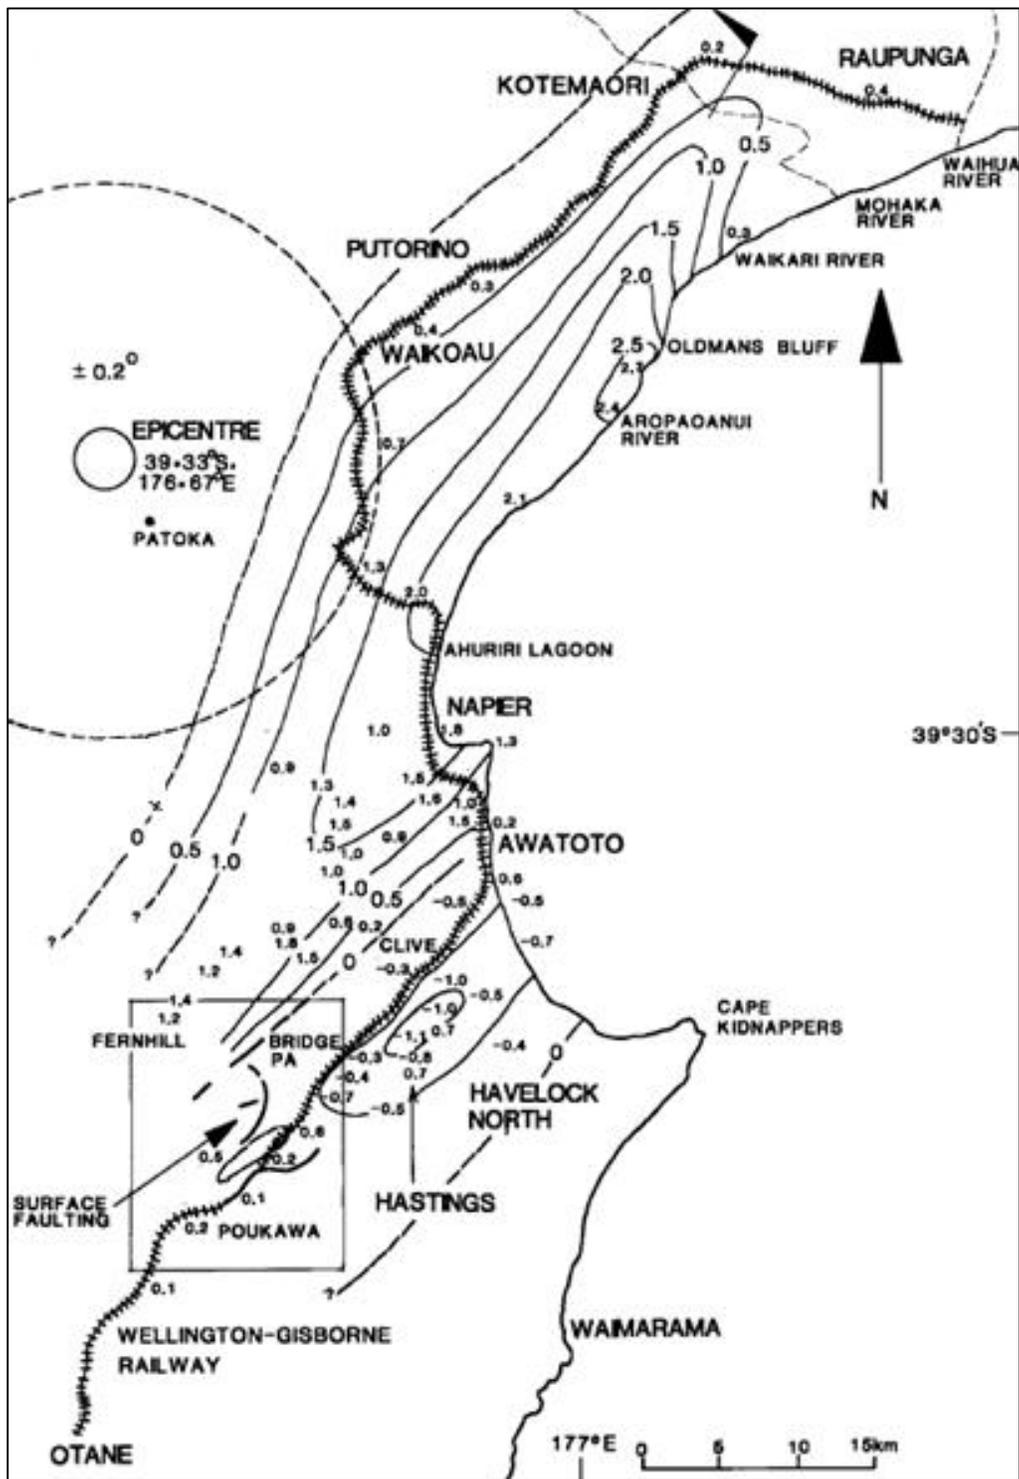
Figure 8: Tectonic movement after the 1931 Hawke's Bay earthquake and its 13 February aftershock (*from Hull 1990*). Note the older location for the epicenter.

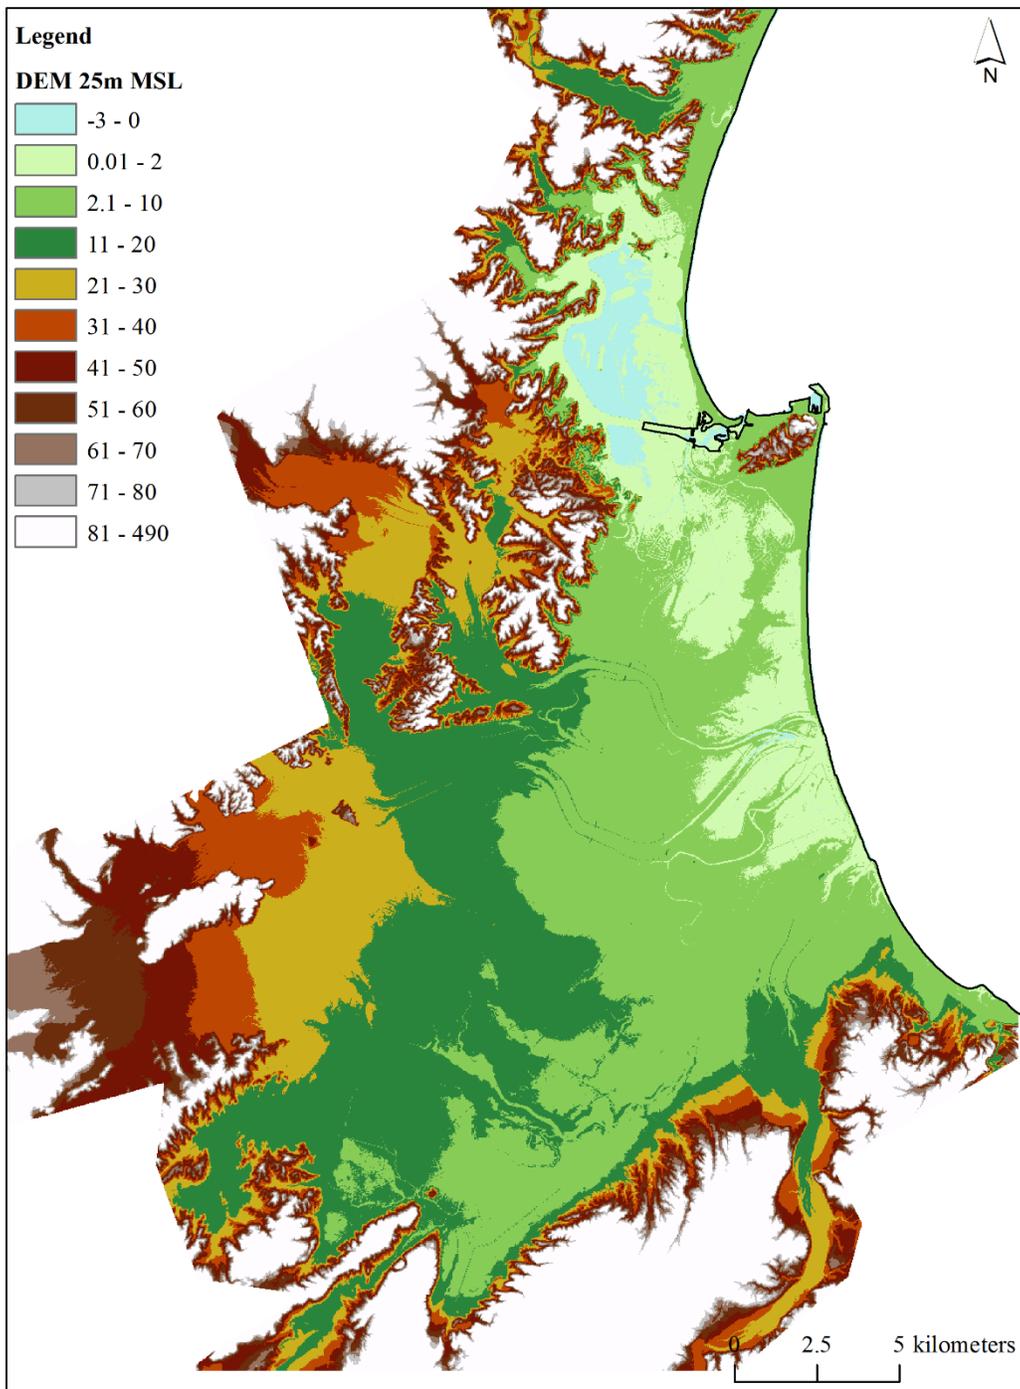
Figure 9: Digital Elevation Model for the Heretaunga Plains

In 2003, Hawke's Bay Regional Council performed a LiDAR survey of the Heretaunga and Ruataniwha Plains. The accuracy of the LiDAR is roughly 1.8 m and the datum is 10 m above mean sea level (MSL). For this study, the terrain was processed to produce a Digital Elevation Model (DEM). The DEM shown in Figure 9 was cropped to the extent of the present study area, expressed in terms of MSL and reshaped to a 25 m × 25 m raster.

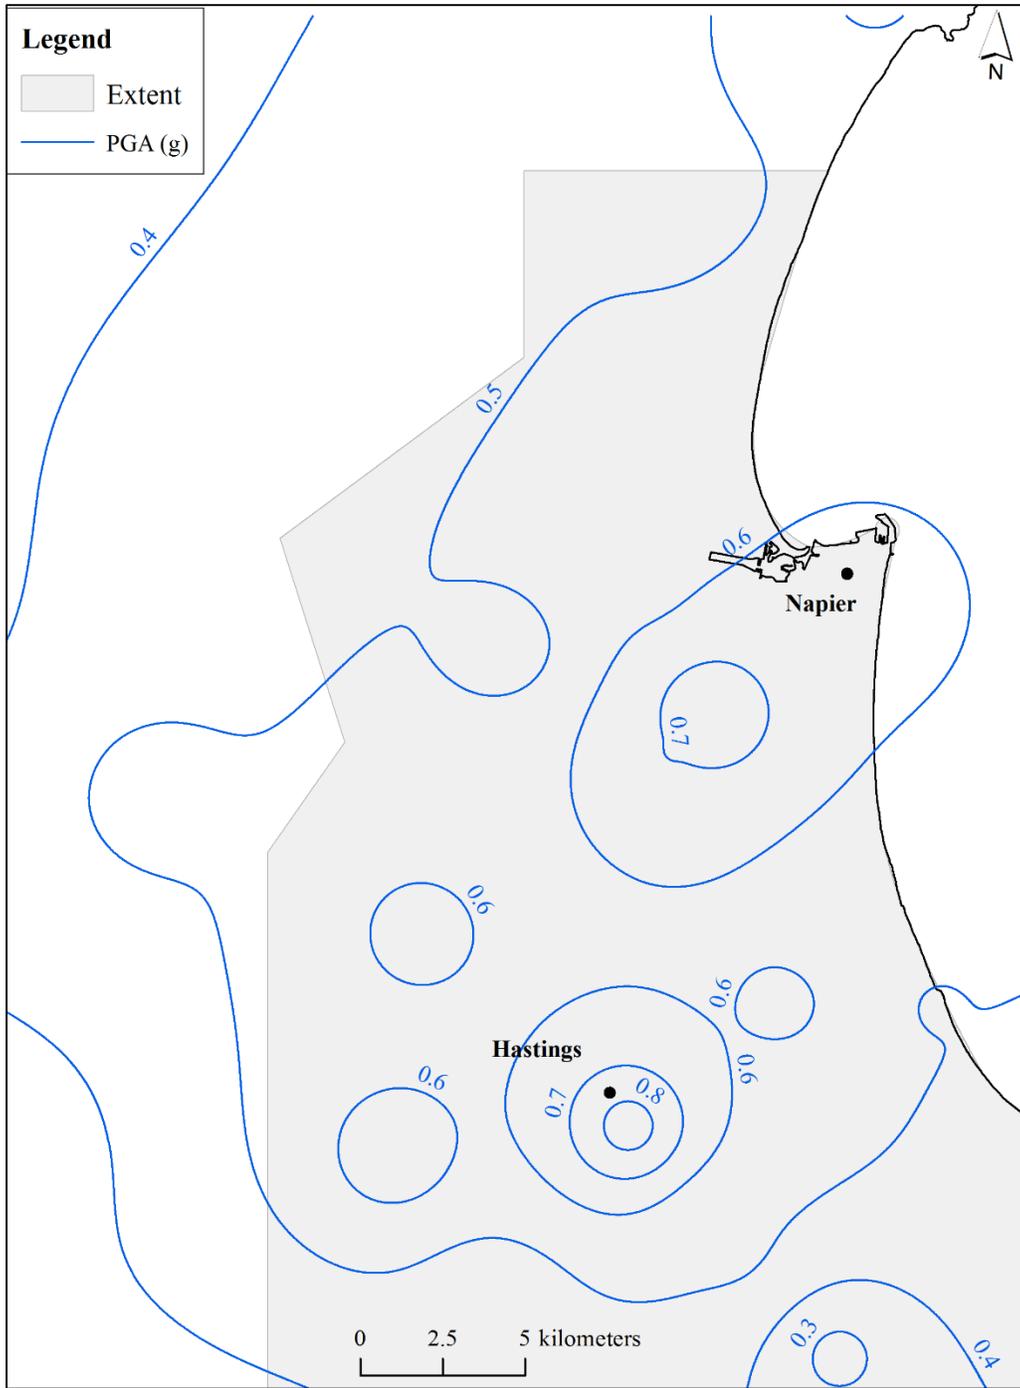
Figure 11: Ground motion characterization based on PGA from MMI

Peak ground acceleration (PGA) is a more useful parameter in assessing liquefaction hazard than MMI intensities. The ground motions for the 1931 Hawke's Bay earthquake were simulated by Bayless et al. (2017) using the Southern California Earthquake Center (SCEC) Broadband Strong Ground Motion Simulation Platform (BBP). Based on historical data from the 1931 Hawke's Bay earthquake, the velocity and density model as well as the earthquake source were characterized. A shallow crustal earthquake source model was used for the simulation. The earthquake was not recorded on ground motion instruments, but the isoseismal map from Dowrick (1998) was used to compare the simulated PGAs with the MMI map. To establish this comparison, simulated PGAs were converted to intensities using the Ground Motion Intensity Conversion Equation (GMICE) from Caprio et al. (2015). The converted intensities were checked against the MMI intensities from Dowrick (1998) and the 2 sets of intensities were in good agreement (Bayless et al. 2017). The resulting ground motion or PGA map for the Hawke's Bay earthquake is shown in Figure 11, and as discussed in subsequent sections of this paper was used in the liquefaction hazard study of the region. More details on the PGA map in Figure 11 are given in Appendix A.

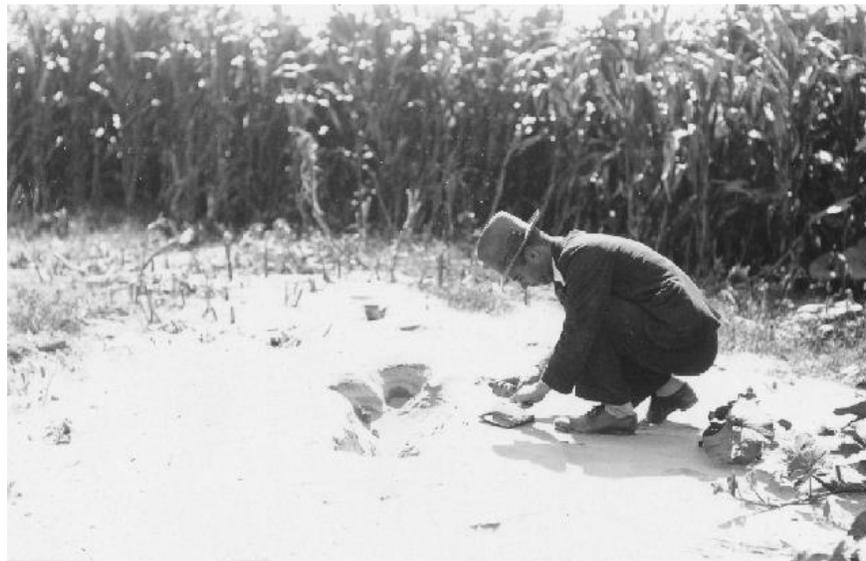
Figure 12: Sand boils at Petane (*from the archives of the MTG Hawke's Bay Museum*)

documented in historical photographs (e.g. Figure 12), personal accounts, books, and newspaper clips. Additionally, published journal articles after the event provide scientific description of liquefaction, although the phenomenon was not fully understood at the time. Callaghan (1933) reports observations of liquefaction manifestations during his inspection after the earthquake, and Fairless and Berrill (1984) report liquefaction effects in Heretaunga Plains, Taradale, Clive, Esk Valley, Mohaka, Tangoio, Petane, and Gisborne. The reported ground damage included sand boils or mud spouts or sand geysers, cracks and fissures, differential settlement, and lateral spreading.

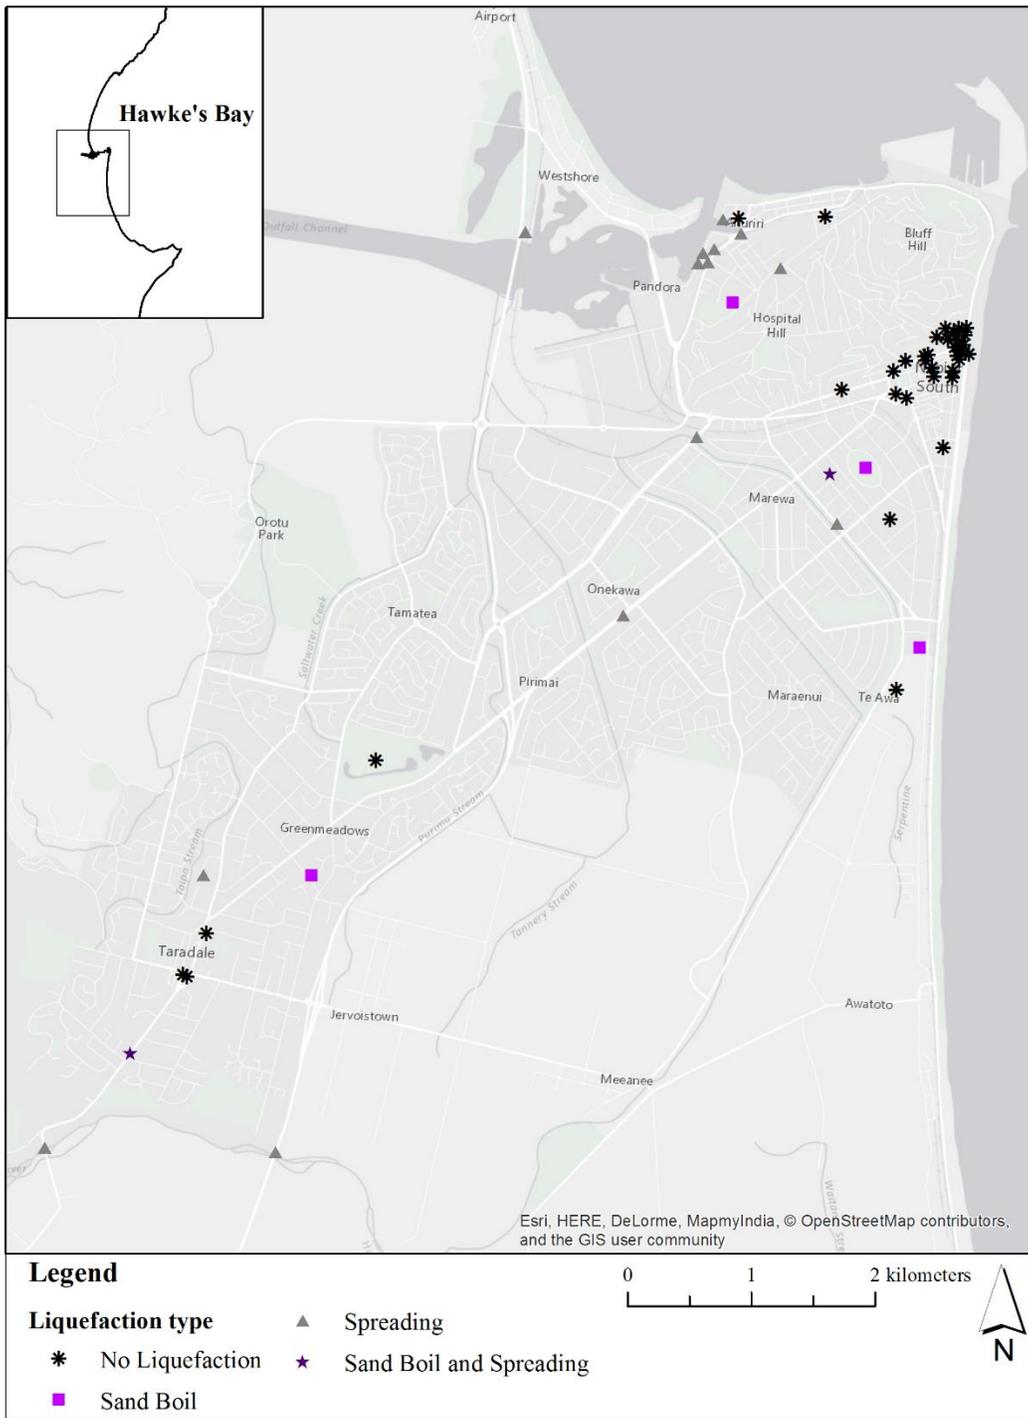
Figure 13: Overview of liquefaction observations around Napier

As stated previously historical photographs, personal accounts, books, newspaper clips, and journal articles provide documentation of the occurrence of liquefaction during the 1931 Hawke's Bay earthquake. These sources were used to develop a database of liquefaction manifestations during the 1931 earthquake. The reported ground damage included sand boils or mud spouts or sand geysers, cracks and fissures, differential settlement, and lateral spreading in Heretaunga Plains, Taradale, Clive, Esk Valley, Mohaka, Tangoio, Petane, and Gisborne. Based on these accounts, a database was compiled and was used to assess the validity of the severity predictions. An example of the collection of observations is shown in Figure 13.

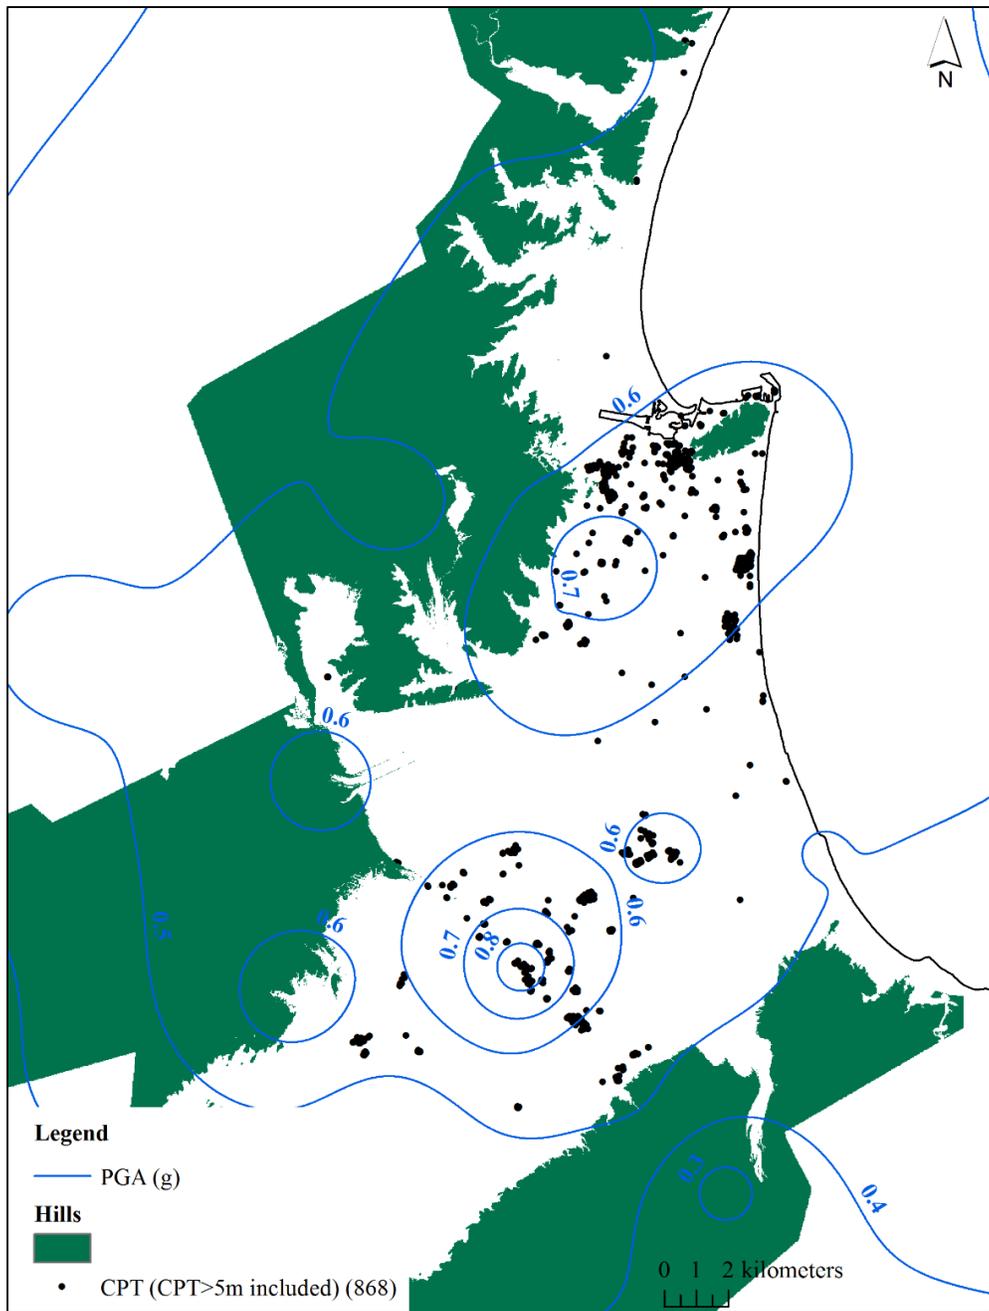
Figure 14: Spatial distribution of CPT soundings with depth greater than 5 m

liquefaction hazard. However, it is also possible that the CPT sounding was terminated at a shallow depth because characterization of the near surface is all that was needed for the project for which the sounding was being performed (e.g., static bearing capacity conditions for lightweight structures). In this case, the calculated liquefaction vulnerability index value for the short CPTs would not be appropriate for use in assessing liquefaction hazard. Since both scenarios are possible, the liquefaction hazard analyses were performed both with and without these “short CPTs” included in the database. The spatial distribution of CPT soundings is shown in Figure 14.

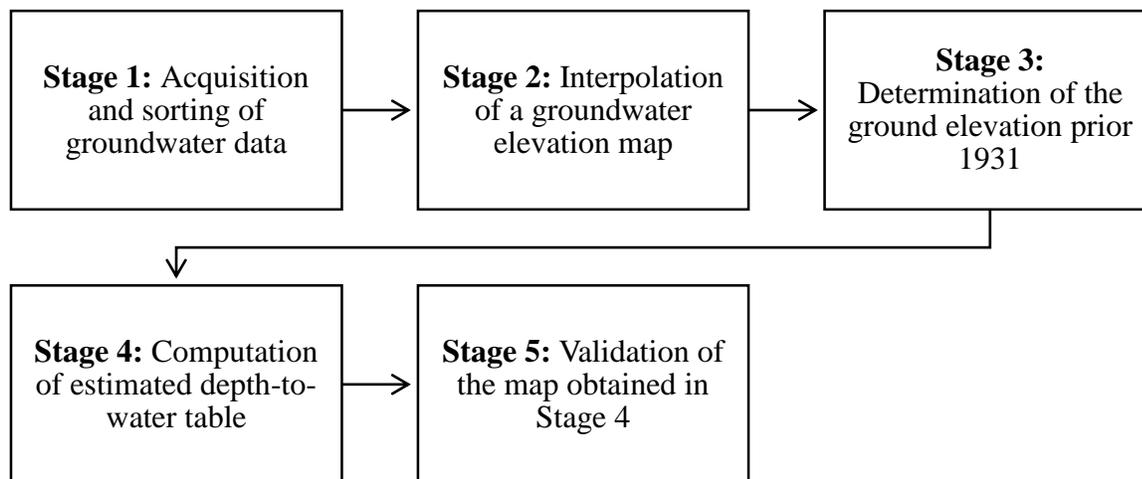
Figure 15: Procedure for the development of the groundwater model

Figure 15 summarizes the procedure used to develop the groundwater model. This procedure is detailed in Appendix C. The estimated GWD at the time of the earthquake using the model is mapped in Figure 16.

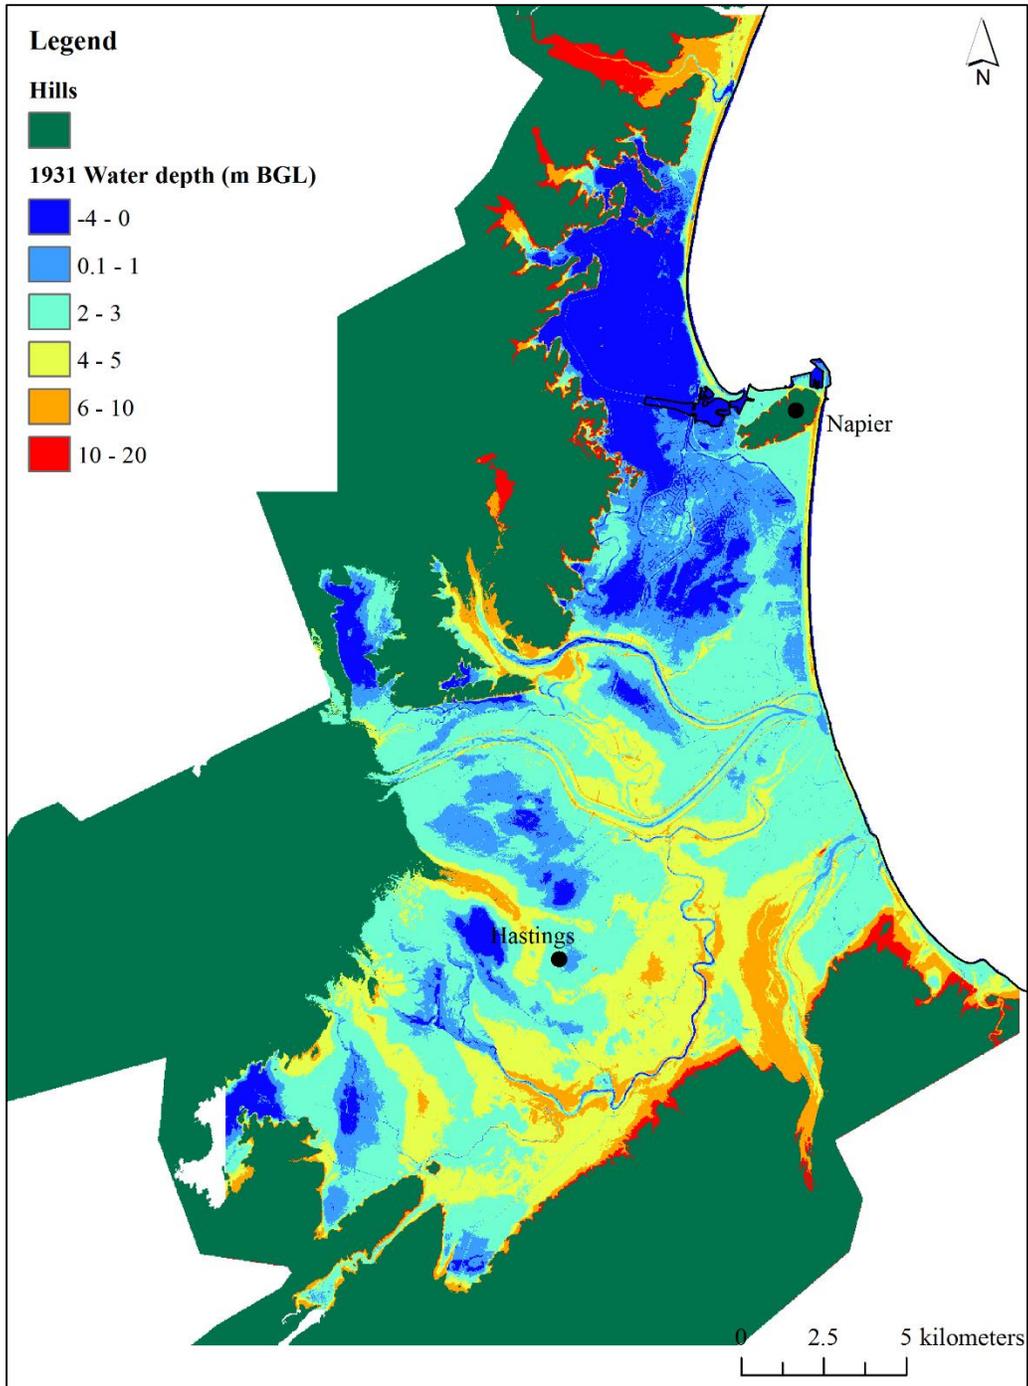
Figure 16: Estimated ground water depths at the time of the 1931 Hawke’s Bay earthquake

The GWD model generates a smooth surface and consequently is an approximate fit of the regressed data. Based on the comparison of predictions and measurements, the model provides the most accurate estimates of groundwater elevation at the center of the study area. The prediction errors increase away from the center of the study area due to the reduction in the spatial density of available data. The areas of interest, Napier and Hastings, fall in the region of the model where the model yields the most accurate predictions. Thus, this model is satisfactory for use in the liquefaction hazard analyses. Nevertheless, further improvements can be made to the model by enhancing the quality of the well database and the number of groundwater monitoring wells.

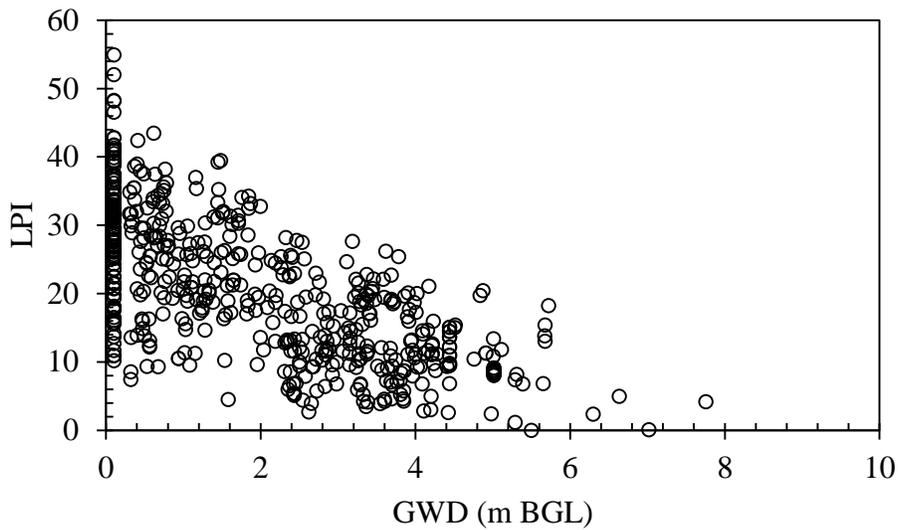
Figure 17: Variation of LPI with respect to GWD (LPI results taken from Case 1)

The uncertainty in GWD was also considered for incorporation in the case matrix in Table 7. Figure 17 is a plot of computed LPI values as a function of GWD for each of the CPT locations for Case 1. As may be observed from this figure, there is a general trend of decreasing LPI values as GWD increases; note that LSN values were also computed and show a similar trend. This implies that the shallower the GWD, the more severe the expected surficial liquefaction manifestations. However, the large scatter in the data suggests that factors other than GWD have a more significant influence on potential liquefaction severity and that the uncertainty in the GWD is not a primary controlling factor. Hence, the decision was made not to incorporate GWD into the case matrix in Table 7.

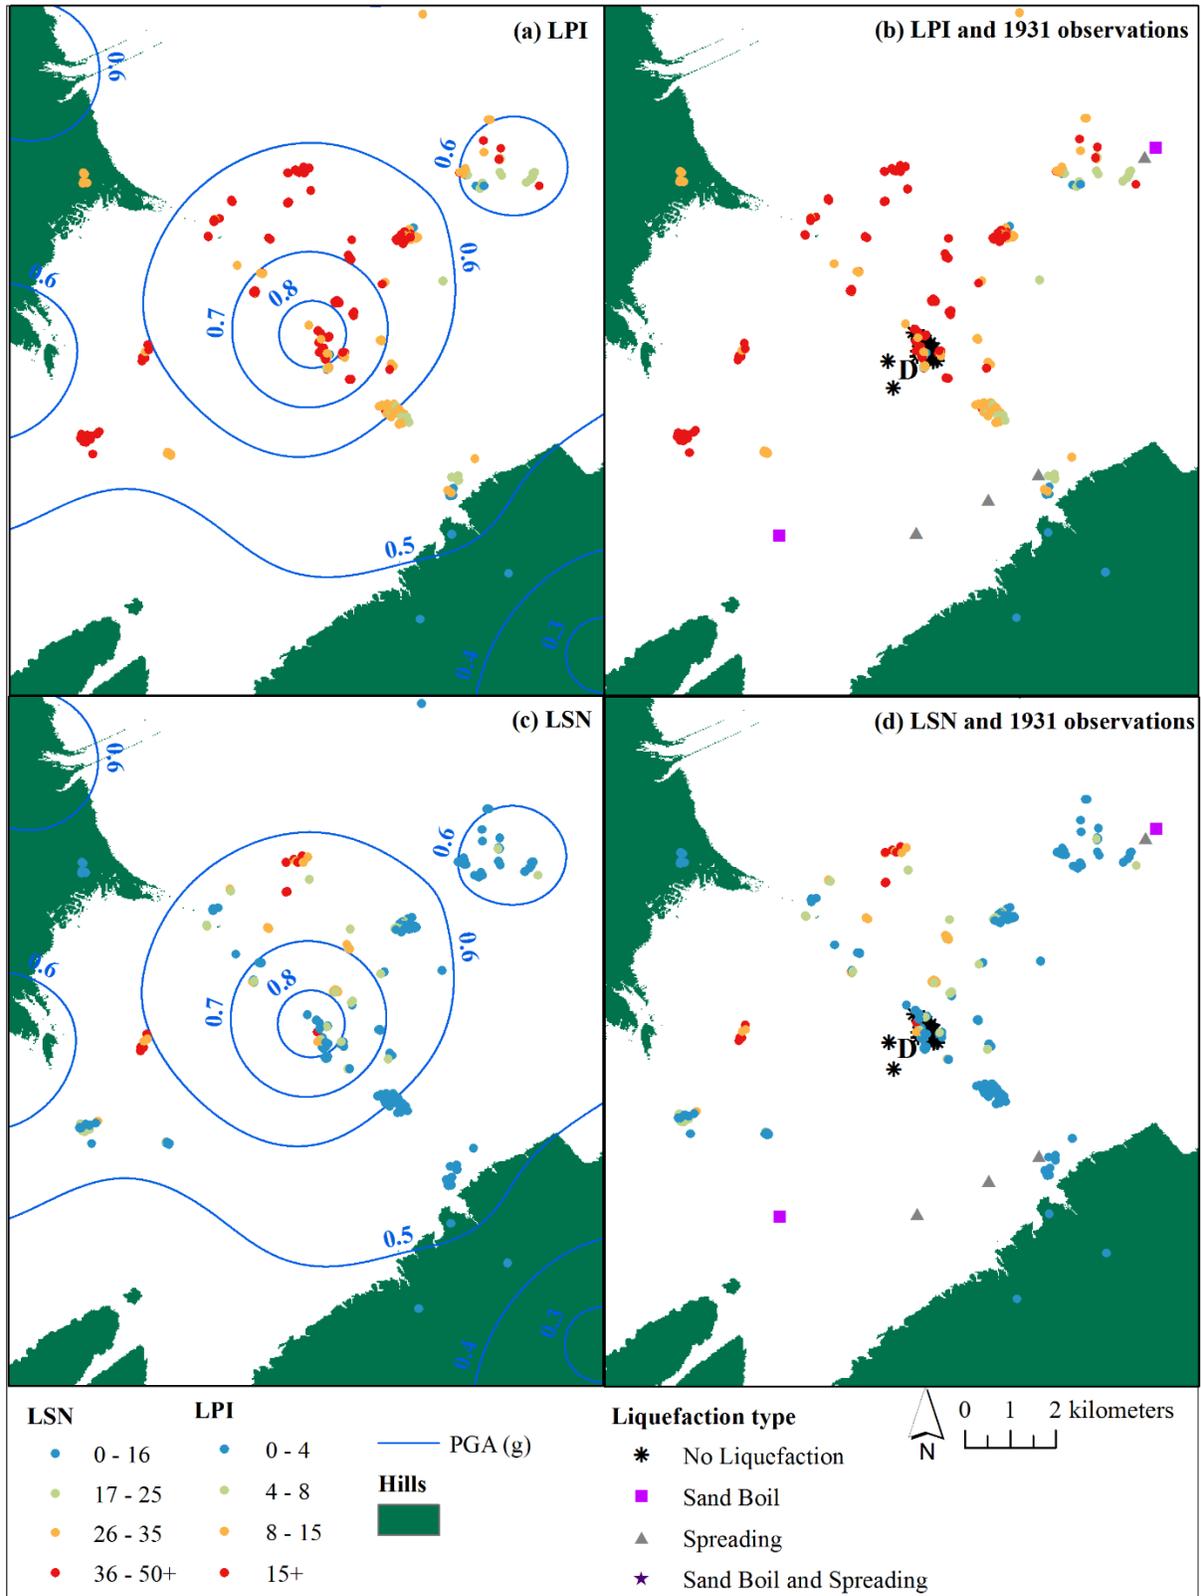
Figure 19: Computed liquefaction severity indices for Hastings- Case 1 (a) LPI, (b) LPI overlaid with 1931 observations, (c) LSN, (d) LSN overlaid with 1931 observations
