**Insights into the Liquefaction Hazards in Napier and Hastings Based on the Assessment of Data from the 1931 Hawke's Bay, New Zealand Earthquake**

Thesis submitted to the faculty of the Virginia Polytechnic Institute and State University in partial fulfillment of the requirements for the degree of

Master of Science  
In  
Civil Engineering

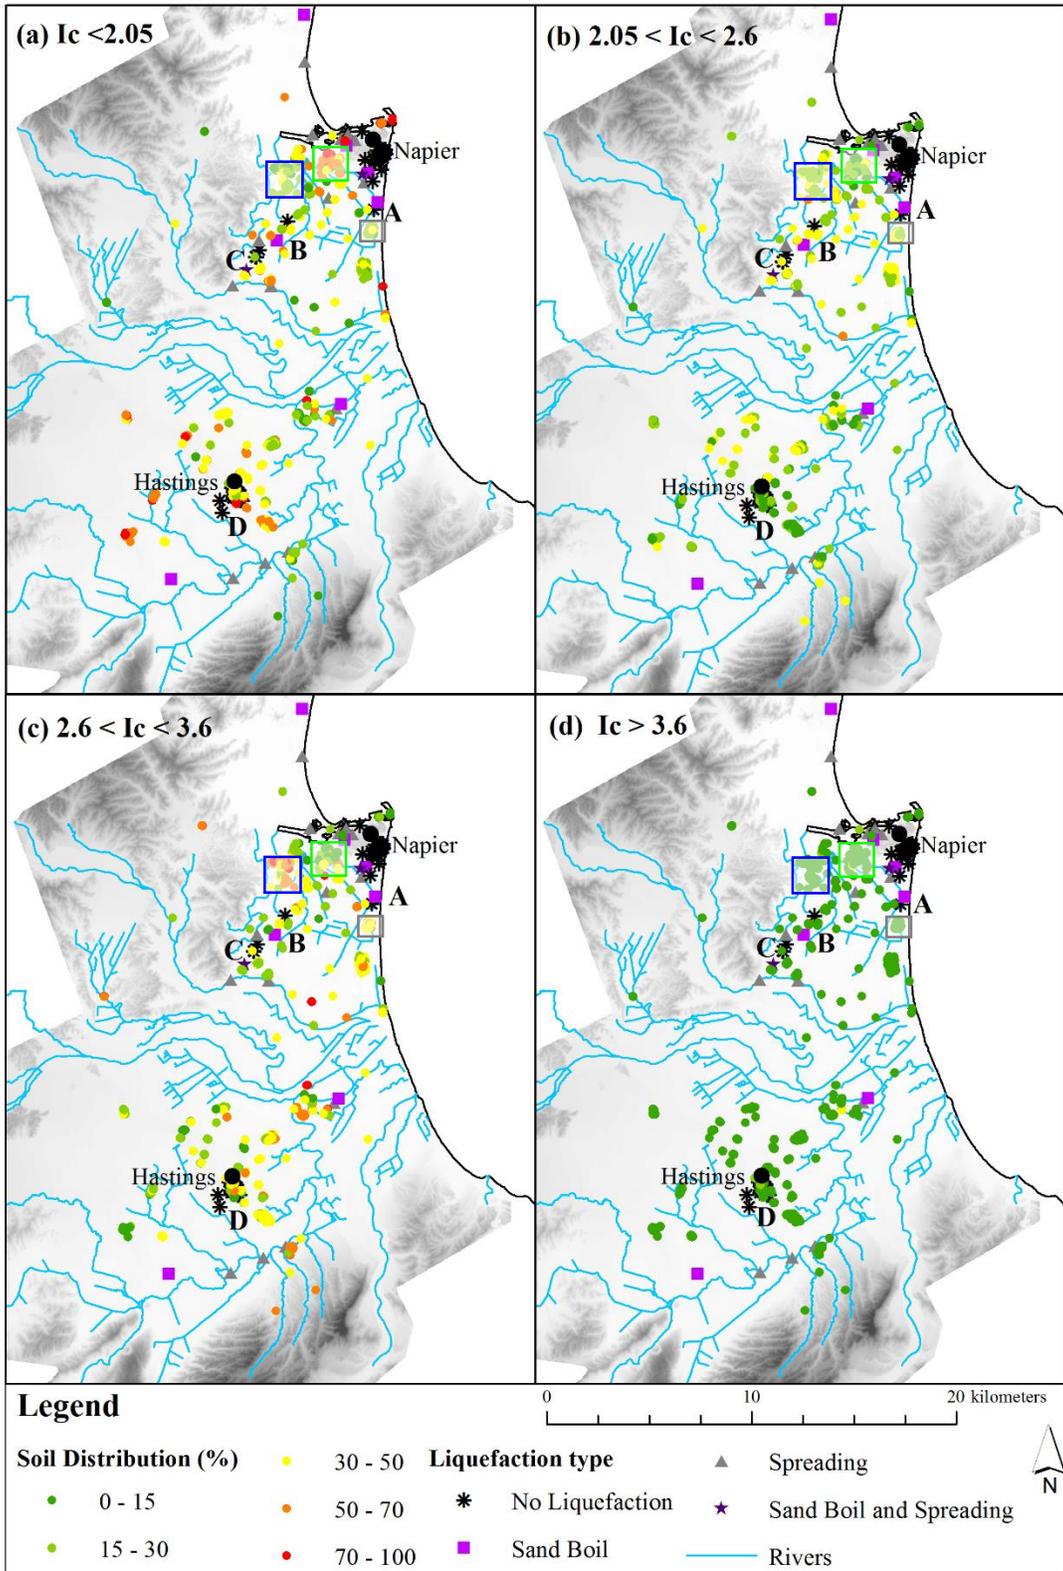
Figure 20: Distribution of soil types in the upper 10 m in the soil profiles based on the soil behavior type index  $I_c$  (colored boxes referred to in the text)

In Hastings, the predicted liquefaction potential based on the LPI map is more severe than that based on LSN (Figure 20). This is likely due to the depth distribution of dense clean sands and plastic soils. A site-specific analysis is required to confirm this finding.

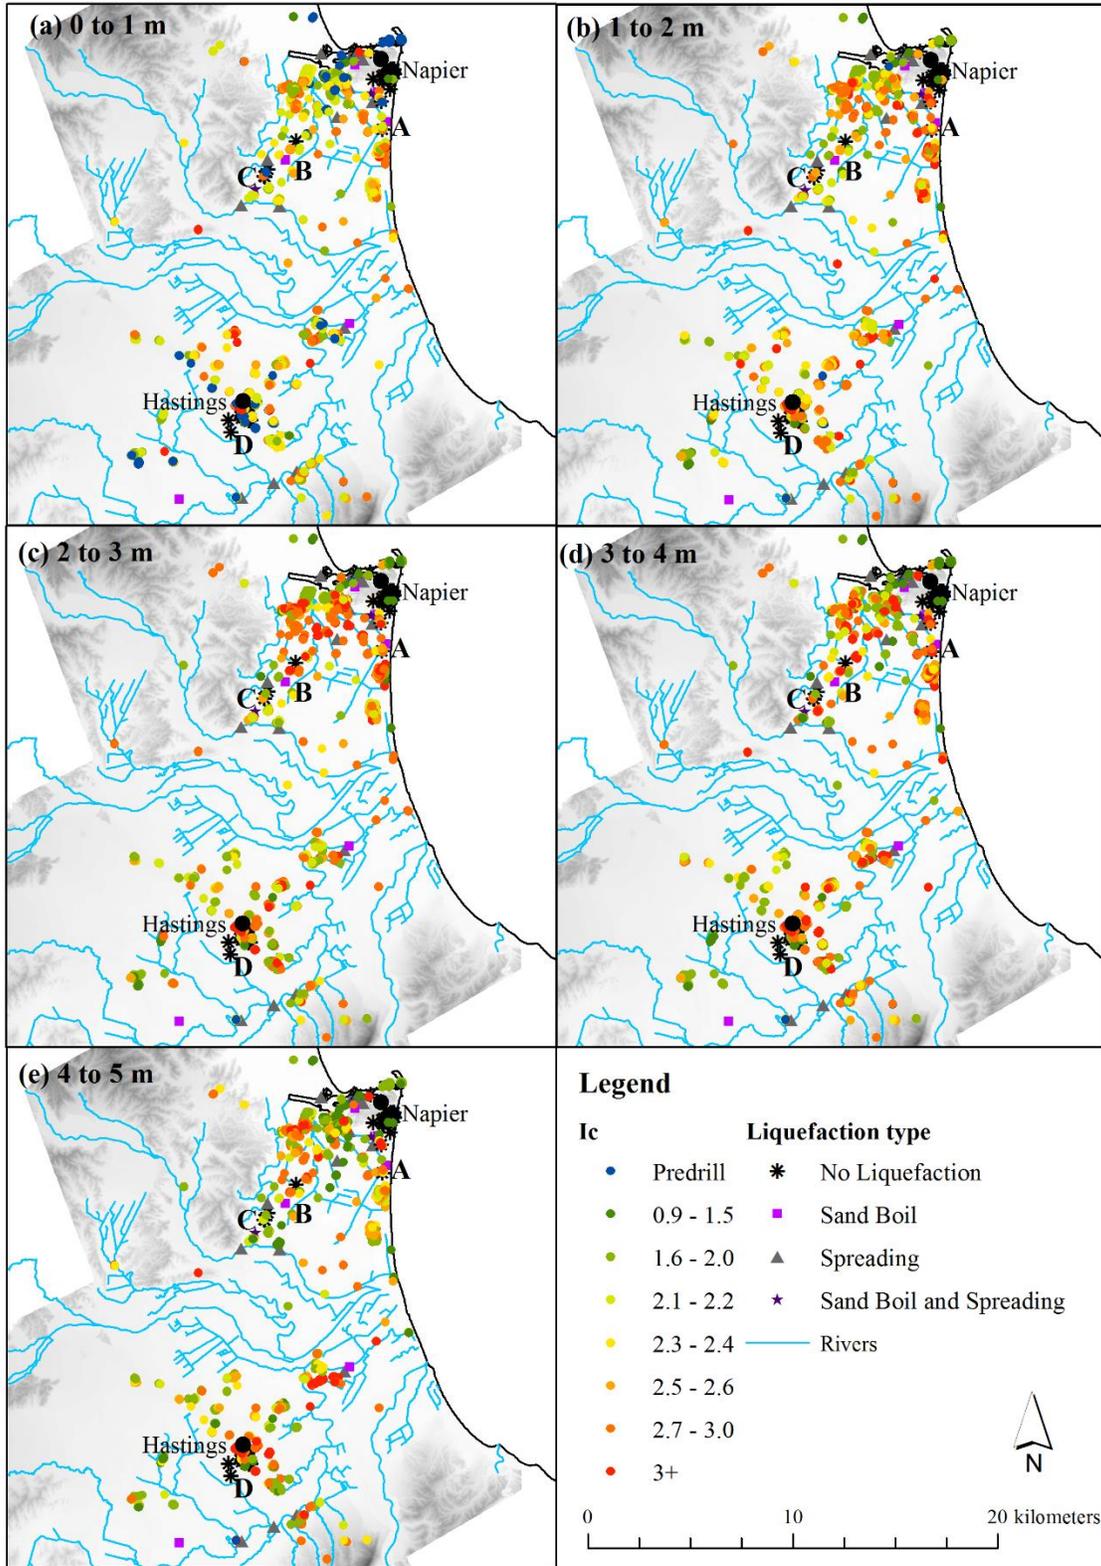
Figure 21: Average  $I_c$  values at 1-m depth intervals for depths of 0 to 5 m

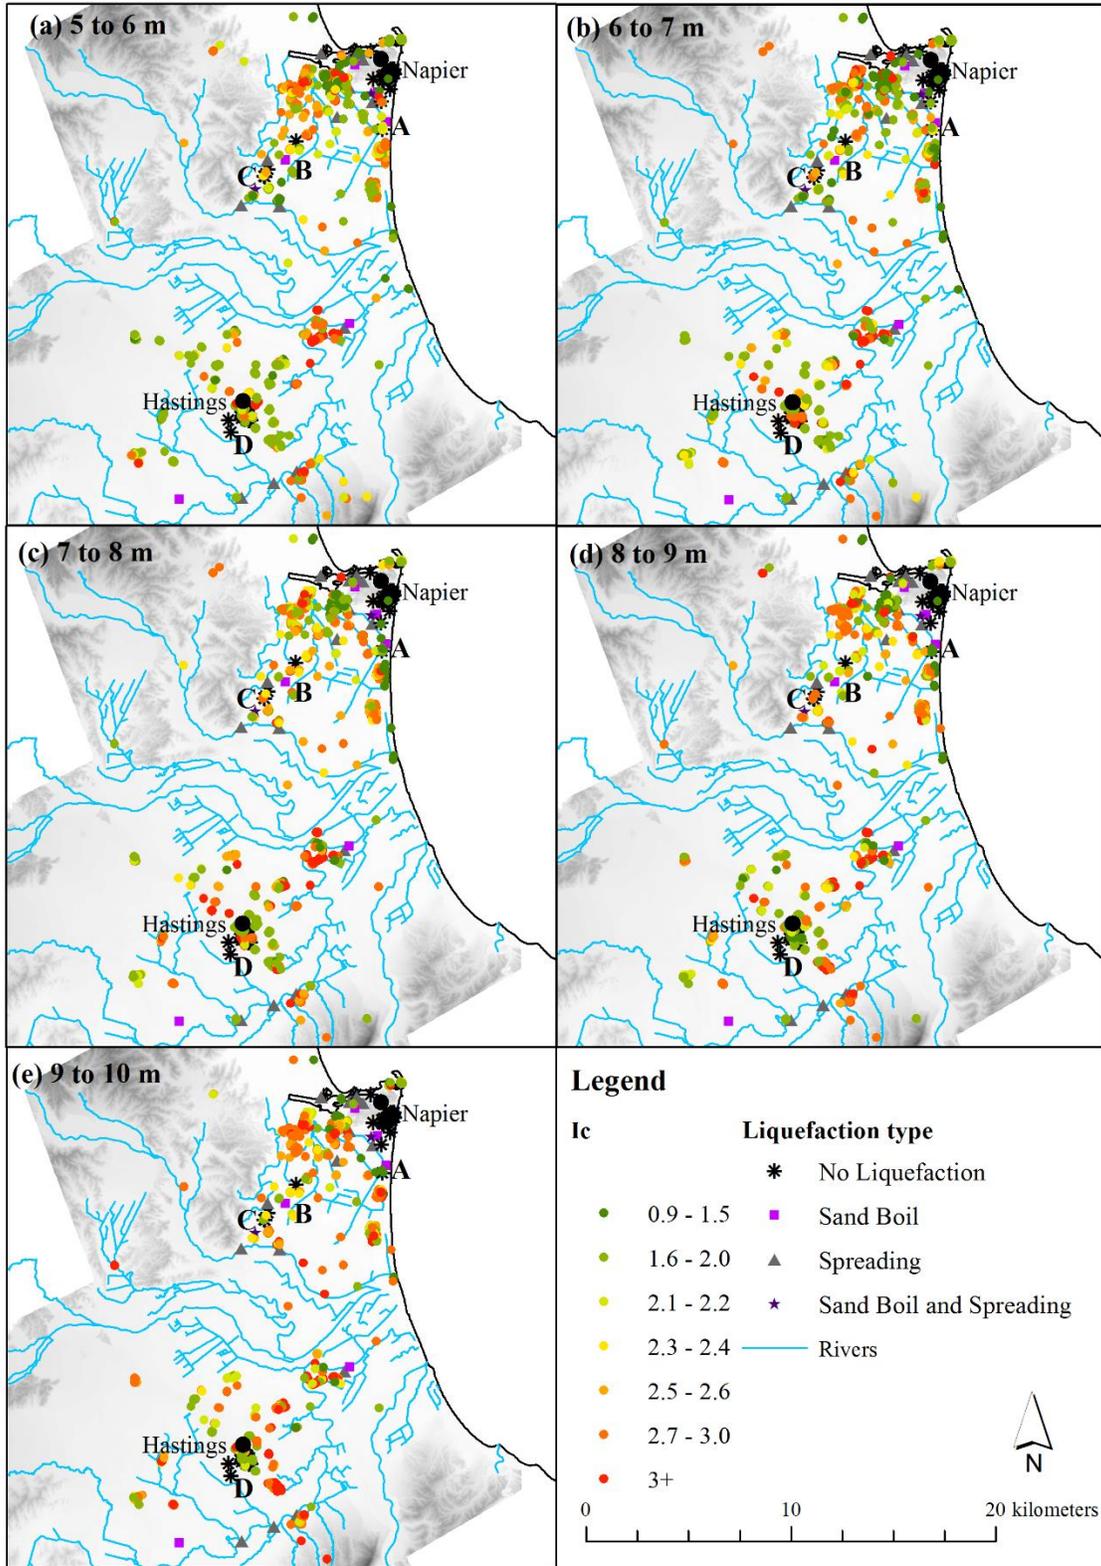
Figure 22: Average  $I_c$  values at 1-m depth intervals for depths of 5 to 10 m

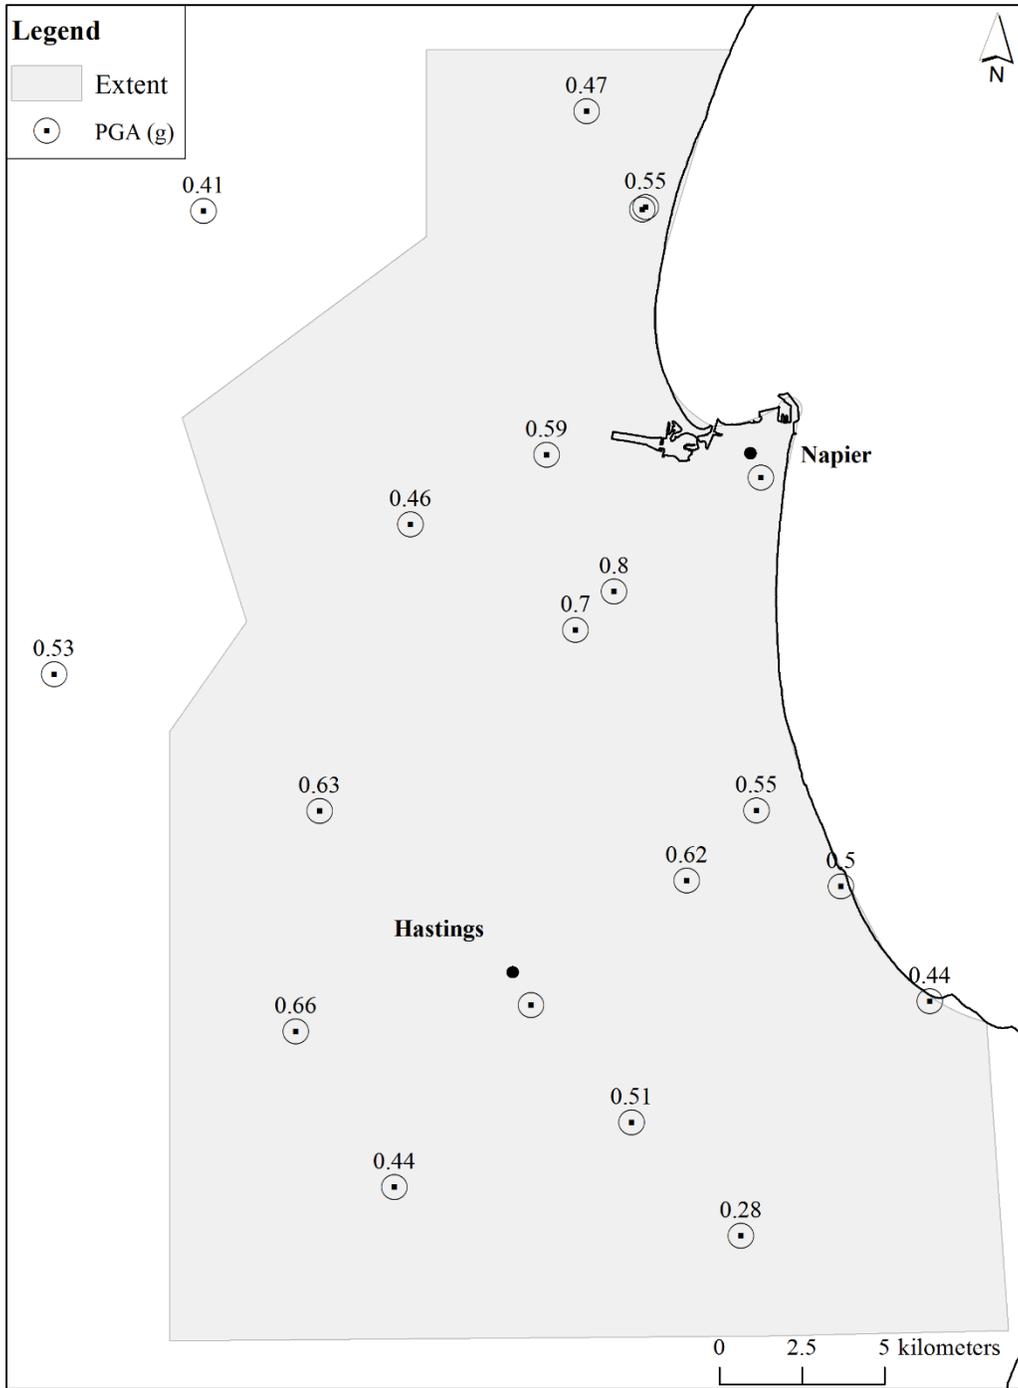
Figure A.1: Simulated PGA points within the extent of study area

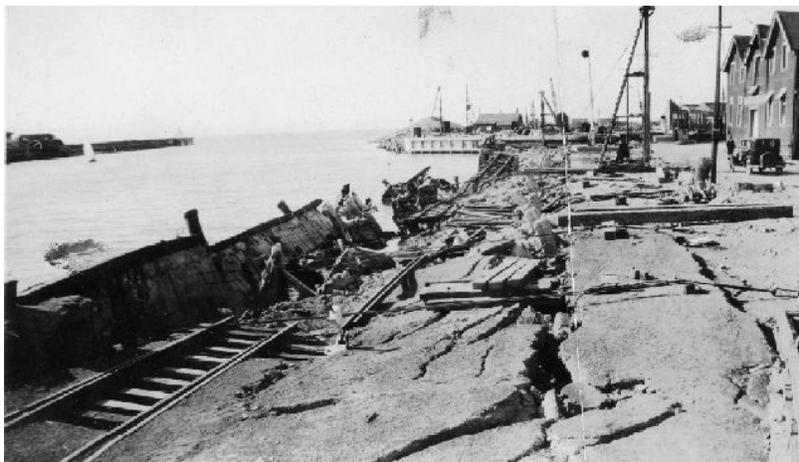
Figure B.1: Lateral spreading of the wharf in Ahuriri (*from the archives of the MTG Hawke's Bay Museum*)

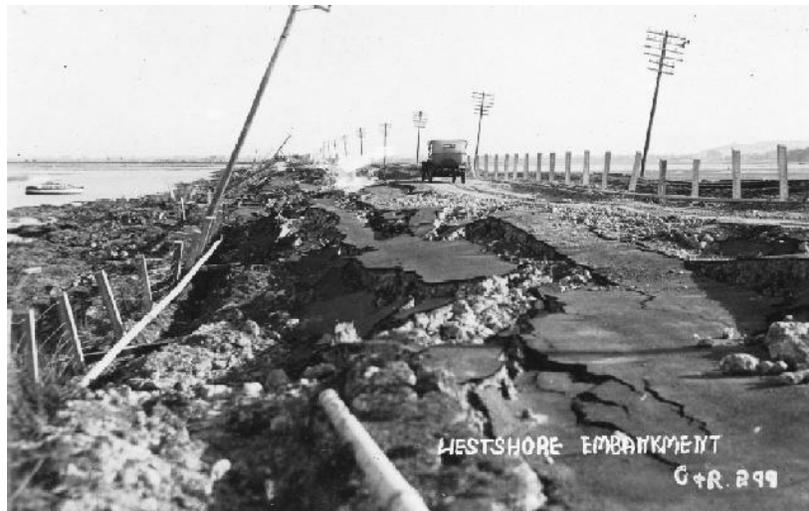
Figure B.2: Severe liquefaction and lateral spreading of the Westshore embankment (*from the archives of the MTG Hawke's Bay Museum*)

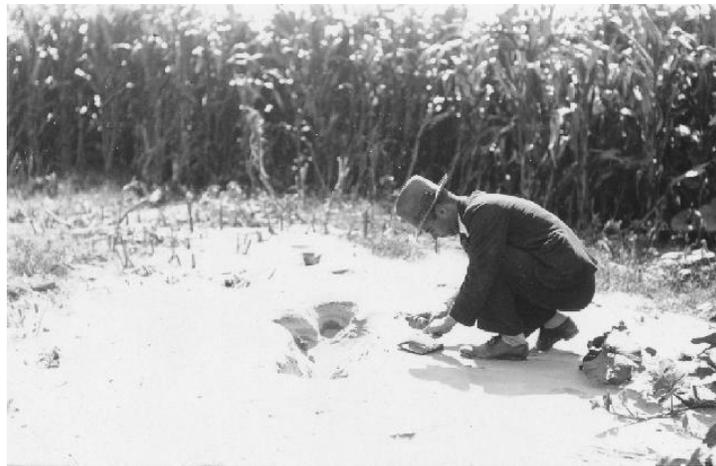
Figure B.3: Sand boils at Petane (*from the archives of the MTG Hawke's Bay Museum*)

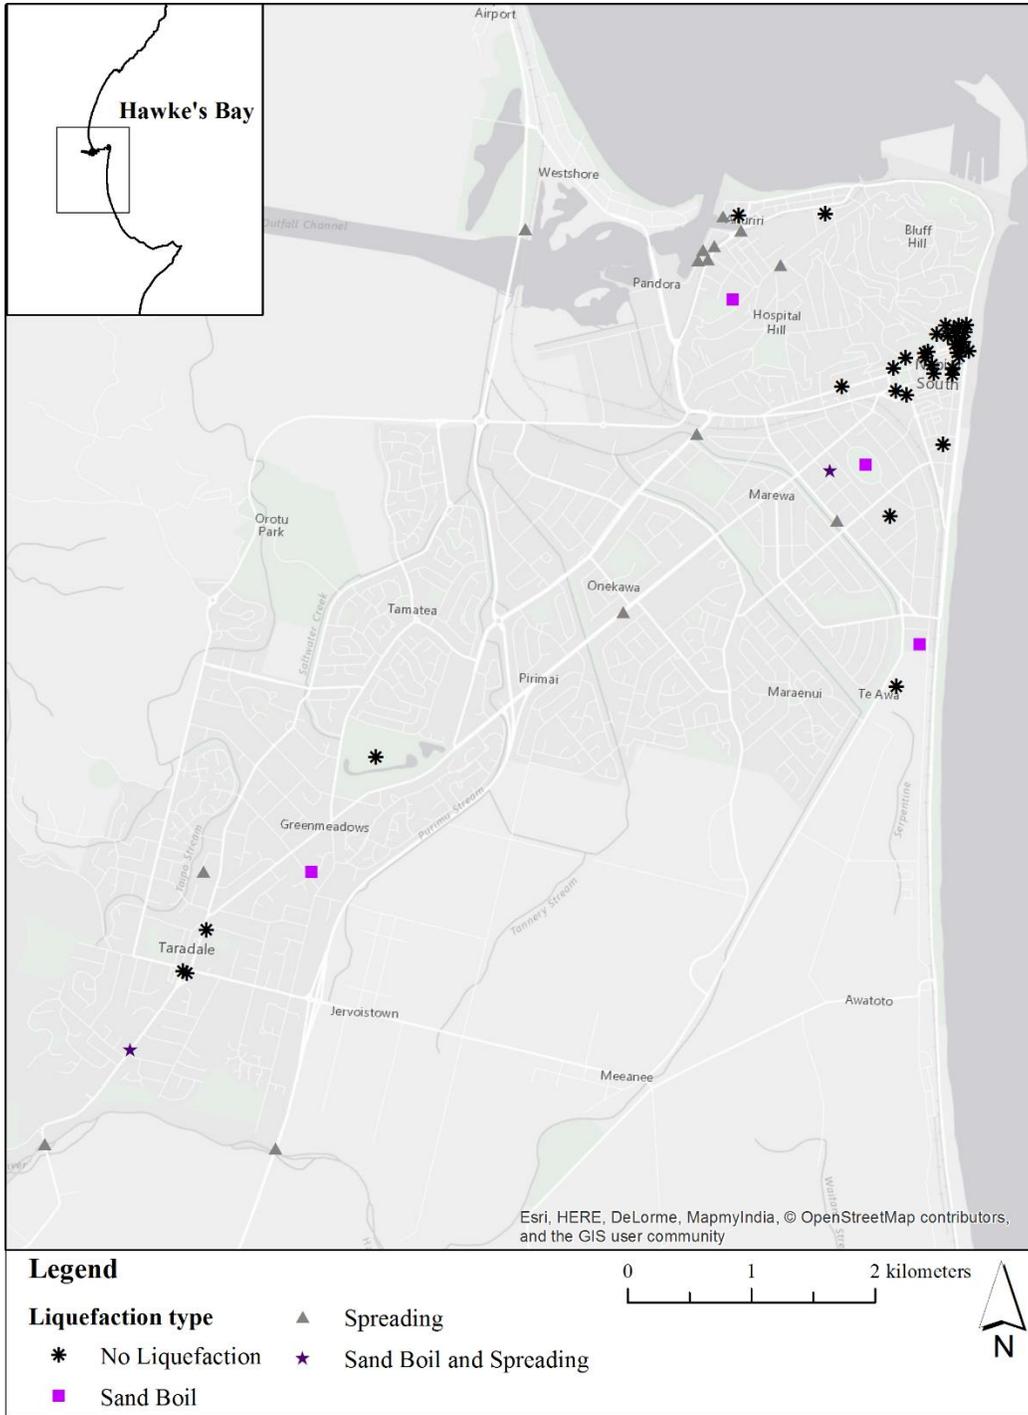
Figure B.4: Historical Liquefaction Sites – Napier/Ahuriri

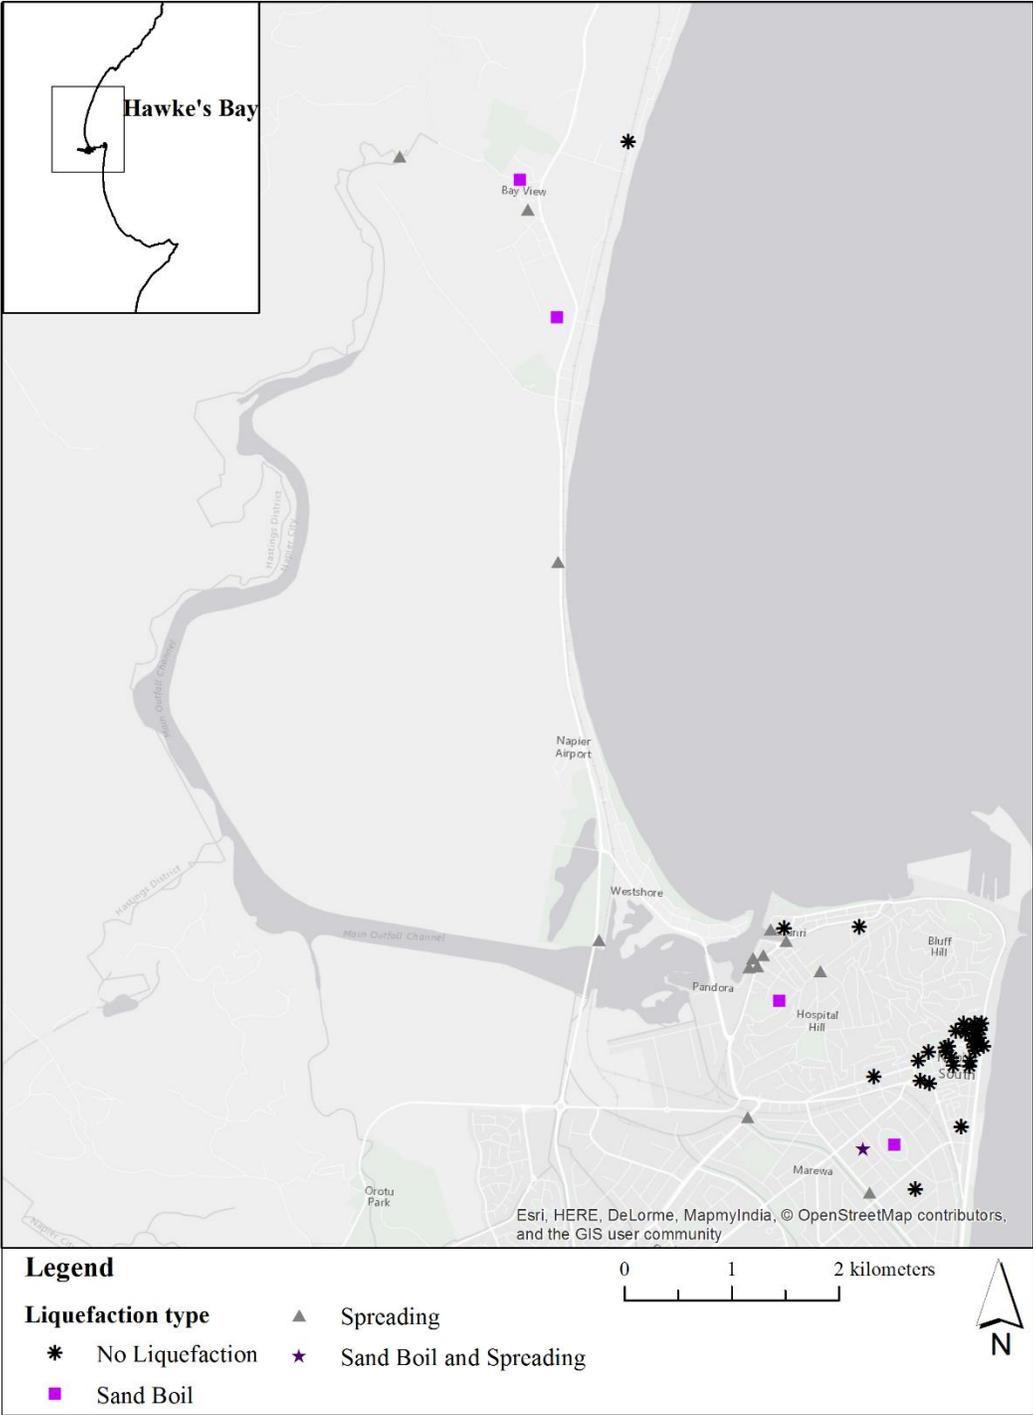
Figure B.5: Historical Liquefaction Sites – Westshore/BayView/Tangoio

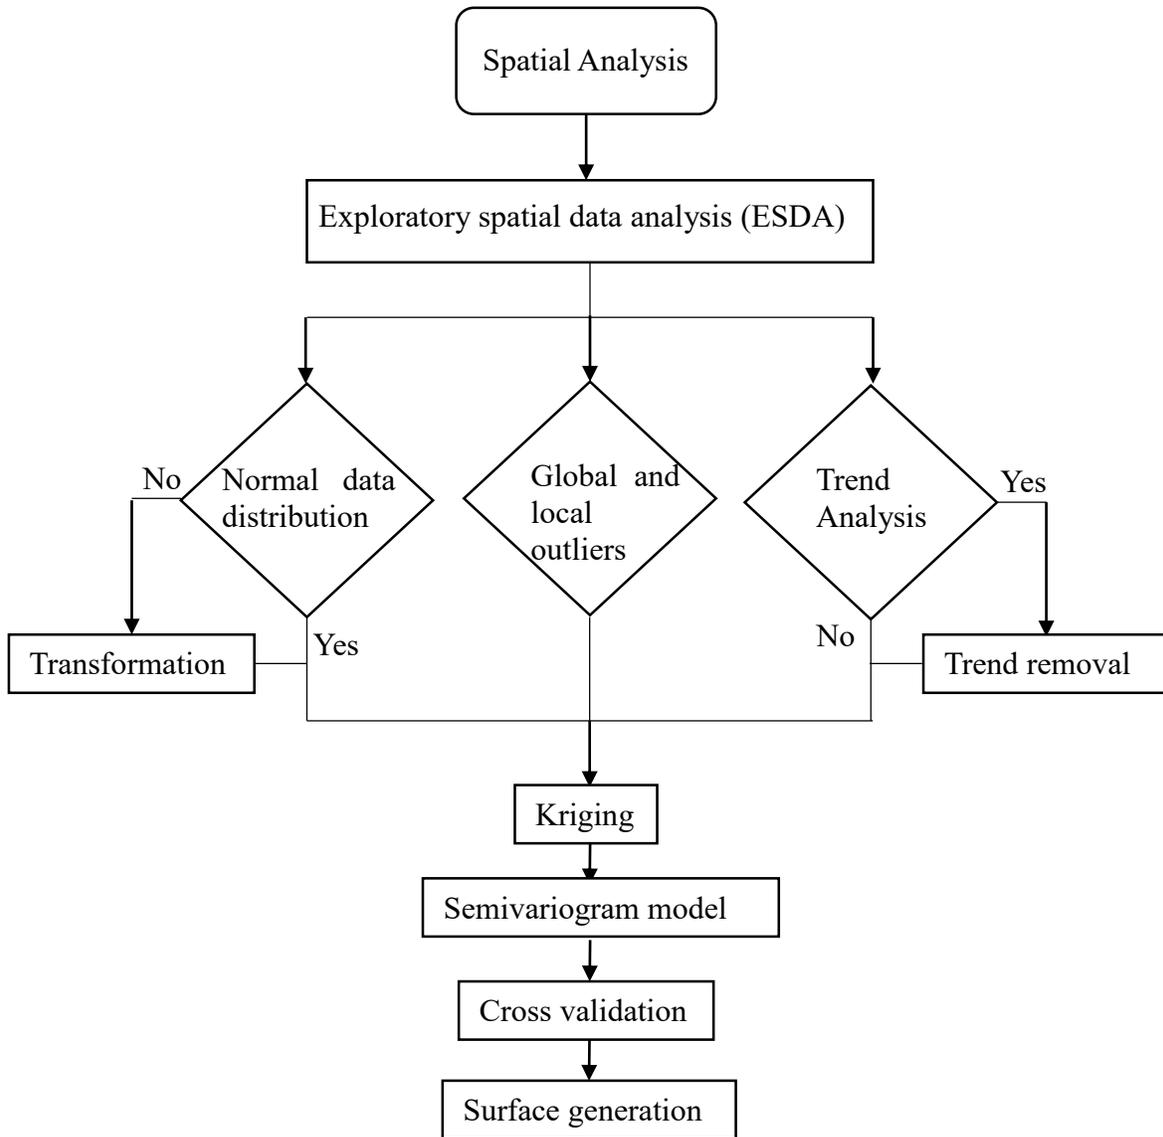
Figure C.1: Flow chart of Geostatistical analysis (*modified from Kumar, n.d.*)

second step is the fitting of a variogram model and spatial interpolation of water levels and the final step is the cross-validation of the prediction map. A flowchart describing the process is shown in Figure C.1.

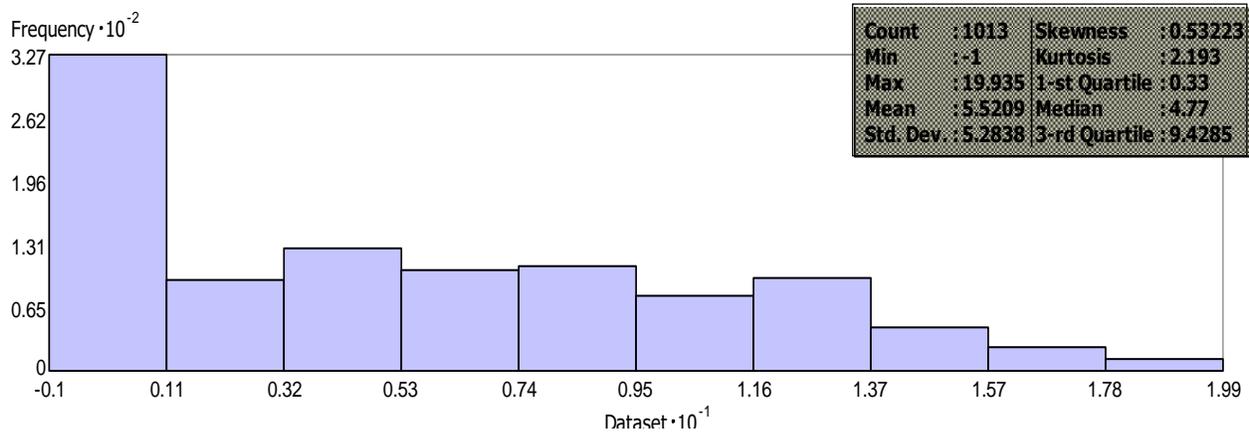
Figure C.2: Histogram, Transformation: none, Dataset: kriging points, Attribute: water elevation

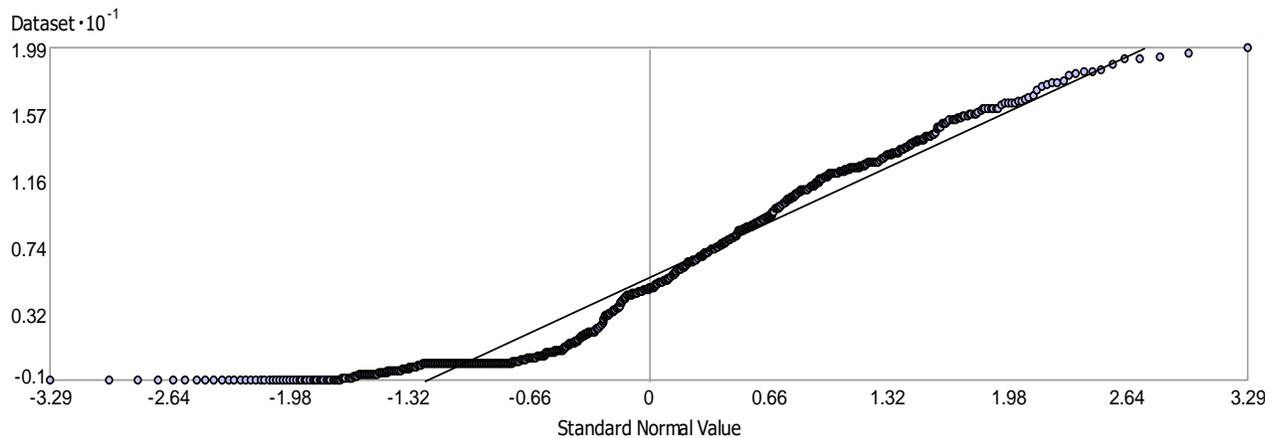
Figure C.3: Normal QQ plot, Transformation: none, Dataset: kriging points, Attribute: water elevation

The **quantile-quantile (QQ) plot** compares the distribution of the data to a standard normal distribution. Generally, the water elevation data are close to the 45-deg line except for the first portion of the line. The closer the points to the straight line, the closer the distribution to a normal distribution.

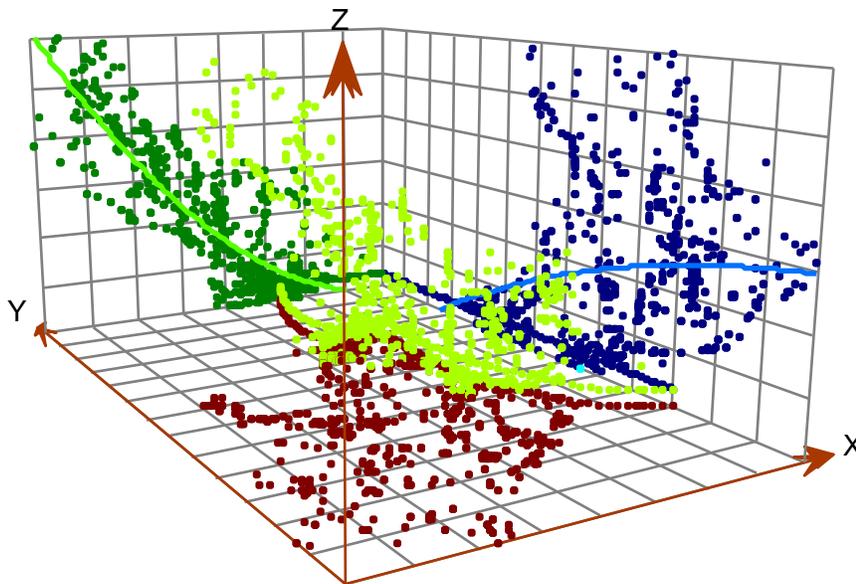
Figure C.4: Trend analysis, 2<sup>nd</sup> order polynomial, Dataset: kriging points, Attribute: water elevation

The **trend analysis** identifies the presence of a global trend in the data (Figure C.4). The trend analysis provides a 3-dimensional perspective of the data and projects the values on the xz and yz planes to allow a better visualization of the global trend. The trend is then fitted by a model and is removed. The interpolation is done on the residuals and then the global trend is added. Figure C.4 suggests that there may be a trend in the data. However, the trend is not strong for all the directions. Thus, the trend removal is not further investigated for two reasons. First, trend removal requires more parameters to be estimated. The more parameters to estimate, the less precise the model becomes. Second, the removal of the trend increases the accuracy of modeling residuals or random short-range variations which is not of concern in this study since the main interest is a more general smooth groundwater surface (Esri 2016).

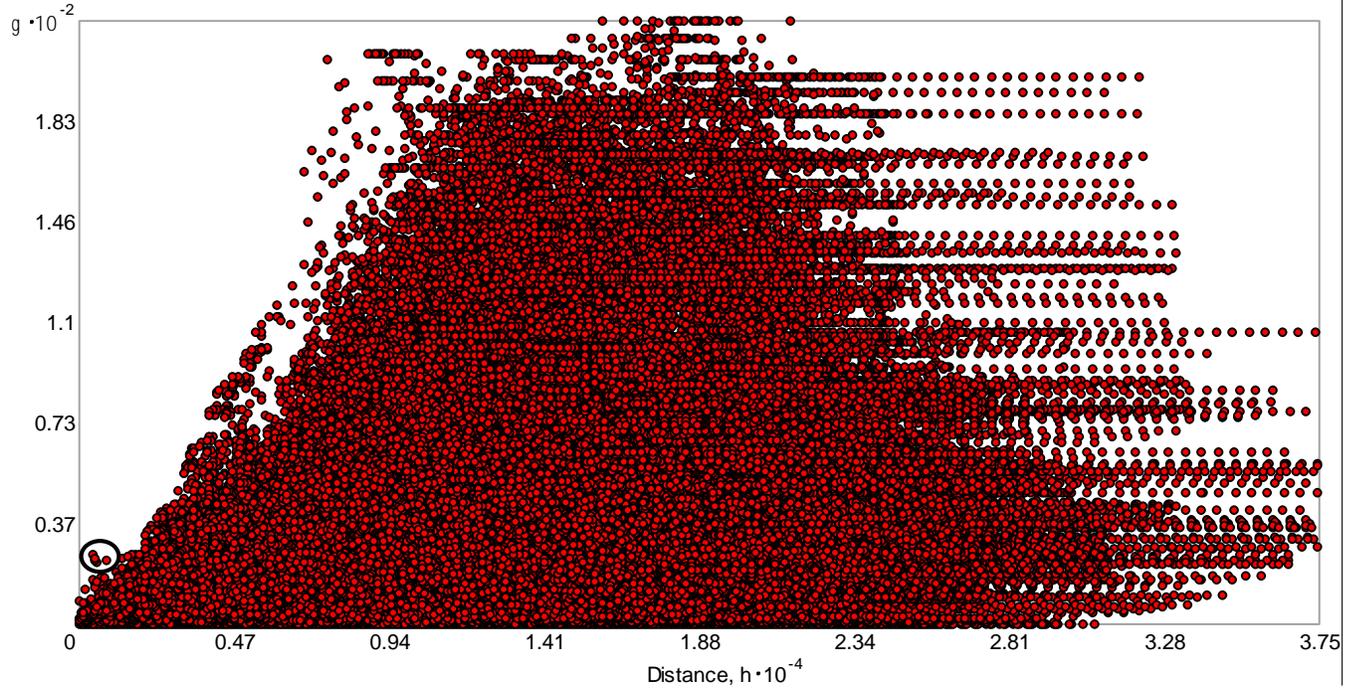
Figure C.5: Semivariogram cloud, lag:1500 m, number of lags: 25, Dataset: kriging points, Attribute: water elevation

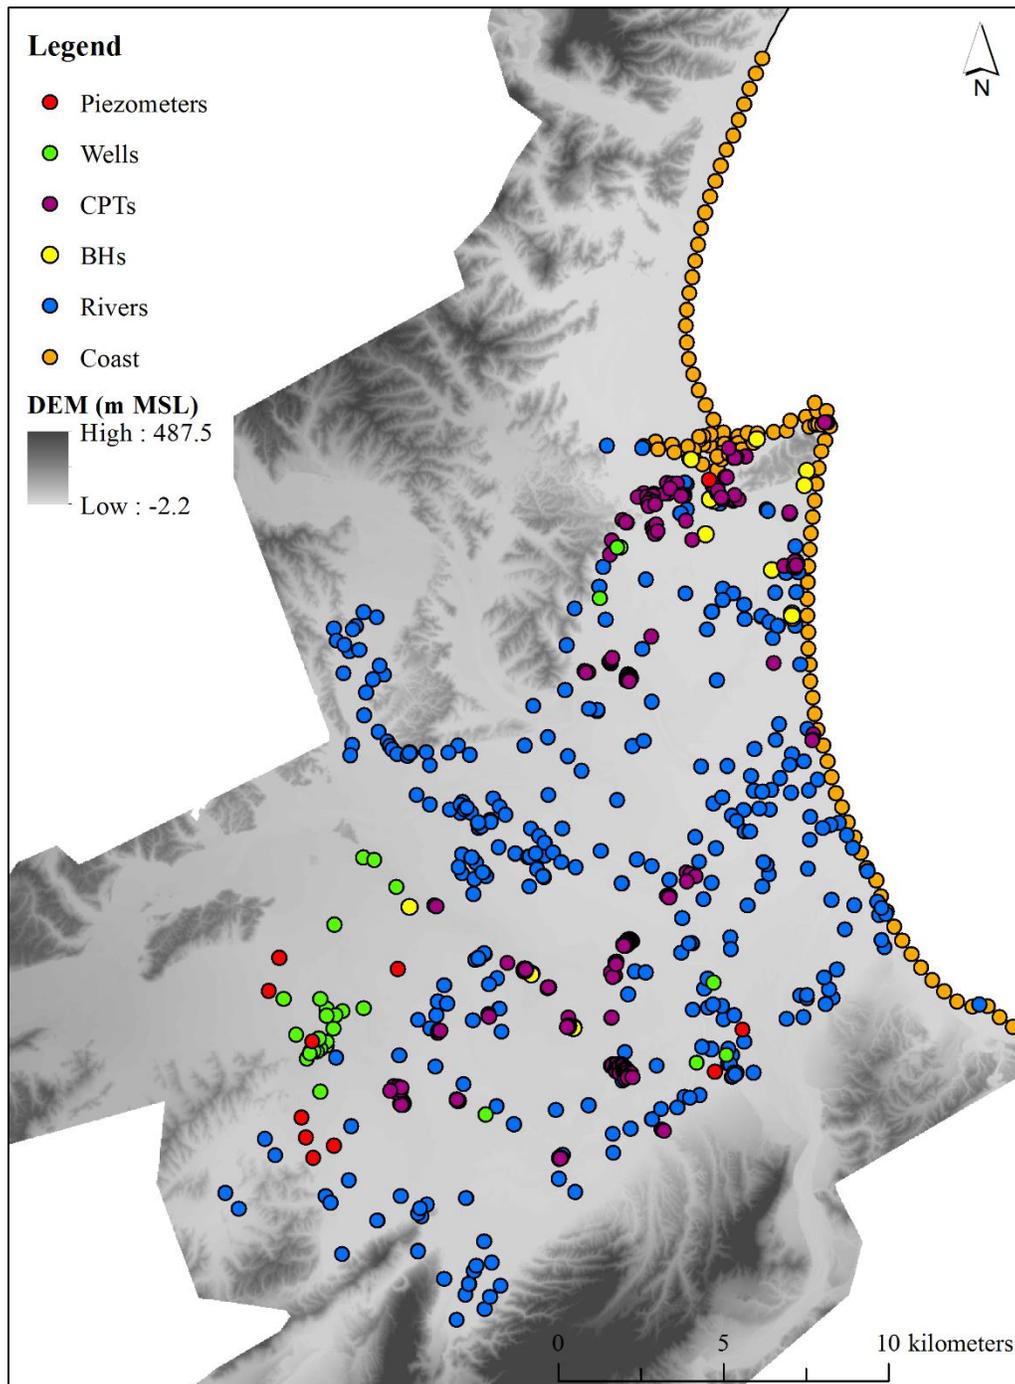
Figure C.6: Input data points for water elevation surface interpolation

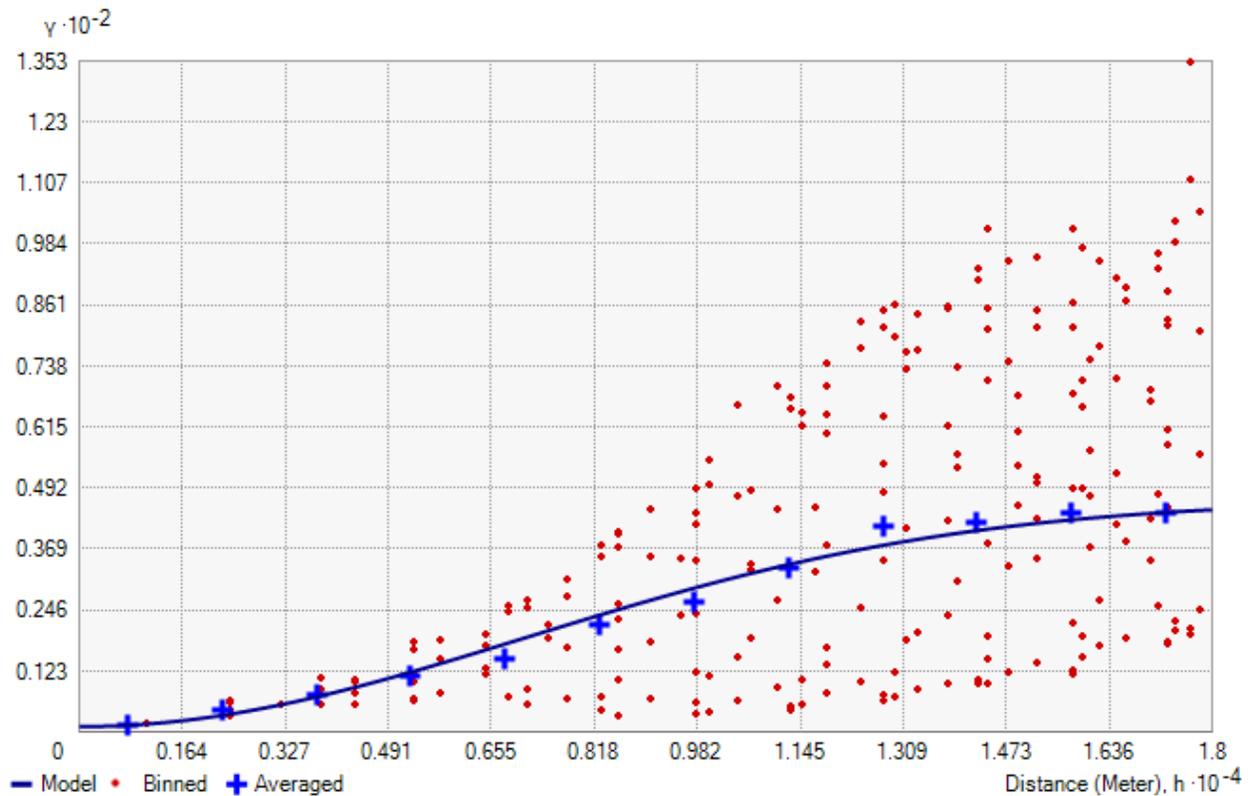
Figure C.7: Semivariogram model

There are many geostatistical methods: Kriging, Co-kriging and Empirical Bayesian Kriging. The last 2 methods were tried and did not yield good models, thus they won't be considered in this work. Kriging will be used in the development of the groundwater model. There are many types of kriging. The most widely used are ordinary, simple and universal. These types were tried for the construction of the ground water model. Ordinary and universal give comparable results. Ordinary kriging is simpler and more used than universal kriging and hence, is used for this model. Input datasets for the ground water level surface under low-flow conditions are shown in Figure C.6. River and coast polylines were converted into points in order to restrain the model spatially and downstream at the coastline. Geostatistical Analyst determines a convenient lag size for grouping semivariogram values. The lag size is the size of the distance class used to group pairs of locations. Thus, the red dots in the empirical variogram in Figure C.5 are binned into lags and then averaged (Figure C.7). The averaged points (blue crosses) are fitted with different models and lag sizes. The best fit model (blue line in Figure C.7) is Gaussian with a lag size of 1500 m. The goal of this model is to characterize a global GWT and thus, inexact data fitting at measured samples is performed to obtain a smooth GWT. Thus, the search neighborhood was set to smooth with a smooth factor of 1.

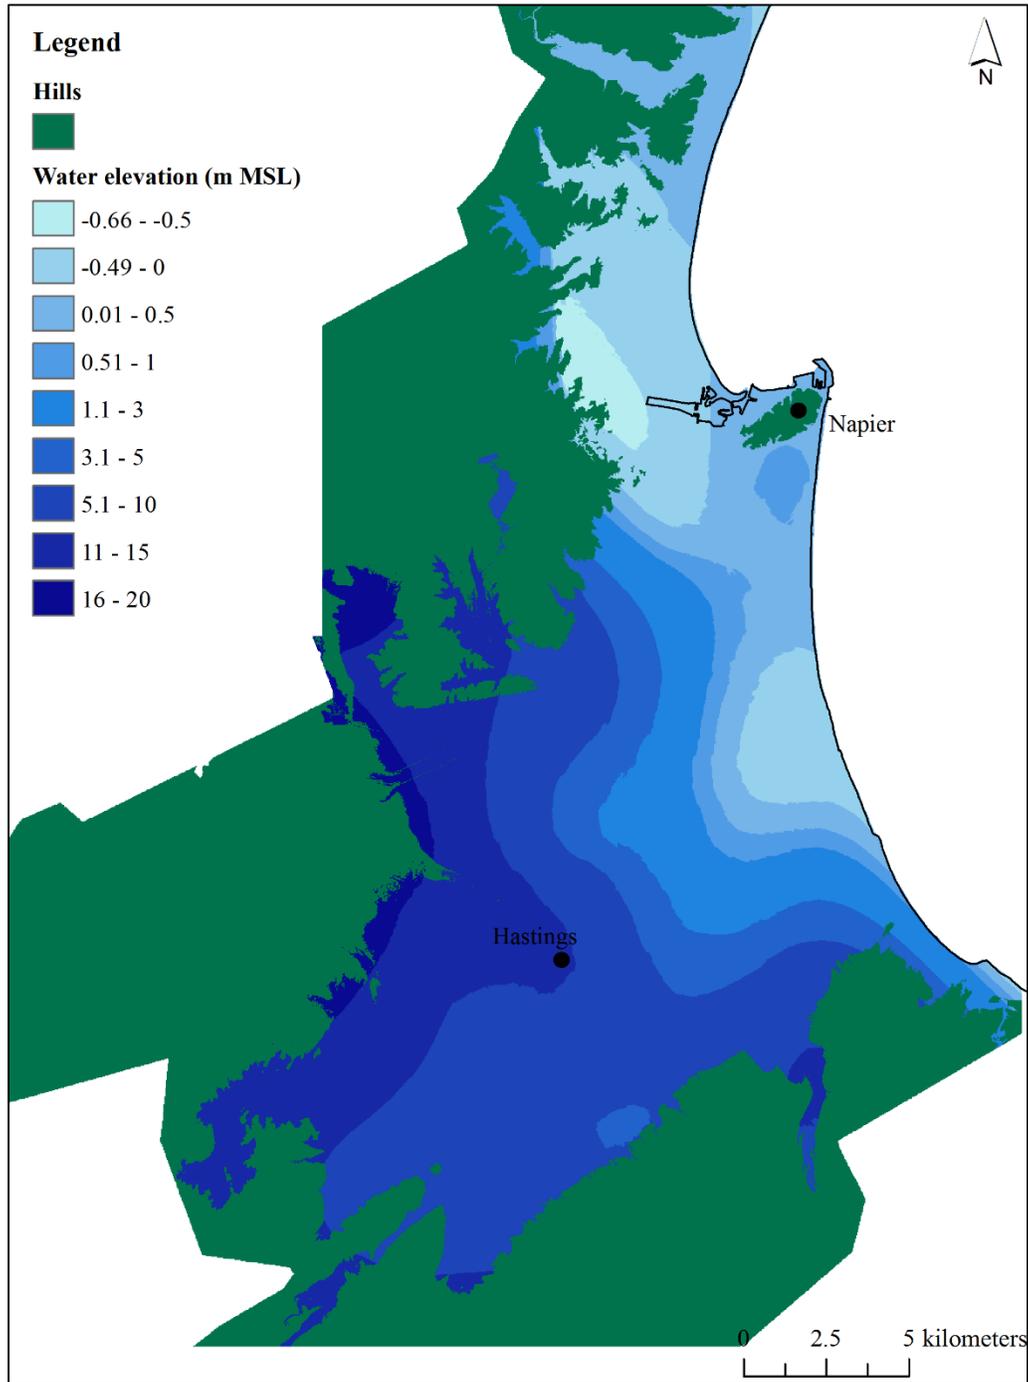
Figure C.8: Water elevation map for the Heretaunga Plains

The best fit model results in the water elevation surface shown in Figure C.8.

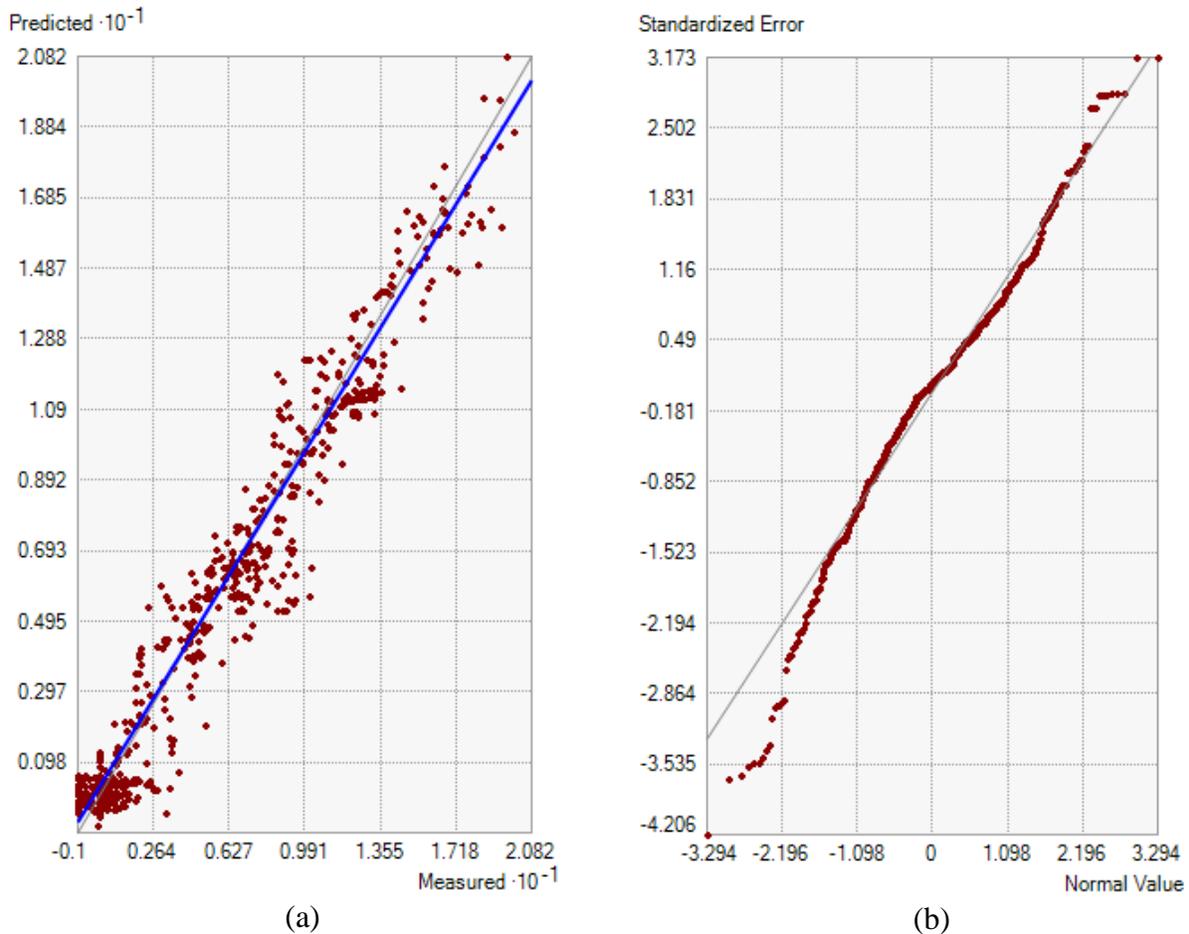
Figure C.9: (a) Comparison between predicted and measured values, (b) normal QQ plot

Figure C.9a provides a graphical comparison between the predicted and the measured values. A good model should have a fit close to the 1:1 line which is approximately the case in this model (0.96 slope of regression line). Another measure of goodness of fit and normality of the data is the normal QQ plot. The QQ plot shows the quantiles of the difference between predicted and measured and the corresponding quantile of a normal distribution. Figure C.9b shows that the predictions follow a normal distribution except for the deviation at small values.

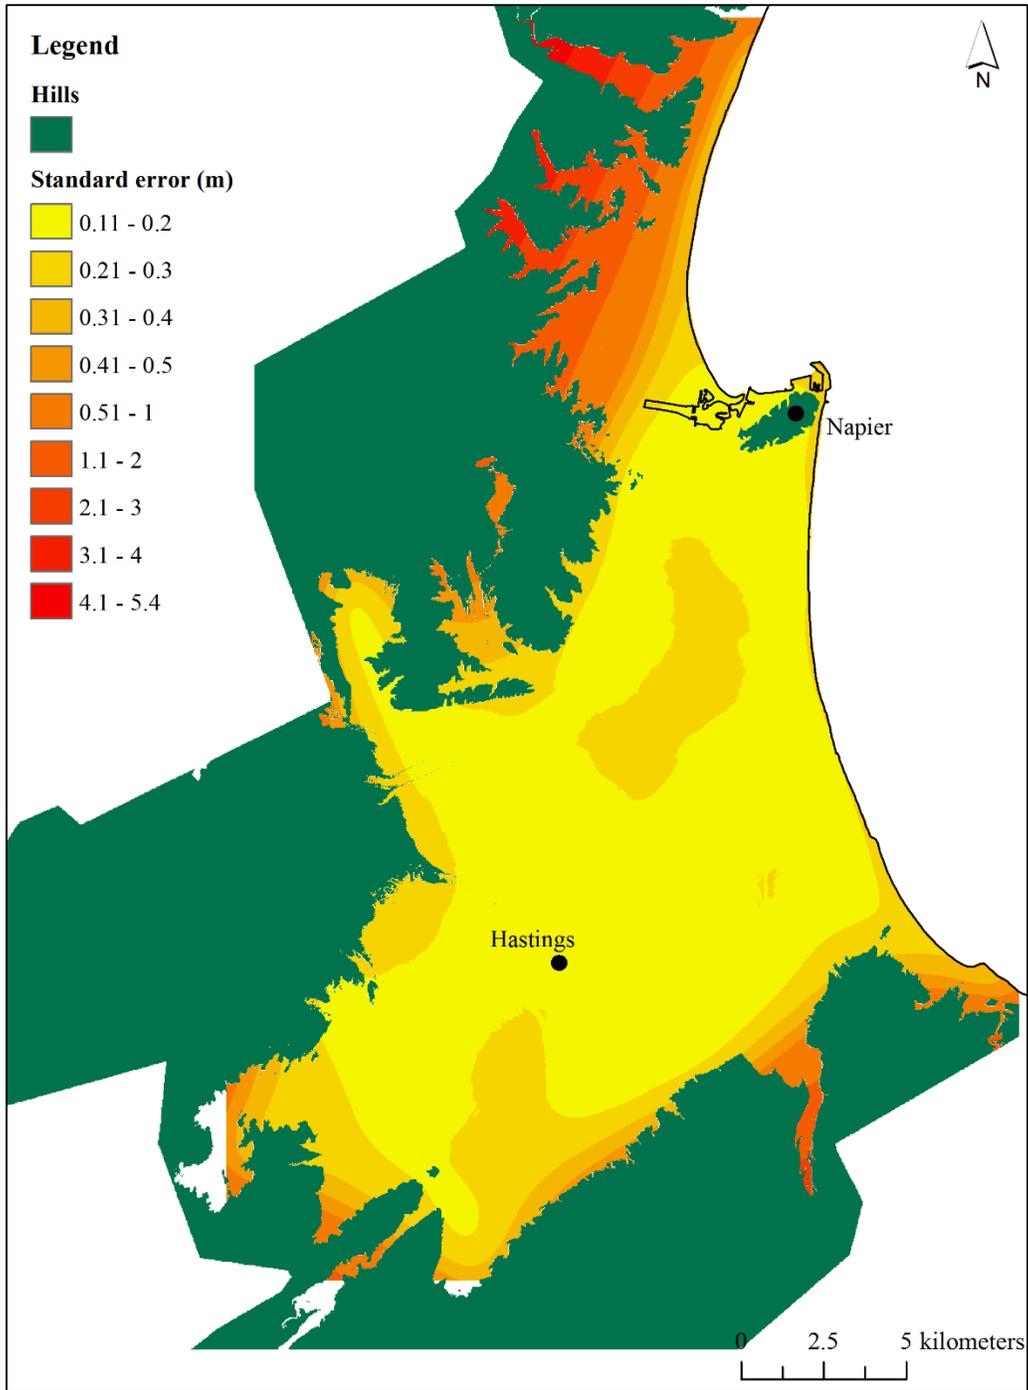
Figure C.10: Prediction standard error map for the Heretaunga Plains
