**Insights into the Liquefaction Hazards in Napier and Hastings Based on the Assessment of Data from the 1931 Hawke's Bay, New Zealand Earthquake**

Thesis submitted to the faculty of the Virginia Polytechnic Institute and State University in partial fulfillment of the requirements for the degree of

Master of Science  
In  
Civil Engineering

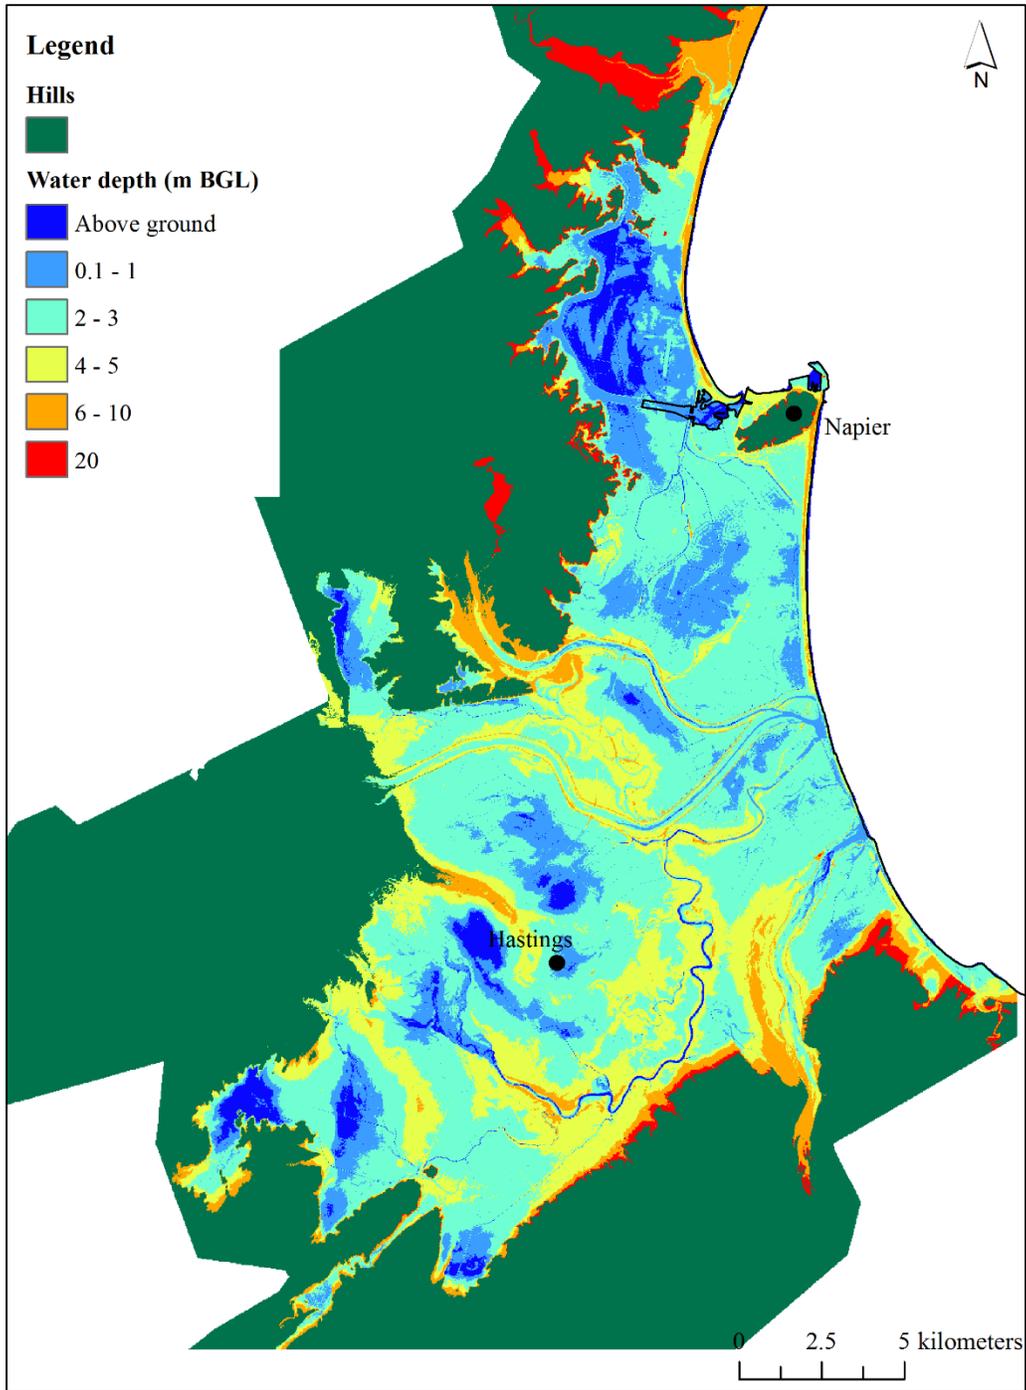
Figure C.11: Depth to water table map for the Heretaunga Plains

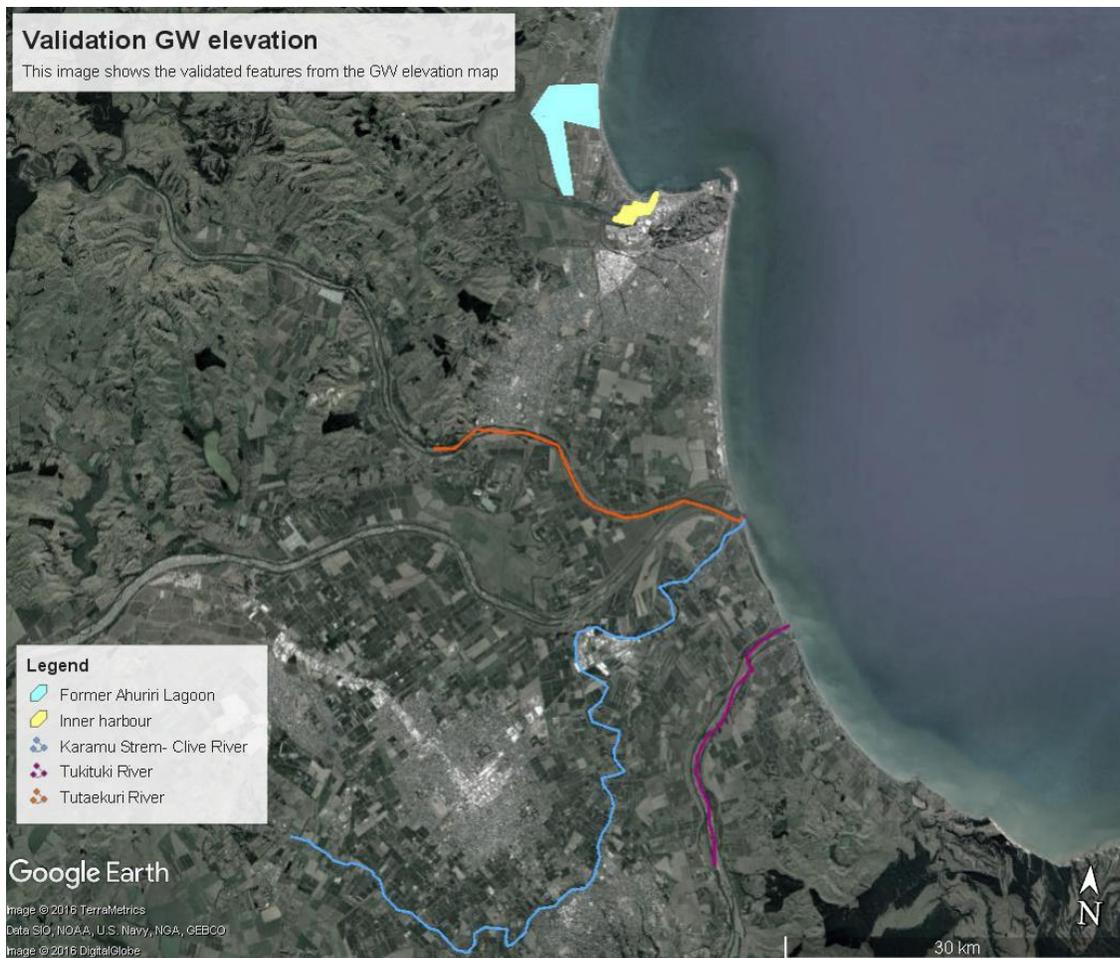
Figure C.12: Validation of surface water as predicted by the contemporary depth-to-water map

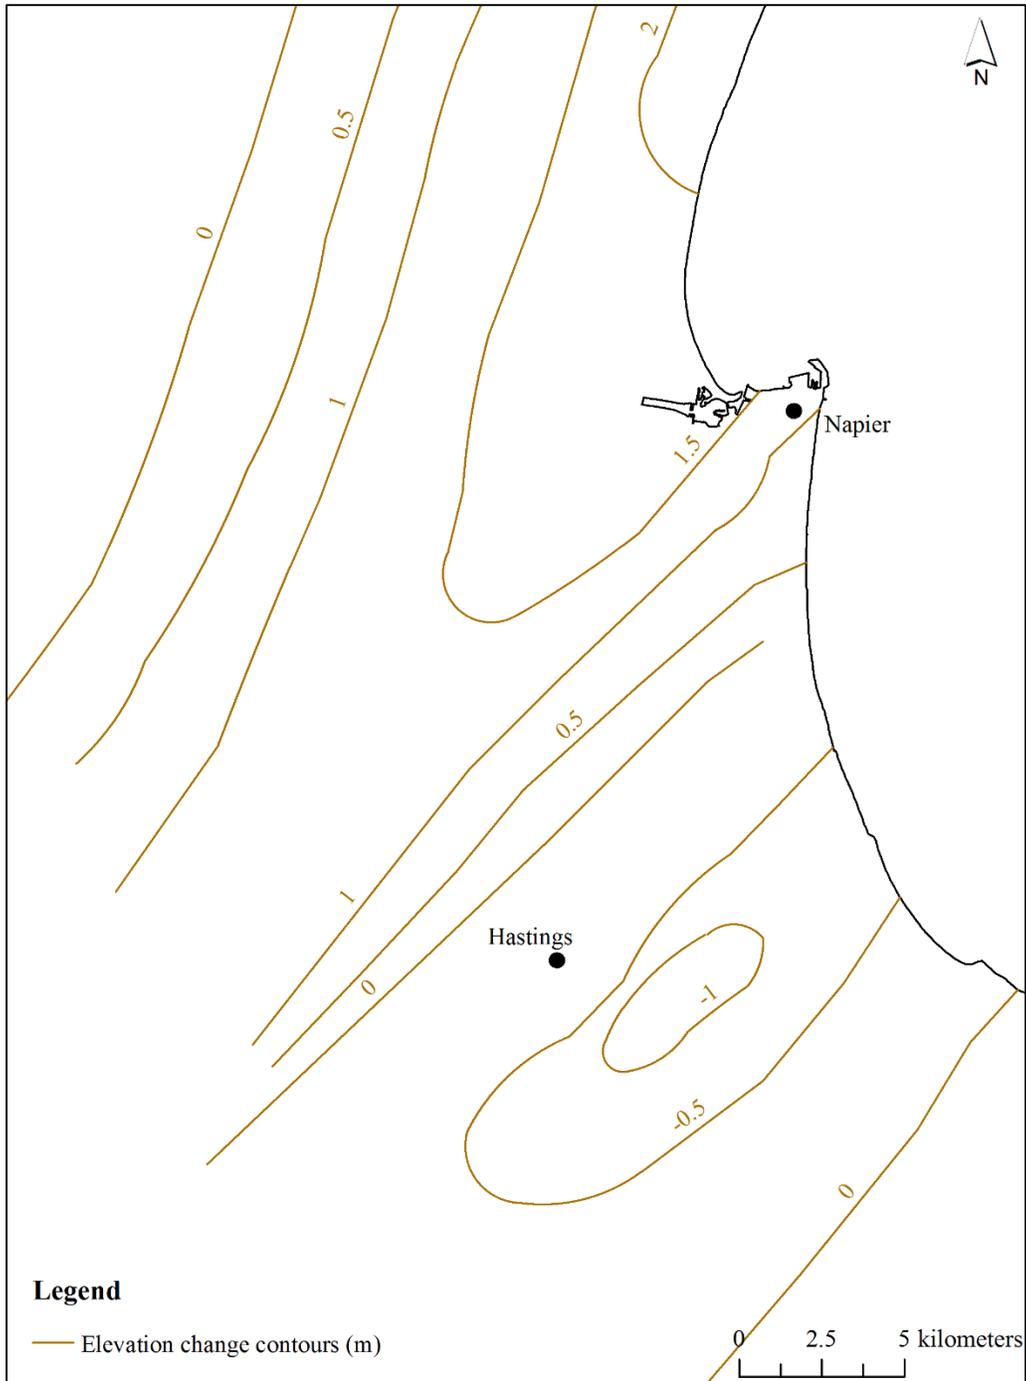
Figure C.13: Changes in elevation the area of study (*reproduced from Hull 1990*)

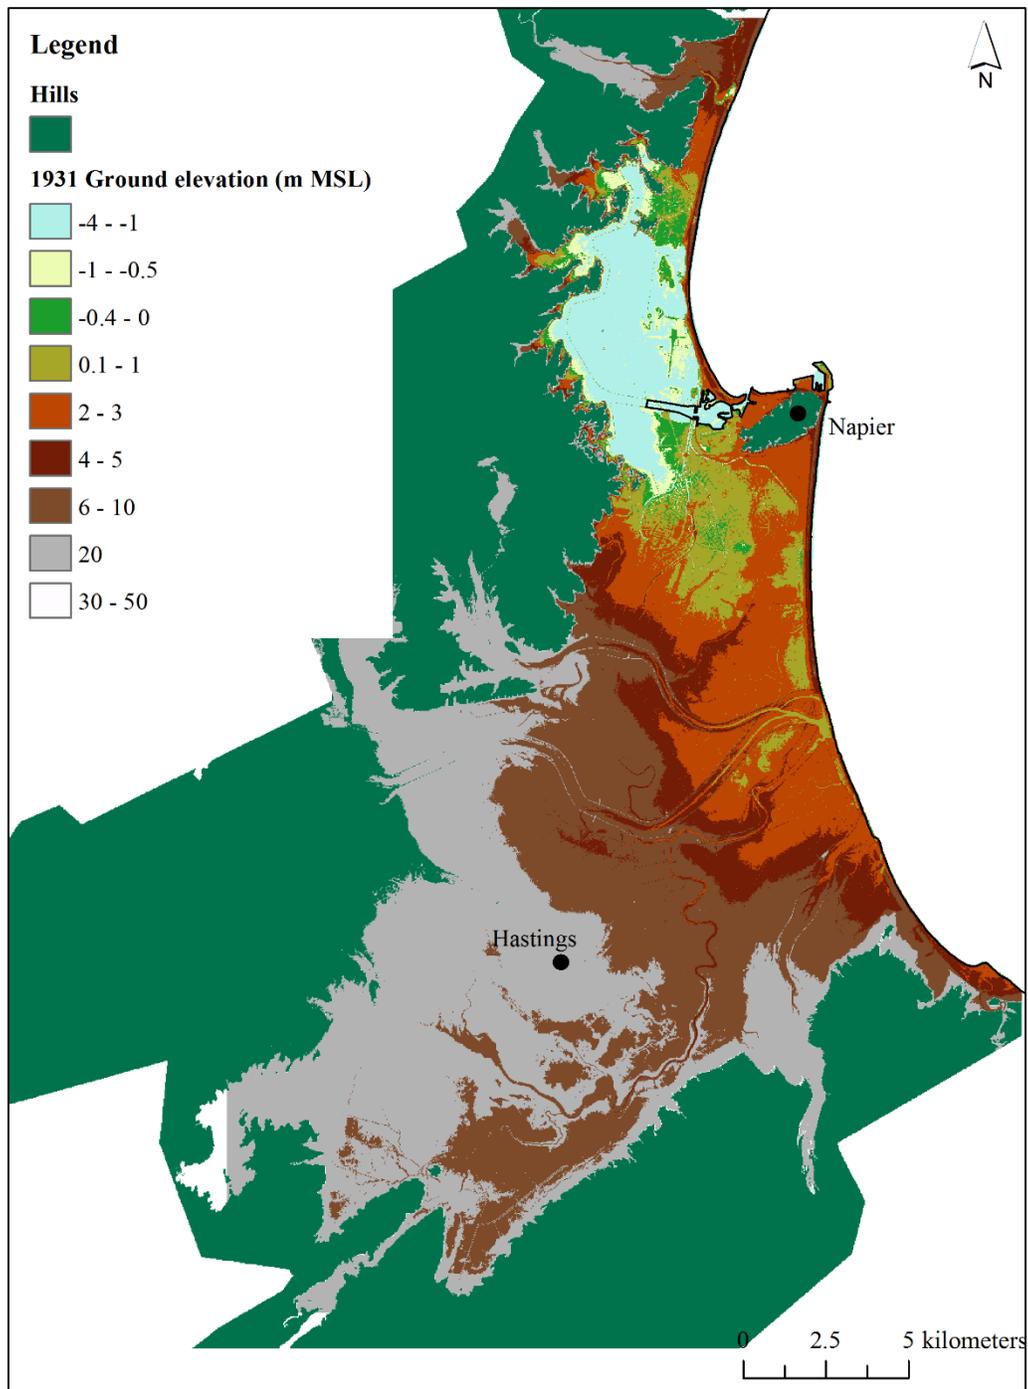
Figure C.14: Pre-1931 estimated ground elevation for the Heretaunga Plains

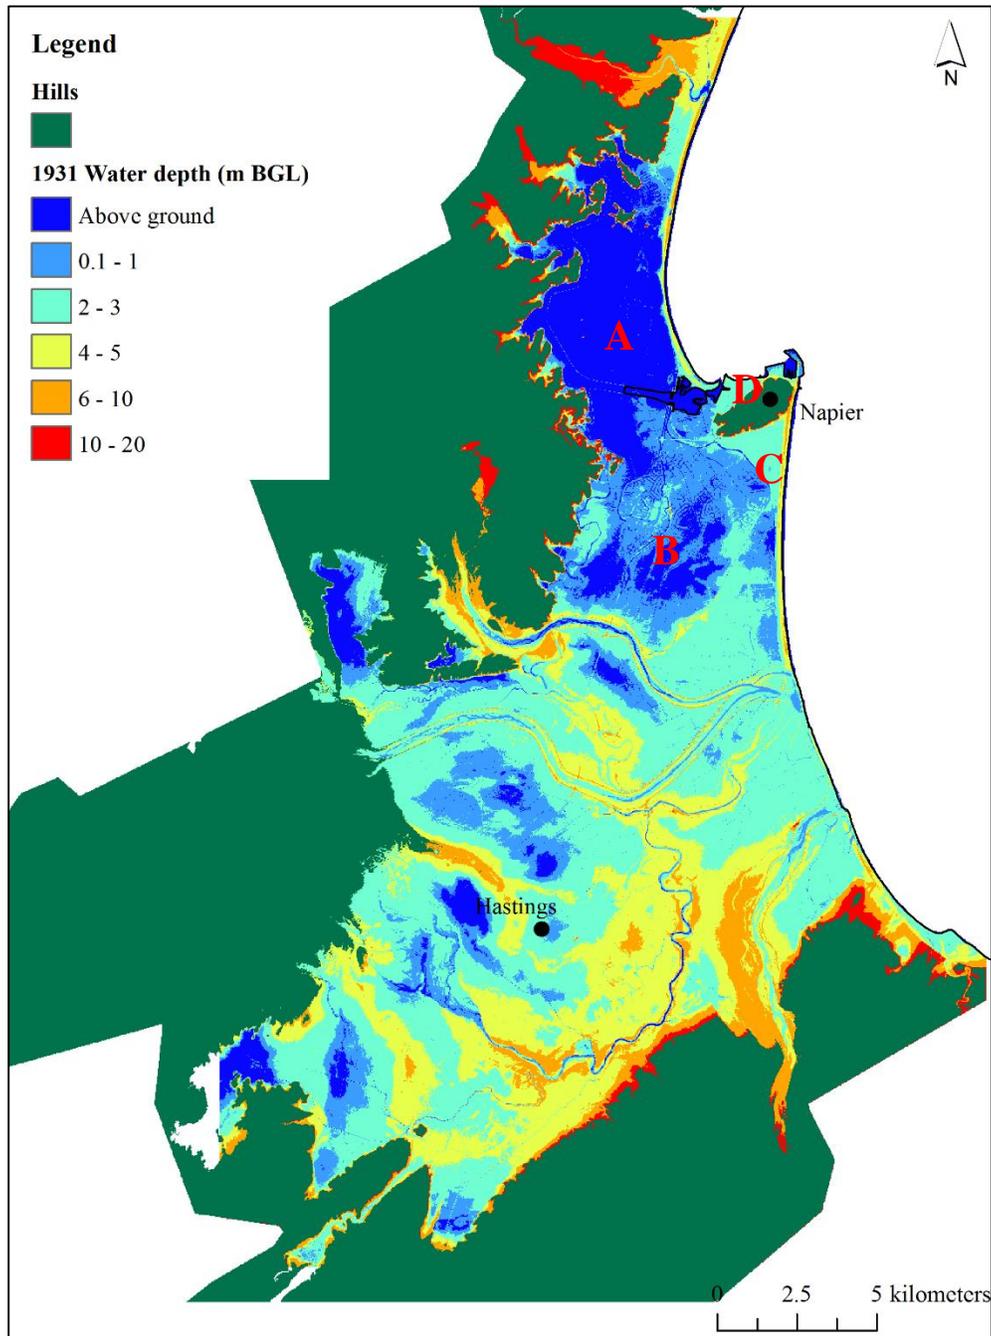
Figure C.15: Pre-earthquake estimated groundwater depths for the Heretaunga Plains

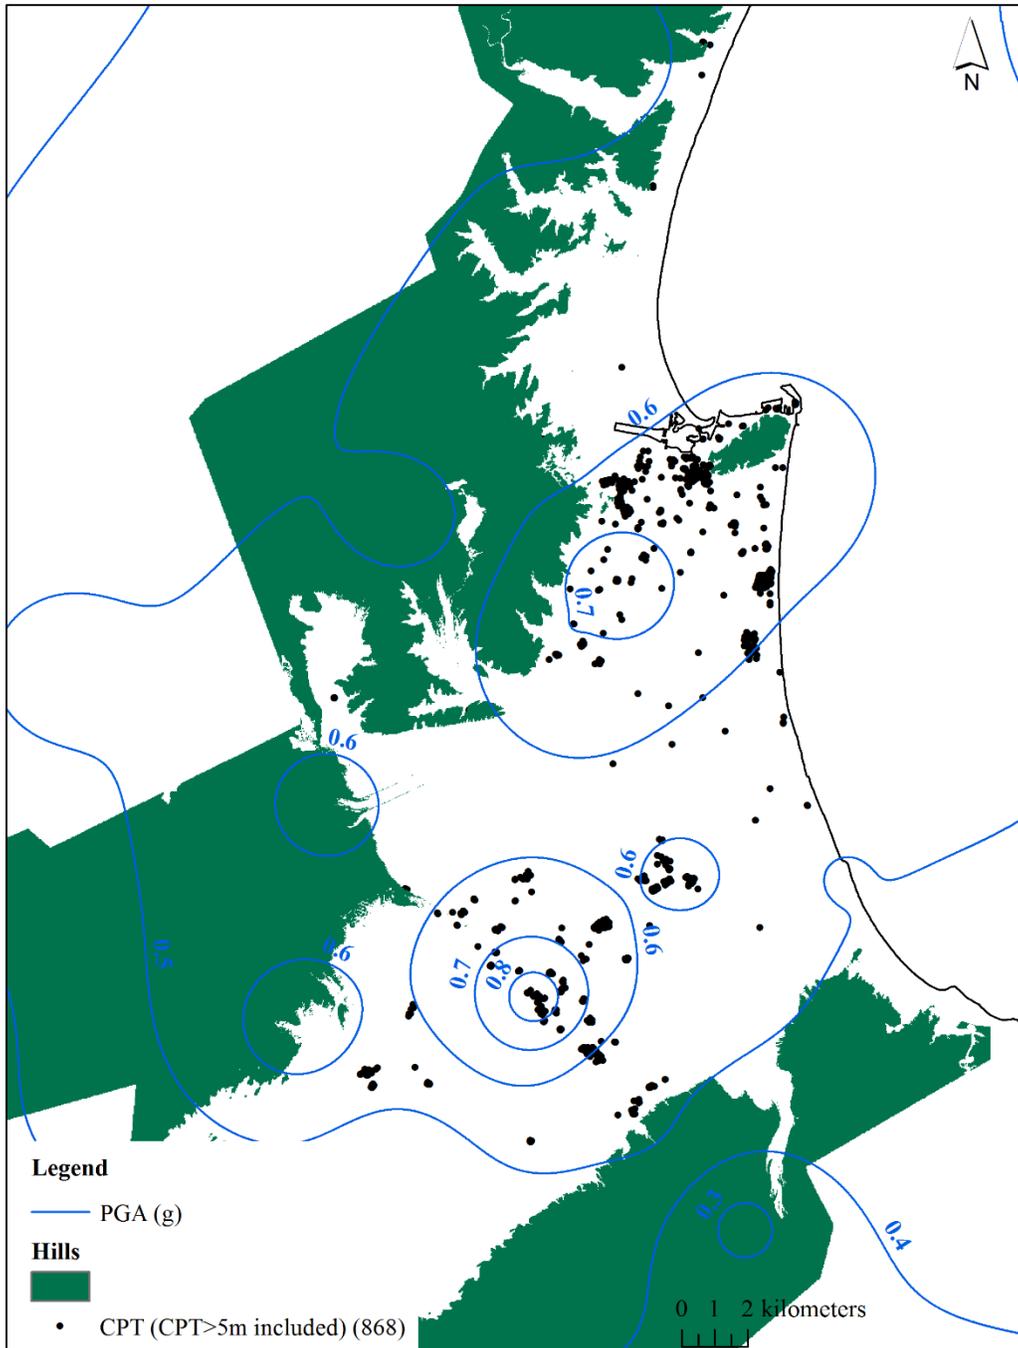
Figure D.1: Spatial distribution of CPT with depth greater than 5m

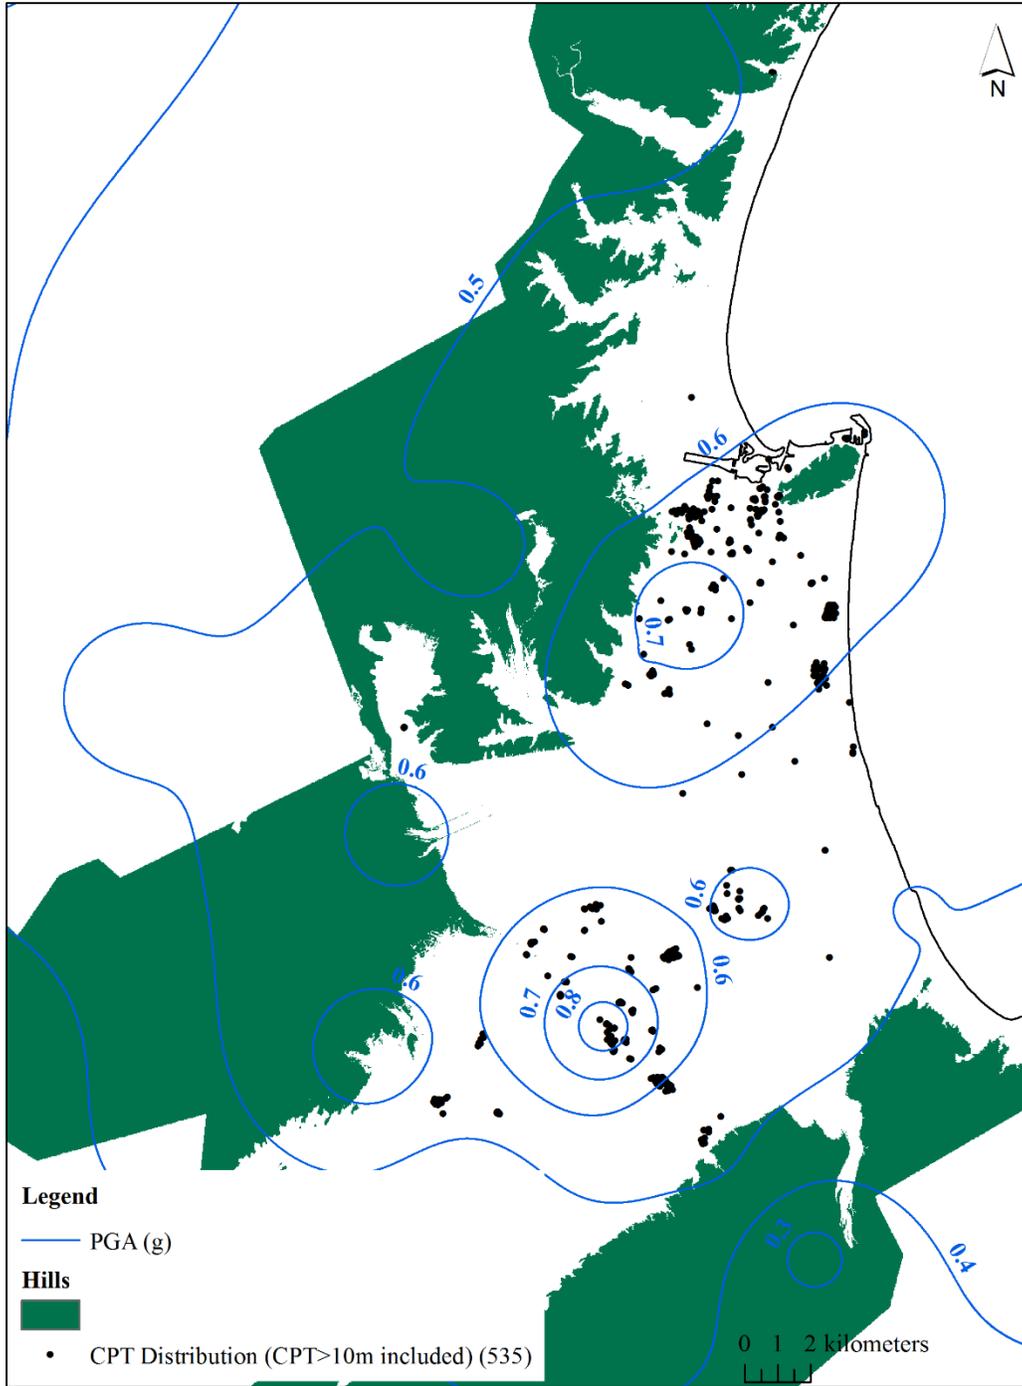
Figure D.2: : Spatial distribution of CPT with depth greater than 10m

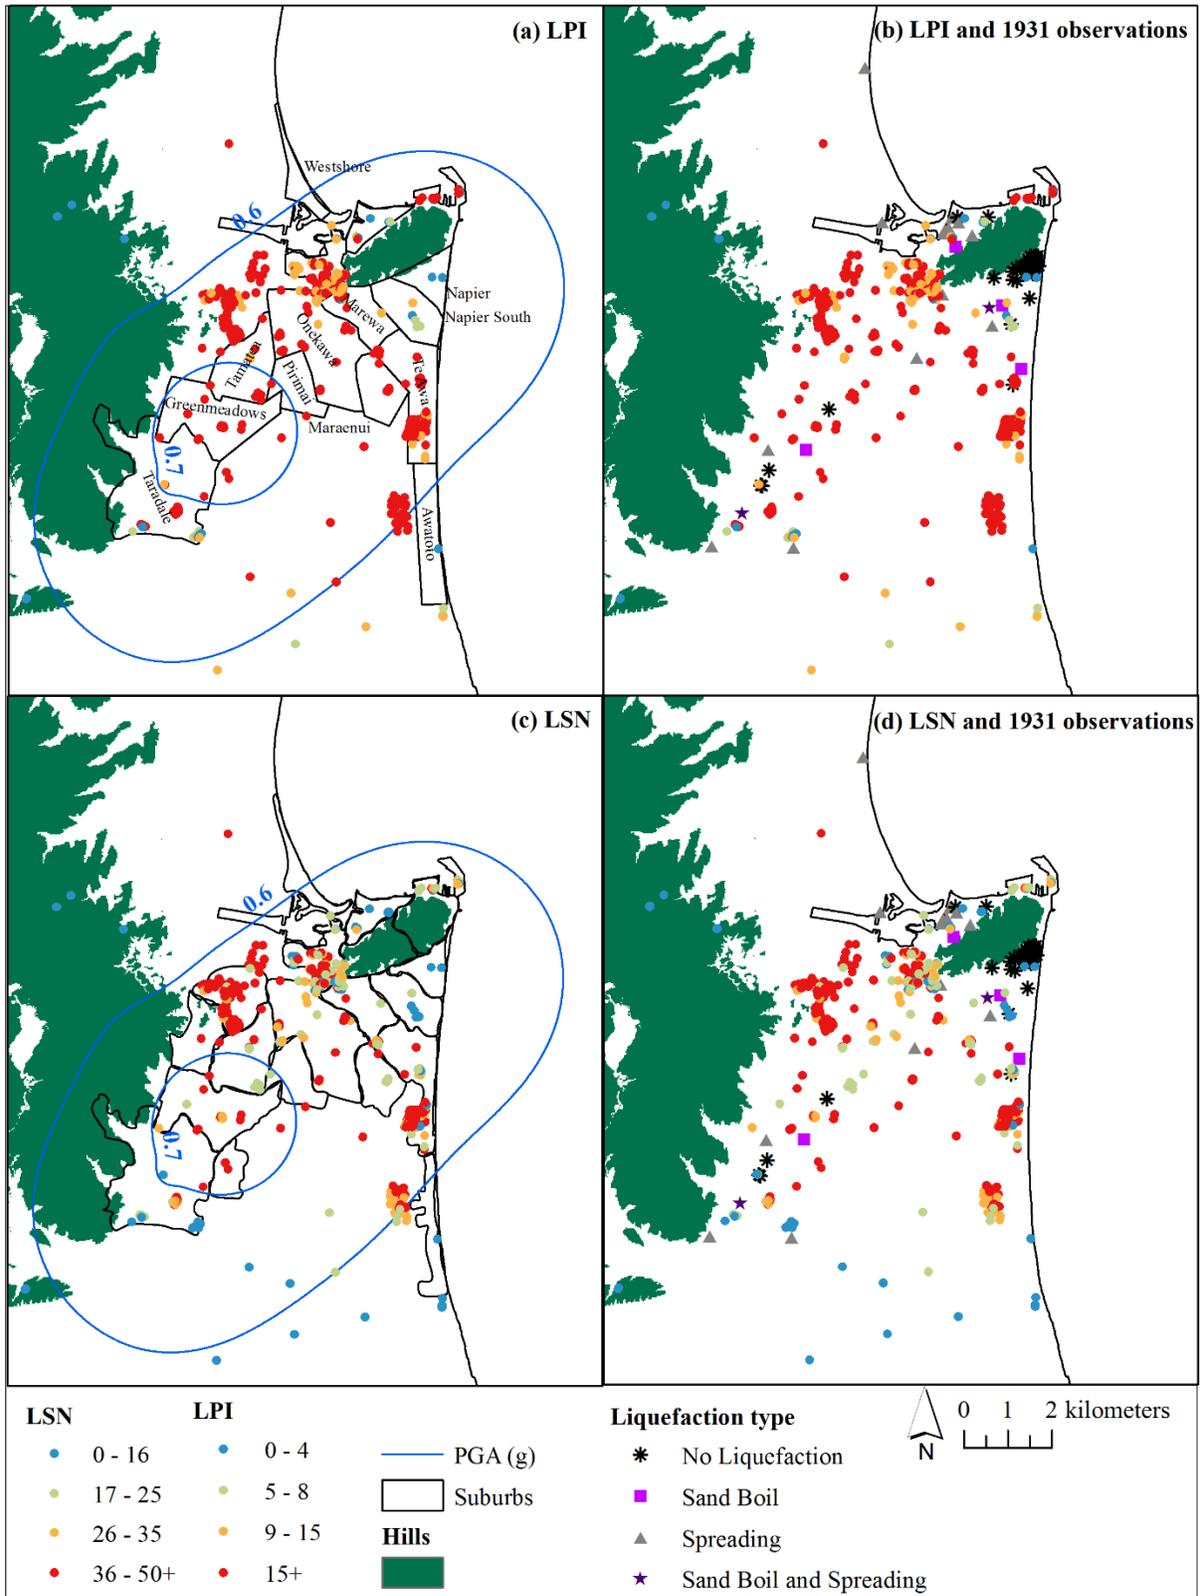
Figure D.3: Computed liquefaction severity indices for Napier- Case 2 (a) LPI, (b) LPI overlaid with 1931 observations, (c) LSN, (d) LSN overlaid with 1931 observations

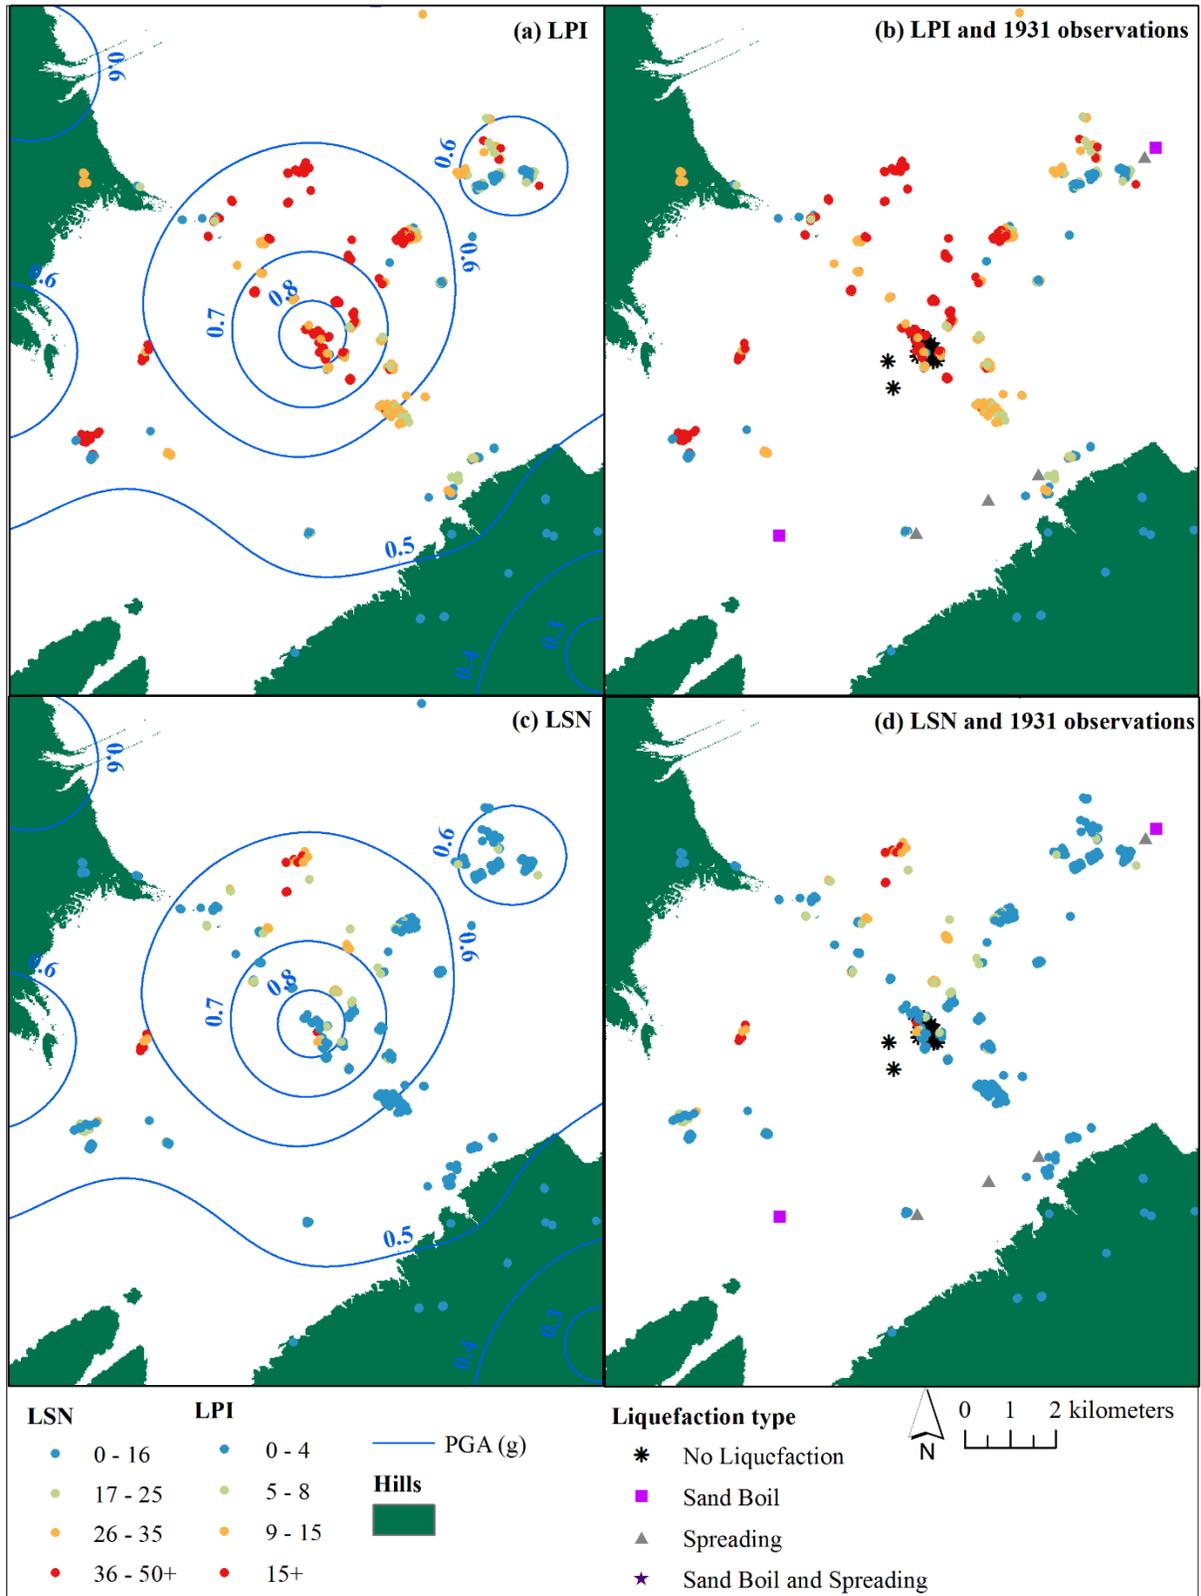
Figure D.4: Computed liquefaction severity indices for Hastings- Case 2 (a) LPI, (b) LPI overlaid with 1931 observations, (c) LSN, (d) LSN overlaid with 1931 observations

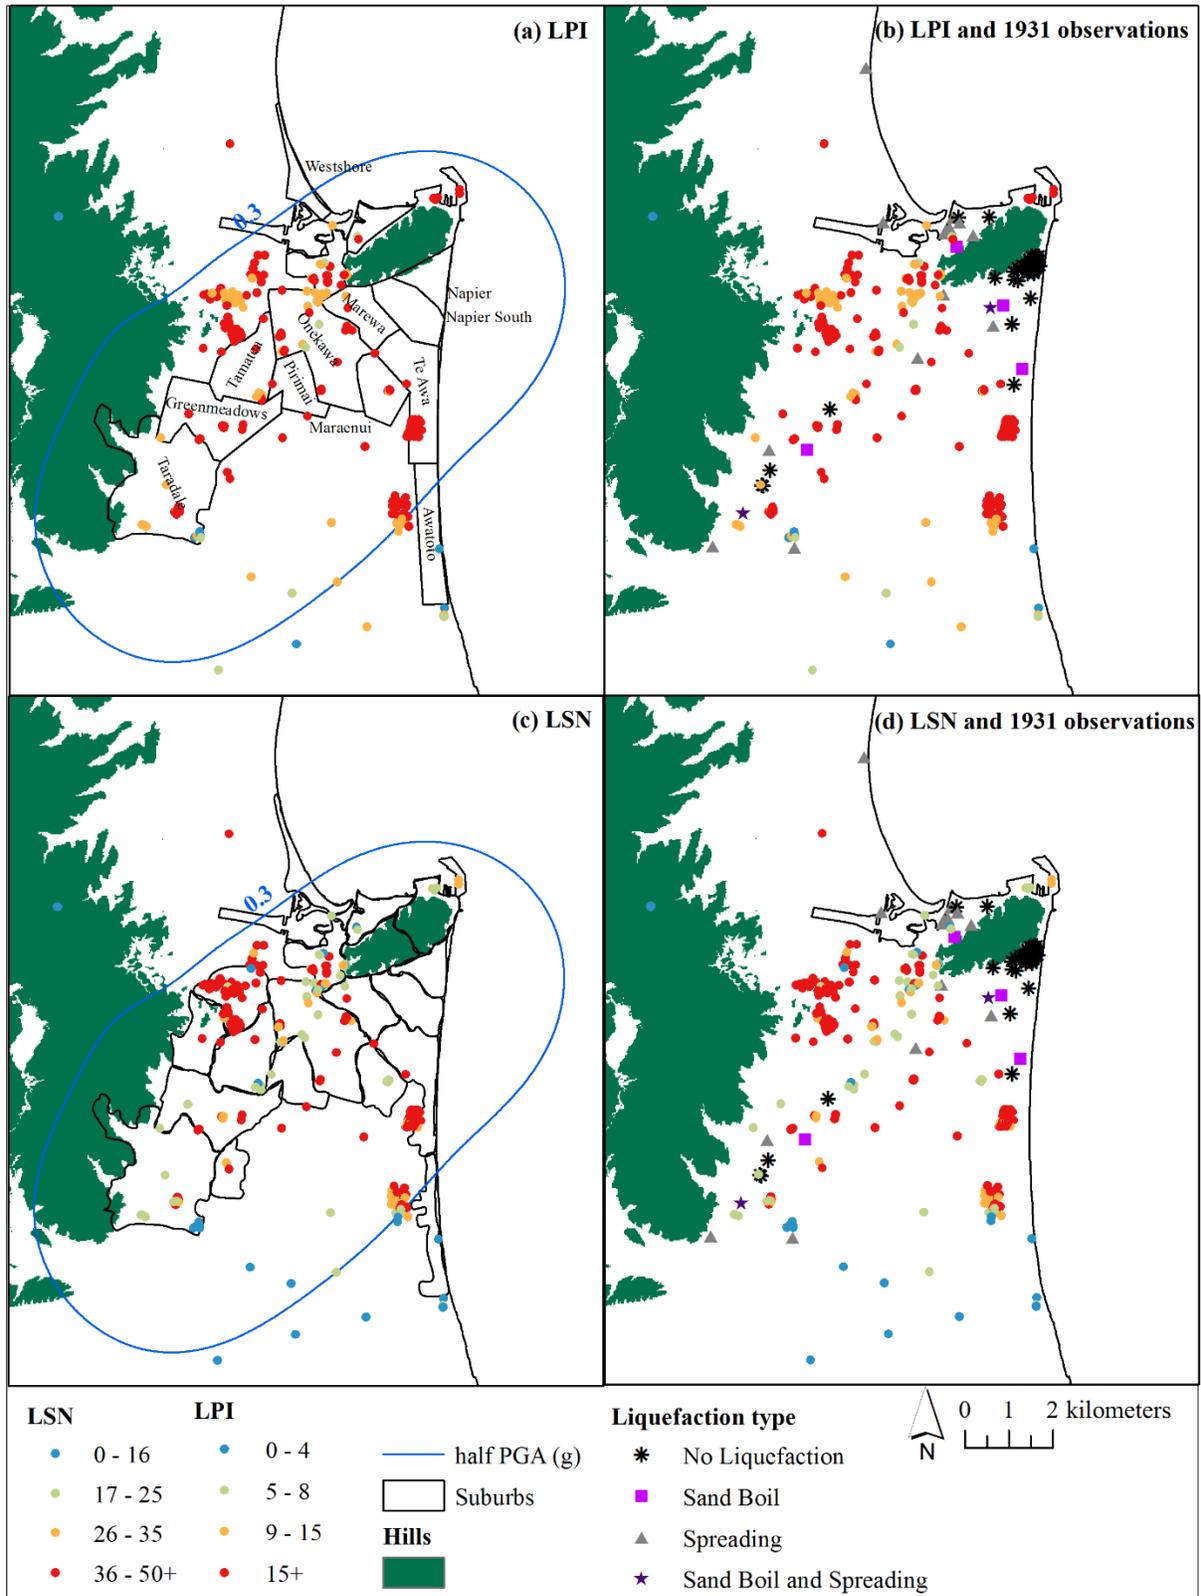
Figure D.5: Computed liquefaction severity indices for Napier- Case 3 (a) LPI, (b) LPI overlaid with 1931 observations, (c) LSN, (d) LSN overlaid with 1931 observations

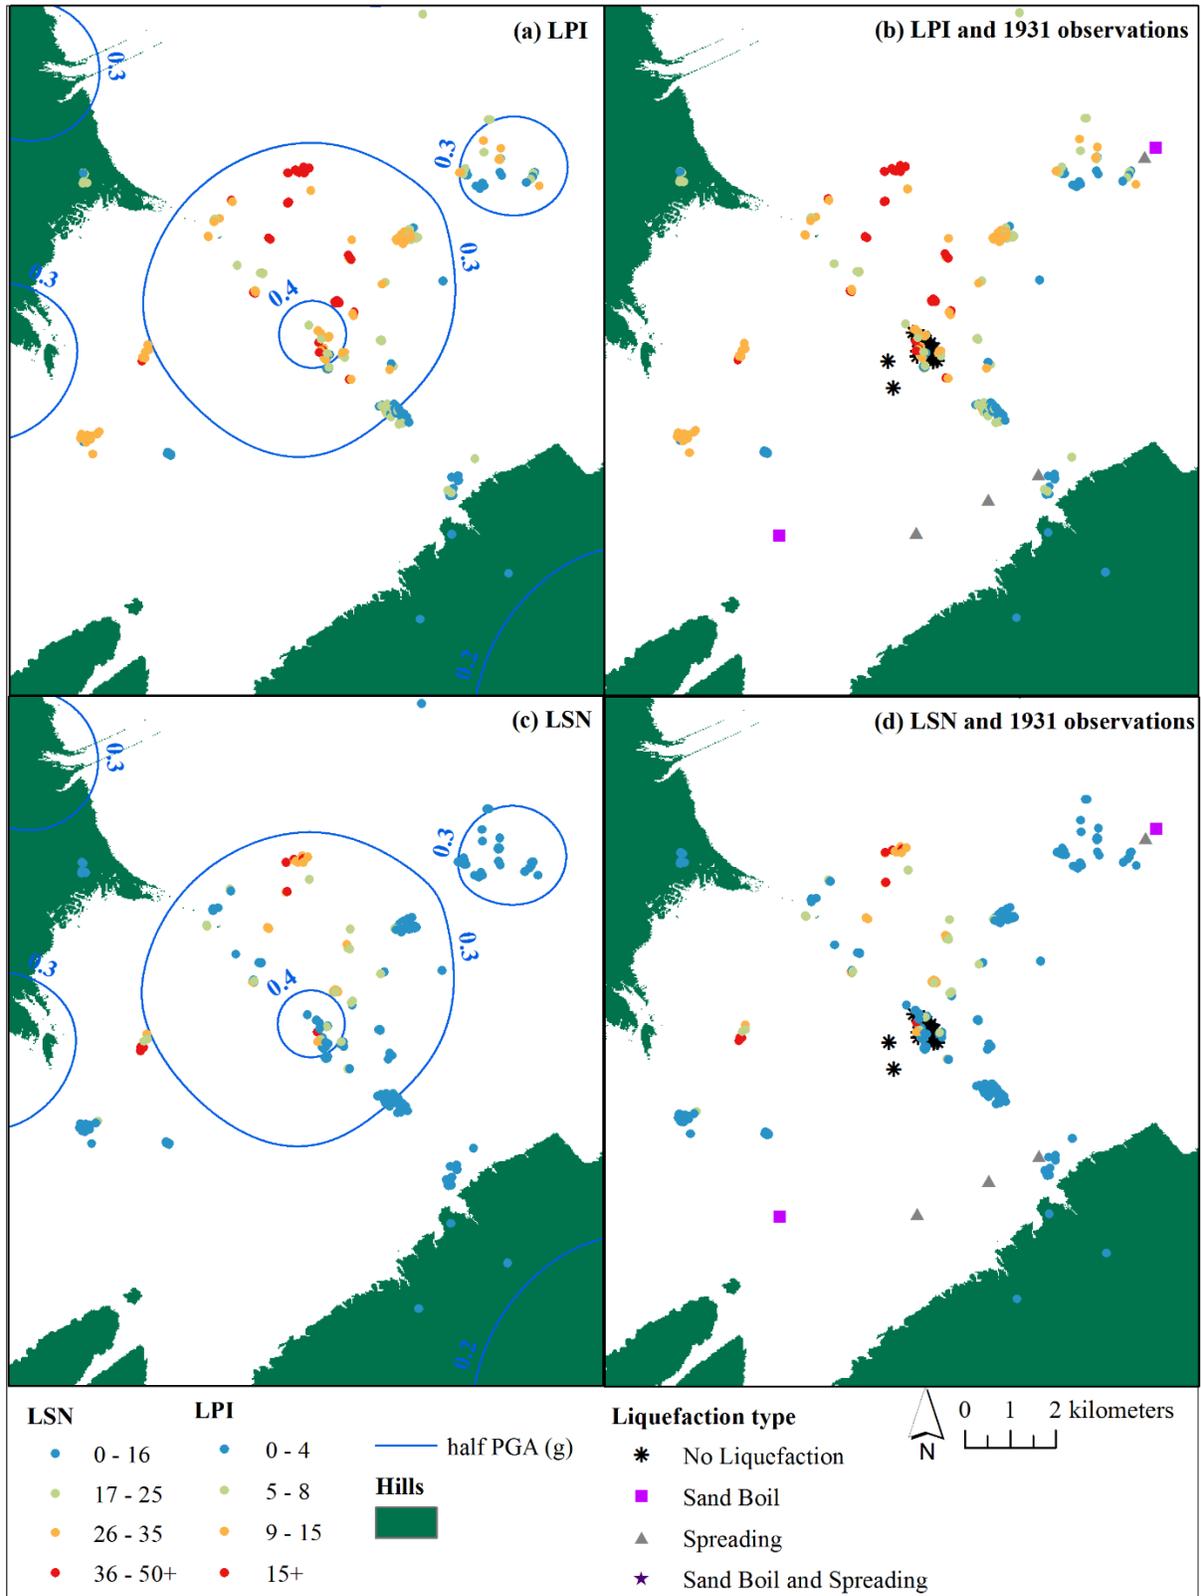
Figure D.6: Computed liquefaction severity indices for Hastings- Case 3 (a) LPI, (b) LPI overlaid with 1931 observations, (c) LSN, (d) LSN overlaid with 1931 observations

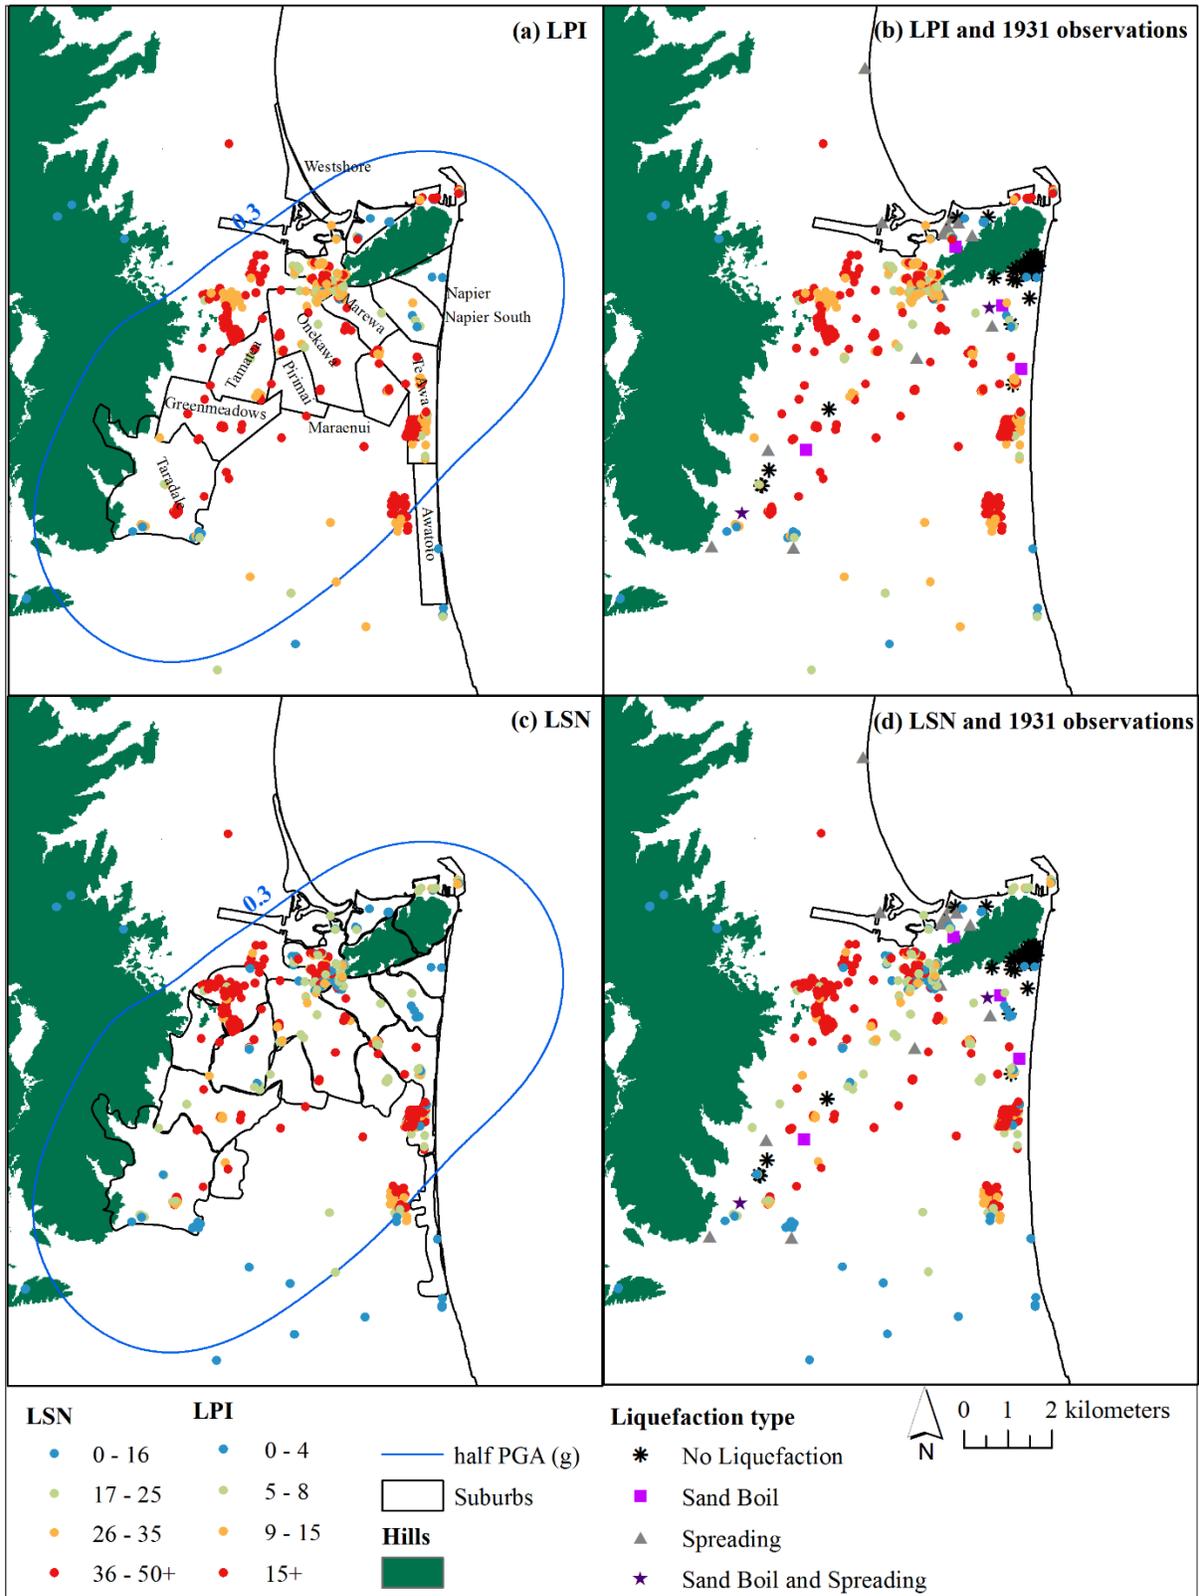
Figure D.7: Computed liquefaction severity indices for Napier- Case 4 (a) LPI, (b) LPI overlaid with 1931 observations, (c) LSN, (d) LSN overlaid with 1931 observations

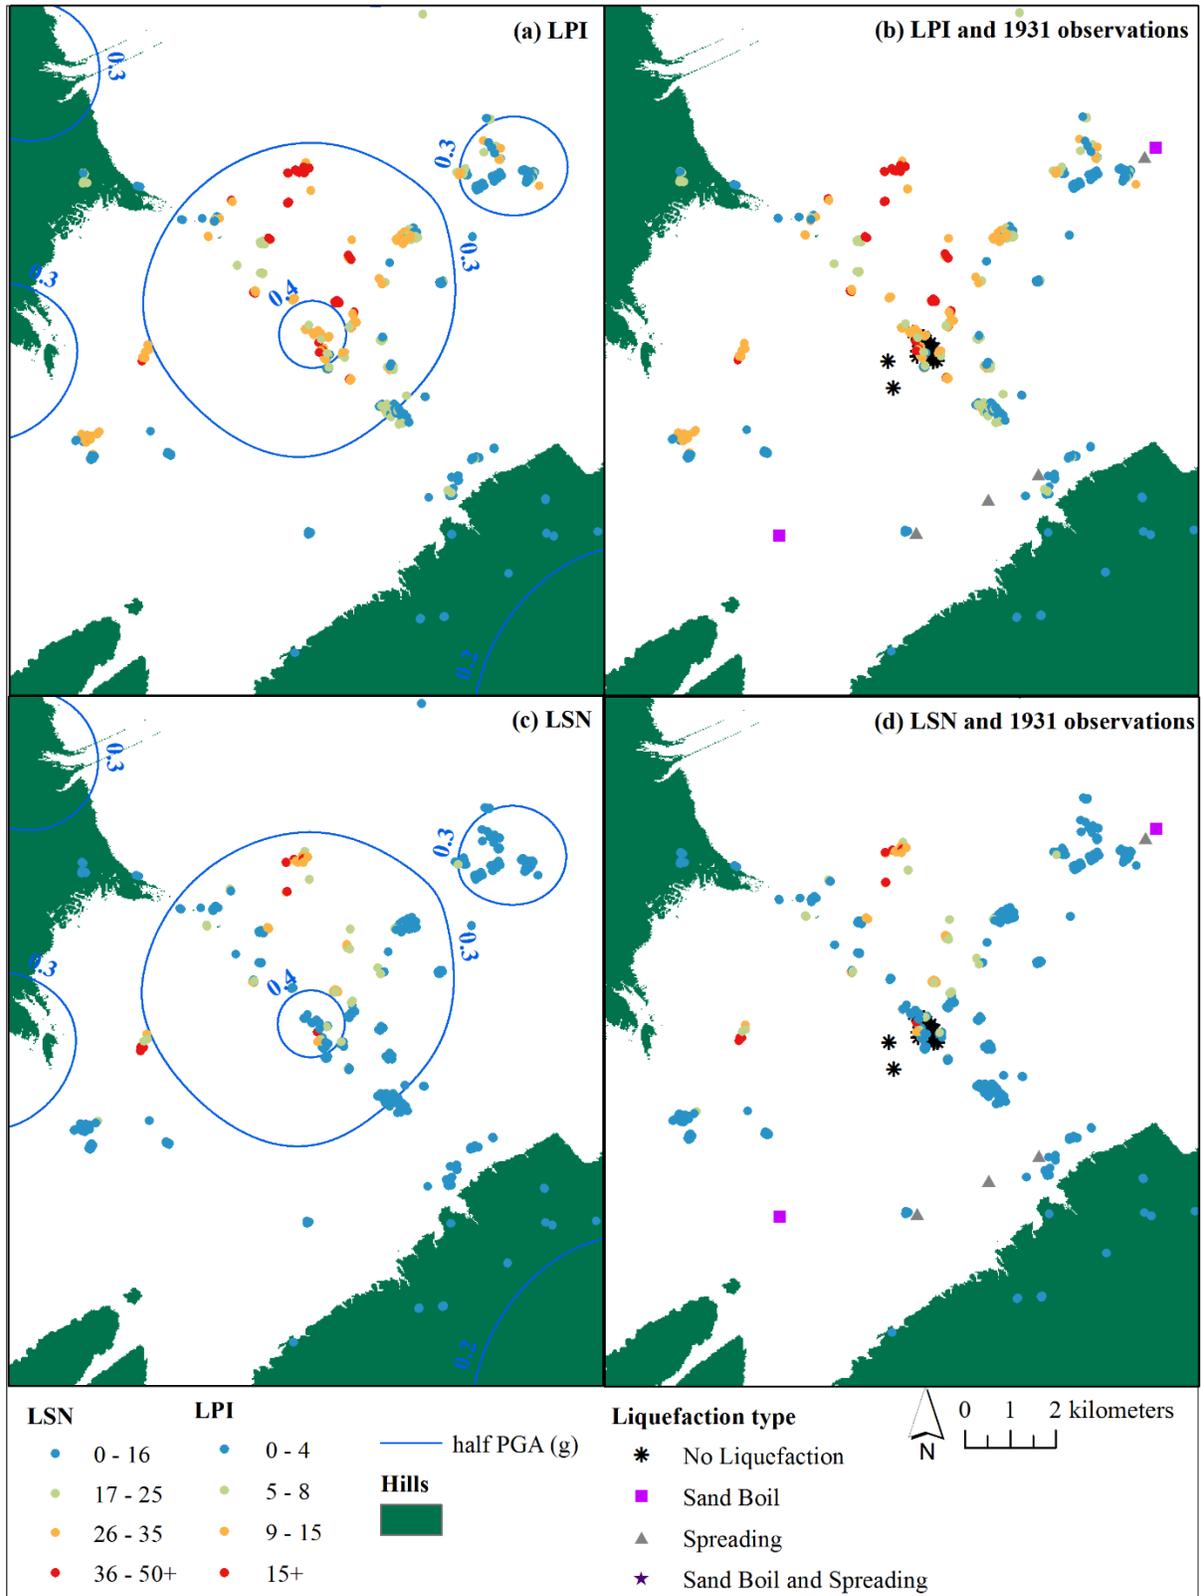
Figure D.8: Computed liquefaction severity indices for Hastings- Case 4 (a) LPI, (b) LPI overlaid with 1931 observations, (c) LSN, (d) LSN overlaid with 1931 observations
