c|d community design
a|c assistance center

Conceptual Designs for Space Planning at the Danville Museum of Fine Arts and History

Danville, Virginia
May 2007

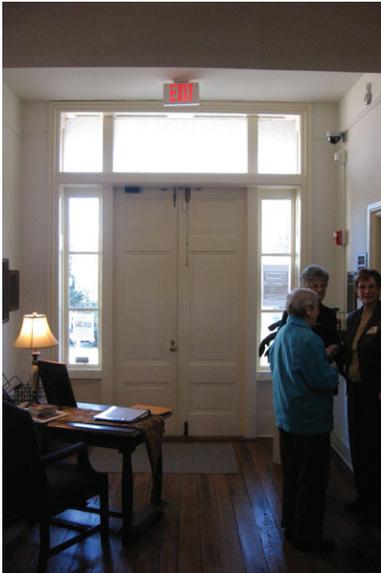
1. The rear entrance to the first floor of the Museum is used most often. The door and its surrounding windows are an important architectural feature and provide natural light.

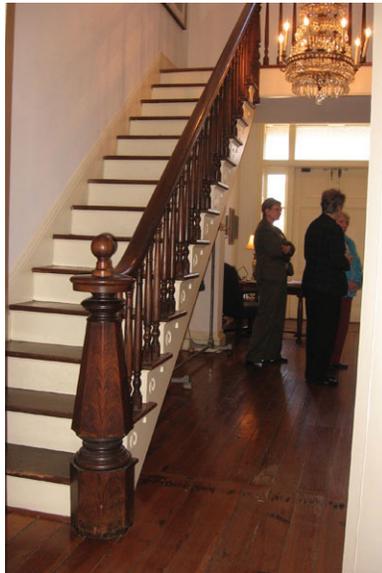
2. The staircase to the second floor is another defining architectural feature of the entry hallway. This view is from the front door towards the rear of the entry hall.

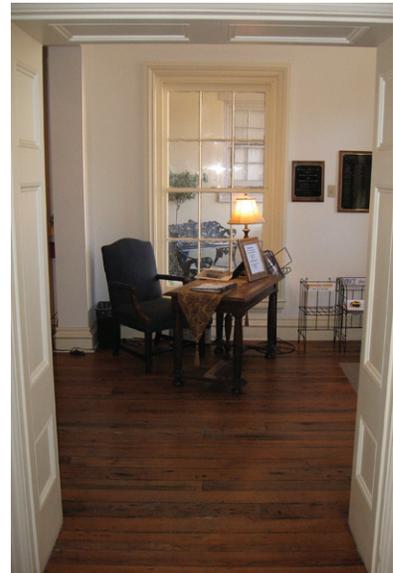
3. A view from near the elevator, shows the desk at the rear entry used by docents to greet visitors. The large window from the porch provides natural light in the entry hall.

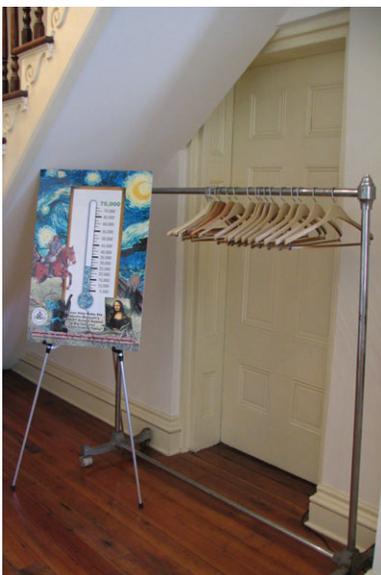
4. A coatrack under the stairs blocks and unused door to a main exhibit room of the house museum portion of the DFMAH.

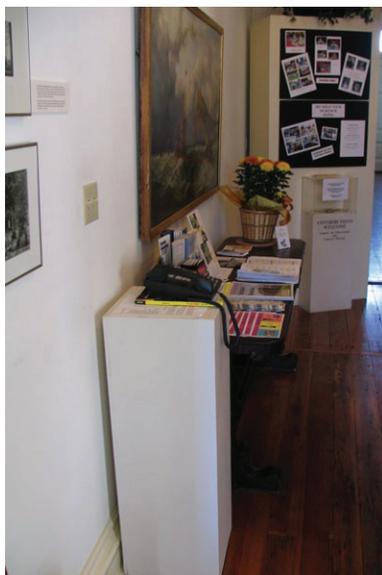
5. The current "information kiosk" is a table with flyers and brochures. A donation box with information about the Museum's programs is in the background.

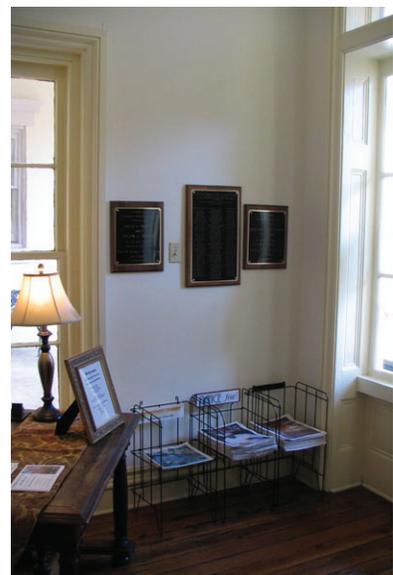
6. More Danville visitor information is placed in newspaper racks. The plaques show awards and major donors.

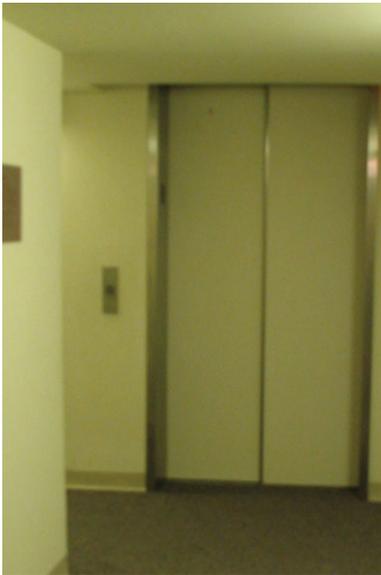
1. The elevator opens to a rather stark space on the basement level.

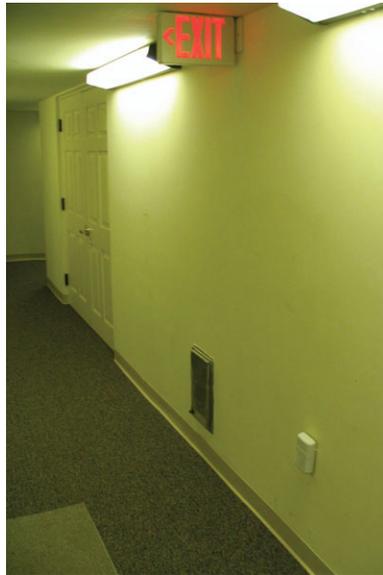
2. A view of the hallway in the service entry area. The elevator is just out of view at the end of the hall on the left. The feeling is institutional and does not provide navigation cues.

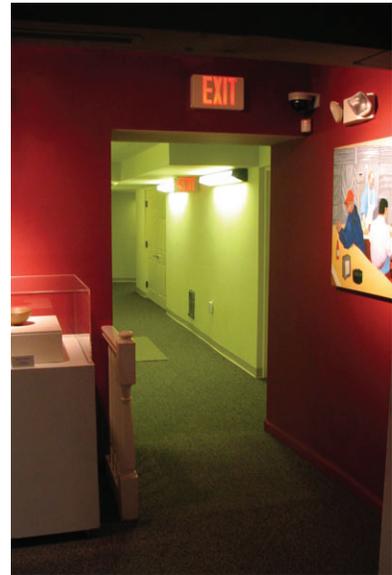
3. A view from the Schoolfield Gallery to the service entry area. The art gallery walls are painted frequently, the red here providing an obvious cue to the gallery's location.

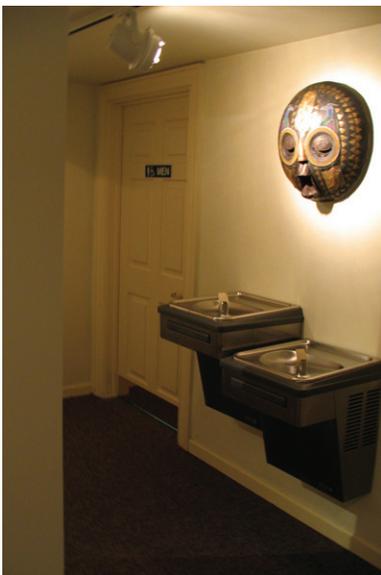
4. The sculpture on the wall near the restrooms is a fun addition that engages visitors and helps them locate the space.

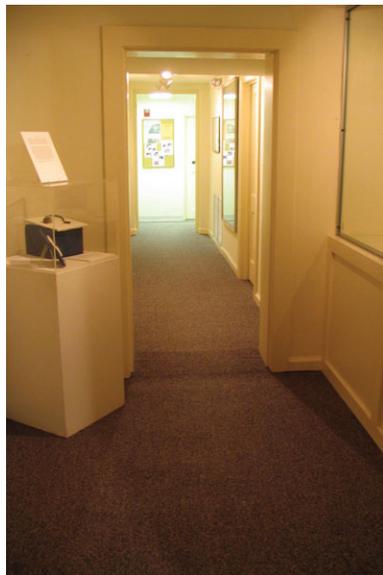
5. View through the office hallway. The door at the end of the hall is the woman's bathroom near the Schoolfield Gallery.

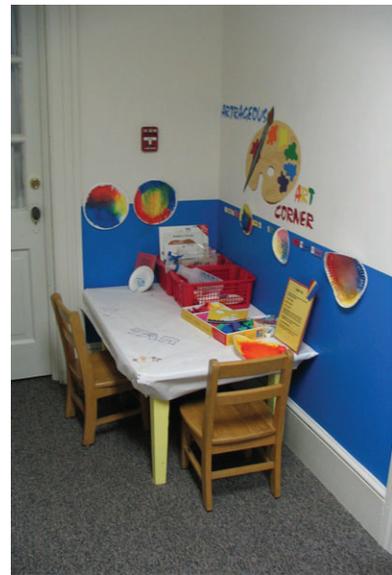
6. Children's art space tucked out of the way in an unused hallway corner in the basement.

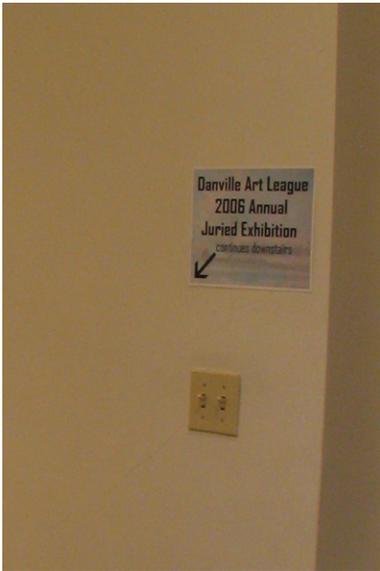
This sign points visitors down stairs to the Schoolfield Gallery for the exhibit below.

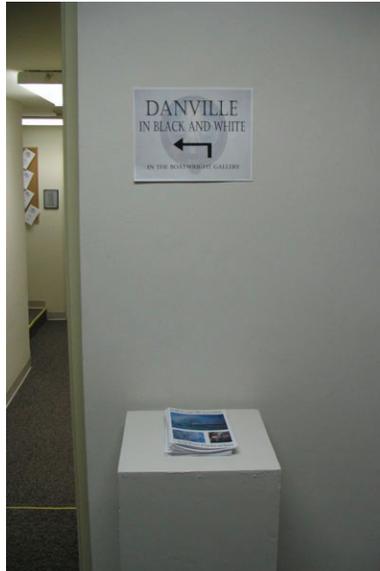
At the basement level, a sign points the way to the exhibition in the Boatwright Gallery.

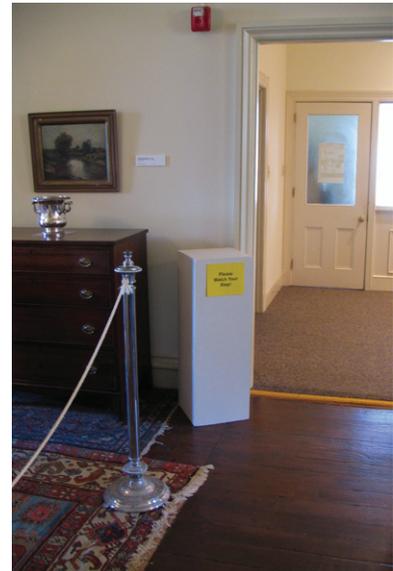
A sign on the first floor in the house museum section of the building announces the tripping hazard at the threshold.

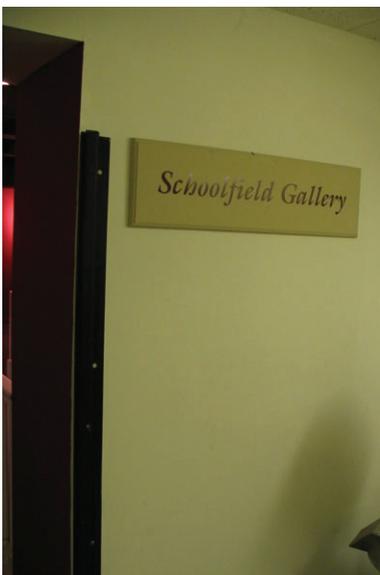
An example of a permanent sign marking the location of the Schoolfield Gallery.

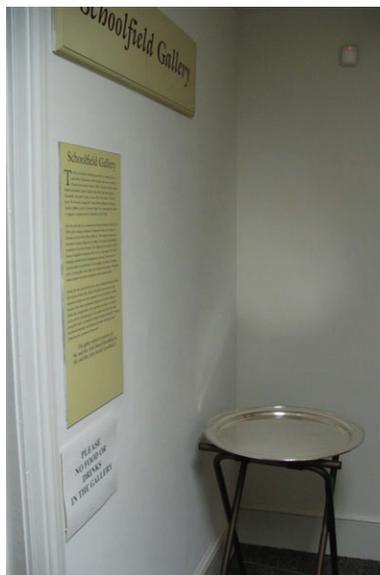
The primary entrance to the Schoolfield Gallery has permanent signs describing the significance of the gallery. A temporary sign has been placed below.

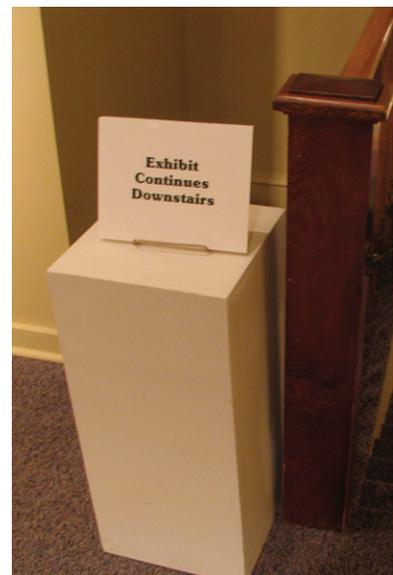
A temporary sign at the top of the stairs on the first floor, guides visitors to the basement level to view the rest of the exhibit.

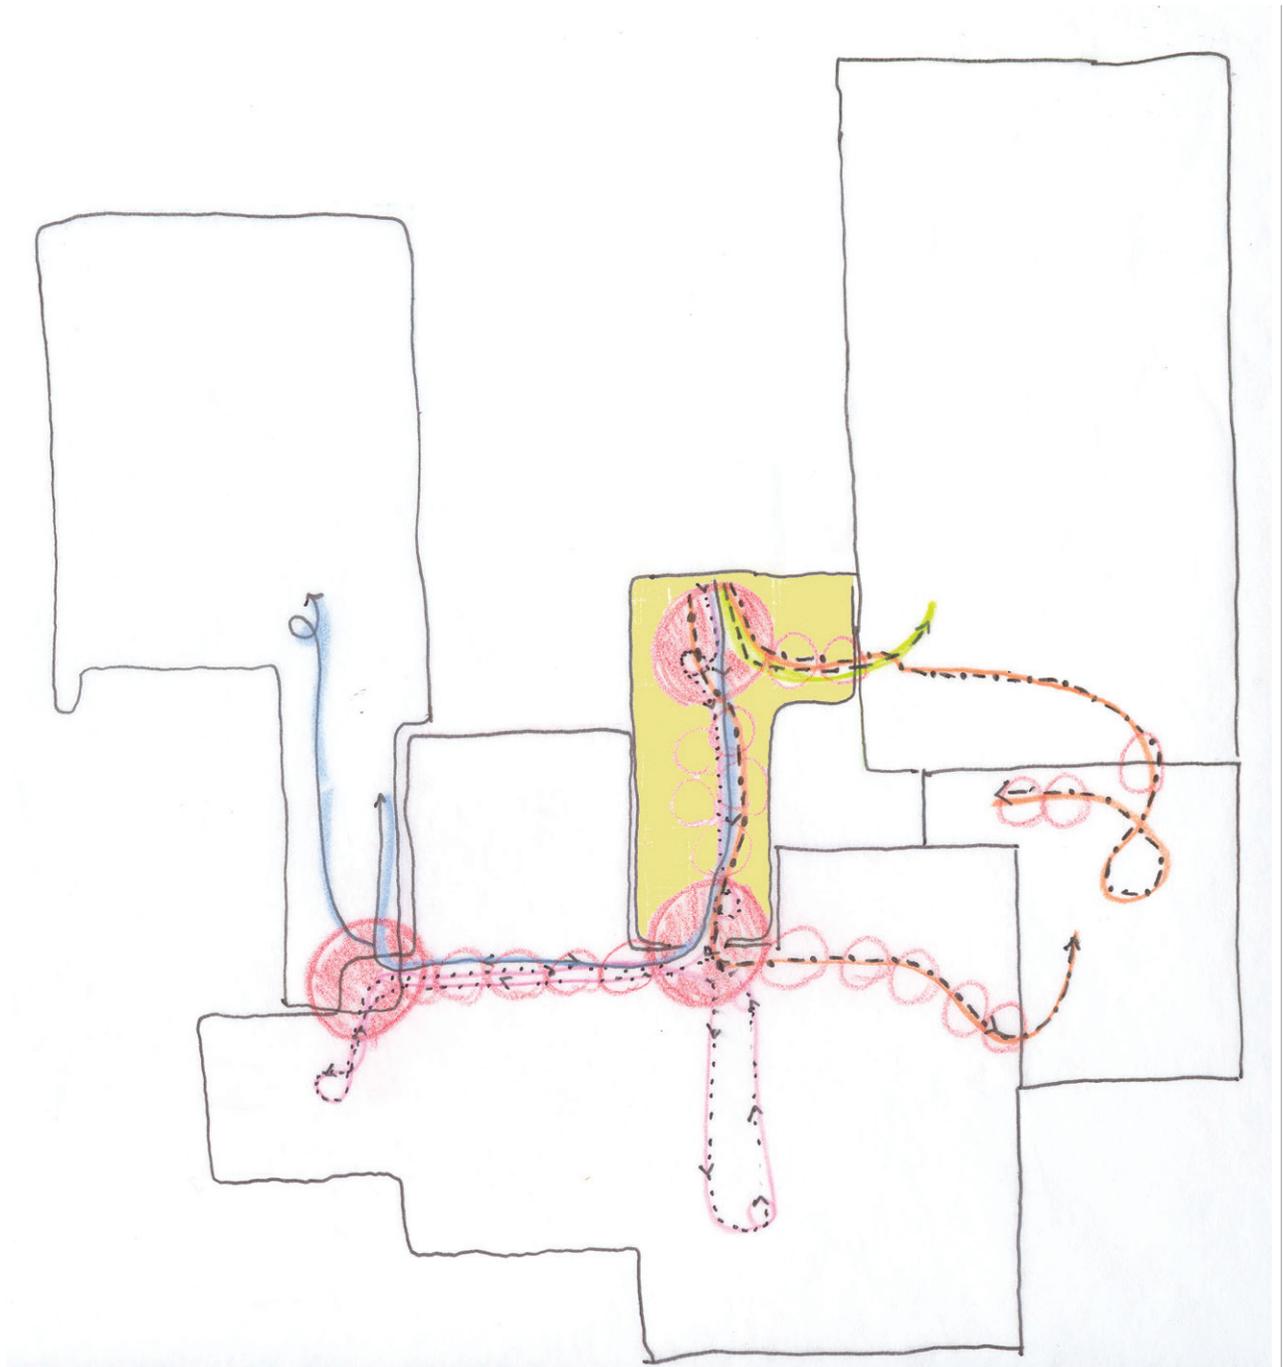
1. TRAFFIC FLOW

The above diagram showing the traffic flow on the first floor of the Danville Museum. All traffic flows through the rear entry hall (shaded in yellow.) Some traffic (yellow) moves to the auditorium which is used for larger programs and can be used after hours. Some traffic (lavender) moves through the house museum and up the stairs to the second floor. Some traffic (blue) moves through the house museum to the art galleries on the first and basement levels. Some traffic (orange) moves to the museum exhibits on the first and basement levels.

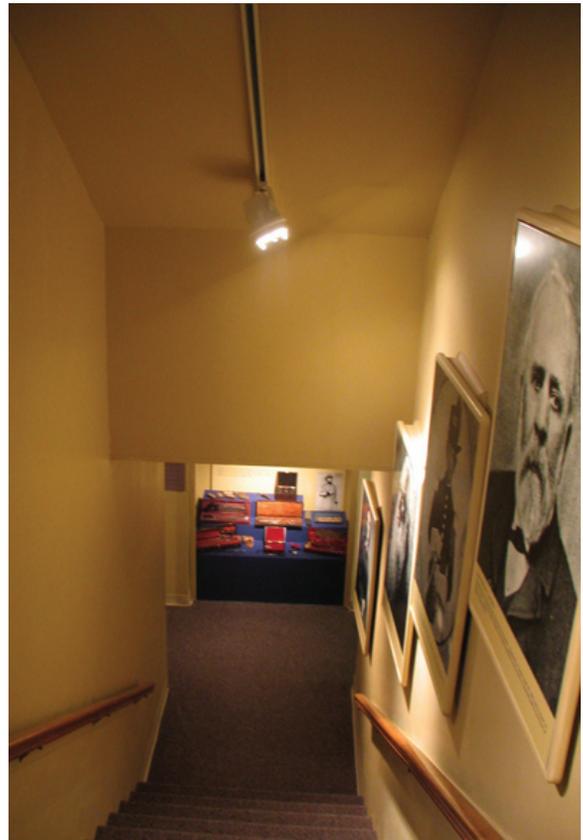
The main stairway to the basement level is located within the museum exhibit area and continues the exhibits on the wall of the stairway.

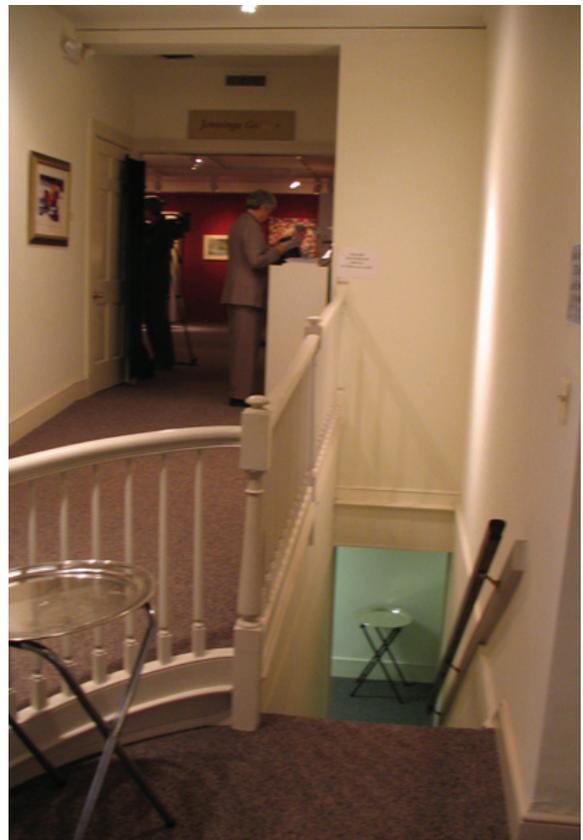
The narrower staircase connecting the galleries on the first and basement levels is a less obvious connection between the spaces.

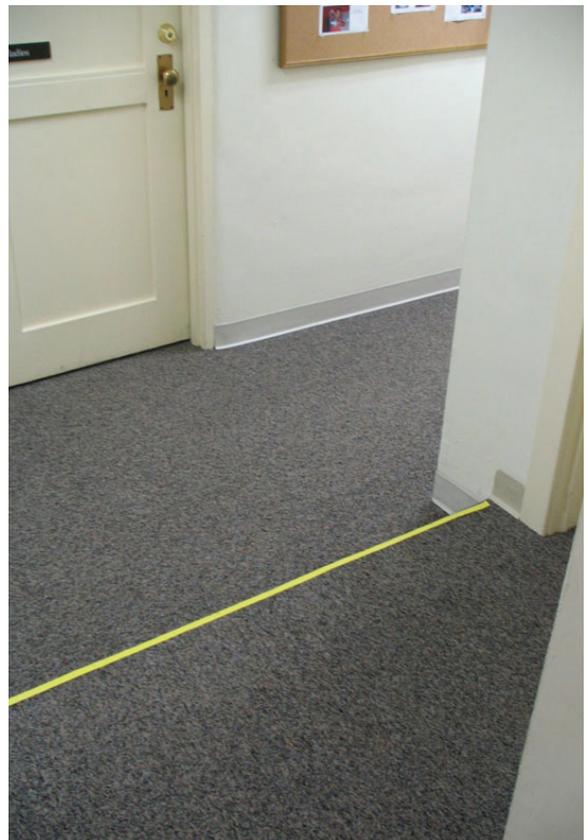
One of a number of level changes in the floor at the basement level is marked with a yellow line for safety.

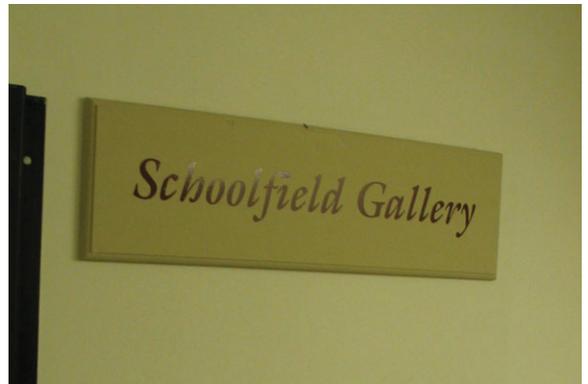
A professional quality permanent sign marks the entrance to the Schoolfield Gallery.

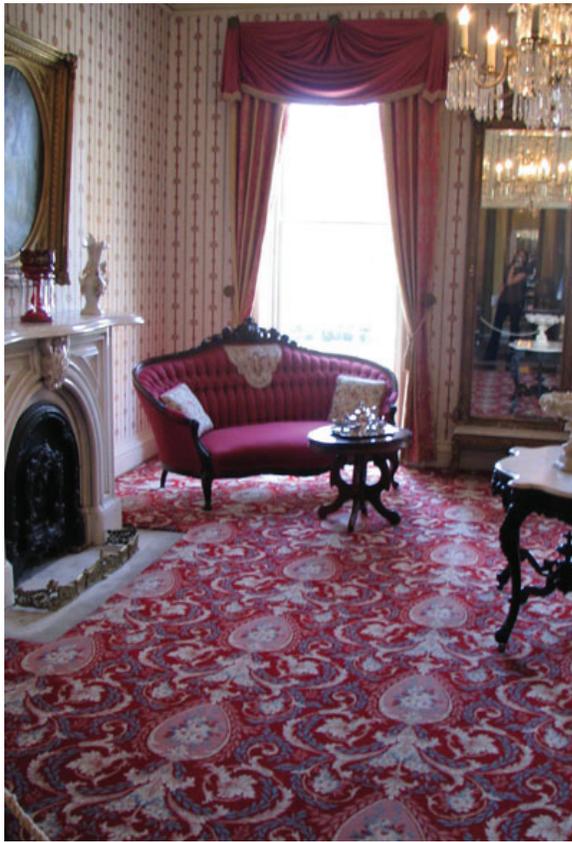
In the house museum portion of DFMAH, the parlor of the Sutherland House exhibits the Rococo design elements of the period.

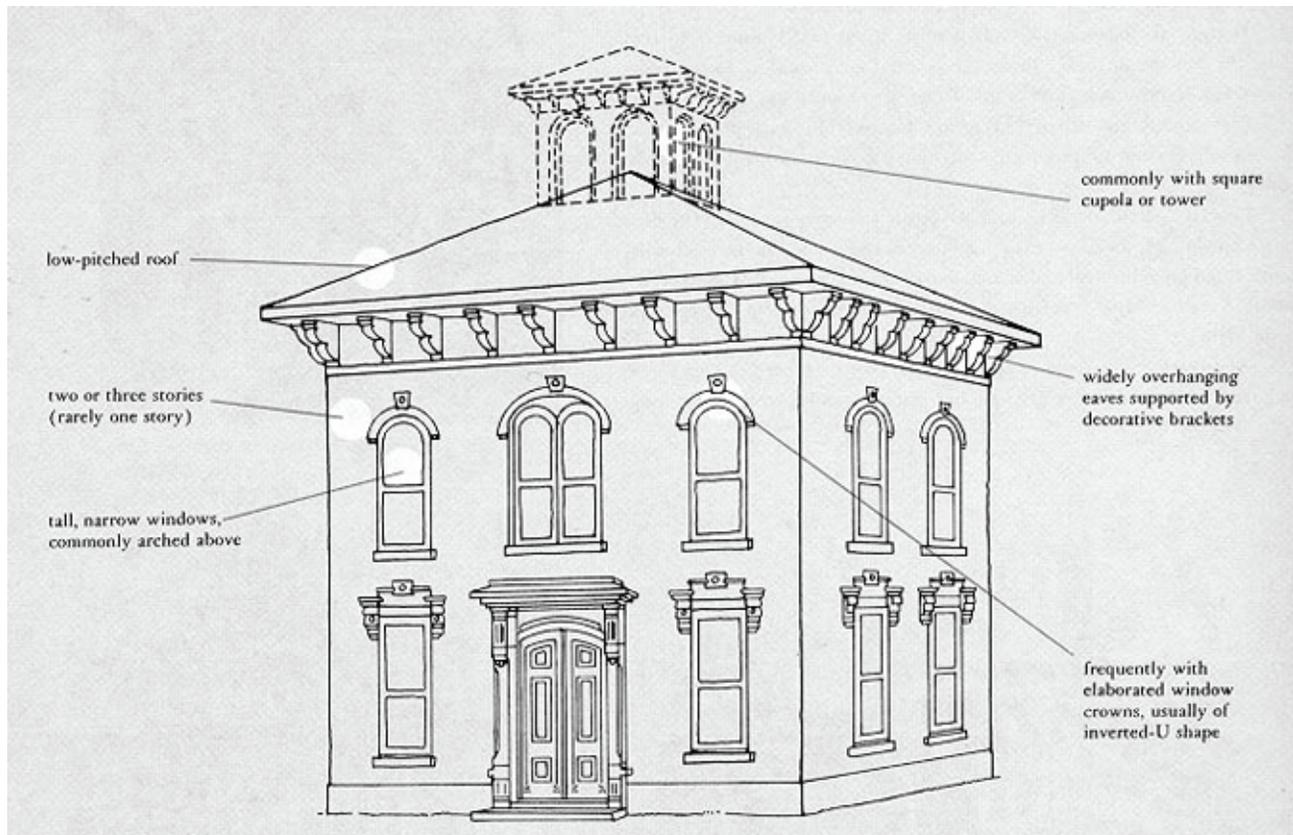
Andrew Jackson Downing's drawing shows the features of an Italianate house very similar to the Sutherland House where DMFAH is housed.

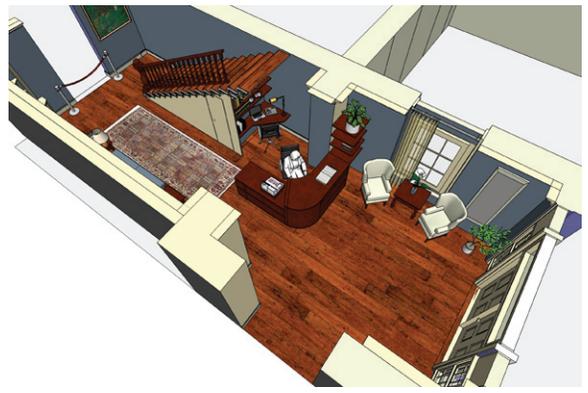
The view of the newly designed entry hall is more functional, yet still retains historical elements.

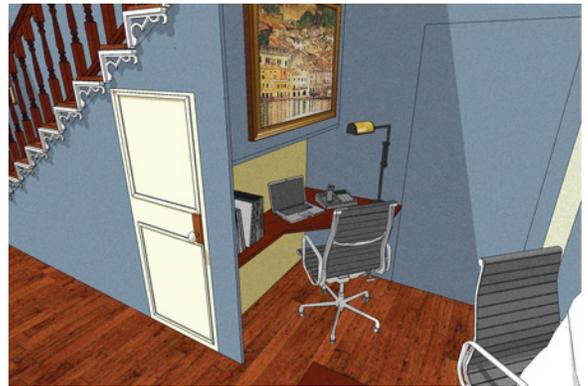
Space under the stairs becomes a pull-out coat closet and also an additional work area.

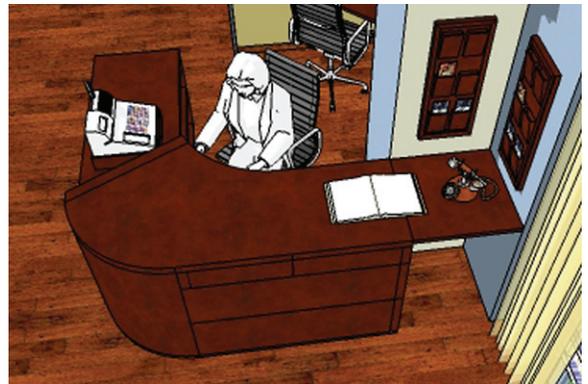
The curved front desk provides work space, while not blocking circulation in the entry hall.

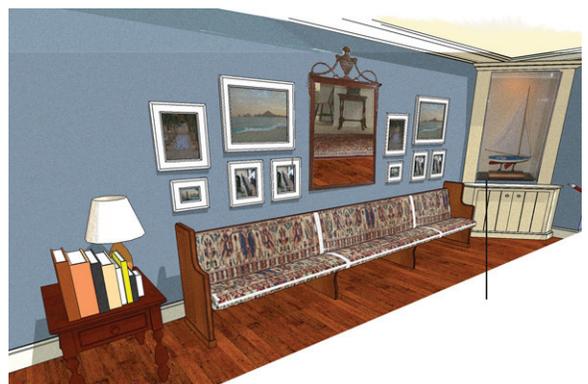
A long bench provides a place for visitors to sit while awaiting a tour while the corner cabinet displays an "object of the month."

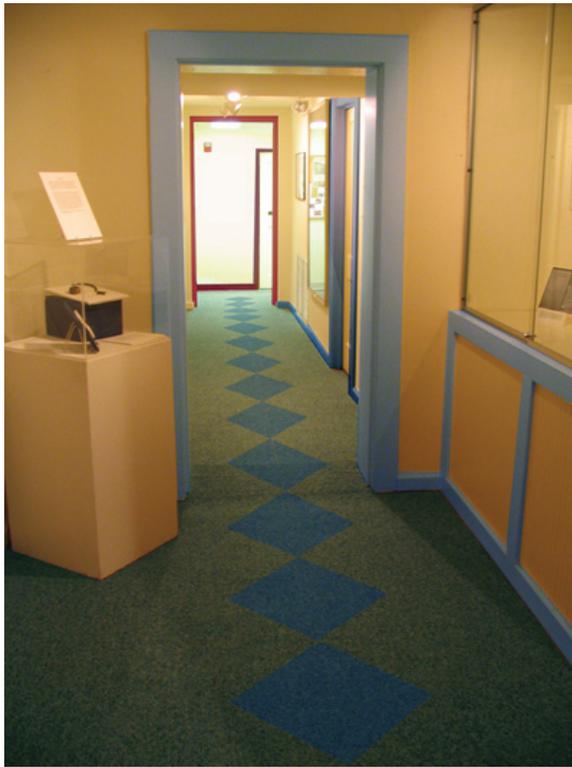
The blue color used on the chair rail and mouldings subtly make visitors aware of their location within the exhibit section of the museum. The diamond pattern in the carpeting helps guide visitors through the museum while the use of the same blue in the carpeting as in the trim leads visitors to other exhibits within the museum.

There was a need to establish a sense of location and direction. This was accomplished through economical and effective decorative changes using color. These changes included the use of carpet floor tiles that are placed as visual cues for the eye. The tiles also are user friendly due to the lack of time, energy, and cost it takes to replace a single tile that becomes worn out as compared to an entire wall-to-wall carpet that must endure years of wear and tear before it can be sensibly replaced.

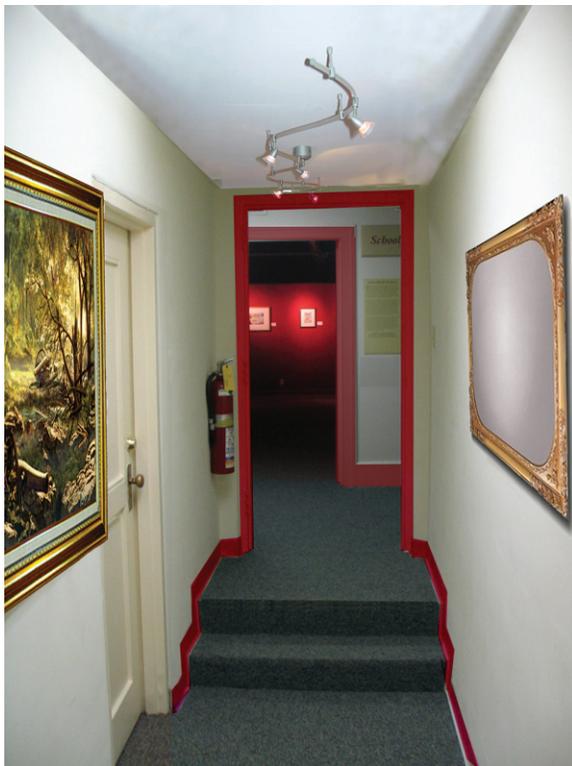
The red paint used on the door frames and baseboards are the visual cue to lead visitors to the art galleries. Only those door frames that lead to the galleries are painted to show that the offices are private space. Gallery quality lighting as well as mirrors and artwork in the hallway help define the public path to the gallery.

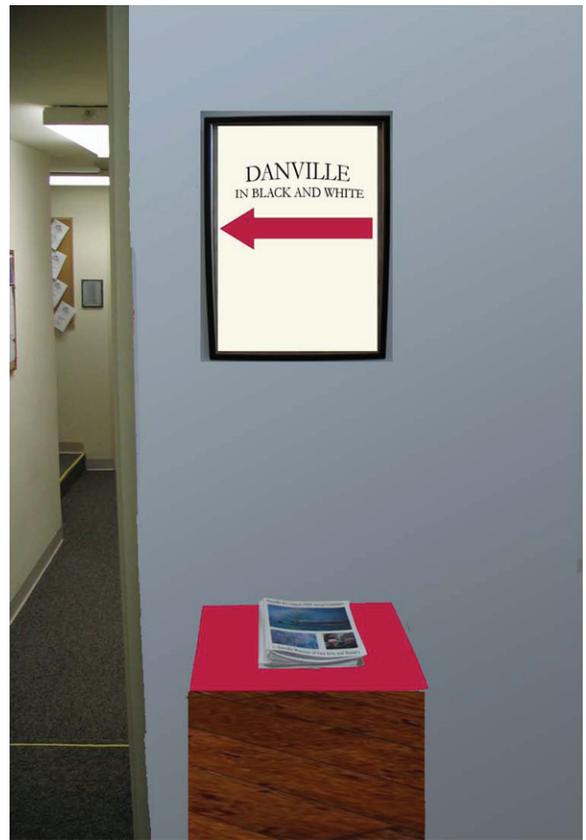
The same red used to paint the trim is used in the arrow of the directional signage to point to art gallery space. A table with information about the art exhibit sports the same color. While creating a more uniform look to DMFAH, these signs also aid with wayfinding.

Another method of maintaining consistency and creating a design feature from the temporary signs is to define the font (or type face), style (bold, italic, upper case, etc.), and size of the type used in the signs. A template can be created with these design features so that each sign has a similar style that can be easily recreated on a computer. The signs would have a neater presentation while also being recognizable as Danville Museum directional signs to aid in wayfinding.

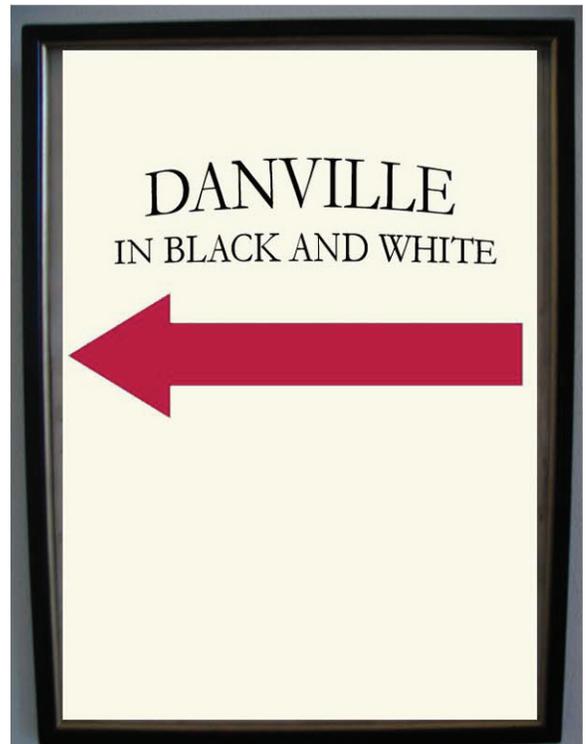
A close up view of the directional sign shows the frame that gives the sign an air of permanence as well as a "Danville Museum style." The sign then becomes an element of the design within the museum.

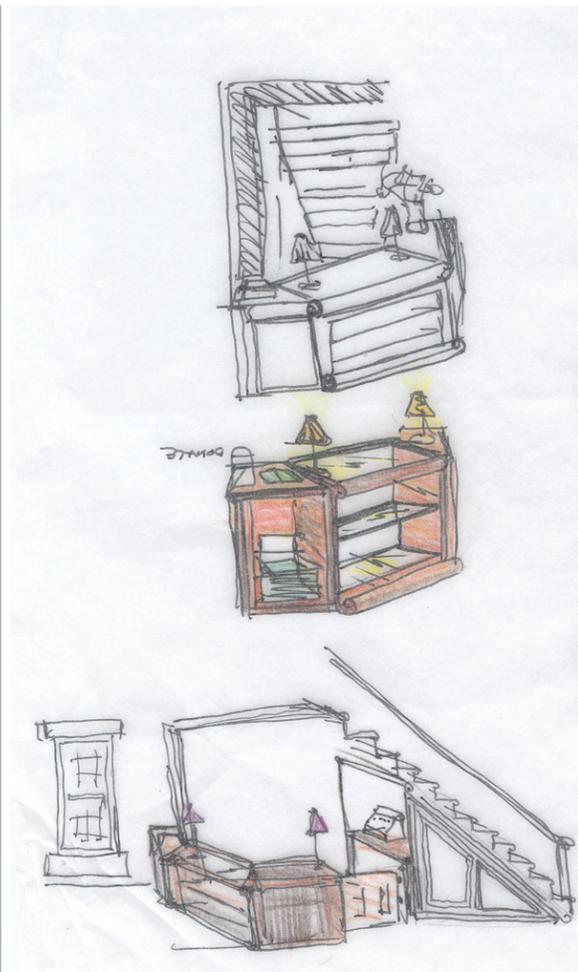
Early sketches of the rear entry hall desk and understair area that led to the preliminary conceptual design.

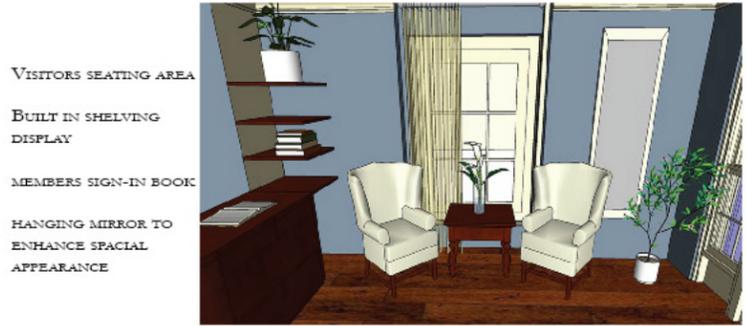
VISITORS SEATING AREA
 BUILT IN SHELVING
 DISPLAY
 MEMBERS SIGN-IN BOOK
 HANGING MIRROR TO
 ENHANCE SPACIAL
 APPEARANCE

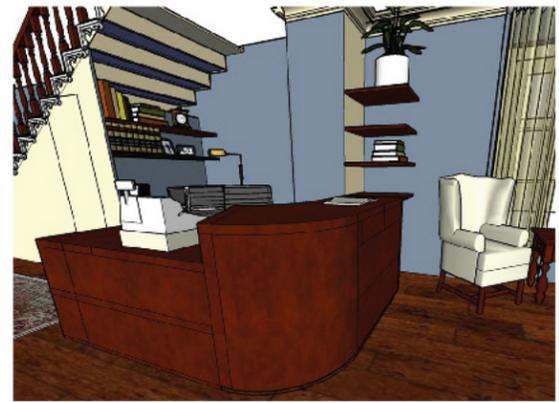
FRONT DESK WITH
 RAISED PLATFORM FOR
 ADDED STORAGE
 CAPACITY AND
 MEMBER SIGN-IN,
 DONATION SPACE
 BUILT-IN SHELVING
 DESK UNIT AND SIDE
 ROLLING PULL OUT
 STORAGE CLOSET FOR
 GUEST'S OUTERWEAR
 AND SECRETARIAL
 STORAGE

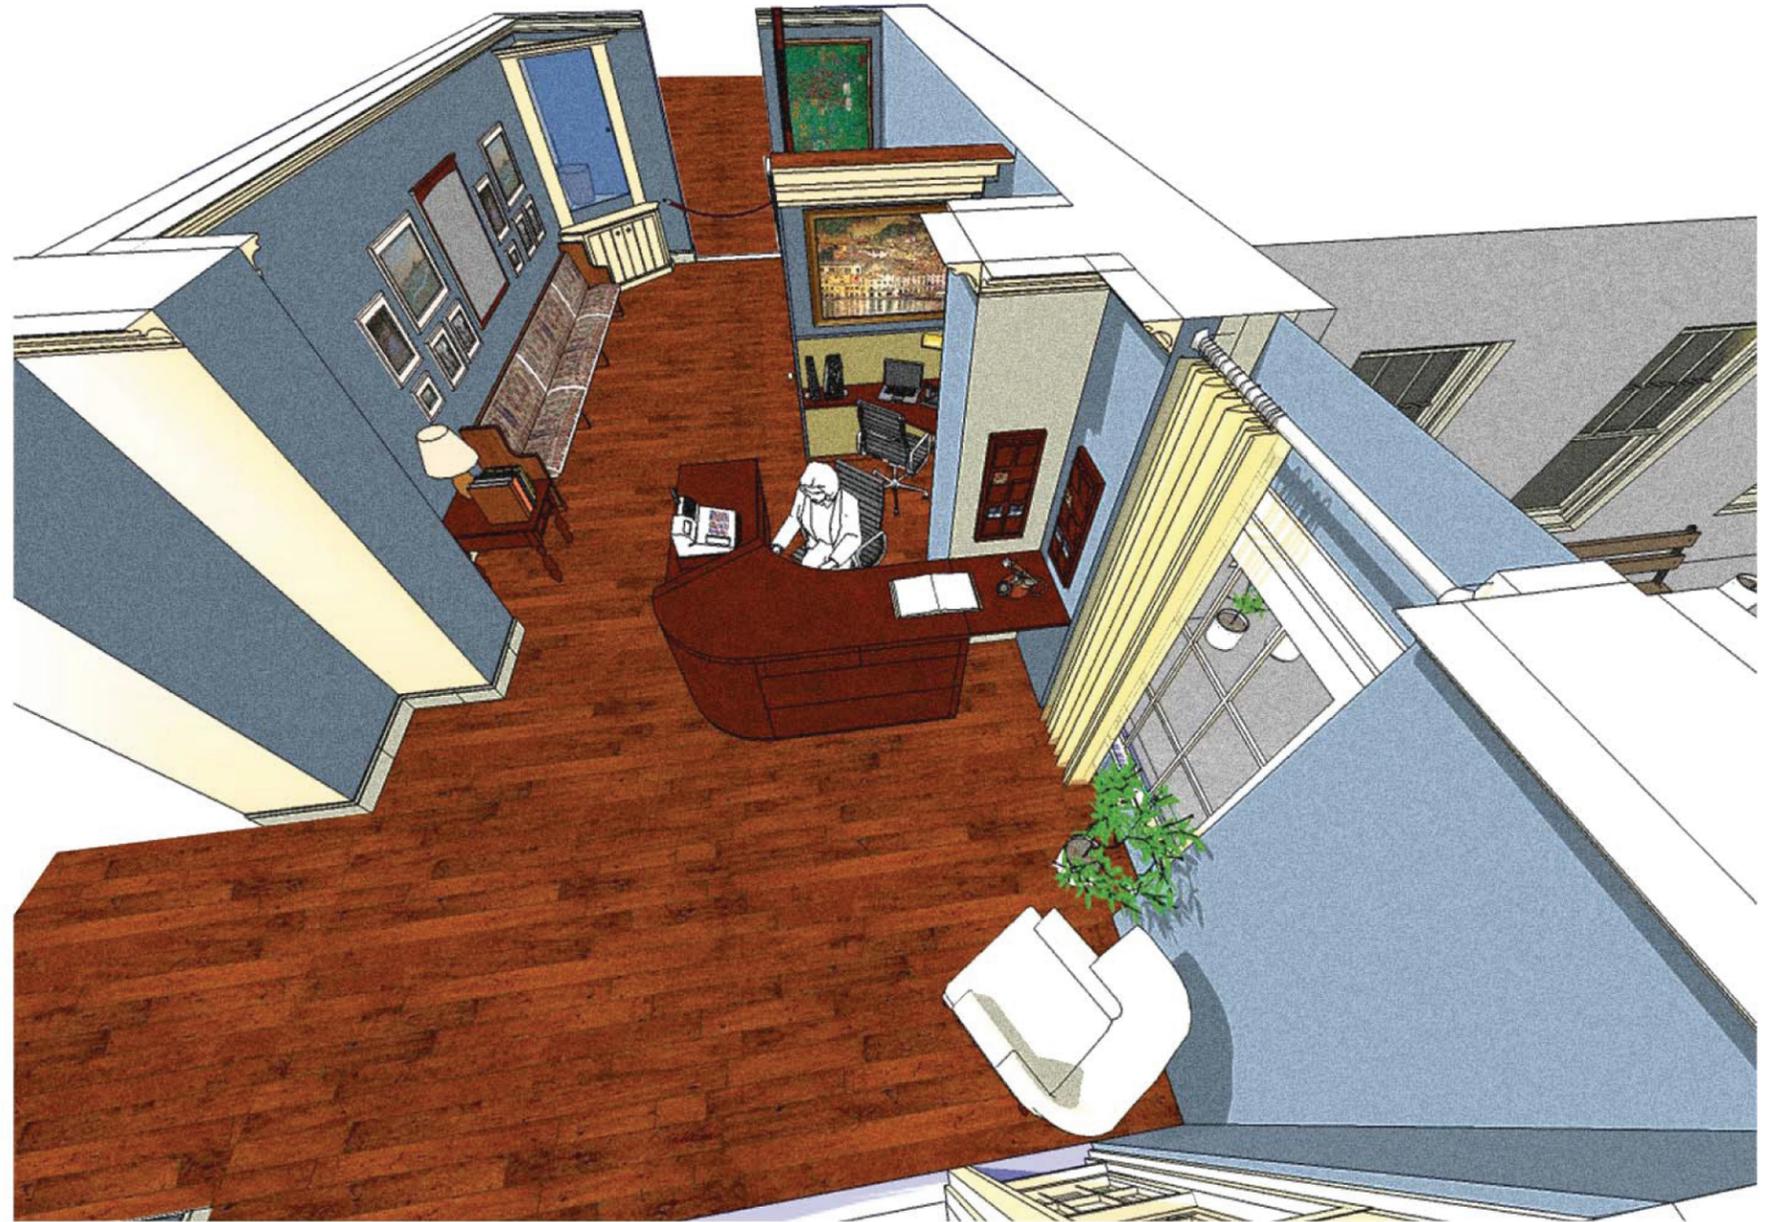
Rear Entry Hall: Bird's Eye View from Entrance
 Final Conceptual Design
 Danville Museum of Fine Arts and History
 Danville, Virginia

The final conceptual design is shown on the following pages. The corner cupboard was converted into a hinged glass front door with a lock closure. Its location takes full advantage of visibility to entering visitors and in close proximity and view of the secretarial space for security purposes. A long pew style bench was placed along the opposing stair wall for maximum visitor seating and the underside of the stair was closed in to extend wall space. A wingback chair that was once part of the front seating area was removed when measurements of the space verified that it would not fit. Small changes to the lower level were made including slight color changes and additions to the floor detail and chair rail.

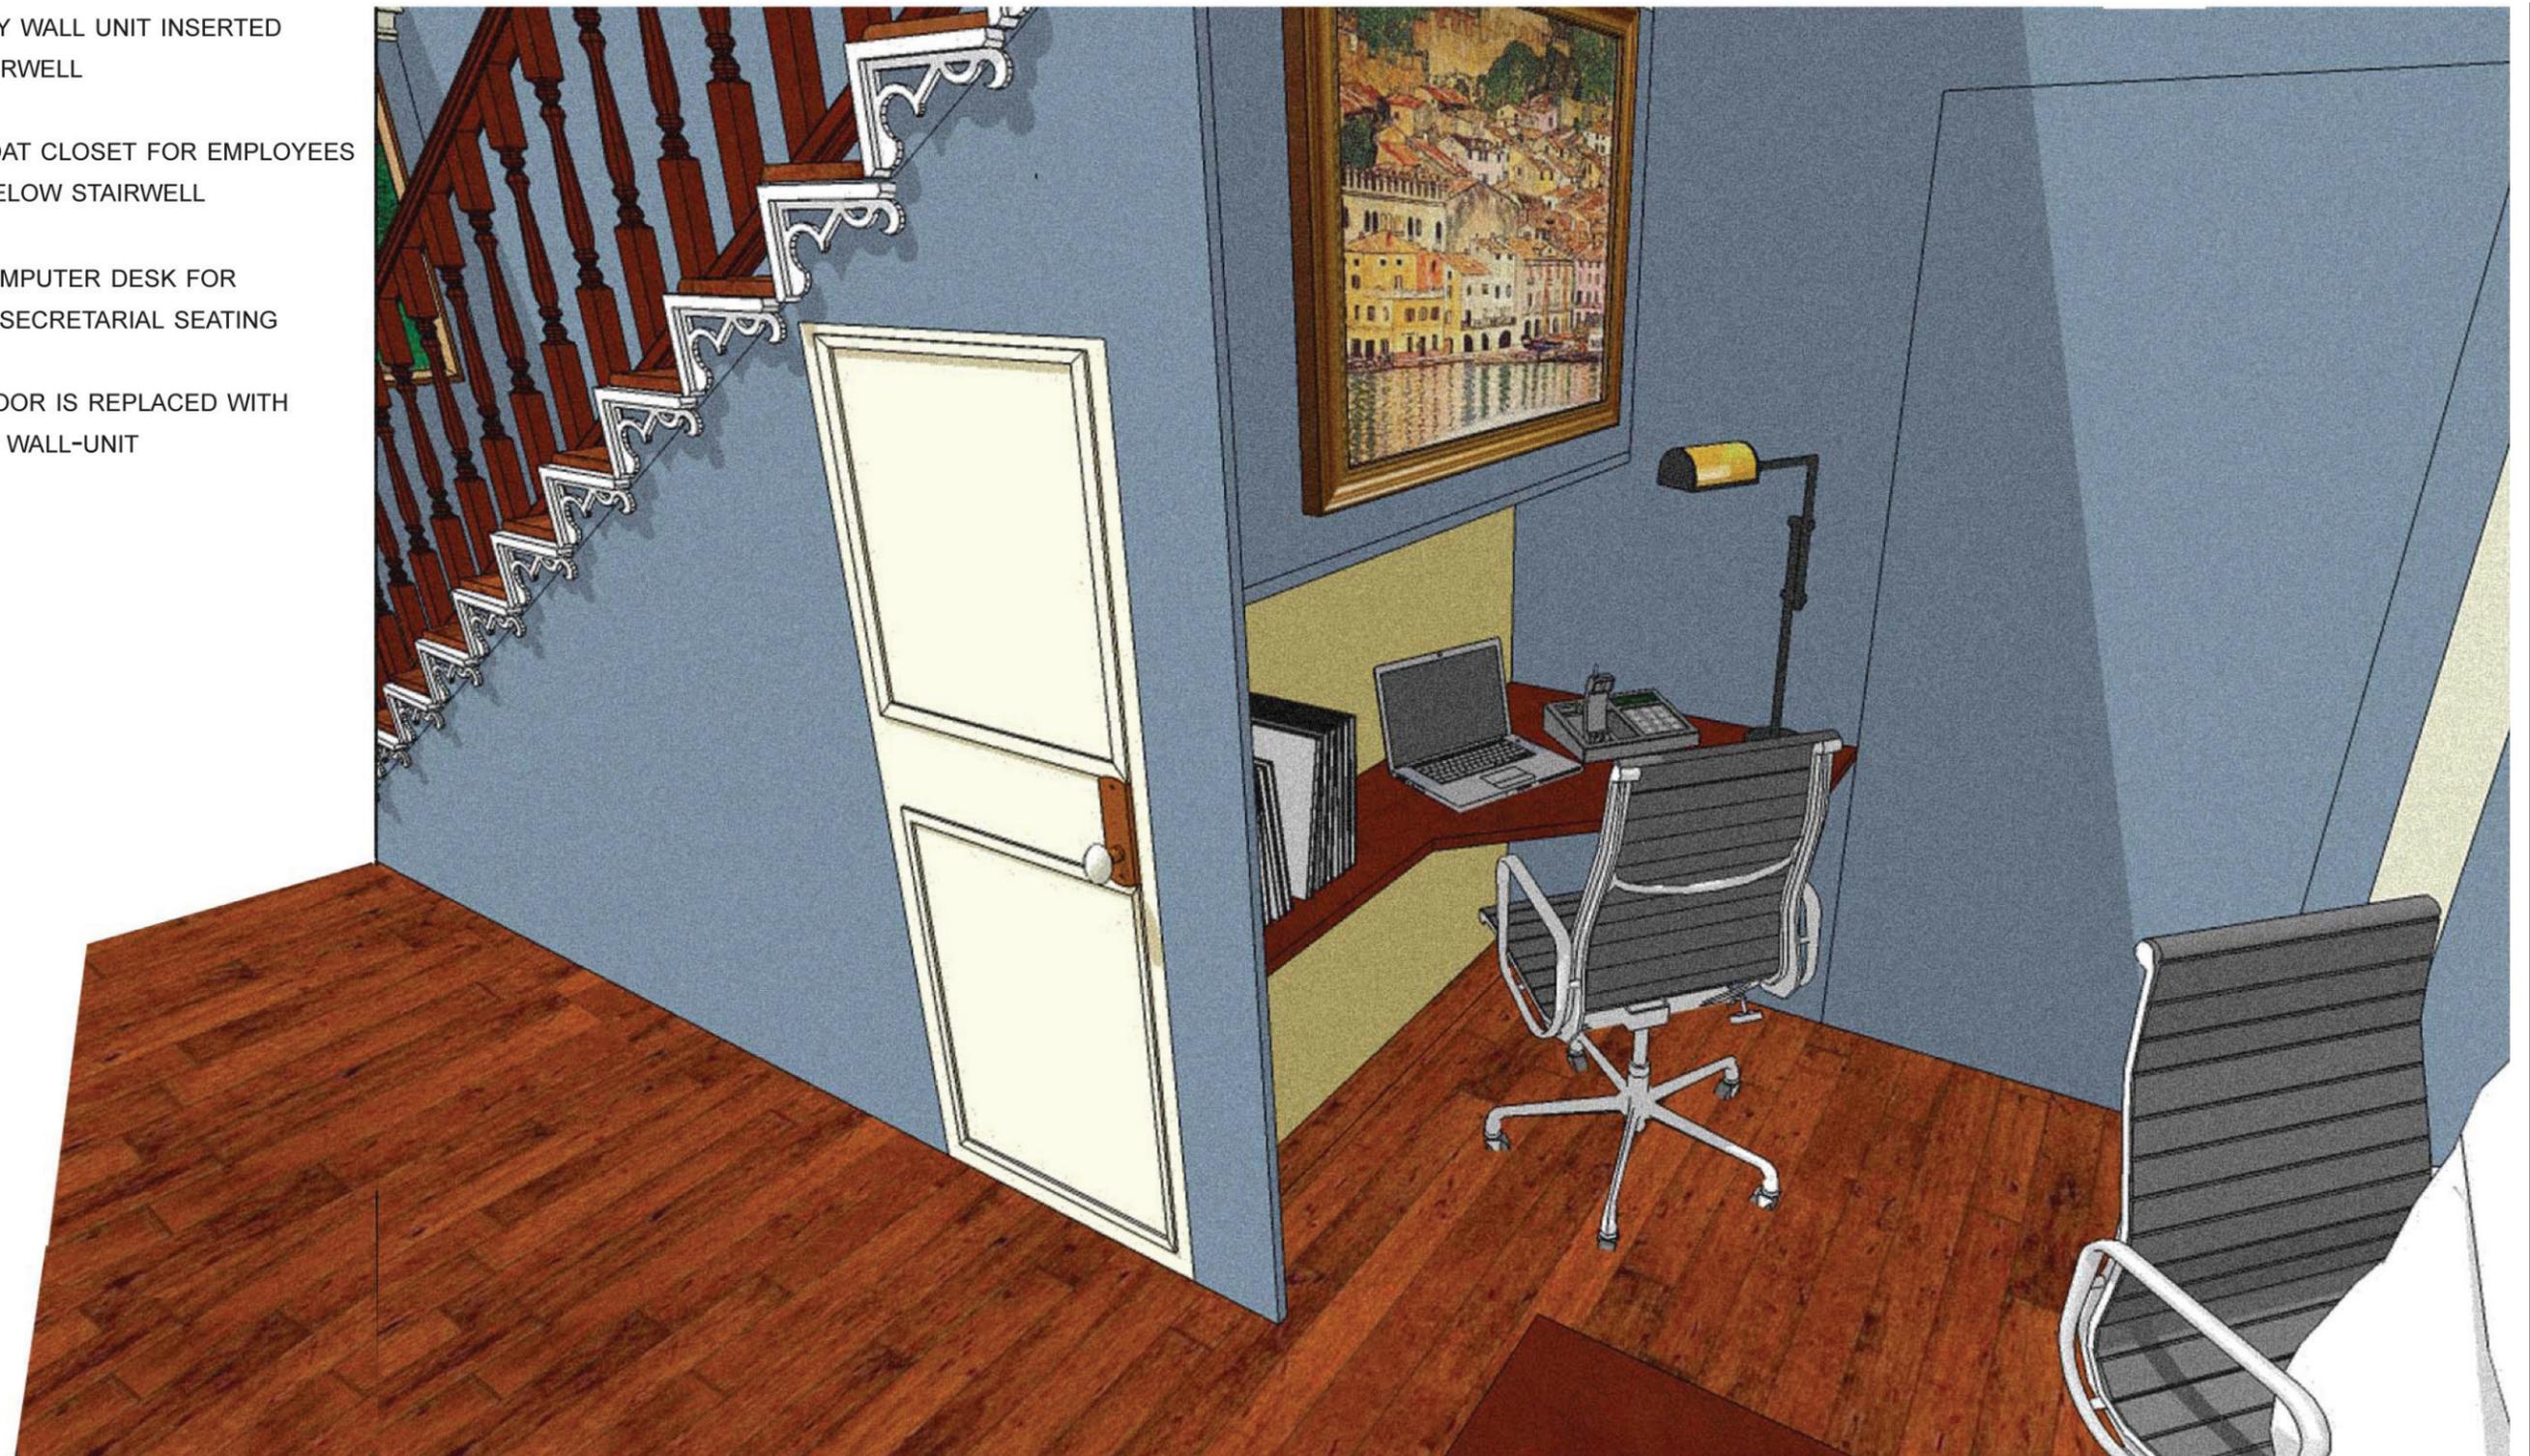
Rear Entry Hall: Understair Storage and Work Space
Final Conceptual Design
Danville Museum of Fine Arts and History
Danville, Virginia

BUILT-IN COMPUTER DESK FOR
ADDITIONAL SECRETARIAL SEATING

EXISTING DOOR IS REPLACED WITH
TEMPORARY WALL-UNIT
