c|d community design
a|c assistance center

Conceptual Designs for Space Planning at the Danville Museum of Fine Arts and History

Danville, Virginia
May 2007

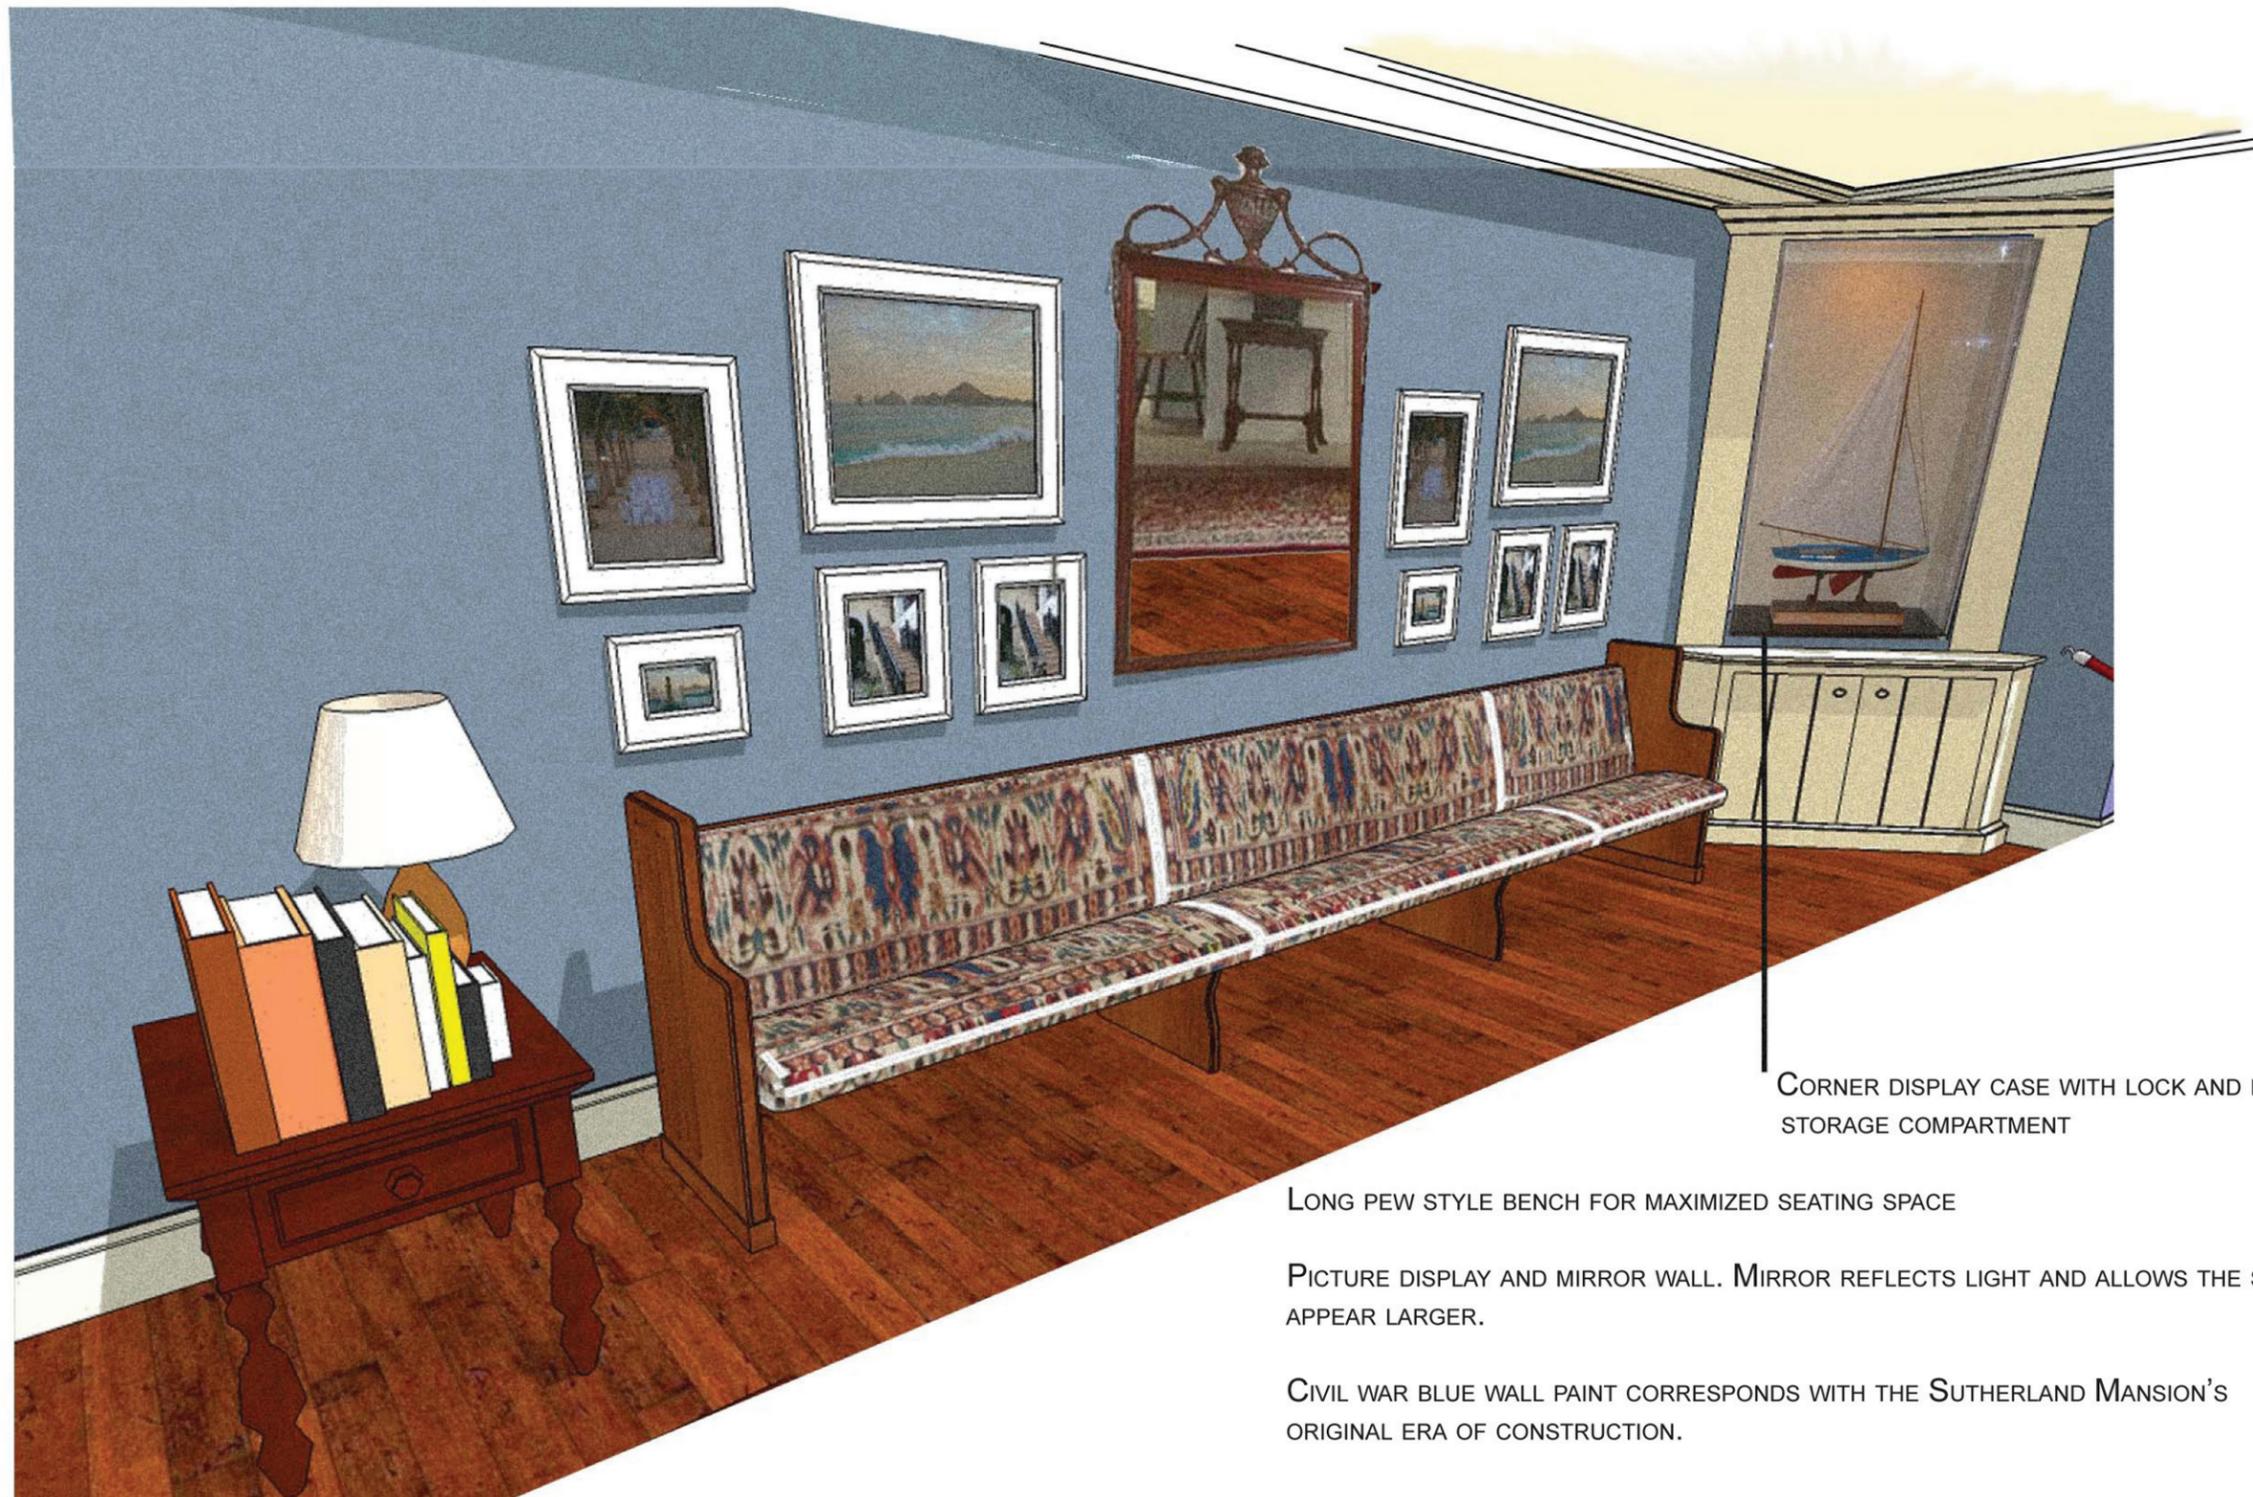
CORNER DISPLAY CASE WITH LOCK AND LOWER STORAGE COMPARTMENT

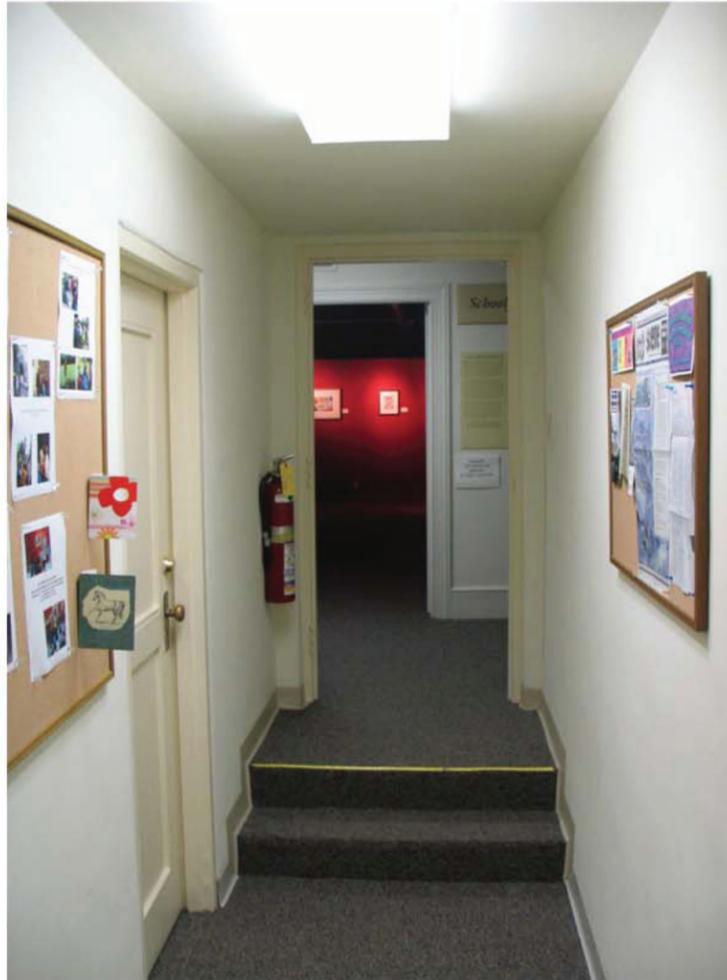
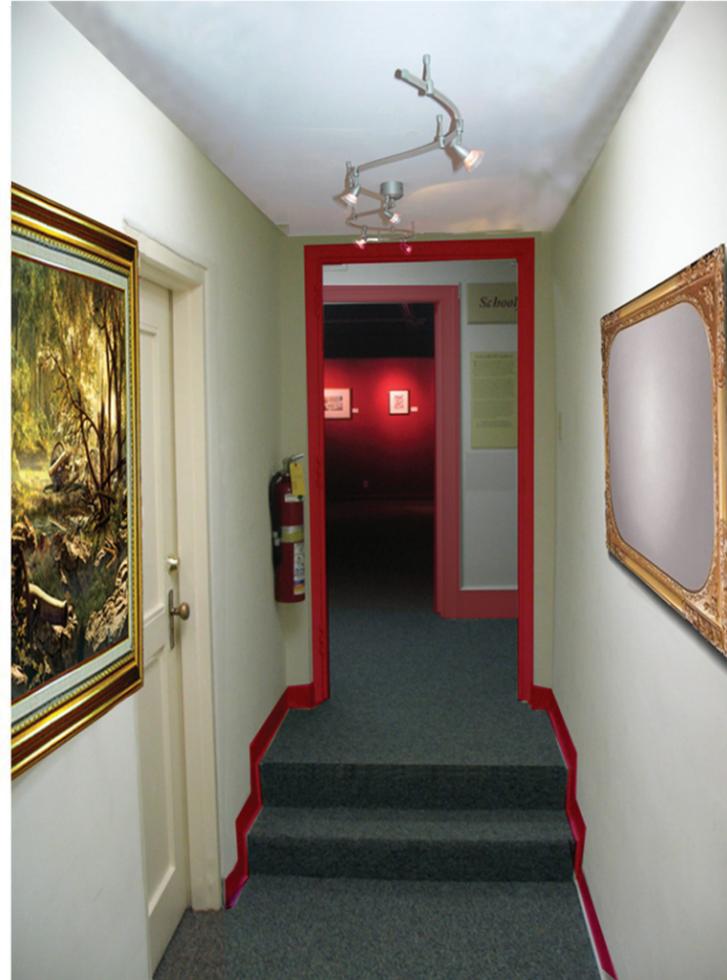
INDIRECT TRACK LIGHTING EXTENDS THE GALLERY DISPLAY AREA WHILE SERVING AS A BRIDGE TO CONNECT THE CIVIL WAR DISPLAY WITH THE GALLERY.

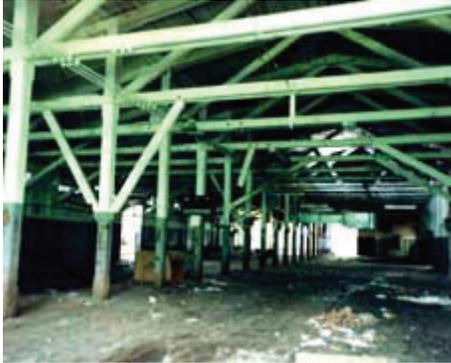
The interiors of mills and industrial buildings are frequently open, unadorned spaces with exposed structural elements. While these spaces can serve many new uses, the floor to ceiling height and exposed truss system are character-defining features that should be retained in rehabilitation. Photo: NPS files.

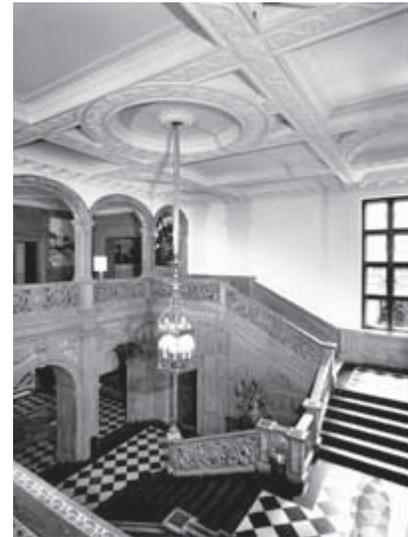
Not only are the features of this early 20th century interior worthy of preservation, the planned sequence of spaces impart a grandeur that is characteristic of high style residences of the period. Photo: Jack E. Boucher, HABS collection.

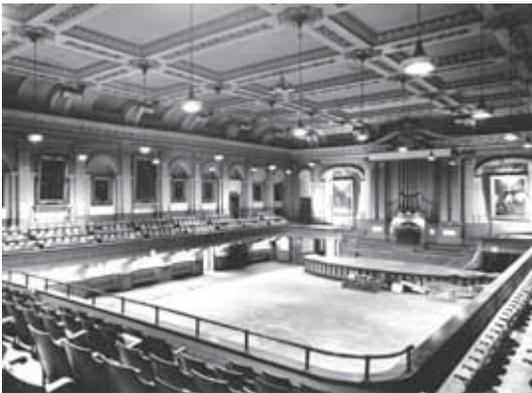
Many institutional buildings possess distinctive spaces or floor plans that are important in conveying the significance of the property. This grand hall, which occupies the entire floor of the building, could not be subdivided without destroying the integrity of the space. Photo: NPS files.

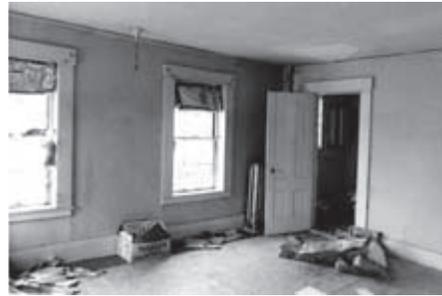
The interior of this 19th worker's house has not been properly maintained, but it may be as important historically as a richly ornamented interior. Its wide baseboards, flat window trim, and four-panel door should be carefully preserved in a rehabilitation project. Photo: NPS files.

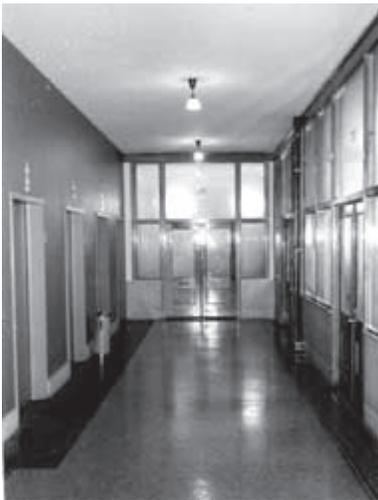
This corridor has glazed walls, oak trim, and marble wainscoting, typical of those found in the late 19th and early 20th century office buildings. Corridors such as this, displaying simple detailing, should be a priority in rehabilitation projects involving commercial buildings. Photo: NPS files.

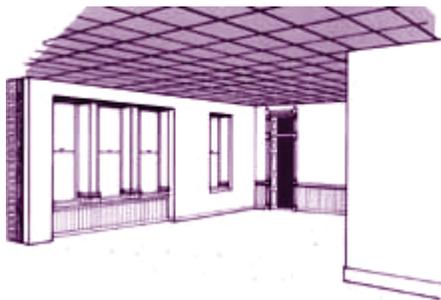
Furring out exterior walls to add insulation and suspending new ceilings to hide ductwork can change a room's proportions and cause interior features to appear fragmented. The interior character of this school classroom that was converted to apartment use has been destroyed. Drawing: Neal A. Vogel

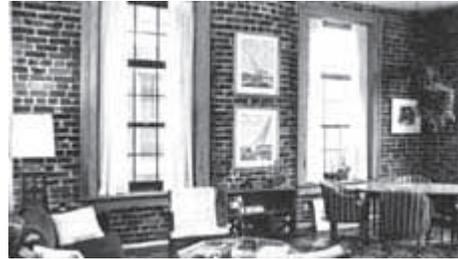
Plaster has been removed from perimeter walls, leaving brick exposed. The plaster should have been retained and repaired, as necessary. Photo: NPS files.

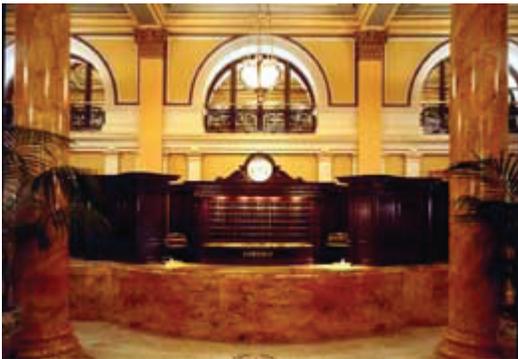
After rehabilitation, this severely deteriorated space was returned to its original elegance. Plaster was repaired and repainted; scagliola columns were restored to match marble; and missing decorative metalwork was re-installed in front of the windows. Photo: Carol M. Highsmith.

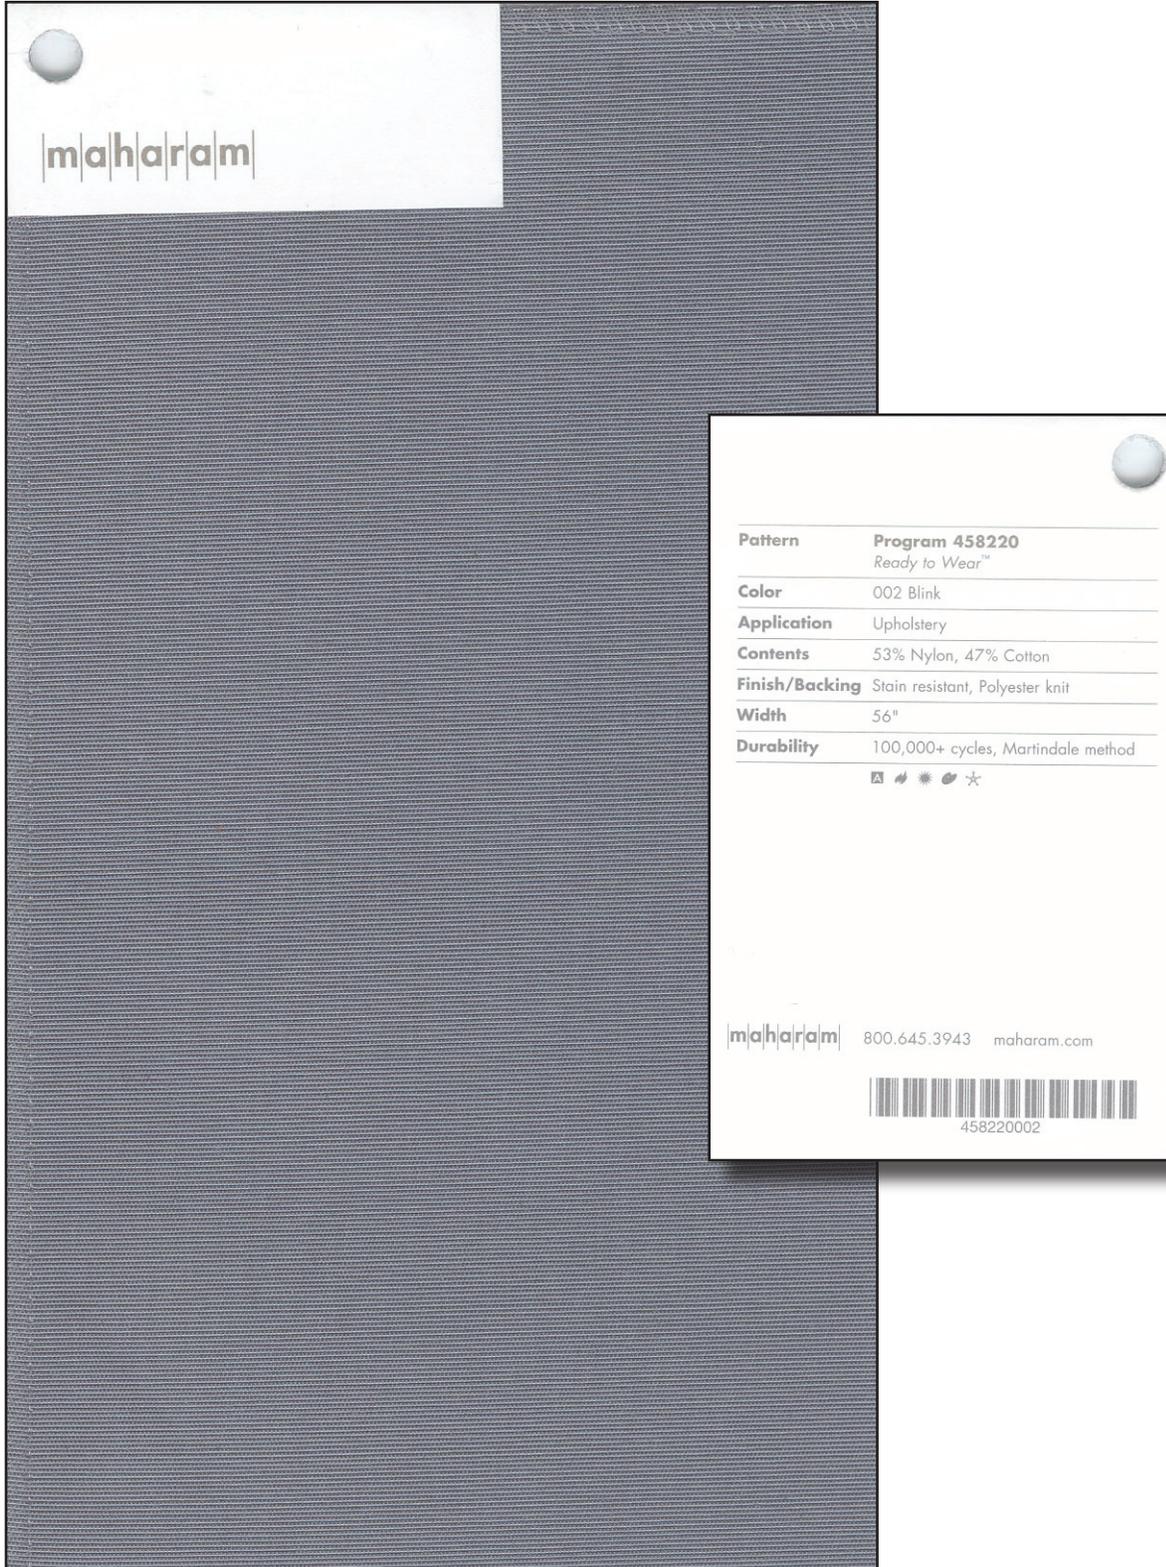
The image shows a large sample of a dark grey, textured fabric material. In the top left corner, there is a white rectangular label with the Maharam logo and a small circular icon. In the bottom right corner, there is a white rectangular card with technical specifications, a Maharam logo, contact information, and a barcode.

Pattern	Program 458220 <i>Ready to Wear™</i>
Color	002 Blink
Application	Upholstery
Contents	53% Nylon, 47% Cotton
Finish/Backing	Stain resistant, Polyester knit
Width	56"
Durability	100,000+ cycles, Martindale method
