Basement Whodunit

An architecture professor plays detective to figure out what alien—and possibly dangerous—substance lies beneath her basement flooring

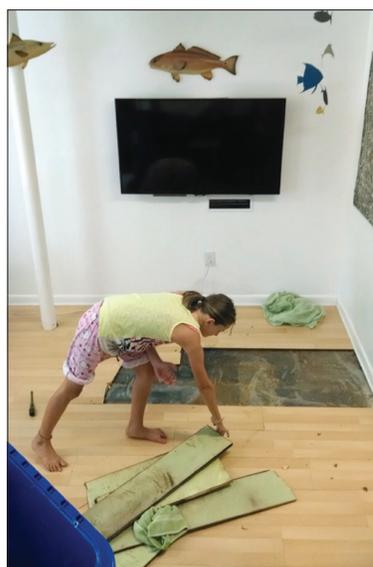
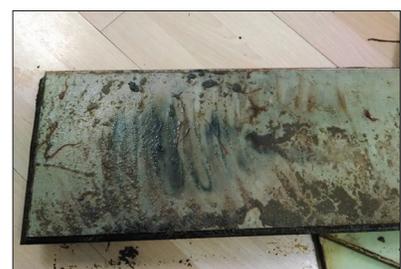
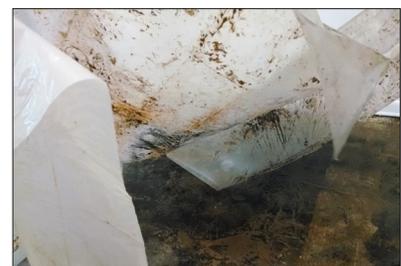
There wasn’t a lot of water, but enough had gotten under the Pergo, and eventually under the polyethylene sheet below, to create a nice layer of mud on top of the concrete slab. In this mud were thousands of tiny worms, both living and deceased. The smell of all this was quite impressive. It seems there was a low point in the slab in the region in question, because the damage was fairly well contained to a roughly 6-foot x 6-foot space. We removed all of these boards and the polyethylene sheet beneath. We mopped up the thin layer of water, mud, and worms, and also took the hammer to the small area of drywall below the TV where water had wicked upward. Then we bleached everything and put the trusty fan back out to dry the area.

Left, my daughter removing the first of the Pergo boards in the affected area. Gloves (and shoes) are for sissies! Upper right, gross worms on the back of Pergo. Lower right, worms, mud, and God knows what else between the polyethylene sheeting and the floor slab.

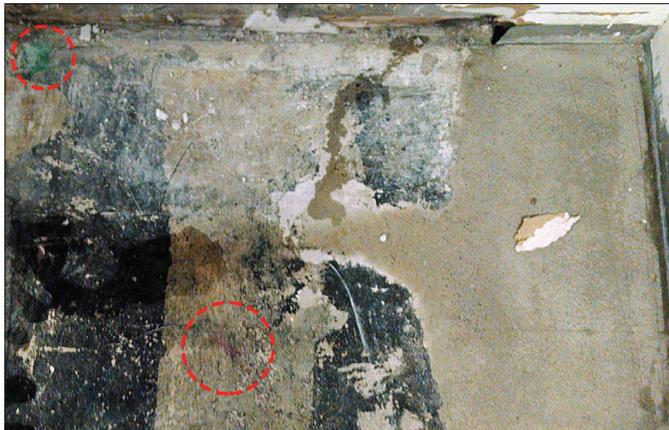
The food coloring plan was no scientific protocol that I’d seen before. I made it up, à la *MythBusters*. I suspected that, on a dry slab, the gel food coloring would remain where I put it until water got it wet, and then it would spread in the direction of the water flow. So whichever coloring got wet first would indicate the source of the water that was rewetting the slab every day. Fortunately, the neon gel food coloring experiment worked pretty well. The green coloring circled in the upper left in the photograph on the top of p. 20 shows that water was coming from a crack near the interior wall, and the purple coloring circled in the lower left shows that water was also coming from a crack in the center of the area. The foundation wall on the right side of

Food coloring experiment to determine the source of the leak.

the image (dye not shown) was also tested, with no movement of the dye there. It soon became obvious that the water was coming mainly from a crack running diagonally from the top center to bottom left—that is, from under the slab.

The answer came a few days later. The basement floor had dried overnight, but in the morning, a small puddle of water reappeared. Finally, I put two and two together and realized I had just started the dishwasher a few minutes prior. I bellowed up the stairs for somebody to stop it. Sure enough, when we stopped the dishwasher, the puddle didn't grow any larger. But of course, that wasn't the full answer. We still had to narrow it down to what is called, in technical parlance, potable (nice) water or sewer (not-so-nice) water. I asked my husband to fill a pot in the kitchen sink. Nothing. Then I asked him to dump said pot of water down the kitchen sink drain. Eureka! It was the pipe full of not-so-nice water, a.k.a. the sewer line, running under the basement slab that had clearly rup-

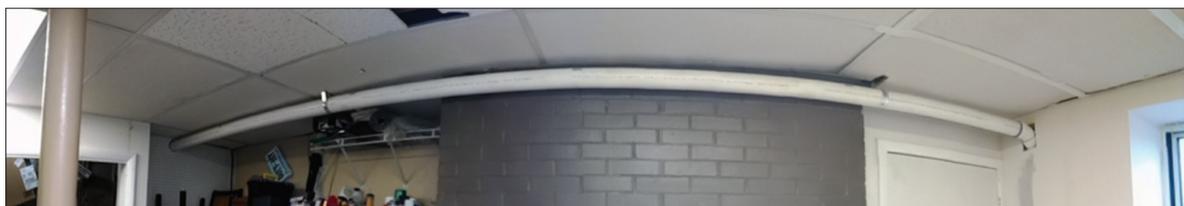
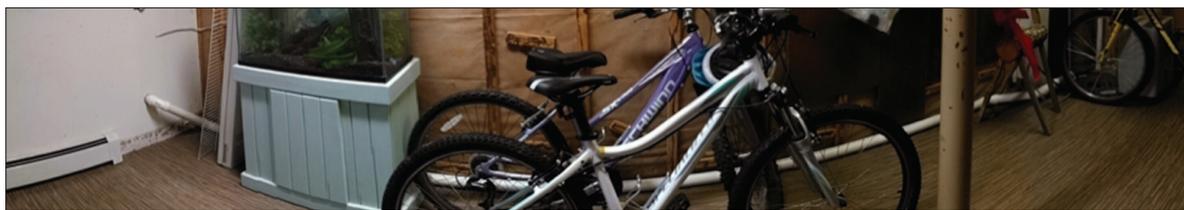
Above, the new sewage pipe runs downward from the kitchen drain (at left), slopes under the ceiling of the storage room and into the exterior wall of the house, and then down and out through the foundation wall into the backyard to tie into the existing sewage line. Below, the other side of the room sports an attractive radon removal pipe near the floor. I figure the two pipes balance one another architecturally, creating a poetic resonance appreciated only by the truly aesthetically inclined. The panoramic photos are curved, not the walls.

There were three options suggested by our plumber, after some head scratching and gnashing of teeth. The first of these involved essentially tracing the broken pipe's path by cutting a new trench clear across the floor of the family room and dodging three columns to tie into the downstairs bathroom sewage line. This did not seem like a great plan for structural and Chihuahua-nervous-condition reasons, and would cost a fair bit. The second option was to run the upstairs kitchen line through the ceiling of the finished part of the basement over to the downstairs bathroom wall, drop it down, and tie it back into the existing sewage line there. To achieve sufficient drop, this would necessitate casing the new pipe in an oh-so-attractive soffit around the perimeter of the family room, which would need to make multiple right turns and end up at about 6 feet 8 inches above the floor before reaching the aforementioned bathroom wall. And that was if we were lucky. Our plumber, who tends toward the philosophical, thought this might be the perfect location to install a pull-up bar. I, who do not tend toward the athletic, demurred. The third option, and the one we picked, was to run the line through the storage room, then run it down inside the exterior wall of the house, out through a hole just below grade, and thence down our nicely sloped backyard to catch up with the rest of the sewage pipe out there. Though this involved cutting unsightly trenches in the yard, it also involved the least ugliness and destruction inside the house itself.

storage room sucking out the radon (as discussed in last year's story) and allowed us to regain a functioning kitchen fairly quickly. And, if the astute among you are wondering, yes, there is a small chance that sewage might back up from potential downstream nastiness into the cracked pipe we left abandoned under the family room slab. But we got the philosophical plumber to unclog the drain in the laundry room (also discussed in last year's story), which should be the lowest point in the system. Any future nastiness should, in theory, show up there first.

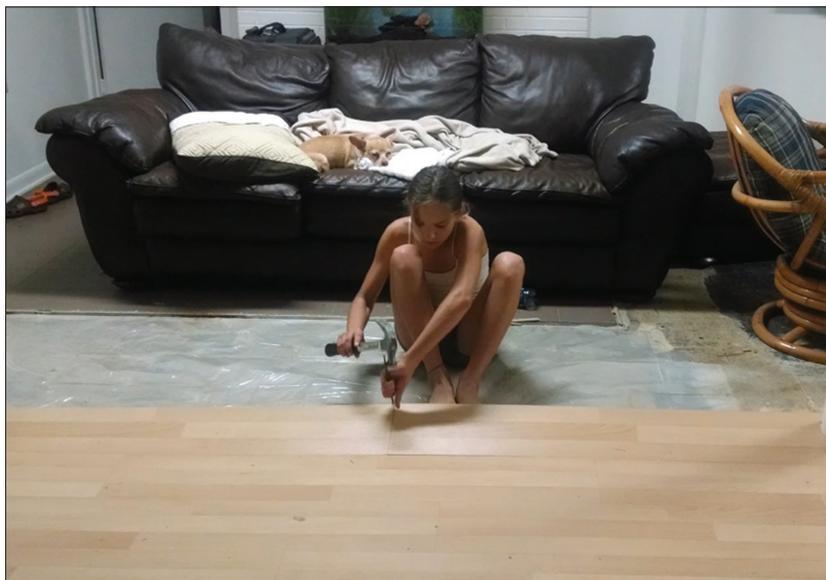
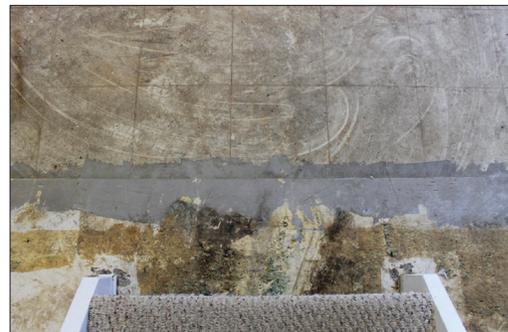
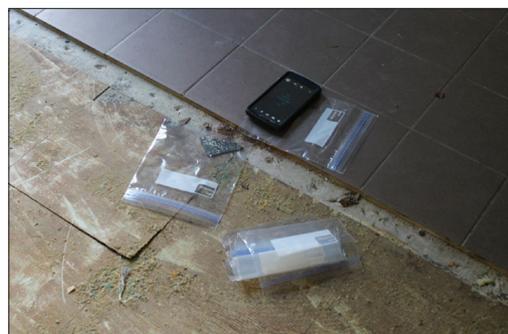
Once this was removed, there was what I have come to refer to as a palimpsest of laziness beneath. Palimpsest is a fancy term I learned in architecture school, generally in reference to surfaces that, when they begin to deteriorate, reveal a rich legacy of prior works from ages past. Our floor was pretty much like that, only the "laziness" part is added because in this case people covered over prior layers in quite ridiculous ways in an effort to git 'er done. There were regions with ghosted outlines of formerly removed floor tile with residual black mastic, which was troubling, and, more troubling still, a region of suspected asbestos-containing floor tile that the nice Pergo installers (remember them?) had ignored and covered over. There was even a cute little ramp up to

Having worked as an architect in a firm also specializing in environmental services such as abatement of lead, mold, and asbestos, I was almost certain that the black mastic contained asbestos, and I was also very suspicious of the remaining floor tile. I called my old firm and they sent out a gentleman with a bunch of baggies and a cell phone who wrote me a lengthy and comprehensive report a few days later saying, essentially, "Yup." Asbestos in these materials is, I'm told, not a huge deal, as it is not particularly friable. However, since I was dealing with a mess already, I was eager to get rid of the tile once and for all.

Left, the elder investigative Chihuahua looks on with rapt attention as my daughter removes the rest of the Pergo. Upper right, a tiny leveling-compound ramp used to feather the edge of asbestos-containing floor tile. Lower right, collecting tile and mastic samples for the lab.

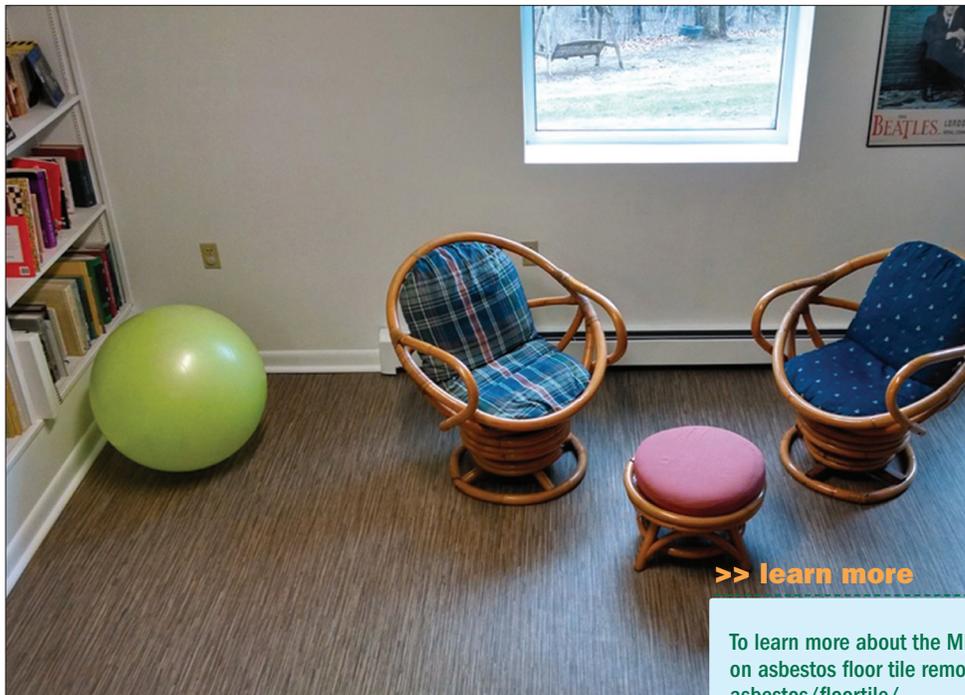
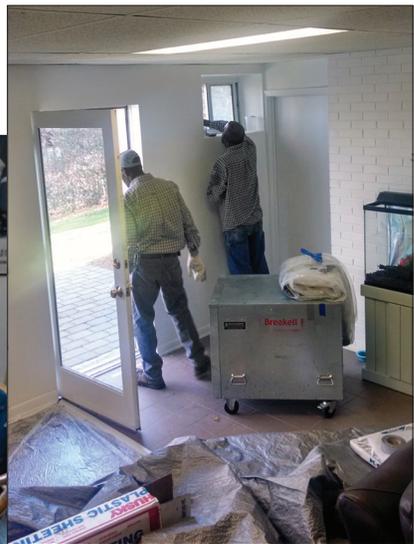
Above, the professionals come in and remove our asbestos. Left, the finished product with worms safely beneath.

About a third of the way in, he remembered that he has back problems. He backed out from under the plastic, defeated, and we called in the abatement contractors, who made short work of the rest of it a week or so later.

The saga ended, quite predictably, with us putting some vinyl down over the entire asbestos-containing-mastic-ridden area, which extended even into the highly attractive storage room mentioned earlier. I know I said in the previous article that if the opportunity ever presented itself, I would fix my floor properly, but I didn't. It had already cost us thousands of dollars beyond the very fair insurance settlement to complete this work, so tile or wood was out of the question. As for carpet, please refer to my earlier statement about the Chihuahuas. I realize this flooring
