REDUCING SEDIMENT IN STROUBLES CREEK, BLACKSBURG, VA

W. Cully Hession
Biological Systems Engineering,
Virginia Tech

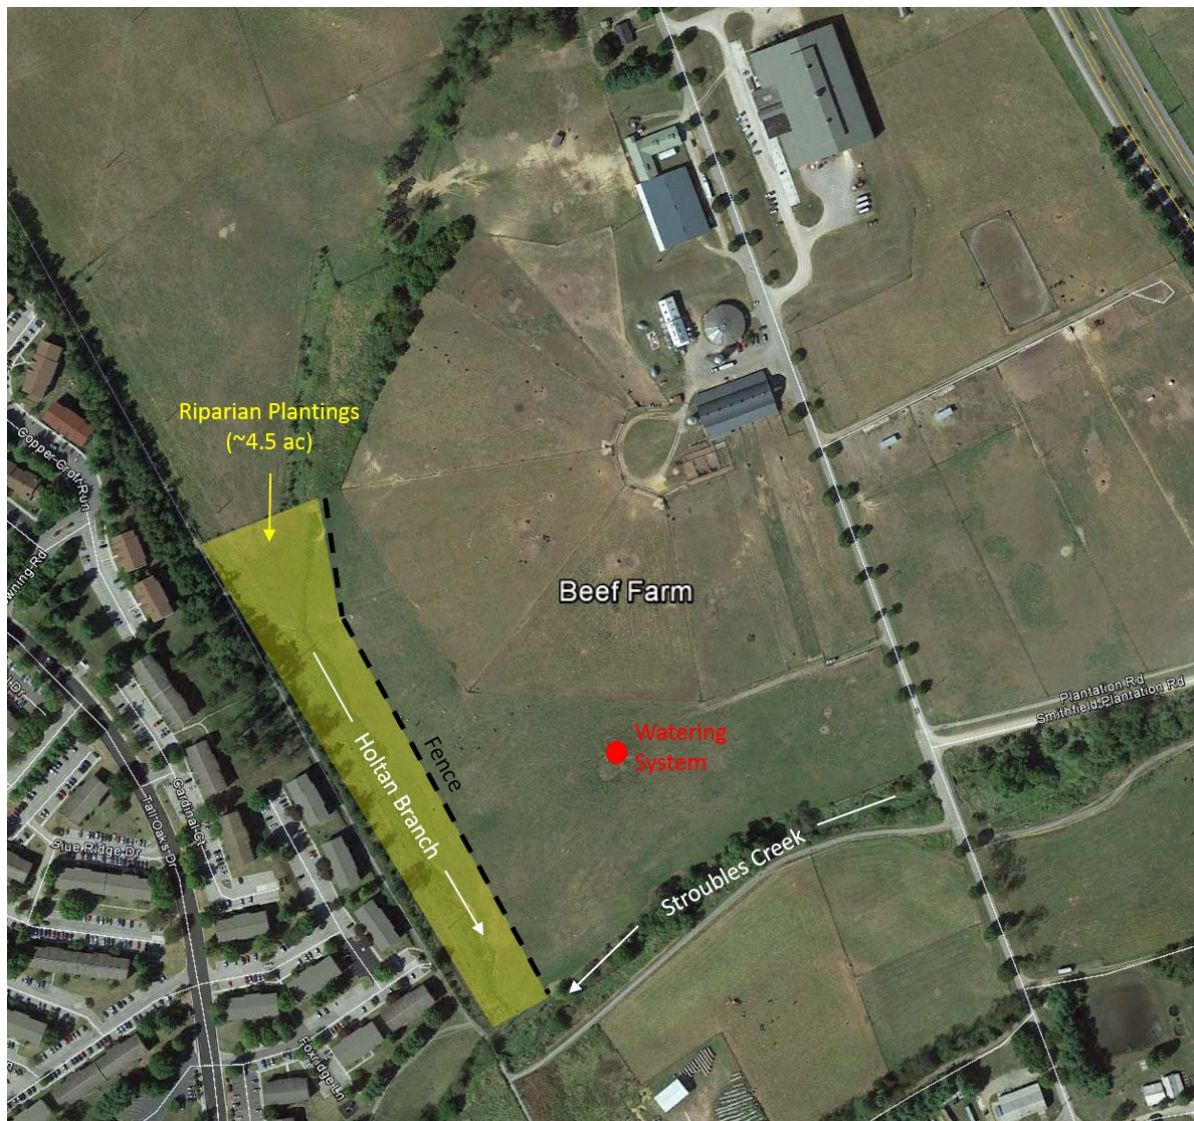
Figure 2. Stream exclusion with watering system and riparian buffer (~4.5 ac) at the Virginia Tech Beef Farm along Holtan Branch.

Our sole agricultural BMP was a Stream Exclusion with Grazing Land Management practice at the VT Beef Farm (Fig. 2). The pasture is adjacent to Stroubles Creek and includes Holtan Branch, a previously unnamed tributary to the creek. While the main stem of Stroubles Creek was fenced off in 1995, cattle were still directly affecting approximately 1,300 feet of Holtan Branch. We fenced one side of this stream (left bank looking downstream), connecting to existing fencing on the upstream and right bank (Fig. 3). The fence length is approximately 1,200 feet and resulted in nearly 4.5 acres of protected riparian area that we planted in a mix of hardwood and wetland plants (Fig. 4 and Fig. 5). We also extended existing water lines and added a new watering system to serve this large pasture area (Fig. 6).

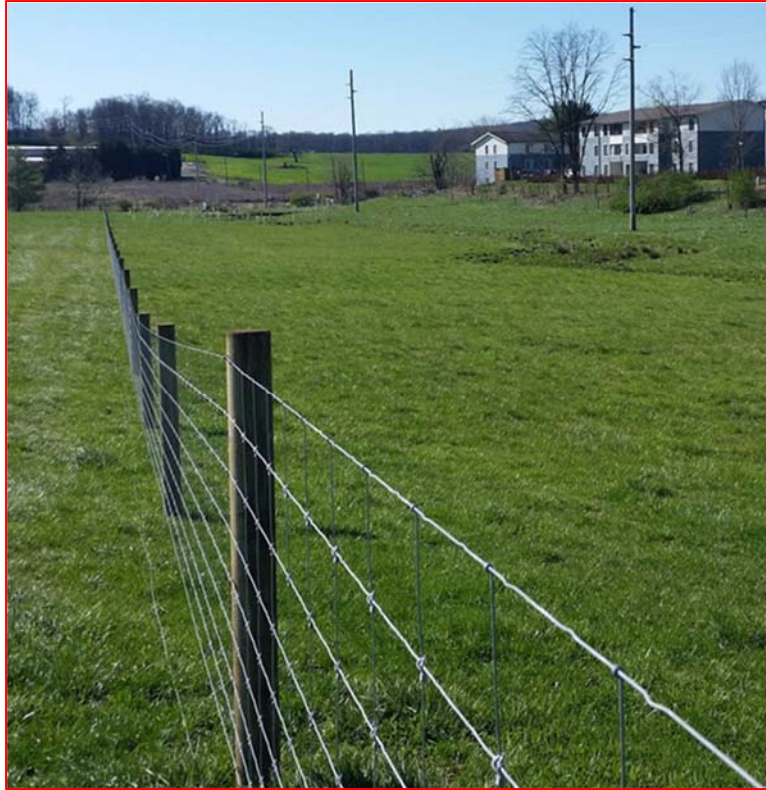
Figure 3. Livestock exclusion fencing along Holtan Branch looking downstream.

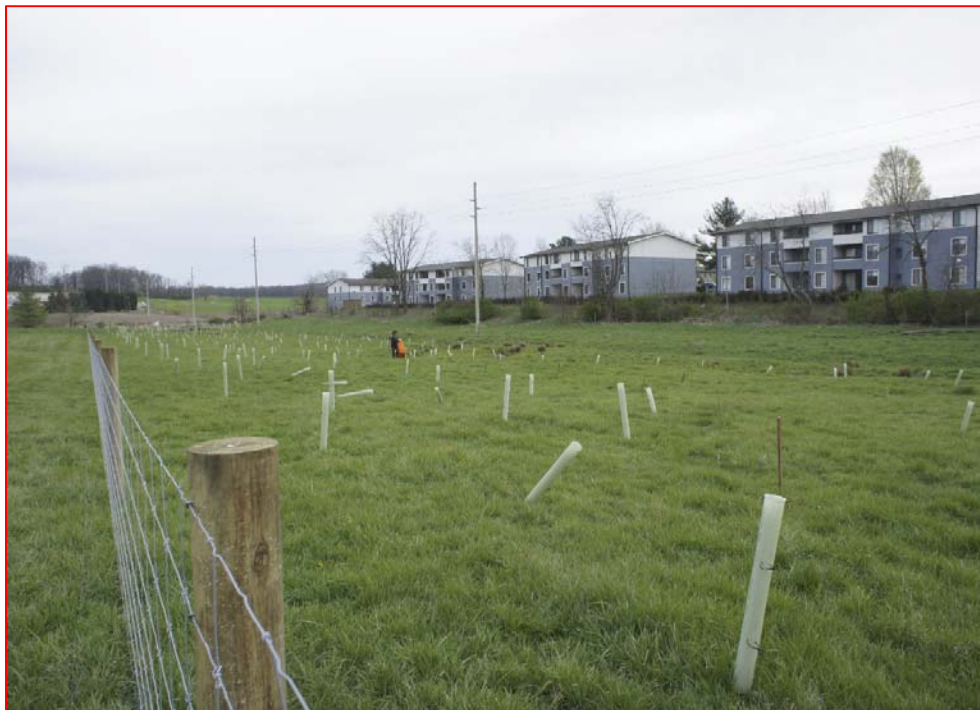
Figure 4. Conservation Services, Inc. planting hardwood trees and shrubs along Holtan Branch (April 2016).

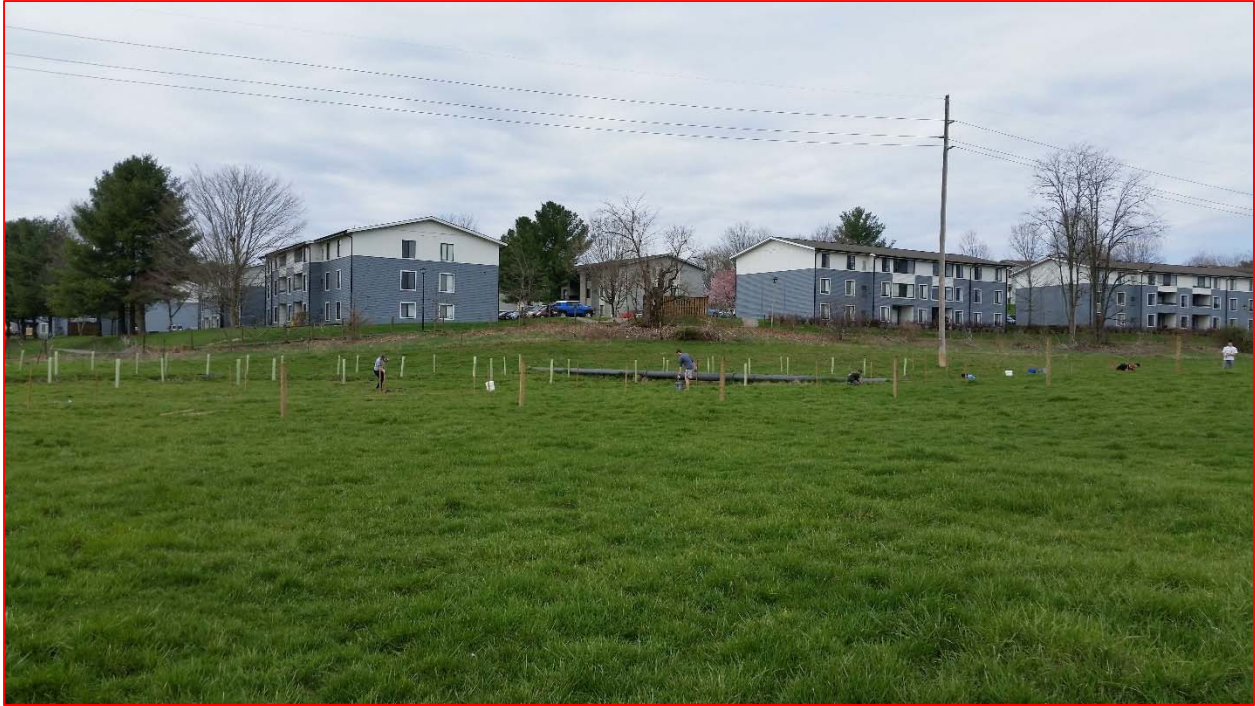
Figure 5. Volunteers from the Stroubles Creek Restoration Initiative (SCRI) planting at downstream end of Holtan Creek just above confluence with Stroubles Creek.

We installed the second riparian forest buffer using volunteer labor along a 300-foot section of Holtan Branch just above the Foxridge Apartment’s pond, creating a 0.35 ac riparian buffer. Here we planted 65 container trees and shrubs purchased from New Leaf Farms, Inc. in Bedford, VA. We completed planting of this riparian buffer during March of 2017, continue to water, and maintain the plantings as of this report writing. Selection of plants and a planting plan (Fig. 8) were coordinated with the Stroubles Creek Restoration Initiative, Foxridge Apartments, and the Hethwood Foundation.

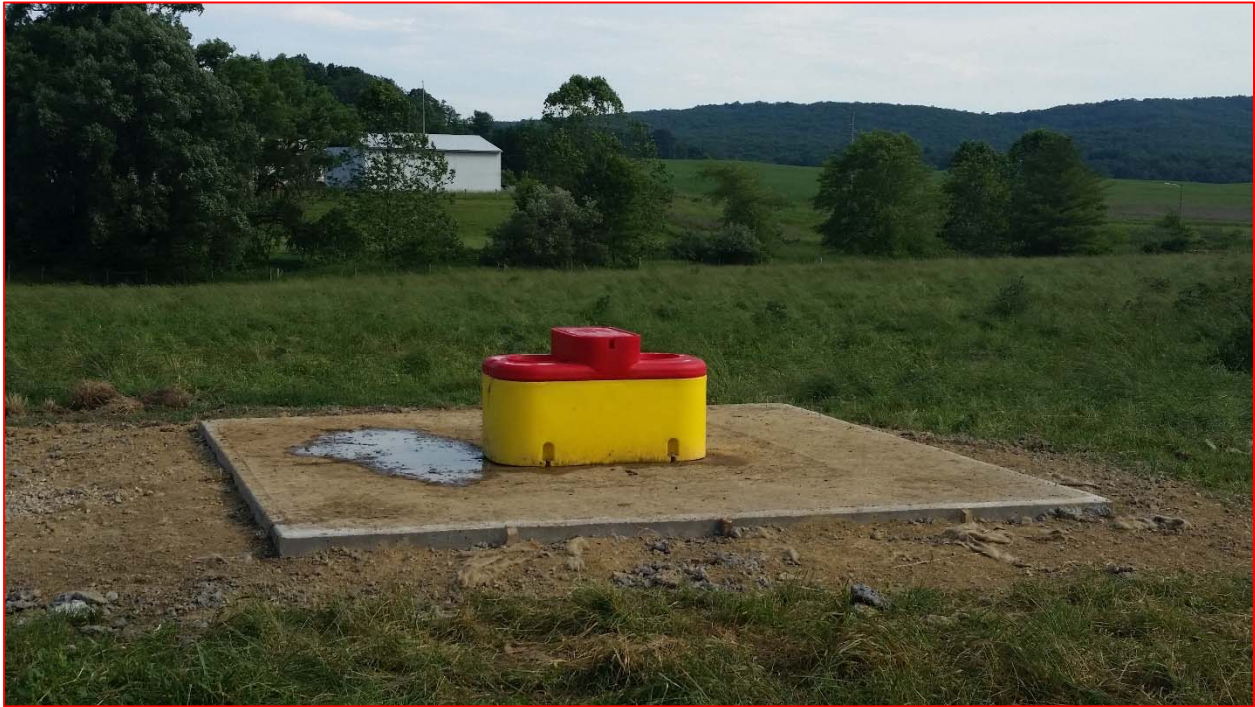
Figure 6. New watering system in pasture at the Virginia Tech Beef Farm.

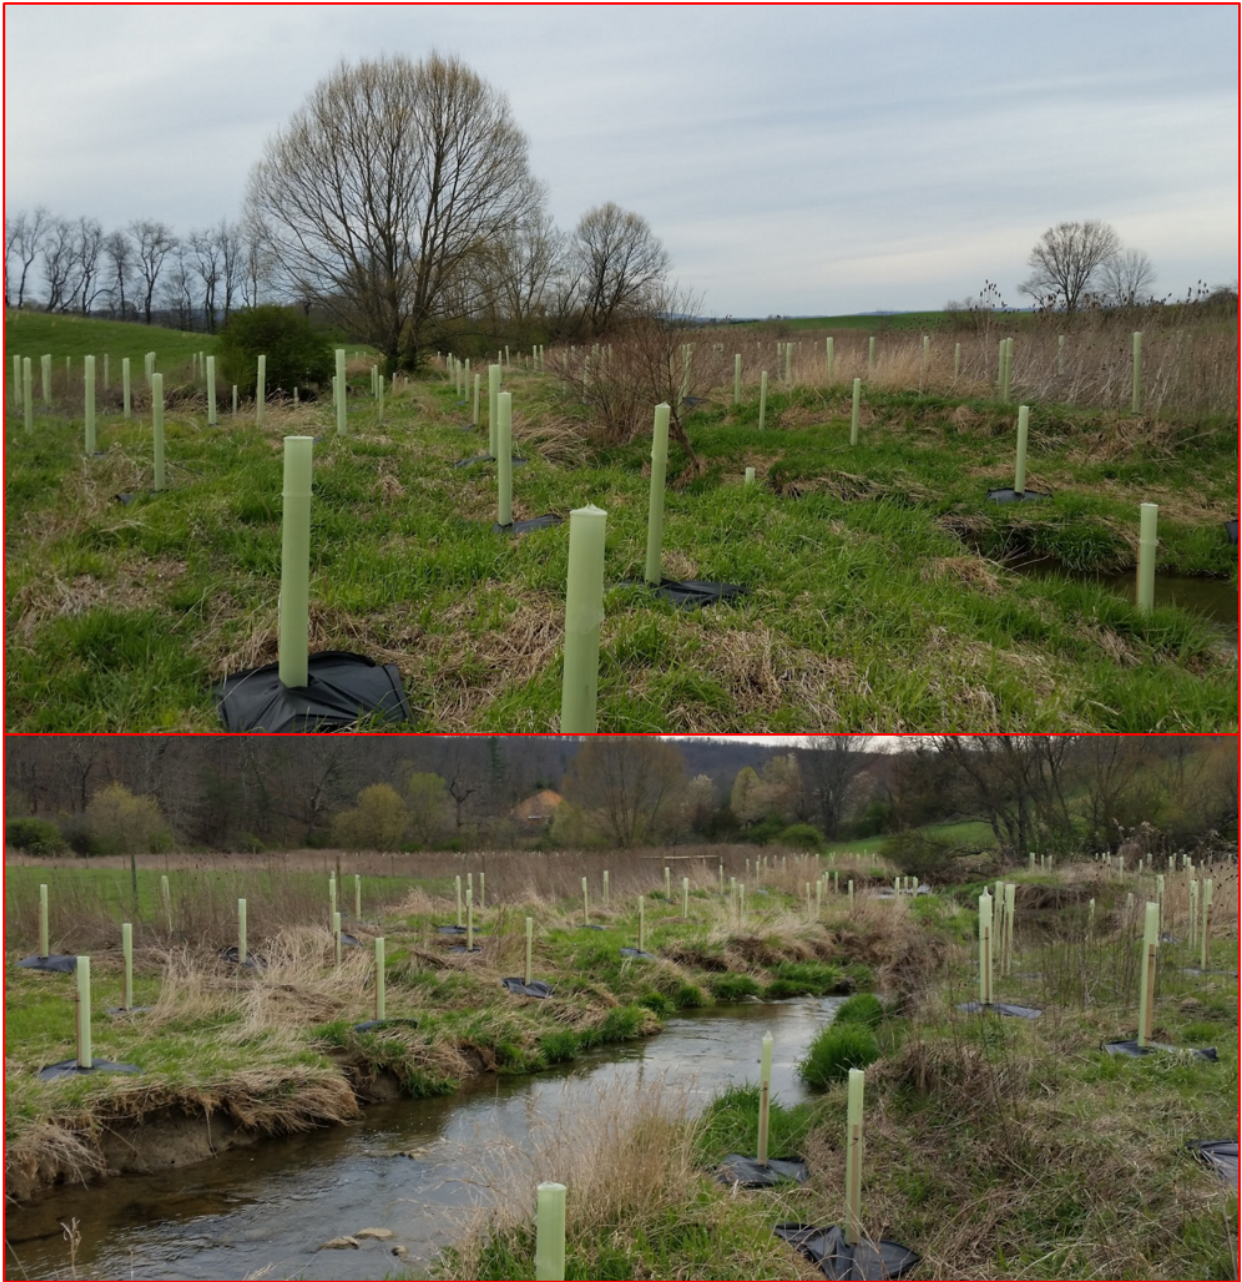
Figure 7. Riparian forest buffer planted near downstream end of the VT StREAM Lab.

We installed two riparian forest buffers along Stroubles Creek and its tributaries. The first was a 900-ft section along Stroubles Creek included planting of 440 hardwood trees to create 3-acre riparian forest buffer at the downstream end of the VT Stream Lab (Fig. 7). These native hardwood seedlings were planted with oak stakes, tree shelters, bird nests, and shade cloth were installed by Conservation Services, Inc.

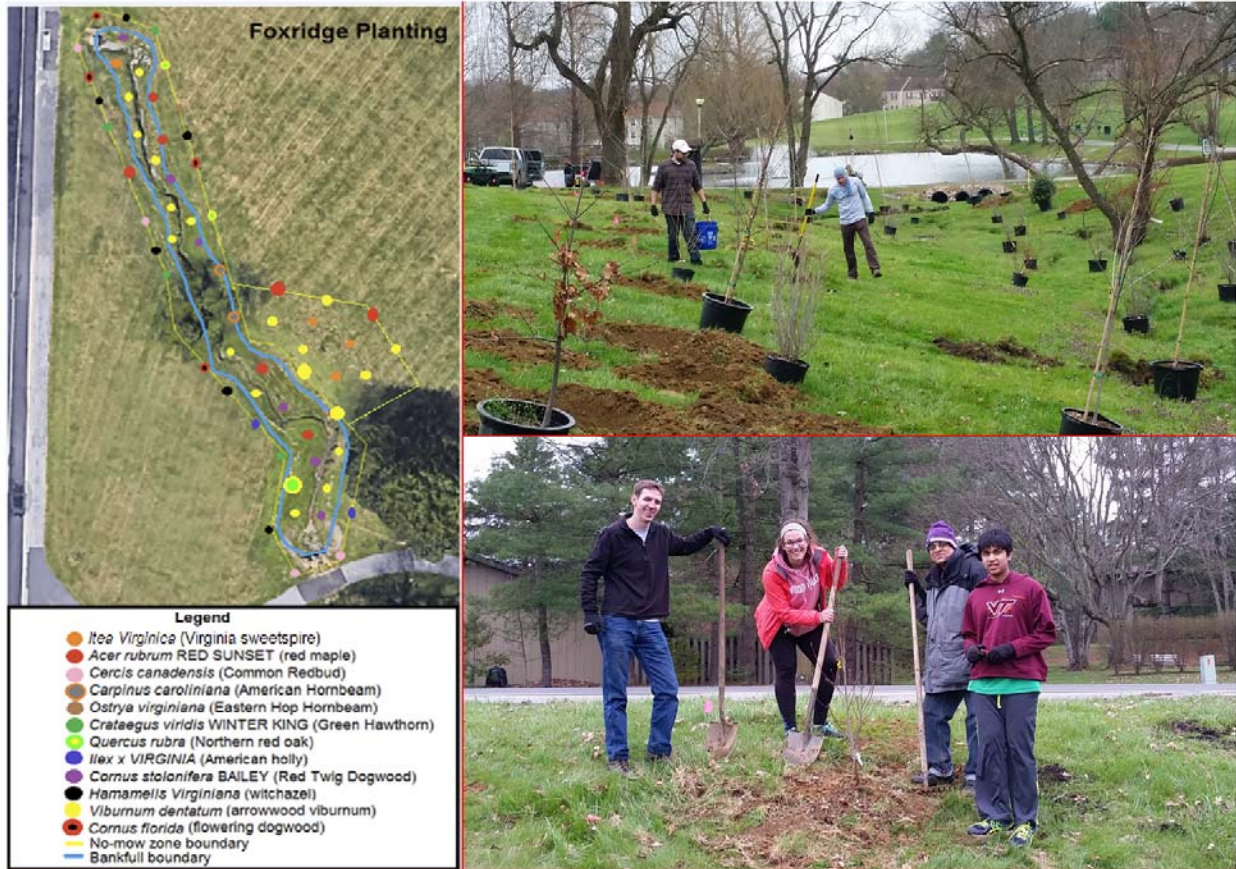
Figure 8. Planting riparian buffer just upstream of Foxridge Apartments pond along Holtan Branch, a tributary to Stroubles Creek. Planting plan shown on left and volunteers shown planting containerized native trees/shrubs on right.

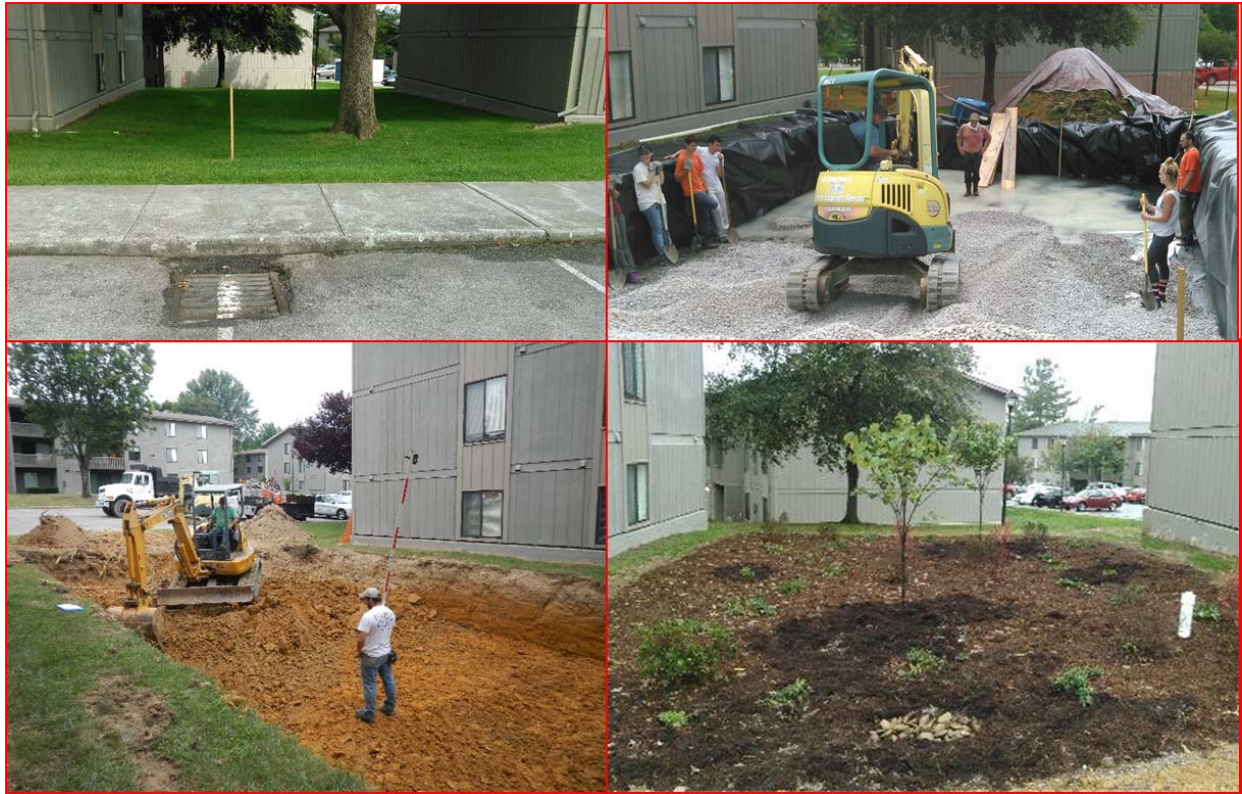
Figure 11. Installation of large bioretention cell at Foxridge Apartments in 2015. Images show before, during and after construction.

We installed three bioretention cells within the Foxridge Apartment complex to treat runoff from several roofs and one parking lot (Fig. 9). These were all designed as part of VT Biological Systems Engineering (BSE) department senior design projects and were installed by volunteers, BSE staff and students, and Foxridge Apartment/HHHunt Corporation personnel in 2015. The two smaller bioretention cells were installed to treat about a tenth of an acre of impervious rooftop each and are four feet deep with an area of 120 ft² (Fig. 10). The larger bioretention treats nearly 0.5 acre of impervious roof and parking lot, is 5-6 feet deep, and has an area of 1,050 ft² (Fig. 11).

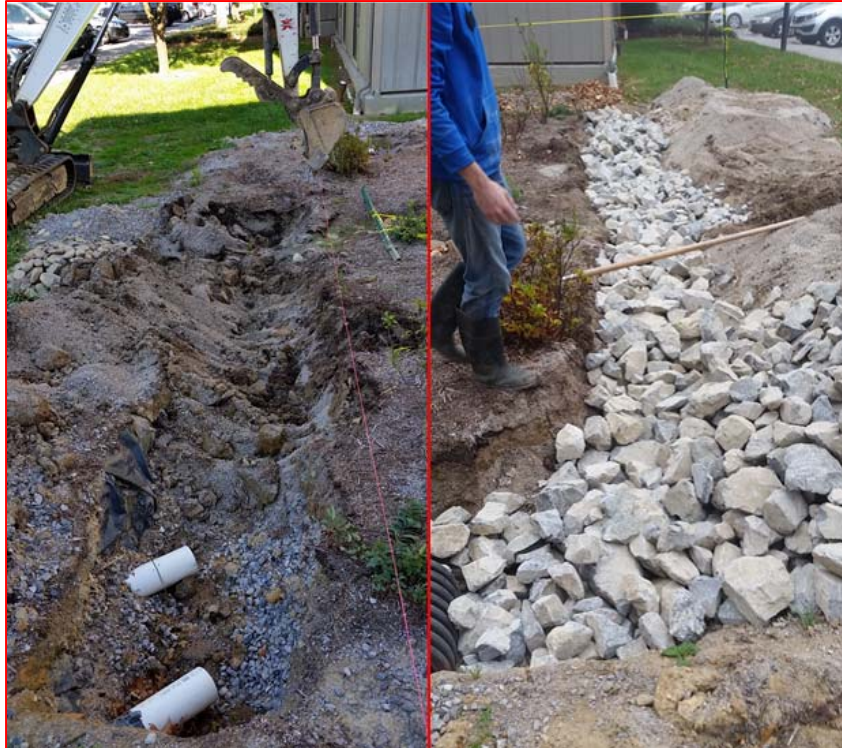
Figure 12. Excavation of bioretention cell and installation of riprap improve flow into BMP.

Due to some problems with clogging, we modified the upstream and downstream ends of the bioretention cell in 2016 (Fig. 12). We also extended the outlet to a storm drain at the bottom of the hill via underground pipe at the request of Foxridge Apartments. We excavated the upper and lower sections of bioretention cell and replaced fill with riprap so the inlet pipes from parking lot and roof downspouts could flow freely into the cell (Fig. 13). This more porous material also provide for more storage of water within the cell during storm events.

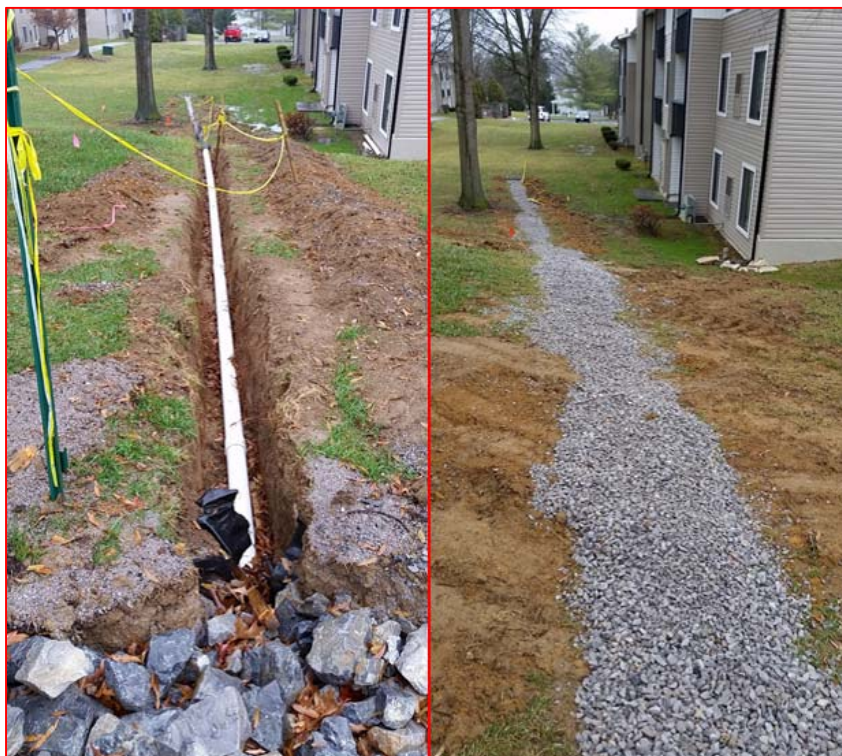
Figure 13. Retrofit of bioretention cell outlet using buried pipe and gravel.

Initially we planned to install a grasses swale to guide water from the outlet of the bioretention cell down the hill toward a stormwater inlet. However, due to some flooding issues around an apartment down the hill (not entirely due to our bioretention cell outlet, but also do to overall drainage issues of the site), Foxridge Apartments asked us to bury our outlet pipe the entire distance (approximately 200 feet). This required hand digging for much of the distance due buried utilities, installation of flexible drainpipe, installation of PVC pipe, and, finally, backfilling with gravel to provide for drainage of surrounding surface water to the storm drain.

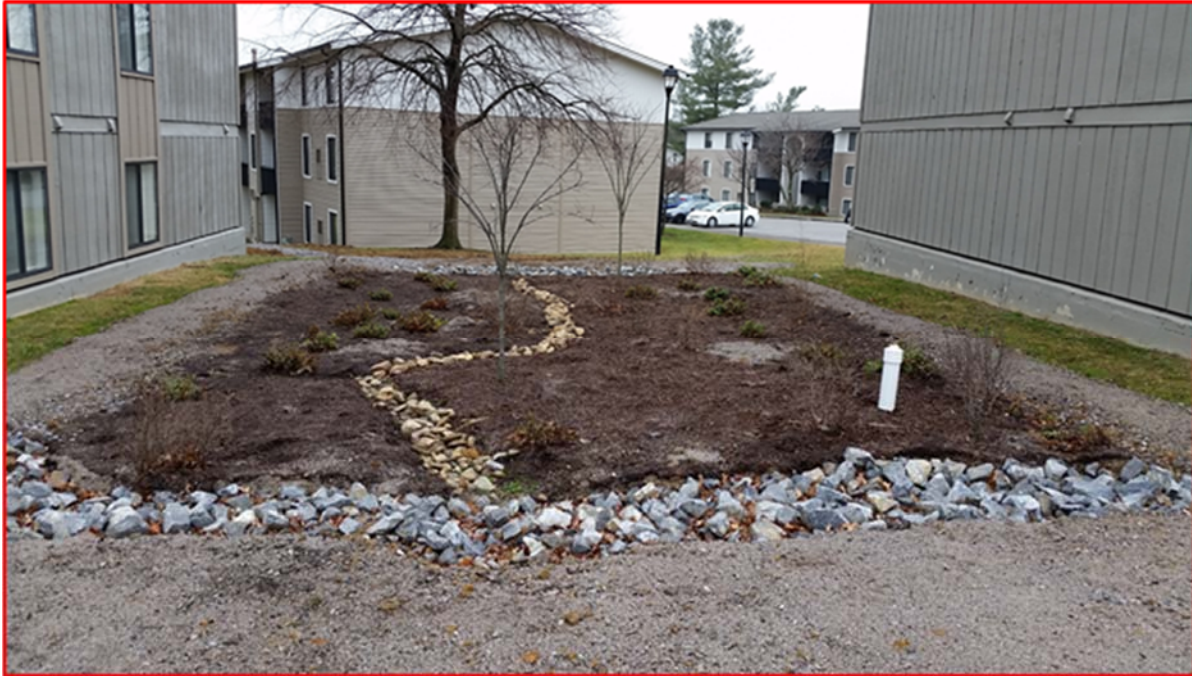
Figure 14. Final retrofitted bioretention cell. We will incorporate topsoil and grass during the spring of 1017.

The final retrofitted bioretention cell is shown in Fig. 14. We have purchased topsoil to spread around the cell to allow for planting of grass during the spring of 2017.

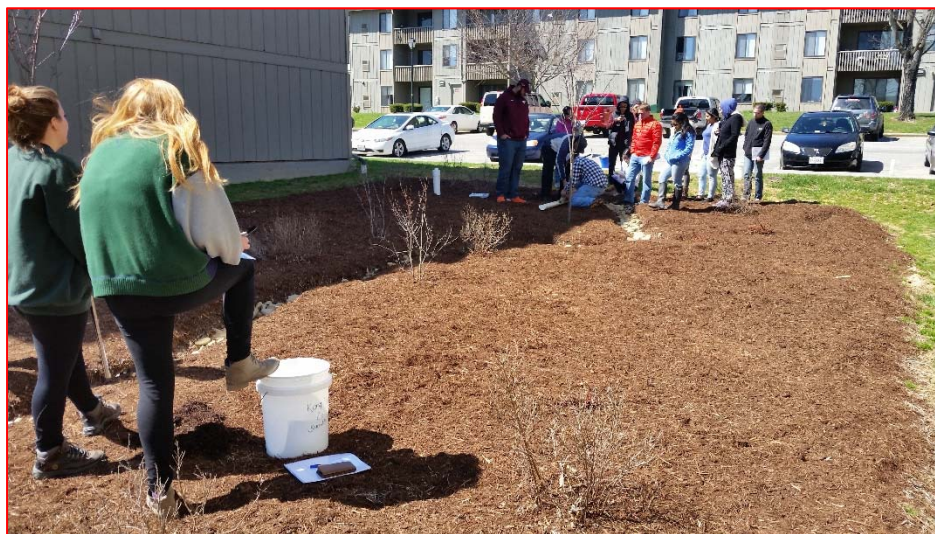
Figure 21. . Classes visiting the large bioretention cell at Foxridge Apartments and taking soil cores for analysis.

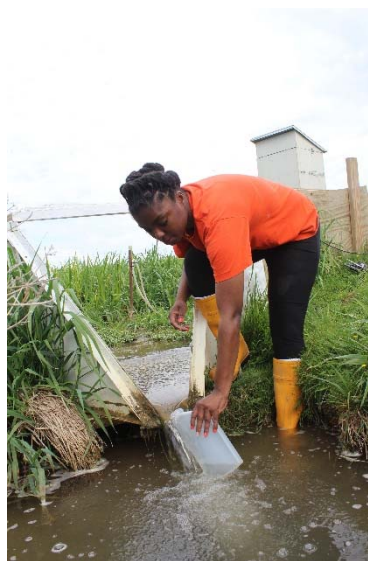
Figure 24. Teneil Sivells taking grab sample at Holtan Branch.

Our monitoring activities focused on assessing the impact of livestock exclusion on flow, sediment, and nutrient loadings. We monitored the small stream (Holtan Branch) targeted for a livestock exclusion BMP, as well as a nearby tributary (Docs Branch) at the StREAM Lab that has not been impacted by cattle since 1995 (Fig. 22). We monitored both tributaries for one year prior to installing fencing at the livestock exclusion site, and one year post-fencing. We installed H-flumes on each tributary at locations with similar contributing watershed areas (Fig. 23). We measured stage continuously in the flumes using pressure transducers. We sampled each tributary monthly using grab samples (Fig. 24), and for nine storm events using our ISCO automatic samplers (Fig. 25).

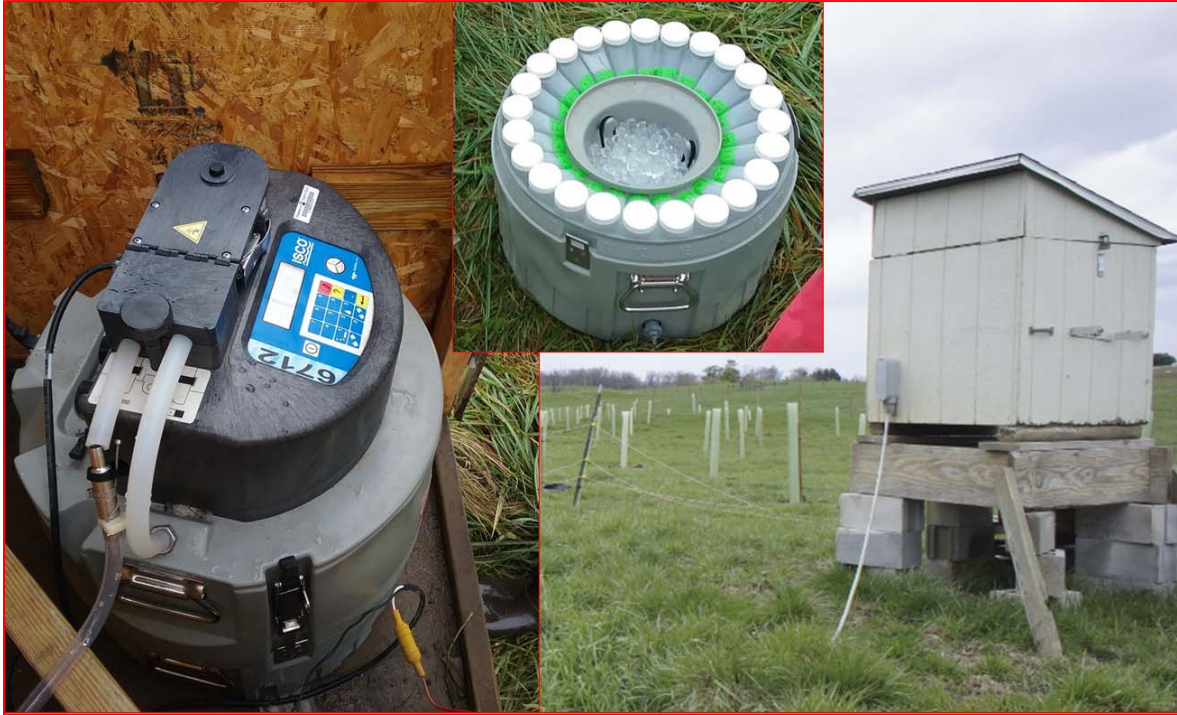
Figure 25. ISCO Automatic Sampler used for sampling storm events. Hut constructed to house the sampler shown on right.

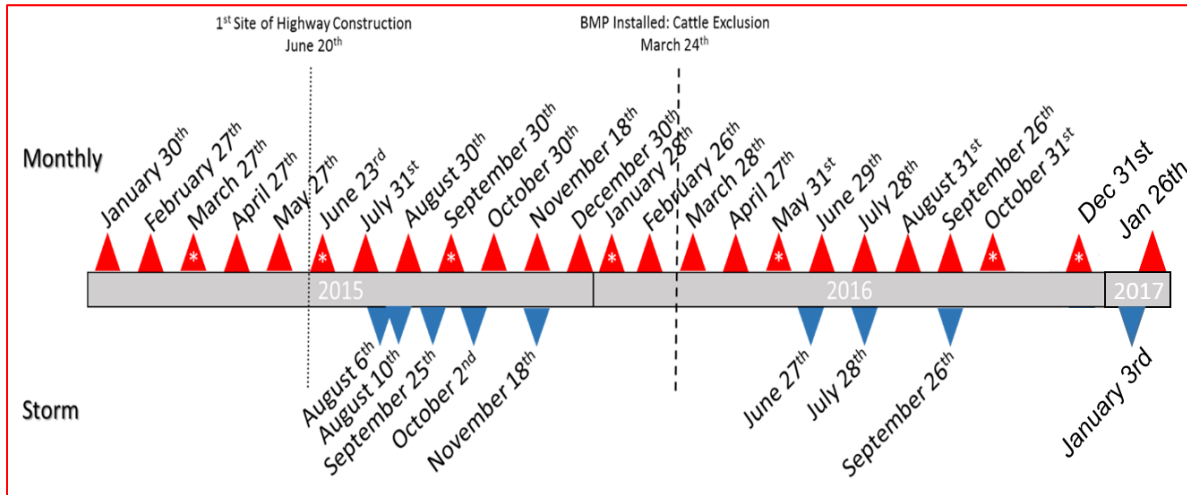
Figure 26. Timeline of sampling events, construction, and BMP installation. Note that we actually capture one more storm event on January 3, 2017 and a final monthly sample at the end of January 2017 (not shown on graphic).

Actual dates of monthly samples and storm samples are shown in Fig. 26. Note that we obtained an additional storm sample and monthly grab sample during January 2017. Unfortunately, in June of 2015, construction began on a new interchange connecting Route 460 to Virginia Tech campus (Fig. 27). This construction is in the headwaters of Docs Branch and required filling in of wetlands. As you can see in Fig. 27, the erosion and sediment control for this construction activity has been abysmal. Therefore, our attempt to use Docs Branch as a control became nearly impossible.

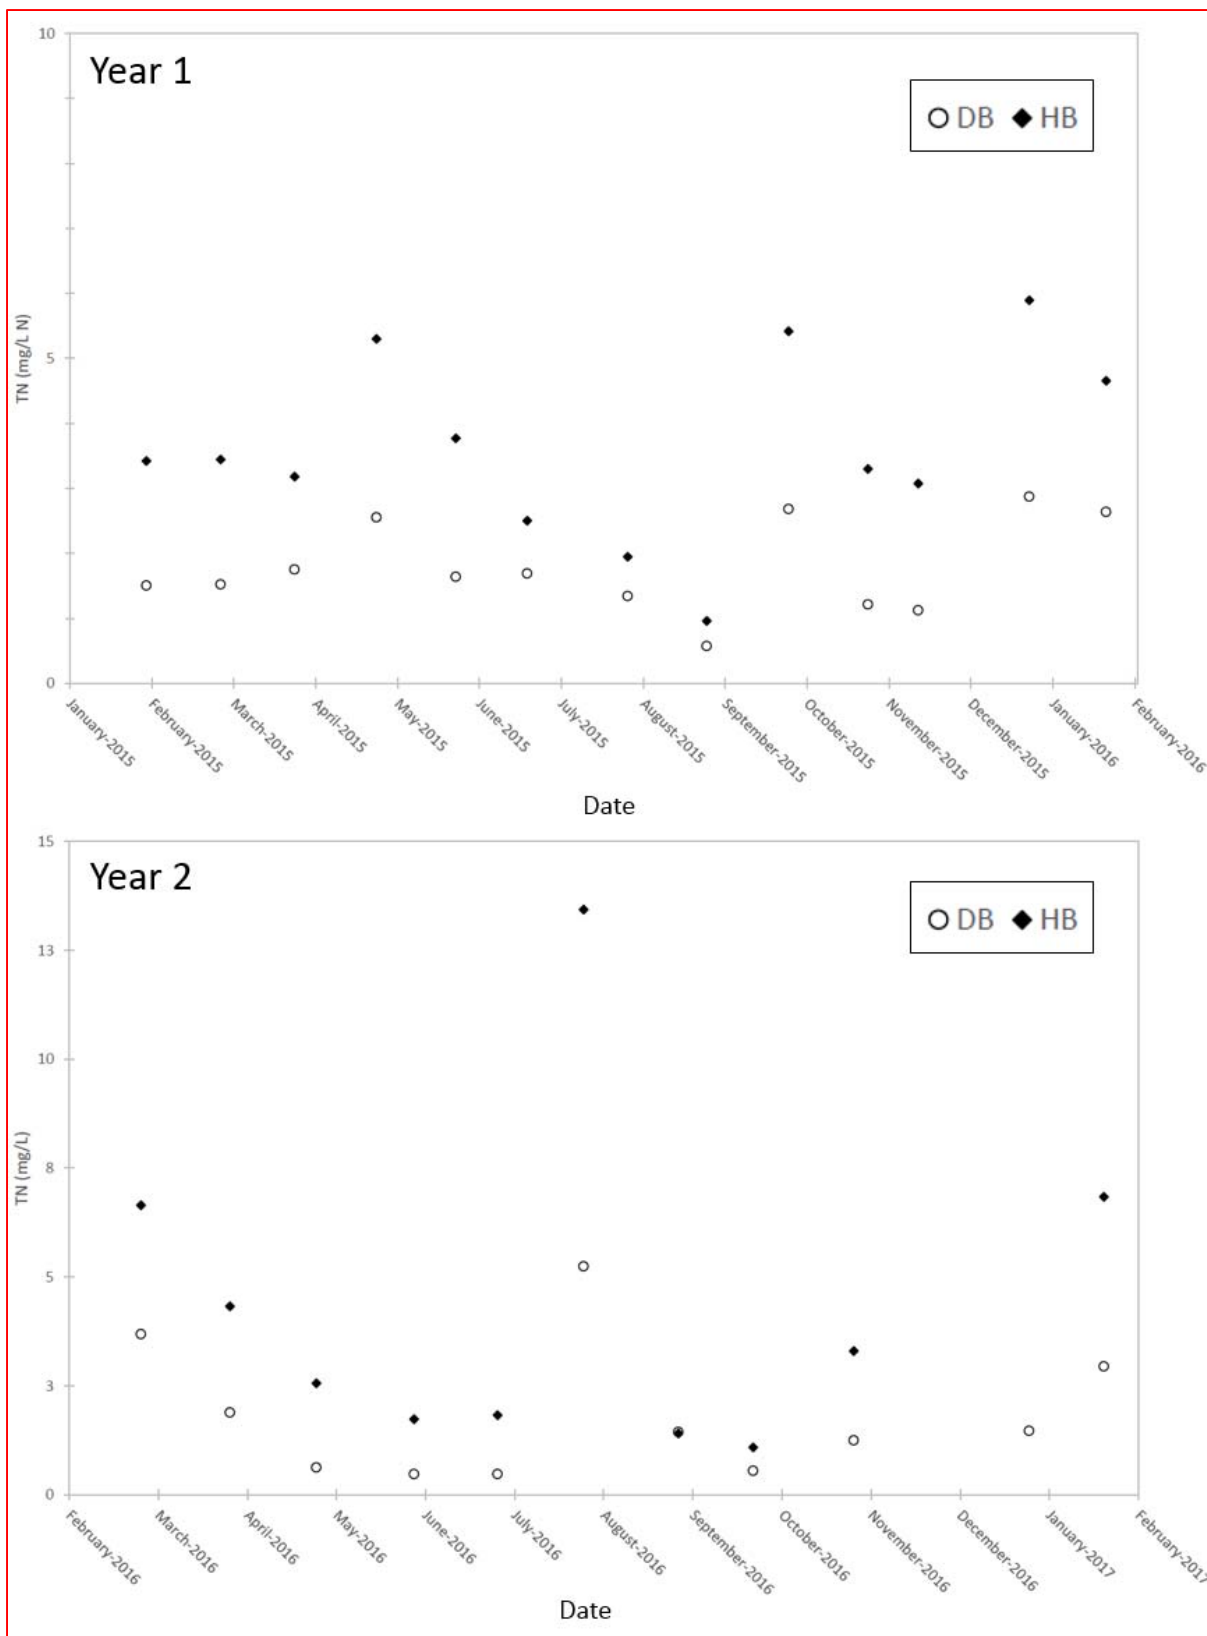
Figure 29. Comparison of Docs and Holtan Branch total nitrogen (TN) concentrations from monthly samples in Year 1 (top) and Year 2 (bottom).

We compare TN concentrations for both years to compare Docs Branch (control) and Holtan Branch (livestock exclusion installed at end of Year 1) in Fig. 29. Based on these monthly grab samples, Holtan Branch always has a higher TN concentration than Docs Branch. There are no obvious changes after we installed livestock fencing, likely because much of the upper reaches of Holtan Branch still have high-density livestock in and around the stream (sheep and horses). Since these concentrations are based on monthly grab samples obtained during near base-flows, TN is really the only parameter we would expect to be different since SSC and TP are mostly influenced by storm flows.
