HYDROGEN INDUCED SURFACE CRACKING  
OF TWO  
ORTHOPEDIC IMPLANT ALLOYS

Thesis submitted to the faculty of Virginia Tech  
in partial fulfillment of the requirements for the degree of

MASTERS OF SCIENCE  
in  
Materials Engineering

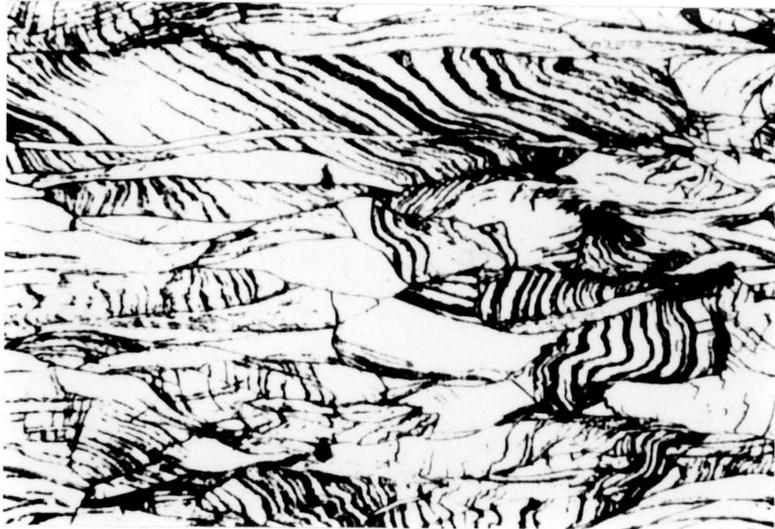
Figure 1. Photomicrograph of HERF  
316 stainless steel (200X)

High dislocation dense slip bands

High dislocation dense boundaries

Deformed twin boundaries

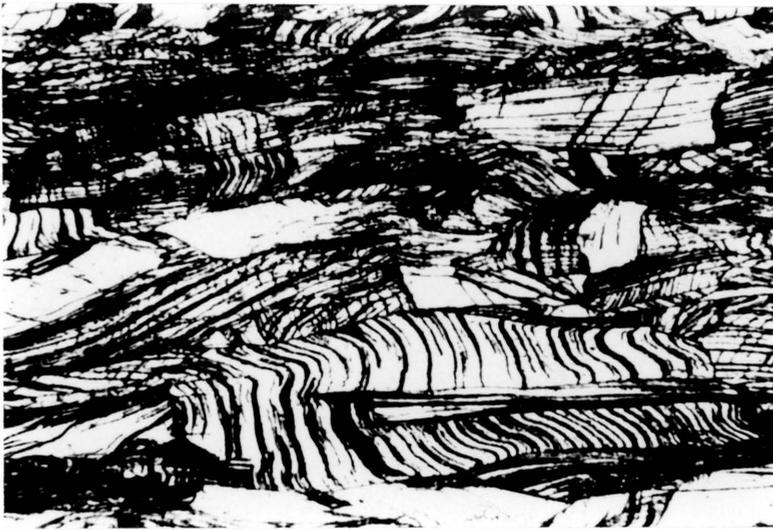
Figure 2. Photomicrograph of S.HERF  
316 stainless steel (200X)

High dislocation dense slip bands

High dislocation dense boundaries

Deformed twin boundaries

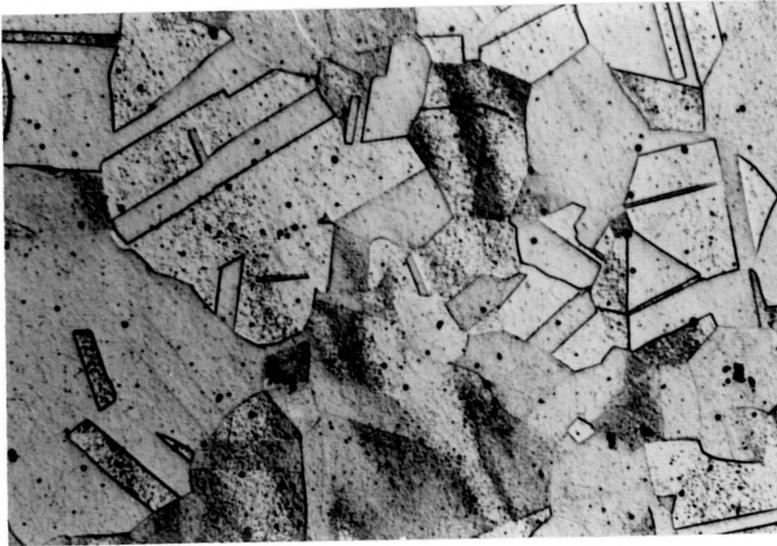
Figure 3. Photomicrograph of A.HERF  
316 stainless steel (200X)

Twin boundaries

Grain boundaries

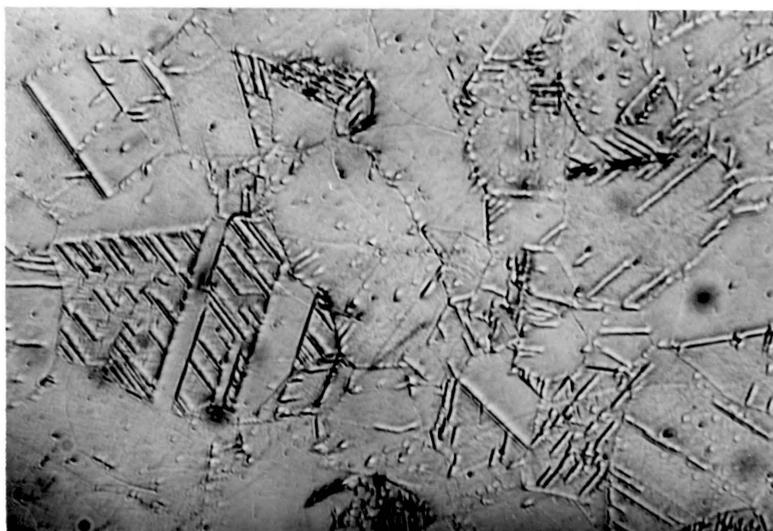
Figure 13      Photomicrograph of A.HERF  
316 stainless steel  
cathodically charged ( $0.05 \text{ amps/cm}^2$ )  
continuously for 2 hours (200X)

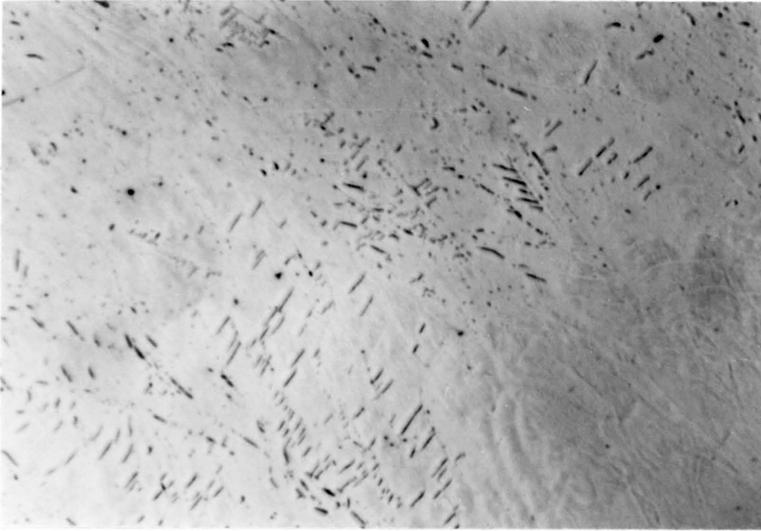
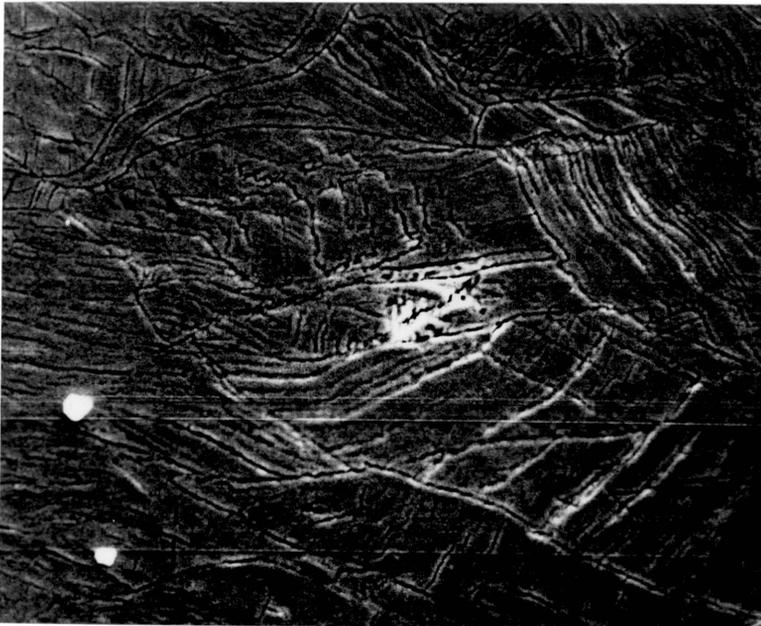
Figure 17

a. Current Density = (0.01 amps/cm<sup>2</sup>) 200X

b. Current Density = (0.50 amps/cm<sup>2</sup>) 2000X  
(S.E.M.)

Photomicrographs showing the effects of current density on S.HERF 316 stainless steel samples which have been cathodically charged for 2 hours at the specified current density

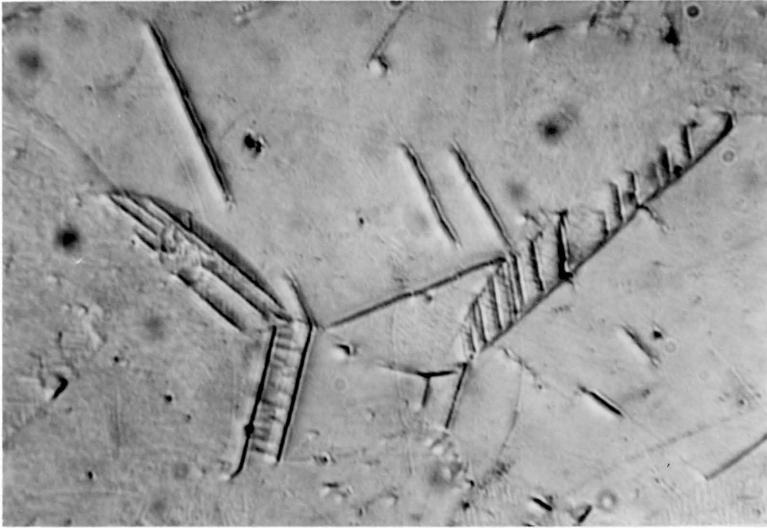
a. Current Density = (0.01 amps/cm<sup>2</sup>) 400X

b. Current Density = (0.50 amps/cm<sup>2</sup>) 800X

Figure 18 Photomicrographs showing the effects of current density on A.HERF 316 stainless steel samples which have been cathodically charged for 2 hours at the specified current density

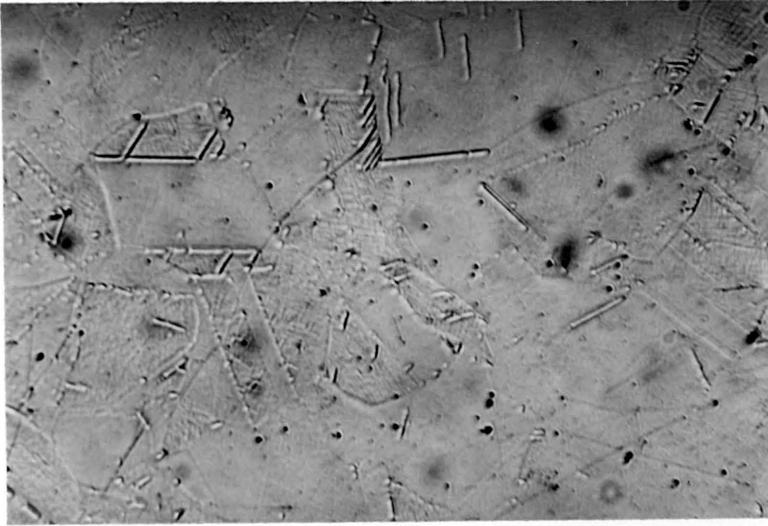
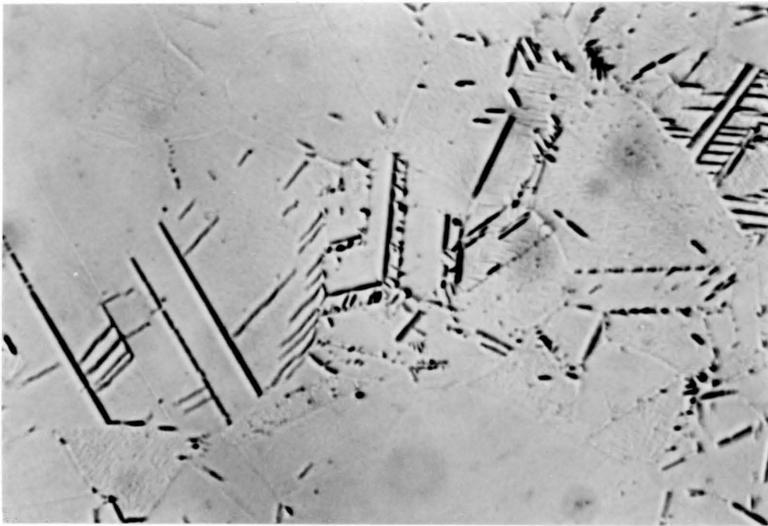
a. Charging Time = 1 Hour (200X)

b. Charging Time = 6 Hours (200X)

Figure 22 Photomicrographs showing the effects of charging time on A.HERF 316 stainless steel samples which have been cathodically charged at a current density of  $(0.01 \text{ amps/cm}^2)$  for the specified time

Holzworth and Louthan established that changes in charging time caused variations in the extent of subsequent surface damage.<sup>44</sup> Photomicrographs in Figures 22 - 26 show the effects of charging time on the various samples tested in this investigation, and illustrate that increases in charging time cause subsequent increases in the amount of surface cracking. But at the low current densities utilized in this study, charging time effects cause only subtle changes in hydrogen absorption, and subsequently only the most susceptible features are cracked. The most susceptible microstructural features crack at the shortest charging
