# *The Virginia Tidal Riverbank Erosion Survey*

**Virginia Agricultural Experiment Station  
Virginia Polytechnic Institute  
Blacksburg, Virginia**

## The Virginia Tidal Riverbank Erosion Survey

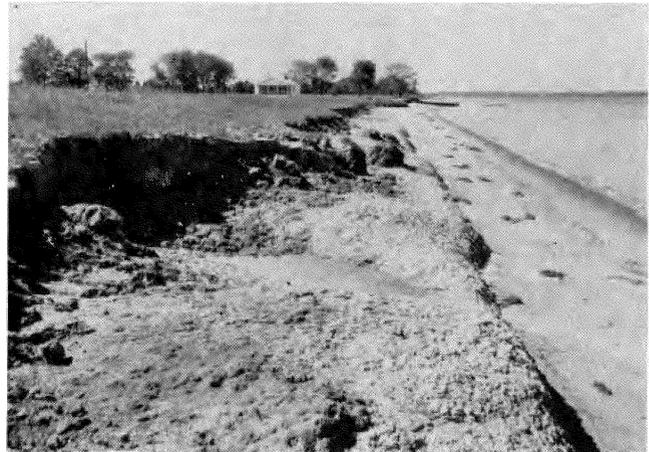
An unsuccessful attempt by the landowner to control bank erosion by sloping and reseeding. Most of this damage was done by a single storm.

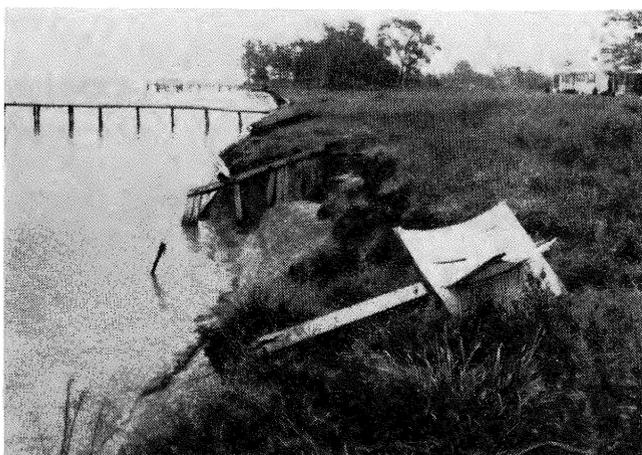
Typical failure of an inadequately designed timber bulkhead. Accelerated bank erosion has commenced.

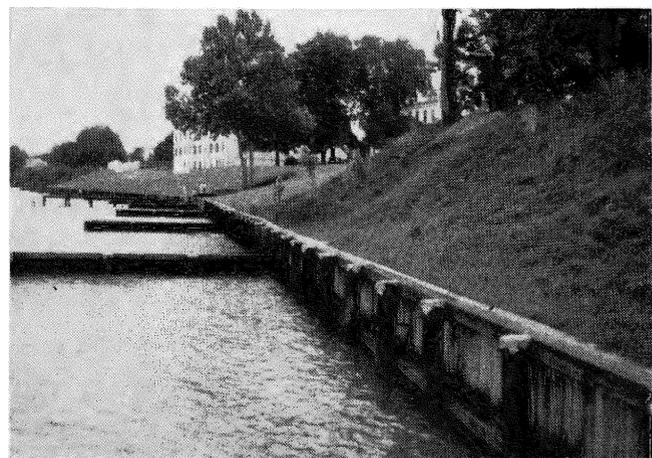
An example of effective erosion control which can be achieved with properly engineered structures, bank sloping, and vegetation.
