Evaluation of a Buried Cable Roadside Animal Detection System

Eco-Transportation and Alternative Technologies Group
Virginia Tech Transportation Institute

Final Report VCTIR 15-R25

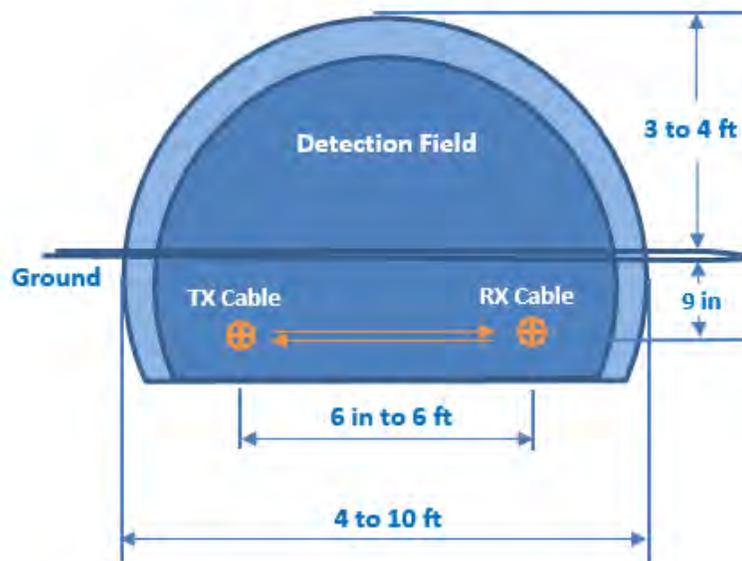
Figure 1. Schematic of Detection System Cable Spacing and Detection Field Characteristics

(TX) cable distributes RF signals along the cable path and the receive (RX) cable picks up the signals and carries them back to the processor as shown in Figure 1. The RF signals form an invisible electromagnetic detection field around the sensor cables that can locate and detect an intruder passing through the field, while the processor triggers an alarm when an intruder disturbs the field. Cable spacing can vary depending on the site conditions and burial depth. The system can detect animals or intruders weighing over 75 lb when installed and calibrated according to the manufacturer’s directions (Senstar, 2013).

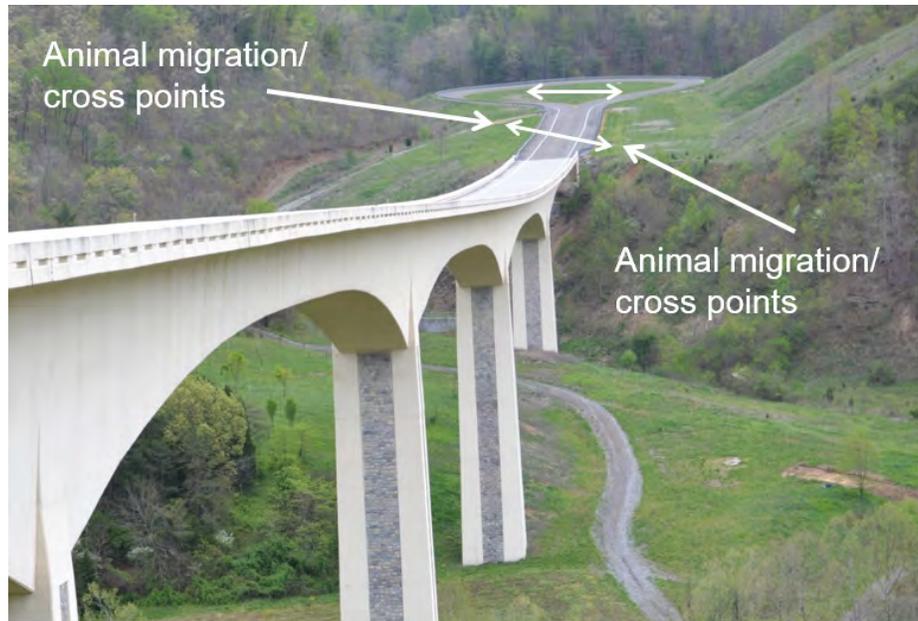
Figure 2. Proposed Test Site at Bottom of Virginia Smart Road Facility

As various cameras were already installed along the Smart Road facility, footage material was collected along the road to identify potential “areas of interest” where animals were migrating and/or crossing frequently. Three months of video surveillance of several locations, covering the fall-winter period, showed that deer, coyotes and bear were observed on multiple occasions crossing and/or stopping to eat or search for food in wooded areas or areas covered by bushes and dense vegetation. Based on the analysis of the acquired video and after further discussions with VCTIR staff, the researchers decided that the best possible location to install the cable sensor would be at the southern end of the Smart Road (Figure 2). This area is located near heavy woods and was the most trafficked by the animals mentioned above.

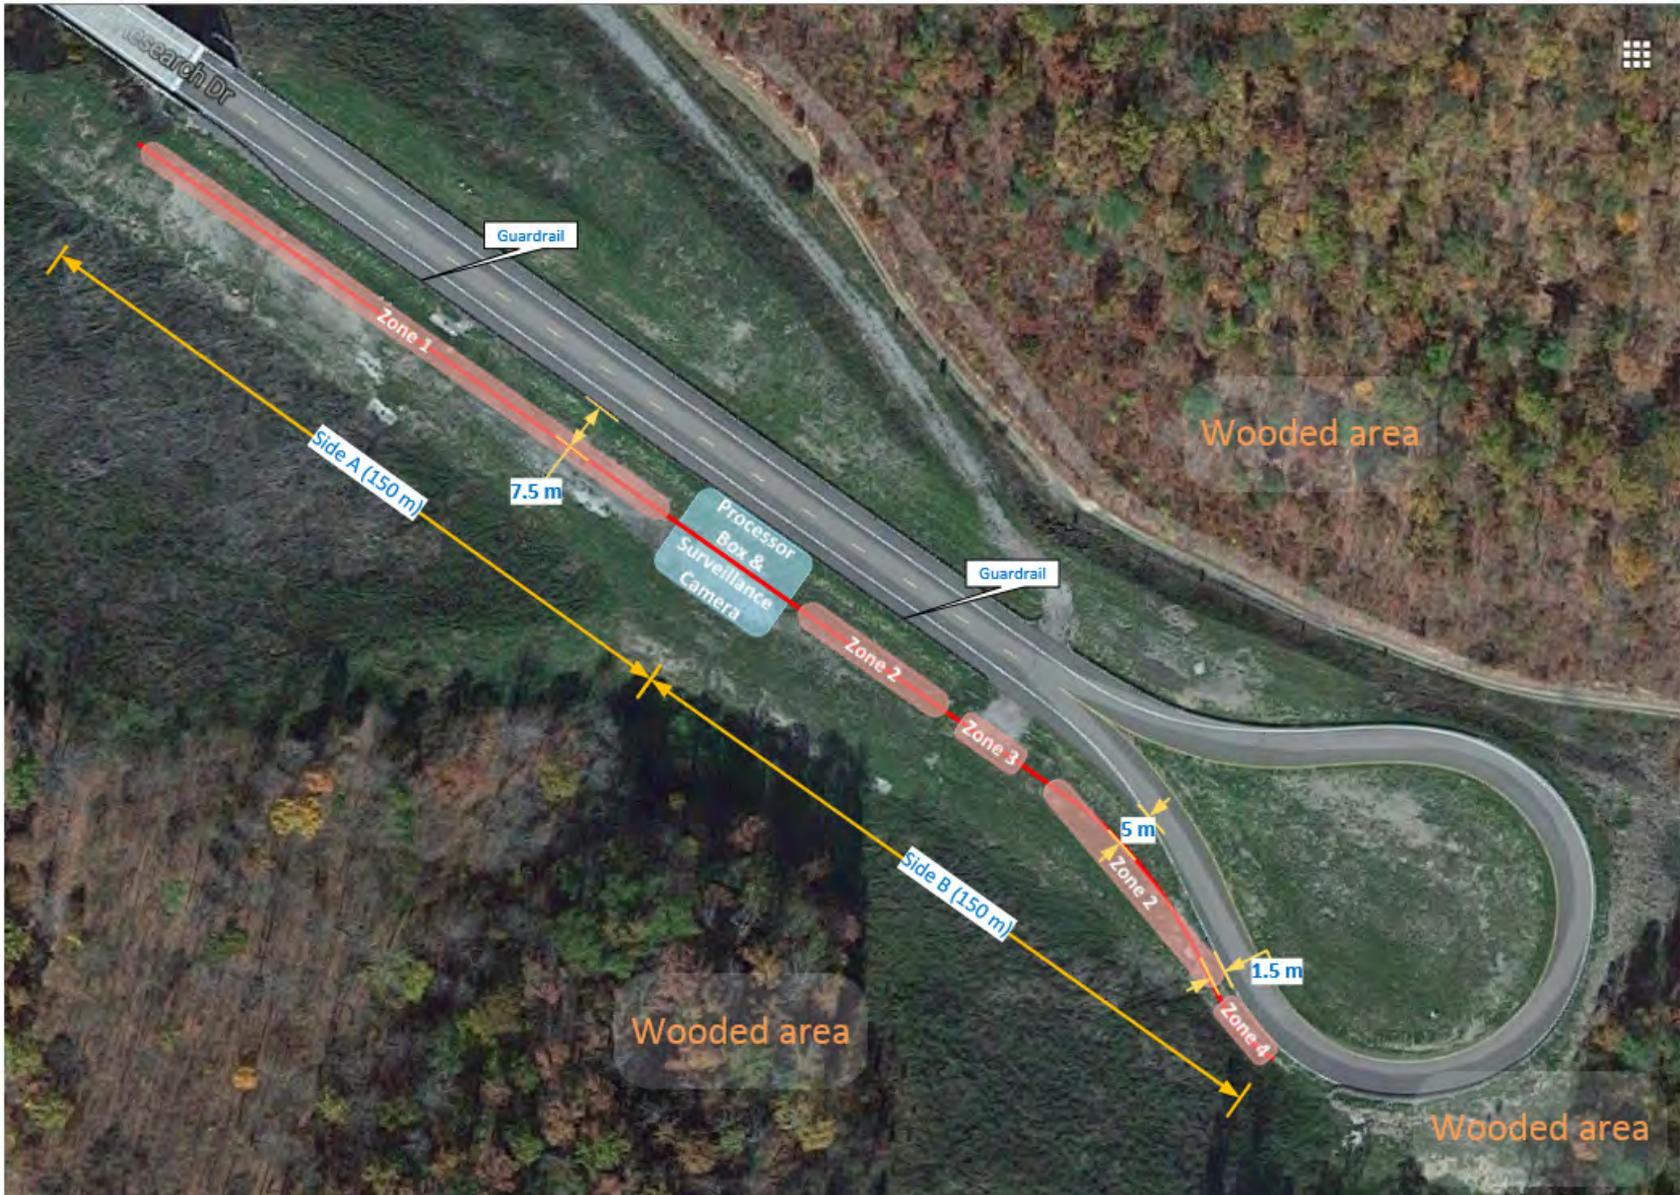
Figure 3. ADS Installation Location and Detection Zones

Additionally, the flat gravelly area extending toward the wooded zone on the left (see Figure 3) allowed for utility vehicles to be driven near the cable for maintenance activities or snow removal. A 12-in wide by 11-in deep trench was dug so that the cables could be installed 6 in apart on the bottom. Before laying the cables in the trench, a 2-in layer of small-sized crushed stone was used as bedding per the manufacturer's recommendation (Figure 4). Cables were then placed on top of the aggregate layer at about 9 in deep with marker tape positioned between them. The tape was buried slightly higher than the sensor cables to prevent cable damage that might result from any excavating activities.

For this OmniTrax[®] sensor system, cables stretch for about 500 ft (150 m) in both directions from the central processor unit (Figure 3). The cable alarm zoning for animal detection was established as follows:

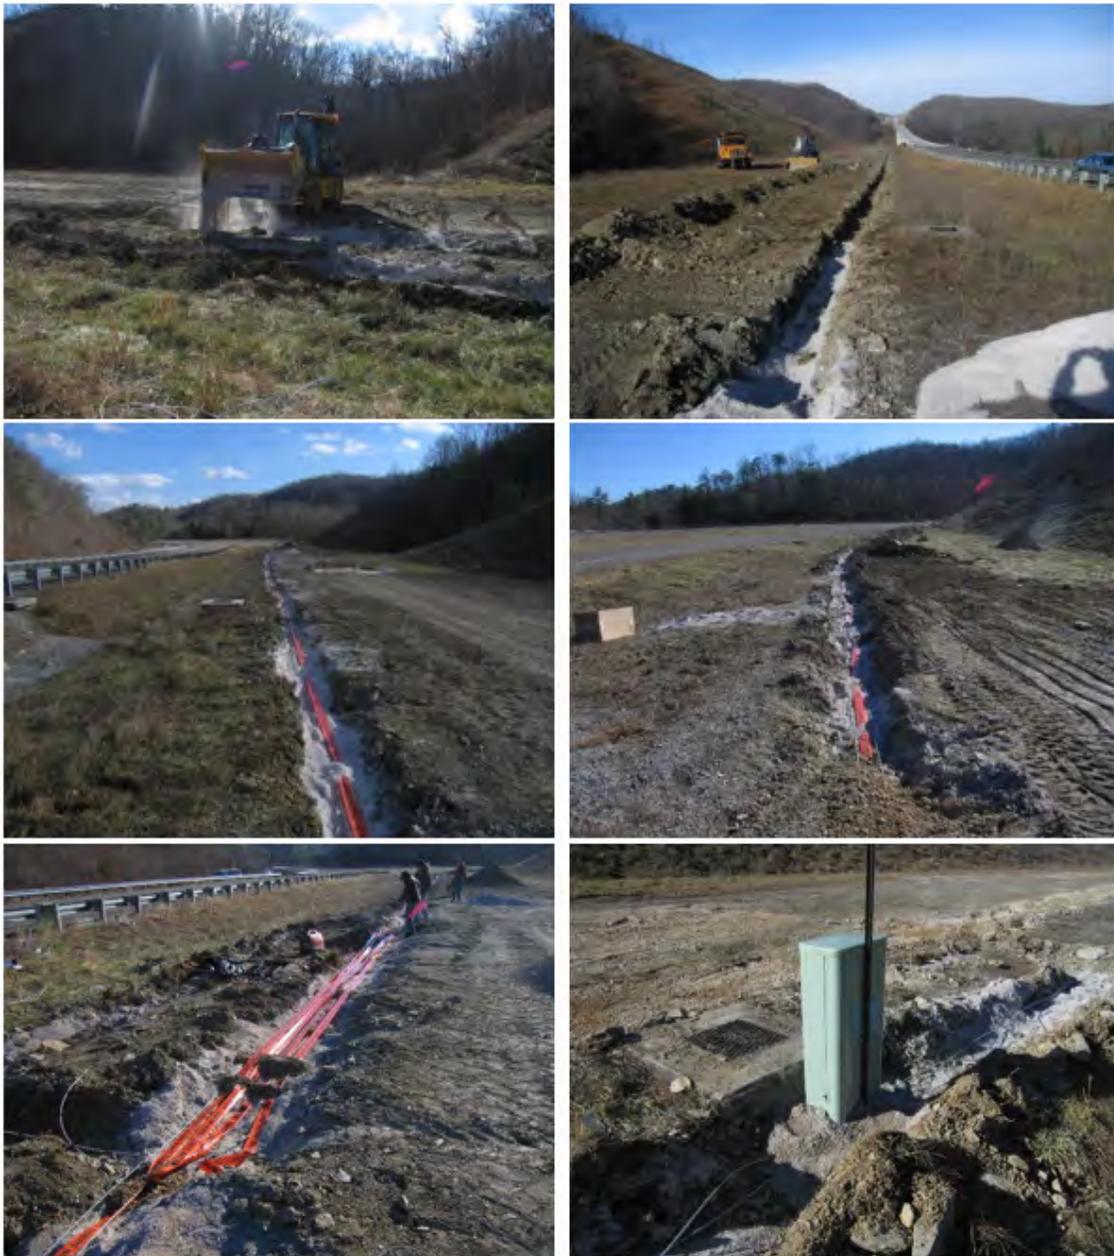
Figure 4. Buried Cable Installation. Trench being filled with fine aggregate (*top left*) and trench bedding after material was leveled (*top right*); cable placement on top of bedding material (*middle left*) and trench backfilling (*middle right*); lead-in cables overlapping along the detection line (*bottom left*) and processor enclosure location (*bottom right*).

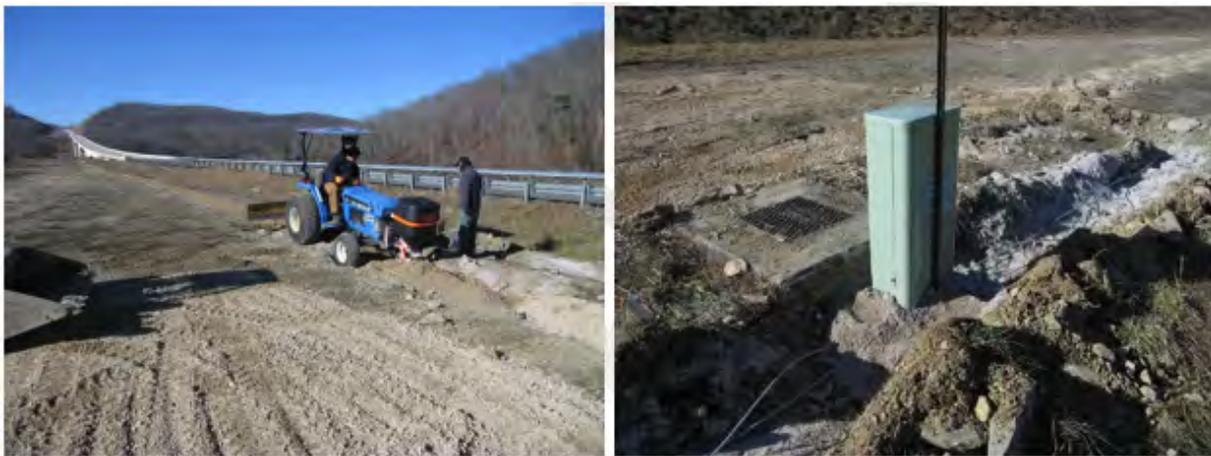
Figure 5. Backfill Material Leveling (left) and Lead-in Cables Connected to the Processor Telecom Enclosure (right). The concrete utility vault can be seen in front of the enclosure.

Before backfilling with coarser material—a half-inch aggregate mixed with sand—the bottom of the trench was leveled and cables were laid straight. A visual inspection along the cables also made certain that spacing was kept at 6 in for the whole length. Concurrently, a separate wider trench was dug for the lead-in cables at the processor location. A location closer to a utility vault where power and fiber optic connections for video surveillance could be installed conveniently was selected for the processor. To ensure full continuous detection at a processor location, the sensor cables were overlapped by 26 ft where the active cables begin. The overlapping occurs at the point where the two detection fields (i.e., sides A and B of the cables) reach full strength (Senstar, 2013). Additional information on cable installation is provided in the Appendix. The bottom left of Figure 4 shows the crossover zone near the wider zone where multiple marker tapes can be seen next to each other. Once the cables were carefully aligned and spaced, they were covered by the aggregate material, which was then leveled and compacted according to the manufacturer’s requirements (Figure 5).

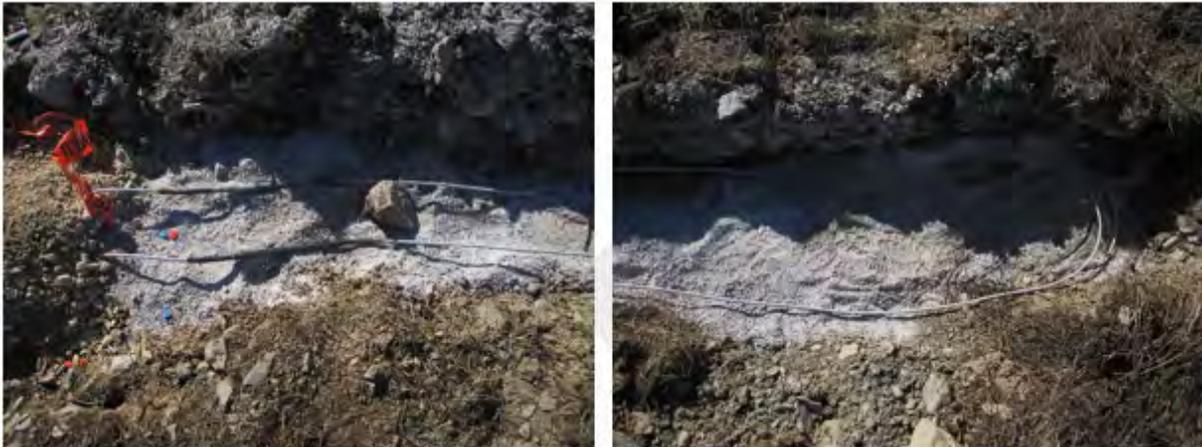
Figure 6. Cable Ends Showing Decouplers (*left*) and Long Terminators (*right*) for Data Flow Termination

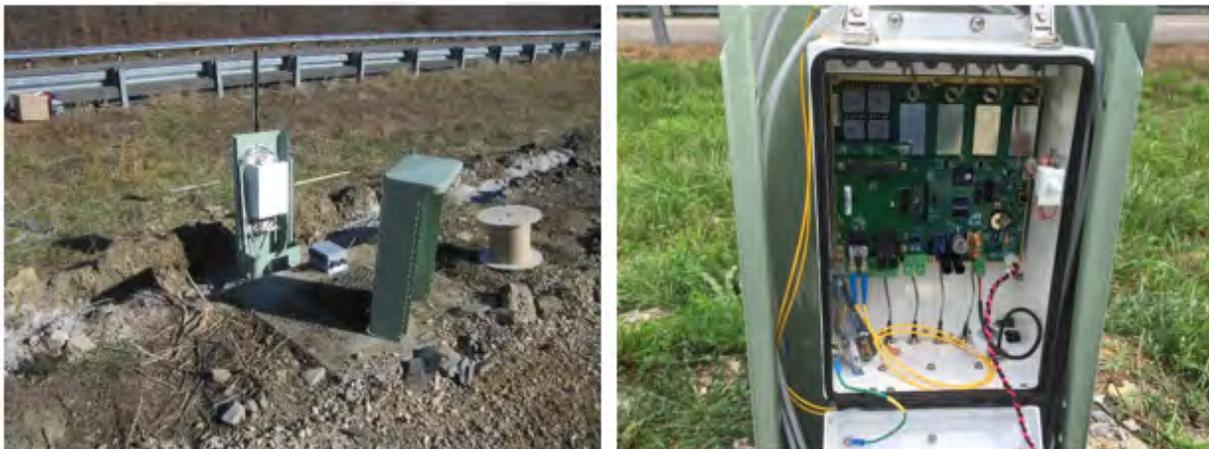
Figure 7. Weatherproof Processor Enclosure Mounted Inside Telecom Enclosure (*left*) and Processor Board Installed Inside Weatherproof Enclosure (*right*). White tamper switch pictured to the right.

The light green telecom enclosure housing the processor box was ground mounted in a concrete base adjacent to the utility vault. This enclosure is typically used for outdoor installations in order to provide additional security and protection from the elements. A custom bracket was installed inside and an OmniTrax[®] weatherproof enclosure to support the processor circuit board was mounted on the bracket (Figure 7).

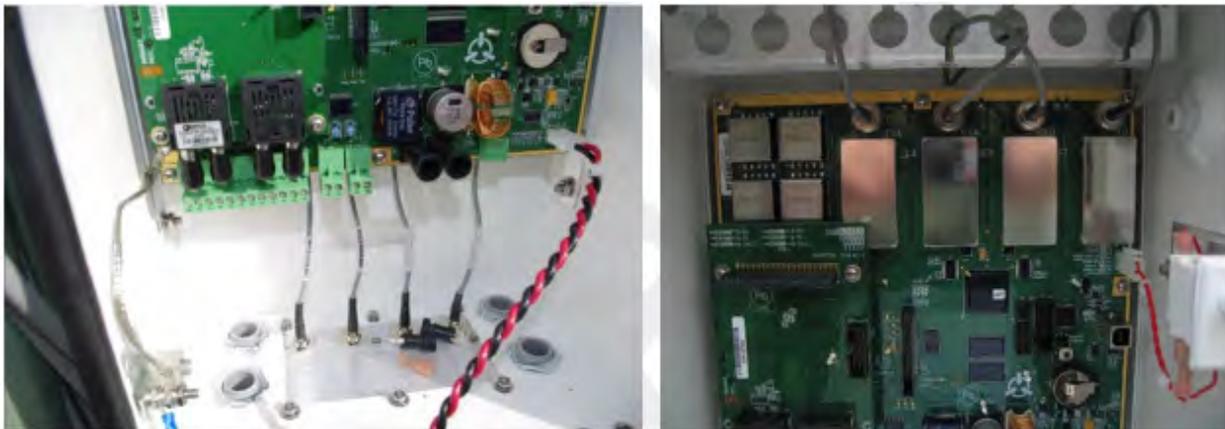
Figure 8. Mini-coax Cable Connections at Bottom of Processor (*left*) and Transmission-Receiving Connections for Sides A and B of Cable Sensors at Top of Processor (*right*).

Moreover, all power and data circuits on the OmniTrax[®] processor and the network interface units include gas capsule lightning and transient protection. A connection to a low resistance earth ground was established to ensure the system's grounding.

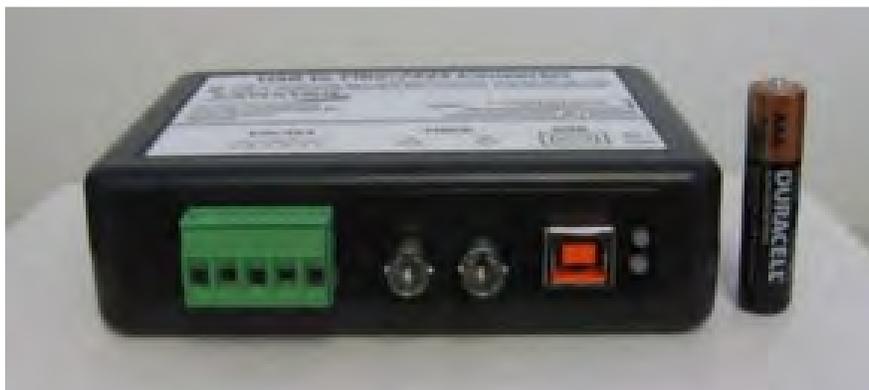
Figure 9. Network Interface Unit (NIU) Used for Establishing Network Communication

In addition to the NIC, a network interface unit (NIU) was provided to establish communication with a computer running UCM and Silver Network Manager (SNM) software. The NIU (Figure 9), which operates on a 12 VDC/USB connection, translates the alarm data and passes it on to the Windows-based SNM, which then interprets the alarm data and passes it on to a PC-based security management system (i.e., Senstar's Alarm Integration Module or StarNeT network).

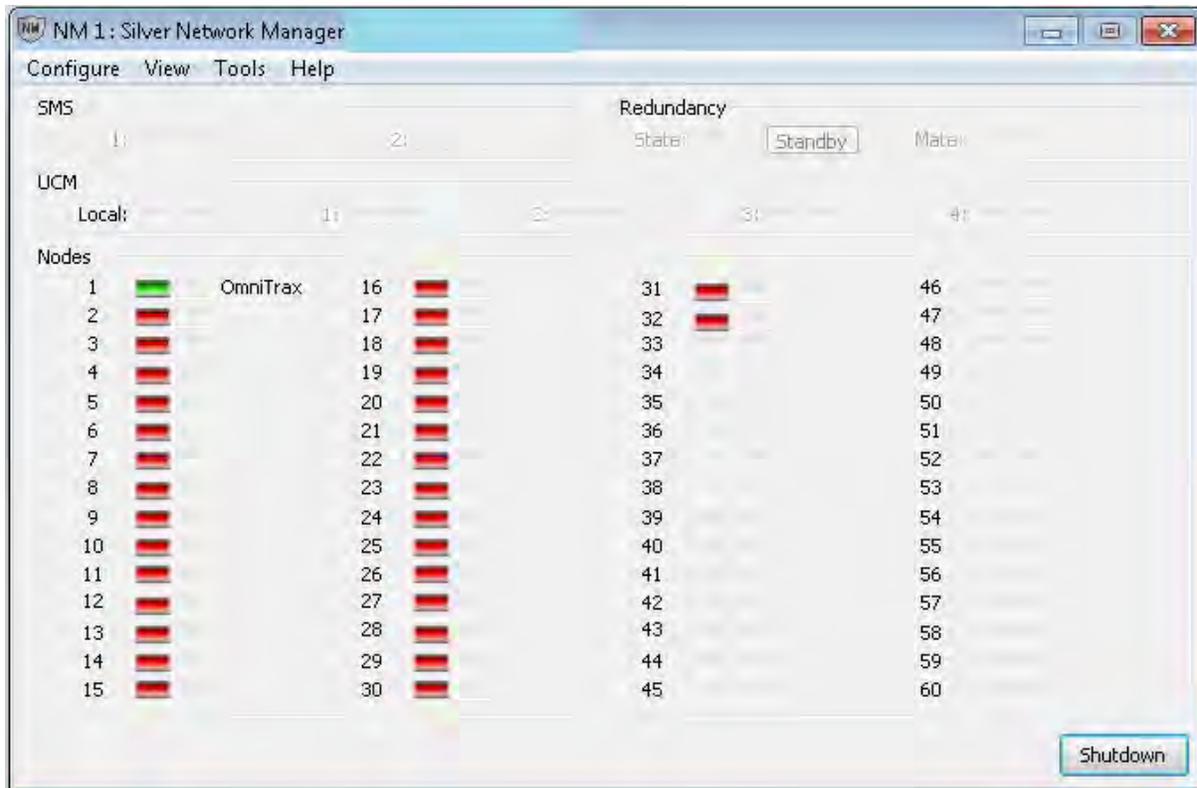
Figure 10. Network Manager Program That Ensures Communication Between Processor and Data Storage Computer. Communication was established through a single-mode fiber optic cable available on the Smart Road.

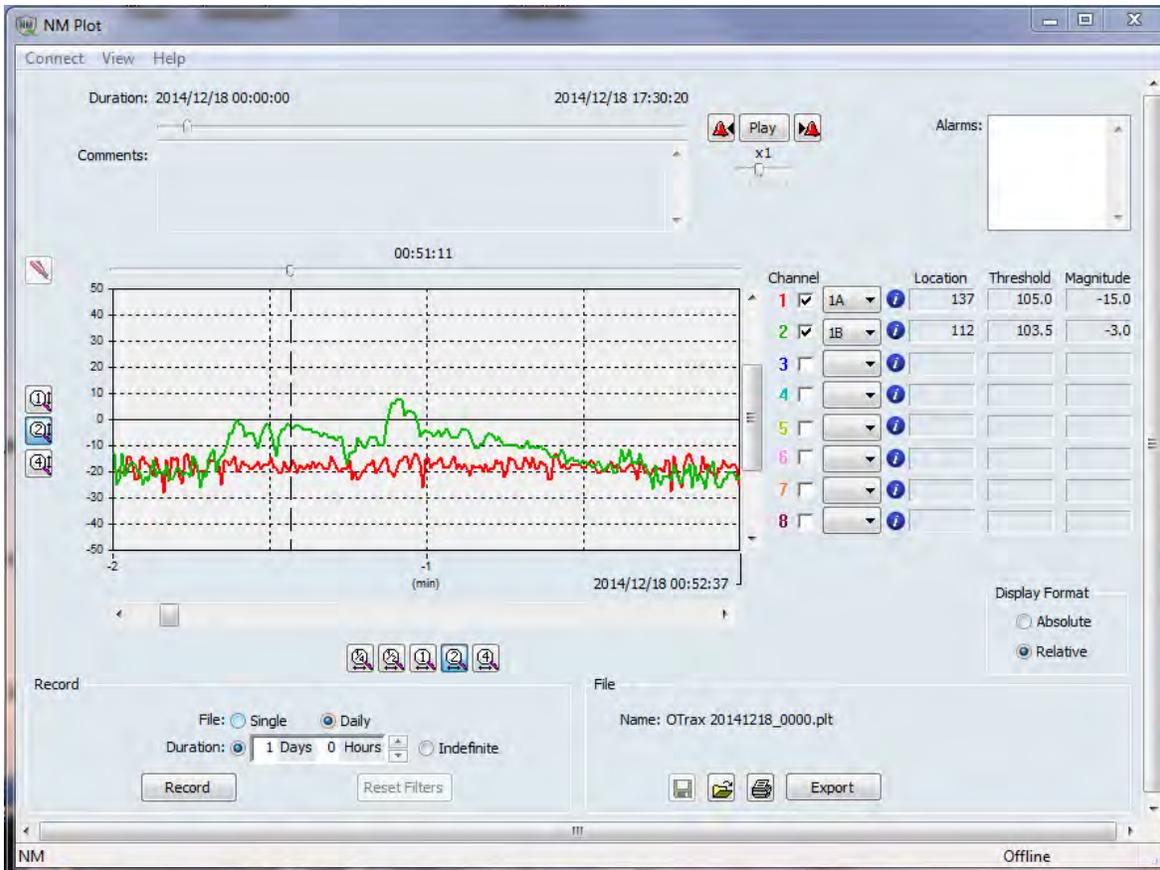
Figure 11. Example of NM Plot Tool Used for Identifying Real-Time Cable Crossing Events. The signal response from both sides of the cable is displayed.

This communication is useful when event history files have to be saved for future reference. Separate NM Plot (Figure 11) and Event Log (Figure 12) windows can be opened to monitor animal activity in real-time. The NM plot process can be programmed so that continuous data can be collected and files generated on a daily basis for both sides of the cable. Relevant information from NM files and Event Logs aids in the development of data reduction methods. The plots offer details on the time and date of the cable monitoring, as well as on the crossing location, threshold at that specific location, and magnitude of the signal.

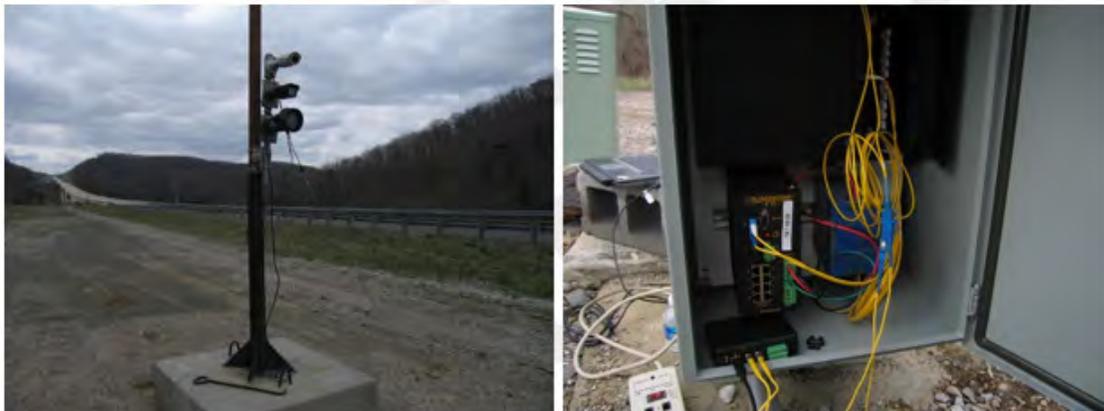
Figure 13. Surveillance Camera (top) and Illuminators Used for Cable Monitoring (left) and Fiber Optic Connection to Smart Road Network (right). The NIU at the bottom was being tested to verify the connectivity and cable response to crossings.

the processor and at the mid-section of side B of the cable to improve nighttime visibility at the middle and far end of the cable. Prior to their on-site installation for continuous data acquisition (video and animal crossing detection) the camera and illuminators were tested to assess their capabilities in different weather and natural light conditions, including nighttime monitoring (Figure 13).

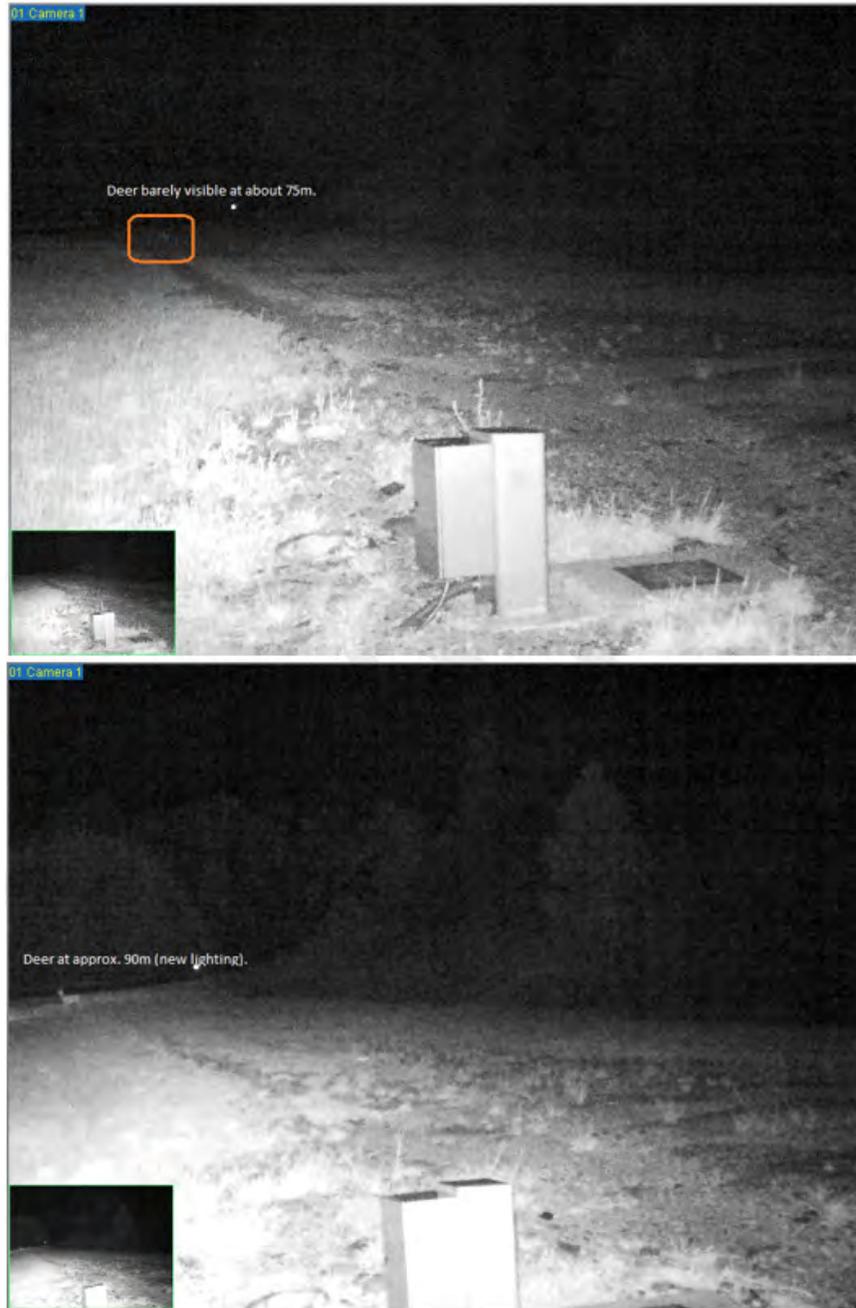
Figure 14. Improved Site Illumination After Installing Additional NIR Illuminators (bottom)

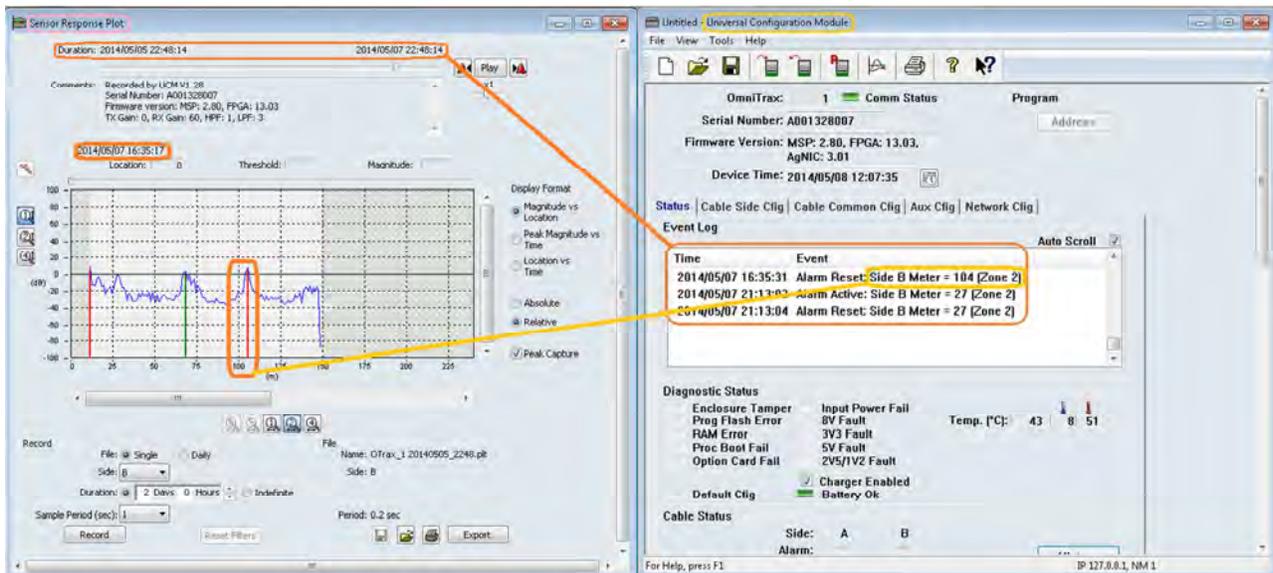
Figure 15. Example of Cable Response Signal Verification Using Event Log

Declared alarms data collected using the cable's proprietary software and recorded videos were analyzed to ensure that the system was detecting valid animal crossings and not providing "false negatives" and/or "false positives." As a first step in evaluating the acquired data, the Event Log box of declared alarms and the NM plots (Figures 10 and 11) for the respective day or time range were reviewed to ensure that a correspondence between the two existed (Figure 15).

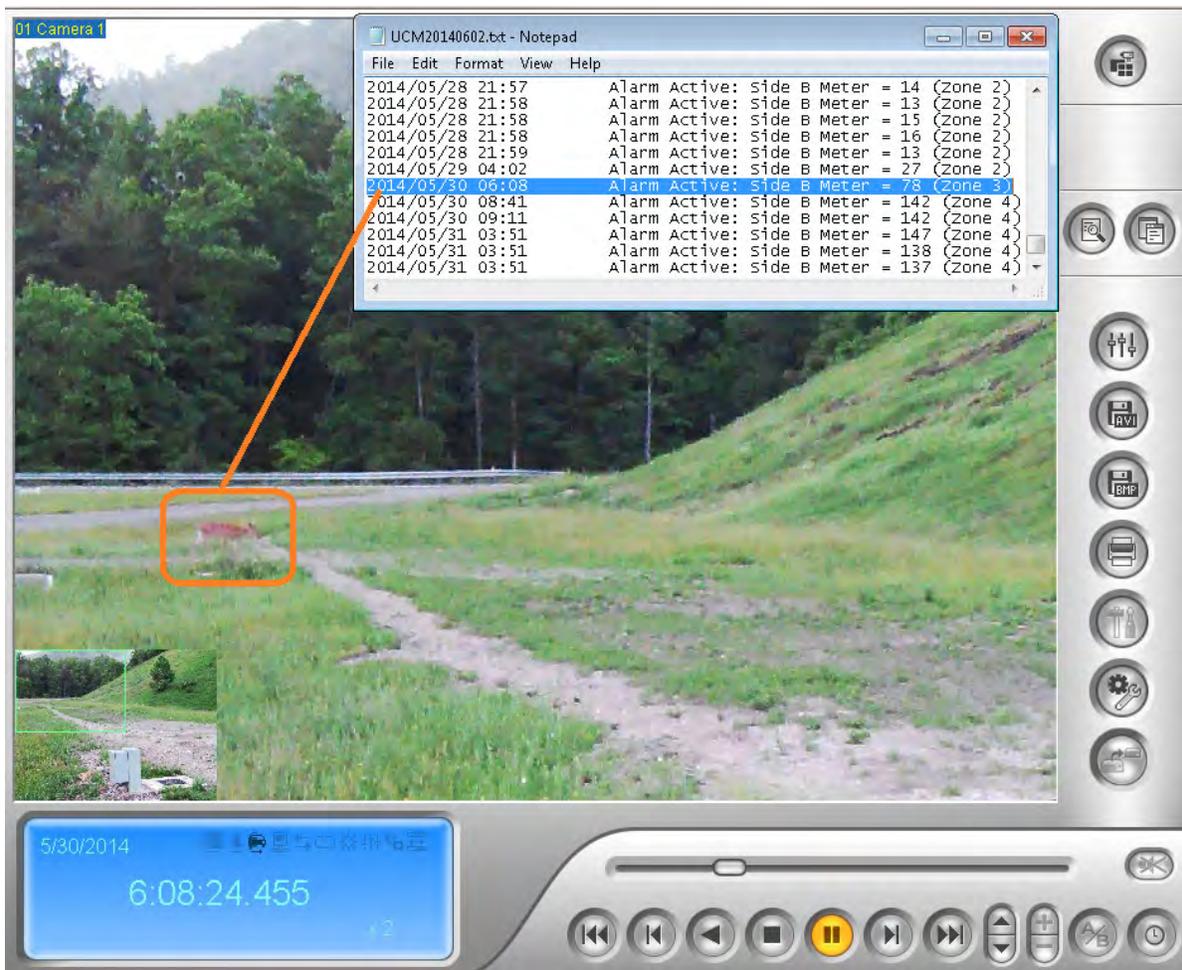
Figure 16. Example of Valid Animal Detection Event

A valid “non-detection” was considered when an intruder/animal was spotted in the recorded video file within a certain range of the cable but neither subsequently crossed nor entered the detection field. As the detection field is about 5 ft wide, any intruder within 2 ft of its centerline will trigger an alarm if the cable is properly calibrated. Targets are detected based on their electrical conductivity, size, and movement (i.e., speed) with the detection probability generally increasing with size. Any target weighing less than 25 lb will not trigger an alarm, although it may disturb the electromagnetic field of the cable and create a small peak in the magnitude of the signal (Figure 11, near the centerline). For situations where various zones of the detection cables pose different threat levels, separate sensitivity thresholds can be set on a per meter basis. An example of valid detection identification is presented in Figure 16. This figure shows that the time when the animal (in this case a white-tailed deer) entered the detection zone (video file review) matches the declared alarm listed in the Event Log box.

A false negative event occurred when an intruder (animal) crossed over the cable or was inside the detection zone (see Figure 16) and an alarm was not declared. This scenario can take place under two conditions: (1) the detection threshold is set too low or (2) the target speed setting is not tuned for very slow or very fast moving intruders. Figure 18 illustrates this situation occurring when a deer did not trigger an alarm while crossing the cable near the processor at 05:31. In this case, the false negative occurred due to a low detection threshold and power factor. For a false negative to occur, an animal must cross the cable or walk within a 2-ft distance of its centerline as shown in the recorded video file (in Figure 16, the deer was captured just over the cable centerline).

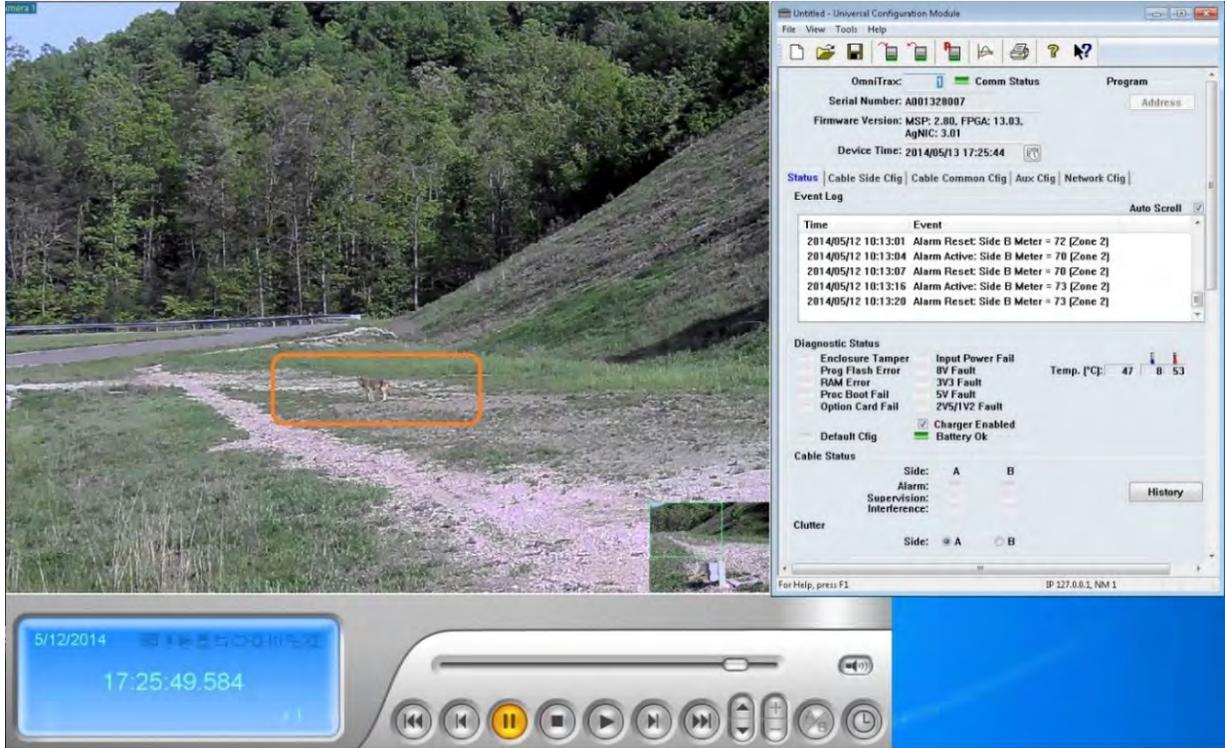
Figure 17. Example of Valid Non-Detection. Coyote stands outside the detection zone.

Figure 17 illustrates a valid non-detection case where a coyote was present near the cable but never entered the detection field or crossed the cable, and thus an alarm was never declared. Also, the alarms Event Log shows that the last declared alarm was at 10:13, while the coyote was spotted at 17:25.

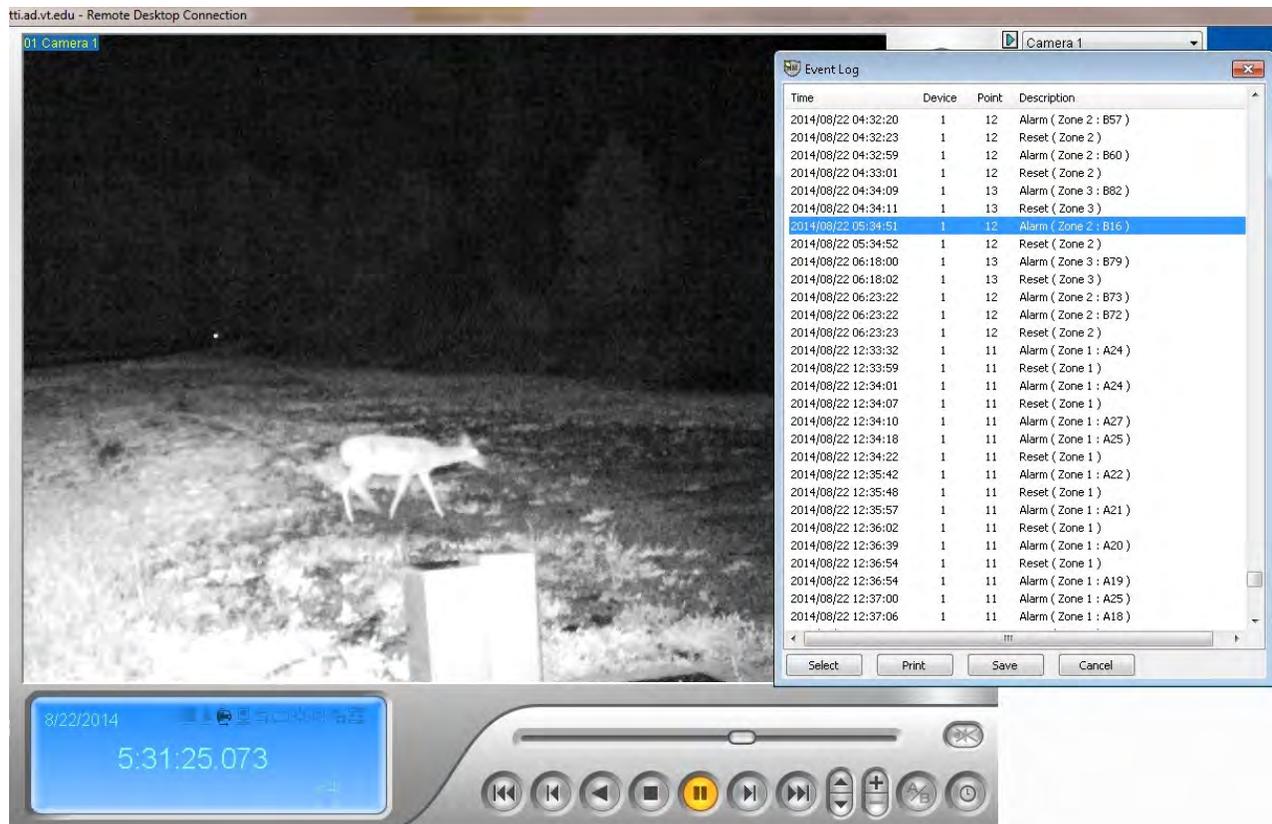
Figure 18. Example of False Negative Event. Deer crossing over the cable did not declare an alarm.

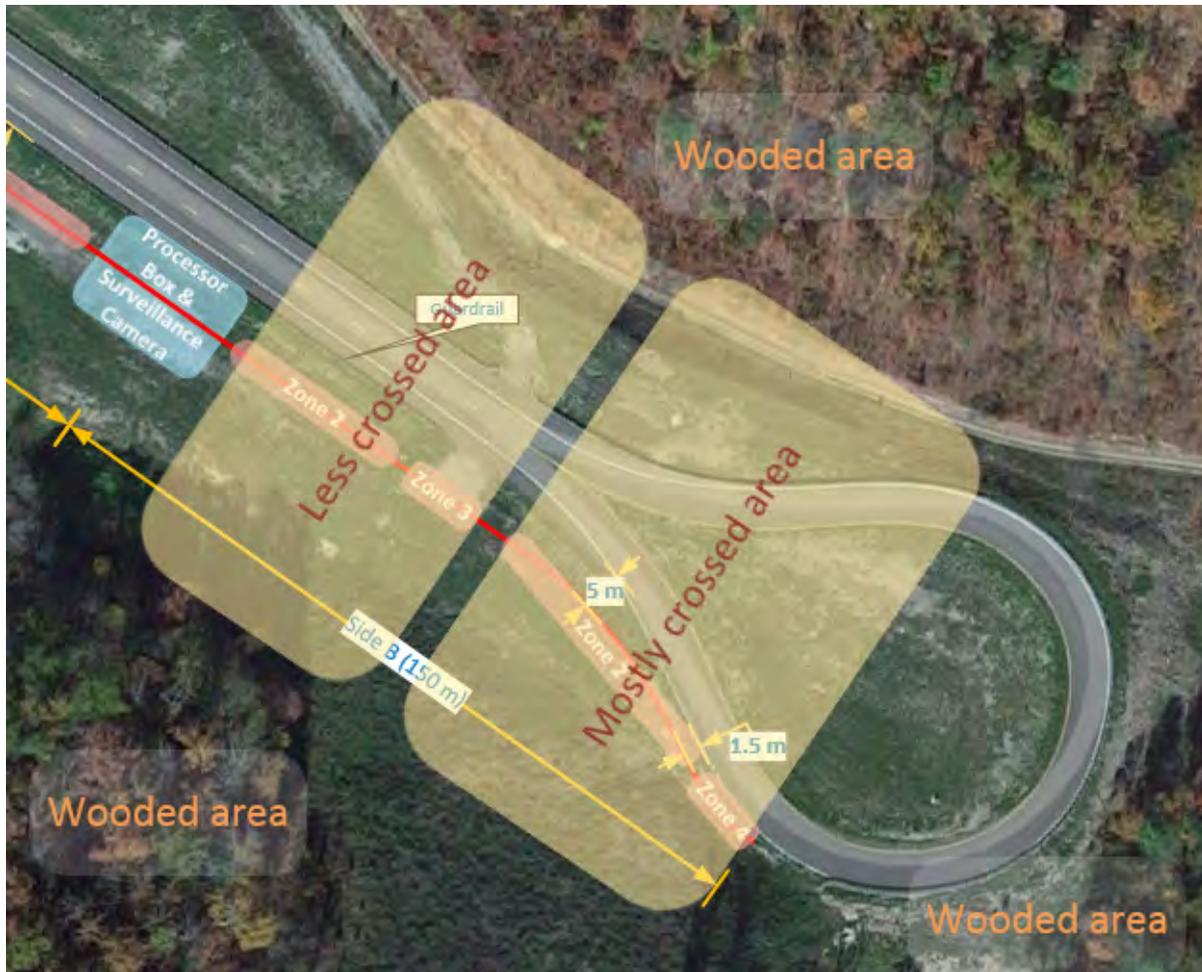
Figure 19. Animal Crossing Areas at Zones 2, 3 and 4 of Cable

Zone 3, which is the gravel-covered access road to the cable area, was crossed by only 68 (6% of the total animal crosses for all zones) animals (mostly deer). This could again indicate that the deer were not willing to walk near the guardrails shielding both sides of the road, or that they simply avoided the grassless access area.

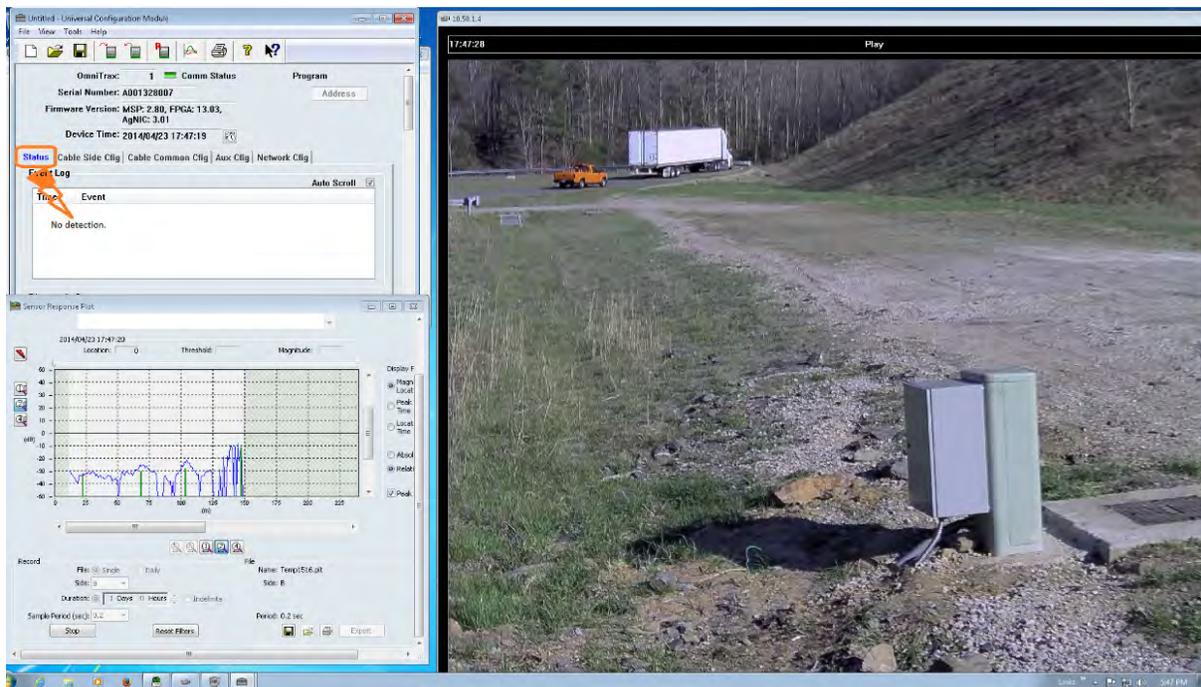
Figure 20. Vehicle Interference Evaluation of Buried Cable

Zones 3 and 4 were defined such that vehicle interference could be monitored differently from Zone 2, as one zone is the access road to the cable area, and the other is close to the road edge line (i.e., the centerline of the cable is 4 ft away from the road edge line). As shown in Figure 20, there was no interference during driving sessions using semi-trailers and pickup trucks. Vehicles were driven at different speeds and with normal wander as on any state highway or primary road. Upon review, the UCM Event Log box and plot response program did not record any alarms during most of the sessions (i.e., there is no crossing of the 0 dB reference line in the plot window, as shown in Figure 15, left pane). However, in cases when a vehicle crossed the edge line and was entering the detection field, an alarm was declared as a regular intruder detection. In these cases, the signal response magnitude depends on the vehicle's distance from the detection field.

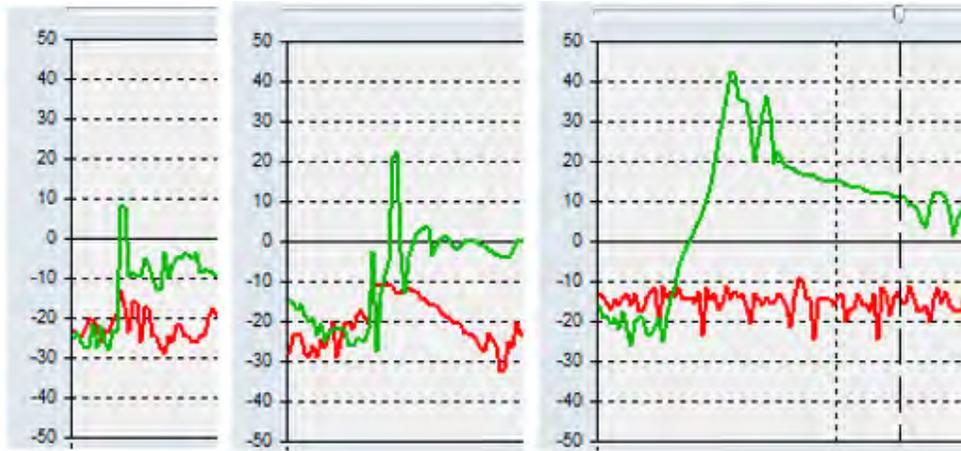
Figure 21. Typical Signal Magnitudes (in dB) of Animal Crossing (left), Human Crossing (middle), and Vehicle Crossing (right).

Typically, the signal magnitude is around 40 dB when a vehicle is driven over the cable, whereas values between 5 dB and 10 dB are observed for animals, and 10 to 20 dB are observed for humans, respectively (Figure 21).

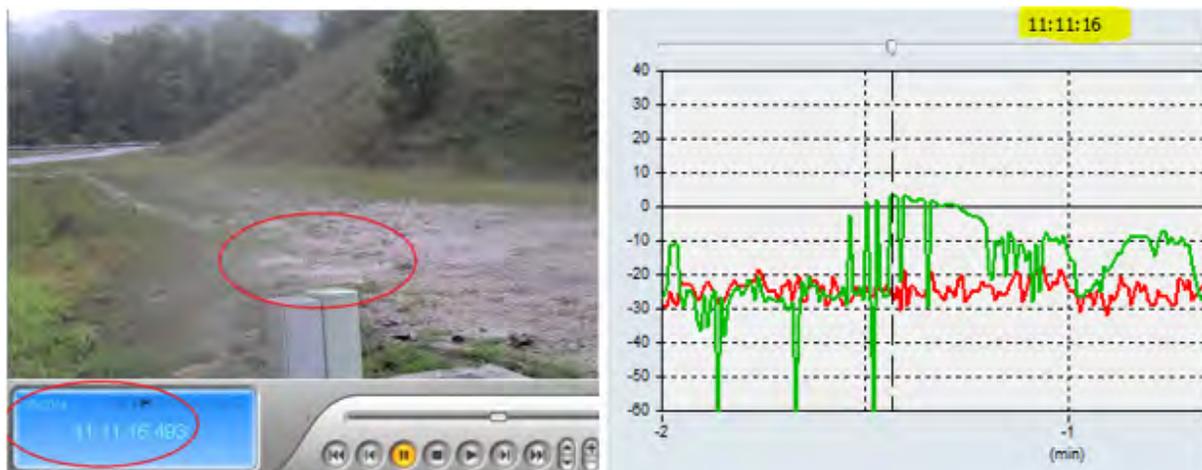
Figure 22. Water Accumulation on Cable Path (left) and Cable Response Plot in NM Software (right)

On several occasions, water accumulating in the depressions created by maintenance vehicles on the cable path caused nuisance alarms (Figure 22). The small areas on the cable path where the depressions formed were leveled and then compacted to prevent such accumulations in the future. Consequently, vehicles were no longer permitted to drive or park near the cable in order to avert similar incidents.

No nuisance alarms have occurred since the ground surface of the detection area above the cable was restored to its previous leveled state. Typically, high magnitude upward/downward spikes with a negative magnitude form in the NM plots when nuisance alarms are triggered by water movement in the field. In Figure 22, signal magnitude on side B of the cable (in green) is pictured in the offline accessed NM plot.

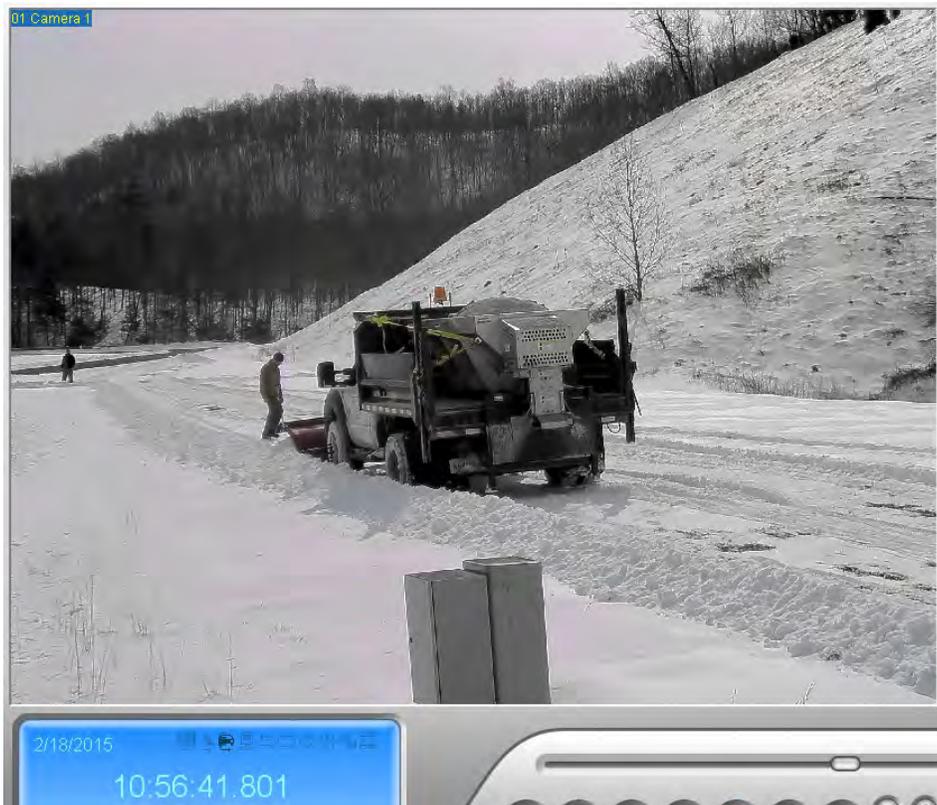
Figure 23. Maintenance Truck Plowing Snow Over Cable

The threshold was not adjusted to compensate for any adverse snow effects, and system performance indicated that snow coverage of the cable as deep as 3 ft did not affect its detection field. In Figure 23, a VDOT maintenance truck is plowing an additional 2-ft layer of snow on top of an already existing 1-ft thick blanket of snow. Snow coverage as a result of plowing occurred twice subsequent to snow events during the period between February 18 and February 26. In addition, no false positives or other events occurred during or after the snowfall.
