Evaluation of a Buried Cable Roadside Animal Detection System

Eco-Transportation and Alternative Technologies Group
Virginia Tech Transportation Institute

Final Report VCTIR 15-R25

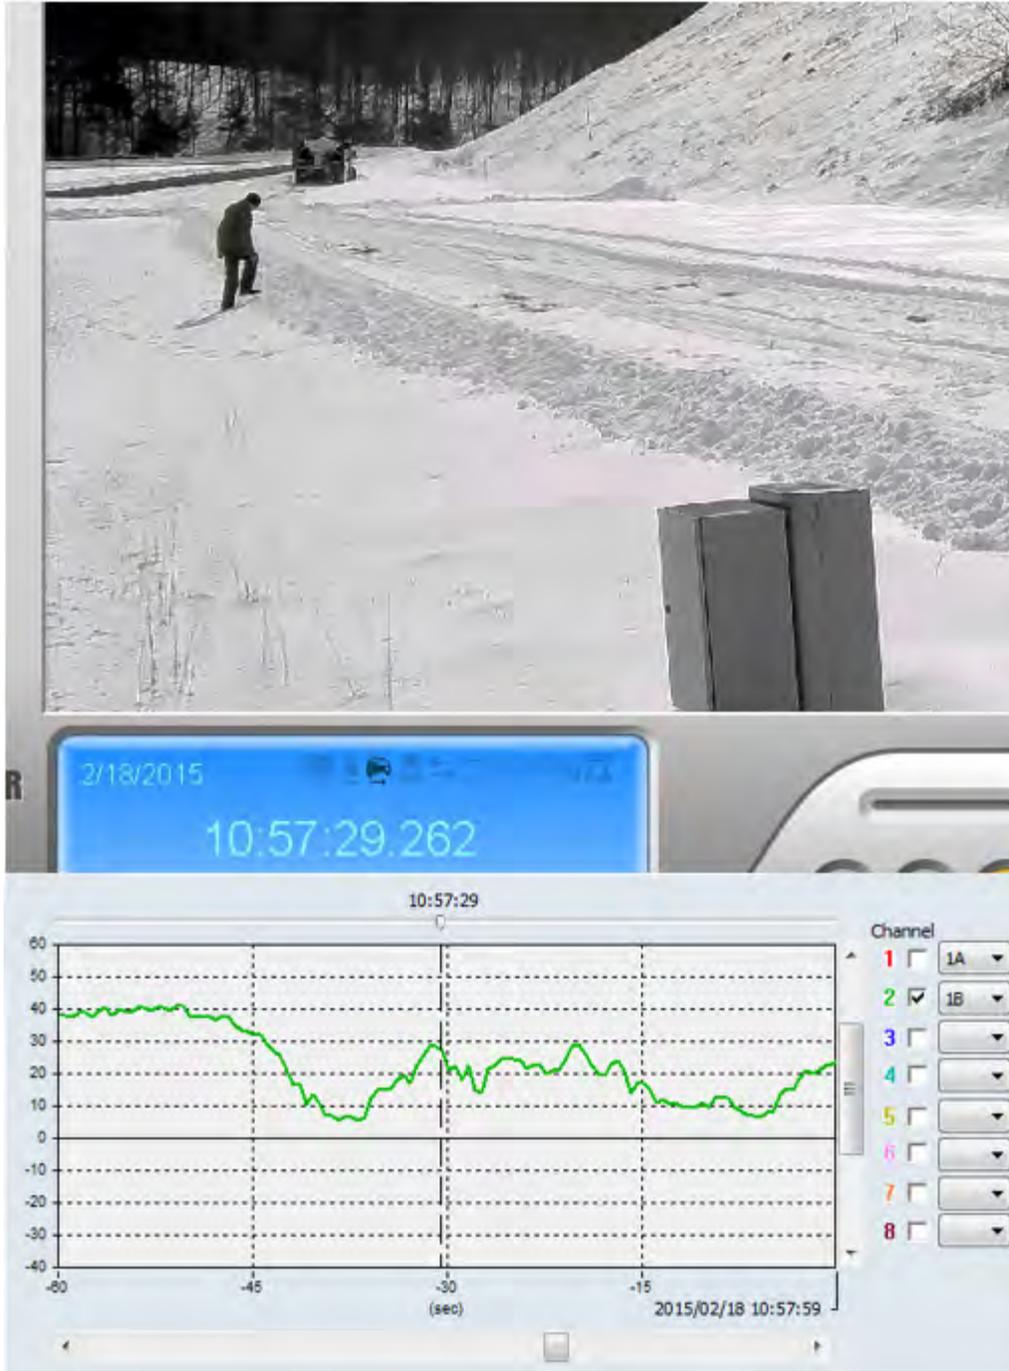
Figure 24. Crossing Performed Shortly After Additional Snow Was Plowed Over Cable (*top*) and Corresponding Detection Signal (*bottom*).

Shortly after being covered by snow, several crossings were performed over the cable by human subjects to further verify its detection capabilities in such conditions (Figure 24). Crossings were executed at different speeds every 20 ft on side B of the cable. The data were analyzed following the same procedures previously described. Cable responses (i.e., signal magnitudes in dB) similar to those recorded before the cable was covered by snow were recorded during tests from both human and vehicle crossings. The signal peaks in Figure 24 correspond to side B only. A walk along the cable path in 1-ft snow depth was performed for the entire side B prior to plowing additional snow over the cable to ensure there were no locations with a weaker detection signal. Furthermore, no false positive or nuisance alarms were triggered by the melting snow during the first week in March when the temperatures had significantly increased.

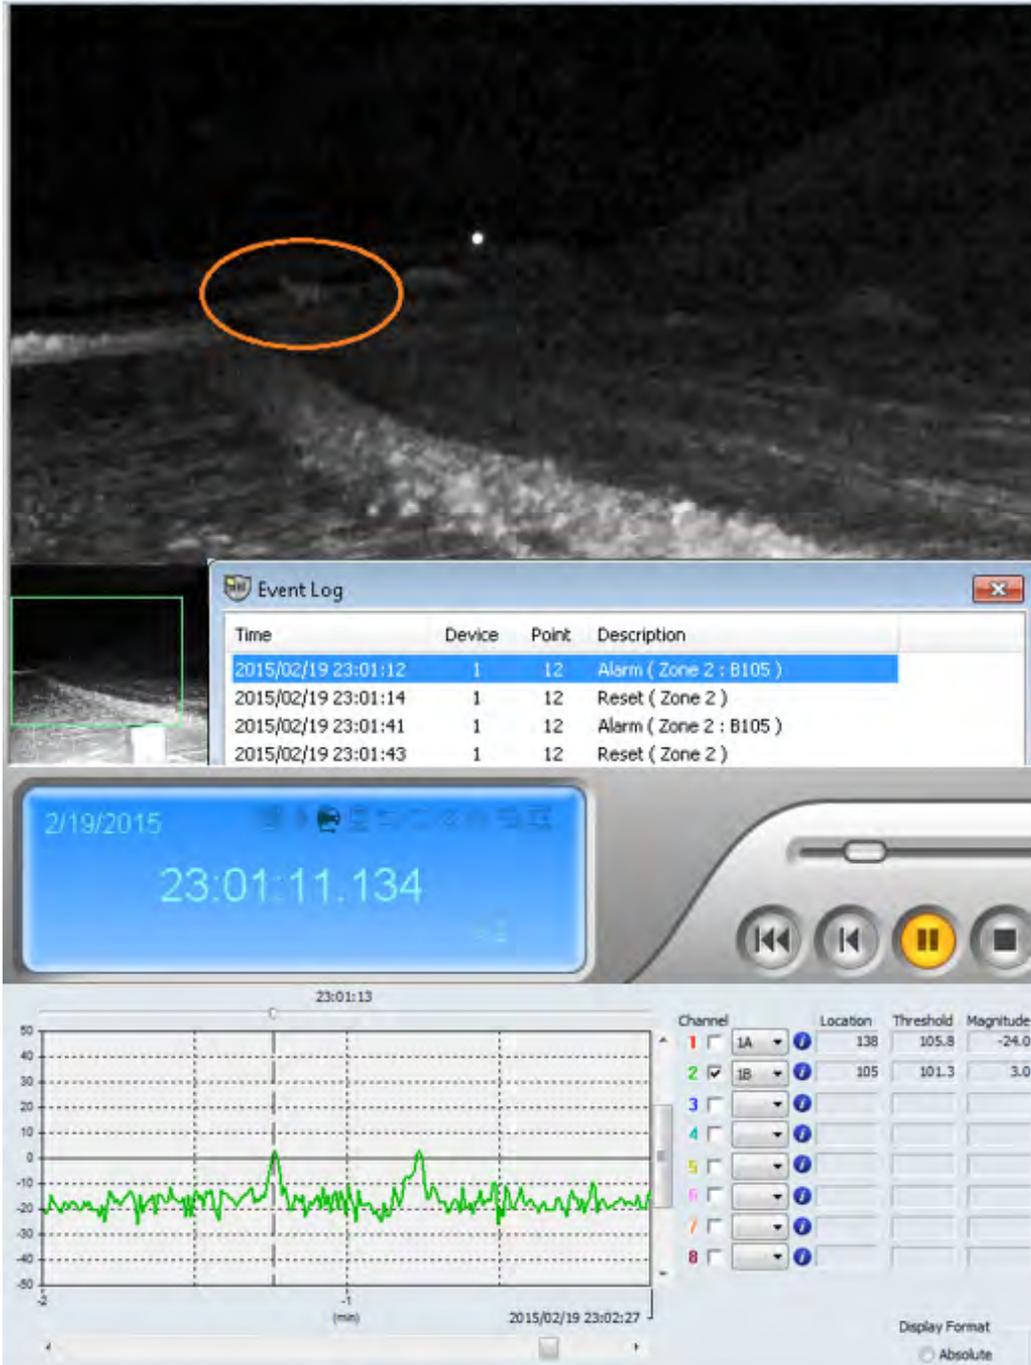
Figure 25. Event Log Alarm Data (top) and NM Plot (bottom) of Deer Crossing Over Snow-Covered Cable

Several deer were detected crossing the cable at different locations in the days following the snow. All events were valid detections and were documented in the detection log. Figure 25 shows a deer walking through the detection field in the 2nd Zone 2 of the cable after it was covered by 3 ft of snow.

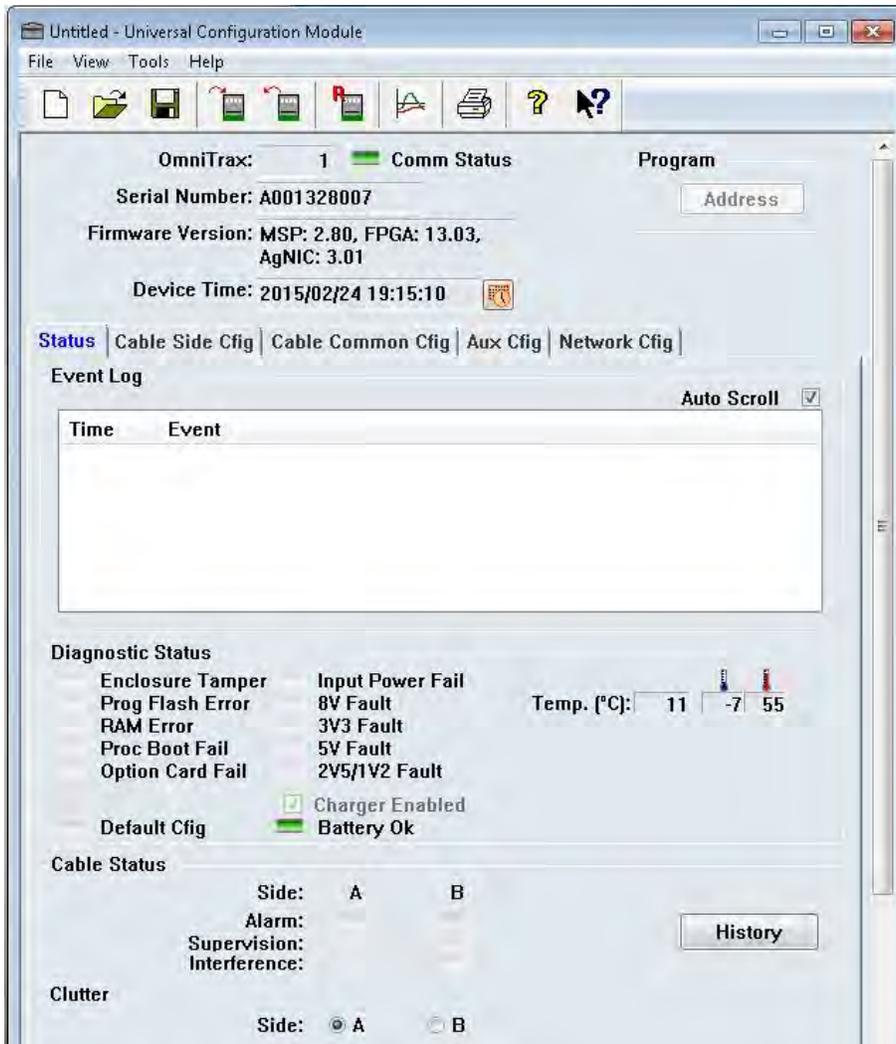
Figure A1. Screenshot of UCM Main Window Showing Cable Status Menu

The cable sensor calibration can be accomplished by using the Universal Configuration Module (UCM), a Windows-based software application, which serves as the calibration, setup, and maintenance tool for the OmniTrax[®] system (Figure A1).

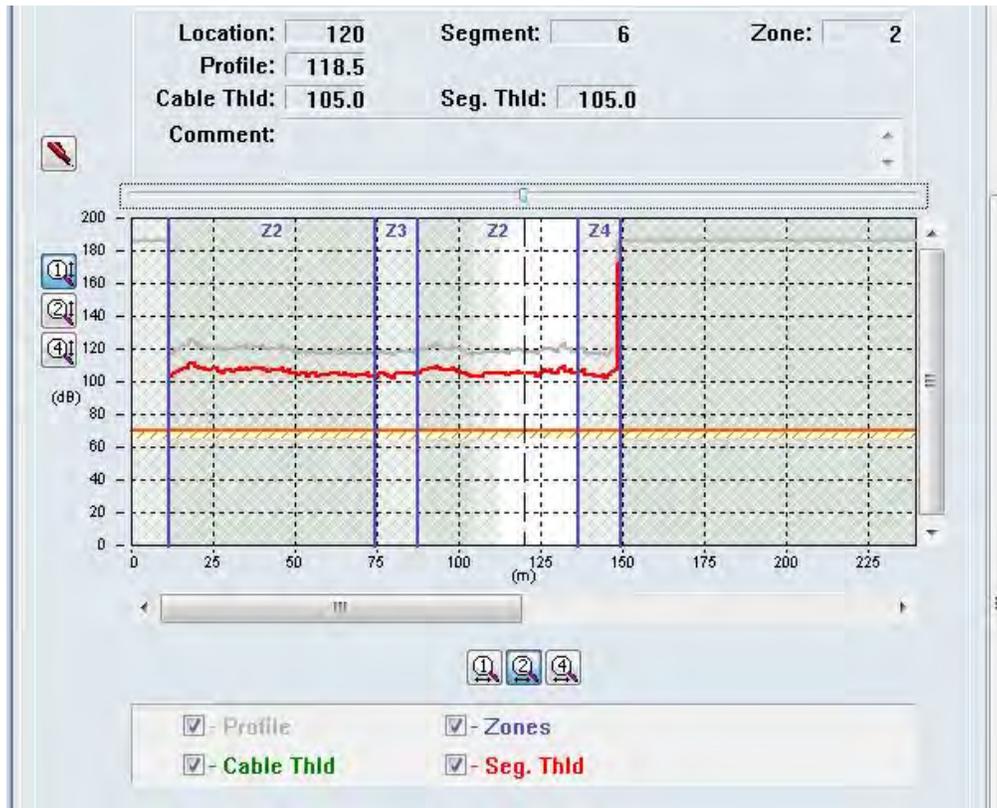
Figure A2. Cable Sensitivity Profile (Grey Line) for Side B. The blue pointer above the plot indicates the locations along the cable to check threshold, in this case meter 120 in the second Zone 2 at 105 dB.

Typically, the SP created during this procedure becomes the baseline for setting the cable margin for the full length of the buried detecting cable (Figure A2) as will be explained in the following section. Side B zoning of the cable (Z2, Z3, Z4) can be seen in the figure along with the profile margin (gray line) and detection thresholds (red line). The meter 0 to meter 10 of the plot indicates the non-detecting area corresponding to the lead-in cable section.

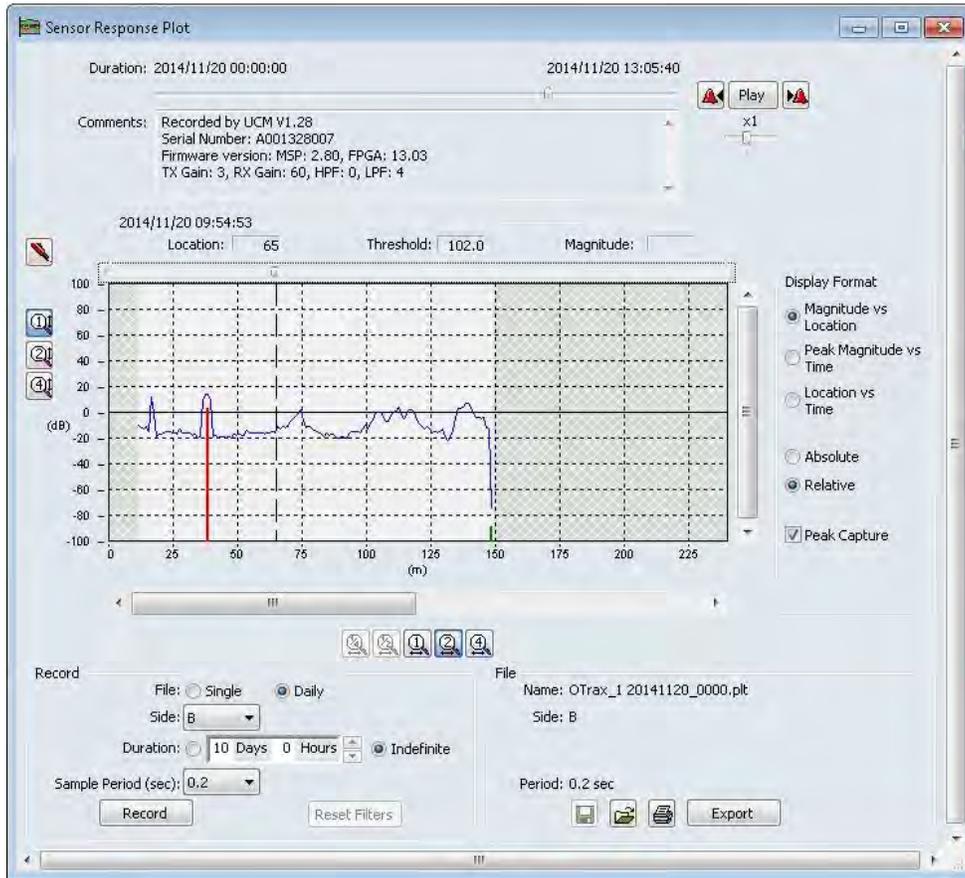
Figure A3. Example of Sensor Response Plot Window Performed in UCM Program. The red vertical bar indicates that an alarm was declared between meter 25 and meter 50 at a specific time.

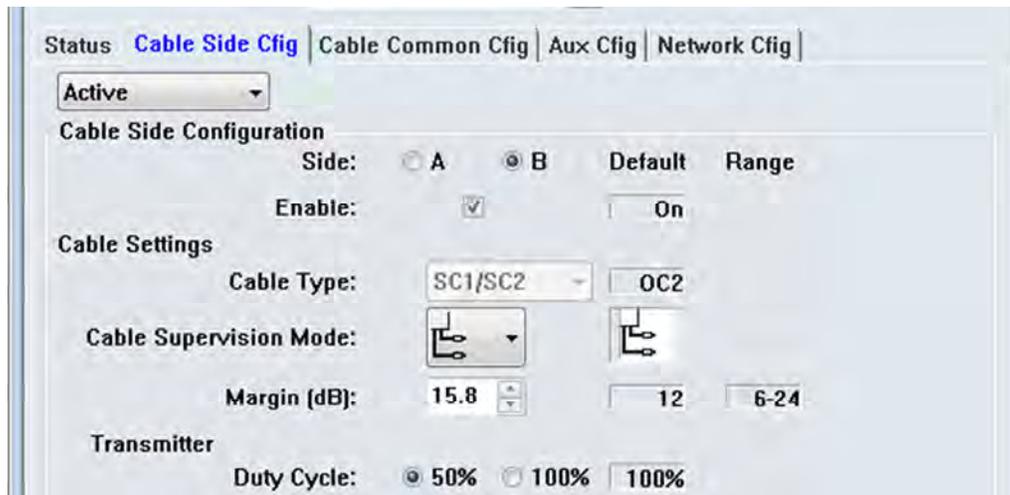
Figure A4. Cable Sensor Margin Adjusted at 15.8 dB for Side B of Cable

selected as the default setting for cable margin due to the rocky soil characteristics. Subsequent adjustments were made during the evaluation period using the Cable Side Configuration feature in the UCM software (Figure A4) due to issues related to heavy rain and soil subsidence. Typically, the alarm threshold adjustment for the full length of the detecting cable is attained when setting up the cable margin.

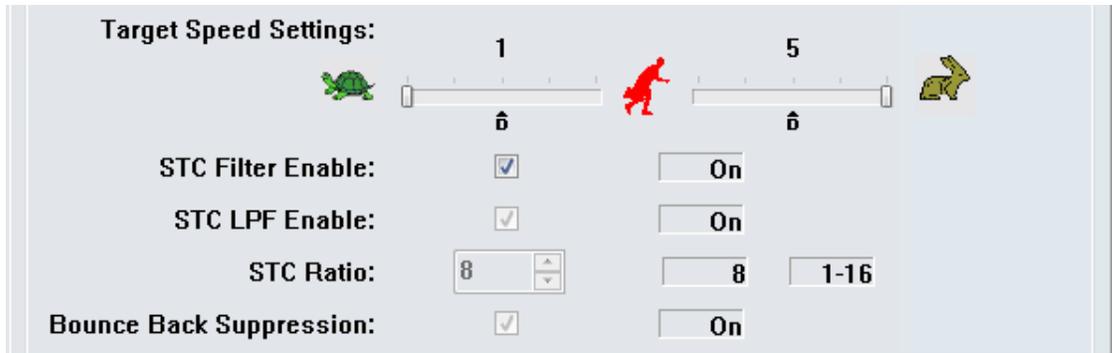
Figure A5. Target Speed Adjustment Using Slow-Fast Speed Sliders

Target speed settings were configured concurrently with cable margins by adjusting the detection frequency filters to adequately detect fast and slow moving targets on the selected cable side. A series of intrusion tests at different locations along the cable path at the slowest and the fastest speeds were successfully performed, as the cable detected all the crossings. Testing was performed by individuals of various masses who were walking and running across the cable. During the target speed testing, the two sliders in the UCM program (one for low speed on the left and one for high speed on the right) were adjusted several times to evaluate the speed effect (Figure A5). It should be noted that cable calibration and parameter setup was performed on site at the time of the installation (December 2013) with a laptop connected directly to the processor via USB. Some of the parameters were subsequently adjusted due to weather effects (mostly heavy rains) and subsidence of the coarse aggregate backfill material.
