Implementation and Evaluation of a Buried Cable Animal Detection System and Deer Warning Sign

Final Report VTRC 19-R28

In this study, the Virginia Department of Transportation (VDOT) in collaboration with the Virginia Tech Transportation Institute (VTTI) implemented and monitored the performance of a BCADS on a public road to provide a real-world assessment of system capabilities and possible operation issues. The BCADS has proved effective and reliable in a previous evaluation performed under more controlled and secure conditions at the Virginia Smart Road facility in Blacksburg, Virginia.

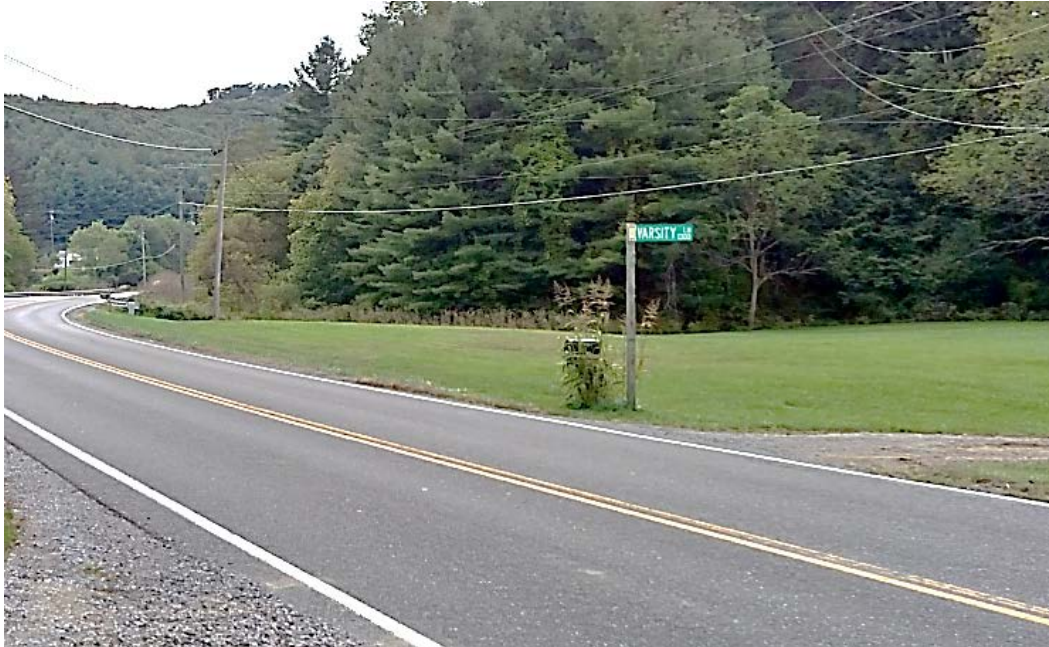
Figure 2. Test Site at Riner Rd. and Varsity Ln. (Driveway) Selected for Cable Installation.

Two locations were selected on Riner Road: one near Varsity Lane (Figure 2) and one near Life Drive (Figure 3). These locations were monitored for deer activity for three months (October to December 2017). Data were collected using trail cameras installed along the road to identify potential areas where animals might migrate or cross frequently. Video surveillance of the two locations showed deer to be the only animals crossing and/or stopping to graze or search for food on multiple occasions in areas near the road. The analysis of the acquired video data indicated that the site near Varsity Lane was trafficked by more deer (36) than the Life Drive site (11). Therefore, VTTI researchers decided to install the cable sensor at the Varsity Lane location. This location also had the advantage of being bordered by heavy woods and traversed

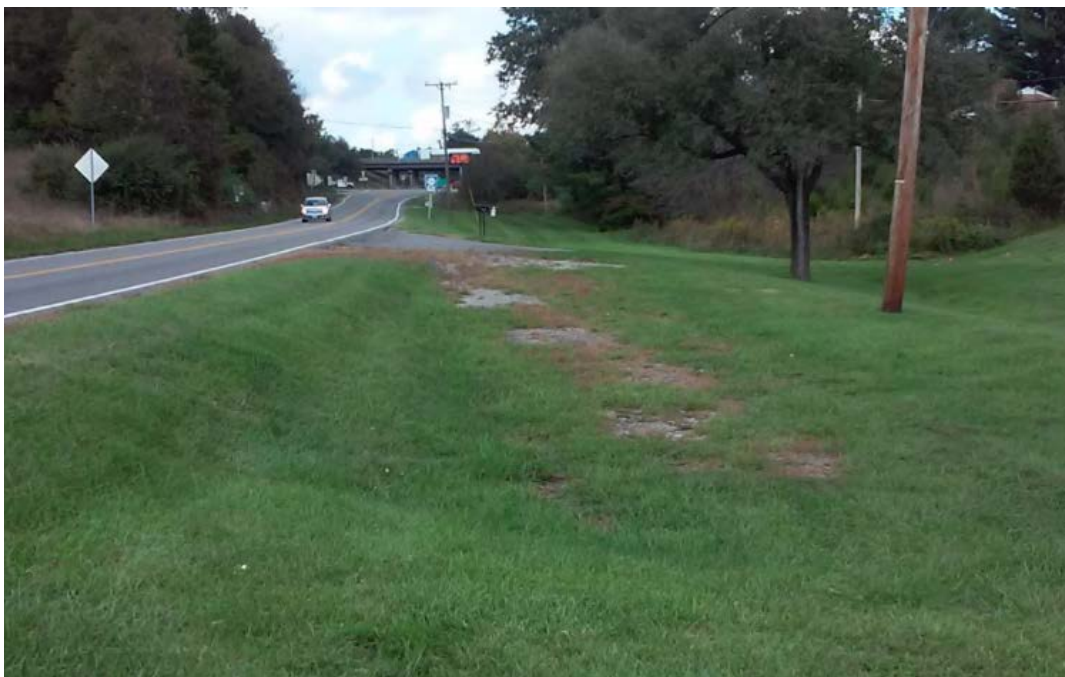
Figure 3. View of the Alternate Test site at Riner Rd. and Life Dr. Looking Northward along State Route 8.

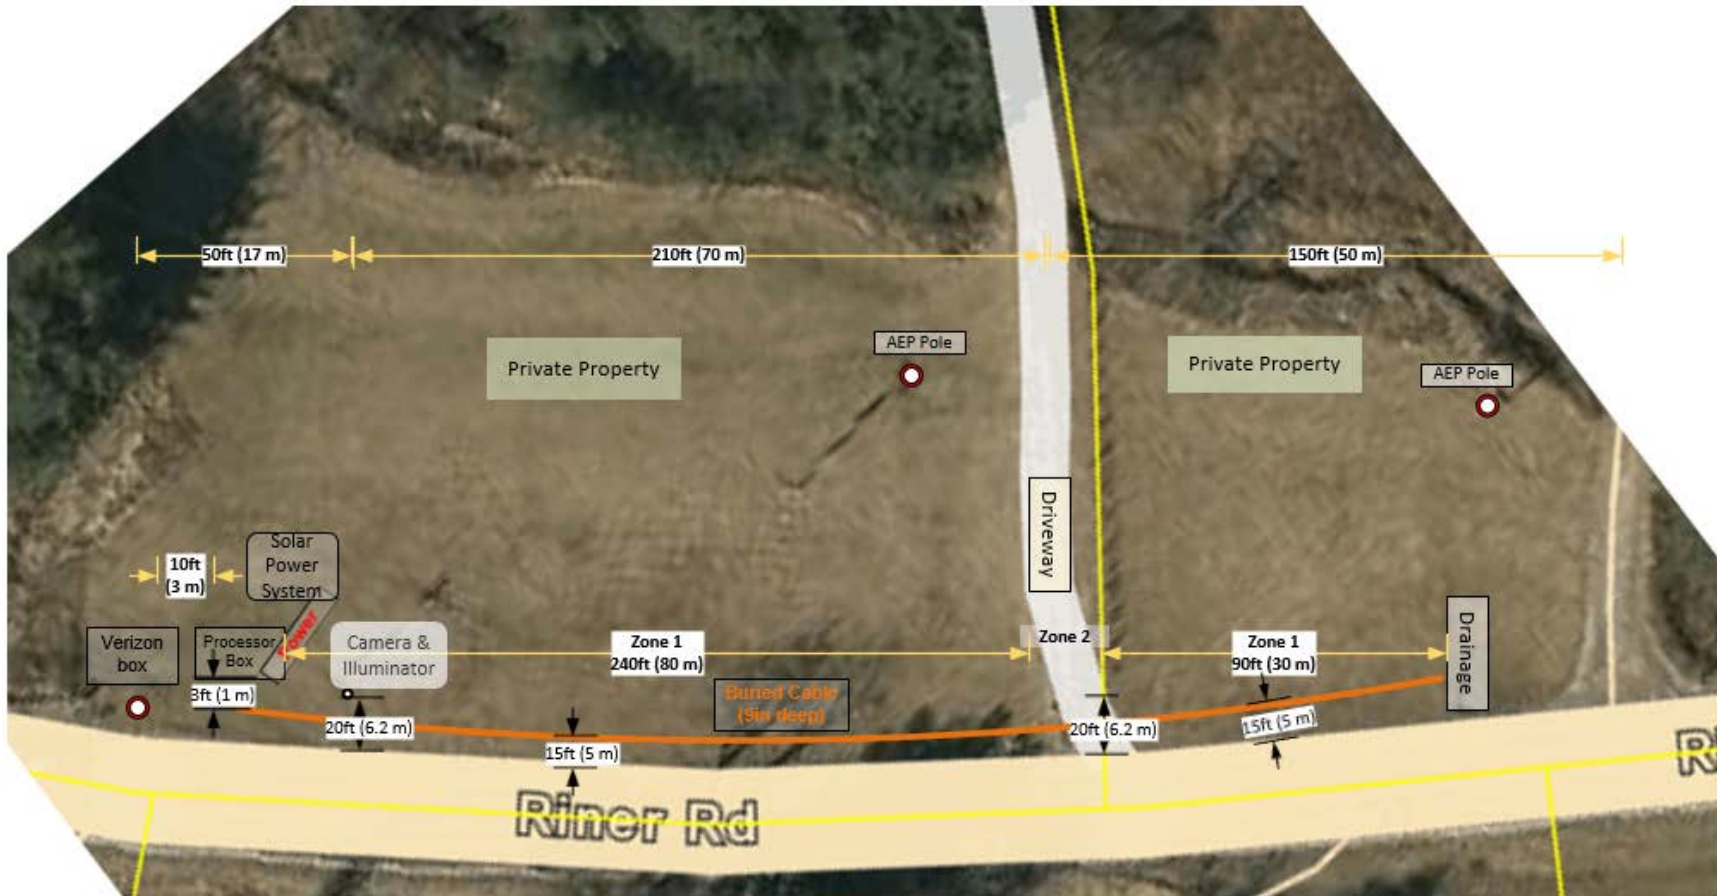
Figure 4 shows an aerial picture of the selected installation area and the detection zones along the cable. The orange line represents the location of the cables. Two OmniTrax[®] BCADS sensor cables were installed approximately 125 m (375 ft) along a route originating near the Processor Box, crossing the Varsity Lane driveway, and terminating approximately 1m (3 ft) short of the drainage feature as shown in Figure 4. The BCADS was configured with "A" and "B" sensing zones in the system software to allow separate monitoring of the driveway for evaluation of vehicle crossing effects. The detection sensitivity and alerting threshold were configured similarly for both zones.

Figure 4. Plan View of the Test Site Showing the Location of the BCADS Installation and Respective Detection Zones. BCADS = buried cable animal detection system.

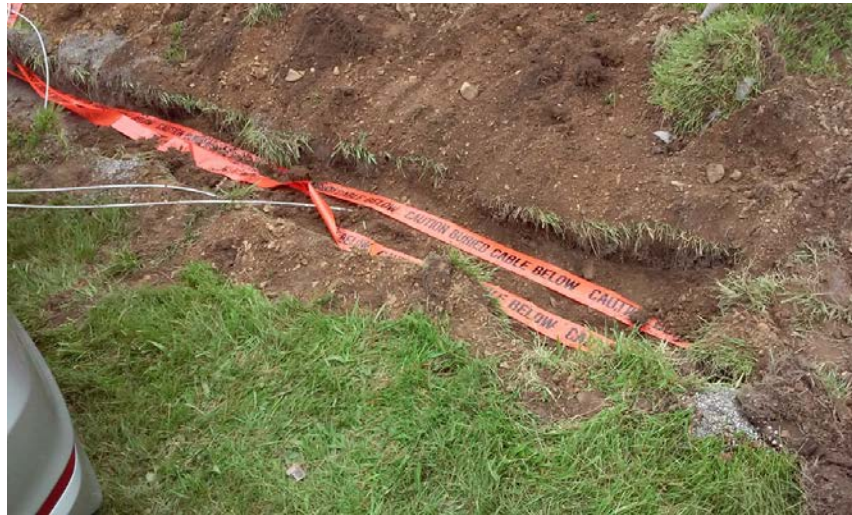
The cables were installed 30 cm (12 in) apart, and parallel, on the bottom of a trench with a width of 33 cm (13 in) and depth of 28 cm (11 in). As in the previous installation at the Virginia Smart Roads, before laying the cables in the trench, a 5 cm (2 in) layer of crushed stone was used as bedding, per the manufacturer’s recommendation. The cables were then placed on top of the aggregate layer at a depth of approximately 23 cm (9 in) with marker tape positioned over them (Figure 5) to prevent cable damage during potential excavating activities. Once the cables were aligned and spaced, they were covered with native soil that was subsequently compacted to the required density (Figure 6).

Figure 5. Trench Being Backfilled After Cables were Placed on the Crushed Stone Base.

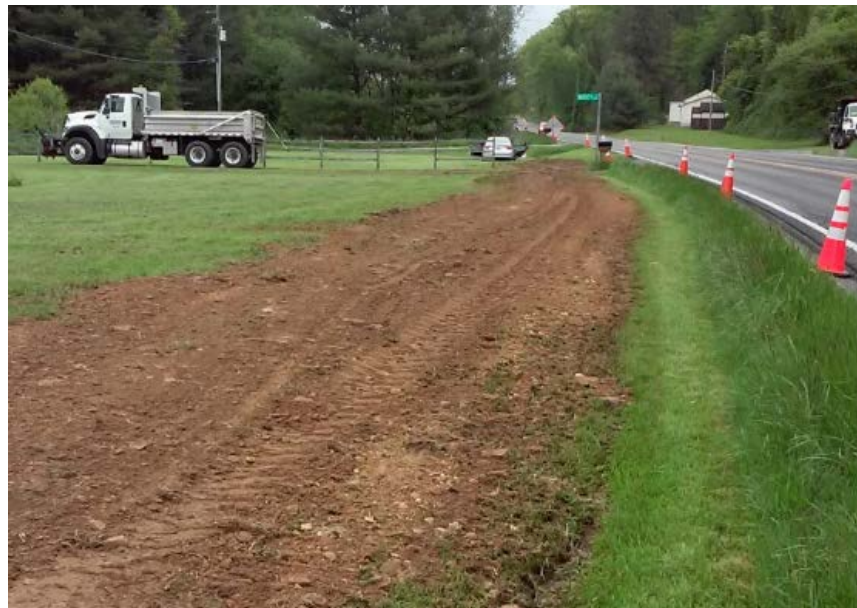
Figure 6. Trench Covered with Compacted Native Soil.

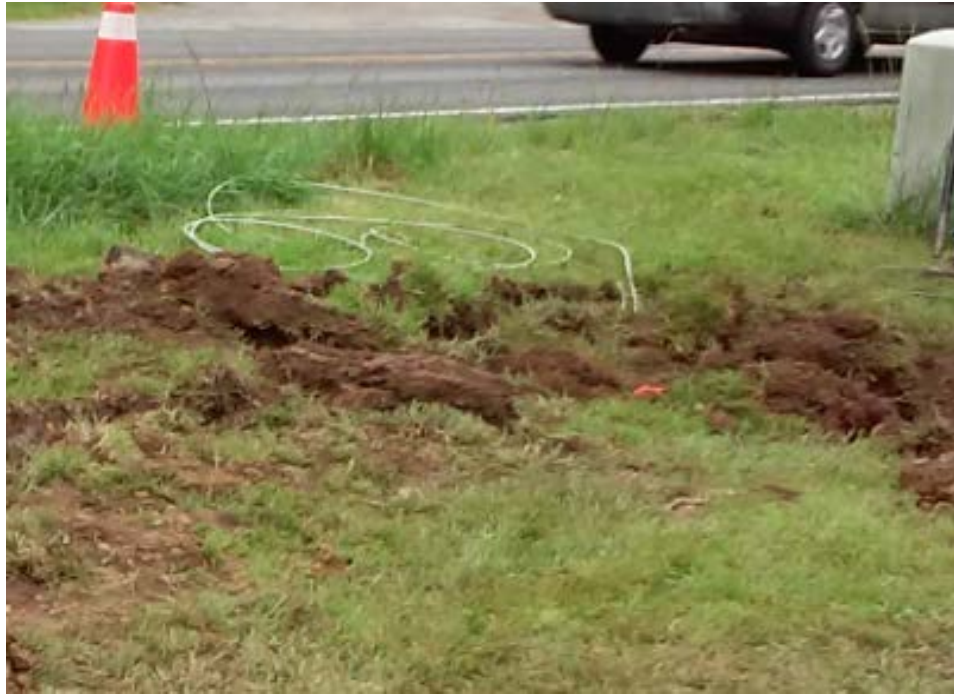
The trench was widened at the south end to house the lead-in cables that connect to the BCADS processor (Figure 7). The cables were installed with some overlap in this area to ensure uniform sensing along the entire length of the cables (Senstar, 2013). Detection field strength

Figure 7. Lead-in Cables That Connect to the Processor Enclosure.

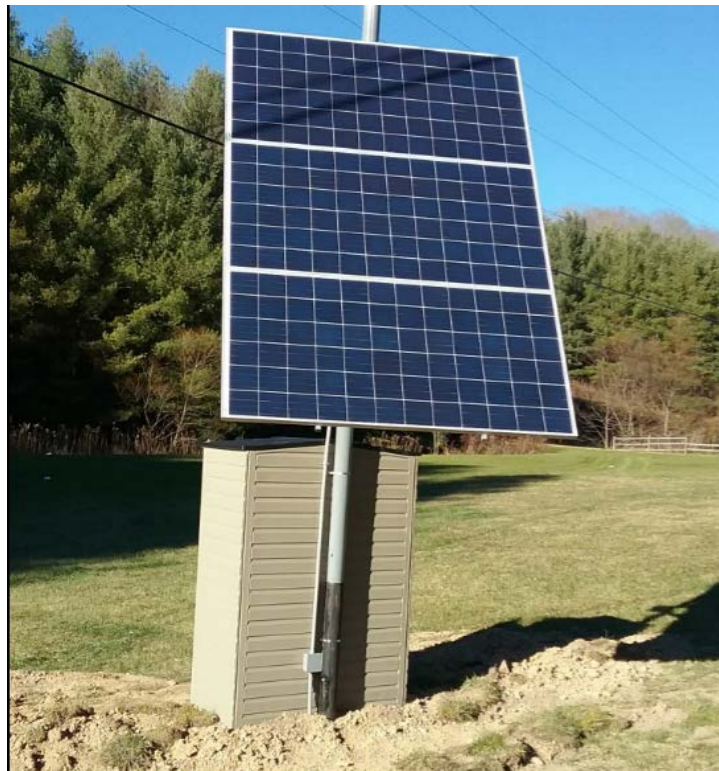
Before calibration, the manufacturer defined the alarm zones in the processor software so that different zone thresholds could be fine-tuned separately if necessary. The processor operates on a 12–48 VDC range (10 W) power supply and can communicate alarms via dry contact closure or a fiber optics or wireless/cellular interface. The BCADS was powered by a solar photovoltaic (PV) system installed 10 m (30 ft) away from the processor box (Figure 9).

Figure 9. Solar Photo-voltaic System Supplying Power to the Buried Cable and Surveillance Equipment.

The solar power system included two absorbent glass mat batteries and a charge controller to maintain battery charge. Additional equipment, including a surveillance camera, mini-computer (for remote access to the system), external hard drive (for data collection), and cellular modem (for wireless data transfer and real-time access for BCADS surveillance) were also powered by the PV system.

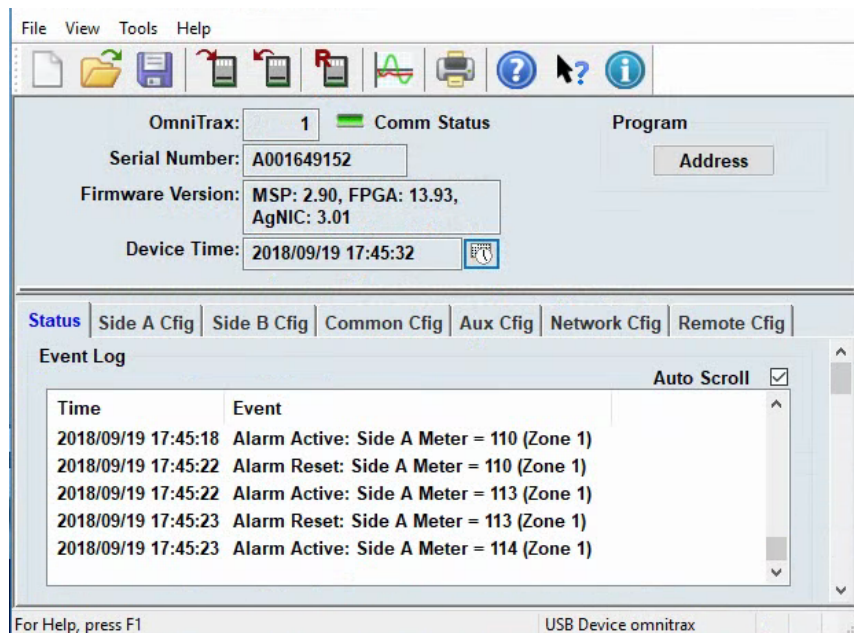
An online connection to the BCADS was established via a cellular modem to allow operation and monitoring of the system from a remote PC. The wireless connection enabled continuous access to the detection system and surveillance camera to monitor the cable alarms and perform detection adjustments as needed via a configuration module (CM) program (Figure 10).

Figure 10. Real-time Detection System Alarm Monitoring Showing the Cable Status, Time Stamp, and Event Log Via a CM Control Window.

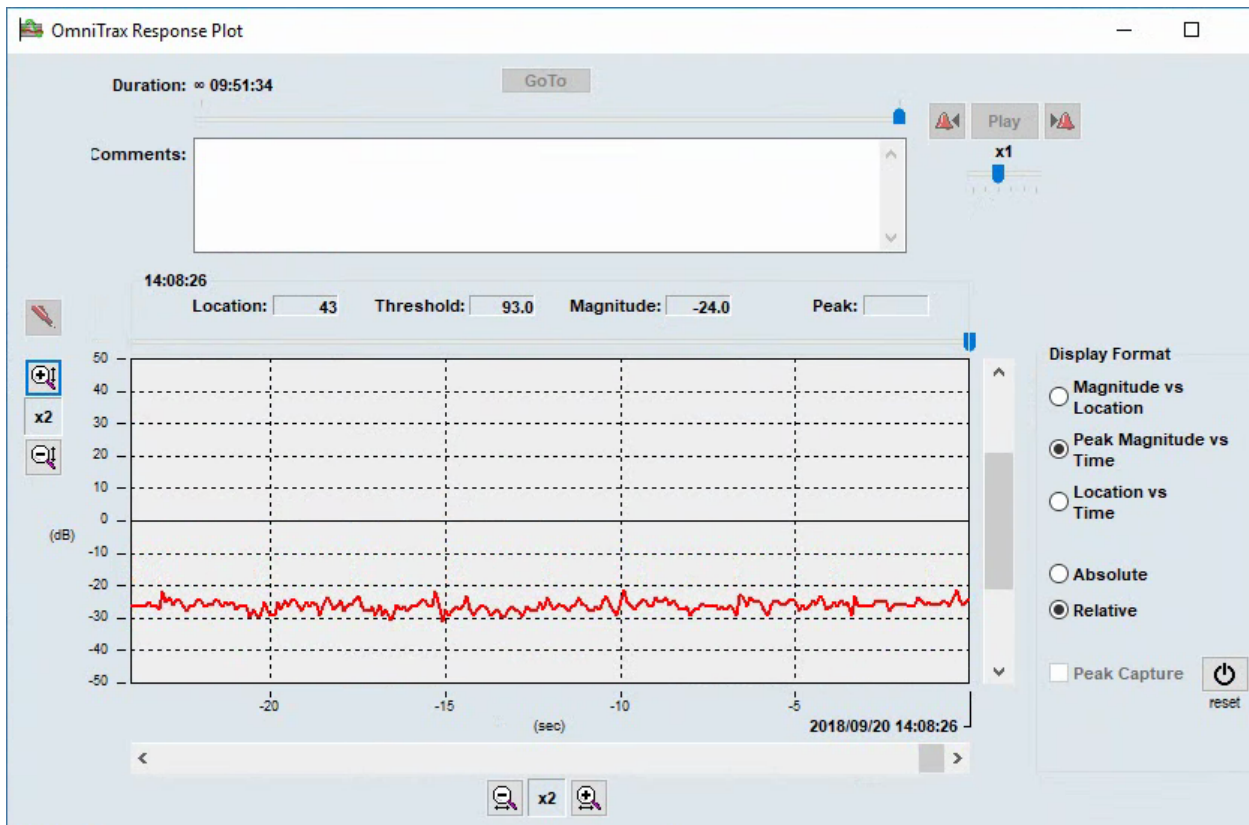
The CM also enabled researchers to determine if power outages or signal interruptions occurred so that troubleshooting could be performed promptly. Generally, regular and timely data entry and/or data quality checks are essential to correct errors, retrieve missing data (by checking alarm history), and verify any unusual data. The CM control window allowed for further system configuration (e.g., node synchronization, network interface selection, and cable side selection) and access to the alarm history file. The program module could be queried to retrieve and save old event history files for future reference. Additionally, a separate response plot window allowed for the real-time monitoring of cable activity and continuous collection of signal data on a daily basis (Figure 11). The plots offered details about the time and date of cable signal monitoring along with the crossing location, threshold at that specific location, and magnitude of the signal (dB).

Figure 11. Example Cable Response Plot Used to Identify Real-time Cable Crossing Events. This Signal Response Indicates No Crossing.

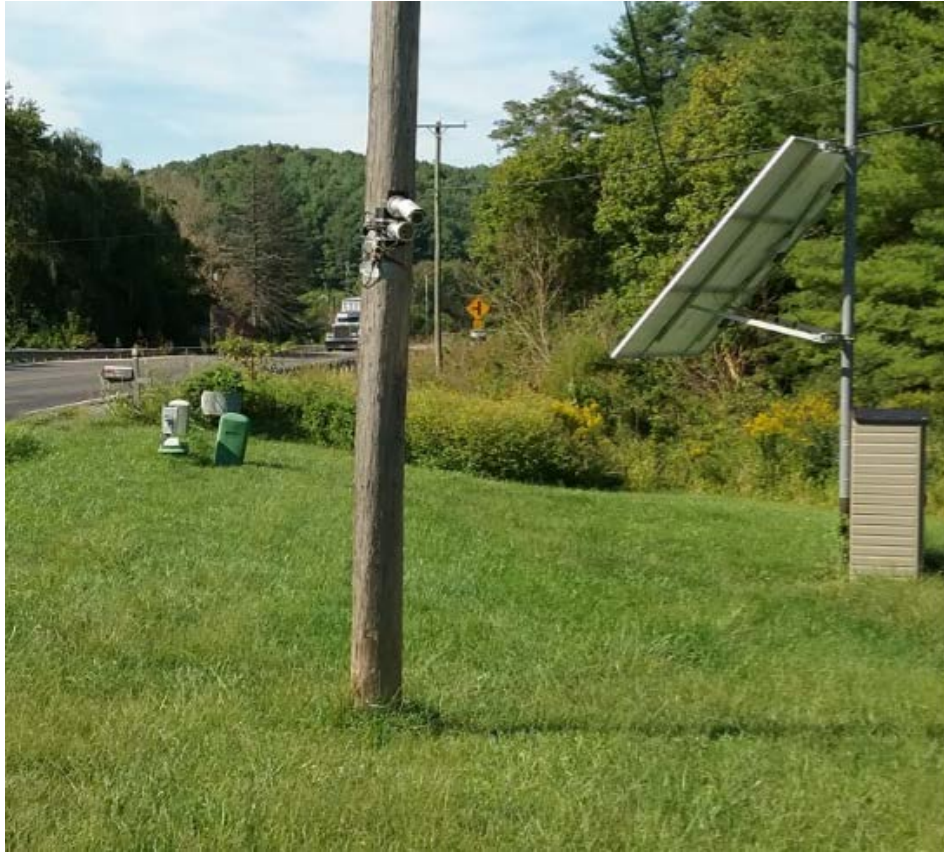
An infrared surveillance camera and a near-infrared illuminator covering distances ranging from 25 m (75 ft) to 100 m (300 ft) were installed near the processor enclosure to monitor side A of the cable toward the Victory Lane driveway (Figure 12). The camera recorded five-minute video clips and automatically adjusted for day/night recording, defogging, and wide dynamic range sensing for enhanced exposure control. Prior to their on-site installation for continuous data acquisition (video and animal crossing detection), the camera and illuminator were tested to assess their capabilities in different weather and natural light conditions, including

Figure 12. Surveillance Camera (*Top*) and Illuminator Used for Cable/Site Monitoring. The Solar Power System (*Far Right*) and Processor Enclosure (*in the Background*) are also Shown.

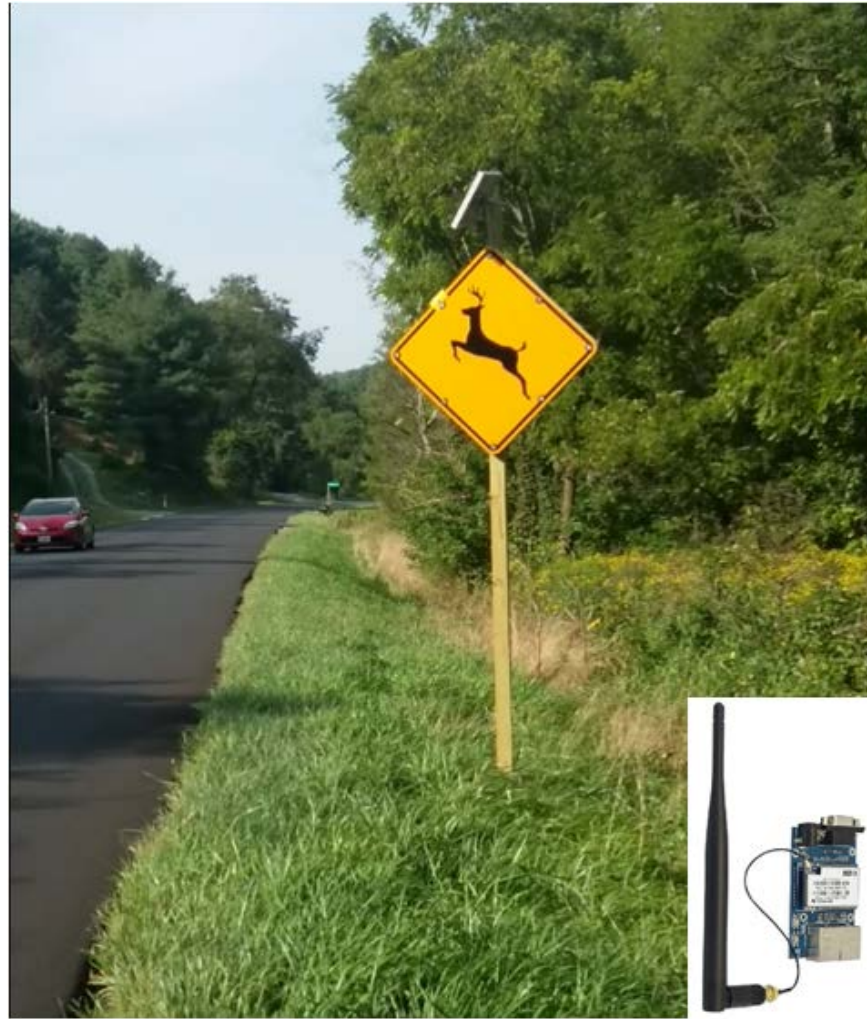
A 90 cm × 90 cm (36 in × 36 in) diamond-shaped flashing deer warning sign was installed approximately 200 m (600 ft) from the processor box on the same side of the road as the BCADS (Figure 13). The sign complied with VDOT requirements for temporary signage and was approved by VDOT's Traffic Operations division. The warning sign was operational continuously and inspected weekly to ensure accurate activation upon alarm triggering along with proper power/communication status. The edges of the sign contained eight yellow light-emitting diode (LED) bulbs powered by a 12-V battery. A small solar photo-voltaic panel (15 W) was installed on top of the sign and connected to the battery for continuous charging. A

Figure 13. Deer Warning Sign with Flashing LEDs Installed on Riner Rd. Wireless Transceivers Shown at Bottom Right. LED = light emitting diode.

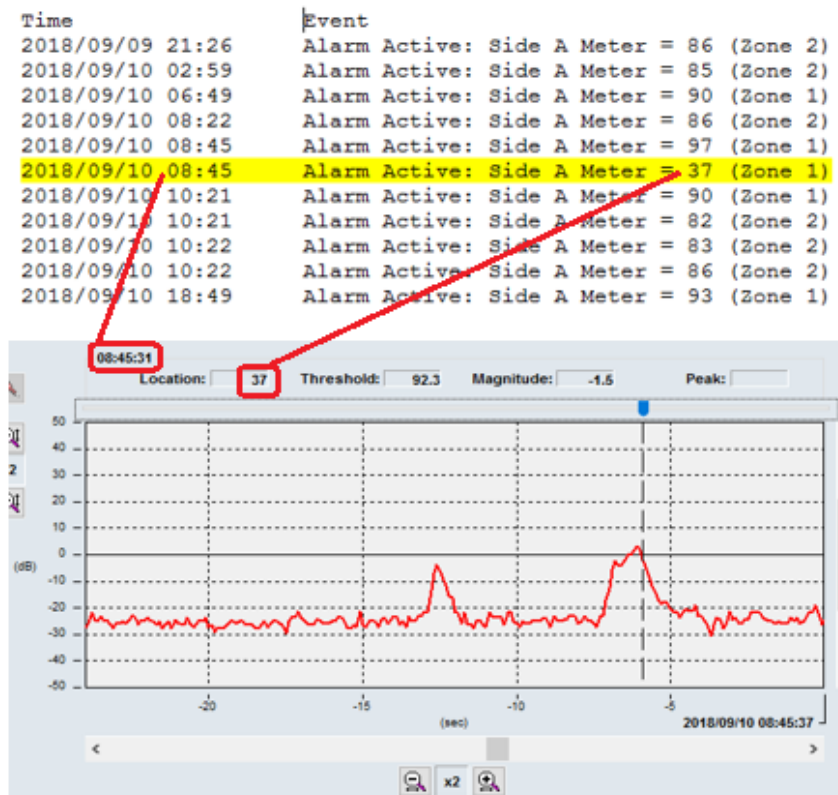
Data from declared alarms collected using the cable's proprietary software and recorded videos were analyzed to ensure that the system was detecting valid animal, human, and vehicle crossings and not providing false negatives and/or false positives. As a first step in evaluating the acquired data, the event log box of declared alarms (or alarm history file) and the response plots (Figure 11) for the respective day or time range were reviewed to ensure adequate correlation between the two programs (Figure 14).

Figure 14. List of Cable System Alarms from the Event Log History File (Top) and Cable Response Plot (Bottom). Signals Exceeding the 0-dB Threshold Indicate Valid Crossings and Declared Alarms in the Event Log box.

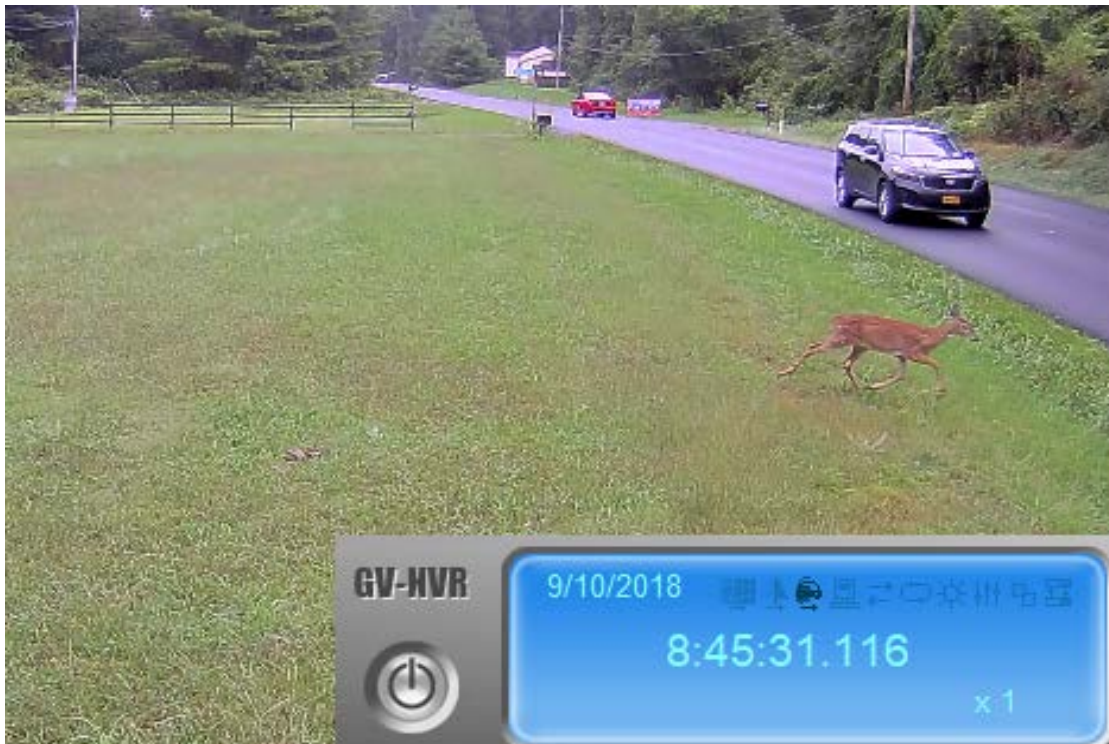
Figure 15. Example of Valid Animal Detection Event Showing Event Date and Time Corresponding to the Declared Alarm in the Event Log Pane (Figure 14).

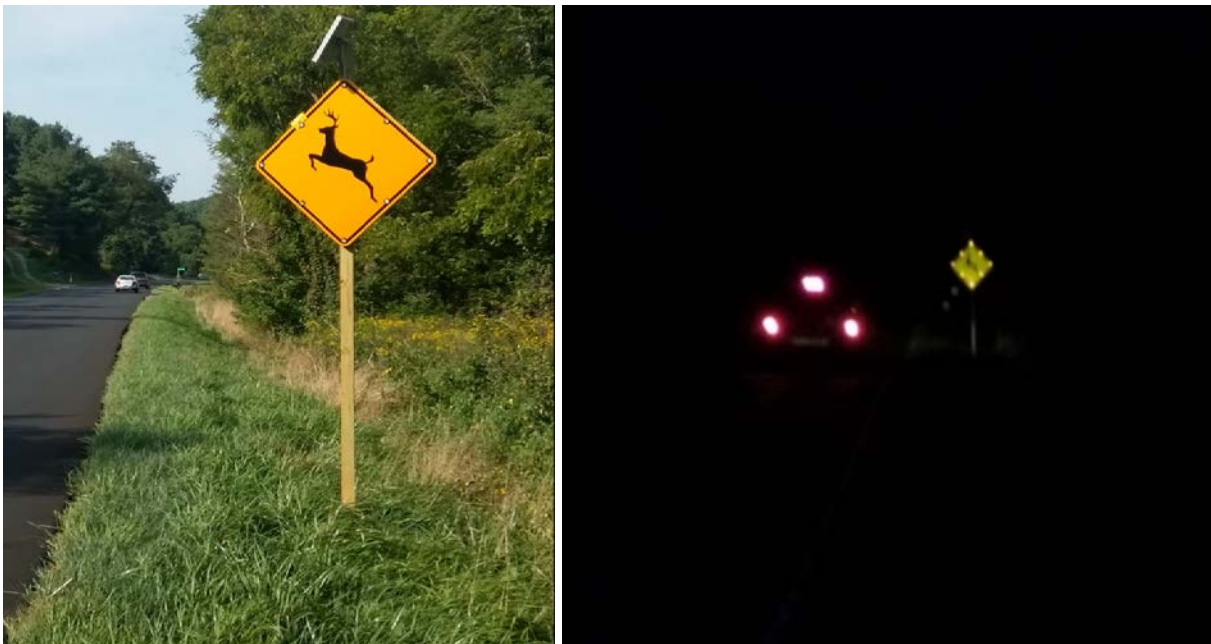
Warning sign activation was verified multiple times by VTTI researchers performing various crossings on foot or in a vehicle. The sign flashed for each crossing, regardless of location or speed, indicated 100% reliability. However, the flashing warning affected drivers' speeds differently during dawn/daylight compared to at dusk/nighttime. The speed data indicate that drivers tended to brake or slow more during the dusk-dawn interval, when the flashing LEDs were visible at distances greater than 25 m (75 ft), compared to in daytime, when the flashing LEDs were clearly observable at approximately 8 m (25 ft). Figure 16 shows the warning sign while activated during the day (at 8 m, 26 ft) and at night (at 25 m, 82 ft).

Figure 16. Warning Sign Flashing During the Day (LEDs Appear as White Dots) and at Night. LED = light emitting diode.

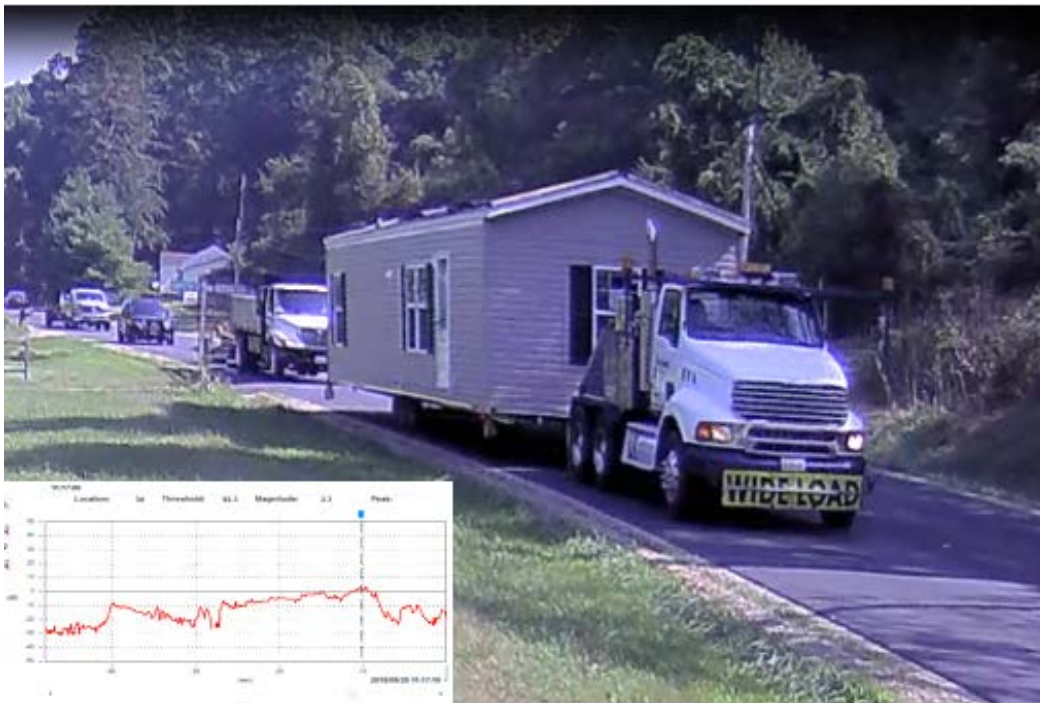
Generally, there was no interference from traffic during the study, regardless of vehicle size or lane wandering. The CM event log box and plot response program did not record any alarms related to the 0-dB reference line in the plot window. However, in some cases, an oversized vehicle crossed the edge line and entered the detection field, especially near the processor box where the field is wider, resulting in a regular target detection (Figure 17). In these cases, the magnitude of the signal response depends on the vehicle's distance from the center of the detection field. The cable response window (inset in the bottom left of Figure 17) shows a gradual increase in signal toward the control box as the vehicle wandered in the lane. Intersection of the red line with the continuous middle axis indicates a triggered alarm.

Figure 17. BCADS Interference Occurred at Various Locations along the Cable System Due to Encroachment of Oversized Vehicles into the Sensing Area. BCADS = Buried cable animal detection system.

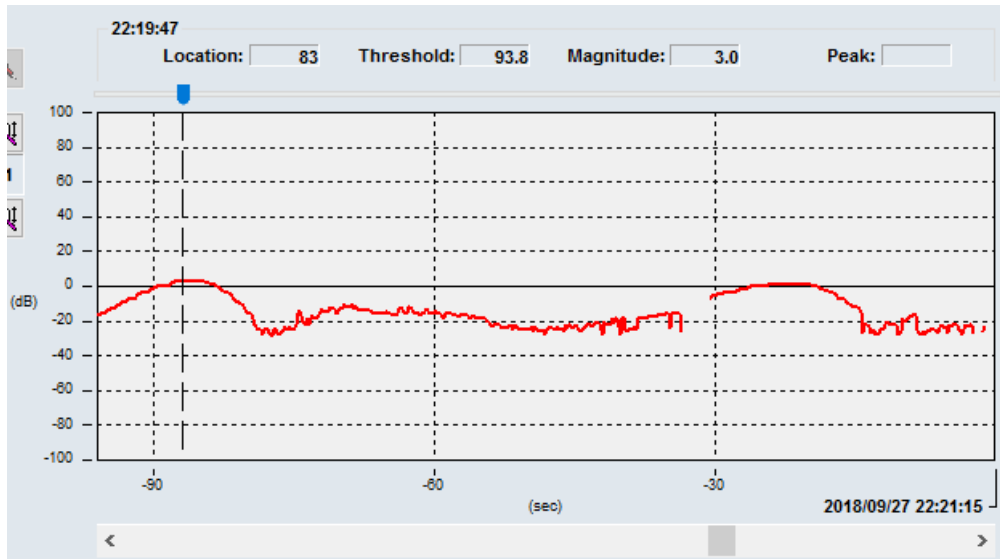
On a few occasions, water flow during long periods of heavy rain caused nuisance alarms near the control box or where the slope accommodated larger flows, as shown in Figure 18. Adequate drainage near the cable area and avoiding sloped terrain when installing the cable should prevent such problems. These alarms can also be avoided if the field sensitivity of the specific location can be diminished by adjusting the cable supervision mode in the cable configuration software.

Figure 18. Detection Cable Response Due to Water Flow near the Driveway. The Location Field Shows Meter 83 For This Event; A Second Event Occurred Later Near the Control Box.

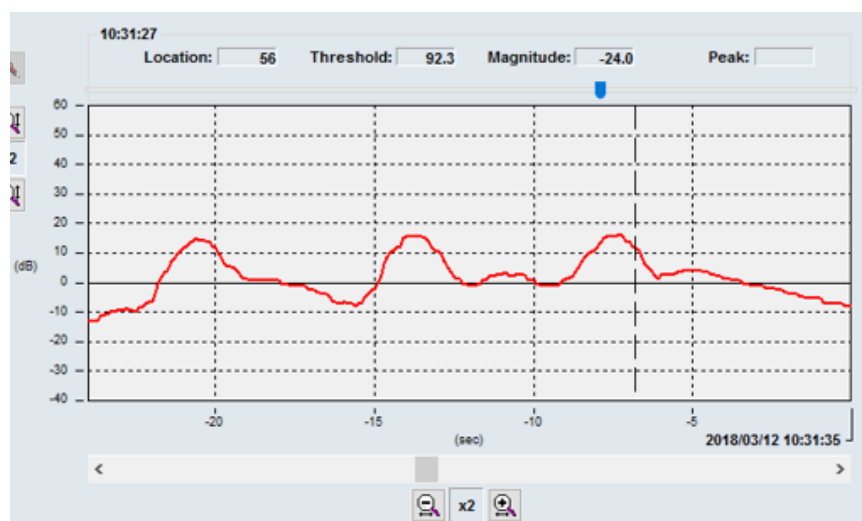
The threshold was not adjusted to compensate for any adverse snow effects, and system performance showed that snow coverage of the cable as deep as 60 cm (2 ft) did not affect its detection field. In addition, no false positives or other events occurred during or after the snowfall. After being covered by snow, several cable crossings were performed by a researcher to further verify its detection capabilities in such conditions (Figure 19). Crossings were executed at different speeds every 6.5 m (20 ft). Cable responses (i.e., signal magnitudes in dB) similar to those recorded before the cable was covered by snow were recorded during tests of both human and vehicle crossings. Furthermore, no false positives or nuisance alarms were triggered by the melting snow.

Figure 19. Detection Cable Response When Crossings were Performed After Snowfall.

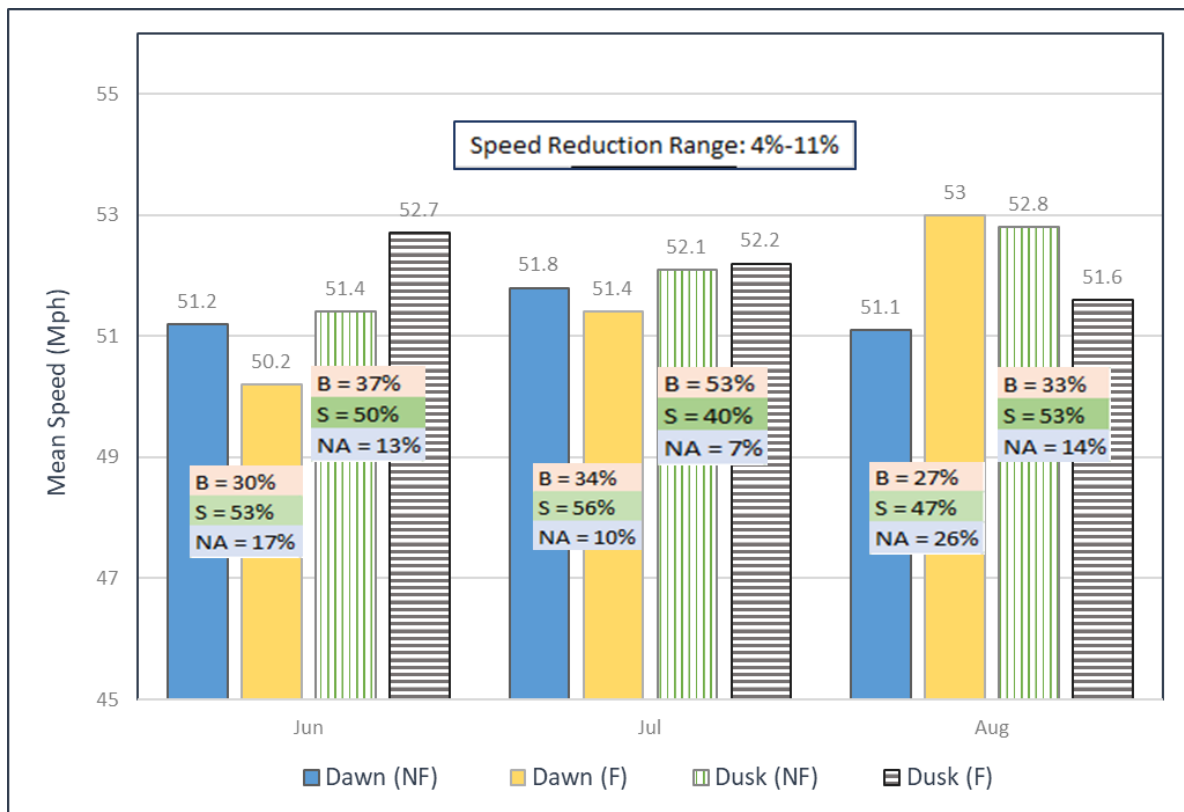
After sign installation, vehicle speed data were collected in a total of six sessions at dusk and dawn within three 24-hour periods in June, July, and August (Figure 20). In each session, speeds were measured using a portable radar gun for 30 vehicles as they approached the flashing warning sign while researchers noted their responses (i.e., if the driver braked or slowed during sign flashing). Sessions were also conducted for 30 vehicles when the sign was not flashing (NF) to compare vehicle speed levels between the activated flashing (F) sign vs. the NF sign. The sign was activated by manually closing the relay alarm-triggering circuit on the processor board. Under this scenario, the sign flashed for 30 seconds followed by a five-second pause in a continuous loop when triggered by a single crossing.

Figure 20. Vehicle Speed and Driver Behavior Related to Warning Sign Operation. B = Braked; S = Slowed; NA = No Action; F = Flashing, NF = No Flashing. Data from 120 vehicles were collected for each month.

Data were collected for vehicles traveling within a minimum of five-second intervals of each other to avoid erroneous radar readings. This interval also allowed the vehicles to perform actions such as braking independently of the leading vehicle (i.e., some following vehicles might have braked as a result of the lead vehicle braking). Figure 20 shows average driver speeds when approaching the area where the warning sign was installed. The speeds were captured both when the sign was inactive and when it was activated during the respective speed recording session.

Although all speeds were below the speed limit posted for that road section (88 km/h, 55 mph), minor differences were noted among various data collection sessions during the three months of data collection. Drivers tended to drive slightly faster at dusk regardless of whether the sign was flashing or not. It is possible that some drivers may have become habituated to the sign and to the fact that they did not see many deer near the road, especially during August. In addition, traffic volume was higher during the dusk-evening period traveling in the direction the sign was facing (more people commuting from work) than during the dawn-sunrise period. The data in Table 3 support this observation, as very few deer were recorded crossing the cable during the dusk and dawn periods: only six deer in June, eight deer in July, and one deer in August were detected. Moreover, some drivers used their high beams while traveling in that area (also seen in the video data), especially when lead traffic was not present, providing improved visibility. Video data analysis did not reveal any DVC during the course of the study, although drivers had to steer over the double line to avoid a potential conflict on a few occasions.
