# Motorcycle Crash Data Analysis to Support Development of a Retrofit Concrete Barrier System for Freeway Ramps

JULY 2019 | Final Report

1. Report No. TTI-Student-04	2. Government Accession No.	3. Recipient's Catalog No.	
4. Title and Subtitle Motorcycle Crash Data Analysis to Support Development of a Retrofit Concrete Barrier System for Freeway Ramps		5. Report Date July 2019

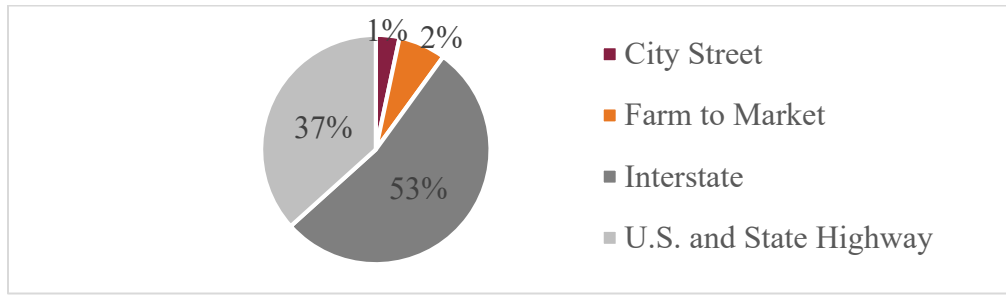
**Figure 2. Chart. Type of road traveled before first harmful event resulting in KA (flyovers/connectors).**

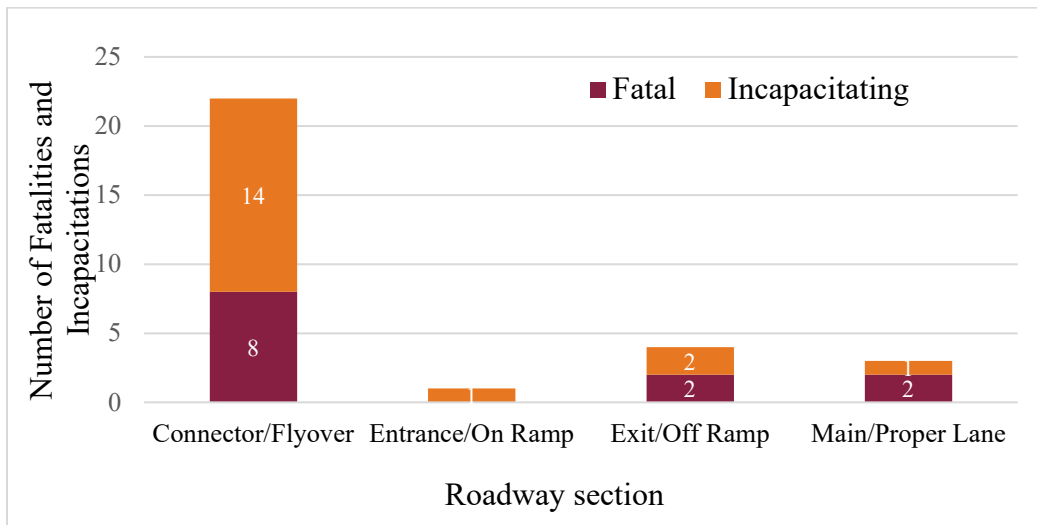
**Figure 3. Chart. All KA on flyovers/connectors for various roadway sections.**

Similarly, different sections of roadway were recorded. Even though all 30 of the fatal and incapacitating cases occurred on flyovers/connectors, only 22 were reported to be flyovers/connectors by the officer. Various other roadway sections where these accidents occurred were on exits/off-ramps and in the main/proper lane, with four and three total KA, respectively. All fatal and incapacitating injuries on flyovers/connectors for various roadway sections can be seen in Figure 3 below.

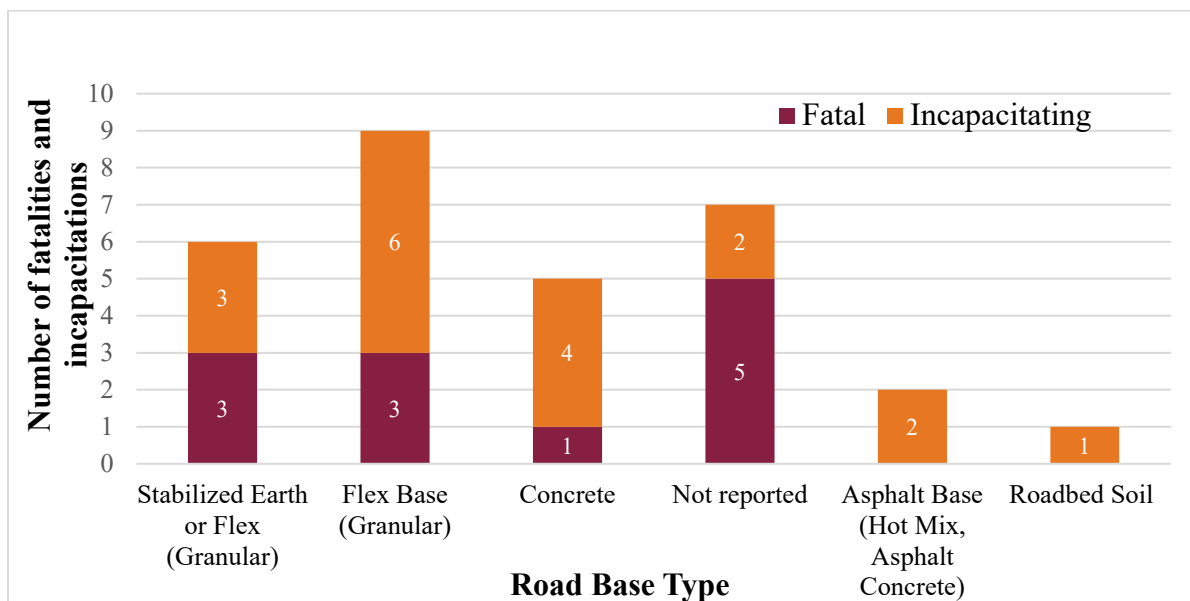
Figure 4. Chart. All KA on flyovers/connectors for various road base materials.

Road materials and configurations were considered in order to better understand the conditions of the road surface at the time of the crash. Seven of the thirty cases contained no information on the road base type or road surface type; however, an analysis was still conducted to see the distribution of injuries in cases where road configuration was recorded. Figure 4 shows the different road base types and the number of both fatal and incapacitating injuries recorded for each base type.

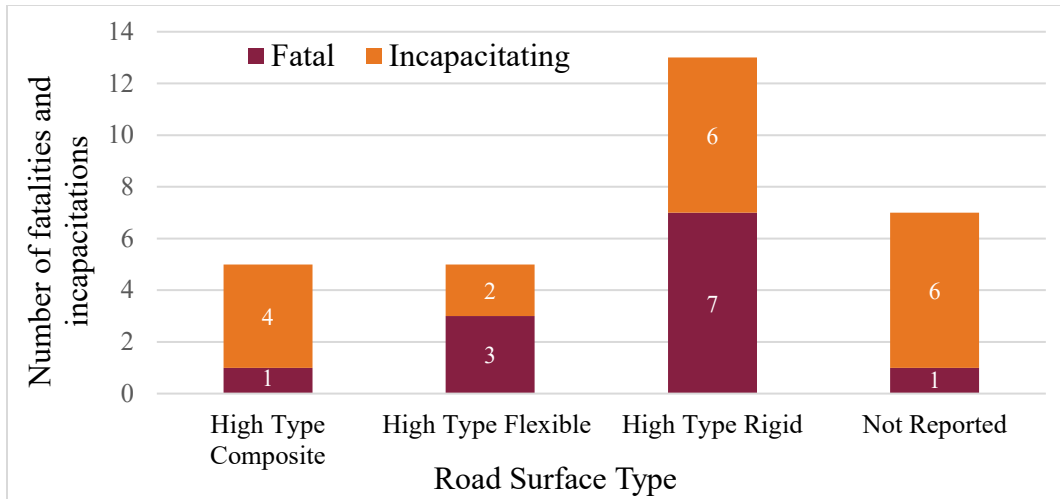
Figure 5. Chart. All KA on flyovers/connectors for various road surfaces.

The road surface type analysis is shown in Figure 5 below. The maximum number of fatalities and incapacitating injuries happened on High Type Rigid road surfaces. The road surface type that was recorded to have the second highest number of fatalities was High Type Flexible, with three fatalities.

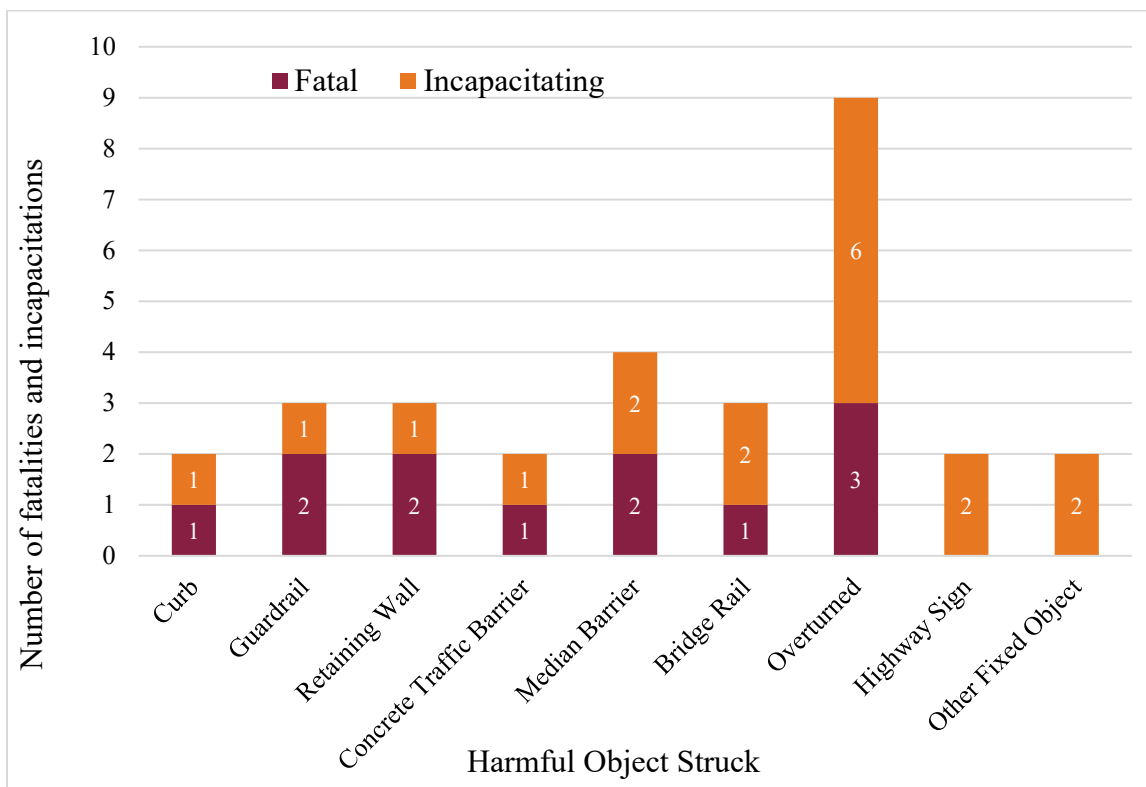
Figure 6. Chart. Distribution of all harmful objects struck resulting in KA on flyovers/connectors.

Figure 6 breaks down the different objects that were struck by motorcyclists in the 30 fatal and incapacitating cases. For cases where no object was struck, many times the bike was overturned, so Figure 6 also shows the number of fatal and incapacitating injuries received by motorcyclists overturning their motorcycle.

Figure 6 demonstrates that many riders involved in a crash on a flyover/connector either struck some type of roadside safety barrier or overturned their bike. On many of these flyovers and connectors, the “median width,” or the distance between where the lane ends and the barrier starts, was found to play some role in the distribution of injuries. Figure 7 shows the number of fatal and incapacitating injuries for different median widths. The highest number of incidences was nine when the median width was between 0 and 10 feet. The next most frequent range of median widths that resulted in either fatal or incapacitating injuries was much larger at 30 to 40 feet. Six KA

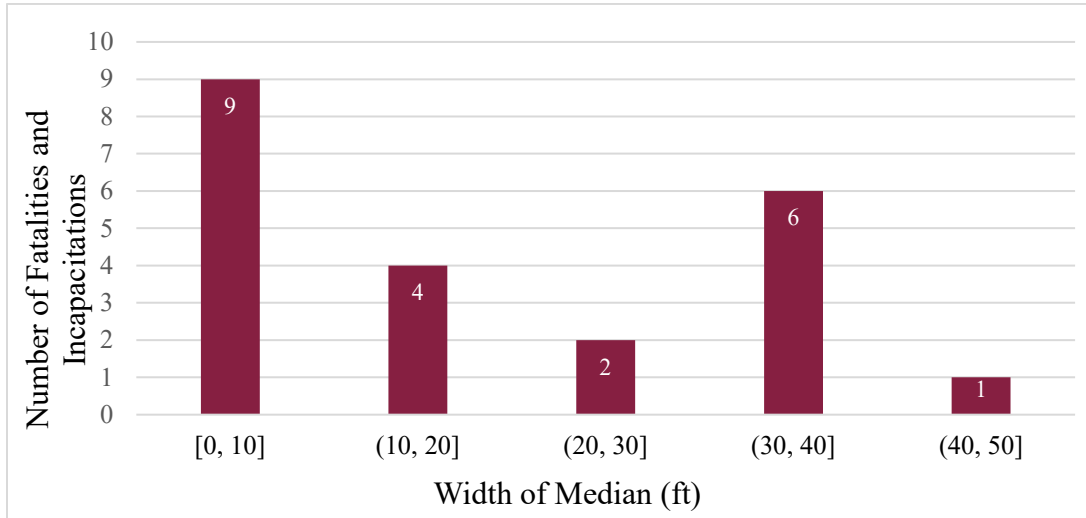
**Figure 7. Chart. All KA for flyovers/connectors with various median widths.**

incidences occurred in the 30- to 40-foot range. Both of these instances could possibly point to a higher risk to riders when the median width is not at an optimal distance away from the rider. Due to the small sample size of KA on flyovers/connectors (only 30 cases), it is difficult to draw this assumption.

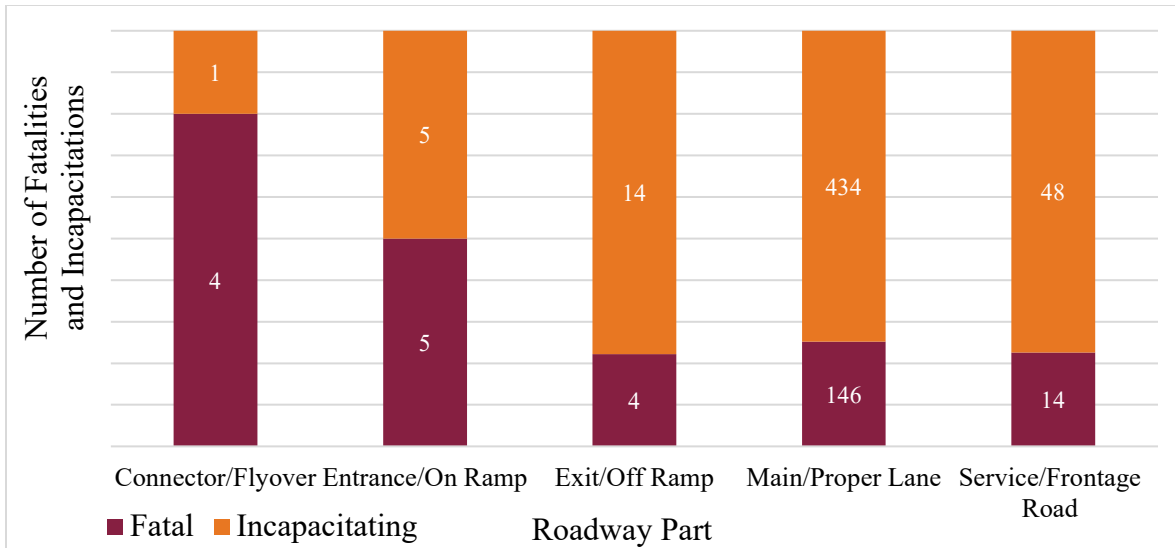
**Figure 10. Chart. All KA on curves for various roadway functional classifications.**

The fatal and incapacitating injury cases happening on curves can be further categorized based on roadway functional classifications. As seen in Figure 10, the majority of fatal and incapacitating injuries occurred in the main/proper lane. The category with the next highest number of fatal and incapacitating injuries was Service/Frontage Road. Very small numbers were recorded on roadways classified as both curves and flyovers/connectors.

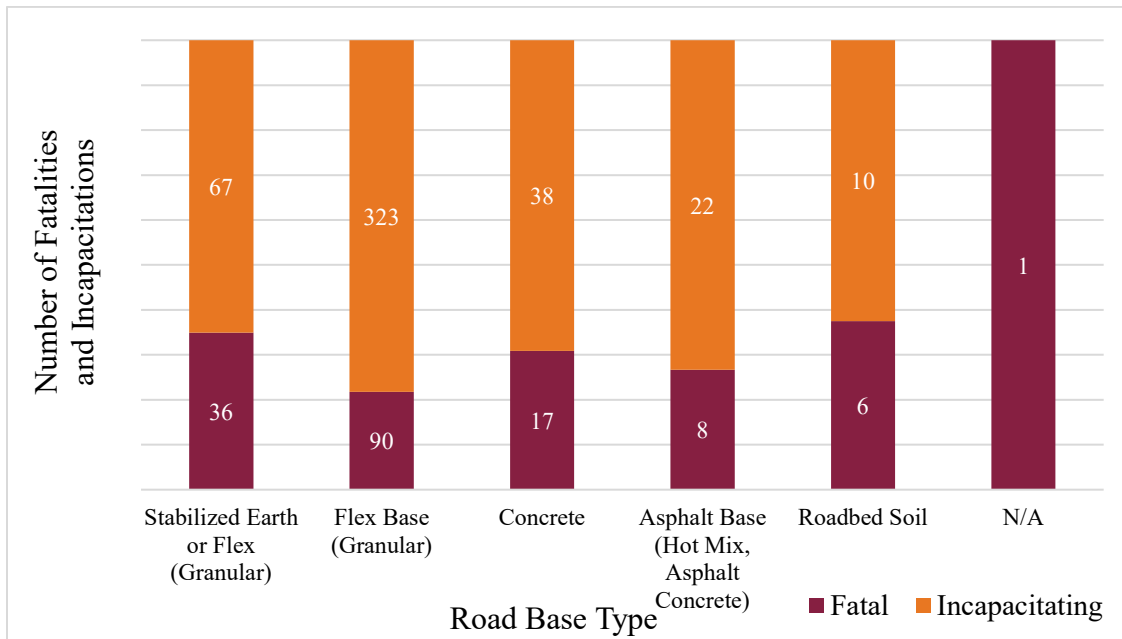
Figure 14. Chart. All KA on curves for various road base materials.

Physical features of the road, such as road base type and road surface type, were also analyzed. Figure 14 shows that the most dangerous road base type was Flex Base Granular, with 323 incapacitating cases and 90 fatal cases. The next most significantly dangerous base type for motorcyclists was Stabilized Earth or Flex Granular, which had 67 incapacitations and 36 fatalities. Figure 15 shows that the two road surface types that produced the most incapacitating injuries were High Type Flexible and Low Type Bituminous Surface-Treated, both with 170 cases each. High Type Flexible was the road surface type that had the highest number of fatalities.

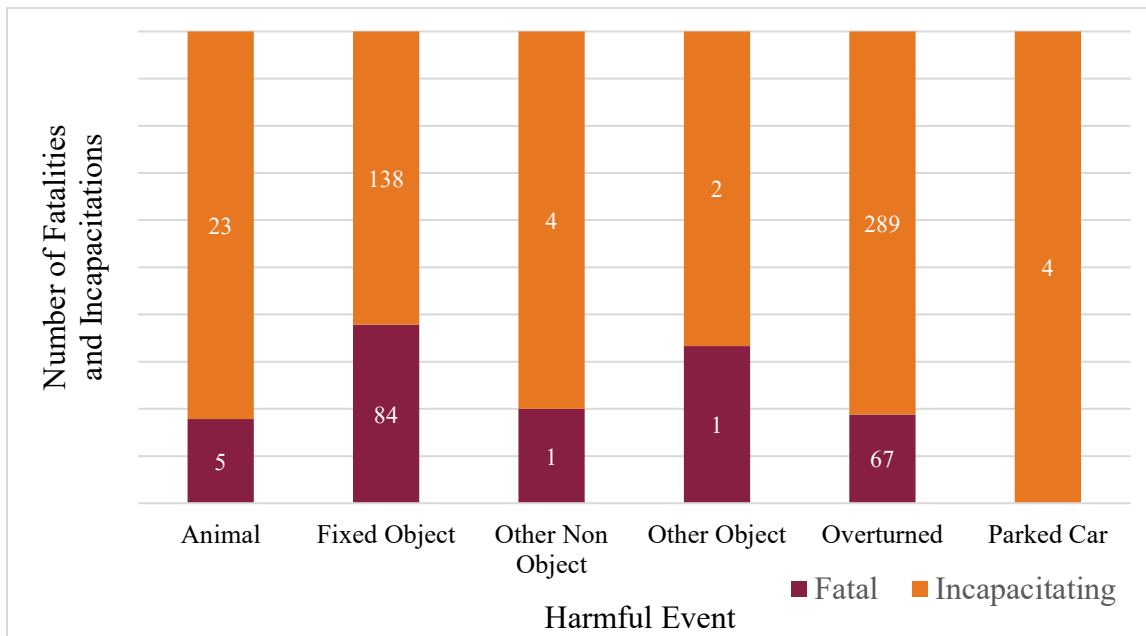
**Figure 16. Chart. All KA on curves for harmful events.**

The next section focuses on the nature of the collision and includes aspects such as harmful events, objects struck, and speed limits. For all 675 fatal or incapacitating cases that happened on curves in Texas, the first injury- or damage-producing event was recorded and is represented in Figure 16.

Similar to flyovers/connectors, the two most common harmful events were collisions with fixed objects and the overturning of the rider’s motorcycle. Out of the 675 cases, 356 of them were classified as overturned. Of these 356, 67 were fatal and 289 were incapacitating. For riders that collided with a fixed object, there were 138 incapacitating cases and 84 fatal cases. Thus, riders on curves who collide with a fixed object are much more likely to be killed. A small number of crashes were caused by animals on the road, with 23 incapacitating cases and 5 fatal cases. Figure 17 further breaks down the different fixed objects that were struck and other roadside objects that caused injuries.

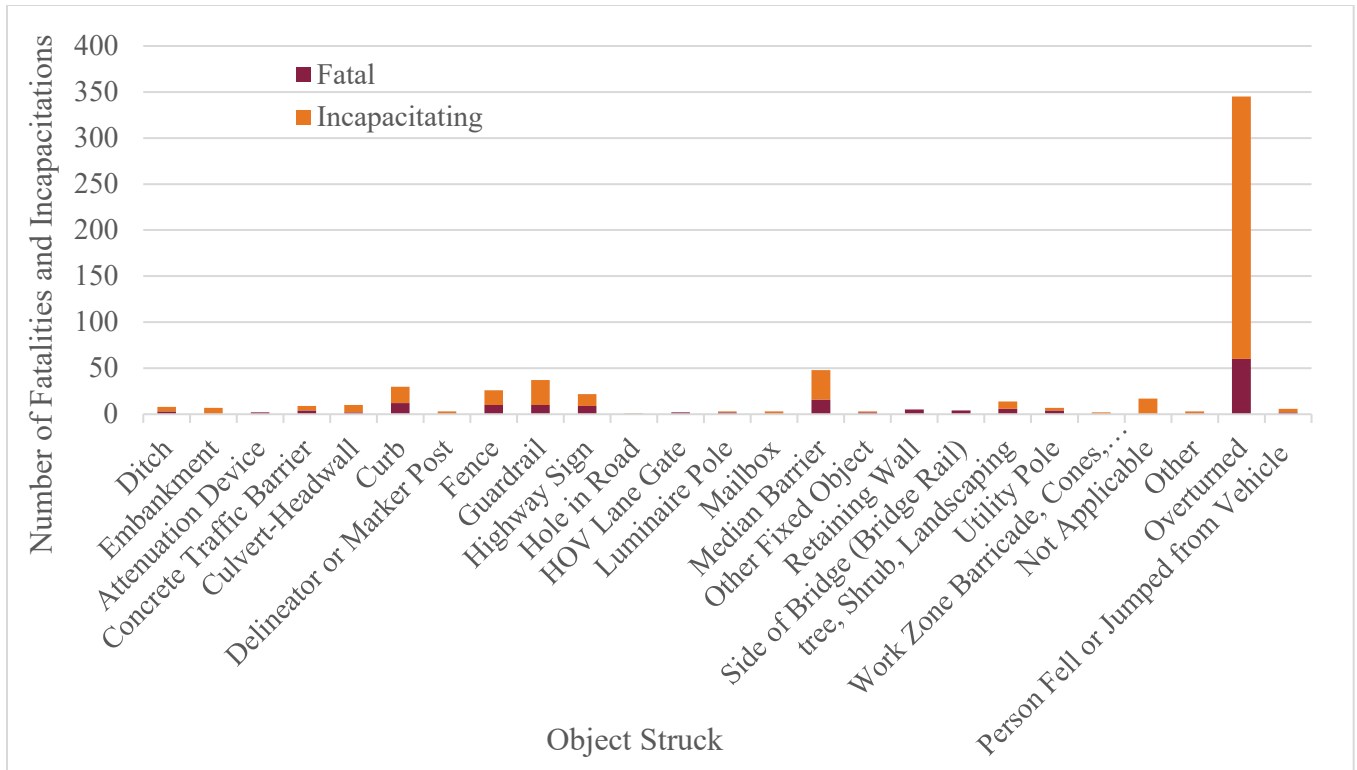
Figure 17. Chart. All KA on curves for objects struck.

Figure 17 provides details on exactly what the motorcycle struck, whether it was some type of roadside barrier system, a natural embankment, or a sign, etc. As previously stated, a large number of motorcyclists overturned and a large number of them hit fixed objects. Median barriers were the most hit object, with 32 incapacitations and 16 fatalities. There were also small numbers recorded for fences, guardrails, signs, and curbs. Figure 18 and Figure 19 show the distribution of crashes that occurred in areas of different posted speed limits. Figure 18 shows the distribution of fatalities, and Figure 19 shows the incapacitations. Note that the speed ranges represent the posted speed limits, not necessarily the speed of the motorcycle at the time of the crash.

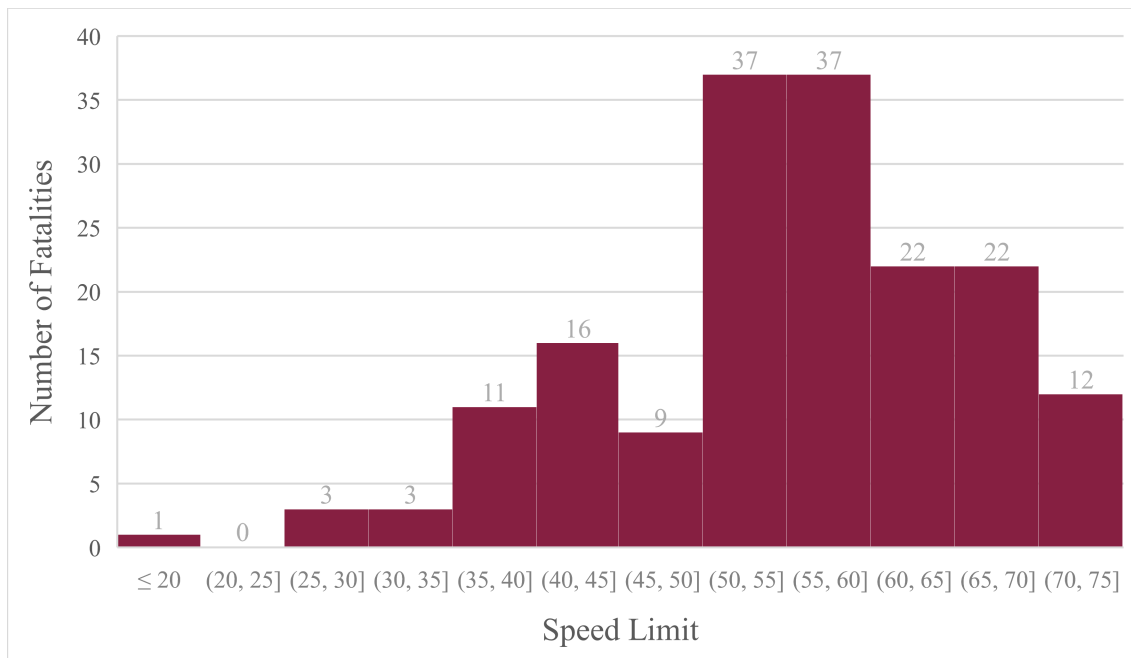
Figure 18. Chart. Distribution of fatalities for different speed limits.

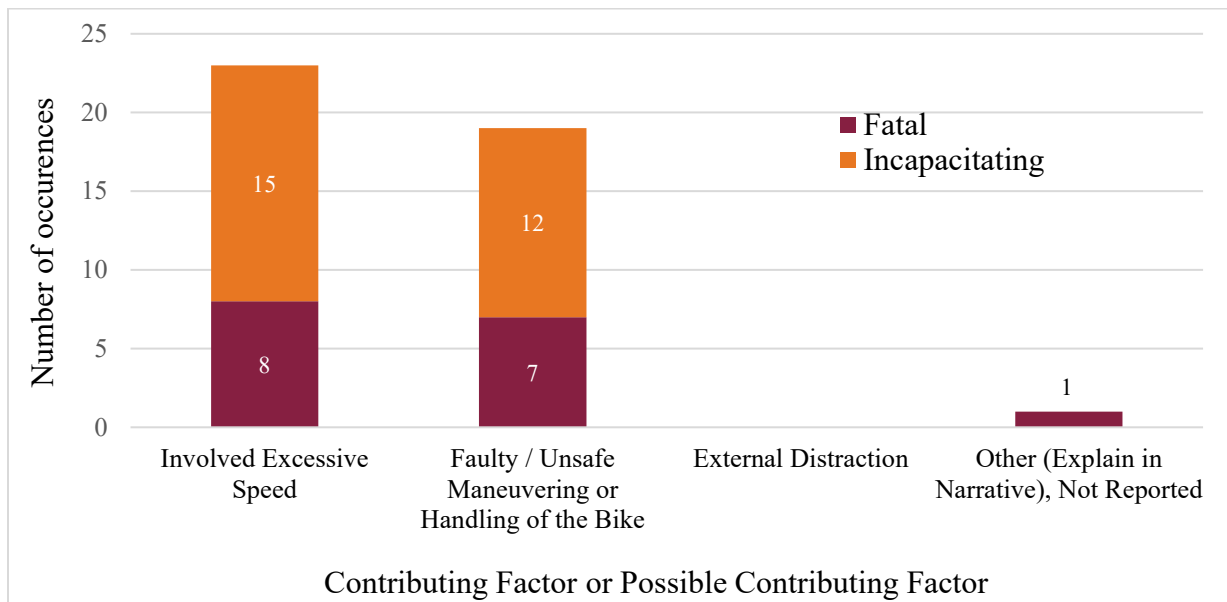
Figure 21. Chart. Distribution of secondary contributing factors and possible contributing factors for KA on curves where the primary contributing factor was “Under the influence.”

From these figures it can be seen that quite often when speeding was a primary contributing factor or possible contributing factor then alcohol was also involved. Similarly, when “Under the influence” was the primary contributing factor, excessive speed was also commonly identified as a possible contributing factor.

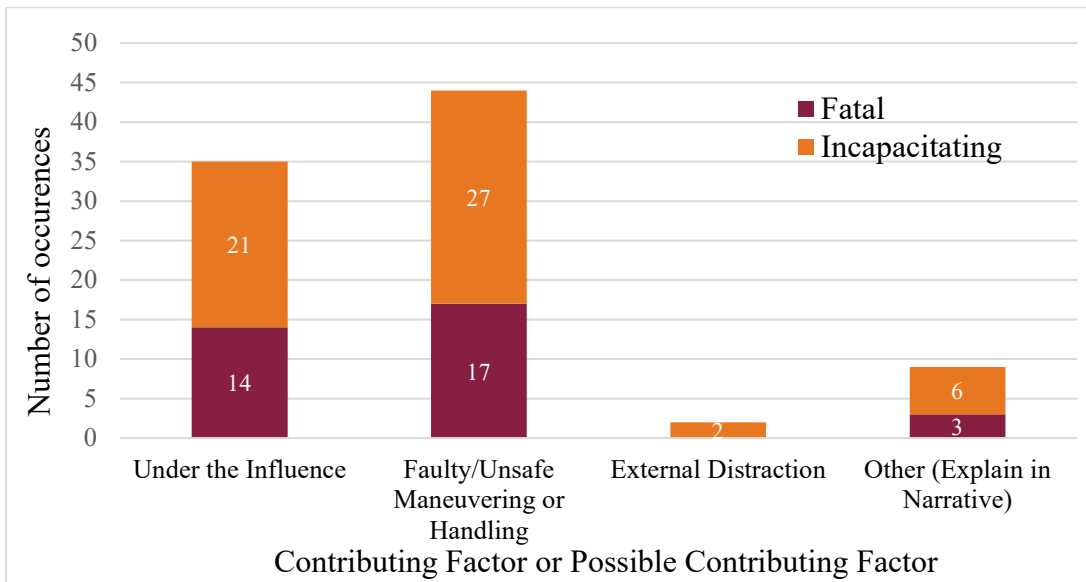
Figure 23. Chart. Distribution of secondary contributing factors and possible contributing factors for KA on curves where the primary contributing factor was “Involved excessive speed.”

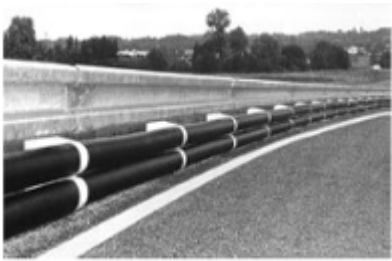
Cable Cover	Cable cover for wire rope safety fence, invented by Mr. Johansson (Sweden).

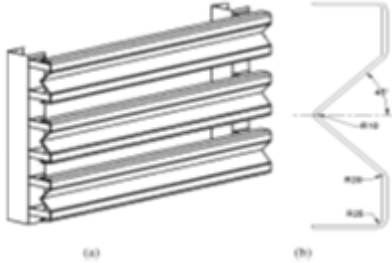
Modified W-Beam Guardrail System for the Control Purpose	W-beam system with one made of PP and the AISI 1020 steel. There is no change in standard dimensions (M617-11 standard) for W-beam.

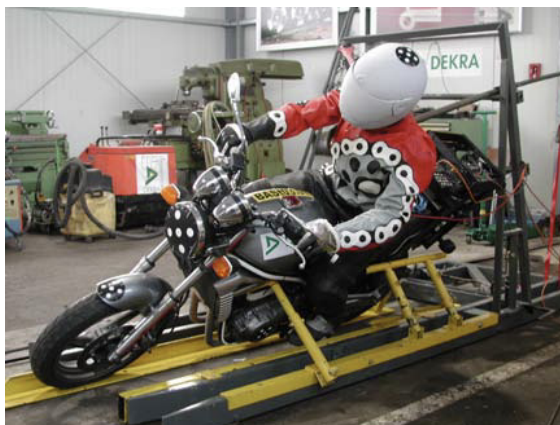
Figure 29. Test sled in inclined position with motorcycle and dummy (Peldschus et al., 2007).

The data were separated into primary and secondary data to distinguish the difference between contact with the safety system and loads that are caused by the fall on the ground. This separation was necessary due to impact of the head on the ground, which caused a high peak in the acceleration data.

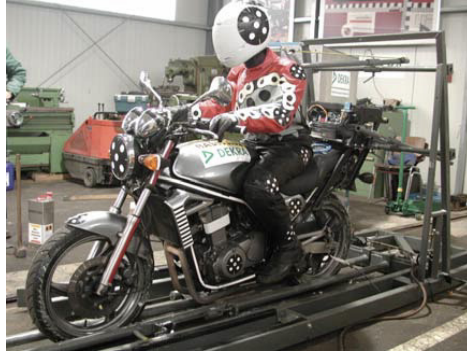
**Figure 30. Test sled in upright position with motorcycle and dummy (Peldschus et al., 2007).**

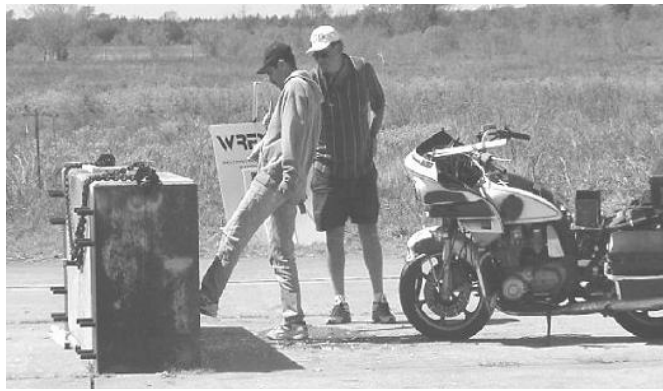
**Figure 31. Concrete barrier and motorcycle type used in full-scale motorcycle crash testing (Adamson et al., 2002).**

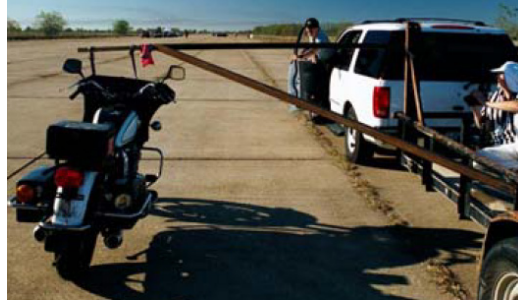
Figure 32. Motorcycle tow system (Adamson et al., 2002).

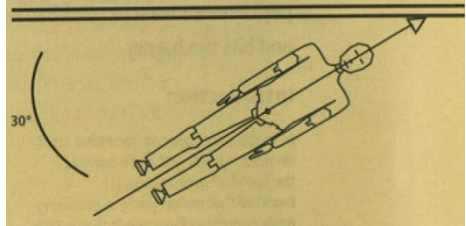
<p>60 km/h 37.3 mi/h</p>	<p>30°</p>
<p><b>Test 2. Dummy parallel to the test item</b></p>

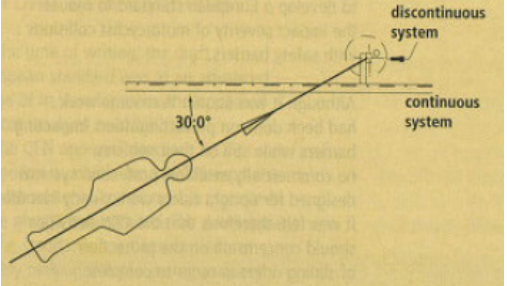
<p>60 km/h 37.3 mi/h</p>	<p>30°</p>
<p><b>Test 2. Dummy aligned with launch path – Mid-Span</b></p>

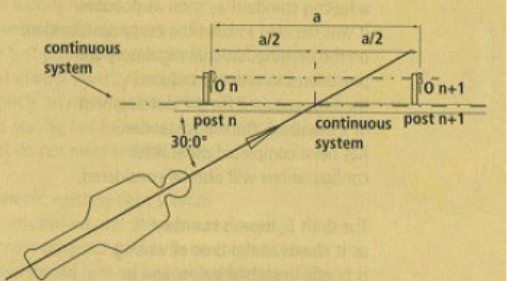
<p>60 km/h 37.3 mi/h</p>	<p>30°</p>
<p><b>Test 3. Dummy aligned with launch path – Post Offset</b></p>

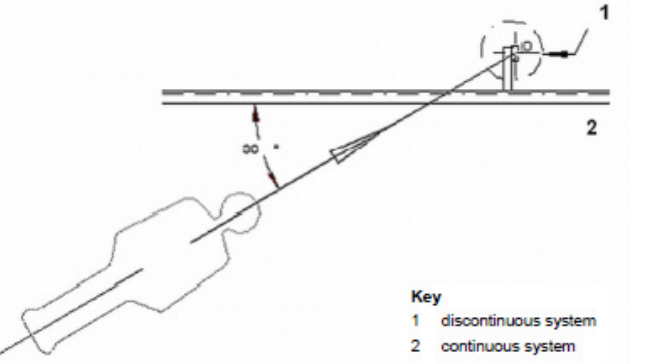
<p>Key 1 discontinuous system 2 continuous system</p>	<p>60 km/h 37.3 mi/h</p> <p>or</p> <p>70 km/h 43.5 mi/h</p>	<p>30°</p>
<p><b>Test 2. Launch Configuration 2: Post-Offset Impact</b></p>

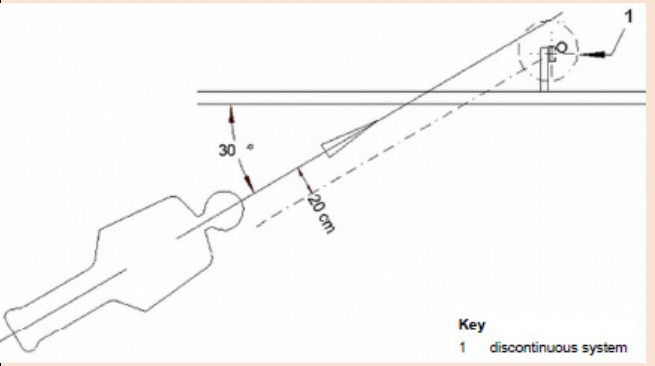
<p>Key 1 discontinuous system</p>	<p>60 km/h 37.3 mi/h</p> <p>or</p> <p>70 km/h 43.5 mi/h</p>	<p>30°</p>
<p><b>Test 3. Launch Configuration 3: Mid-Span Impact</b></p>

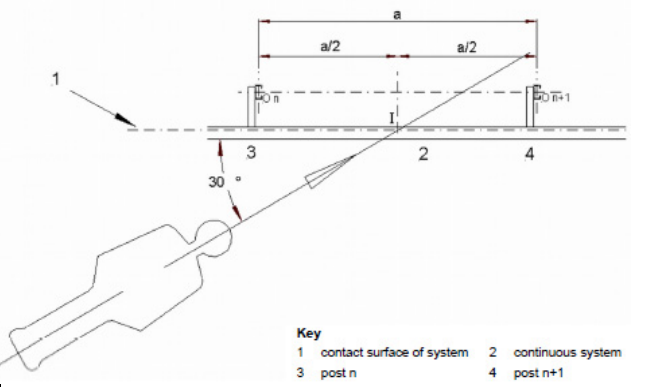
<p>Key 1 contact surface of system    2 continuous system 3 post n    4 post n+1</p>	<p>60 km/h 37.3 mi/h</p> <p>or</p> <p>70 km/h 43.5 mi/h</p>	<p>30°</p>

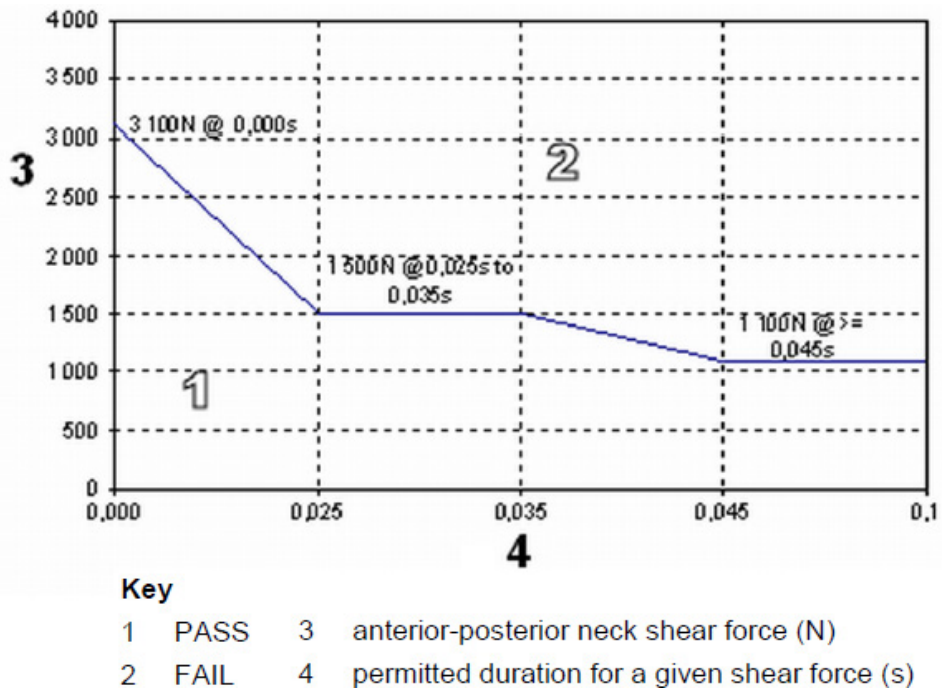
Figure 33. EN 1317-8 Technical Specification Force and Moment Criteria

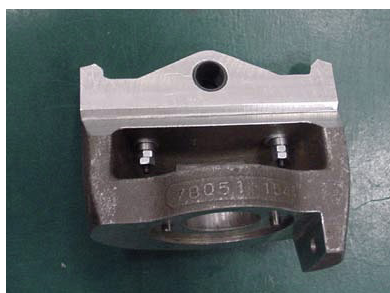
Figure 35. Frangible shoulder for Hybrid III dummy (Peldschus et al., 2007).
