Linking Stream Restoration Success with Watershed, Practice and Design Characteristics

Thesis submitted to the faculty of the Virginia Polytechnic Institute and State University
in partial fulfillment of the requirements for the degree of

Master of Science
In
Biological Systems Engineering

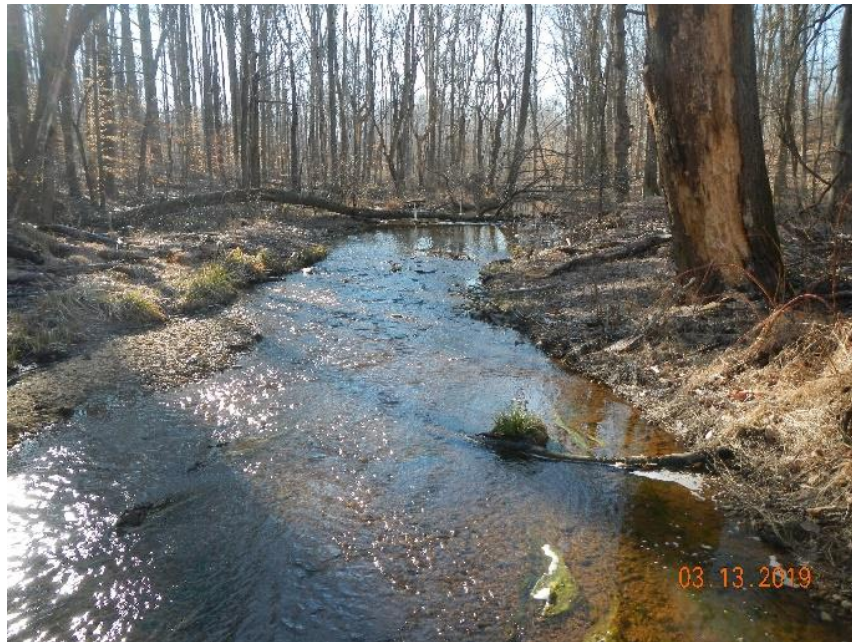
Figure 4-3 Representative photograph of project 7

Overall, function assessment scores determined from field visits ranged from 42% to 100%. Lower function scores were commonly a result of low bed heterogeneity, high bank heights, and lack of, or invasive-dominated, riparian vegetation, while projects scoring higher in the function assessment displayed bed and bank features associated with geomorphic stability (i.e. equilibrium). Visually, projects that tended to score higher for function had low bank heights and well-established, native vegetation. For example, projects 7 and 28 scored perfect scores in the function assessment, and both exhibit the aforementioned attributes of a functionally successful stream restoration project. Photographs shown in Figure 4-3 and Figure 4-4 highlight these characteristics.

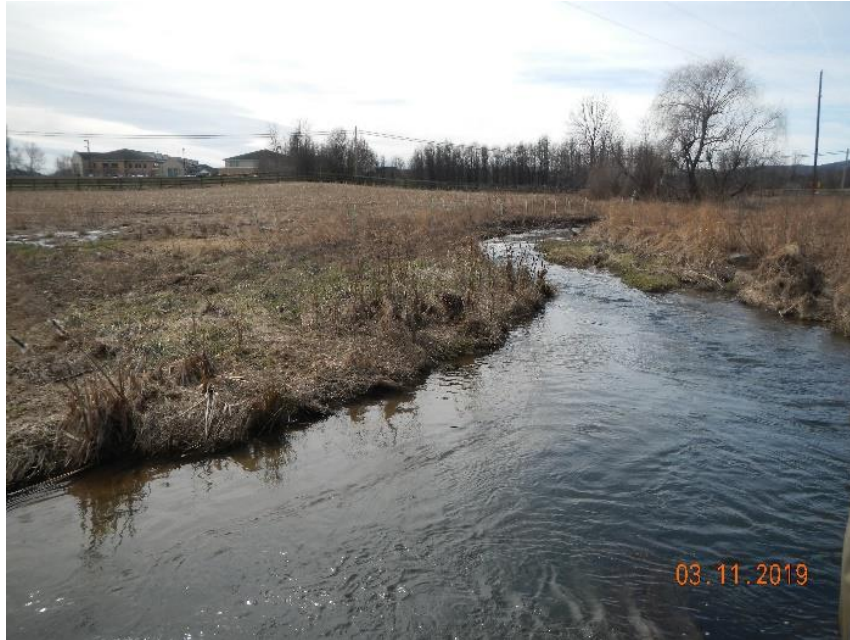
Figure 4-4 Representative photograph of project 28

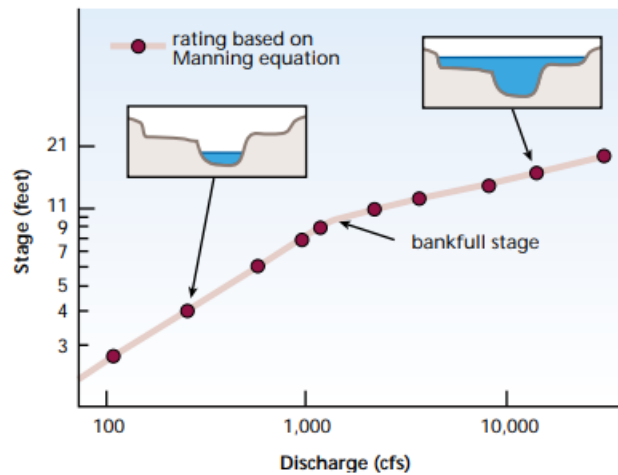
Figure 4-5 Determining bankfull stage from a rating curve (from FISRWG, 1998)

The continuity equation shows that as discharge increases, either flow area or velocity must increase. Likewise, Manning's equation shows that as discharge increases, wetted perimeter must increase to balance the extra driving force with additional friction. In effect, flow area increases until flow reaches the floodplain, when wetted perimeter increases dramatically as the flow spreads across the relatively horizontal cross section. This behavior is well-illustrated in figure 4-5. As can be seen in the rating curve (stage-discharge relationship), larger increases in discharge result in smaller increases in stage when the flow has reached the floodplain.

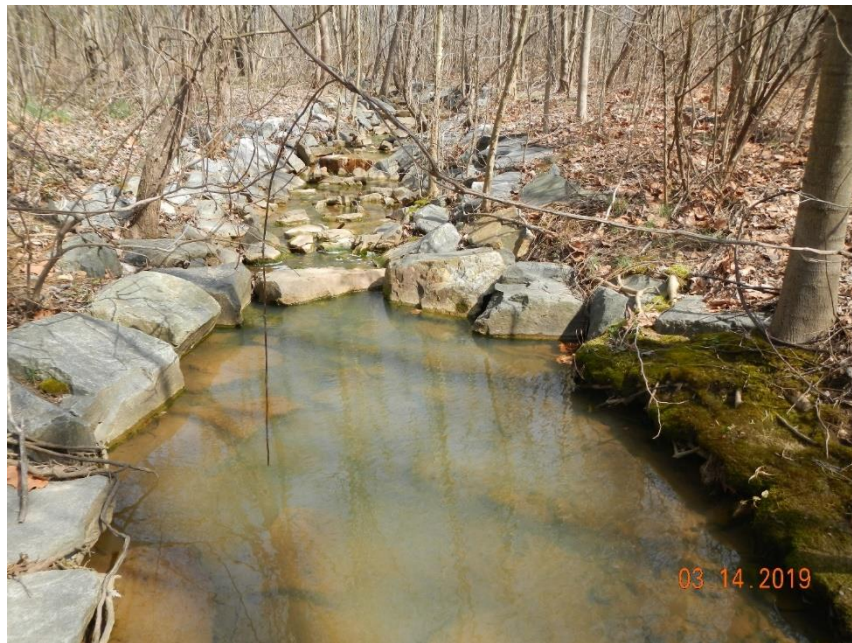
Figure 4-7 Conservative design of project 19

Interestingly, however, log of construction year reappeared as a significant variable when D_{50} was included as a predictor (i.e., when projects missing D_{50} information were removed). As projects 3 and 22 were two of the three projects removed for missing D_{50} , the only difference between the datasets used in the “Design>0” and “Design>0 including D_{50} ” regressions was the removal of project 19 for missing D_{50} . As such, project 19 clearly exerted a large influence on the “Design >0” regression, likely because project 19 was a relatively old project (constructed in the early 2000s) but received a high design score of 84%. Upon further observation of project 19, it became apparent that it was designed conservatively using a large amount of rock that was large

relative to the stream size, a technique that was atypical of the older projects assessed in this study. A representative photograph of the design approach used in project 19 is shown in Figure 4-7.

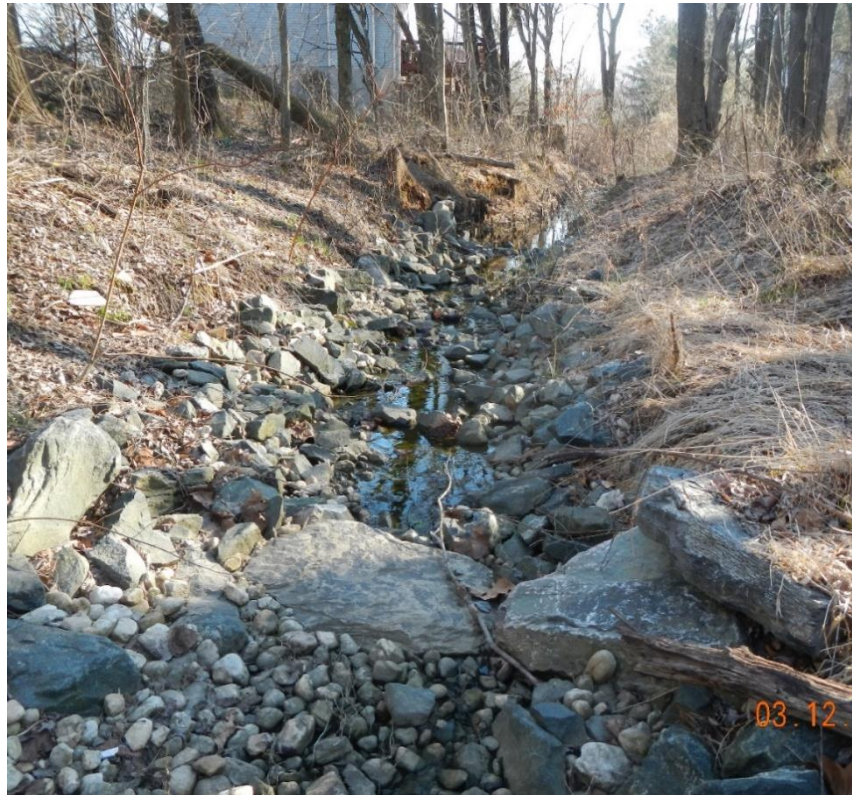
Figure 4-9 Representative photograph of project 47

The greatest differences between scores occurred when the design score was high and the function score was low (e.g., projects 1, 4, 21, 33, 34, 42, and 47). These projects were constructed in areas confined by development and included a lot of large rock in their designs. For example, project 47 scored 100% for the design, indicating the construction was resilient and stable. The function score, however, was only 50%, as it scored low for all function categories except bank stability and riparian vegetation. The remaining categories are indicators of sediment transport function, which was not apparent during the field assessment. As can be seen in Figure 4-9, project 47 consisted of a majority of large rock, so sediment mobility was not intended. This project was located adjacent to a housing development, where space for construction was limited, and where out-of-bank flooding would have impacted homes. At some points along the stream, the project limits of disturbance aligned with adjacent property lines. Because of these spatial constraints,

restoration of geomorphic function was difficult, and preference was clearly given to channel stability.

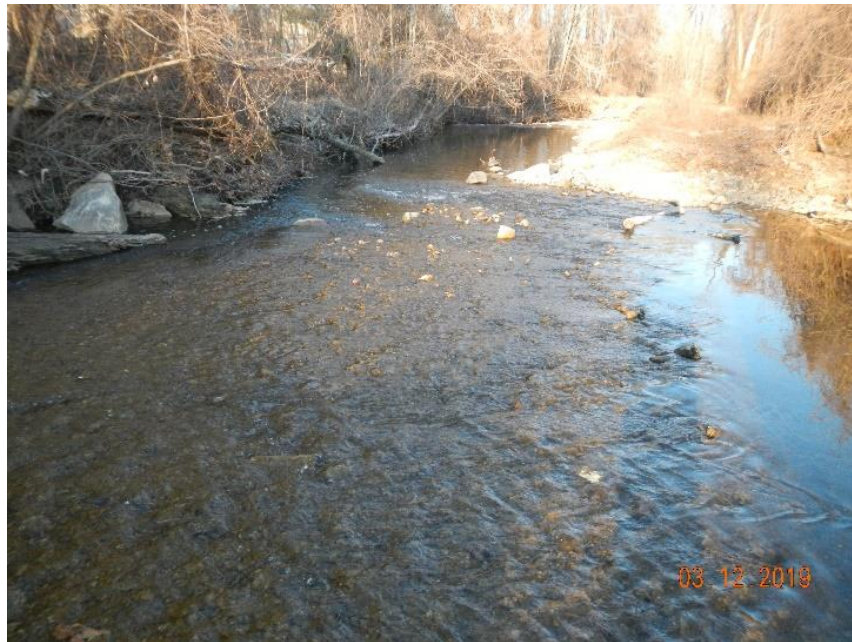
Figure 4-10 Representative photograph of project 3

In contrast, projects 3 and 22 scored zero in the design assessment but exhibited many geomorphic processes. These two projects were two of the oldest projects assessed in this study, having been constructed prior to 2000. In both projects, the majority of in-channel work consisted of bank stabilization through stone or wood placement. As none of the bank stabilization measures were observed during the field assessments, they had failed over the course of the projects' lifetime. Since they were minimally invasive to the stream channel; however, their failure did not have large effects on stream function. Both projects received high scores for bedforms, substrate,

and cover, but exhibited poor floodplain connectivity. Photographs of these two projects are shown in Figures 4-4 and 4-5. Note that both projects appear to be functioning as natural streams, but no intact structural design components are apparent.

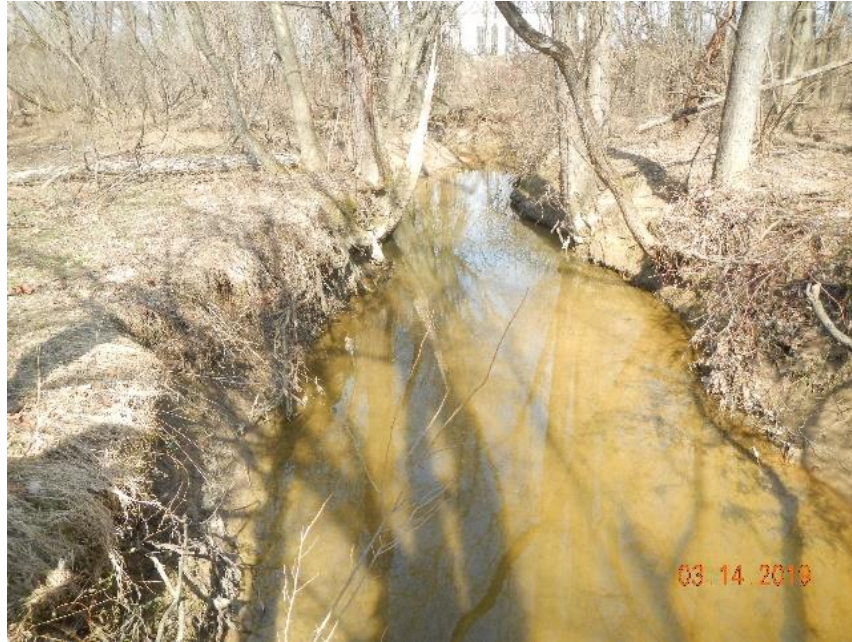
Figure 4-11 Representative photograph of project 22

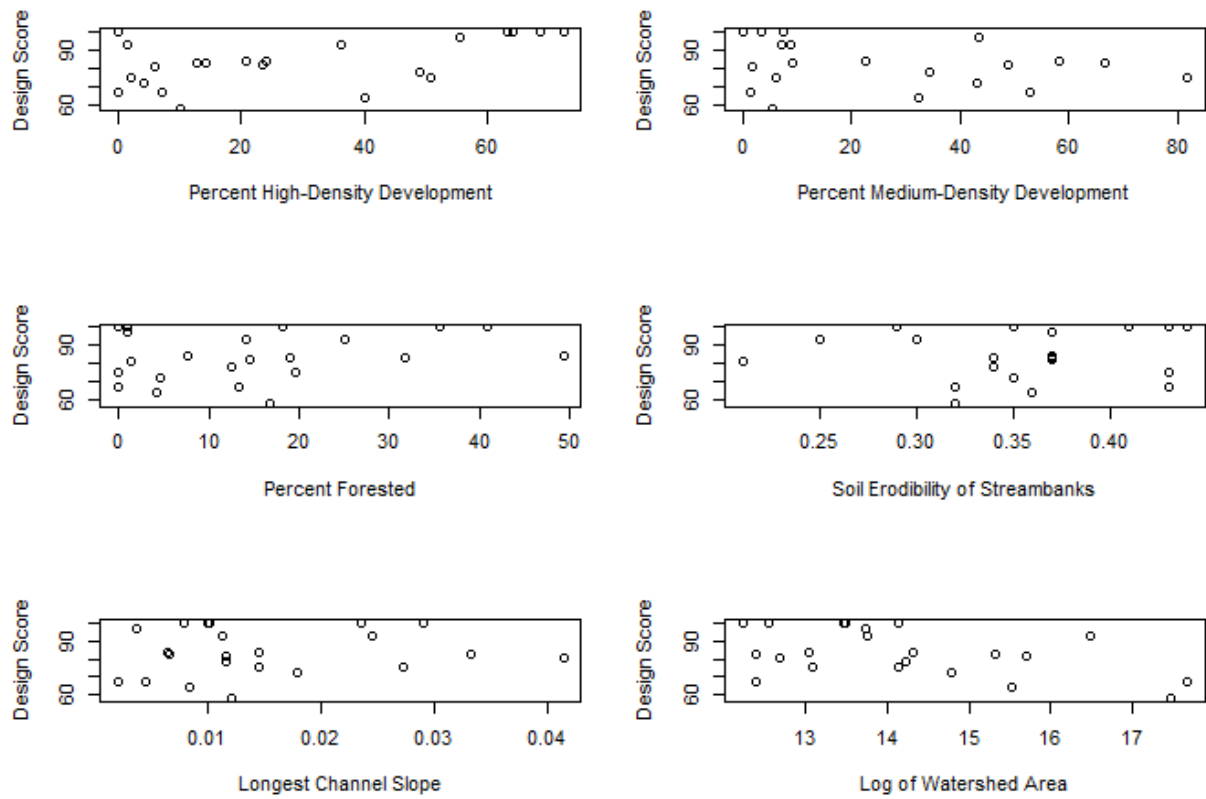
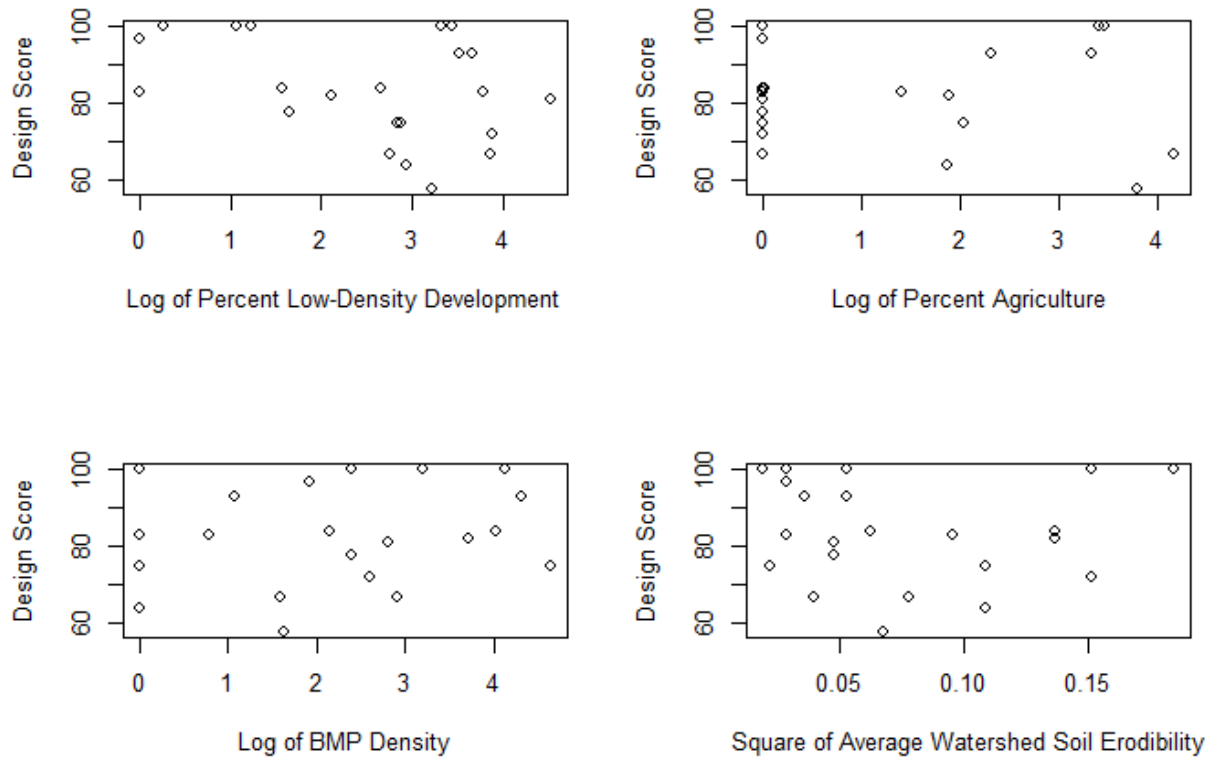
Figure D-2 Design score vs watershed-level variables

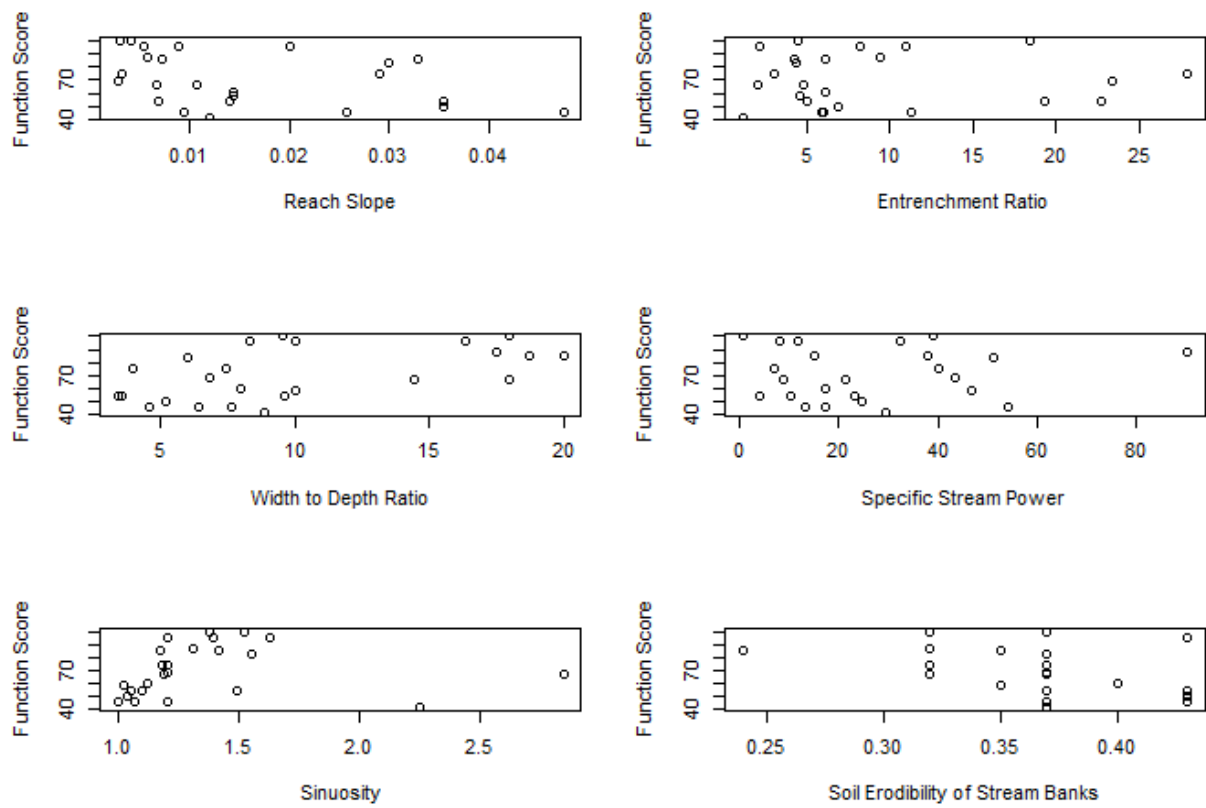
Figure D-4 Function score vs project-level variables

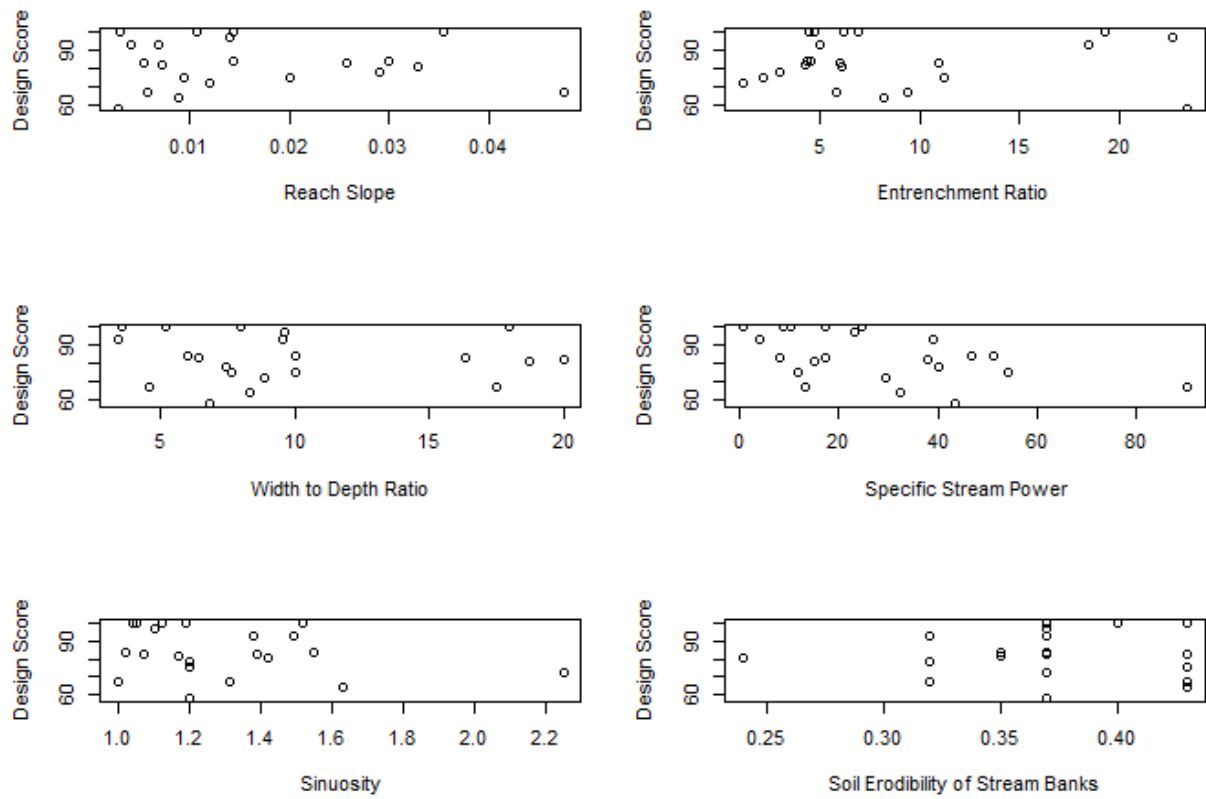
Figure D-5 Design score vs project-level variables

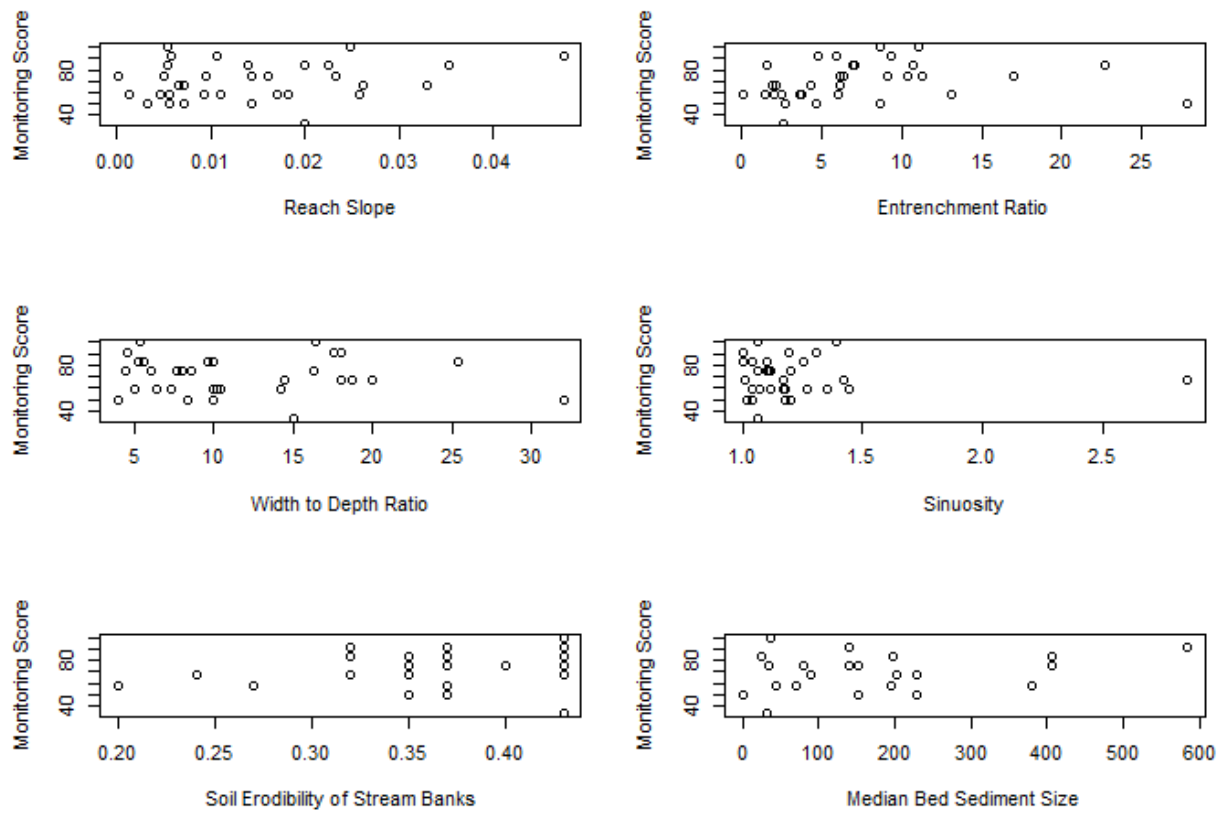
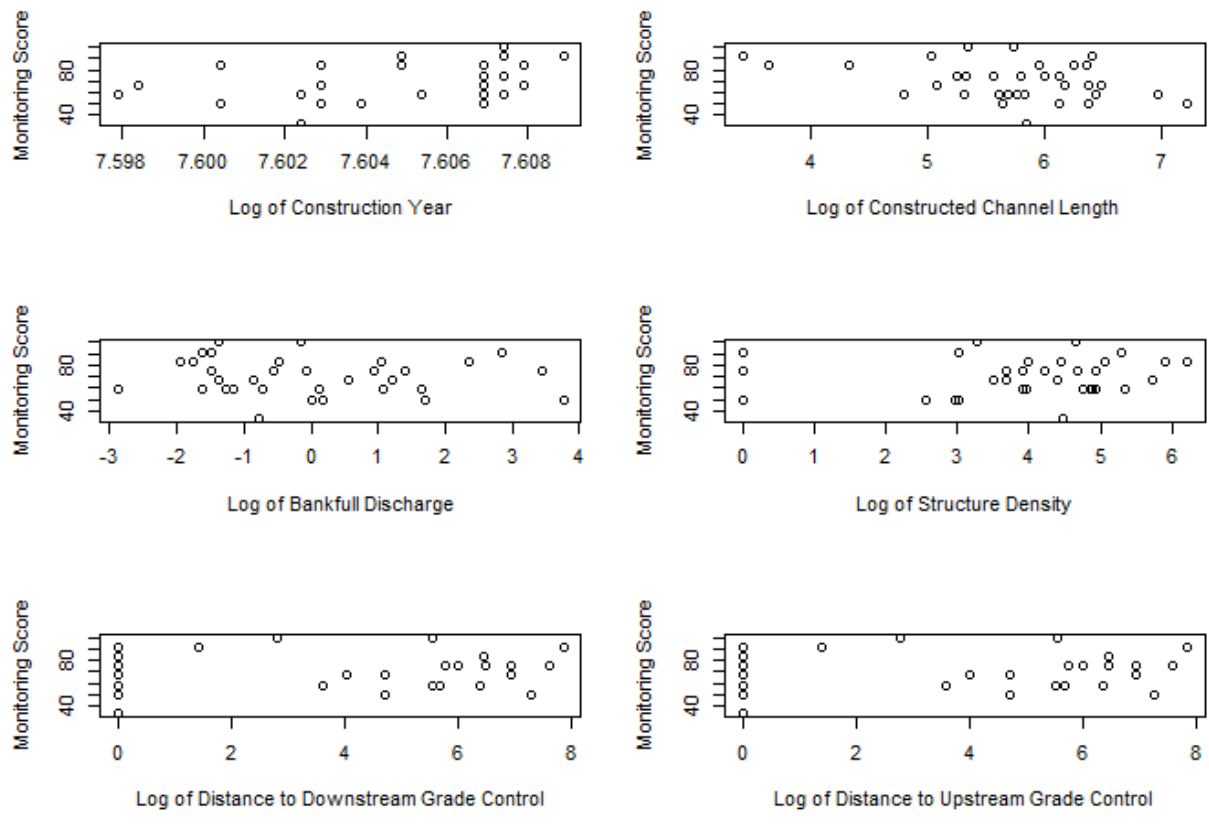
Figure D-6 Monitoring score vs project-level variables

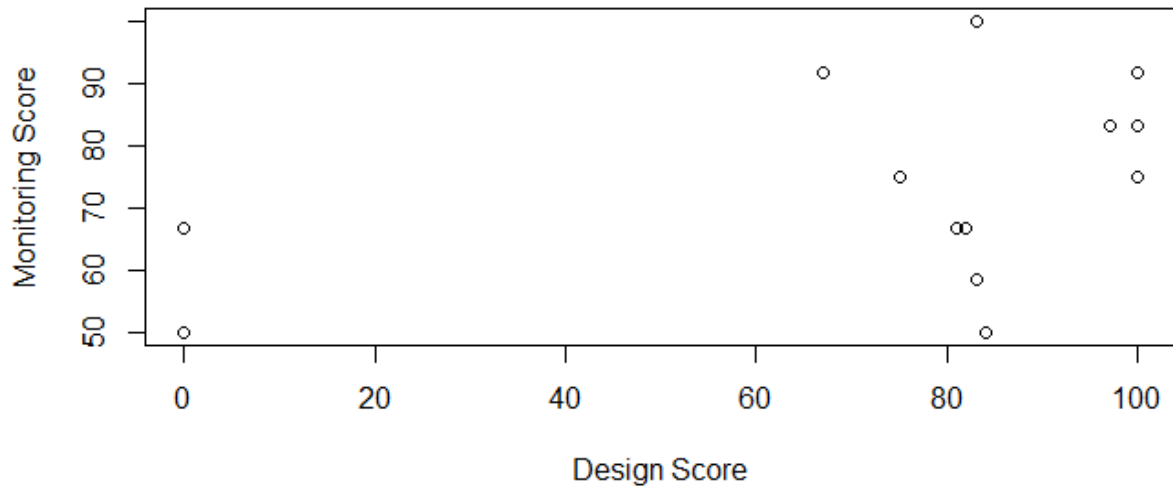
Figure D-9 Monitoring Score vs Design score
