USE OF PHOTOGRAMMETRY AIDED DAMAGE DETECTION FOR RESIDUAL STRENGTH ESTIMATION OF CORROSION DAMAGED PRESTRESSED CONCRETE BRIDGE GIRDERS

Thesis submitted to the faculty of the Virginia Polytechnic Institute and State University in
partial fulfillment of the requirements for the degree of

Master of Science
in
Civil Engineering

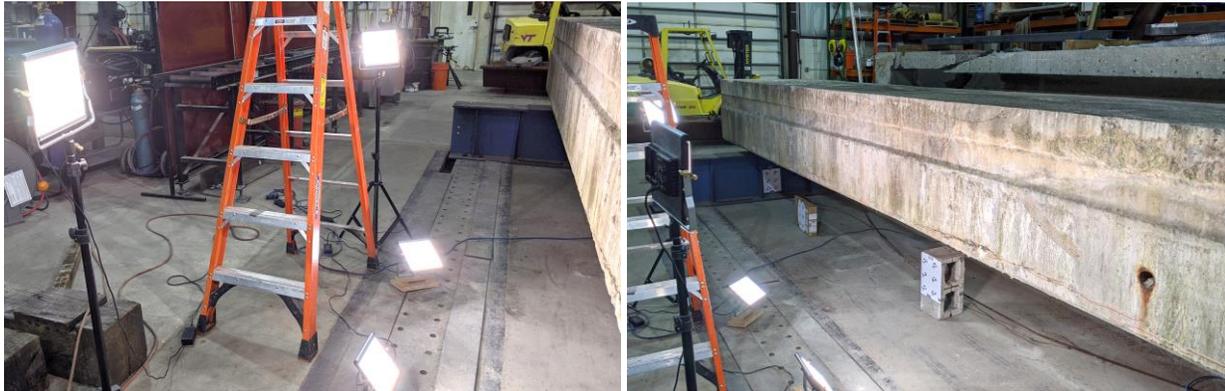
Figure 3.2. LED Lights Used to Capture Images of the Girders in an Indoor Setting

The surroundings of the girders had to be well lit while taking the images. It was observed that using almost the same background lighting for the images captured from each side of the object, helped to get better results. Different sides of the girders were usually found to be illuminated differently, both when capturing the images outside and inside, due to the surroundings of the girders. For this reason, when working inside the laboratory setting, LED lights were used to provide artificial lighting to reduce the effect of shadows and relatively darker regions around the girders. Care was taken so that the LED lights did not obstruct the field of view of the camera and that the portion of the girder exposed to lighting was uniformly lit. The lights were moved around the beams as the process of image capture continued. Bi-color (yellow and white light) LED lights used while taking images of the box beam inside the laboratory were of model NEEWER NL480 (Power: 28W, Lumen: 3360Lux/m) and are shown in Figure 3.2. Two lights were used to illuminate the side surface of the beam and two lights for the bottom surface. For some of the beams, images were captured in an outdoor setting. In these cases, it was ensured that there was enough light (sunny day). If the times of the day varied too much during the image capture process, the quality of the point cloud was affected by different regions having different illumination. So, it was made sure that the times of the day did not vary too much during the process. No artificial lighting was used during the image capture process in outdoor settings. The bottom surfaces of the beams were dimly lit. Due to this, it was important to choose the camera parameters that provided good illumination on the bottom surfaces. Another major difficulty while capturing images outside is the glare from the sunlight. Care had to be taken that the images from each location did not have too much glare due to the sun. When images are captured using a UAV,

lighting is required for the dimly lit parts of the bridge. More work is to be done to determine the optimal lighting to capture sharp and well-lit images. As mentioned in Section 2.2, Dorafshan et al. (2017) used a minimum surface illumination of 200 Lux for capturing good images of a steel bridge to identify the cracks. They did not reconstruct a 3D mesh model from the images and used the images directly to identify the cracks manually.

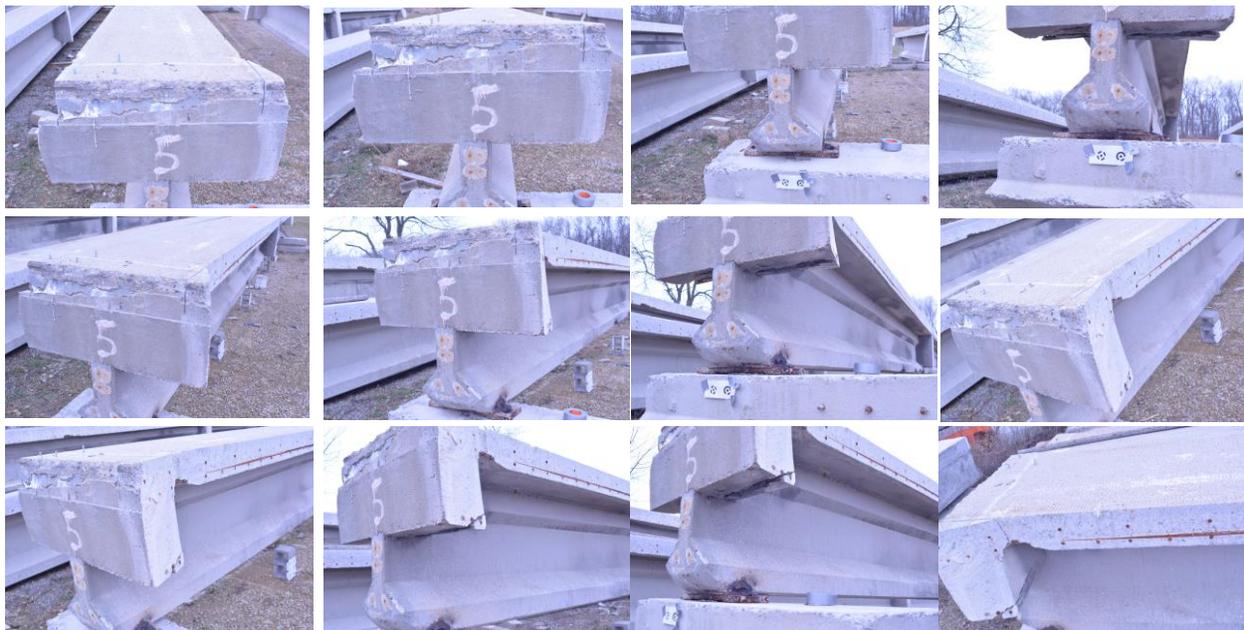
Figure 3.4. A Sequence of Images from Consecutive Locations Captured for Point Cloud Reconstruction of I-Beam 5

In this process, images were captured with a handheld camera at various locations by walking around the beam so that the entire beam is covered. The total number of images taken was dependent on the availability of space around the beam. The goal was to cover the entire beam incrementally. At each location, only some portion of the beam was in the frame of the camera, and images were taken at multiple levels (from top to the bottom of the girder) using a ladder, to cover the whole cross-section of the beam including the bottom surface. The bottom of the beam was captured only from a side angle with the camera held at a low height from the ground, not going all the way underneath the beam. All the image capture locations of the handheld camera for I-Beam 5 are shown in Figure 3.3. In each picture, only a part of the cross-section of the beam was visible. This can be seen in Figure 3.4 where a sequence of images taken for I-Beam 5 is shown. Care was taken such that any two consecutive images and images from two consecutive locations had about 70-75% overlap. The overlap between two images at the same location (capturing different levels along the depth) can be called side overlap and the overlap between images from each location along the length of the beam is called forward overlap. For aerial photography, Agisoft recommended a 60% of side overlap and 80% of forward overlap. This overlap requirement has to be satisfied if the image capture is done with a UAV. It was ensured

such that each point on the beam was captured in at least two pictures so that the software can locate this point in three dimensions. Regions that could not be seen in more than one image, called blind-zones were avoided. Swift movement from one location to another or in between two consecutive pictures, caused the camera to be unstable which caused the pictures to be blurry. Blurry images had to be avoided.

It was ensured that the portion of the beam being photographed, covered the maximum area on each frame while taking the images. The entire cross-section of the beam was always not in the frame. Hence, for example, if the deck of the beam and only a portion of the top flange was in the first image frame, the next image was taken such that it covered a portion of the top flange and the region down maintaining an overlap of 70-75% with the previous image. A sequence of images captured from consecutive locations starting at one of the ends of I-Beam 5 is shown in Figure 3.4. Some of the intermediate images between the images shown in Figure 3.4 are not included here because it is recommended not to use excessive overlap. Although the actual images set had more intermediate images, the overlap was not large enough to cause problems in the point cloud of I-Beam 5. In other trials conducted, an excessive overlap of about 90% between consecutive images was found to be problematic, as it caused black colored noise on the point cloud. An overlap below 60% between two consecutive images is not recommended in the documentation. Optimal image overlap would result in more stable alignment and reconstruction results. Markers were placed at about 5 ft to 6 ft spacing underneath the beams on both sides. These markers can be seen underneath the box beam in Figure 3.2. In this research, markers were not used to establish a coordinate system for the point cloud as the real-world distances between the markers were not measured.

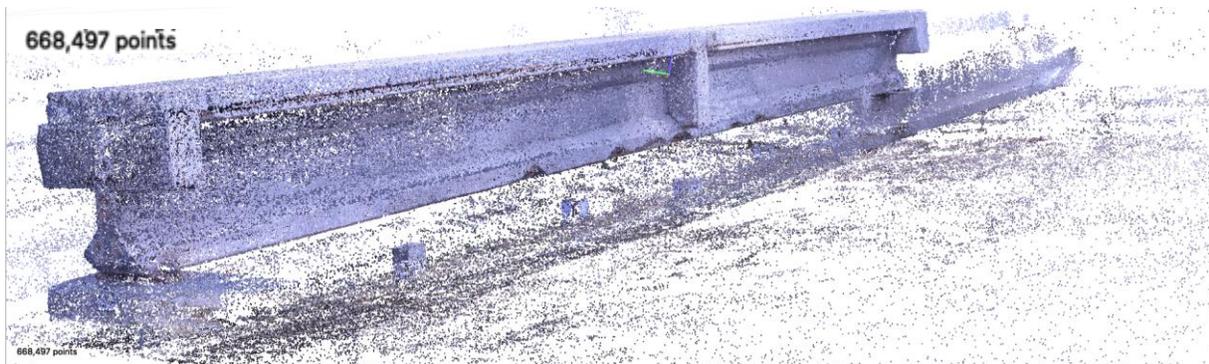
a) Sparse Point Cloud for Lesner Bridge I-Beam 5

Figure 3.6. Sparse Point Cloud, Dense Point Cloud and Textured Mesh Model of Lesner Bridge I-Beam 5

The first step in building the 3D digital state model of the girders using Agisoft Metashape is, aligning the photographs and generating a sparse point cloud as described. Parameters used for ‘Align Photos’ step on Agisoft Metashape are shown in Figure 3.5a. Time taken for this step is demonstrated in Chapter-4 Section 4.1. Sparse point cloud generated for I-Beam 5 shown in Figure 3.6a contains a large number of points from the surroundings around the object of interest. These surroundings were not needed and had to be removed to reduce the time taken for the next step, dense point cloud reconstruction. This is done by moving and resizing the ‘region’ of the object on Agisoft Metashape, which meant specifying a bounding box around the object in the sparse cloud. The software built a dense cloud for the points lying only inside the bounding box, and this was found to reduce the time taken for dense point cloud step drastically. Bounding box specified around the sparse point cloud of I-Beam 5 is shown in Figure 3.6b.

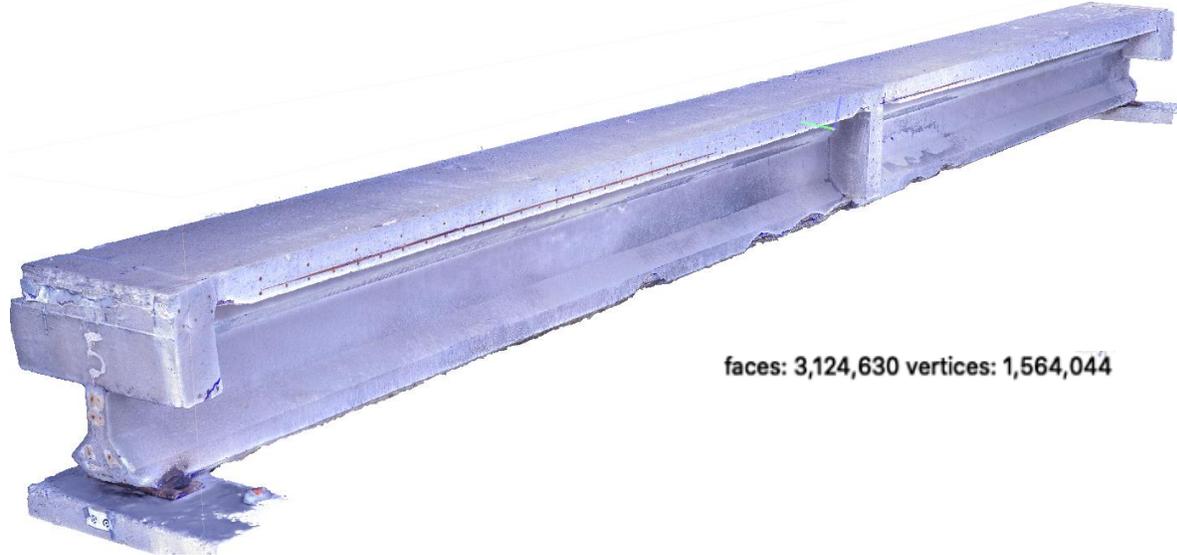
d) Digital State Model (DSM) for I-Beam 5 texture mapped using Texture Count of 1 and Texture Size of 12288

After a surface mesh is generated on the dense point cloud, texture is applied to it using images of the bridge girder with cracks highlighted. Crack-like features were detected on the images which were earlier used for generating the dense point cloud of the girder, using artificial intelligence. A U-Net type network was trained on semantic-level labeled images of cracked surfaces as explained in Section 2.4.1.3.1.2. The process of training the network and using the

trained model to detect crack-like features on the images of the bridge girders are explained in Section 3.1.2.1. The original images (called cameras in Agisoft Metashape), were replaced with the new crack-detected images. The parameters used for the Texture mapping step are shown in Figure 3.5d. Two main parameters used in this step were texture size and texture count. Trials were conducted to determine optimal values of these parameters that give a texture that was not blurry. The results of these trials are summarized in Section 4.1.1.2. A texture count of 1 and a texture size of 12288 were found to give a satisfactory result. These parameters corresponded to the size and number of texture atlas pages generated. For example, a texture size of 12288 consisted of an atlas page (image) of size 12288 x 12288 pixels with several smaller images of portions of the girders combined to form the bigger image. When the textured mesh was exported from Agisoft Metashape in the further steps, a texture size of 12288 generated only one texture image of 12288 x 12288 pixels. These models access the information on the atlas pages using texture coordinates. The textured model, which is referred to as a digital state model (DSM) in this report, for I-Beam 5 is shown in Figure 3.6d. After this step, the dense point cloud and the textured model of the girder were exported from Agisoft Metashape as explained in Section 3.1.2.2.

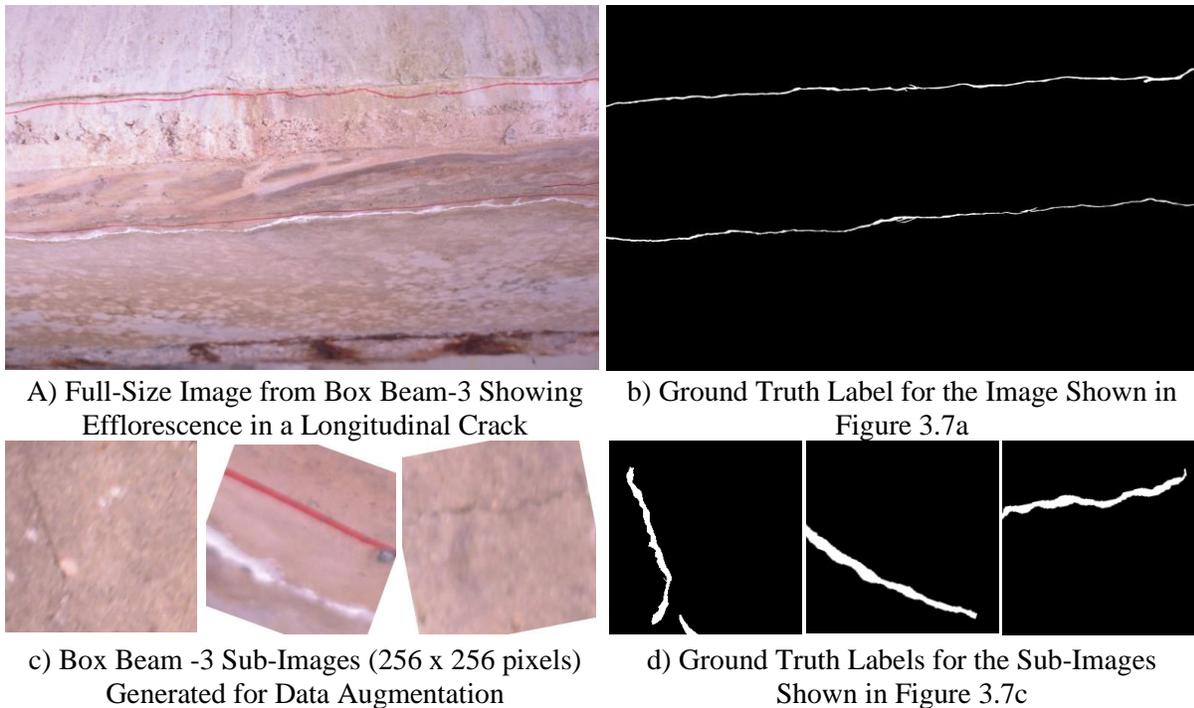
Figure 3.7. Sample Images, Sub-Images and Ground Truth Labels from the Box Beam-3 Images Added to the Assembled Dataset

Other cracks on the box beam were narrower or did not have a distinct dark-colored opening. To include this type of cracks in the damage detected, six images of size 4800 x 3200 pixels, from the box beam images set were added to the combined dataset. Ground truth labels (at pixel-level) for these six images were prepared using a tool called GIMP (The GIMP Development Team, n.d.), by drawing around the boundaries of cracks on the images. The labels were greyscale images that had cracks in white color and the uncracked concrete in black color. An image showing longitudinal cracking on the Box Beam-3 and the corresponding ground truth labels are shown in Figure 3.7a and Figure 3.7b, respectively. The images and the corresponding labels were split into sub-images of size 256 x 256 pixels. Data augmentation is done on the sub-images by applying transformations such as flipping vertically, flipping horizontally, and rotating by an arbitrary angle. This was done to increase the size of the training and validation datasets. The images rotated or flipped for data augmentation are shown in Figure 3.7c and their ground truth labels are shown in Figure 3.7d. The sub-images from the box beam images were added to the combined dataset, making the size of the entire dataset to have about 22,000 sub-images of size 256 x 256 pixels and their corresponding ground truth labels.

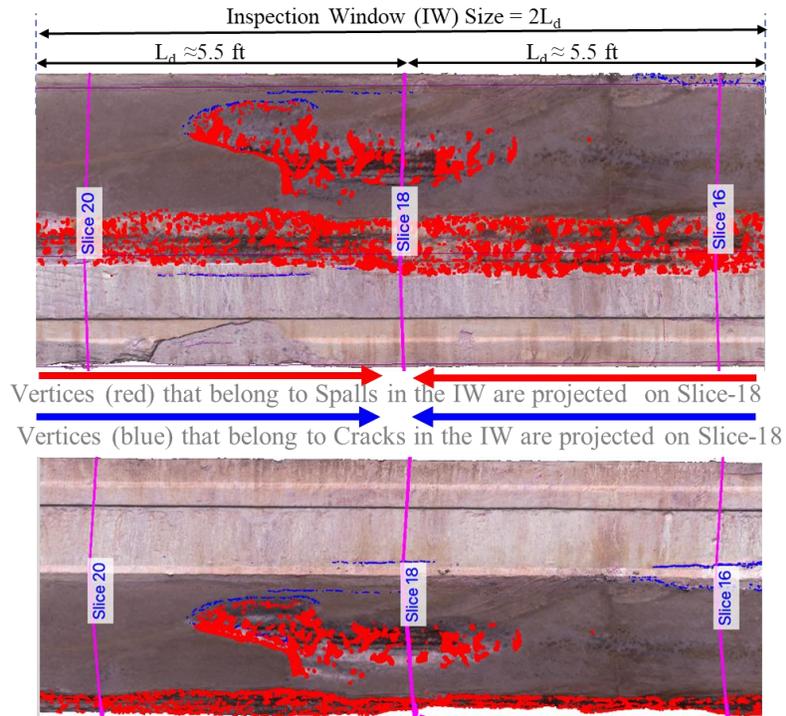
a) Damage Inside the Inspection Window Projected on to the Slice No. 18

extracted from the box beam dense point is shown in Figure 3.10. Red and blue points constituting spalls and cracks, respectively projected on to the Slice-18 are demonstrated in Figure 3.10a.

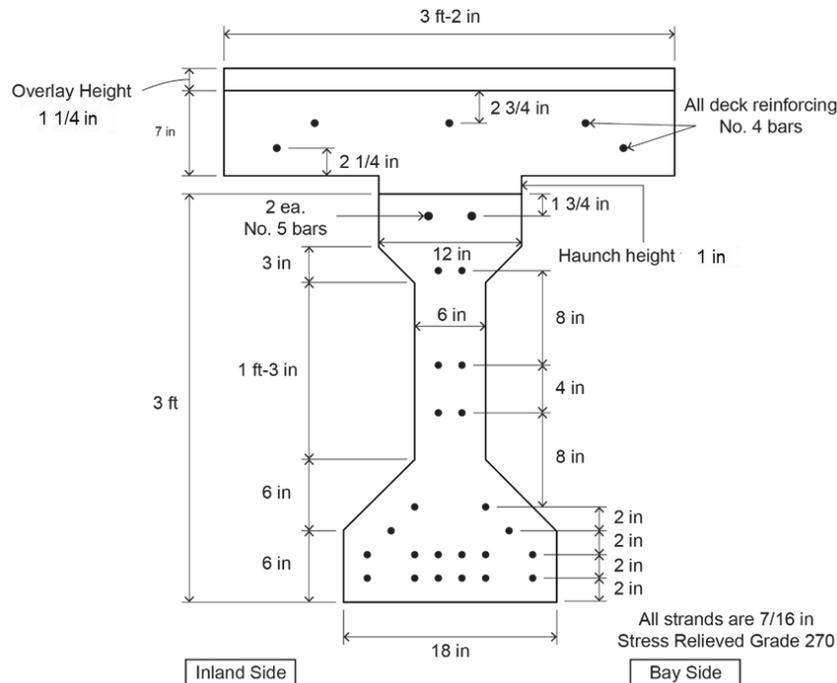
Figure 3.16. Cross-Section of Lesner Bridge I-Beam 9 from Alfailakawi (2019)

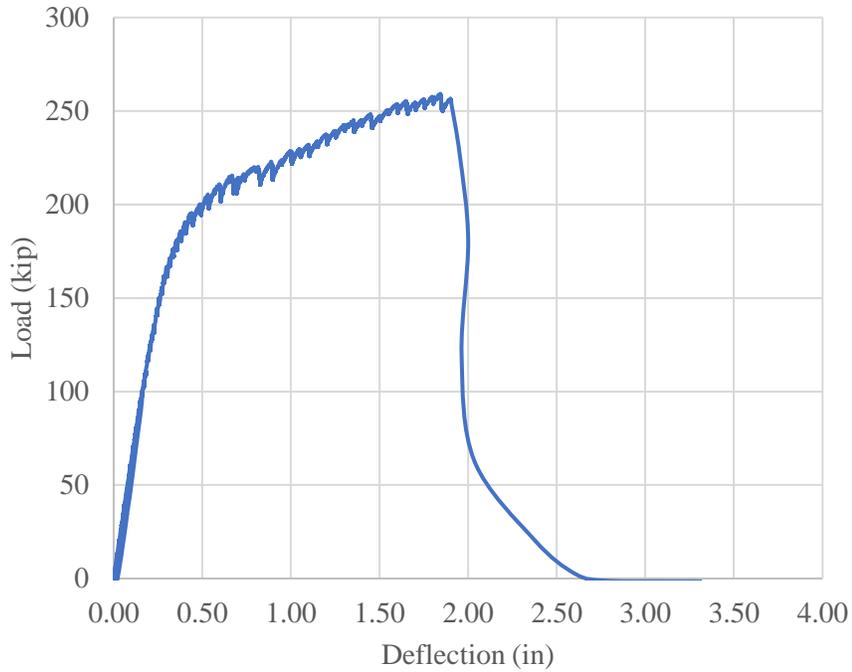
Figure 3.18. Load-Deflection Curve for Test-1 on Aden Road Bridge Box Beam-3

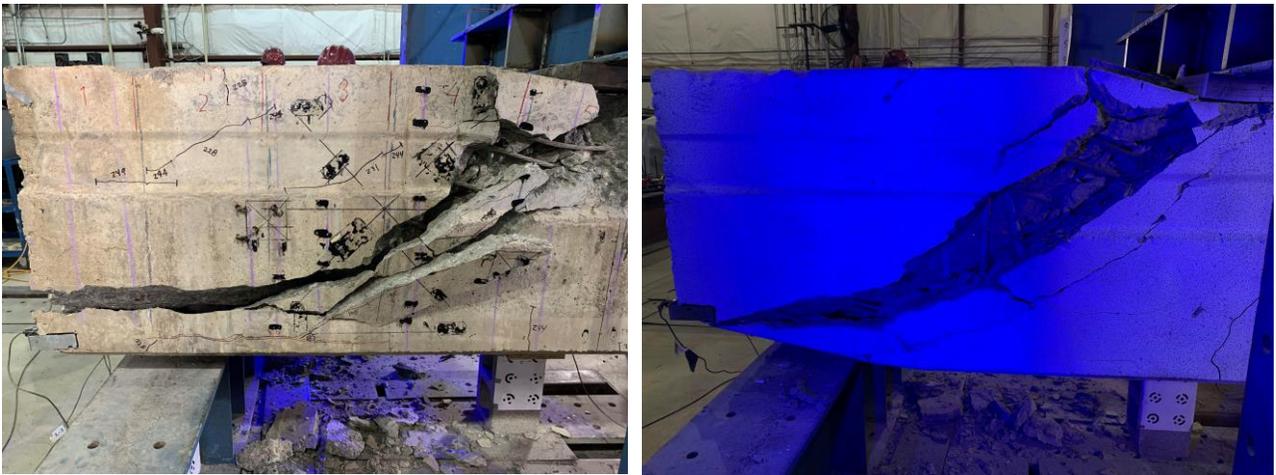
Figure 3.19. Shear Failure in Test-1 on Aden Road Bridge Box Beam-3

The beam endured a maximum load of 259.2 kip before it failed in a shear failure. The moment demand at the location of the point load, corresponding to this maximum load including self-weight moment was calculated to be 1029 kip-ft. The end of the beam after testing is shown in Figure 3.19.

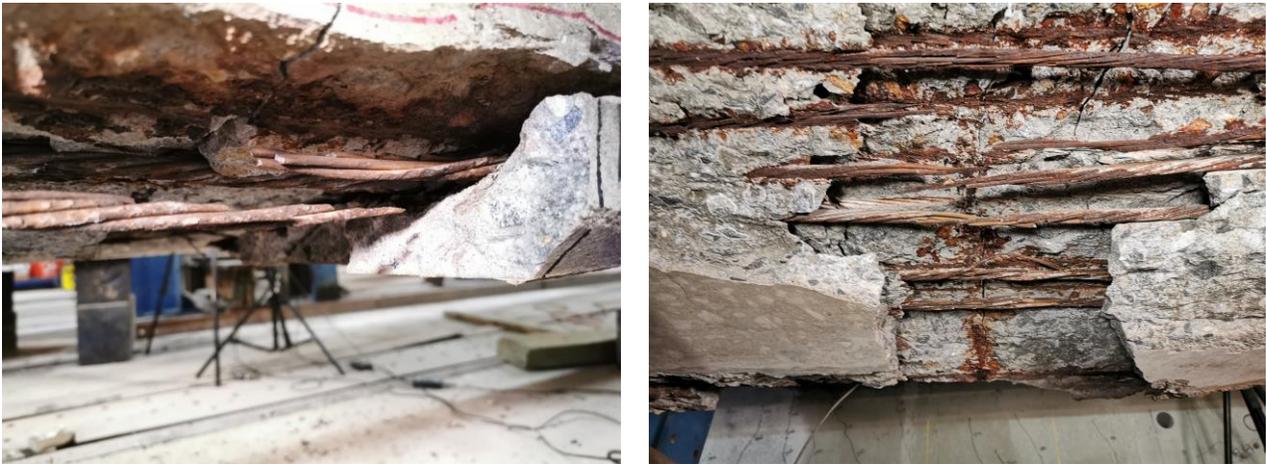
Figure 3.22. Strand Rupture in Test-2 on Aden Road Bridge Box Beam-3

Failure in this test did not occur at the section where the point load was applied. At the failure location, which was about 4.96 ft from the loading section, the prestressing strands started rupturing. The section at which strand rupture occurred, had a spalling in the middle with five exposed strands before the test, due to corrosion damage. This section was 45.46 ft away from the left end. This spalling and heavily corroded prestressing strands at this section altered the failure mode from a shear failure or a flexural failure at the section of loading to strand rupture at the spalled region. The Load-Deflection response showed strength and stiffness degradation as the strands fractured. The test was stopped at a point as the load continued to drop. The region at which the failure occurred is shown in Figure 3.22. The beam endured a maximum load of 230.5 kip before the load started dropping. The maximum moment demand at the failure section including self-weight moment was calculated to be 848.6 kip-ft. The maximum moment demand at the section where the point load was applied, including self-weight moment, was 896.3 kip-ft.

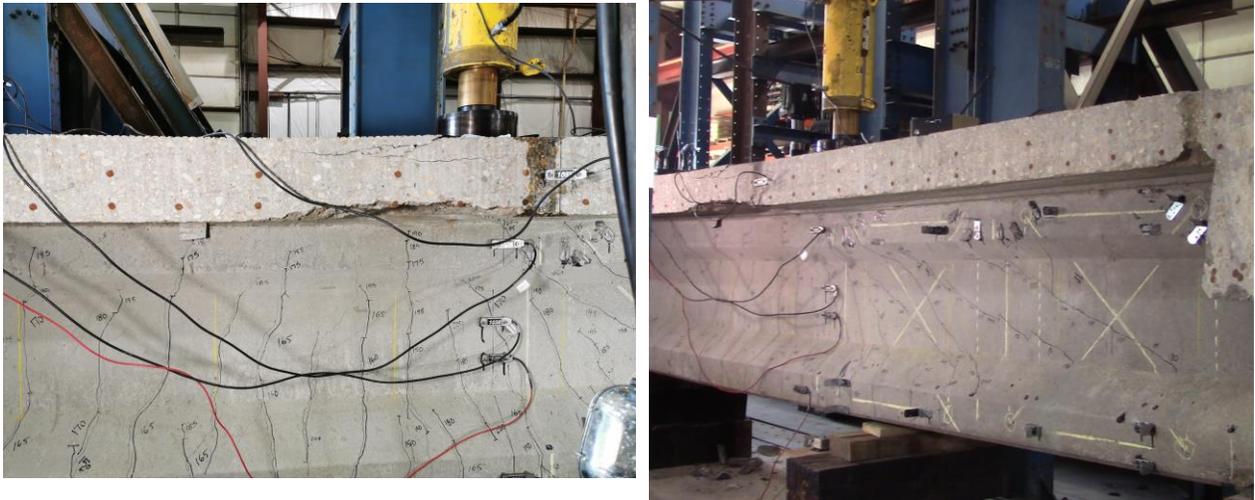
Figure 3.25. Crushing Failure in Top Slab in Test-1 on I-Beam 9

The failure observed in this end occurred due to flexural crushing in the deck of the beam, unlike the expected shear failure. The location of the point load was determined expecting a shear failure to avoid a direct compression failure between the point load and the support. But the shear span chosen caused a flexural failure instead. The failure in top slab (deck) is shown in Figure 3.25. The maximum load at which the failure occurred was 264.8 kip. Maximum moment demand due to the point load and self-weight of the beam was 1880 kip-ft.

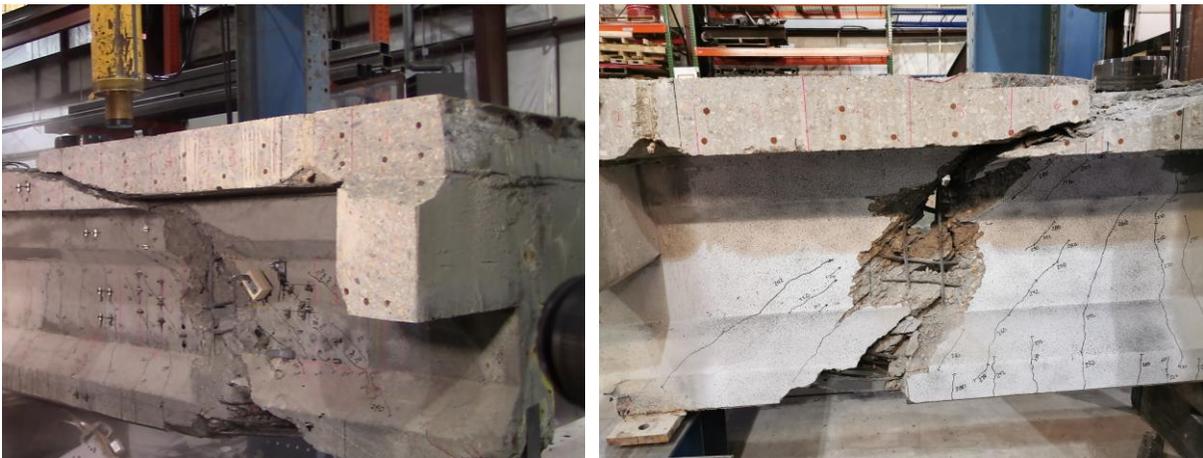
The beam at this end endured a maximum load of 382.4 kip before it failed in a shear failure. A steeply inclined crack that originated from the section of the point load was observed. This inclined crack did not extend all the way into the support but instead took the path adjacent to a spall and a crack (corrosion damage). The end of the beam after testing is shown in Figure 3.28. The moment demand corresponding to this maximum load including self-weight moment was calculated to be 1910 kip-ft.

Figure 3.28. Shear Failure in Test-2 on I-Beam 9

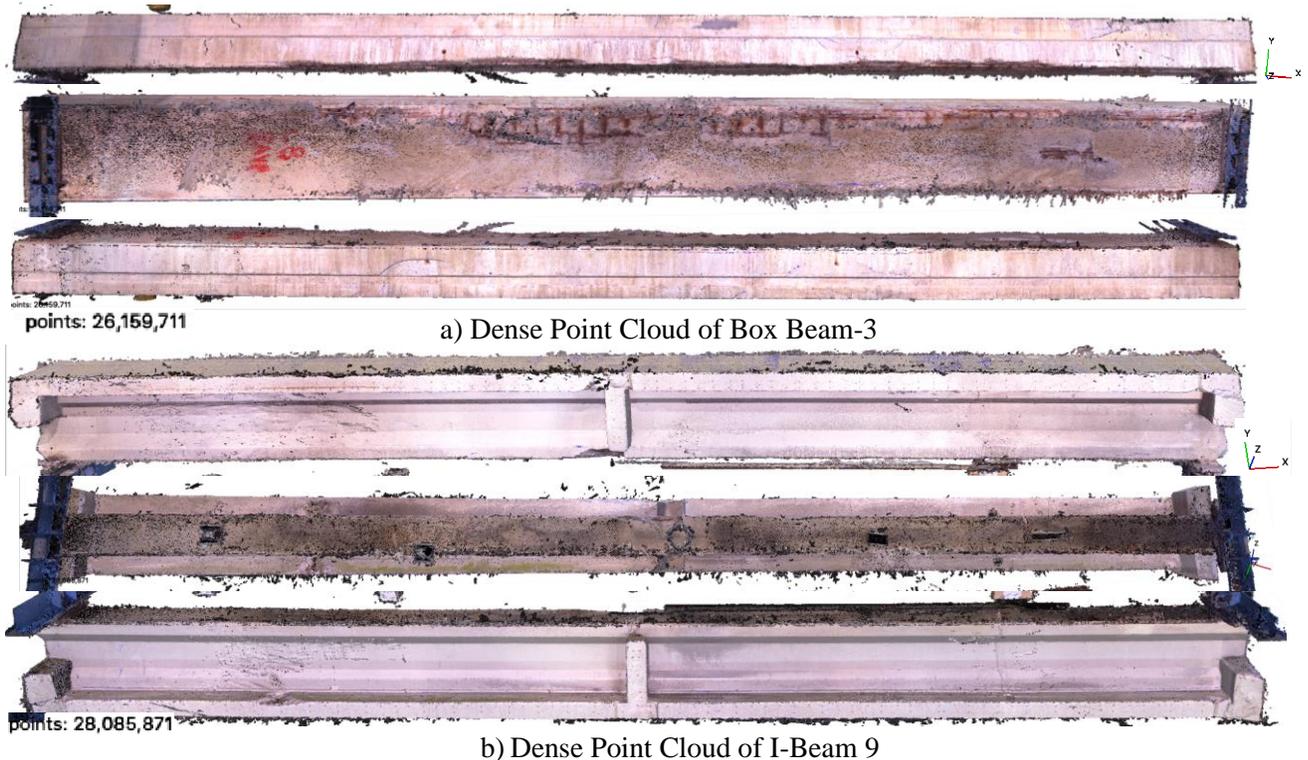
c) Dense Point Cloud of I-Beam 5

The procedure for alignment of images and dense point cloud generation steps are described in Sections 3.1.1.2 and 3.1.1.3. The alignment step generates a sparse point cloud which is further densified in the dense point cloud generation step. The parameters used in Agisoft Metashape for these steps are shown in Figure 3.5. Building a dense point cloud involves a quality parameter. Trials were conducted on the computer whose specifications are mentioned in Section 3.2 to determine the parameters that satisfy the requirements of the current research. It was found that, for the number of images mentioned in Table 4.1, a ‘high’ quality parameter for dense cloud required high computational capacity. The high quality parameter used for dense cloud generation for Box Beam-3 with all images in a single chunk caused the computer to run out of memory. For other beams with fewer images, even if the computer successfully built the dense clouds, the next step, surface mesh generation ran out of memory. To deal with these problems, a ‘low’ quality parameter was used for dense point cloud generation in this research. For the purposes of this research, a low quality parameter was found to be satisfactory even it downscaled the original images by a factor of eight. The sparse point cloud for Lesner Bridge I-Beam 5 is shown in Figure 3.6. Dense point clouds of all four girders used in this research, built using a low quality parameter on Agisoft Metashape are shown in Figure 4.1.

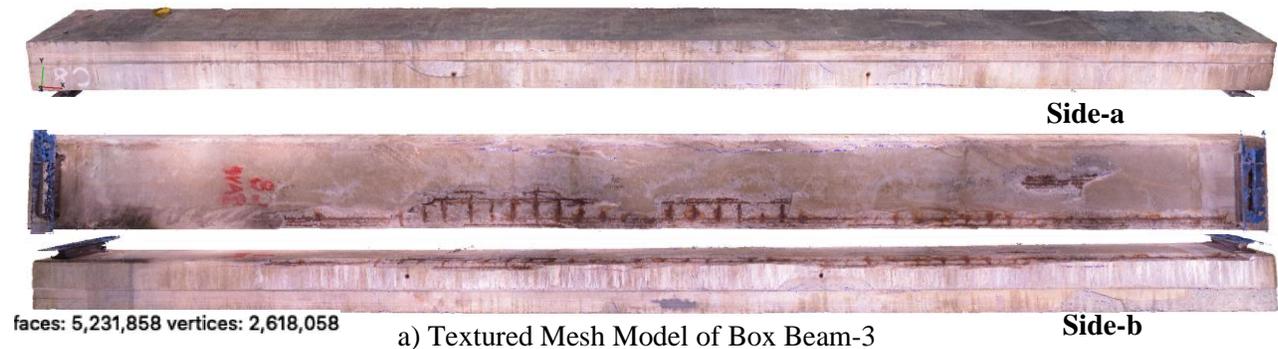
Figure 4.2. Textured Mesh Models of the Bridge Girders Reconstructed Using Agisoft Metashape

Surface meshes were generated on the dense point clouds and textured with images on which cracks were highlighted as explained in Section 3.1.1.5. The recommended parameters for these steps are presented in Figure 3.5. Results of crack detection on the images of the bridge girders using a U-Net as described in Section 3.1.2.1. Textured mesh models of all four bridge girders are shown in Figure 4.2. Sides a and b are labeled for convenience in further steps.

It can be observed from the textured mesh models of Box Beam-3 and I-Beam 9 shown in Figure 4.2a and Figure 4.2b, built from images captured in a laboratory setting, that the bottom surfaces are well captured owing to the illumination from LED lights. The bottom surface of I-Beam 1 had some dark regions owing to a lack of lighting at the end of the day. The texture built also had holes at one location which were covered by false texture. Hence, it was very important to have good lighting to obtain good quality point clouds and textured mesh models. Access available underneath the beams was only about 3 ft for both indoor and outdoor image capture settings. In actual bridges, the access available underneath the girders would be much greater which would facilitate better illumination. Lighting is a major factor to be considered when exploring the use of this method on actual bridges. Also, the time taken to capture the images has to be reduced in order to maintain stable natural lighting conditions during image capture. As explained in Section 4.1.1.1, large overlap maintained in the images captured in the current research increased the total number of images. It is possible to get complete point clouds of the girders with reduced overlap (minimum 60%) resulting in a reduced total number of images captured. To get larger number of points, a medium or high quality parameter can be used for dense cloud reconstruction step.

The textured mesh models shown in Figure 4.2 had cracks highlighted on them. Crack detection on 2D images and on the texture are discussed in Section 4.2.1. Time taken for surface mesh generation and texture mapping steps for Box Beam-3 are shown in Table 4.2. In total, it took about three hours for building a textured model of Box Beam-3 from a low quality dense point cloud (1803 images in a single chunk) on Agisoft Metashape, as mentioned in Table 4.2. This time does not include the time taken by the Neural Network to detect crack-like features on the 2D images of girders, which is discussed in Section 4.2.1.

- In Test-2, the failure occurred due to the rupture of strands in the bottommost layer at the location of spalling in the middle of the bottom surface with five exposed strands that can be seen in Figure 4.2a. As strain compatibility analysis with CON-WHT-THR-R did not capture this failure mode, STL-HOG-THR-R and STL-HOG-THR-ORG material parameters were used to find the ultimate strain in the bottommost layer strands at the time of fracture. Strain compatibility analysis with STL-HOG-THR-R was found to give a better but not accurate prediction of the ultimate rupture strain as 1.305%. These exposed strands shown in Figure 4.33 were in a heavily corroded 'wire loss' state of corrosion.

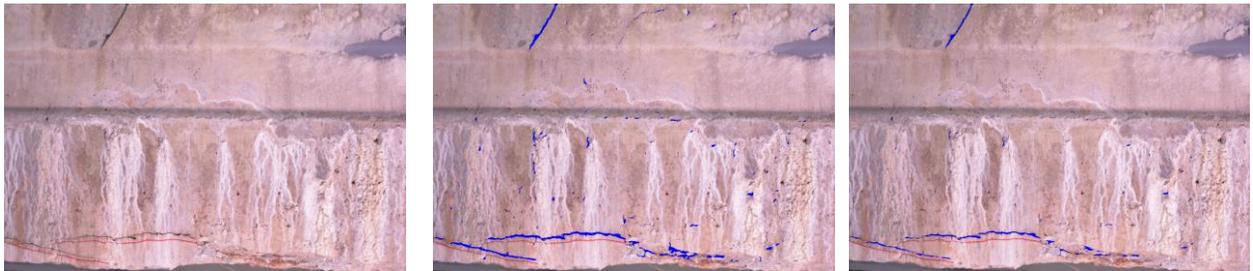
a) Cracks on Side of Box Beam-3

Figure 4.3. Output of Crack Detection Using U-Net Trained for 10 Epochs and Tested with Threshold and Stride Ratio as Specified

Parameters in the testing process included a threshold value, which was used to cut off some noise or false positives from the detection as explained in Section 3.1.2.1.1 and a stride ratio to feed the large images of size 4800 x 3200 pixels as patches of size 256 x 256 pixels on which the model was trained on. These parameters were determined using trial and error. Some of the images used to build the point clouds and their predicted damage from U-Net are shown in Figure 4.3. The effect of the threshold parameter was studied for values of 0.3 and 0.5. It can be observed that the model suffers from false positives (Figure 4.3a). In Figure 4.3a, more reduction in background noise can be observed for a threshold value of 0.5 when compared to a threshold value of 0.3. Major sources of noise included portions of edges of the beams (Figure 4.3b and Figure

4.3c), portions of spalls (Figure 4.3b), and other crack-like features. Cracks in Figure 4.3f and Figure 4.3g were missed to a large extent. The model, in general, did not perform well for very wide cracks such as in Figure 4.3g. As explained in Section 3.1.2.1.1, six images from Box Beam-3 dataset were divided into patches of 256 x 256 and data augmentation was done to increase the number of sub-images in the dataset and to improve the performance of the model in detecting the cracks filled with efflorescence (a labeled image is shown in Figure 3.7). The improved performance of the model in detecting such cracks after adding these sub-images to the dataset can be observed in Figure 4.3d. It can be observed in Figure 4.3b that very narrow cracks on the bottom surface of the beam (highlighted with a red marker) with efflorescence were only partly detected. When a threshold value of 0.5 was used, some portions of the cracks that were detected with a threshold of 0.3, went undetected. This can be observed in Figure 4.3c. In order not to miss portions of cracks, a threshold value of 0.3 to 0.4 was used in the testing phase in the current research. More noise was observed on darker images and more cracks were missed from blurry images. The effect of stride ratio is demonstrated in Figure 4.4.

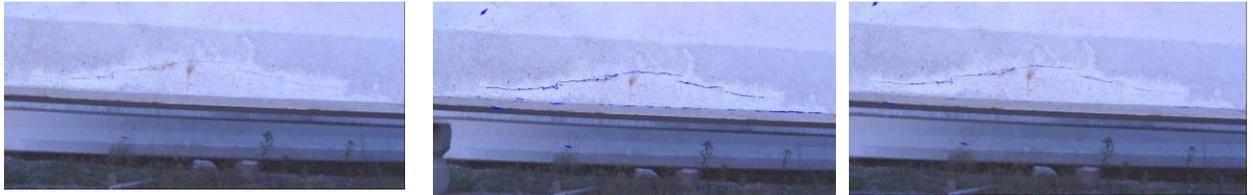
e) Narrow Crack on Bottom Flange of I-Beam 1

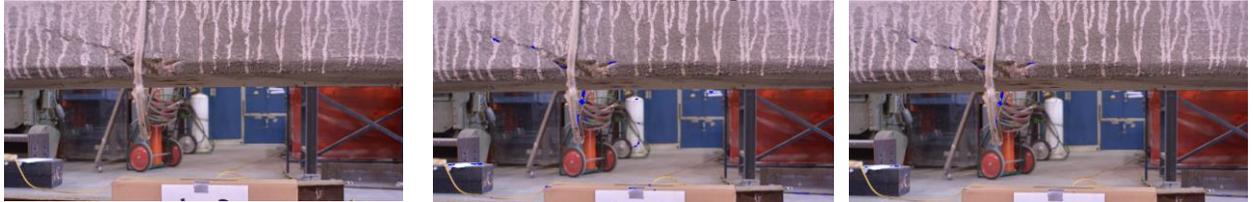
f) Crack on Bottom Flange of I-Beam 9

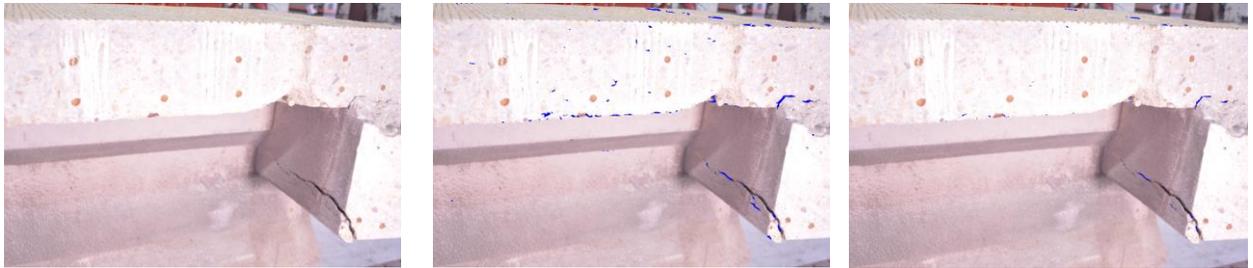
g) Wide Crack on Diaphragm of I-Beam 9

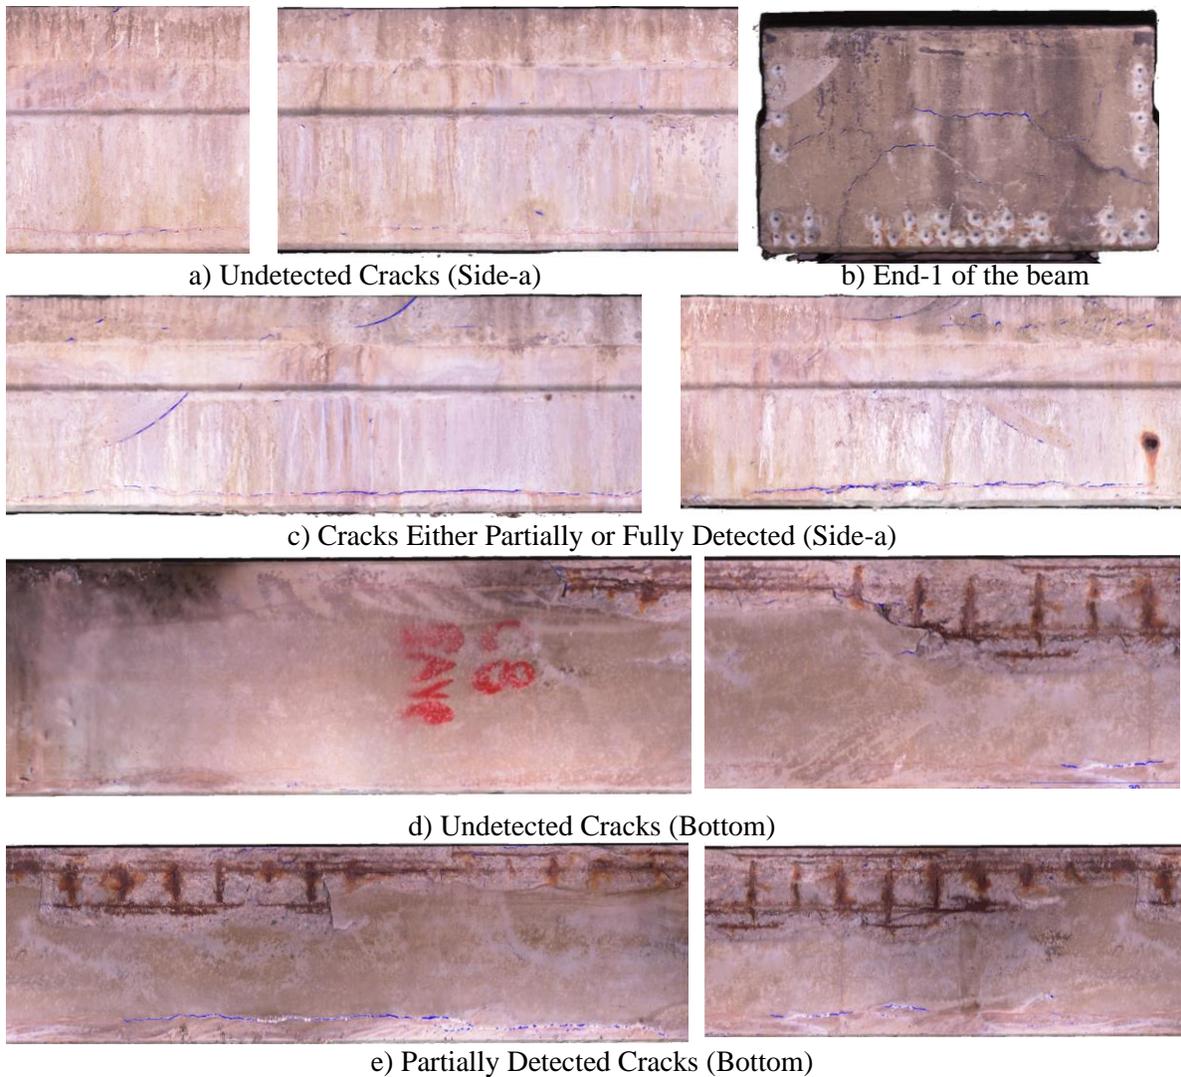
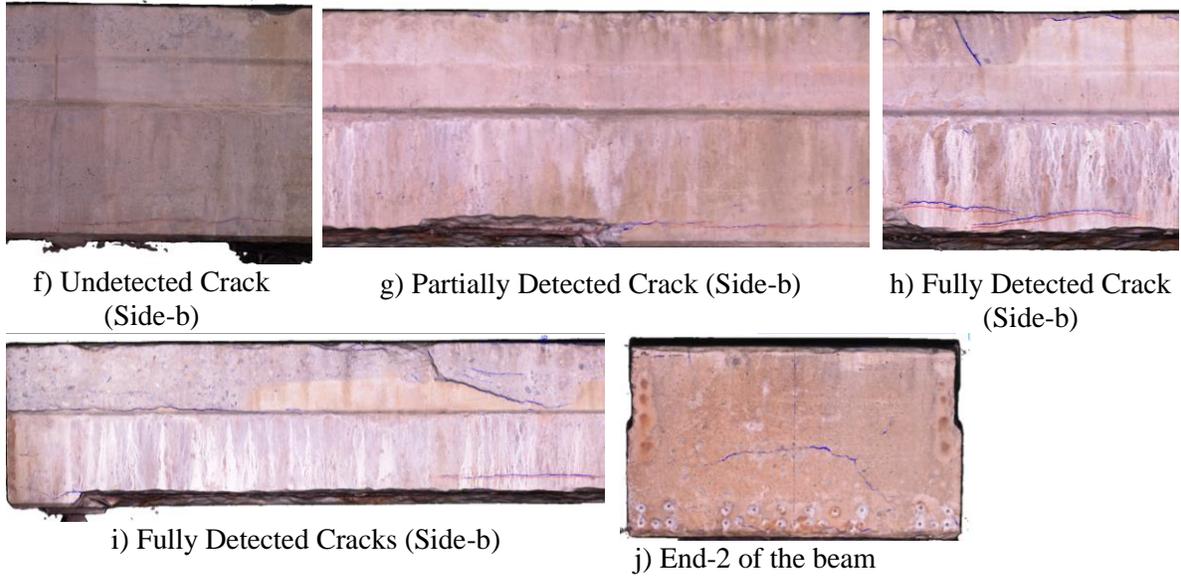
Figure 4.5. Cracks on the Textured Mesh Model of Box Beam-3

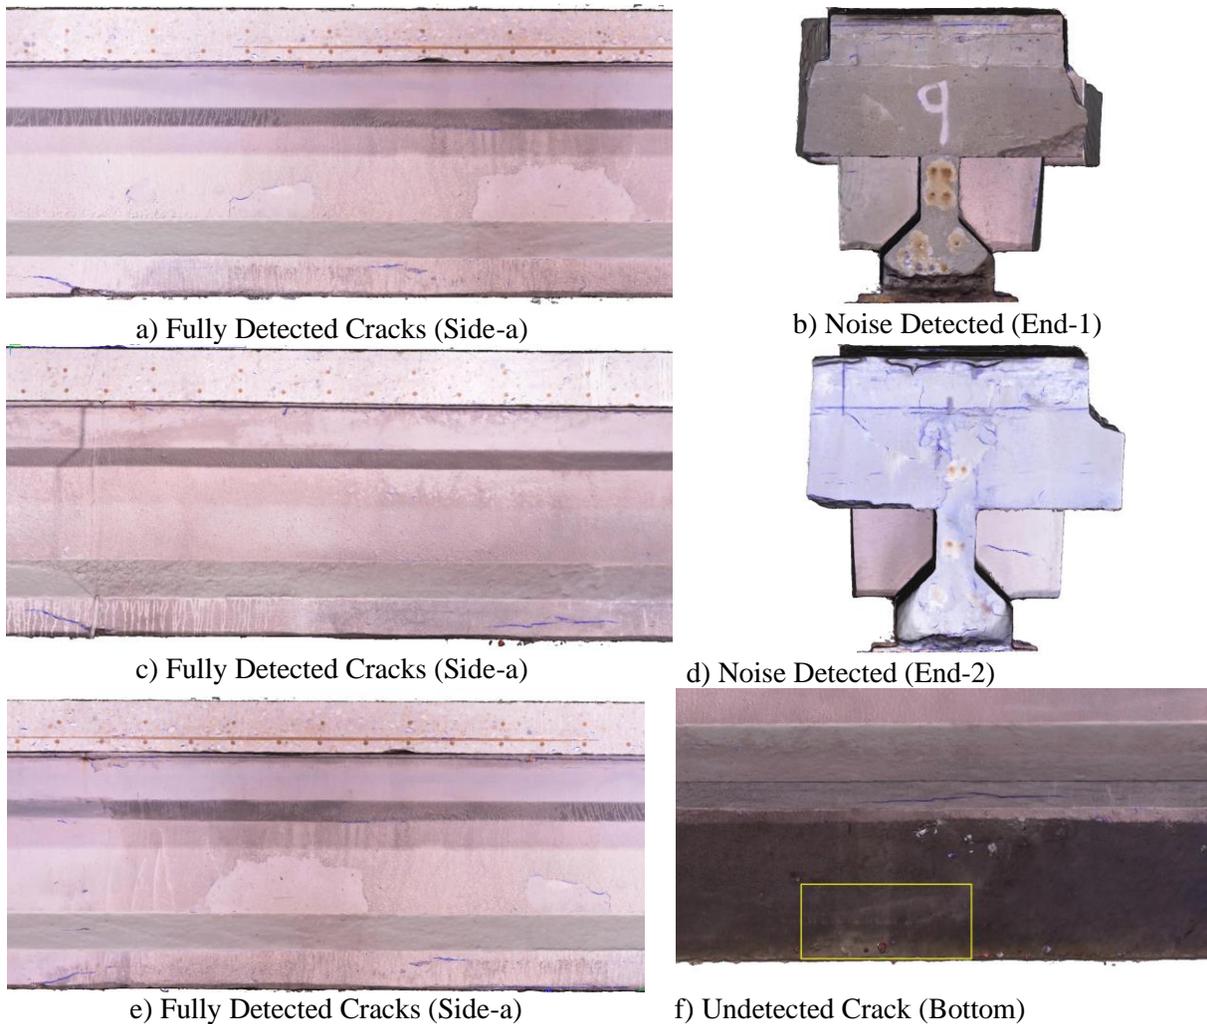
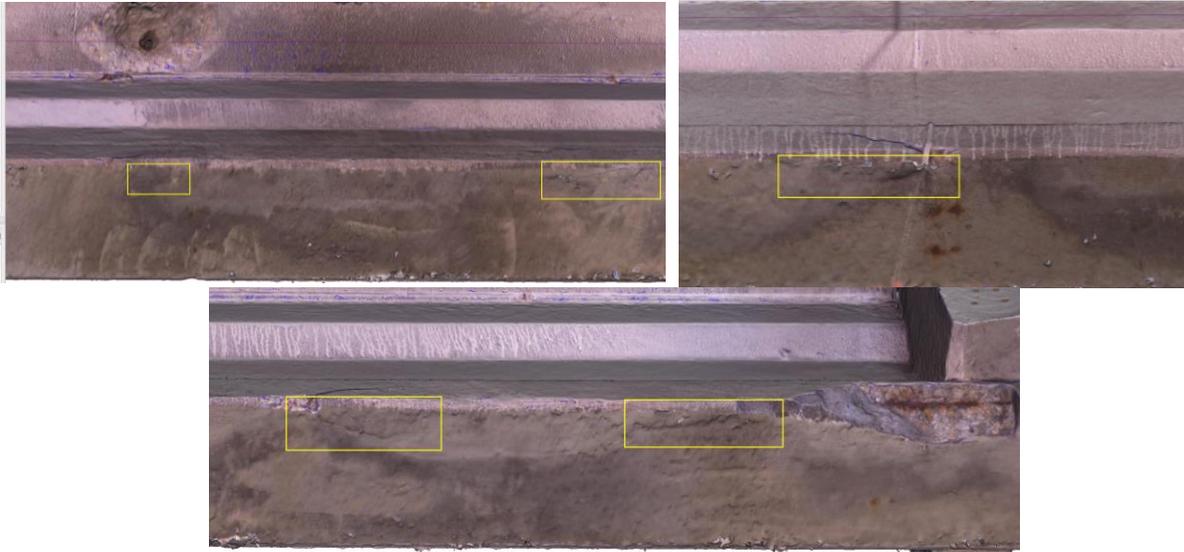
g) Undetected Cracks (Bottom) Highlighted Using Bounding Boxes
 Figure 4.6. Cracks on the Textured Mesh Model of I-Beam 9

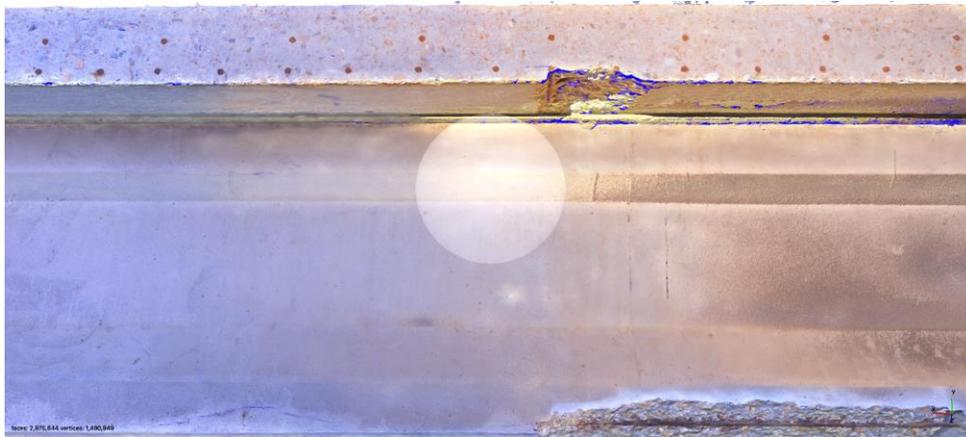
a) Fully Detected Cracks (Side-a)

Figure 4.7. Cracks on the Textured Mesh Model of I-Beam 1

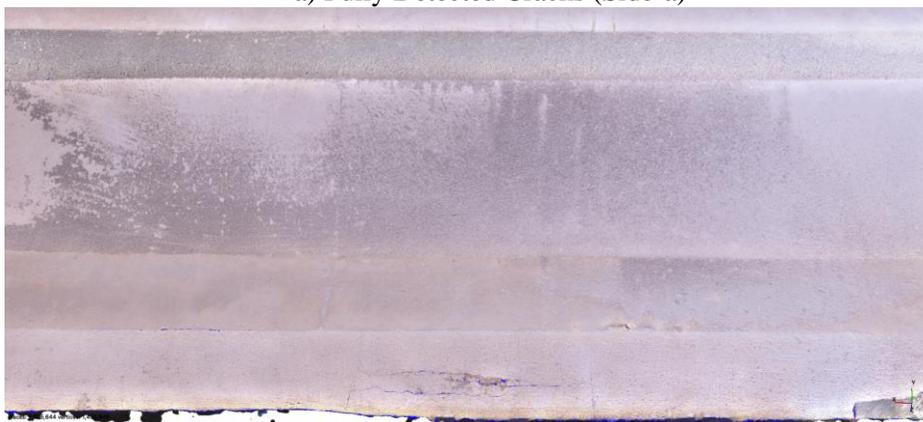
b) Fully Detected Cracks (Side-a)

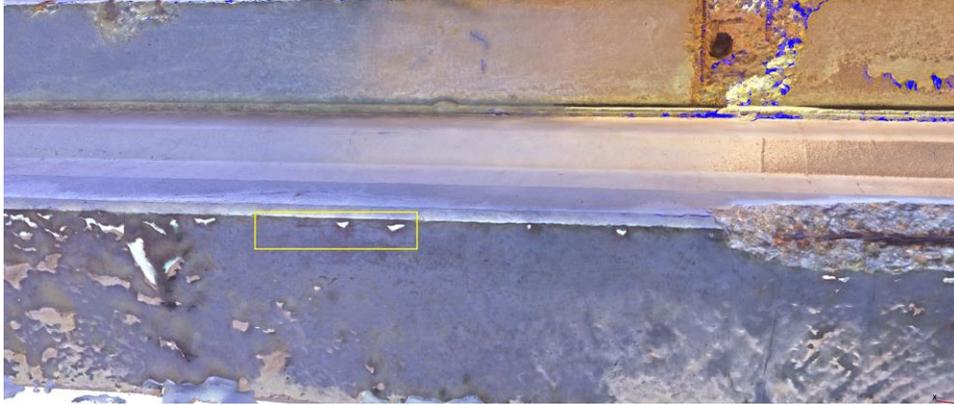
c) Undetected Crack (Bottom)

The cracks on the bottom of the beams were sometimes the extensions of the damage present on the sides of the bottom flange, as can be observed in Figure 4.6. So, these regions had to be checked thoroughly to locate missing cracks. One of the reasons for the cracks on the bottom surface going undetected could be due to the angle at which the images of the bottom surfaces of the beams were captured during image acquisition. The model was not trained on such pictures. So, more training images from the current dataset can improve the performance of this model. It was observed that, for a crack to be detected on the textured mesh, the crack did not need to be detected on all images that it was seen in. For example, if a crack feature were seen in nine different images, but it was detected by the model only in two of the nine images, this crack could still be included in the texture. In the next step, colors from the crack detected images were applied to the dense point clouds of the girders. The points belonging to the cracks are isolated using thresholding and cleaned to eliminate the background noise. This is demonstrated in the following sub-section.

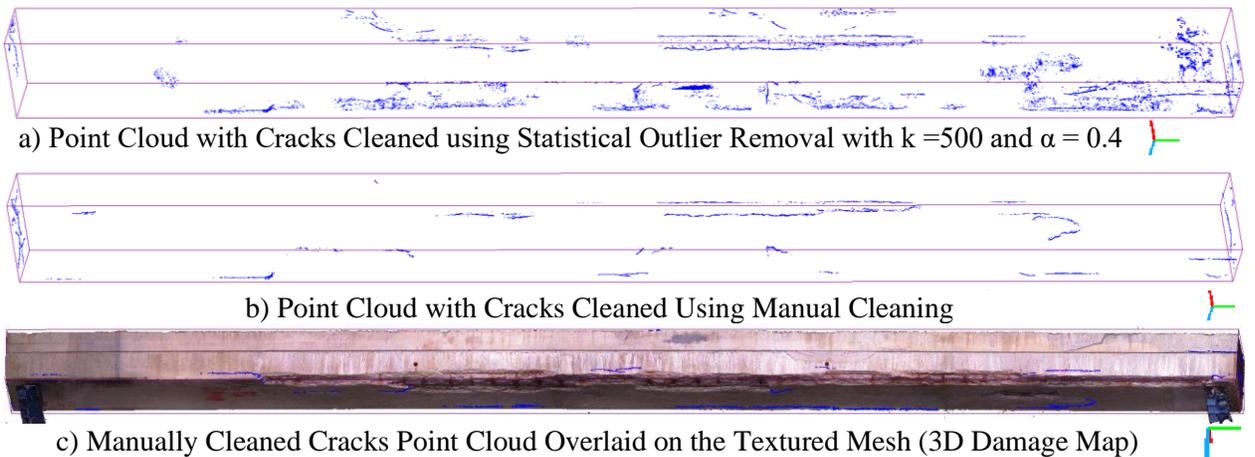
Figure 4.10. Point Cloud with Cracks on Box Beam-3 Cleaned Using SOR with $k = 500$ and $\alpha = 0.4$ and Manual Cleaning
