USE OF PHOTOGRAMMETRY AIDED DAMAGE DETECTION FOR RESIDUAL STRENGTH ESTIMATION OF CORROSION DAMAGED PRESTRESSED CONCRETE BRIDGE GIRDERS

Thesis submitted to the faculty of the Virginia Polytechnic Institute and State University in
partial fulfillment of the requirements for the degree of

Master of Science
in
Civil Engineering

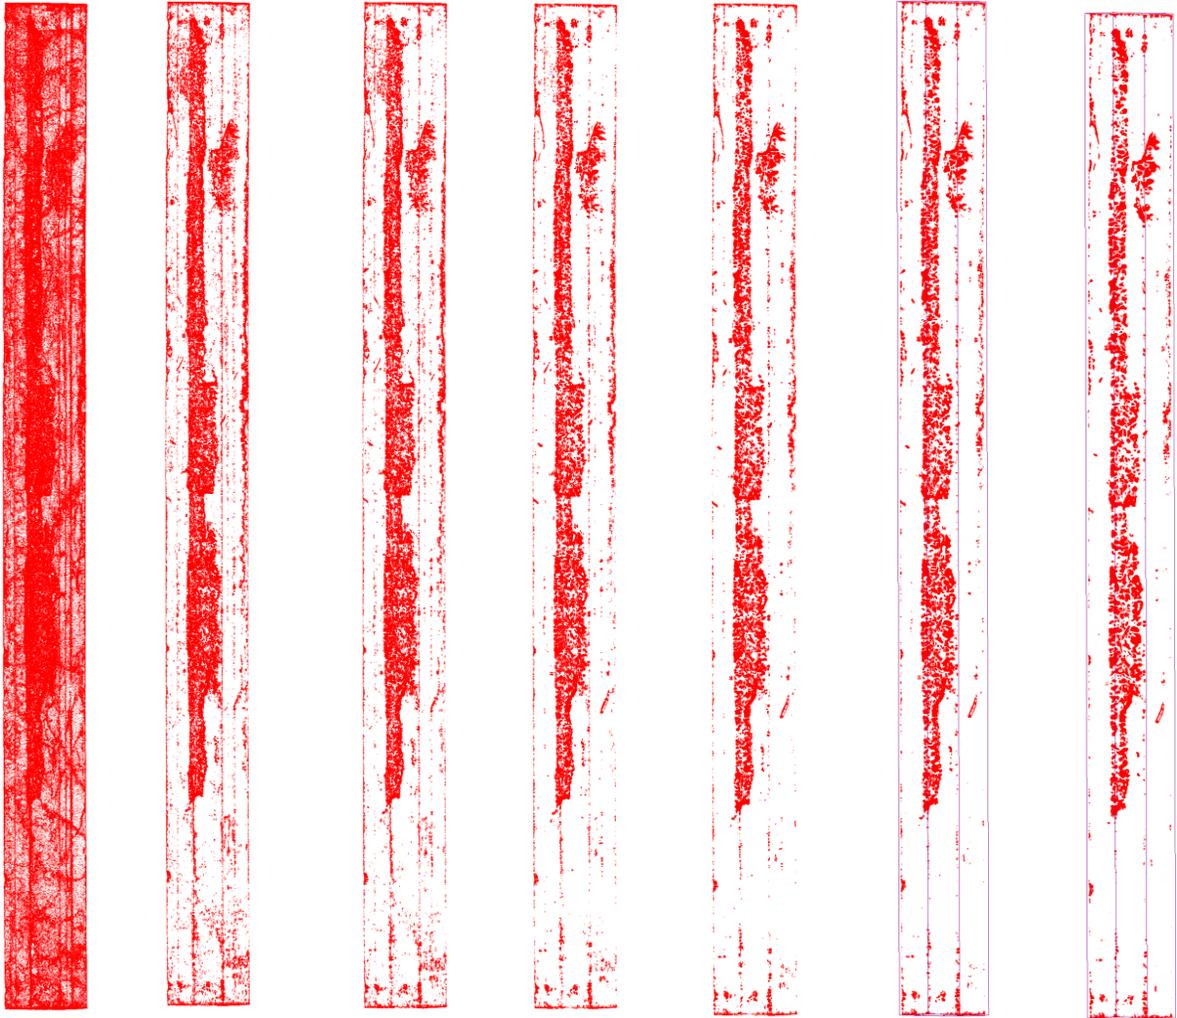
$k=3,$ threshold = 2 deg.
 $k=30,$ threshold = 2 deg.
 $k=50,$ threshold = 2 deg.
 $k=100,$ threshold = 2 deg.
 $k=150,$ threshold = 2 deg.
 $k=200,$ threshold = 2 deg.
 $k=300,$ threshold = 2 deg.

From Figure 4.14, it was evident that a low value of 'k' caused too much noise in the damage detection which is not desirable. As the value of 'k' was increased, the noise was reduced. The detected damage at this stage was overlaid on top of the textured mesh of the box beam in Figure 4.15. As shown in Figure 4.15, all the damage detected from this approach was not corrosion damage as it included some of the surface roughness, surface holes, and wear and tear on the girders. So, the detected damage was cleaned using the statistical outlier removal (SOR) approach described in Section 2.5.2. These parameters were also determined using trial and error. For further cleaning to retain only spalling due to corrosion damage, manual cleaning was done using CloudCompare before the results were subject to clustering. A 'k' value of 150 was chosen for 3D level damage detection in the current work. However, higher values of 'k' can also be chosen to avoid cleaning up too much. The result of 3D level damage detection for Lesner Bridge I-Beam 9 using $k = 150$ and threshold angle = 2 deg. is shown in Figure 4.16. The result of 3D level damage detection for Lesner Bridge I-Beam 5 and I-Beam 1 using $k = 150$ and threshold angle = 4 deg. are shown in Figure 4.17 and Figure 4.18, respectively. Cleaned-up versions of the 3D-level damage detection on Box Beam-3, I-Beam 9, I-Beam 5 and I-Beam 1 using SOR filter with parameters $k = 2000$ and Multiplier for standard deviation $\alpha = 0$ and using manual cleaning are shown in Figure 4.19. Cleaned up spall point clouds overlaid on top of the textured mesh models of the girders (shown in Figure 4.19) are used as 3D damage maps in the subsequent steps.

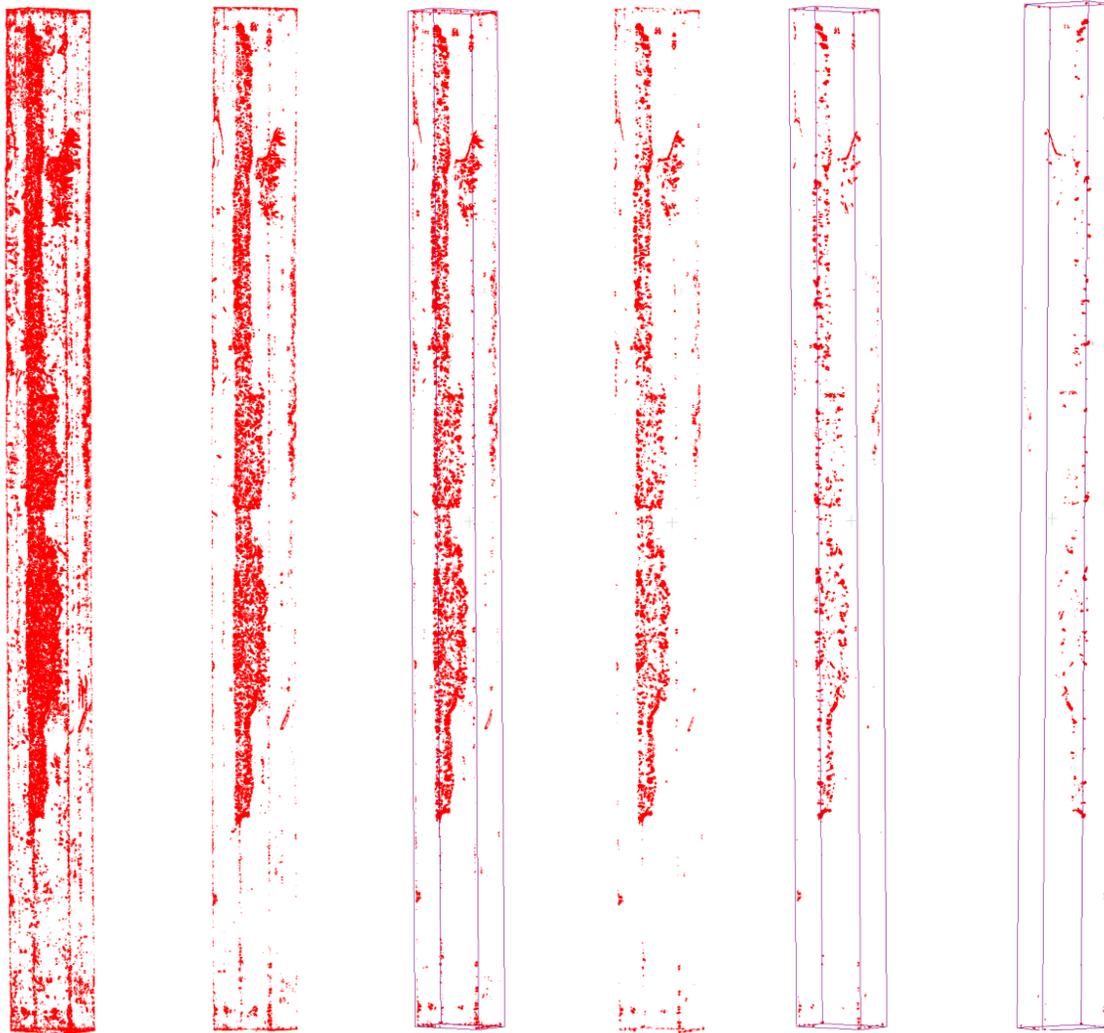
k=150 threshold = 1 deg. k=150 threshold = 2 deg. k=150 threshold = 3 deg. k=150 threshold = 4 deg. k=150 threshold = 6 deg. k=150 threshold = 10 deg.

error to arrive at optimal parameters because the optimal value of ‘k’ would depend on the density of the point cloud.

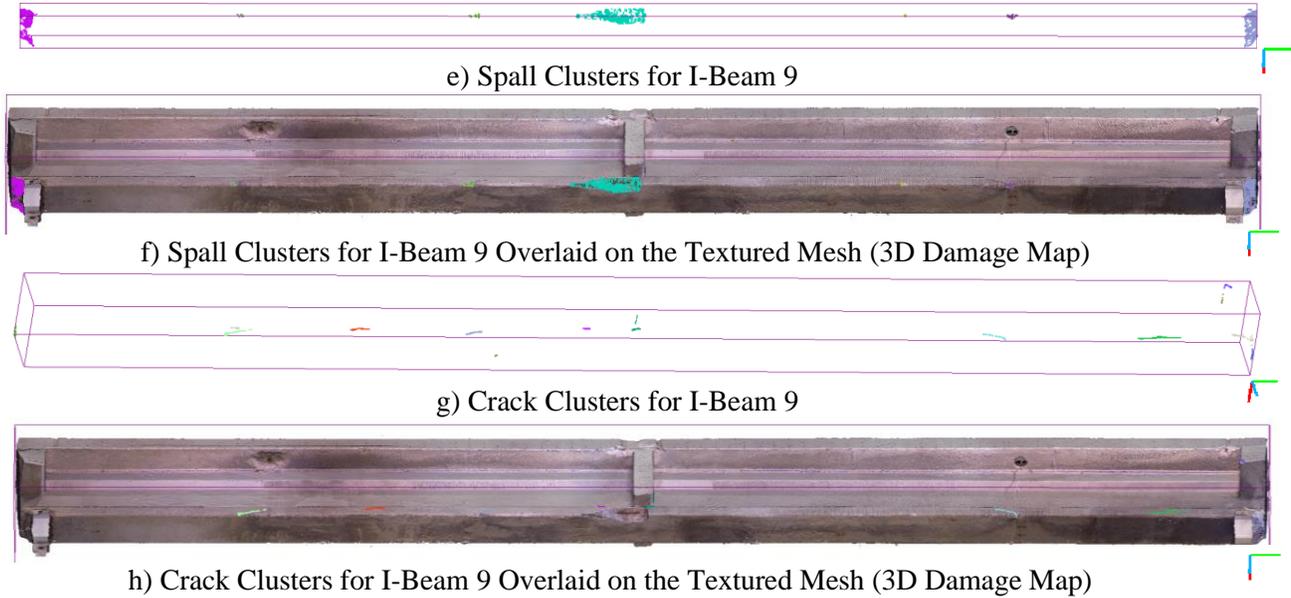
Figure 4.21. Cracks and Spalls Clusters for Box Beam-3 and I Beam-9

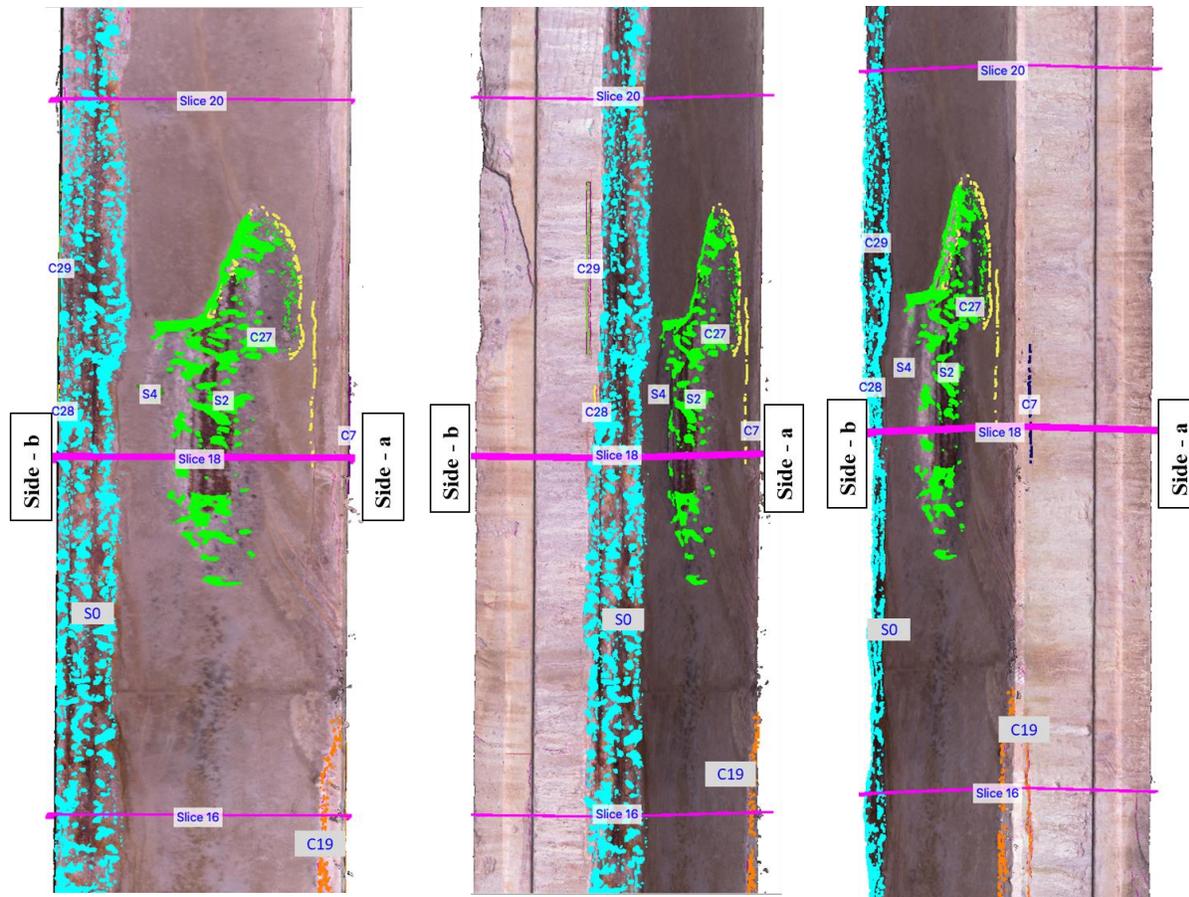
Figure 4.27. Damage Clusters in the Inspection Window to be Considered for Strength Estimation at Slice-18 of Box Beam-3

Crack C7 lay on Side – a, and cross-sectional areas of strand numbers 15 and 25 had to be reduced by 25%, as they were located close to the crack at a distance less than 3 in. Crack C19 on Side-a shifted transversely on the bottom of the beam, from one strand to another affecting Strands 14, 15, and 25. As per the recommendations, strands in different layers that lie directly on a longitudinal crack had to be reduced to 75% of their cross-sectional areas. For the same reason, Crack C27, located beside the spall in the middle (S2), affected both strands 13 and 24. Distance from the edge of the point cloud to this crack was measured on CloudCompare to confirm that the strands in both the layers have to be reduced by 25%. Cracks C28 and C29 on Side – b affected Strand 16 in the second layer. However, the Spall S0 completely exposed strand 16 along with the Strands 1, 2, 3 on the bottommost layer. All these strands had to be neglected completely from the strength calculation. Similarly, the five exposed strands, 6, 7, 8, 9, 10 due to the Spall Cluster S2 were taken to 0% of their areas. Strand 10 was partially exposed and was still reduced to 0% to be conservative. Spall S4 was wrongly classified as a separate cluster from S2 by the clustering algorithm, and Spall S7 was observed to be noise. As per the recommendations, all other strands in the cross-section had to be reduced to 95%, as the beam had a significant amount of longitudinal cracking. Strands reduced to 0%, 75% and 95% of the areas are shown in Figure 4.25. After making all these reductions, the total reduced area of prestressing strands at this section is calculated in Table 4.8. The number of strands in each layer to be reduced to 0%, 75%, and 95% of the cross-sectional areas are also shown in this table.

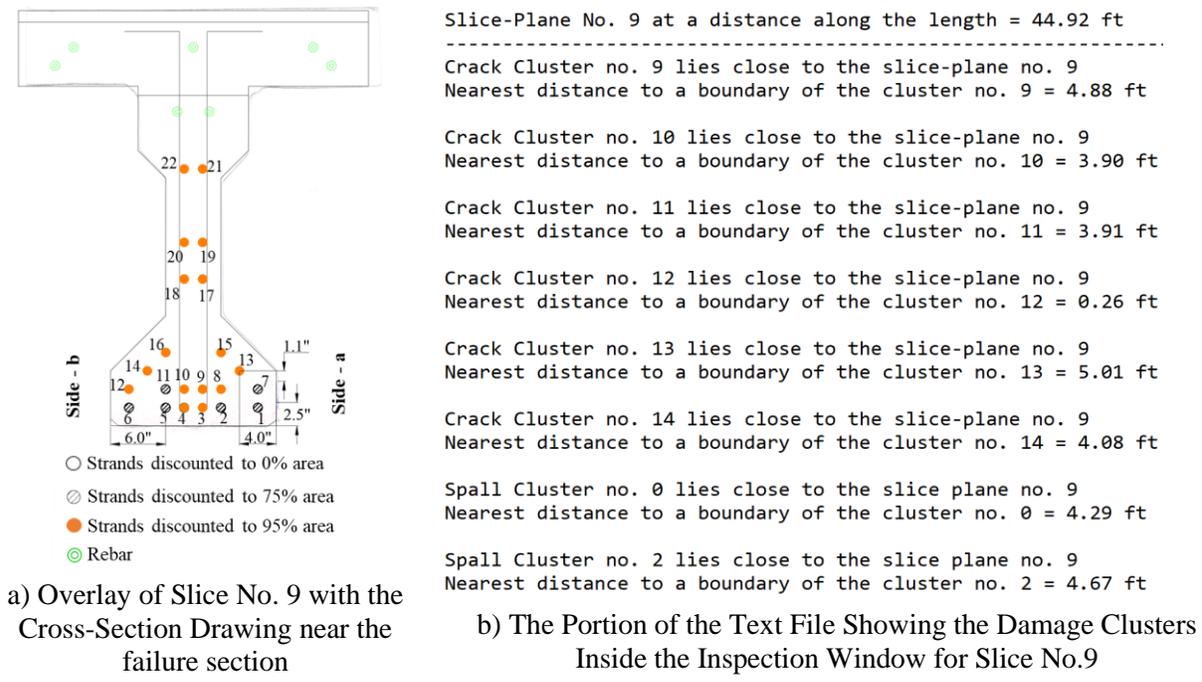
Figure 4.28. Tools for Strength Estimation at Section of Failure in Test-2 on Lesner Bridge I-Beam 9

times 5.5 ft was chosen. Damage clusters that fall inside the Inspection Window for Slice-9 were identified in the text-file shown in Figure 4.28b. In Figure 4.30, a portion of the textured mesh of the Box Beam-3, that falls inside the Inspection Window for Slice-9 is shown. Side-a and Side-b in Figure 4.30 correspond to the Side-a and Side-b in Figure 4.28a. The damage (spalls and cracks) points lying inside the Inspection Window for Slice-9 were projected on to the slice-section. The overlay (Figure 4.28a) shows these points in red and blue colors in the bottom portion of the beam, which correspond to the spalls and cracks present inside the Inspection Window, respectively.

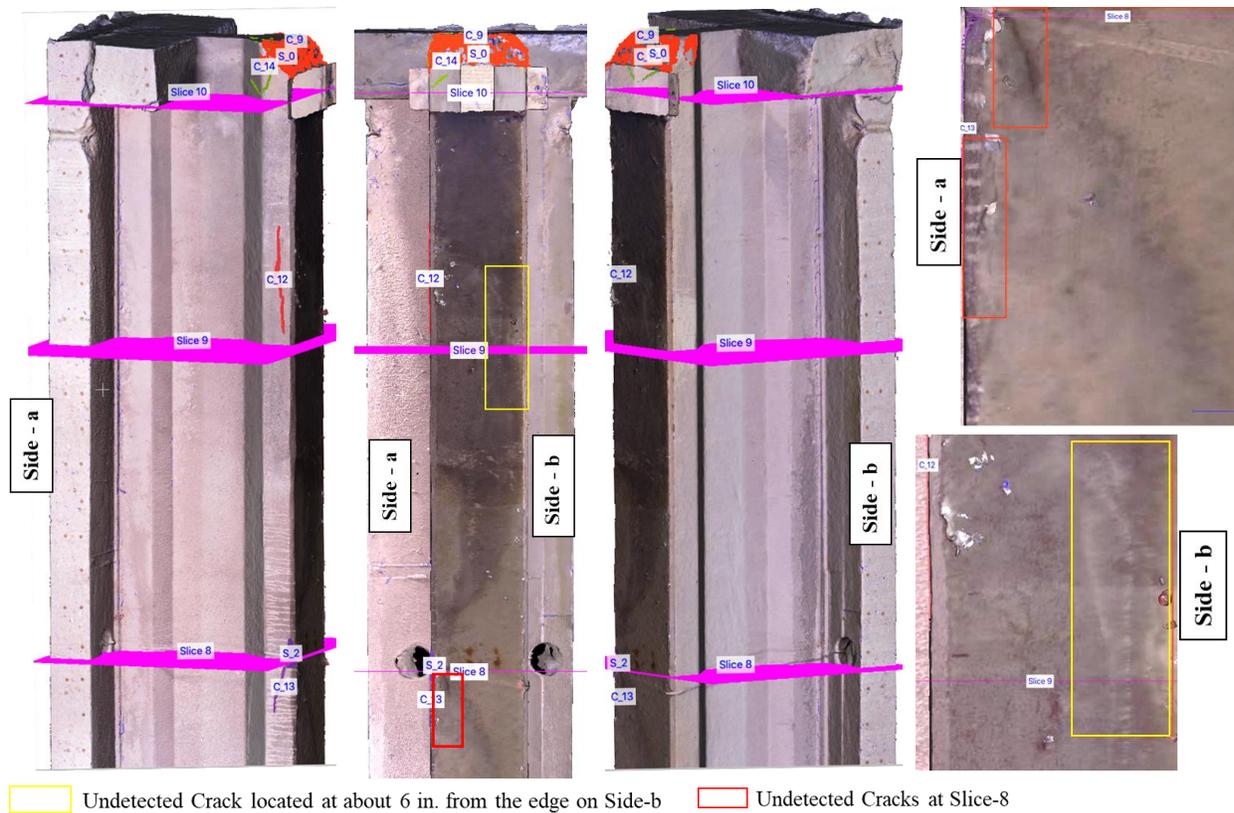
Figure 4.30. Damage Clusters in the Inspection Window to be Considered for Strength Estimation at Slice-9 of I-Beam 9

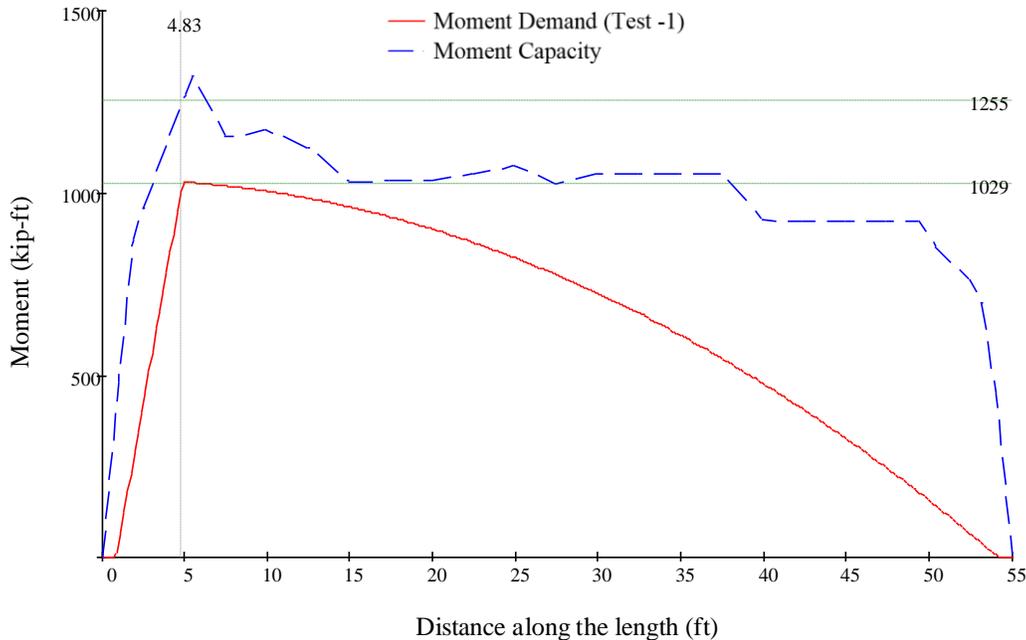
Figure 4.31. Moment Capacity (Strain Compatibility analysis with CON-WHT-THR-R) vs. Demand Comparison at the section of failure in Test-1 on Aden Road Bridge Box Beam-3

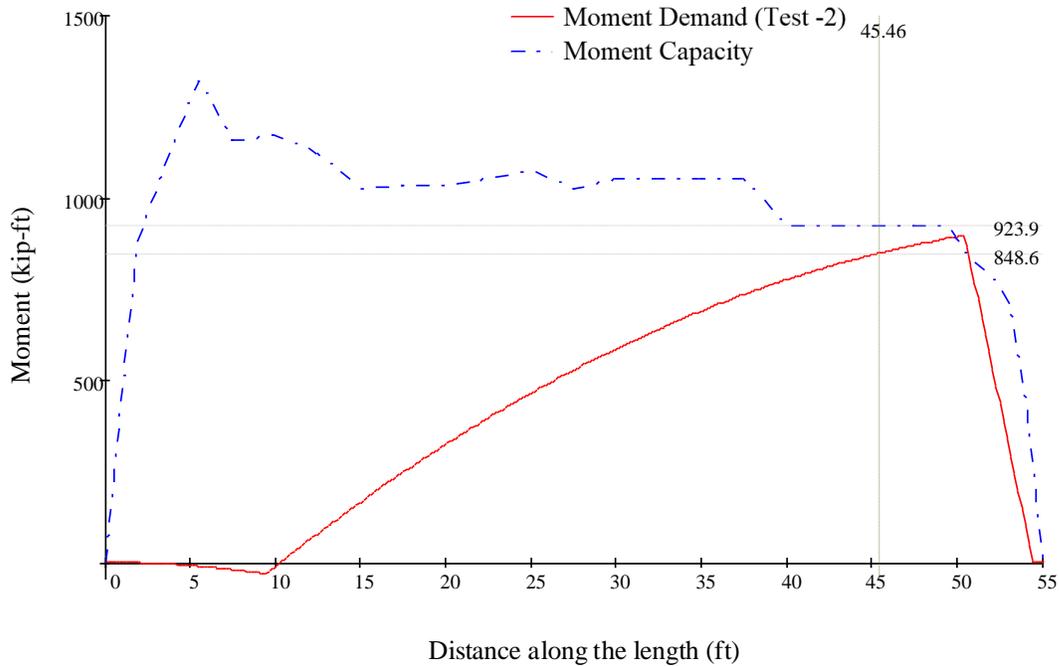
Figure 4.32. Moment Capacity (Strain Compatibility Analysis with CON-WHT-THR-R) vs. Demand Comparison at the section of failure for Test-2 on Aden Road Box Beam-3

The beam failed at a section 45.46 ft away from the left end with rupture of strands in the bottommost layer. The maximum moment demand including the self-weight moment at the failure section was 848.6 kip-ft. The total moment demand at the section (at a distance of 50.42 ft from the left end) where the point load was applied was 896.3 kip-ft. The positive moment capacities at the slice-sections calculated using Strain Compatibility analysis with CON-WHT-THR-R material parameters described in Section 3.1.3.7.1, following the recommendations of Naito et al. (2011) and the moment demand along the length of the beam, corresponding to the maximum external load and self-weight moment are shown in Figure 4.32. The moment capacities calculated at these two locations are summarized in Table 4.12.

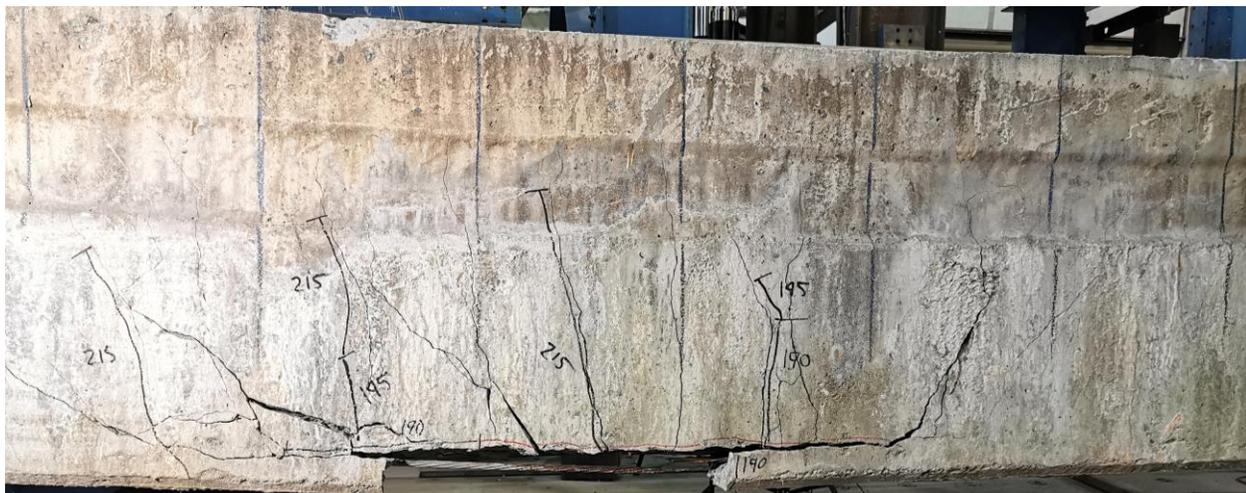
Figure 4.34. Region of Failure in Test-2 on Box Beam-3 from Al Rufaydah (2020)

On the other hand, using a reduced strand cross-sectional area that predicted a bottommost layer ultimate strain of 1.305% gave a Neutral axis depth of 4.16 in. This could have been closer to the actual value of the ultimate strain. Furthermore, reducing the cross-sectional area of strands further to incorporate the actual condition of the unexposed strands in Figure 4.33 predicted an ultimate strain of 1.61% but reduced the Neutral axis depth to 3.66 in. This value of Neutral axis depth is a little less when compared to the estimated value of 4 in. to 8.5 in. Hence, the estimated ultimate strain of 1.61% could be slightly on the higher side. Considering the large range of estimated Neutral axis depth of 4 in. to 8.5 in., it is possible that the actual value of the ultimate strain was slightly lower than 1.305%. It is also possible that the strands are actually contributing a cross-sectional area slightly greater than 2.507 in² that was considered in this calculation as mentioned in Table 4.8. To sum up, it can be understood that the strands contributed a cross-sectional area that is less than the full or undamaged area even in the initial portion of the load-deflection of the curve until it ruptured. This could have also resulted in a reduction in the stiffness of the beam in the initial region of the load-deflection curve. This has to be investigated further using finite element analysis.

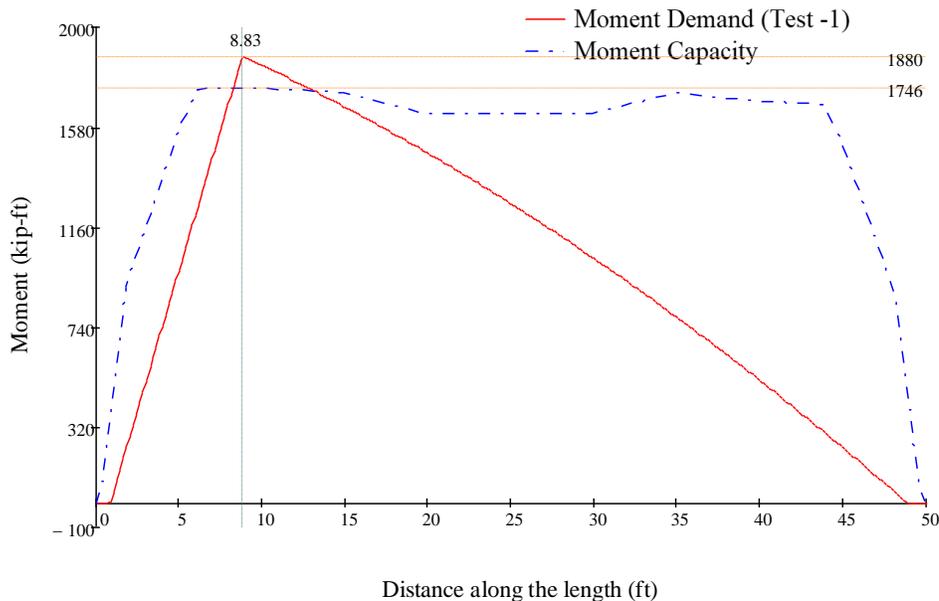
Figure 4.35. Moment Capacity (Strain Compatibility Analysis with CON-WHT-THR-R) vs. Demand Comparison at the section of failure for Test-1 on Lesner Bridge I-Beam-9

In this test, failure occurred with concrete crushing in the deck at the section where the load was applied using an actuator, as discussed in Section 3.1.4.2.1.1. The maximum moment demand to cause the failure (at a distance of 8.83 ft from the left end) including the self-weight moment was 1880 kip-ft. The moment capacity of the beam calculated at the location of the failure, using strain compatibility analysis (CON-WHT-THR-R) described in Section 3.1.3.7.1 with a Whitney stress block model for compressive stress distribution in concrete, is shown in Table 4.16. The capacities at the slice-sections calculated using this analysis, following the recommendations of Naito et al. (2011) and the moment demand along the length of the beam corresponding to the maximum external load in Test-1 and the self-weight moment, are shown in Figure 4.35 to make comparisons at the section of failure.

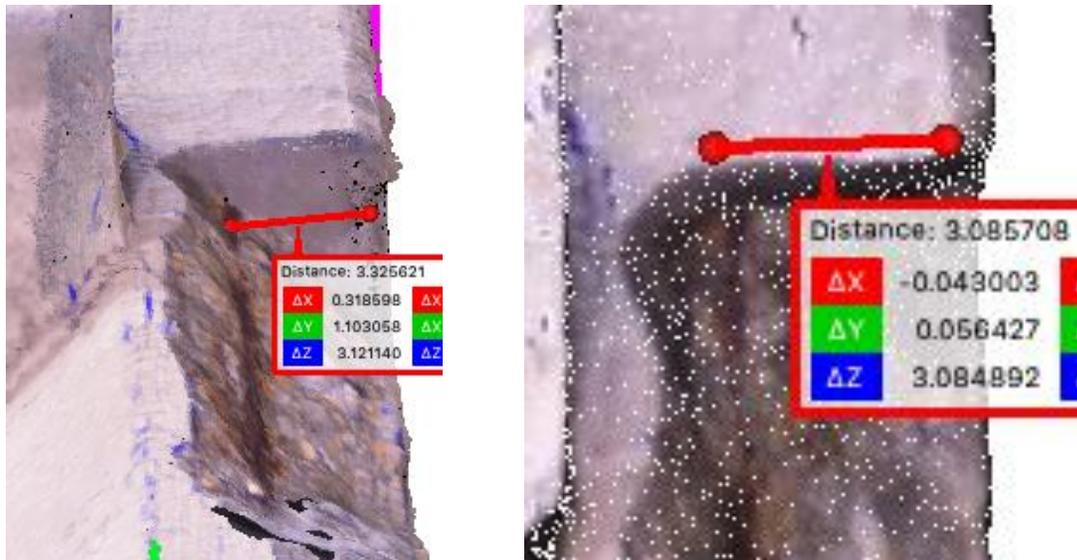
Figure 4.36. Measurement of Actual Effective Cover to the Strands in the Bottommost Layer of I-Beam 9 in as-built condition using CloudCompare

dimension (depth of the bottom flange) as a baseline and is hence, not very accurate. It was confirmed from the measurements on the textured mesh that the depth of the bottom flange matched the bottom flange depth of 6 in. shown in the design cross-section drawing. This discrepancy in the effective cover between the design drawing and the as-built condition could be attributed to a quality control issue during construction. Therefore, strain compatibility analysis (CON-HOG-EXPT-R) was repeated for the failure location by offsetting the strands in the bottom four layers of the cross-section by an inch upwards. In this analysis, the strand offset was neither shown nor considered to determine the corrosion damage associated with the slice-sections (in Section 4.3.2.1). It was only accounted for in the strength calculations. The results of this analysis for the failure location are also included in Table 4.16.

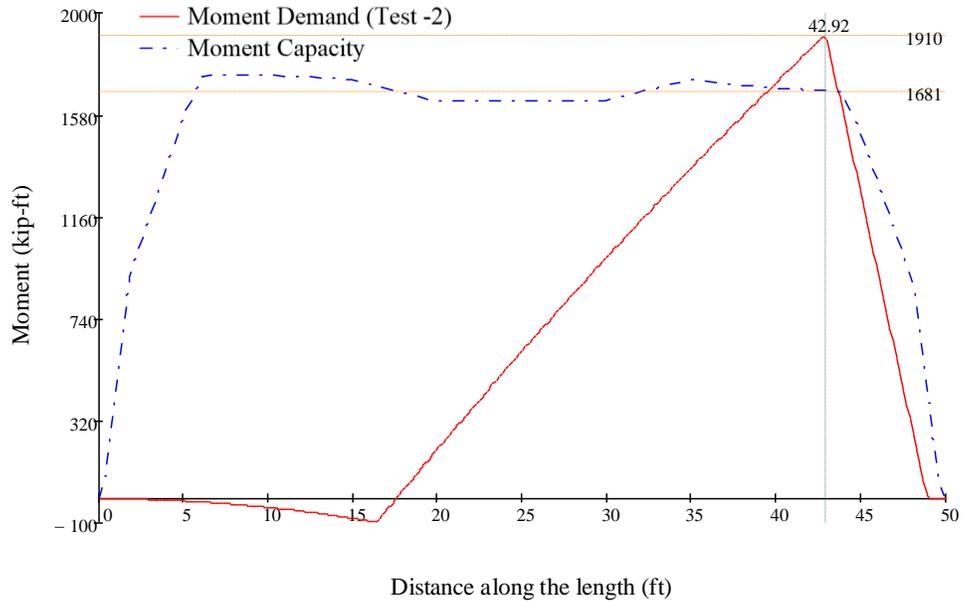
Figure 4.37. Moment Capacity (Strain Compatibility Analysis with CON-WHT-THR-R) vs. Demand Comparison at the section of failure for Test-2 on Lesner Bridge I-Beam-9

analysis with CON-WHT-THR-R, CON-HOG-THR-R, and CON-HOG-EXPT-R (as explained in Section 3.1.3.7) are summarized in Table 4.17.

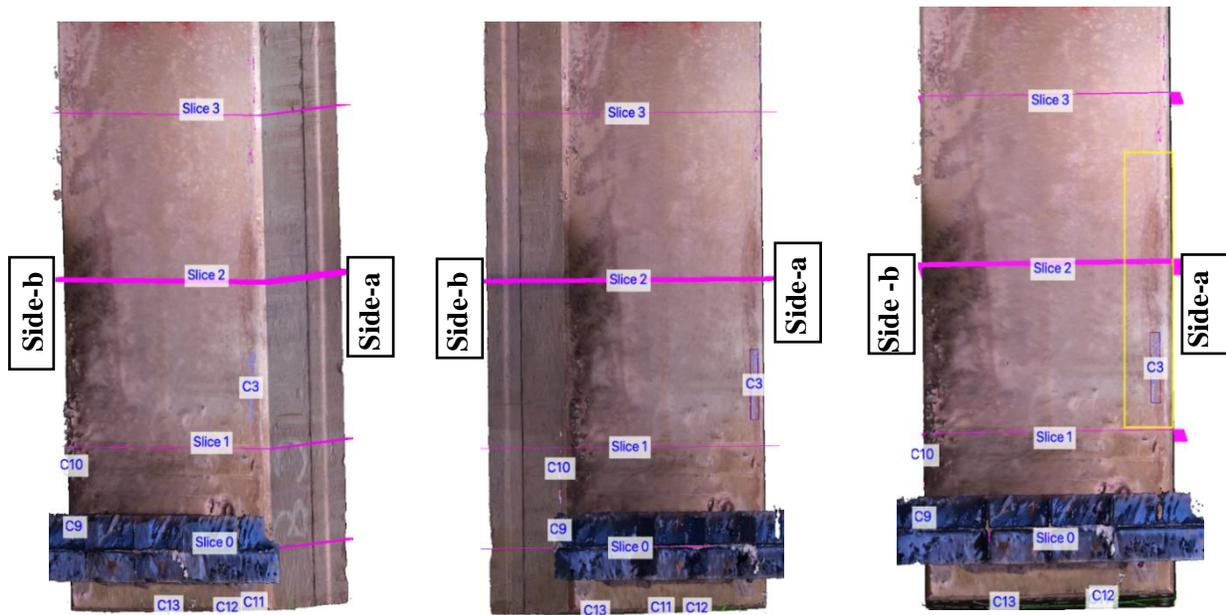
Figure A.4. Damage Clusters in the IW considered for Strength Estimation at Slice-1

This slice is the closest to the failure section in Test-1 on Box Beam-3. So, this corrosion damage and the reduced area of strands also applies to the section of failure in Test-1.

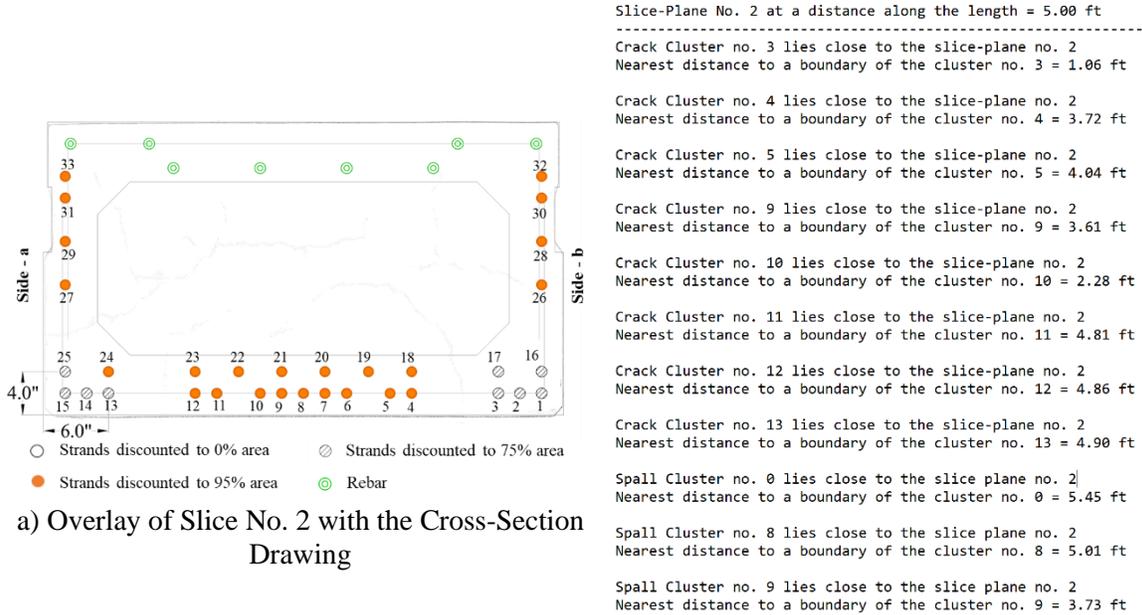
Figure A.5. Tools for Strength Estimation at Slice-2 on Aden Road Bridge Box Beam-3

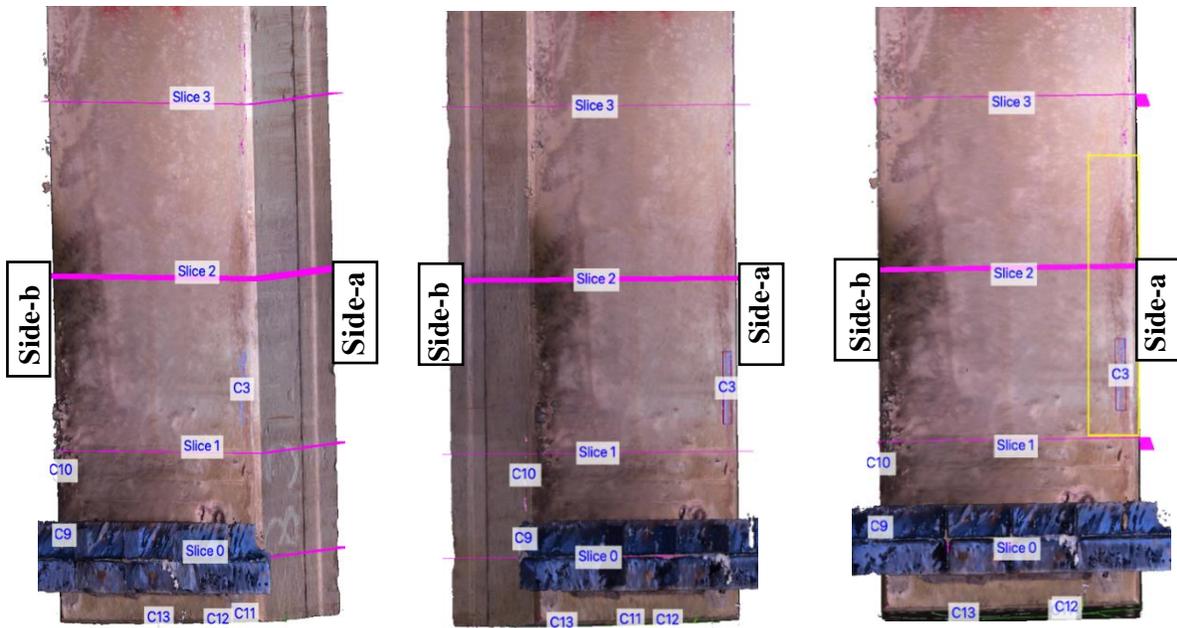
Figure A.6. Damage Clusters in the Inspection Window to be considered for Strength Estimation at Slice-2 of Box Beam-3

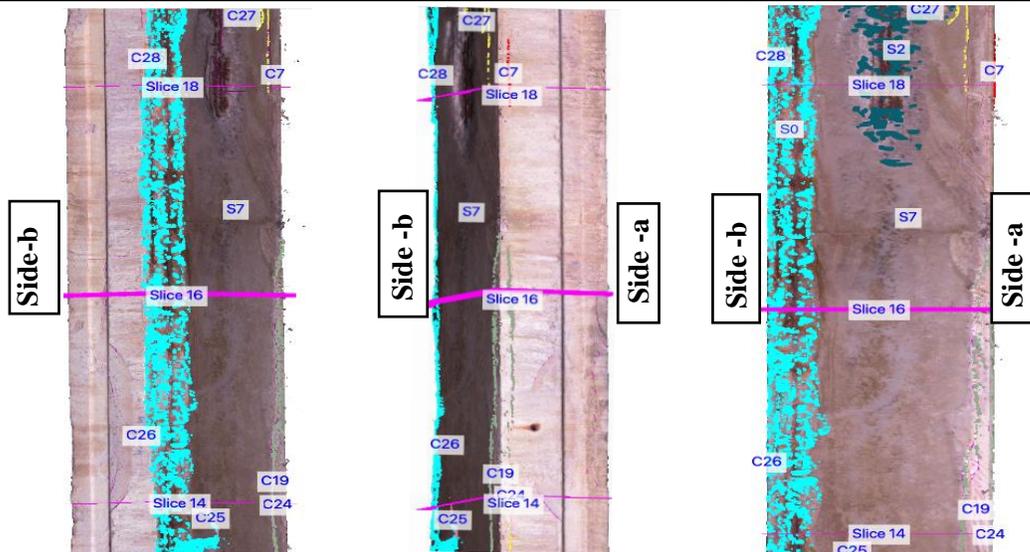
Damage Cluster in IW	Location	Strands Affected	Strand Exposure	% Area Considered
C7, C19, C24	Side - a	13,14, 24, 15, 25	Unexposed	75%
C27	Middle + Side-a	13, 24	Unexposed	
C26, C28	Side - b	1, 16	Exposed	0%
S0	Side - b	1, 2, 3,16		
C25	Middle	6, 7	Exposed (Strand 10 is slightly exposed)	0%
S2	Middle	6, 7, 8, 9, 10		
S1, S7	Noise	-	-	-

Figure A.34. Damage Clusters in IW considered for Strength Estimation at Slice-16 of Box Beam-3

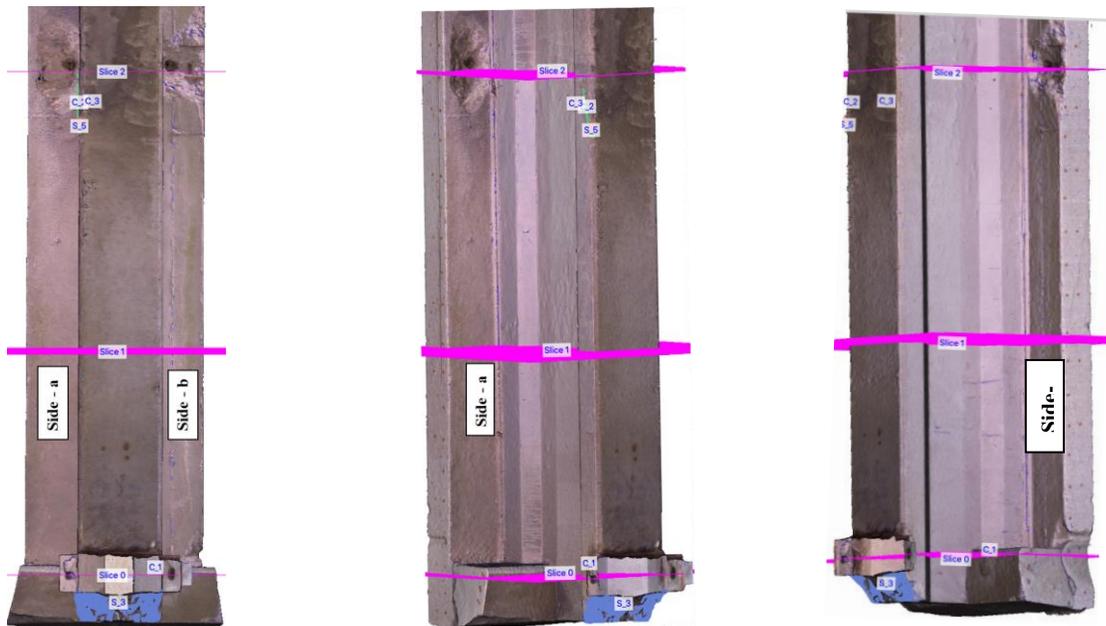
Damage Cluster in IW	Location	Strands Affected	Strand Exposure	% Area Considered
C1	Side - b	None. Crack in the end diaphragm	Unexposed	-
S3	At the end of the beam	None. Effect on the strength due to end damage clusters was already accounted for	Unexposed	-
-	-	Other strands unaffected due to cracks		95%

Figure B.2. Damage Clusters in the IW considered for Strength Estimation at Slice-0 and Slice-1

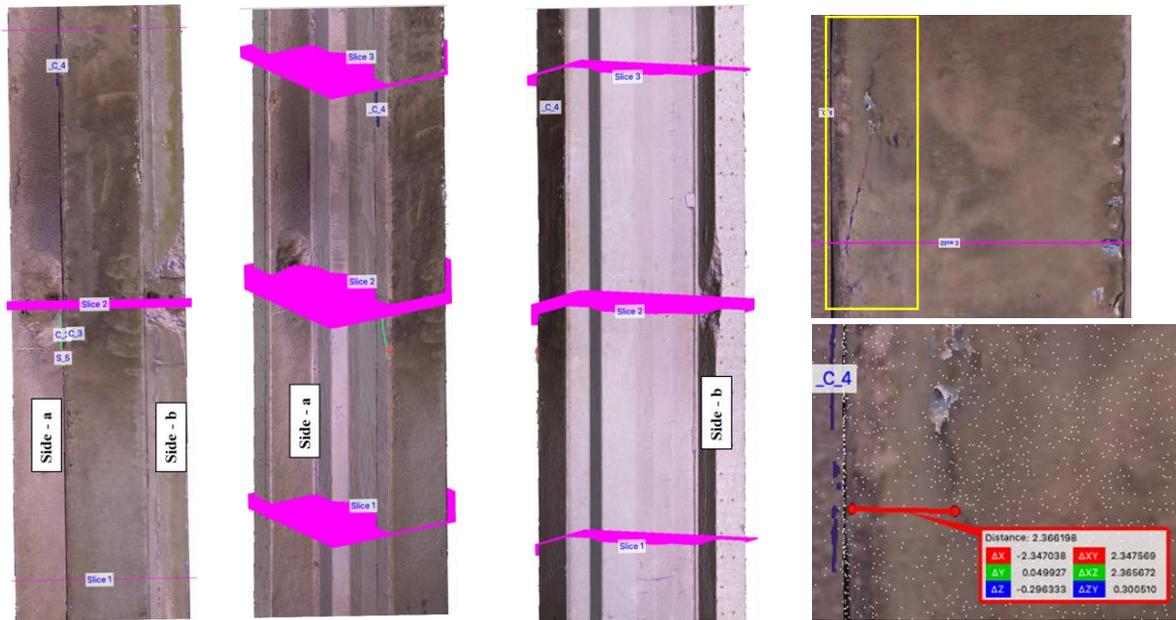
Damage Cluster in IW	Location	Strands Affected	Strand Exposure	% Area Considered
C2, C3, C4	Side-a	1, 7	Unexposed	75%
S5	Side-a	None	-	-
Undetected crack near Slice 2	Side-a	1, 7. Strand 2 is unaffected as it is located at 3in. from crack	Unexposed	75%
Undetected crack near Slice 3	Side-a	1,7		
-	-	Other strands unaffected due to cracks		95%

Figure B. 6. Damage Clusters in the IW considered for Strength Estimation at Slice-2

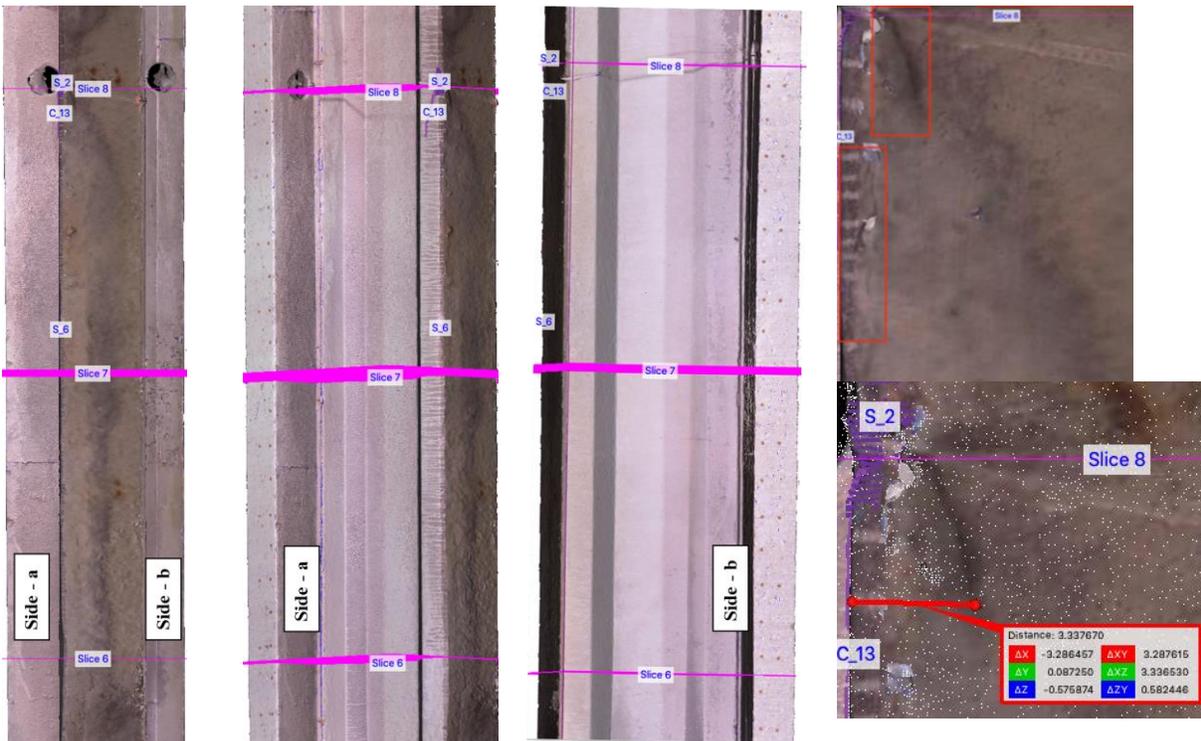
Damage Cluster in IW	Location	Strands Affected	Strand Exposure	% Area Considered
C13	Side-a	1, 7	Unexposed	75%
S2	Side-a	None	-	-
Undetected crack near Slice 8	Side-a	2	Unexposed	75%

Figure B.16. Damage Clusters in the IW considered for Strength Estimation at Slice-7

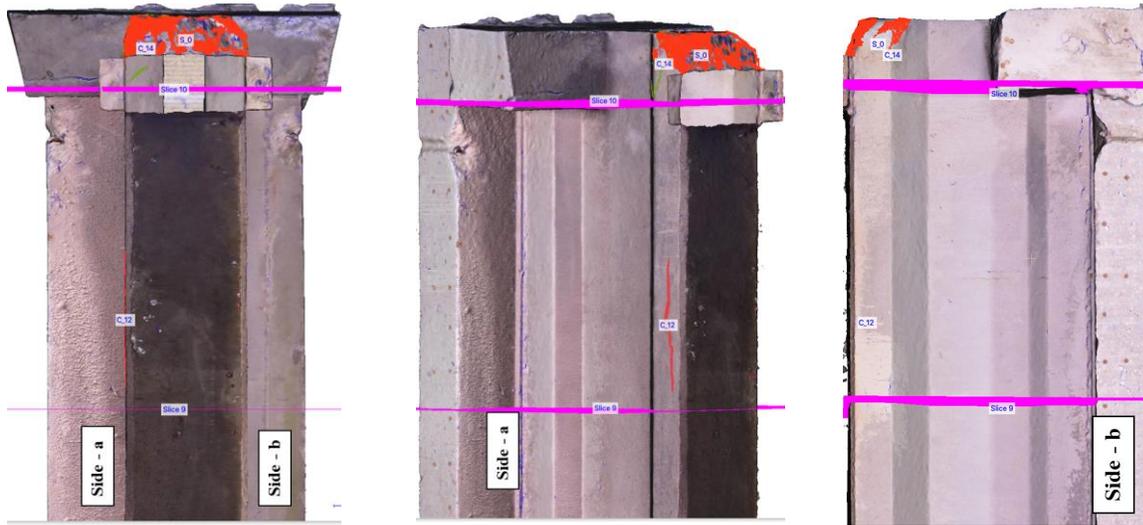
Damage Cluster in IW	Location	Strands Affected	Strand Exposure	% Area Considered
C9, S0	At the end of the beam	Effect on the strength already accounted for	-	-
C10, C11	End diaphragm	Do not affect the strength	-	-
C12, C14	Side-a	1, 7. It was assumed that Strand 13 was not affected due to C13, C14	Unexposed	75%
S2	Side-a	Does not affect any strands	-	-
Undetected Cracks at Slice-9	Side-b to Middle	5, 6 and 11	Unexposed	75%

Figure B.20. Damage Clusters in the IW considered for Strength Estimation at Slice-10
