Mechanical and Physical Properties of Additive Friction Stir Deposited Aluminum

Thesis submitted to the faculty of the Virginia Polytechnic Institute and State University
in partial fulfillment of the requirements for the degree of

Master of Science
In
Materials Science and Engineering

June 13th, 2022
Blacksburg, VA

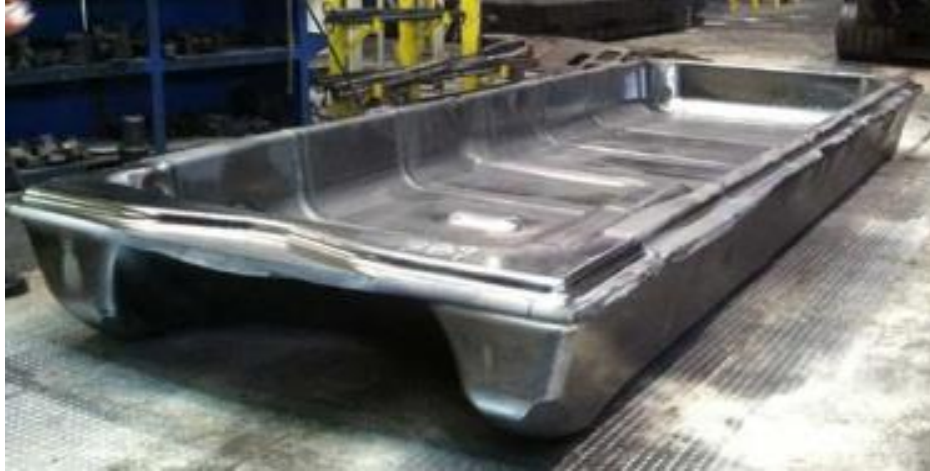
Figure 1.2 The largest forged underbody hull was created jointly with ALCOA and the GVSC [3], [4].

The Jointless Underbody Hull project was started to push the limits of the more mature manufacturing methods, such as welding, forming, and forging. Redesigns included increasing the thickness of the underbody, adding steel reinforcing plates, and reducing or eliminating welds [3]. The largest forged underbody hull, Figure 1.2, is an example of this project [4].

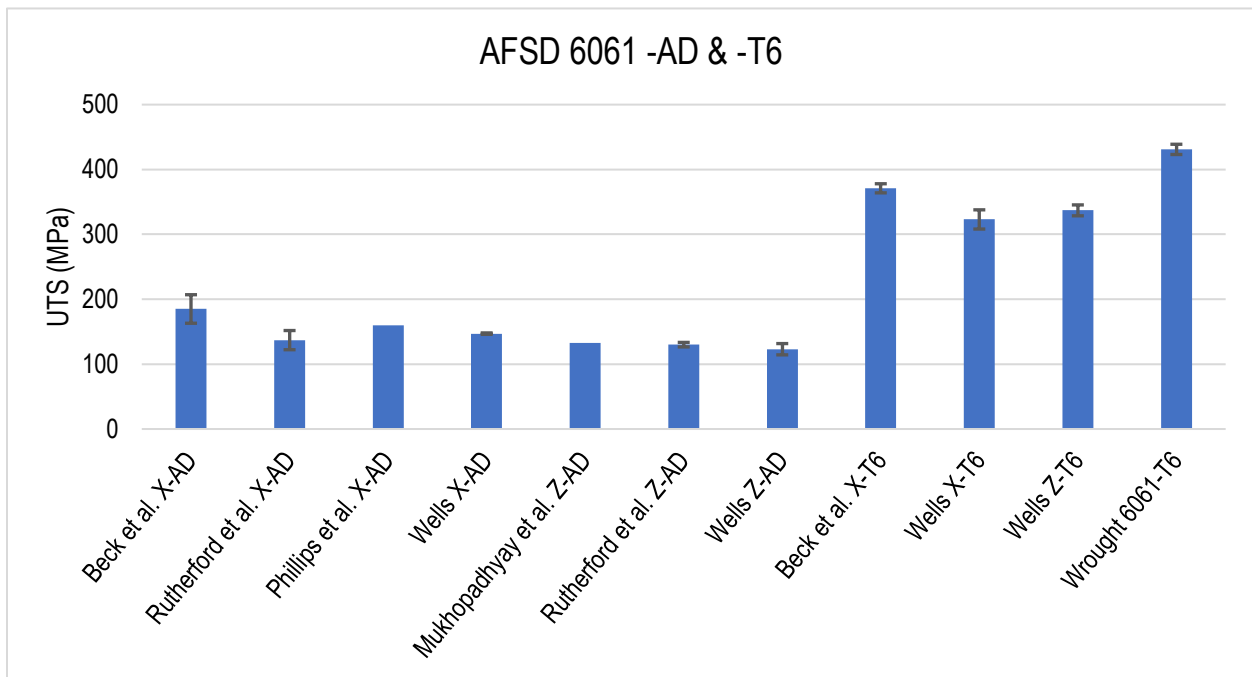
Figure 2.5 Ultimate tensile strength of the AFSD 6061 material in various orientations and conditions.

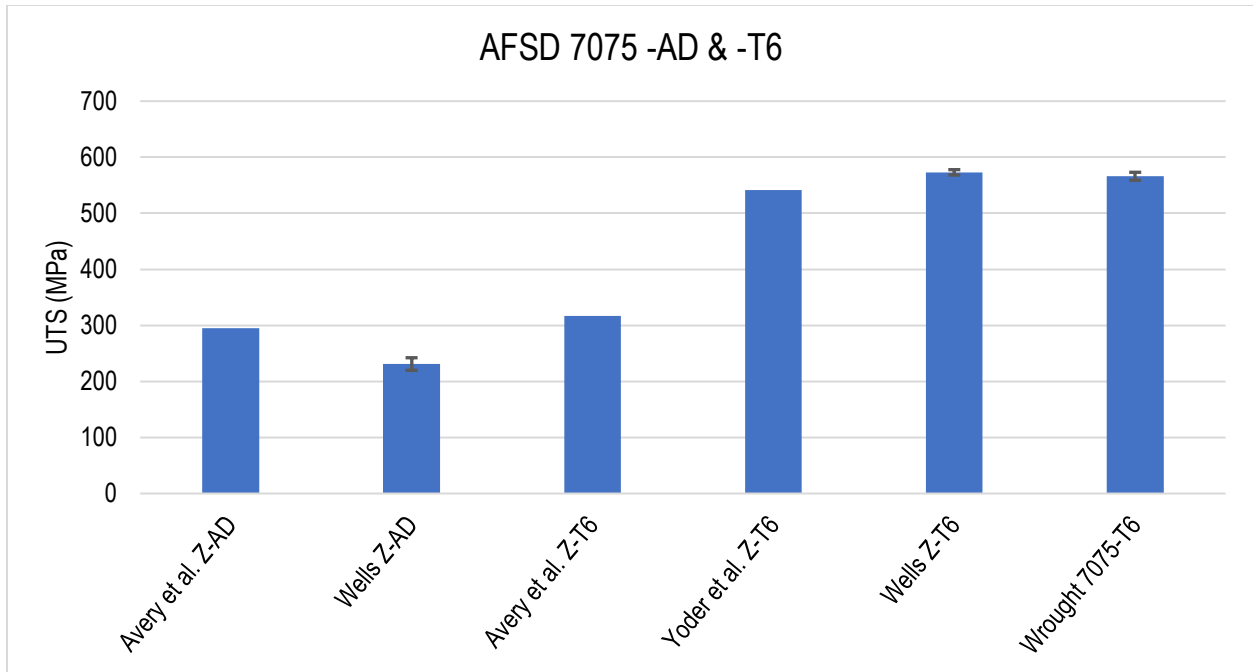
Figure 2.6 Ultimate tensile strength of the AFSD 7075 material in various orientations and conditions.

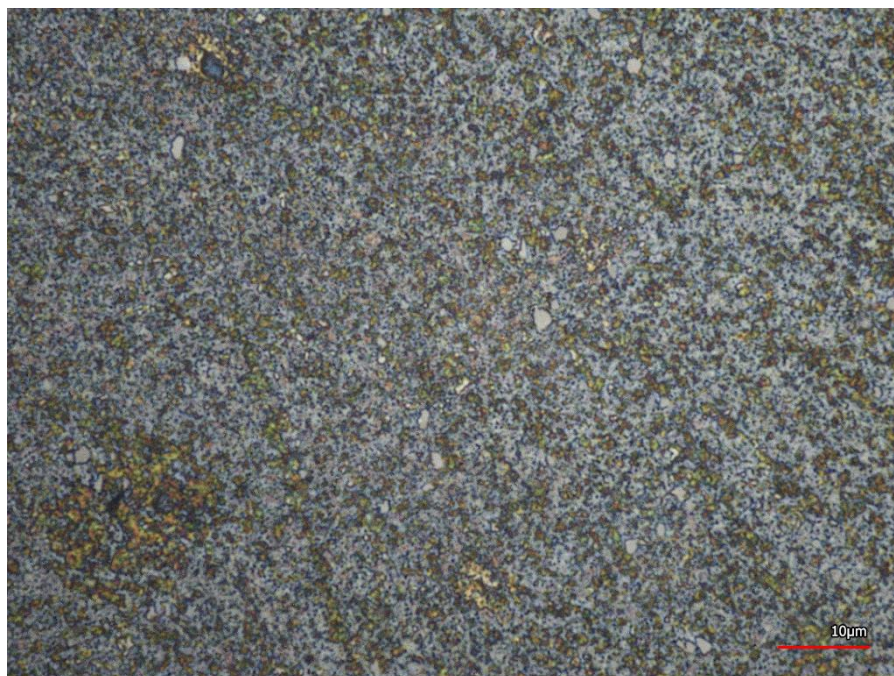
Figure 5.6 The microstructure of the as-deposited AFSD Z 7075-AD #12 material etched with Weck's reagent showed a very fine-grained size at 150X.

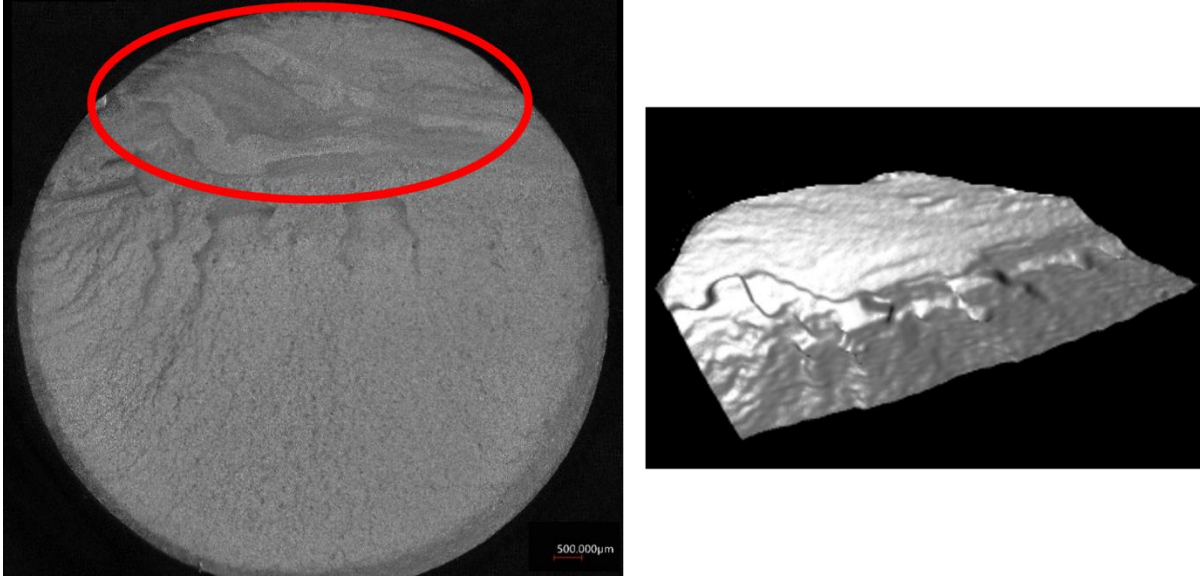
Figure 5.17 An overview of the fracture surface (left) and the 3d rendering of the red circled ‘waved’ section (right).

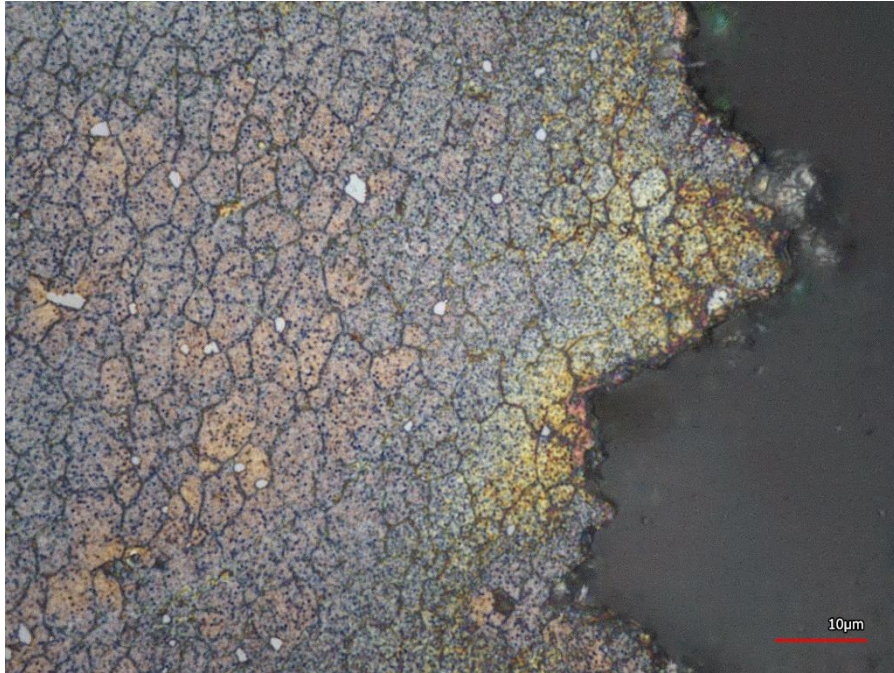
Figure 5.20 Sample AFSD Z 7075-T6 #14 near the fracture surface etched with Weck's and at 150X showed failure occurs at the grain boundaries.

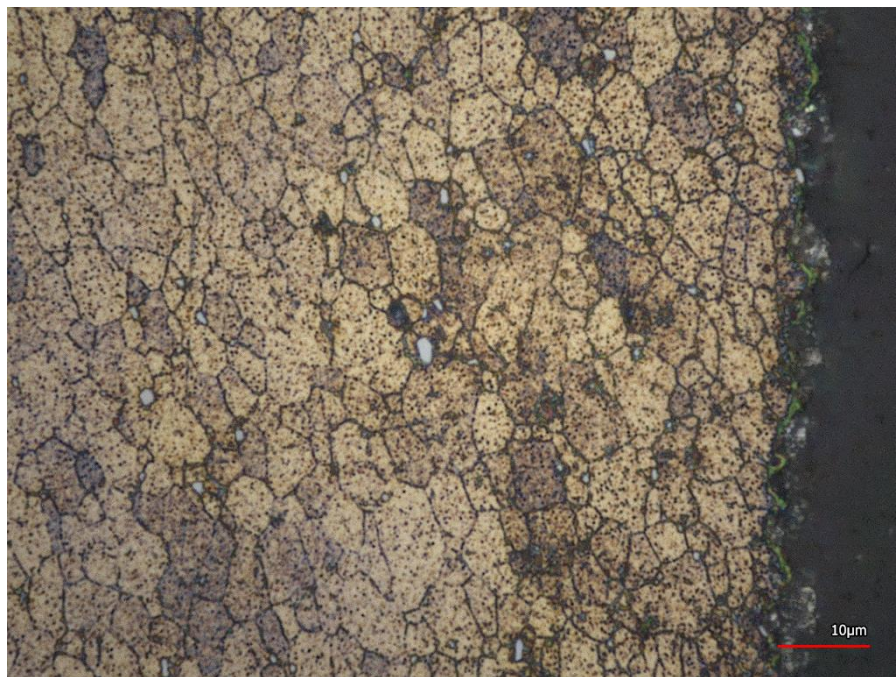
Figure 5.24 The cross section of the fracture surface at 150x after etching with Weck's reagent revealed that fracture was along the grain boundaries.
