Developing a Framework for Historic Restoration Projects:  
A Case Study of the Catawba Farm Dairy Barn

A thesis submitted to the faculty of the Virginia Polytechnic Institute and State University in partial fulfillment of the requirements for the degree of

Building Construction

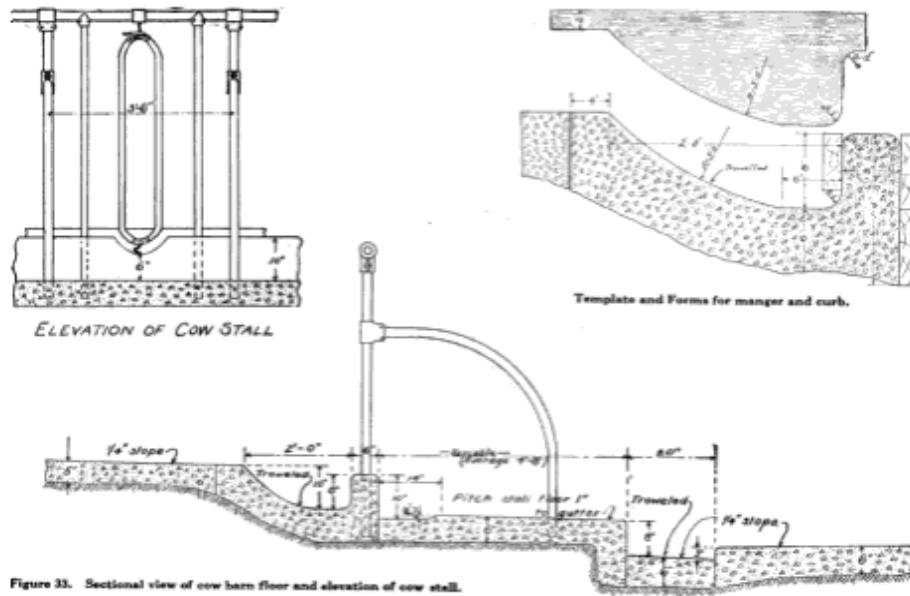
**Figure 2-2: Cross Section of Concrete Dairy Facility**

more sanitary facilities because dairy workers could conceivably “hose down” the facility to keep the areas clean (Carrington 1914). One 1914 publication entitled *Concrete for the Farmer* states “the ease with which concrete can be kept in a sanitary condition makes its use very desirable in dairy barns. It is especially advisable that the floor of such a building be constructed of concrete” (UPCC 1914). Below is a cross section from that same publication showing the ideal construction for the dairy barn floor and cow stall, followed by a picture showing this technique demonstrated in the Catawba Dairy barn.

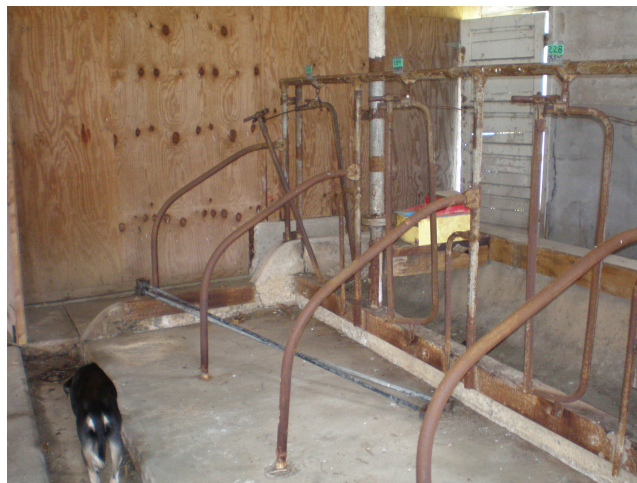
**Figure 2-3: Catawba Farm Dairy**

Many early 20<sup>th</sup> century dairy barns had facilities for housing the cattle, holding the grain, and milking and bottling stations for the barn's production (UPCC 1914). Conceivably, the front two rooms of the barn providing housing and feeding areas for dairy cattle, the rear room provided housed the milking parlor, and the silos stored the grain for the cattle (see figures below).

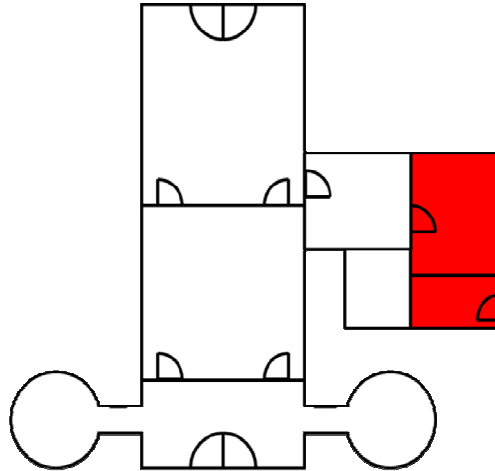
**Figure 2-7: Barn Addition**

A 1950's hospital insurance document indicates the then-recent construction of an addition to the dairy barn for a bottling and sanitation facility (Foulke 1950). The diagram below shows the likely location of that addition.

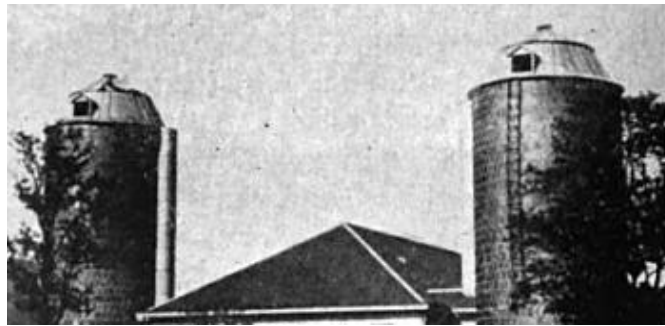
**Figure 2-8: Original silo roofs**

Additionally, as the pictures below show, the silo roofs underwent a change at some point in the barn's life. The first picture shows the original, taller silo roofs, and the second shows the current remnants of shorter profile silo roofs.

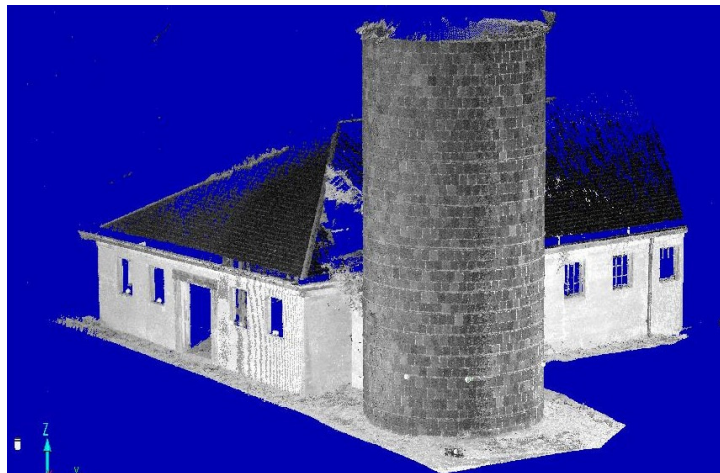
**Figure 3-4: 3-D point cloud of dairy barn**

The researcher initially chose to approach the forensic examination of the farm structure by conducting laser scanning analyses of the building. The researcher used a Faro Scene laser scanner and Faro Scene software to take scans of the building in order to produce 3-dimensional point cloud pictures of the facility. Figure 3-2 shows a point cloud of the dairy barn facility generated on site.

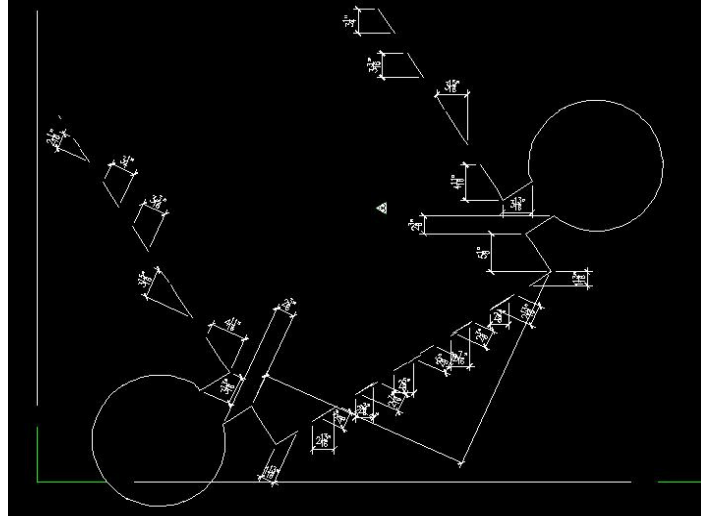
**Figure 3-5: AutoCad drawing of dairy barn**

The researcher then exported those scans to AutoCad and used Point Cloud software to try and produce “as built” dimensional documentation of the building. Figure 3-3 shows a drawing of the silo layout as produced in AutoCad.

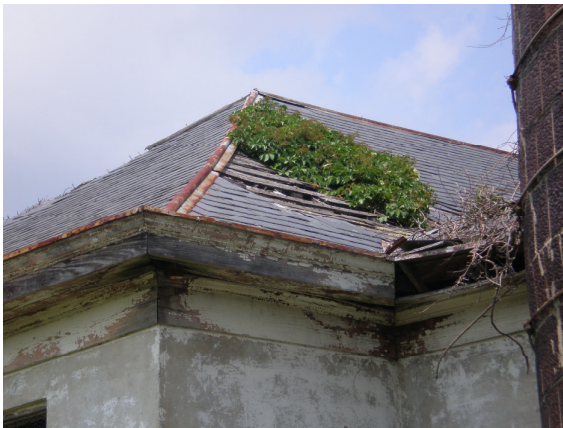
**Figure 4-1: Front room roof**

The roof of the building consists of slate with a wood sheathing and wood rafters. The roof over the milking parlors (rear two thirds of the building) is in relatively decent shape. However, the front of the building has severe water damage. It appears that the roof began to deteriorate as slate shingles loosened, allowing water to penetrate the sheathing and the rafters. This enabled serious rot. Figures 4-1 and 4-2 show pictures of the damage to the ceiling of the front room and the damage to the roof.

The rafters, beams, and columns for the front of the building all need replacement. Because the state of the water damage allowed some sagging of the ceiling joists for the front room of the barn, the reconstruction will require jacking up the ceiling to successfully and levelly connect the front of the barn to the rear two thirds of the barn. Other than the front of the building, the rest of the roofing is in decent shape and will require cleaning and replacement of some broken shingles.

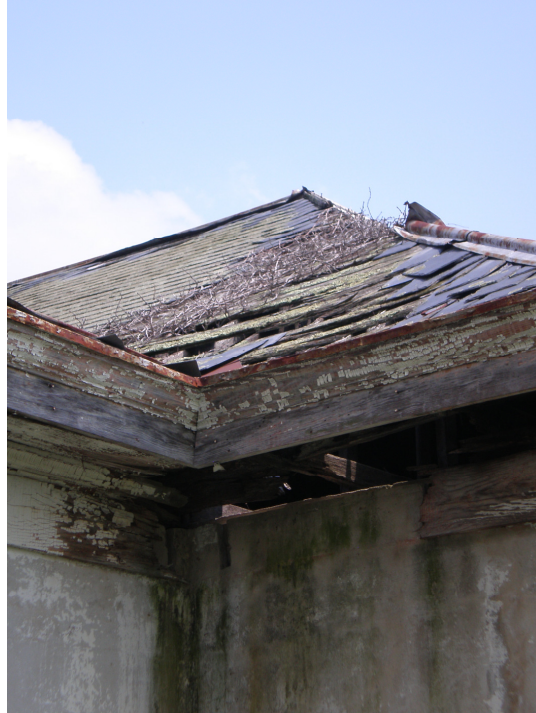
**Figure 4-3: Gutter deterioration**

The gutter system for the entire building needs replacement in order to prevent further deterioration to the roof due to water leakage and poor drainage. Figure 4-3 shows the current state of the gutter system.

- Because much of the building’s deterioration occurred because of water damage over time, the gutter replacement emerges as an immediate task. This task is integral to maintaining the roof support restoration project.

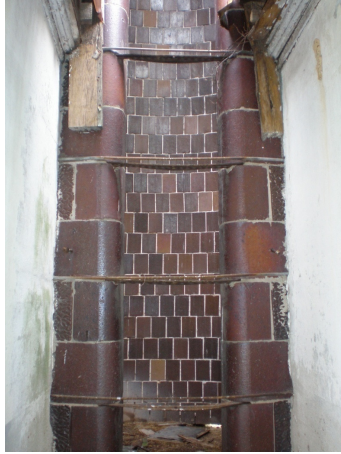
The foundation for the main section of the building is in good shape, but the silo foundations, should the silos be used as habitable spaces in the building's future, need further reinforcement. The floors inside the silos are earthen and need replacement with poured concrete. Additionally, the open-air hallways between the front room and silos need enclosure. As the original use for the silos was to store grain, portions of the sides of the silos are open and originally utilized wood enclosures depending upon the level of the grain. The contractors will need to enclose those openings to make the silos a habitable space. Lastly, the metal silo roofs and wooden roofing structures need replacement. The following figures show the damage and obstacles to rehabilitating and renovating the silos.

**Figure 4-4: Side openings**

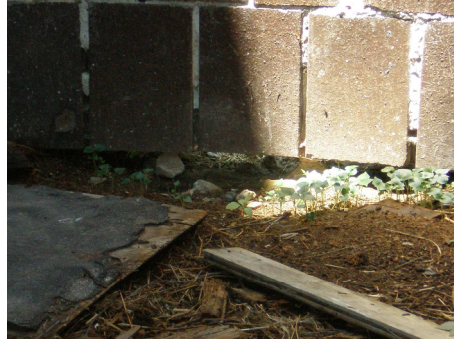
**Figure 4-5: Earthen floor and foundation gaps**

- Re-support silo foundations
  - While the silos are somewhat structurally sound in their current stage, the erosion of the foundations due to the silage requires attention should the silos have a use in any of the alternatives. In interviews, the silos emerged as a favorite portion of the building to the community, so their restoration and use is integral to maintaining support for the restoration project.
    - Recommendations for Resupporting Silo Foundations
      1. The silos are 14 feet in diameter in the interior with 8” thick ceramic block walls. In order to ensure that the structure stays sound during the resupporting process, the team should approach the foundations in a staggered fashion (see figure below)

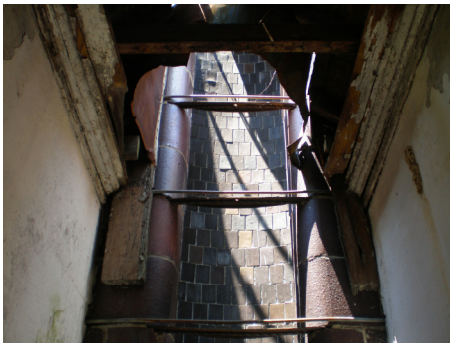
**Figure 4-6: Opening between rooms**

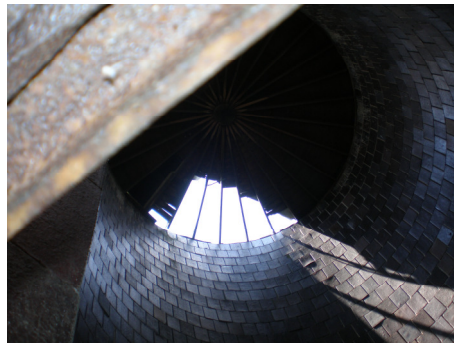
**Figure 4-7: Silo roof damage**

- Silo roof replacement
  - As each future use alternative requires the use of the silos, the metal roofs require replacement. It up to the project leaders to determine whether to restore the roofs to their original profile or to replicate the existing roof structures.

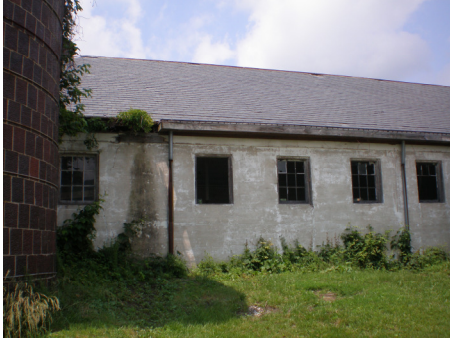
Virtually all of the windows in the dairy barn structure are missing or broken. Several doors are missing as well, and the ones that are present in the structure need replacement due to age or water damage. The replacement of these building members is especially important for regulating the interior temperature and moisture.

**Figure 4-8: Missing and broken windows**

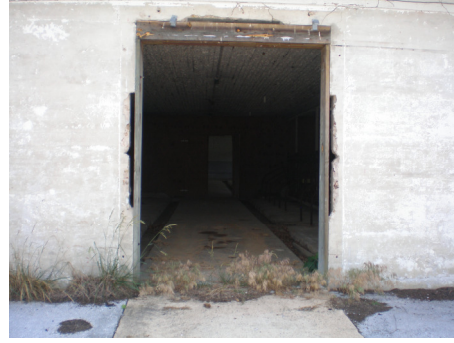
**Figure 4-9: Missing door**

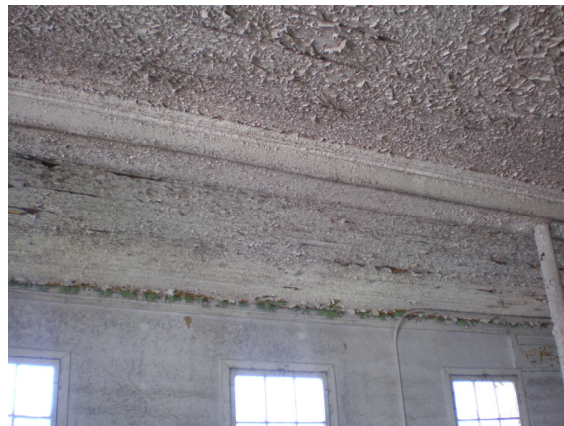
The ceilings in the building's interior have lead based paint peeling from them. This is an issue that the barn owners must address early in the restoration process.

**Figure 4-10: Peeling lead paint**

- Lead paint remediation
  - Lead paint presents an important safety consideration for any person or persons involved with the restoration of the building. Remediation and removal should be an urgent task.
    - Recommendations for lead paint remediation:
      1. Take care to have the proper safety equipment including a filtered respirator, eye protection, and full protection for all exposed skin
      2. Power wash the ceilings with low pressure water (no higher than 600 psi).

3. Hand scrape any loose paint after power-washing
4. Allow sufficient drying time before painting

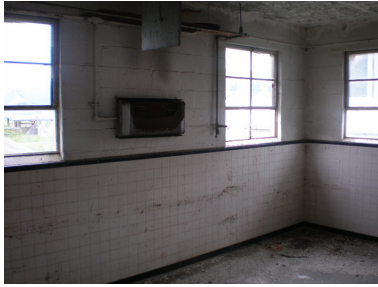
**Figure 4-11: Bottling room plumbing**

In order to repurpose the building for any commercial or private use, the wiring and plumbing will need updating. The current wiring is somewhat updated, but will need inspection and work to meet current codes. The plumbing consists of spigots running to the milking parlor. Plumbing also exists in the addition to the original barn in the part that was used for sterilizing and bottling. In both cases, the plumbing will need inspection and updating to accommodate a more modern use.

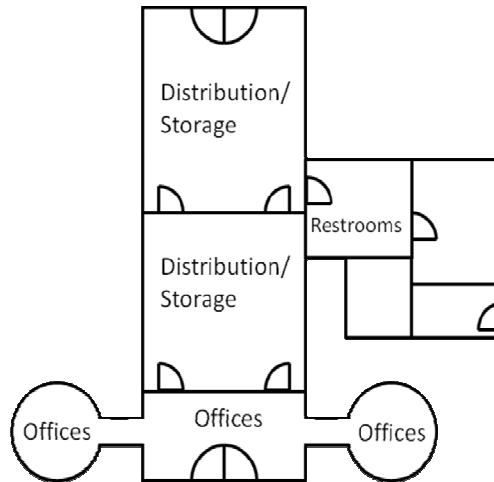
**Figure 4-15: Possible food distribution center layout**

Figure 4-15 shows a possible layout for the proposed use as a food distribution center.

In addition to the baseline restoration tasks, the installation of a food distribution center would require the following additional construction tasks:

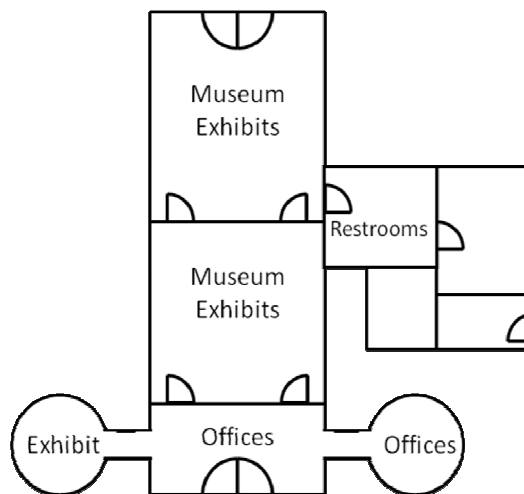
**Figure 4-16: Possible museum layout**

Figure 4-16 shows a possible layout for the proposed use as a museum.

In addition to the baseline restoration tasks, the installation of a museum would require the following additional construction tasks:

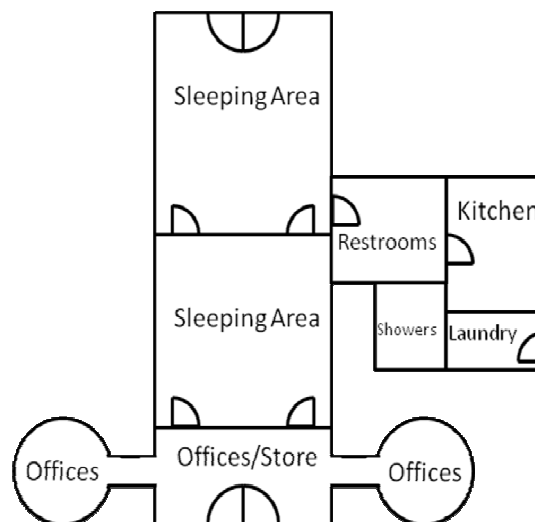
**Figure 4-17: Possible layout for hostel**

Figure 4-17 shows a possible layout for the proposed use as a museum.

In addition to the baseline restoration tasks, the installation of a hostel would require the following additional construction tasks:

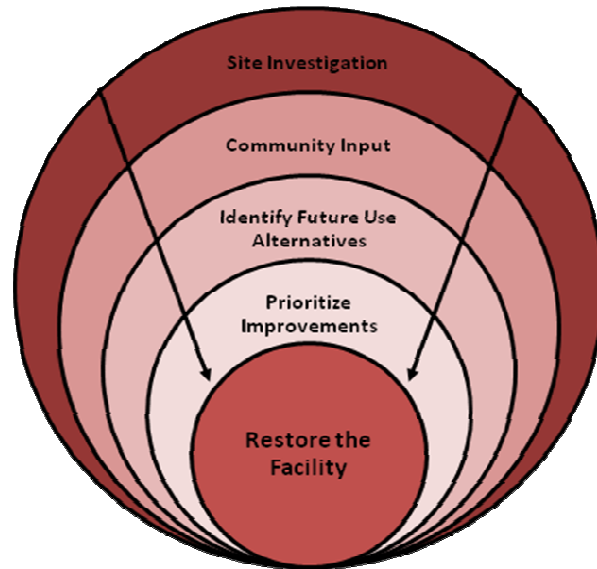
**Figure 4-18: Framework**

The method used to evaluate the Catawba dairy barn restoration led to the development of a framework for communities at large to consider and prioritize tasks for restoration projects. The following figure shows the proposed framework followed by sections explaining the various steps associated with the framework.

The framework includes four important steps in the approach to community historic restoration projects.

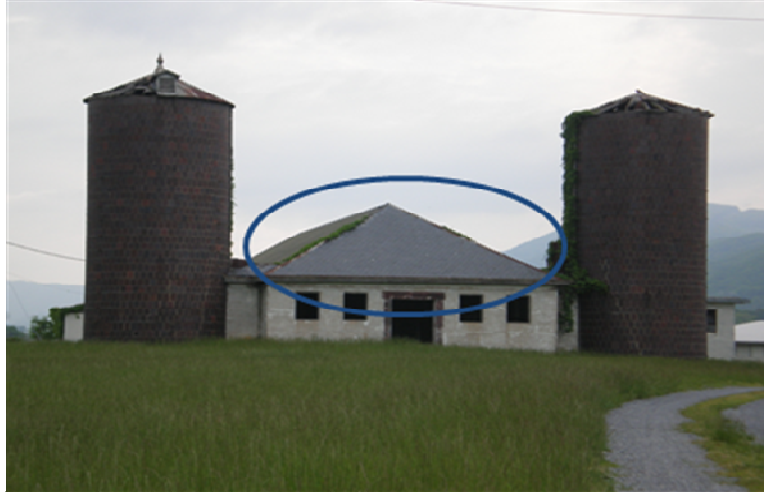
**Figure 4-23: Barn roof**

- Roof and attic support restoration
  - This task is immediate because the front room roof requires attention to keep the front portion of the structure from collapsing in the near future. Should the roof collapse, there exists the possibility that the community and owner might question the validity of restoring the building and choose to forgo the restoration project.
    - Recommendations for roof support restoration: The roof in the front portion of the building requires immediate attention (see figure below)

1. Remove slate from the front of the building
2. Remove front roof structure
3. Utilize jacks to support the attic floor from underneath
4. Replace attic floor girders and beams in the front of the building
5. Remove slate from front room portion of the building
6. Replace attic flooring
7. Replace king posts, rafters, roofing boards and purlins

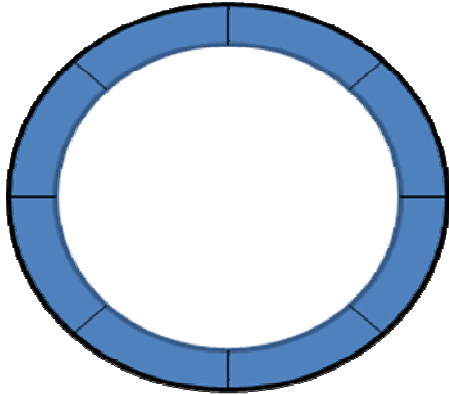
**Figure 4-24: Silo foundation restoration plan**

The team should re-support the foundation by addressing every other section of the silo foundation and allowing the foundation sections to cure between pours.
