ANALYSIS AND TESTING OF THE TRANSVERSE TENDON BEHAVIOR IN THE  
VARINA-ENON

Thesis submitted to the faculty of the Virginia Polytechnic Institute and State University  
in partial fulfillment of the requirements for the degree of

Master of Science  
In  
Civil Engineering

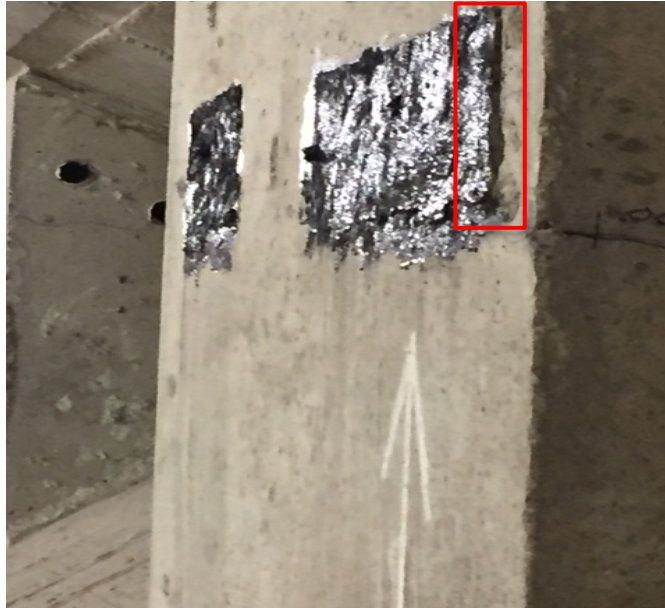
Also, in the Varina-Enon Bridge, inspectors have noted locations where it appears that the pour-back material in the block out pockets on the inside of the bridge has been dislodged, possibly due to strand fractures. Figure 1-5 shows the dislodged block out pocket on the inside of the Varina-Enon Bridge.

**Figure 1-5 The Dislodged Block Out Pocket on the Inside of the Varina-Enon Bridge**

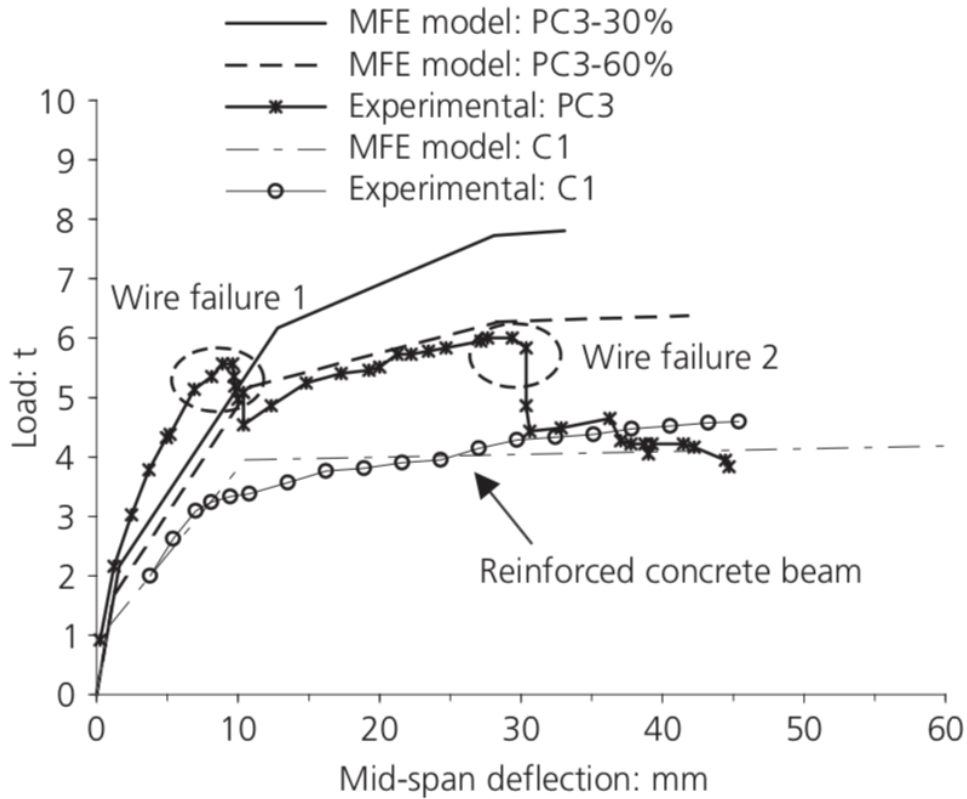
Figure 2-1 is a comparison of MFE simulation and experimental results for beam PC3. The graphs show separate curves for the MFE model after 30%, 60% and 100% steel corrosion reduction. In Figure 2-1, the experimental curve matches the 30% steel cross section reduction until it reaches the first wire failure. After that, the 60% cross section reduction follows the experimental curve until the second wire failure, and at the end when all of the wires are broken, the curve almost corresponds to reinforced concrete behavior. That shows the changes in the behavior of the prestressed concrete as the strands are losing strength and failing.

**Figure 2-1 Comparison of MFE Simulation and Experimental Results for Beam PC3 (Castel et al., 2012)**

The MFE model matched laboratory test very closely, however they were slightly different because the model designed with the limited knowledge of materials properties and post-cracking stiffness.

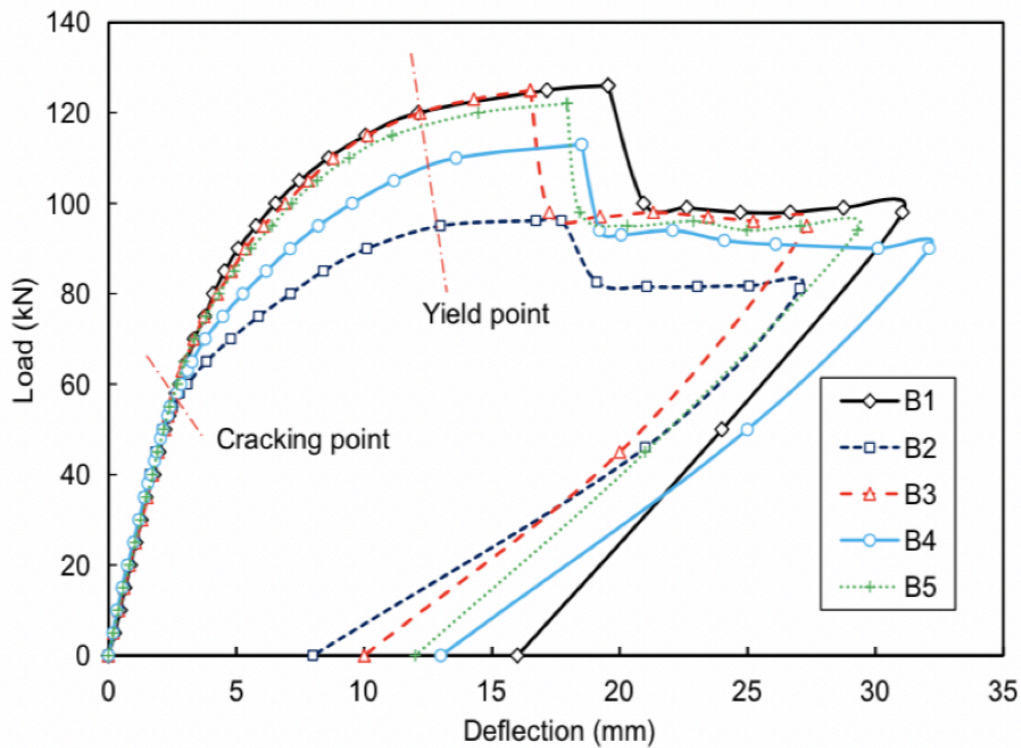
In research conducted by Wang et al. (2013), the objective was to investigate the effect of insufficient grouting-induced strand corrosion on the flexural behavior of post-tensioned concrete beams. Five post tensioned beams with different grouting conditions were built at the lab and were subject to loading. The result of these five post-tensioned beams showed the crack distribution and crack width depend on qualities of grouting and the ungrouted length and position. Figure 2-2 shows the typical load-deflection curves for the beams

Full grouting (B1), No grouting (B2), Grouting in only half of the duct cross-section (B3), No grouting in the half span (B4) , No grouting in the central region (B5).

Before the cracking point, all the beams have same load-deflection behavior. However, insufficient grouting, the ungrouted length and position affect the post-cracking stiffness and the

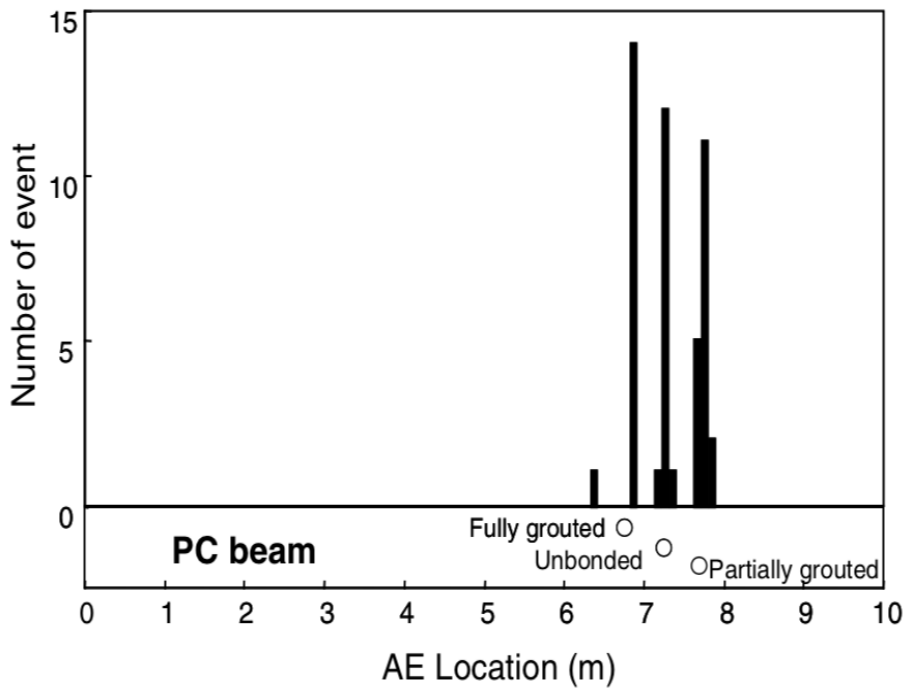
Figure 2-3 Location of all the Events Detected by AE in the B2 Beam (Yuyama et al., 2006)

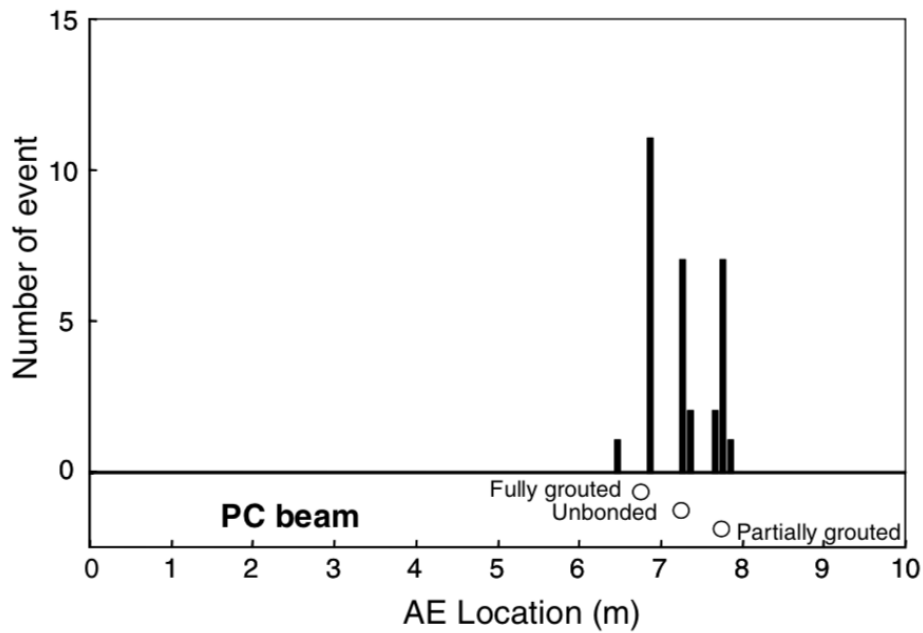
Figure 2-4 Location of all the Events Detected by AE in the B3 Beam (Yuyama et al., 2006)

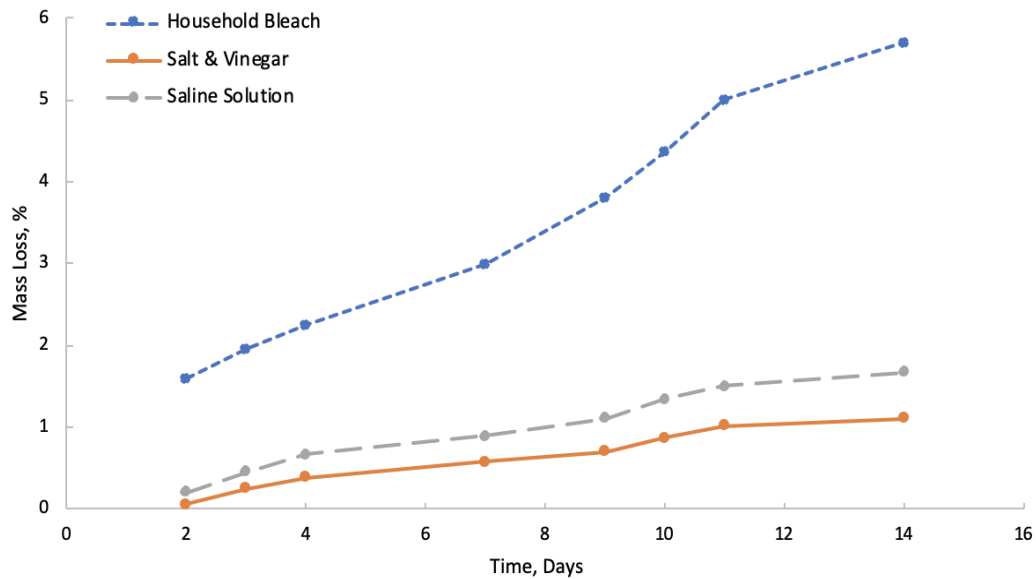
Results show that household bleach was the most effective solution to corrode the tendons. The specimens in bleach experienced 3% mass loss after seven days and 5.7% after fourteen days respectively. Figure 3-2 represents a graph of mass loss over time for the specimens submerged in all three solutions.

**Figure 3-2 Mass Loss vs. Time Graph for Specimens Submerged in Bleach**

As shown in Figure 3-2, the mass loss percentage for the specimens in salt and vinegar and salt and water are very small compared to the one in the household bleach. In addition, Figure 3-3 shows a specimen before and after it has been submerged in bleach for seven and fourteen days.

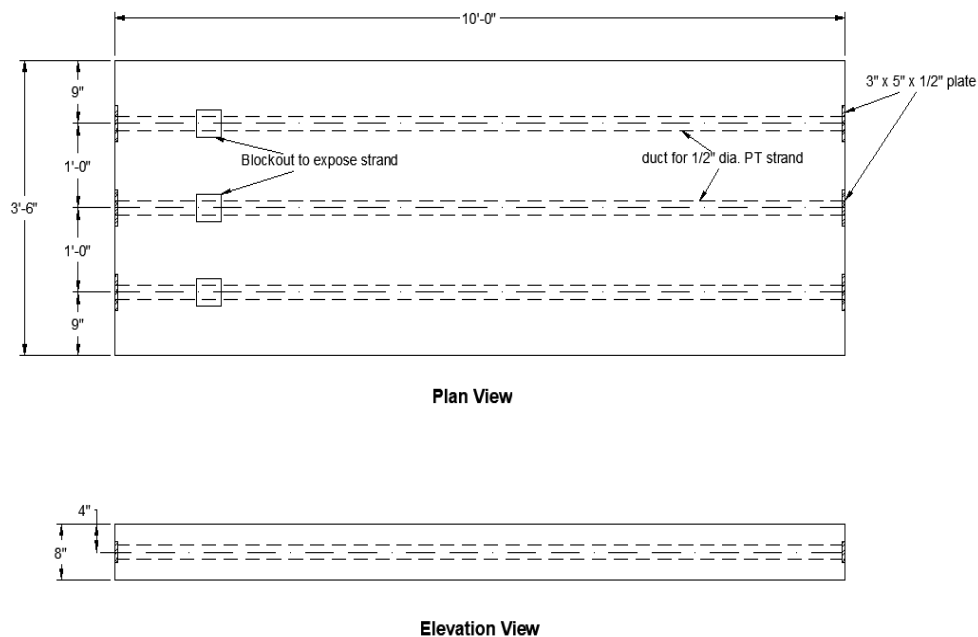
The main purpose of the small specimen was to estimate the time needed to break the tendons by using both methods combined: submerging in saline solution and reverse cathodic protection. A 4 ft by 10 ft slab with thickness of 8 in. was built at the lab. The slab was constructed with 0.5 in. diameter strands at 10 in. spacing and each tendon was in a 1 in. by 2 in. corrugated plastic duct. Figure 3-4 shows the drawing of elevation view and plan view of the small specimen.

Figure 3-4 Drawing of Plan View and Elevation View of the Small Specimen

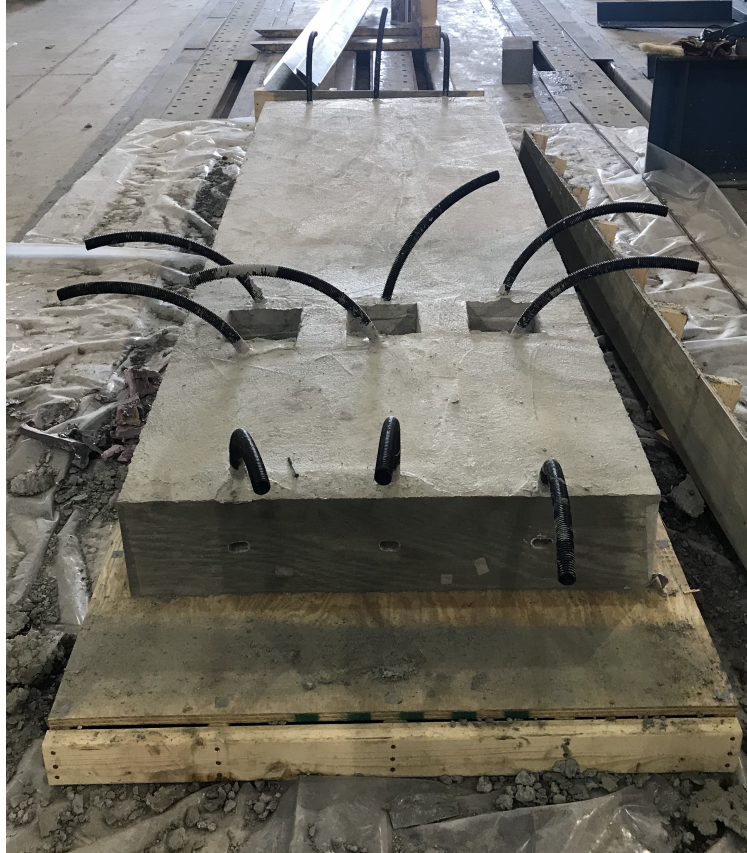
There were block-outs over each duct to allow access to tendons for corrosion purposes. After placing concrete, the block outs were taken out and the ducts were cut off so the strands would be exposed for the corrosion test. Figure 3-6 shows the slab after the concrete was placed. In addition, Figure 3-7 shows a clear view of the inside of the block out after the duct was cut off.

**Figure 3-6 The Slab After Concrete was Placed**

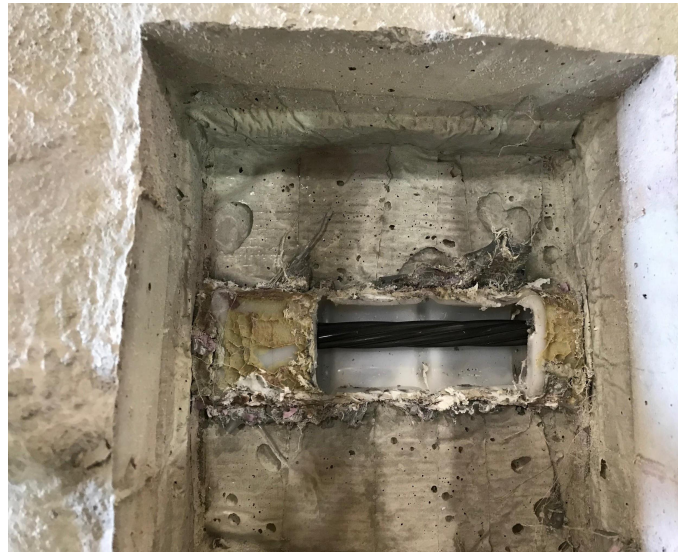
**Figure 3-7 A View of the Block Out After the Duct was Cut Off**

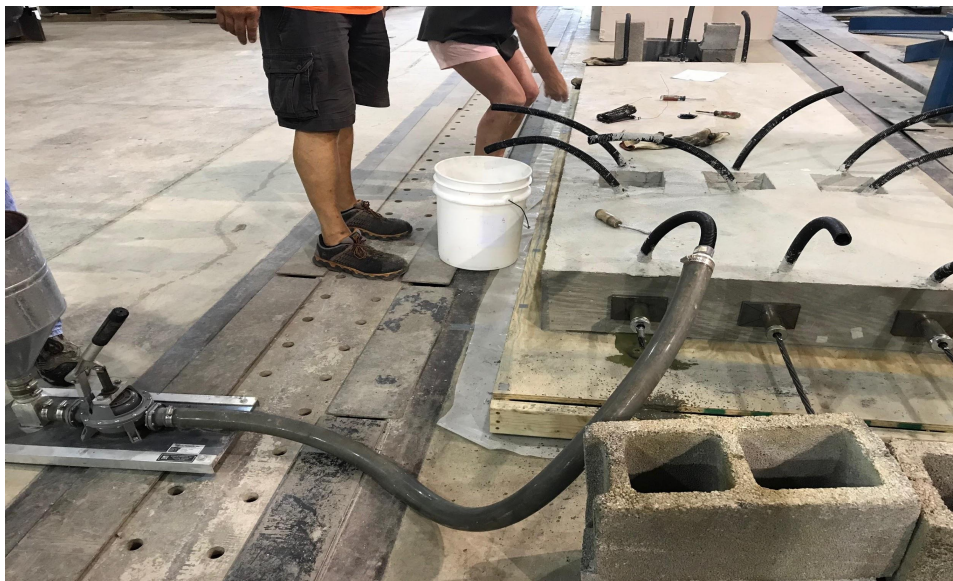
The ducts at the block outs were plugged by using a spray foam to prevent grout entering the block outs. The grouting process was conducted by attaching the black tubes in the slab to the grouting tube. The grout that was used for this specimen had a water-cement ratio of 0.45, which represents a good grout. Figure 3-8 shows the grout pump and grout tube connected to the plastic tube during the grouting process.

**Figure 3-8 Grouting Process**

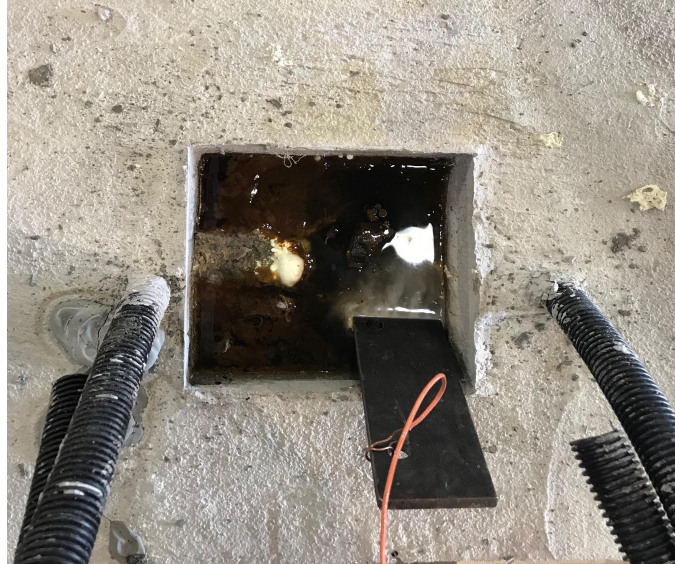
**Figure 3-10 The Block Out During the Corrosion Experiment**

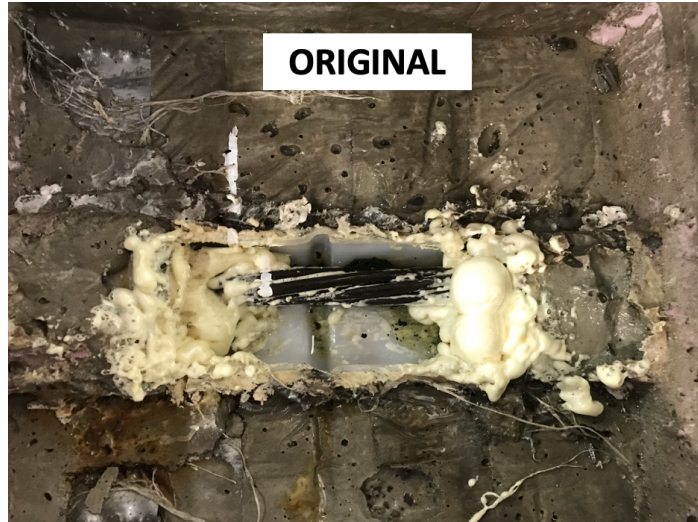
The corrosion process was conducted six hours per day for a total of three days, and at the end of each day, the saline solution was removed from the block out and pictures were taken to record all the changes in the strand condition. The tendon was fully corroded after three days, and it was fully dissolved in the saline solution. This process was repeated for all three block outs and the result was similar for all tendons and they were broken after 3 days. Figure 3-11 presents the progress in the strand corrosion process over three days. This artificial corrosion developed localized corrosion in the strands and proved to be an effective method to corrode the tendons. By using this method, the tendons will reach the desired condition and break.

Figure 3-11 Progress in the West Strand Corrosion Over Three Days

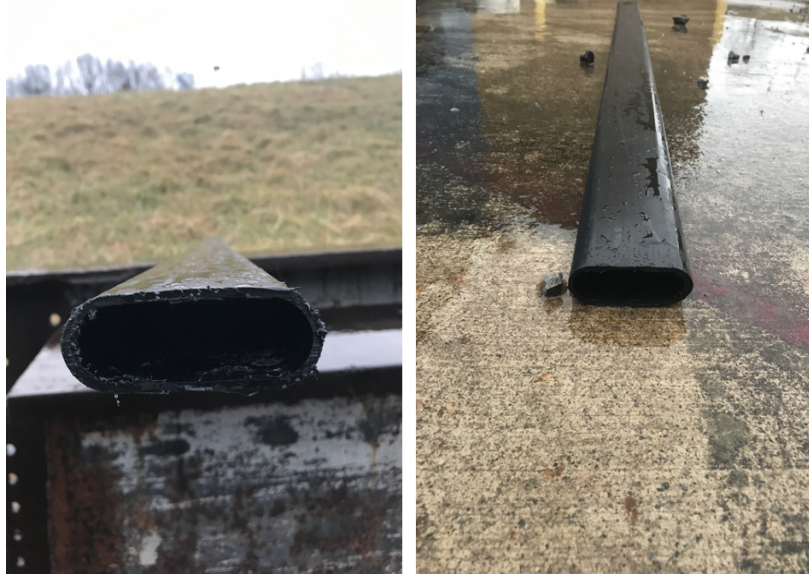
Figure 3-15 shows the smooth flat duct that was used in the full scale specimen to mimic the ones used in the Varina-Enon Bridge.

**Figure 3-15 View of the Smooth Duct**

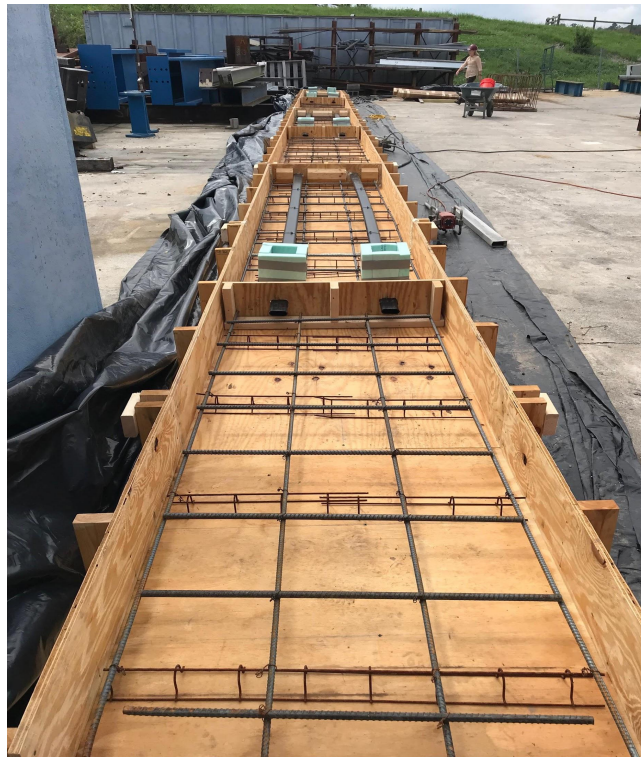
Minimum reinforcement was placed in the slab for handling and to control cracking in the concrete. No. 4 bars with 15 in. spacing were used for both transverse and longitudinal reinforcement, and the end section contains of No. 4 hoops.

Sixteen block outs were built into this specimen: two for corrosion purposes and 14 for the ease of the demolition process. Figure 3-17 shows transverse and longitudinal reinforcement and the ducts before placing the concrete. Figure 3-18 shows the reinforcement in the end section.

**Figure 3-17 Transverse and Longitudinal Reinforcement and the Ducts**

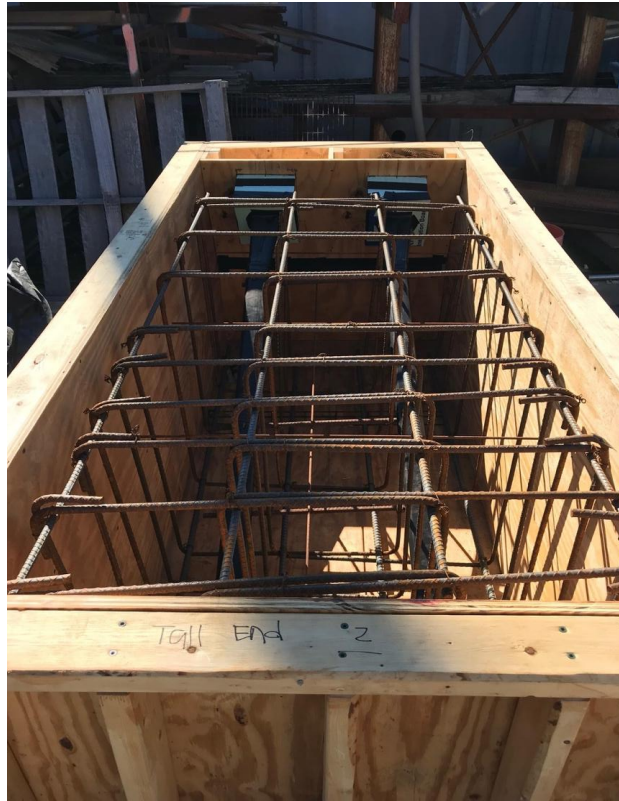
**Figure 3-18 Reinforcement at the End Section**

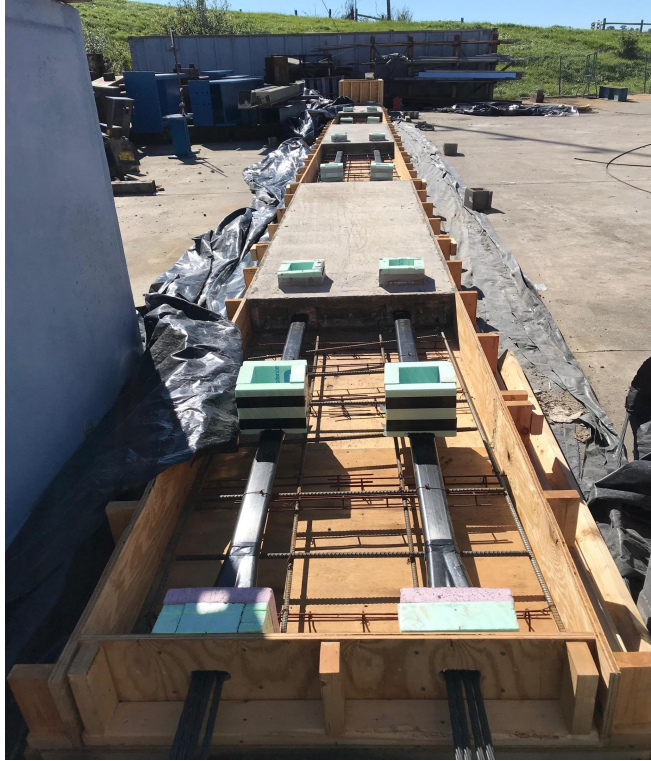
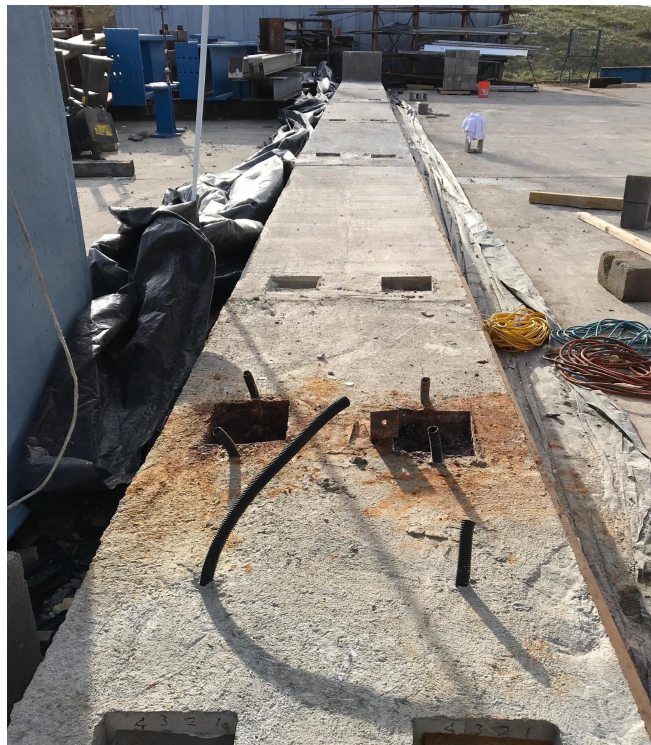
The slab was casted in two stages for the ease of the demolition process and bulkheads with shear keys were used to separate the sections from each other. In order for the bulkheads to be disconnected from each section after the first cast, a mixture of talc and liquid soap was used as the bond breaker. After each cast, concrete cylinders were made, and they were tested in order to measure the strength and the modules of elasticity of the concrete. Figure 3-19 shows the full scale specimen in the both stages of casting.

**a) Casting Stage 1**

**b) Casting Stage 2**

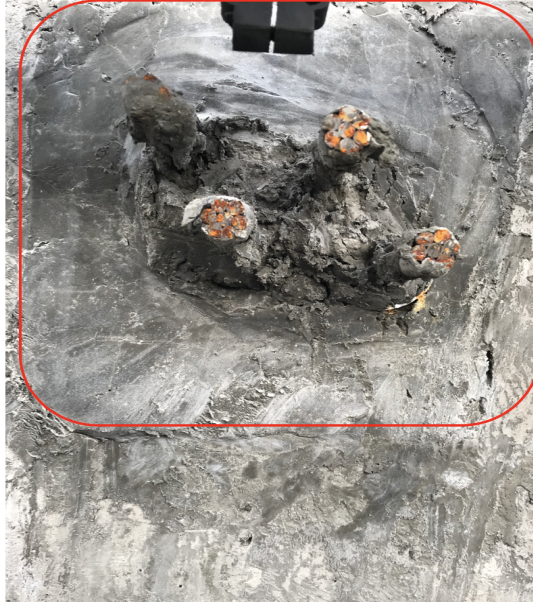
In addition, pour-back material in the block out pockets on the inside of the Varina-Enon Bridge have been dislodged, possibly due to strand fractures. So, LVDT sensors were installed in the full scale specimen on the pour-backs at anchorage block-outs to determine if any movement at the pour-backs occurred. Figure 3-22 shows the pour-back material in the block out pockets.

**Figure 3-22 The Pour-Back Material in the Block Out Pockets**

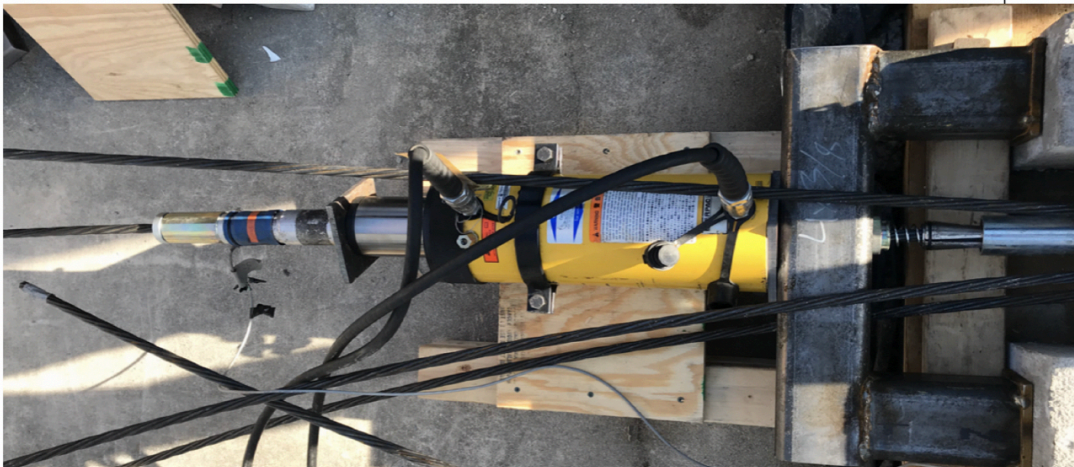
Each tendon was stressed separately by using a hand pump. Figure 3-23 shows a detailed drawing and the actual set-up during the stressing process.

**Figure 3-23 Detailed Drawing and the Actual Set-up During the Stressing Process**

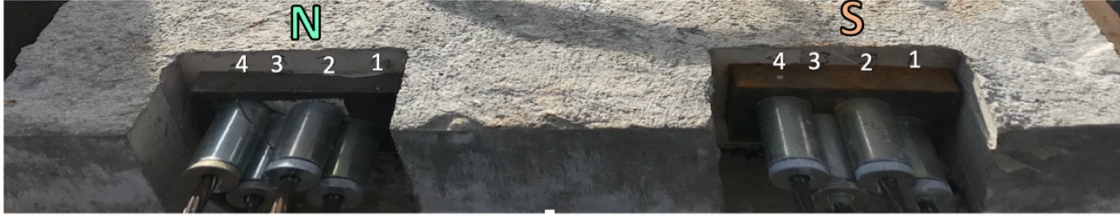
**Table 3-3 Prestressing Data for Full Scale Specimen**

Load(kip)	Live end North				Live end South			
	1	2	3	4	1	2	3	4
4	5.00	4.38	5.00	5.94	3.13	4.19	4.75	4.81
14	6.56	5.81	6.63	7.38	5.00	5.75	6.38	6.38
22	7.81	7.00	7.94	8.88	6.19	6.88	7.56	7.50
30	8.88	8.13	9.19	9.06	7.44	8.13	8.81	8.63
38	10.00	9.25	10.50	10.63	8.69	9.38	10.06	9.81

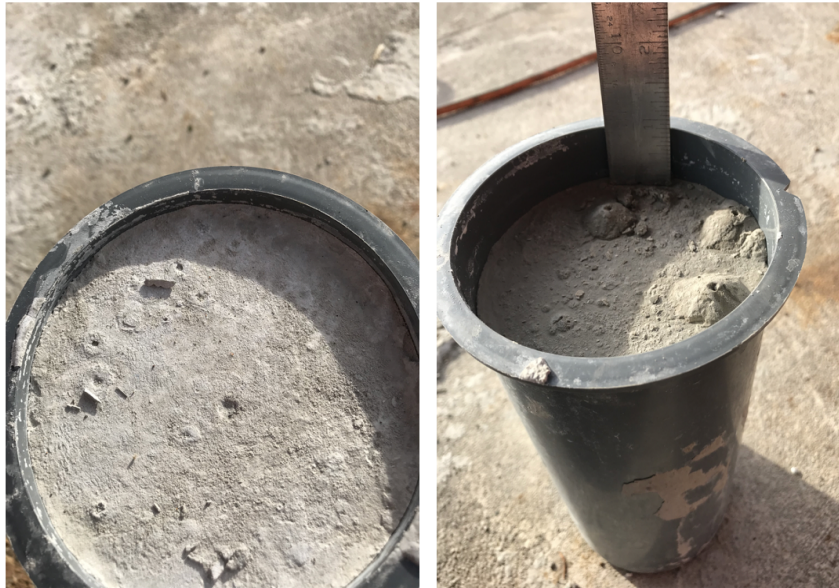
To analyze different scenarios and generate the most effective solution for the problem, two different qualities of grouting were used for this specimen: one duct was well grouted and the other one poorly grouted. The grouting process was conducted by attaching the black tubes in the slab to the grout pump. A water cement ratio of 0.45 was used for one duct which represents well grouted and the second duct was filled with a poor quality grout which had a water cement ratio of 0.65. Figure 3-24 shows two cylinders filled with different qualities of grout: a) good grout and b) poor quality grout.

a) b)  
**Figure 3-24 Cylinders Filled with Different Qualities of Grout**

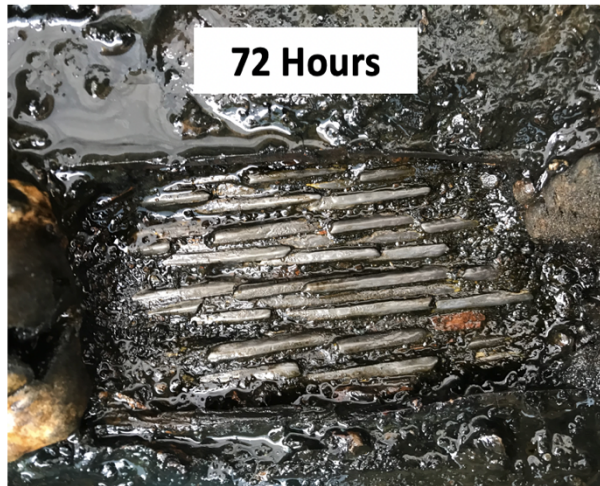
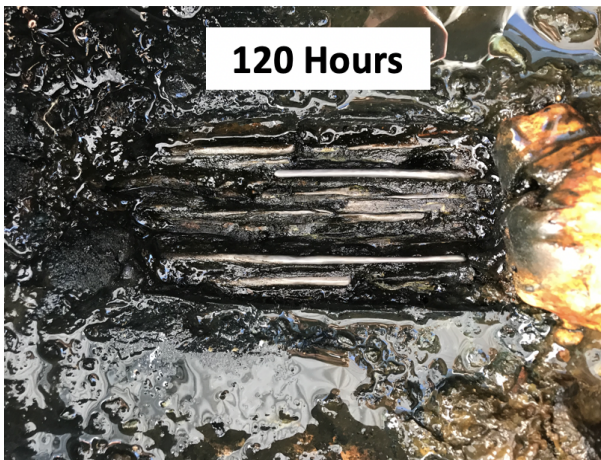
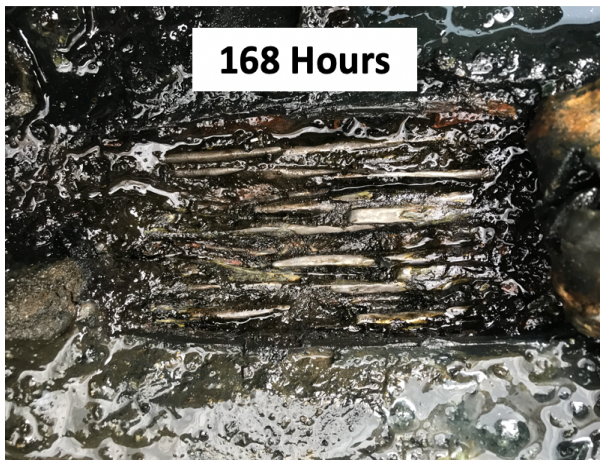
As it was mentioned before in the previous chapter, the corrosion process for the full scale specimen was longer than the small specimen due to greater steel cross section and the environmental condition. Therefore, after conducting the corrosion process for 216 hours, all of the strands fractured, and the tendons were fully dissolved. In both poorly grouted and well grouted duct, the first break occurred within 48-72 hours. Figure 4-1 presents the progress in the strand corrosion process in the well grouted duct.

**Figure 4-1 Progress in the Strand Corrosion in Well Grouted Duct**

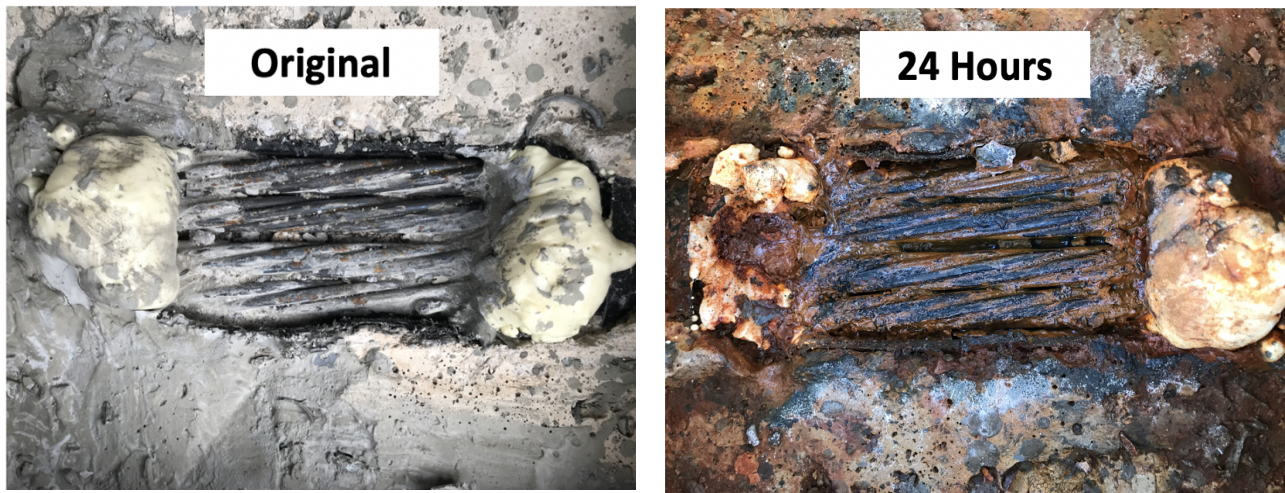
Figure 4-2 Progress in the Strand Corrosion in Poorly Grouted Duct

As mentioned before, the poorly grouted duct experienced the first break between 48-72 hours too, and it followed the same trend as the well grouted and the tendons were fully corroded and disconnected after 216 hours. Figure 4-2 shows the progress in the strand corrosion process in the poorly grouted duct.

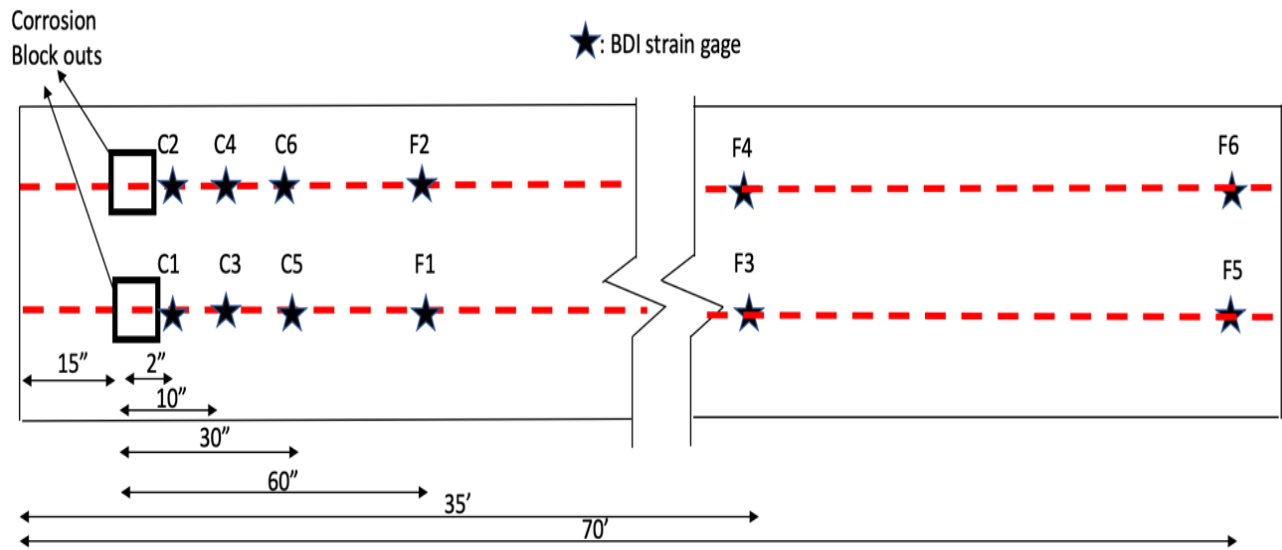
As mentioned in the previous chapter, BDI strain gauges were installed on the full scale specimen before the prestressing process. The purpose was to be able to confirm the strain in the concrete with the calculated strain after all eight strands were stressed and to monitor strains as strands broke. Figure 4-3 shows a plan view of the slab with the locations of the BDI strain gauges.

Figure 4-3 Locations of the BDI Strain Gauges on the Full Scale Slab

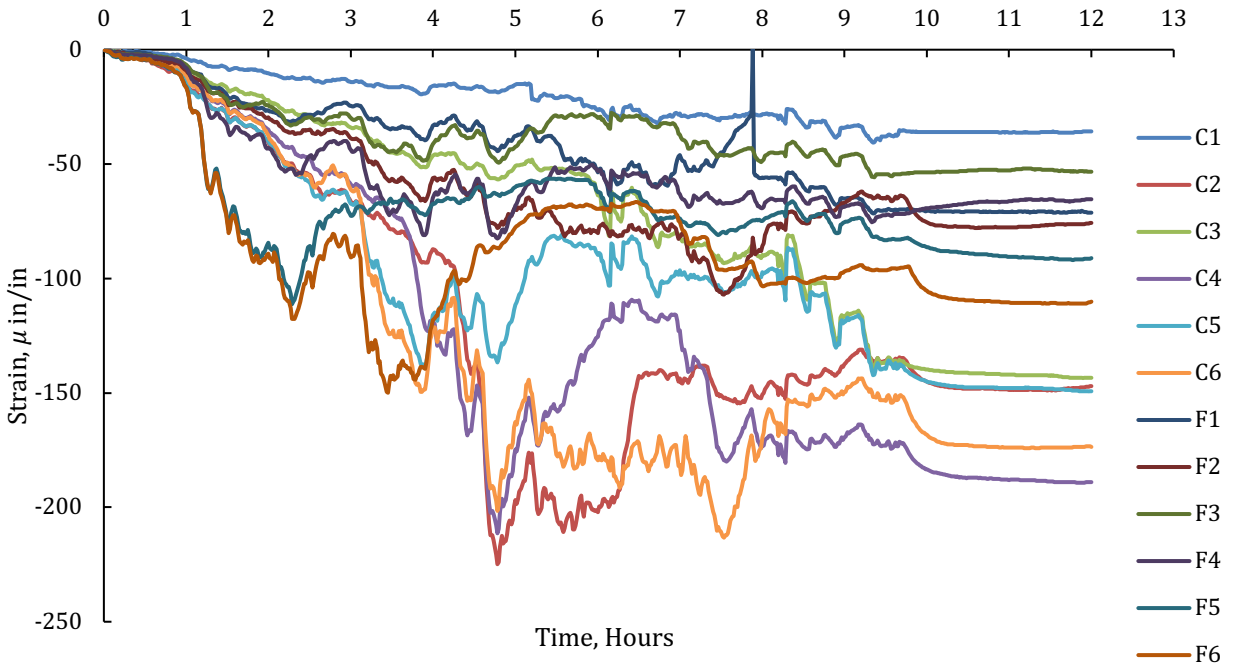
Figure 4-4 shows the strain in concrete measured by all the strain gauges three hours before and after the stressing of the tendons. To get a better understanding of the strain data, a graph for only one of the BDI gauges is provided below. Figure 4-5 shows the concrete strain captured by strain gauge 5 (Close 5).

Figure 4-4 Strain in Concrete Before, during and after the stressing of the tendons
