**FINAL CONTRACT REPORT**

**EFFECTS OF SOIL AMENDMENTS AND OTHER PRACTICES ON THE SUCCESS  
OF THE VIRGINIA DEPARTMENT OF TRANSPORTATION'S NON-TIDAL  
WETLAND MITIGATION EFFORTS**

June 2005  
VTRC 05-CR25

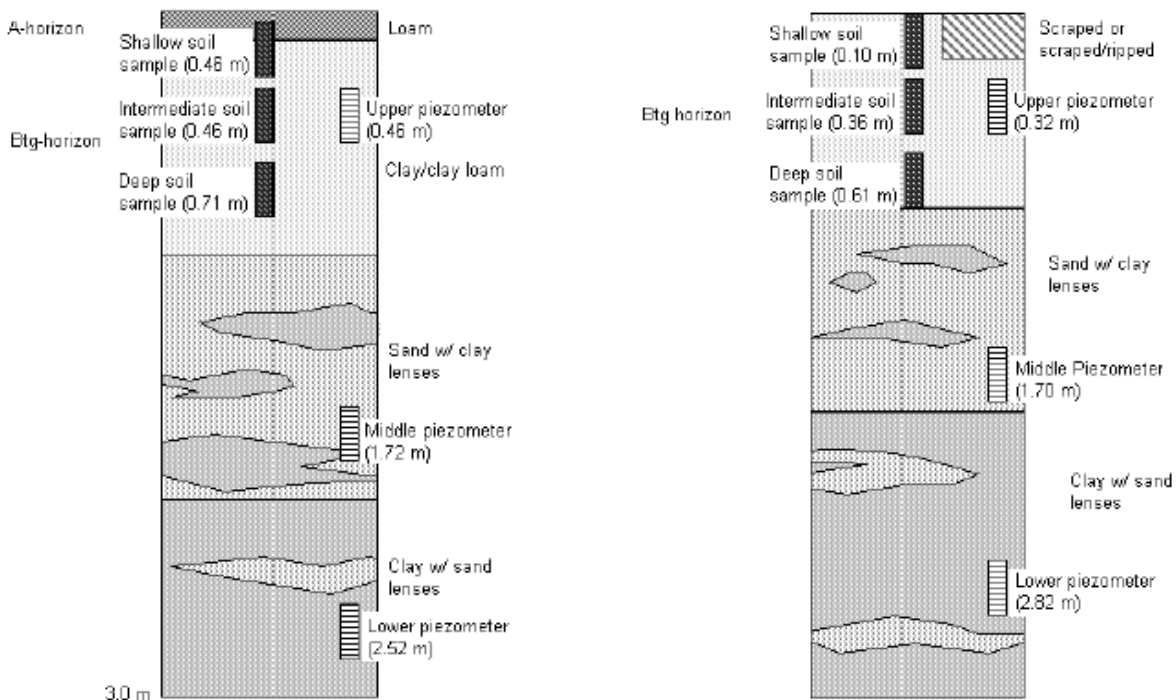
**Figure 11. Diagram illustrating the relationships between soil horizons, strata, and piezometer screens at sites at CCW. Soil sample depths refer to analyses of soil density reported in Despres (2004). Left, Conditions in natural wetland site with piezometer nests CCP-3. Right, Conditions in constructed wetland with piezometer nest CCP-1.**

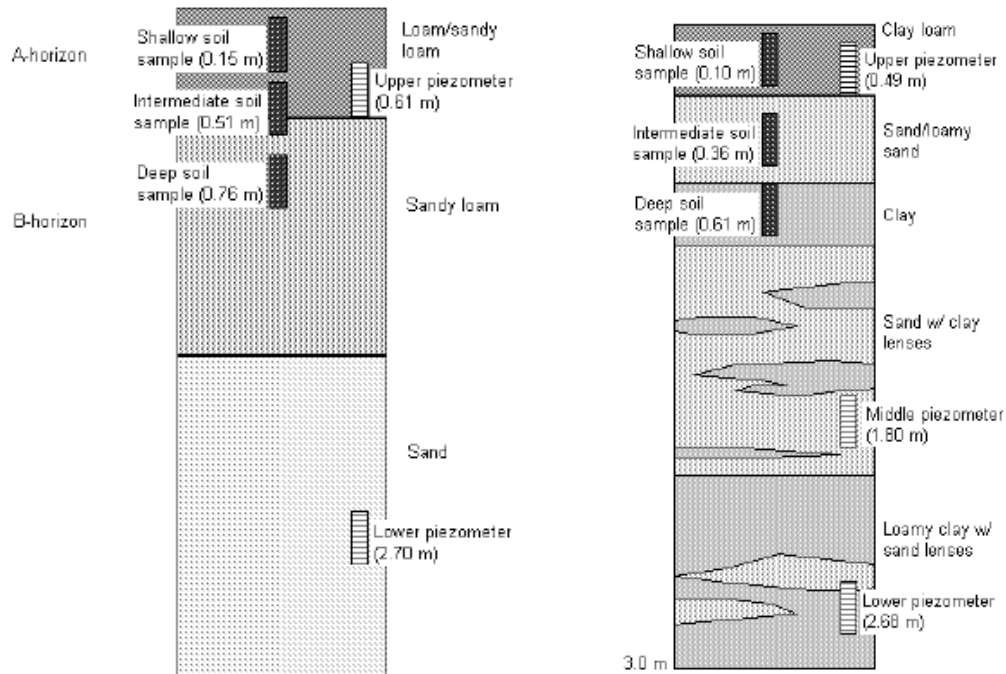
**Figure 13. Diagram illustrating the relationships between soil horizons, strata, and piezometer screens at sites at SB. Soil sample depths refer to analyses of soil density reported in Despres (2004). Left, Conditions in natural wetland site with piezometer nests 201 and 213. Right, Conditions in constructed wetland with piezometer nest SB-2.**

At the SB location, there were several major differences between the soils of the constructed and natural sites. As seen in Figure 13, the natural site consisted of a relatively uniform sandy loam, overlain by an argillic Bt-horizon. At the constructed site, material that was used to fill in the lakes varied in grain size and texture. The result was the creation of an artificial stratigraphic profile that consisted of a very compacted sandy loam at the surface, underlain by several sand looser layers interbedded with thin clay lenses throughout. Below the alternating clay/sand layers, at a depth of approximately 2.6 m, was a much more massive clay bed of at least 0.5 m in thickness (limit of hand auger). To determine the extent of the relatively clean sands present between the compacted surface and tight clay at depth, several boreholes were made around the piezometer nest SB-2. These borings indicated that the buried sand strata extend in at least 5 m in all directions from SB-2. Of particular note is that the sand layers extended from SB-2 to the surface water canal 20 m to the west. The sand beds outcropped along the side and bottom of the canal.

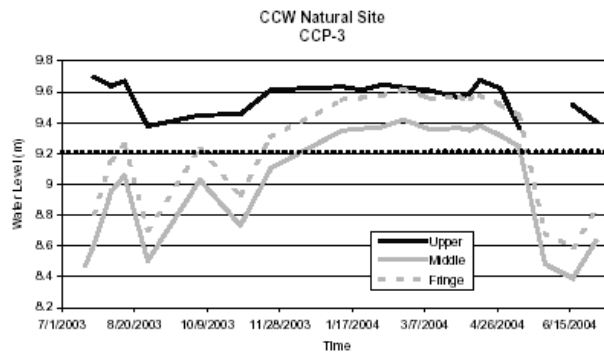
**Figure 14. Hydrograph of biweekly data from piezometers that illustrate long-term recharge conditions and variations in soil saturation conditions at the natural wetland site (CCP-3) at CCW.** The dotted line marks the top of the (potentially) saturated fringe, as suggested by the middle piezometer values. Note that during the recharge season (Nov-Apr) hydraulic heads in subsurface soil horizons and the saturated fringe rise higher than the screen of the upper piezometer. During these periods, the soils would be endoaquic; during other periods, water levels in horizons near the surface appear to be “perched” suggesting epiaquic conditions.

At the SB site, piezometer nest 213, which located in the natural wetland demonstrated nearly the same “stacked” hydrologic pattern between the upper and lower piezometers that indicates recharge conditions. At the SB constructed site the three piezometers of SB-2 demonstrated the same variable patterns among the piezometers that were seen in the biweekly hydrograph data (Figure 19). The upper piezometer, SB-2A, tended to remain dry throughout much of the sampling period except during wetter periods. The middle piezometer, SB-2B, tended to exhibit a ‘flashy’ pattern while SB-2C, the lower piezometer had relatively constant water levels, showing slight response to wetter periods, especially when the water level in SB-2B was high.

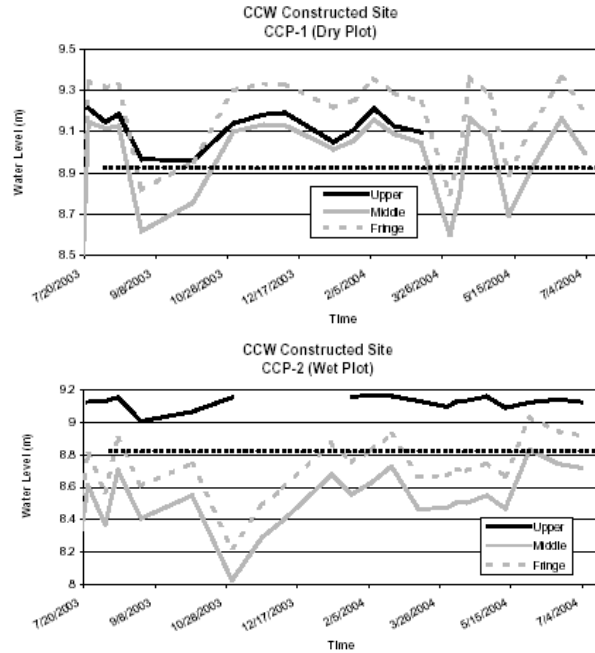
**Figure 15. Hydrographs of biweekly data from piezometers that illustrate long-term recharge conditions and variations in soil saturation conditions at the constructed wetland sites (CCP-1 and CCP-2) at CCW. The dotted line marks the top of the (potentially) saturated fringe, as suggested by the middle piezometer values. Top, At CCP-1, note that during most of the year hydraulic heads in subsurface soil horizons and the saturated fringe rise higher than the screen of the upper piezometer. During these periods, the soils would be endoaquic. Bottom, At CCP-2, most periods of the time monitored exhibited epiaquic conditions.**

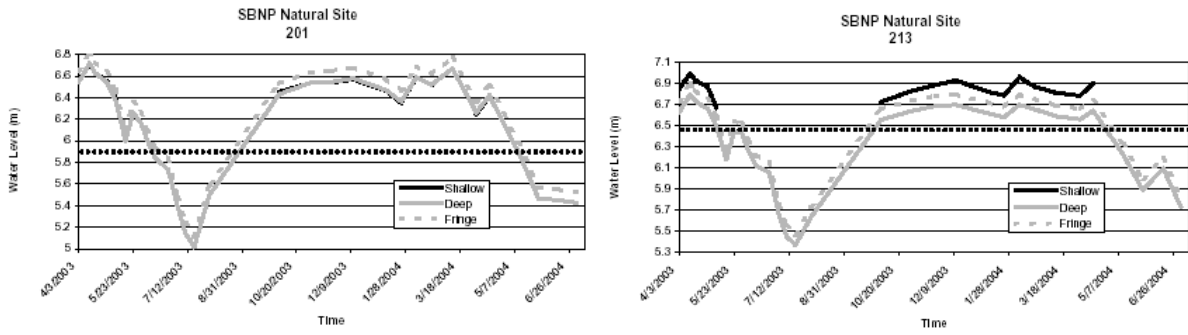
**Figure 16. Hydrographs of biweekly data from piezometers that illustrate soil saturation conditions at natural wetland sites (201 and 213) at SB.** The dotted line marks the top of the saturated fringe, as suggested by the deep piezometer values. Note that during the recharge season (Oct-Apr) hydraulic heads in subsurface soil horizons and saturated fringe rise higher than the screen of the shallow piezometer. During other periods, water levels in horizons near the surface were below the screen of the shallow piezometer. Thus during the entire time period monitored, the soils displayed endoaquic conditions.

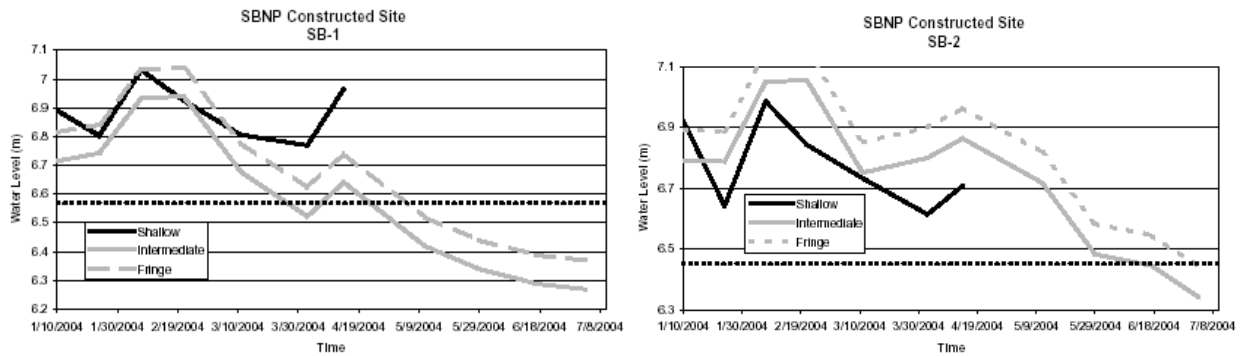
**Figure 17. Hydrographs of biweekly data from piezometers that illustrate soil saturation conditions at constructed wetland sites (SB-1 and SB-2) at SB.** The dotted line marks the top of the saturated fringe, as suggested by the intermediate piezometer values. Note that during the recharge season (Jan-Apr) hydraulic heads in subsurface soil horizons and the saturated fringe rise higher than the screen of the shallow piezometer. During other periods, water levels in horizons near the surface were below the screen of the shallow piezometer. Thus during the entire time period monitored, these indirect hydrologic data suggest that the constructed wetland soils displayed endoaquic conditions. As discussed in the text, though, direct observations of dry soil horizons sampled in boreholes directly next to surface puddles indicate that epiaquic conditions actually are very common here.

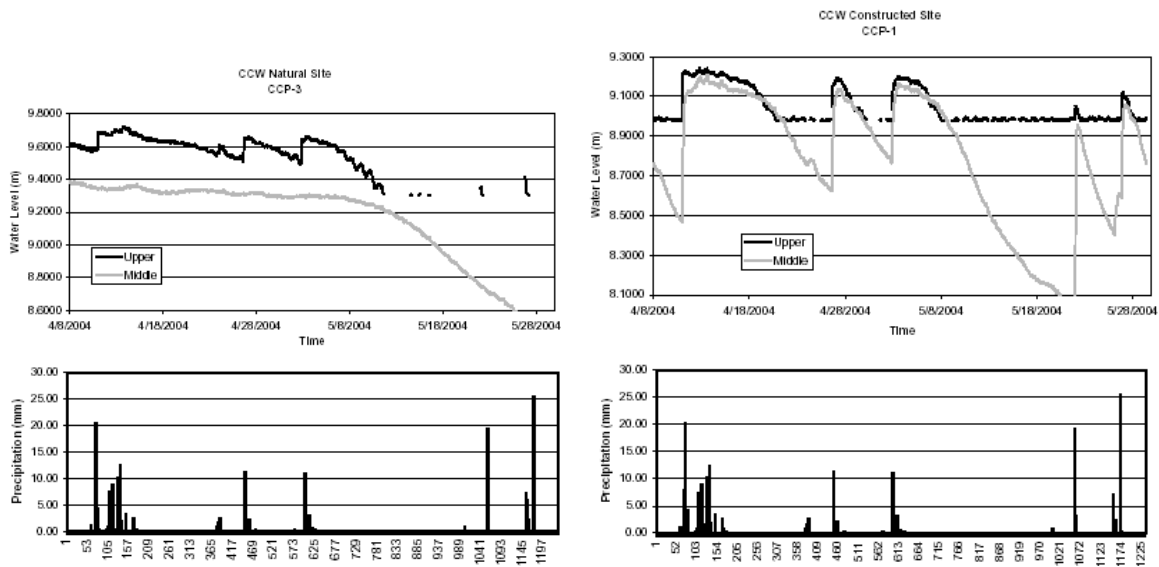
**Figure 18. Hydrographs of hourly data from piezometers and of rainfall at CCW sites.** Left, Fluctuations in the natural wetland nest (CCW-3). Note the middle piezometer (1.72 m deep) shows minor changes following recharge events. Right, Fluctuations in the “dry plot” in the constructed wetland nest (CCW-1) that experienced significant cracking. Note the middle piezometer (1.70 m deep) shows very rapid and significant responses following recharge events.

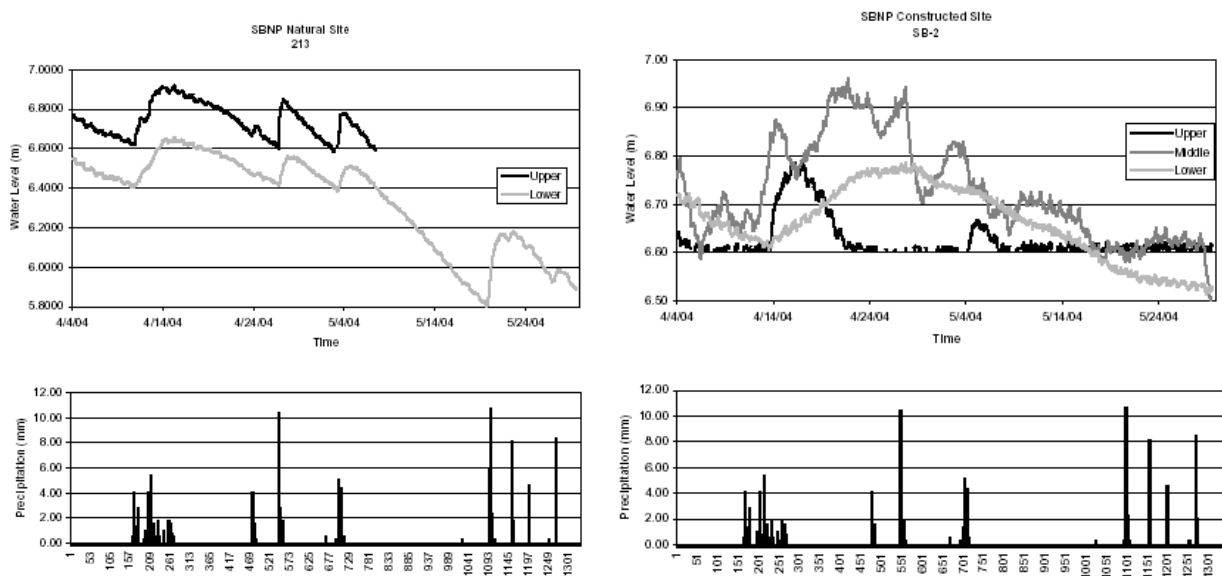
**Figure 19. Hydrographs of hourly data from piezometers and of rainfall at SB sites.** Left, Fluctuations in the natural wetland nest (213). Note the lower piezometer (2.70 m deep) shows rapid and only slightly muted changes following recharge events. Right, Fluctuations in the constructed wetland nest (SB-2) located in highly stratified sediments. Note the upper piezometer (0.49 m deep) is in compacted fine sediments that are saturated for limited periods only after rainfall events. The middle piezometer (1.80 m deep) is in a sand bed connected to a neighboring water-filled canal that was pumped lower episodically. The lower piezometer (2.68 m deep) is in compacted fine sediments that show muted and delayed hydrologic responses to the head changes in the overlying sand bed.

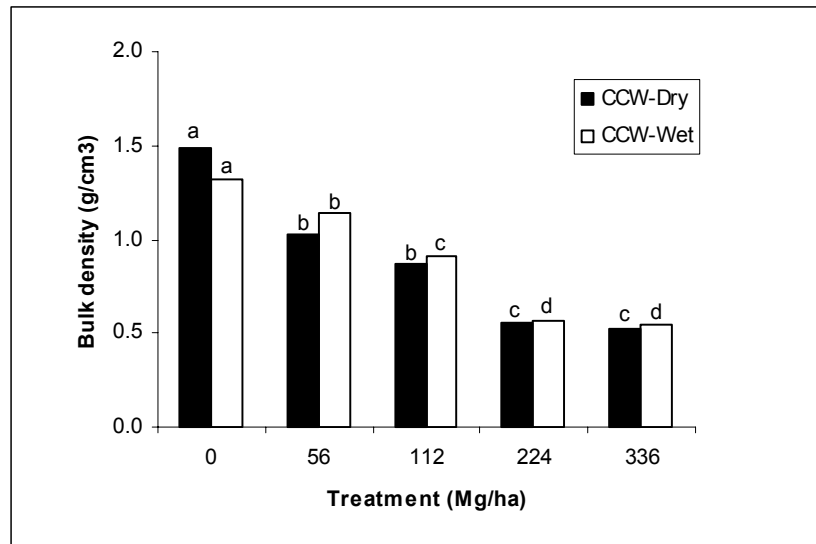
Figure 20. Results for mean surface bulk density in relation to organic matter loading rate in CCW-Dry and CCW-Wet. Means followed by differing letters by experiment are significantly different at  $P < 0.05$ .

The addition of organic matter to mineral soil increases soil aggregation, thereby increasing porosity (Stevenson, 1994; Buol et al., 1997). A high porosity, or percentage of pore space, contributes to low bulk densities and high water holding capacity (both on a weight and volume basis). Surface bulk density in CCW-Dry and CCW-Wet significantly decreased with an increase in organic matter loading rate up to the addition of 224 Mg/ha (treatment 4 in Figure 20). Surface bulk densities did not differ between treatments 4 and 5 in both CCW-Dry and CCW-Wet, indicating a maximum treatment effect in relation to bulk density at the addition of 224 Mg/ha of organic matter amendment. Significant differences were not present between treatments in either CCW-Dry or CCW-Wet for subsurface bulk density samples collected at a depth of 25-30 cm below the surface.

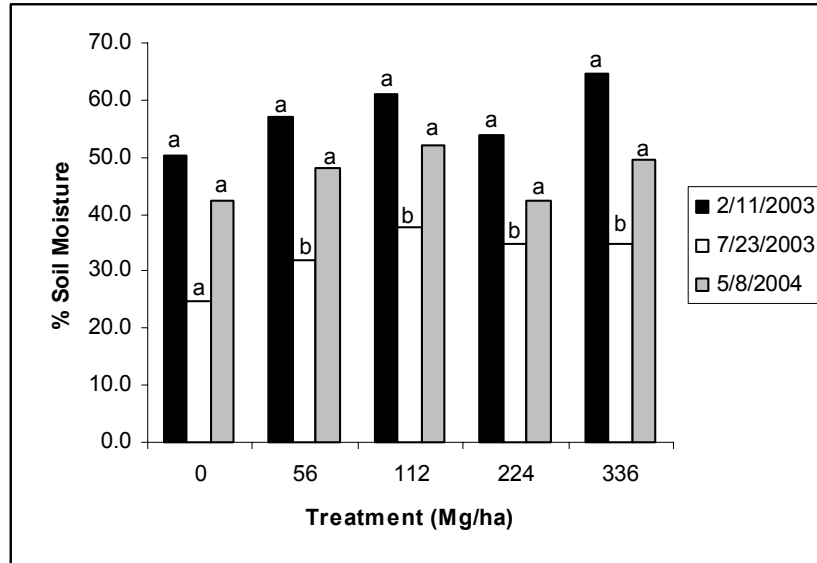
Figure 21. Results for mean soil moisture content for CCW-Dry. Means followed by differing letters for each date are significantly different at  $P < 0.05$ .

As described above, soil organic matter content affects soil moisture. Although significant differences between treatments were generally not present in the CCW-Dry experiment, an evident pattern occurred over the three sampling dates (Figure 21). In the first three organic matter treatments, volumetric soil moisture slightly increased with an increase in loading rate. Soil moisture consistently decreased from treatment 3 to treatment 4 and proceeded to increase from treatment 4 to treatment 5. In two out of the three sampling dates, treatment 3 yielded the highest soil moisture. This trend is most likely due to the substantial elevation increase associated with higher loading rates present in treatments 4 and 5. Treatments 4 and 5 were consistently observed above the saturated soil level while the lower rate treatments were below the saturated zone.

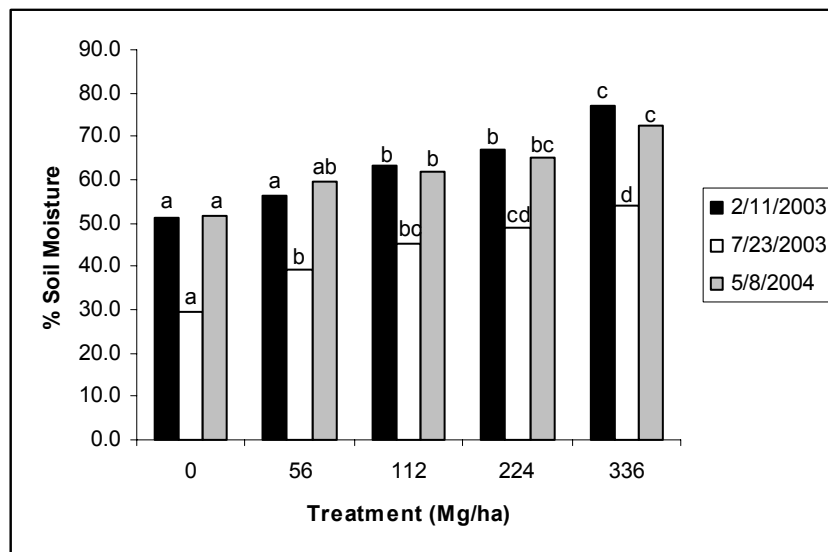
Figure 22. Results for mean % moisture per treatment for CCW-Wet. Means followed by differing letters for each date are significantly different at  $P < 0.05$ .

Significant differences ( $p$ -value  $< 0.05$ ) in soil moisture occurred between treatments in the CCW-Wet experiment. Volumetric soil moisture increased linearly with increasing compost loading rates (Figure 22). These results were expected due to the known absorption and water holding capacity of organic matter (Stevenson, 1994). Under saturated conditions, such as those present in CCW-Wet, an increase in soil organic matter is obviously conducive to an increase in soil moisture.

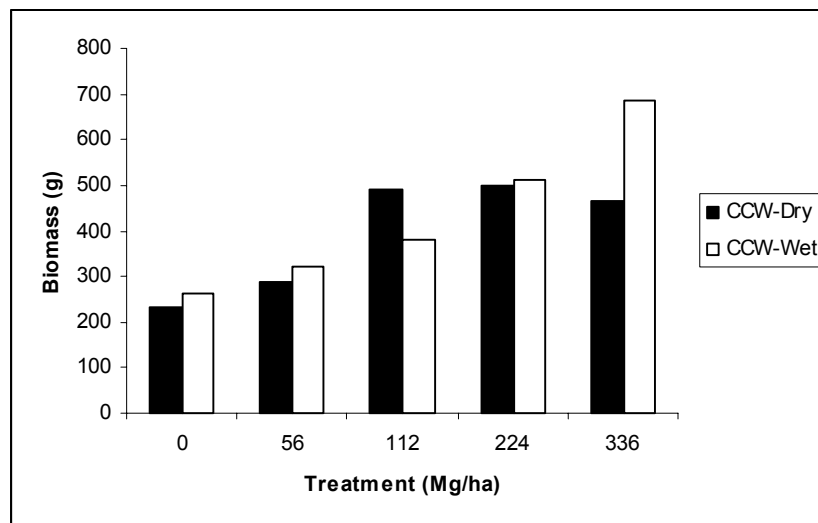
Figure 23. Mean biomass results for organic matter treatments in CCW-Dry and CCW-Wet.

Results from the biomass study conducted in the summer of 2003 revealed a linear increase in total biomass with an increase in loading rate for the CCW-Wet experiment (Figure 23). Total biomass in CCW-Dry steadily increased from treatment 1 to treatment 4 and then slightly decreased from treatment 4 to treatment 5. It was expected for total biomass to increase as organic matter loading rates increased due to improved water and nutrient availability.
