CORROSION PROTECTION OF THIN PRECAST  
CONCRETE SECTIONS

Edgar Franklin Massie, Jr.

A Thesis Submitted for Partial  
Fulfillment for the Degree of

Virginia Polytechnic Institute

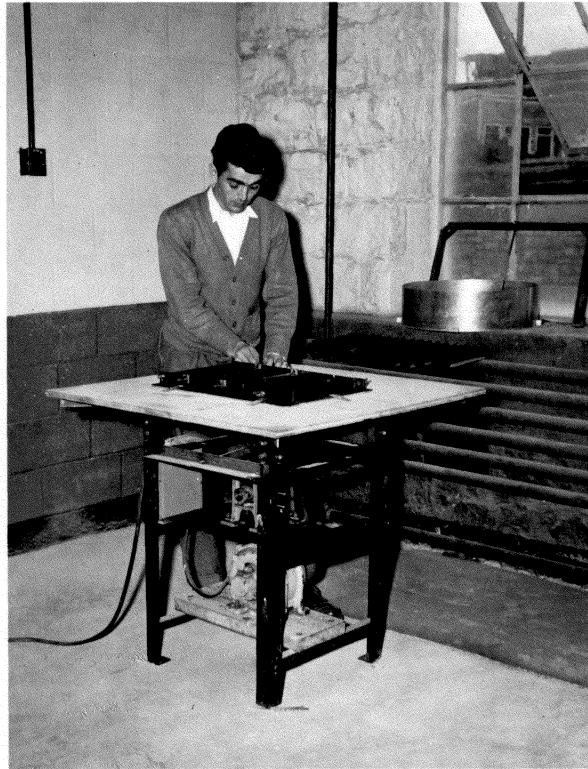
Fig. 1  
Vibration Table  
and Slab Forms

1. The concrete vibrating table, as shown in Fig. 1, was used in this investigation. It was designed in the Virginia Polytechnic Institute

Applied Mechanics Department and was built by the V. P. I. Engineering shops. Its one-half horsepower motor and 0.01 inch eccentric cam are capable of producing a maximum acceleration of 54 feet per sec. per sec. It fulfills the requirement that the test samples be vibrated, as are actual field structures.

2. The concrete forms, as shown in Fig. 1, were designed by the V.P.I. Applied Mechanics Department and were made by the V.P.I. Engineering shops.

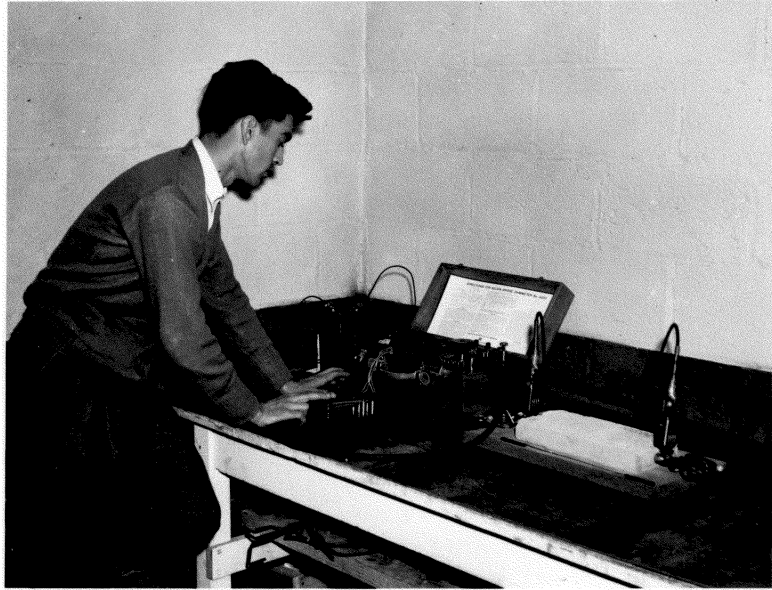
Fig. 3

5. The resistance bridge, as shown in Fig. 3, is a Leed and Northrup Portable Kelvin Bridge. It has a total range of measurement from 0.0001 ohm to 26.6 ohms with a limit of error of 0.2 per cent.
