# New Approach to Connections between Members of Adjacent Box Beam Bridges

Kedar Ram Halbe

Dissertation submitted to the faculty of the Virginia Polytechnic Institute and  
State University in partial fulfillment of the requirements for the degree of

Keywords: Connection details, adjacent box beam bridges, UHPC, VHPC, shear key, diagnostic  
test

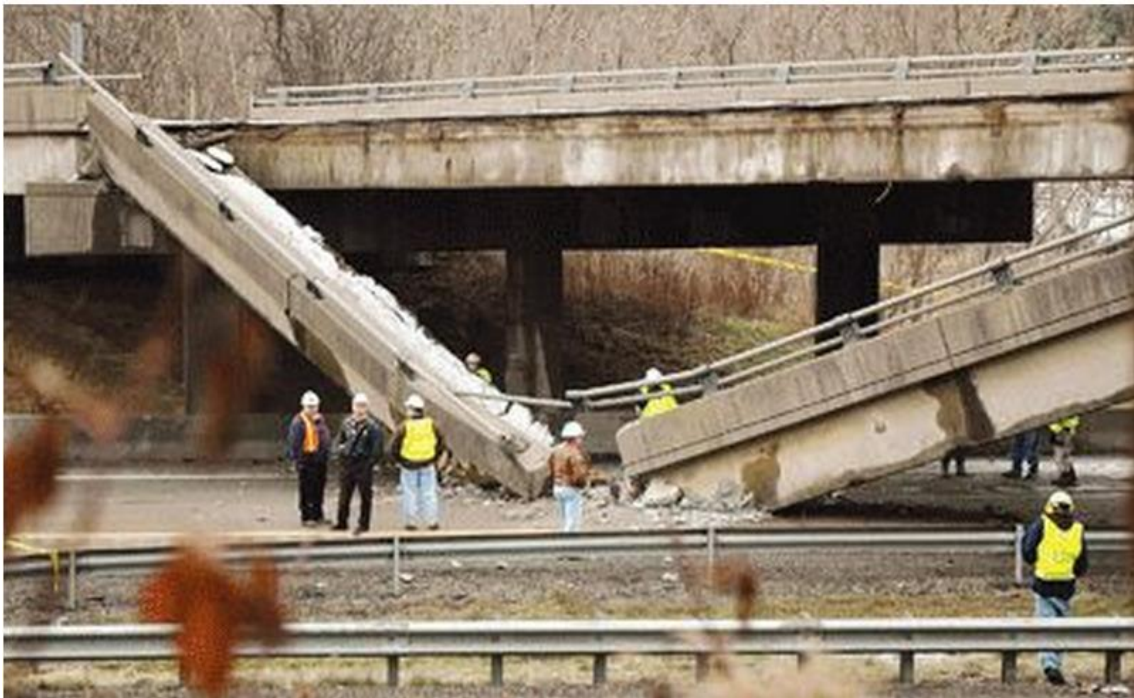
*Figure 4: Collapsed fascia beam of the Lake View Drive Bridge.*  
(<http://www.constructionequipmentguide.com/I-70-Overpass-Collapses-in-Western-PA/6500/>)

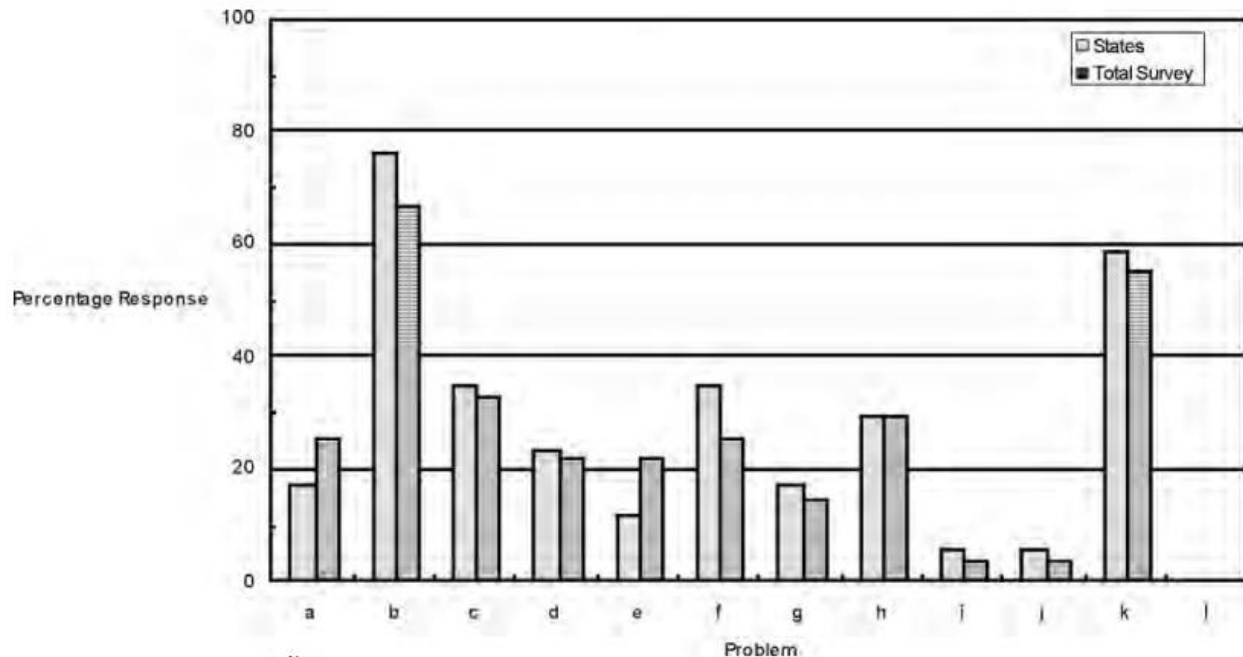
Figure 12: Summary of distresses observed in ABBB system. Russell (2009).  
[Information available in public domain]

Russell (2009) surveyed various state DOTs and agencies to highlight the typical problems in the ABBB systems that were observed by those states/agencies. The most common issues faced by these bridge systems were the longitudinal cracks at the beam – grout interface and the corresponding water and salt leakage. The results of the survey are summarized in Figure 12.

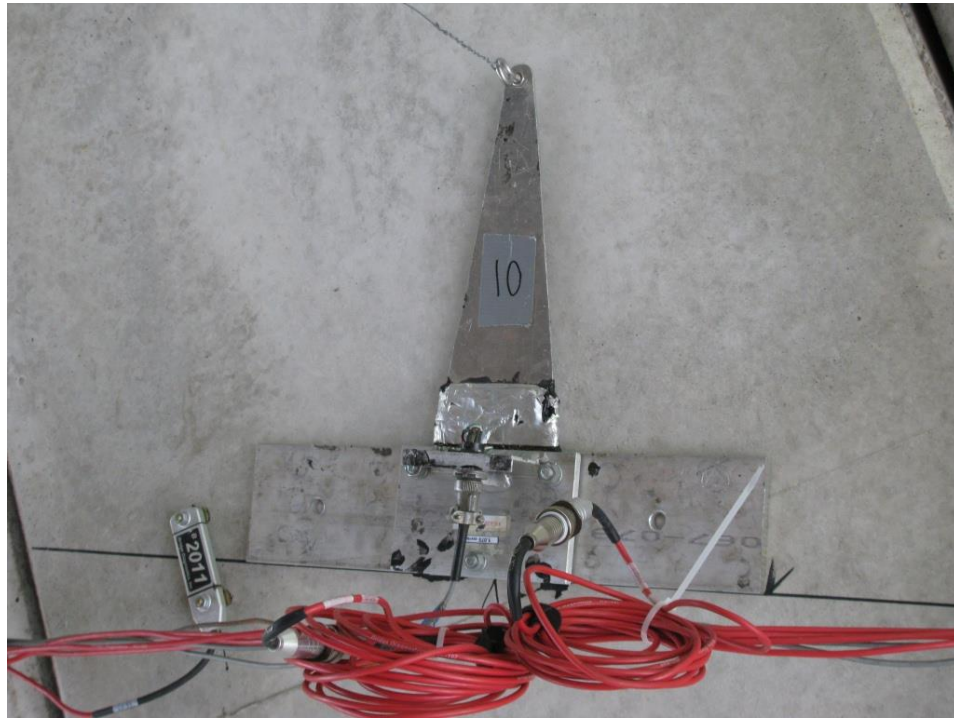
*Figure 35: Deflectometers on Beam Bottom.*

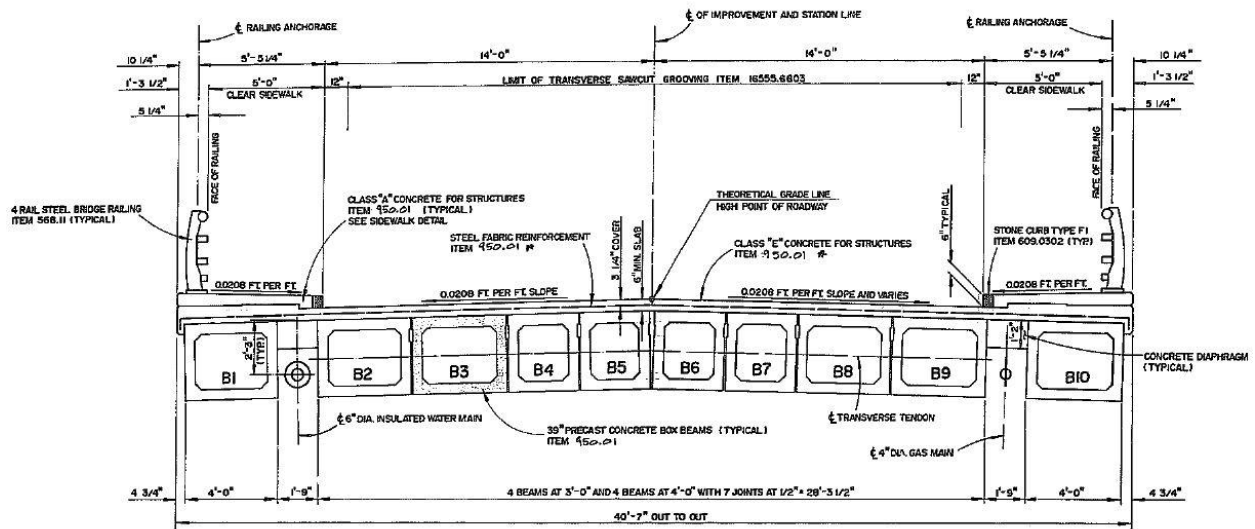
Figure 46: Bridge cross-section.

The bridge consisted of 10 box girders. The size of the four interior girders was 36 in. x 39 in. and the remaining girders were 48"x39". The girder connection detail was the typical partial depth grout connection. This girder connection detail was used for the eight interior girders. There was a gap between the fascia girders and the adjacent interior girder to allow for utility lines to traverse the creek. The bridge had a composite concrete topping. Welded wire fabric was utilized to reinforce the concrete topping. The cross-section of the bridge is shown in Figure 46.

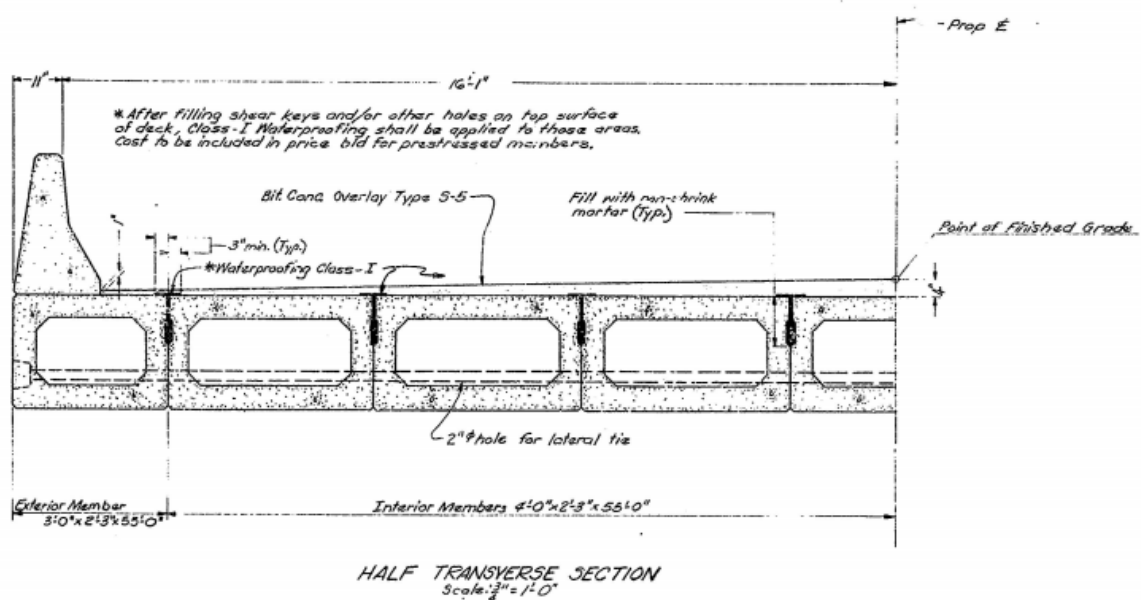
Figure 52: Half cross-section of ARB.

were provided at the girder ends and at the location of transverse PT. The cross-section details of ARB are shown in Figure 52.

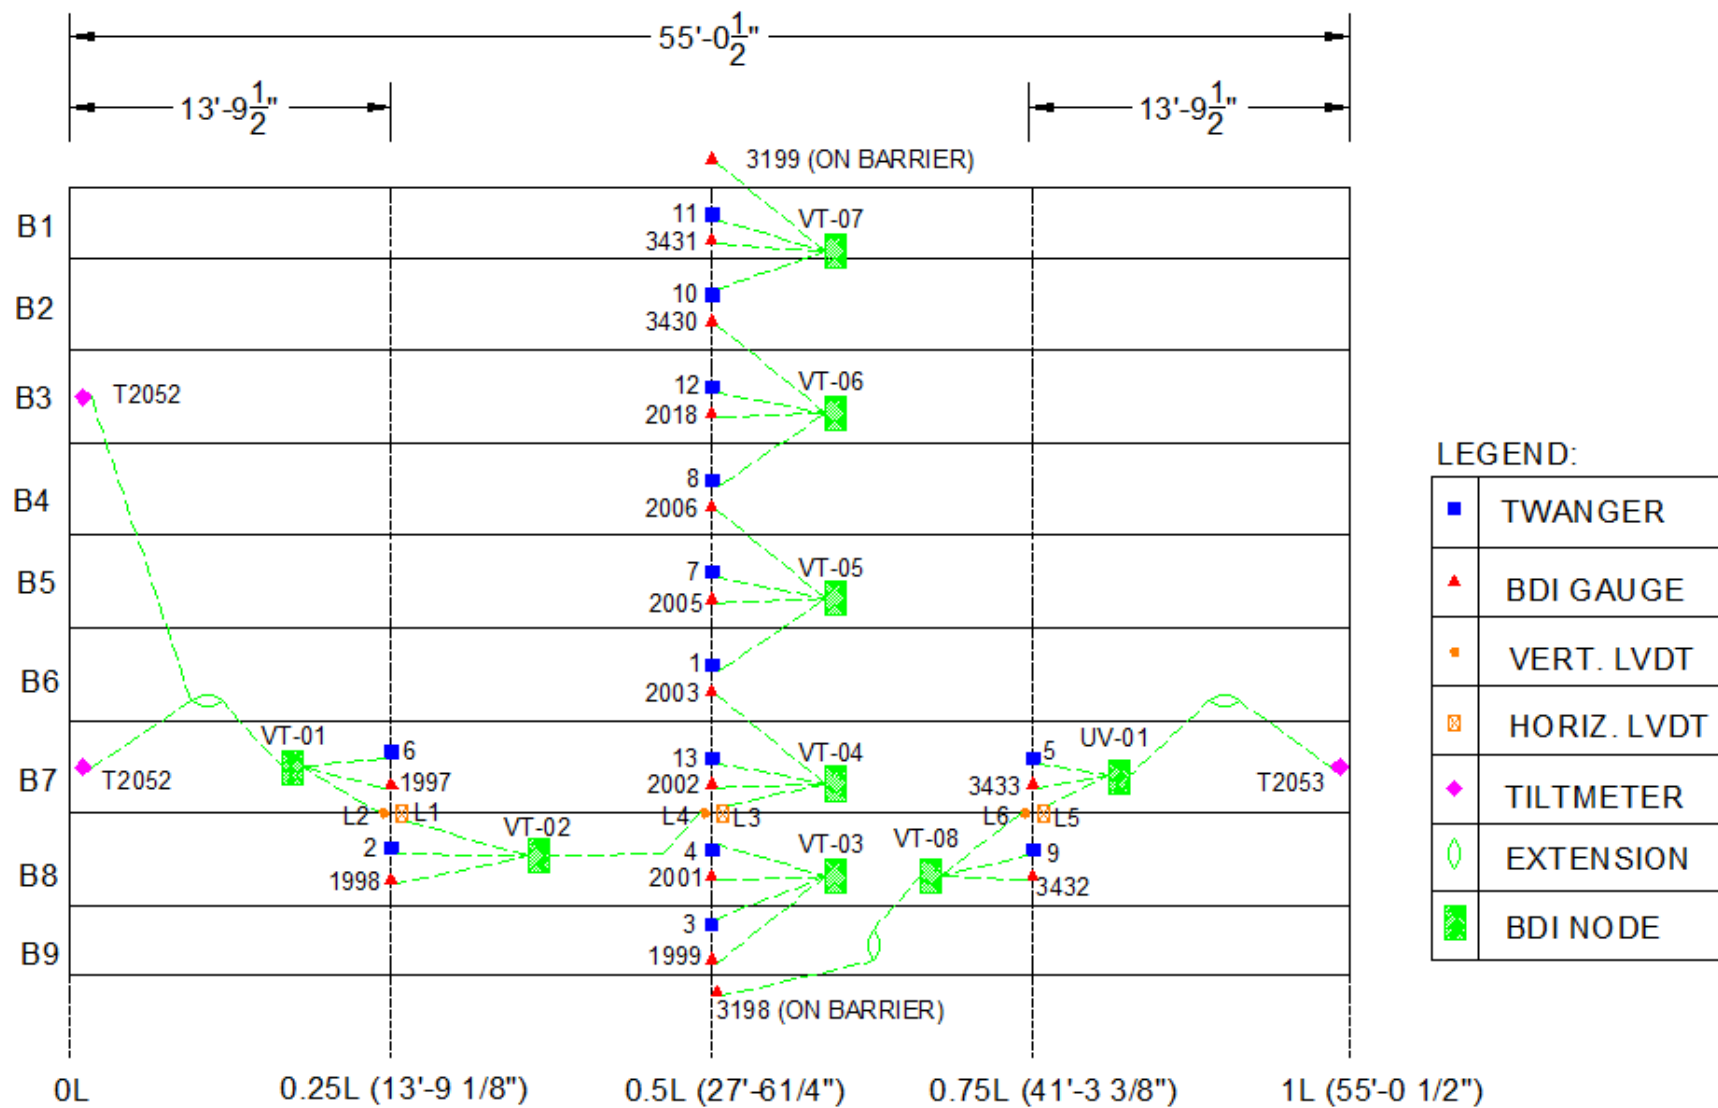
Figure 53: ARB layout and instrumentation.

Tiltmeters, as shown in Figure 40, were attached to each end of the bridge on the underside of girder(s) to measure the rotations undergone by the superstructure. The tiltmeters were attached at 0L and 1L of the bridge span. The tiltmeters were attached to girder B7 when the trucks were driven in the eastbound lane. For the truck runs in the westbound lane, tiltmeter at 0L was moved over to girder B3.

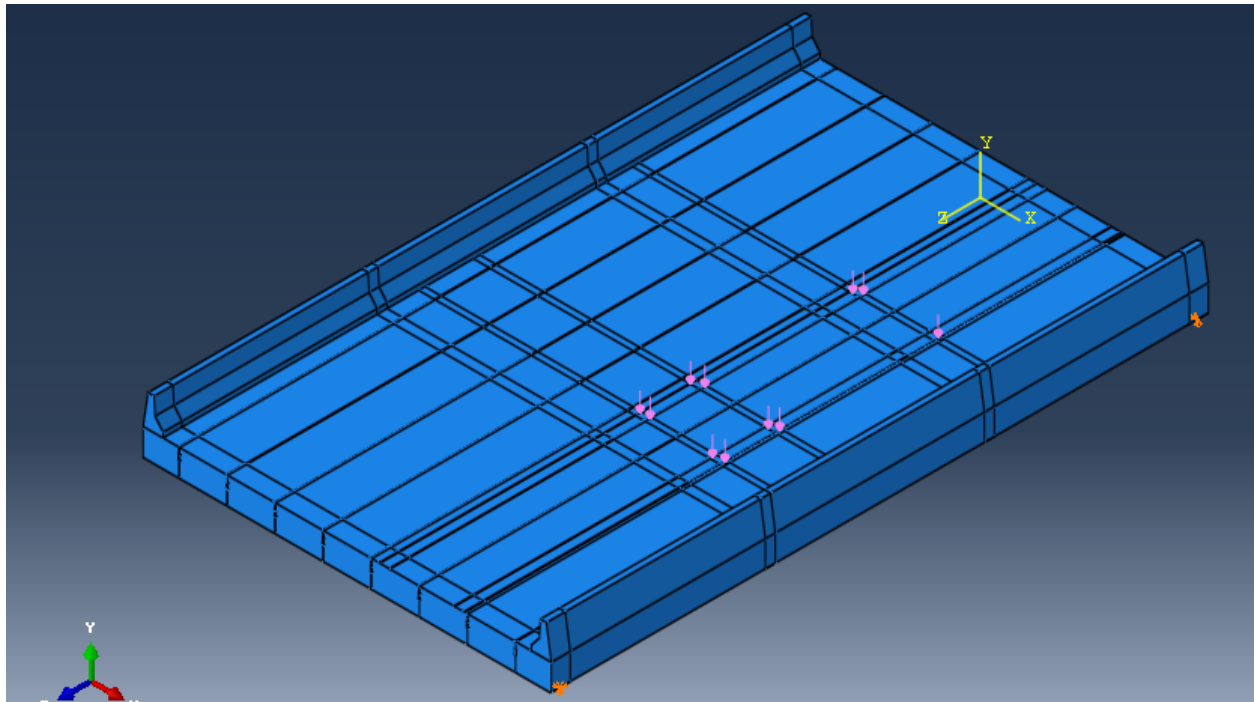
Figure 57: FEA model of the ARB with truck tire patches.

The ARB diagnostic test was simulated through FEA in ABAQUS. Field tests were performed on this bridge to quantify the actual bridge responses of ABBB. The ARB was selected for FEA simulation since it was a single simply supported span with no skew and without a composite topping. The KVCB model was deemed to be more complex since the bridge had a skew, it was not known whether there was a full composite action between the concrete topping and the bridge beams and finally the full depth cracks at the continuity diaphragm made the two spans partially continuous. On the other hand, the ARB joints and beams were severely deteriorated and it was difficult to know the degree to which the adjacent beams would interact through the cracked shear keys. However, the purpose of modeling the FSB was to compare the flexural strains in the bridge beams, relative displacements between adjacent beams and the transverse distribution factors of a bridge with sound joints. Hence ARB was modeled in ABAQUS. The FEA model of the ARB is shown in Figure 57. The VDOT dump trucks used in the diagnostic tests were modeled as tire patches and the axle weights were applied as pressure.

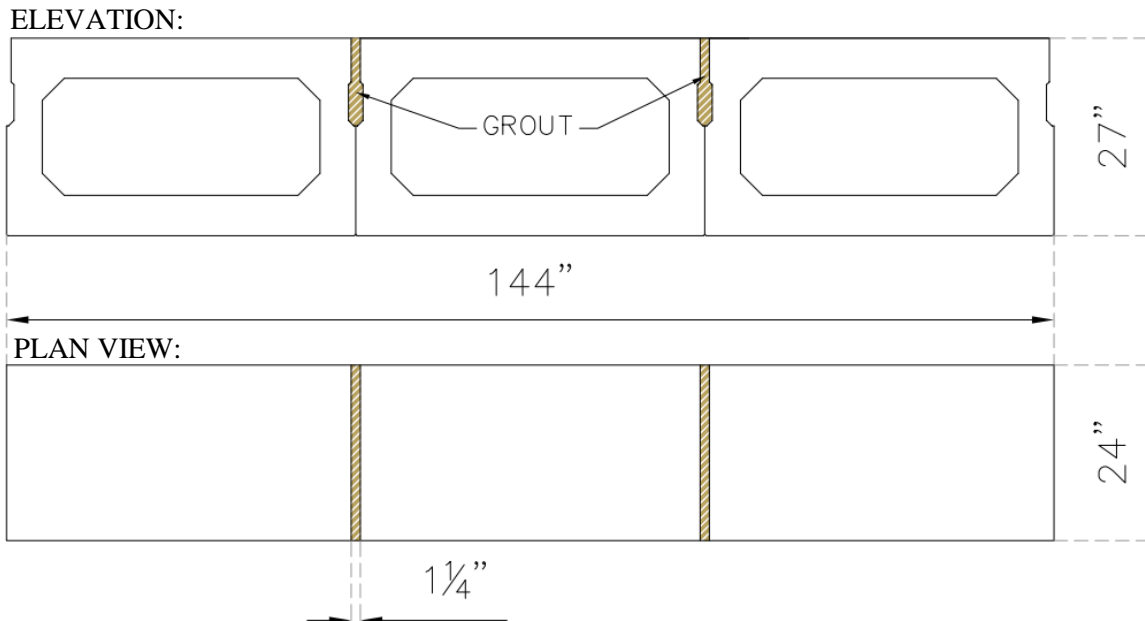
*Figure 75: SA specimen with current partial depth grouted keyway.*

The existing connection detail of partial depth keyway with grout was tested with the SA specimens. This specimen was tested in order to ensure that the behavior observed in the diagnostic bridge tests could be replicated using SA specimens. The specimen with existing connection detail is shown in Figure 75.

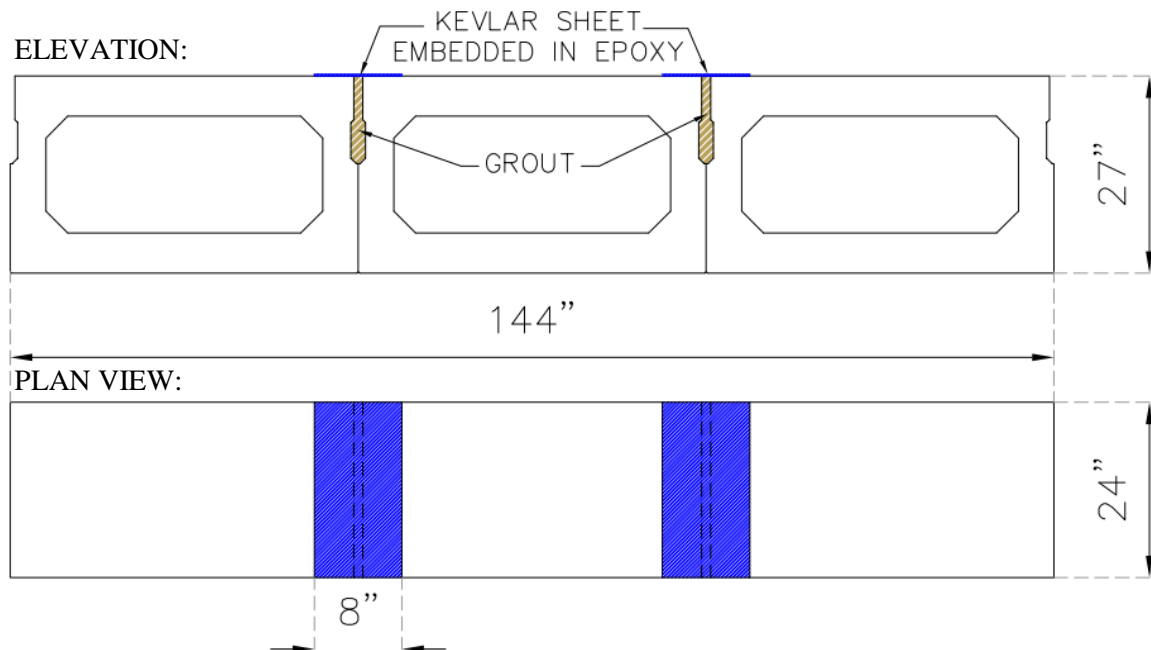
Figure 76: SA specimen with existing connection detail reinforced with Kevlar and Epoxy.

The performance of the K&E was tested using the specimen shown in Figure 76. The focus of this test was to study if the K&E was able to prevent cracking, provide waterproofing and transfer loads across a cracked joint.

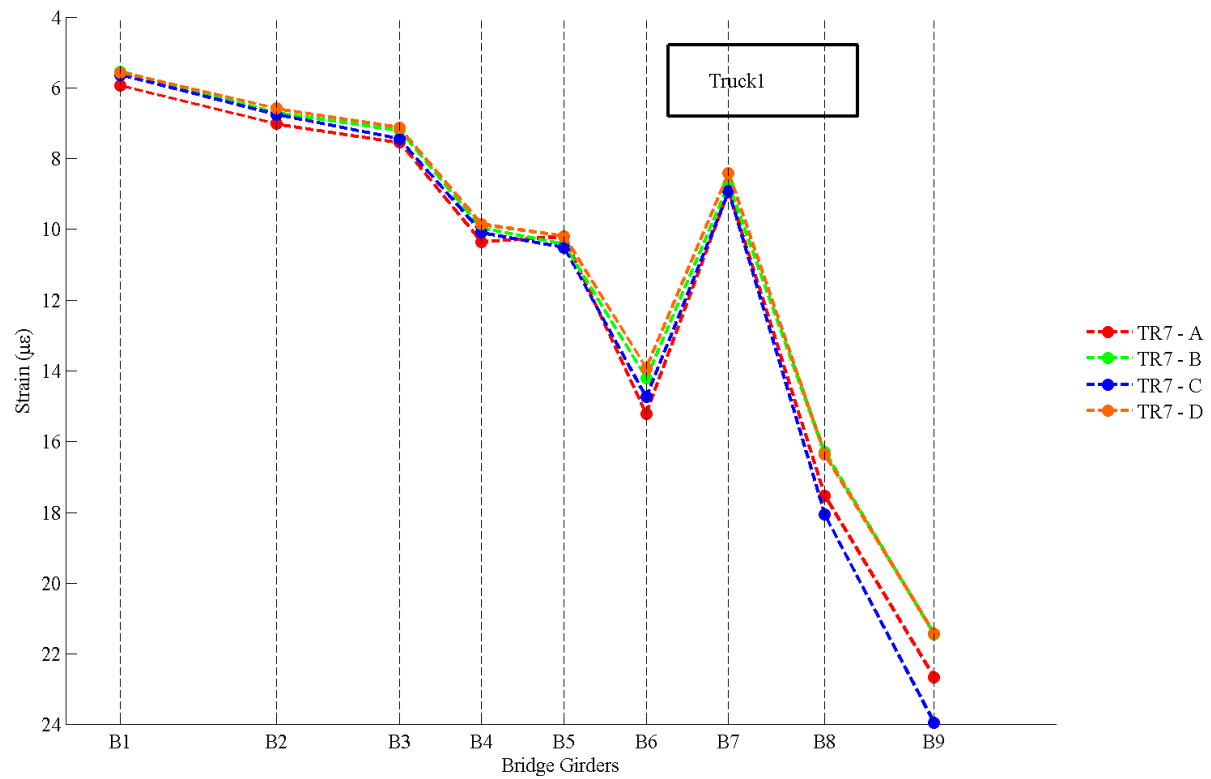
Figure 106: Strain distribution in transverse direction for all passes in Run 7.

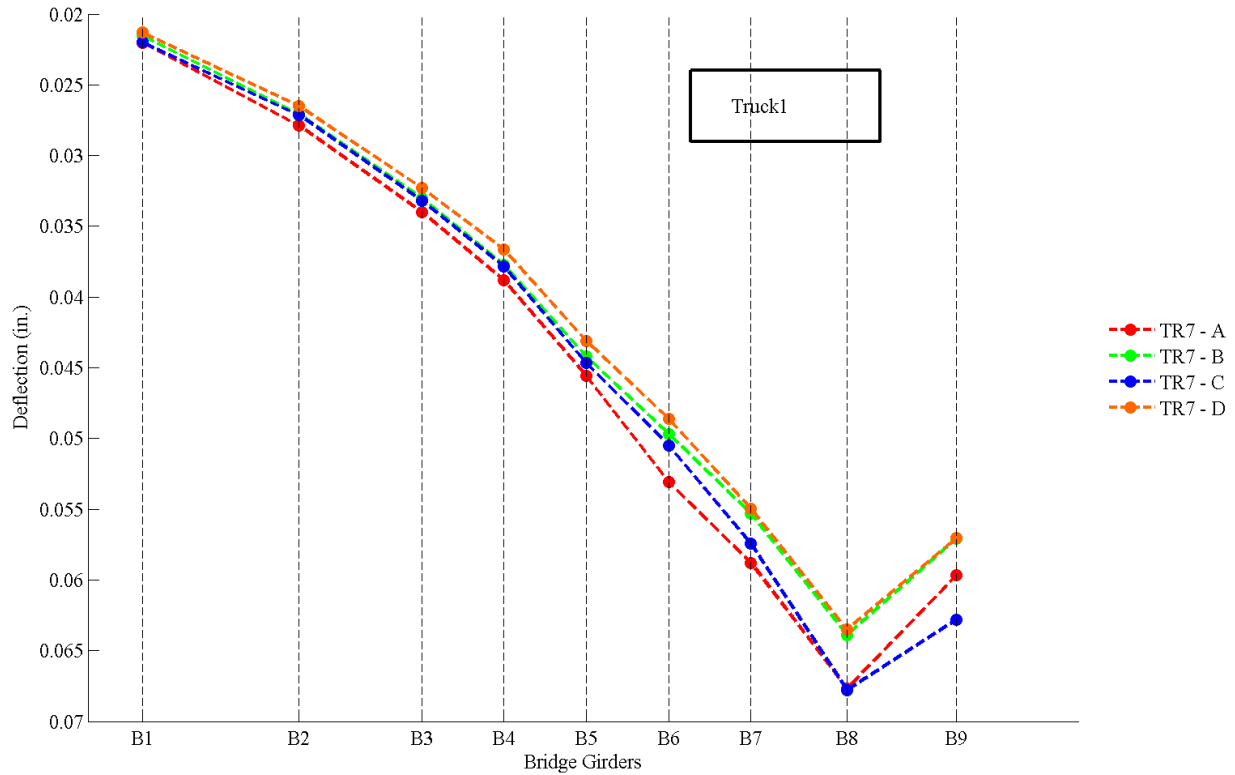
Figure 112: Distribution of girder deflection in transverse direction for all passes in Run 7.

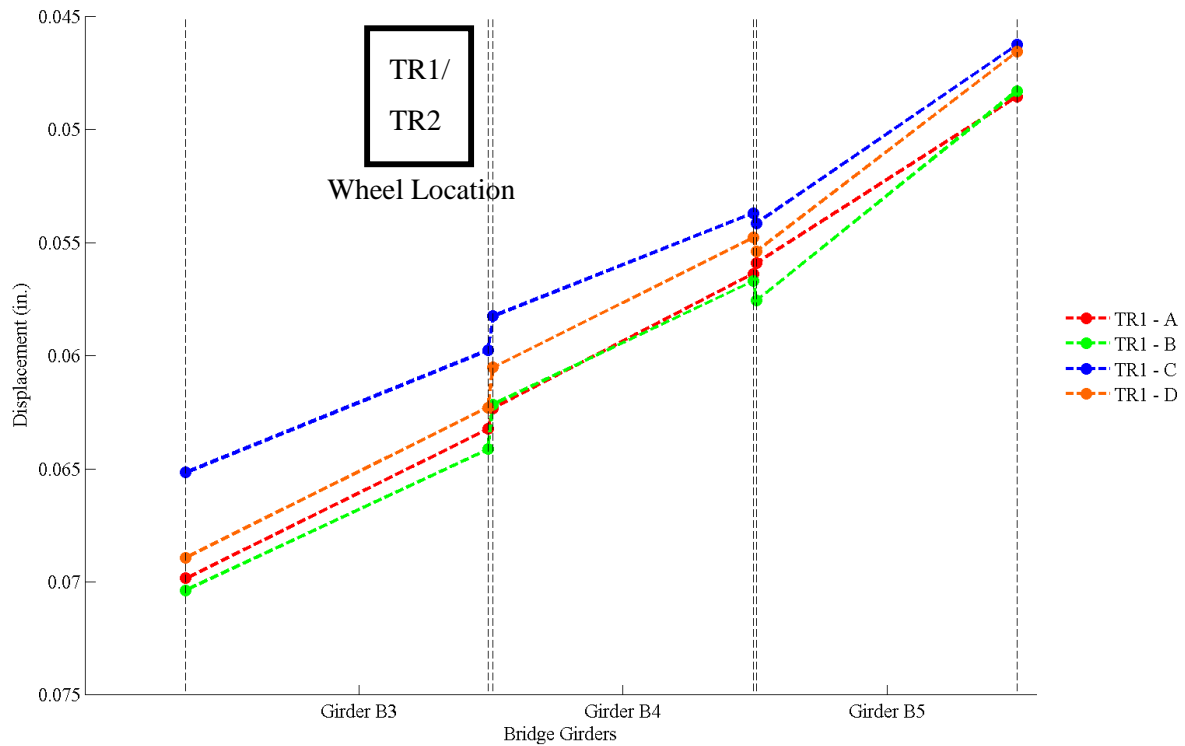
Figure 113: Relative vertical displacement between adjacent girders for all passes during Run 1.

The measurement of relative displacements between girders was an essential part in the live load test of the KVCB. The bridge was known to have the problematic partial depth shear key detail. Consequently, the KVCB displayed the signs of shear key failure through reflective cracks on the deck notably between girders B1 and B2, B5 and B6, B8 and B9 in the south span and girders B2 and B3, B7 and B8 in the north span. To observe the transverse displacements between the adjacent girders a cluster of LVDTs were attached vertically to the underside of girders B3 through B5. Girders B3 through B5 were selected on the basis that there were no visible signs of deterioration at these joints, which allowed for closer examination of the transverse behavior of the adjacent girders under load. The LVDT cluster, as shown in Figure 36, was positioned such that the displacement of each girder was recorded at center of each web. Recording displacements of the girder webs allowed for studying the relative vertical deflection and also relative rotation between the boxes. The measurements of displacements made by the LVDT cluster are presented in Figure 113 through Figure 118. The displacements are presented for instances when the magnitude of relative displacement was the highest, which typically was when the rear axles were closest to the instrumented locations. In these plots the axis of individual LVDTs is plotted but not individually demarcated. Instead the girder designation is shown between the vertical LVDT axes.

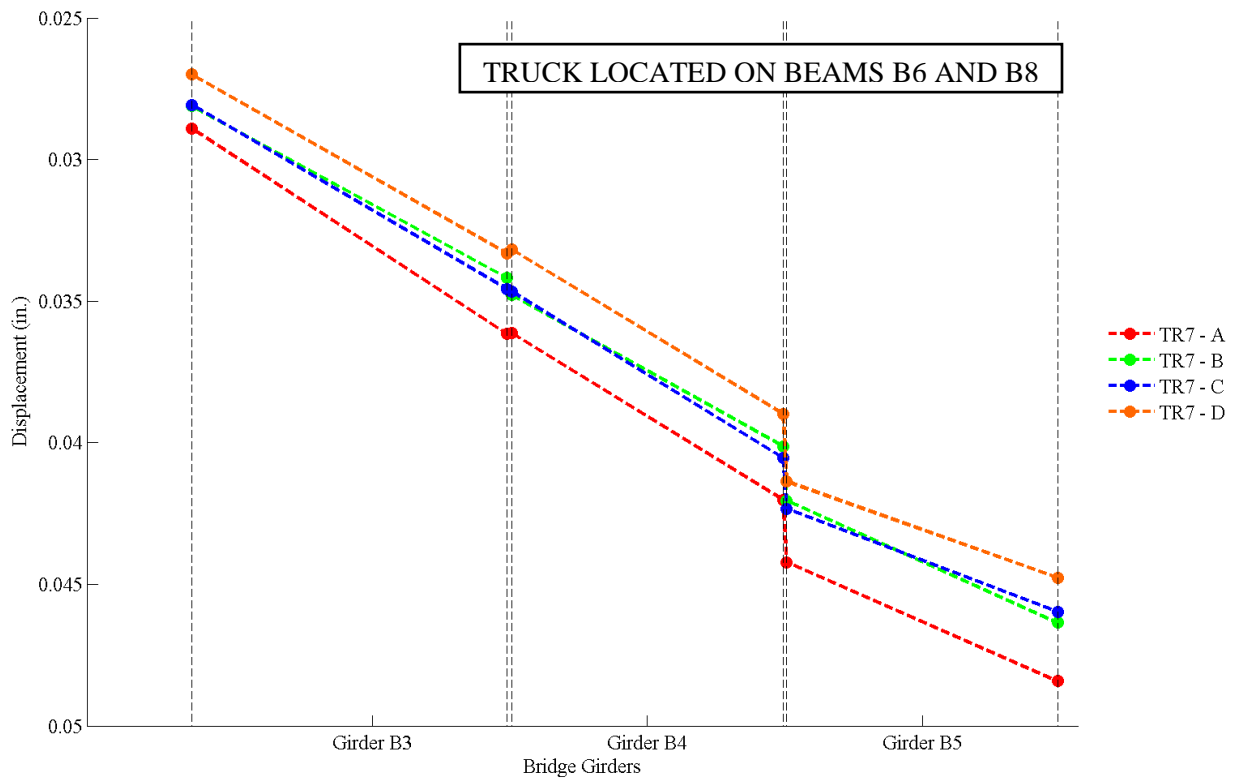
Figure 118: Relative vertical displacement between adjacent girders for all passes during Run 7.

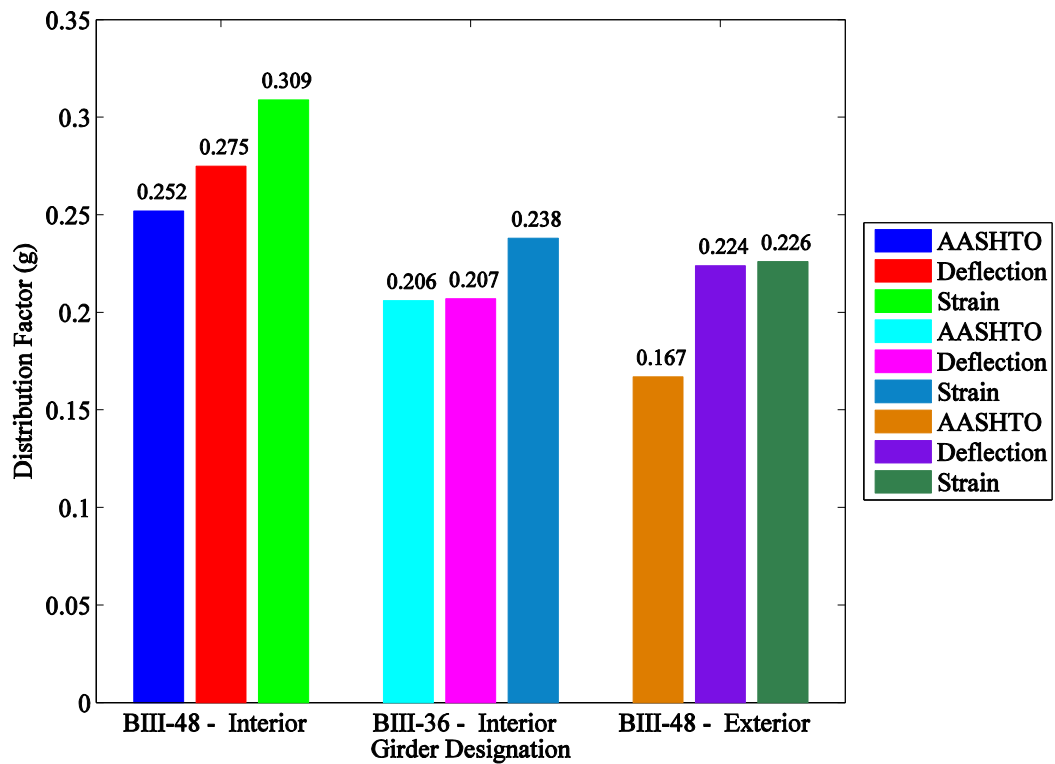
Figure 122: Comparison of GDFs calculated for multiple lane configuration with skew correction.

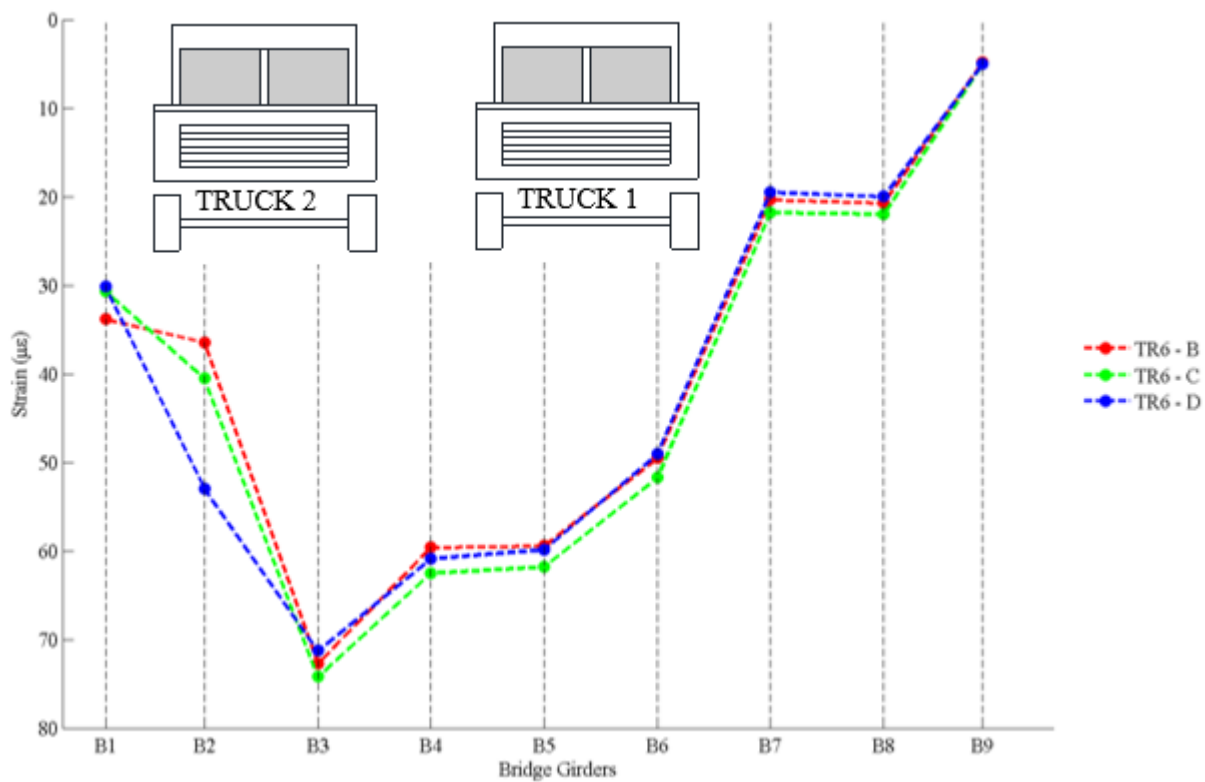
Figure 128: Transverse strain distributions for all reported truck passes in Run 6.

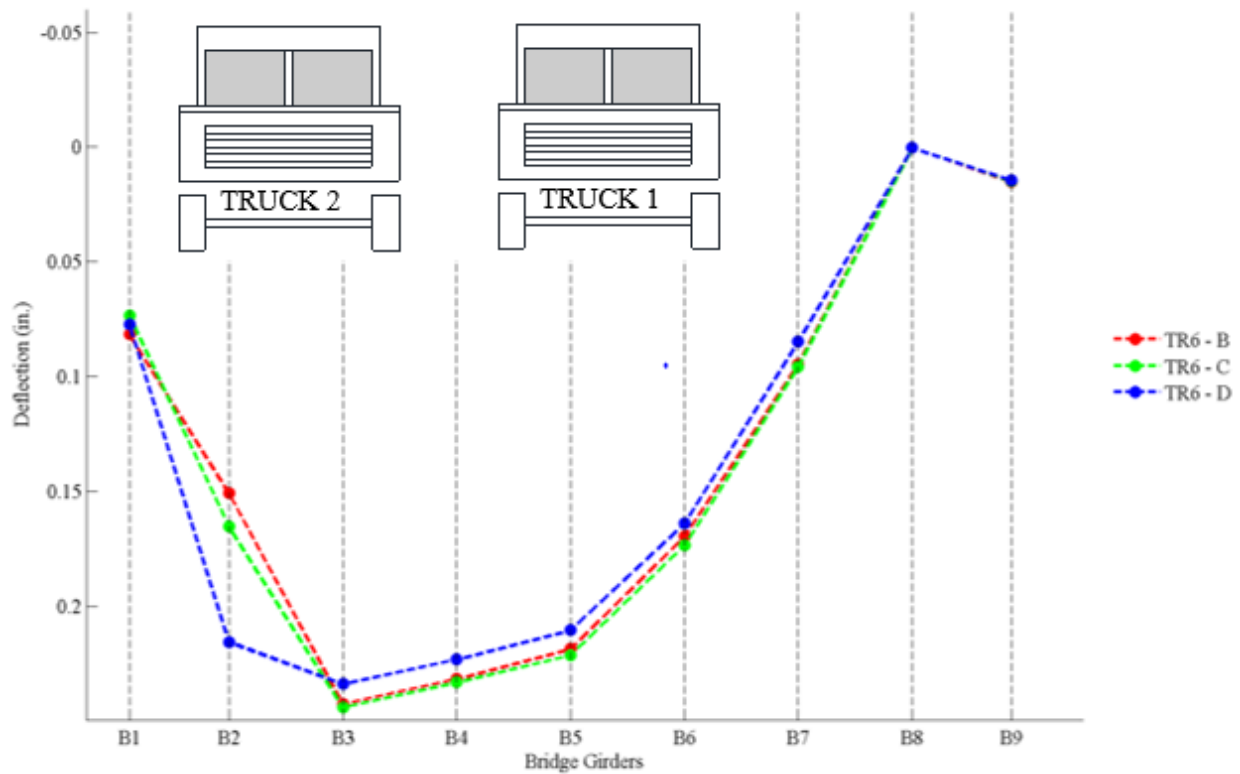
Figure 134: Transverse variations in girder deflections for all reported truck passes in Run 3.

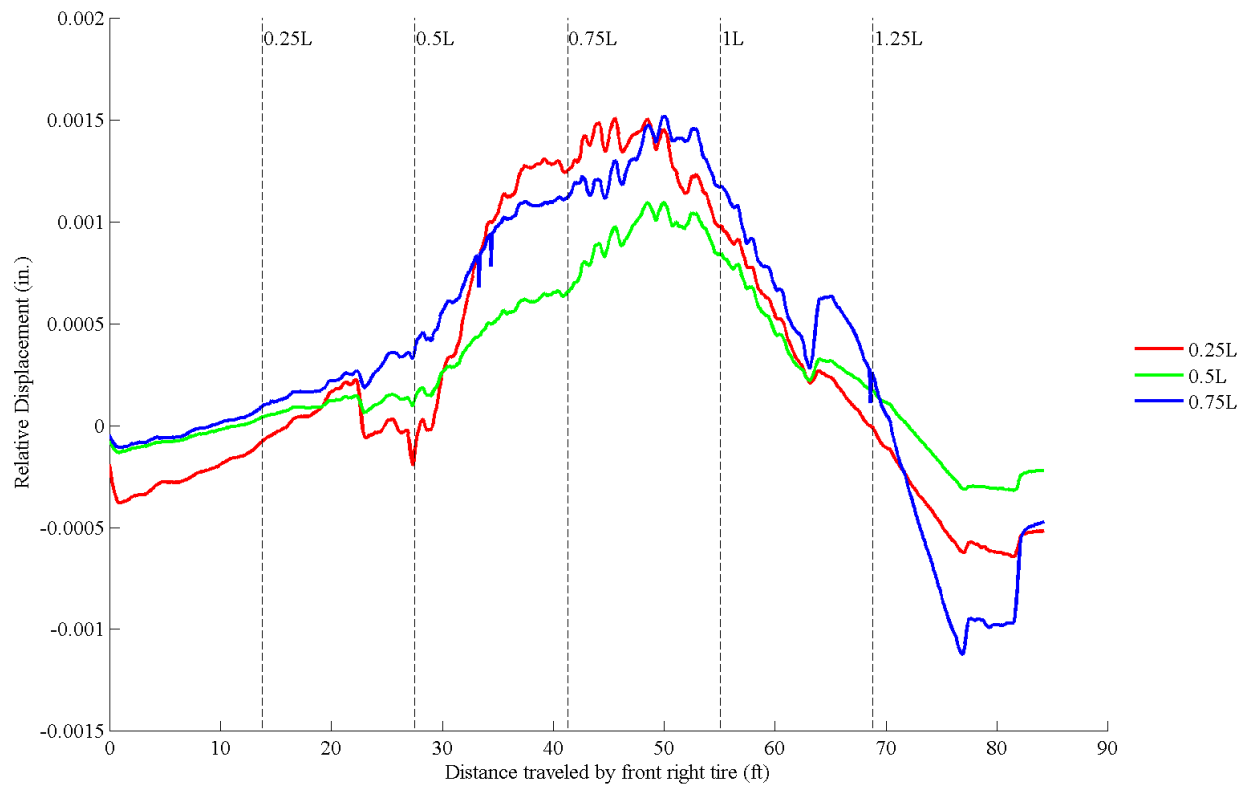
Figure 136: Typical horizontal displacement response for Run 1.

It can be observed that a constant horizontal displacement was seen as a response to Truck Run1 in which the truck tires were on the opposite sides of the instrumented joint. A smaller response was expected at the 0.25L and 0.75L since those locations were closer to the supports. However, the equal response indicated that the girder ends also rotate transversely even when two bearing pads were used to support the beam, one bearing pad under each web.

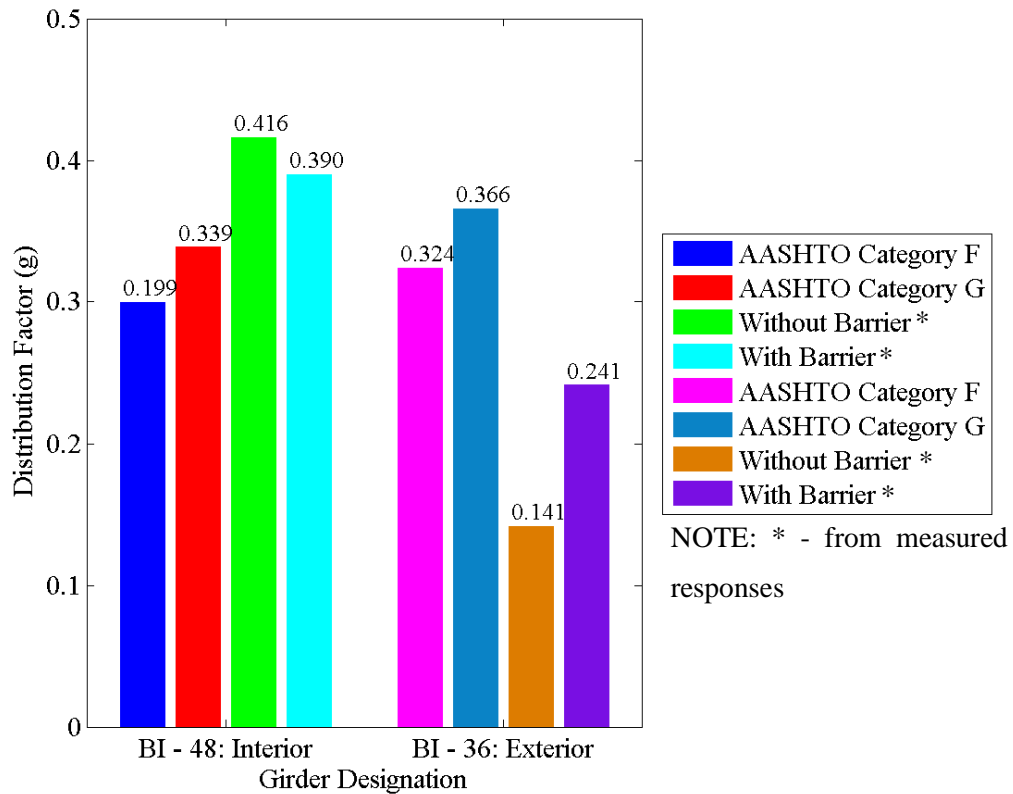
Figure 141: GDFs for multiple lane configuration.

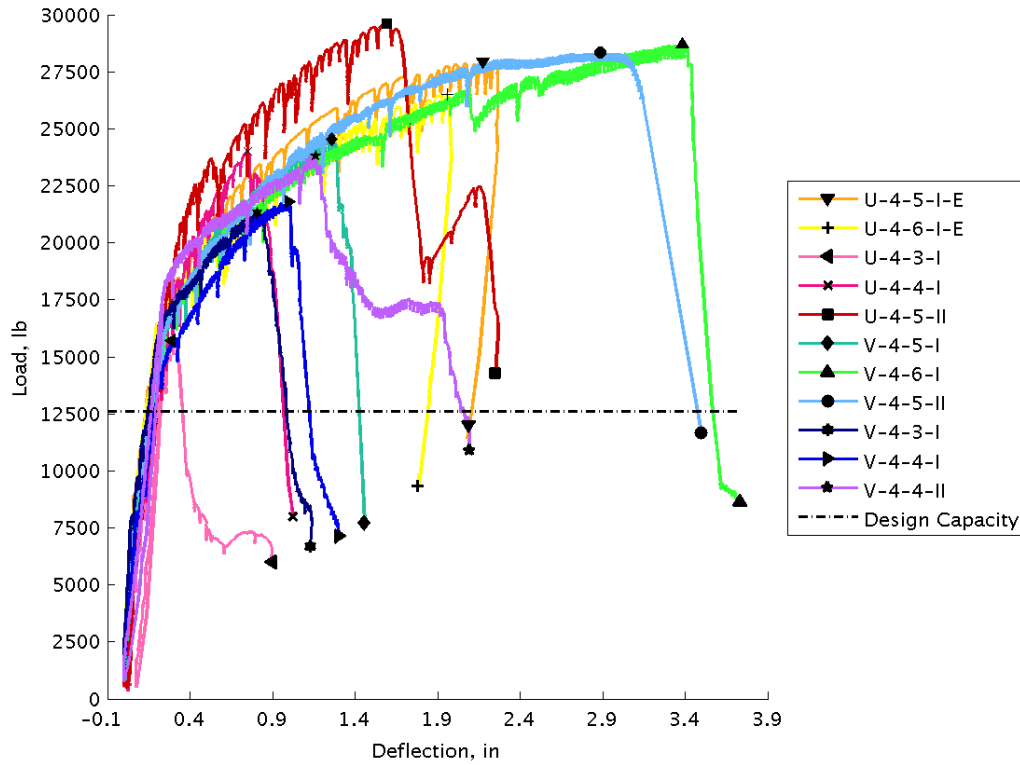
Figure 162: Load vs. south end deflection for all specimens with No. 4 bars.

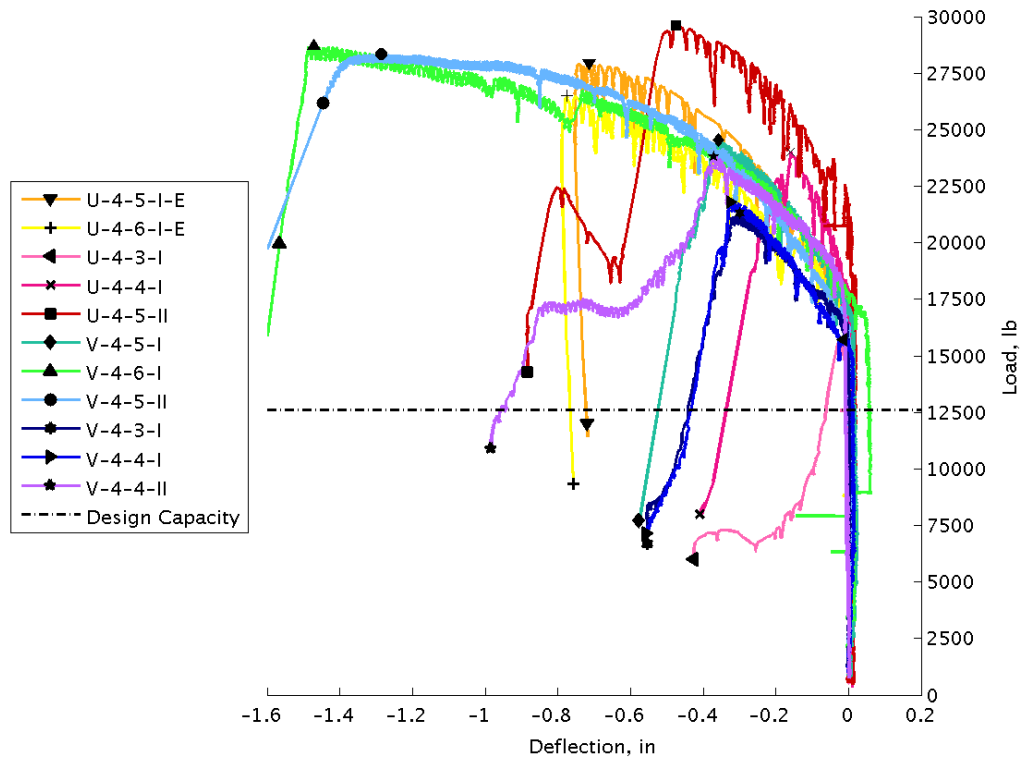
Figure 164: Load vs. midspan deflection for specimens with No. 4 bars.  
(Note that upward displacement is negative).

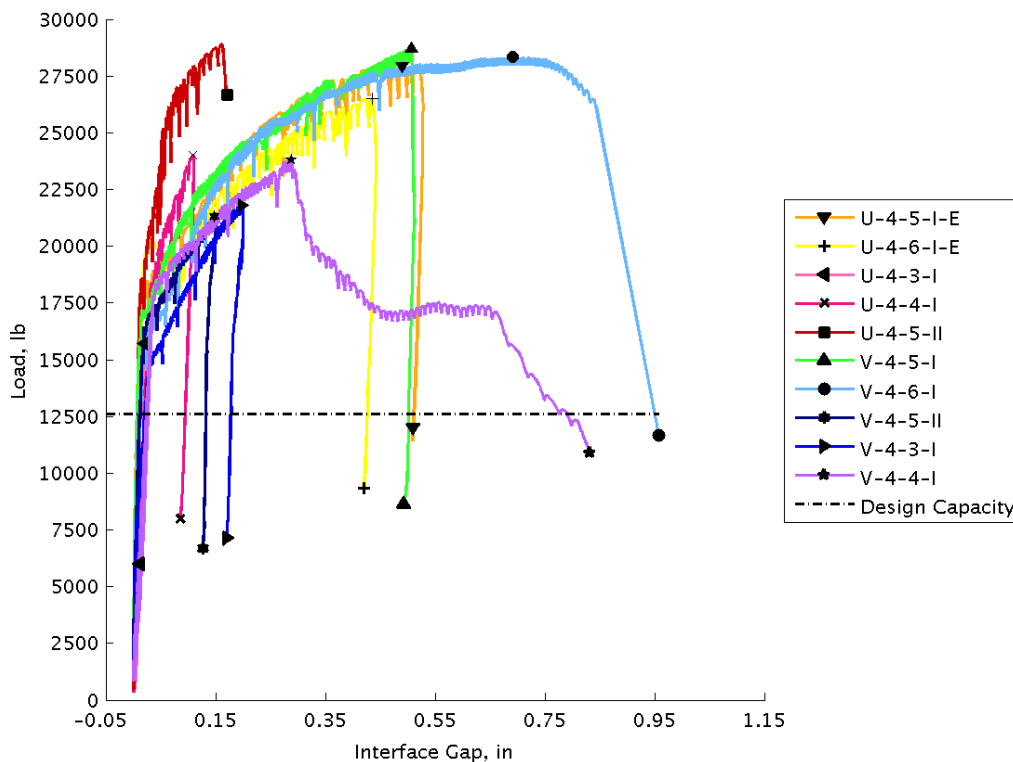
Figure 169: Load vs. north interface displacement for specimens with No. 4 bars.

The measurements were plotted with respect to the externally applied load as shown in Figure 169 and Figure 170. It can be observed that the load vs. interface displacement plots for all specimens are very similar prior to the interface debonding. After debonding the interface gaps at either end widened at different rates. Except for specimen U-4-3-I, all specimens showed evidence that the tension reinforcement had yielded and begun to strain harden. Slip was indicated when the gap opened considerably as the load dropped off. Note that slip occurred at the south interface for most specimens, but at the north and south for specimen V-4-4-I. The north interface of specimens U-4-5-I-E and U-4-6-I-E widened more than the south interface. Potentially, the reinforcement could have pulled out or ruptured at this end but both tests were stopped prior to the occurrence of failure.

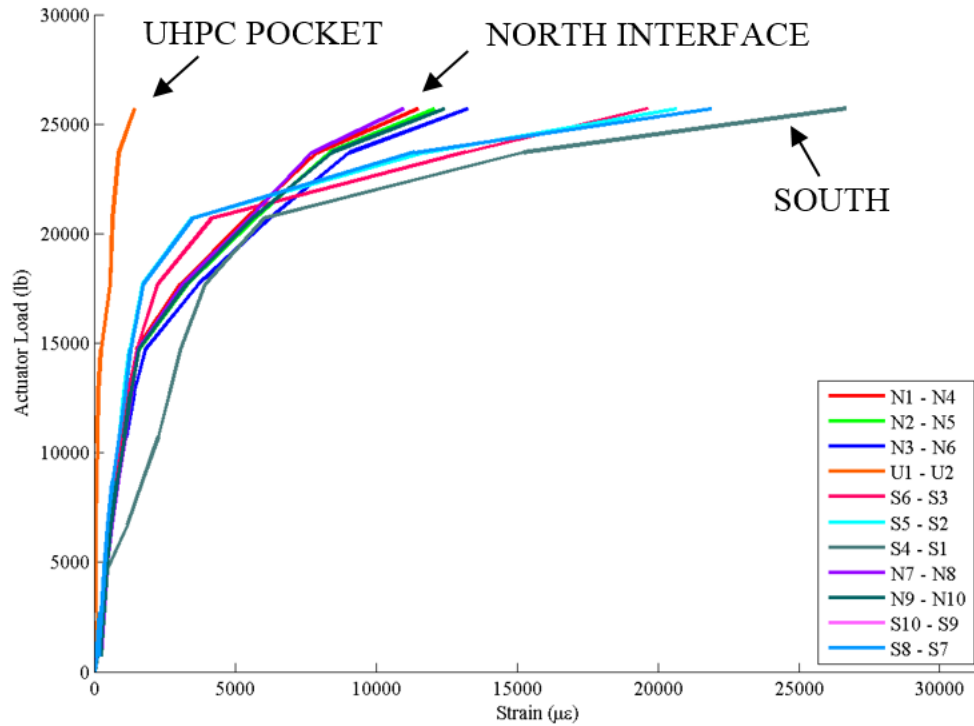
Figure 172: DEMEC strain measurements at the top of the beam for specimen U-4-5-I-E.

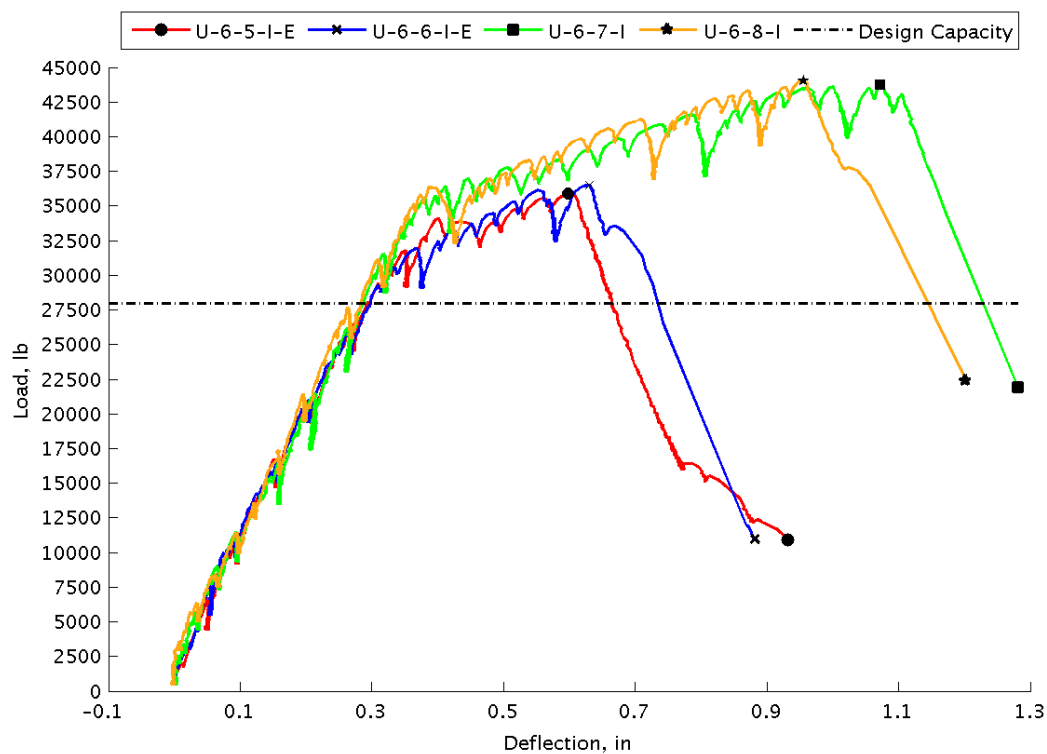
Figure 185: Load vs. south deflection for all specimens with No. 6 bars.

The load vs. deflection behavior of the No. 6 specimens is shown in Figure 185, Figure 186 and Figure 187. All specimens with No. 6 initially bars displayed very similar linear load vs. deflection behavior. The specimens with equal amounts of tension and compression reinforcement displayed non-linear behavior at lower loads than the specimens with the greater area of compression reinforcement. The specimens with greater compression reinforcement also failed at higher loads than those with equal areas.
