# New Approach to Connections between Members of Adjacent Box Beam Bridges

Kedar Ram Halbe

Dissertation submitted to the faculty of the Virginia Polytechnic Institute and  
State University in partial fulfillment of the requirements for the degree of

Keywords: Connection details, adjacent box beam bridges, UHPC, VHPC, shear key, diagnostic  
test

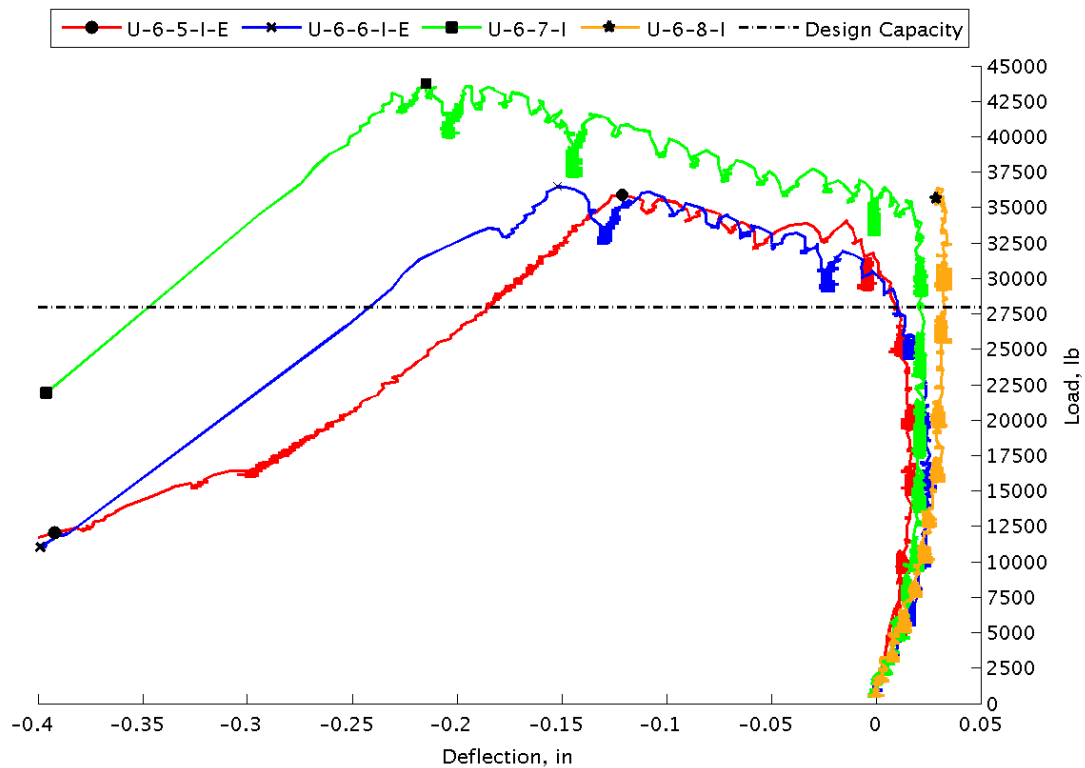
Figure 187: Load vs. Midspan Deflection for All Specimens with No. 6 Bars.  
(Note: upward deflection is negative)

The load vs. deflection behavior of the No. 6 specimens is shown in Figure 185, Figure 186 and Figure 187. All specimens with No. 6 initially bars displayed very similar linear load vs. deflection behavior. The specimens with equal amounts of tension and compression reinforcement displayed non-linear behavior at lower loads than the specimens with the greater area of compression reinforcement. The specimens with greater compression reinforcement also failed at higher loads than those with equal areas.

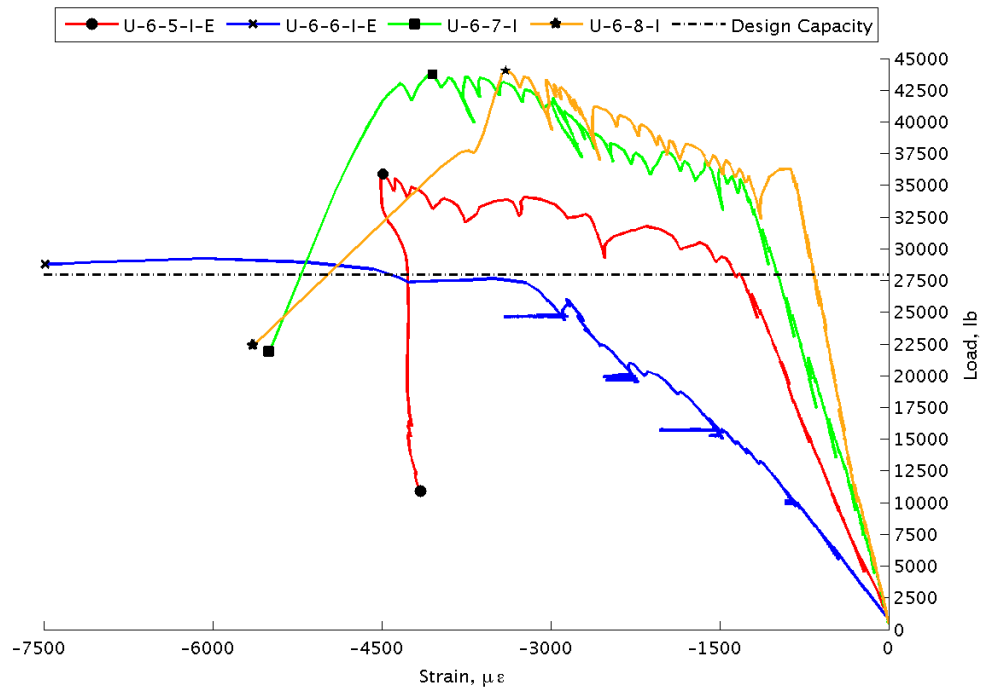
Figure 189: Load vs. reinforcement strain (West) for all specimens with No. 6 bars.

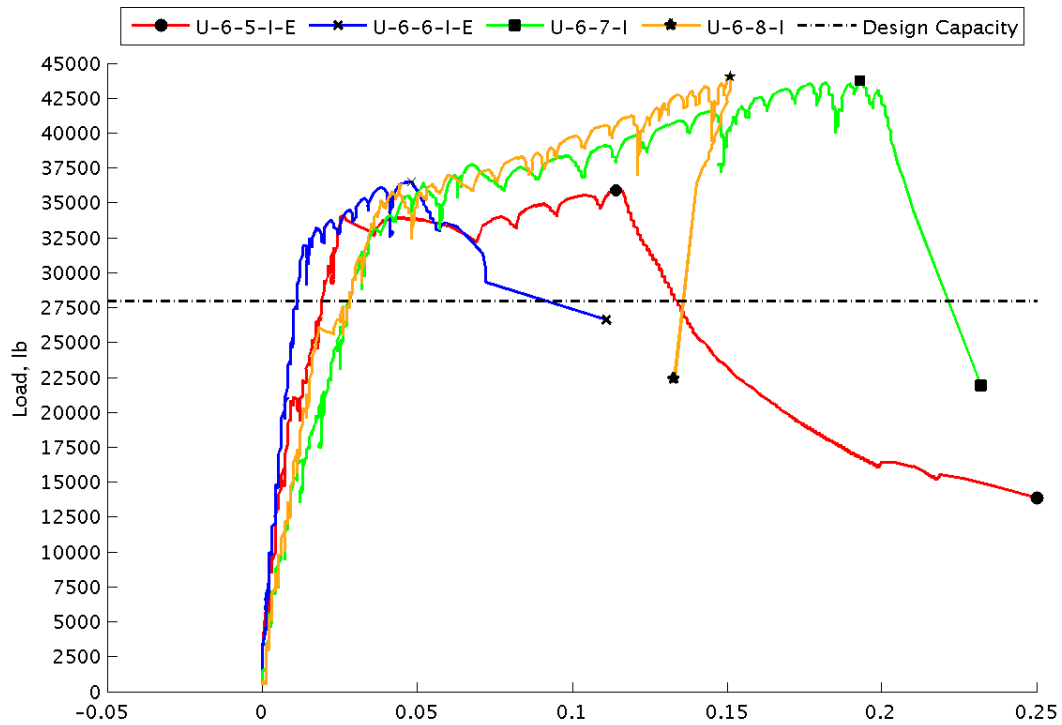
Figure 190: Load vs. north interface displacement for all specimens with no. 6 bars.

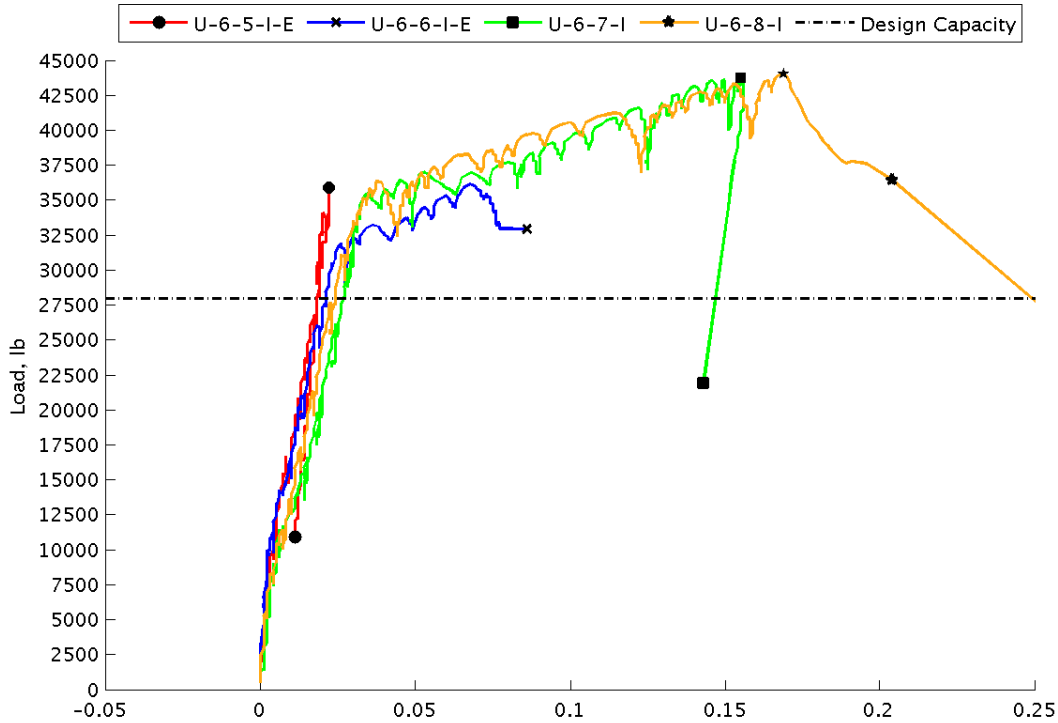
Figure 191: Load vs. south interface displacement for all specimens with No. 6 bars.

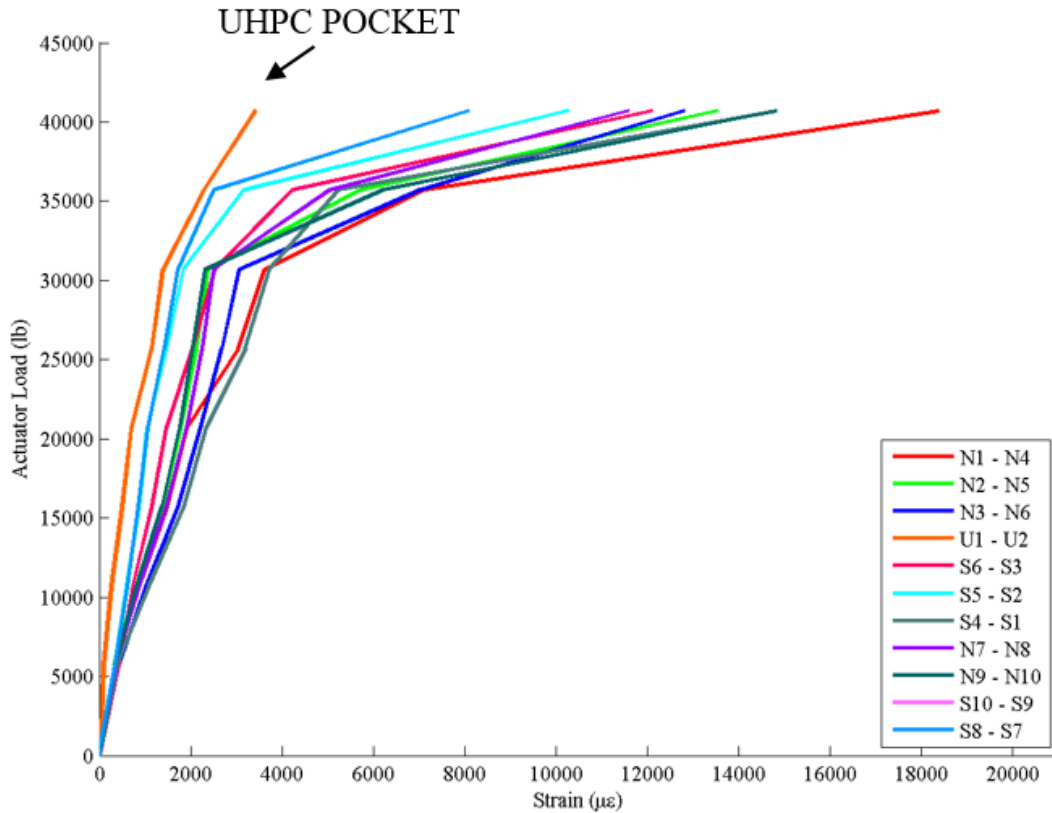
Figure 192: Strain variation observed at the top of the UHPC pocket in U-6-8-I.

Figure 192 presents the surface strain measurements made with the DEMEC gauge at the top of the UHPC pocket for the specimen U-6-8-I. The numbering of the DEMEC points is as shown in Figure 172. The plot is typical for specimens with No. 6 bars. As seen in the specimens with No. 4 bars, the cracks, and hence the strains, at the interface were very large compared to the cracks within the UHPC pocket.

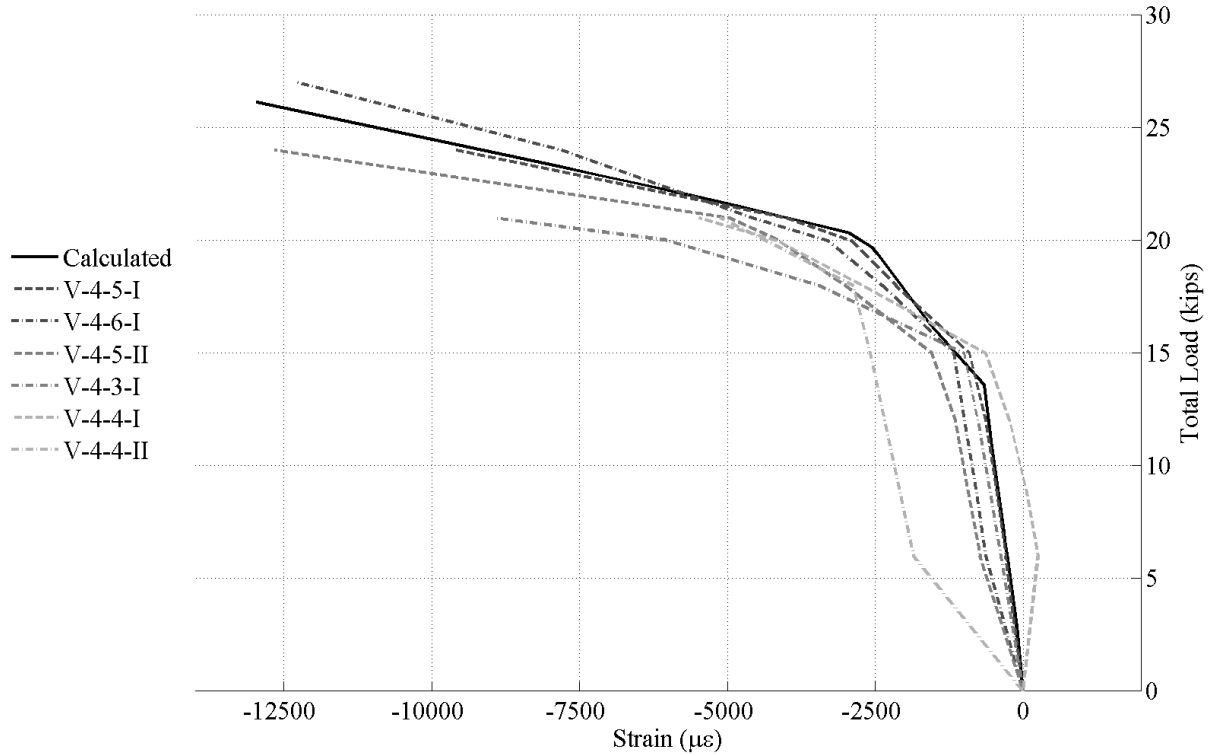
Figure 203: Load vs. strain at bottom of compression reinforcement for specimens with Two No. 4 bars at top and two no. 8 at bottom of beam with VHPC.

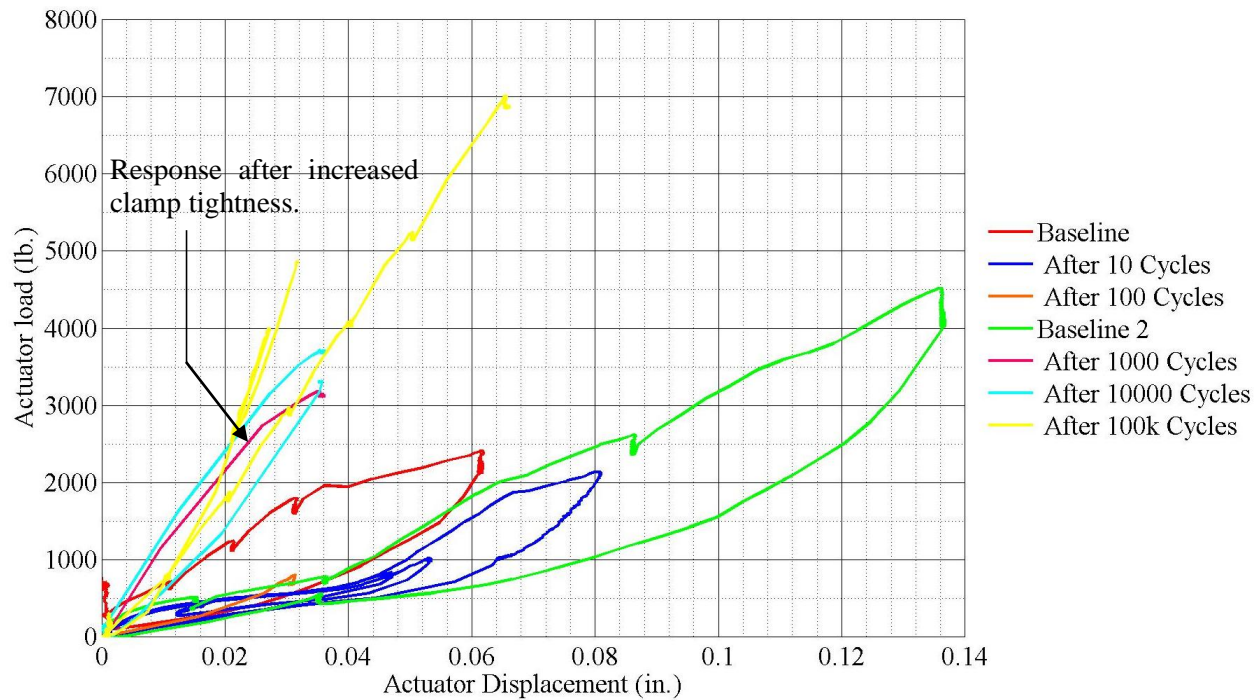
Figure 208: S1 - actuator load vs. actuator displacement.

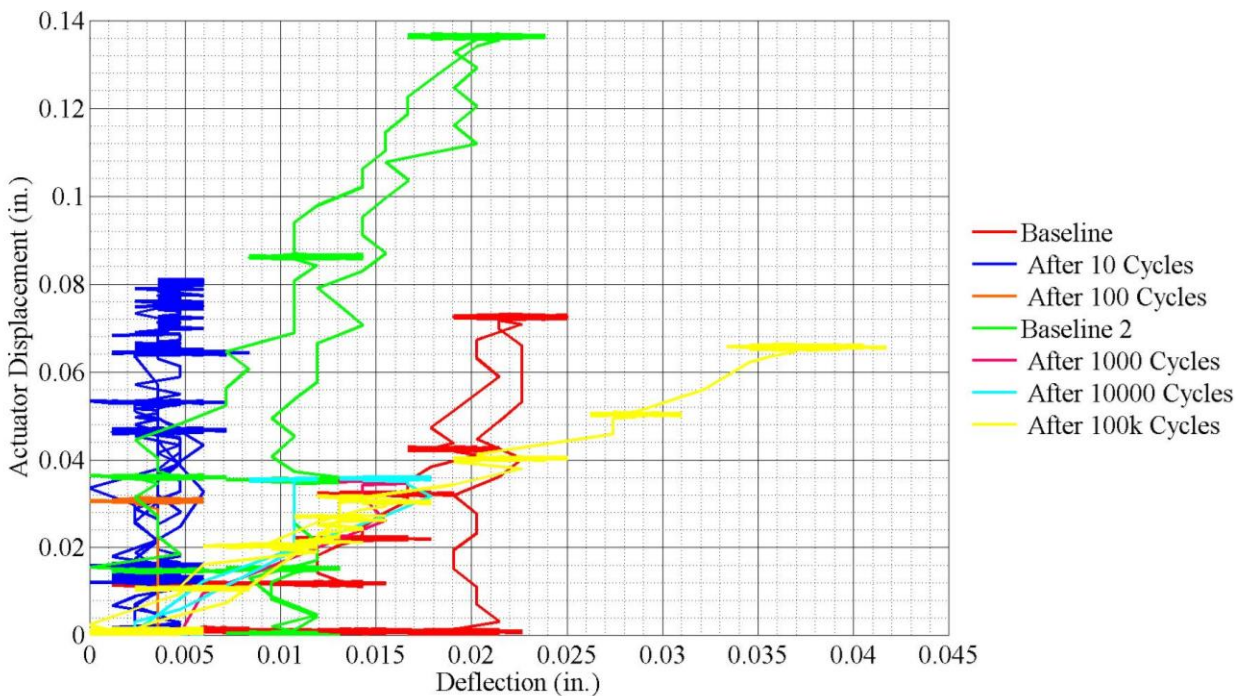
Figure 209: S1 – variation in vertical displacement near interior north support beam.

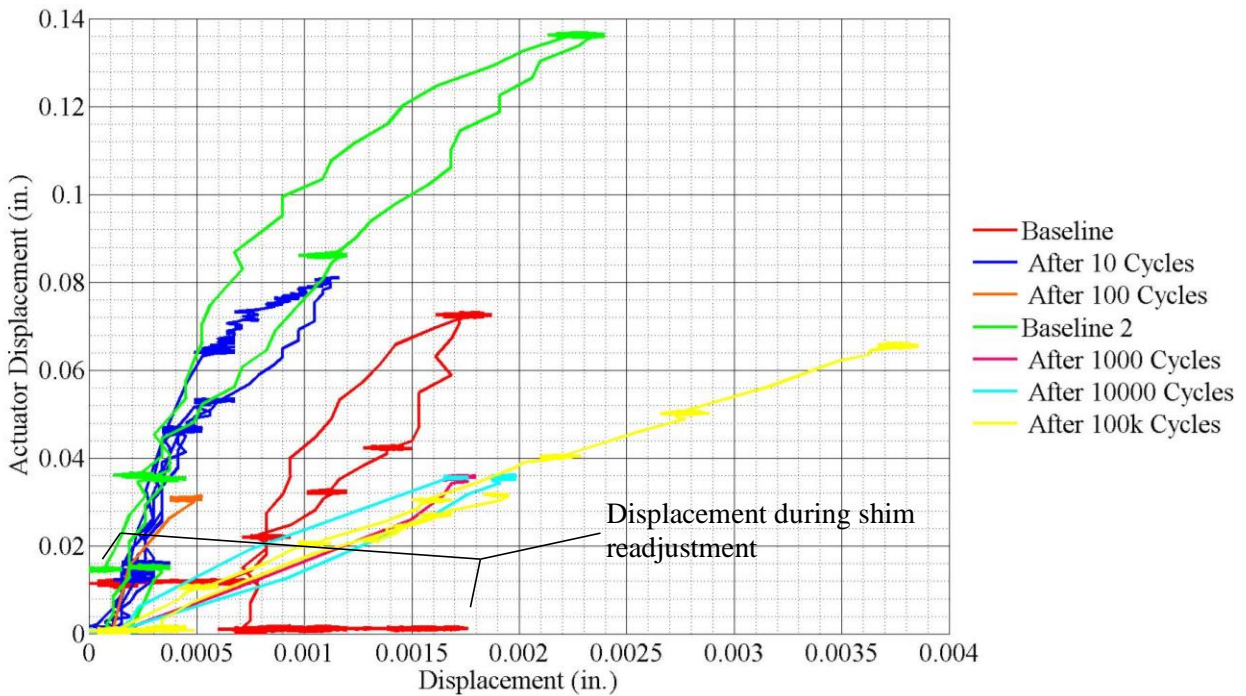
Figure 210: S1 – variation in north joint displacements during fatigue testing.

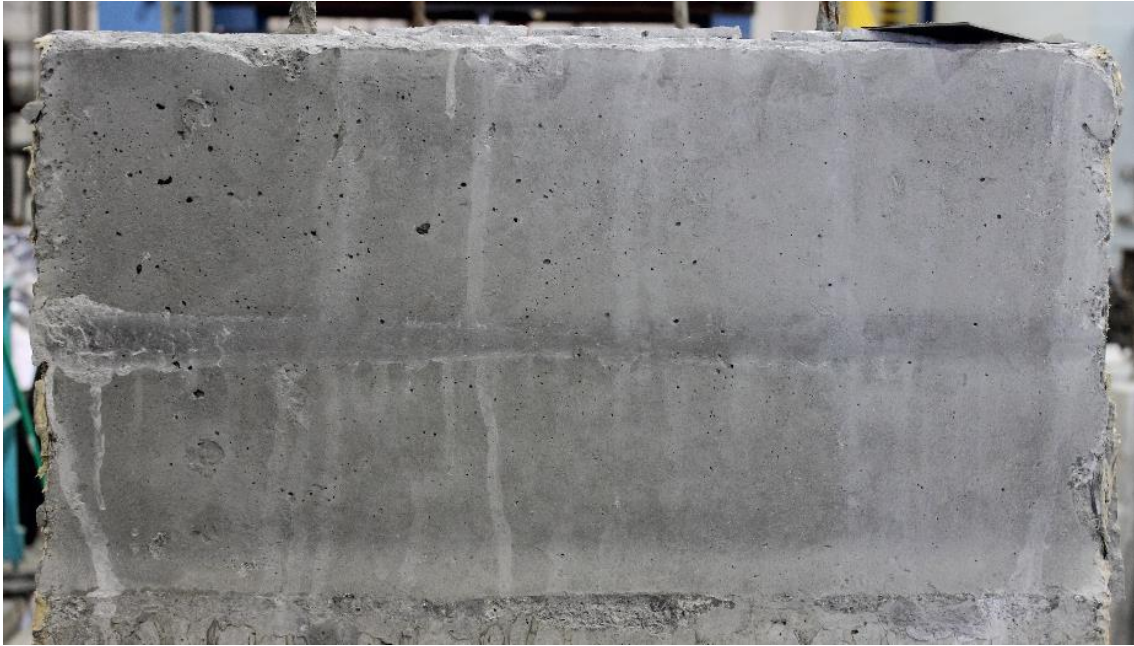
*Figure 215: S1 – no trace of grout in the joint.*

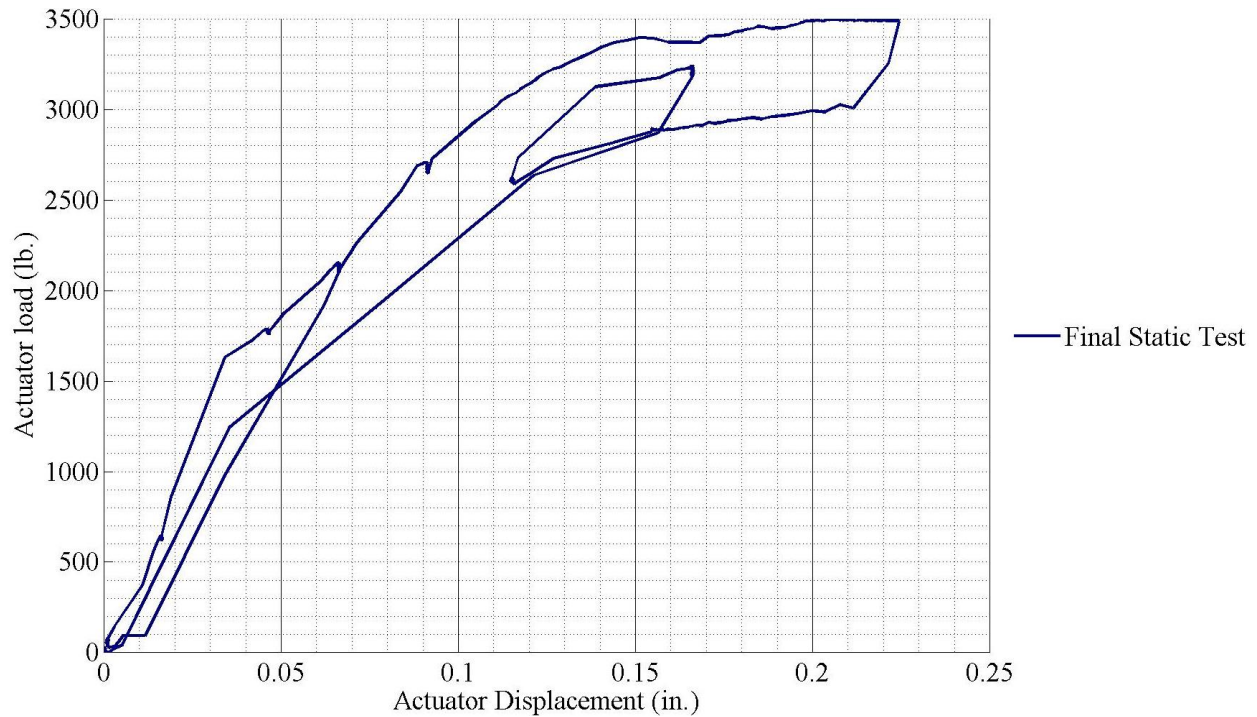
Figure 216: S1 – actuator load vs. displacement, final static test.

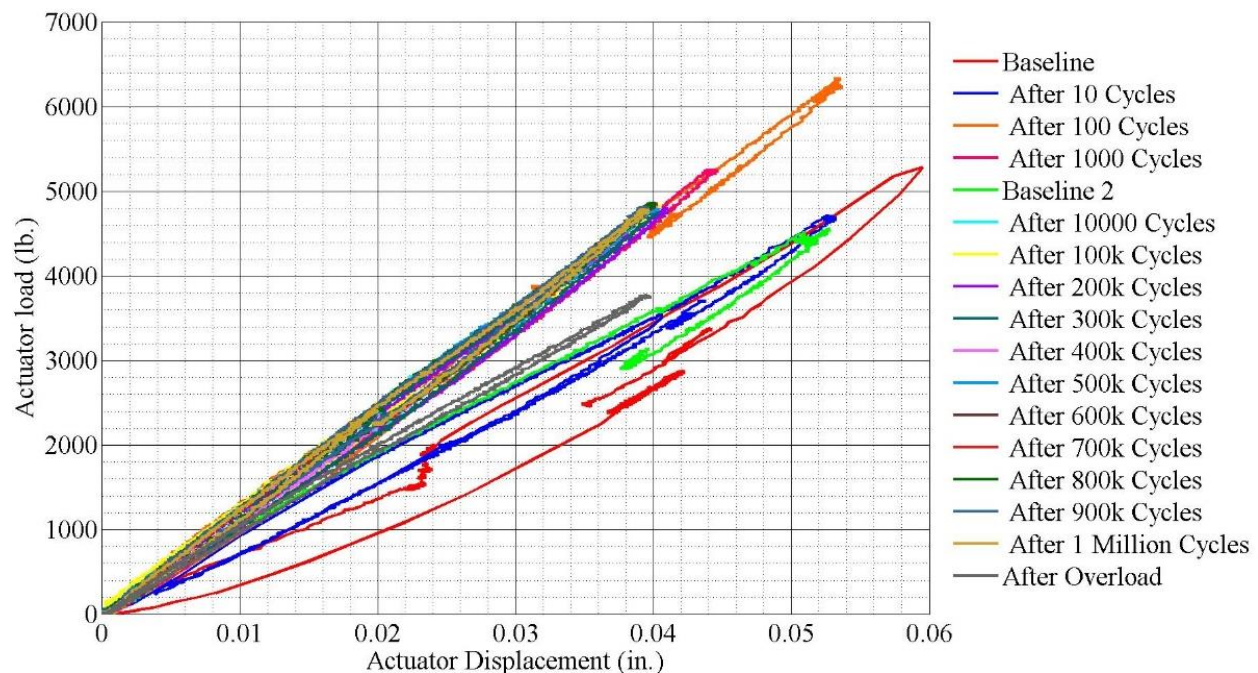
Figure 218: S2 - actuator load vs. actuator displacement.

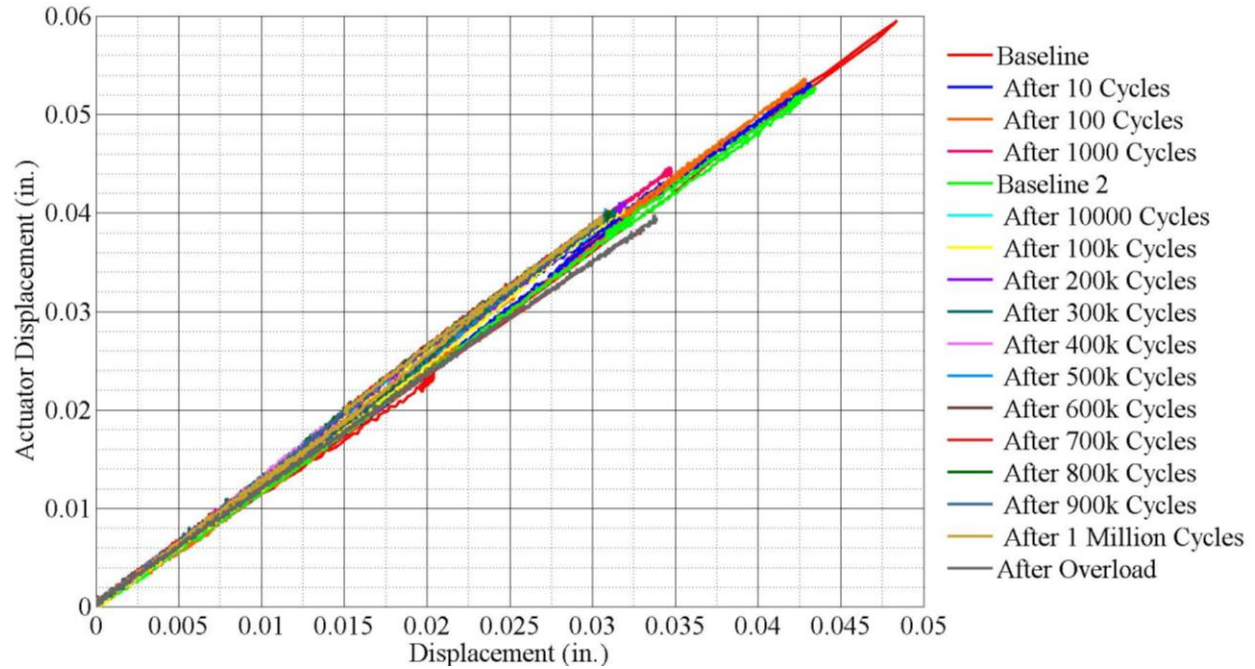
Figure 219: S2 – actual specimen displacements plotted with respect to actuator displacements.

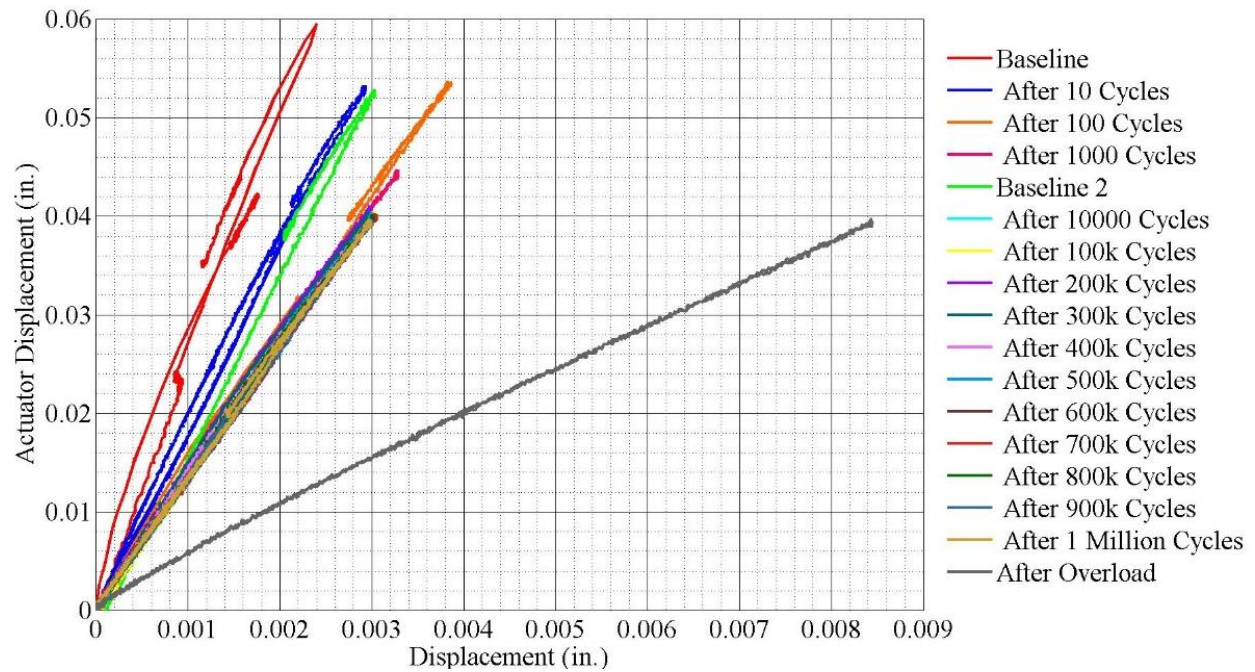
Figure 220: S2 – variation in NE joint displacements during fatigue testing.

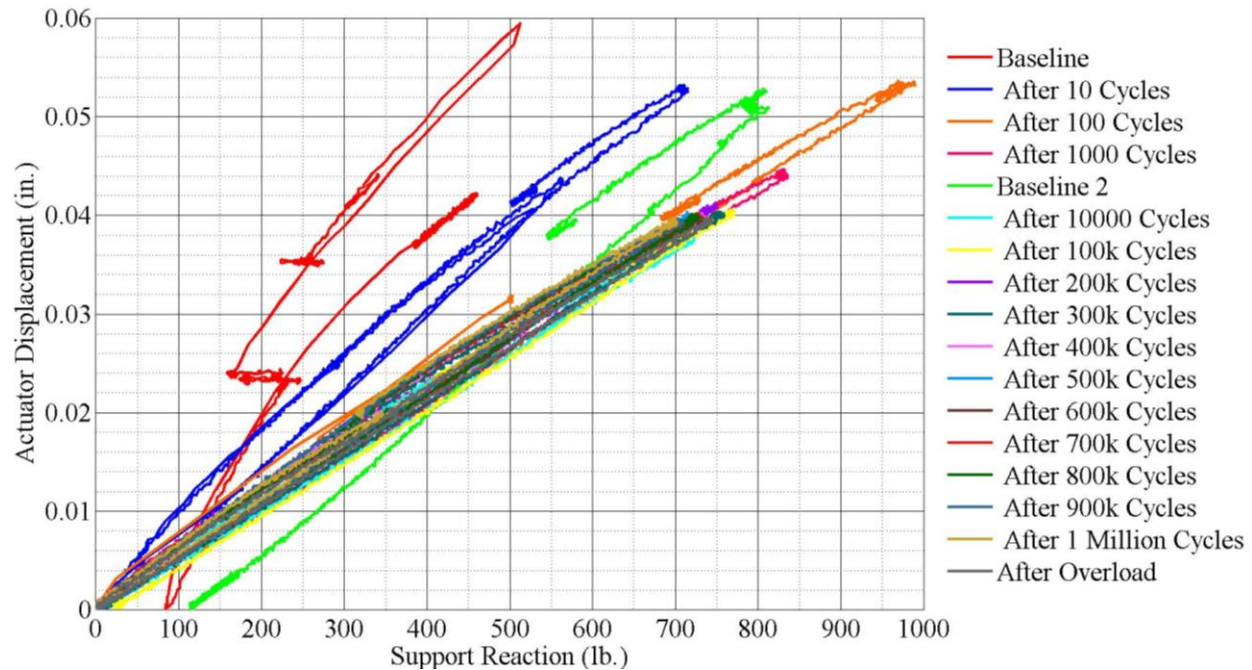
Figure 226: S2 – Variation in reaction during static tests at interior north support beam.

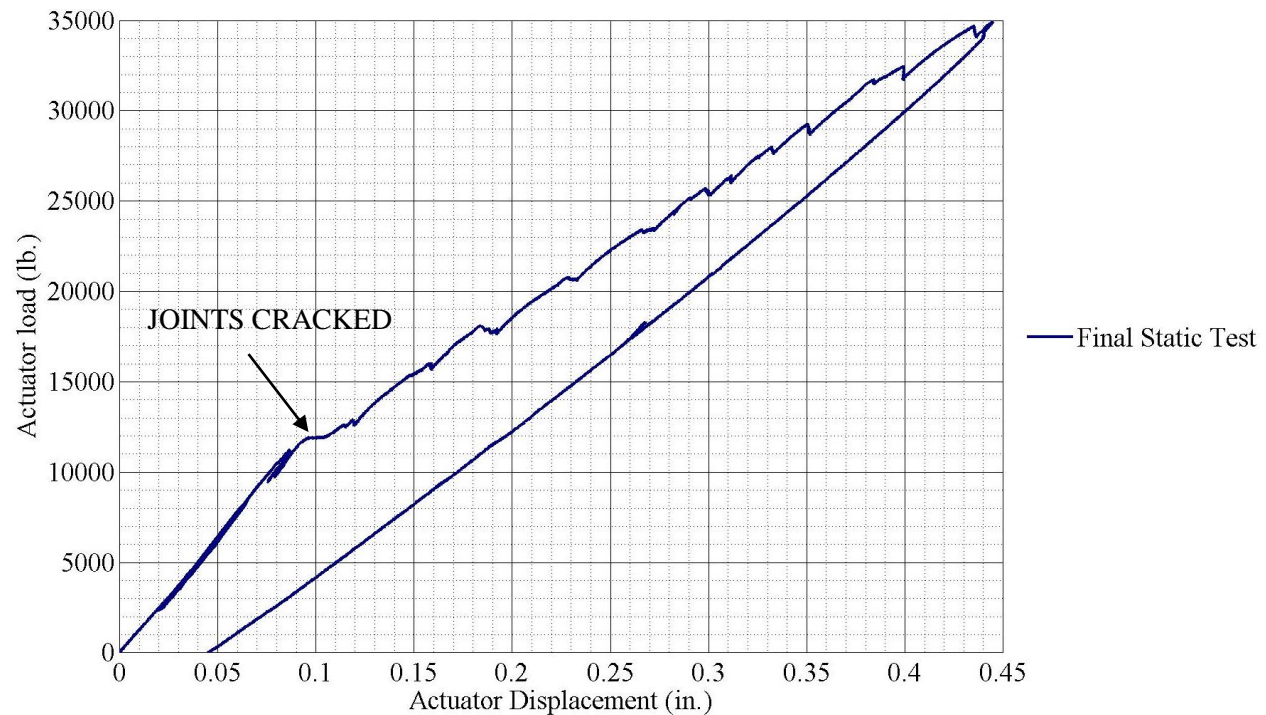
Figure 229: Load vs. displacement for S2 – final static test.

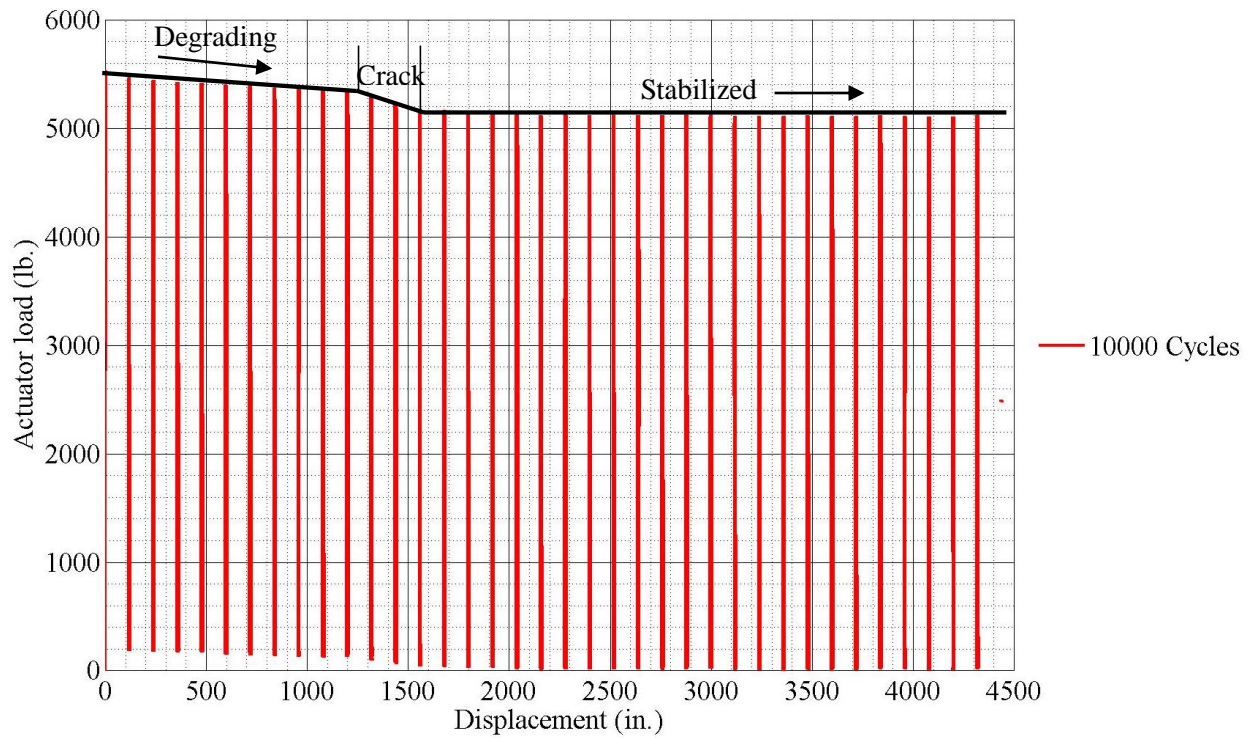
Figure 230: Change in magnitude of actuator load during fatigue test due to crack propagation.

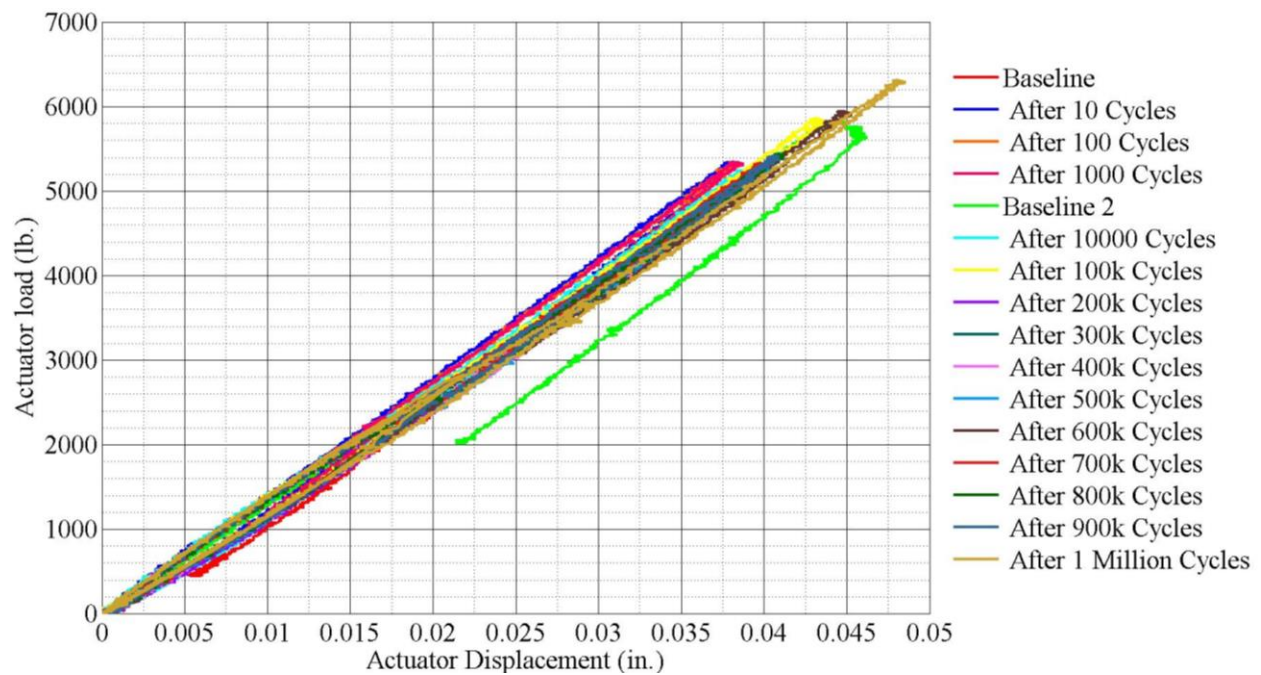
Figure 232: S3 – actuator load vs. actuator displacement.

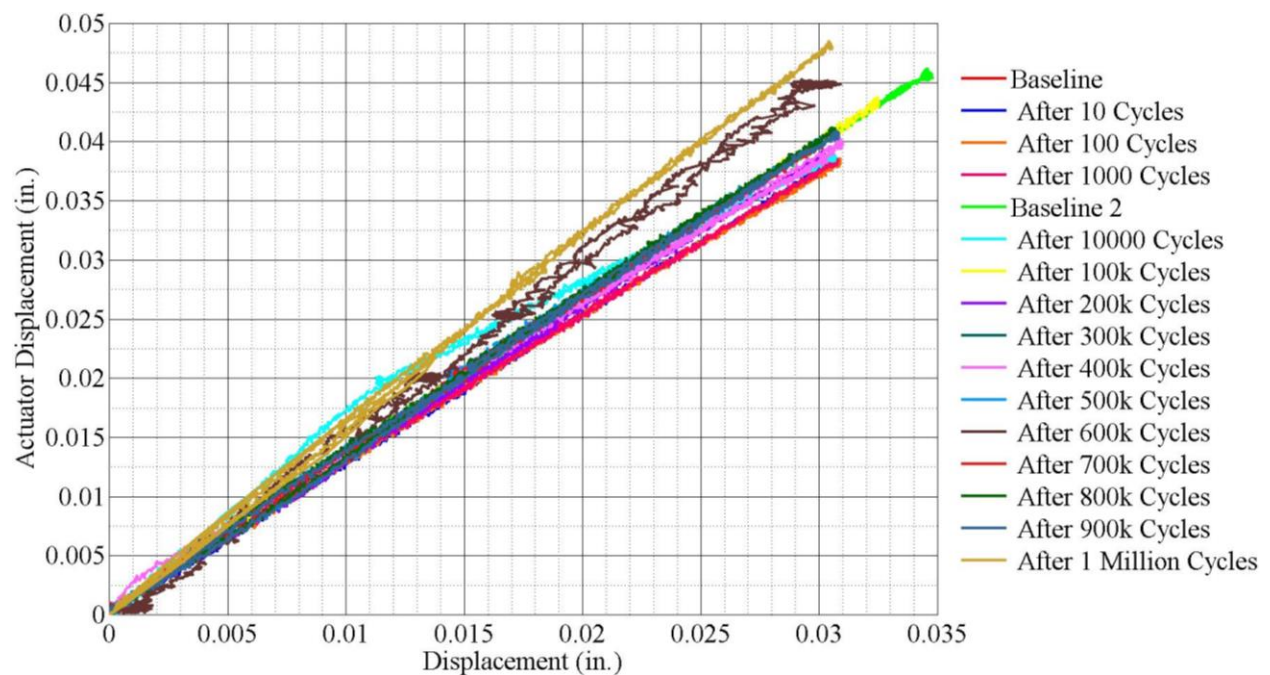
Figure 233: S3 – actual displacements imparted to specimen.

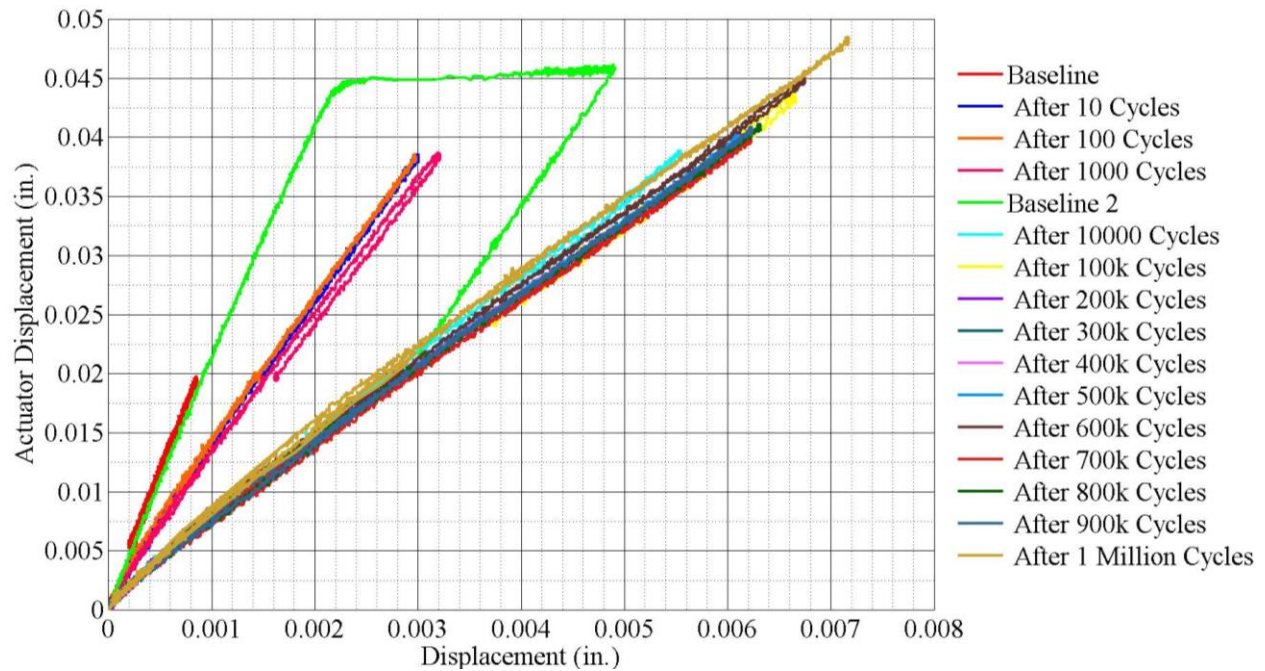
Figure 234: S3 - variation in NE joint displacements during fatigue testing.

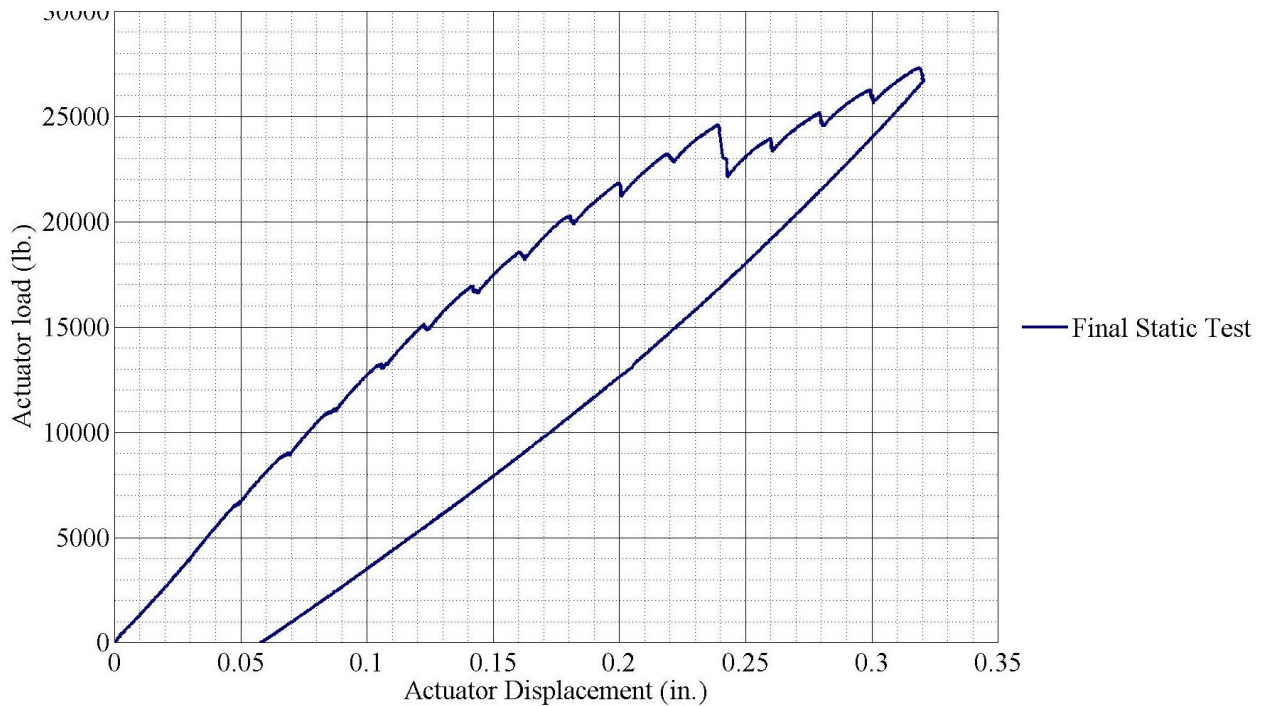
Figure 240: S3 – load vs. displacement plot for final static test.

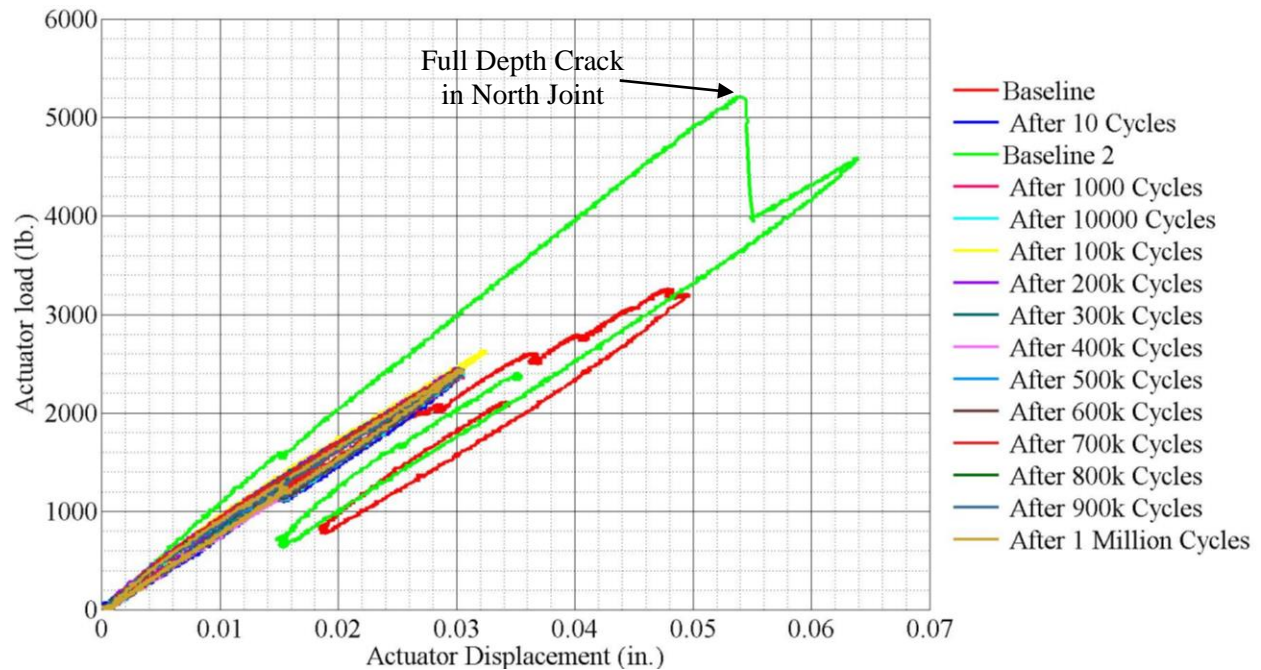
Figure 241: S4 – actuator load vs. actuator displacement.

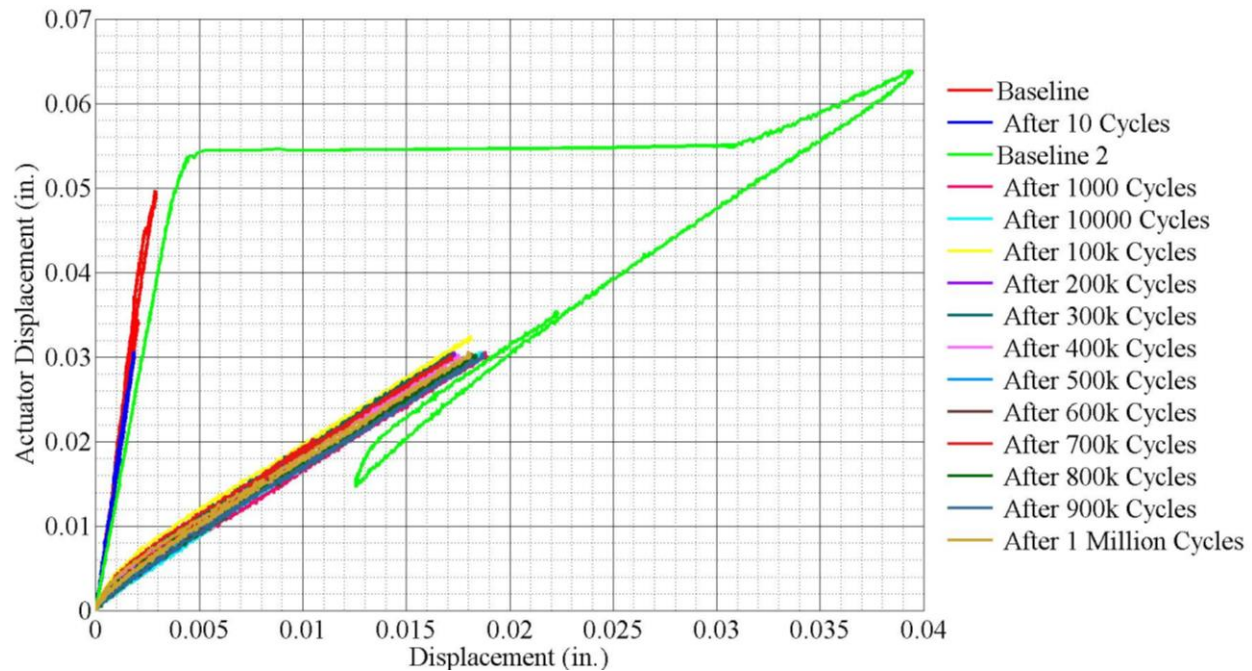
Figure 243: S4 – variation in NE joint displacements during fatigue testing.

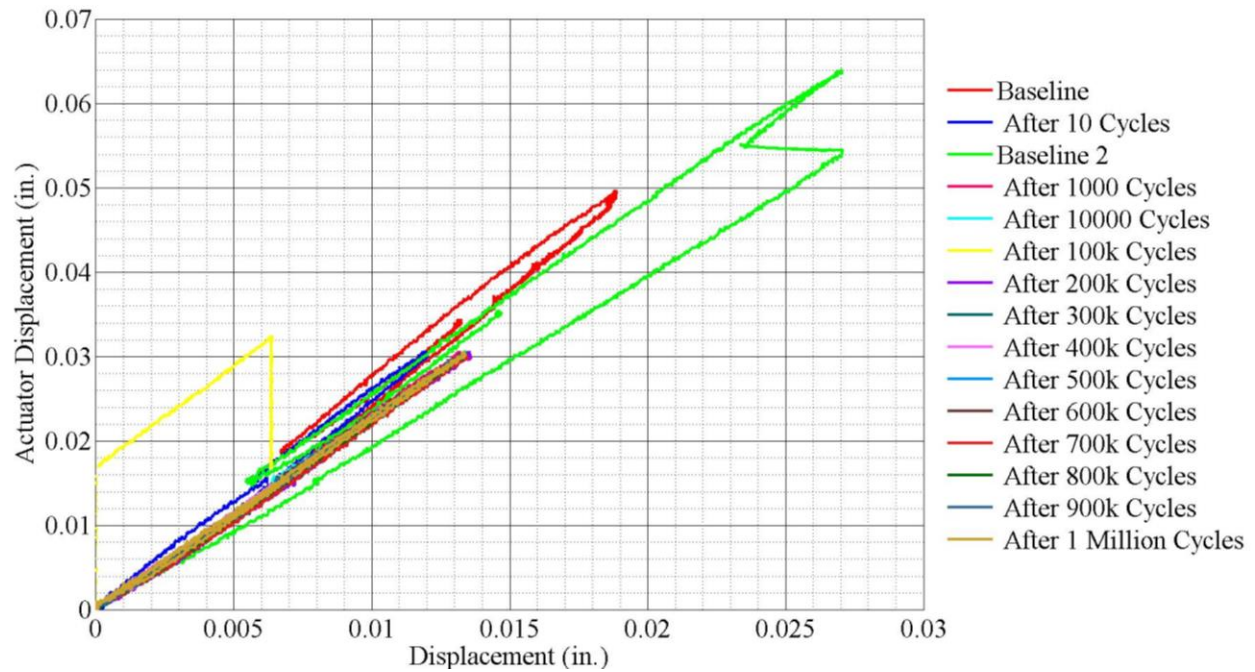
Figure 247: S4 – variation in vertical deflection near interior south support beam during fatigue.

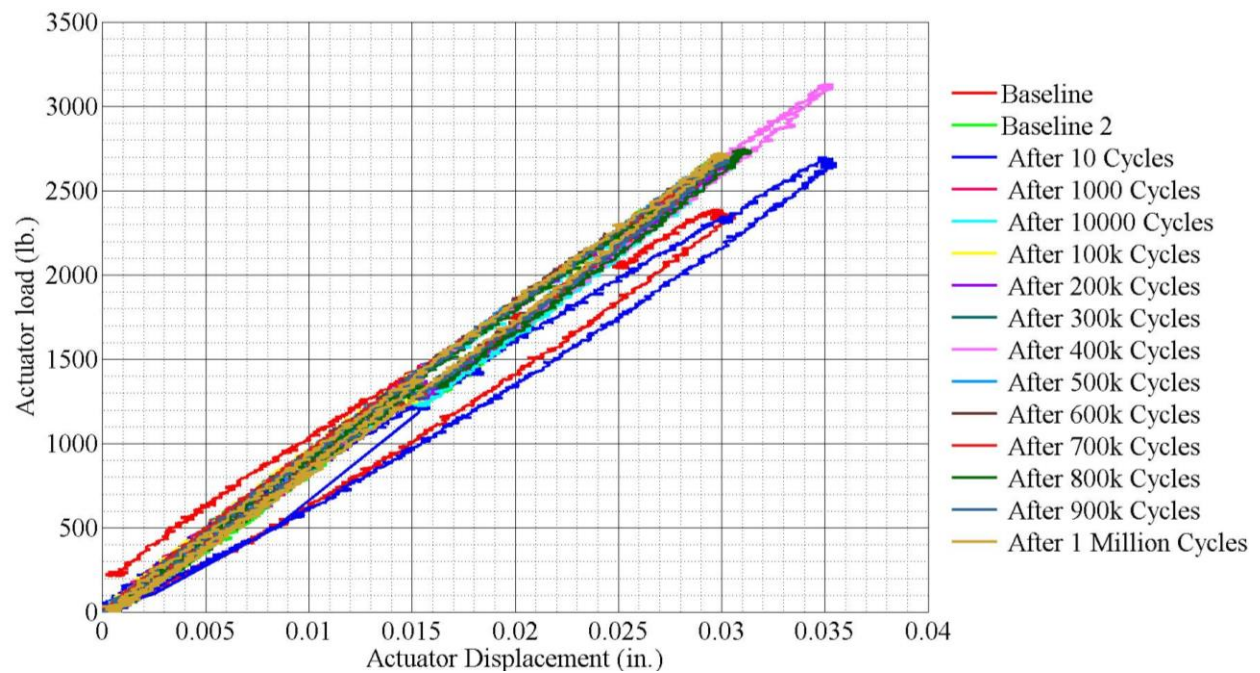
Figure 255: S5 – actuator load vs. actuator displacement.

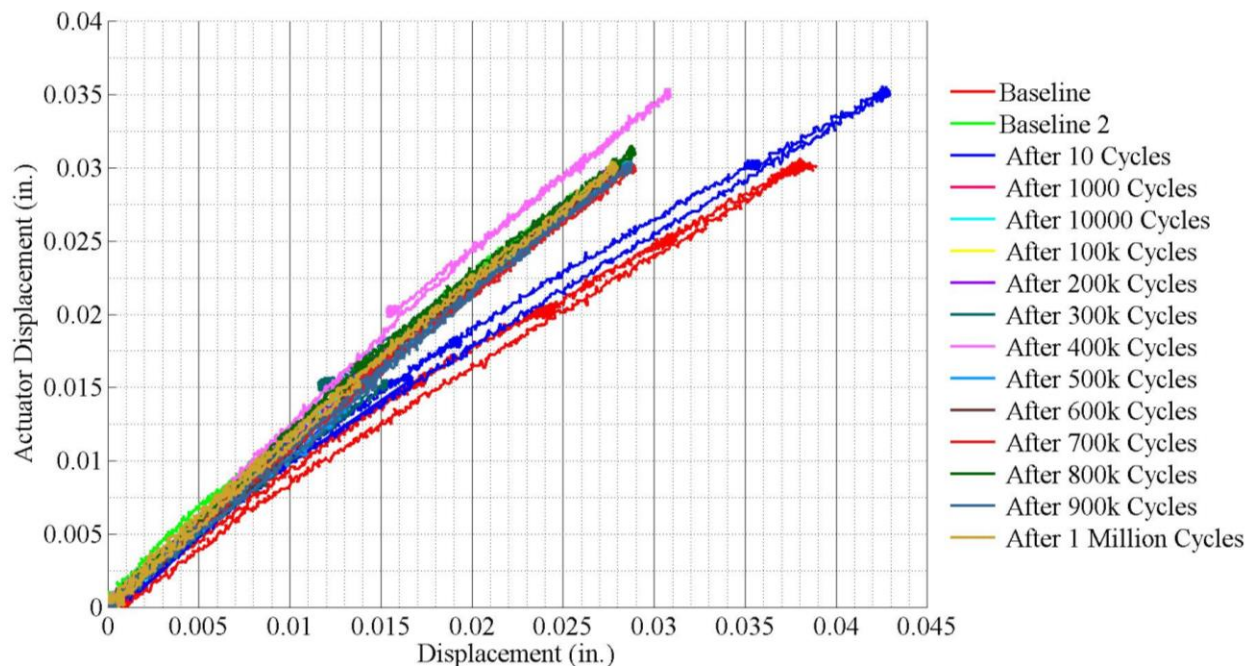
Figure 256: S5 – actual displacements imparted on specimen.
