# New Approach to Connections between Members of Adjacent Box Beam Bridges

Kedar Ram Halbe

Dissertation submitted to the faculty of the Virginia Polytechnic Institute and  
State University in partial fulfillment of the requirements for the degree of

Keywords: Connection details, adjacent box beam bridges, UHPC, VHPC, shear key, diagnostic  
test

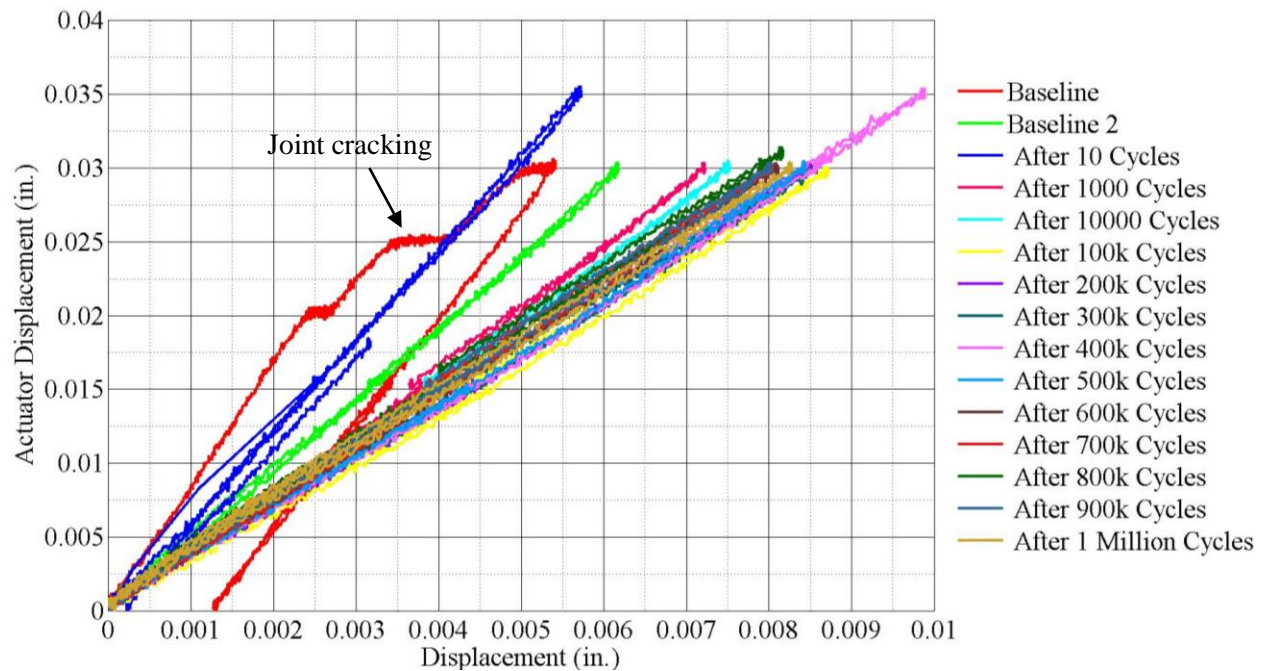
Figure 257: S5 – variation in NE joint displacements during fatigue testing.

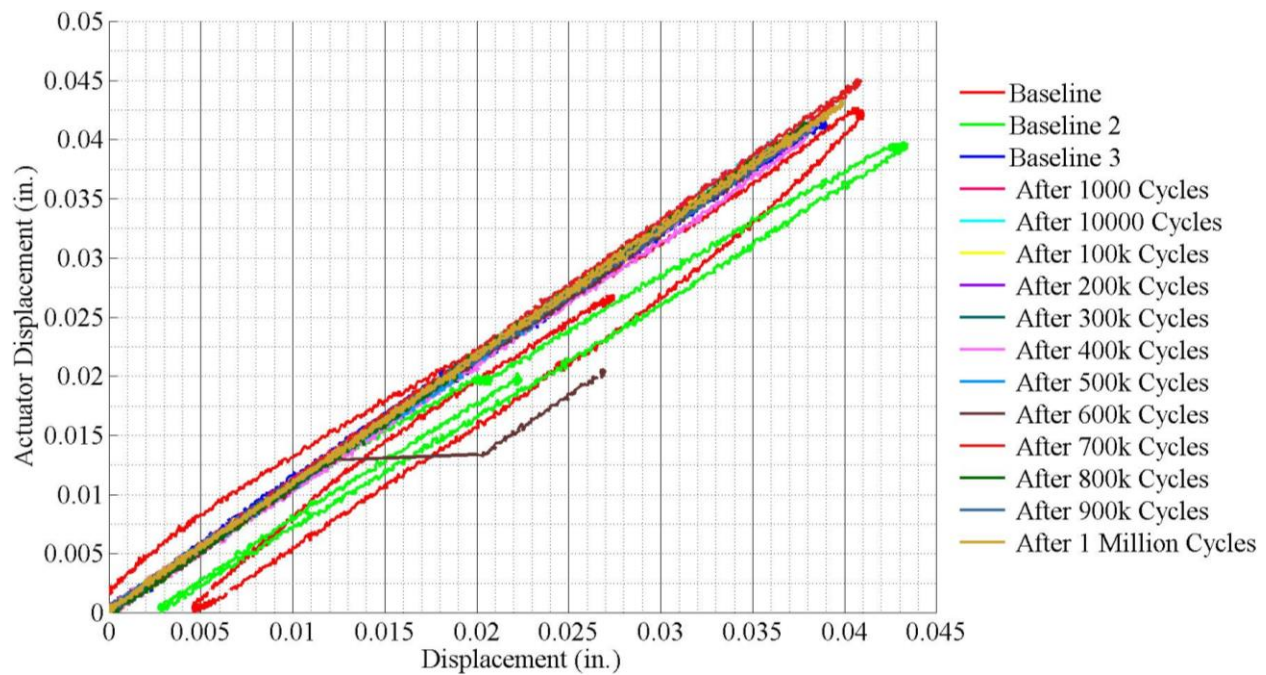
Figure 267: S6 – actual displacements applied to the specimen.

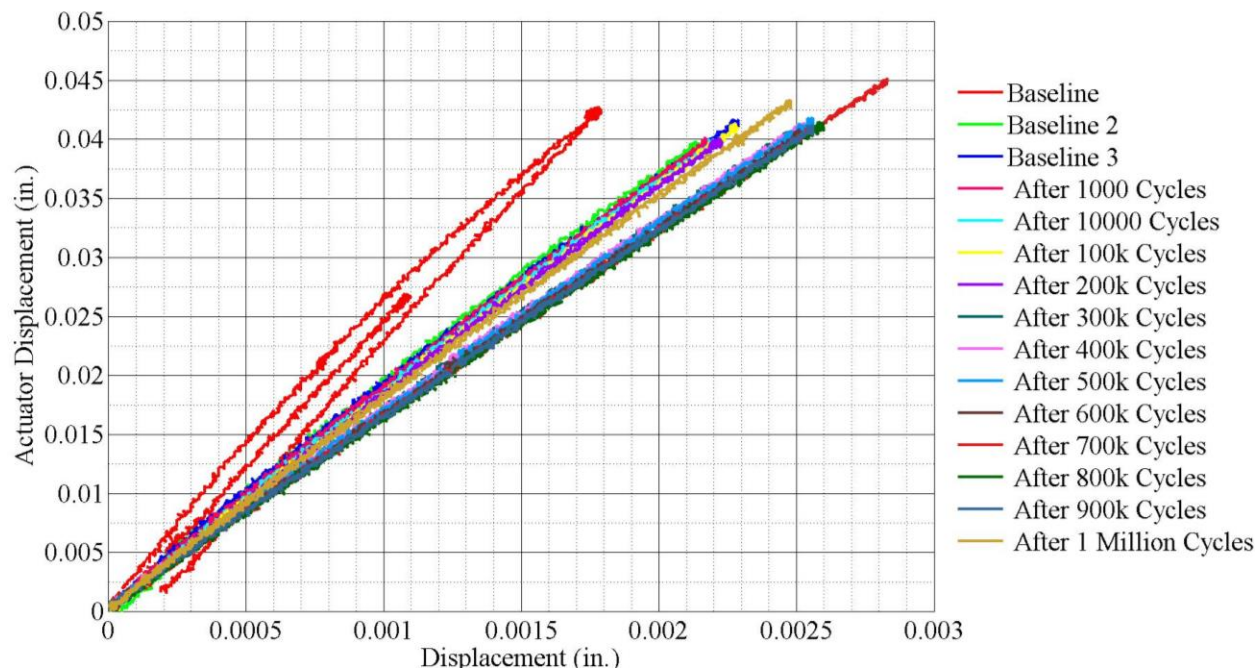
Figure 268: S6 – variation in NE joint displacements during fatigue testing.

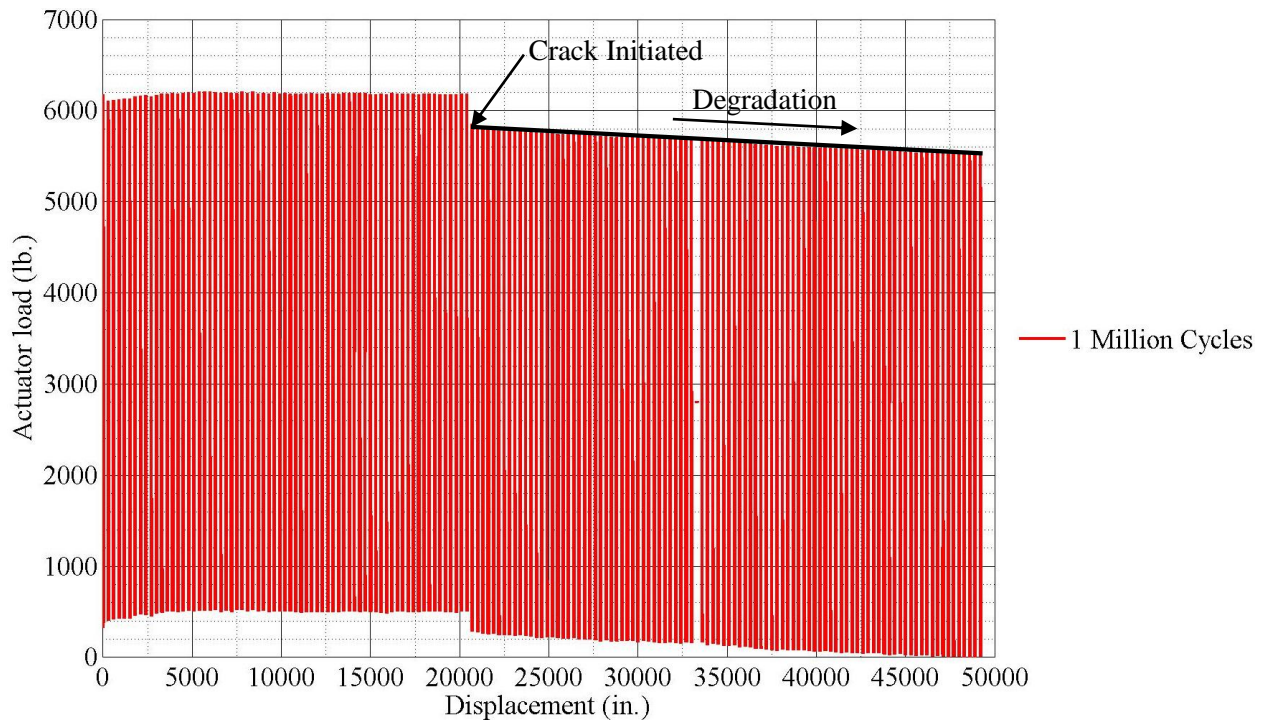
Figure 272: S6 – drop in load after south joint cracking.

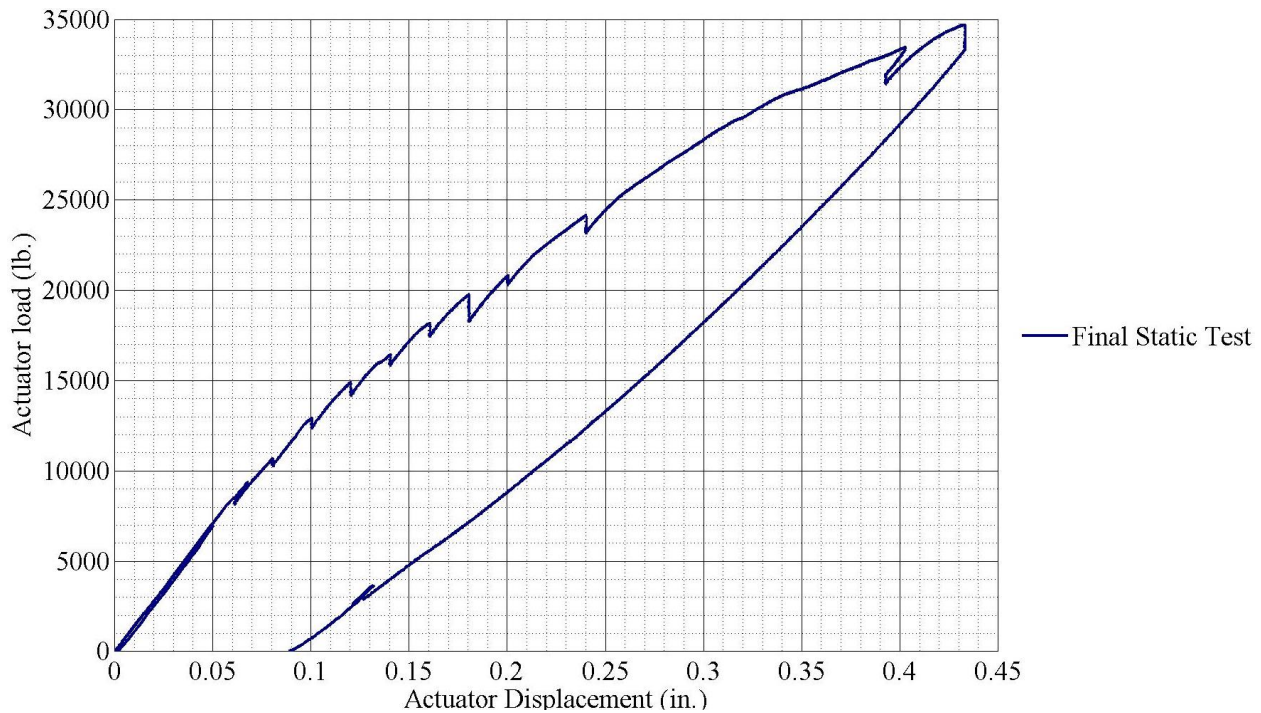
Figure 273: S6 – load vs. displacement, final static test.

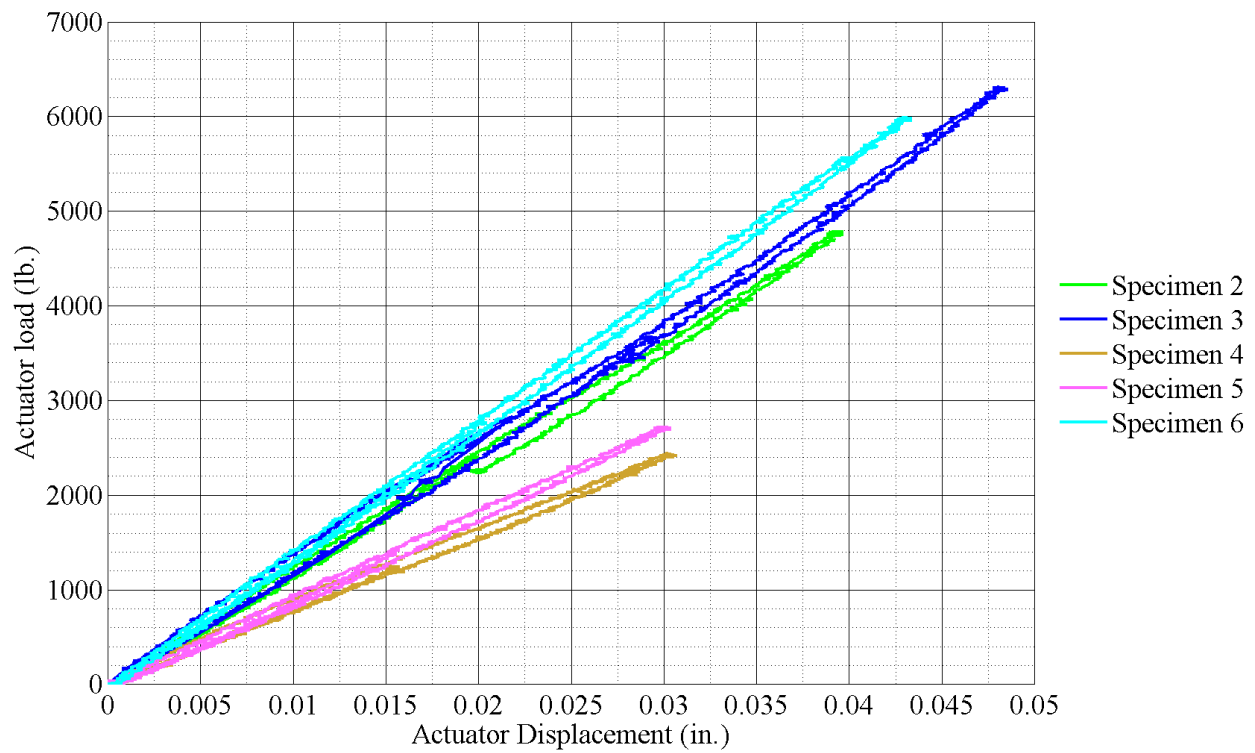
Figure 276: Comparison of actuator displacements for static test after 1 million cycles.

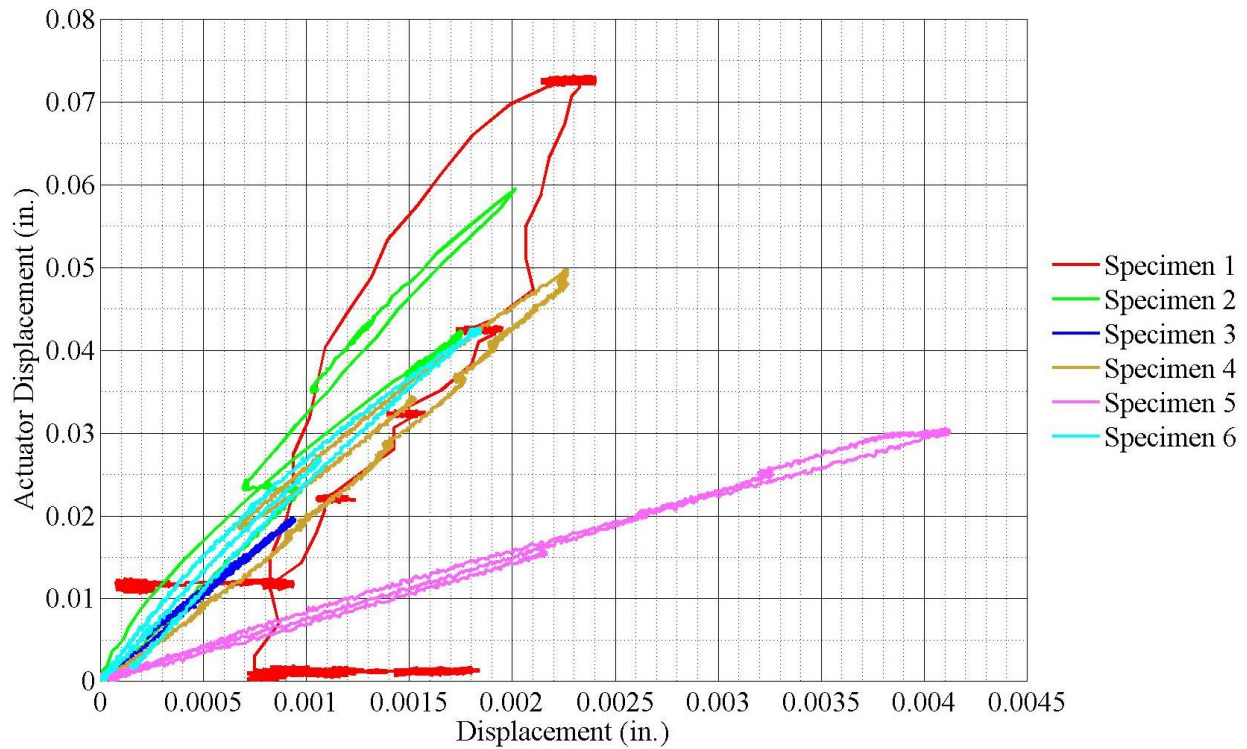
*Figure 278: Comparison of south gap displacements for first baseline static test.*

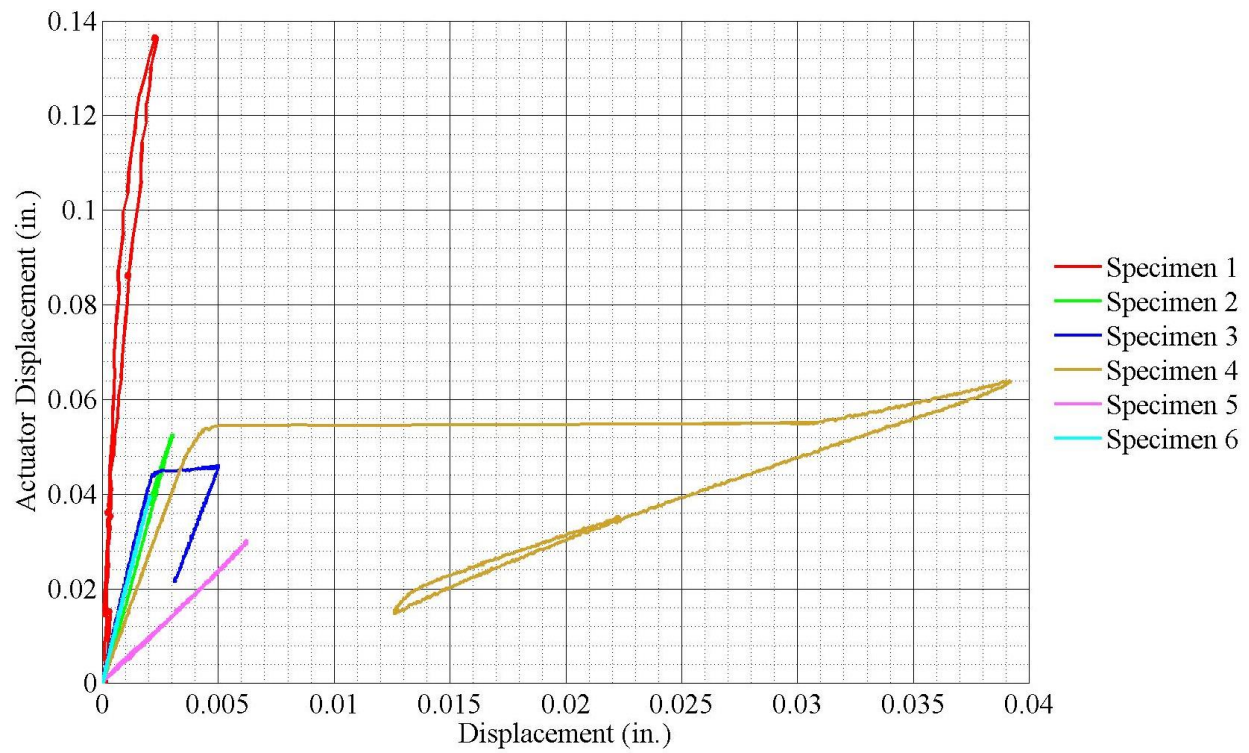
Figure 279: Comparison of north gap displacements for second baseline static test.

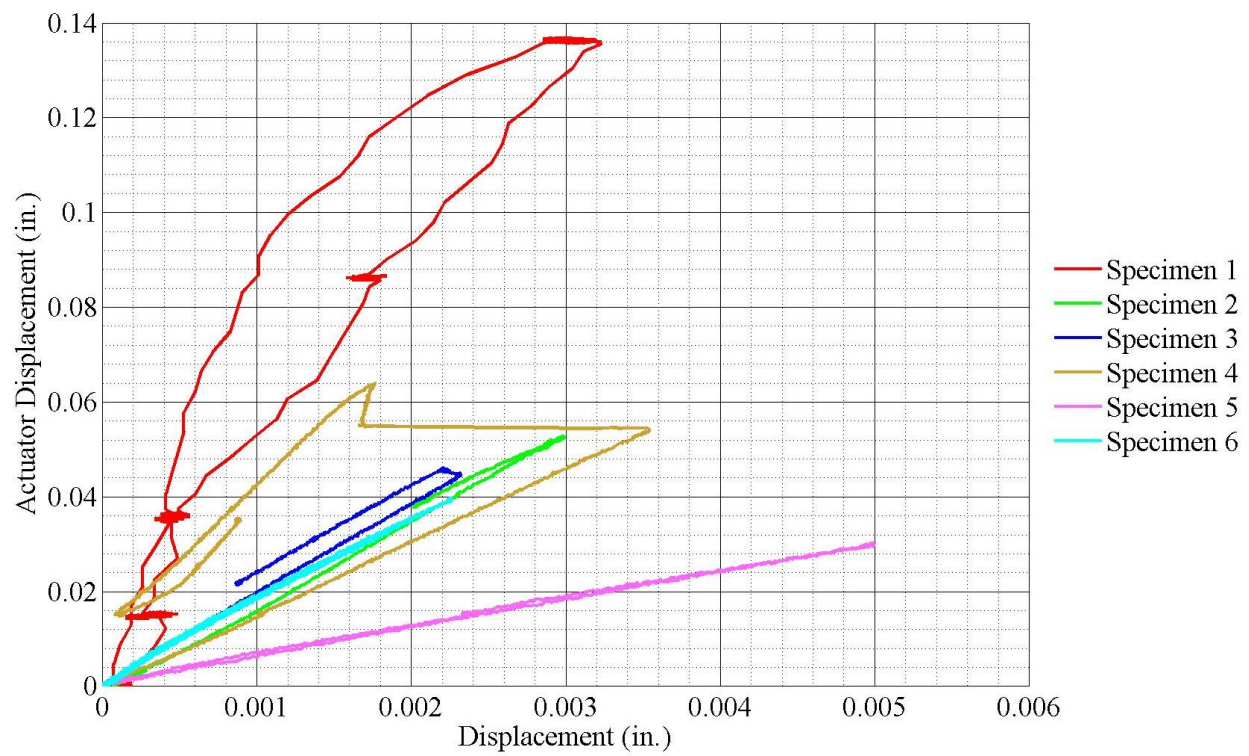
Figure 280: Comparison of south gap displacements for second baseline static test.

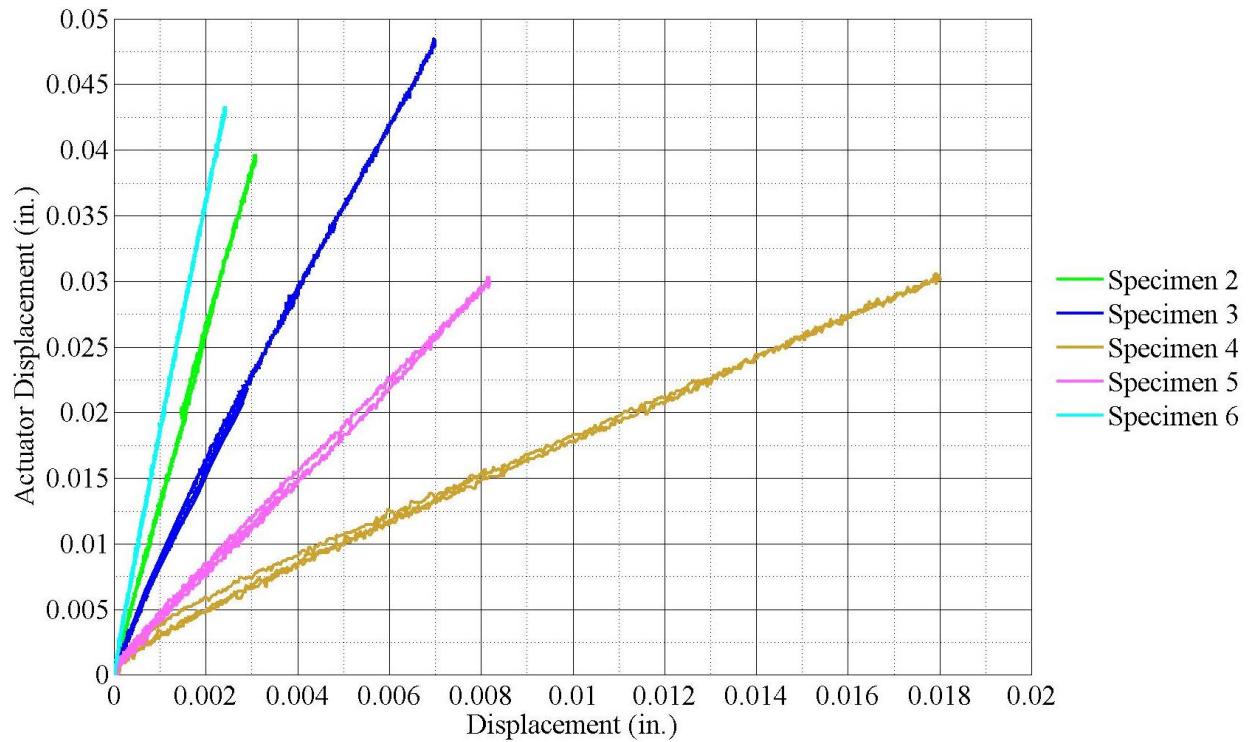
*Figure 281: Comparison of north gap displacements for static test after 1 million cycles.*

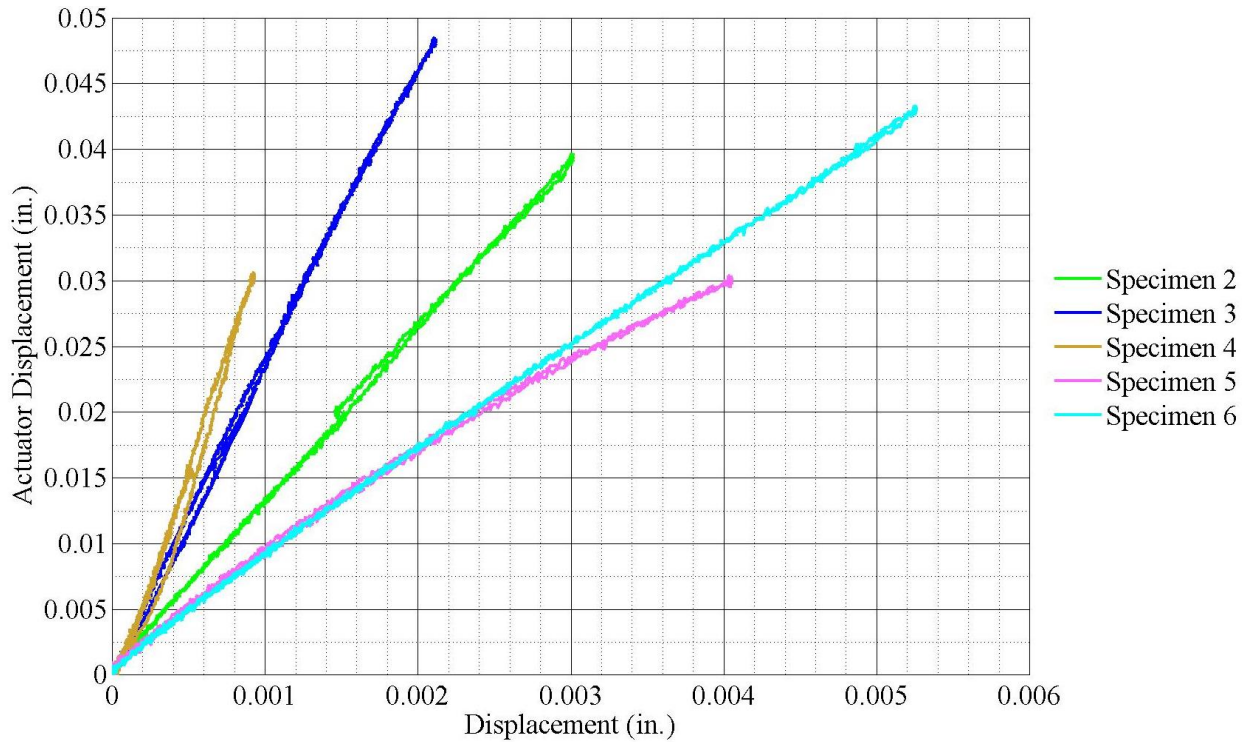
Figure 282: Comparison of south gap displacements for static test after 1 million cycles.

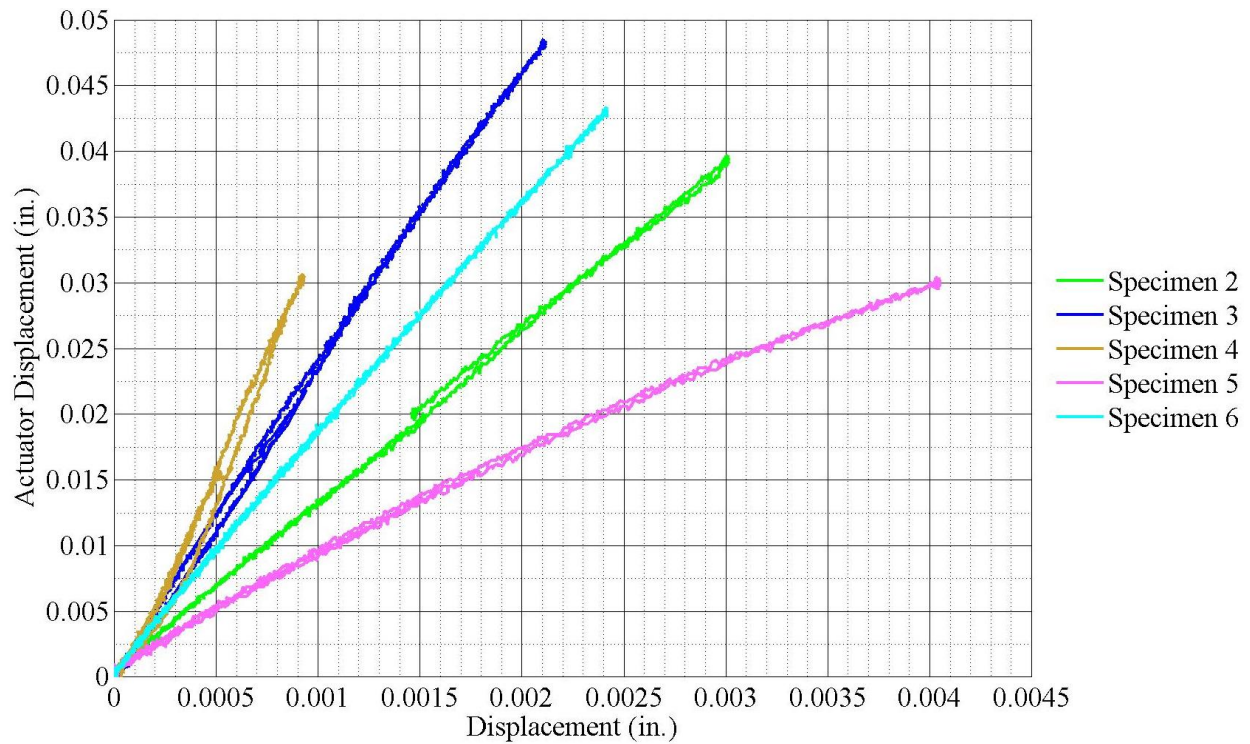
Figure 283: Comparison of minimum gap displacements in all specimens after 1 million cycles.

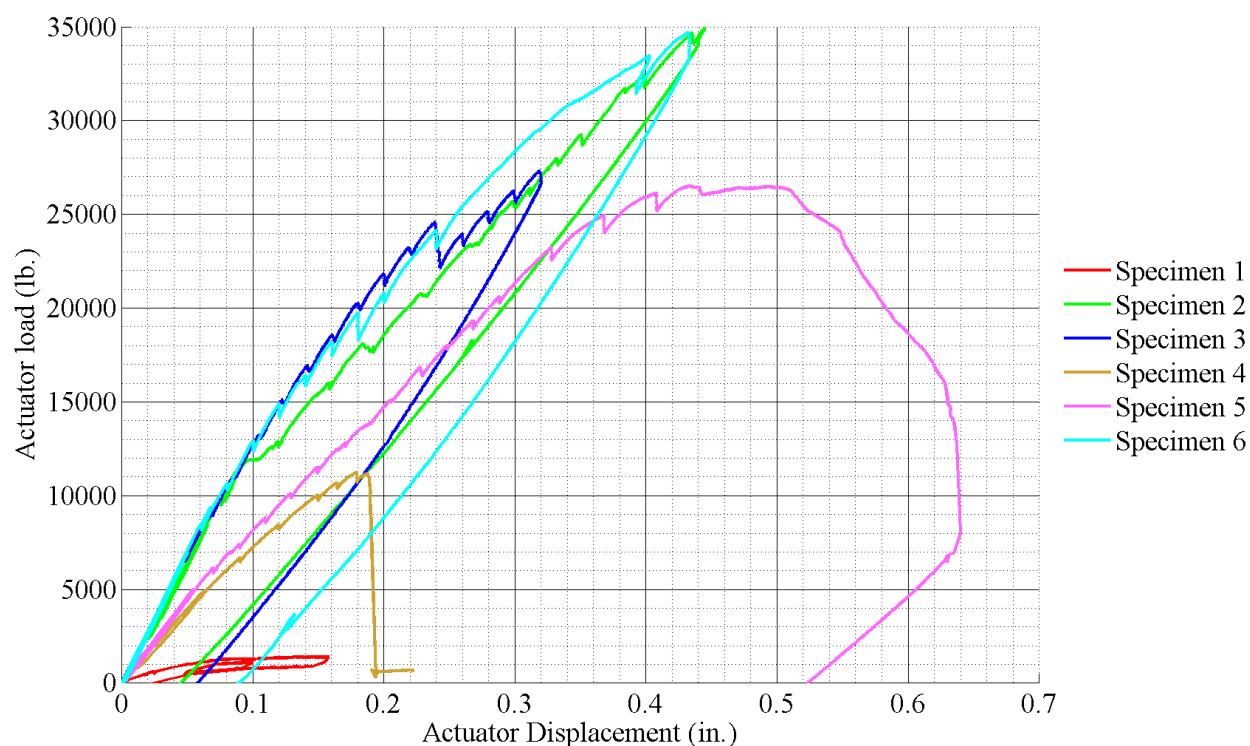
Figure 285: Comparison of load vs. deflection behavior for the ultimate strength test.

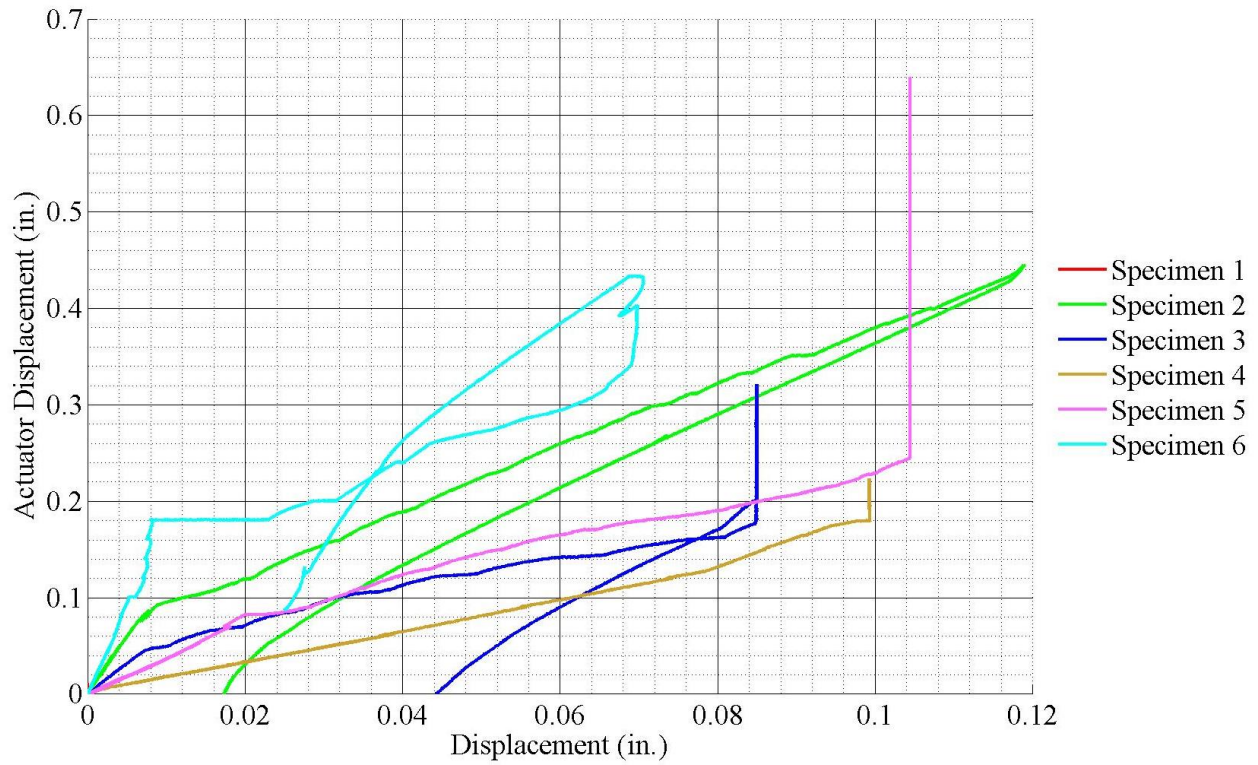
Figure 286: Comparison of north gap displacements for the ultimate strength test.

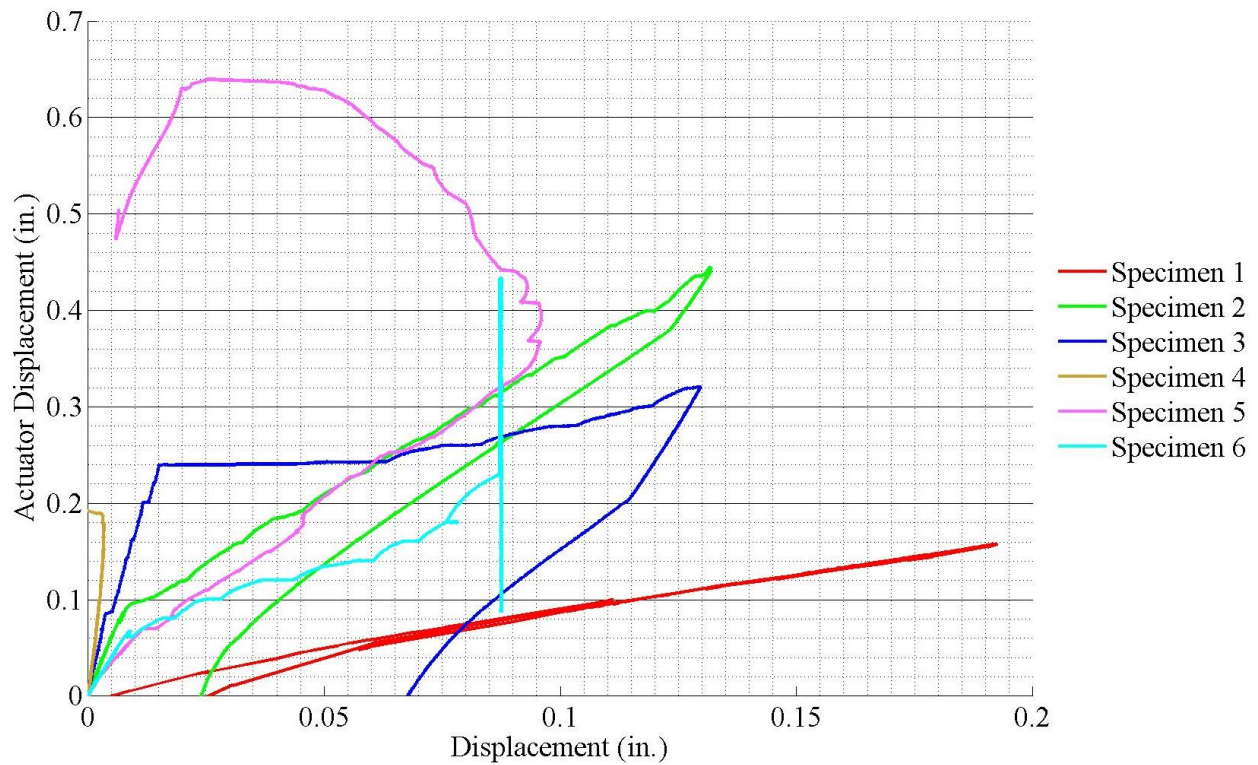
Figure 287: Comparison of south gap displacements for the ultimate strength test.

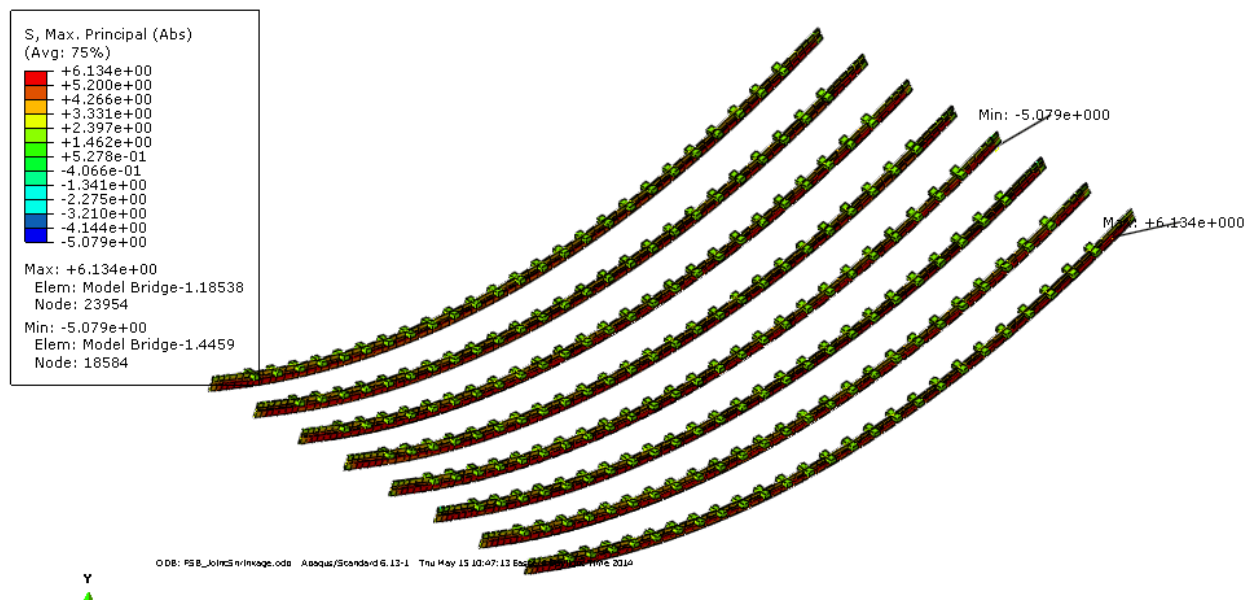
Figure 290: State of stress in joints and spliced connections due to application of ultimate shrinkage strain.

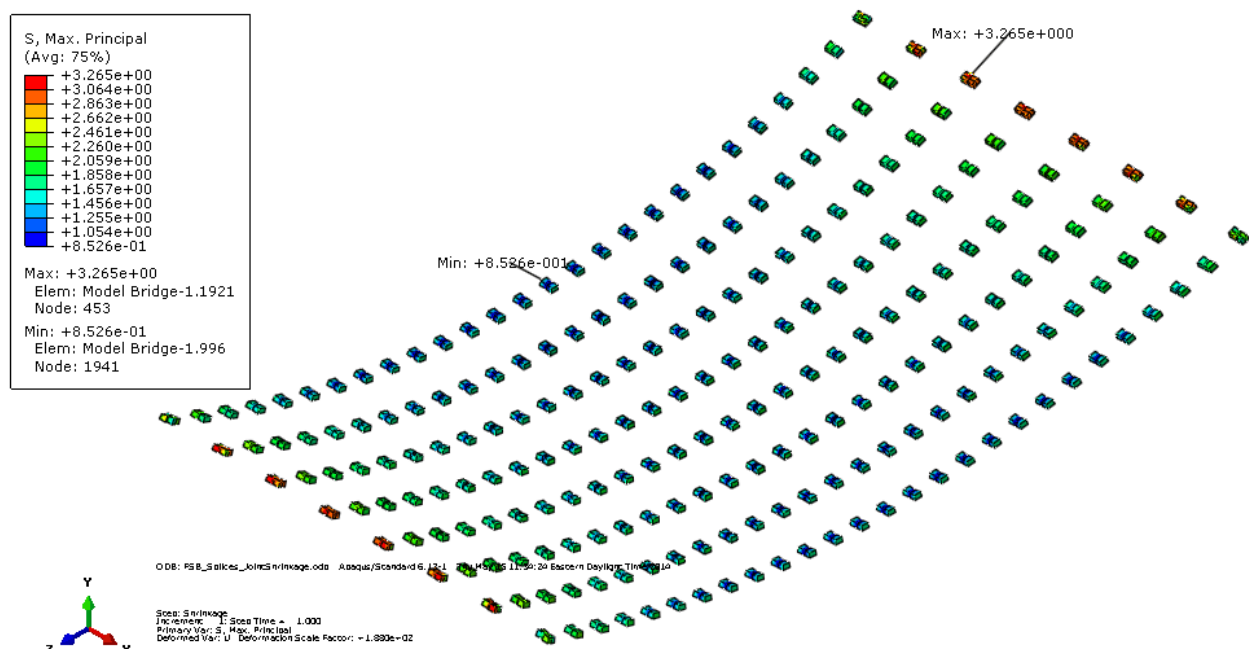
Figure 291: Maximum principal stresses in spliced connections due to application of ultimate shrinkage strain.

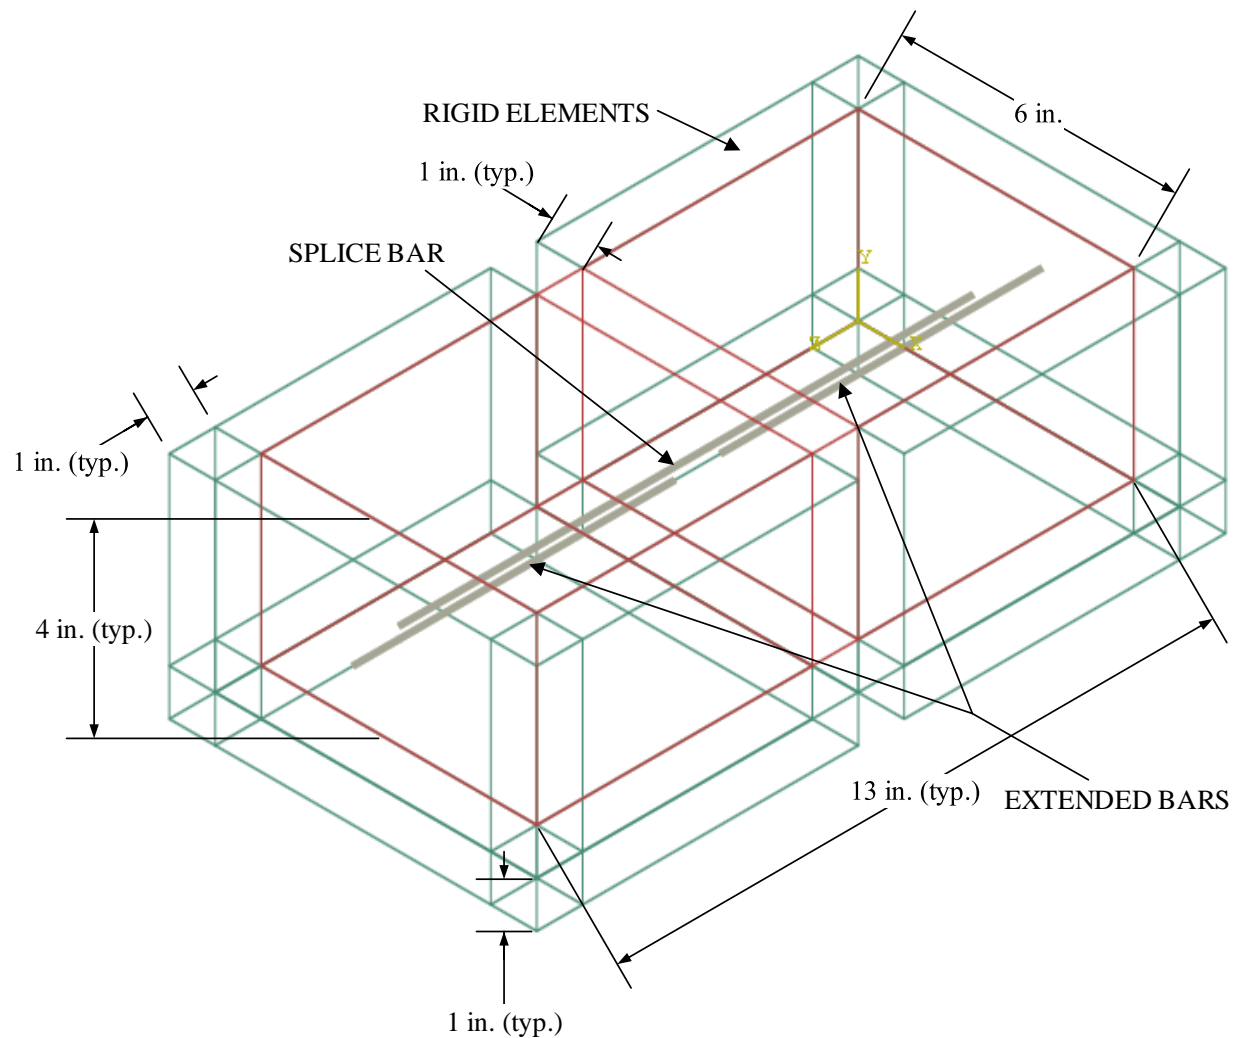
*Figure 292: Details of single splice model.*

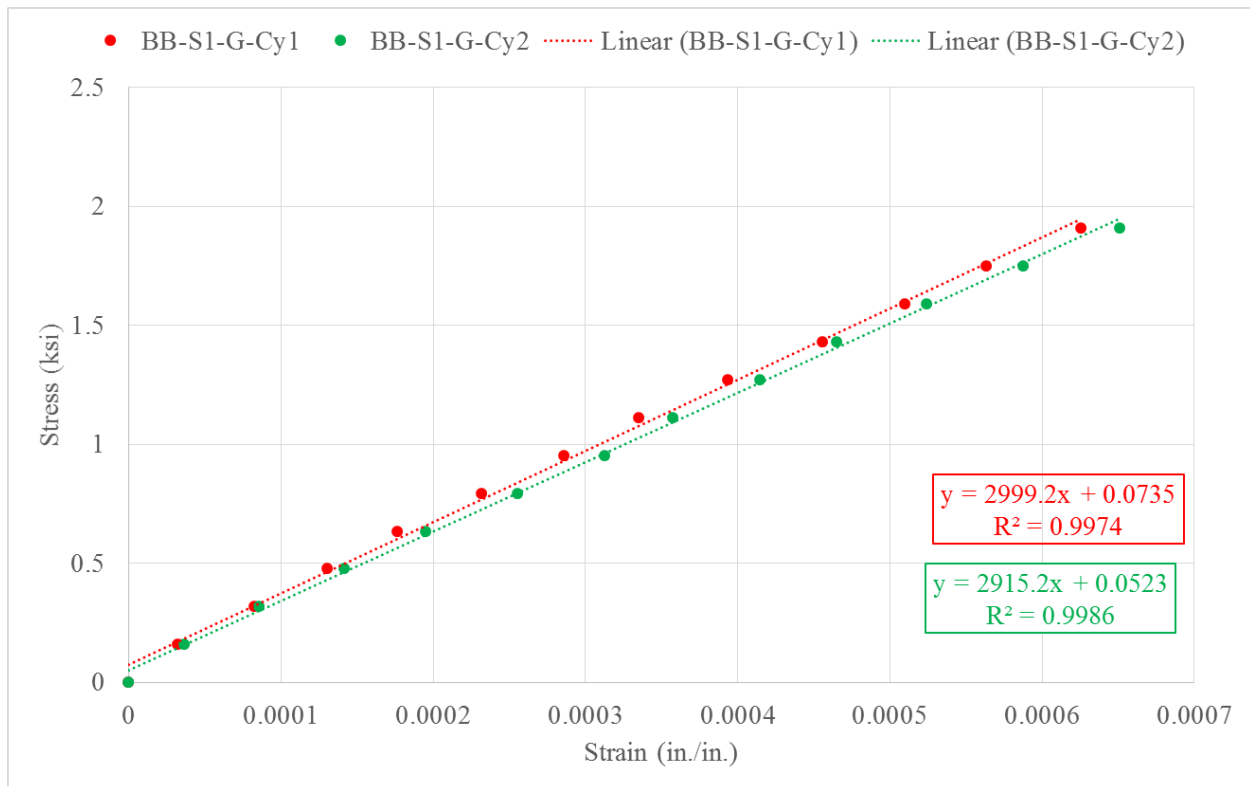
Figure 308: Modulus of elasticity of grout used in Specimen 1 at the start of fatigue test.
