PERFORMANCE OF A BRIDGE DECK WITH GLASS FIBER
REINFORCED POLYMER (GFRP) BARS AS THE TOP MAT OF
REINFORCEMENT

MASTERS OF SCIENCE
In
CIVIL ENGINEERING

December 2004
Blacksburg, Virginia

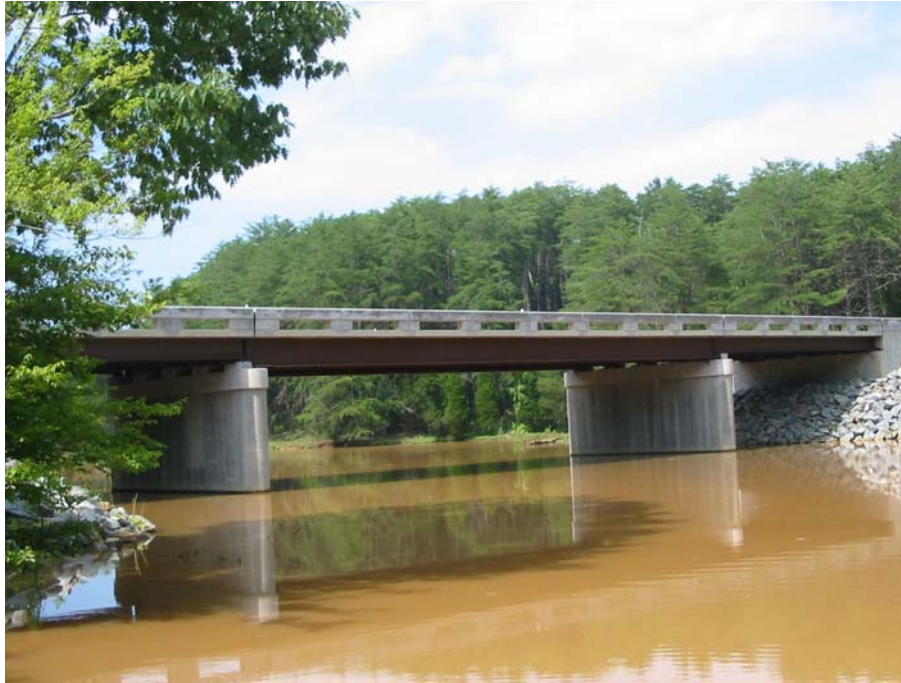
Figure 1.1: Route 668 Bridge Over Gills Creek

To investigate the effectiveness and durability of GFRP bars as reinforcement for concrete decks, the Virginia Department of Transportation (VDOT) and the Virginia Transportation Research Council (VTRC) with funding provided through the FHWA’s Innovative Bridge Research and Construction (IBRC) program worked with Virginia Tech to construct the Route 668 Bridge over Gills Creek located in Franklin County, Virginia. The bridge was completed in July 2003 and is pictured in Figure 1.1. The deck of one span is reinforced with GFRP bars as the top mat and steel rebar as bottom mat.

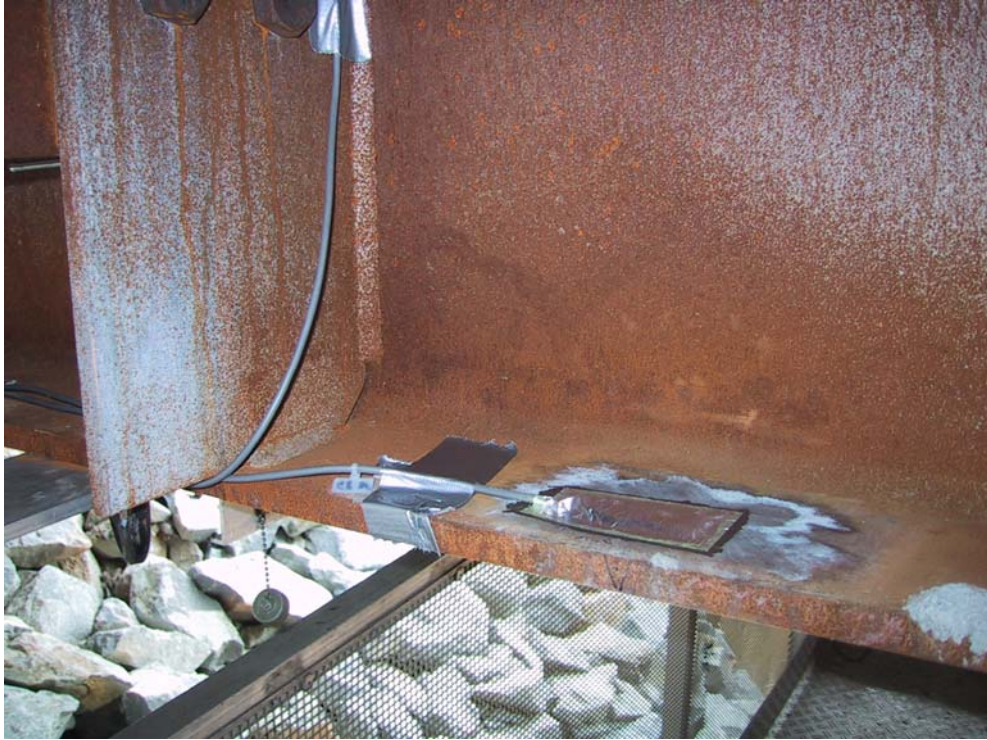
Figure 3.4: ER Strain Gauge on Steel Girder

Each steel girder of Span A and C had strain gauges applied to the top of the bottom flange at midspan. An ER gauge is pictured in Figure 3.4. These gauges were the same type of gauge installed in the deck on the epoxy-coated steel reinforcing bars. The strains recorded by the strain gauges were used to calculate the girder distribution factors and the dynamic load allowances. ER strain gauges were not applied on the top flange as in the previous test because the data collected from the top flanges did not provide very useful information.

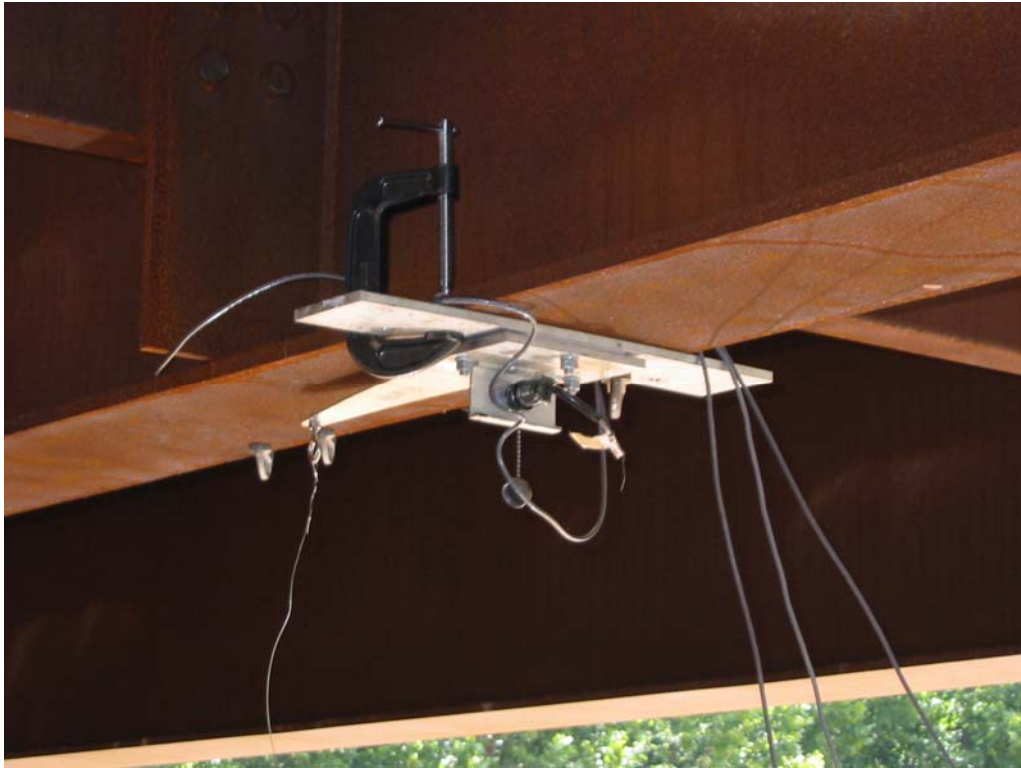
Figure 3.5: Deflectometer Clamped to Steel Girder

testing. The pre-deflection caused a strain in the top of the plate. When the truck ran over the bridge causing the girders to deflect, the decrease in strain was measured and converted to a corresponding deflection. The deflectometers are connected to the mobile data acquisition system using shop-installed plugs. During each test, the deflection of the girder was recorded.

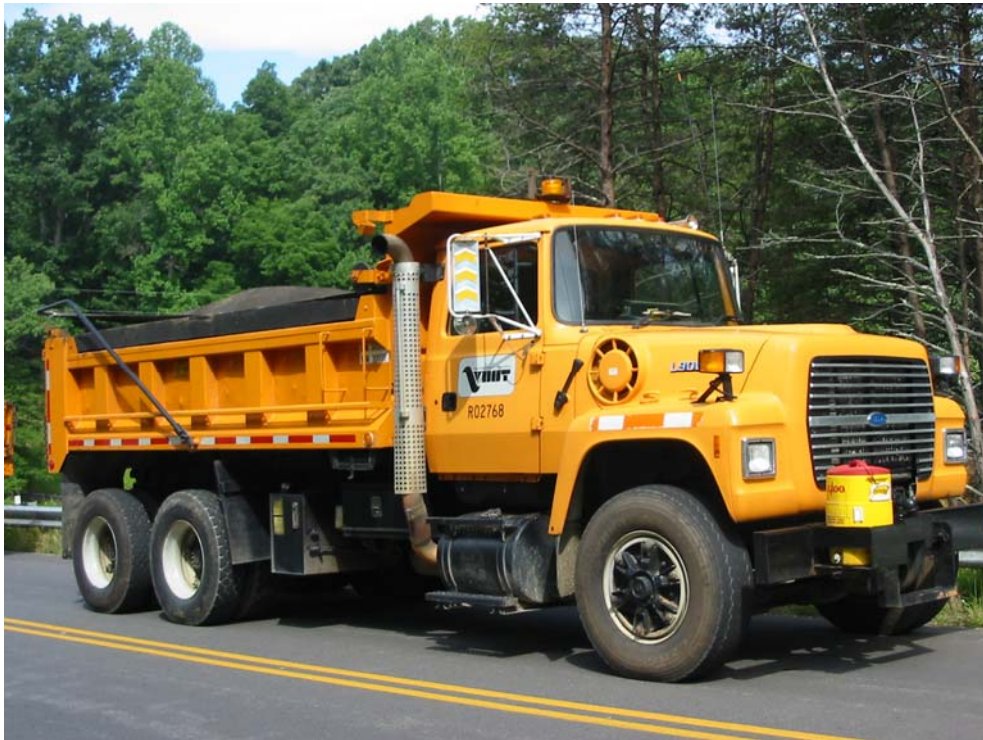
Figure 3.7: VDOT Dump Truck used for Live Load Testing

A dump truck from VDOT was used for the live load testing of the bridge deck. It was the same truck used for the live load testing of the bridge one year prior. The truck was loaded with stone at a quarry. The front axle of the truck weighed 13.52 kips and the rear axle weighed 36.32 kips. The rear axle consisted of two axles, so the weight was assumed to be split between the two. The front wheels measured 6 ft-9 in. center-to-center and 7 ft-10 in. out-to-out. The rear wheels measured 6 ft center-to-center and 8 ft-4 in. out-to-out. The distance between the first and second axle was 14 ft-10 in. and between the second and third axle was 4 ft-5 in. The dump truck is pictured in Figure 3.7.

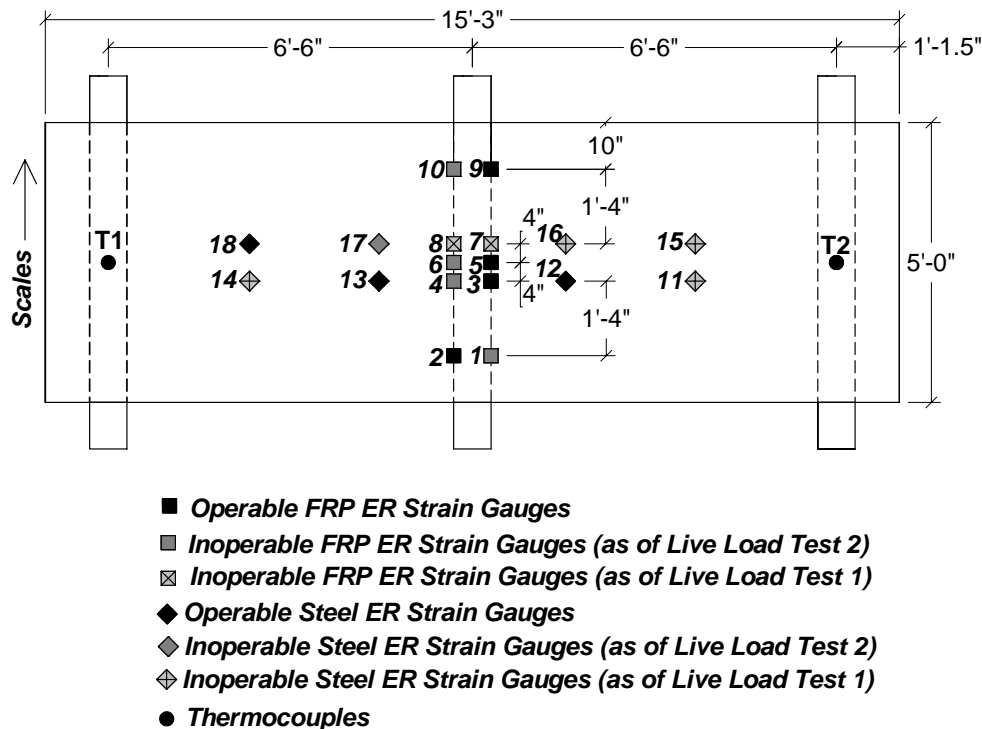
Figure 3.8: Weigh Station Slab Instrumentation Plan

The deck was instrumented with ER strain gauges and thermocouples. The layout of the instrumentation can be seen in Figure 3.8. All of the gauges were applied to transverse bars. The lead wires of all the gauges and the thermocouple wires run through a pipe into a hole that is easily accessible for testing. All of the gauges and thermocouples were monitored with a permanent datalogger, and the ER strain gauges were used for the live load testing.

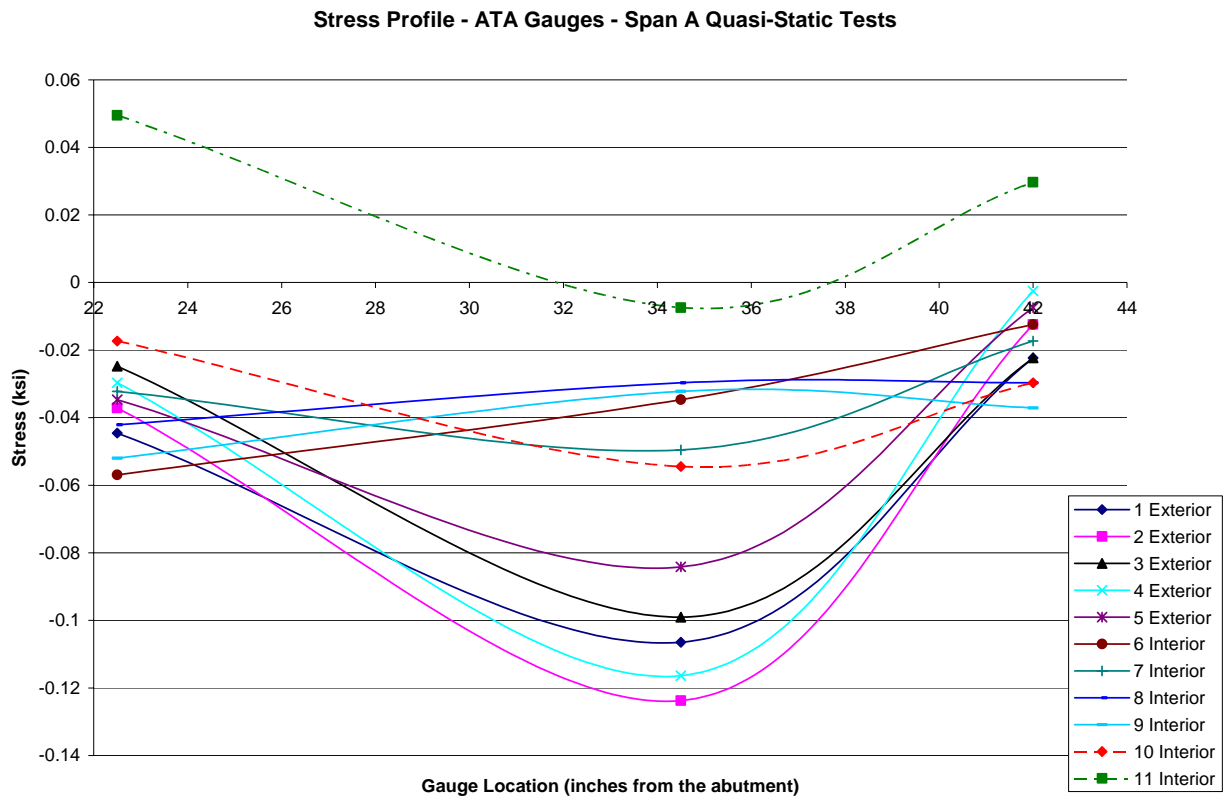
Figure 4.1: Stress Profile for ATA Gauges Under Quasi-static Loading

Figure 4.1 is the stress profile of the ATA gauges from the quasi-static tests. The ATA gauges are located over the first interior girder at the abutment of Span A. The stresses ranged from -124 psi to 50 psi. The maximum tensile stress of 50 psi was well below the allowable tensile stress of 13.9 ksi. Test 11 was the only test showing the bars going into tension. Besides test 11, the stresses were all compressive ranging from -124 to -2.5 psi.

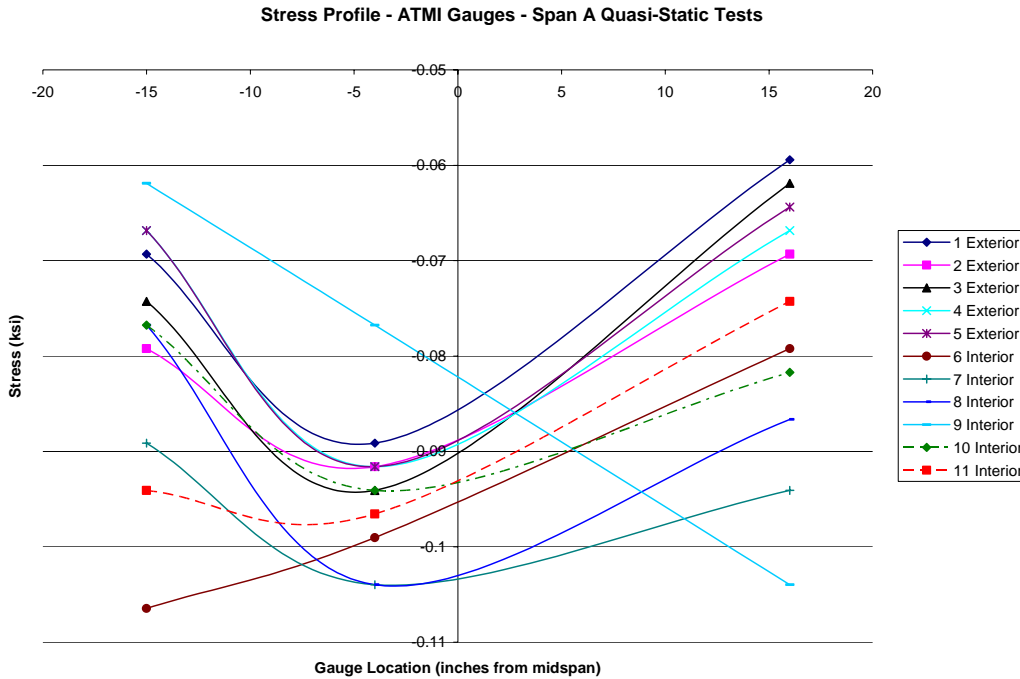
Figure 4.3: Stress Profile for ATMI Gauges Under Quasi-static Loading

The stress profiles for the ATMI and ATME gauges from the quasi-static tests are shown in Figure 4.3 and Figure 4.5, respectively. The ATMI gauges are over girder 4 at midspan, and the ATME gauges are over girder 5 at midspan. The comparison between the quasi-static stress profiles of a few months after the deck was poured and one year later for the ATMI and ATME gauges are shown in Figure 4.4 and Figure 4.6, respectively.

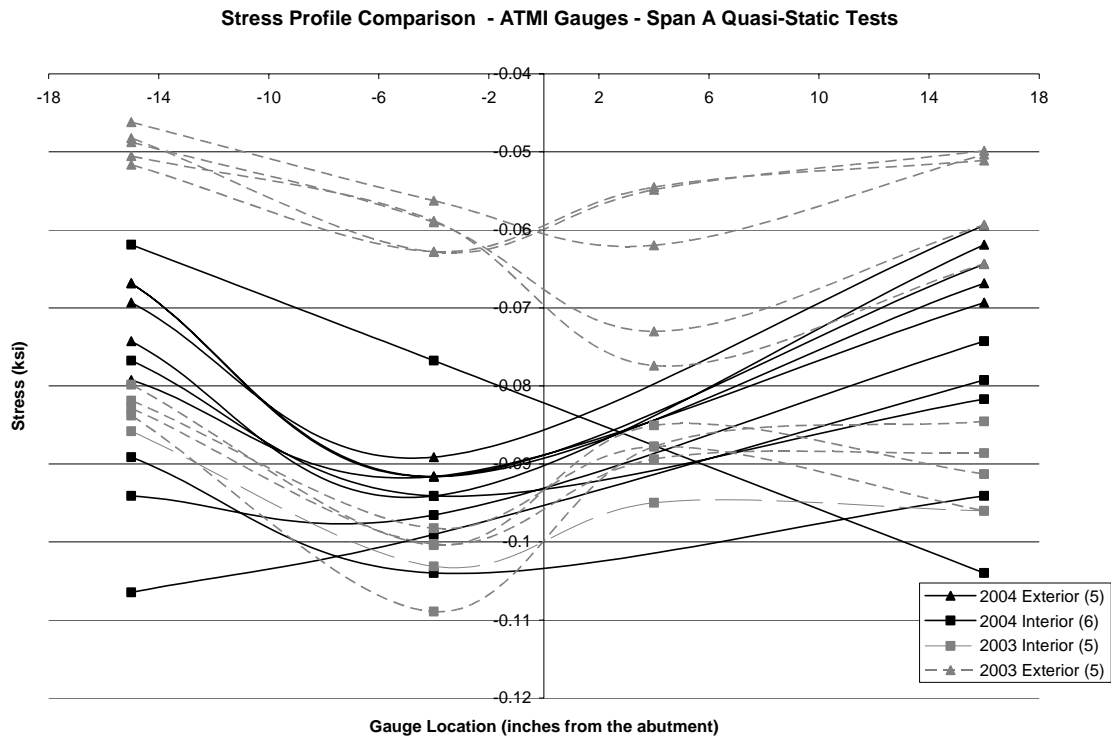
Figure 4.4: Comparison of Stress Profiles for ATMI Gauges Under Quasi-static Loading

In the 2004 live load testing, the ATMI gauges had very similar responses to the interior and exterior orientations. The stresses ranged from -106 psi to -62 psi for the interior orientation, and -95 psi to -60 psi for the exterior orientation. In general, the interior orientation created larger stresses in the GFRP bars. This makes sense because the ATMI gauges are located over the first interior girder. Essentially, when the truck load is closer the stresses are higher. It is interesting that for both orientations, the stress profile has a parabolic trend, with the higher stresses at the edge bars.

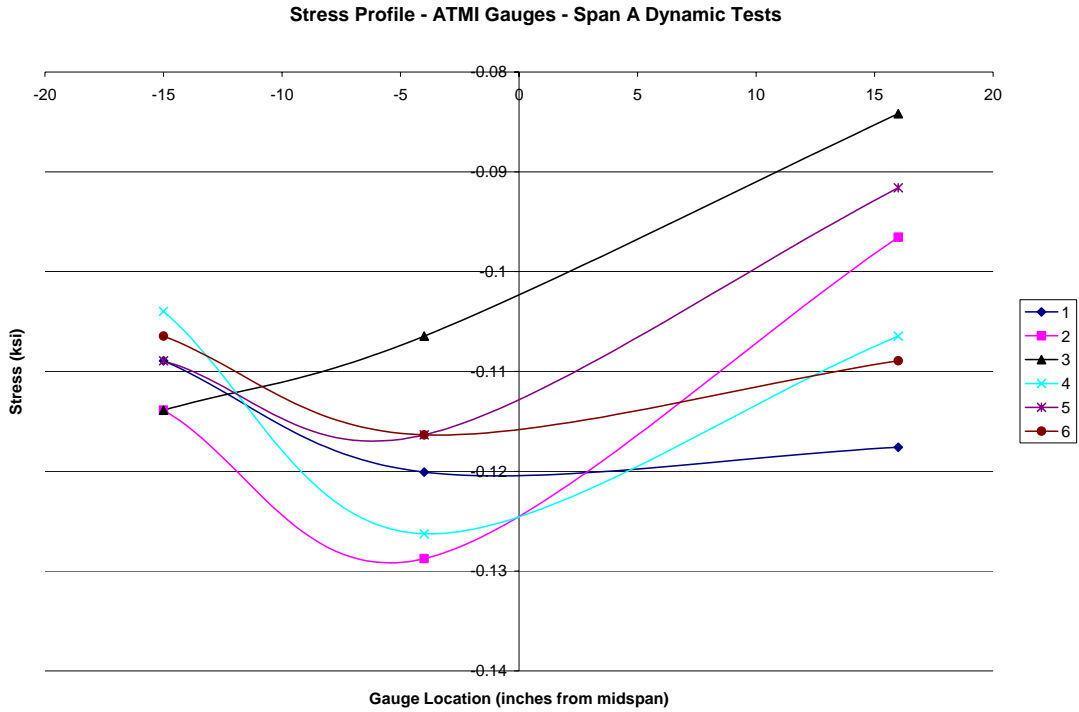
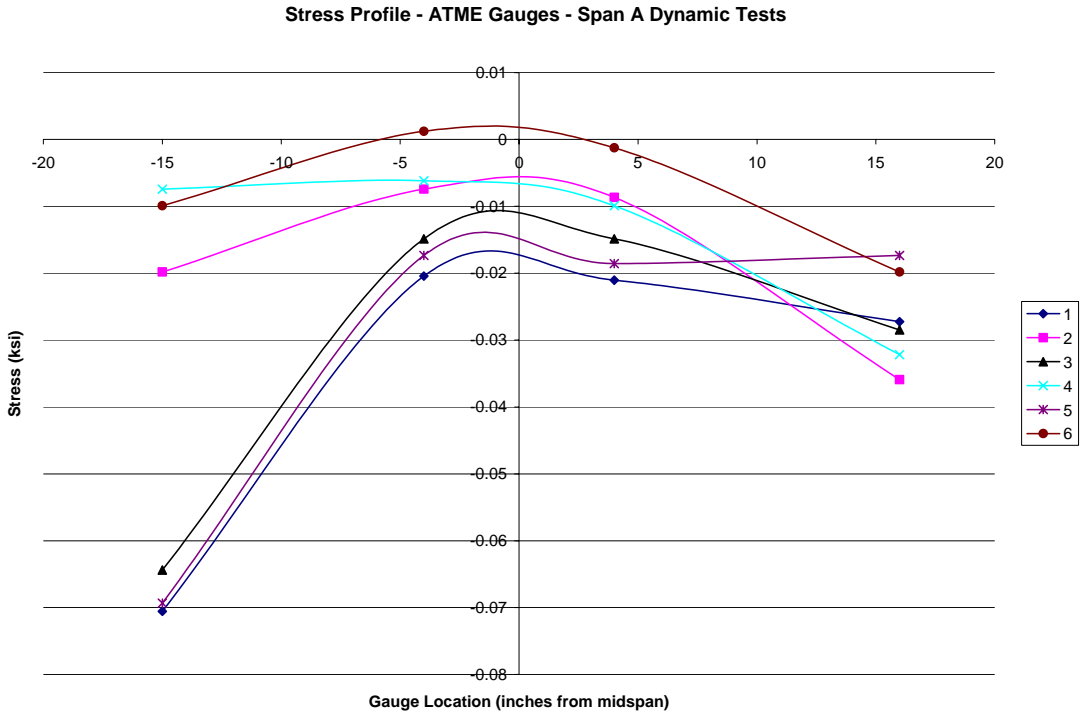
Figure 4.7, Figure 4.9, and Figure 4.11 show the stress profiles for the ATA, ATMI, and ATME gauges. The comparison between the dynamic stress profiles of a few months after the deck was poured and one year later for the ATA, ATMI, and ATME gauges are shown in Figure 4.8, Figure 4.10 and Figure 4.12, respectively. All of the gauges had higher compressive stress in 2004 than in 2003. In 2004, the ATA gauges were mostly in tension for the dynamic loading. When the truck is traveling at fast speed, the bearings must provide more resistance causing a more local response. The 2004 ATMI gauges were all in compression. In 2003, some of the ATME gauges were in tension and some in compression. The 2004 dynamic live load tests resulted in all of the ATME gauges in compression.

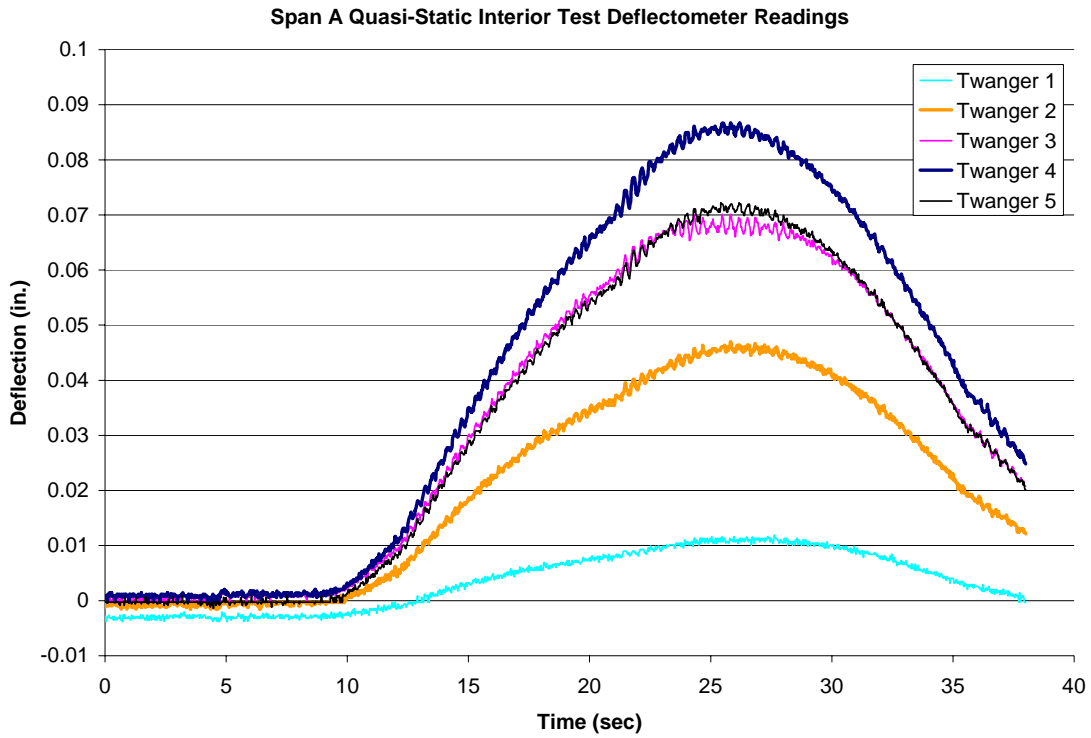
In order to determine the girder distribution factors, the girder responses must first be determined. To get an idea of the accuracy of the instrumentation, example plots of the readings from the deflectometers, ER strain gauges, and WIM gauges on Span A are shown in Figure 4.13 through Figure 4.15. In Span A, the accuracy of the deflectometers was approximately ± 0.001 in. The ER strain gauges had an accuracy of approximately $\pm 8 \mu\epsilon$, and the WIM gauges had an accuracy of approximately $\pm 3 \mu\epsilon$. For Span C, the deflectometers had an accuracy of approximately ± 0.001 in. The ER strain gauges had an accuracy of approximately $\pm 3 \mu\epsilon$, and the WIM gauges had an accuracy of approximately $\pm 0.5 \mu\epsilon$. Note that the ER strain gauge on girder 1 did not work during the live load testing. Also, the WIM gauge on girder 2 was not reading accurate results, and a WIM gauge was not installed on girder 6.

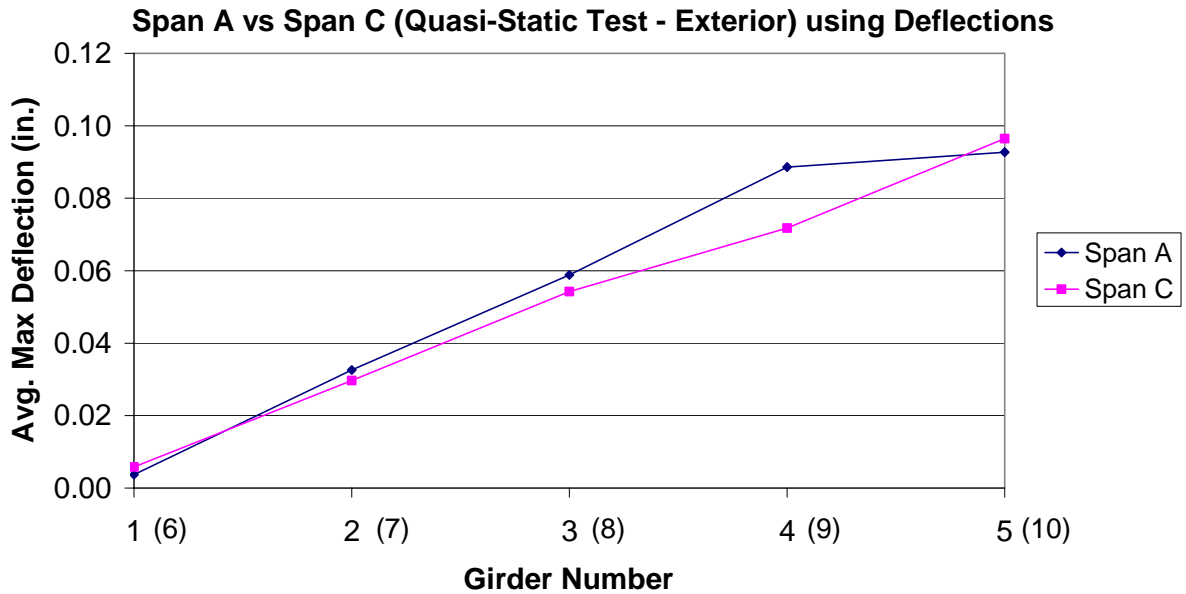
The average maximum deflections for Span A and Span C were compared for each truck orientation in Figure 4.16 through Figure 4.18. The girder deflections of Span A were higher than of Span C for all the truck orientations. The biggest deflection difference was from the dynamic live load tests. Span A and Span C also followed different trends. When the truck is traveling over the first interior girder (girders 4 and 9), it was expected that the girder with the highest deflection would be the girder under the truck. This was true for the interior orientation tests for Span A but not for Span C in both the dynamic and quasi-static tests. For the exterior orientation, both Spans A and C had the largest maximum deflection at the exterior girder under the truck location (girders 5 and 10).

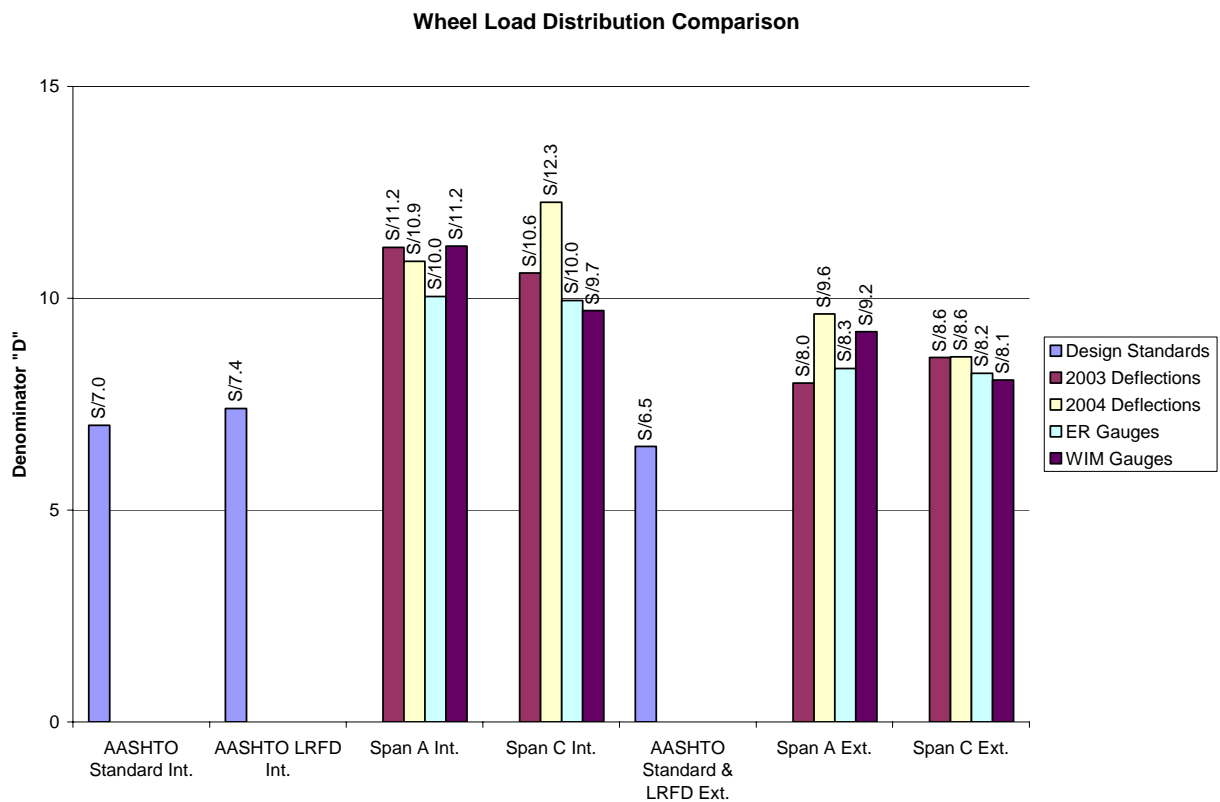
Figure 4.25: Distribution Factor Comparison

The process of determining the GDF's and the "D" factors was also carried out using the strains recorded by the ER gauges and the WIM gauges. Figure 4.25 shows a graphical representation of the "D" factor for both the 2003 and 2004 live load testing. For the interior configuration, the quasi-static and dynamic "D" values were averaged together to get a combined average as shown in Table 4.7 and Table 4.8. The AASHTO Standard Specification Interior distribution factor of S/7.0, AASHTO LRFD Interior factor of S/7.4, and AASHTO Exterior distribution factor of S/6.5 for one lane loaded are also included in Figure 4.25 for comparison to the recorded results. For ease of comparison, the AASHTO LRFD distribution factor was converted from a fraction of a lane load to a wheel line. The calculations of the AASHTO LRFD distribution factors and the intermediate results for the ER strain gauges and WIM gauges are in Appendix A. Please note that a larger D value corresponds to a smaller GDF.

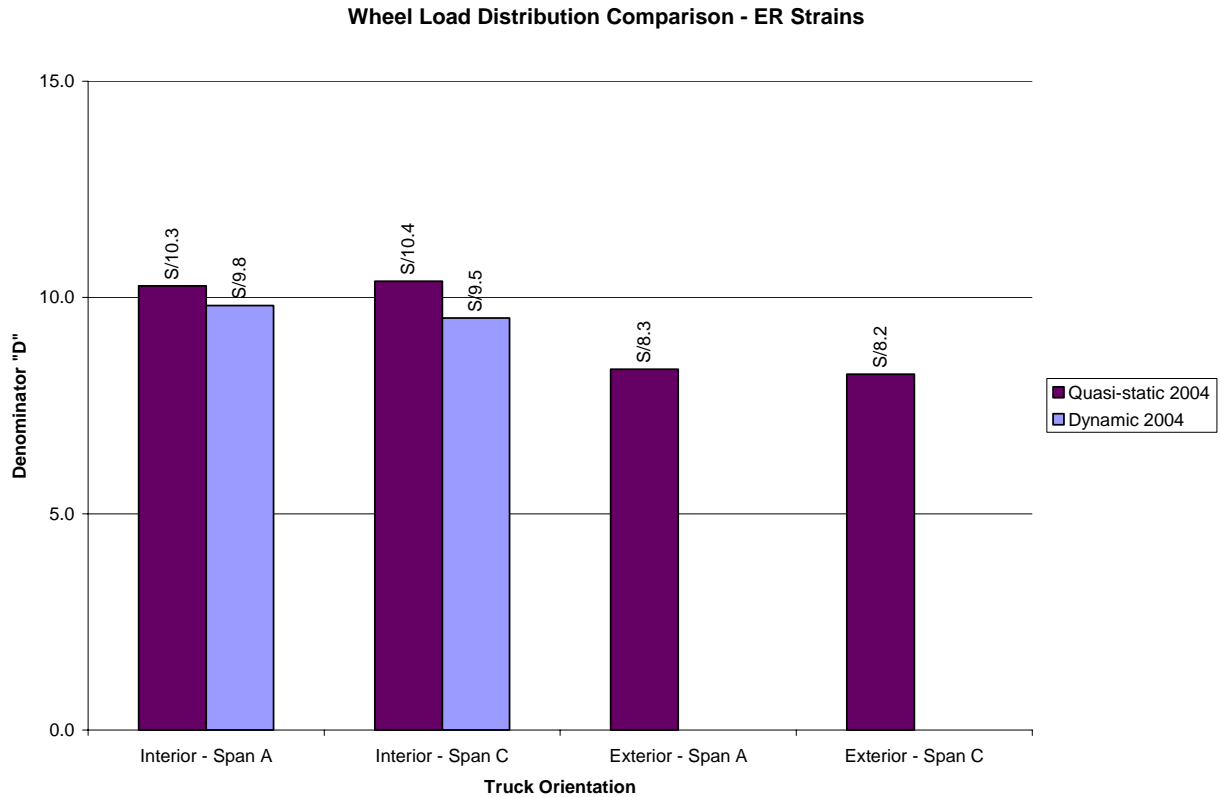
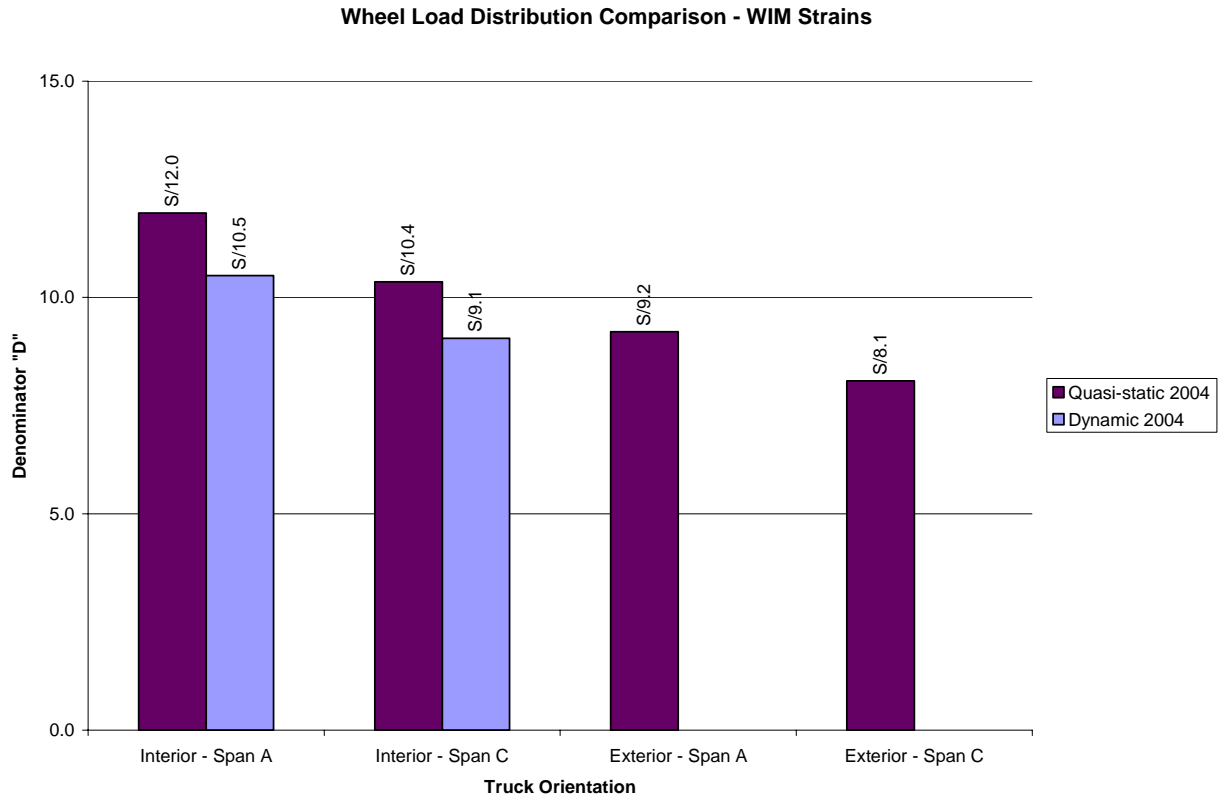
Comparisons between the distribution factors of the two spans were also made using the information obtained from the ER strain gauges and the WIM gauges. Only data from the live load testing in 2004 was used since only three girders were equipped with ER strain gauges and WIM gauges in 2003. The average distribution factors are displayed in Figure 4.27 and Figure 4.28. The average distribution factors for the interior orientation determined using the ER strains for quasi-static and dynamic loading are similar with S/10.3 and S/9.8 for Span A and S/10.4 and S/9.5 for Span C. The exterior orientation resulted in nearly identical average GDF's for Span A and Span C with S/8.3 and S/8.2, respectively.

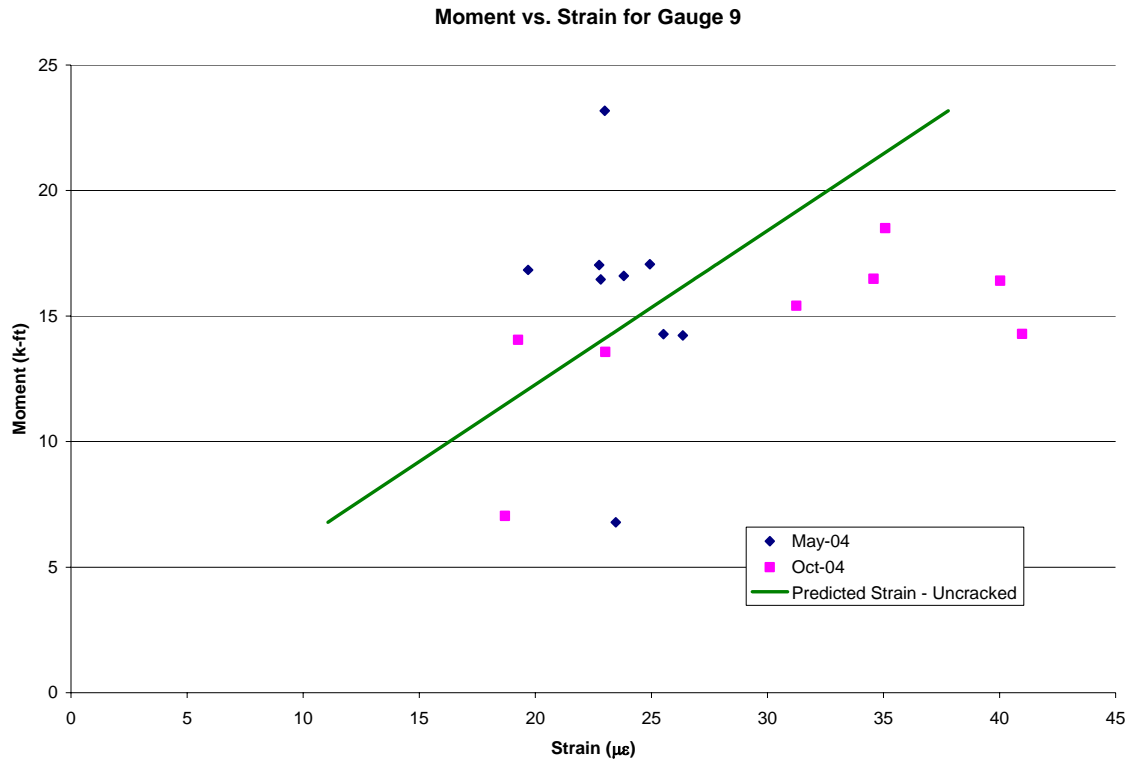
Figure 4.35: Moment vs. Maximum Strain for Gauge 9

To compare the two live load sessions, the moments were plotted versus strain for each test along with the predicted strains for the applied moment. The plot for gauge 9 is shown in Figure 4.35. Strains increased over time, ranging from 20 to 26 $\mu\epsilon$ in May and then 19 to 41 $\mu\epsilon$ in October. However, they were closer to the predicted strains of an uncracked section indicating that minimal to no cracking was experienced at the gauge's location.

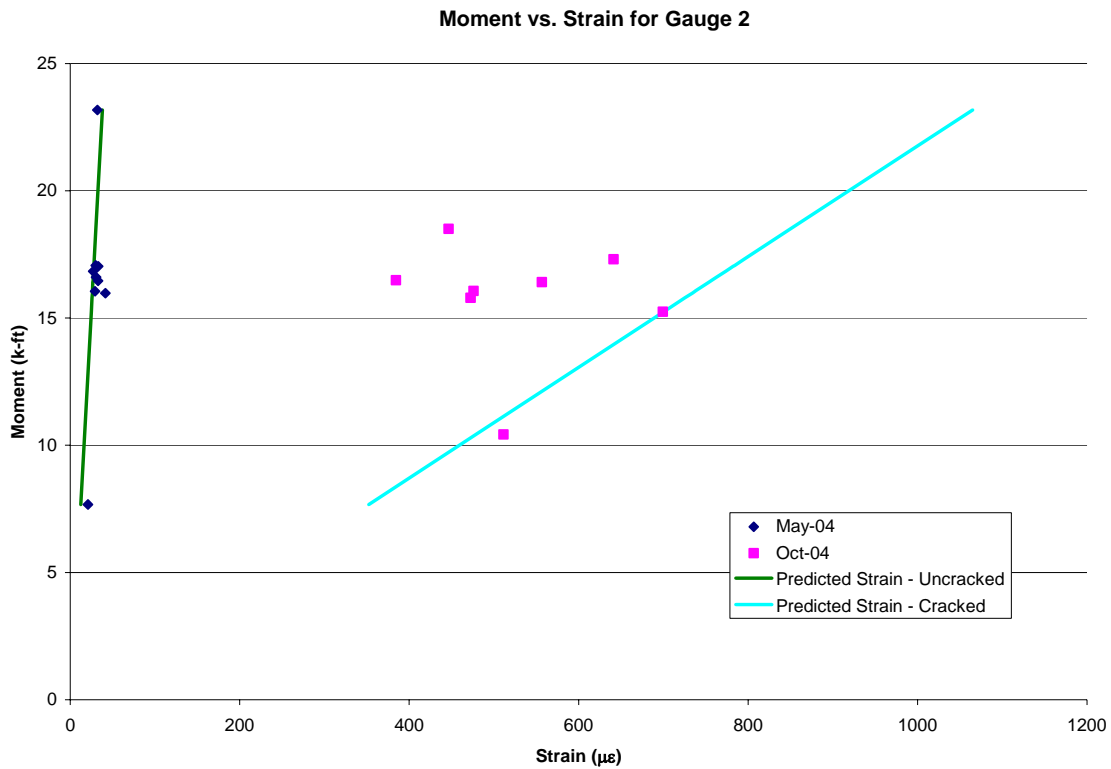
Figure 4.36: Moment vs. Maximum Strain for Gauge 2

An example of a gauge that had larger strains close to the predicted cracked strains is in Figure 4.36. Gauge 2 had the largest strains for the second live load session. All of the other gauges showed an increase in strain, but not near the predicted strain for a cracked section. Gauge 1 had large magnitudes in May compared to the rest of the gauges. This could mean that it was starting to work improperly, especially because it was not operable in October. That could also be the reason that gauge 2 was showing such high strains in October. It seems unlikely that the location just around gauge 2 was cracked and not around any other gauges.
