# Linking Stream Restoration Success with Watershed and Design Characteristics

# The goal of this project is to improve understanding of the conditions under which stream restoration projects are successful

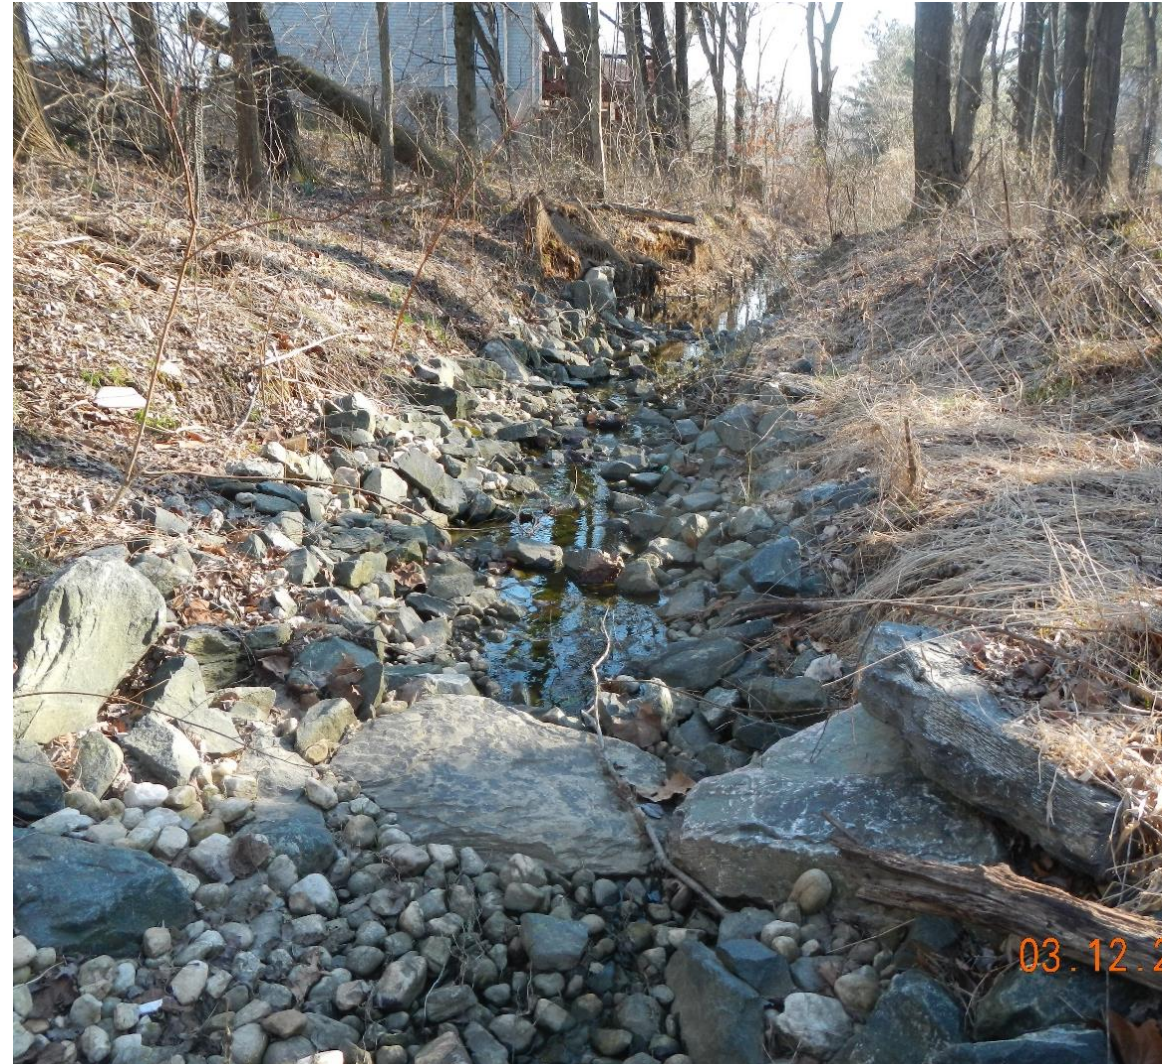
## Example: Project 47

- 100% design score
- 50% function score
- Confined - urban subdivision
- Step-pool channel
- Rock-lined

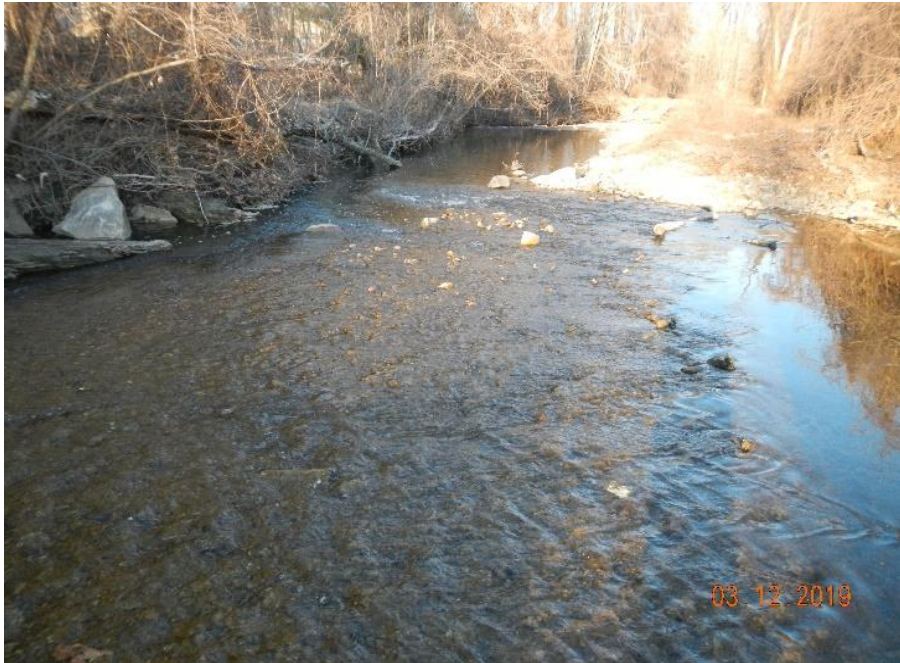
Project 3  
(1995)

Projects 3 and 22 scored 0% on the design assessment but maintained high scores in the bedforms, substrate and cover categories.

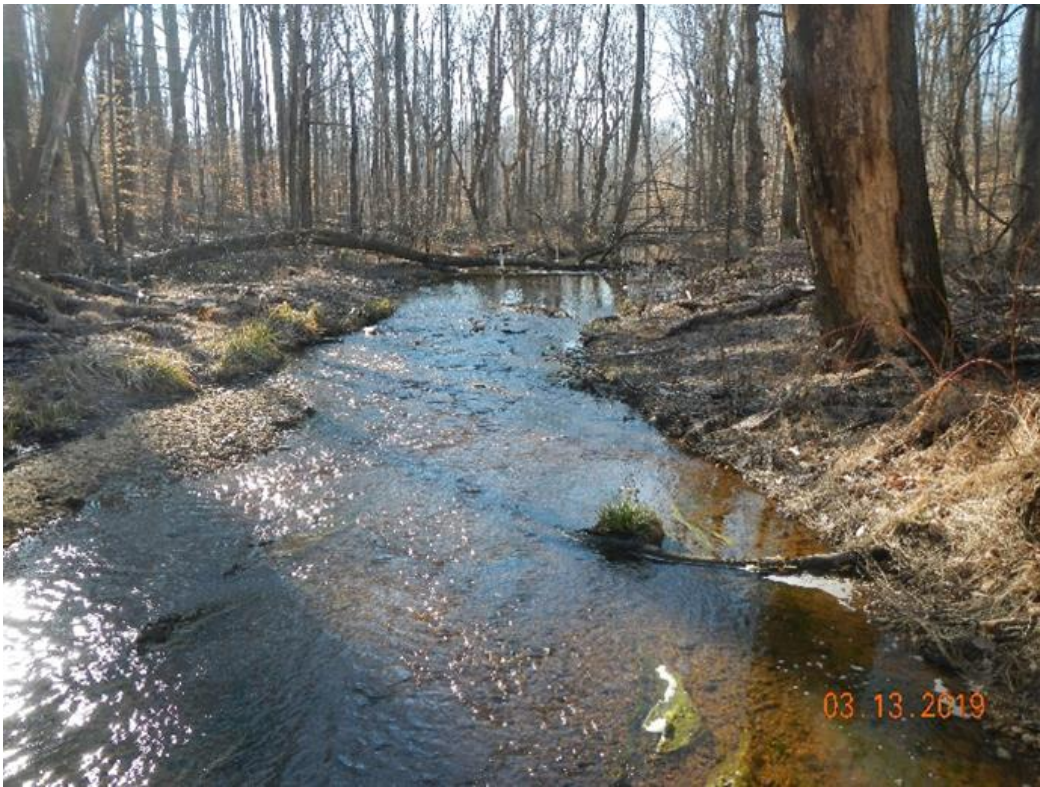
Project 7

Projects with higher geomorphic function had low bank heights, native vegetation, and accessible floodplains.
