**Field and Laboratory Tests of a Proposed  
Bridge Deck Panel Fabricated from  
Pultruded Fiber-Reinforced Polymer Components**

Thesis submitted to the Faculty of the  
Virginia Polytechnic Institute and State University  
in partial fulfillment of the requirements for the degree of

Master of Science  
in  
Civil Engineering

May 14, 2001

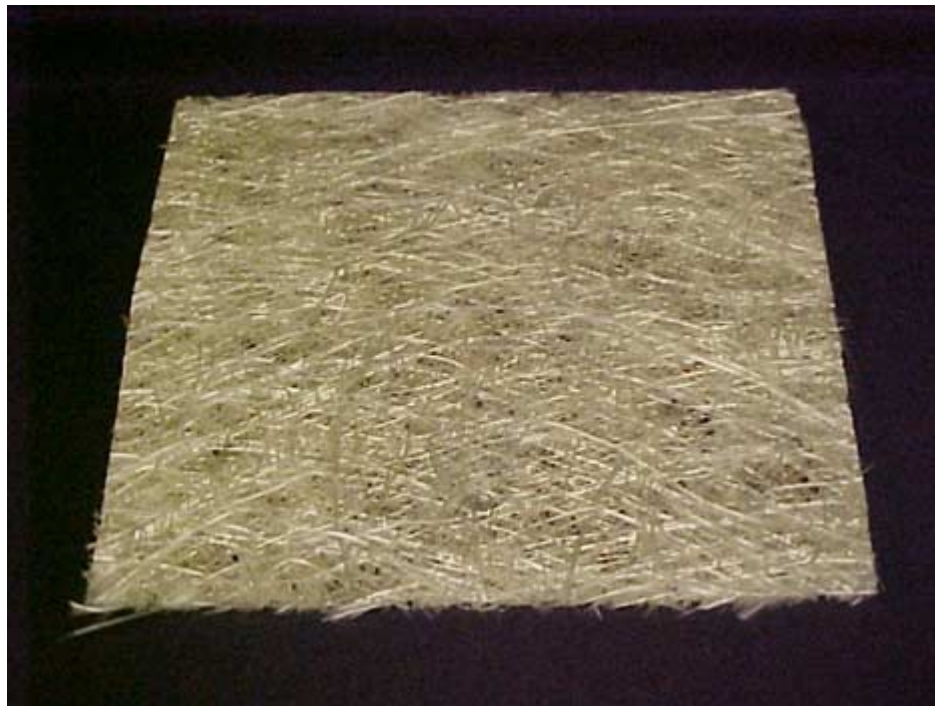
**Figure 2.2** Sample cutout of continuous strand mat

The primary components of the FRP deck panel are 6-inch tubes (*Figure 2.1*) and 3/8-inch plates. The tubes and plates are pultruded fiberglass structural shapes (Strongwell, 1998) produced by Strongwell, Corporation. They contain E-glass reinforcement—in the form of continuous strand mats [CSM (*Figure 2.2*)] and roving (*Figure 2.3*)—embedded in an isophthalic polyester resin. The glass-fiber fraction of these particular shapes is typically 50-60% of the total volume of the shape while the mat and roving are present in approximately equal amounts. All the shapes had a surfacing veil of polyester non-woven fabric that encases the glass reinforcement and provides a layer of resin at the surface. The surface veil also eliminates “fiber blooming” (the presence of glass fibers on the surface) and thus provides a smooth finish to the structural shape.

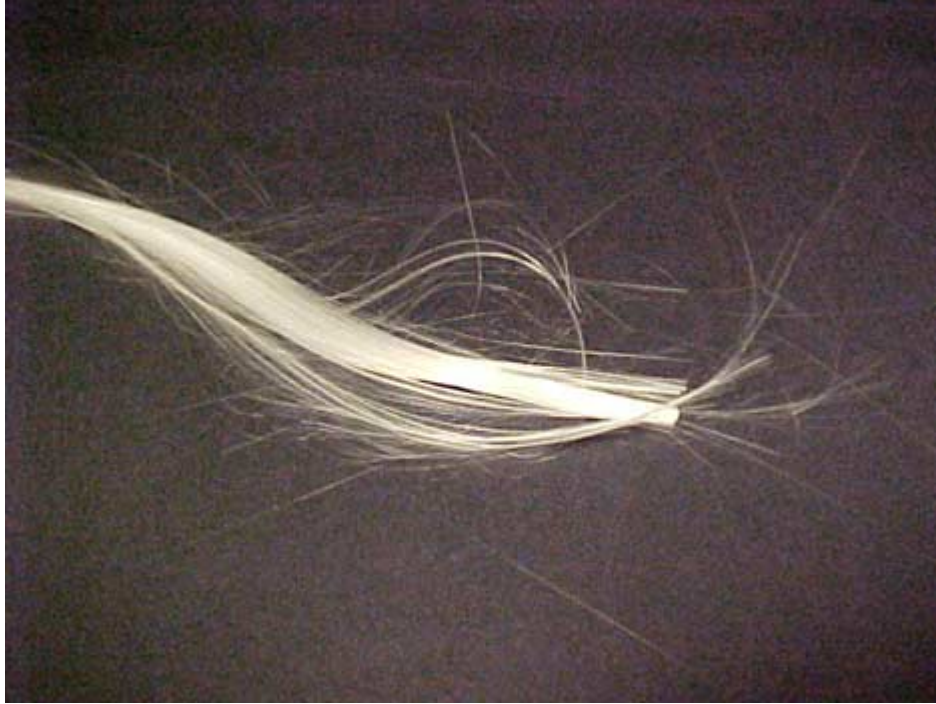
**Figure 2.3** Sample of glass roving

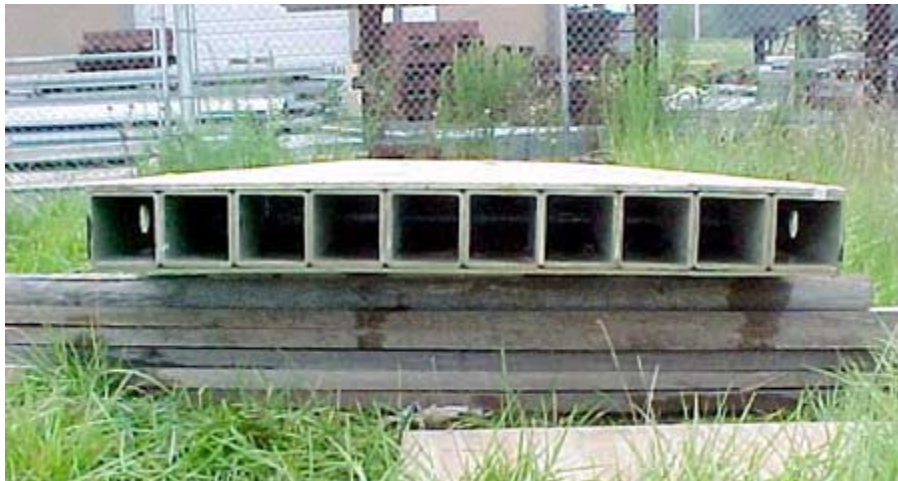
**Figure 2.4** End view of FRP deck panel

A prototypical model of one of the FRP deck panels can be seen in *Figure 2.4*. Each deck panel (*Figure 2.5 and 2.6*) was 5 feet wide, 15.25 feet long, and 6 ¾ inches deep (not including the wearing surface). The two panels were made of ten 15.25-foot long FRP tubes “sandwiched” between two 3/8-inch FRP plates. Though similar in most respects, there were some significant differences between the two decks. Because of these differences, the panels have been given two distinct names. From this point on, the first FRP deck will be referred to as “Deck 1” while the

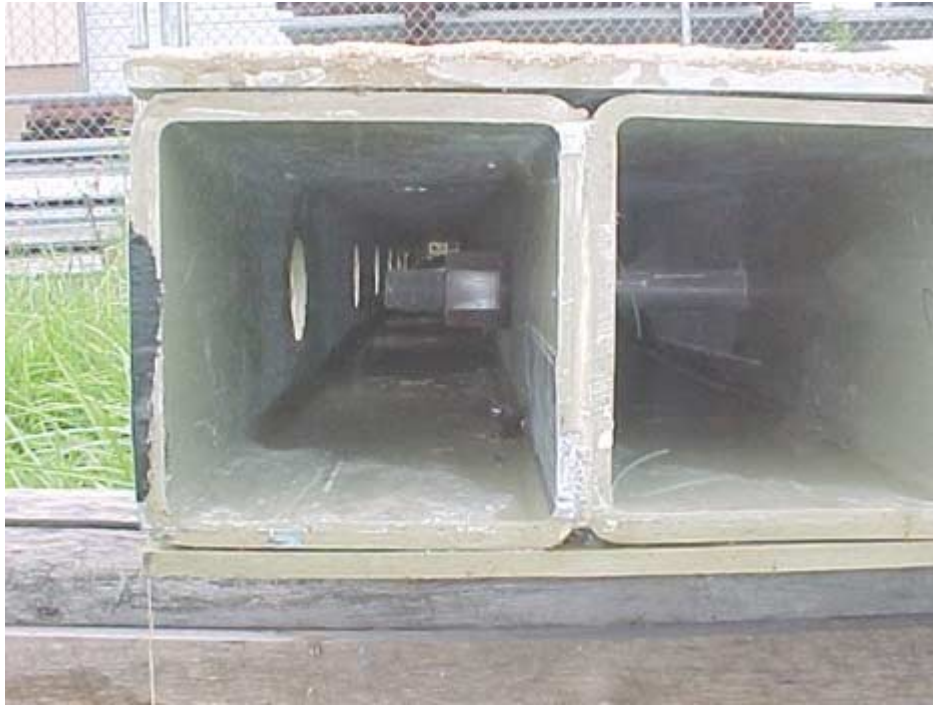
**Figure 2.7** End view of thru-rod assembly

Top plate not shown for clarity

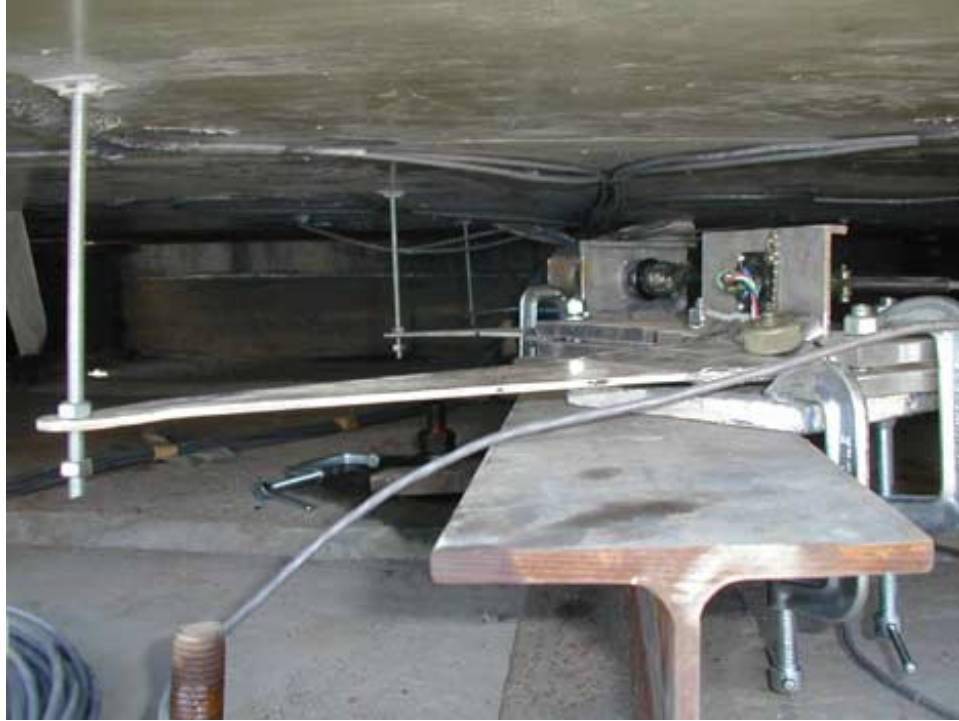
**Figure 4.11** Deflectometer positioned beneath FRP deck during Field Test 2

Deflections recorded during Field Test 2 were measured using “deflectometers” made at Virginia Tech. Each deflectometer consisted of a 1/4-inch cantilevered aluminum plate clamped between two 3/8-inch thick aluminum blocks that were bolted together. Four strain gages (adhesively bonded to the underside of the cantilevered plate) were wired to create a full bridge. A threaded rod was attached to the end of the cantilevered plate; the top of this rod made contact with the underside of the deck (*Figure 4.11*). As the deck deflected, it would push down the rod and bend the cantilevered plate, thereby inducing a change in signal measured by the full bridge of strain gages.

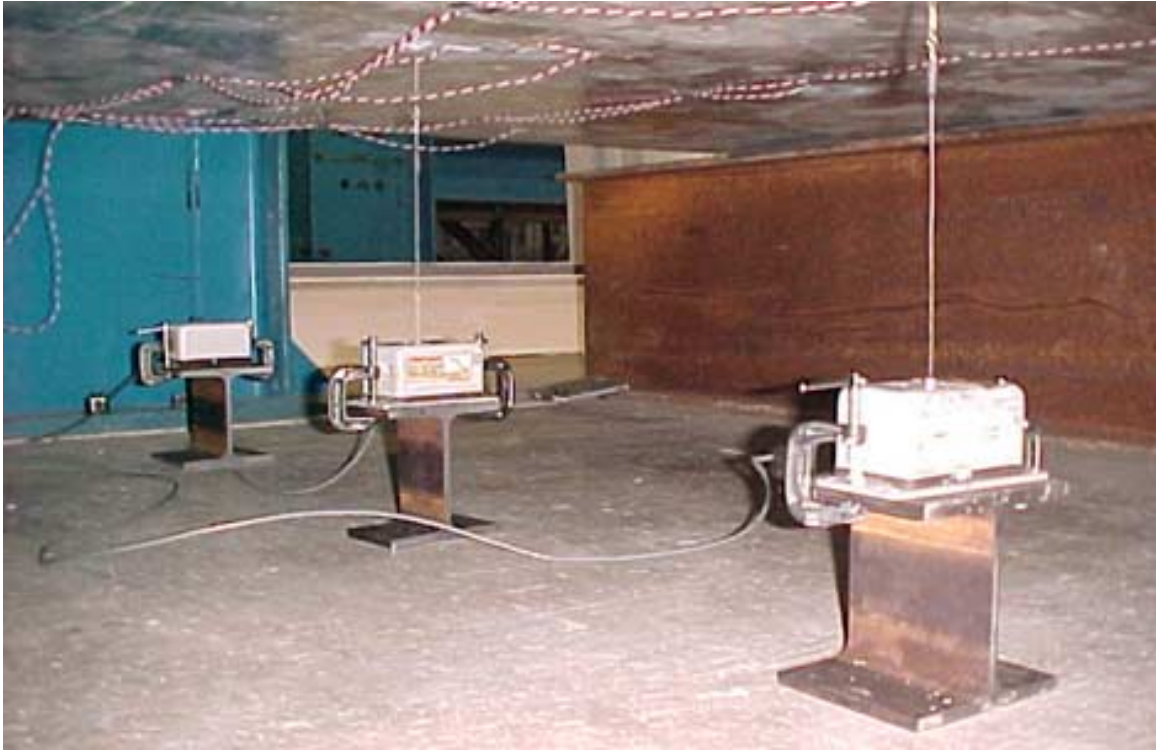
**Figure 5.1** Wirepots positioned beneath the middle of one of the deck spans during an arbitrary lab test

The running average method was used because there was some “bounce” in the raw data, as shown in *Figure 5.2*. This was attributed primarily to the wirepots, and was probably a result of the rate at which the deck was loaded. When operating the pump, it was difficult to apply load in small increments. One “click” of the pump would send fluid into the hydraulic cylinder at such a high rate that as much as 1 to 2 kips of load was instantaneously delivered to the deck. This high rate of application of load produced a large—but short term—acceleration in deck deflection. This acceleration would cause the cable (which is normally kept in tension) of the wirepot (see in *Figure 5.1*) to go slack, thereby leading to the “bounce” in the recorded deflection.
