Impedance-Based Structural Health Monitoring of Wind Turbine Blades

Thesis submitted to the faculty of the Virginia Polytechnic Institute and State University
in partial fulfillment of the requirements for the degree of

Master of Science
in
Mechanical Engineering

August 31, 2007
Blacksburg, Virginia

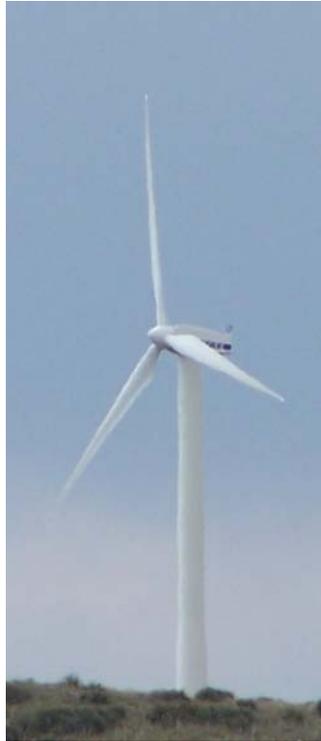
Figure 1.1: Modern three blade HAWT

Today, wind turbines (WT) can generate megawatts of power and have rotor diameters that are on the order of 100 meters in diameter. Modern WT, like the one shown in Figure 1.1, are nearly all horizontal-axis WT (HAWT) and have three rotor blades. The components of a modern WT can be seen in Figure 1.2. The nacelle sits on top of a tall tower and houses the shaft coming from the rotor, a gearbox, and the generator. The nacelle and rotor can yaw on the tower so that the rotor faces into the wind. The blades of modern WT are manufactured borrowing technology from the boat building industry, are made of both glass and wood composites, and have an airfoil shape adapted from aeronautical engineering (Hau 2006). The blades have the ability to pitch in the rotor hub to maintain the optimal angle of attach given the conditions as well as to pitch far enough to stop the rotor in extreme conditions. Some turbines also have internal brakes to stop the rotor as shown in the illustration.

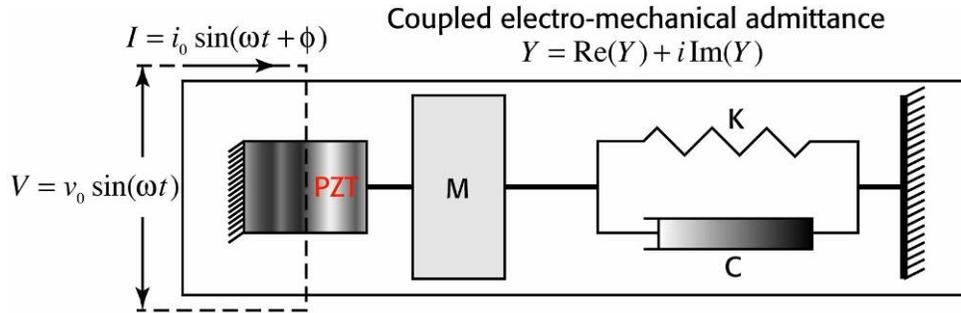
Figure 1.4: Model used to derive electromechanical admittance of PZT bonded to structure.

The impedance-based SHM (IBSHM) method makes use of the electromechanical coupling of PZT patches. When a PZT is bonded to a structure it forms a collocated sensor and actuator, often referred to as a self-sensing actuator. When a voltage is applied across the PZT, the structure is displaced and conversely, when the structure is displaced a voltage is developed in the PZT. Therefore, the PZT can both actuate the surrounding area of the structure as well as sense the resulting structural response. If the PZT is driven with a sinusoidal voltage, this will cause the local area of the structure to vibrate and the structural response will cause an electrical response in the PZT. A one dimensional model of this setup is shown in Figure 1.4.

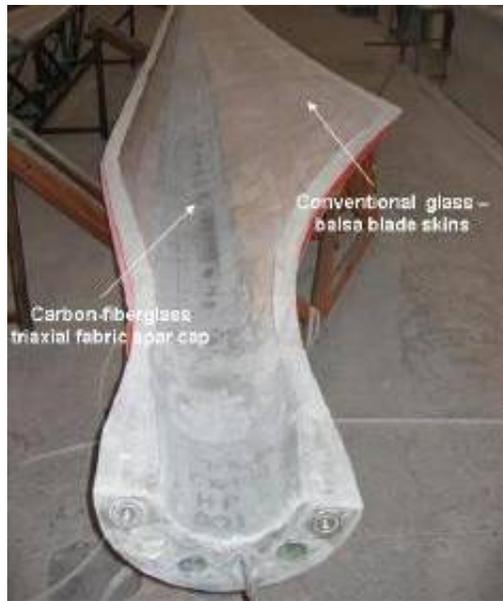
Figure 2.1: CX-100 high pressure skin showing carbon fiber spar cap infused with typical glass/balsa skin. (Paquette *et al.* 2006)

The WTB section tested is from a CX-100 (Carbon eXperimental-100 kW) blade. The CX-100 is a 9 meter long subscale experimental blade that was manufactured by TPI Composites in Rhode Island and was developed by SNL as part of research to incorporate carbon fiber in WTBs. This research included building subscale blades that incorporate carbon fiber which would be tested to static failure, modal tested, fatigue tested, and field tested on actual 100 kW WTs. The results of these tests were then compared to modeling (Paquette *et al.* 2007a; Paquette *et al.* 2006). The section used for this testing comes from a blade that was static tested to failure at NREL's NWTC. The CX-100 has carbon fiber in the spar cap region of the blade infused with the blade skin, which is made of more typical glass fiber and balsa. This can be seen in Figure 2.1 and an overall picture of a similar blade, TX-100, can be seen in Figure 2.2.

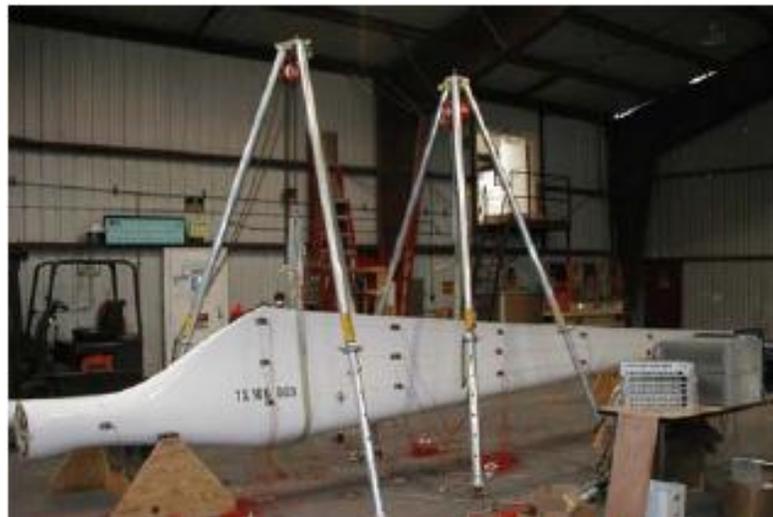
Figure 2.2: Overall picture of TX-100 blade. (Paquette *et al.* 2006)

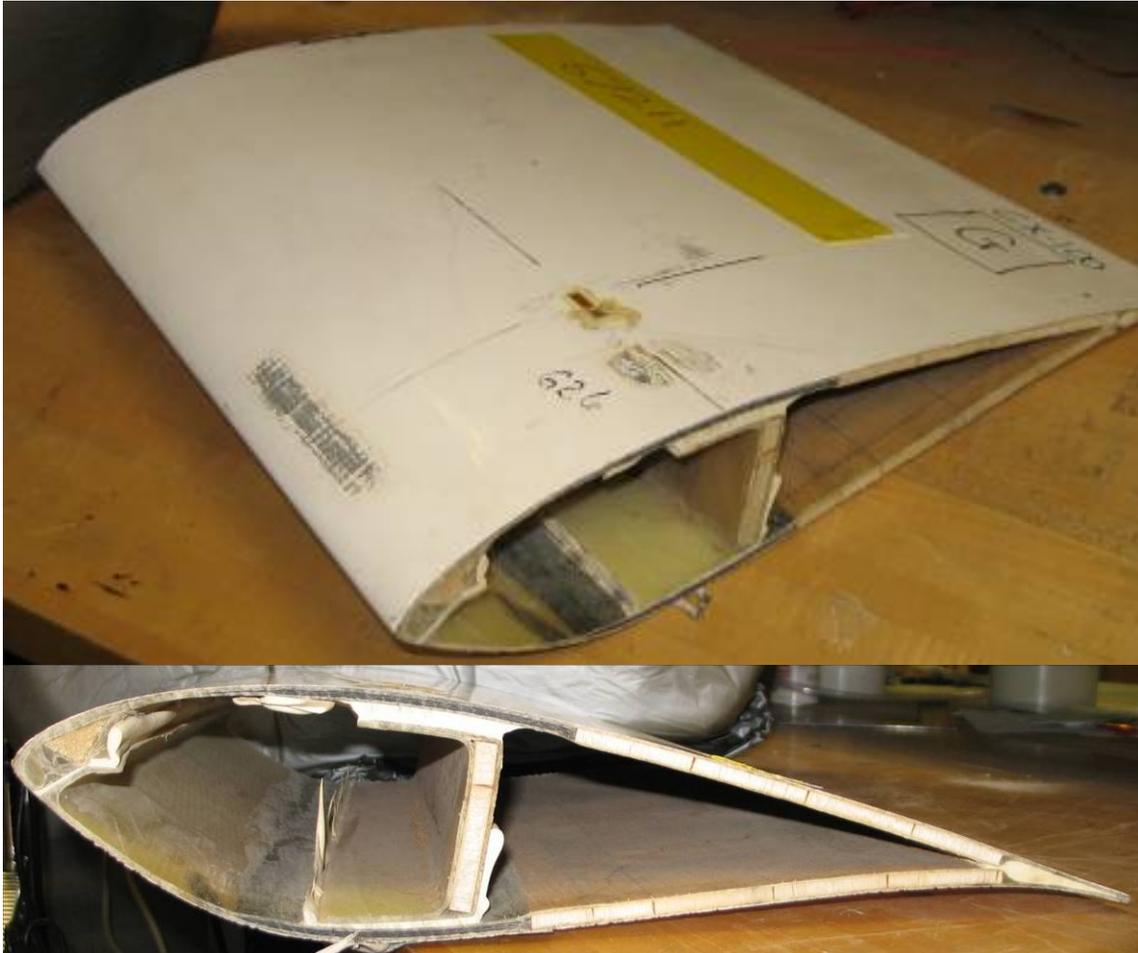
Figure 2.3: CX-100 blade section

the spar are made of balsa covered by fiberglass. Carbon fiber is incorporated into the spar cap regions of the skins. The section used for testing is from just over two-thirds of the way down the length of the blade and is around 40 cm long.

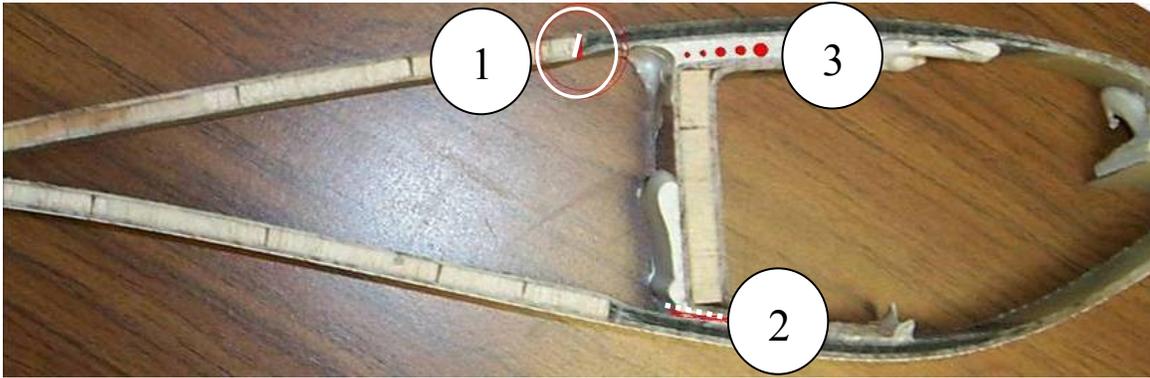
Figure 2.4: CX-100 Cross-section with damage modes

Typical damage locations and modes were suggested by SNL based on experience, blade models, and physical testing of the blade. Damage mechanisms are shown in Figure 2.4 on a cross section of the CX-100. Location 1 is on the LP side of the blade, which is where the carbon fiber spar cap meets the balsa skin. The damage mode here is separation of the two sections. Location 2 is adhesive between the spar and the spar cap on the HP side of the blade. The damage mode is cracking of the adhesive. Location 3 is the adhesive between the spar and the spar cap on the LP side of the blade. The damage mode here is pitting of the adhesive.

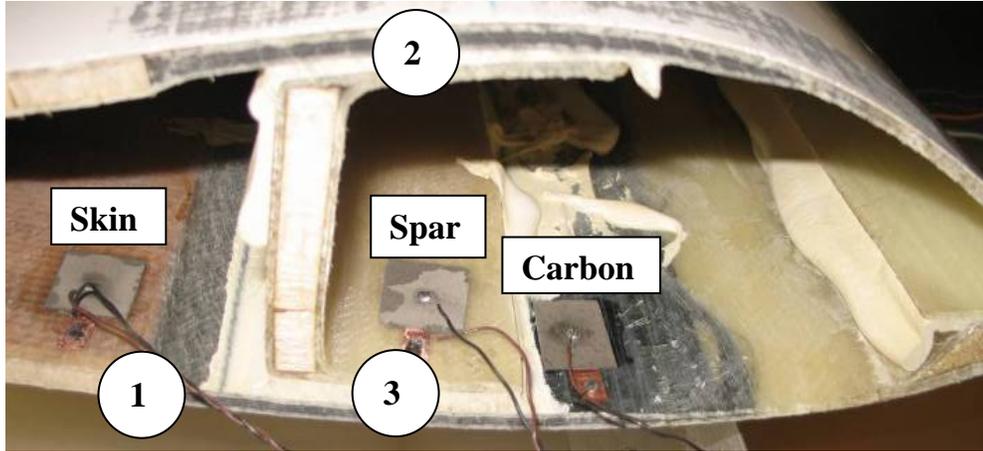
Figure 2.5: Sensor names and locations (damage locations shown for reference)

The PZT patches used for IBSHM testing are roughly 2 x 2 cm and are made from 0.27 mm thick PSI-5H4E material from Piezo Systems, Inc. They were tested in three locations on the blade which are shown in Figure 2.5. The left patch location is above the balsa skin section near the balsa/carbon intersection and will be referred to as the Skin patch. The patch in the middle is on the fiber glass spar flange and will be referred to as the Spar patch. Finally, the patch on the right is on the carbon fiber spar cap will be referred to as Carbon. To install the Carbon patch some of the extraneous adhesive on the spar cap had to be removed to make room for this sensor as seen in Figure 2.6. Some of the testing was completed before the carbon patch was installed, but these baseline measurements were not compared to those afterwards because of the mass difference.

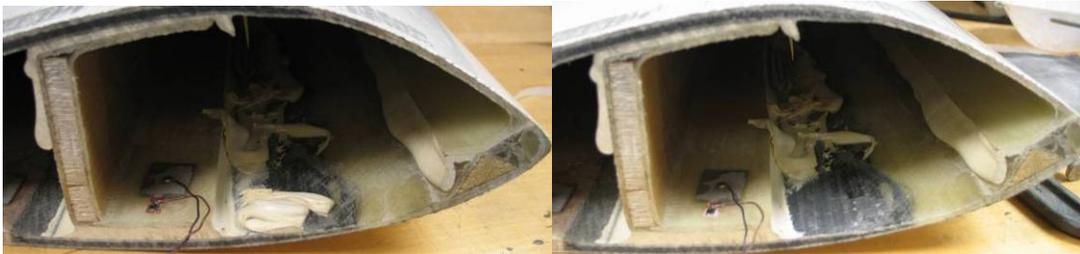
Figure 2.6: Removed adhesive for carbon fiber pzt.

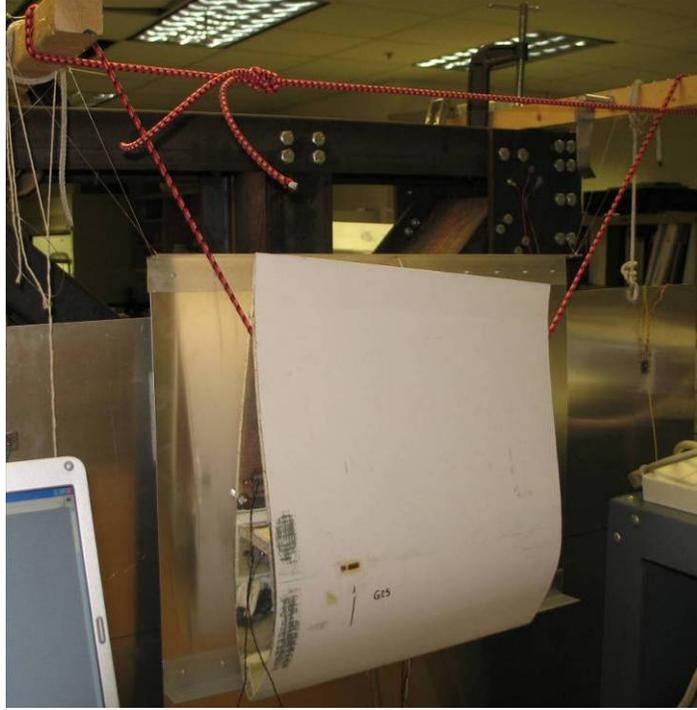
Figure 2.7: Test setup of WTB section.

Although the impedance method is typically not affected by boundary conditions, the blade is suspended in nearly free-free condition for consistency for testing as shown in Figure 2.7. The device used for measuring the impedance of the PZTs was an HP4194A impedance analyzer which interfaced with a laptop through a GPIB port. A Labview program developed by Simmers (2005) was used to control the analyzer and record the impedance data. A resolution of 10 Hz was used in gathering impedance data with a 1 volt magnitude excitation and settings on the HP4194A of 4 averages and “medium” integration time.

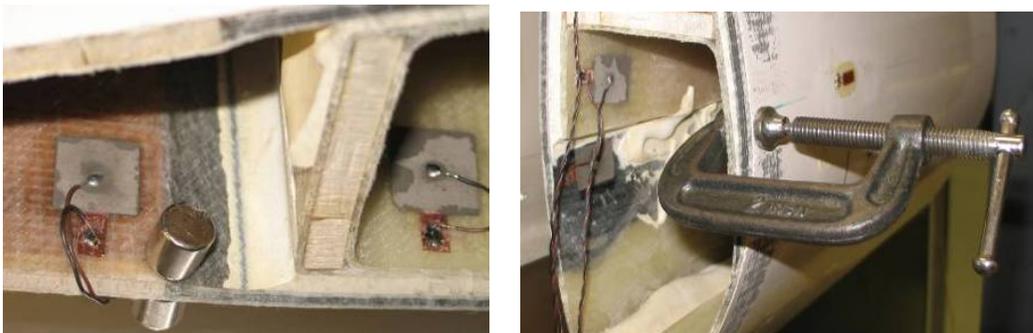
Figure 2.8: Indirect damage methods: Added mass (25g magnets) in location 1 and added stiffness (C-clamp) in location 2.

The first type of tests performed on the blade were indirect forms of damage such as adding mass to and changing the local stiffness of the blade. The indirect damage being simulated was based on damage locations provided by SNL. Simulated damage by adding mass was accomplished by attaching magnets to the blade with a combined mass of approximately 25 grams at the three damage locations. The magnets can be seen in Figure 2.8 in location 1. Also, to simulate damage by changing the local stiffness of the blade in the three locations, a 2 inch C-clamp was attached to the blade, as seen in Figure 2.8 at location 2. The C-clamp also added 215 grams of mass to the blade. Finally, to get an idea of the range of sensing, additional tests were run moving the masses down the blade away from the sensors. Masses were kept in the same three locations relative to the cross section of the blade but were placed at 13, 25, and 40 cm away from the sensor end of the blade. These distances also roughly correspond to 1/3, 2/3, and all the way down the blade section.

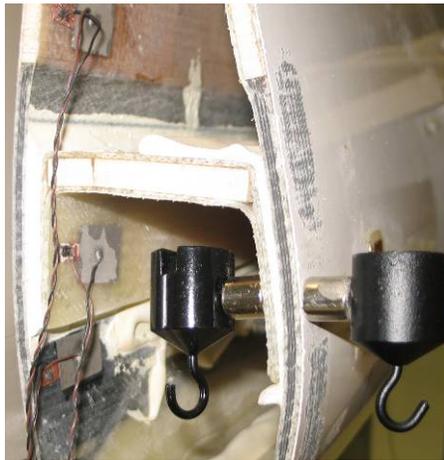
Figure 2.9: Additional (225g) mass simulated damage at location 2

Tests were also run with additional mass in the same locations near the sensor and down the blade. One-hundred gram weights were placed on each magnet to obtain 225 grams of total weight. This configuration can be seen in Figure 2.9. However, the results of these tests are omitted because they produced smaller damage metrics than the 25 gram tests. This was exactly the opposite effect that was desired with a larger mass but was likely due to the fact that adding mass actually made the magnets have a more difficult time staying together so despite adding mass, the clamping force of the magnets on the structure was actually less. This was the case so much in fact that no results were obtained for location 3 because the magnets would not stay clamped to the blade.

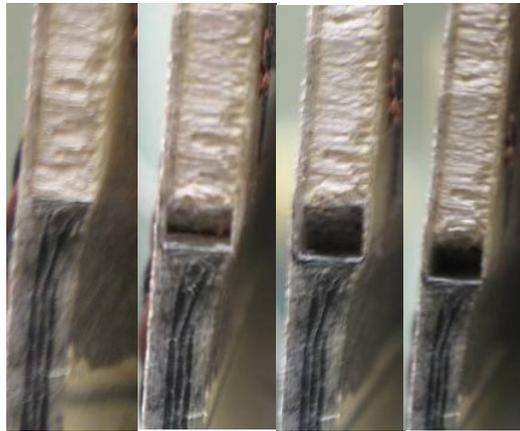
Figure 2.10: Progressive damage in location 1

Location 1 is the connection of the carbon fiber spar cap to the balsa skin. The damage mode at this location is separation of the two sections. Damage at the sensing end was produced by driving a chisel in between the two sections. This damage was added progressively, with three baselines being taken initially and then impedance measurements taken after each progression of damage and compared to the initial baseline. Three damage states were produced: an 8 mm deep/3 mm wide at opening notch, a 15 mm deep/5 mm wide at opening notch, and a 19 mm deep/5 mm wide at opening notch. This damage can be seen in Figure 2.10 moving left to right. Damage in this location was also tested down the length of the blade in the form of 2.5 cm long gaps in the balsa/carbon fiber by driving a chisel into the gap from the outside of the blade, as is seen in Figure 2.11, at 3, 12, 22, and 31 cm down the blade. The gelcoat on the outside of the blade was removed initially for all locations before the initial baselines so that only the effect of separating the balsa and carbon fiber was taken into account. For these tests, two baselines were initially taken, and two measurements were taken after each damage state (starting from the far end of the blade and working back towards the sensing end). Since the cumulative effect of the damage was not desired in these tests, each set of two measurements was compared to the previous two, and then would become the baseline for the next damage state, and so forth.

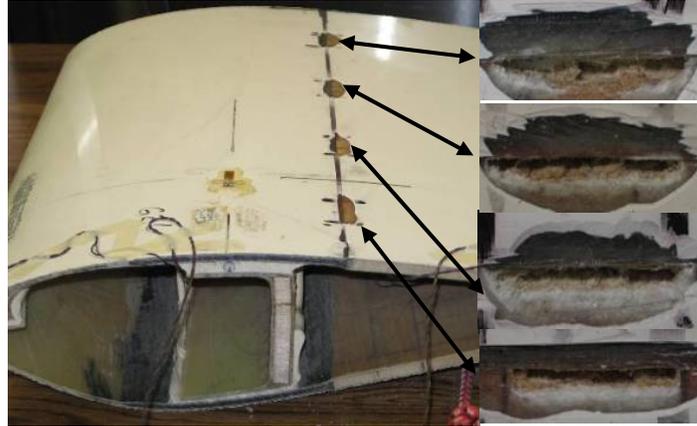
Figure 2.11: Damage in location 1 located down the length of the blade

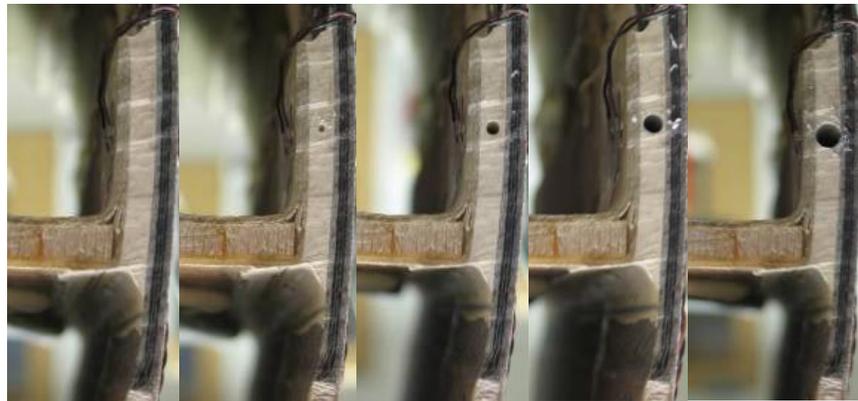
Figure 2.12: Progressive damage in location 3

For location 3, a series of tests similar to those for location 1 were conducted. Location 3 is the adhesive between the spar flange and the spar cap, and the damage mode in this location is pitting of the adhesive. For the progressive damage at the sensor end of the blade, holes of increasing size were drilled into the adhesive 4 cm deep with diameters: 1.6, 3.2, 4.8, and 6.4 mm. This damage can be seen in Figure 2.12 moving from left to right. In Figure 2.13, the locations down the length of the blade are shown. These holes were drilled as close to perpendicular to the length of the blade as possible, but due to the geometry of the blade section not all the holes are perfectly perpendicular. Slightly different angled holes are not anticipated to be a problem since damage is applied no matter what the angle is. These holes are all roughly 5-6 cm deep, 6.4 mm in diameter, and were drilled (starting at the far end and moving toward the sensing end) at 0, 5, 13, 20, and 28 cm from the sensors.

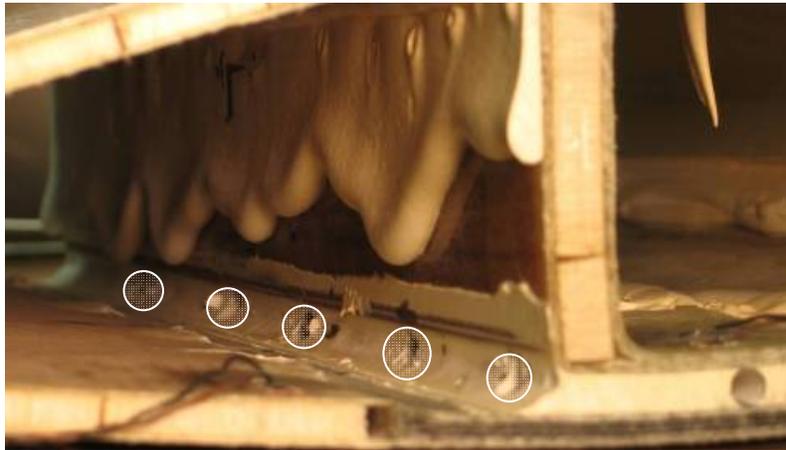
Figure 2.13: Damage in location 3 located down the length of the blade

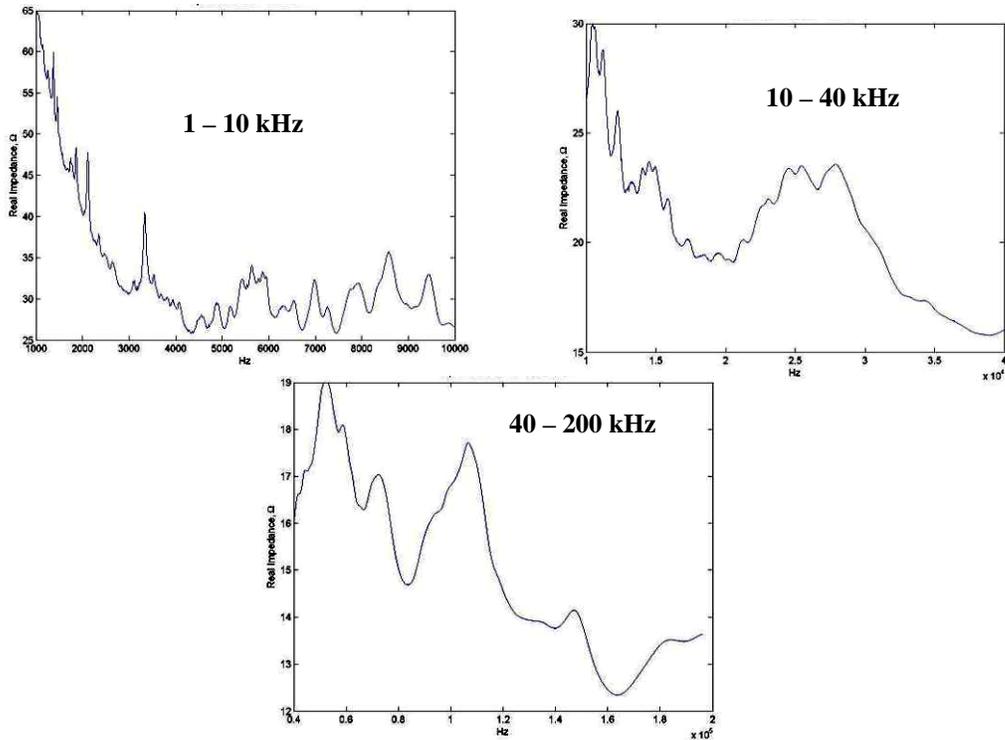
Figure 2.14: Spar baseline impedance

Initially, baseline impedance signatures were obtained for all three PZT patches from 1-200 kHz to see the characteristics of the impedance signatures. An example can be seen in Figure 2.14 and the baselines for the other two patches are in Appendix A. The impedance baselines show for all three PZTs for frequencies greater than 60 kHz, the impedance has a relatively flat response with peak density lower than typically used for the impedance method. The range from 3-30 kHz has more typical peak density, although some of this range (3-10 kHz) is lower than typical frequencies used for impedance based SHM. Low structural response at higher frequencies is likely due to the high structural damping of the blade, especially that of the balsa.

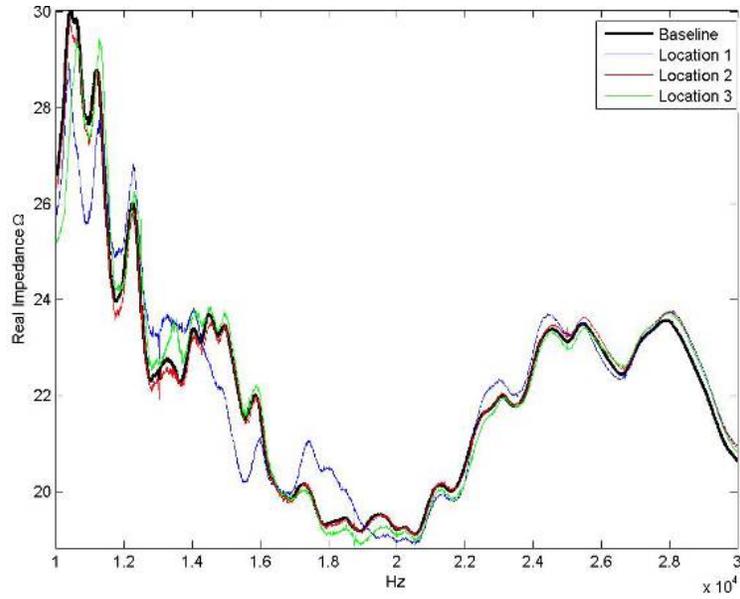
Figure 2.15: Impedance plot for spar sensor, 10-30 kHz, added mass

For the magnet and C-clamp tests, several frequency ranges were investigated within the range 3 – 30 kHz: 3-10, 10-17, 17-24, 24-31, 10-30, and 3-20 kHz. Also several frequency ranges greater than 30 kHz were also investigated for the C-clamp tests: 30-60, 60-90, 90-110, and 30-100 kHz. Examples of the impedance plots from indirect damage testing are shown in Figure 2.15 and Figure 2.16. They are both from the spar sensor from 10-30 kHz. Figure 2.15 is the added mass test and Figure 2.16 is the added stiffness test for all three locations. Change in the impedance from baseline to damage states can clearly be seen. The remaining impedance signatures from the indirect damage tests are shown in Appendix A.

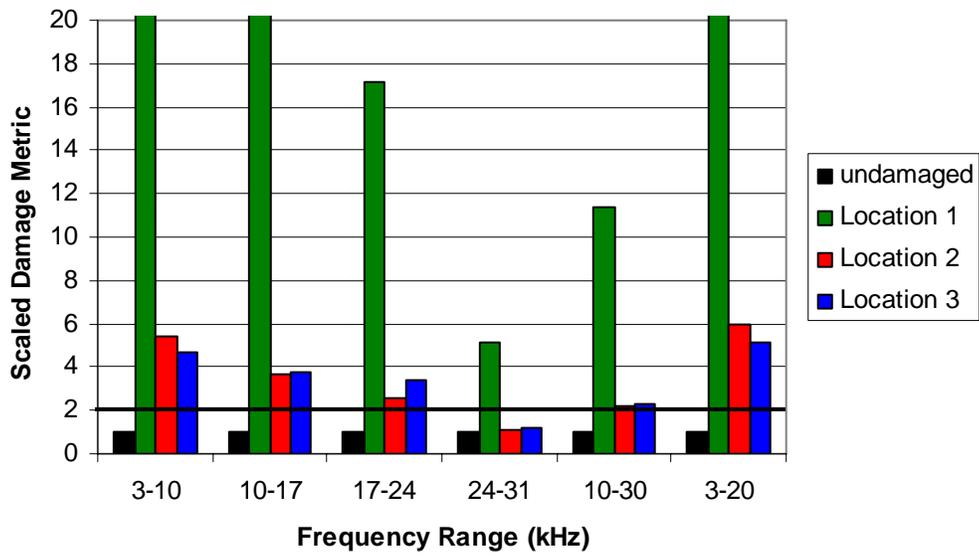
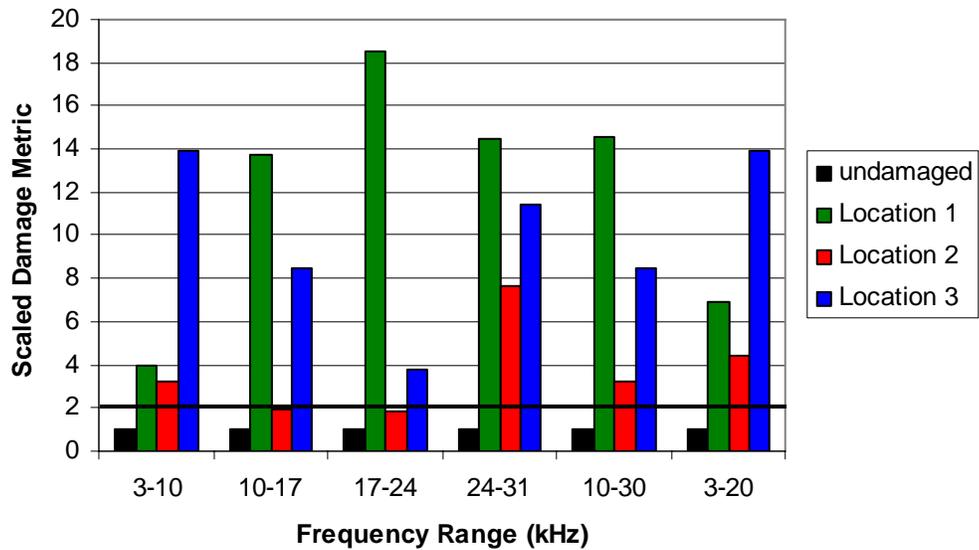
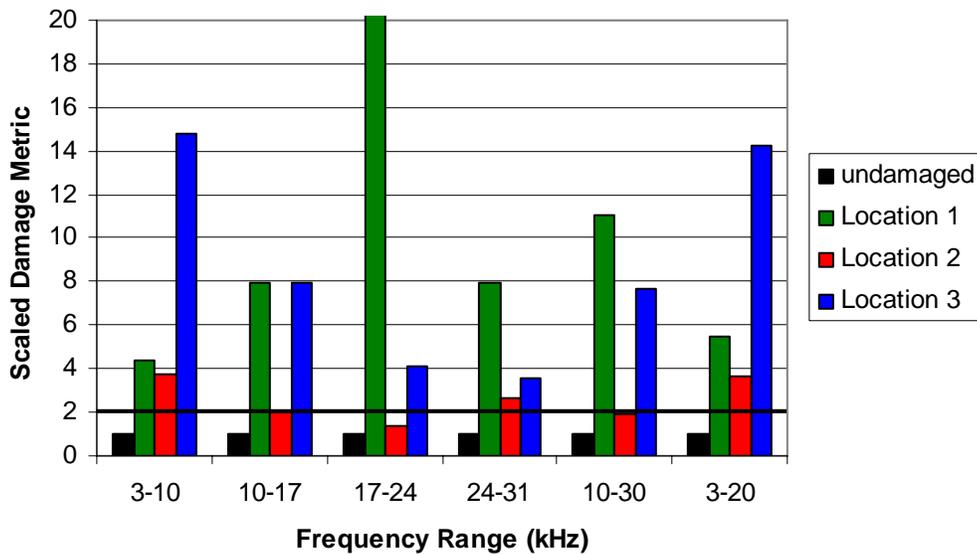
Figure 2.17: Skin: Added mass (25g): Damage metrics calculated for several frequency ranges.

Figure 2.18: Spar: Added mass (25 g): Damage metrics calculated for several frequency ranges.

Figure 2.19: Carbon: Added mass (25 g): Damage metrics calculated for several frequency ranges.

This section contains the results for the simulated damage using the 25 gram magnets at the sensor end of the blade at locations 1, 2, and 3 for the three sensors. The results are shown in Figure 2.17 - Figure 2.19 . Again, in damage metric charts, each group of damage metrics is scaled so that the average of baseline metrics is equal to one. Also, the undamaged metric represents the average of multiple measurements.

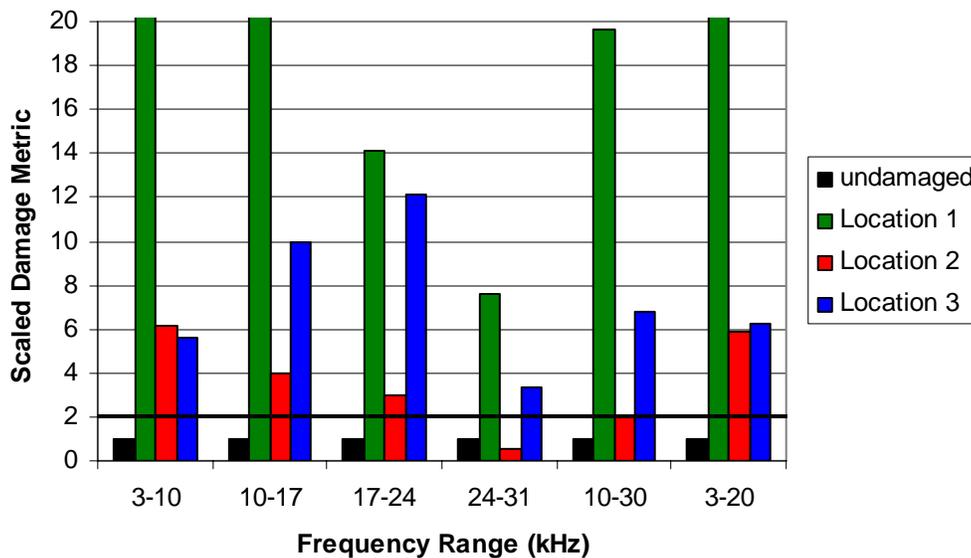
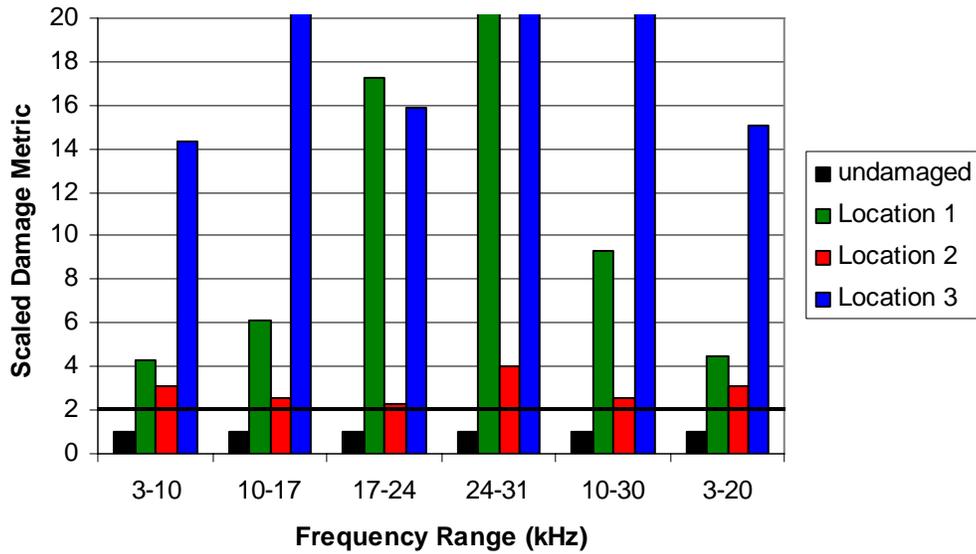
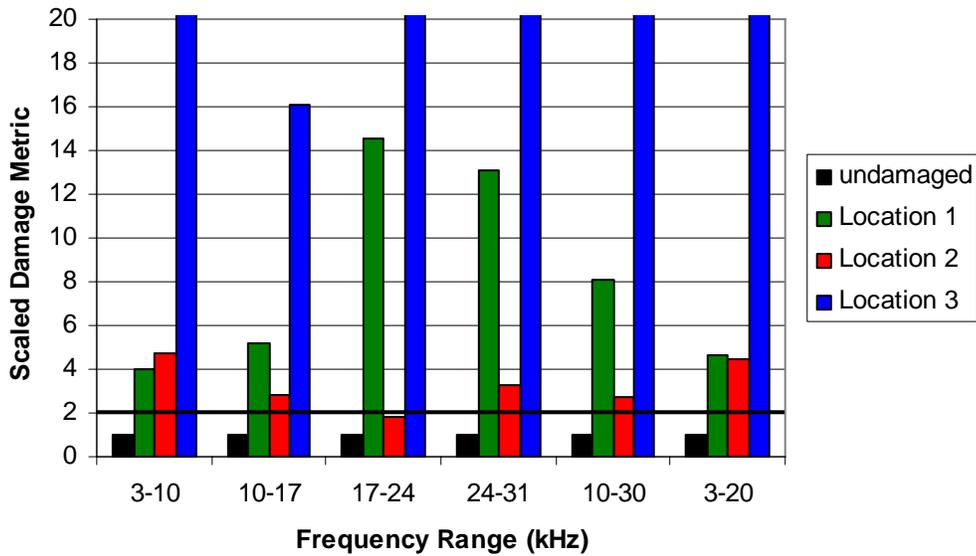
Figure 2.20: Skin, clamp: Damage metrics calculated for several frequency ranges.

Figure 2.21: Spar, clamp: Damage metrics calculated for several frequency ranges.

Figure 2.22: Carbon, clamp: Damage metrics calculated for several frequency ranges.

This section contains the results for the simulated damage using the C-clamp at the sensor end of the blade at locations 1, 2, and 3 for the three sensors. The results are shown in Figure 2.20 - Figure 2.22.

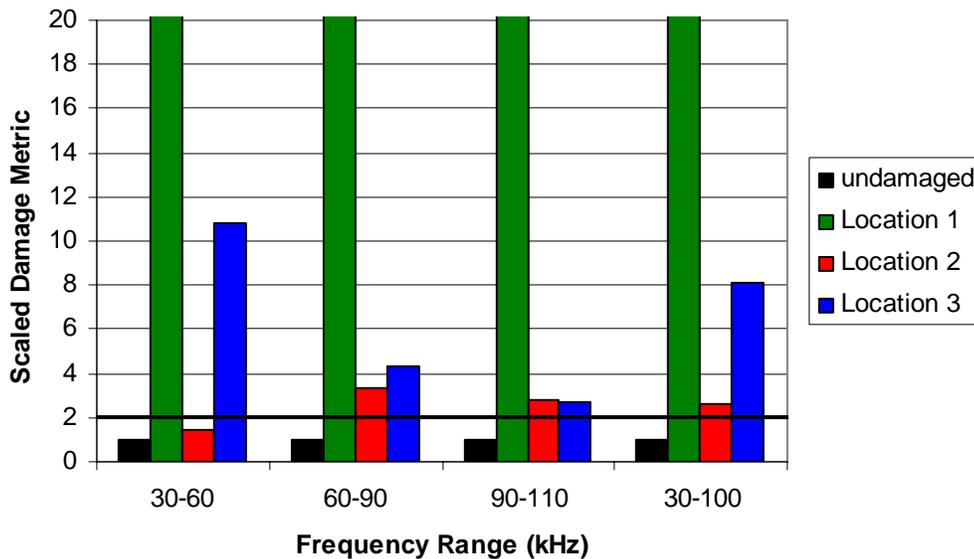
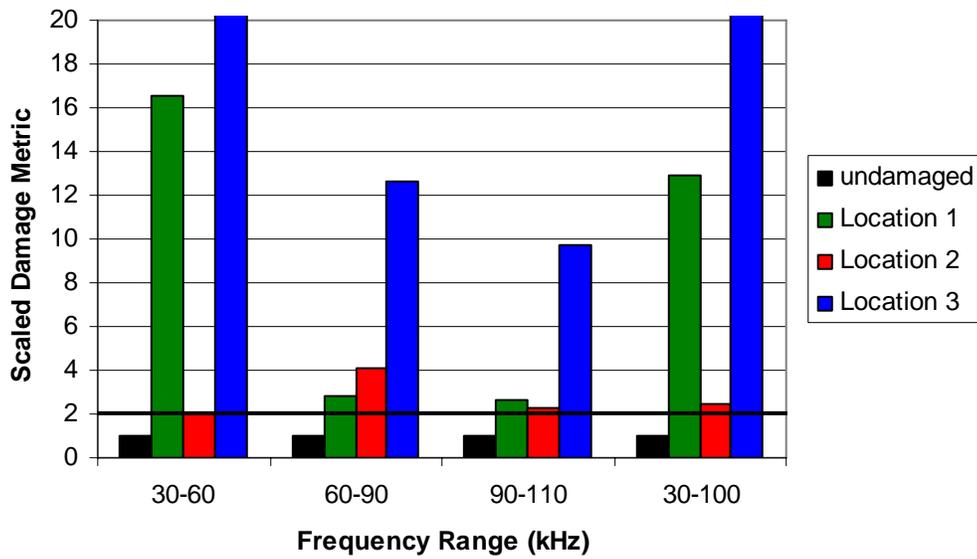
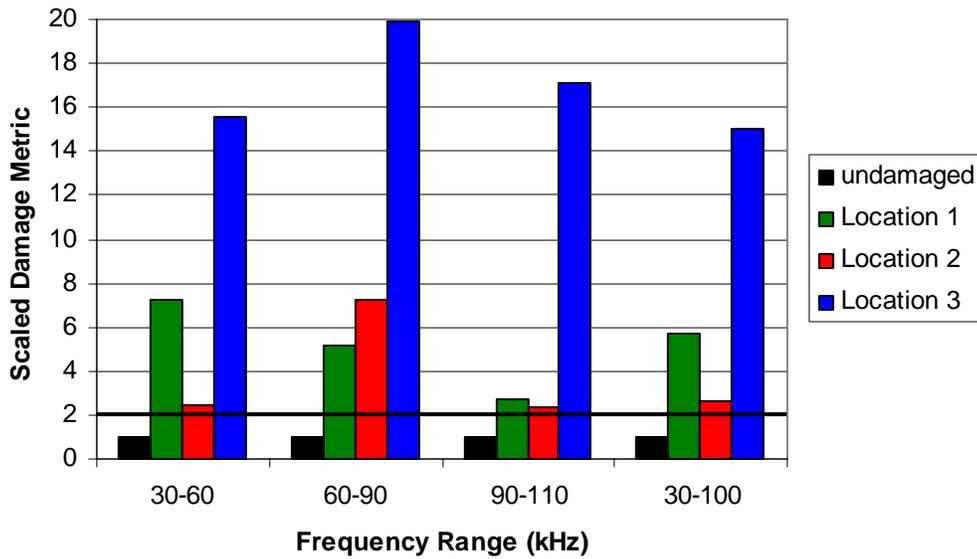
Figure 2.23: Skin, clamp: Damage metrics calculated for several frequency ranges.

Figure 2.24: Spar, clamp: Damage metrics calculated for several frequency ranges.

Figure 2.25: Carbon, clamp: Damage metrics calculated for several frequency ranges.

This section contains the results for the simulated damage using the C-clamp at the sensor end of the blade at locations 1, 2, and 3 for the three sensors. With the C-clamp damage more change was seen in impedance plots in the higher frequency range (30-100 kHz) more typical of impedance-based SHM. Several frequency ranges were investigated in this higher range: 30-60, 60-90, 90-110, and 30-100 kHz. The damage metric results are shown in Figure 2.23 - Figure 2.25.

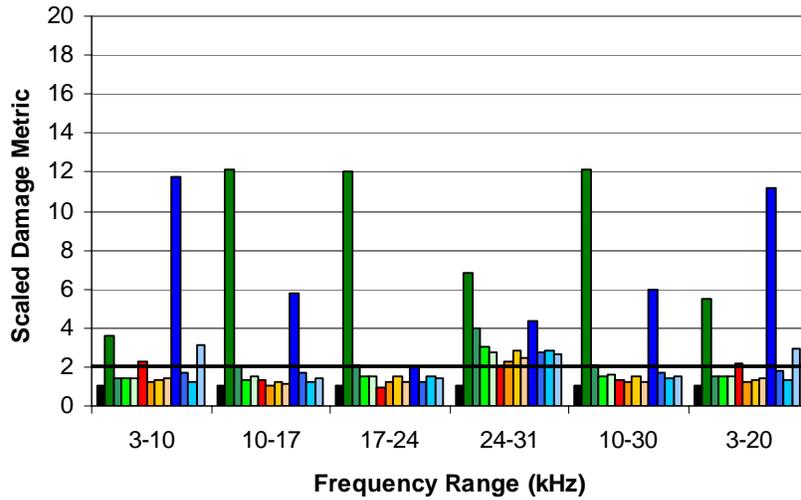
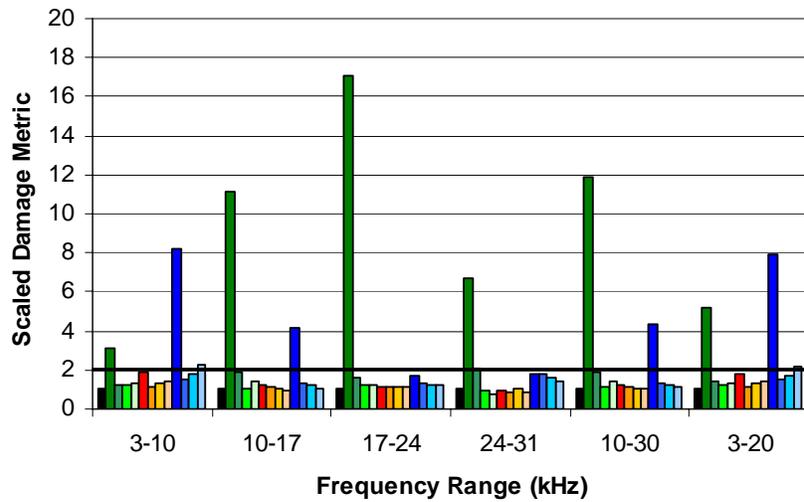
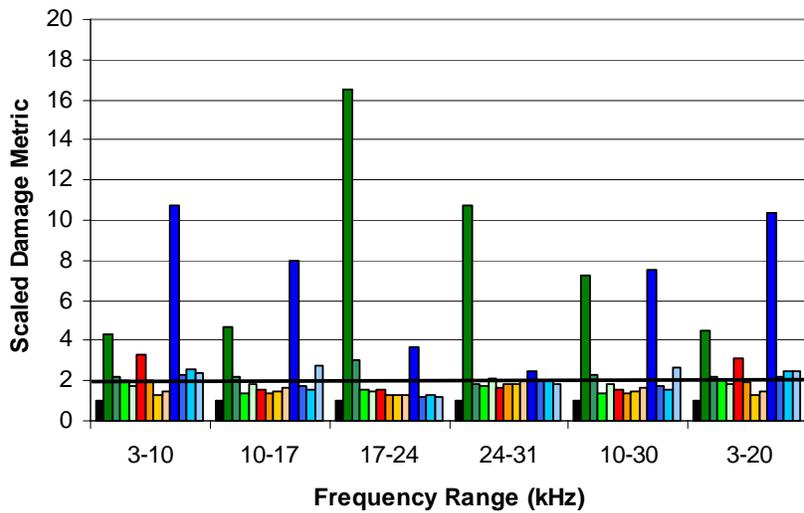
Figure 2.26: Spar, moving mass: Test 1, Damage metrics calculated for several frequency ranges.

Figure 2.27: Spar, moving mass: Test 2, Damage metrics calculated for several frequency ranges.

Figure 2.28: Carbon, moving mass: Damage metrics calculated for several frequency ranges.

This section contains the results of tests on the spar and carbon sensors where the 25 gram magnets were used to simulate damage in locations 1, 2, and 3 down the blade section. These tests were run at the sensor end and at locations 13, 25, and 40 inches down the blade. Damage metric results are shown in Figure 2.26 - Figure 2.28. These figures have 4 results for each location. Each color group is for a specific location (green for location 1, red for location 2, and blue for location 3) and as the damage is moved further down the blade (13, 25, and 40 cm) the shade of the color gets lighter. The test on the spar sensor was run twice and results from both tests are shown.

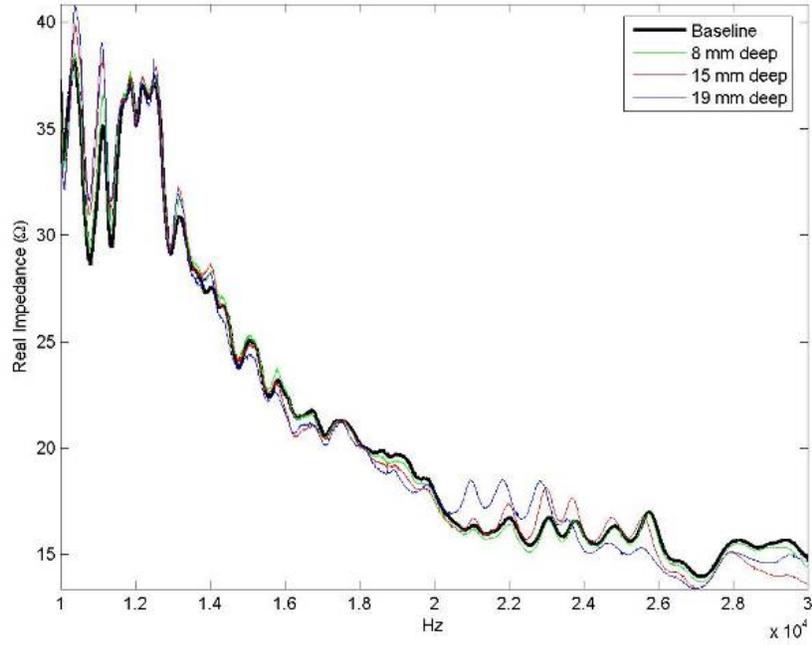
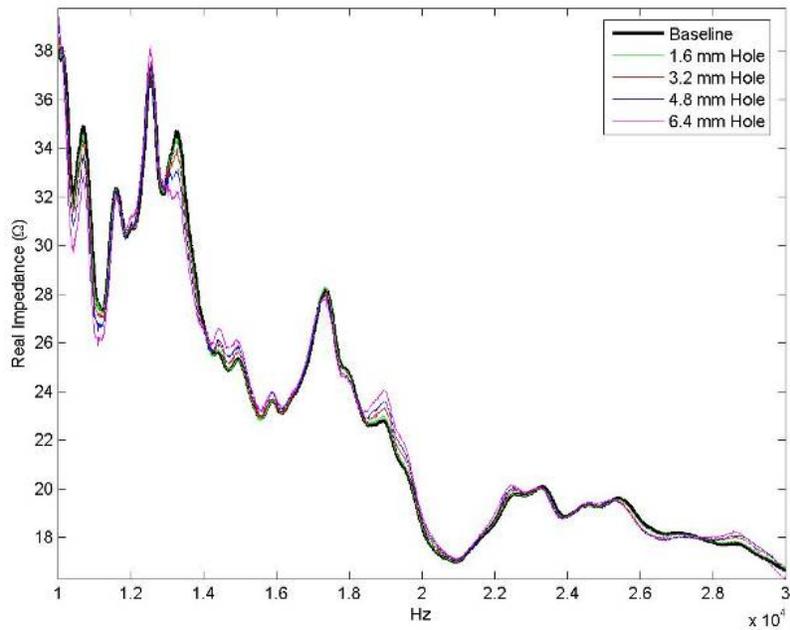
Figure 2.29: Impedance plot for skin sensor, 10-30 kHz, location 1 sensor end progressive damage

Figure 2.30: Impedance plot for carbon sensor, 10-30 kHz, location 3 sensor end progressive damage

Examples of impedance plots from actual damage testing are shown in Figure 2.29 and Figure 2.30. Figure 2.29 displays results from the skin sensor at 10-30 kHz for the progressive separation of the carbon and balsa sections at location 1 on the sensor end of the blade. Figure 2.30 shows the carbon sensor from 10-30 kHz for the increasing diameter holes in the adhesive at location 3 on the sensor end of the blade. Change in the impedance from baseline to damage states can clearly be seen in both cases. The remaining impedance plots for actual damage testing can be found in Appendix B.

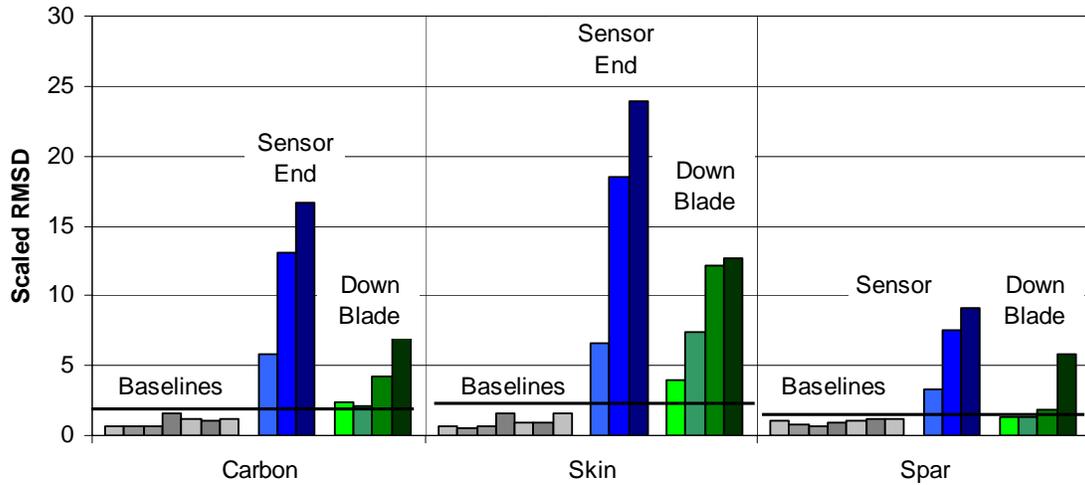
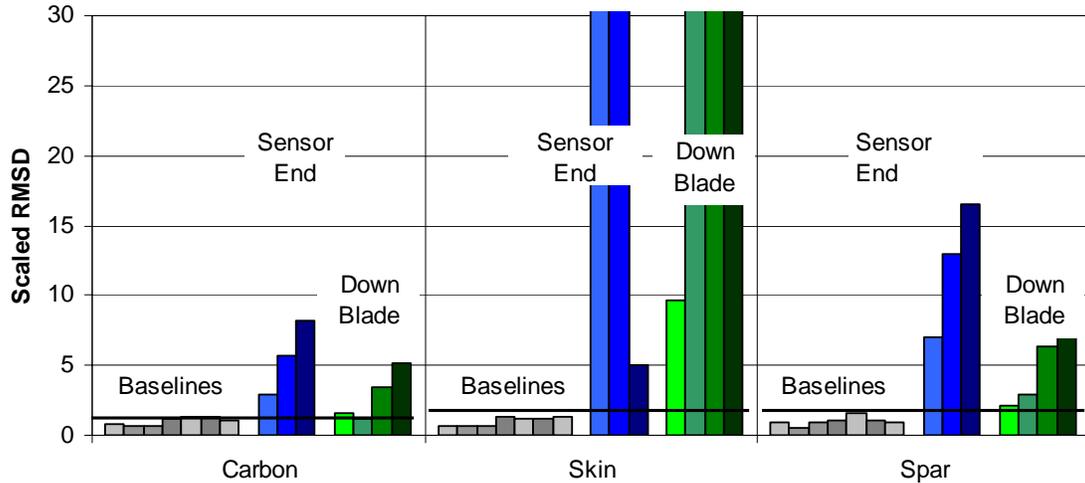
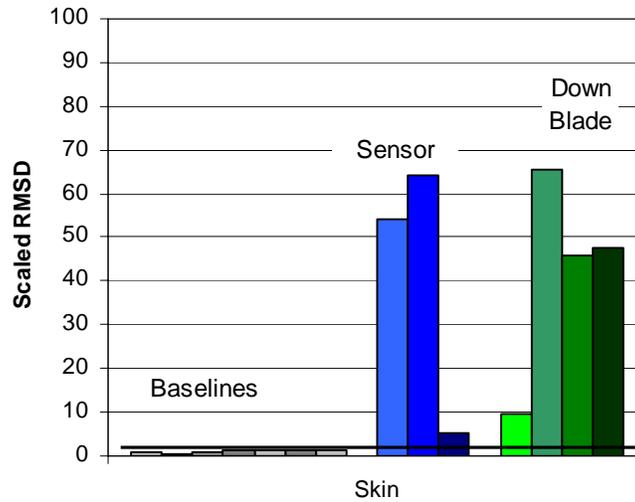
Figure 2.31: Damage metrics for location 1 actual damage tests, 10-30 kHz.

Figure 2.32: Damage metrics for location 1 actual damage tests, 30-60 kHz.

Figure 2.33: Damage metrics for location 1 actual damage tests, 30-60 kHz. Enhanced view of skin PZT

60 kHz range. Figure 2.33 shows the 30-60 kHz range for the skin PZT in more detail. Results are shown for both progressive damage at the sensor end of the blade and damage down the length of the blade for all three sensors. For each sensor, the first group is baselines, second is progressively larger gaps between carbon and balsa (darker shade indicates worse damage), and the third is gaps in carbon and balsa (31, 22, 12, and 3 cm from the sensors, darker shade indicates damage closer to sensor).

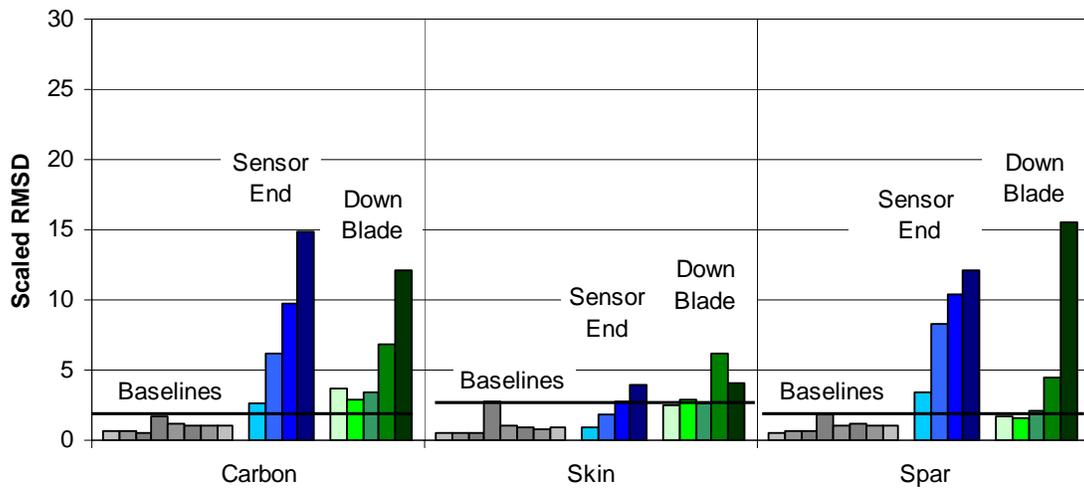
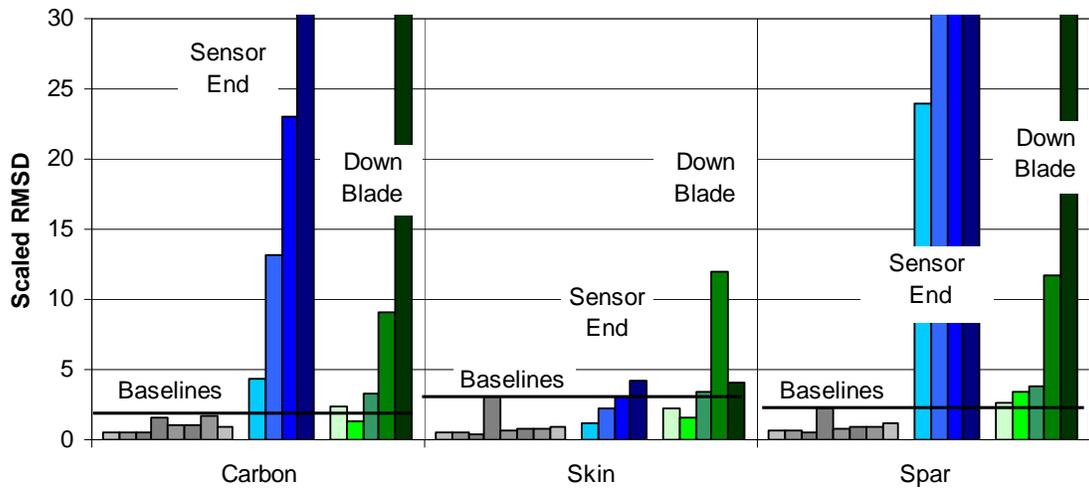
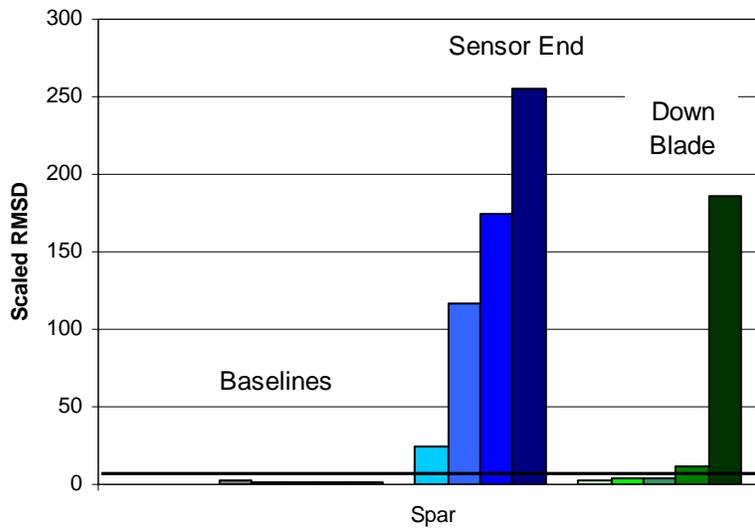
Figure 2.34: Damage metrics for location 3 actual damage tests, 10-30 kHz.

Figure 2.35: Damage metrics for location 3 actual damage tests, 30-60 kHz.

Figure 2.36: Damage metrics for location 3 actual damage tests, 30-60 kHz. Enhanced view for the spar PZT

Figure 2.34 shows the scaled RMSD damage metrics of the holes in the adhesive at location 3 for the 10-30 kHz frequency range and Figure 2.35 shows the 30-60 kHz range. Figure 2.36 shows the results of the spar PZT from 30-60 kHz in more detail. Results are shown for both progressive damage at the sensor end of the blade and damage down the length of the blade for all three sensors. For each sensor, the first group is baselines, second is progressively larger holes in adhesive as the shade gets darker, and the third is holes in adhesive getting closer to the sensors as shade gets darker (28, 20, 13, 5, and 0 cm from the sensors).

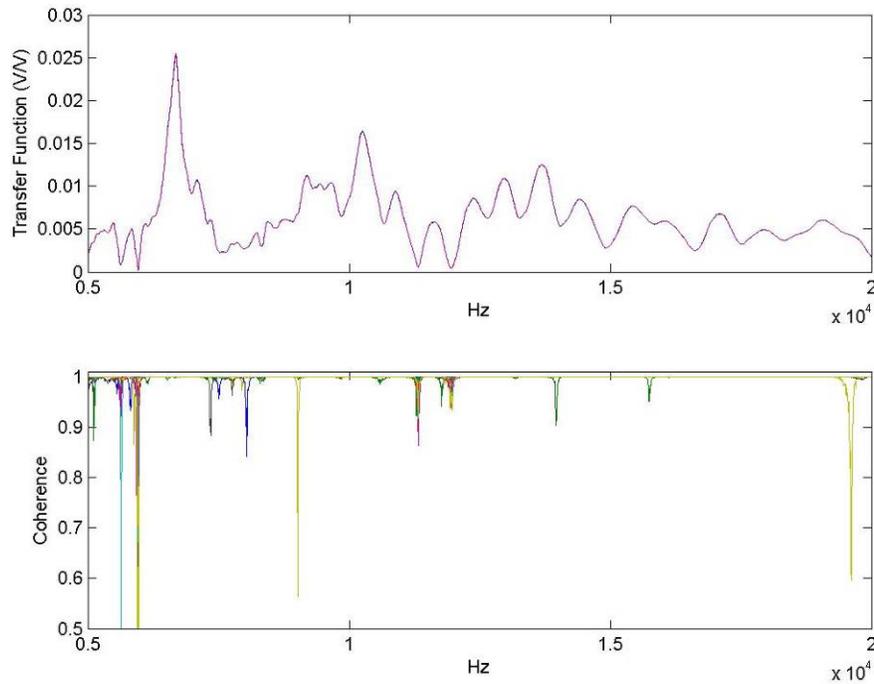
Figure 3.1: Baseline transfer function and coherence, skin/carbon PZTs, 1V random signal input

The baseline transfer function of the skin/carbon PZT combination is shown in Figure 3.1 along with its coherence for the 1 volt random signal excitation. The remaining baseline transfer functions along with their coherence are shown in Appendix C. The shape of the transfer function is similar to that of the impedance plots of the impedance method. Coherence is acceptable except for at resonances and anti-resonances. As seen in Appendix C, the coherence improves a small amount for the 5 volt input compared to the 1 volt input. All of the transfer functions have several peaks in the 5-20 kHz range.
