Impedance-Based Structural Health Monitoring of Wind Turbine Blades

Thesis submitted to the faculty of the Virginia Polytechnic Institute and State University
in partial fulfillment of the requirements for the degree of

Master of Science
in
Mechanical Engineering

August 31, 2007
Blacksburg, Virginia

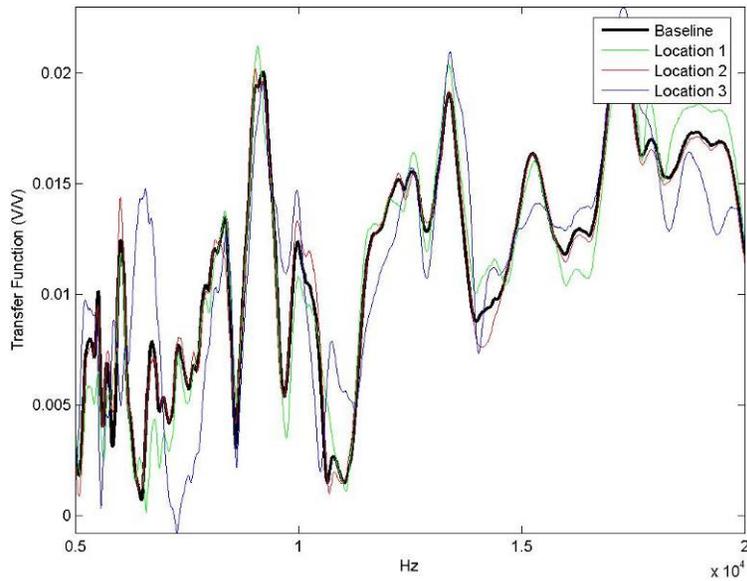
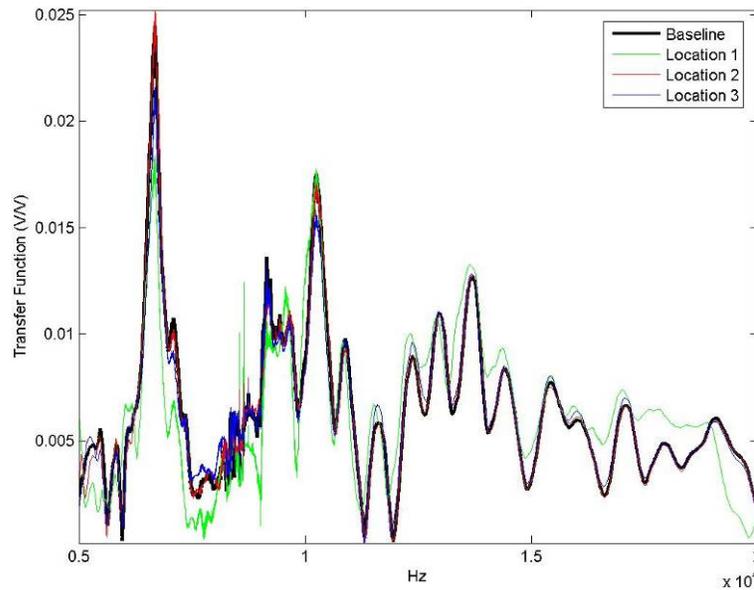
Figure 3.2: Spar/Carbon transfer function, 1V random signal, added stiffness

Figure 3.3: Skin/Carbon transfer function, 5V chirp signal, added mass

This section contains the results of the HFRF method tests using indirect damage on the sensing end of the blade. Examples of the transfer function plots are shown in the following figures. Figure 3.2 shows the transfer function of the spar/carbon PZT combination for the added stiffness test with the 1 volt random excitation signal. Figure 3.3 shows the transfer function of the skin/carbon PZT combination for the added mass test with the 5 volt random excitation signal. Change from baseline to damage states can clearly be seen in the transfer functions. The remaining transfer function plots for the HFRF indirect damage tests can be found in Appendix C.

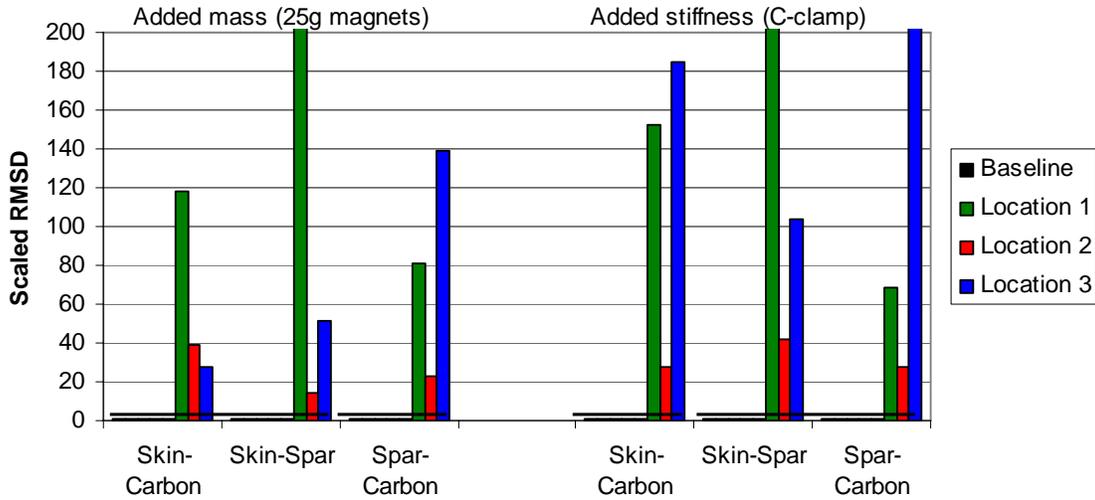
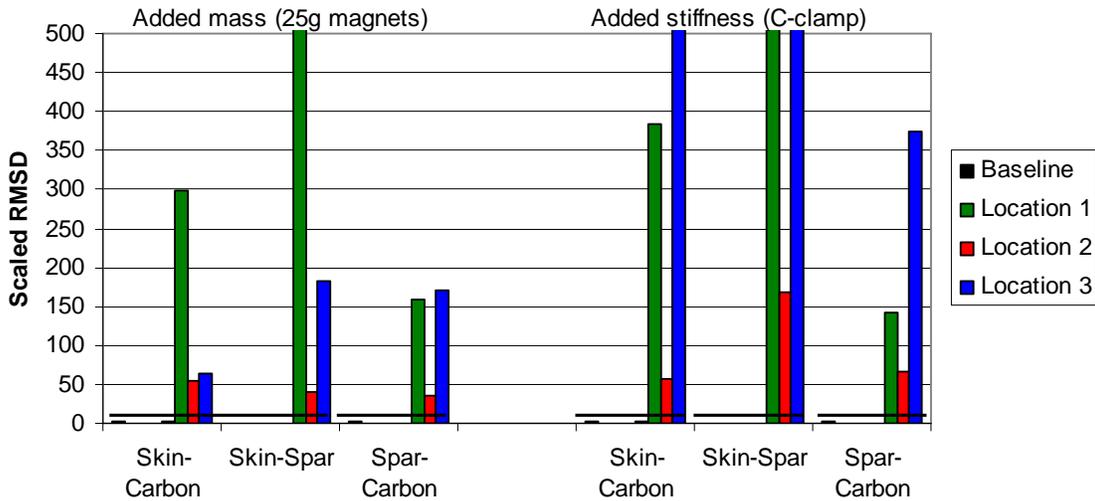
Figure 3.4: Added mass (25g) and stiffness (C-clamp) at sensor end. 1V random signal input

Figure 3.5: Added mass (25g) and stiffness (C-clamp) at sensor end. 5V chirp signal input

for IBSHM in Chapter 2, in the damage metric charts each group of damage metrics are scaled so that the average of baseline metrics is equal to one.

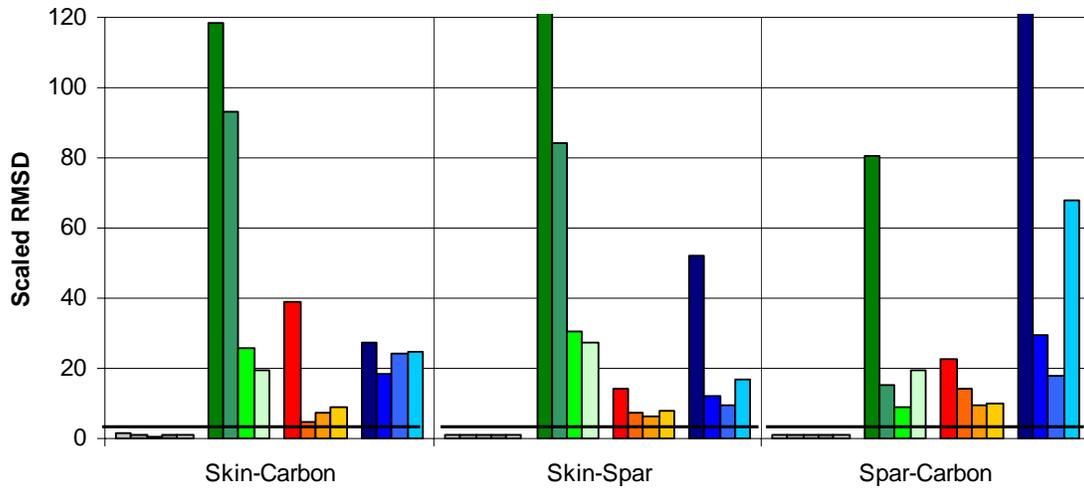
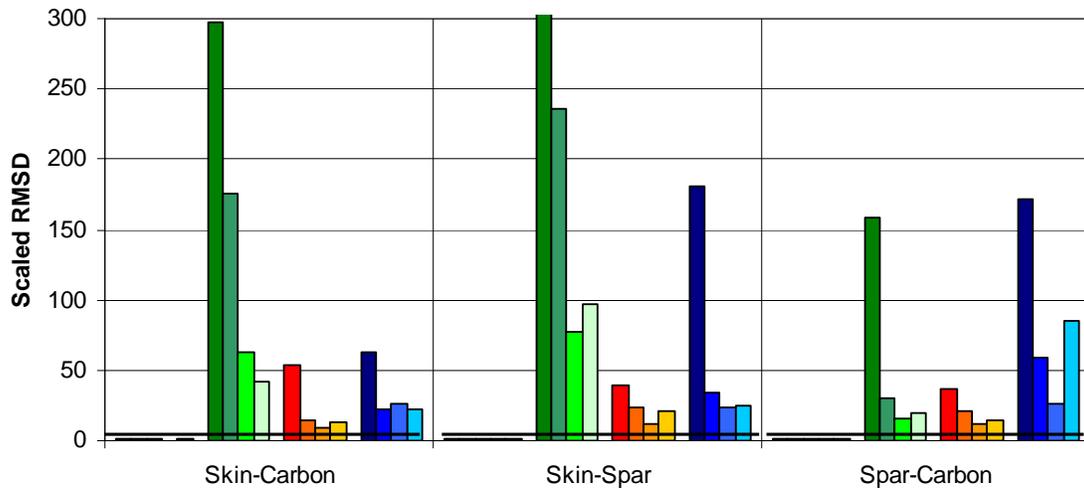
Figure 3.6: Moving mass results. 1V random signal input.

Figure 3.7: Moving mass results. 5V chirp signal input.

This section contains the results of tests on all three input/output PZT combinations where the 25 gram magnets were used to simulate damage in locations 1, 2, and 3 down the blade section. These tests were run at the sensor end and at locations 13, 25, and 40 inches down the blade. Damage metric results are shown in Figure 3.6 and Figure 3.7 for the 1 volt random signal and 5 volt chirp input signals respectively. These figures have 4 results for each location. Each color group is for a specific location (green for location 1, red for location 2, and blue for location 3) and as the damage is moved further down the blade (13, 25, and 40 cm) the shade of the color gets lighter.

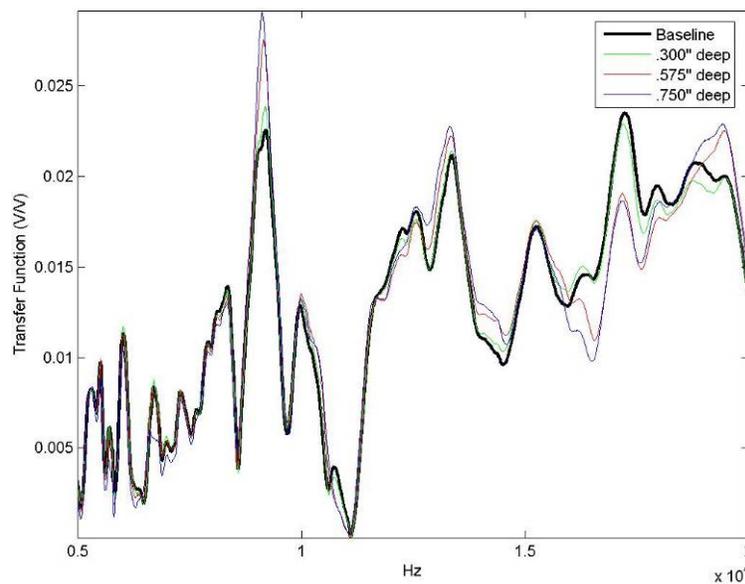
Figure 3.8: Spar/carbon PZT combination, location 1 split at sensor end

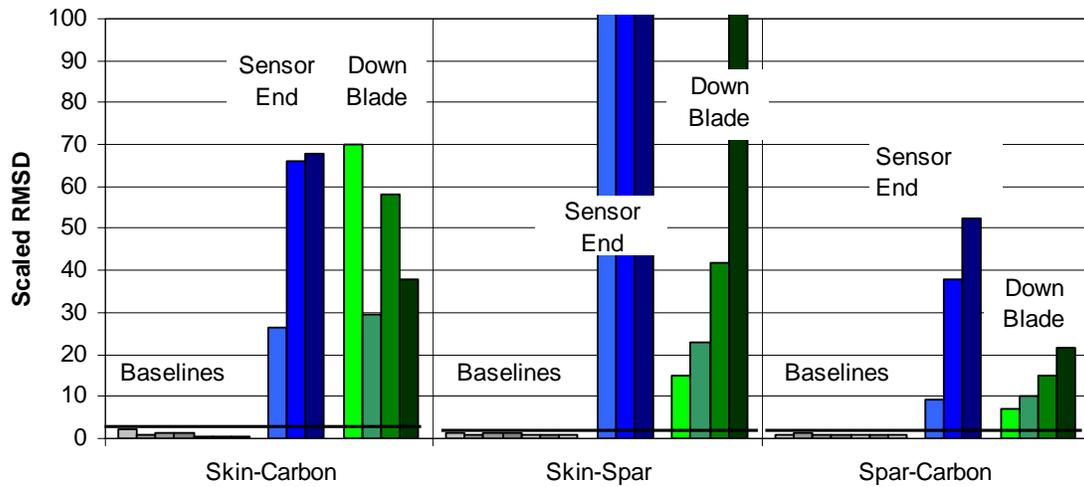
Figure 3.10: Damage metrics for location 1 actual damage HFRF test

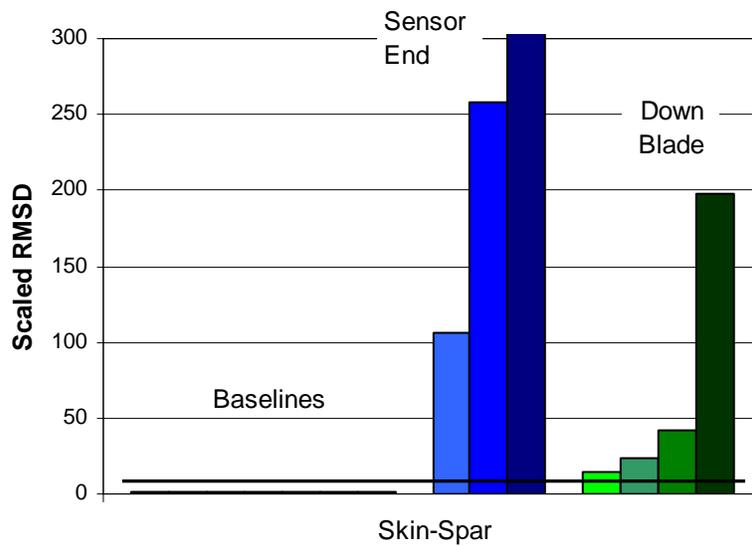
Figure 3.11: Damage metrics for location 1 actual damage HFRF test, enhanced view of skin/spar PZT combination

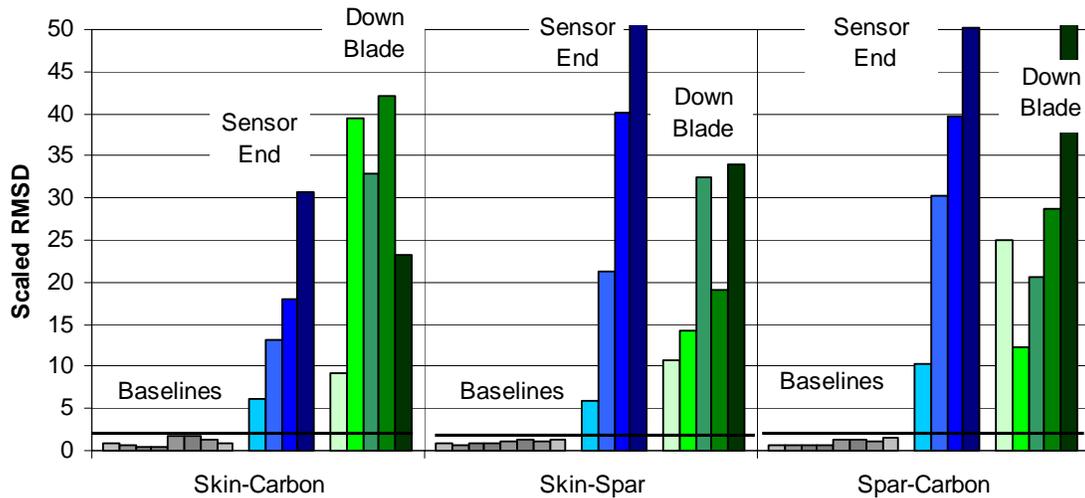
Figure 3.12: Damage metrics for location 3 actual damage HFRF test

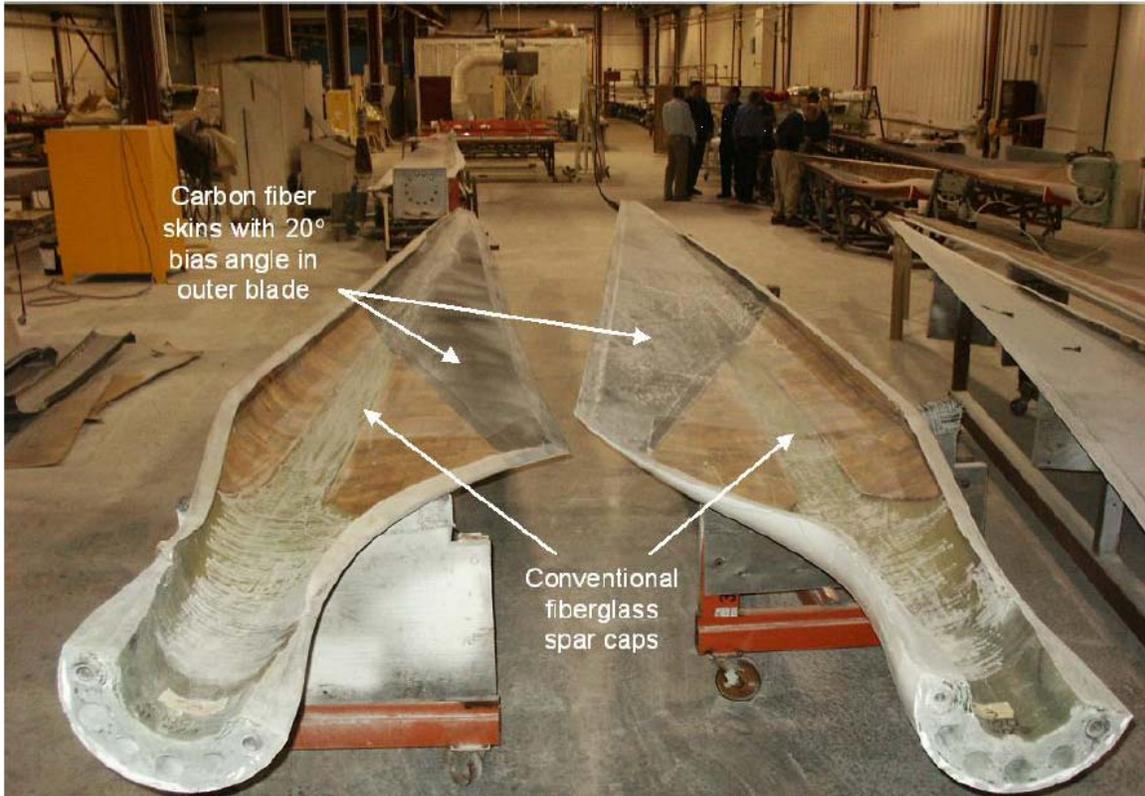
Figure 4.1: TX-100 HP and LP skins showing implementation of carbon fiber into design. (Paquette *et al.* 2006)

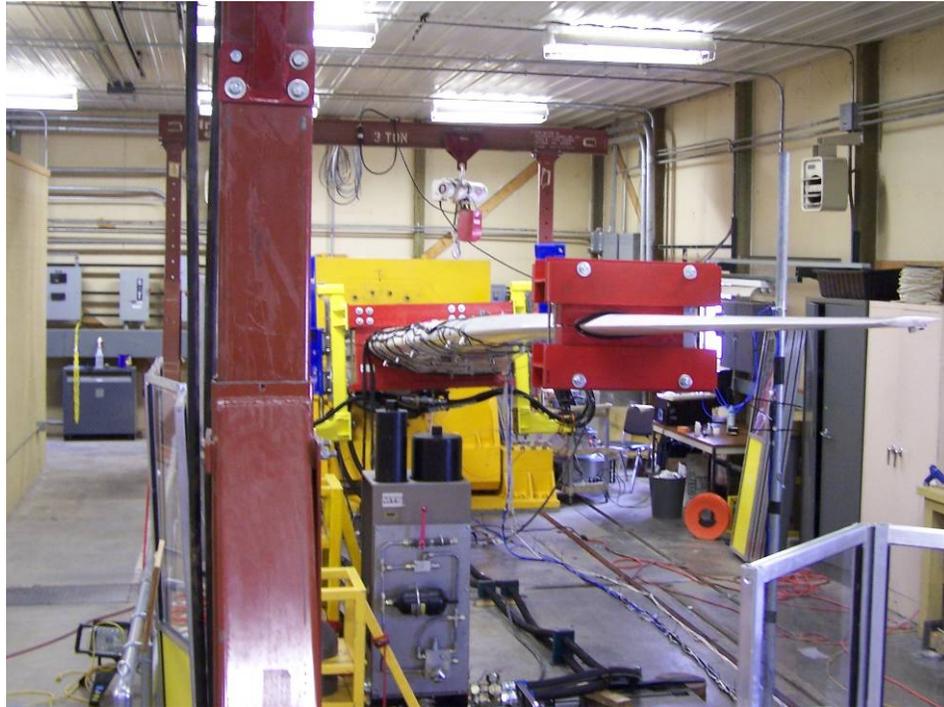
Figure 4.2: TX-100 fatigue test setup

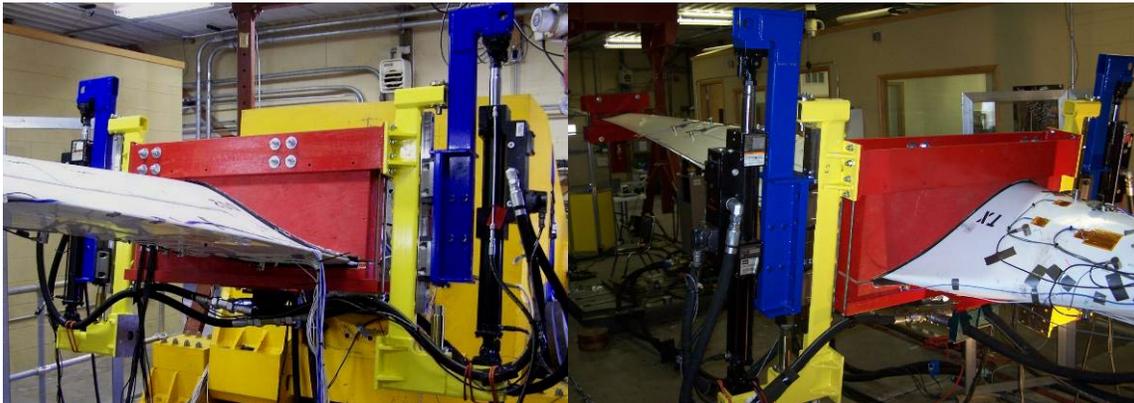
Figure 4.3: UREX inboard saddle

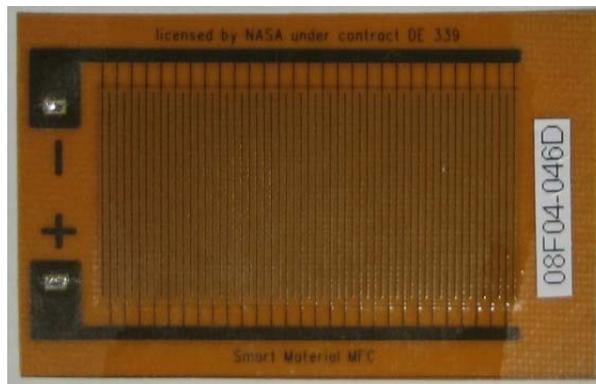
Figure 4.4: Smart Material MFC, model number M2814 P1, 28x14mm active area, 37x17mm overall

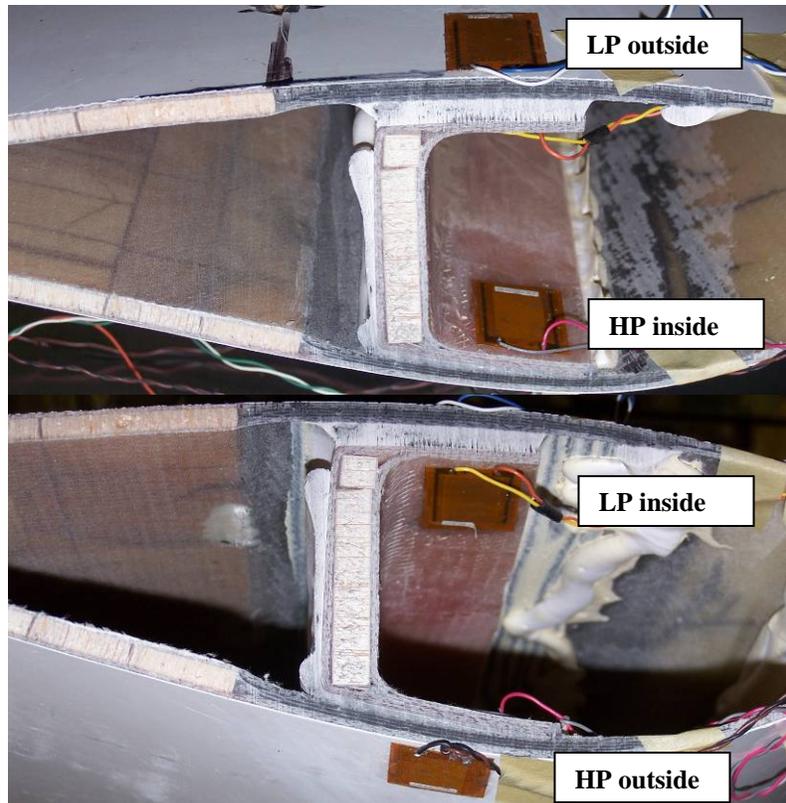
Figure 4.6: MFC locations on CX-100 WTB section

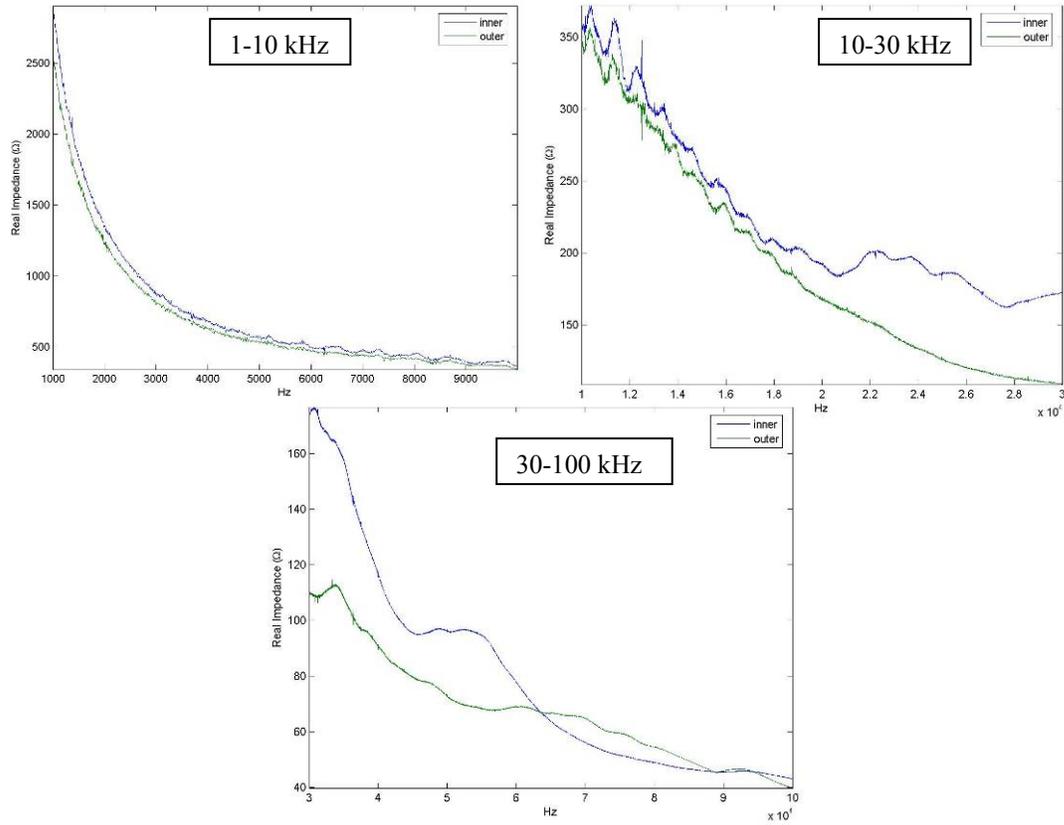
Figure 4.7: Baseline impedance for inner and outer LP MFC

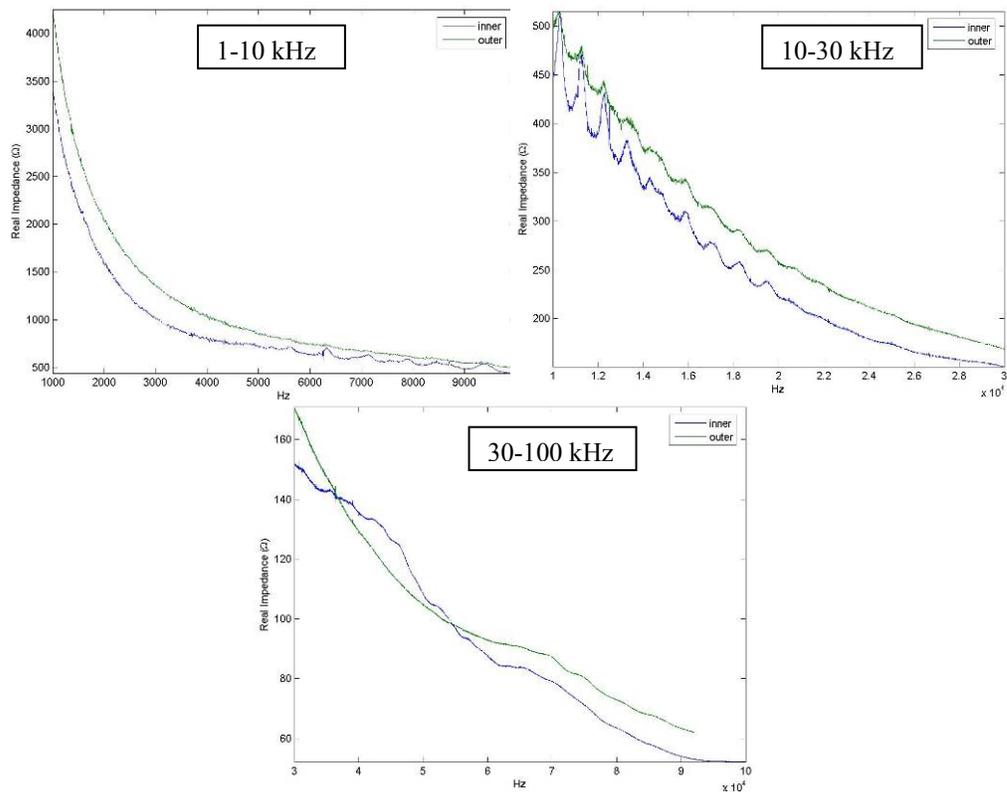
Figure 4.8: Baseline impedance for inner and outer HP MFC

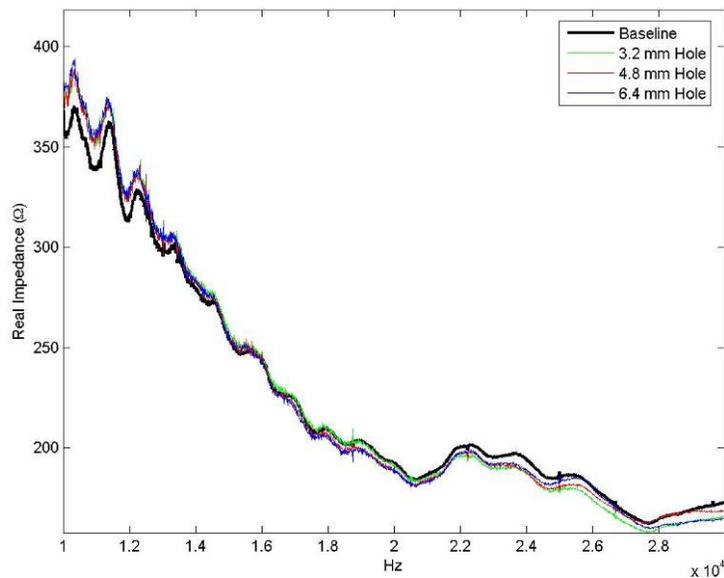
Figure 4.9: Impedance plot for LP inner MFC, progressively larger holes in adhesive

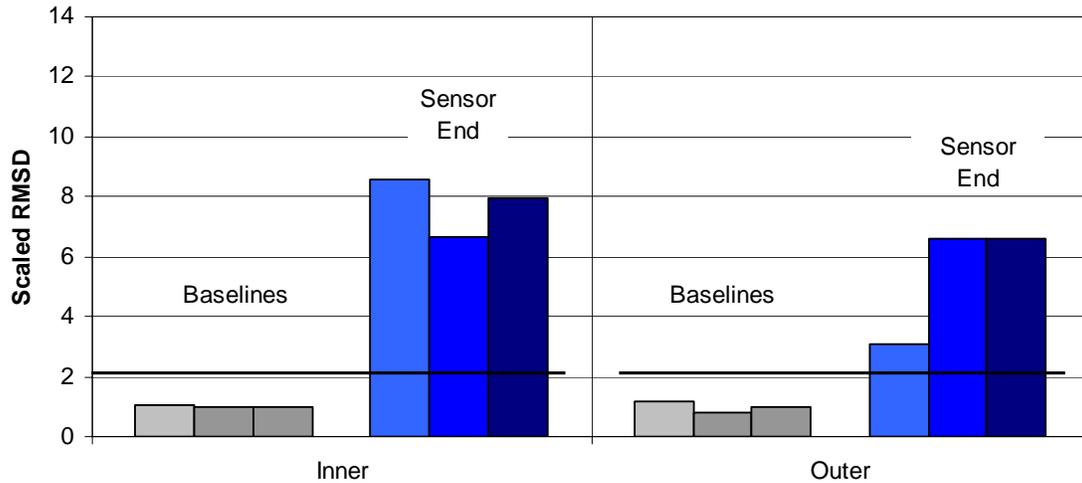
Figure 4.11: Damage metrics for LP inner and outer MFC, progressively larger holes in adhesive

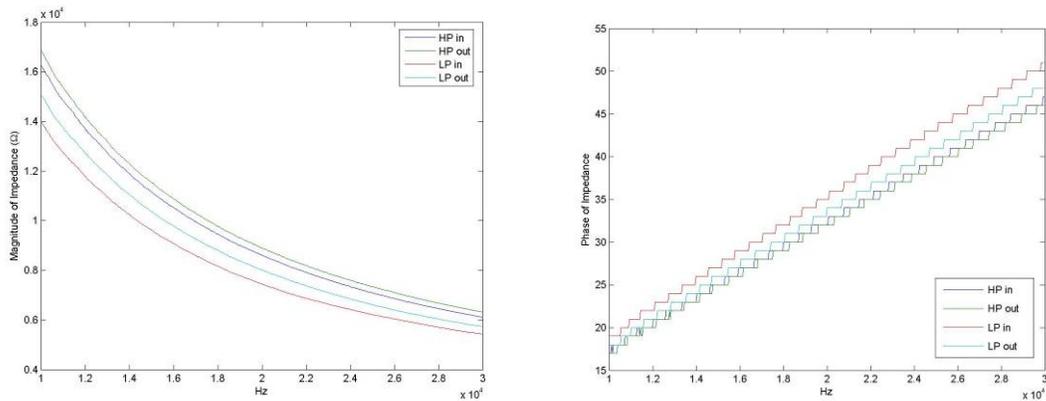
Figure 4.12: Magnitude and phase of baseline impedance for 4 MFCs: AD5933.

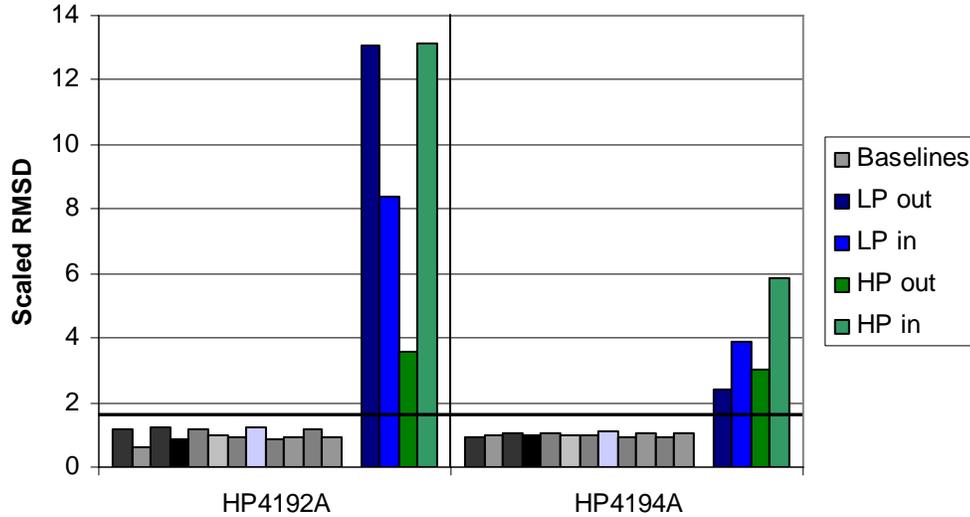
Figure 4.14: Damage metrics comparing HP4194A and HP4192A results of indirect damage test using MFCs

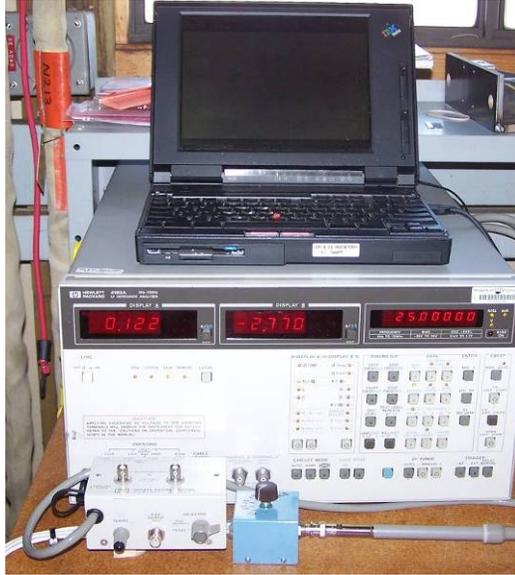
Figure 4.15: IBSHM measurement setup for TX-100 fatigue test. Laptop, HP4192A impedance analyzer and switch box.

The HP4192A was shipped to NWTC for the fatigue test along with a laptop running Piezoelectric Resonance Analysis Program (PRAP) version 2.1 software to control the impedance analyzer and record data. This setup can be seen in Figure 4.15. Also seen in this figure and in a closer view in Figure 4.16 is a switchbox. The switchbox was built so that all 6 MFCs that were bonded to the blade could be connected to the impedance analyzer simultaneously, and then one could be selected at a time to be input. This greatly simplified the routine for collecting impedance data.

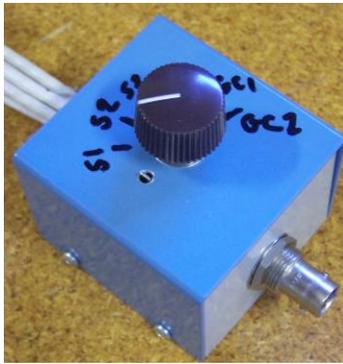
Figure 4.16: Switch box to input 6 MFCs into HP4192A for TX-100 fatigue test.

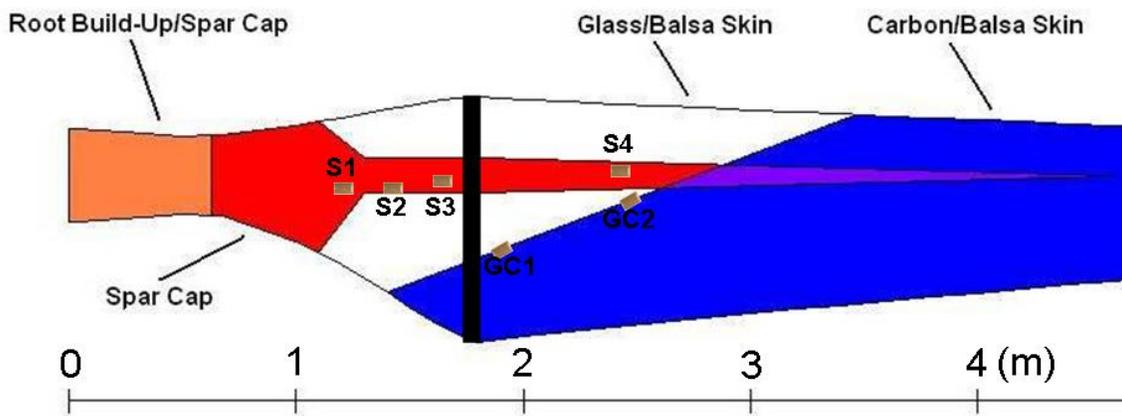
Figure 4.17: Layout of MFCs for IBSHM on TX-100 schematic.

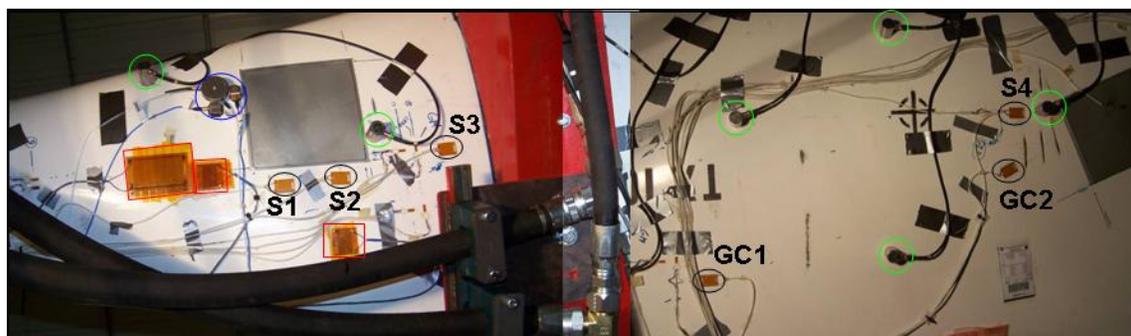
Figure 4.18: Picture of MFC layout on downward facing (LP) side of TX-100. Also shown are sensors for other damage detection methods.

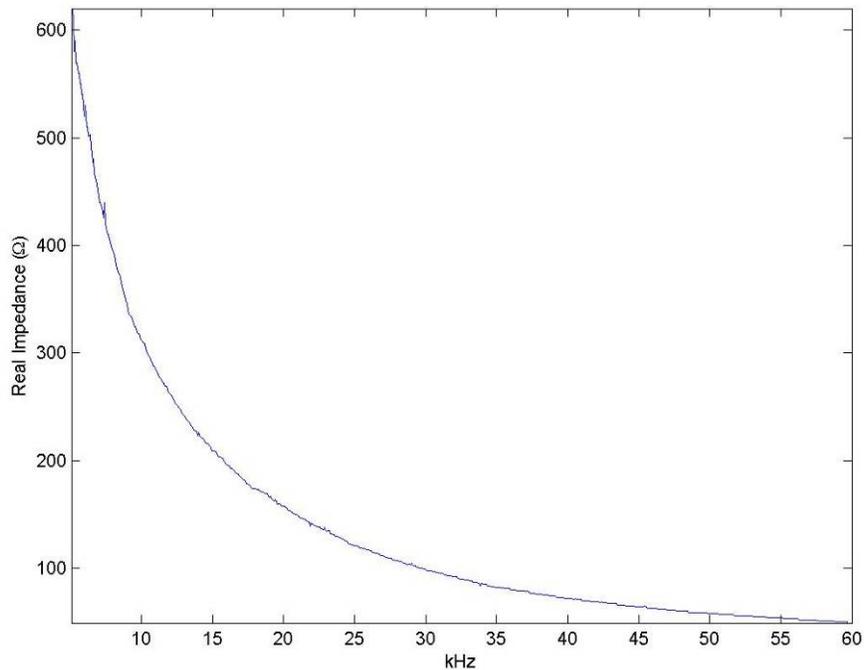
Figure 4.19: Baseline impedance plot for s3 MFC, 5-60 kHz

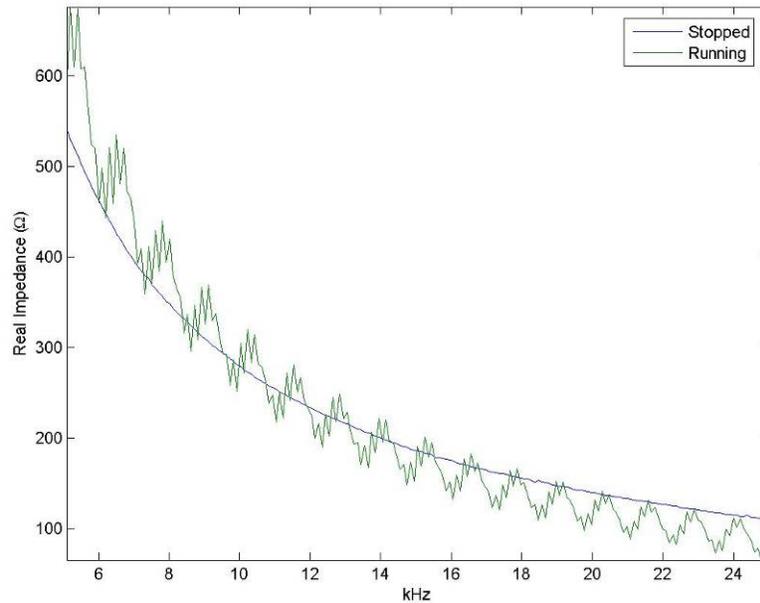
Figure 4.20: Impedance signature of s3 MFC, both with fatigue test stopped and running illustrating “beat” frequency

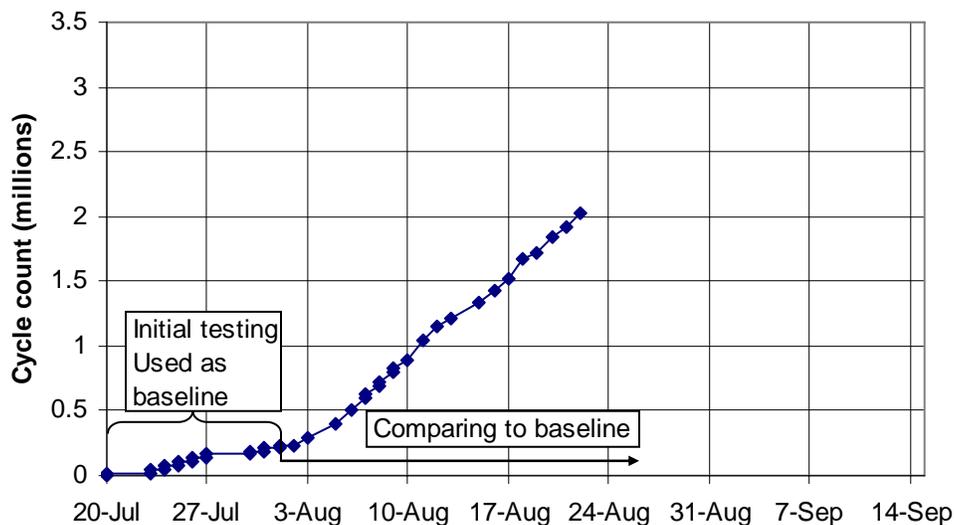
Figure 4.21: Graph of fatigue test cycle count showing where baseline measurements took place.

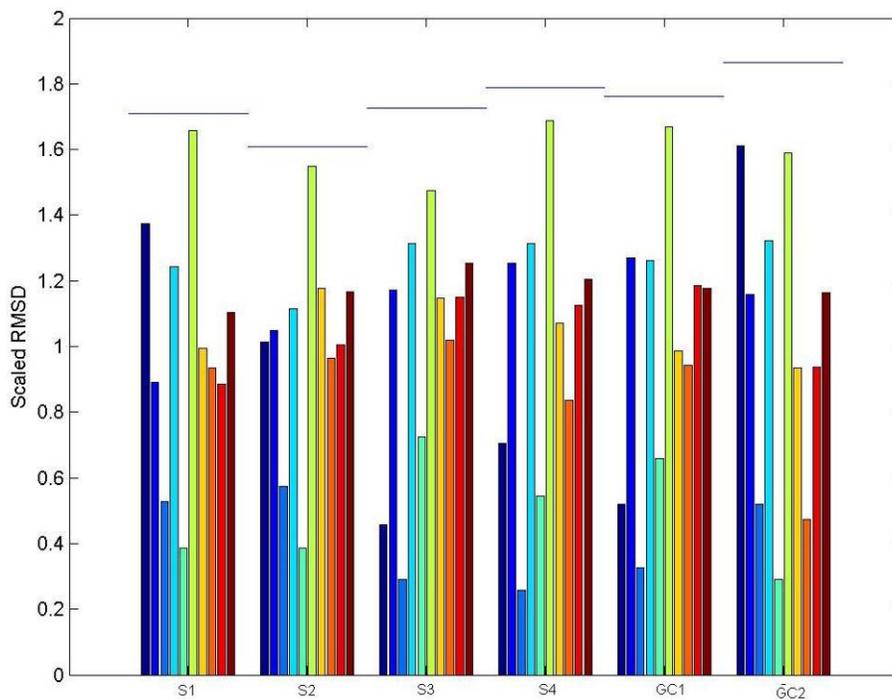
Figure 4.22: Baseline damage metrics for fatigue test for 6 MFCs shown with resulting damage thresholds.

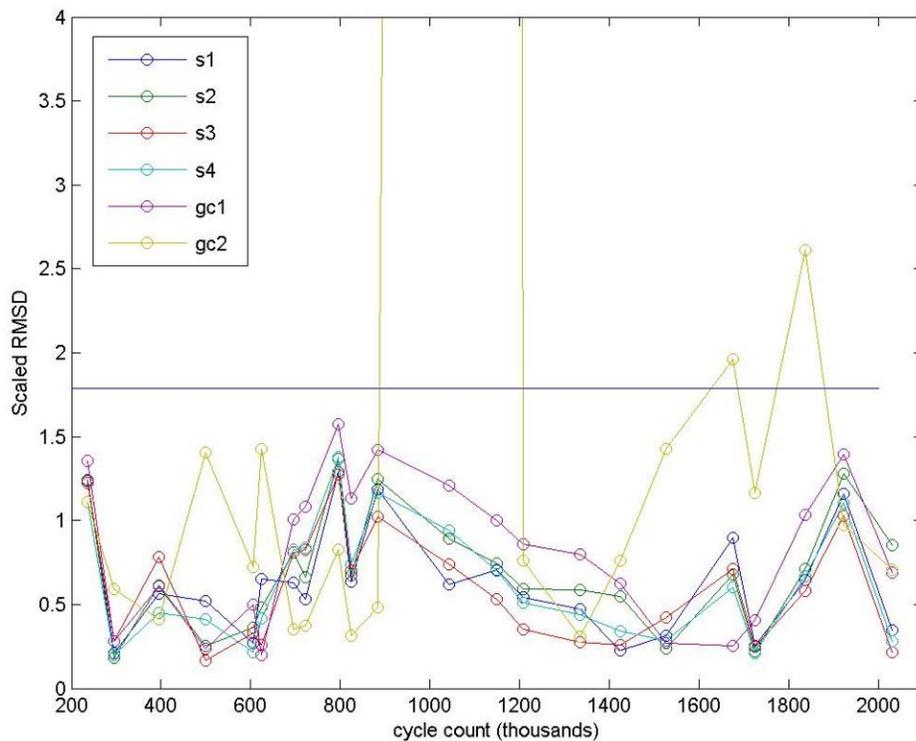
Figure 4.23: Damage metrics for fatigue test plotted versus cycle count and shown with damage threshold.

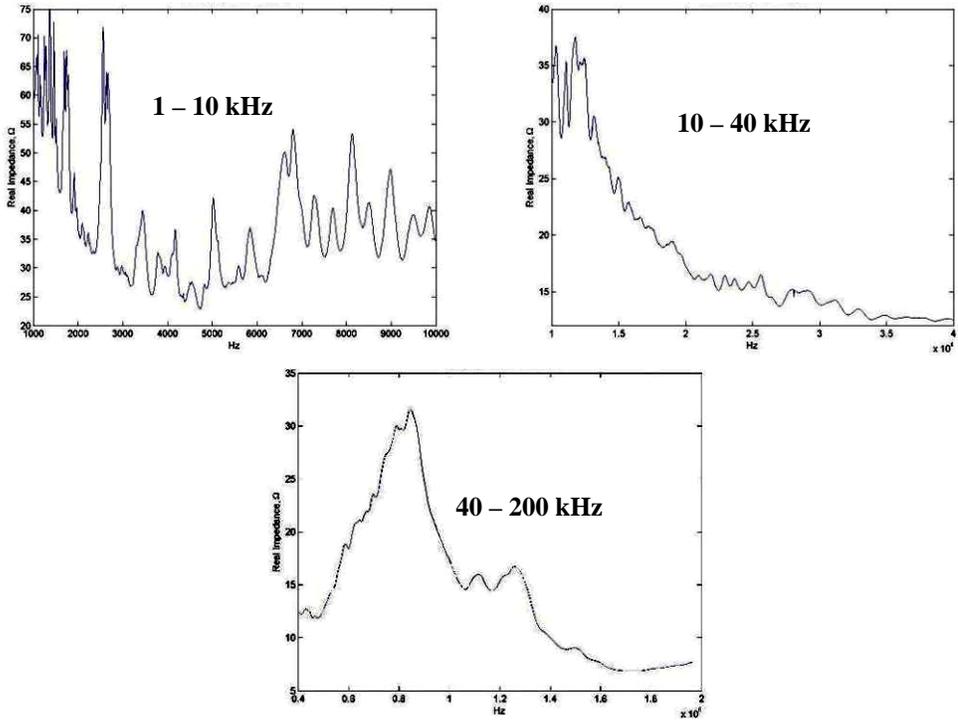
Top/Skin Baseline Impedance
