EVALUATING ABRASIVE WEAR RESISTANCE OF EXTRUDER TOOLING
MATERIALS USING THE DRY SAND RUBBER WHEEL ABRASION TEST

Thesis submitted to the faculty of the
Virginia Polytechnic Institute and State University
in partial fulfillment of the requirements
for the degree of

Materials Engineering

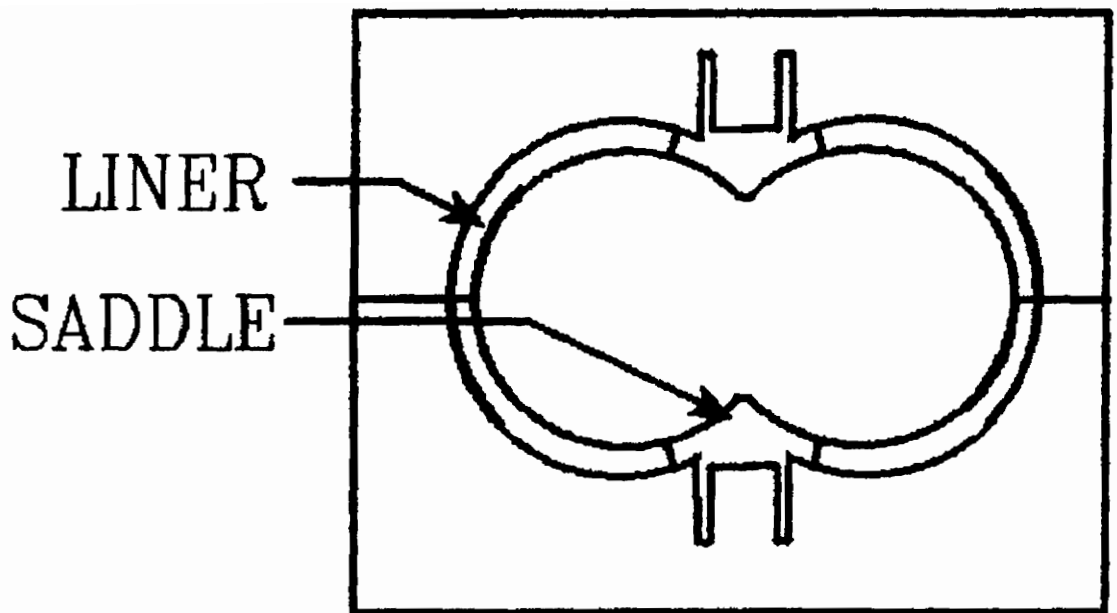
Figure 1: Schematic of an extruder barrel showing liners and saddles

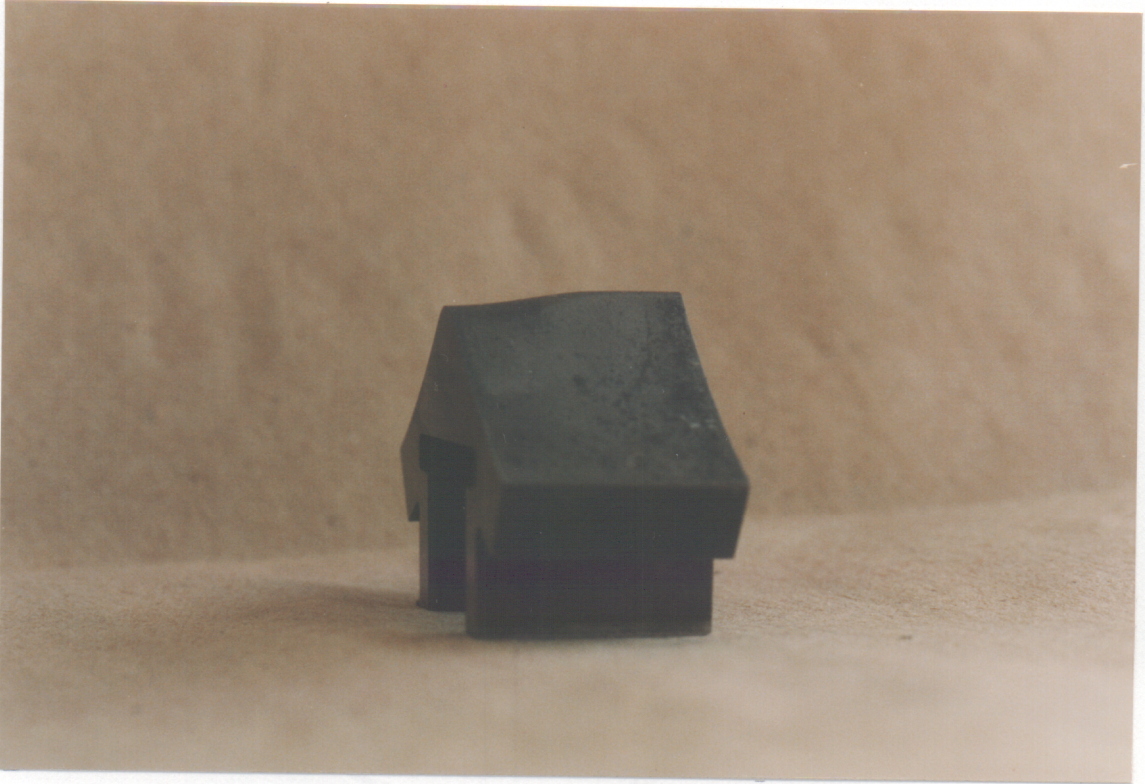
Figure 2: Worn saddle returned from service

Examination of field worn parts shows that wear occurs initially, and most severely, on the ridge of the saddle and on the outer corners of the mixing elements. Wear of the saddle is illustrated in Figure 2 and the equivalent region of a linerless barrel is shown in Figure 3. The wear regions on a typical mixing element are shown in Figure 4. Note that

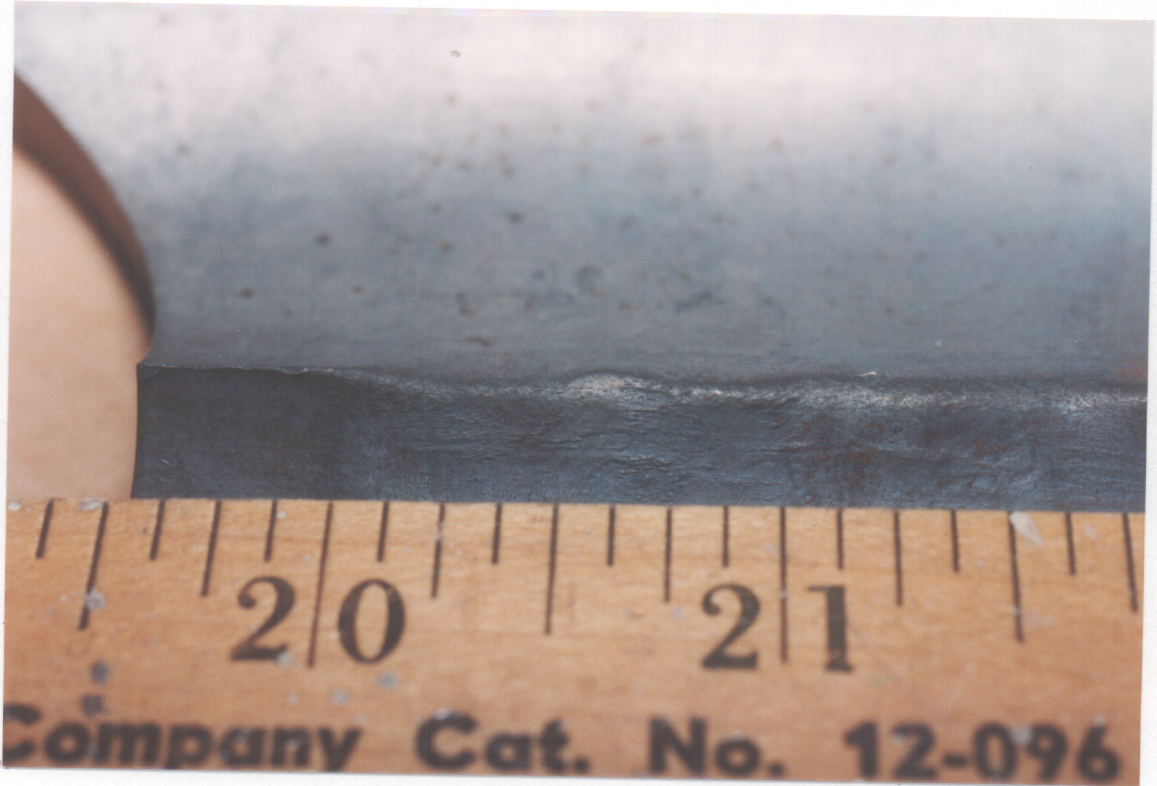
Figure 3: Worn saddle region of a linerless barrel

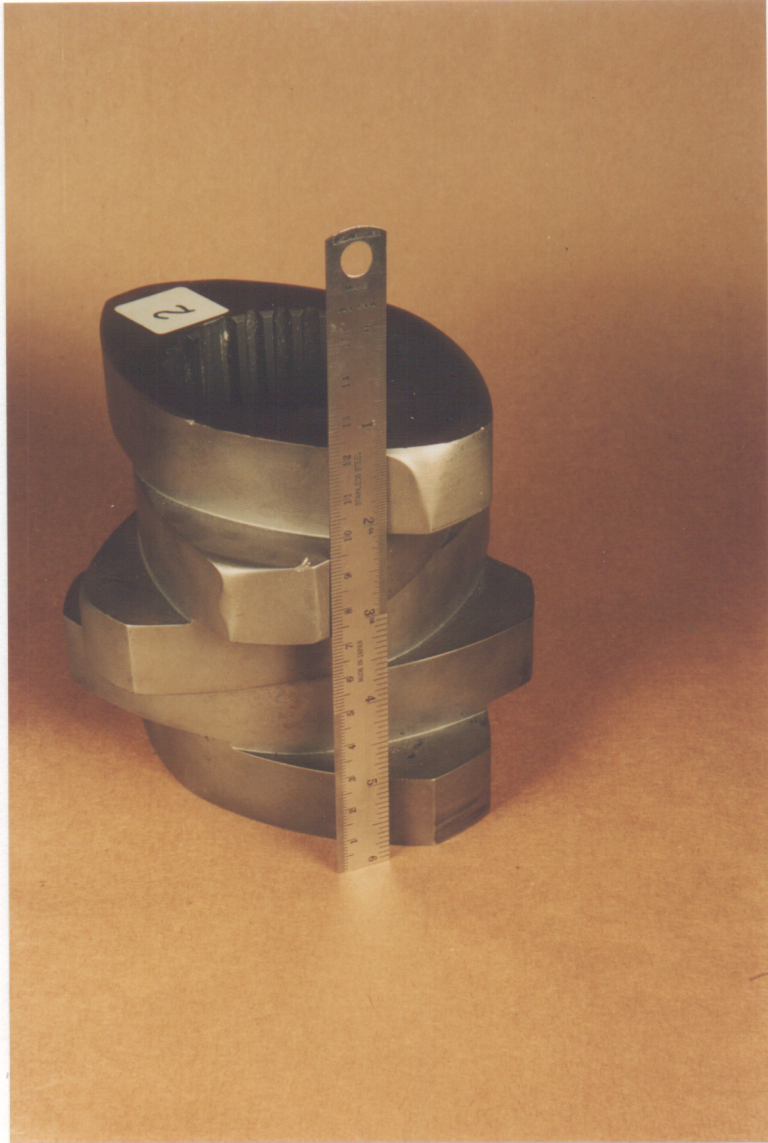
Figure 4: Worn mixing element removed from service

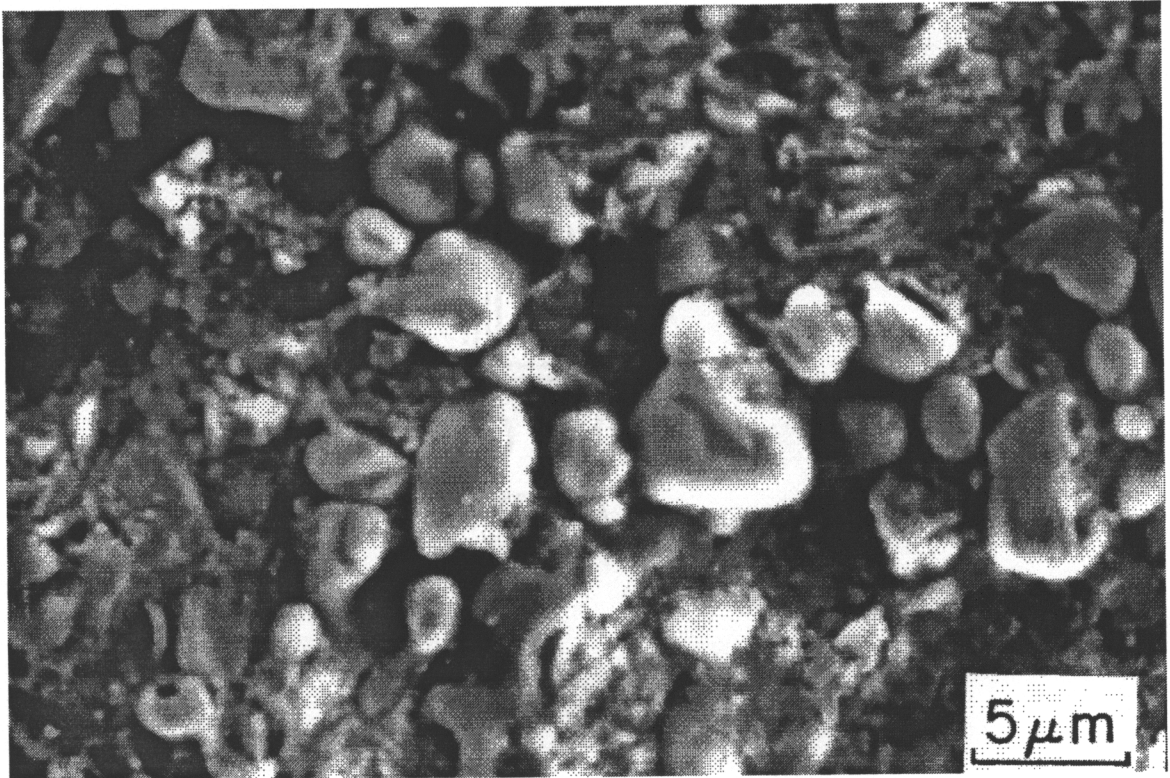
Figure 5: Surface morphology of high wear region of saddle

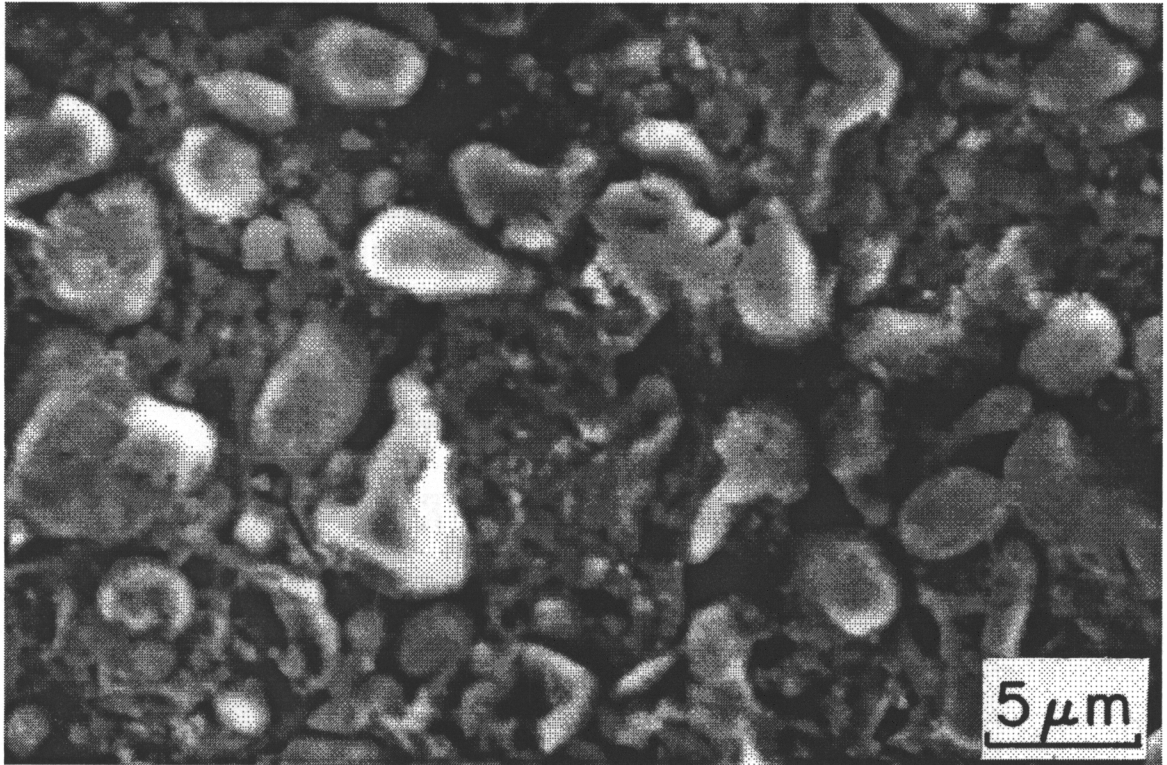
Figure 6: Surface morphology of low wear region of a saddle

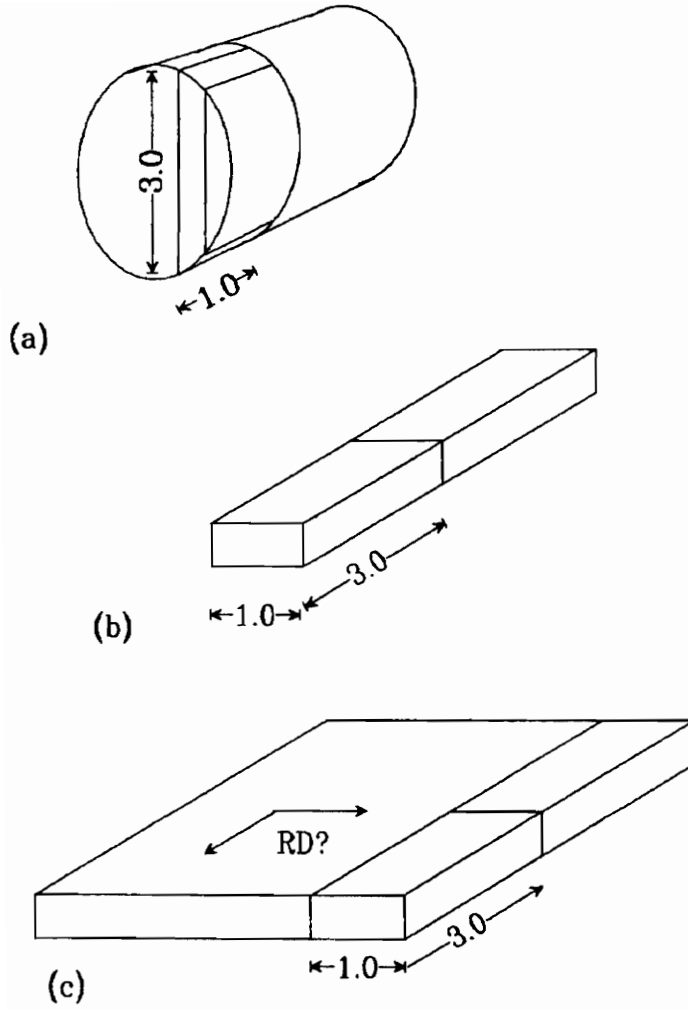
Figure 7: Sample configuration and orientation

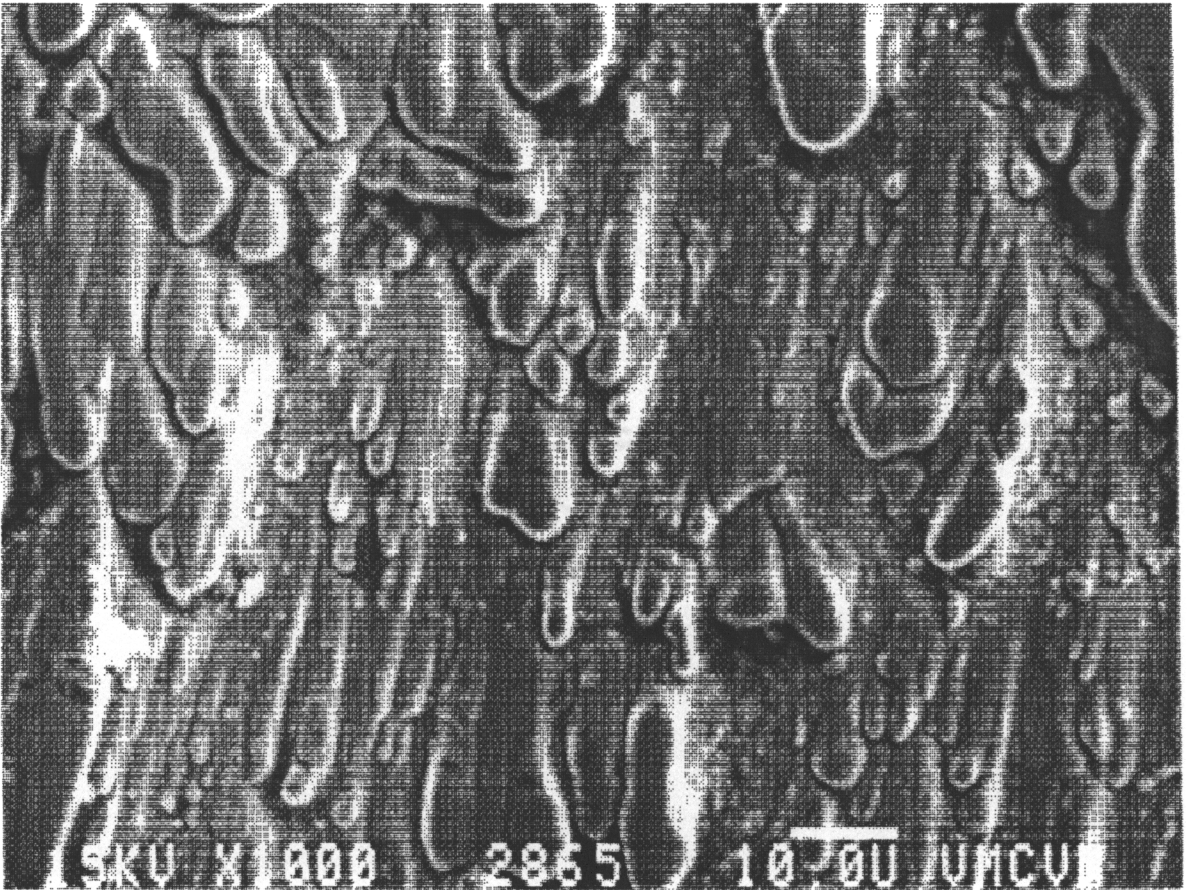
Figure 16: "Galled" region of D-2 steel wear scar abraded by Glasgrain fused silica showing exposed carbides

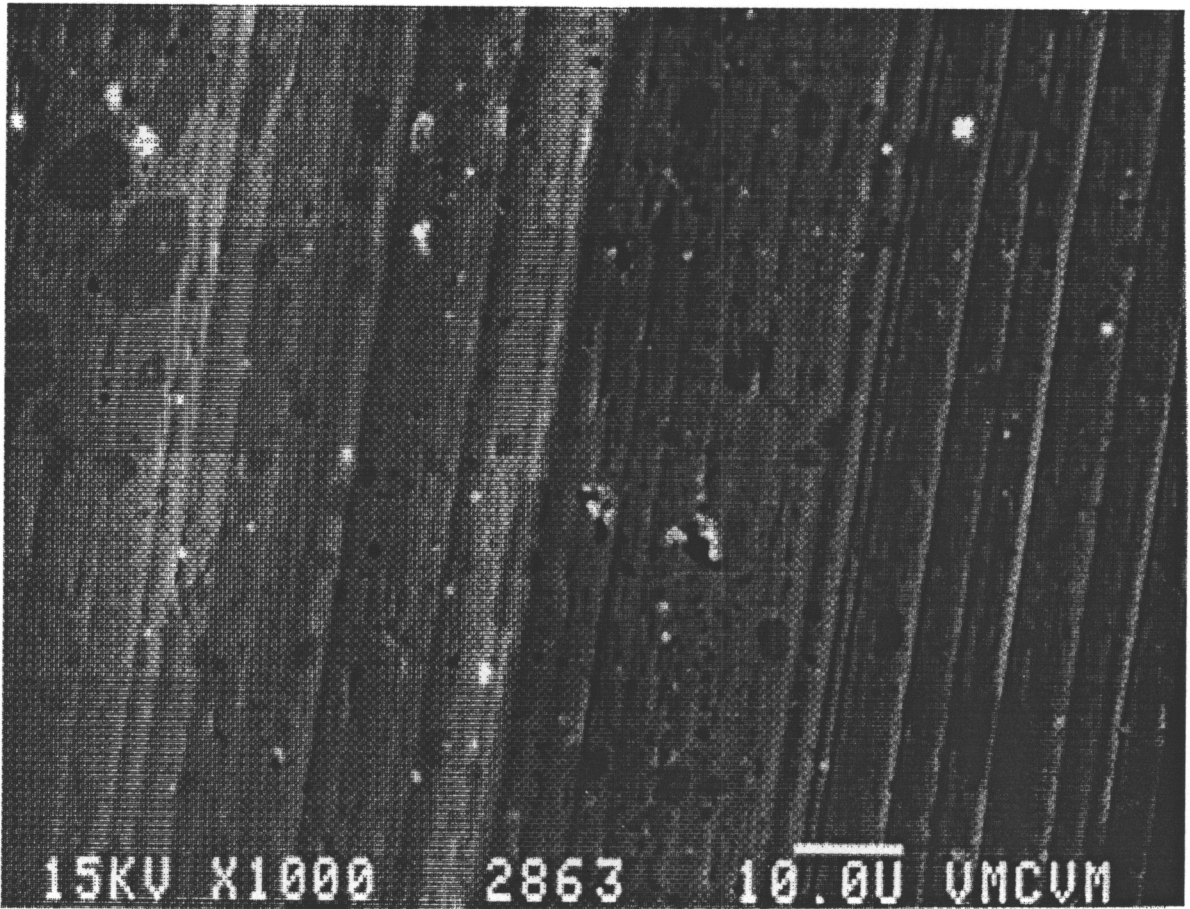
Figure 17: "Polished" region of D-2 wear scar abraded by Glasgrain showing linear scratches .

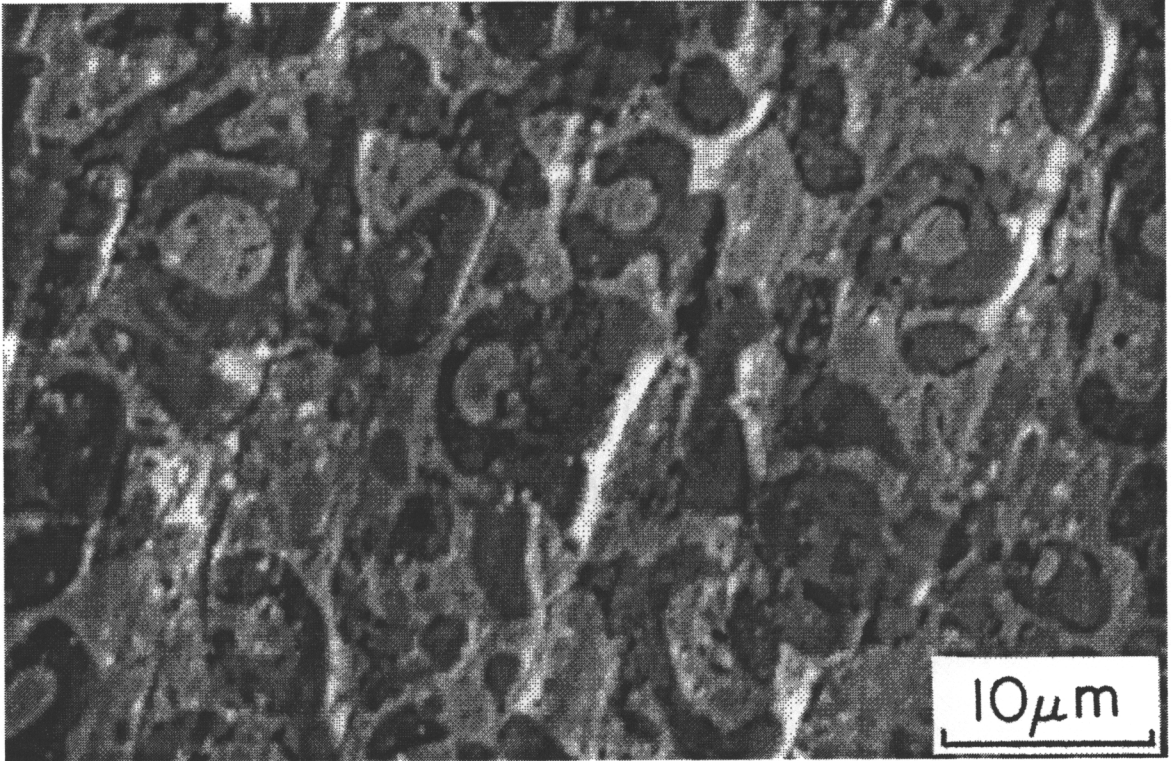
Figure 18: Wear scar surface of FerroTiC abraded by Glasgrain fused silica

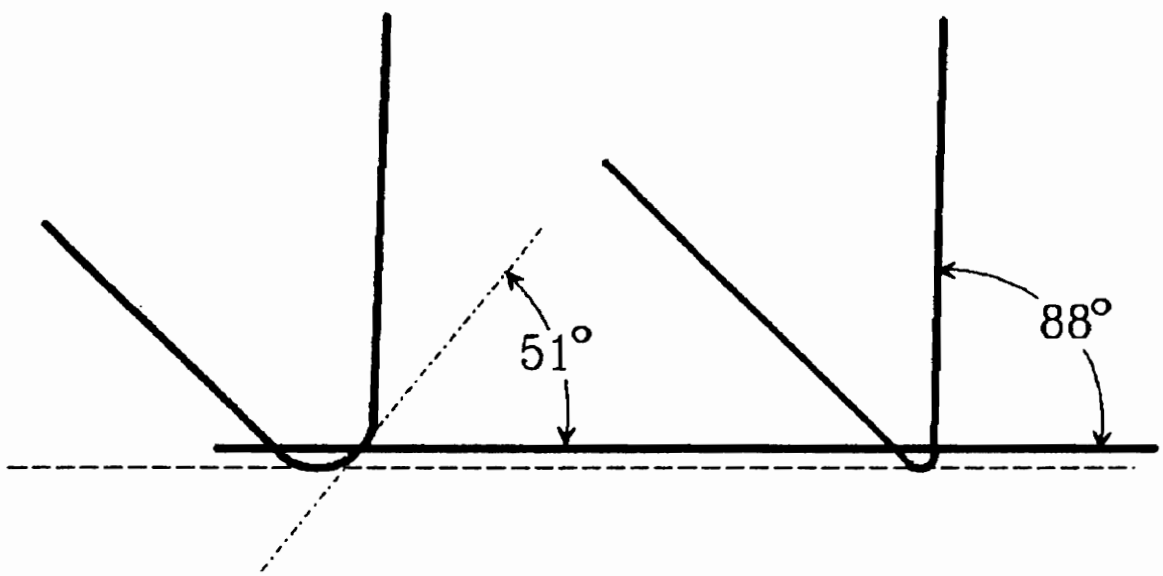
Figure 19: Effect of asperity tip radius on critical angle

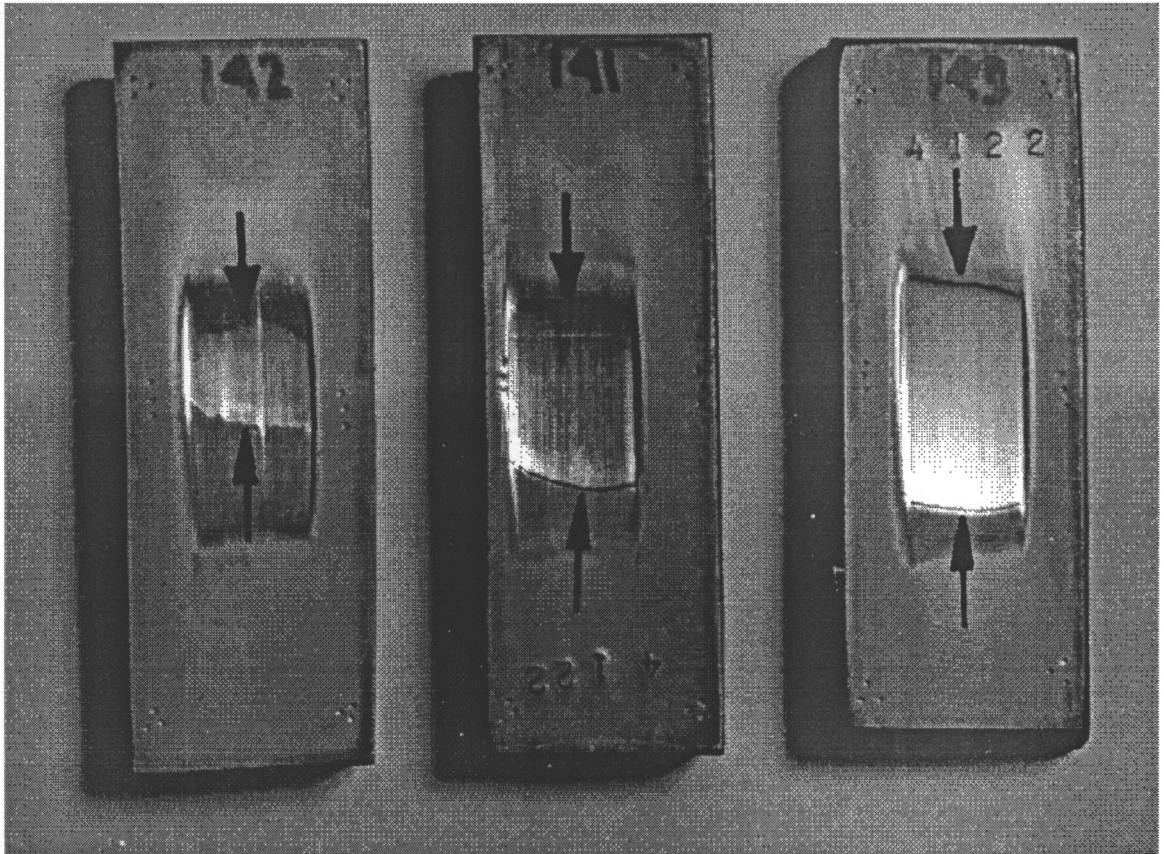
Figure 22: Interrupted test samples showing movement of the wear scar with test duration.

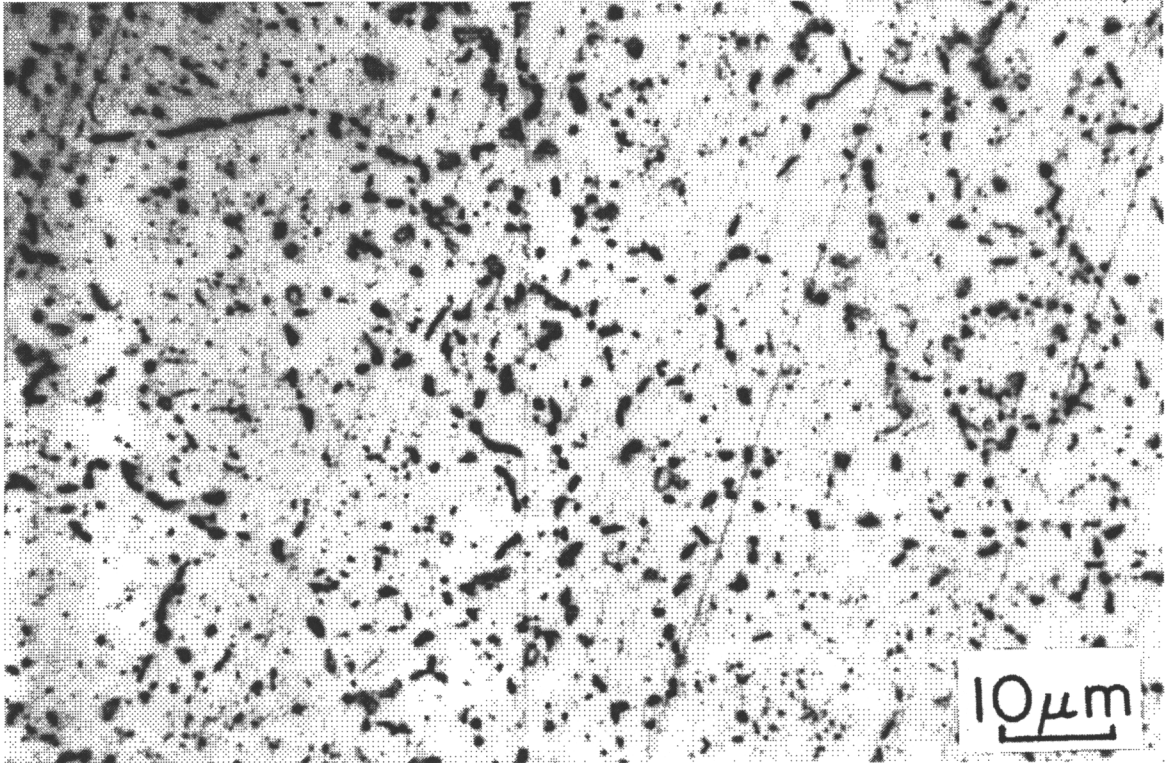
Figure 23: Microstructure of Thyssen 4122.

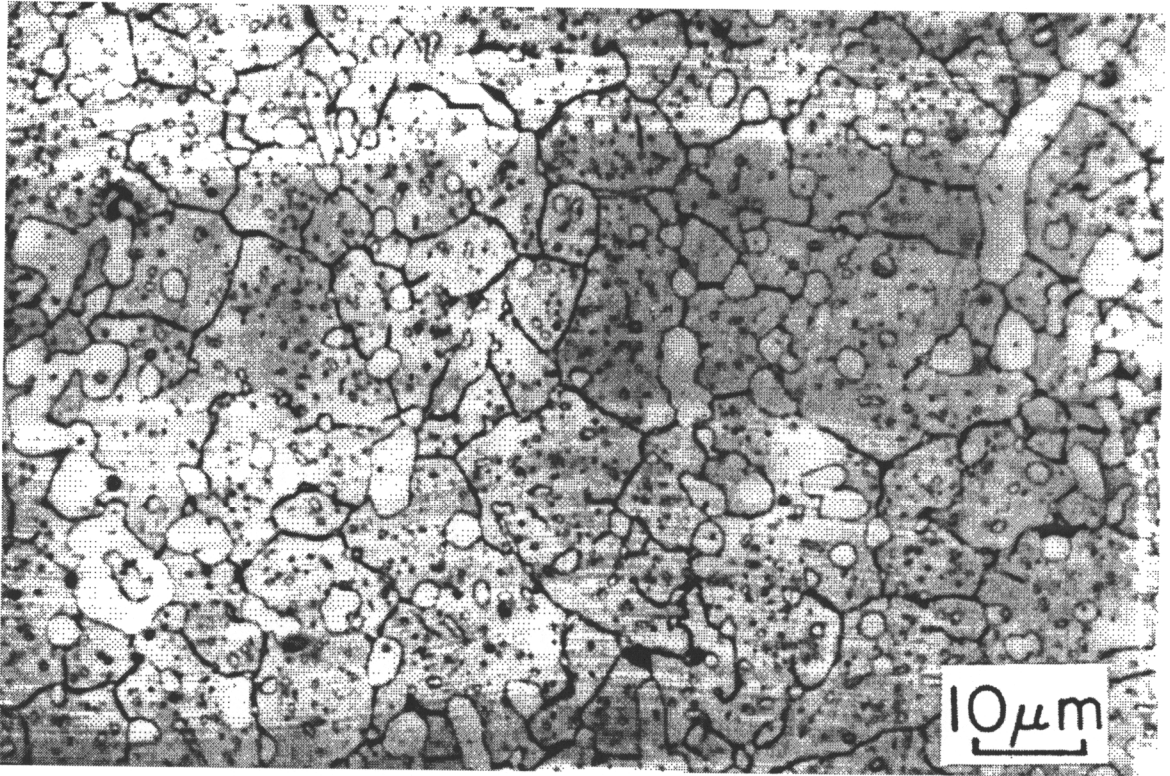
Figure 24: Microstructure of D-2 tool steel.

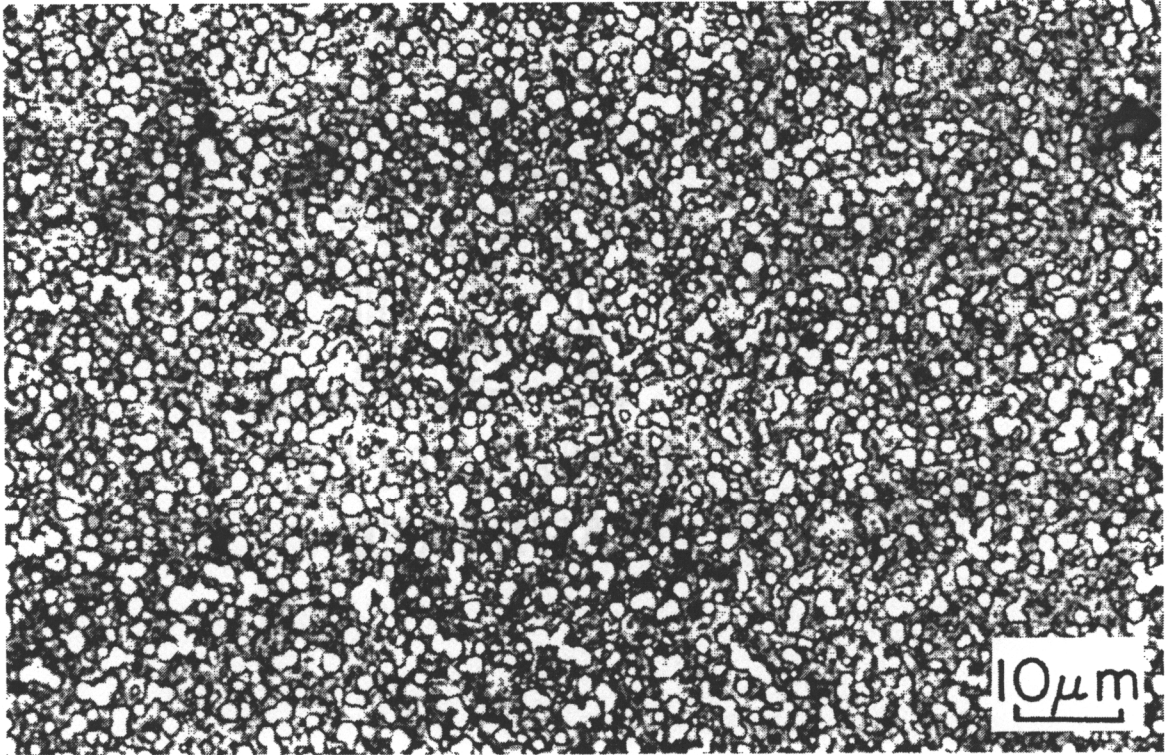
Figure 25: Microstructure of CPM10V.

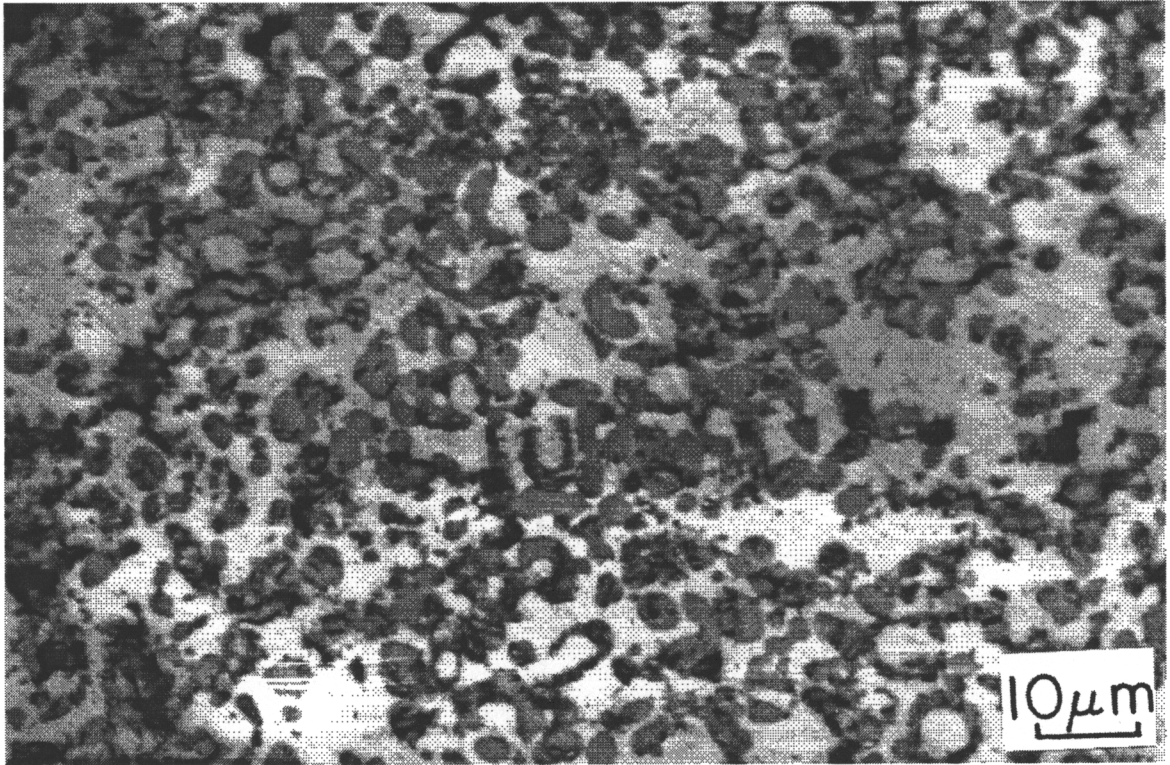
Figure 26: Microstructure of FerroTiC CM45.

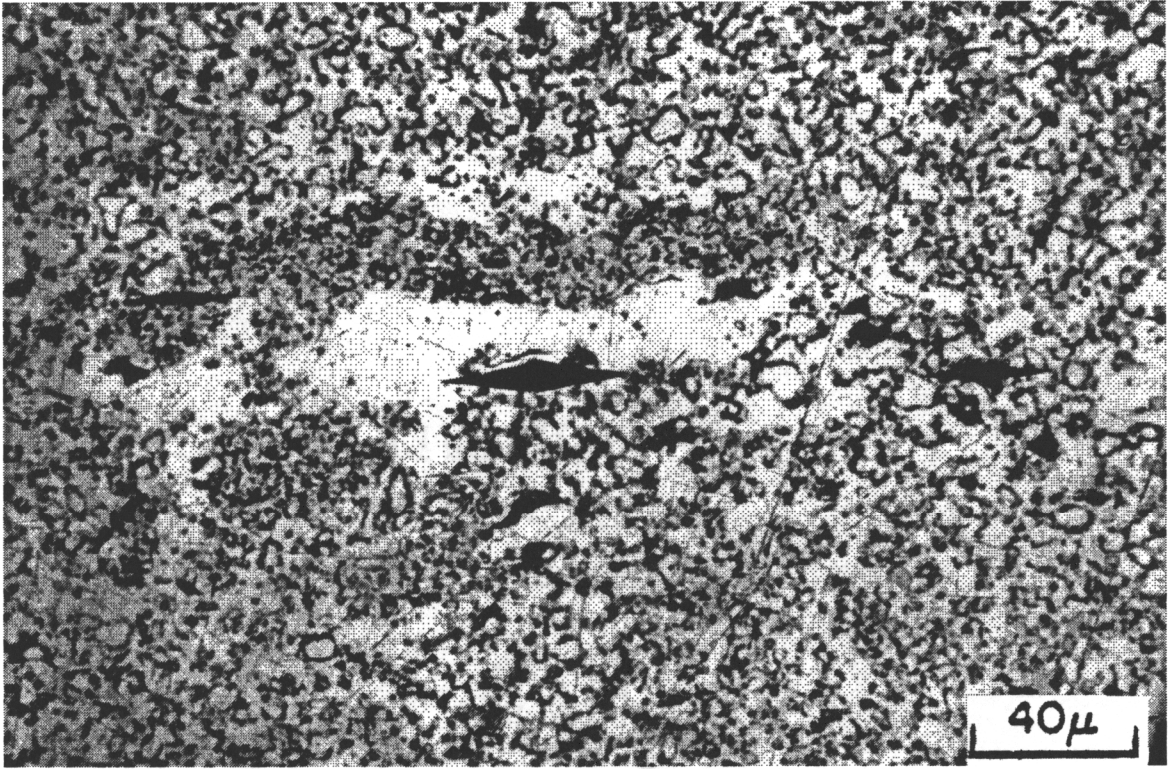
Figure 27: Nonuniform distribution of titanium carbides in FerroTiC CM45.

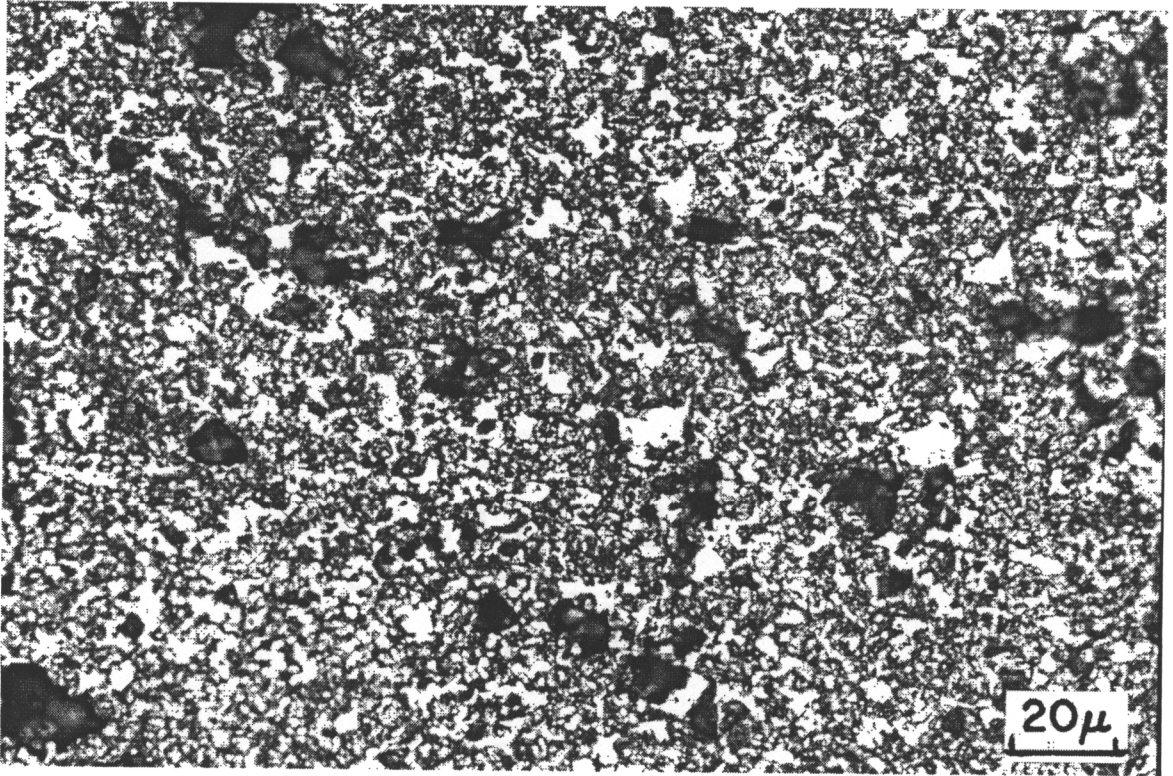
Figure 28: Microstructure of FerroTiC CM25.

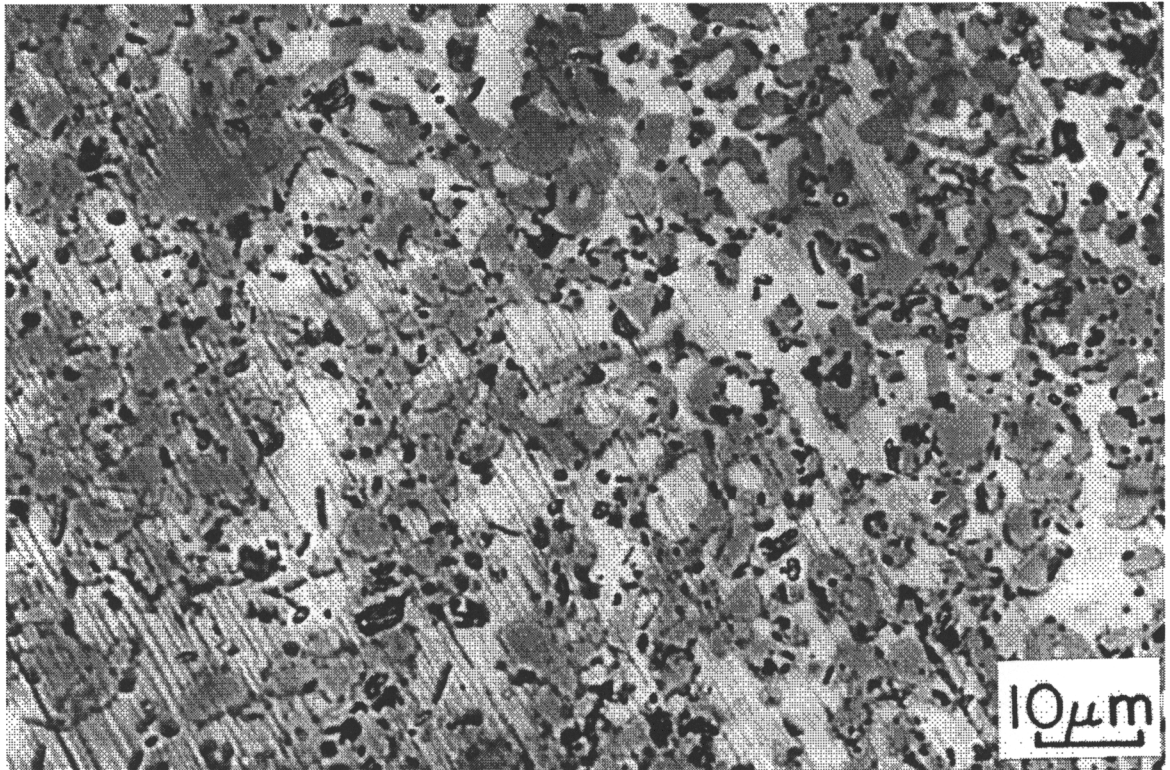
Figure 29: Microstructure of Ferrotitanit.

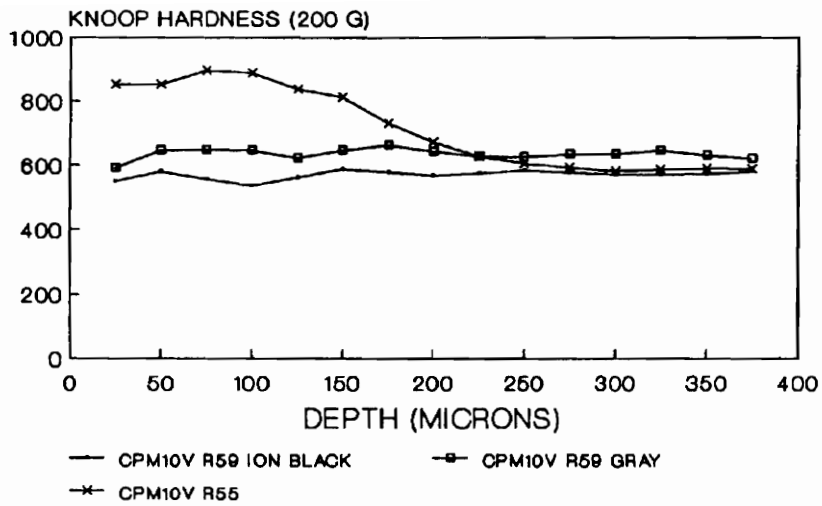
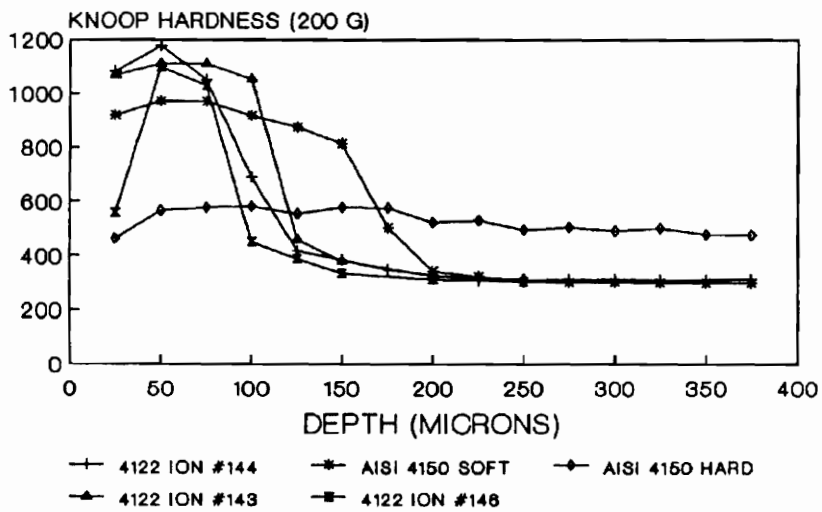
Figure 30: Microhardness versus depth profiles for ion nitrided samples.

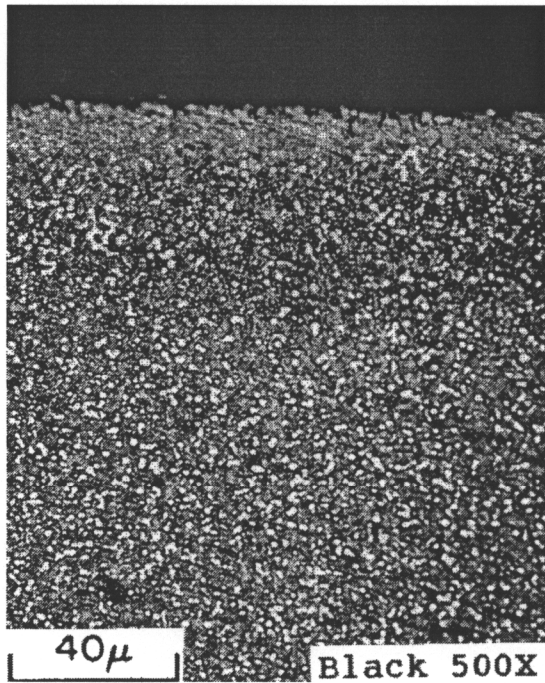
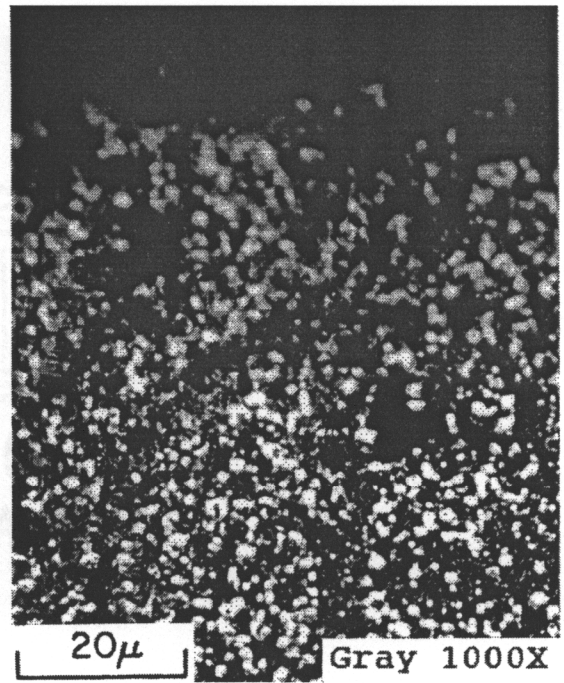
Figure 35: Microstructures of the gray and black ion nitrided CPM10V RC 59 samples showing lack of nitride layer on the gray sample and thin layer on the black sample.

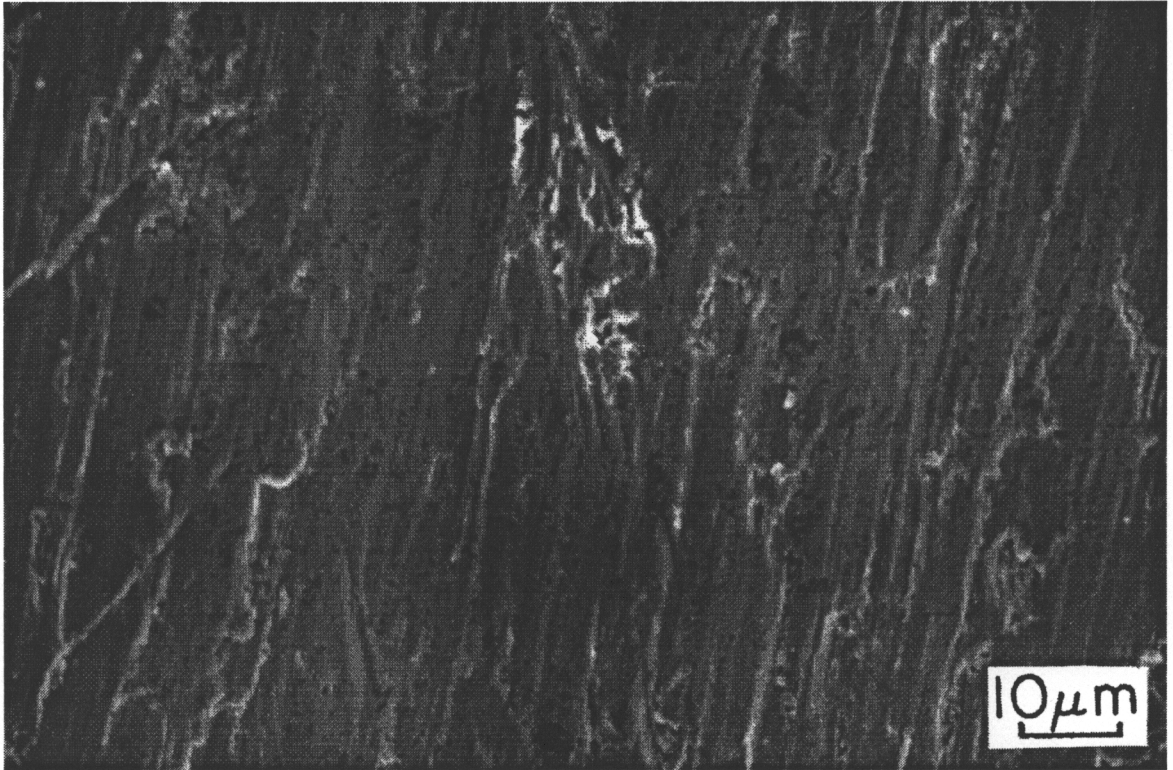
Figure 36: Wear scar on Thyssen 4122.

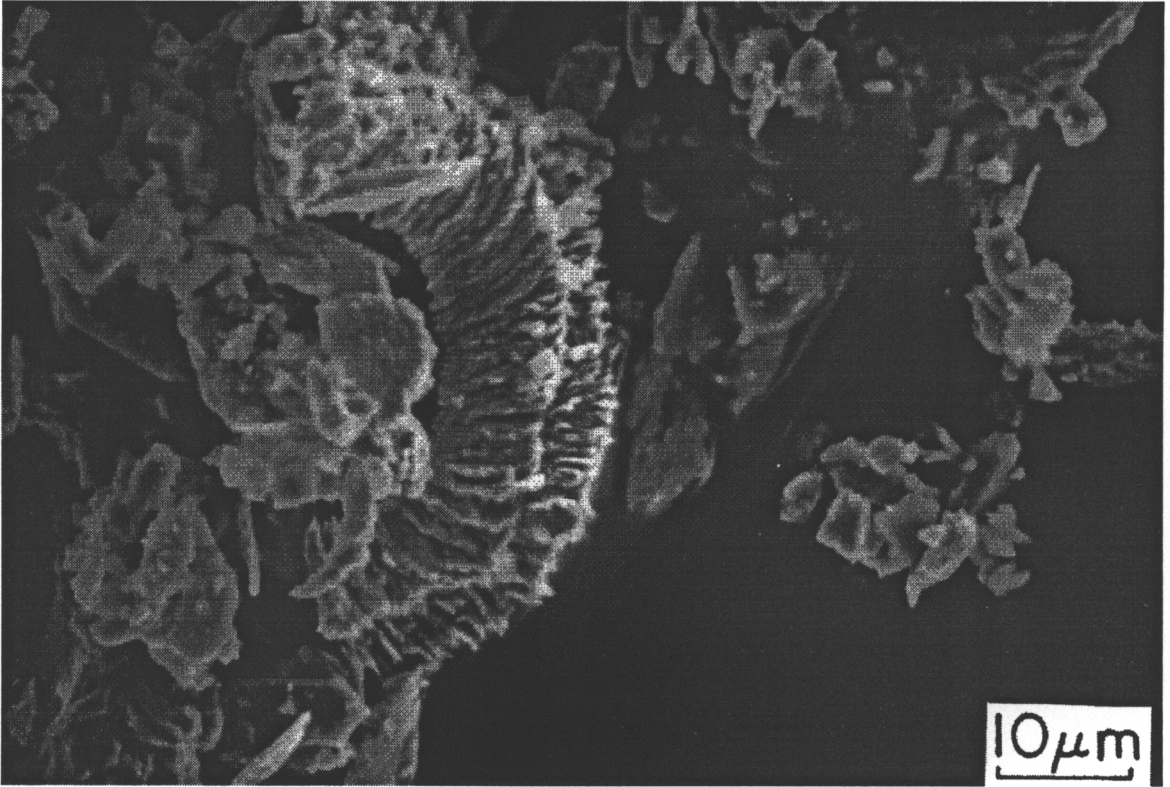
Figure 37: Microchip wear debris from Thyssen 4122.

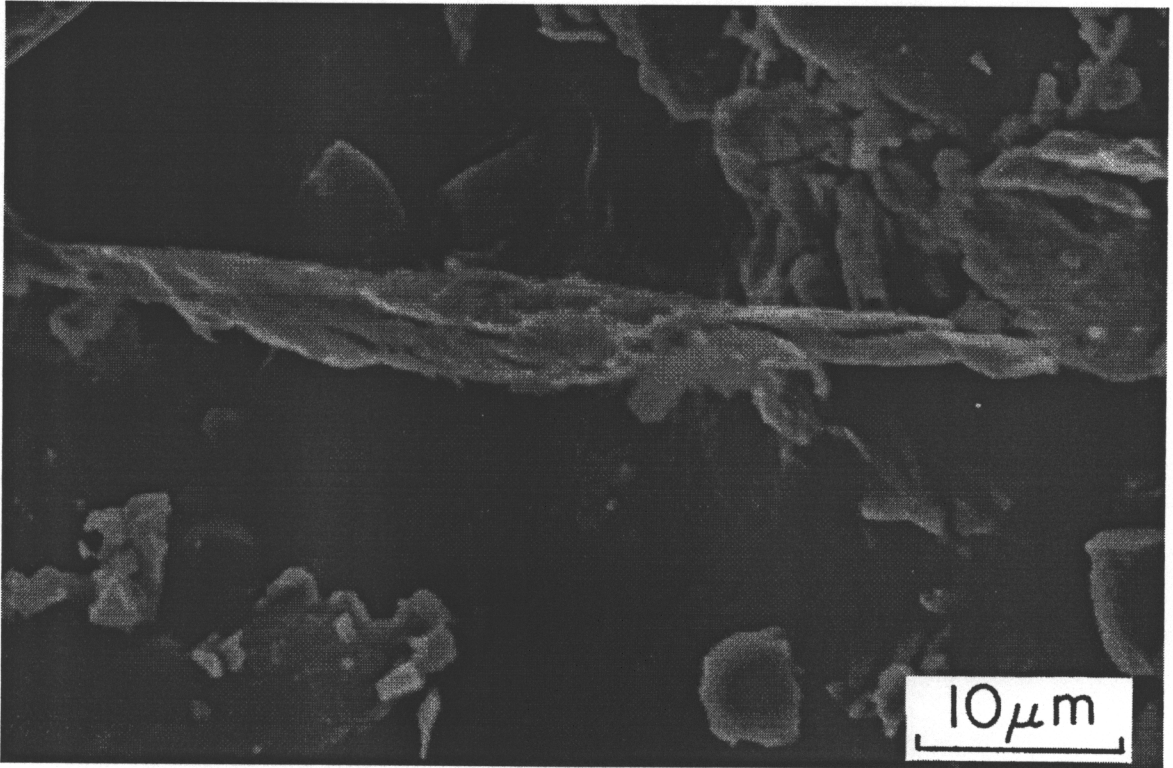
Figure 38: Acicular plowing wear debris from Thyssen 4122.

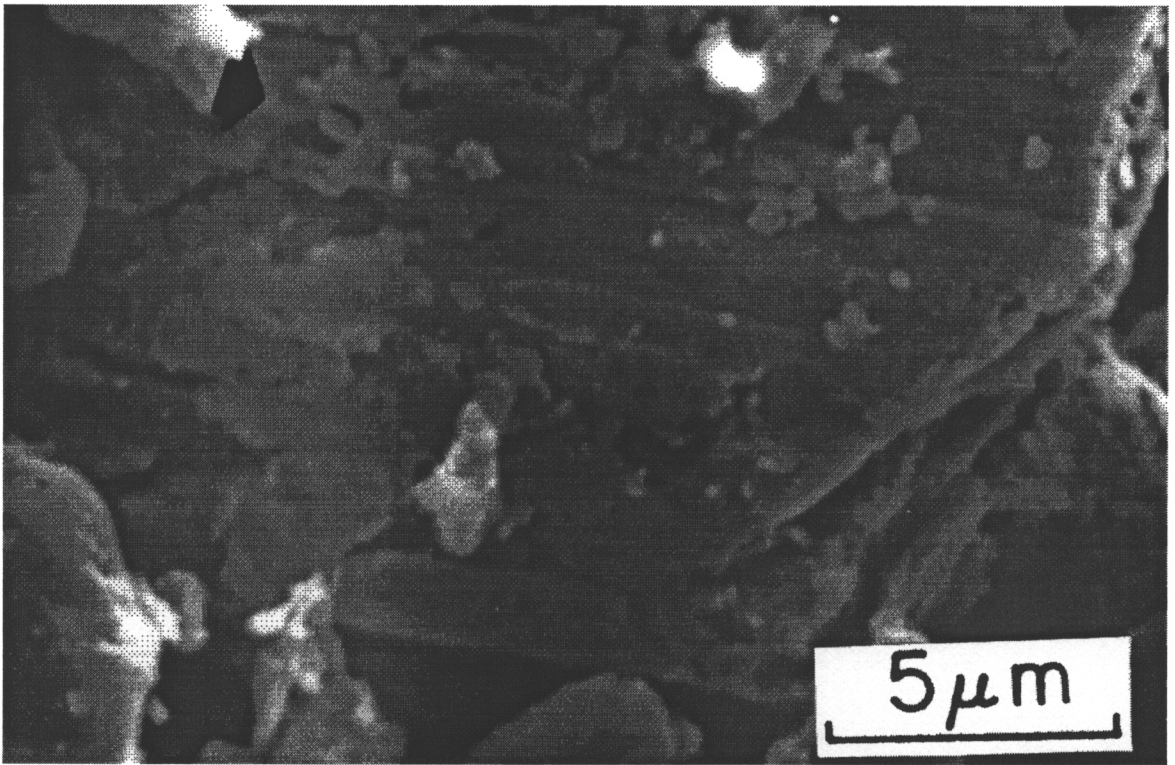
Figure 39: Sand grain fragment with transferred metal.
