EVALUATING ABRASIVE WEAR RESISTANCE OF EXTRUDER TOOLING
MATERIALS USING THE DRY SAND RUBBER WHEEL ABRASION TEST

Thesis submitted to the faculty of the
Virginia Polytechnic Institute and State University
in partial fulfillment of the requirements
for the degree of

Materials Engineering

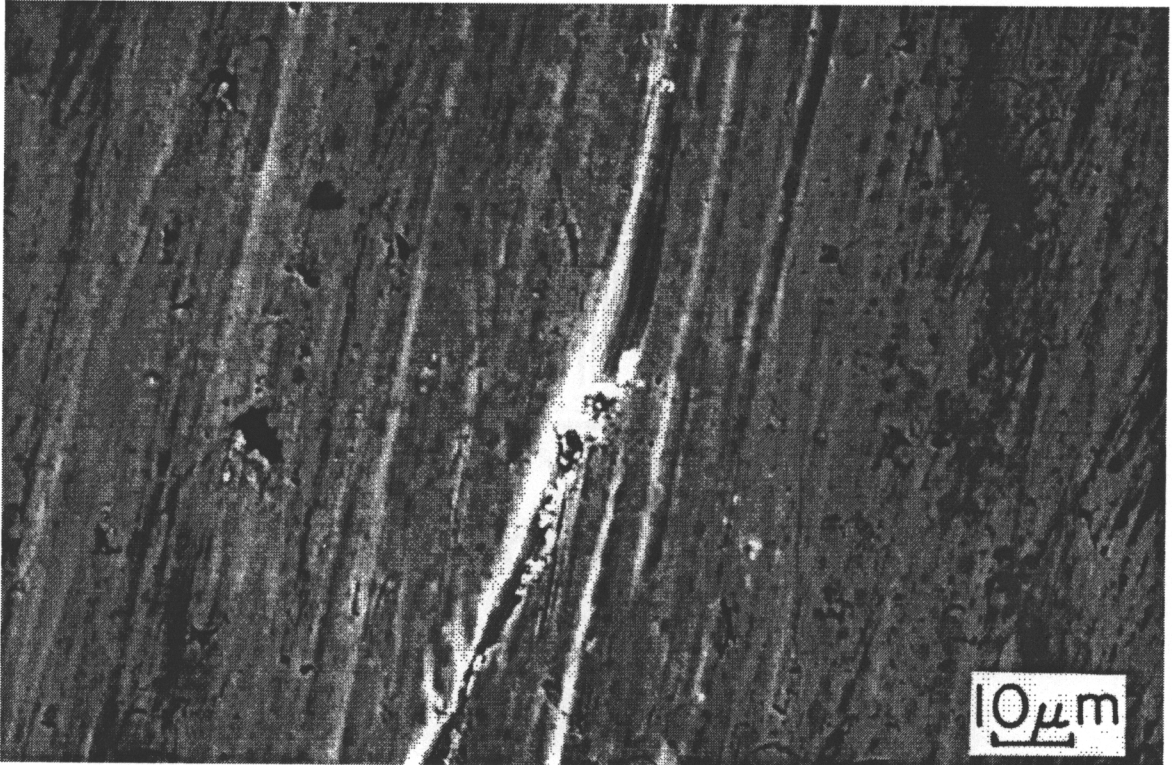
Figure 40: Wear scar on D-2 tool steel. Debris at bend in scratch contains silica and may indicate fracture of a sand grain.

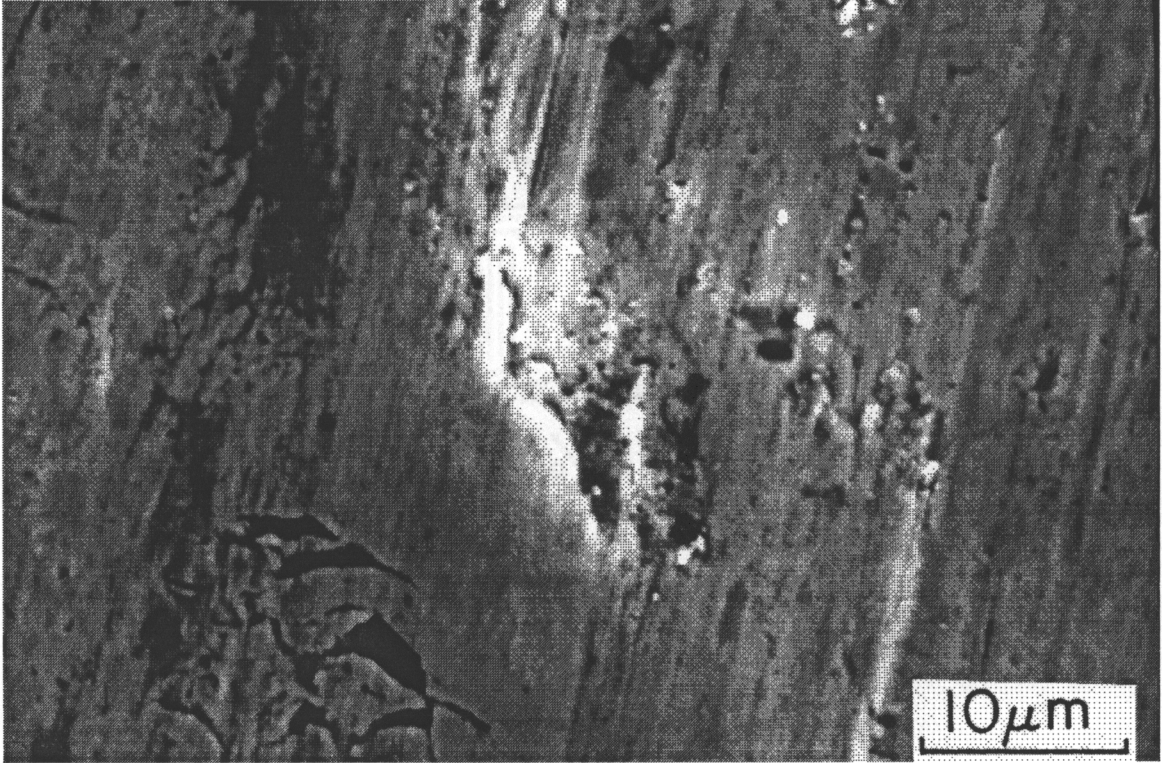
Figure 41: Ridge of plowed metal on a D-2 wear scar showing transverse cracks.

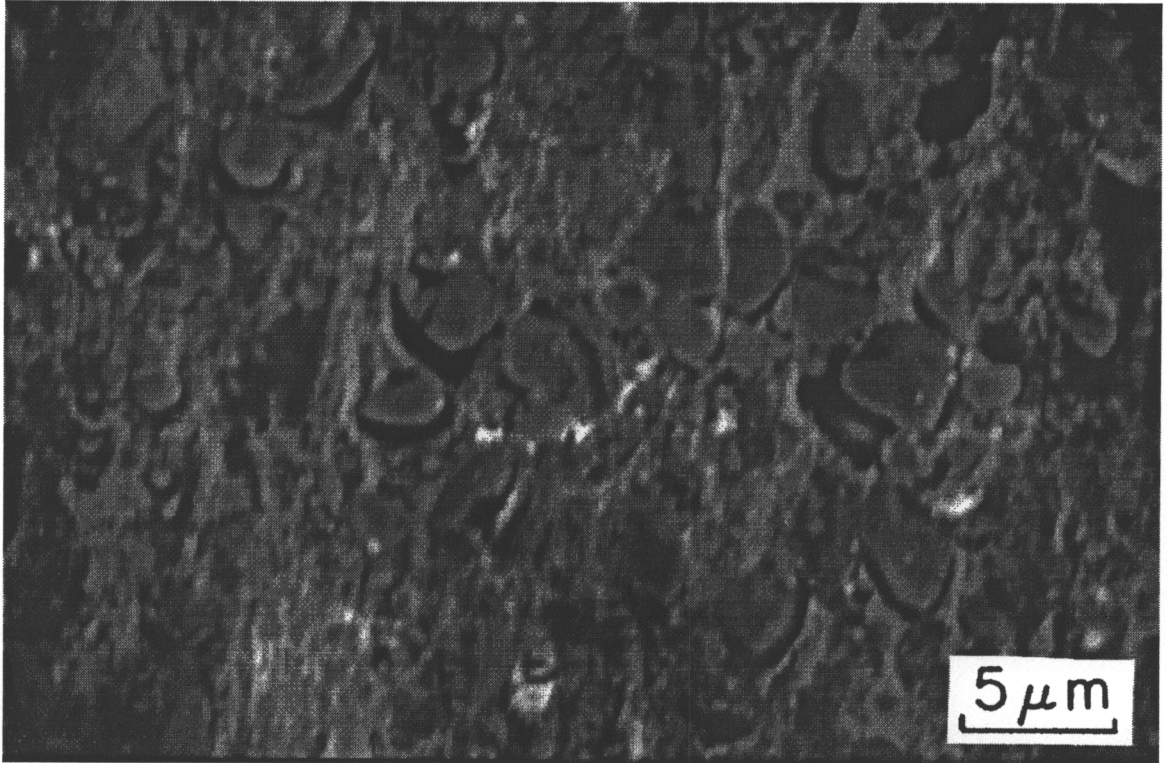
Figure 44: Wear scar on FerroTiC CM45 showing exposed titanium carbides shifted in the matrix.

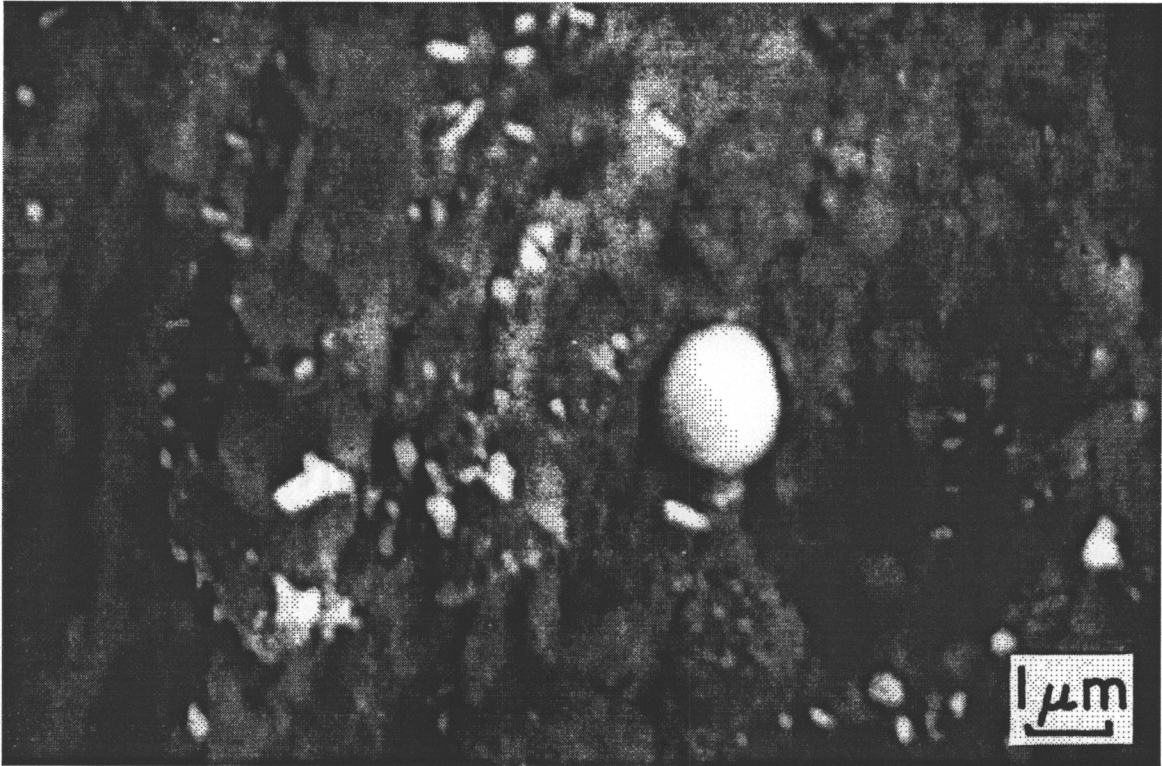
Figure 45: Wear sheet detaching from FerroTiC CM45 wear scar.

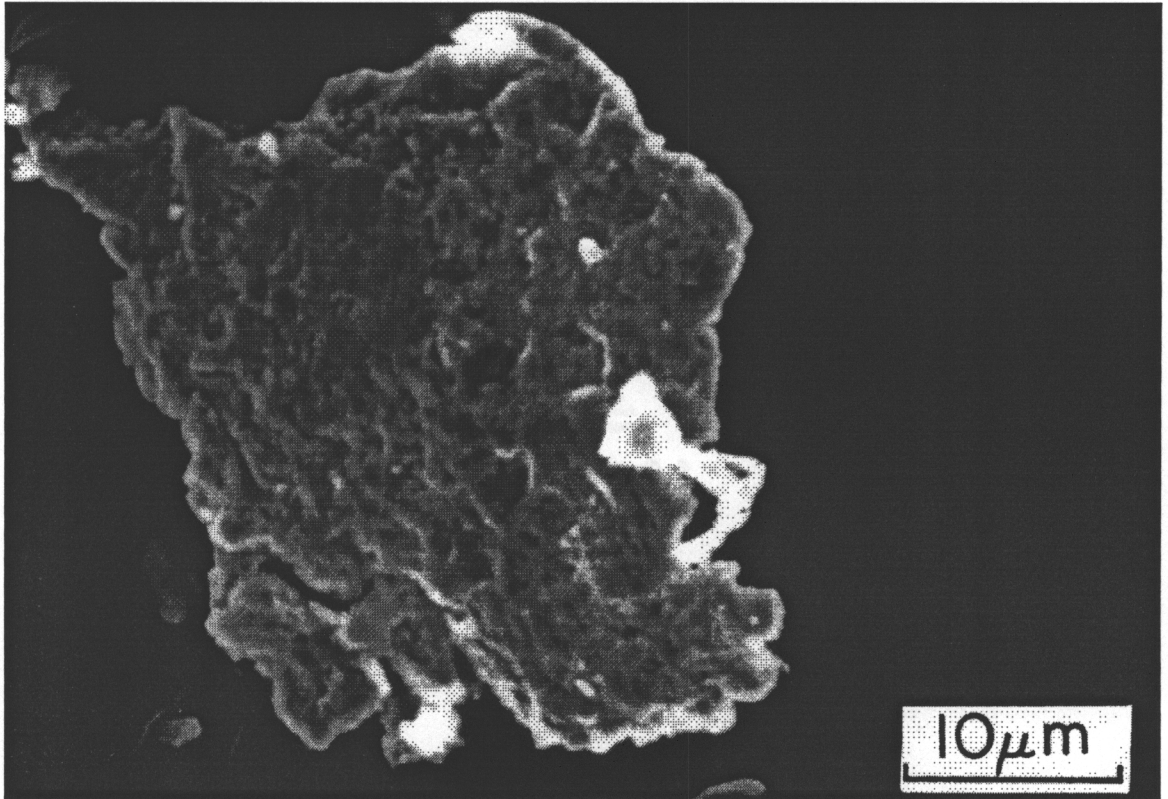
Figure 46: Plate shaped particles in wear debris from FerroTiC CM45.

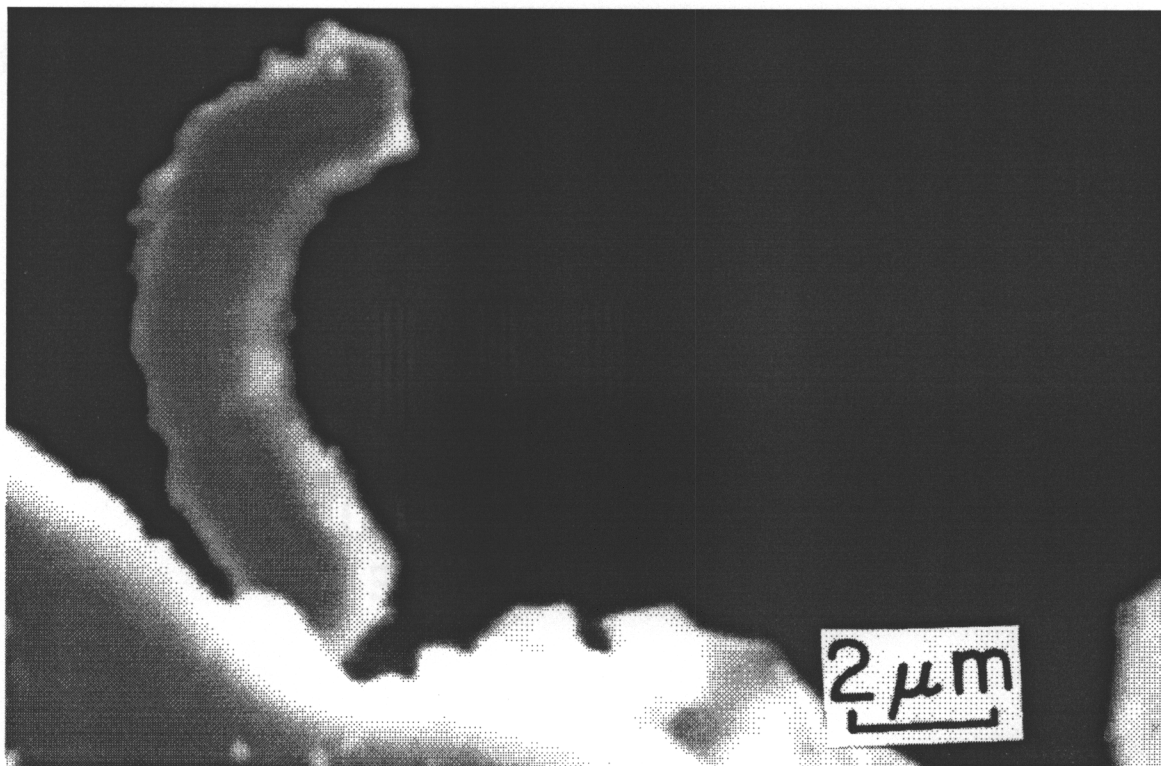
Figure 47: Microchip type particles in wear debris from FerroTiC CM45.

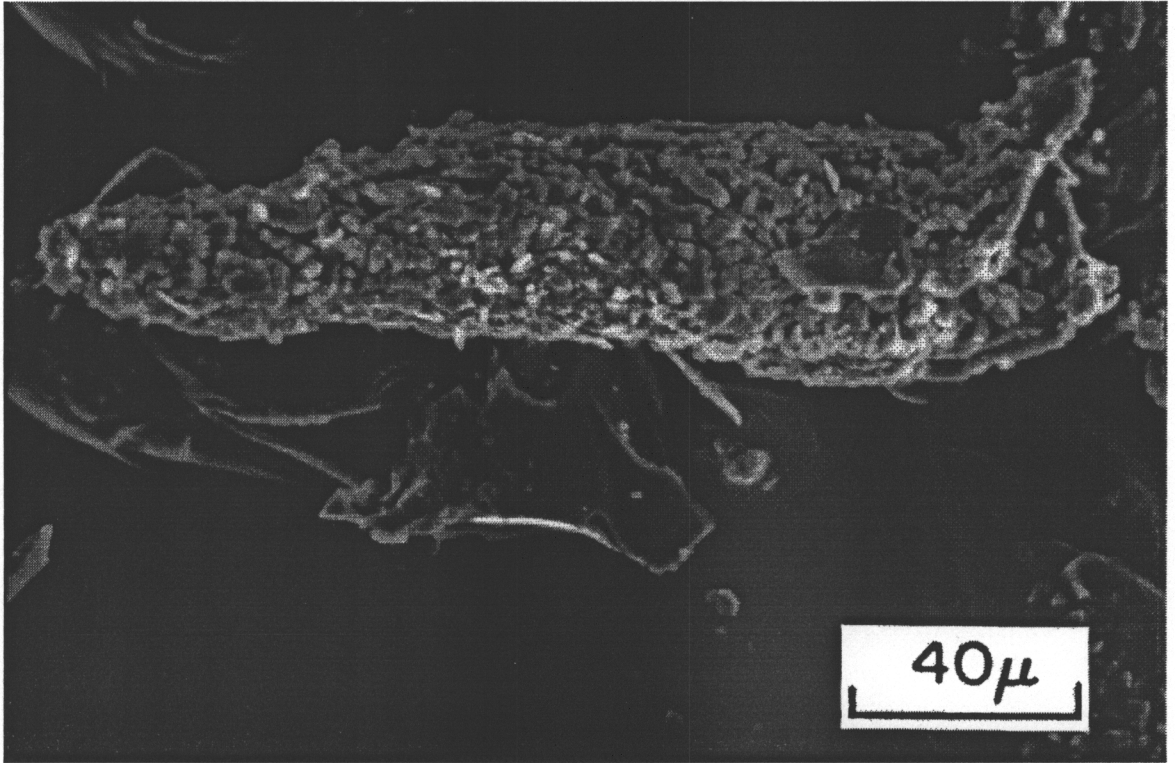
Figure 48: Cigar shaped particle in wear debris from Ferrotic CM45.

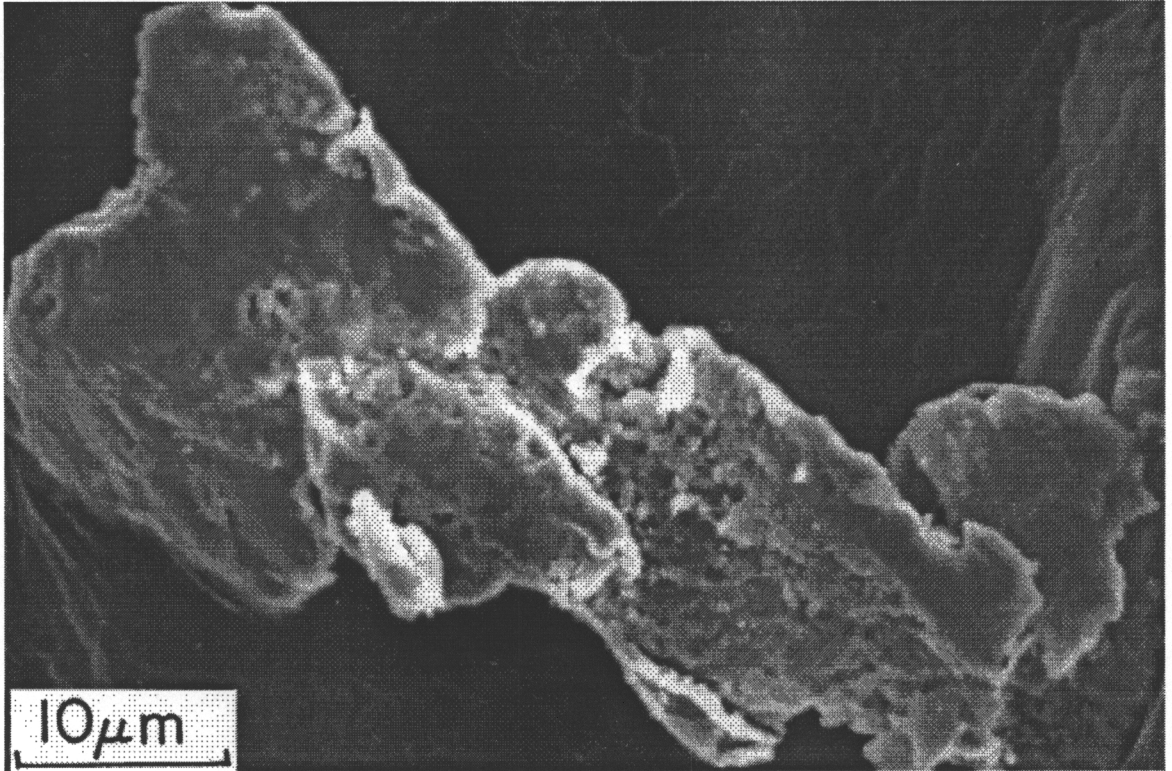
Figure 49: FerroTiC CM45 plate type wear particle becoming rounded into a cigar shaped particle.

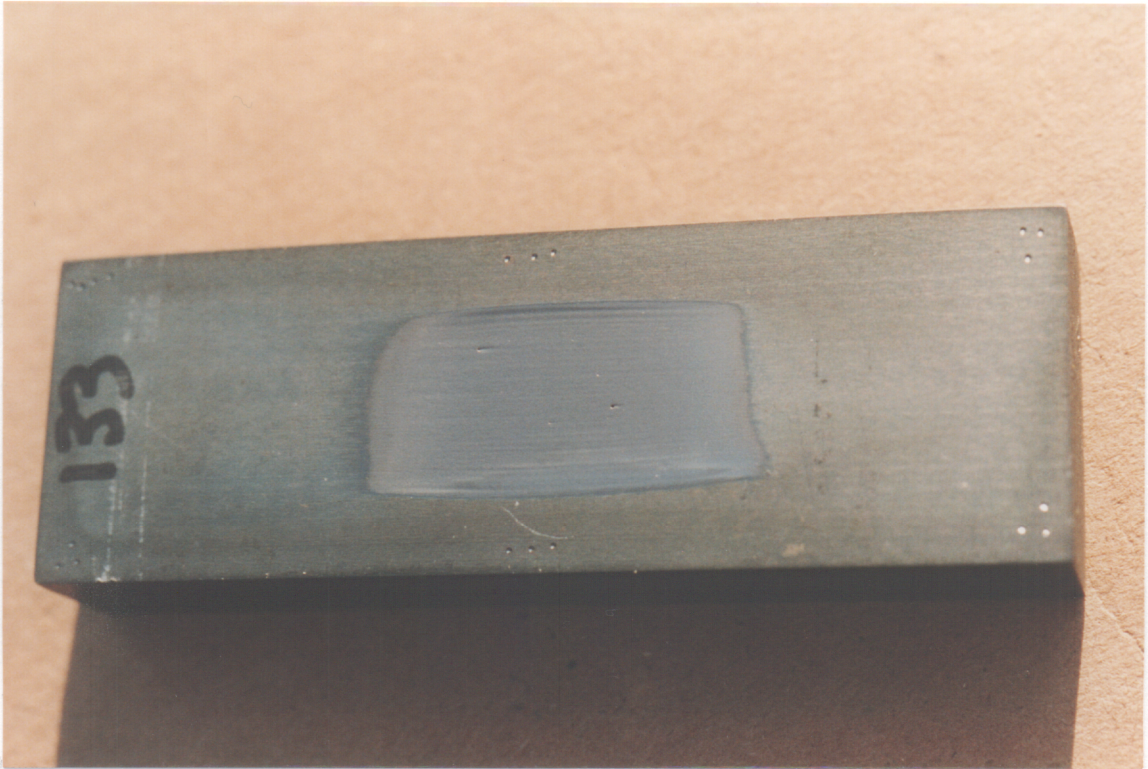
Figure 50: Macrograph of FerrotiC CM25 wear scar showing pits and striations.

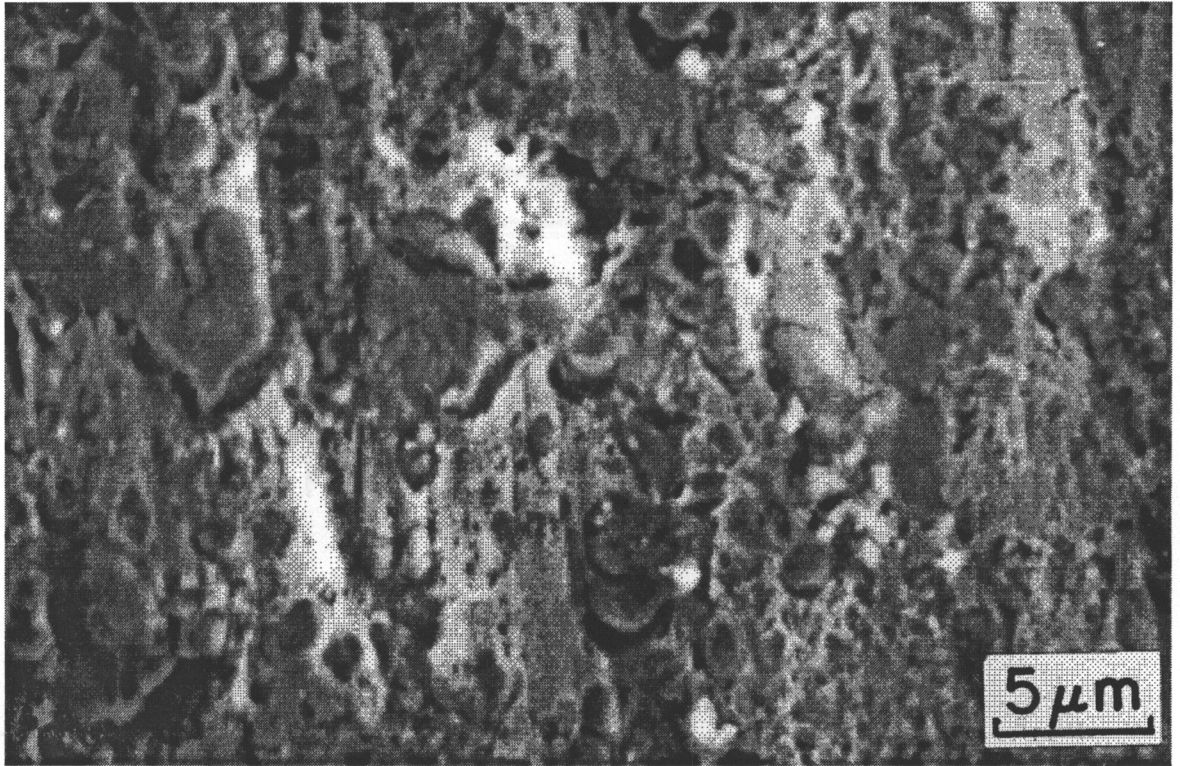
Figure 51: Wear scar on FerroTiC CM25.

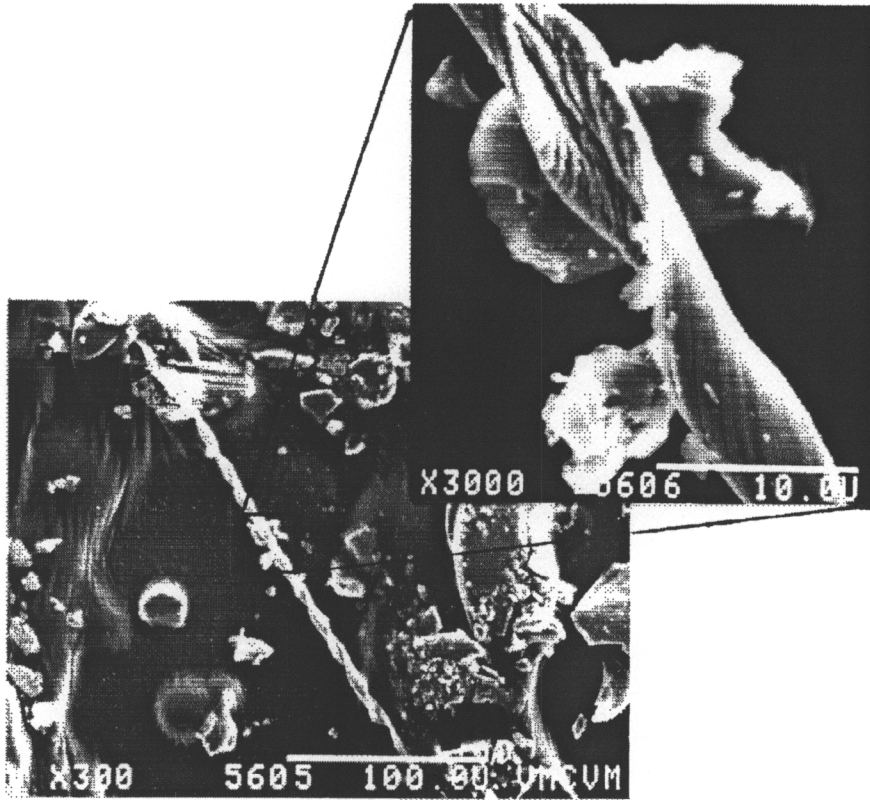
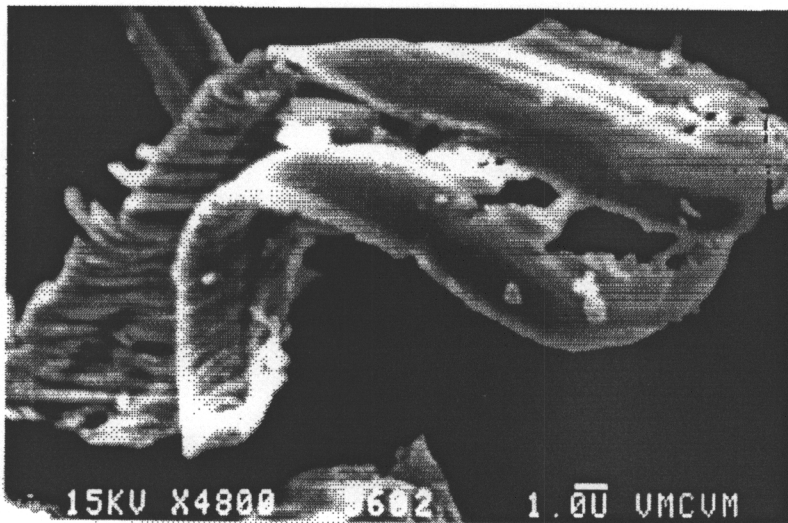
Figure 52: Microchips in wear debris from FerroTiC CM25.

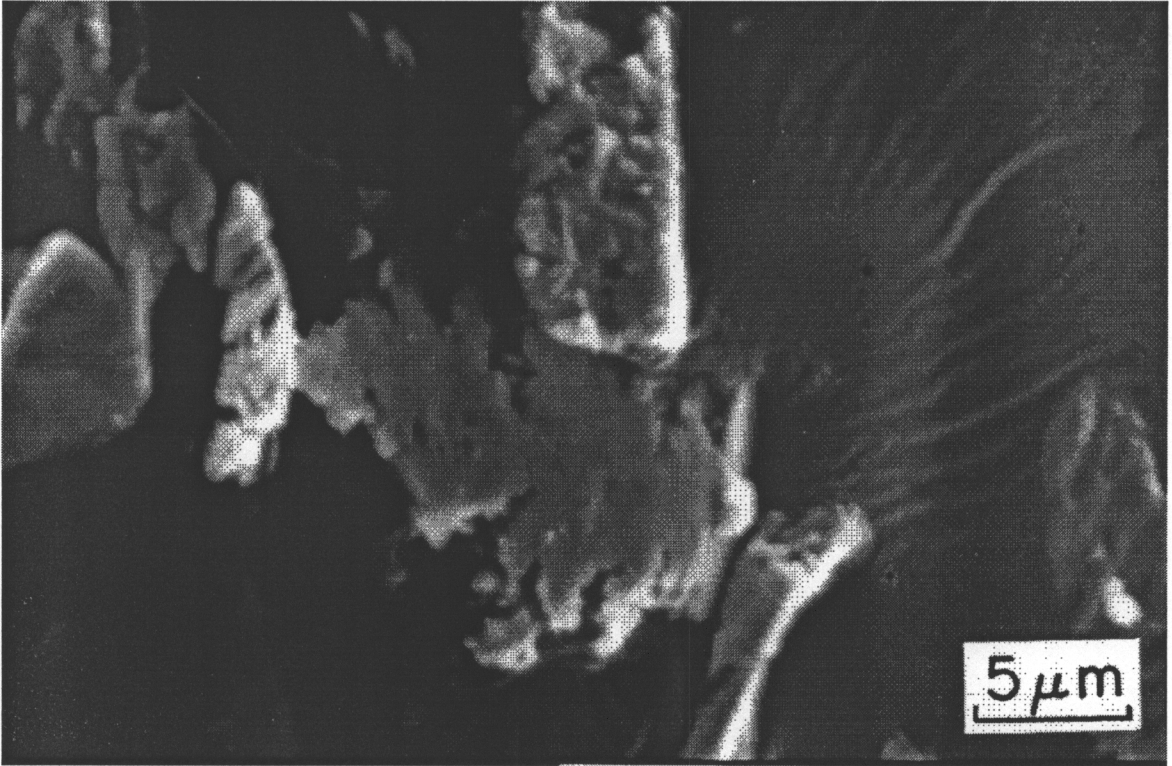
Figure 53: Plate type wear debris from FerroTiC CM25.

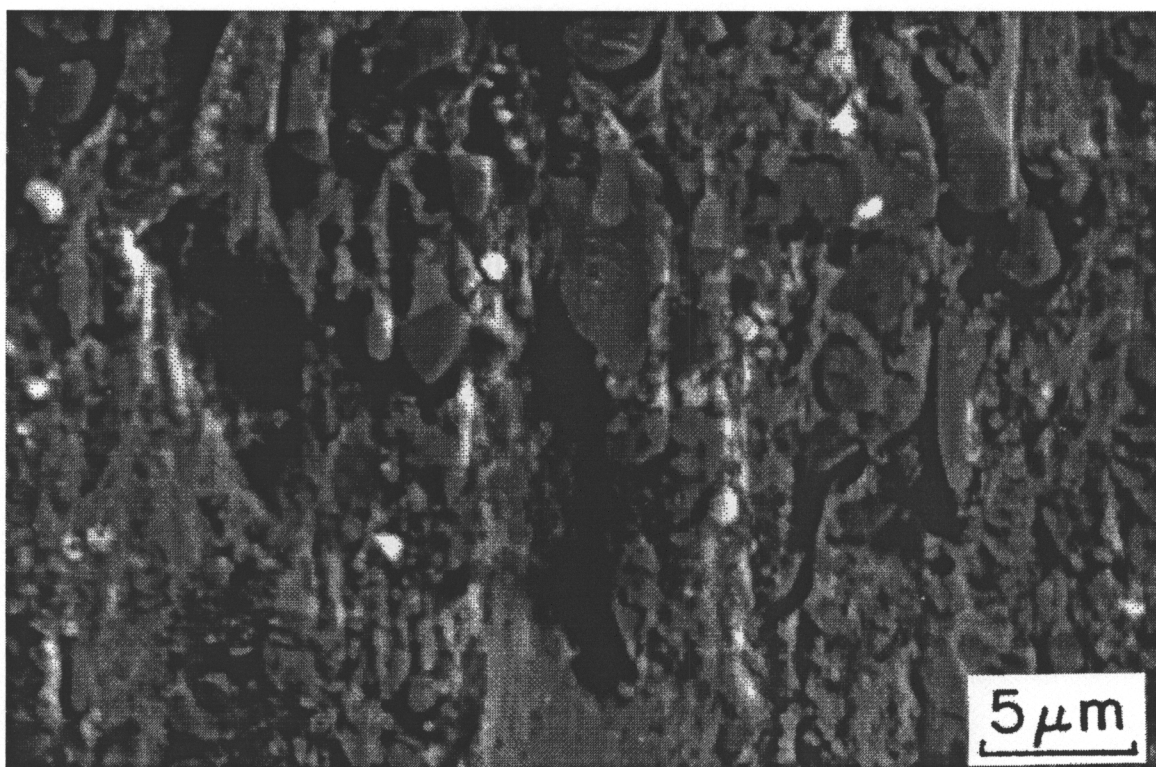
Figure 54: Wear scar on Ferrotitanit. Note cracks in surface.

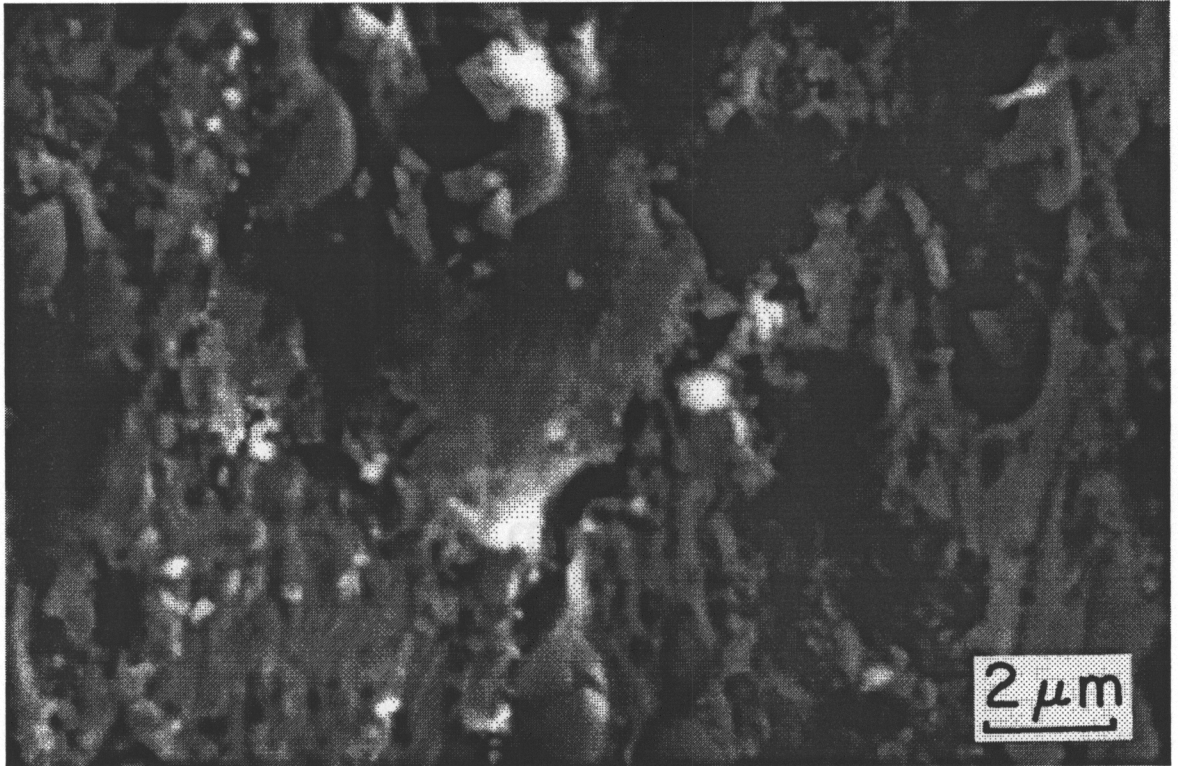
Figure 55: Loosely attached wear sheet on Ferrotitanit.

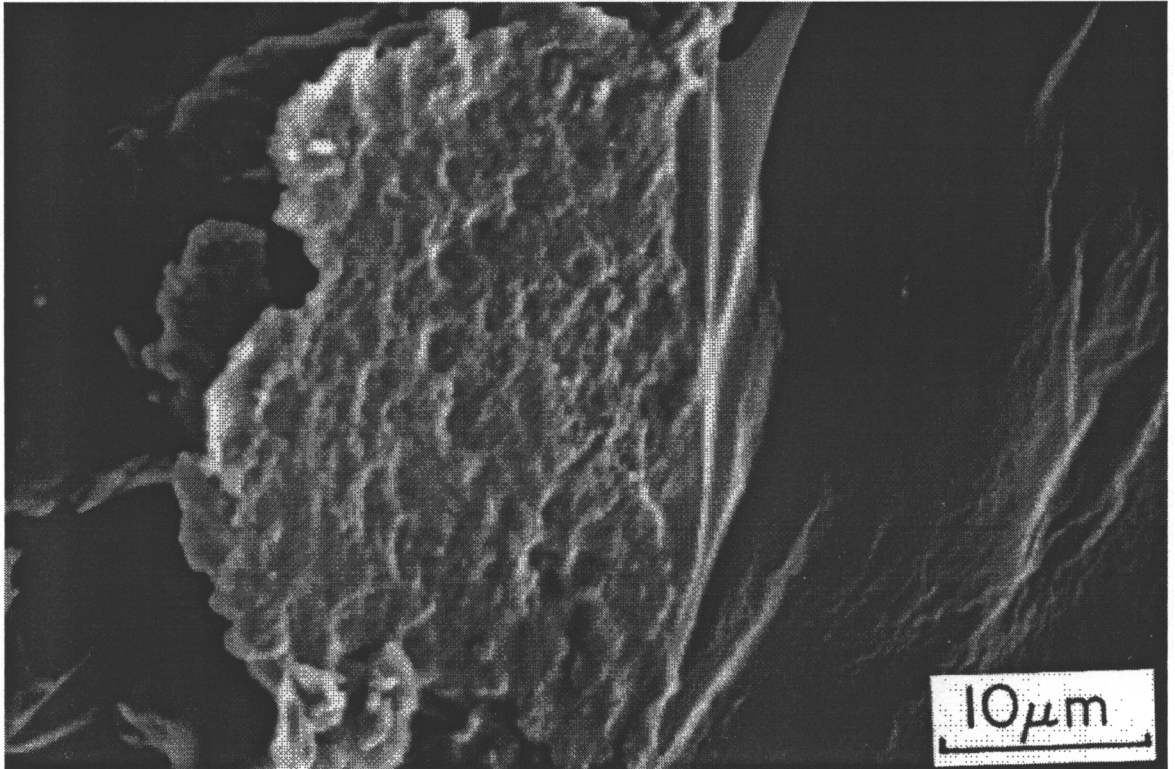
Figure 56: Sheet or plate type wear particles typical of Ferrotitanit.

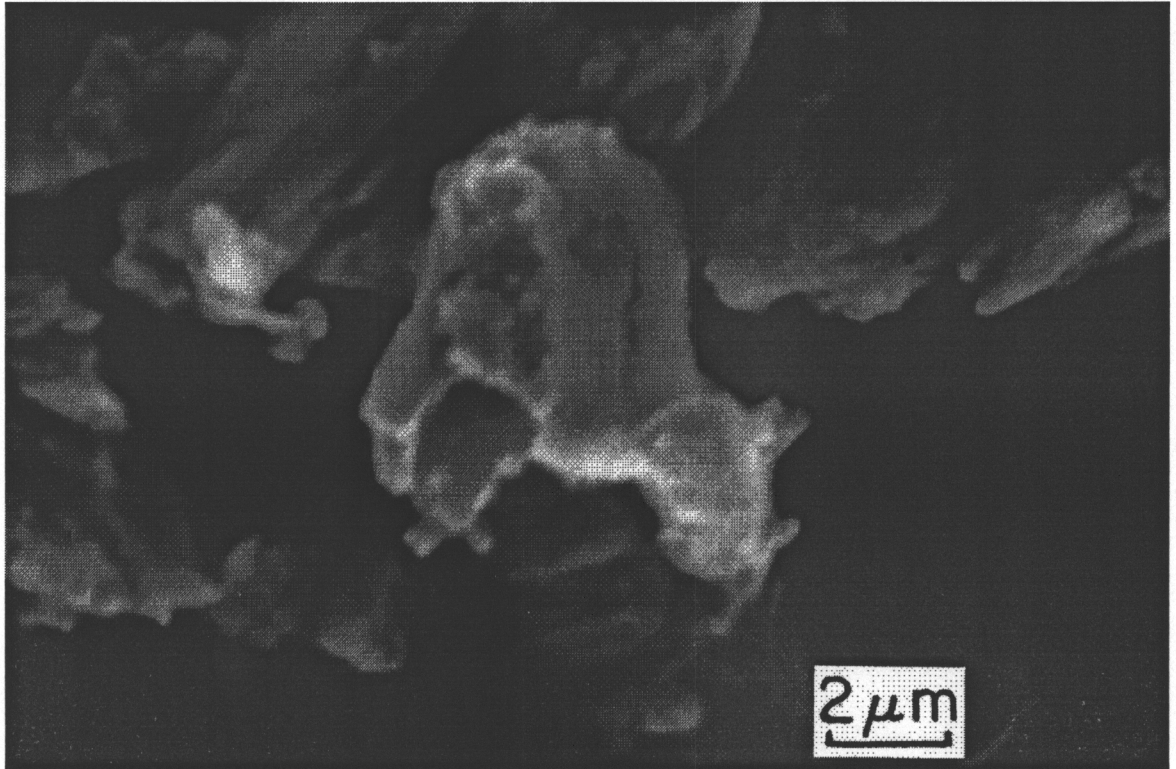
Figure 57: Small microchip containing a titanium carbide particle found in the wear debris from Ferrotitanit.

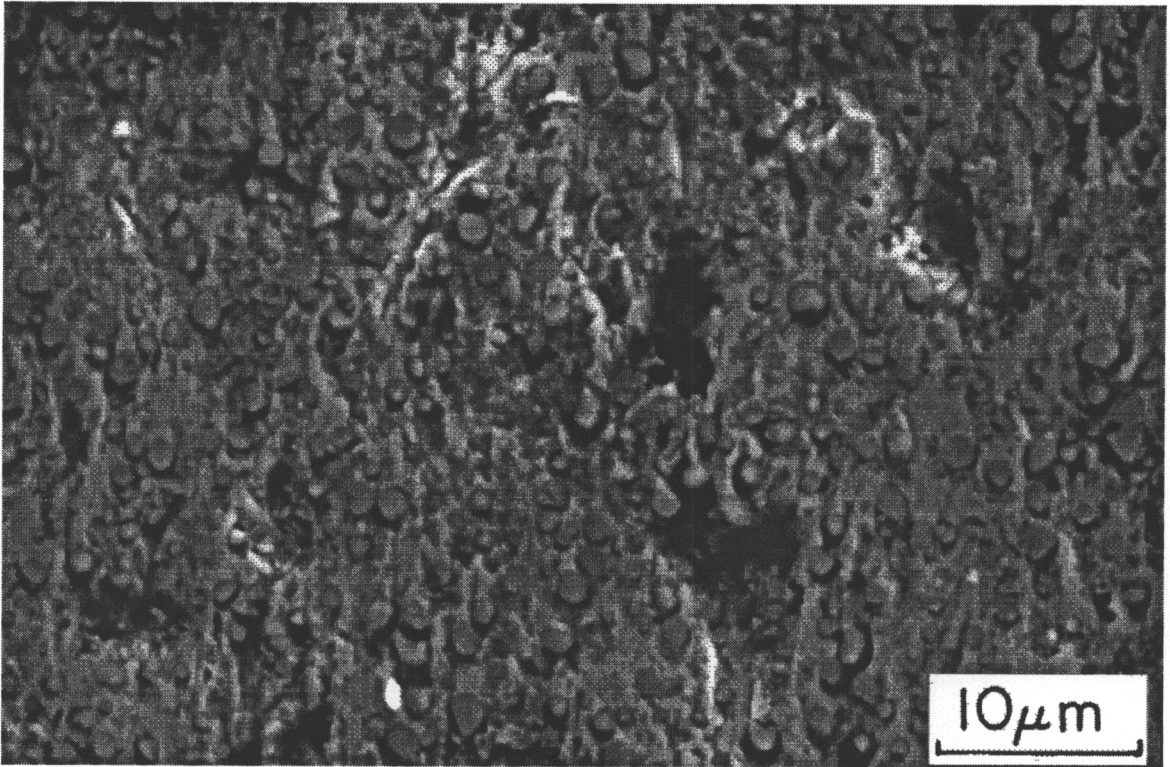
Figure 58: Pits in wear scar of CPM10V RC 55.

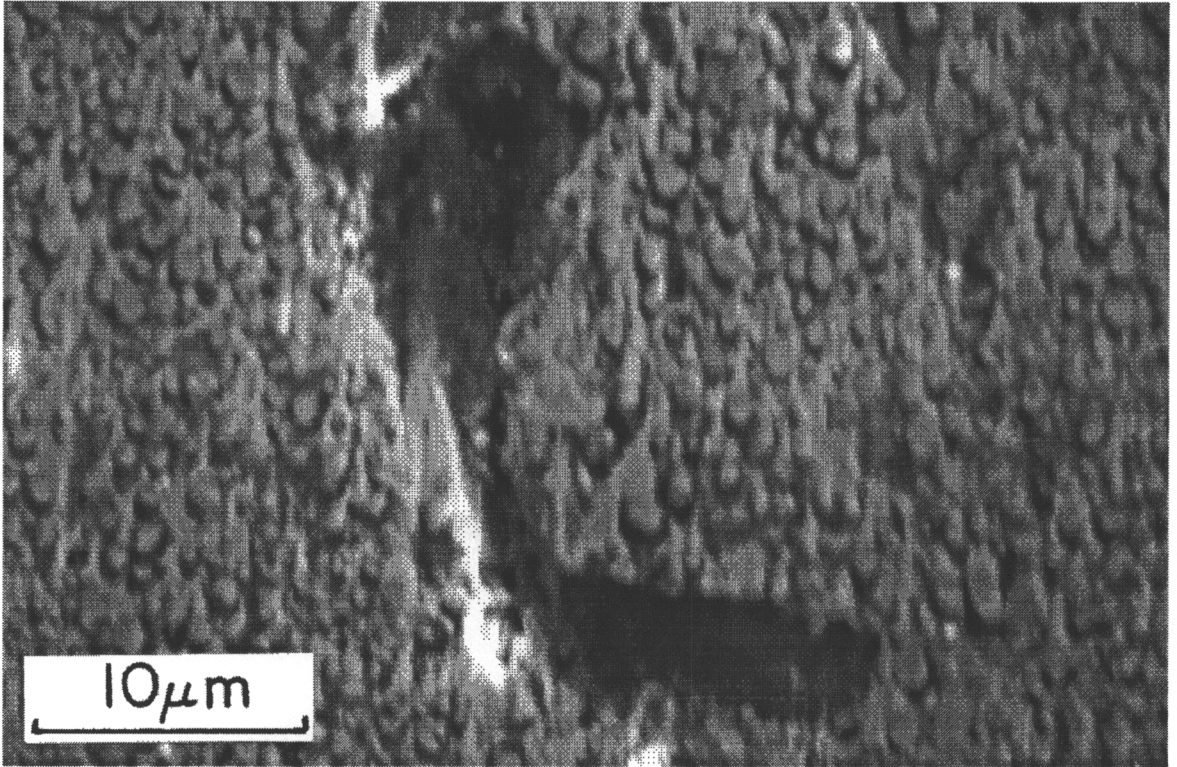
Figure 59: CPM10V RC 59 wear scar.

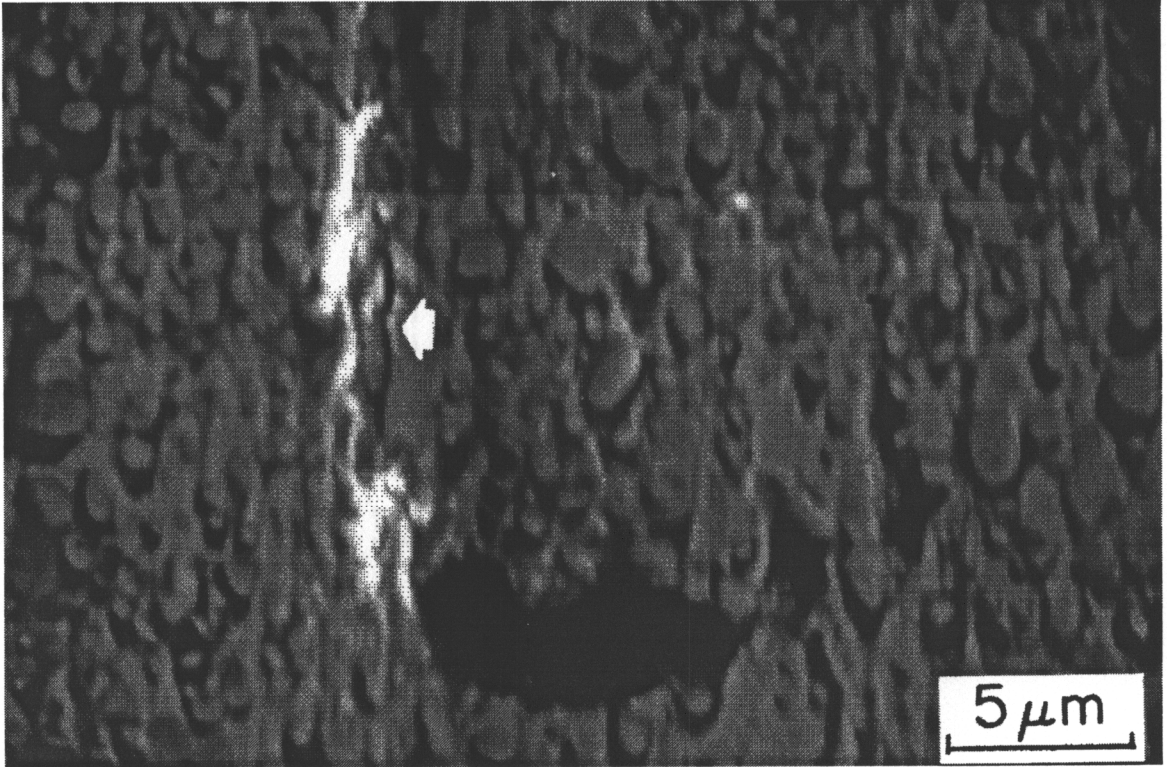
Figure 60: Crack in bottom of "L" shaped pit in CPM10V RC 59 (arrow).

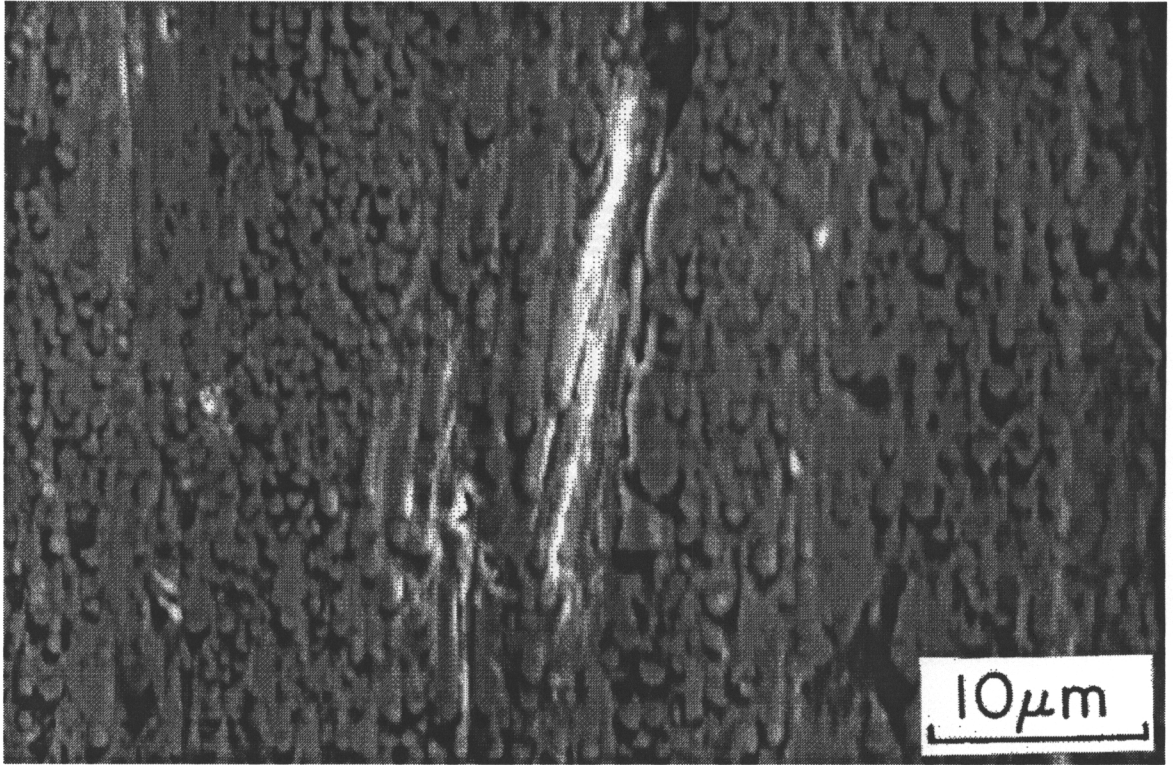
Figure 61: Large gouge in wear scar of CPM10V RC 59 with longitudinal crack at right edge.

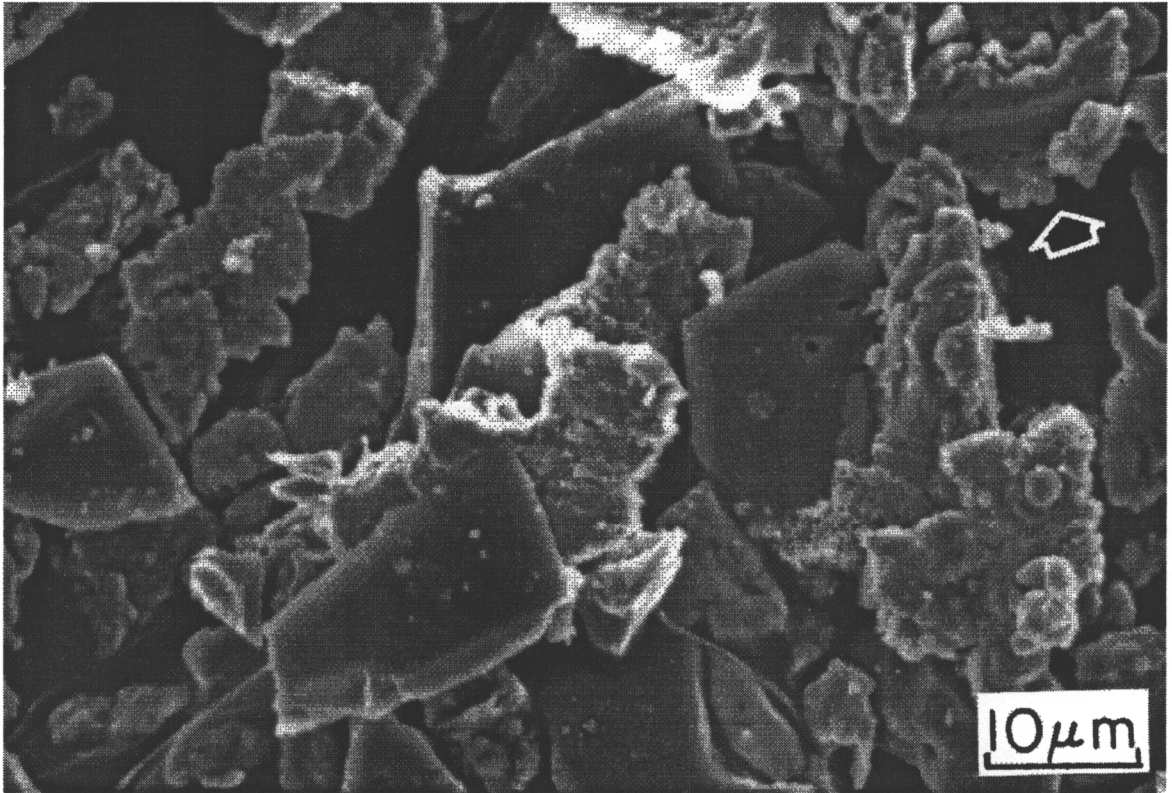
Figure 62: Wear debris from CPM10V RC 59 consisting mostly of sheet or plate type particles, with occasional microchips (arrow).

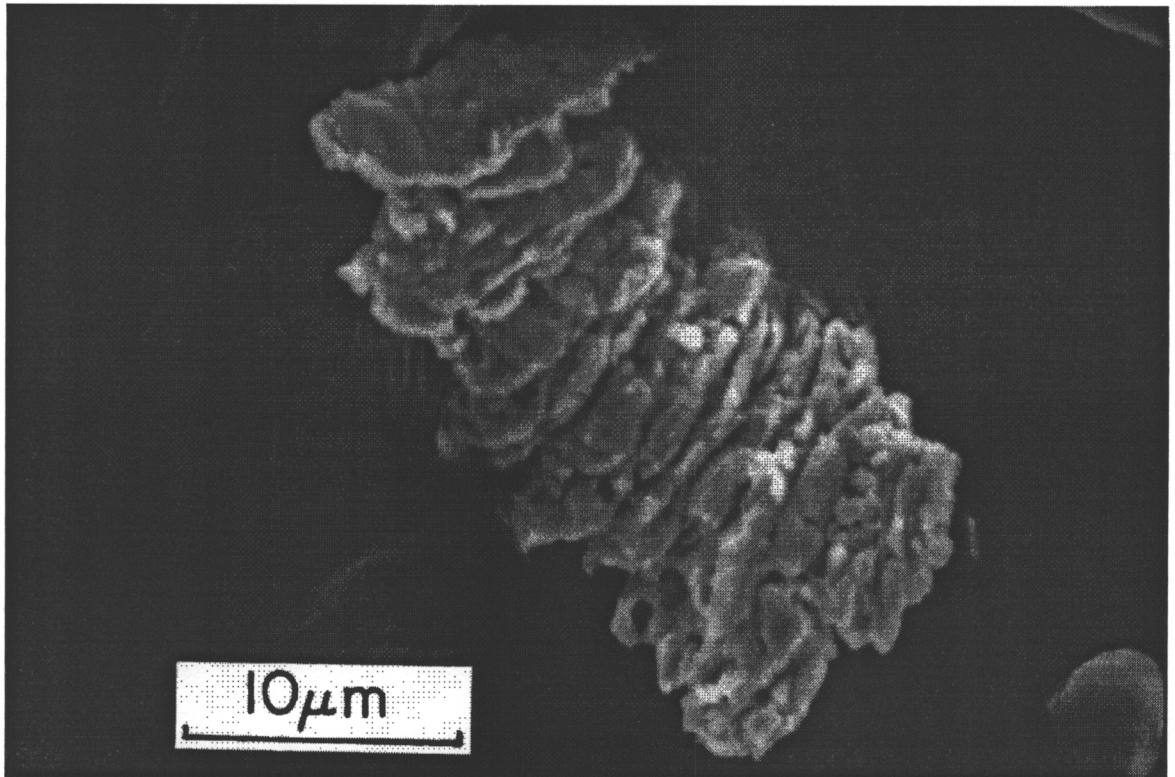
Figure 63: Wear particle from CPM10V RC 59 which may have formed by wedging.

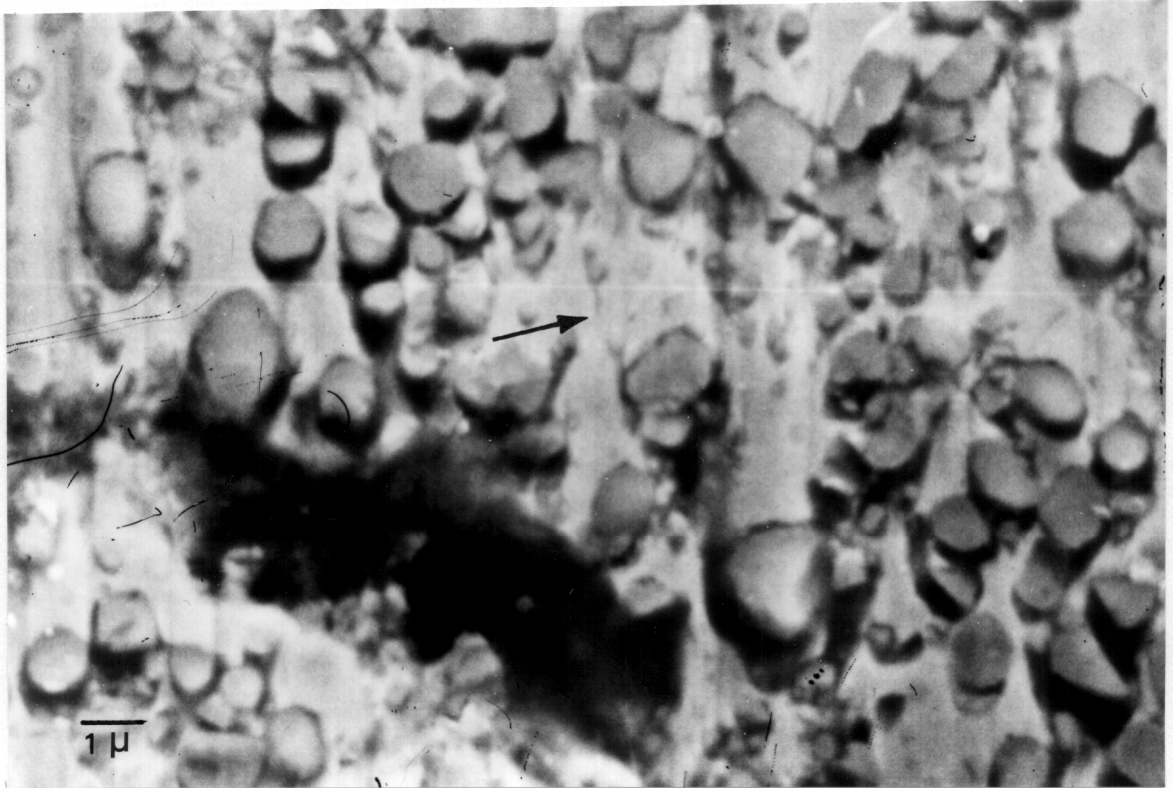
Figure 64: Cracks (arrow) in wear scar of ion nitrided CPM10V RC 55.

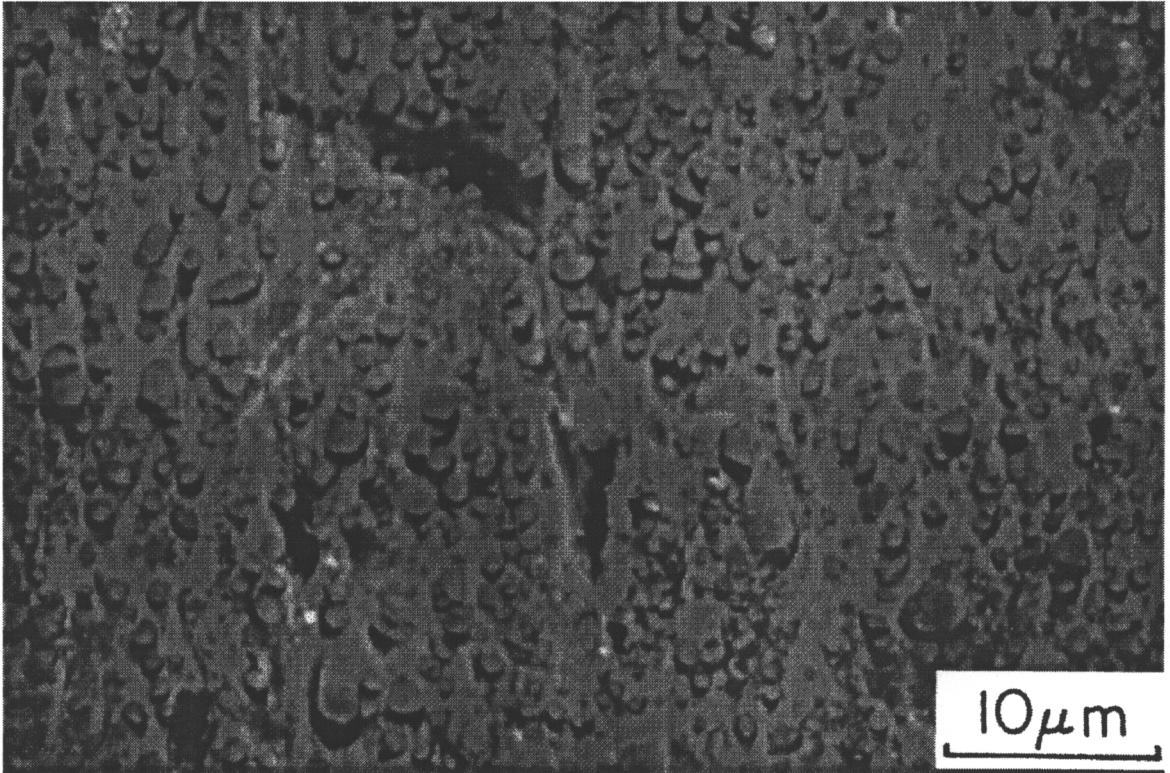
Figure 65: Pits in wear scar of ion nitrided CPM10V RC 55 (same region as Figure 64).

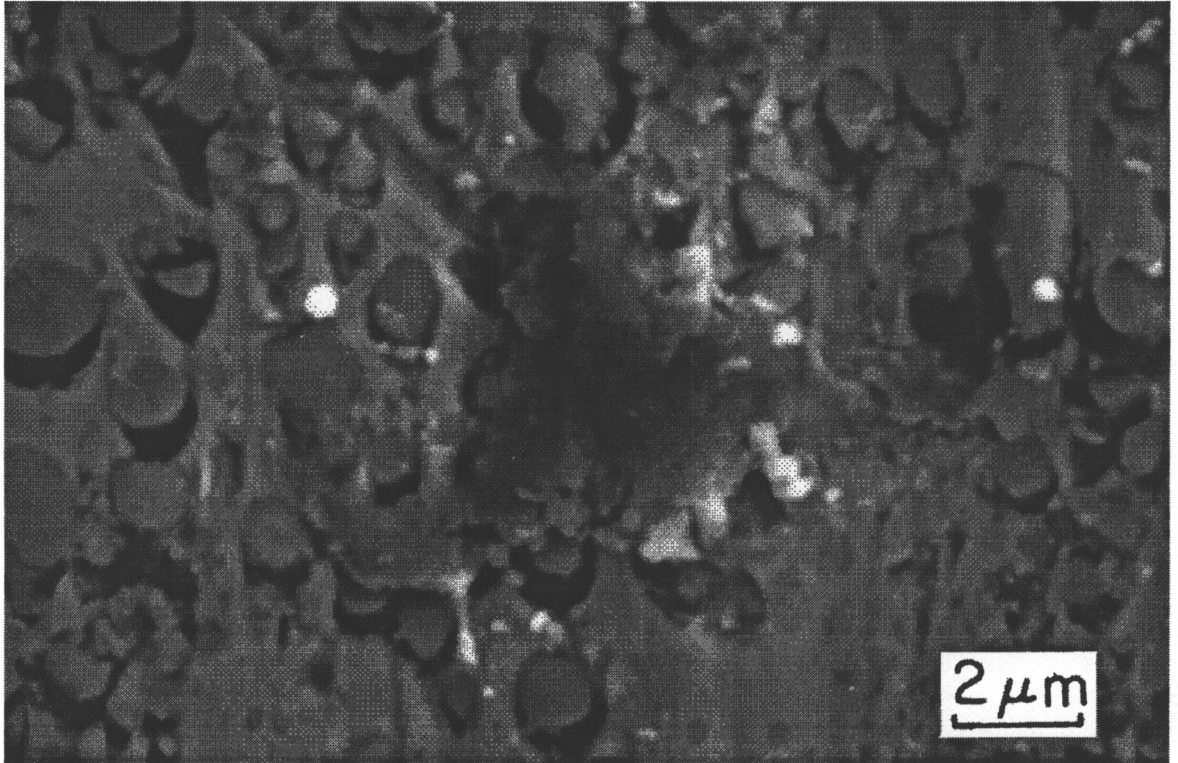
Figure 66: Loosely attached wear sheet in wear scar of ion nitrided CPM10V RC 55.
