EVALUATING ABRASIVE WEAR RESISTANCE OF EXTRUDER TOOLING
MATERIALS USING THE DRY SAND RUBBER WHEEL ABRASION TEST

Thesis submitted to the faculty of the
Virginia Polytechnic Institute and State University
in partial fulfillment of the requirements
for the degree of

Materials Engineering

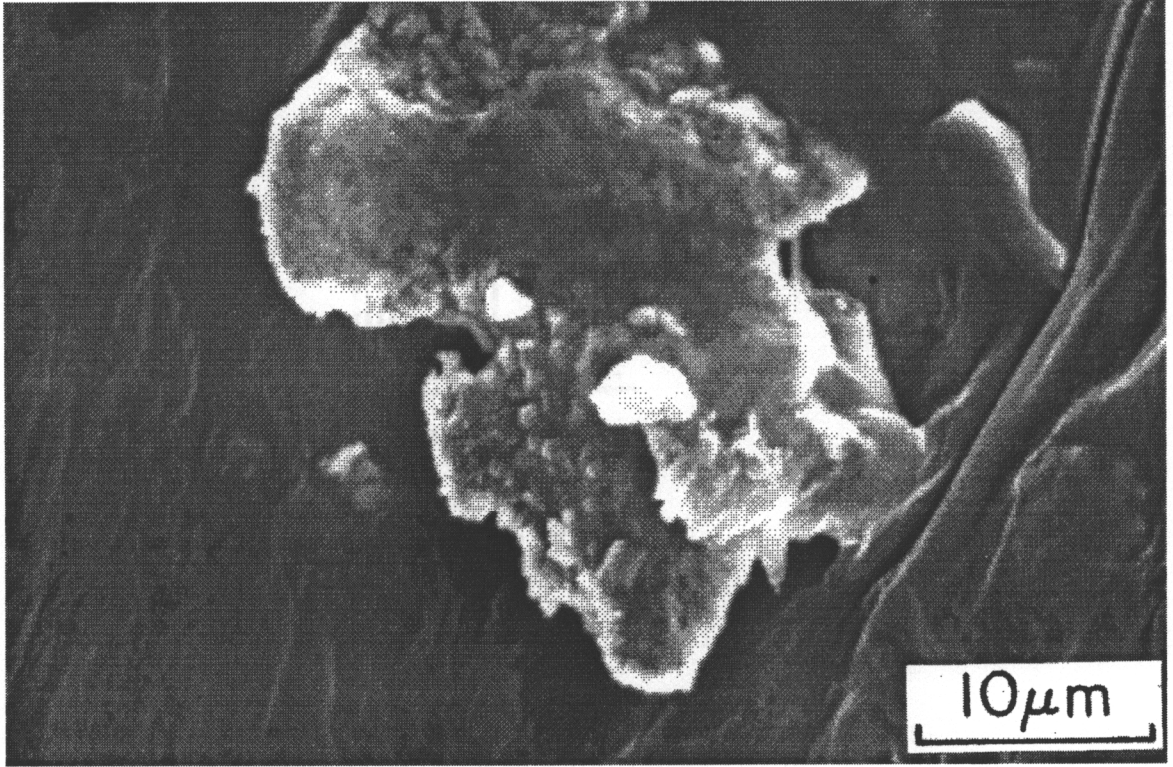
Figure 67: Sheet type wear particle in debris from ion nitrided CPM10V RC 55.

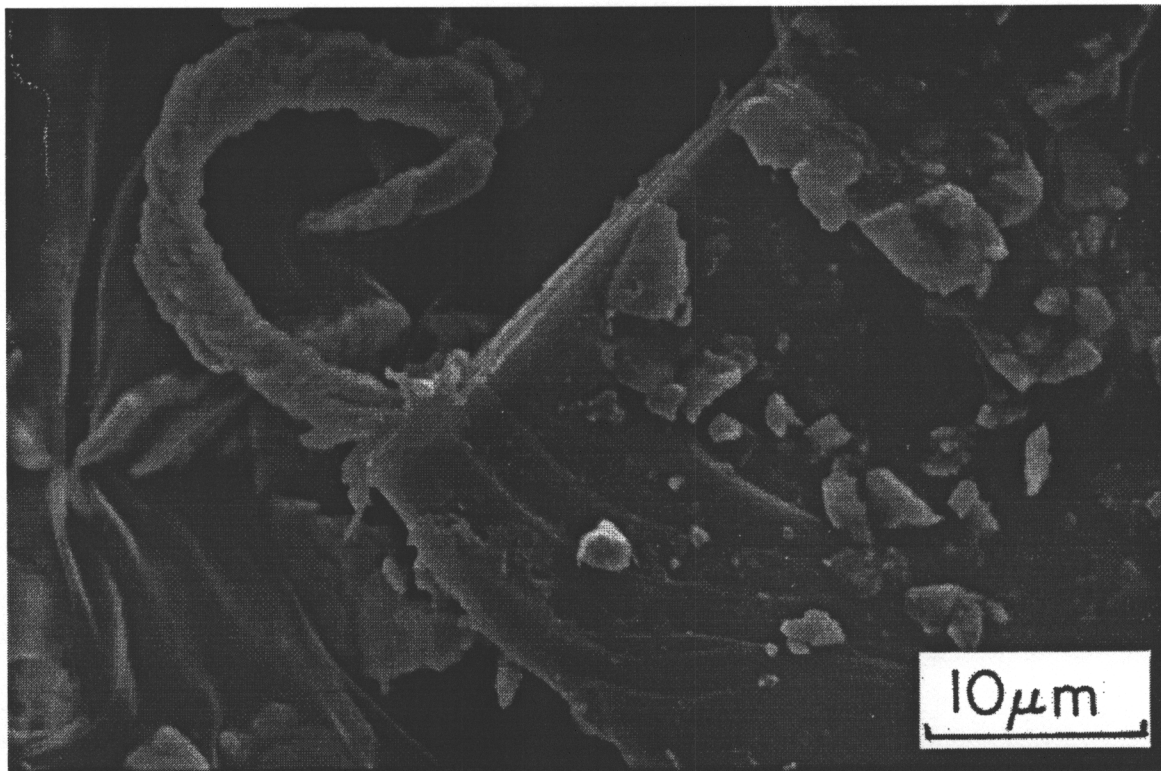
Figure 68: Microchip attached to silica fragment in debris from ion nitrided CPM10V RC 55.

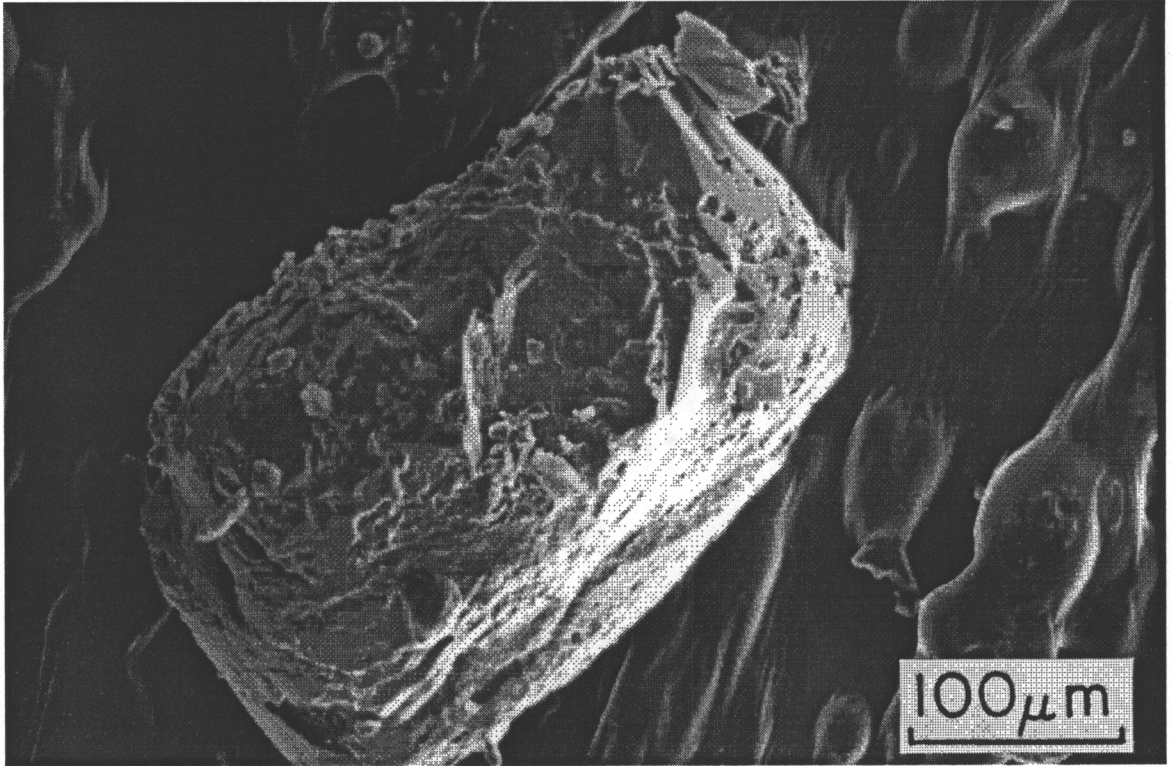
Figure 69: Used sand grain with wear debris.

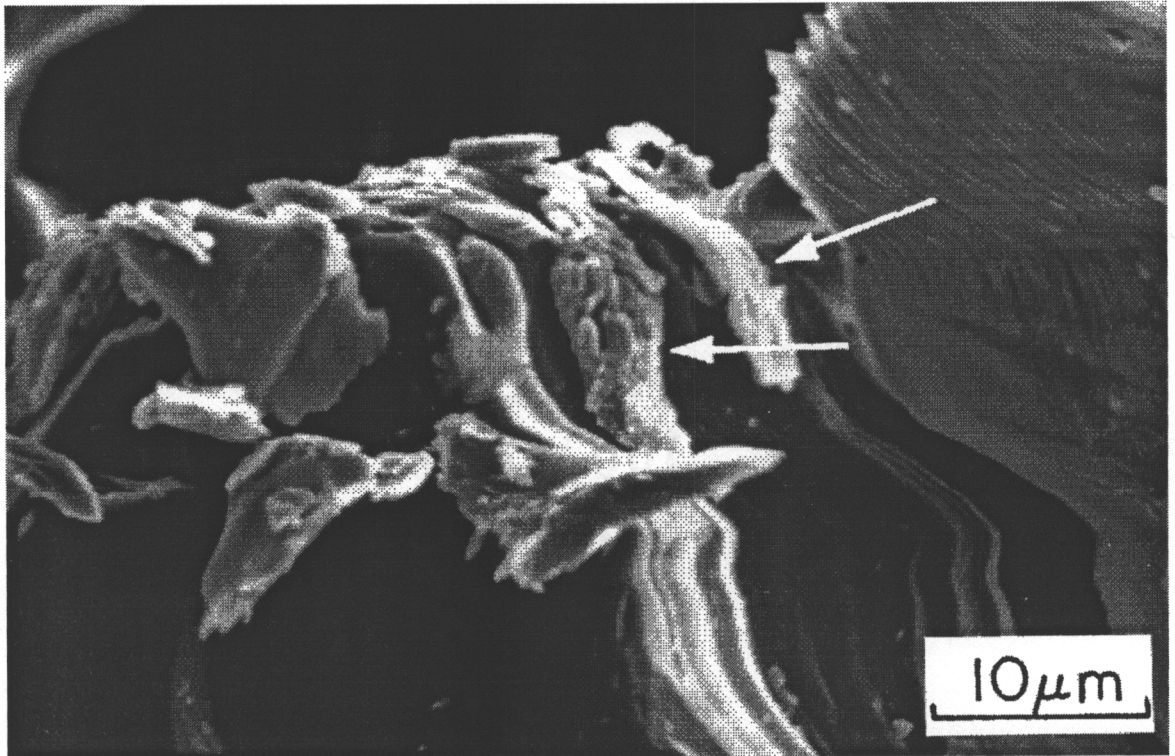
Figure 70: Enlarged view of crystal terminations on sand grain in Figure 69, showing microchips (arrows).

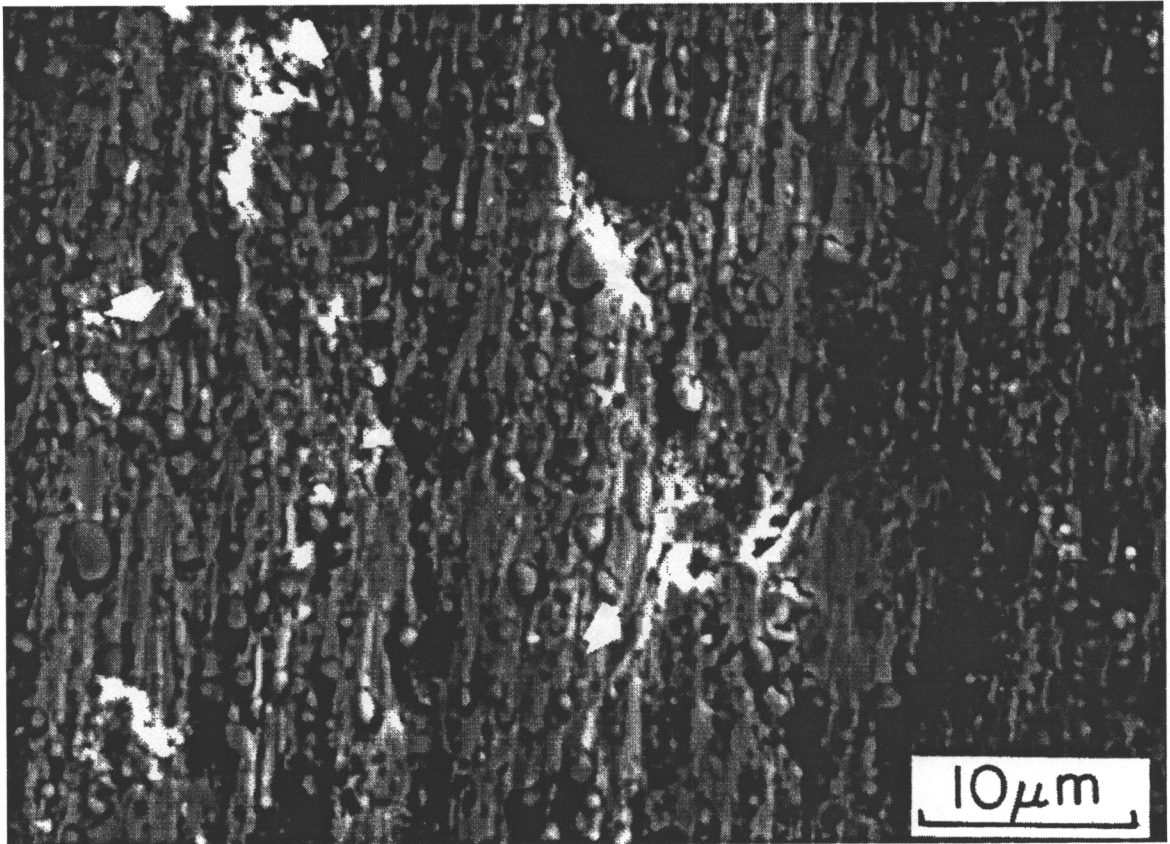
Figure 71: Wear scar on a gray sample of ion nitrided CPM10V RC 59 showing several cracks at the edge of wear sheets (arrows).

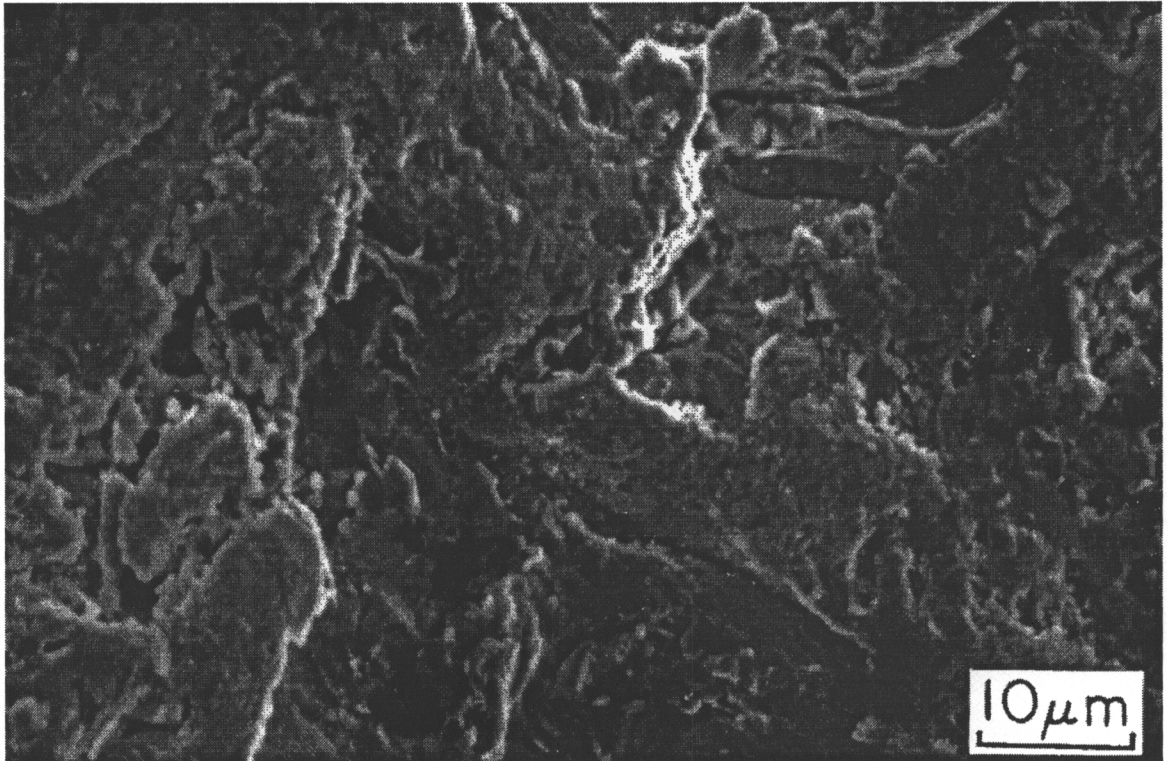
Figure 72: Unworn surface on a gray sample of ion nitrided CPM10V RC 59 showing several cracks.

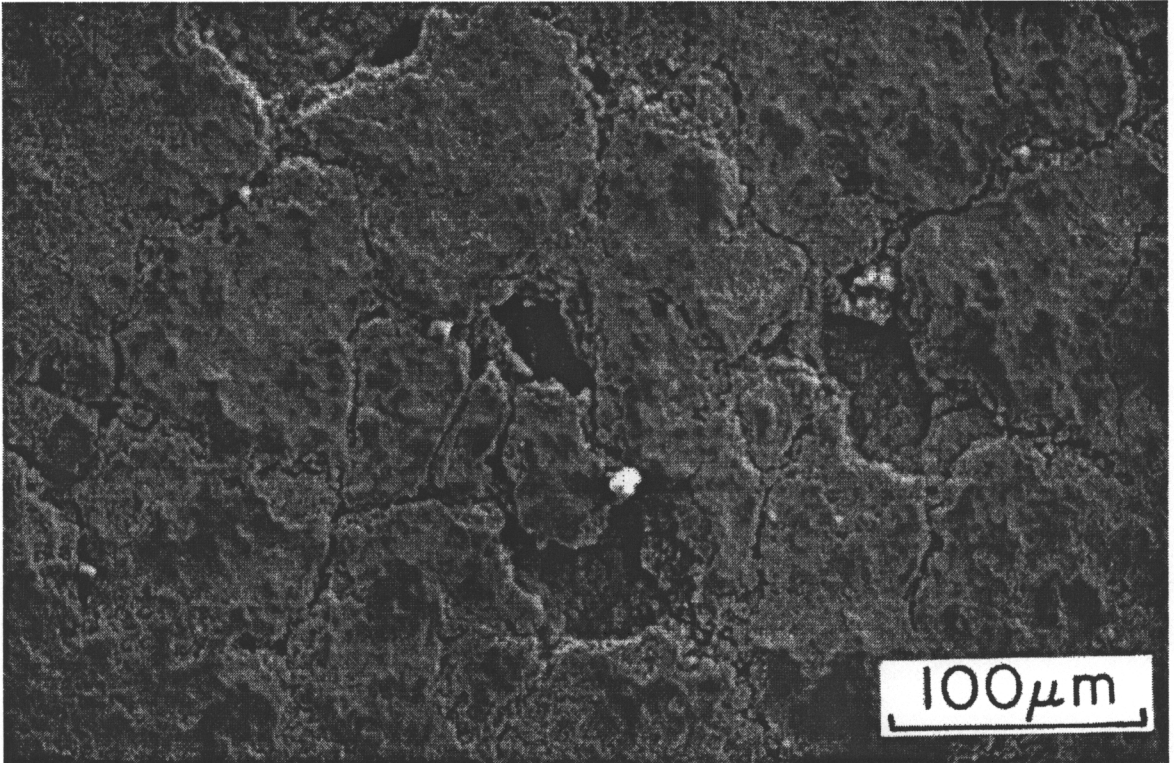
Figure 73: Entry region of wear scar on a black sample of ion nitrided CPM10V RC 59 showing surface layer spalling off.

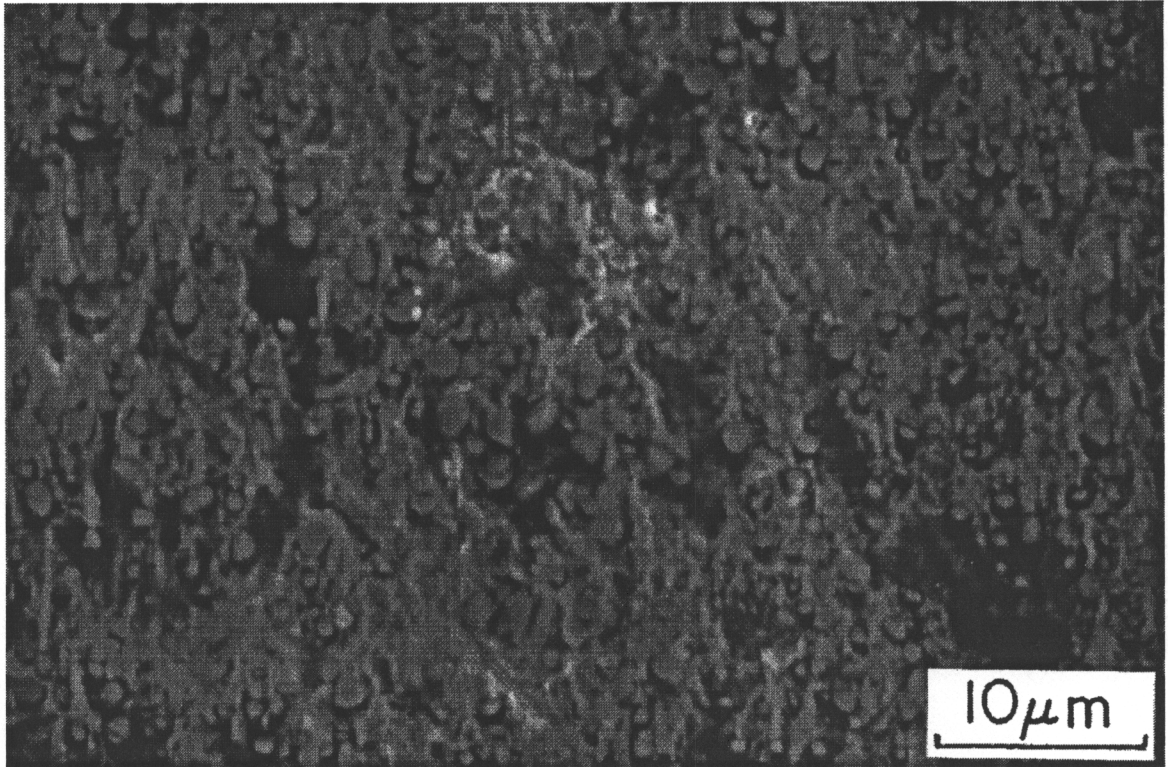
Figure 74: Center of wear scar on a black sample of ion nitrided CPM10V RC 59.

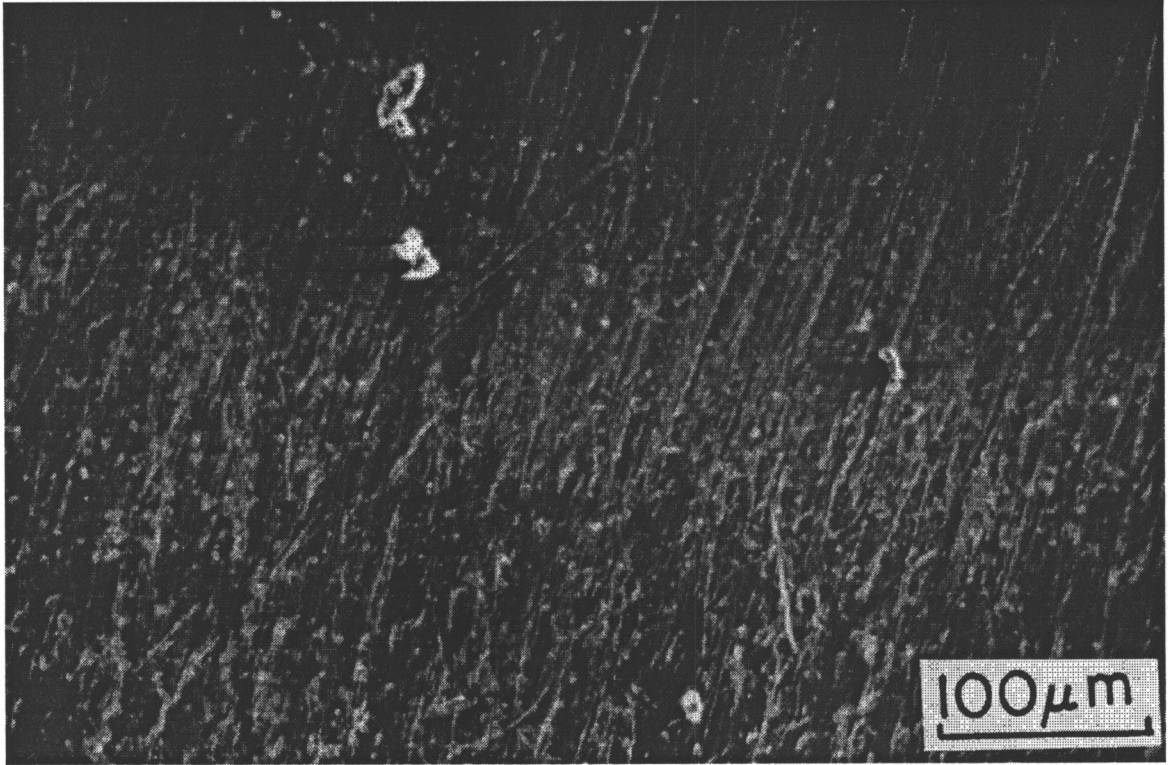
Figure 75: Transition in appearance of wear scar on ion nitrided Thyssen 4122.

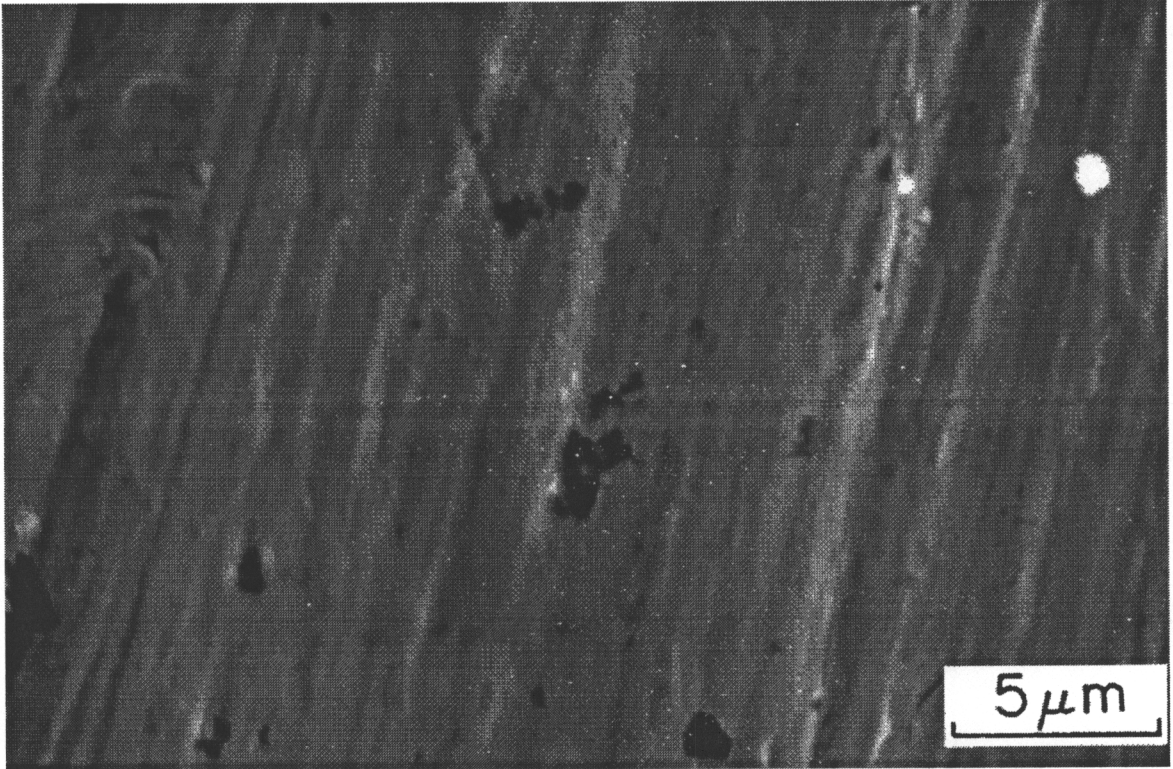
Figure 76: Linear scratches on nitride layer of wear scar on ion nitrided Thyssen 4122.

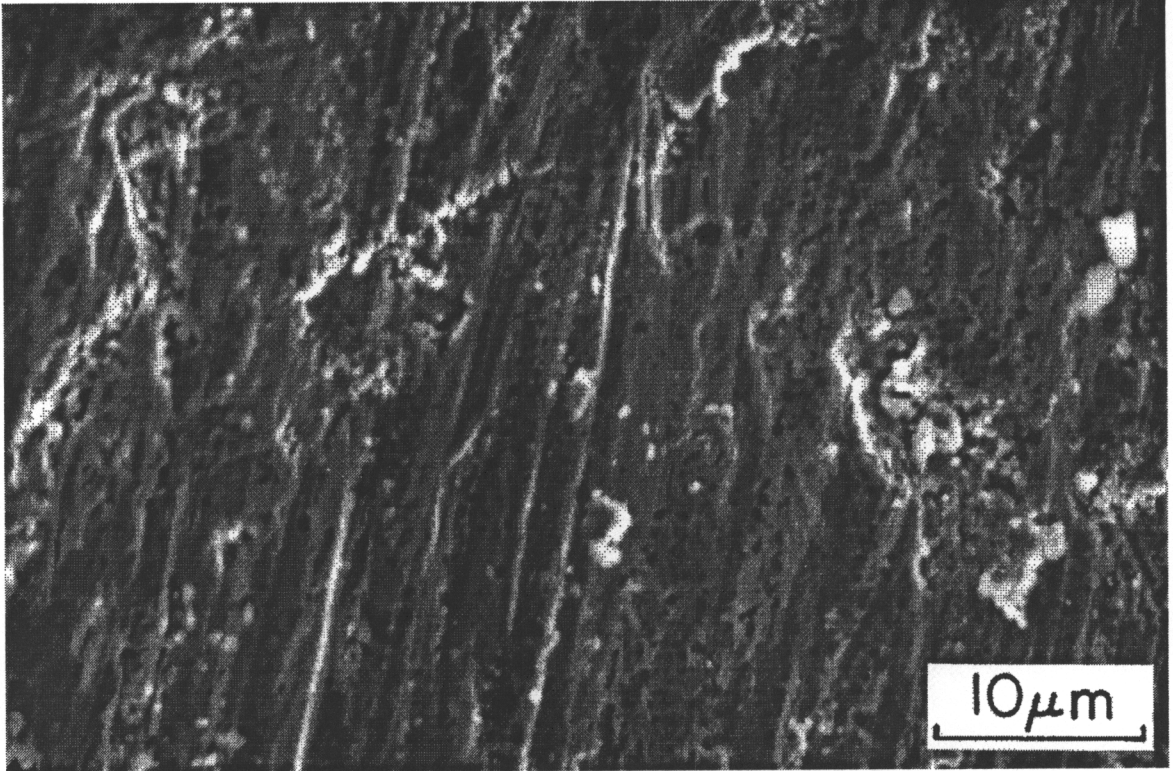
Figure 77: Sheet of loosely attached smeared metal in wear scar on ion nitrided Thyssen 4122.

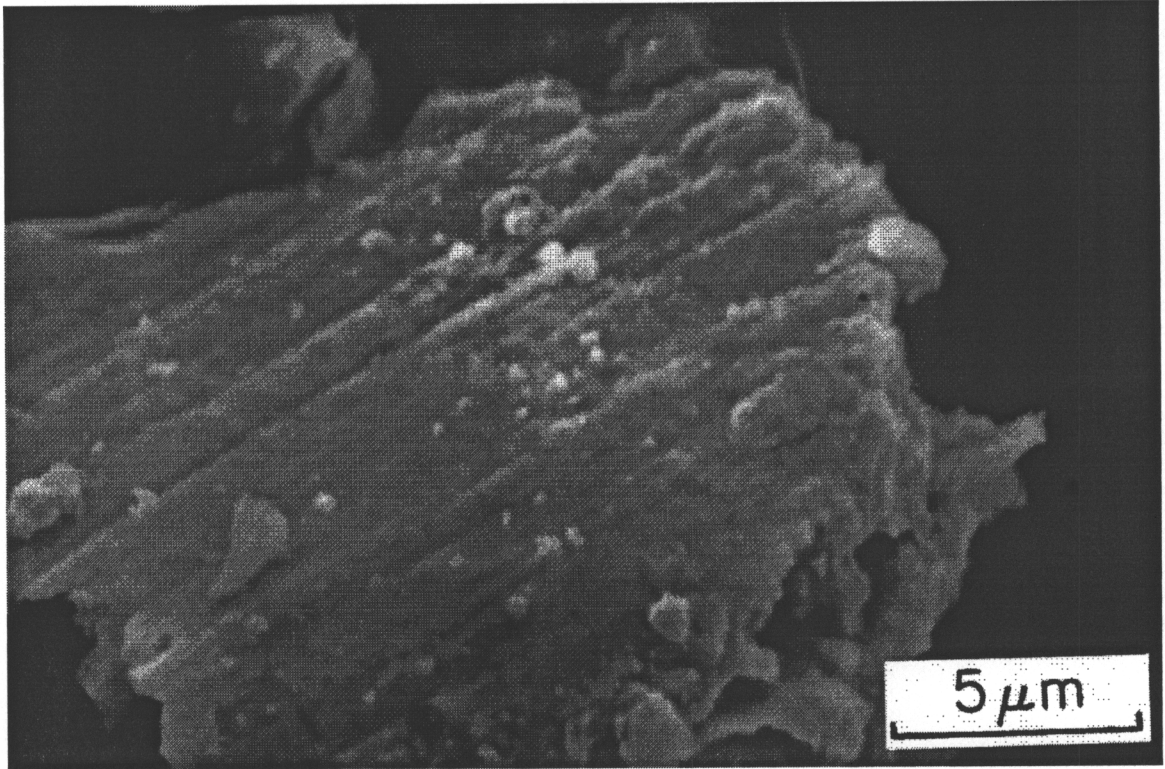
Figure 78: Wear sheet, with scratches, in debris from ion nitrided Thyssen 4122.

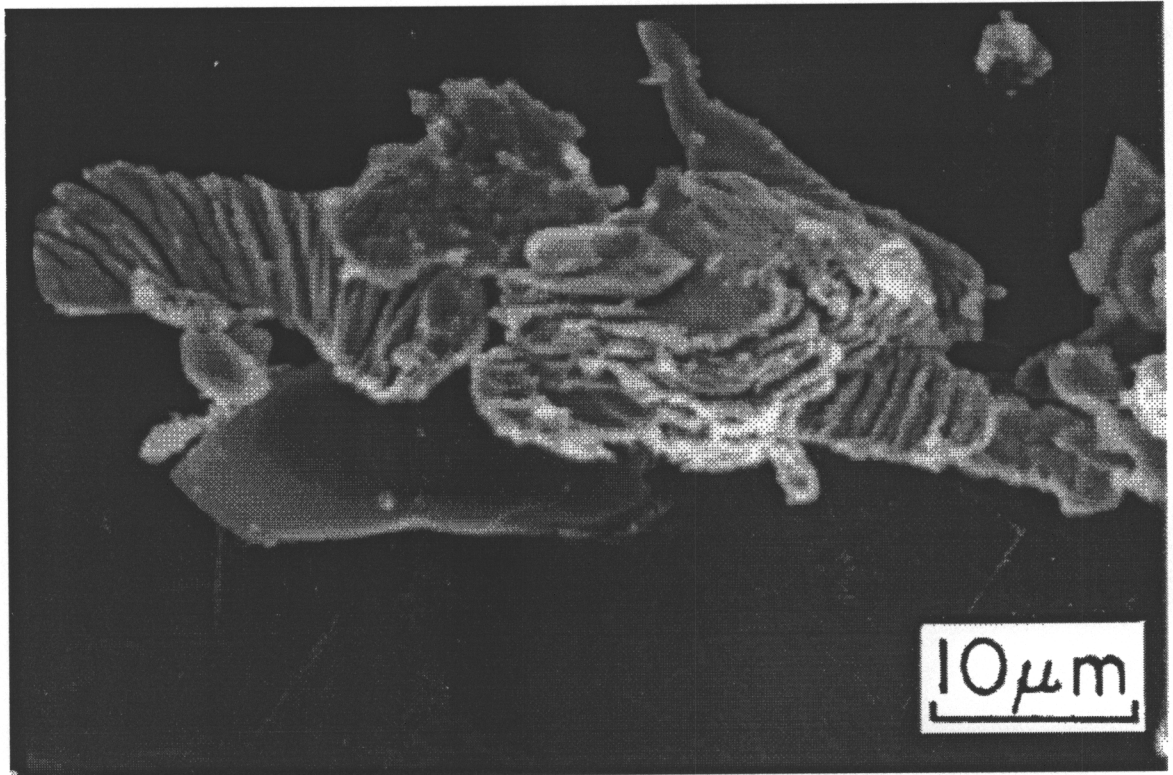
Figure 79: Microchip with thick center region in debris from ion nitrided thyssen 4122.

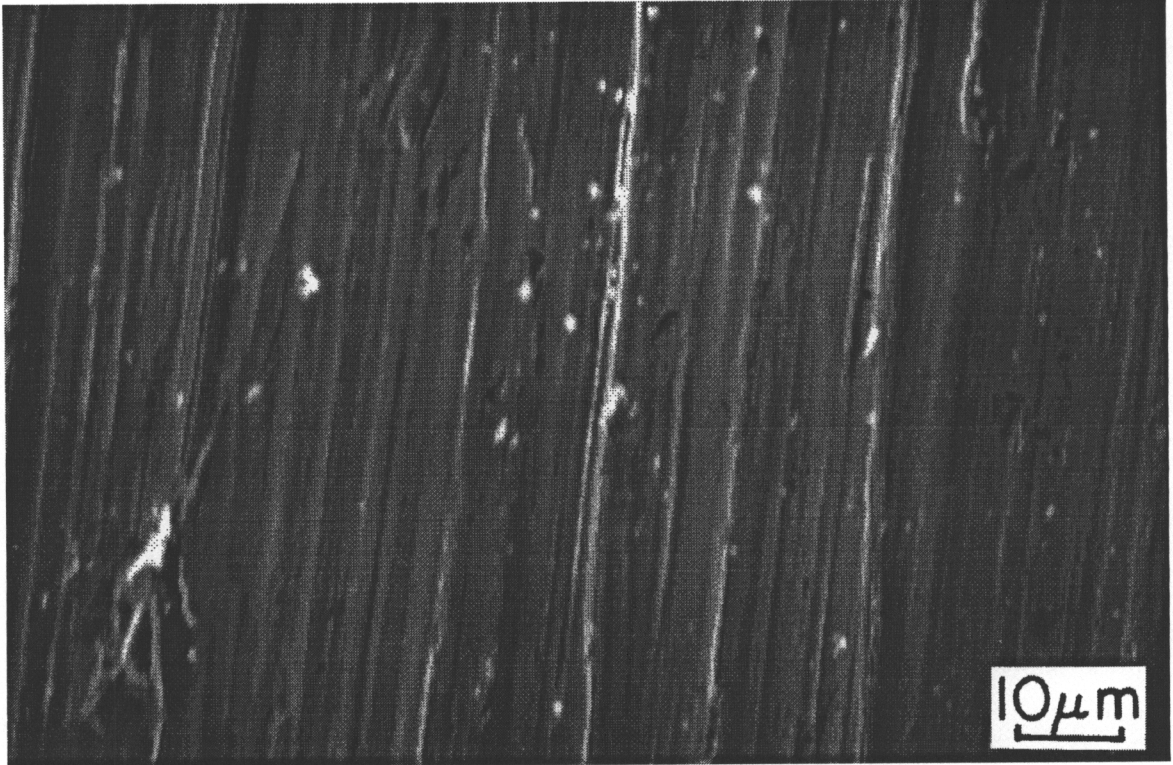
Figure 80: Sharply defined microcutting type scratches in nitride layer at ends of wear scar on ion nitrided AISI 4150.

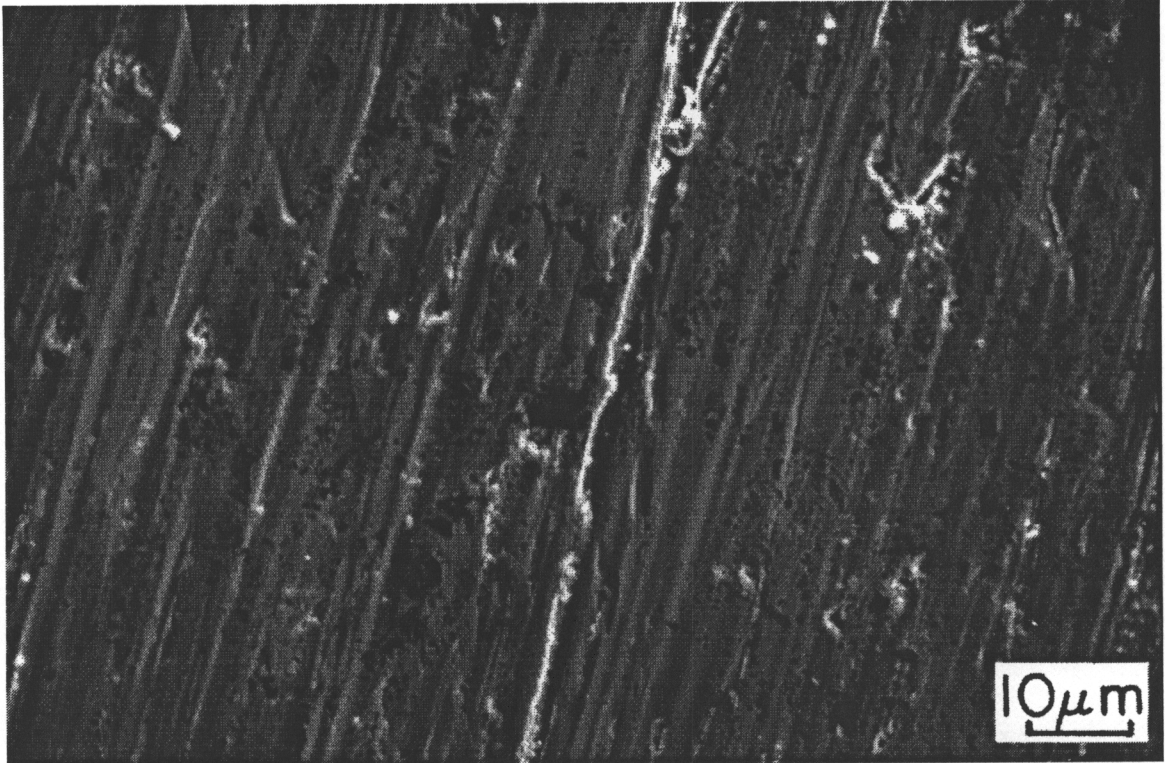
Figure 81: Smeared and dented plowing type scratches in nitride layer at the ends of wear scar on ion nitrided AISI 4150.

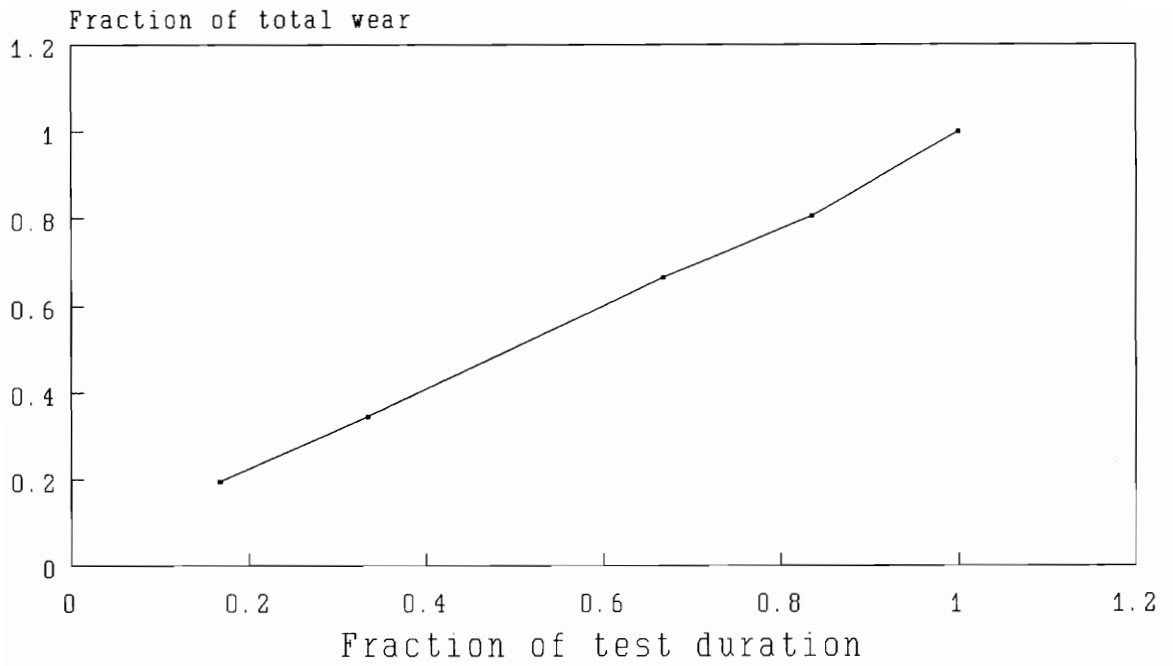
Figure 82: Interrupted tests on D-2, showing a linear relationship of wear to sliding distance.

Interrupted tests showed that the wear rate was constant for the steels in the non-nitrided condition. After nitriding, the wear rate increased with test duration. The nitriding was found to act as a barrier coating providing an initial period of very low wear until the nitride layer is broached. The wear rate then increases to approximate the wear rate of the non-nitrided samples.

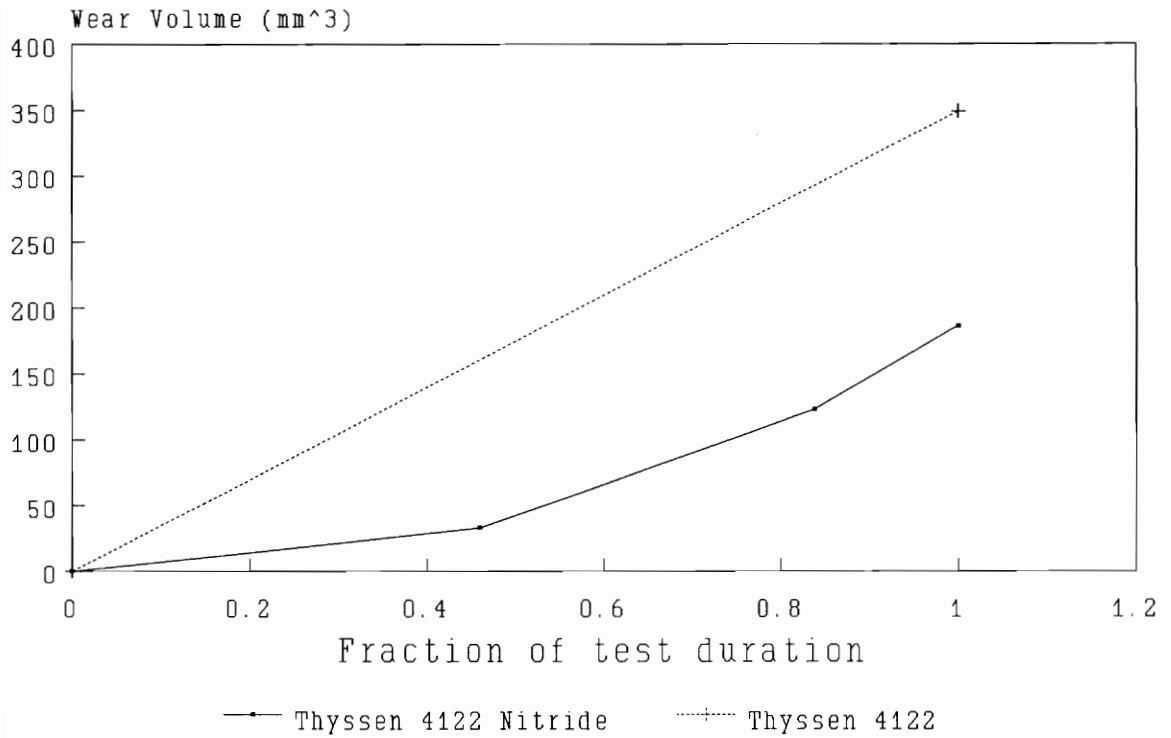
Figure 83: Interrupted tests on ion nitrided Thyssen 4122, showing a nonlinear relationship of wear rate to sliding distance.
