## FINAL CONTRACT REPORT

# IMPLEMENTATION AND NON-DESTRUCTIVE EVALUATION OF COMPOSITE STRUCTURAL SHAPES IN THE TOM'S CREEK BRIDGE

M. D. Hayes, J. Haramis, J. J. Lesko,  
T. E. Cousins, J. C. Duke, R. E. Weyers

May 2000  
VTRC 00-CR7

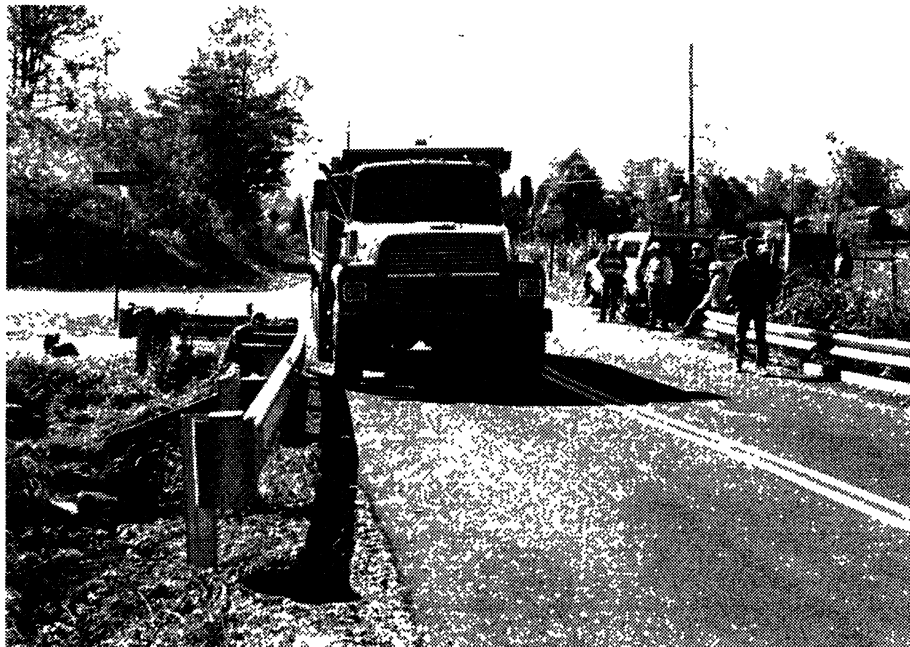
**Figure 10.** Field test of the Tom's Creek Bridge.

Field testing of the rehabilitated bridge was performed to establish service load deflection, strain levels, load distribution, the degree of composite action, and dynamic load effects. The first of several controlled vehicle field tests was conducted in October of 1997 by Virginia Tech and VTRC with a 214 kN (24 ton) dual rear axle VDOT truck (Figure 10). Dynamic tests were conducted with the vehicle traveling over the bridge at speeds of roughly 40 and 64 km/h (25 and 40 mph). The maximum safe speed of the test vehicle on the bridge was 64 km/h therefore this was the maximum test vehicle speed used during the field test. Quasi-static tests were also performed with the vehicle traveling at about 3 km/h (2 mph). Each test was run at three locations consistent with the loading cases investigated in the lab testing: left lane, right lane, and center of the bridge. Prior to testing, each stringer-deck connection was tightened to 41 N-m.

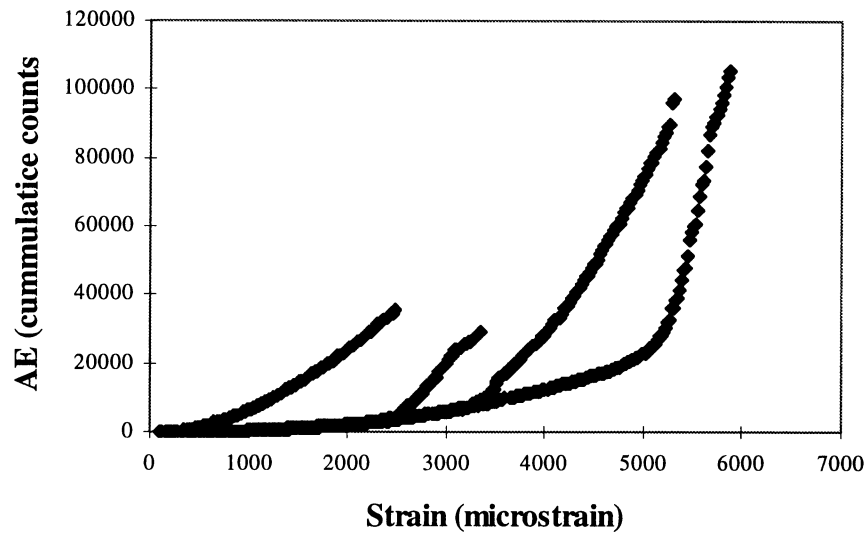
**Figure 15.** AE detected from a transducer placed on the **compression flange** during loading of a beam ultimately loaded until failure. The AE detected during unloading is not displayed, and AE was detected during each loading until the load increase was terminated, with some low levels of AE detected during momentary holds at maximum load.

In order to provide design data to the engineer of record, one beam was loaded in four-point bending to increasingly higher deflections, with intermingled unloading, until finally the beam failed. Two plots displaying the AE detected during these loading sequences is shown in Figures 15 and 16. These data were obtained by placing one AE sensor on the bottom flange (which experiences primarily tensile loading). The AE detected on the tensile flange exhibit the Kaiser effect, (that is the AE does not reoccur upon reloading until the previous maximum load is reached) while that from the compressive flange appears to exhibit a Felicity ratio that is quite low. (The Felicity ratio was developed to generalize the Kaiser effect concept and corresponds to the ratio of the load for which AE is observed on reloading to the previous maximum loading. A material exhibiting the Kaiser effect has a Felicity ratio of 1.)

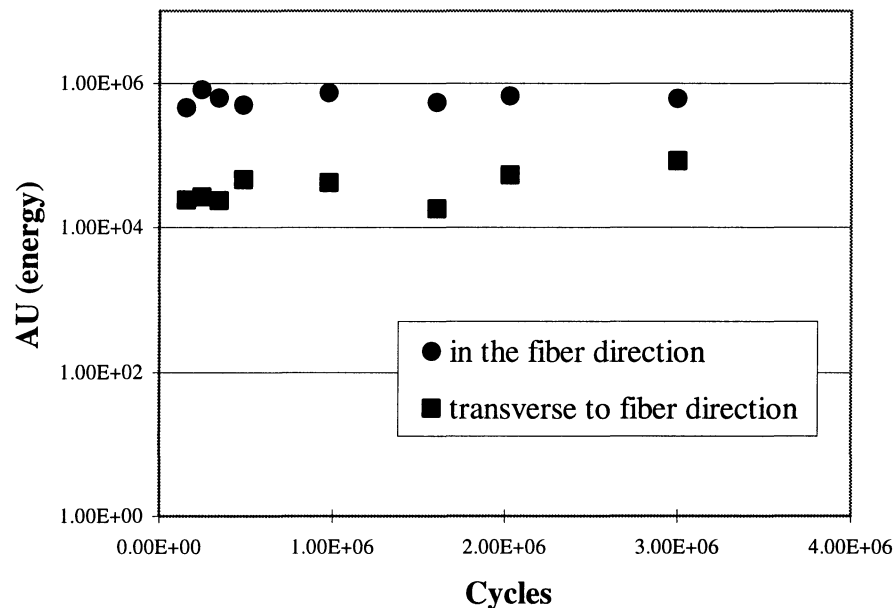
**Figure 17.** AU evaluation, quantified by energy detected by placing a receiving transducer in a direction with respect to the exciting transducer either in the fiber direction or transverse to the fiber direction, after different numbers of accumulated load cycles.

AU evaluation was performed in regions of load application during a four-point load bending cyclic fatigue test of one beam. The AU evaluation was made with and across the primary axis of the beam following an increment in number of loading cycles. Figure 17 displays an example of the AU evaluation results with and transverse to the reinforcement direction for one of the regions. The AU evaluation is essentially constant for each direction, with the difference in values between the two directions due to the decreased energy transmission across the fiber direction. Residual flexural stiffness measurements after each increment in cycles indicate that essentially no change was detected at this level of strain even after  $3 \times 10^6$  cycles.

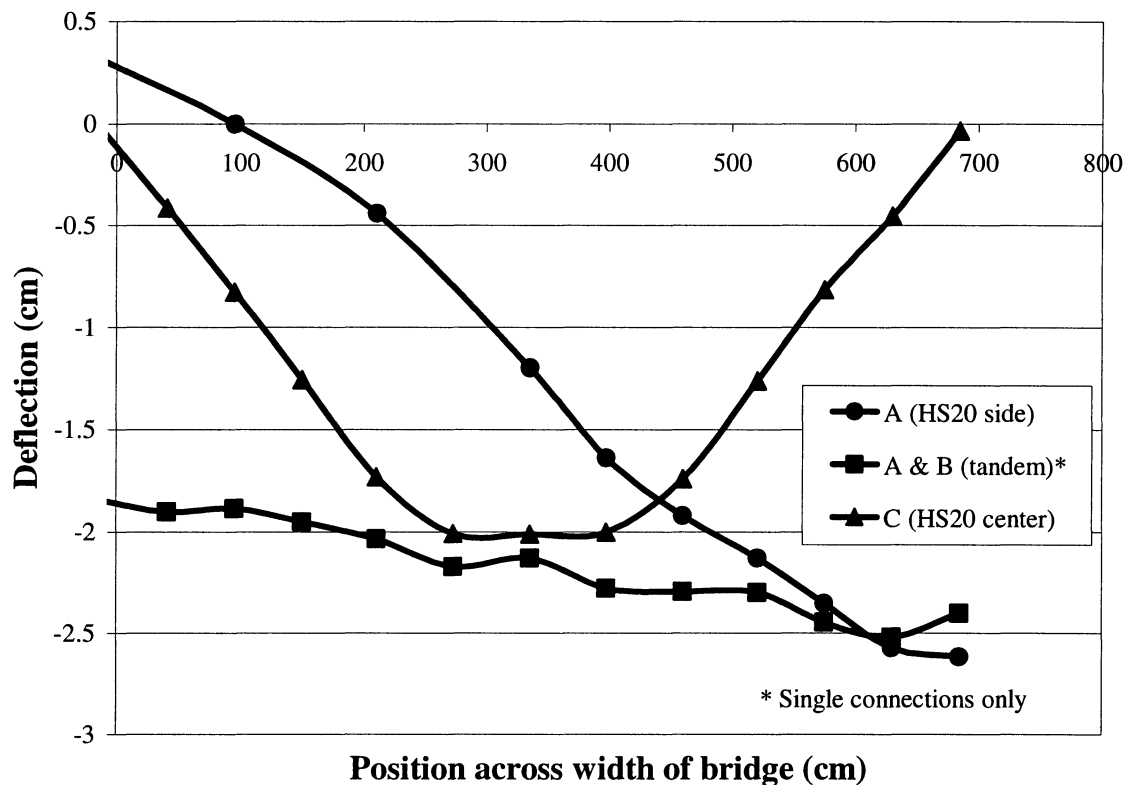
**Figure 18.** Comparison of deck panel deflections for three HS20 loading cases. Cases A and C are for triple connections, while the tandem loading results are for single connections only.

For the side loading scenario (loading case A in Figure 18), the wheel loads were positioned above composite beams 15/16 and 21/22, at locations of 4.27 m and 6.10 m respectively (measured with reference to beam #1, along the centerline). The largest deflection and strain values were observed at beam 22; a maximum deflection of 27 mm was measured at an axle load of 187 kN (a 72 kN wheel load with a 30% dynamic load allowance). This indicates an  $L/200$  deflection response,  $L/255$  if the impact factor is excluded, where  $L$  is the clear span. Again these measurements are taken from the structure which does not include curb rails and foundations connections. The maximum strain at the 187 kN axle load was  $979 \mu\epsilon$ . Deflections and strains for the side loading case with single connections only are shown in Figure 19 and Figure 20. The positive deflections and strains between composite beams 1 and 4 (0 to .82 m) indicate uplift at the structure's edges. Recall that the beams were not constrained at the abutments so as to prevent upward vertical displacement.

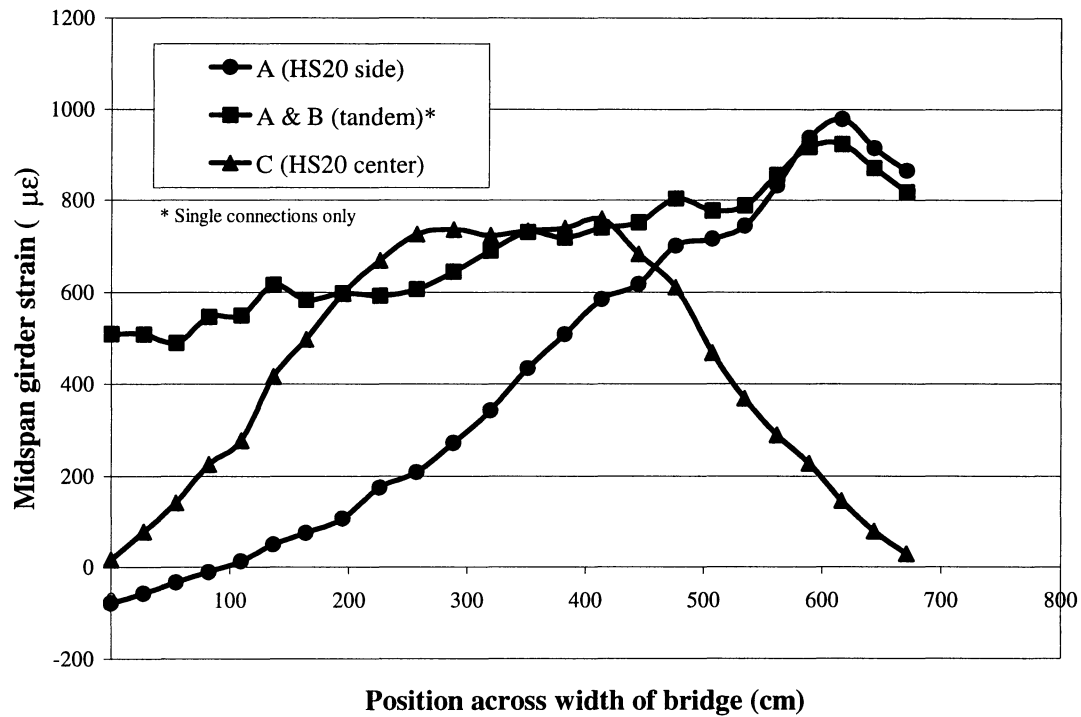
**Figure 19.** Comparison of center bending strains under different HS20 loading cases.

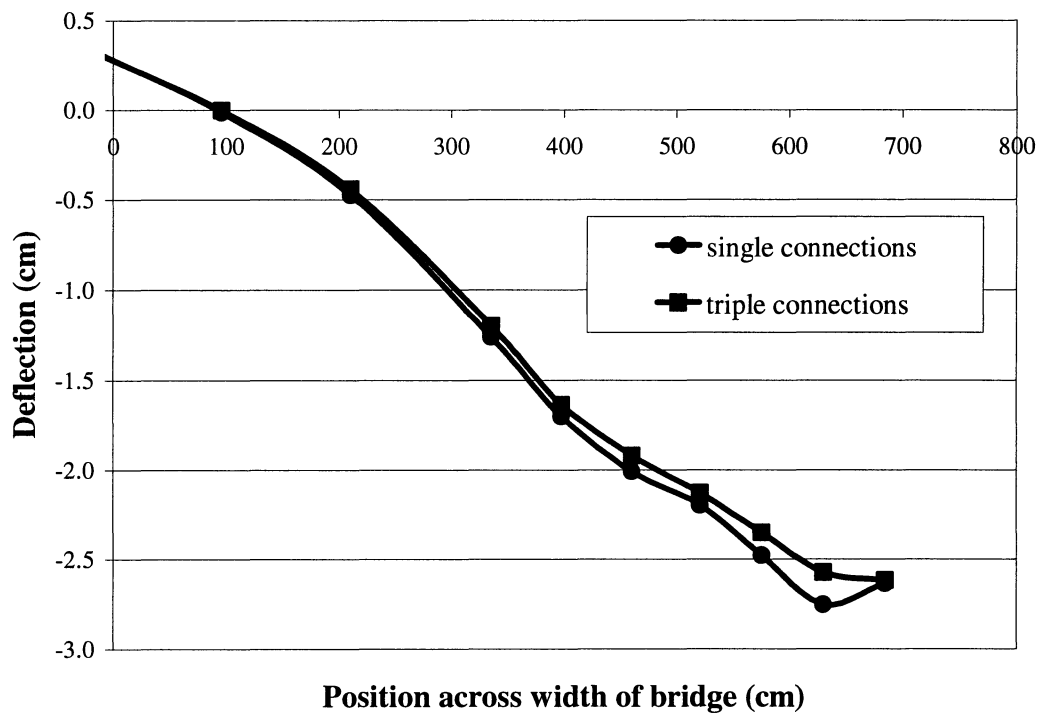
**Figure 20.** Mid-span deck panel deflections under HS20 side loading with two different connection sets.

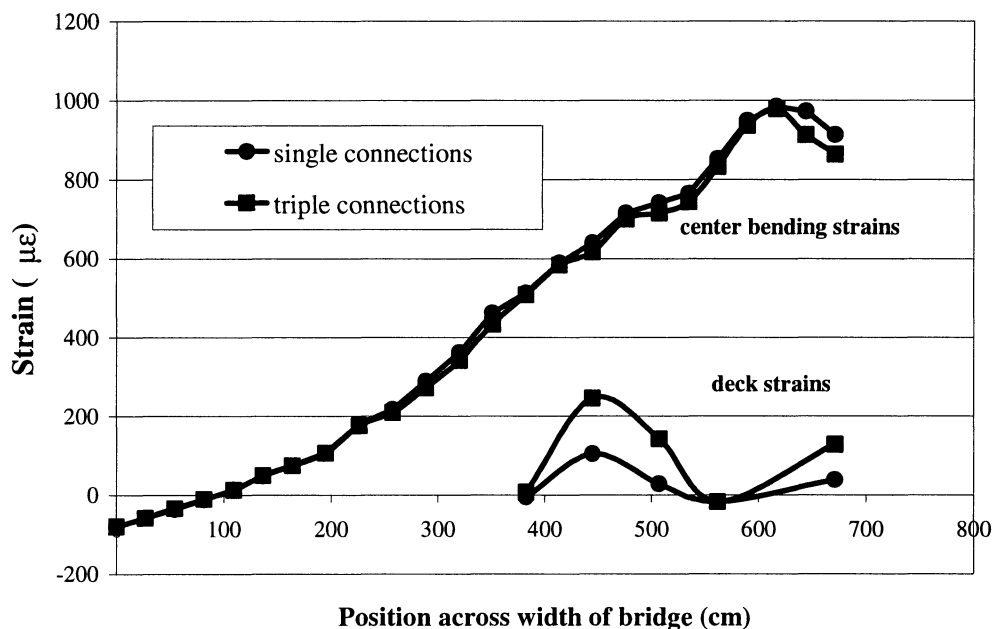
**Figure 21.** Girder bending and deck strains under HS20 side loading with two different connection sets.

In order to determine the effect of the connections on the degree of composite action, the additional connections were added (as illustrated in Figure 8). On the right half of the structure (nearest the loading), two more spanner connections (for a total of three) were added at nearly all of the connection sites. Thus, the number of connections on that half of the structure was nearly the same as what is being utilized in the actual bridge. The structure was then loaded under the side loading design scenario. The deflections and strains decreased only slightly (6-7%) with the additional connections (Figures 20 and 21). The timber deck strains increased some with the addition of more connections, but the maximum deck strain was still relatively small at 245  $\mu\epsilon$ . Furthermore, the change in the location of the neutral axis of the composite beams was negligible (less than a 2% shift), indicating little or no composite action.

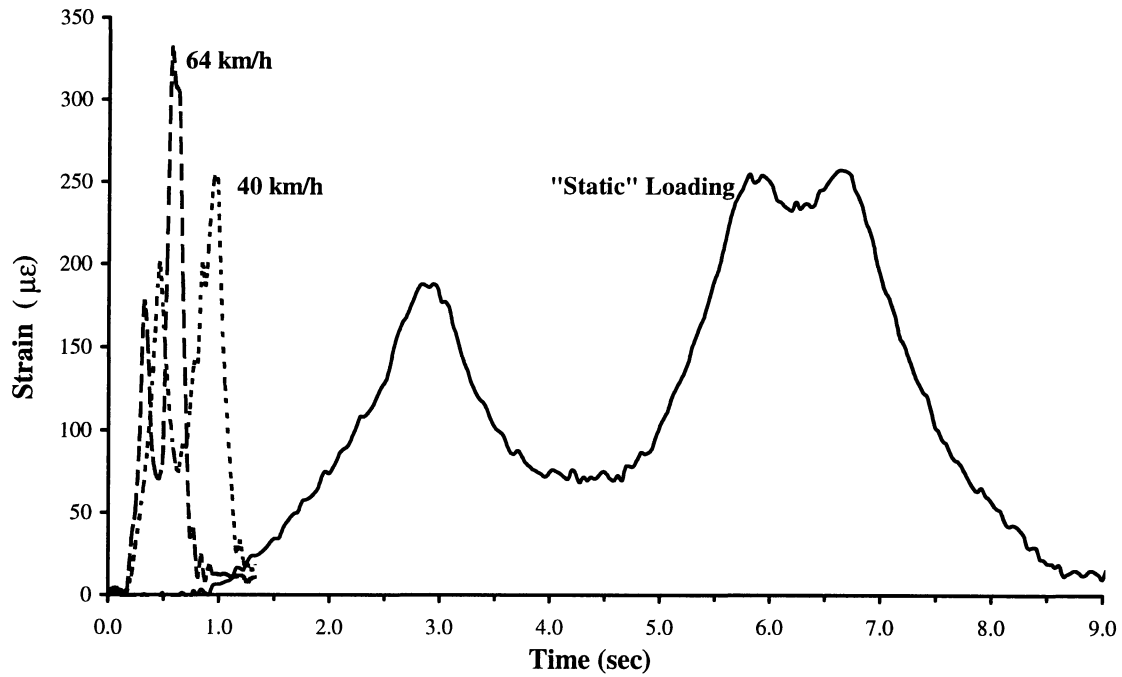
**Figure 22.** Dynamic response of the bridge during field tests. Maximum bending strains (girder #4) are shown for each vehicle speed.

Data taken from the tests at all three speeds (3, 40, and 64 km/h) were analyzed to identify the actual impact factor for this structure. Typically, the largest increases in deflections and strain at the 64 km/h speed were, on average, 45% for center left and right lane passes, as shown in Figure 22. At 40 km/h there was a negligible dynamic effect for center left and right passes.

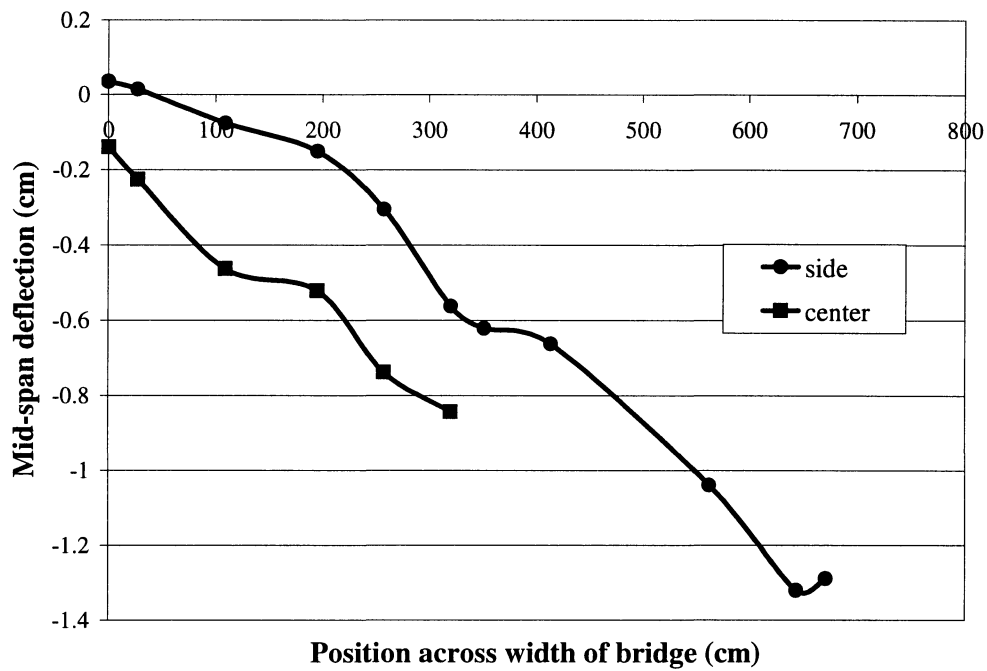
**Figure 23.** Center deck panel deflections under the side and center loading cases for field tests.

deflections are linearly scaled to HS20-44 loading (187 kN). This is a substantial smaller deflection as compared to the L/200 response observed in the laboratory testing, as shown in Figure 24. The increased stiffness of the field structure is due specifically to the curb stiffening introduced by the curb rails which were not present during the laboratory testing (see Figure 4). The deflection data under both side and center loading from the laboratory and field-testing are compared in Figure 24 and 25. Here again the field test data has been linearly scaled by 3.5 times to correspond to HS20-44 loading.

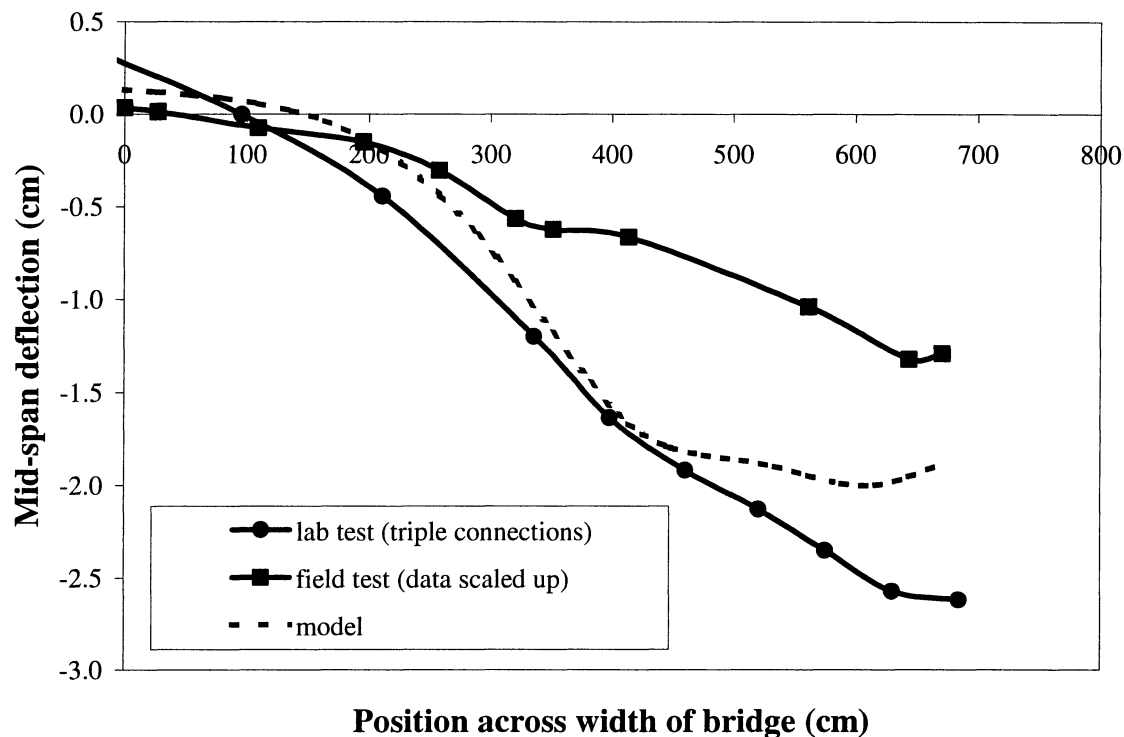
**Figure 24.** Comparison of center deck panel deflections under HS20-44 side loading in both the laboratory and field.

As discussed above the increased stiffness of the actual bridge as compared to the lab mock-up is most likely attributed to the addition of the curb rails along the edges of the deck. However, girder-to-abutment connections and the addition of all stringer-to-deck connections in the actual bridge can possibly contribute to the bridge stiffness.

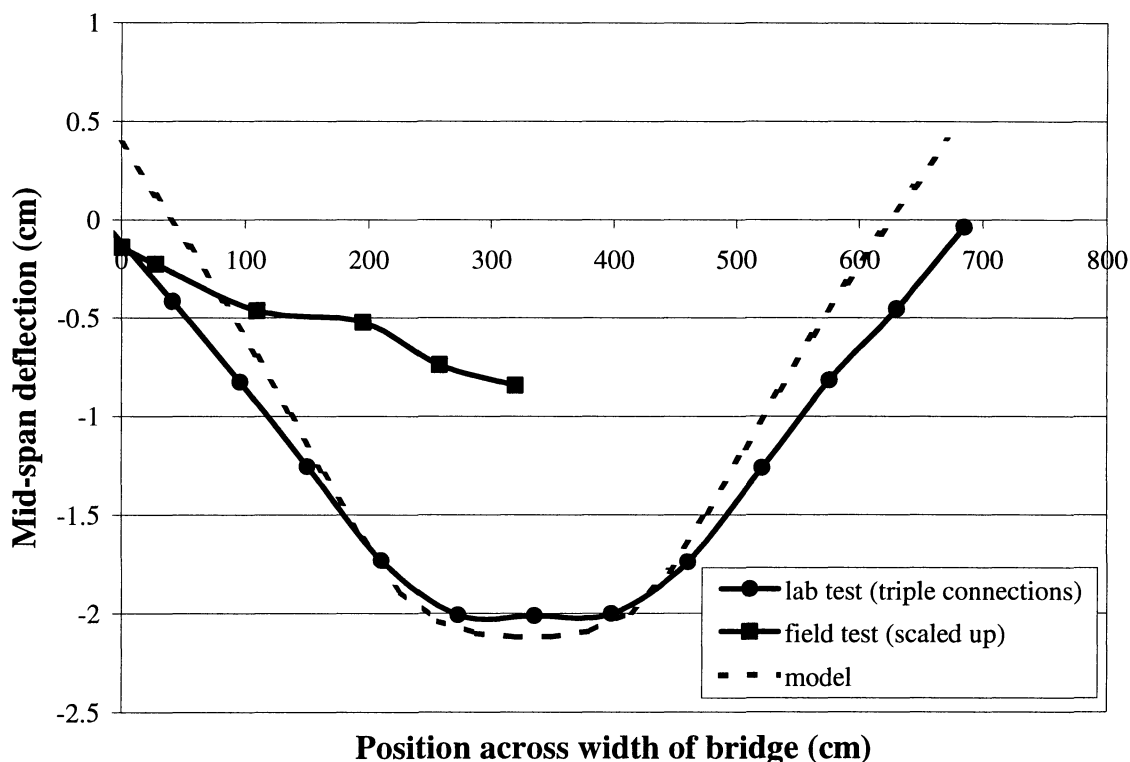
**Figure 25.** Comparison of center deck panel deflections under HS20-44 center loading in both the laboratory and field.

Greater stiffness of the rehabilitated bridge relative to the lab mock-up is also observed for the center loading case (Figure 25). The mid-span bending strains on the composite girders under center loading are shown in Figure 26. A maximum strain of  $135 \mu\epsilon$  was measured, so that under HS20-44 loading, the maximum expected strain would be about  $470 \mu\epsilon$ . This corresponds to a factor of safety of over 7 using the projected A-allowable for this particular span. Again, the deck strains observed during the field tests were relatively small ( $\approx 300 \mu\epsilon$ ) yet the shift in neutral axis was slightly greater (less than 10 %). A subsequent field test demonstrated that axial (tensile) load was present in the beams as a result of axial constraints present by the abutments (further details to be reported Rux, 1999).

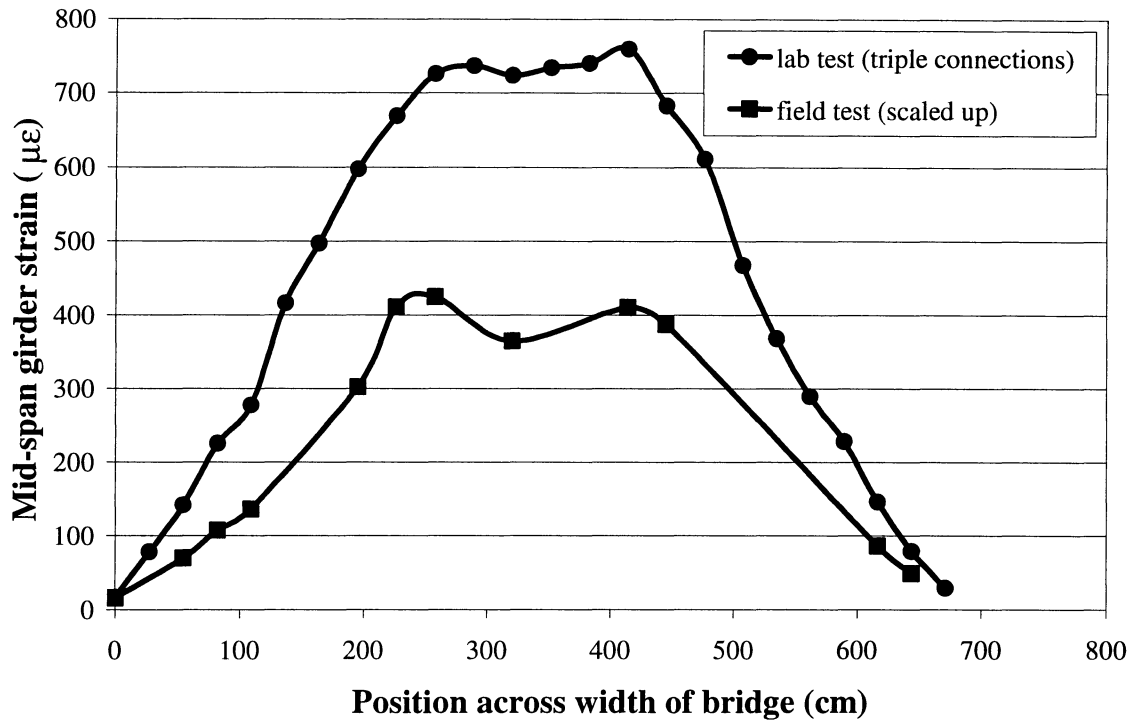
**Figure 26.** Mid-span bending strains on selected composite girders in field tests.

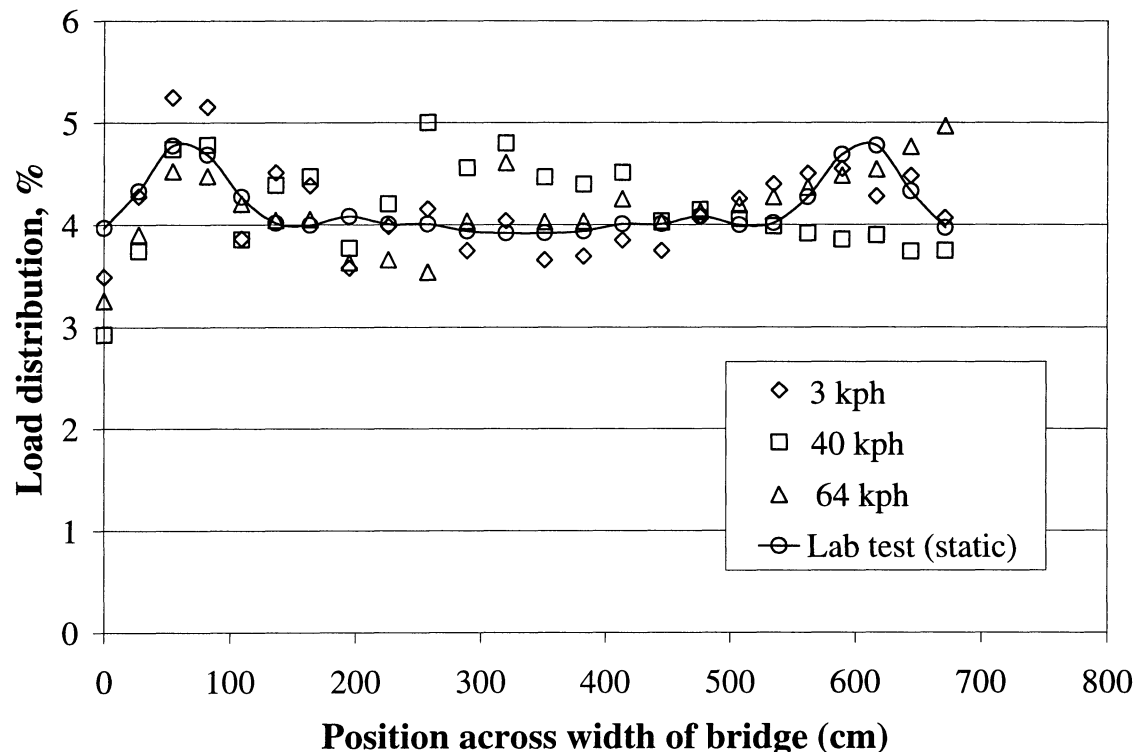
**Figure 27.** Load distribution across width of bridge for various field tests (dynamic and quasi-static) and lab test (quasi-static).

The bending strains on the bottom flange of each composite beam were used, assuming that strains are linearly proportional to the applied load and inversely proportional to the beam stiffness in bending and shear. The percentage of load carried by each stringer was determined for the case of tandem axle loads positioned in-line at mid-span by dividing the strain on a beam by the total strains resulting from the tandem axle loads (Figure 27). The data indicates that the load distribution is fairly uniform, with an average applied load per beam of 4.2% and is independent of vehicle speed.

In AASHTO (1996), the nearest type of structure for which specifications regarding load distribution are given is a steel stringer and timber deck design. For a deck depth equal to 10.2 cm (4 in), the load fraction per beam under one wheel line loading (one wheel patch, for this bridge) is the stringer spacing ( $S$ , in feet) divided by 4.0; Load Distribution Factor ( $LDF = s/4$ ). For a depth greater than 15.2 cm (6 in), a fraction of  $S / 4.5$  is specified. For the 13.0 cm (5.13 in) depth of the glue-lam system used here,  $S / 4.0$  is considered for comparison purposes. The load fraction per beam under two tandem truck axles (four lines of wheel loads) would be  $S / 16$ . This corresponds to a design distribution factor of about 6% for the average girder spacing in the Tom's Creek Bridge. Therefore, in comparison with a steel/timber design, the design load distribution factor conservatively estimates the load distributed to any one composite girder.
