VHPC Material Characterization and Recommendations for the Buffalo Branch Bridge
Rehabilitation

Thesis submitted to the Faculty of the Virginia Polytechnic Institute and State University in
partial fulfillment of the requirements for the degree of

Civil Engineering

Keywords: Adjacent Box Beam Bridges, UHPC, Shear Key, Live Load Test

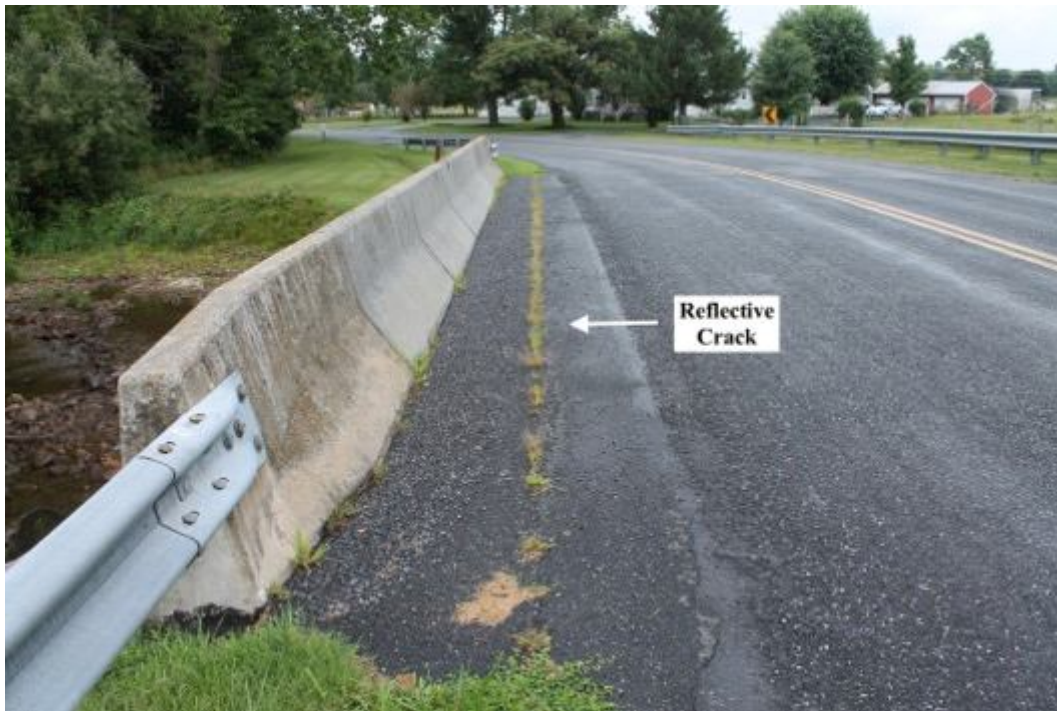
Adjacent prestressed girder bridges are comprised of either precast adjacent box beams or voided slab sections as the superstructure with a deck or topping placed directly on top. The precast members are traditionally connected with a shear key filled with grout and transversely tied at intermittent diaphragm locations. This ensures transverse load transfer between neighboring adjacent members. By using precast members, these bridges are fairly simple and can be rapidly constructed due to a significant amount of work done beforehand offsite at a precast plant. Adjacent box beam bridges are an efficient design for short spans and bridge locations with low vertical clearance requirements. However, over time the traditional grout shear key tends to deteriorate causing reflective cracking to propagate through the deck and into the wearing surface as shown in Figure 1.

Figure 1. Reflective cracking

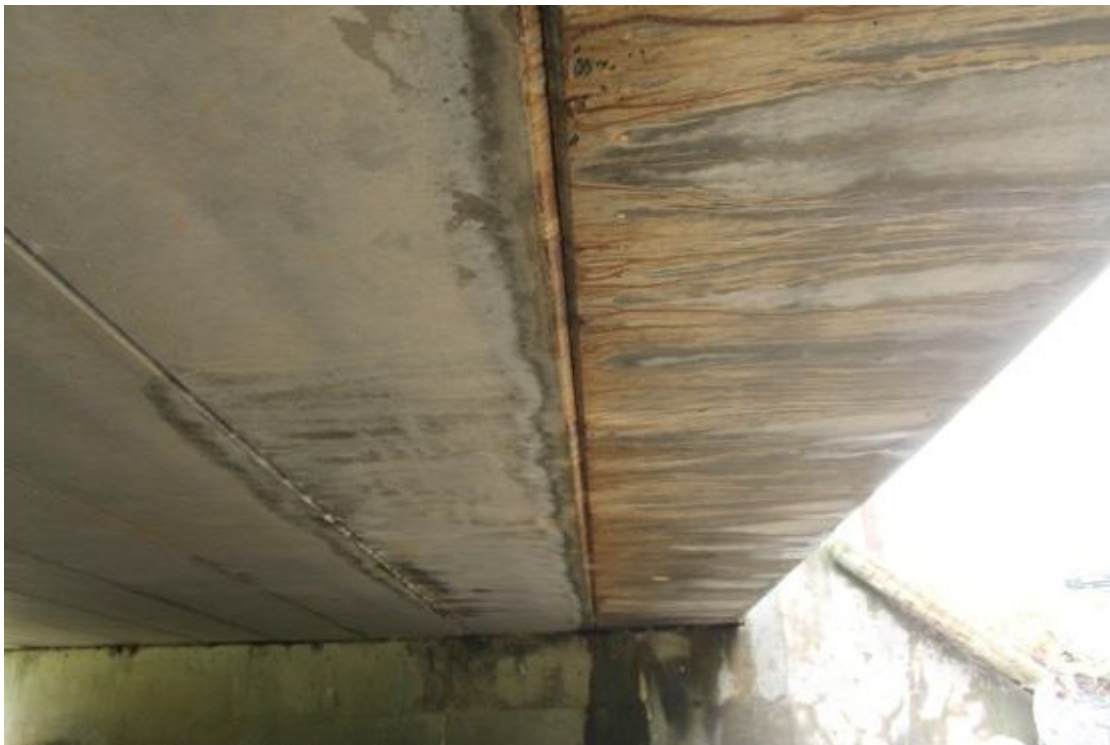
These reflective cracks allow for water and corrosive agents such as deicer salts to seep down into the joints which, if left untreated, can eventually cause the reinforcing and prestressing steel in the precast members to corrode. This leads to the need for bridge repair or replacement well before its design life, negating the assessed economic value of the adjacent member system. Reflective cracking allowing water to leak through the joint can be seen in Figure 2, which is the underside of the joint in Figure 1.

Figure 2. Leaking joint

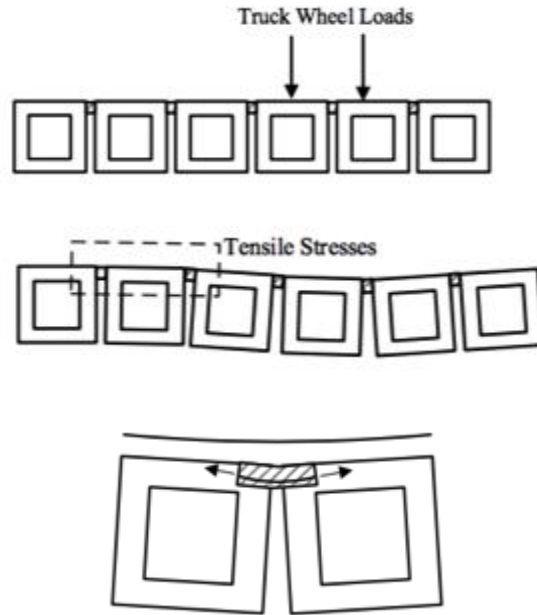
Halbe et al. (2014) report on tests performed to determine the minimum lap splice length required to fully develop No. 4 bars in UHPC and VHPC-Large. Adjacent box beam bridges can have rigid connections at the top flange, causing transverse tensile stresses to develop due to traffic loads and long-term effects (from shrinkage and temperature). A test method was developed to mimic the lap splice region in adjacent precast members shown in Figure 7.

Figure 7. Splice location in adjacent box beam bridges (Halbe et al., 2014)

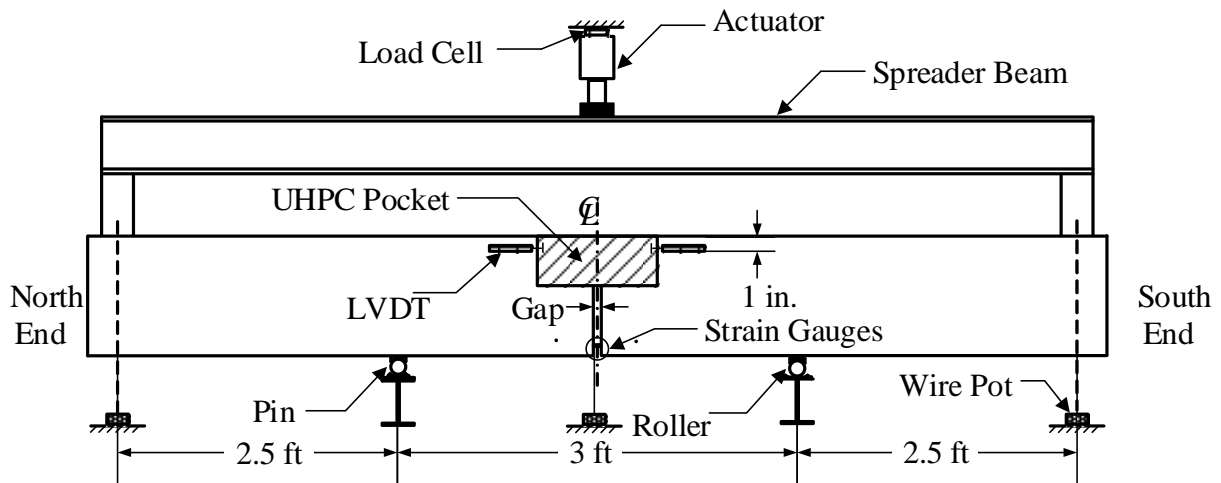
The reinforcing steel was spliced in the pocket and filled with either UHPC or VHPC. It was then loaded in the configuration shown in Figure 9 so that the splice was in a region of constant moment and remained in tension until failure.

Figure 9. Lap splice test setup (Halbe et al., 2014)

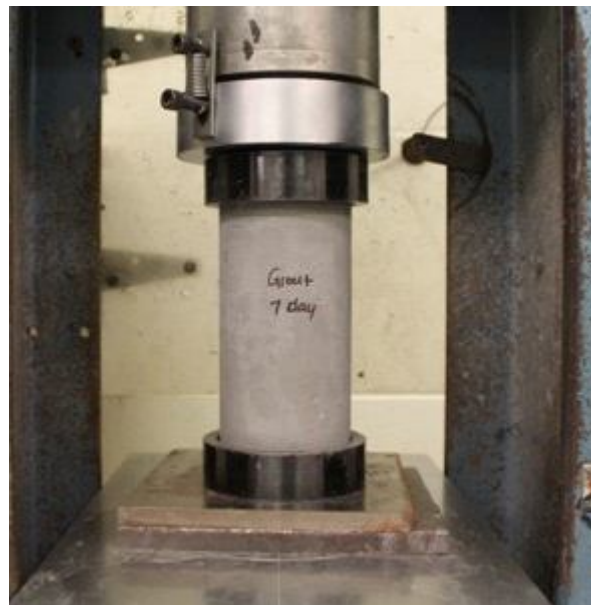
Compressive strength tests were performed in accordance with ASTM C39 with 4 in. x 8 in. cylinders. The cylinders were cured by placing 4 mil plastic over the top to ensure that the moisture did not escape. On the day of testing, cylinders were typically saw cut to obtain a uniform loading surface. The ends were either capped in sulfur or neoprene end caps were used for loading. Cylinders were typically tested in groups of three and at ages ranging from 12 hrs. to 28 days. A cylinder test using the neoprene end caps is shown in Figure 16.

Figure 16. Compressive Test

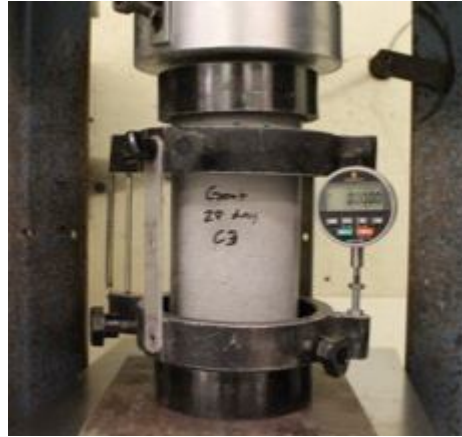
Figure 18. Modulus of Elasticity Test

Cylinders used for compressive strength tests were also used to determine the modulus of elasticity with ASTM C469. A modulus collar was attached to the cylinders and the cylinders were loaded slowly while recording the gauge readings and load. The test set-up is shown in Figure 18.

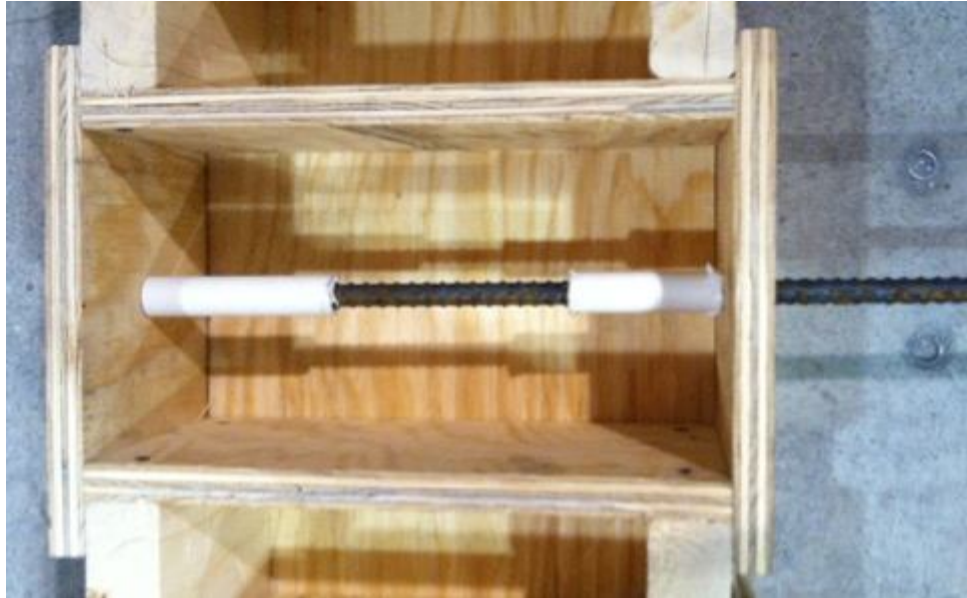
To prevent the reinforcing steel from pulling out the top section of the VHPC in a cone failure, the top of the reinforcing steel was only bonded towards the center of the VHPC block. The reinforcing steel was debonded in the bottom 4 in. and top 3 in. of the VHPC block so that the 5 in. bond was more centrally located. The steel was debonded by covering it with PVC pipe in these regions. This is shown in Figure 20.

Figure 20. Bonded vs debonded reinforcing steel for pull out specimen

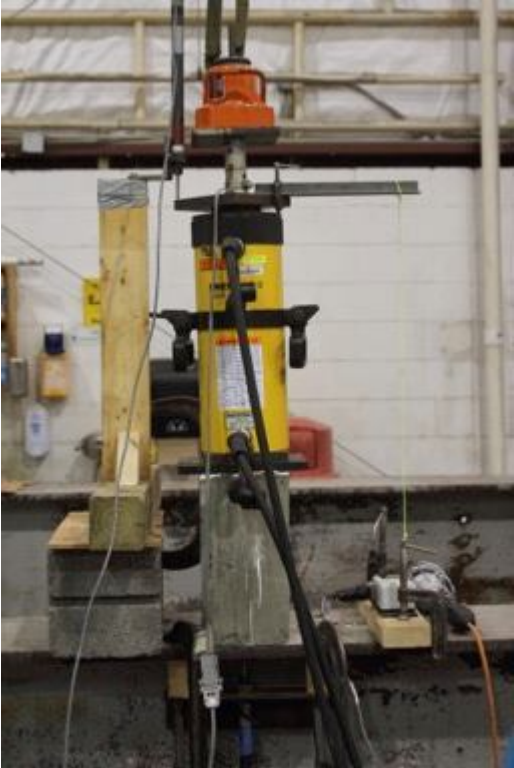
Figure 21. Pull out test setup

Several pull out specimens were cast at the same time so that the tests could be performed at different early ages. The instrumentation for the pull out tests consisted of Linear Variable Differential Transformers (LVDTs) and wire pots, which were installed to measure displacement. The bottom LVDT was used to determine if the reinforcing steel was slipping through the VHPC and being pulled out the top. The top LVDT and the wire pot were both attached to the top of the ram to measure how far the steel had been stretched. The load cell was used to determine the load that was applied by the ram. As the ram was manually pump controlled, the approximate load rate ranged from 100 lbs./second to 500 lbs./second and the

load cell also helped to monitor the load rate. The test set-up and instrumentation is shown in Figure 21. The pull out specimens were tested 12 hrs, 1 day, 2 day, and 7 days after placing.

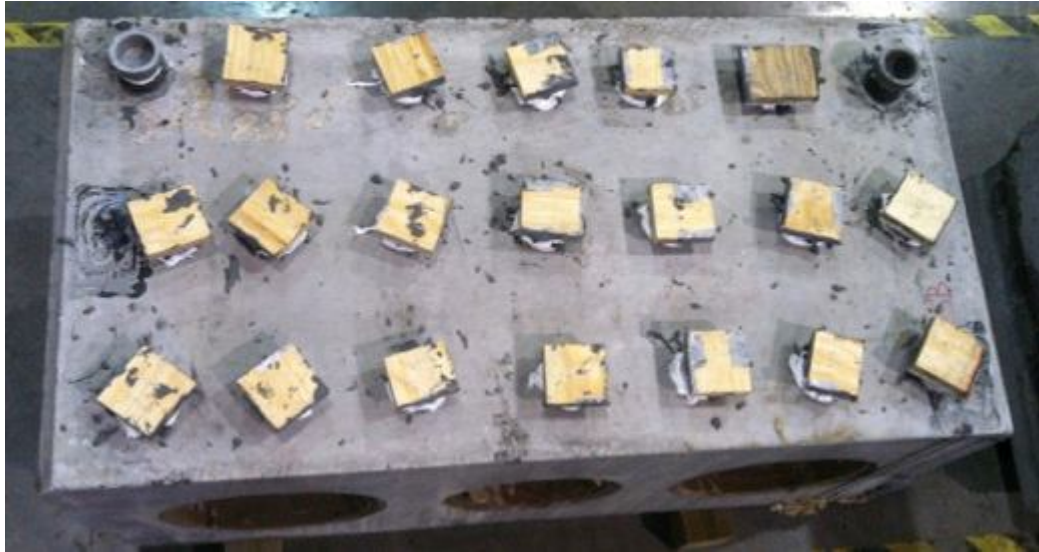
Figure 23. Bond Overview

The results presented here were obtained by casting 2 in. diameter x 1 in. tall pucks of VHPC on the bottom of precast concrete members. The bottom of the precast member was chosen because it was the largest surface area that allowed for more pucks to be cast on the same member. It also accurately represented the shear key because the precast plant where the members were obtained used the same metal formwork at the shear keys and bottom of the member. The pucks were cast on a horizontal surface because it was not practical to cast them vertically and the results of tension pull off bond are believed to be the same. Also, the test results were to be compared to the results obtained by Joyce (2014) and so the test was set up in an identical method. An overview of multiple VHPC pucks being cast on the bottom of a precast member is shown in Figure 23.

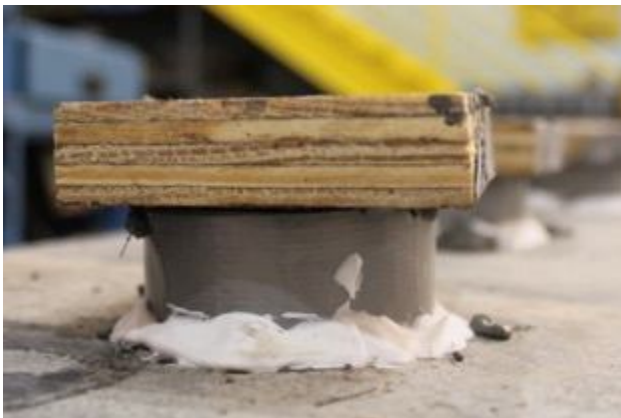
Figure 24. Bond Puck with wood top

After VHPC is placed, it immediately starts to form a skin-like layer at the surface. To prevent this from happening with the pucks, a piece of duct-tape covered wood was set on the surface of the puck immediately after placing and is shown in Figure 24. The objective of this was to ensure that the epoxy bonded with the entire puck, instead of just the skin. A threaded metal cap was typically epoxied to the top of the pucks 12 to 24 hours before testing and is shown in Figure 25.

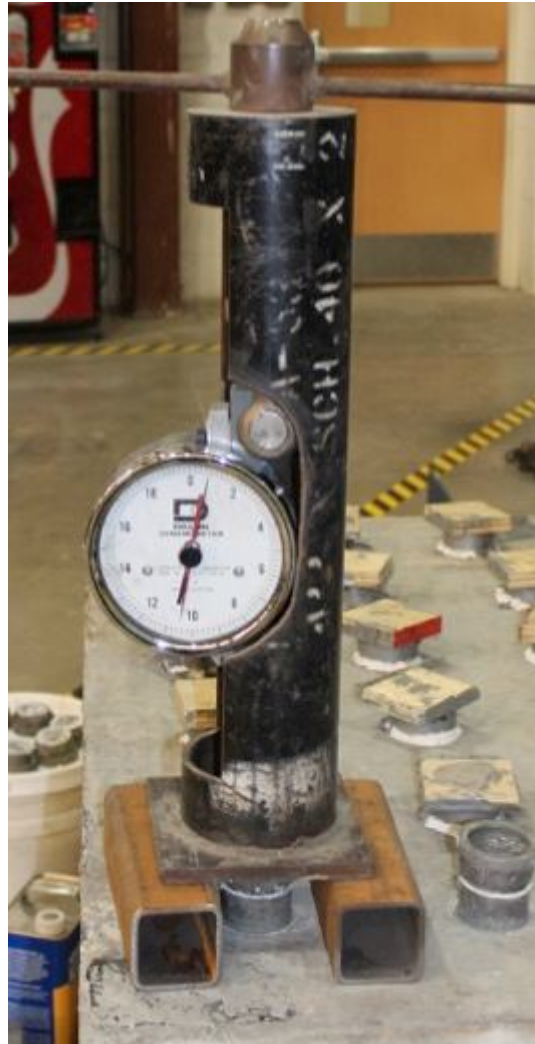
Figure 26. Bond Test

A hook was screwed into the metal cap and attached to a tension load cell and the tension load was applied by twisting the jack. The test set-up is shown in Figure 26.

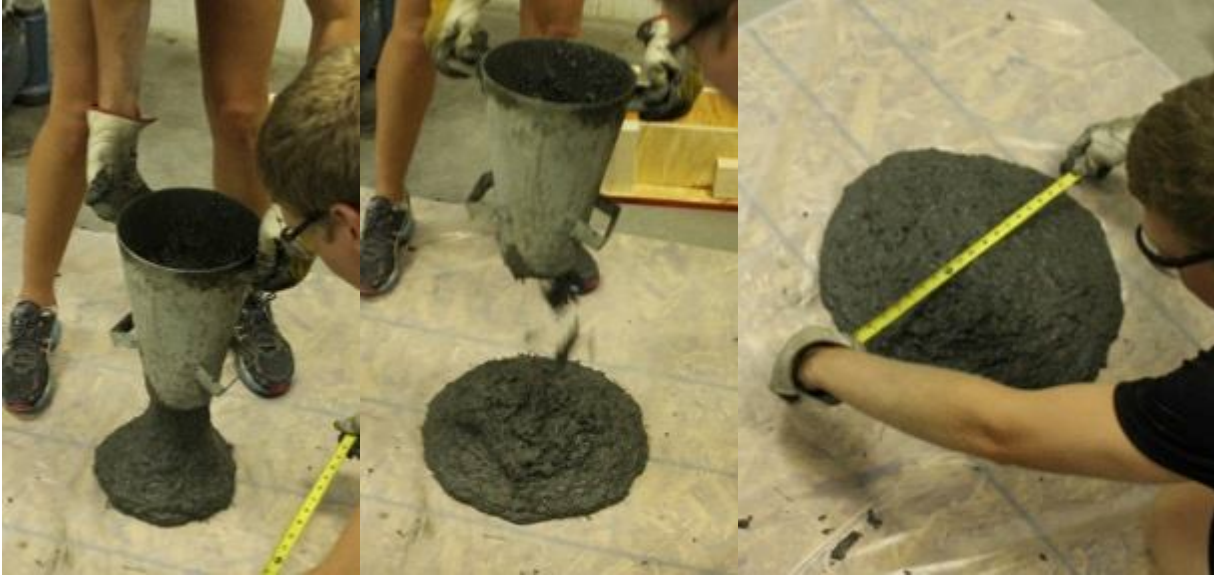
Figure 27. Inverted Cone and Slump Testing

The workability was quantified using ASTM C1611. The inverted slump test is shown in Figure 27. The spread was measured at different times during the mixing procedure.

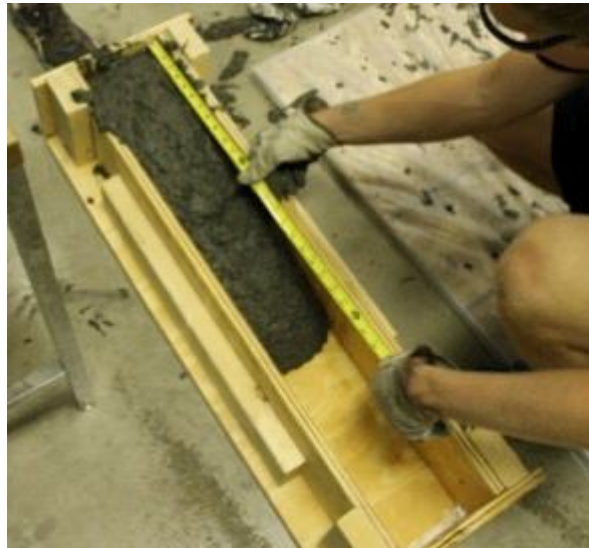
Figure 28. Box test

The flow was measured in other, more unique ways. The box test was created to mimic a closure pour and determine the distance the VHPC-Large could reasonably be expected to flow. A 6 in. x 6 in. x 5 ft. box was made and six large scoops of the VHPC-Large were placed into one end. The distance it flowed was recorded after 15 seconds. The test setup is shown in Figure 28.

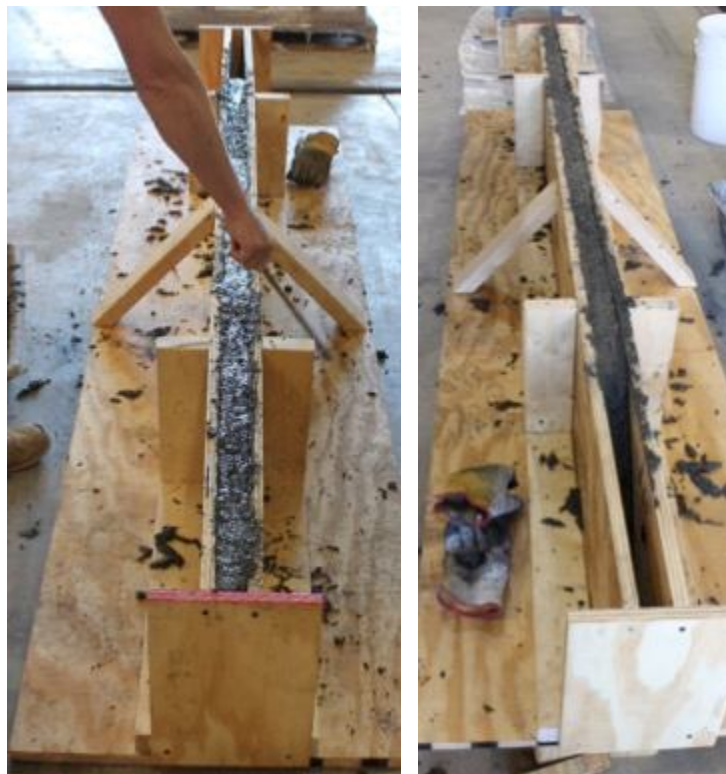
The shear key slope flow test was made to replicate the depth and slope of the shear keys along the length of the Buffalo Branch Bridge to determine if the shear key at the low end of the bridge would need to be covered to prevent the VHPC-Small from overflowing. A 1.5 in. x 12 in. x 8 ft. box was made and initially placed on supports at the same 0.8% grade slope as the bridge. The VHPC-Small was placed in the top of the slot starting at the low end and moving to the high end. Because the VHPC-Small did not overflow on the low end after 5 min. with continued tapping on the sides to agitate it, the elevation difference was changed to 5 in. to represent the full elevation change of the bridge. The shear key slope flow test is show in Figure 29.

Figure 29. Shear key flow test

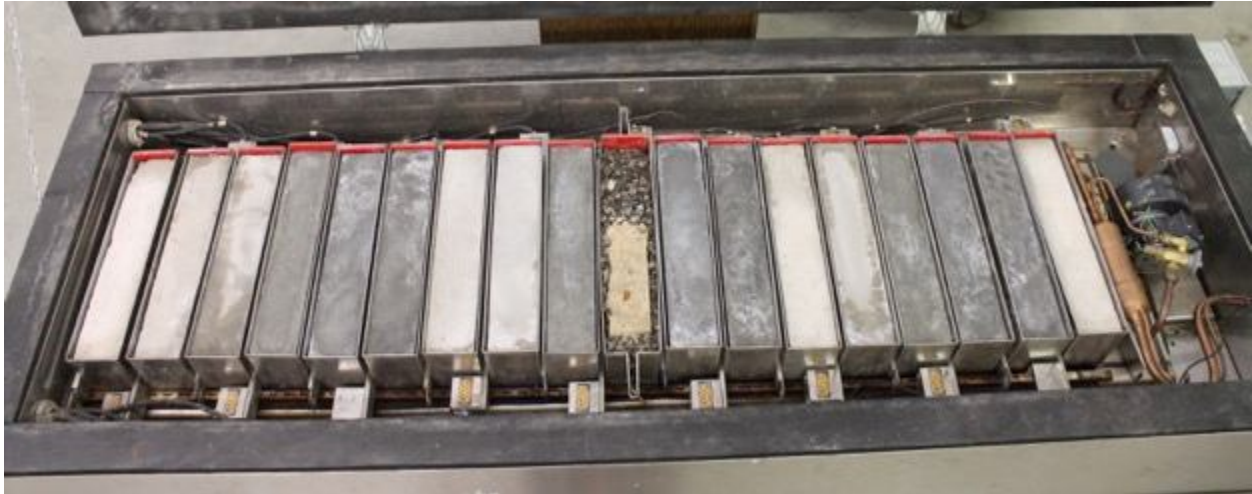
Figure 31. Freeze/Thaw Machine

The durability was measured following ASTM C666 Procedure A. Three freeze/thaw specimens 3 in. x 4 in. x 16 in. were cast for each of the five mixes. Typically every 35 cycles the specimens were removed and their weight and resonant frequencies were recorded. They were then returned to the freeze/thaw machine. The specimens in the freeze/thaw machine are shown in Figure 31.

Data was recorded from 0 cycles to 306 cycles when the freeze/thaw machine would no longer cycle temperatures. The freeze/thaw machine exhibited problems maintaining a constant freezing and thawing rate.

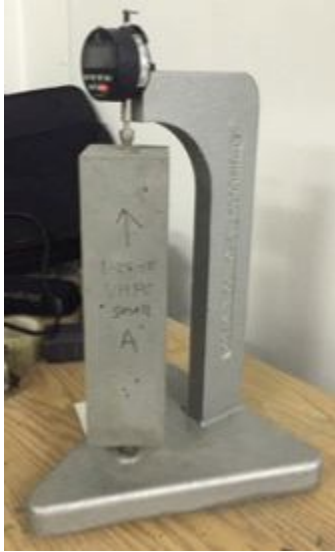
Figure 32. Shrinkage testing comparator

Shrinkage tests were performed in accordance with ASTM C157. Prisms (3 in. x 3 in. x 11¼ in.) were cast in pairs and the shrinkage was typically measured daily for the first 14 days after demolding. The comparator is shown in Figure 32. Measurements were then taken weekly until 50 days when the measurements were taken monthly.

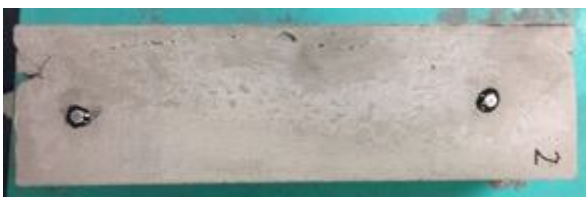
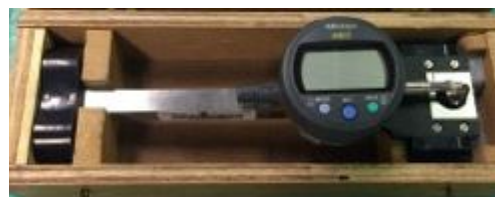
Figure 33. Shrinkage bar with discs and DEMEC extensometer

The ASTM C157 comparator to measure length change had a very small tolerance on acceptable lengths. Three of the shrinkage specimens cast were out of that range and were not able to be measured. These bars were instrumented with locating discs for a DEMEC extensometer on the top and bottom of the specimen to measure the surface shrinkage. Both the shrinkage bars and DEMEC are shown in Figure 33. Measurements were taken at the same time interval as the rest of the shrinkage prisms.

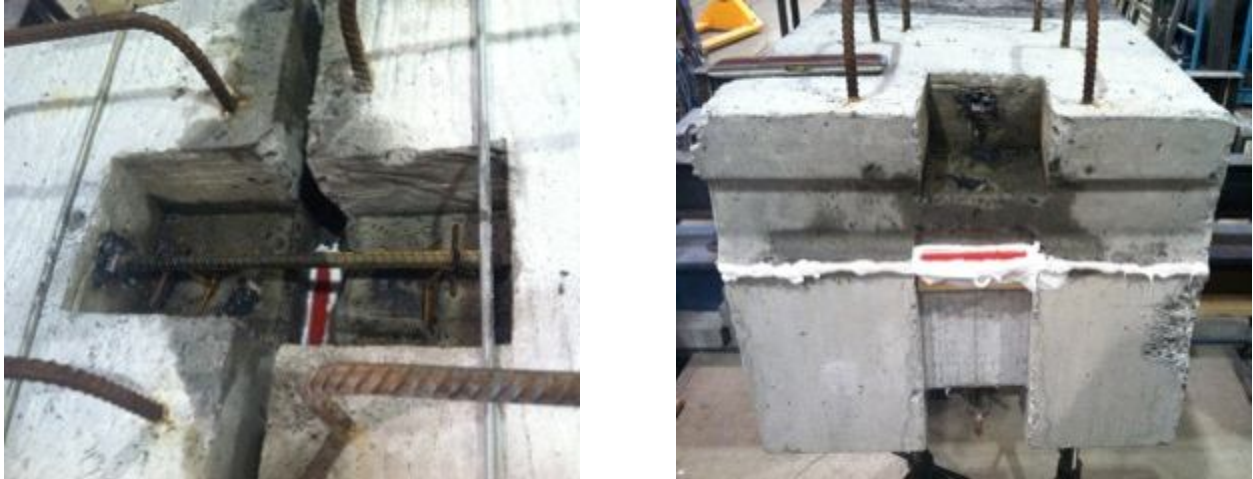
Figure 35. Non-contact voided slab connection

The voided slab sub-assembly was connected by a traditional shear key but also included a 6 in. long blockout pocket with a 6 in. non-contact lap splice over the joint. The joint and shear key were filled with VHPC-Large. The connection pocket can be seen in Figure 35 with a non-contact splice bar in place.

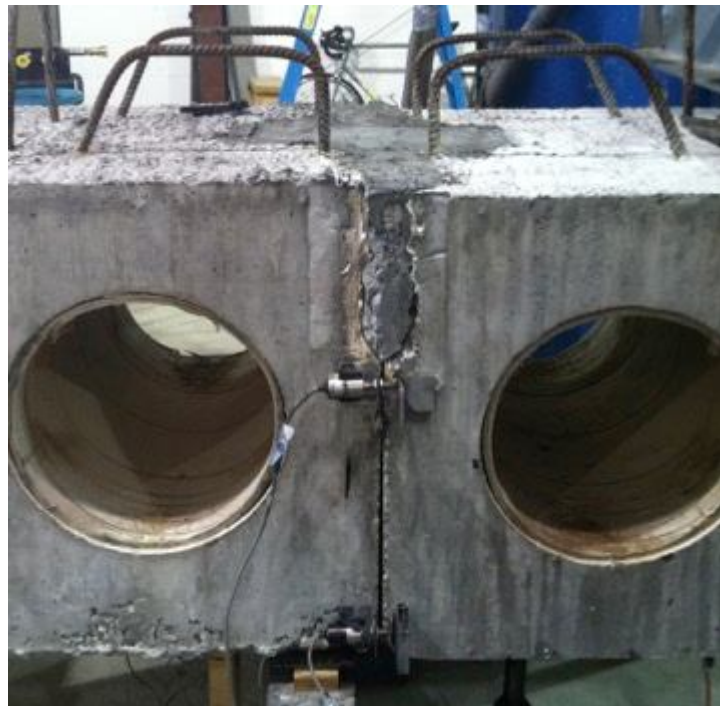
Figure 36. Joint instrumentation

The sub-assembly was instrumented with LVDTs at the bottom of the shear keys on both sides of each joint, which can be seen in Figure 36. The purpose of the LVDTs was to monitor the amount the joints opened during the testing.

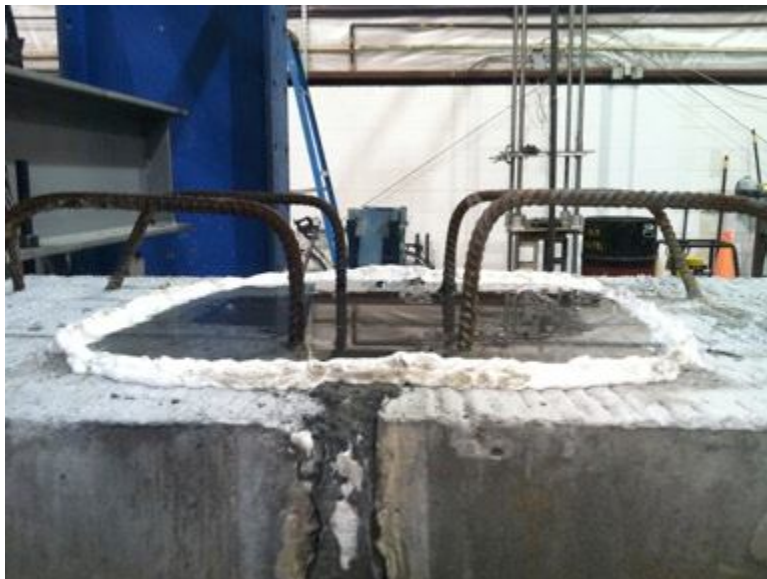
Figure 37. Water ponding for voided slab

Testing began with an initial static test in which the center voided slab was lowered at a slow rate to a vertical displacement of 0.03 in. and then raised back up by 0.03 in. so that the specimen returned to its initial “zero point”. After the initial static test, cyclic tests began by lowering the specimen by 0.015 in. and then cycling it between 0.03 in. and the “zero point” at a frequency of 3 hertz. Cyclic testing was performed in groups of cycles starting at 10 cycles and ending at 1,000,000 cycles. The groups for cyclic testing were 10 cycles, 100, 1,000, 10,000, and then every 100,000 cycles until the test reached 1,000,000 cycles. Static tests were performed after each group of cyclic testing, with the initial static test being performed before the specimen underwent any cyclic testing and the final static test being performed after the 1,000,000 cycles. During testing, water was ponded on top of the joint to monitor if cracking was occurring. This can be seen in Figure 37.

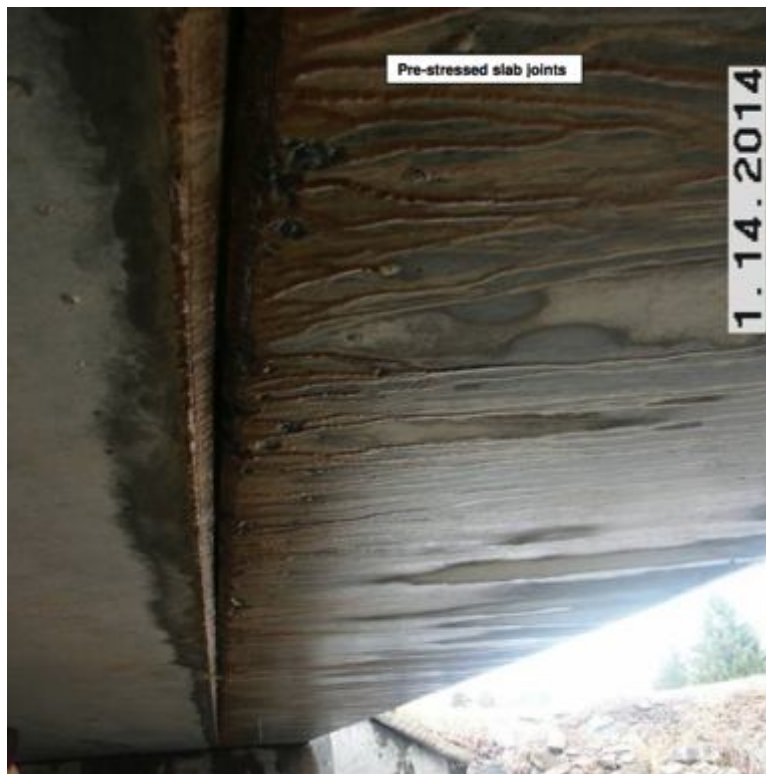
The VDOT visual inspection of the Buffalo Branch Bridge performed in January 2014 stated that water and efflorescence were seeping through the furthest downstream joint for the full length and for the second downstream joint and the furthest upstream joint within six feet of the abutments. A picture of the leaking downstream joint included in the inspection report is shown in Figure 38.

Figure 38. VDOT visual inspection report picture of downstream joint leaking

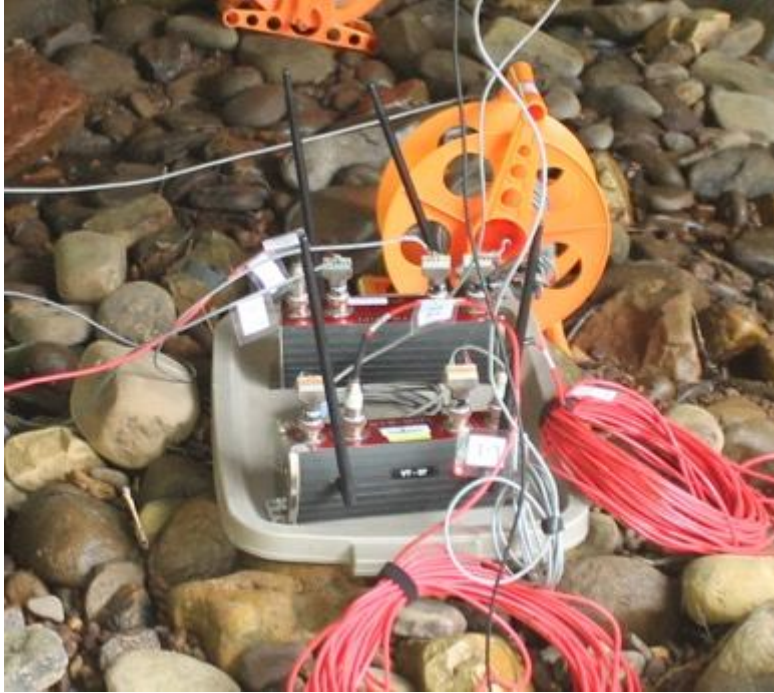
Figure 43. BDI nodes

The data acquisition system (DAS) and software used was the Structural Testing System (STS) by Bridge Diagnostics Incorporated (BDI). The STS consisted of three main components: the computer software, DAS base station, and nodes. The sensors were wired directly to the nodes shown in Figure 43. Each node was capable of connecting to four sensors.

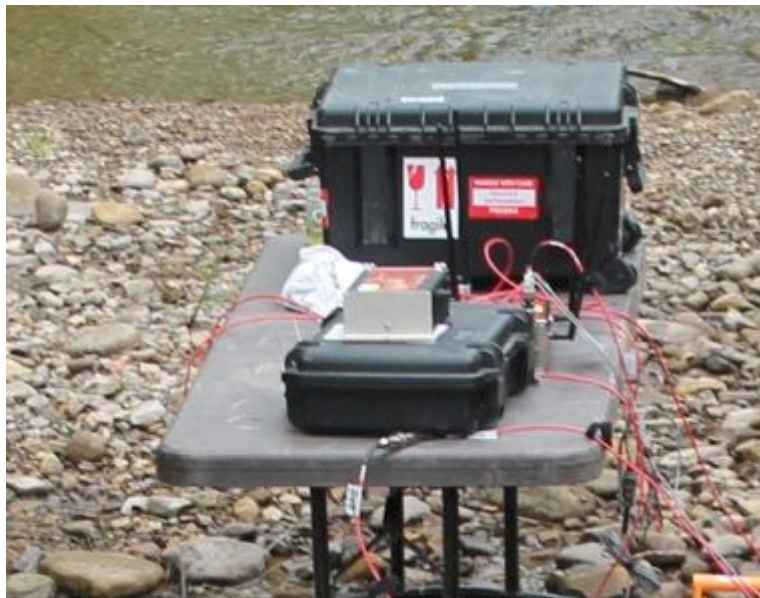
Figure 44. DAS base station

The BDI nodes transmitted the data wirelessly to the computer through the DAS base station shown in Figure 44.

The nodes were placed under the bridge with the instrumentation and the computer was located on top of the bridge to be able to better monitor truck location.

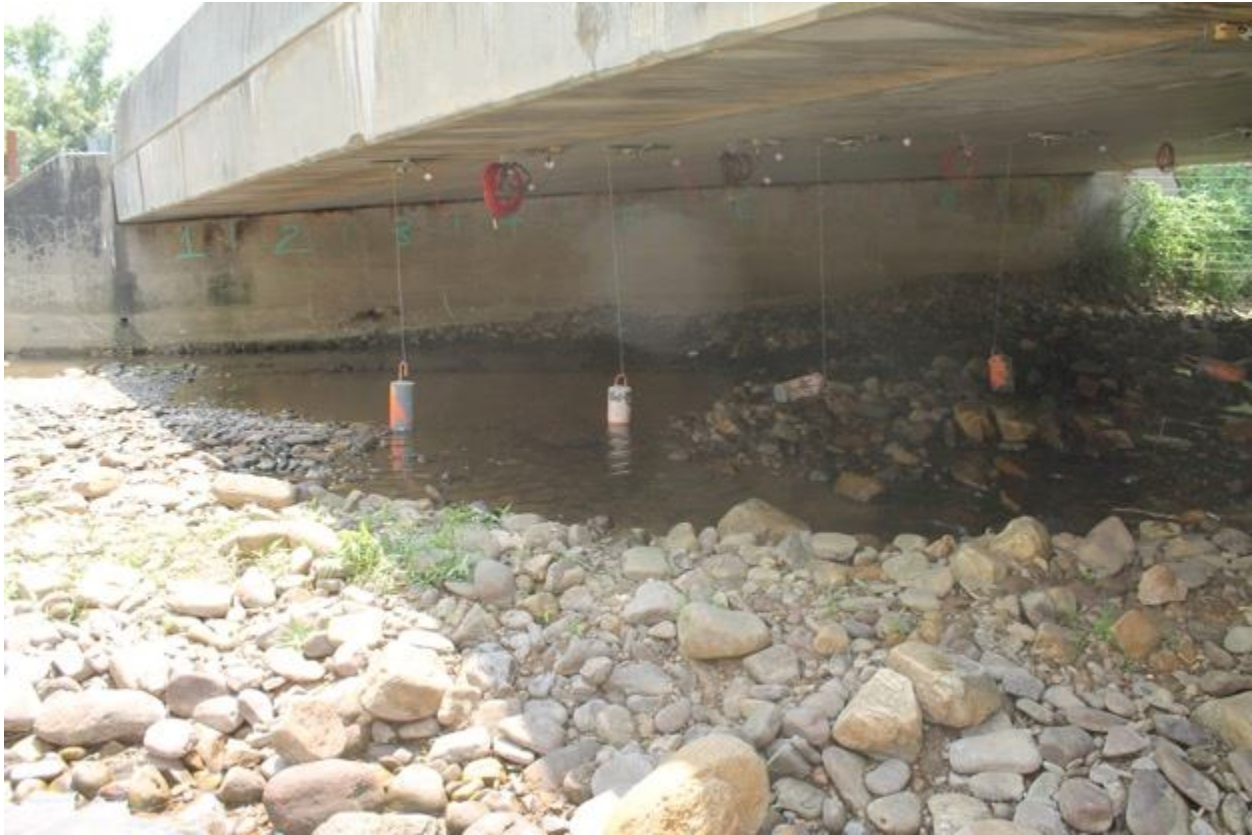
weight will be released and the change in strain will measure the deflection. The deflectometers with the weights attached are shown in Figure 46.

Figure 46. Deflectometers with weights attached

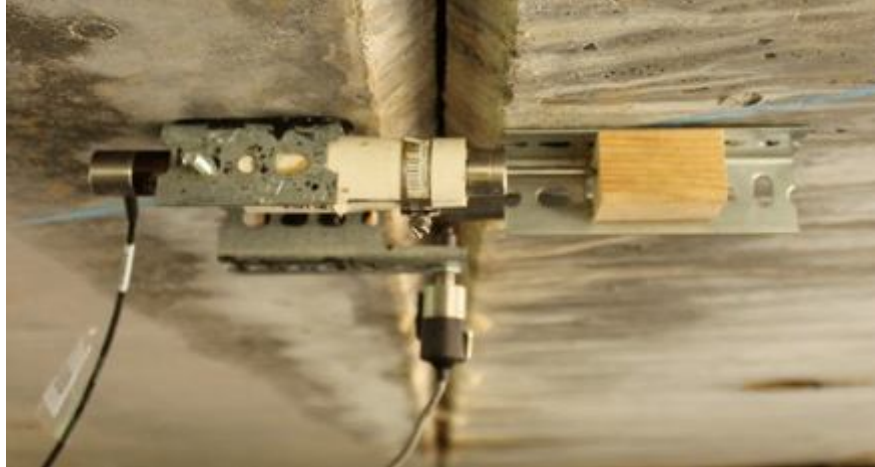
Figure 47. Horizontal LVDT

LVDTs were used to measure the horizontal and vertical relative displacements of adjacent box beam members. The LVDTs were strategically placed at the location of the highest expected relative girder displacements. A horizontally oriented LVDT is shown in Figure 47.

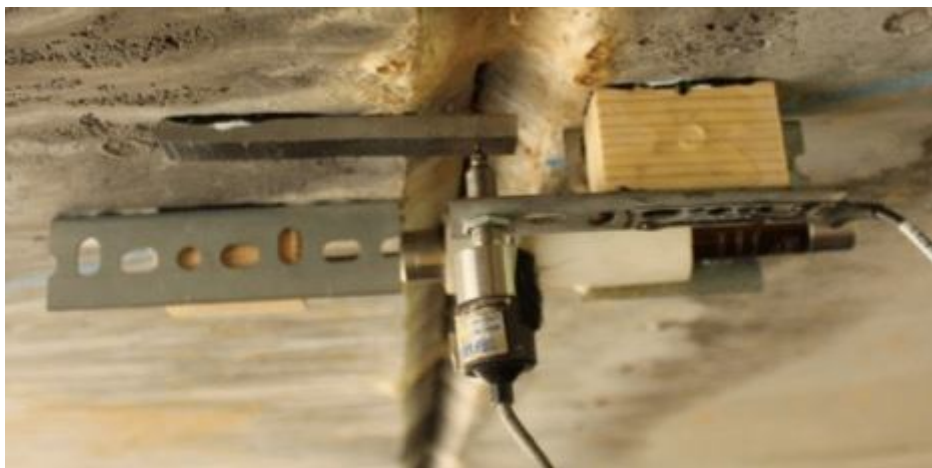
Figure 48. Vertical LVDT

The horizontal LVDT was glued to the bottom edge of a box beam and a wooden block was glued to the bottom edge of the neighboring box beam so that the LVDT measured differential horizontal movement between the two box girders. Likewise, the vertical LVDT attachment was glued to the bottom edge of a box beam and a piece of steel was glued to the bottom edge of the neighboring box beam. The vertical LVDT was then bolted into a hole to stay in place at the center of the joint as to measure the relative vertical displacement, as seen in Figure 48.

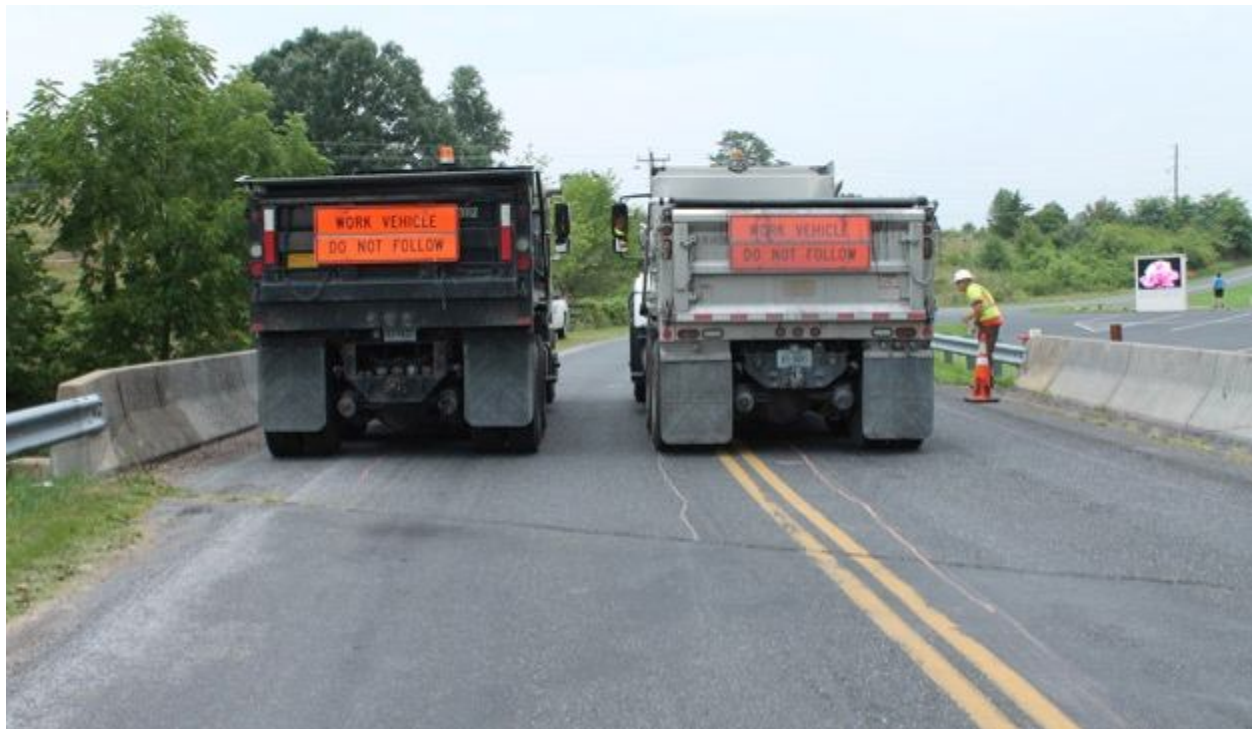
The direction of the trucks combined with the skew was such that the front right tire was the first to reach a location and the back right tire was the last to leave. Figure 49 shows the location of the trucks being marked.

Figure 49. Marking location of truck

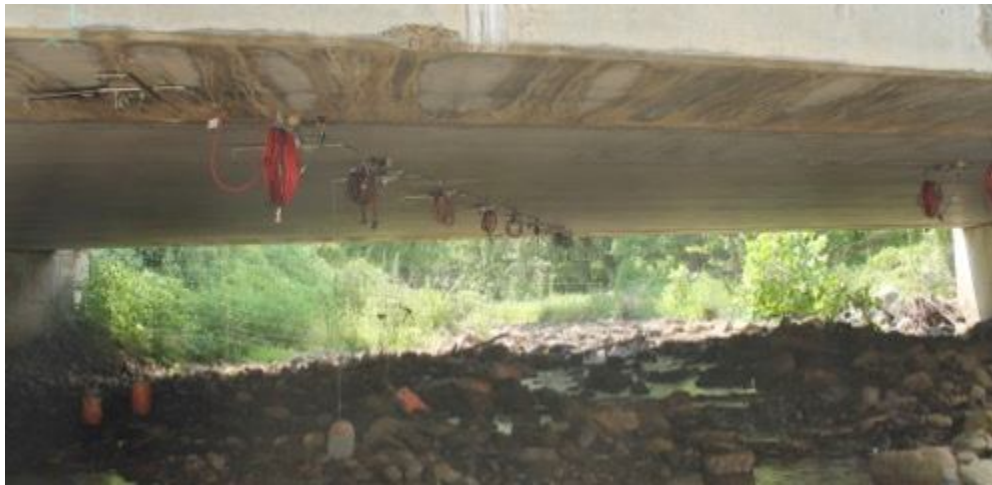
BDI strain transducers and deflectometers were placed at midspan on the bottom of each box beam to measure the longitudinal strain and vertical deflection. Due to the visible signs of deterioration in the two external downstream joints, vertical LVDTs and horizontal LVDTs were placed at midspan and quarterspan, where the most leaking appeared to have occurred, on the two external downstream joints. To be able to compare the results of the relative displacement in deteriorated joints to seemingly undamaged joints, the two external upstream joints were also instrumented with vertical LVDTs and horizontal LVDTs. An overall look at the actual instrumentation is shown in Figure 50 and the instrumentation plan is shown in Figure 51.

Figure 50. Overview of instrumentation

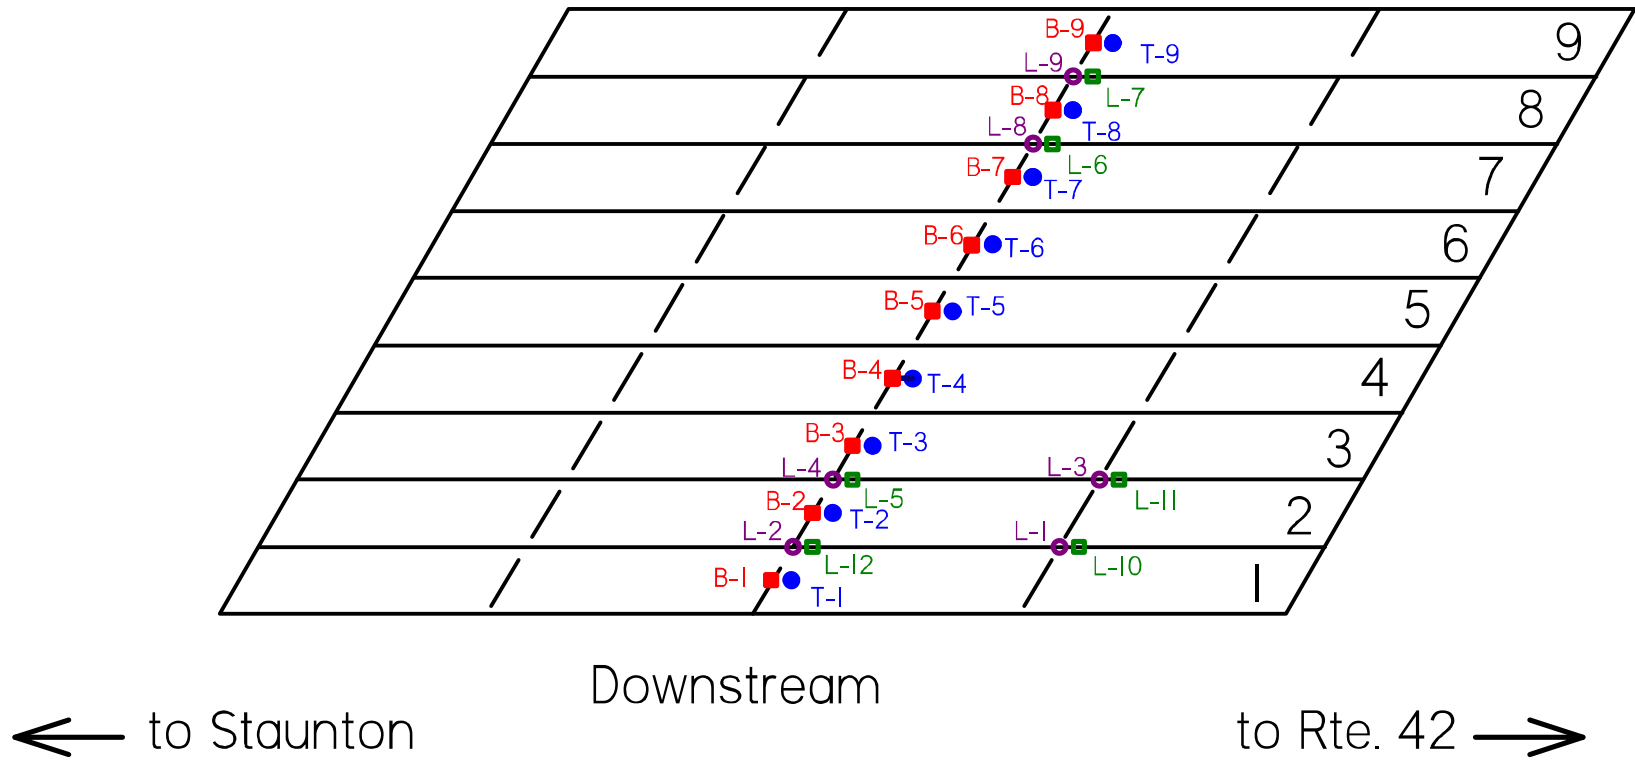
Figure 51. Instrumentation plan

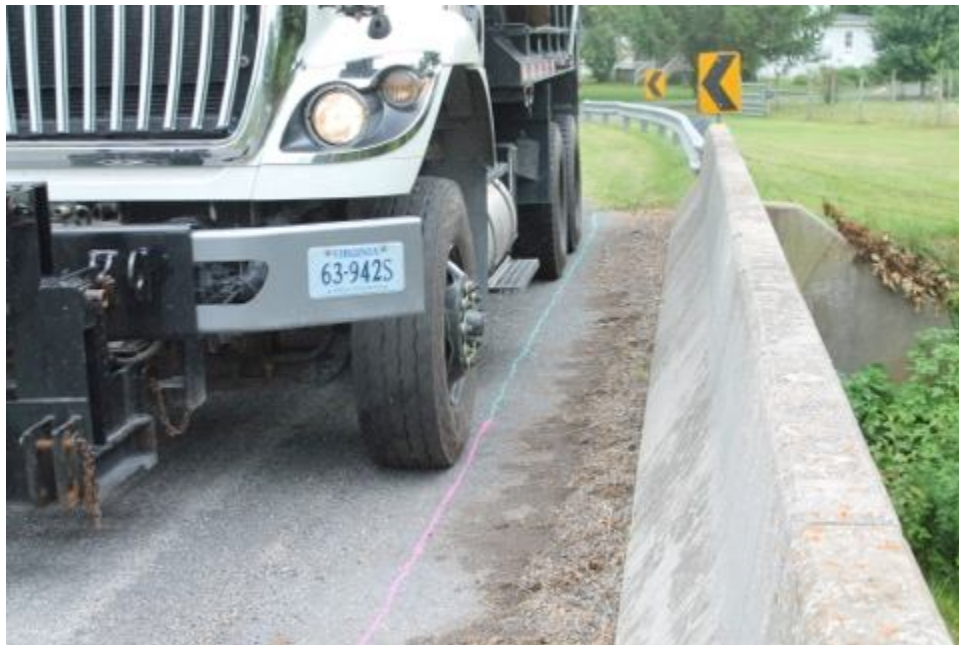
Figure 52. Truck following line

A total of six quasi-static load cases were tested by driving the same loading truck over the bridge in three separate runs. Brightly colored chalk lines were drawn on the bridge deck at the joints where the truck load ideally would be applied. The chalk line marked the outside edge of the front left tire so that the driver could follow it more easily and focus on maintaining the slowest possible speed of two to three mph. Figure 52 shows the truck applying the load at the joint by driving along this line.

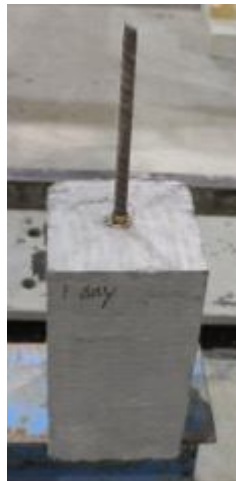
The pull out tests were performed on VHPC-Large and VHPC-Small specimens at ages ranging from 12 hrs. to 7 days and the reinforcing steel ruptured each time as shown in Figure 69.

Figure 69. Ruptured reinforcing steel

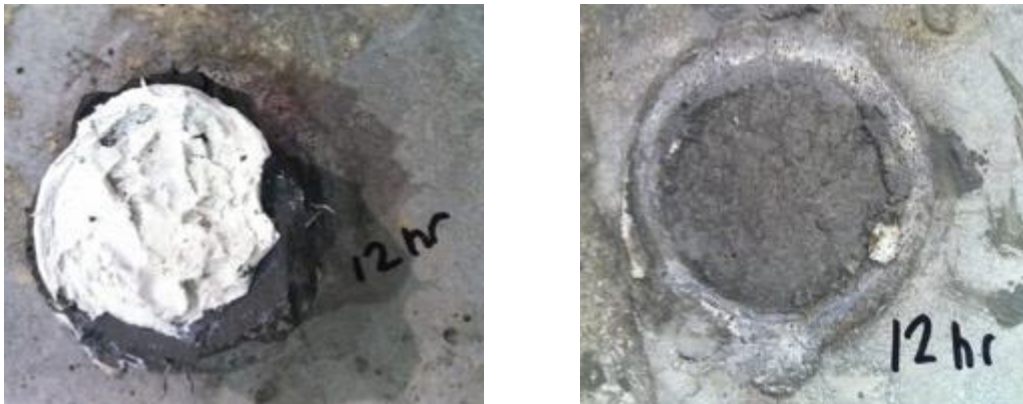
The classification for different bond failures are as specified in ASTM D7234 (2012) and the VHPC failure classifications experienced in these tests are presented. The typical failure mode observed in the VHPC at 12 hours and one day was substrate failure C in which the bond failed at a thin layer of cementitious material. This is shown in Figure 76 where a thin layer of cementitious material is still visible on the precast concrete. A few of the 12 hour tests failed at the epoxy because there was not adequate time for it to fully cure.

Figure 76. Typical VHPC 12 hour to 1 day failure

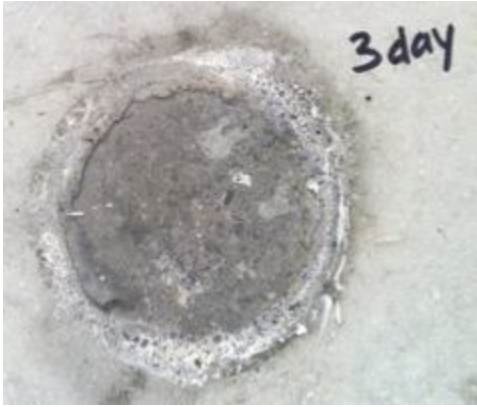
The typical failure mode observed in the VHPC at testing ages of two days to five days was substrate failure B in which the bond failed at the cement paste but was not strong enough to fracture the aggregate. This is shown in Figure 77 where there is no longer a thin layer of cementitious material left on the precast concrete and the aggregate is still fully intact.

Figure 77. Typical VHPC 2 day to 5 day failure

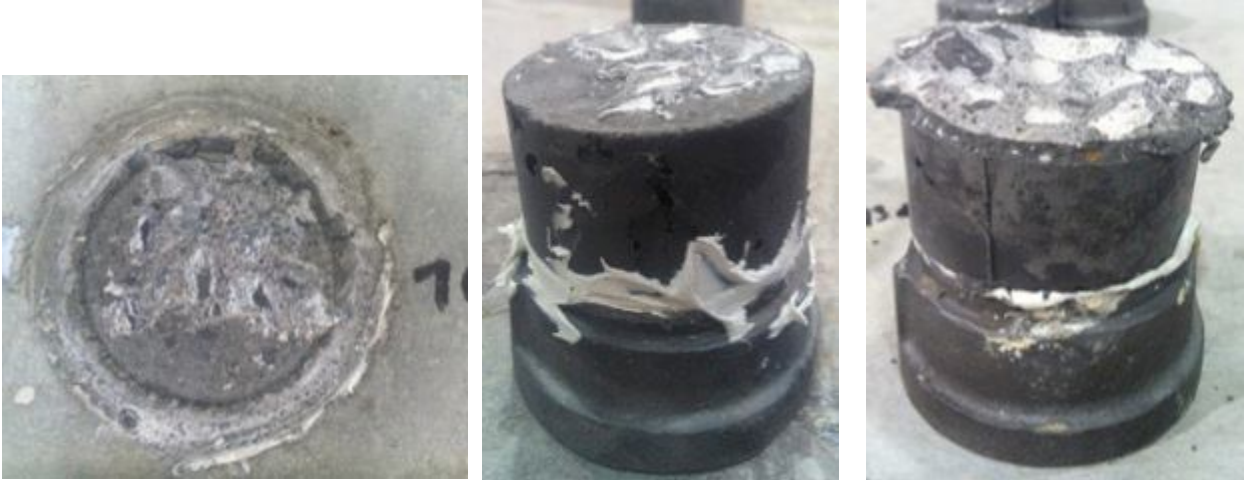
The typical failure mode observed in the VHPC at seven days and older was substrate failure A in which the bulk of the cement paste was detached along with fracturing the aggregate inside the precast concrete member. This is shown in Figure 78 where the left two pictures were taken at seven day tests and the right one was taken at 28 days.

Figure 78. Typical VHPC 7 days and older failure

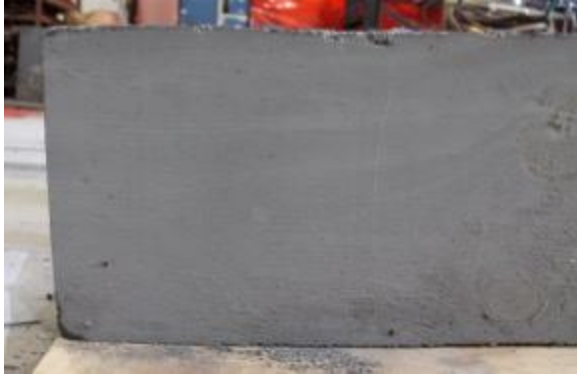
Figure 82. Shear key flow test lower end

To examine what happens when two batches are placed next to each other, the top half of the joint was rodded while the bottom half was not. The results of this are shown in Figure 82 and Figure 83. As can be seen, a cold joint formed on the bottom half of the upper end where the two batches were not rodded together.
