VHPC Material Characterization and Recommendations for the Buffalo Branch Bridge
Rehabilitation

Thesis submitted to the Faculty of the Virginia Polytechnic Institute and State University in
partial fulfillment of the requirements for the degree of

Civil Engineering

Keywords: Adjacent Box Beam Bridges, UHPC, Shear Key, Live Load Test

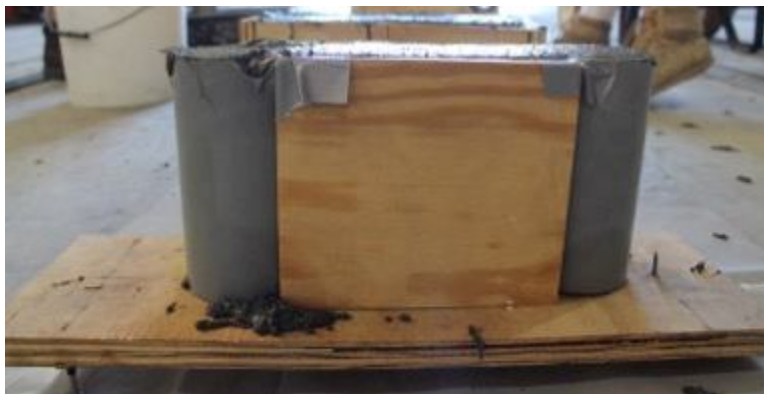
The transverse slope of the geometric cutouts was also found to not cause the VHPC to overflow on the low end. A picture of this is shown in Figure 84 where the VHPC-Small is still level after being placed on an incline.

Figure 84. Dog bone slope results

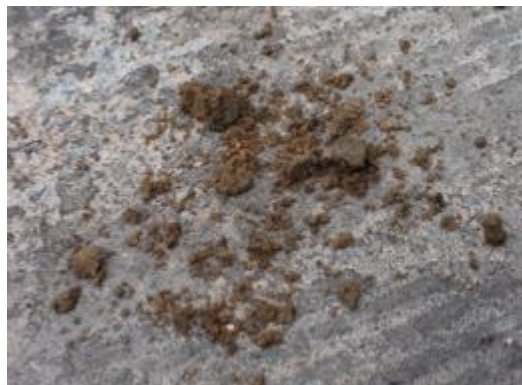
Figure 110. Deteriorated grout

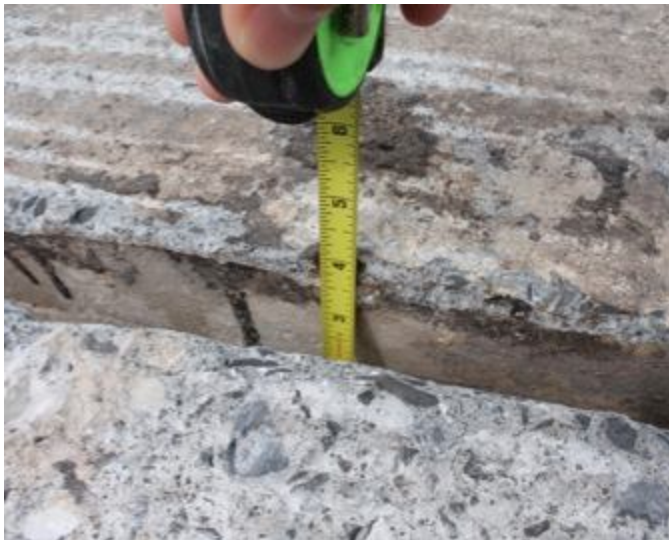
Figure 111. Typical depth of cleared joints

While the shear keys were 12 in. deep, typically only 4 in. of grout was removed and is shown in Figure 111. On the exterior joints where the grout was clearly deteriorated four in. into the shear key, the top four in. of the shear key was still the only grout to be removed because that was as deep as the jackhammer could reach into the shear key. This is shown in Figure 112.

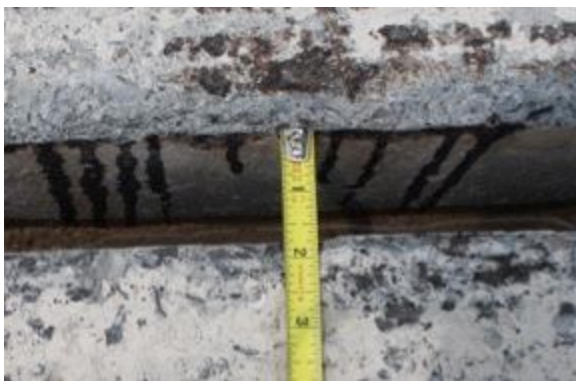
Figure 113. Varying width of joints

Due to the varying width of the upstream joints shown in Figure 113 and the jackhammer being able to fit deeper, there were sections where the grout was cleared out up to 6 in. deep.

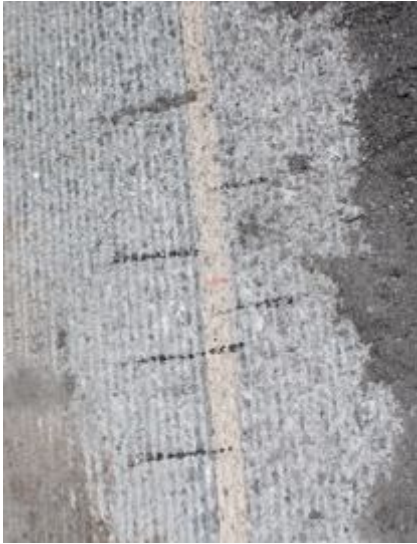
Figure 114. Reinforcing steel locations

Locating the reinforcing steel began with measuring out where the dog bones would be cut. A dog bone was placed at midspan and the spacing was measured from there to the end of

the bridge at 2, 3, or 4 ft and is indicated by a red line in Figure 114. Next, a pachometer was used to locate the reinforcing steel on both sides of the dog bone location and is indicated by a black line in Figure 115.

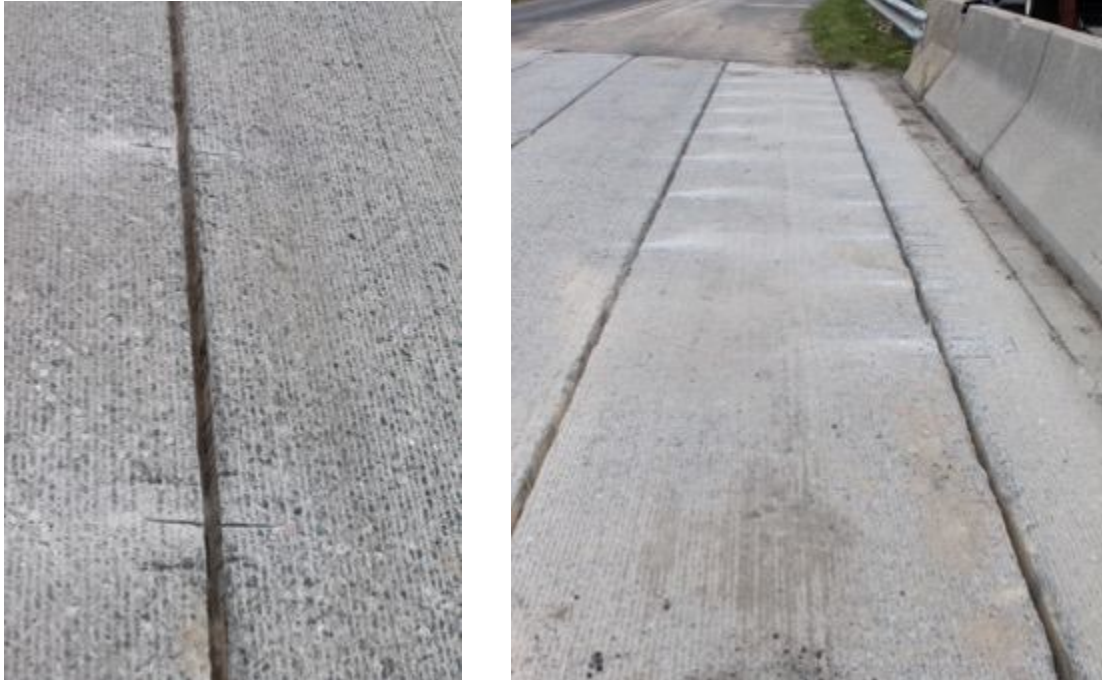
Figure 116. Dog bone locations and surrounding reinforcing steel marked

After the initial spacing of the dog bones was positioned and the reinforcing steel marked, the final locations of the dog bones were marked by saw cutting into the adjacent box means shown in Figure 116.

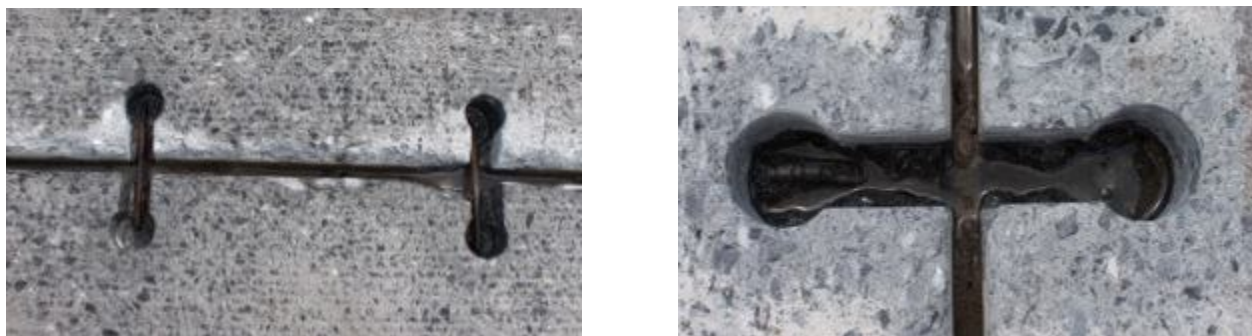
Figure 117. Dog bones

Once the location of the dog bones were cut and the joints cleared, the dog bones were cut and are shown in Figure 117. Cutting the dog bones took approximately 20 minutes each and began by cutting both ends with a 3 in. core drill. Next, the inside was cut with a saw blade and the whole dog bone was chiseled out.

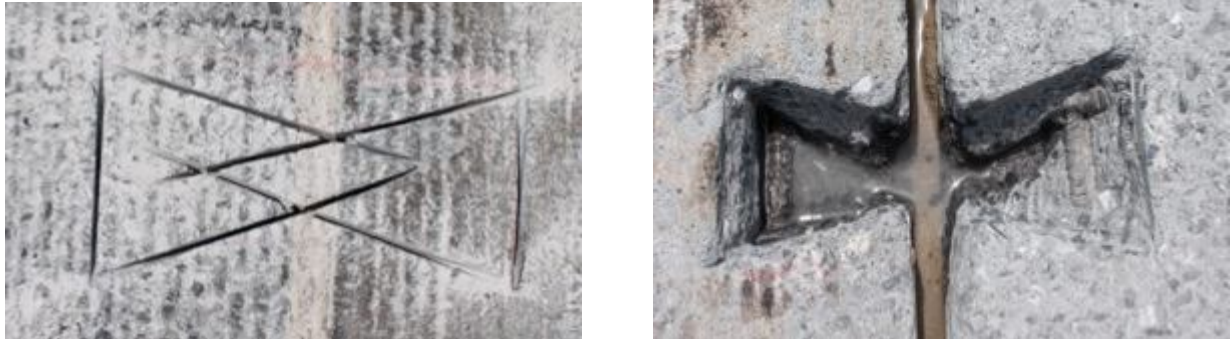
Figure 118. Bowtie

One bowtie, shown in Figure 118, was cut at midspan of joint 7 to determine how difficult it was to cut without cutting through the reinforcing steel. Cutting the bowtie also took

approximately 20 minutes. To avoid cutting completely through the reinforcing steel in the precast concrete member, the ends of the bowtie were chiseled out

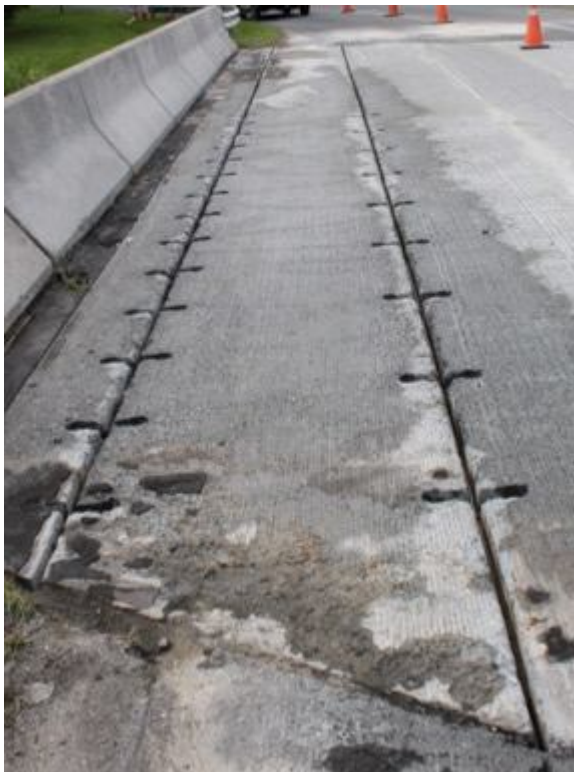
Figure 119. Joints 1 and 2

Figure 119 shows joint 1 with dog bones spaced at 2 ft and joint 2 with dog bones spaced at 3 ft as specified in the proposed rehabilitation plan except using dog bones instead of bowties. Figure 120 shows joint 7 with only a bowtie at midspan and joint 8 with dog bones spaced at 4 ft.

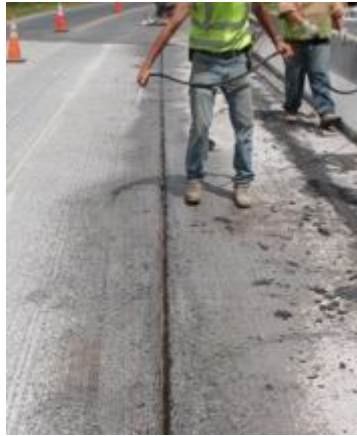
Figure 121. SSD joints

The joints were sand blasted and sprayed with a hose to create a SSD condition immediately before placing the VHPC, shown in Figure 121.

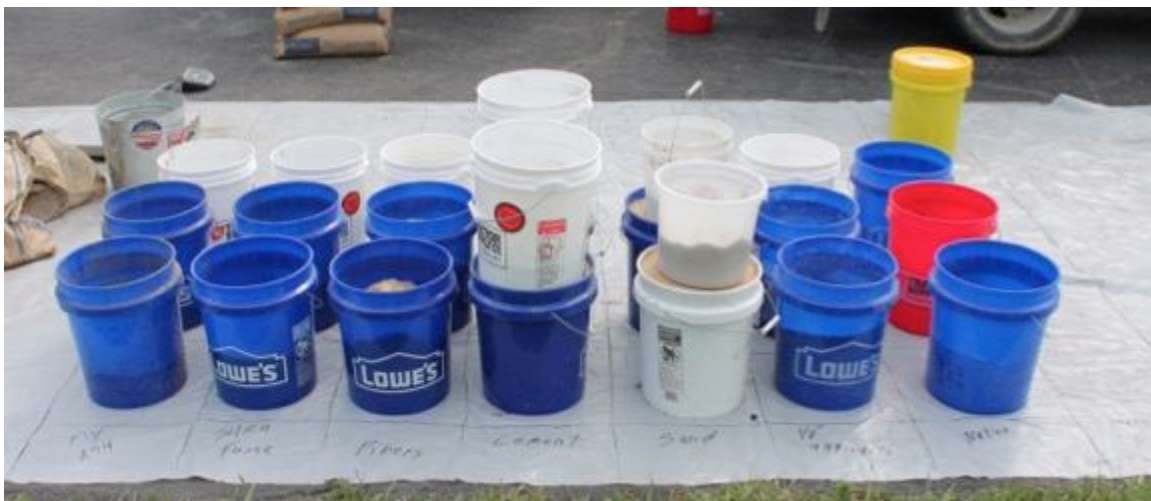
Figure 122. Materials pre-weighed

On the first day of placing, the first batch of VHPC began mixing at 9:30 am. The goal was to start mixing the VHPC before the temperature increased so that the VHPC would remain workable longer. Before mixing, the contractor weighed out the required amount of each material in buckets and aligned them on a tarp with a chart outlining the materials and batch number, shown in Figure 122. This allowed for the mixing process to start smoothly.

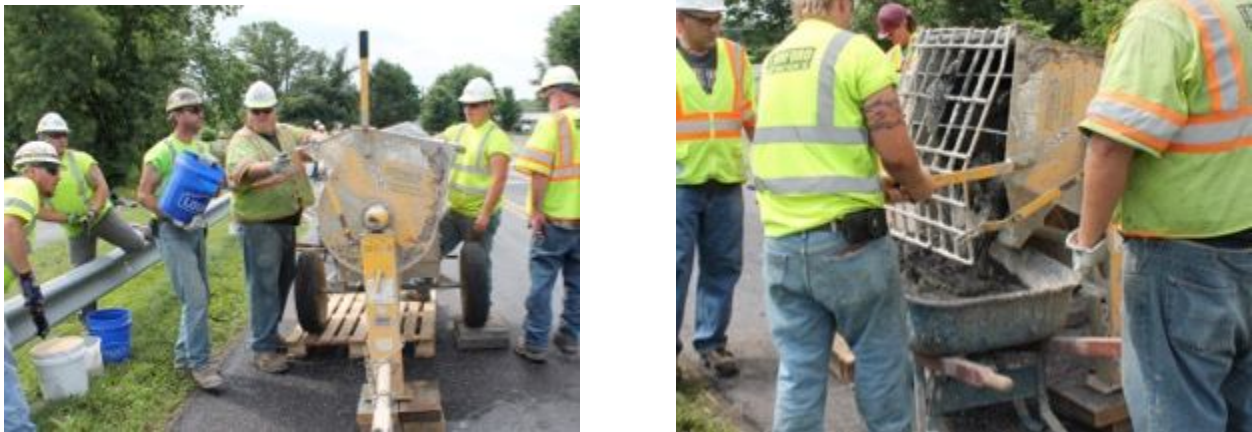
Figure 123. Mixing

The mixing and placing procedure followed what was specified in the proposed rehabilitation plan except for only using one mixer. Only one mixer was used because the joints were only cleared 4 in. instead of all 12 in. causing not as much VHPC to be required which allowed for the joints to still be placed quickly with just one mixer. Figure 123 shows the pre-weighed materials being added to the mixer and the mixed VHPC being dumped into the wheelbarrow.

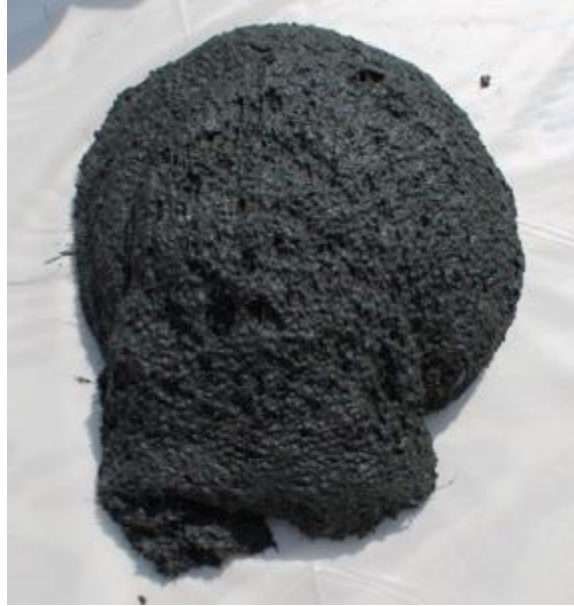
Figure 124. Slump test, VHPC too stiff

After the VHPC was adequately mixed, the inverted slump test was performed to measure the spread. The original slump test from the first batch on day one of placing is shown in Figure 124. With a spread of 12 in., the VHPC was too stiff to place. It was returned to the mixer and more HRWR was added. Retarder was also added to improve the workability of the VHPC.

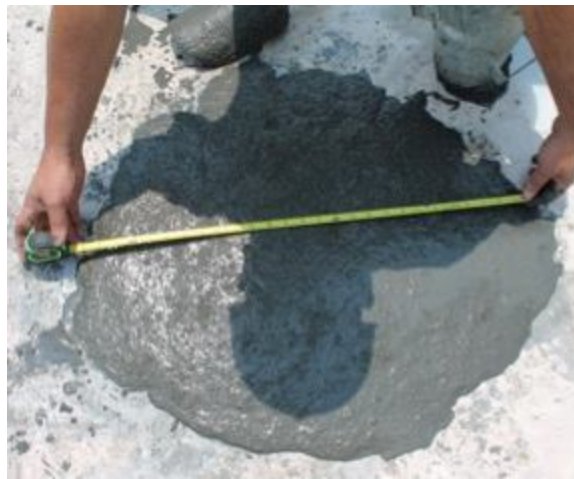
Figure 125. Slump test, VHPC too flowable

On the contrary, the original slump test from the first batch on day two of placing had too large of a spread at 27 in.. Figure 125 shows evidence of bleeding from the water sheen on the surface and the mortar halo surrounding the VHPC.

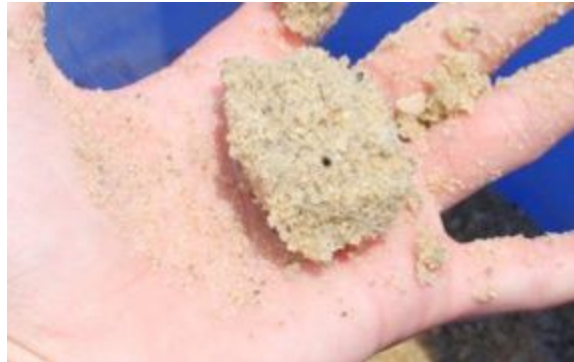
Figure 126. Wet sand

After noticing the bleeding in the first batch on day two, the materials were examined more closely. It rained at night between the first and second days of placing the joints and the

sand was not properly covered. Instead of using dry sand, the sand was wet enough to hold the shape of a ball as shown in Figure 126.

To measure the moisture content of the sand, a 4 in. x 8 in. cylinder sample of the wet sand was taken and immediately capped so that the moisture would not escape. The weight of the wet sand and metal bowl was 2410 g.. The bowl containing the sand sample was placed in the oven to dry and the dry weight of the bowl and sand was 2270 g.. The moisture content was then calculated to be 6.0 %. Figure 127 shows a VHPC batch with a slump test of 18 in. to illustrate what target spread looked like.

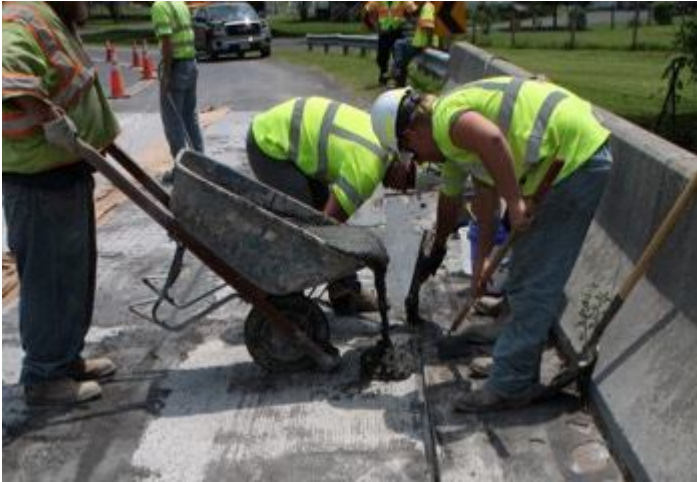
Figure 128. Dumping VHPC from wheelbarrow

After the workability of the VHPC was determined to be adequate, the wheelbarrow was filled and dumped at the joint, shown in Figure 128.

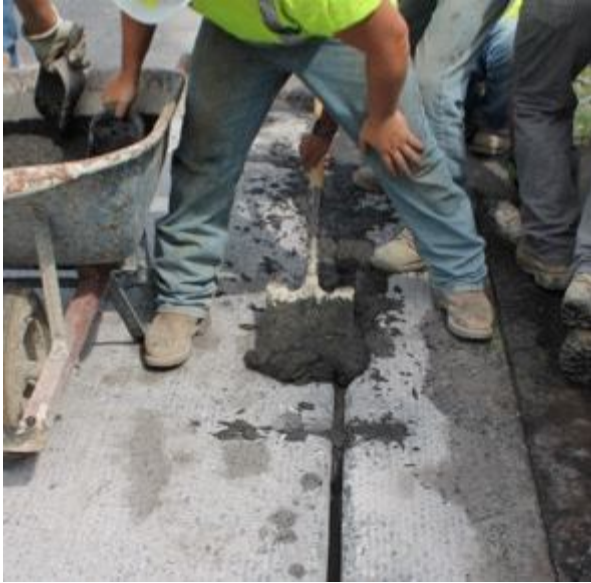
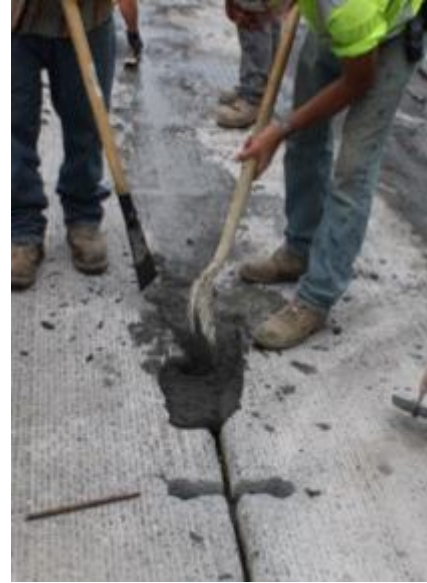
Figure 129. Spreading VHPC with shovels and scoops

Figure 129 shows the piles of dumped VHPC being spread along the joint using shovels and scoops.

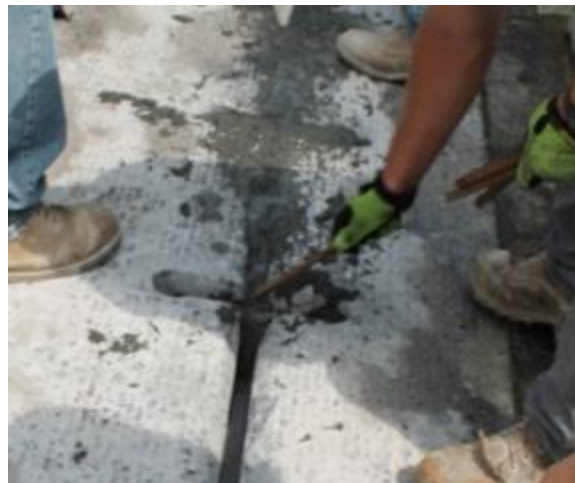
Figure 130. Placing reinforcing steel in dog bones

Because the contractor did not have chairs to sit the reinforcing steel on, approximately 1 in. of the VHPC was placed in the dog bone and then the reinforcing steel was set on top of it, shown in Figure 130 and Figure 131.

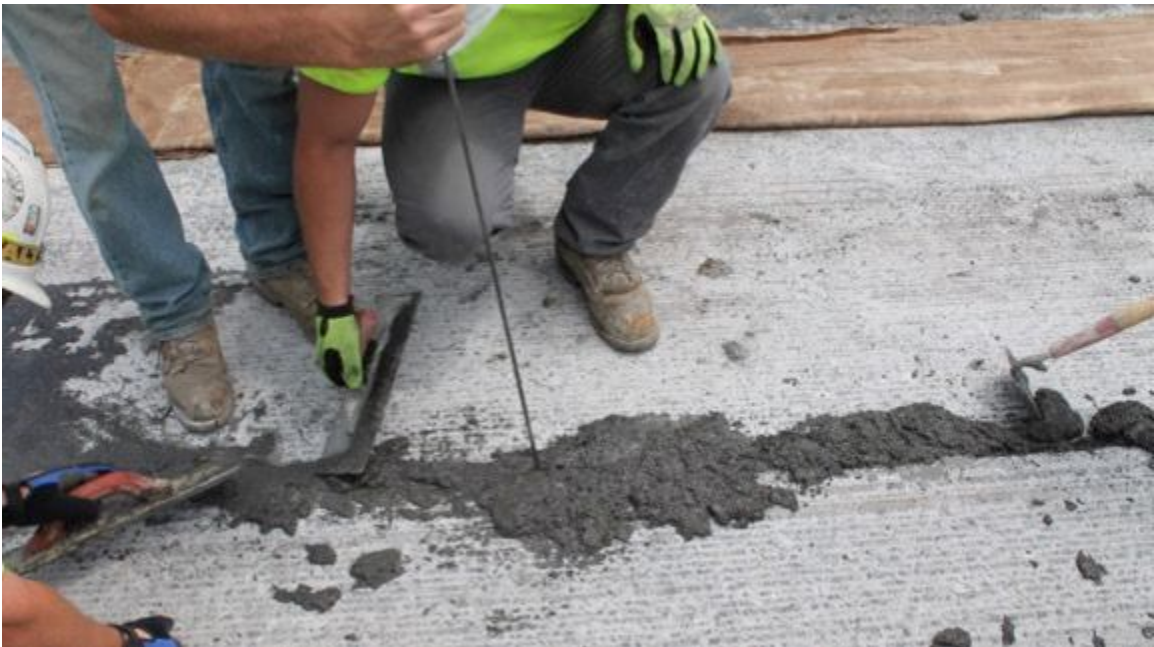
Figure 132. Rodding VHPC where batches meet

To prevent cold joints from forming where two batches of the VHPC met, it was rodded throughout the section where the two batches met, shown in Figure 132.

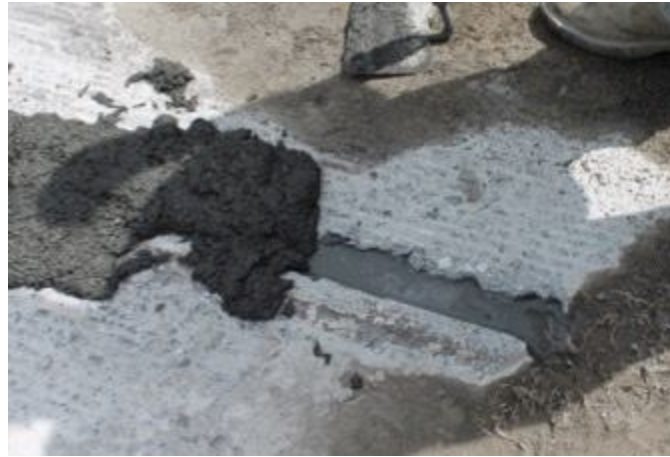
Figure 133. Water building up at the end of joint

One area of concern that arose while placing was the contractor's interpretation of a SSD surface. The joints had a thin layer of water in the bottom of them when the VHPC was placed. The VHPC was placed starting at the higher elevation end and moving towards the lower

elevation end. This caused the layer of water to be pushed along the joint until it pooled at the end. Figure 133 shows the full four in. depth of the joint filled with the pooled water.

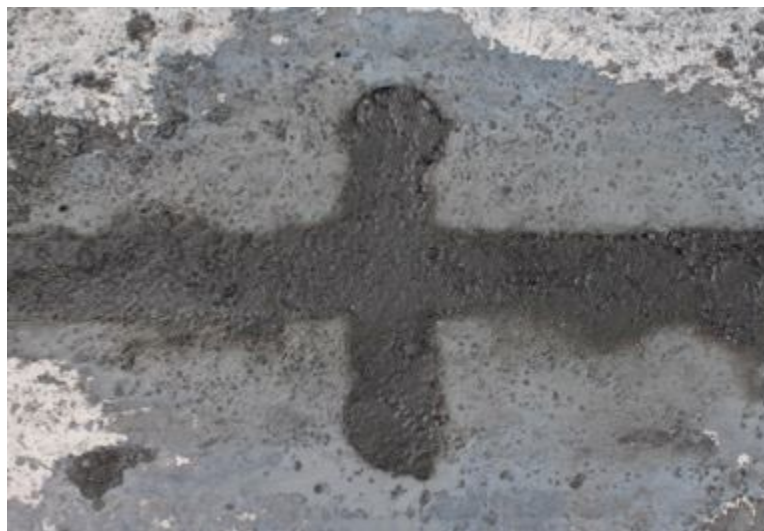
Figure 134. Curing dog bone

The VHPC began to cure very quickly, as evident in Figure 134 and Figure 135 by the skin forming on the surface of the dog bone and bowtie before the VHPC was placed in the entire joint and covered with wet burlap.

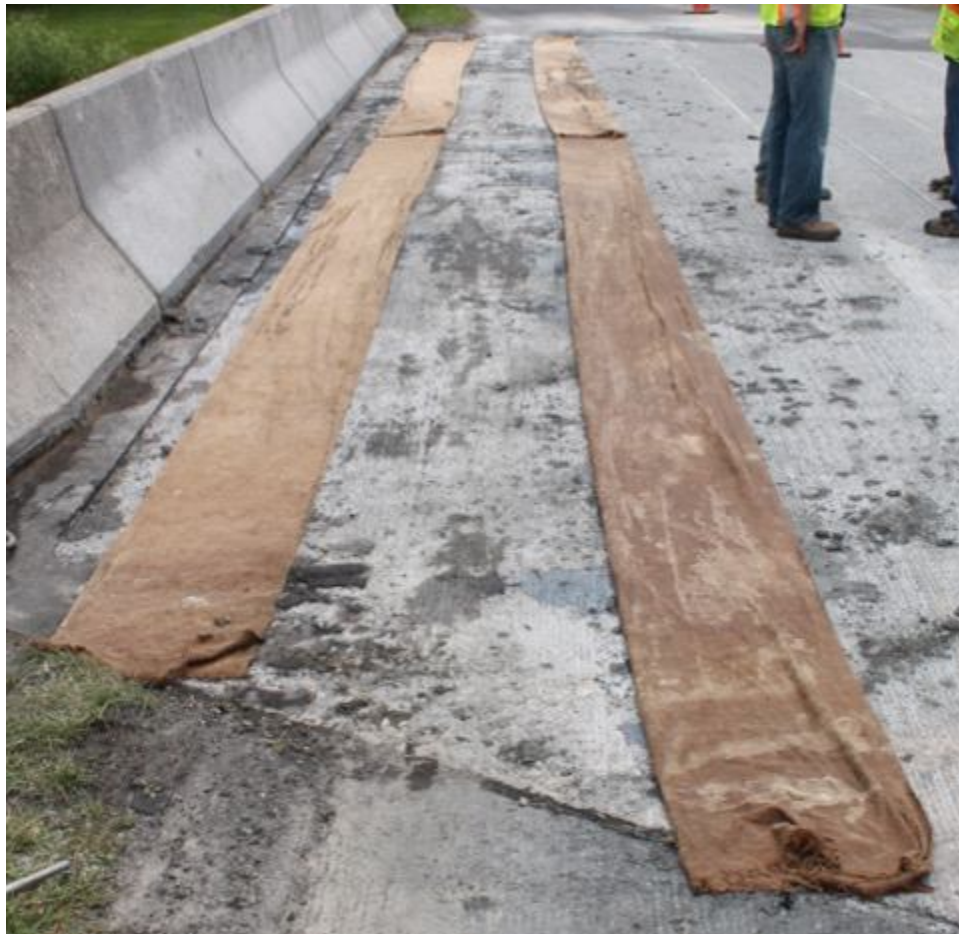
Figure 136. Wet burlap covered joints

Once the VHPC was placed in entire length of the joint, the joint was covered with wet burlap to moist cure the joints and improve the rate of curing. This is shown in Figure 136.

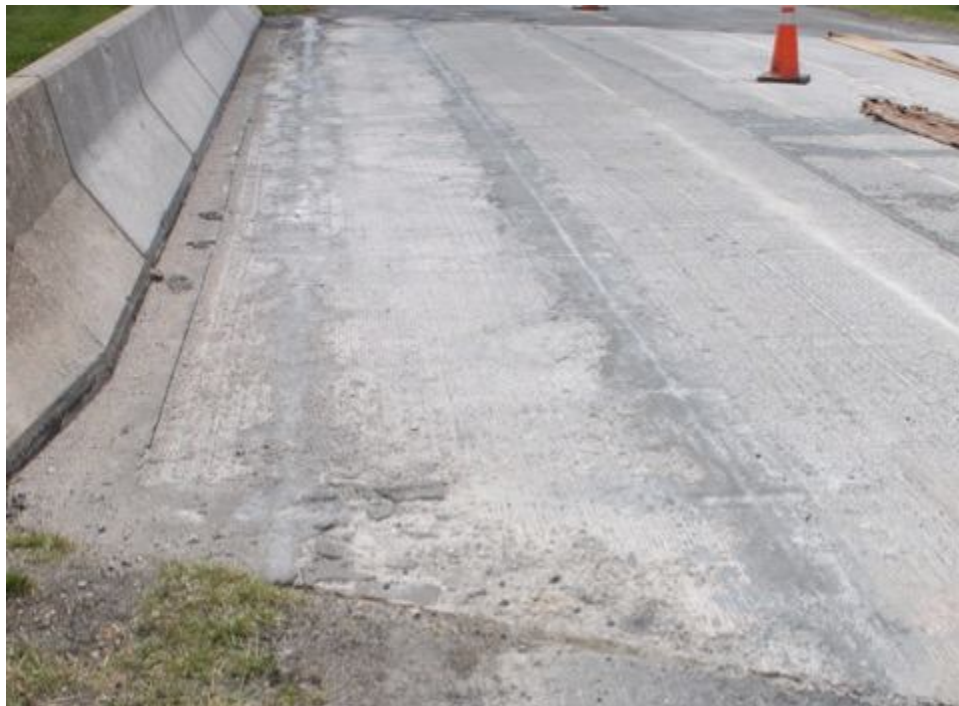
Figure 137. Cured joints

On day one the downstream joints were completely placed by 12:00 pm and on day two the upstream joints were completely placed by 1:00 pm. At 5:00 pm each day, the traffic lane traveling over the newly placed joints was opened back up. Therefore, the VHPC was allowed to moist cure for five hours on day one and four hours on day two before traffic was directed back on it. Figure 137 and Figure 138 show the downstream joints that were placed on day one after being driven on from 5:00 pm to the following morning. The traffic does not appear to have affected the joints.

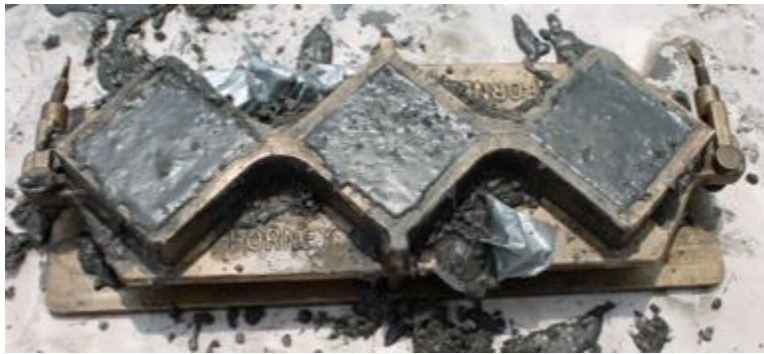
Figure 139. VHPC cubes

To measure the compressive strength, 2 in. cubes were made for each batch mixed except for the final batch mixed on day two and are shown in Figure 139. To measure the splitting tensile strength, six 3 in. x 6 in. cylinders were made from the final batch mixed on day two.
