METHODS FOR EVALUATION OF THE REMAINING SHEAR STRENGTH  
IN STEEL BRIDGE BEAMS WITH SECTION LOSSES DUE TO CORROSION  
DAMAGE

Thesis submitted to the faculty of the Virginia Polytechnic Institute and State  
University in partial fulfillment of the requirements for the degree of

Keywords: Corrosion, Steel Beam, Load Rating, Bridges

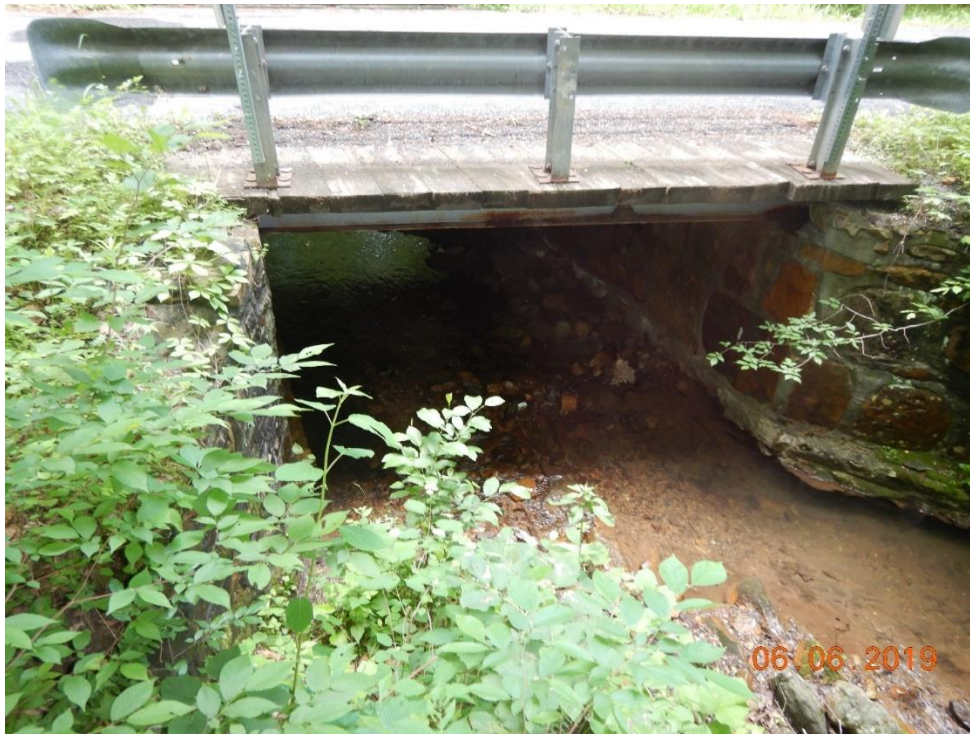
**Figure 3. Example of an SS8 bridge in Alleghany County, Virginia (VDOT, 2019)**

An example of structures in Virginia that receive low amounts of maintenance is SS8 bridges, which refers to bridges with steel beams and timber deck superstructures (Figure 3). These structures comprise 17.2% or 2,509 of the 14,547 bridges in the VDOT inventory (VDOT 2019). In addition to atmospheric moisture, water can also be stored in the bridge timbers or in dirt and debris on the abutment seat prolonging the beam's exposure. In this case, the experienced corrosion can be severe and concentrated

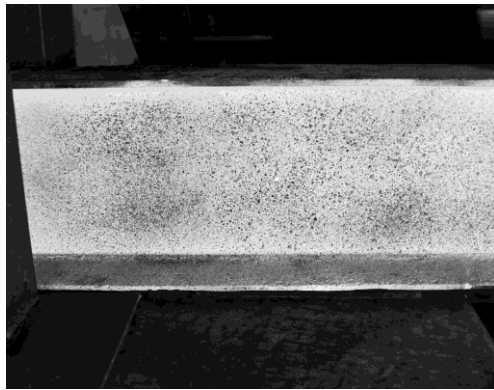
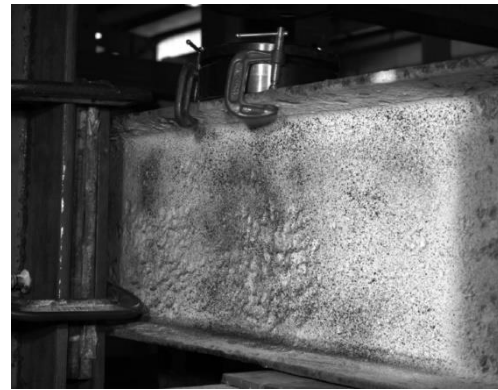
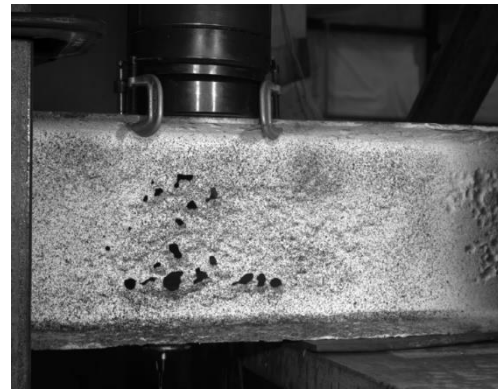
The first set of beams tested were S8x18.4 beams and featured heavy section losses due to corrosion spread across the beam end webs. A total of nine beams from a single bridge were brought to Virginia Tech in August of 2018. Four beams with varying corrosion damage were selected for testing and assigned damage levels ranging from low to high. Images of these four beams with applied stochastic patterns are provided in Figure 21.

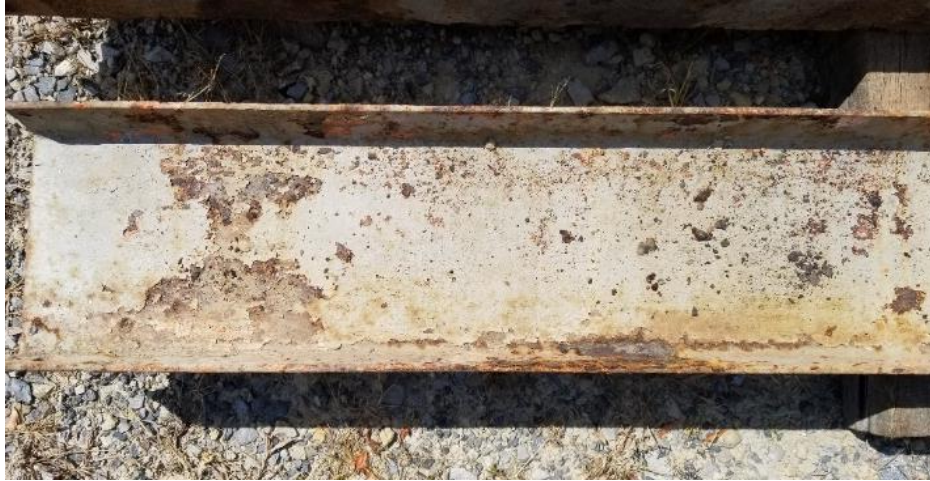
**Figure 22. Image of Specimen 1-S8-L After Arrival at Lab**

The first set of the deteriorated beams tested were the S8x18.4 shapes. These specimens came from a steel beam timber deck bridge, which had experienced severe localized corrosion on several beam webs and flanges. This deterioration was likely due to exposure to atmospheric moisture, roadway leakage, and moisture absorbed by the timber deck planks. Figure 22 shows an image of the first specimen tested after arrival at the Virginia Tech Structures Laboratory. The first specimen was nearly undamaged besides some paint coating failure and minor corrosion near the beam end and small portions of the lower flange. Initial preparation began with stripping the beams of paint at the tested end with a chemical paint removal treatment. An example of the first beam after cleaning is shown in Figure 23.

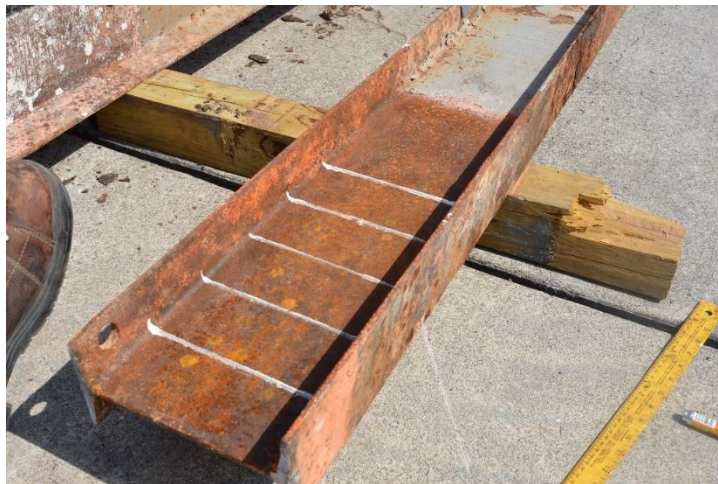
**Figure 23. Specimen 1-S8-L Stripped of Paint**

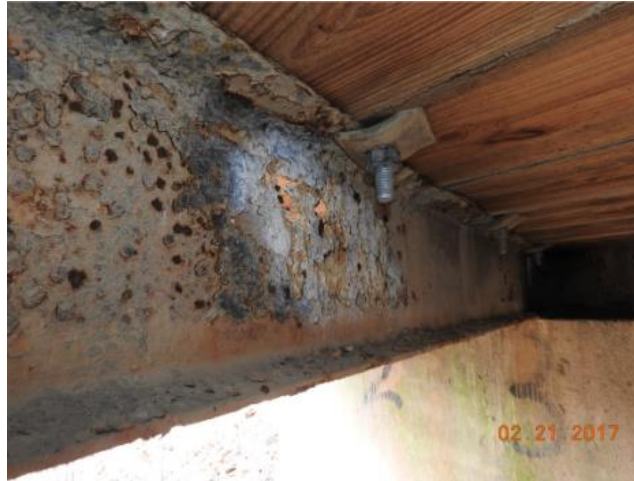
**Figure 24. Example of Steel Beam Timber Deck Web Corrosion**

Specimen 2-S8-ML featured significantly more section loss than specimen 1-S8-L. The decision to use this beam as the Medium-Low specimen was driven by the presence of significant section losses without any through-web holes. As the study progressed, it became clear that the corrosion on specimens 2-S8-ML, 3-S8-MH, and 4-S8-H were unlike most patterns' characteristic of deck joint failure. The deterioration of a joint failure would follow the path of water runoff along the height of the beam end and near the bottom flange where water typically pools. The bridge this specimen came from was a steel beam timber deck design, making it likely that the wood absorbed and stored water, which was gradually released onto the web surface. Figure 24 shows an image taken of one of the bridge beams during service and illustrates this full-height web corrosion.
