CHAPTER 6

LATERAL LOAD TESTS

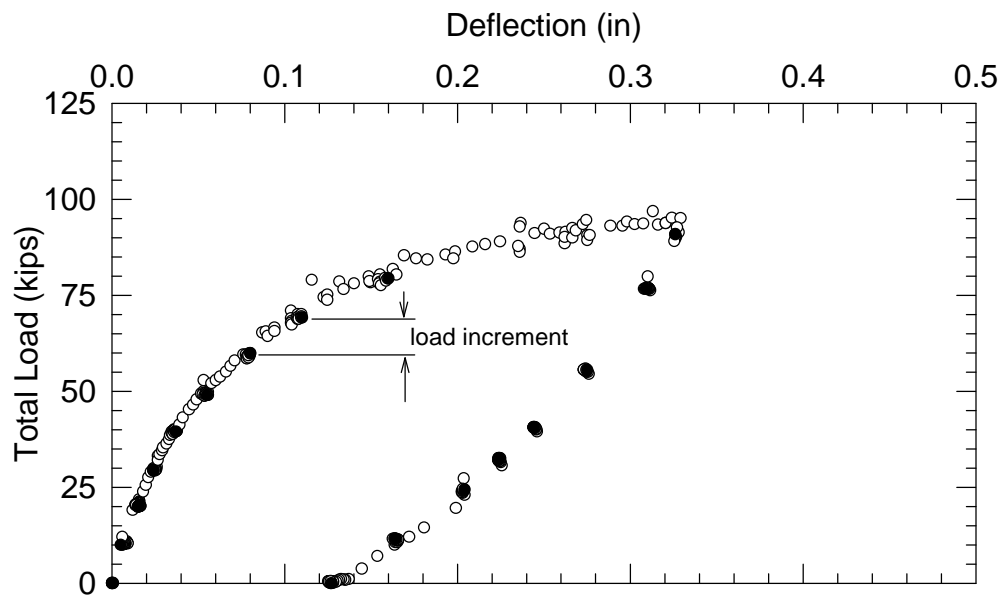
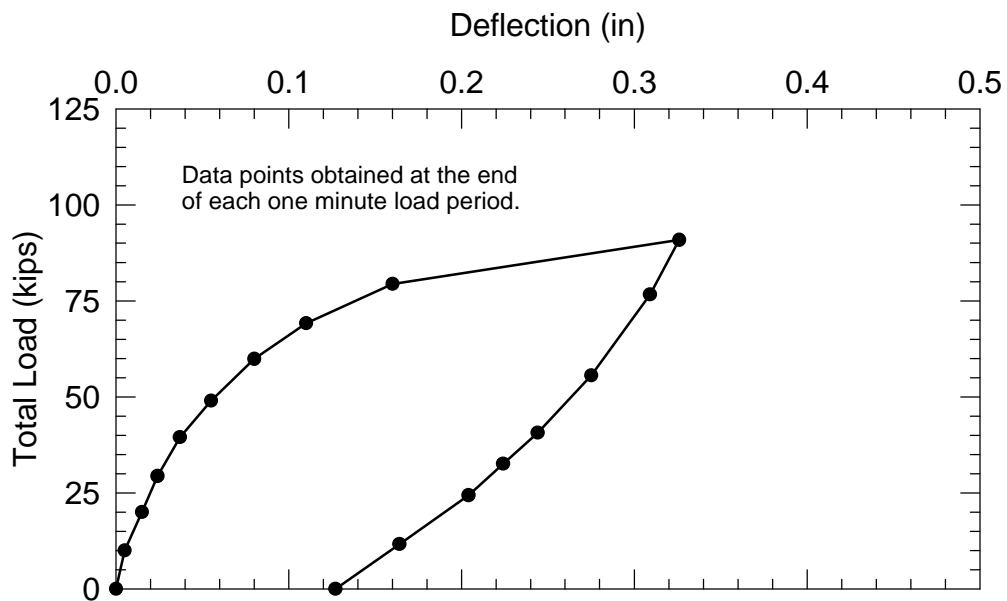
Figure 6.1. Typical load-deflection curve for SE pile cap backfilled with compacted gravel.

(a) Raw data from pile cap load test.

(b) Filtered data.

minute-long pause was maintained between increments, at constant load. A typical distribution of data points obtained during the incremental procedure is shown in Figure 6.1(a). For easier viewing, intermediate points were filtered, and only the data at the end of each one-minute pause was plotted, as shown in Figure 6.1(b). A line or smooth curve was fit through the end points to facilitate comparisons among the various tests.

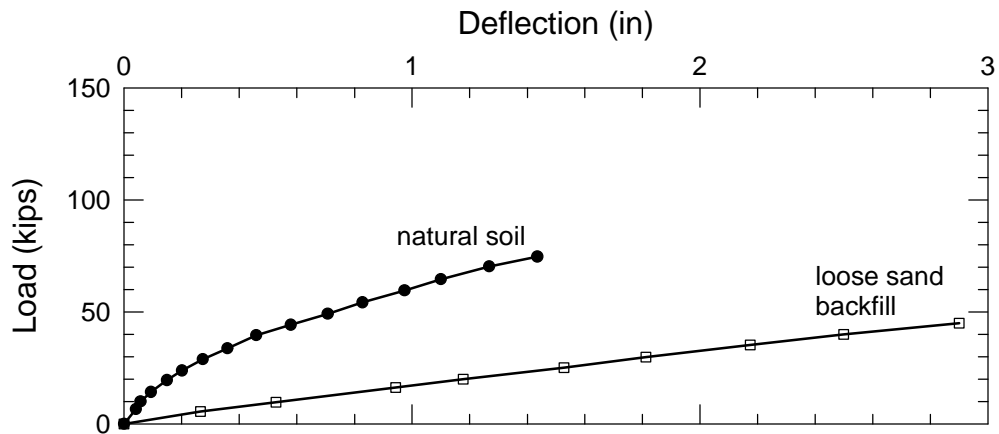
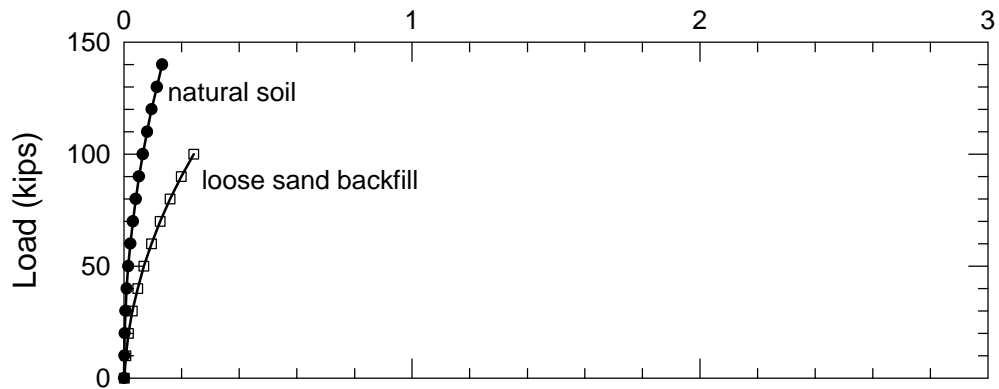
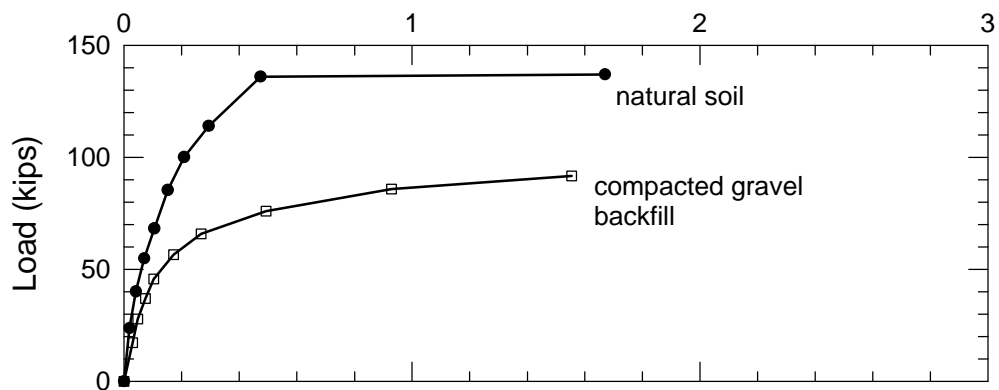
Figure 6.2. Typical results from lateral load tests performed at the field test facility.

(a) South pile measured response.

(b) SE pile cap measured response.

(c) Bulkhead measured response.

Examples of load versus deflection results for the south pile, SE cap, and bulkhead are shown in Figure 6.2. These plots cover the typical range of load and deflection values that were measured during the tests. Applied loads ranged from 0 to 140 kips, and maximum deflections ranged from 0.1 to almost 3 inches. For instance, the south pile deflected about 2.9 inches in loose sand, at a load of 45 kips (Figure 6.2a). While the SE pile cap in contact with natural soil deflected about 0.1 inches, at a load of

140 kips (Figure 6.2b). The bulkhead deflected approximately 1.6 inches at a load of 137 kips in natural soil and 90 kips in compacted gravel, as shown in Figure 6.2(c).

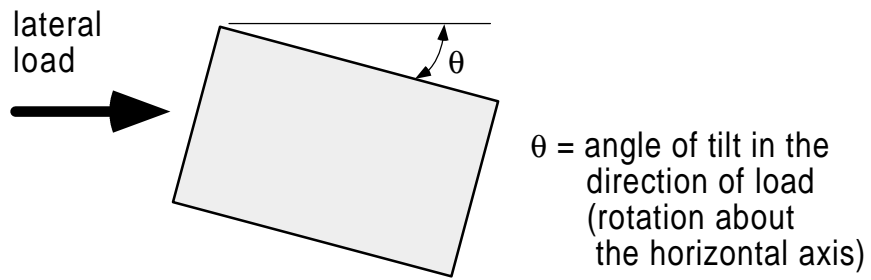
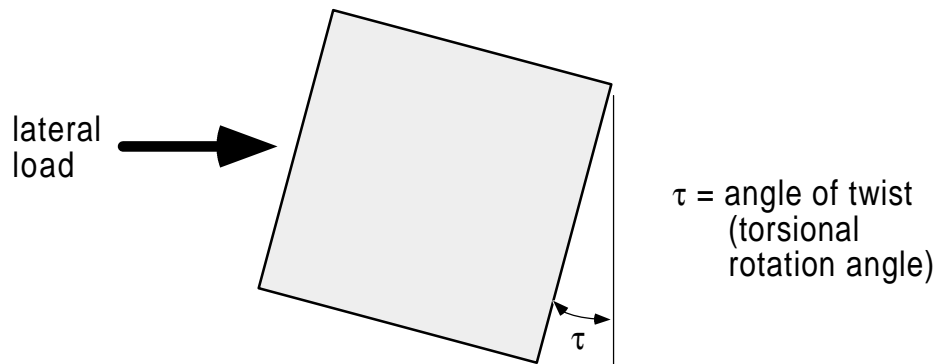
Figure 6.3. Description of pile cap rotation angles.

(a) Cross-section of laterally loaded pile cap (exaggerated behavior).

(b) Plan view of laterally loaded pile cap (exaggerated behavior).

Terms used to describe rotations of pile caps are defined in Figure 6.3 as follows:

q = the angle of tilt in the direction of load (rotation about the horizontal axis), and

t = the angle of twist or torsion of the cap about a vertical axis.

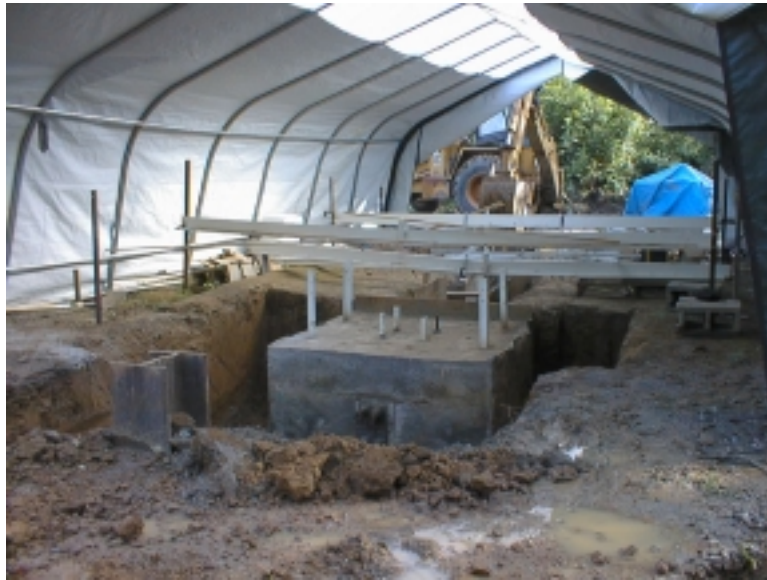
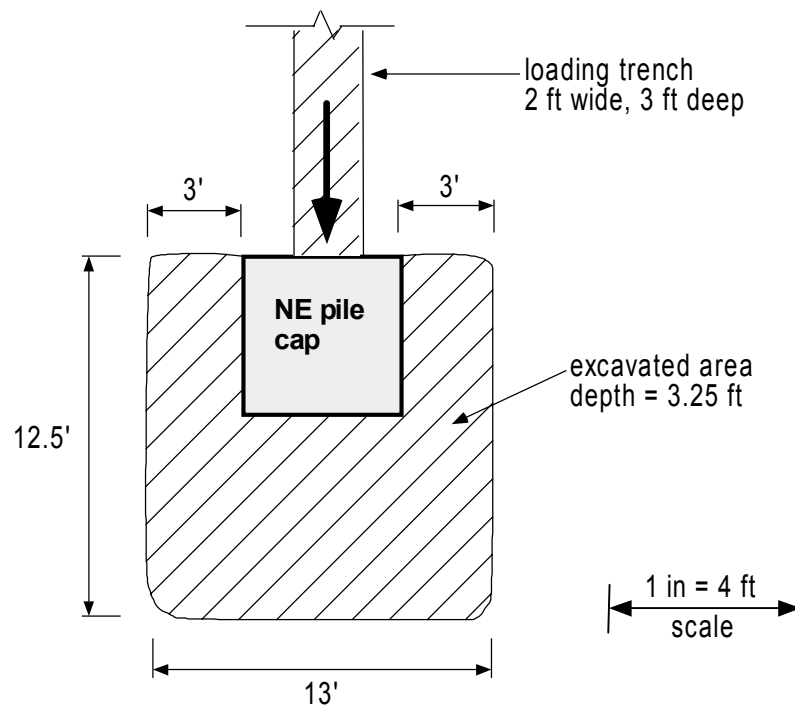
Figure 6.14. NE pile cap with soil excavated from sides and front.

(a) Photograph of soil excavation around pile cap.

(b) Plan view of excavation around NE pile cap.

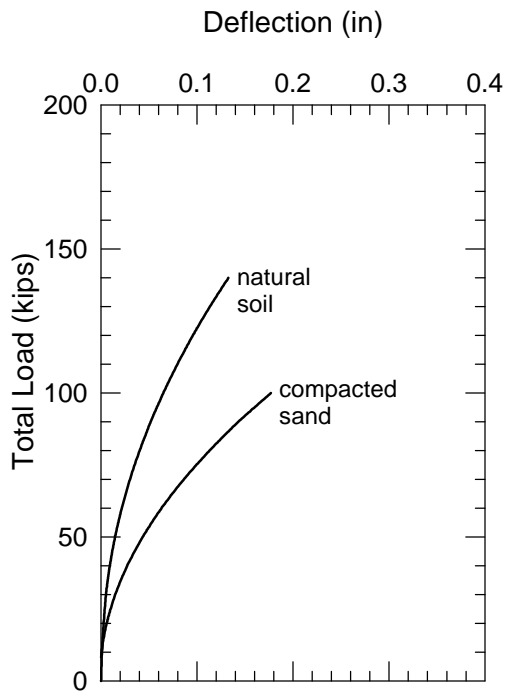
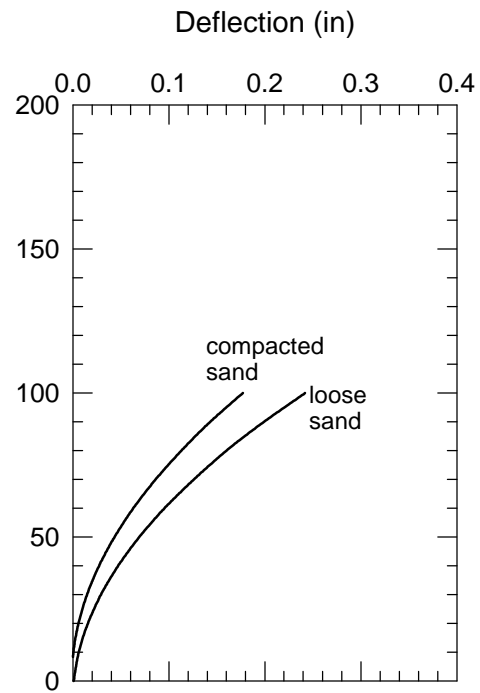
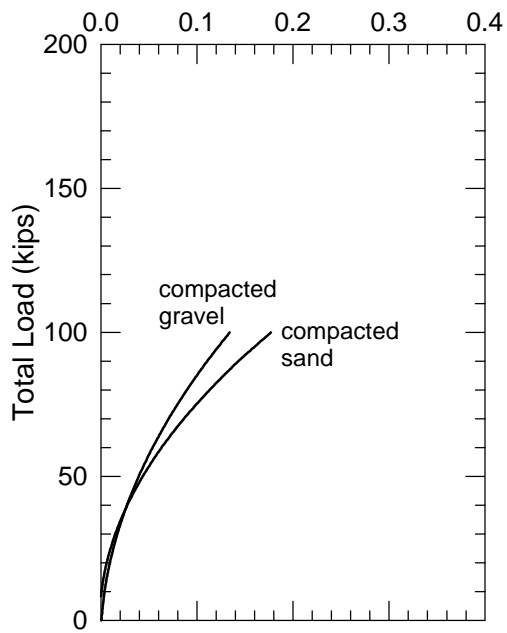
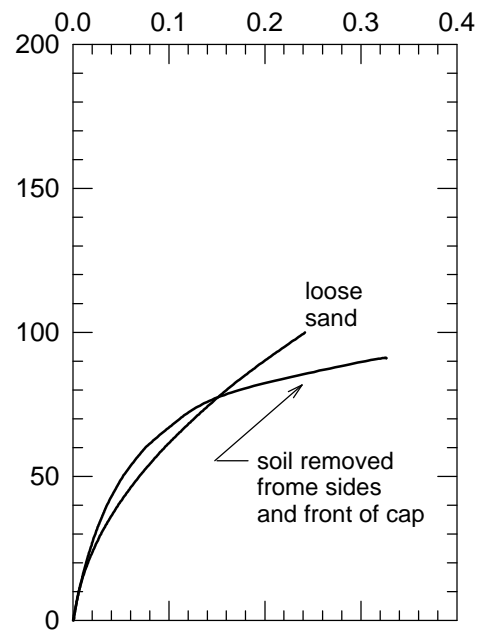
Figure 6.20. Effect of backfill type and density on load-deflection response of SE pile group.

(a) Natural soil vs. compacted sand.

(b) Compacted sand vs. loose sand.

(c) Compacted gravel vs. dense sand.

(d) Loose sand vs. no backfill.

Tests were performed on the SE cap using four different backfill conditions, to further study the effect of soil strength on lateral load response. Direct comparisons are shown in Figure 6.20 for the following conditions:

1. Figure 6.20(a) – natural soil versus dense sand,
2. Figure 6.20(b) – dense sand versus loose sand,
3. Figure 6.20(c) – dense gravel versus dense sand, and
4. Figure 6.20(d) – loose sand versus no soil.

The most obvious trend in these comparisons is the direct relationship between backfill strength and lateral load behavior. Smaller deflections were observed in the stiffer, stronger soils, and deflections noticeably increased as soil strength and stiffness decreased. The stiffest, strongest soils are the natural undisturbed soils (smallest measured deflections) followed in decreasing order by dense gravel, dense sand, loose sand, and no soil (largest measured deflections).

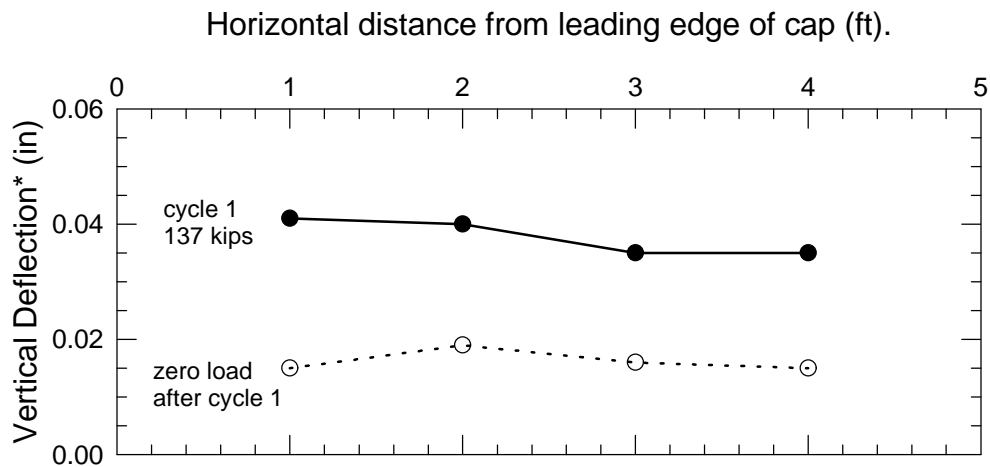
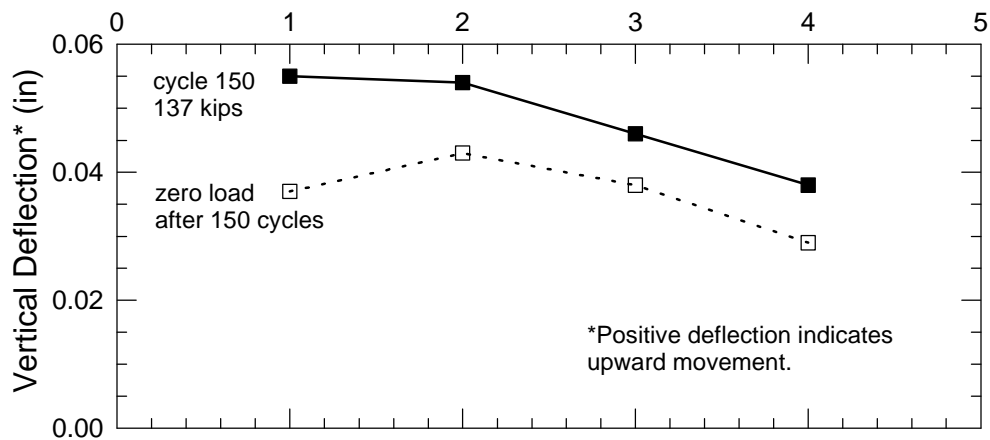
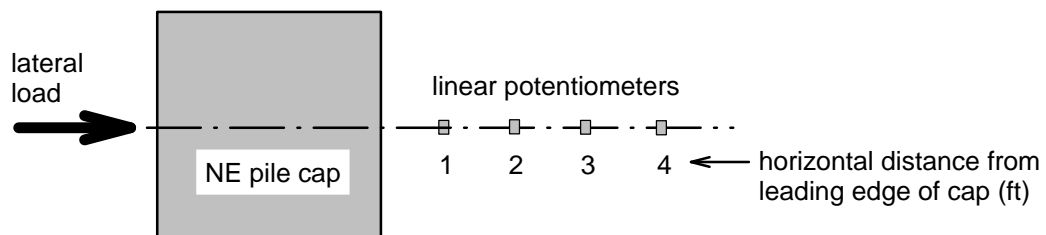
Figure 6.23. Vertical deflection of gravel backfill surface in front of NE 36-in-deep pile cap.

(a) Vertical movement caused by first load cycle.

(b) Vertical backfill movement after 150 load cycles.

(c) Plan view of setup for measuring backfill surface deflection.

The vertical deflections were all in an upward direction, and the maximum values at peak load were observed in the potentiometers located one foot from the cap face. The vertical deflections were small, approximately 50 % of the horizontal cap deflections. The maximum permanent vertical deformation (the residual deflection after the 120 kip load was decreased to zero) was upward and occurred 2 feet in front of the cap.

Because the measured vertical deflections are very small, it is difficult to draw any firm conclusions from the results. The most significant observation is the upward movement of the backfill surface. This is caused by a combination of factors including dilatant behavior in the dense gravel backfill and the initial development of a passive soil wedge. As cap movements increase, the passive soil wedge will have a tendency to move

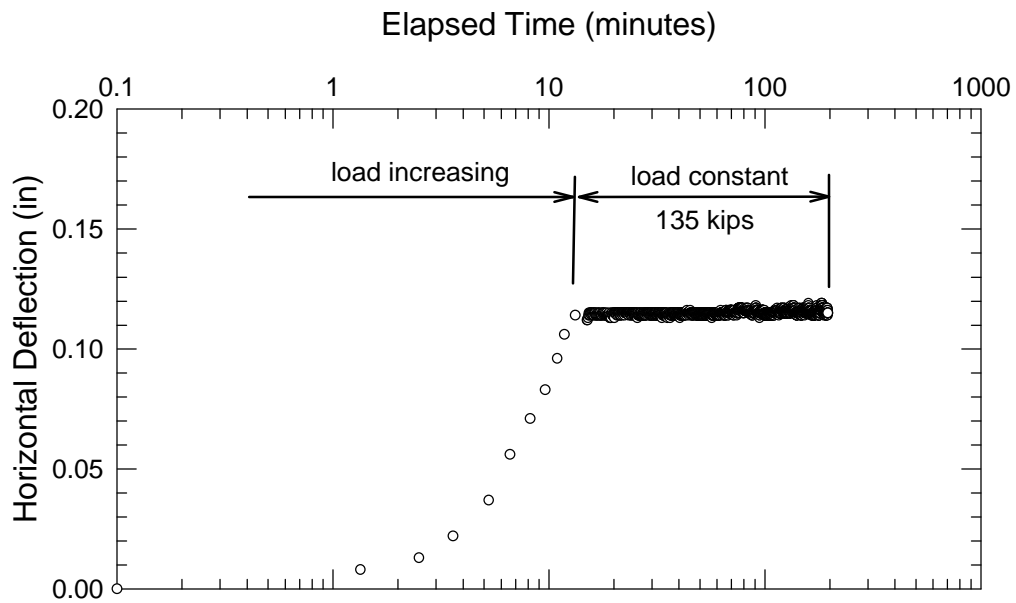
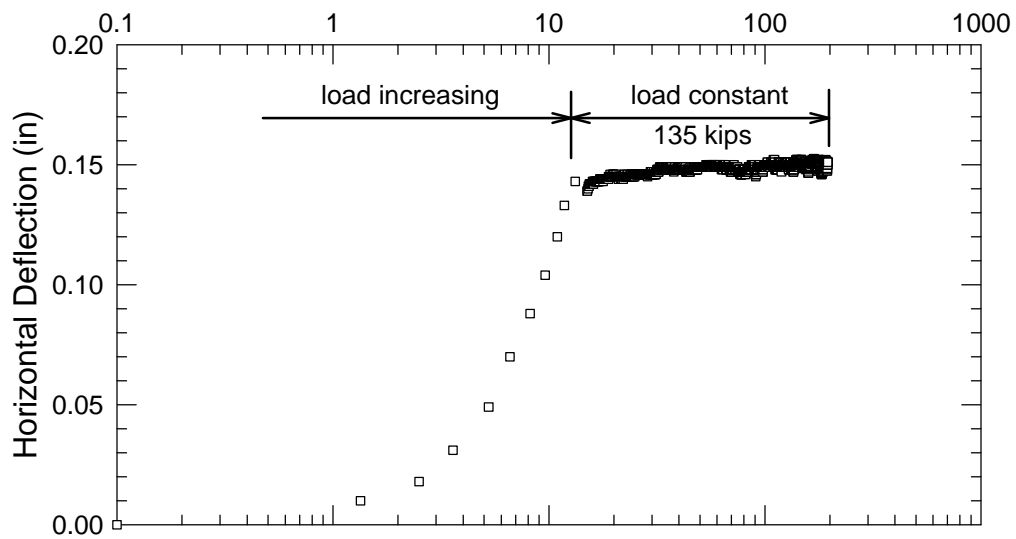
Figure 6.24. Effect of sustained load on NE and NW pile caps backfilled with compacted gravel.

(a) NE pile cap response at a sustained load of 135 kips.

(b) NW pile cap response at a sustained load of 135 kips.

Loads were incrementally increased to 135 kips and then held constant. As shown in Figures 6.24 and 6.25, there were no significant changes in horizontal deflections during sustained application of load. These results are comparable to the long-term performance of vertically loaded footings founded in dense granular soils or in overconsolidated low-plasticity fine-grained soils (same types of soil used in this study).
