REPAIR OF IMPACT-DAMAGED PRESTRESSED BRIDGE GIRDERS USING  
STRAND SPLICES AND FIBER-REINFORCED POLYMER

Thesis submitted to the faculty of the Virginia Polytechnic Institute and State  
University in partial fulfillment of the requirements for the degree of

Keywords: Prestressed concrete repair, flexural tests, FRP, Strand Splices

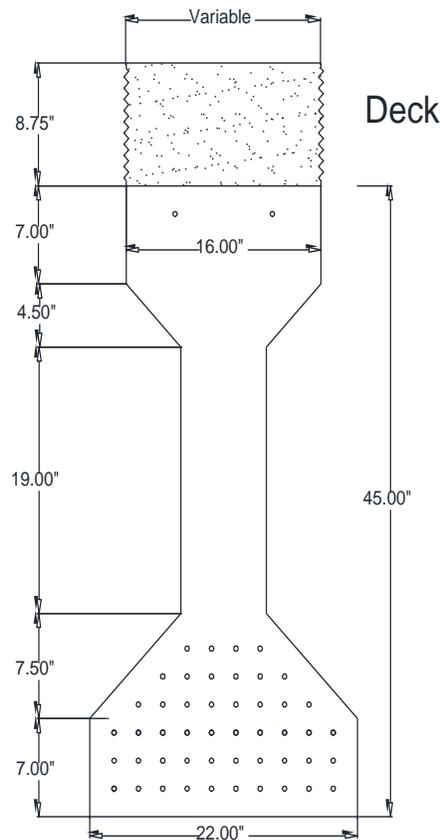
**Figure 2. Typical AASHTO Type III Girder Cross Section Tested**

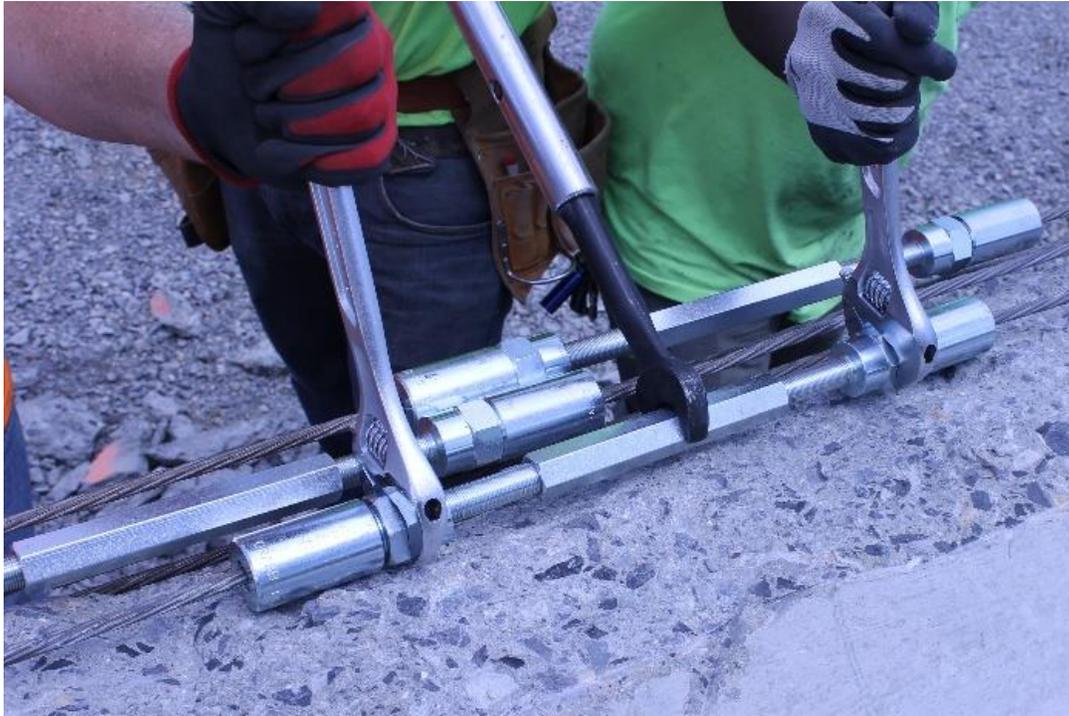
**Figure 4. Splice Chuck Installation**

torque wrench during the installation process. Figure 5 and Figure 6 show the layout for a repair using four and eight splice chucks respectively.

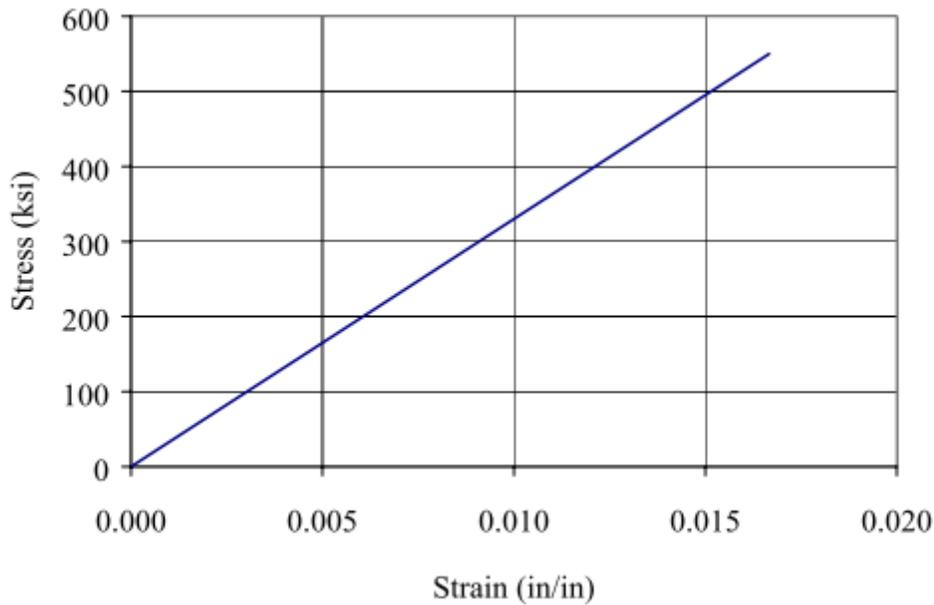
**Figure 7. Carbon Fiber Stress Strain Curve Wipf, T. J., Klaiber, F. W., Rhodes, J. D., & Kempers, B. J. (2004b). *Effective Structural Concrete Repair: Repair of Impact Damaged Prestressed Concrete Beams with Carbon Fiber Reinforced Polymer (CFRP)*. Iowa State University, Department of Civil, Construction, and Environmental Engineering. Ames: Iowa Department of Transportation. Retrieved December 12, 2014, Used under fair use, 2015**

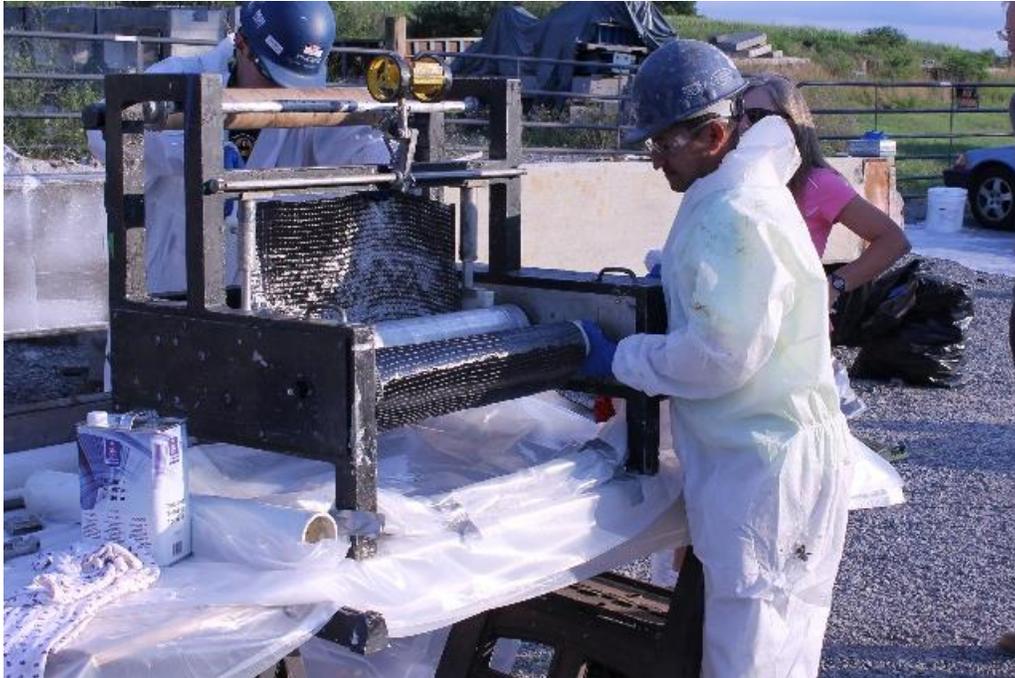
**Figure 8. Fiber Reinforced Polymer Saturation Process**

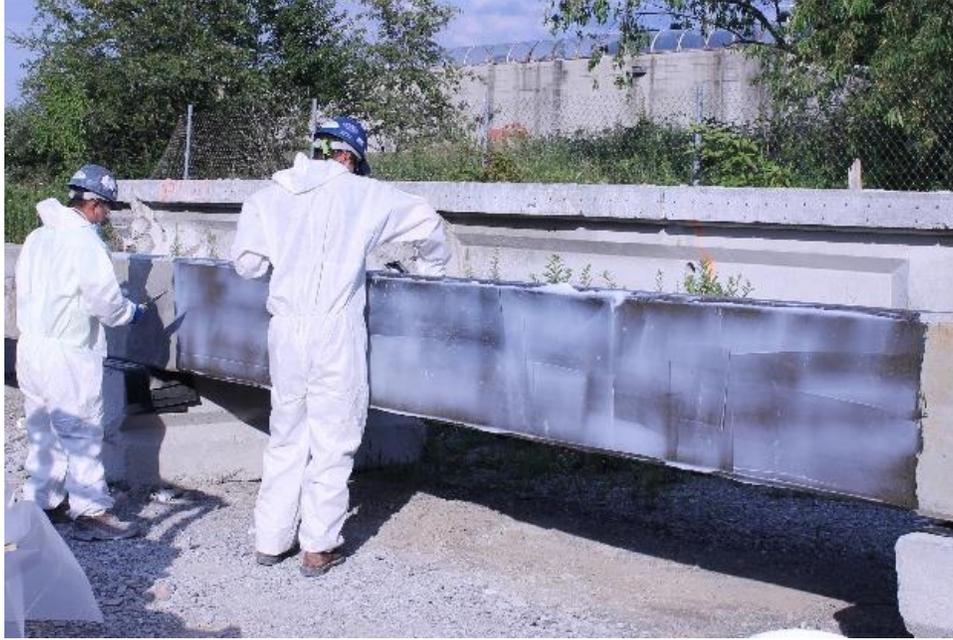
**Figure 10. Fiber Reinforced Polymer Installed Over Damaged Section**

While using FRP has many advantages, there are some things that the designer must consider. The epoxy is susceptible to ultraviolet and fire damage and must be protected in some fashion. The material properties of the various types of FRP are different than steel and need to be considered as they will change the behavior of the girder from its original design. While the strength of the FRP is greater than with steel, it is stiffer and lacks the plastic behavior which can result in a more sudden failure mode. If too much material is used, the result may be a compressive failure rather than a tension failure. Also, it takes a specially trained crew to install the system. If it is not installed correctly, there is potential for the epoxy to set incorrectly resulting in an insufficient bond which may cause the material to “un-zip” from the girder (Wipf, et. al., 2004b). Figure 8 shows the saturation process for a wet lay-up FRP strip, Figure 9 shows an externally bonded wet-lay FRP being installed, and Figure 10 shows the final product.

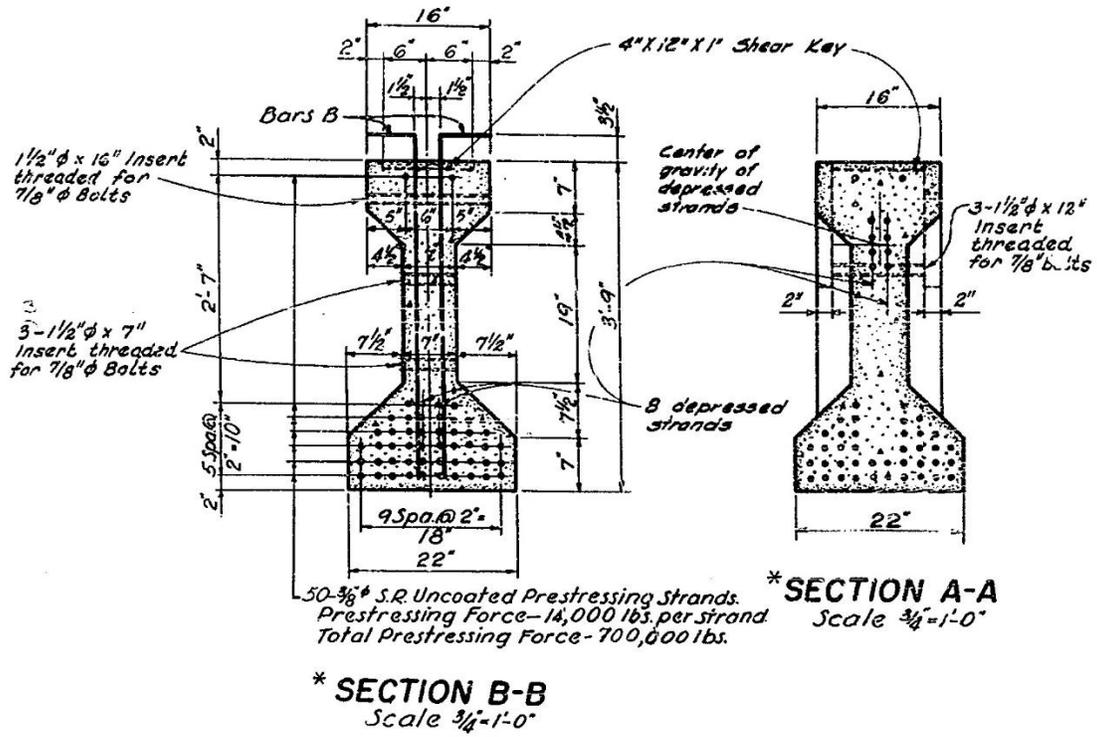
Figure 11. Girder Cross Section from Bridge Plans

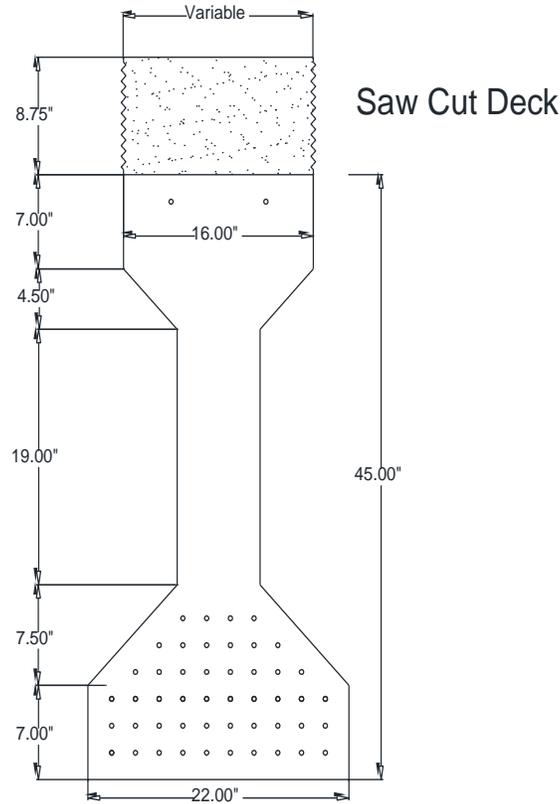
**Figure 12. Typical AASHTO Type III Girder Cross Section Tested**

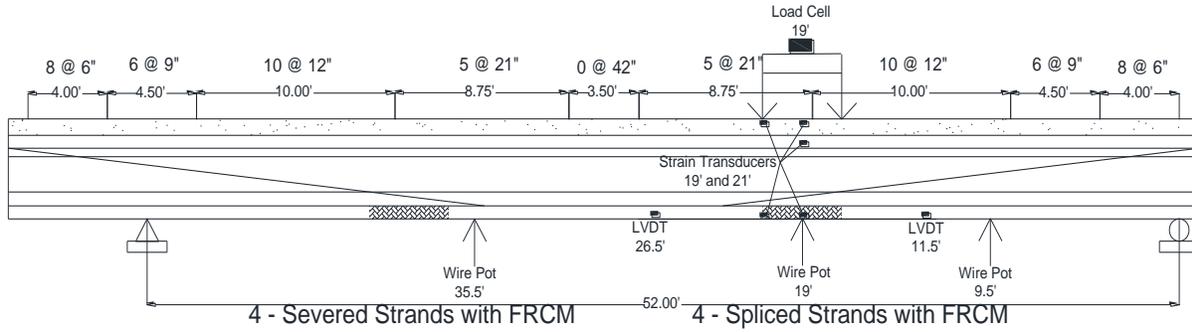
**Figure 21. Test 6 Set-up**

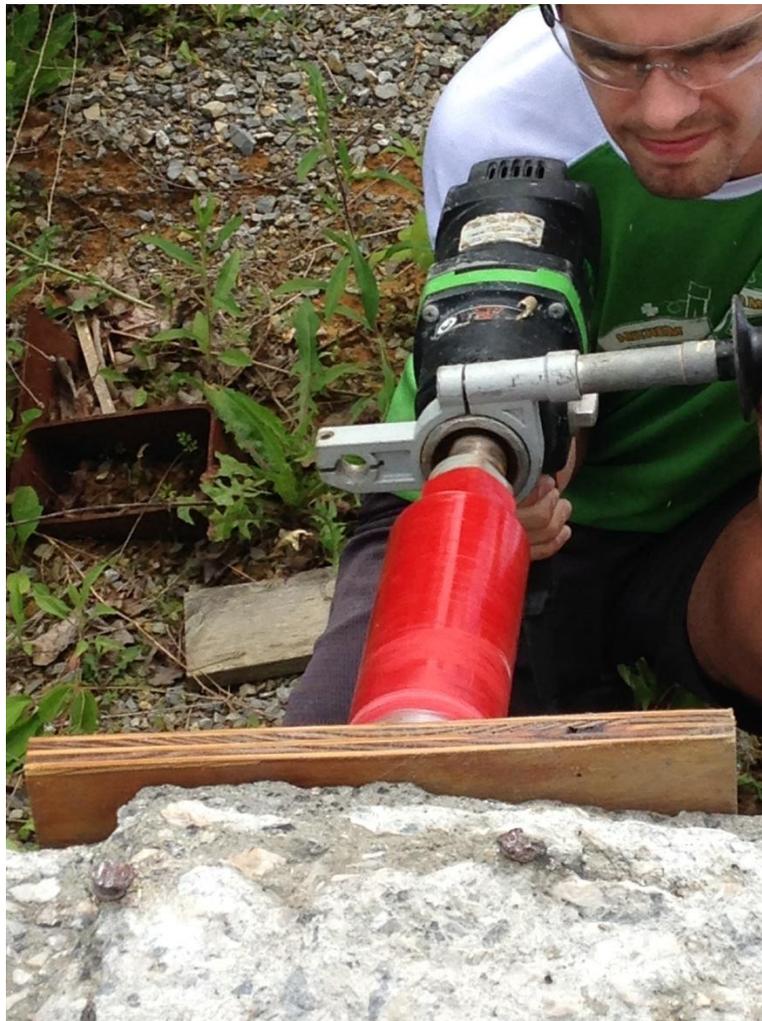
**Figure 22. Concrete Core Removal (Photo used with permission of Mark Jones, 2015)**

approximately 6 in long. The other two cylinders from the girder were used to conduct an ASTM C496 splitting tensile test (ASTM International, 2015).

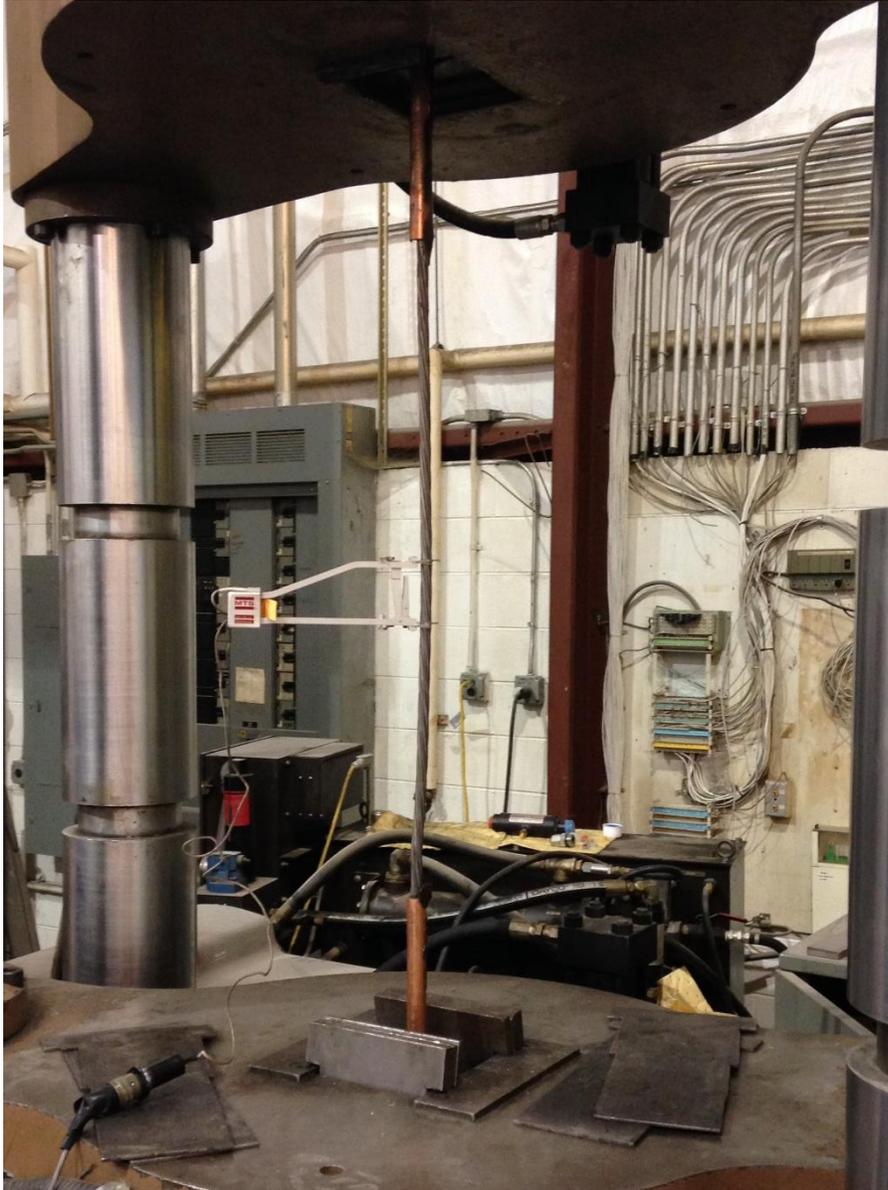
**Figure 23. Prestress Strand Tensile Test**

To determine the material properties of the prestressing steel, two 4 ft long pieces of prestressing strands were extracted from Girder A. The strands were prepared for testing following the procedures developed by Salomon (2014) and Loflin (2008). Copper tubing was used to pad the strands to mitigate the potential for a premature failure from a stress riser caused by the grips. The tubing had an interior diameter of 0.5 in. It was cut in half lengthwise and cut into approximately 10 in long sections. The sections were sand blasted to create a rough surface for the best condition to bond with the epoxy. The epoxy mix was made from West System 105A epoxy resin, West System 205 epoxy hardener, and 120 Aluminum Oxide Grit with a ratio of 5 fluid ounces of grit to 5 squirts each from the manufacturer provided pump of the epoxy resin and hardener. The epoxy and grit mixture was poured into each half of the copper tubing and each end of the strand was sandwiched between the tubing halves. The tubing was held together with clamps and the epoxy was allowed to dry for a minimum of 24 hours. The strands were placed in the SATEC universal machine and the hydraulic V-grips were used to grip the copper tubing on either end of the strand as shown in Figure 23. Data was recorded using the SATEC internal extensometer, the internal load cell, an external wire pot attached to the bottom of the SATEC loading platform, and an external extensometer placed on the strand. The tension test results indicate that the strands are grade 250 ksi (Nilson, 1987).

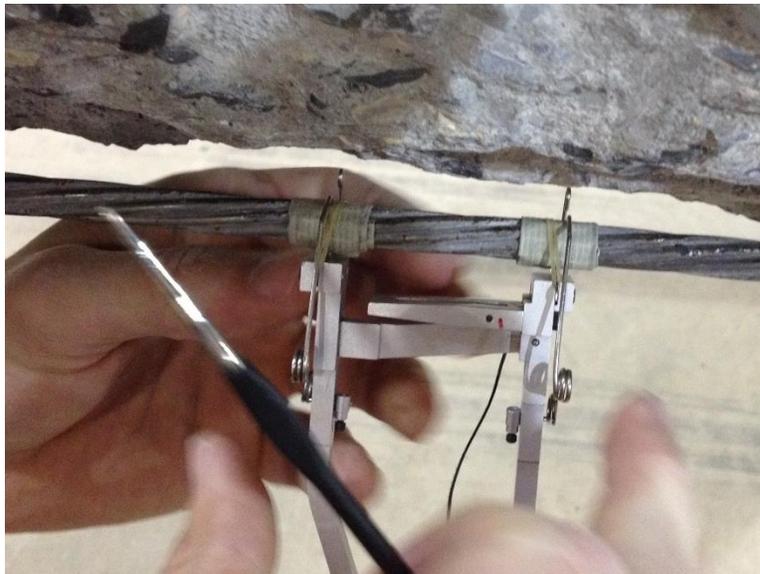
**Figure 24. Extensometer Attached to Strand (Photo taken by Mark Jones, used under fair use 2015)**

Figure 26. This distance was chosen to minimize the effects of temperature change during the cutting process. Six strands were cut with an extensometer attached to them. Based on these values, it can be determined that the extensometer slipped on the second, third, fourth, and sixth strands. The stress for the second, third, and sixth strands were past the yield stress and indicate that the elastic assumption associated with the stress-strain relationship is not valid. The fourth strand's stress indicated that it was in compression. In these cases, acknowledging the vibrations caused by the grinder while cutting the strands and the violent shortening of the strand as each wire was cut, the most likely cause of the variation was due to slipping of the instrumentation during testing. When averaging the first and fifth strands, the effective prestress force was 132 ksi.

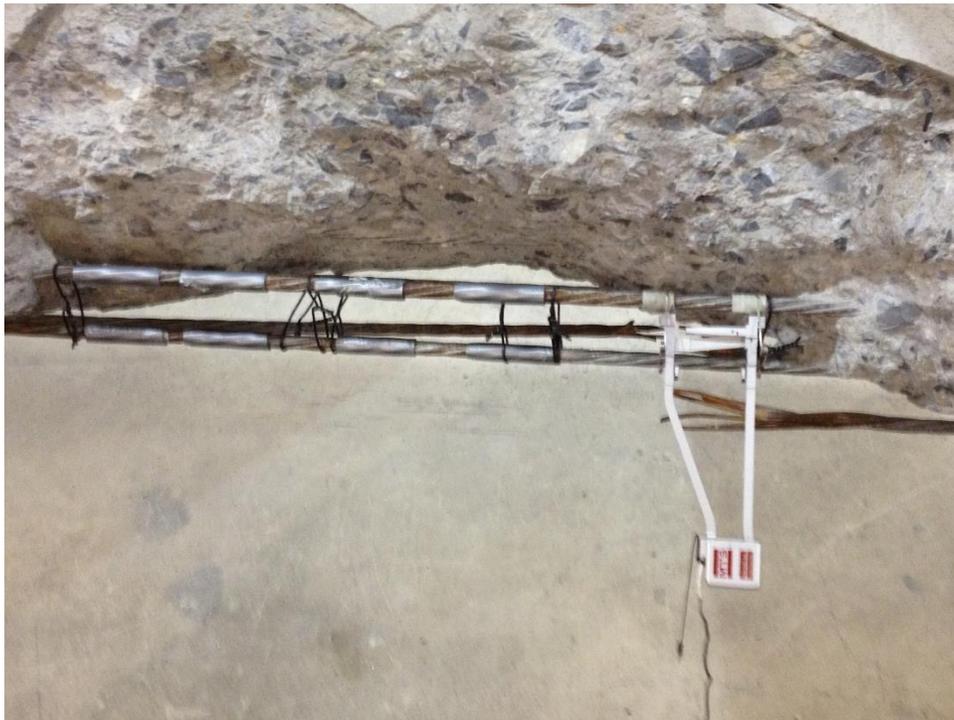
**Figure 26. Extensometer Location on Strand (Photo taken by Mark Jones, used under fair use 2015)**

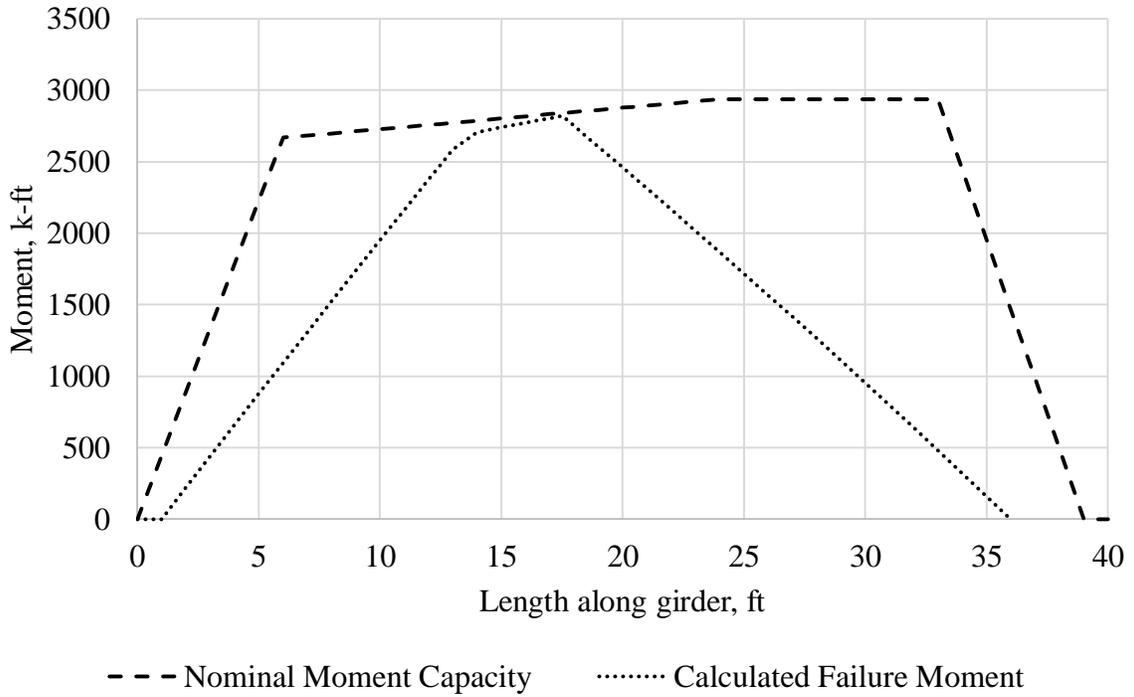
Figure 27. Nominal Moment Capacity versus Calculated Failure Moment for Test 1

In order to develop the plan for the test set-up and decrease the probability of a shear failure while ensuring the desired flexural failure, the girder nominal moment and shear capacities were determined using provisions of AASHTO LRFD Bridge Design Specification (American Association of State Highway and Transportation Officials, 2012) and the girder material properties (Jones, 2015). The nominal moment capacity of this girder at the points of load application was 2940 k-ft. This corresponds to a calculated load of 348 kips. Figure 27 shows the nominal moment capacity of the tested section of Girder A and the maximum calculated moment resulting from a load of 348 kips. Figure 28 shows the absolute values of the nominal shear capacity of Girder A and the maximum shear force resulting from a load of 348 kips. As shown in Figure 28, the maximum shear force is close to, but less than, the nominal shear capacity at about 13 ft and around 18 ft from the left support. Other loading arrangements were investigated, however this loading arrangement was chosen to minimize the potential for a shear failure since the desired failure mode was flexural (Jones, 2015).

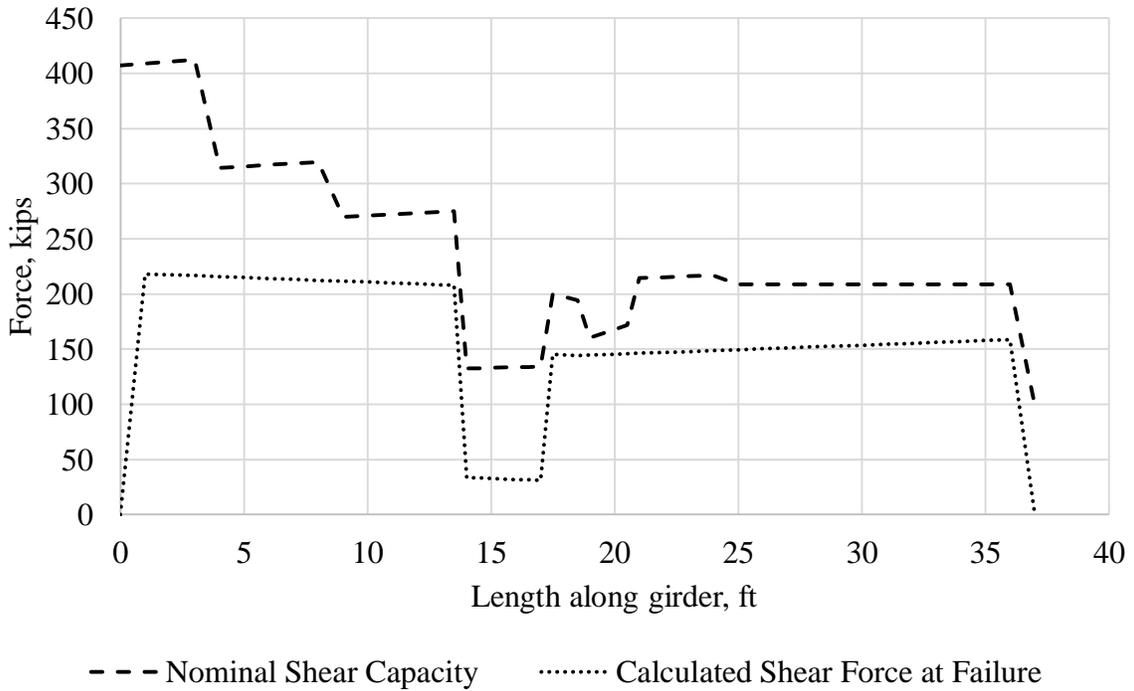
Figure 28. Nominal Shear Capacity versus Calculated Shear for Test 1

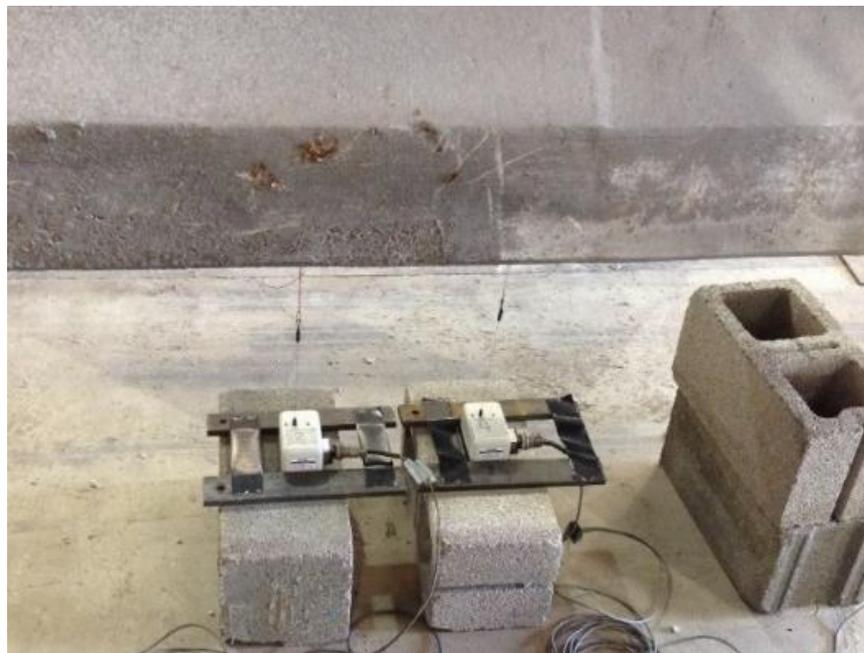
**Figure 34. Wire Pots below Load Point to Measure Deflection (Photo taken by Mark Jones, used under fair use 2015)**

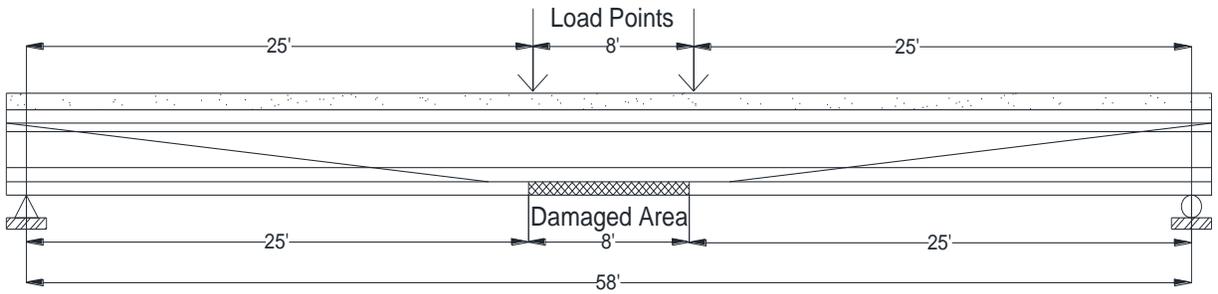
**Figure 35. Girder B Damage Location**

Wipf, Klaiber, Rhodes, and Kempers (2004a) reported that some departments of transportation replace a girder if any strand is damaged from the impact of overheight vehicles. Other departments of transportation reported that a prestressed girder is replaced when 10% of strands were damaged. The maximum number of damaged prestress strands allowed to be repaired by any state before the damaged girder would be replaced was 25%. In addition, based on results in Table 4, eight damaged strands on an AASHTO Type III girder is the maximum number of strands to efficiently repair using externally bonded FRP (Harries, et. al., 2012). Considering this information, damaging 17% of strands or eight strands was chosen. Subsequent girders were inflicted with less damage so the data from tests could be scaled to compare results.

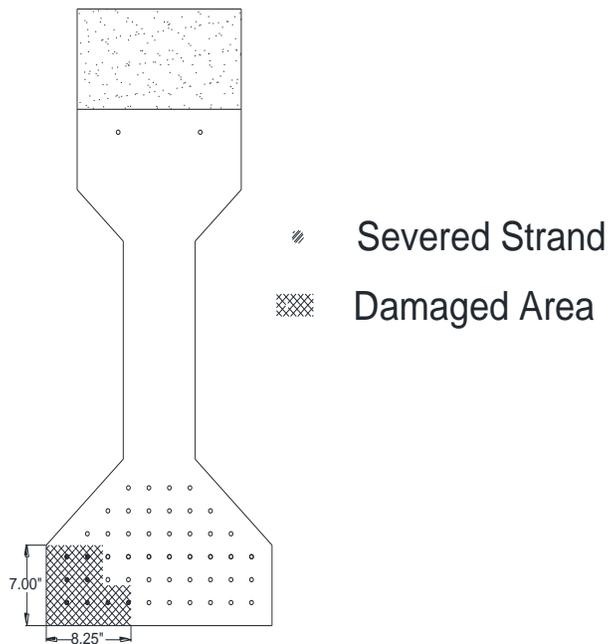
**Figure 36. Girder B Cross Section through Damaged Area with Severed Strand Locations Shown**

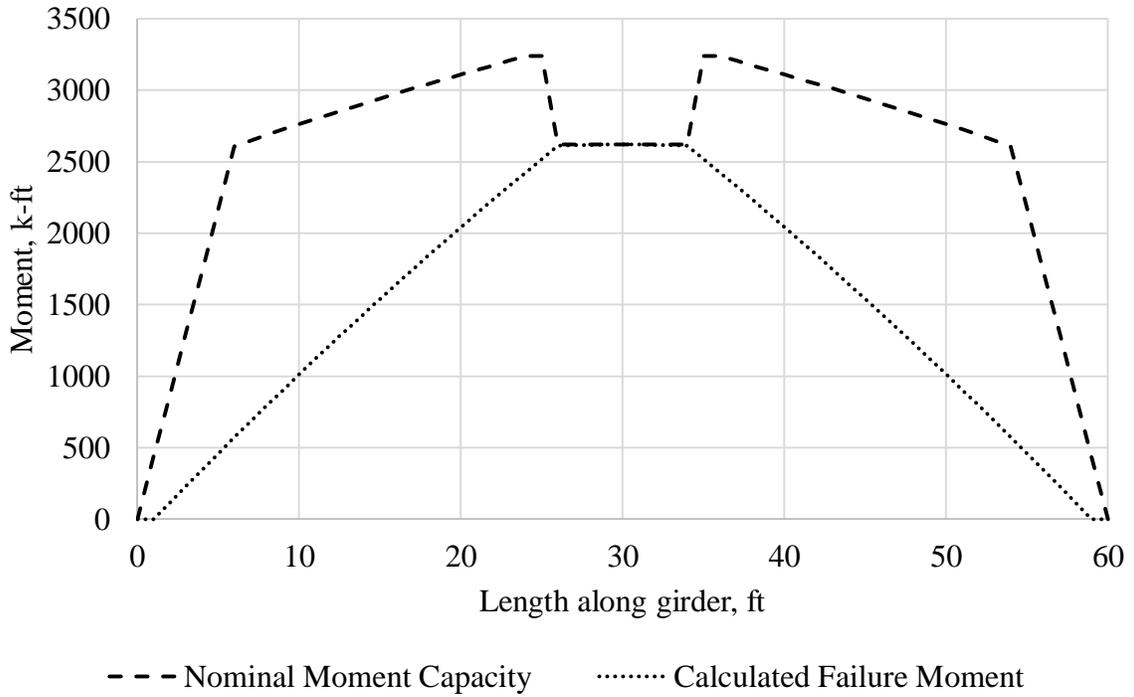
Figure 37. Nominal Moment Capacity versus Calculated Failure Moment for Test 2

In order to develop the plan for the test set-up and decrease the probability of a shear failure while ensuring the desired flexural failure, the girder nominal moment and shear capacities were determined using the provisions of AASHTO LRFD Bridge Design Specifications (American Association of State Highway and Transportation Officials, 2012) and the tested girder material properties (Jones, 2015). The nominal moment capacity of this girder at the points of load application was 2620 k-ft. This corresponds to a load of 176 kips. Figure 37 shows the nominal moment capacity of Girder B and the maximum calculated moment resulting from a load of 176 kips. Figure 38 shows the absolute values of the nominal shear capacity of Girder B and the maximum calculated shear force resulting from a load of 176 kips. Other loading arrangements were investigated, however this loading arrangement was chosen to minimize the potential for a shear failure since the desired failure mode was flexural (Jones, 2015).

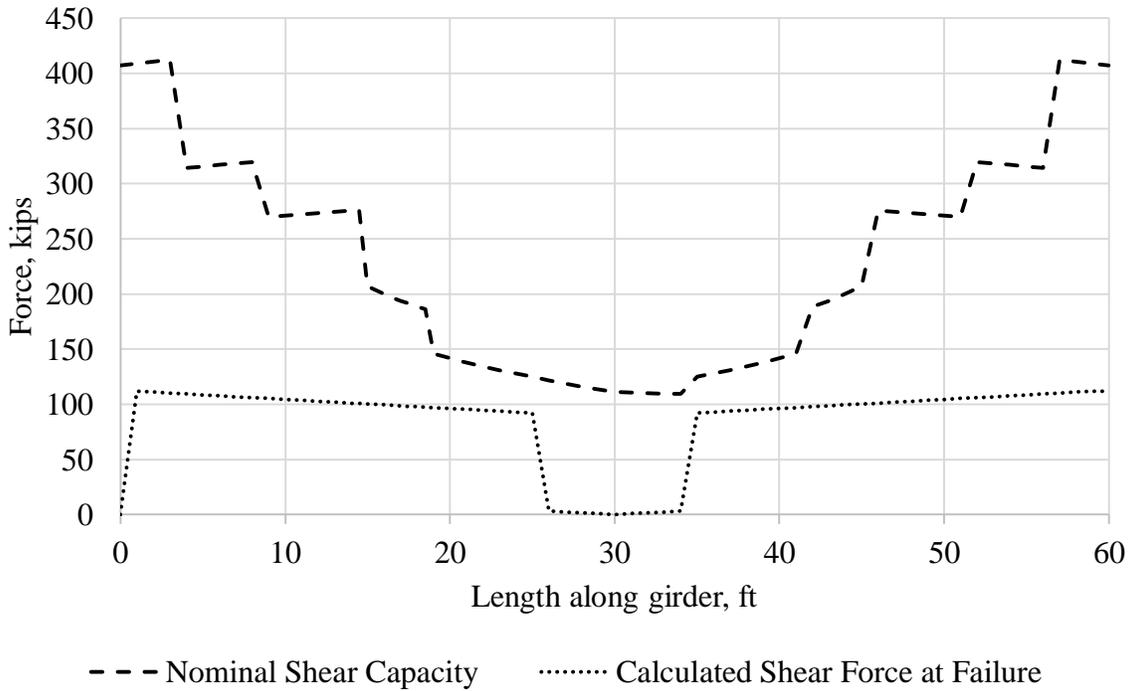
Figure 38. Nominal Shear Capacity versus Applied Shear for Test 2

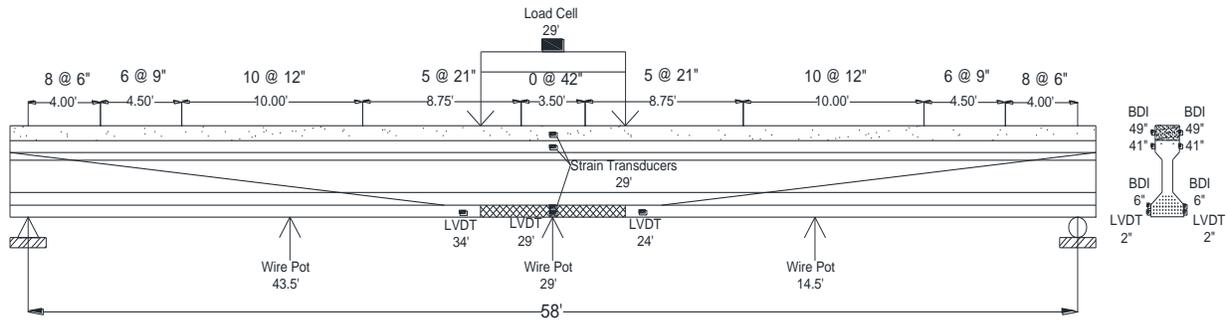
**Figure 43. Test 2 Set-up and Instrumentation Plan**

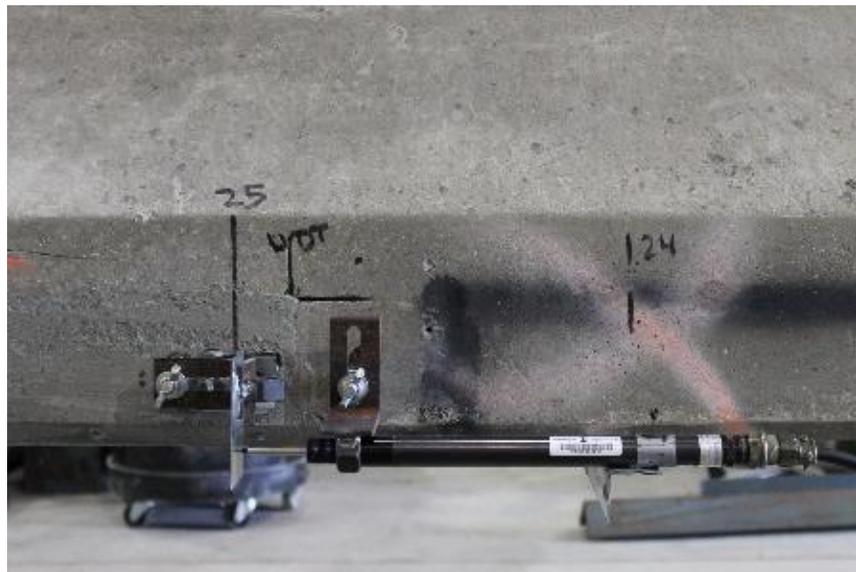
**Figure 46. LVDT at Repair Interface**

of the girder as shown in Figure 46. The gauges on the unrepaired side of the girder were used as a baseline to evaluate with the gauges on the repaired side and determine if there was a significant slip along the interface of the repair section and original concrete. A 400 kip load cell was placed between the actuator and the load frame to measure the applied load.

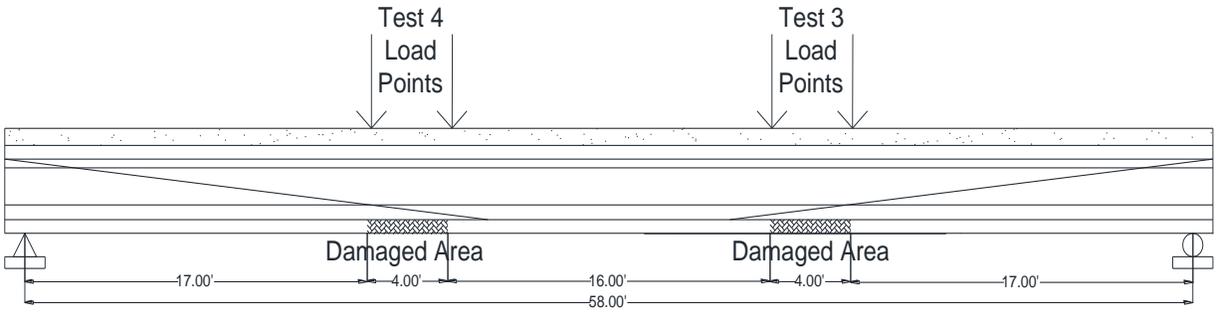
**Figure 47. Girder C Damage Locations**

For test 3, Girder C, a 60 ft girder, was damaged for 2 ft on either side of both third points. Of the 48 prestressing strands in the bottom flange of the girder, four were intentionally severed at each location during damaging. Four feet was chosen as the length for damage to allow Girder C to be damaged in two locations as shown in Figure 47. The two damage locations allowed two repair techniques to be tested on the same girder without one repair influencing the other repair's test results. In addition to reducing the length of damage, the number of severed prestressing strands was reduced to four strands. Figure 48 shows the locations of the strands that were severed during the damaging process.

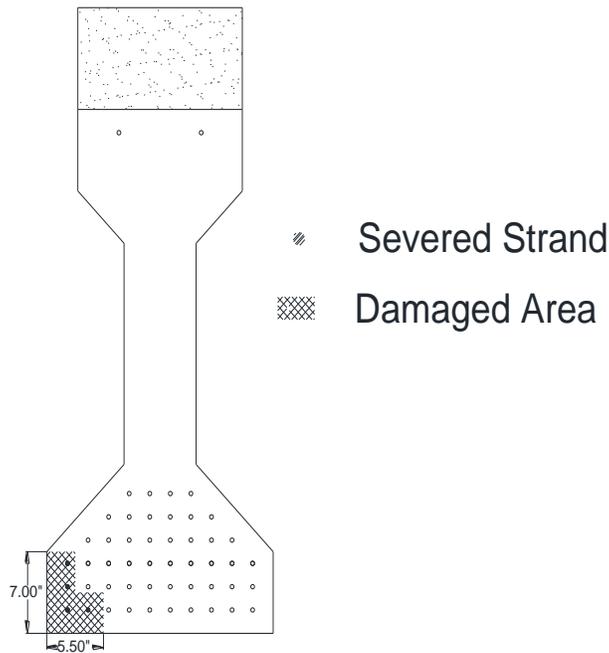
**Figure 48. Girder C Cross Section through Damaged Area with Severed Strand Locations Shown**

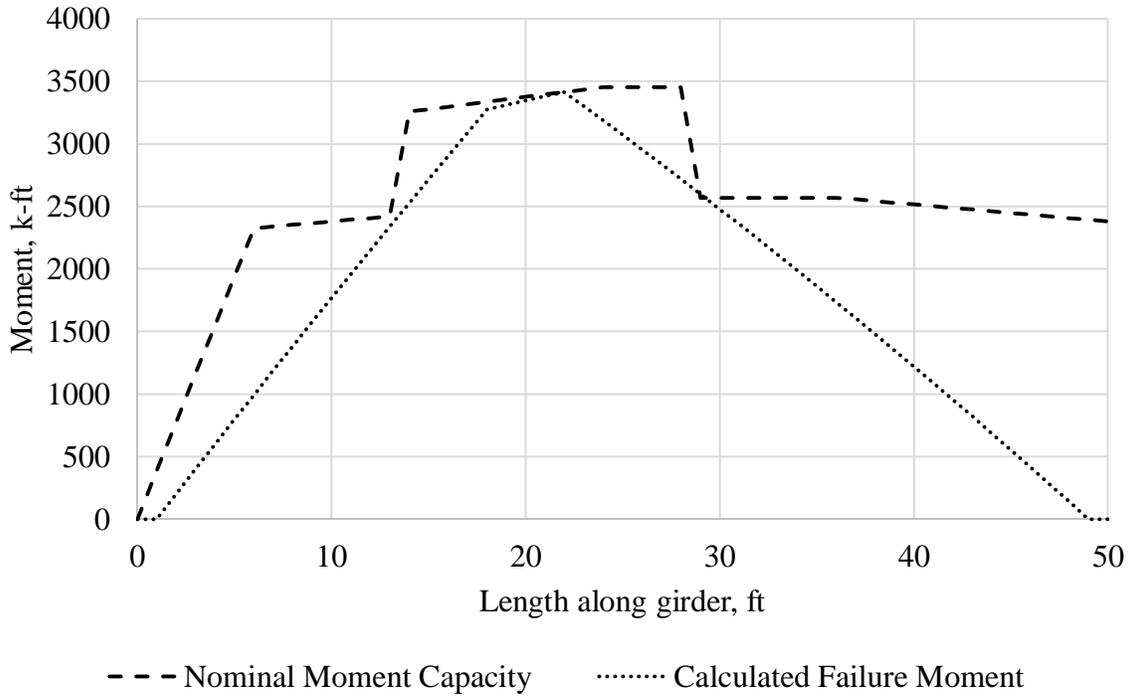
**Figure 49. Nominal Moment Capacity versus Calculated Failure Moment for Test 3, Iteration 1**

The nominal moment capacity of this girder at the points of load application was 3410 k-ft. This corresponds to a load of 293 kips for iteration 1 and 268 kips for iteration 2. Figure 49 shows the nominal moment capacity of Girder C and the maximum calculated moment resulting from a load of 293 kips. Figure 51 shows the nominal moment capacity of Girder C and the maximum calculated moment resulting from a load of 268 kips. Figure 50 shows the absolute values of the nominal shear capacity of Girder B and the maximum calculated shear force resulting from a load of 293 kips. Figure 52 shows the absolute values of the nominal shear capacity of Girder B and the maximum calculated shear force resulting from a load of 268 kips. Other loading arrangements were investigated, however this loading arrangement was chosen to minimize the potential for a shear failure since the desired failure mode was flexural (Jones, 2015).

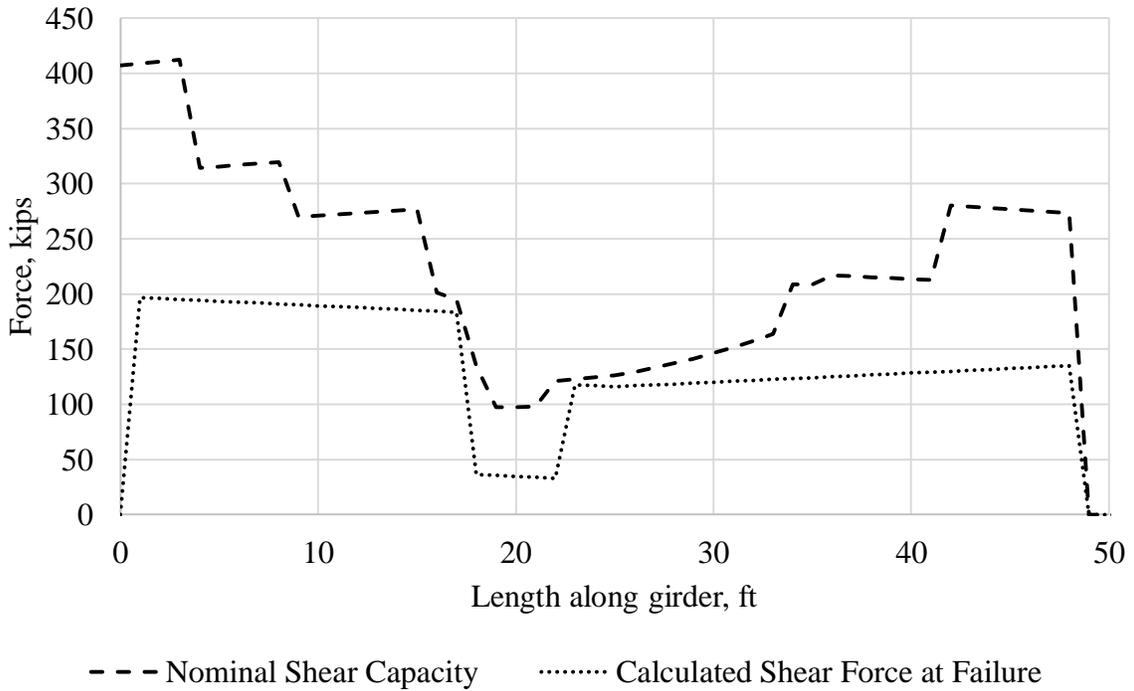
**Figure 50. Nominal Shear Capacity versus Calculated Shear for Test 3, Iteration 1**

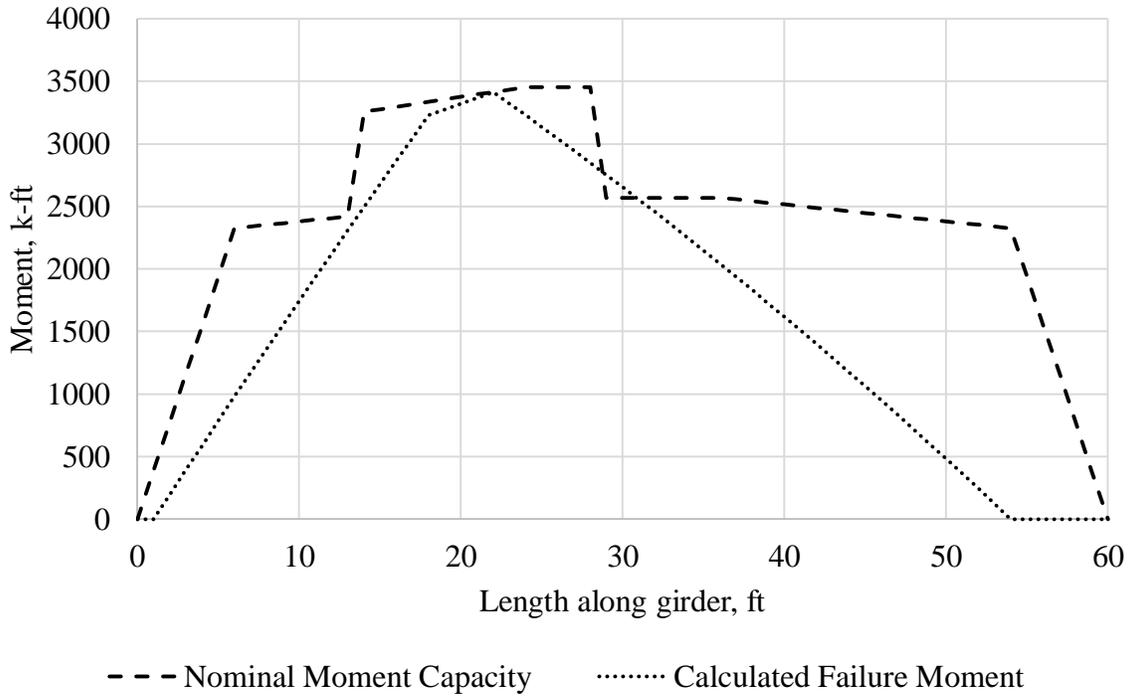
**Figure 51. Nominal Moment Capacity versus Calculated Failure Moment for Test 3, Iteration 2**

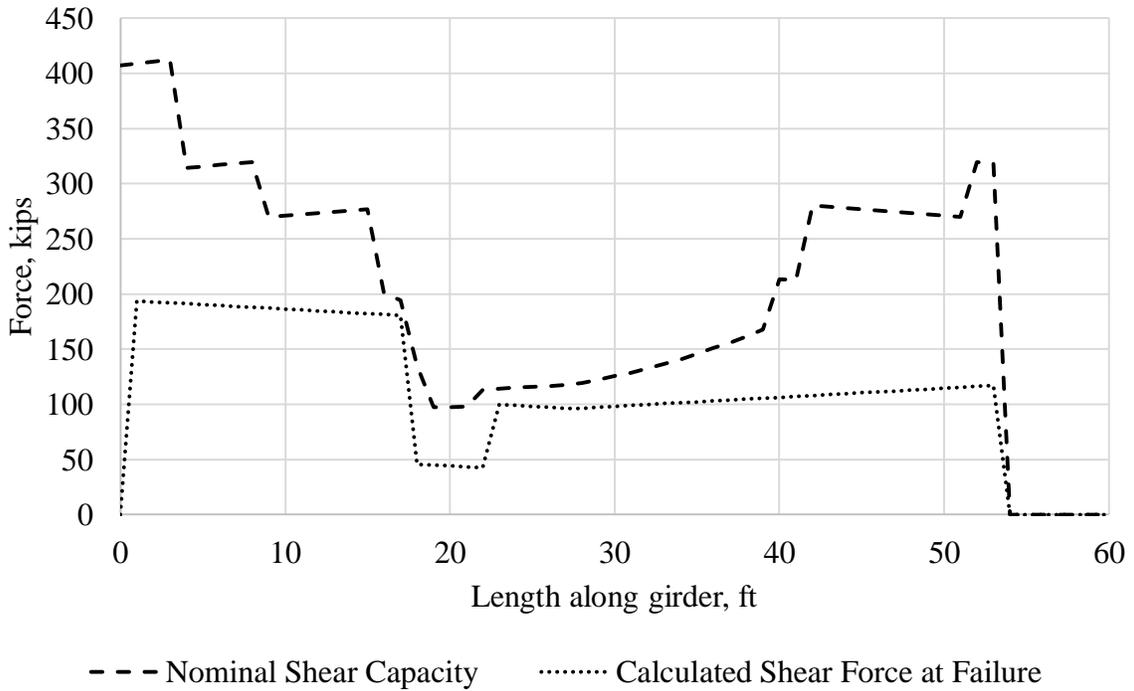
**Figure 52. Nominal Shear Capacity versus Calculated Shear for Test 3, Iteration 2**

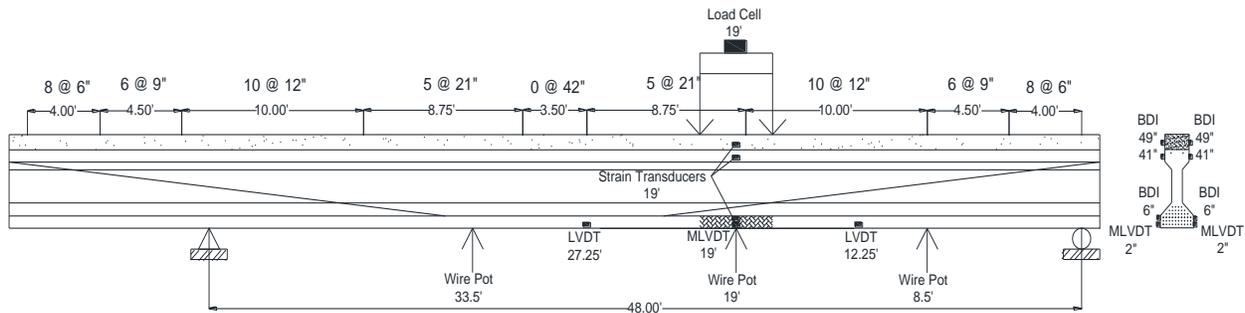
**Figure 58. Test 3, Iteration 1 Test and Instrumentation Set-up**

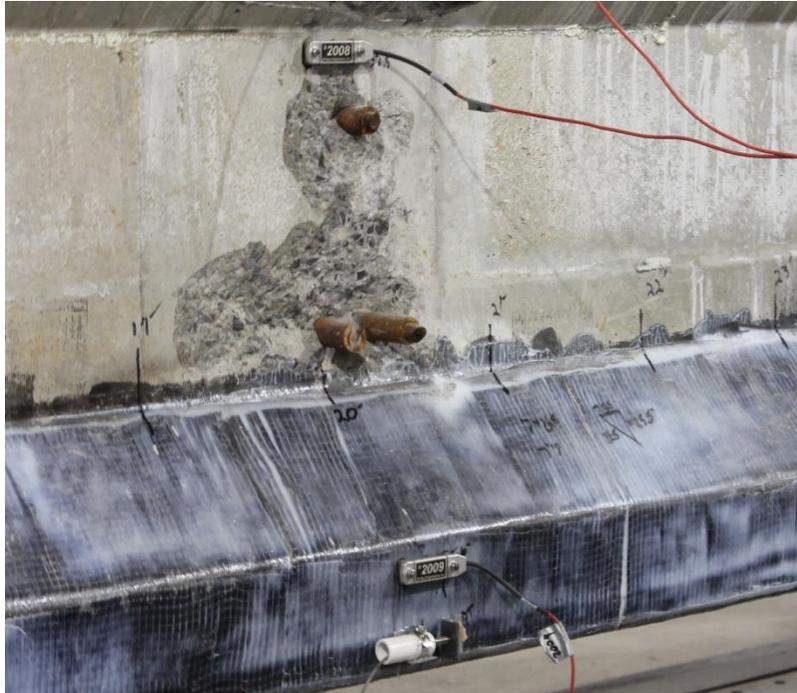
**Figure 60. Strain Transducers on Damaged/Repaired Side of Girder (Photo taken by Ioannis Koutromanos, used under fair use 2015)**

transducers were placed on either side of the girder at 6, 41, and 49 in from the bottom of the girder. Figure 60 and Figure 61 show the layout of the strain transducers on each side of the girder. One LVDT was placed on each side of the girder at both interfaces between the FRP and the girder as shown in Figure 62. These were used to measure any slip along the interface that may indicate a failure with the adhesive. A 400 kip load cell was placed between the actuator and the load frame to measure the applied load.

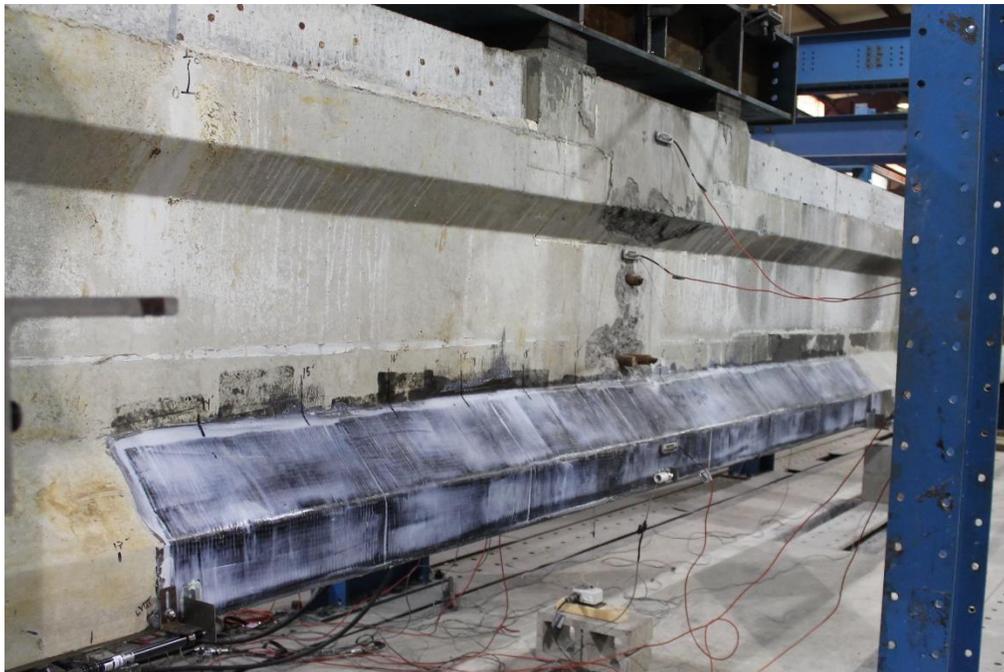
**Figure 61. Strain Transducers on Undamaged Side of Girder**

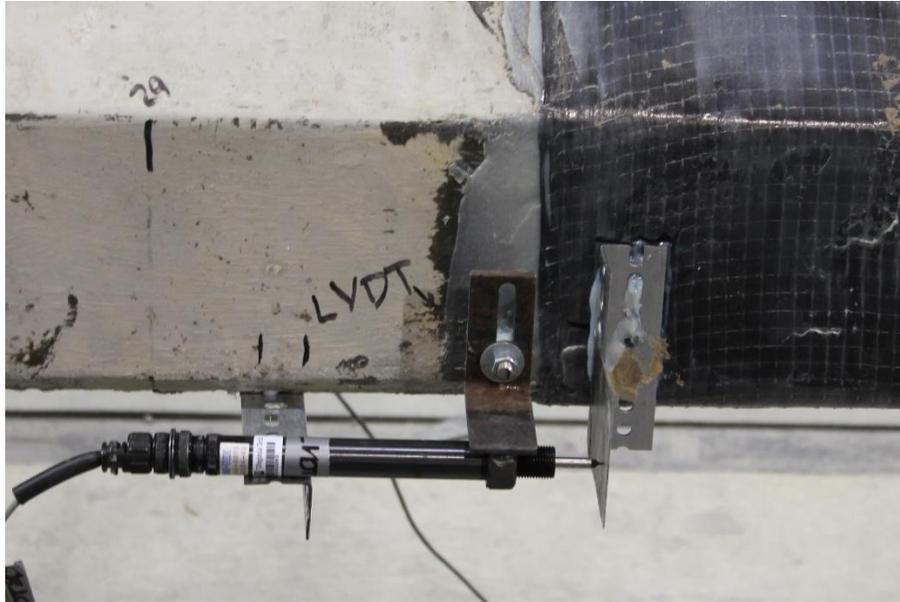
**Figure 62. LVDT at FRP and Concrete Interface**

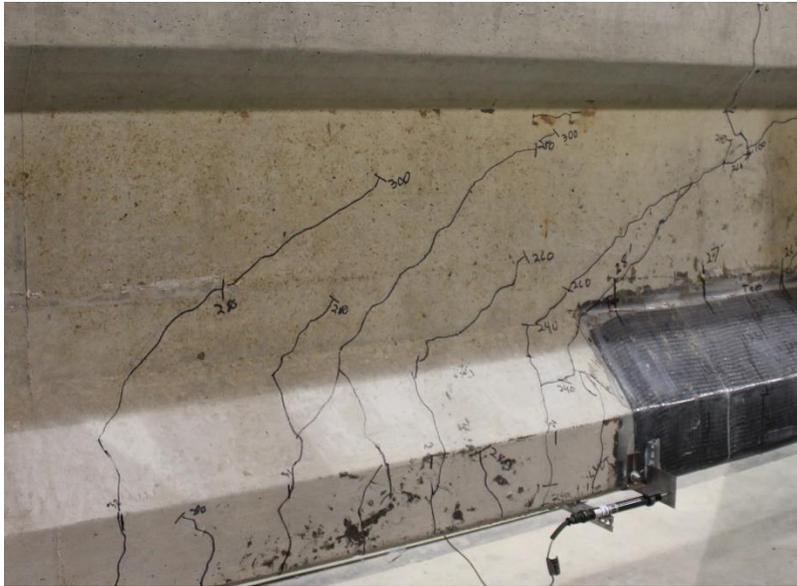
**Figure 63. Shear Cracking in Midspan Region during Iteration 1 (Photo taken by Ioannis Koutromanos, used under fair use 2015)**
