REPAIR OF IMPACT-DAMAGED PRESTRESSED BRIDGE GIRDERS USING  
STRAND SPLICES AND FIBER-REINFORCED POLYMER

Thesis submitted to the faculty of the Virginia Polytechnic Institute and State  
University in partial fulfillment of the requirements for the degree of

Keywords: Prestressed concrete repair, flexural tests, FRP, Strand Splices

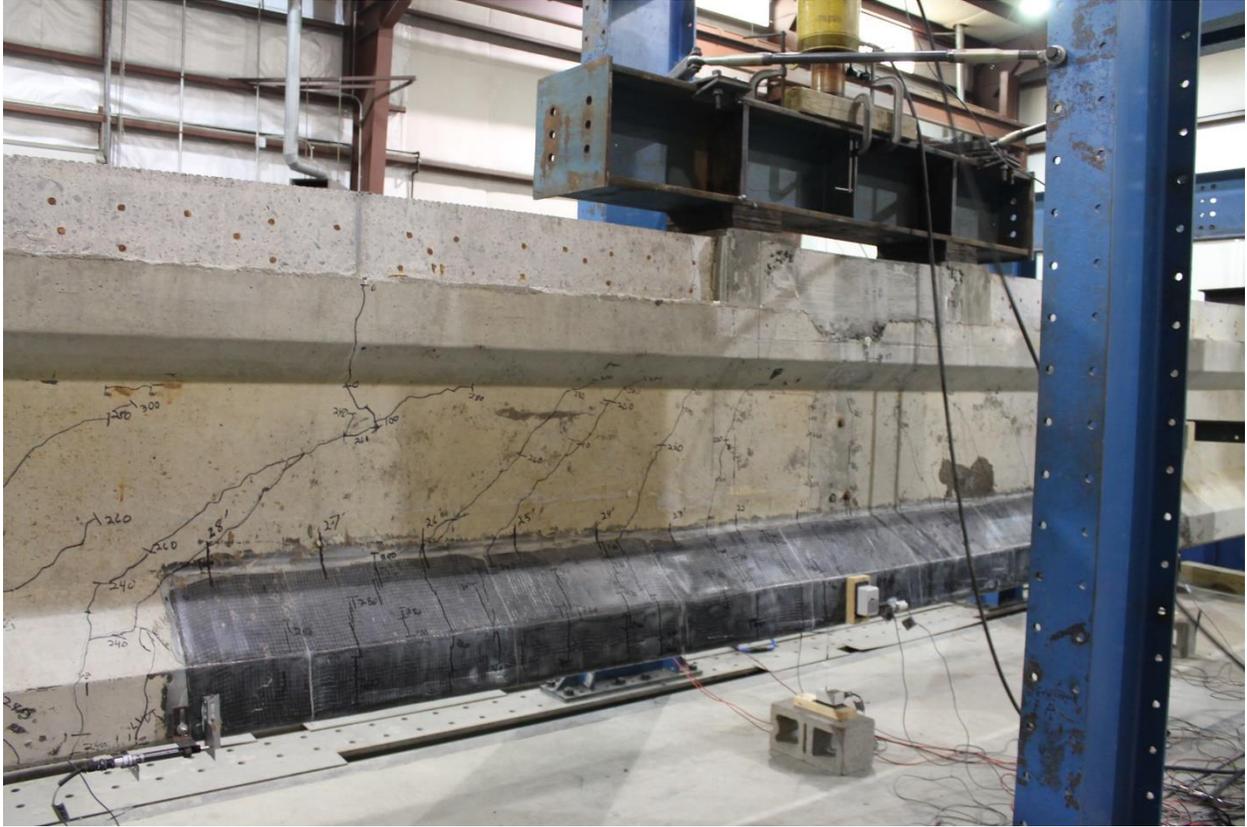
**Figure 64. Cracking Near Peak Load for Iteration 1 (Photo taken by Ioannis Koutromanos, used under fair use 2015)**

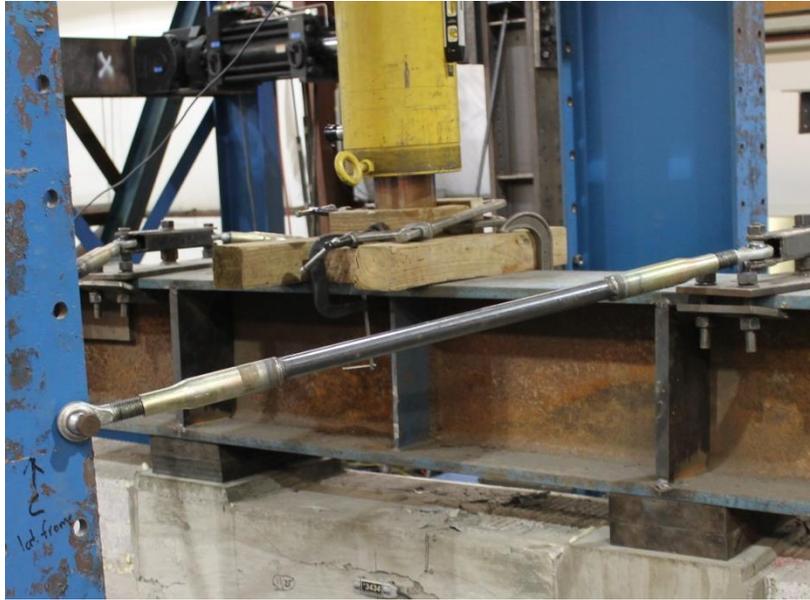
Figure 65. Brace for Actuator (Photo taken by Mark Jones, used under fair use 2015)

longer exerting a consistent vertical force on the girder. A frame to hold the actuator level used in the second iteration of Test 4 was used to try to keep the actuator from slipping. The frame is shown in Figure 65. After the third attempt to load the girder to failure, the concrete in the constant moment region between the load points showed evidence indicating a flexural compression failure similar to Test 4 and the test was determined to be complete.

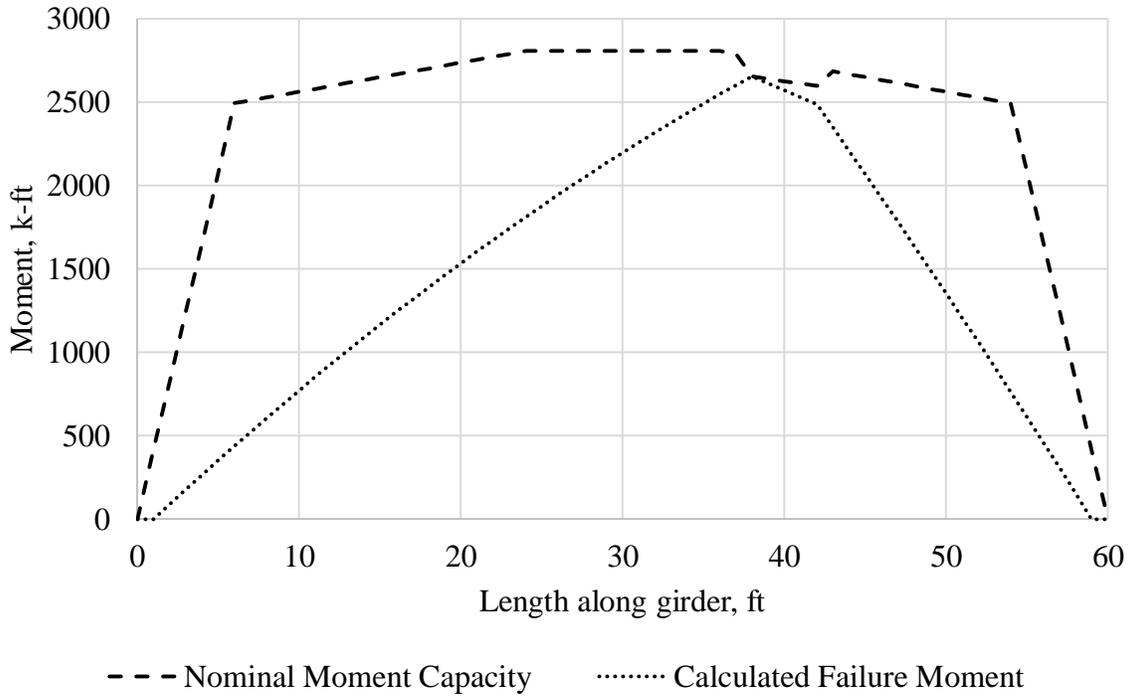
**Figure 66. Nominal Moment Capacity versus Calculated Failure Moment for Test 4, Iteration 1**

The nominal moment capacity of this girder at the points of load application was 2660 k-ft. This corresponds to a load of 187 kips for iteration 1 and 216 kips for iteration 2. Figure 66 shows the nominal moment capacity of Girder C and the maximum calculated moment resulting from a load of 187 kips for iteration 1. Figure 68 shows the nominal moment capacity of Girder C and the maximum calculated moment resulting from a load of 216 kips. Figure 67 shows the absolute values of the nominal shear capacity of Girder B and the maximum calculated shear force resulting from a load of 187 kips. Figure 69 shows the absolute values of the nominal shear capacity of Girder B and the maximum calculated shear force resulting from a load of 216 kips. Other loading arrangements were investigated, however this loading arrangement was chosen to minimize the potential for a shear failure since the desired failure mode was flexural. In addition, it minimized the potential for slipping from the actuator (Jones, 2015).

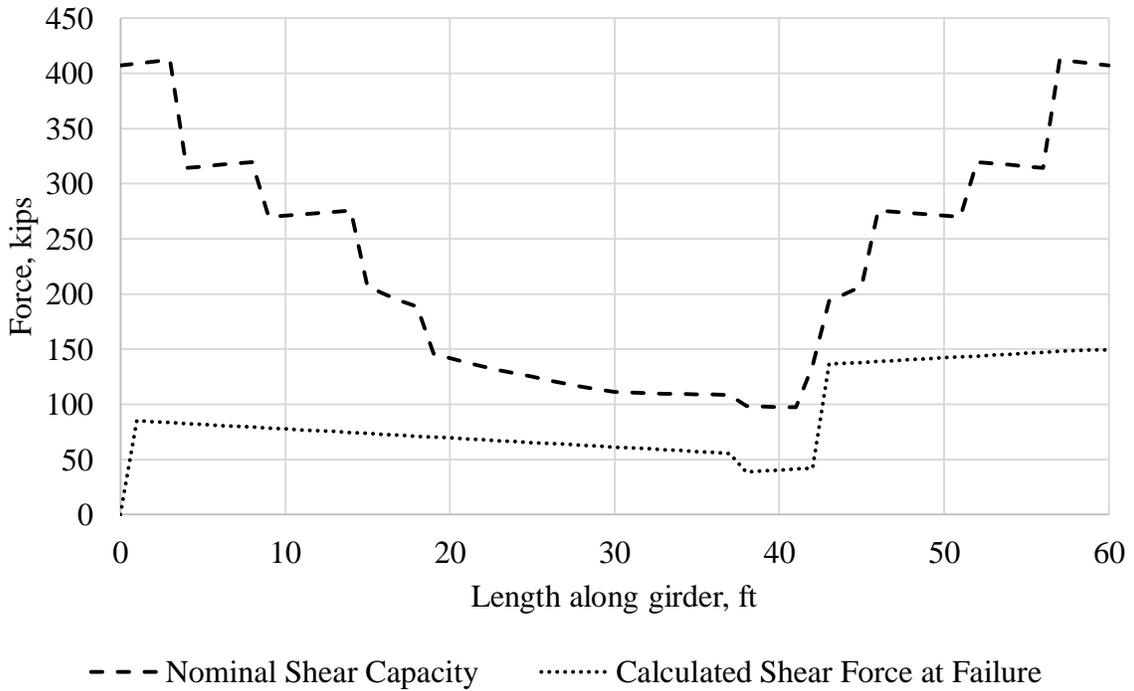
**Figure 67. Nominal Shear Capacity versus Calculated Shear for Test 4, Iteration 1**

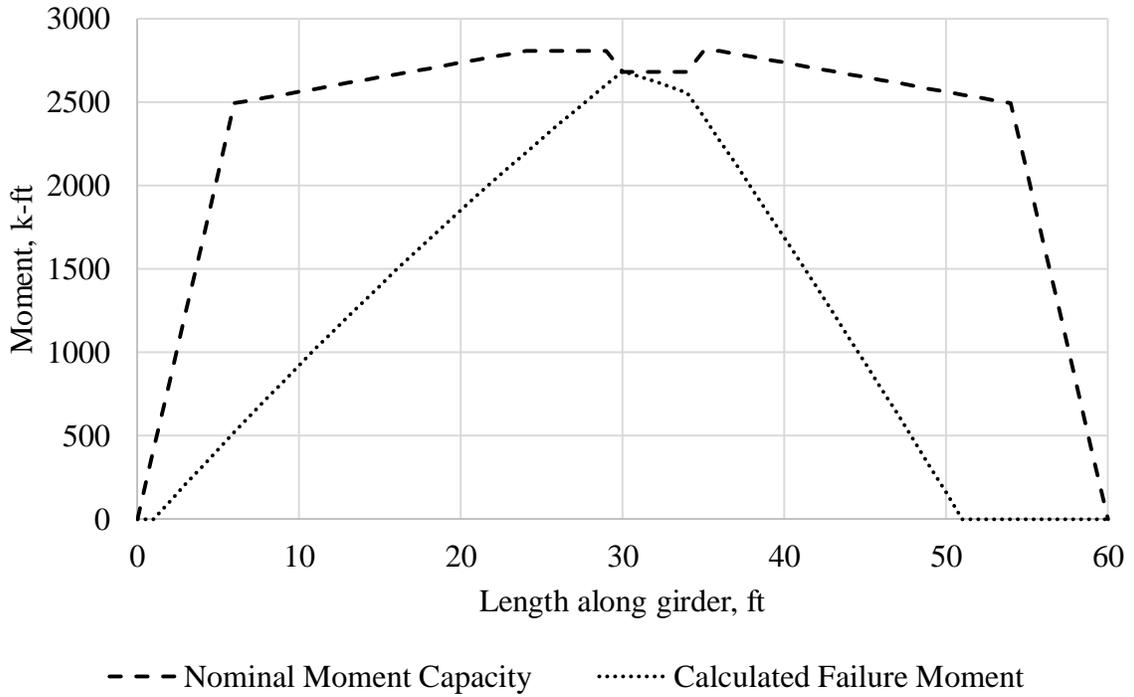
**Figure 68. Nominal Moment Capacity versus Calculated Failure Moment for Test 4, Iteration 2**

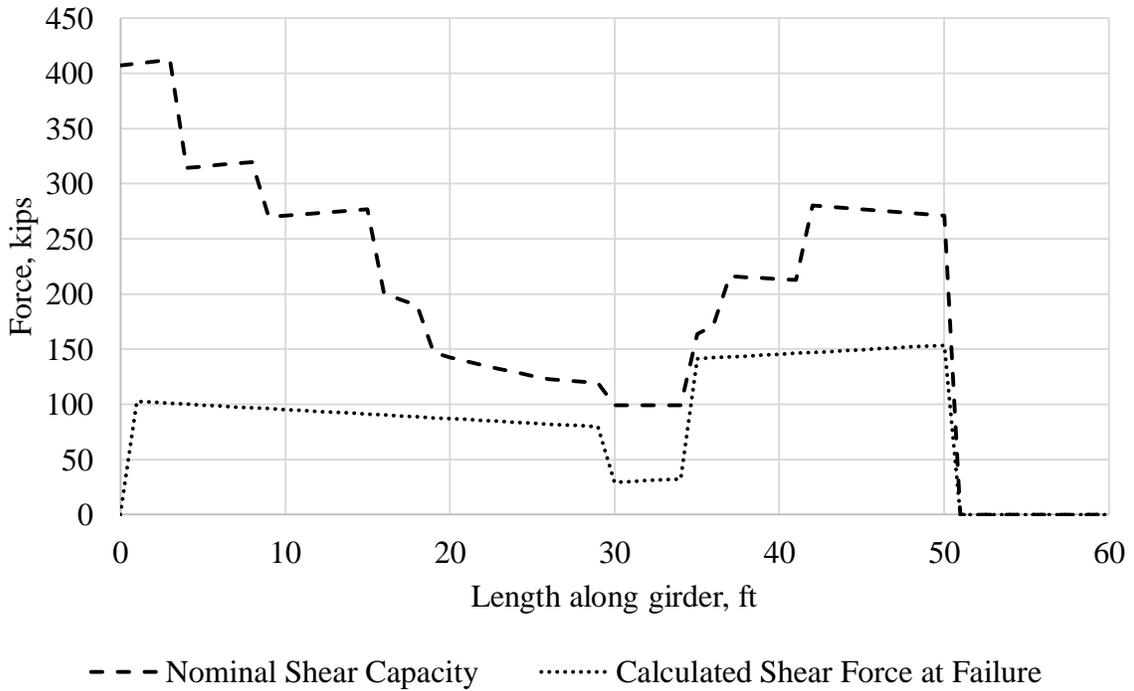
**Figure 69. Nominal Shear Capacity versus Calculated Shear for Test 4, Iteration 2**

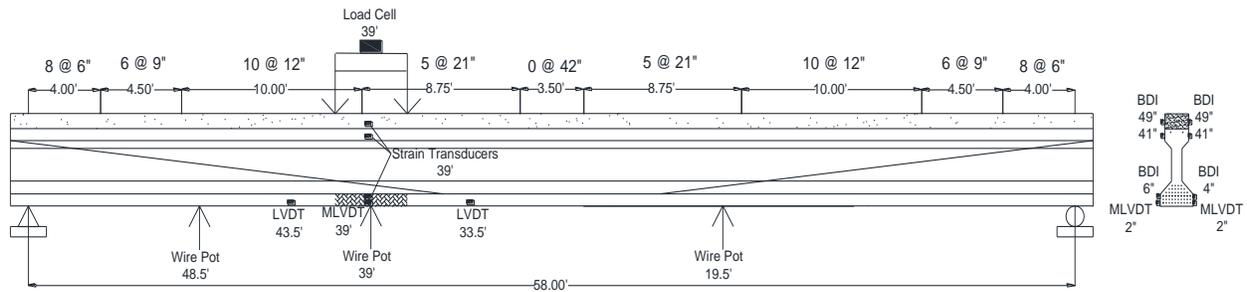
**Figure 73. Test 4, Iteration 1 Set-up and Instrumentation Plan**

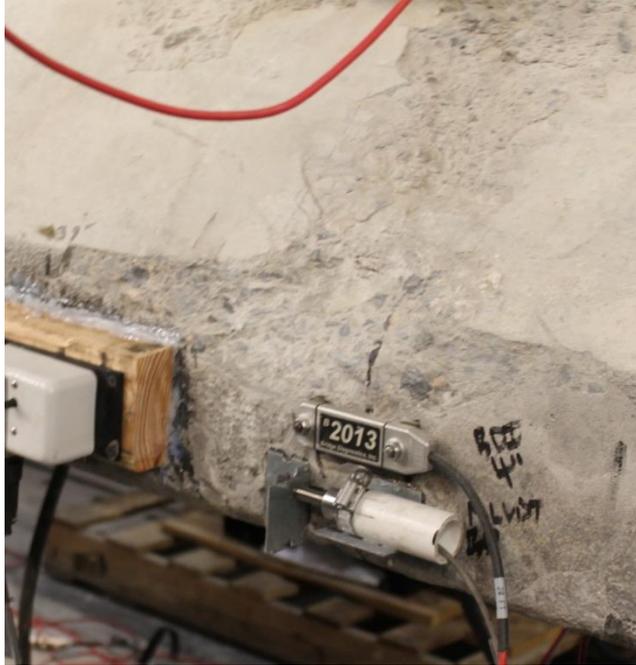
**Figure 75. Damage on Girder near Strain Transducer Location (Photo taken by Ioannis Koutromanos, used under fair use 2015)**

allow them to be placed directly across from each other. The damage is shown in Figure 75. The set-up of the strain transducers is shown in Figure 76. Four LVDT strain gauges were placed at the repair interface. One was placed on each end of the repair with one on the opposite side of the girder. The two on the undamaged side were used to compare the strain at the interface to indicate any slipping between the new and the old concrete. A 400 kip load cell was placed between the actuator and the load frame to measure the applied load.

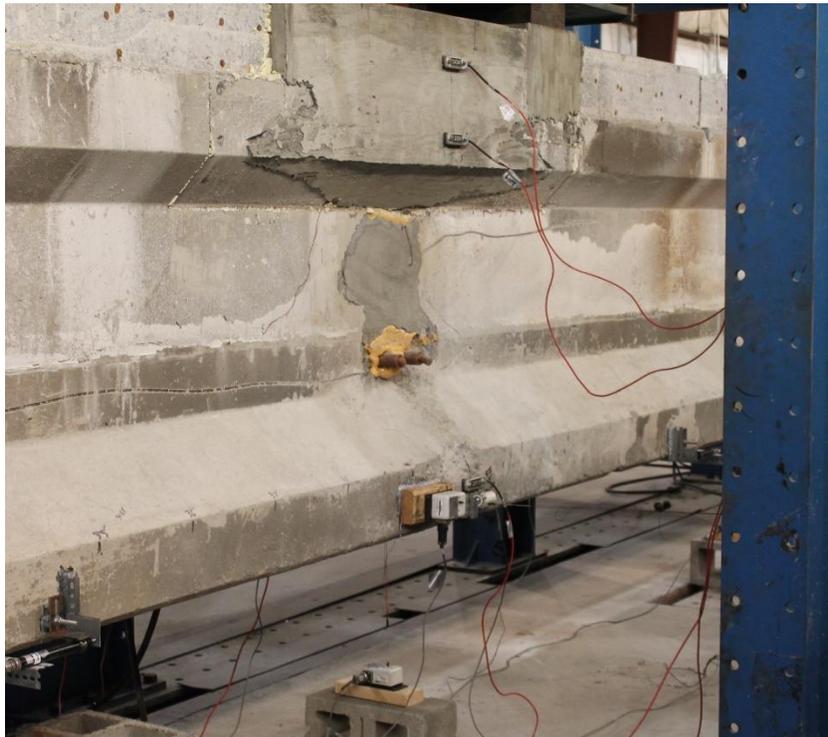
**Figure 76. Strain Transducer Set-up Below Load Point**

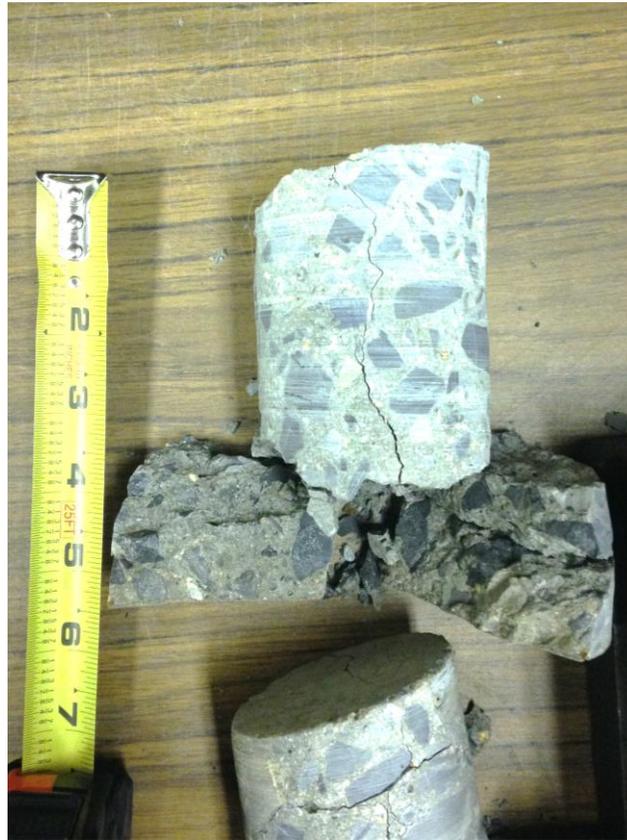
**Figure 77. Girder Concrete Tensile Test**

Cylinder #	Load (lbs)	Diameter (in)	Length (in)	Strength (psi)	Average (psi)
5	7,500	2.75	4.50	386	424
6	10,000	2.75	5.00	463

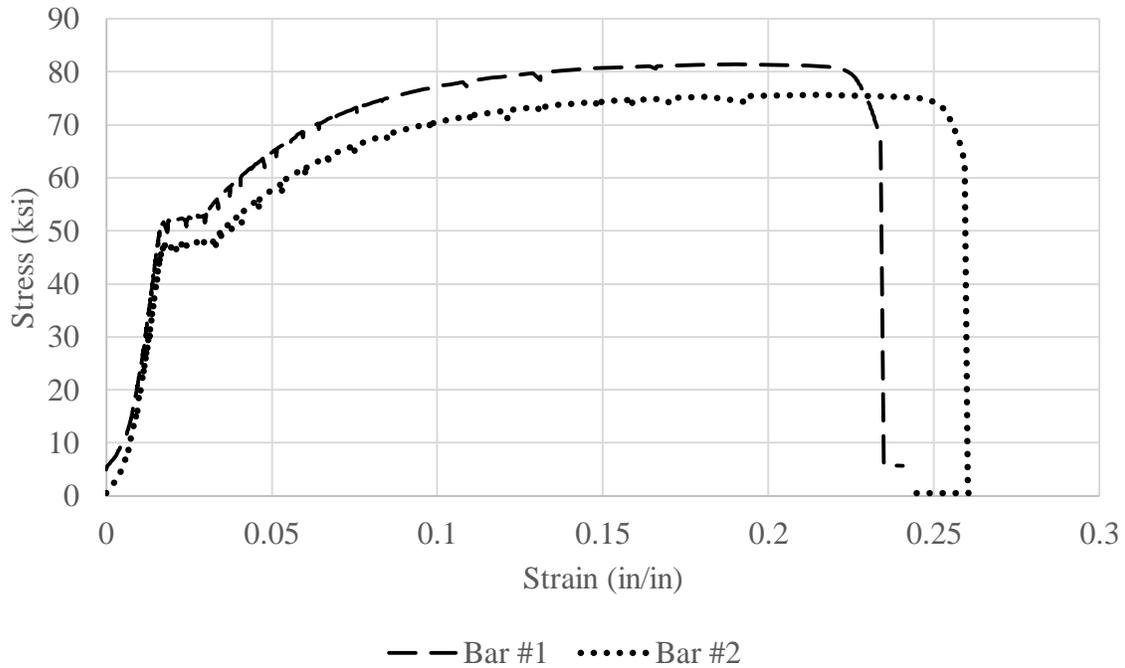
Figure 78. Reinforcing Bar Stress Strain Relationship

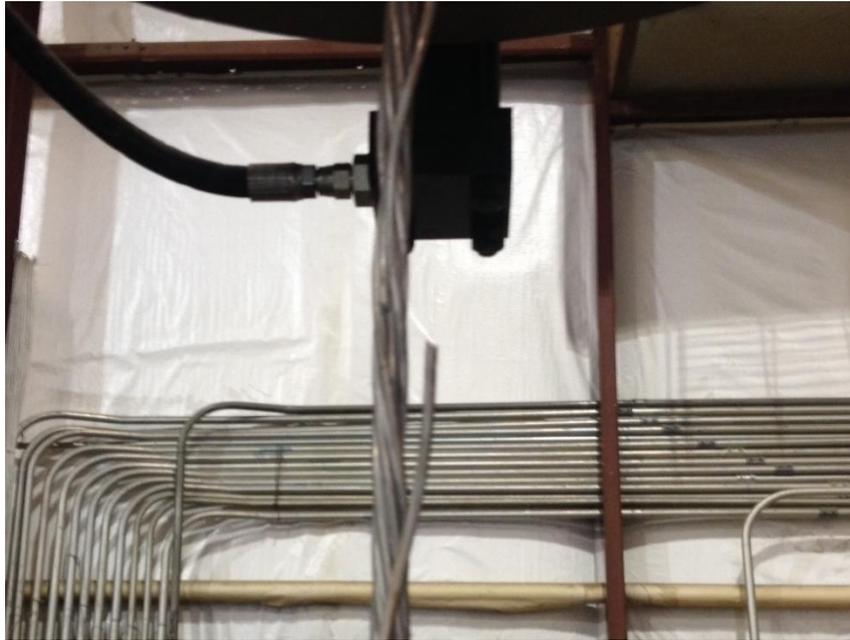
**Figure 79. Prestress Tensile Test Strand Rupture (Photo taken by Mark Jones, used under fair use 2015)**

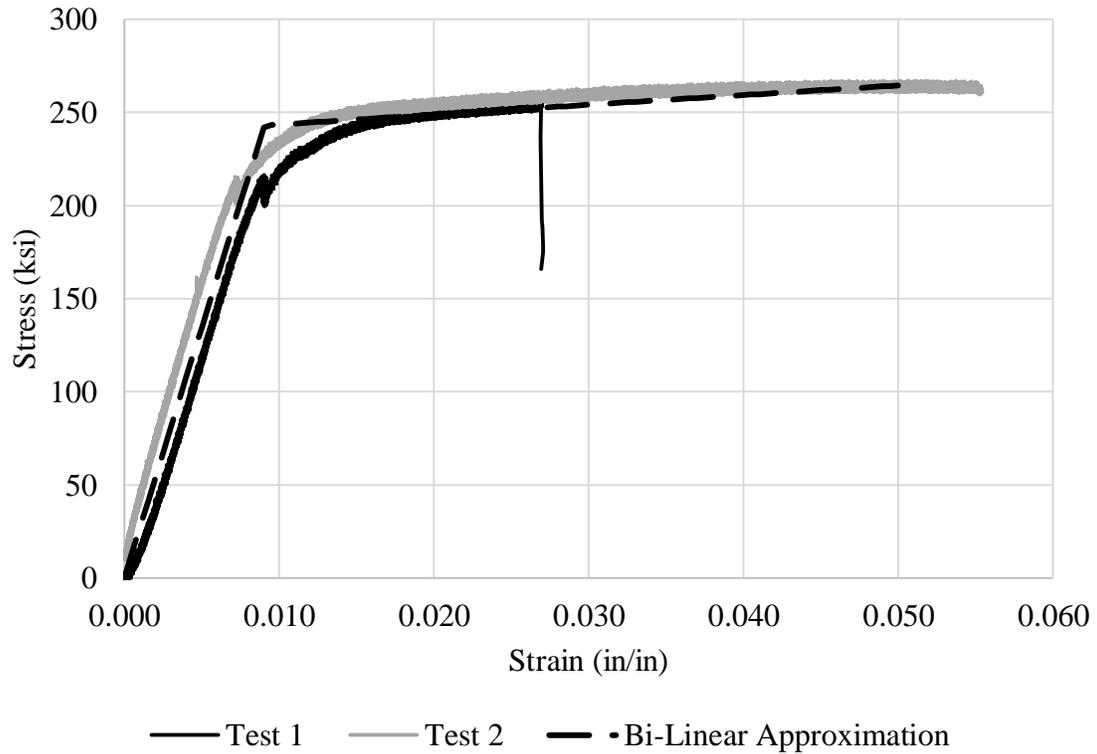
**Figure 81. Prestress Steel Stress - Strain Relationship Gangi, M. (2015). Nonlinear Beam Modeling of the Repair of Impact-Damaged Prestressed Bridge Girders. Virginia Polytechnic and State University, Department of Civil and Environmental Engineering. Blacksburg: Virginia Center for Transportation Innovation and Research, Used under fair use, 2015**

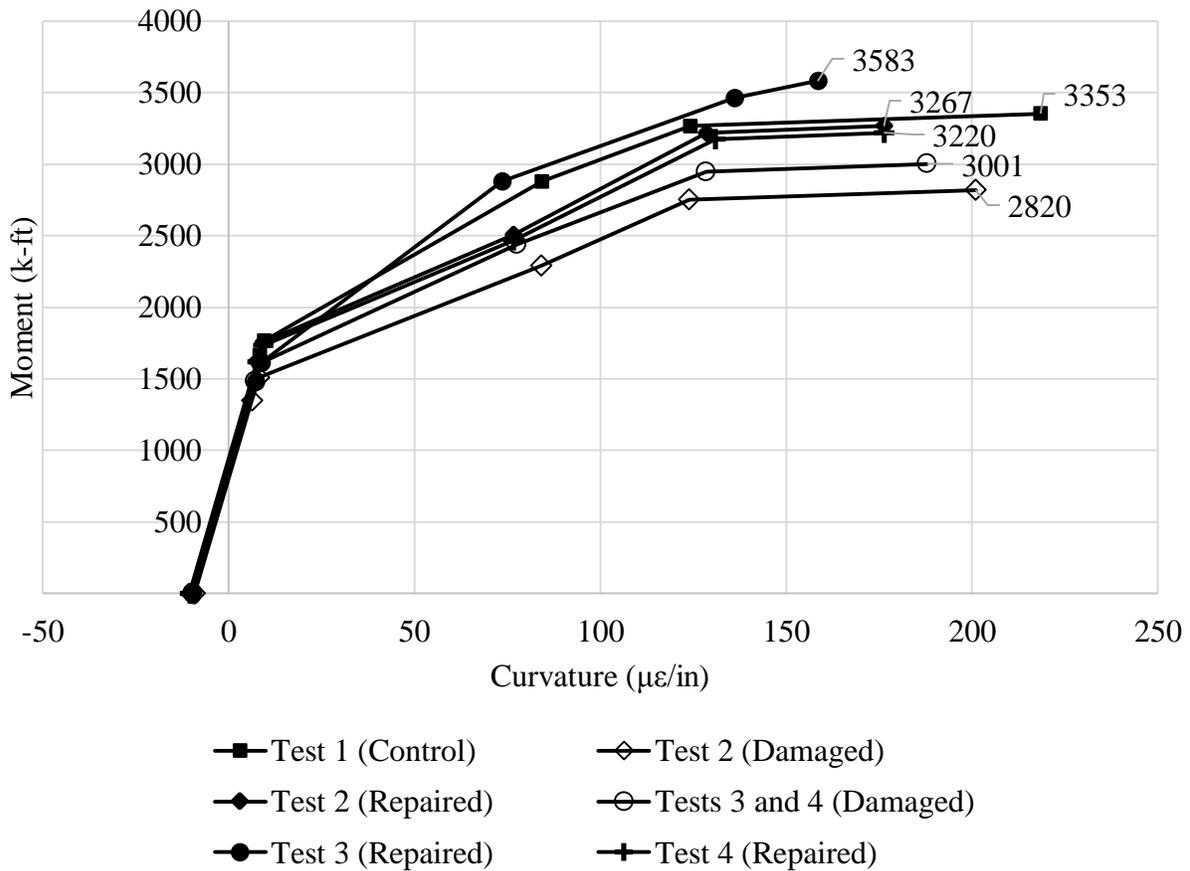
Figure 82. Calculated Moment-Curvature Behavior

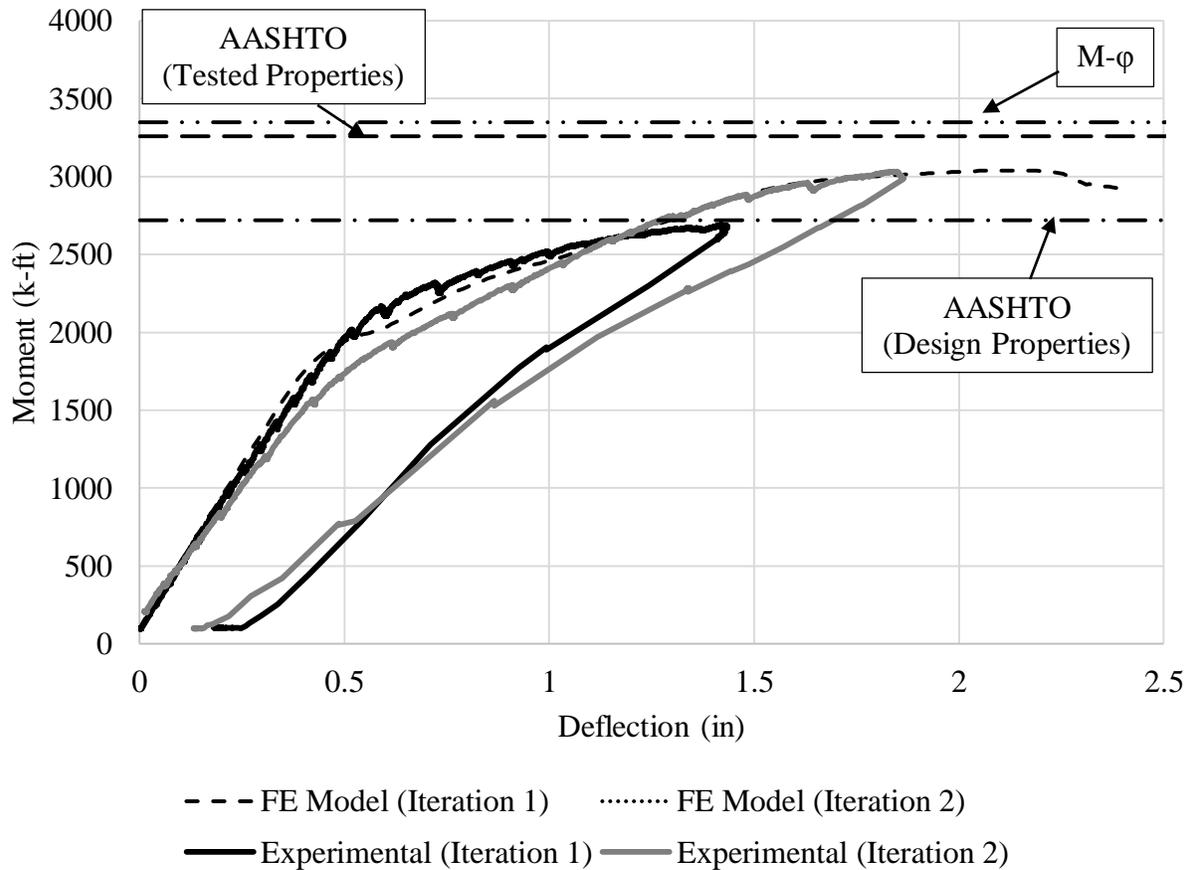
**Figure 83. Test 1 Moment Deflection Behavior**

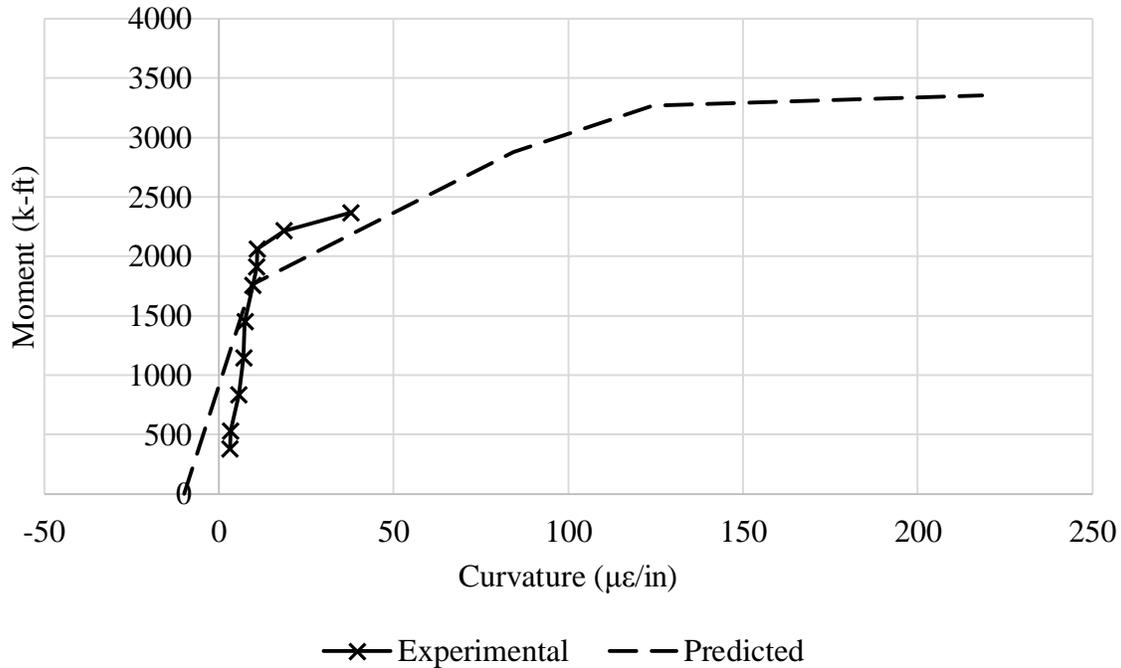
Figure 84. Test 1 Moment-Curvature Relationship

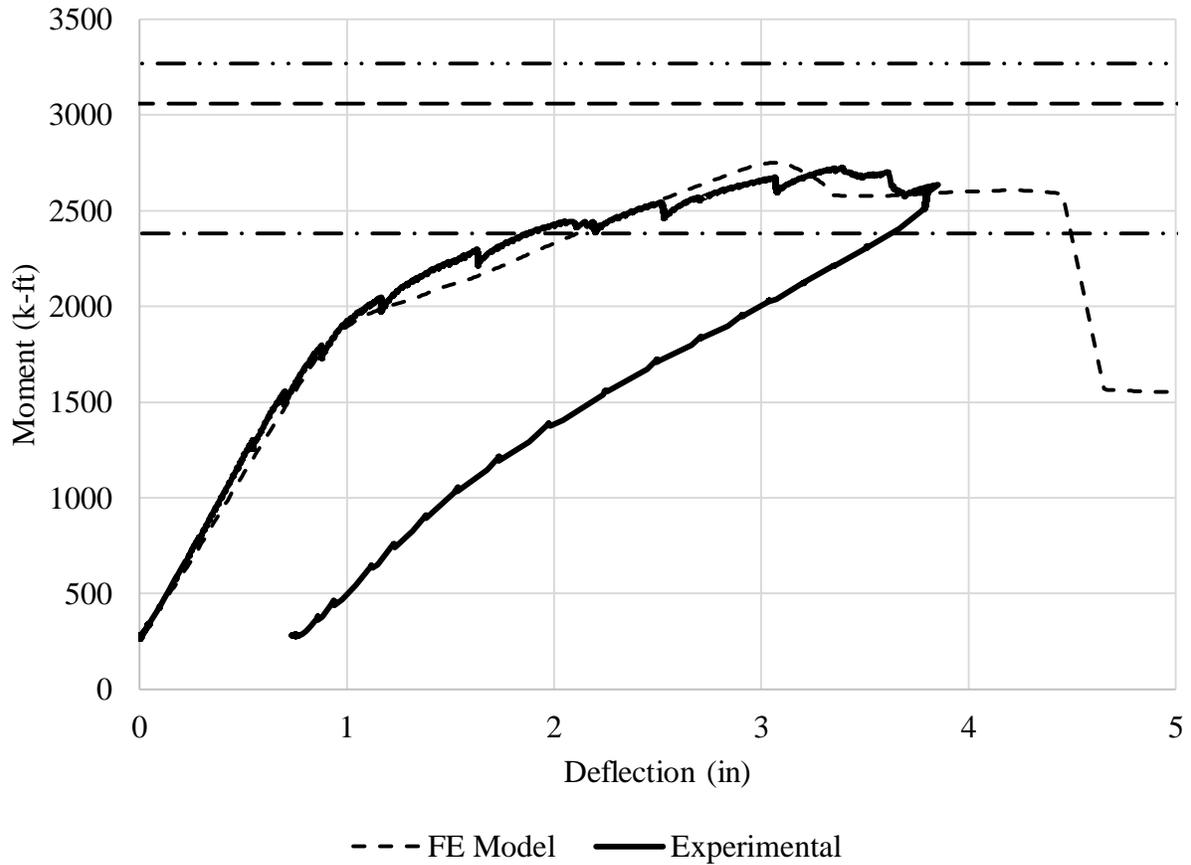
Figure 85. Test 2 Moment Deflection Behavior

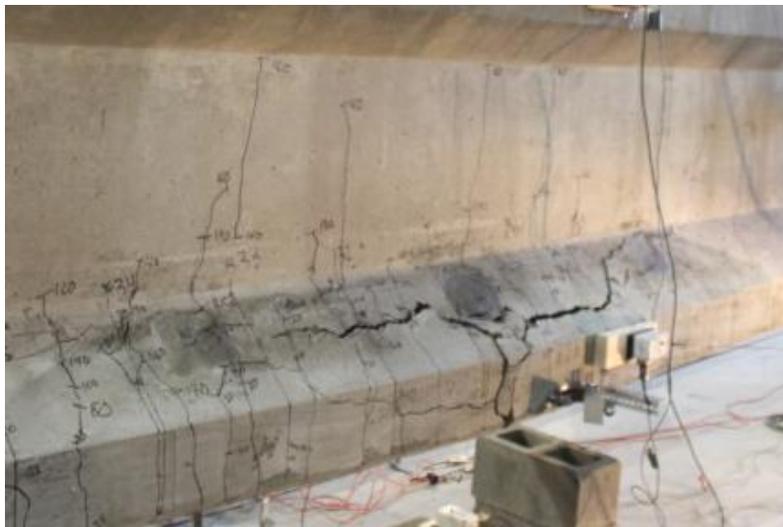
**Figure 86. Flexural Cracks in Patch Concrete near Failed Strand Splice (Photo taken by Ioannis Koutromanos, used under fair use 2015)**

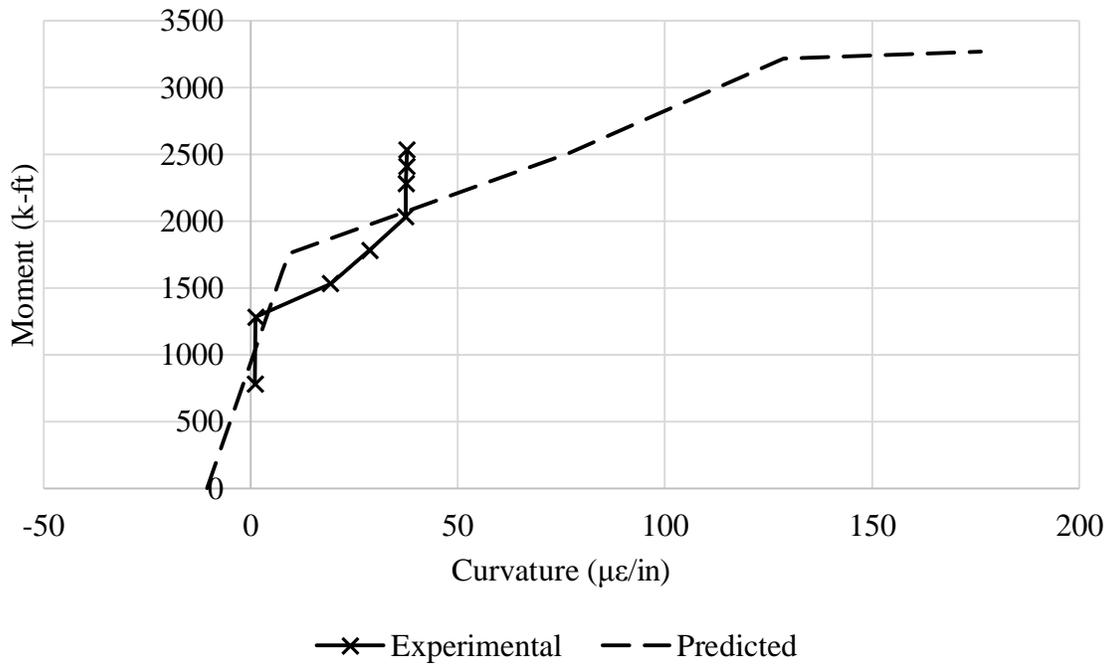
**Figure 87. Test 2 Moment-Curvature Relationship**

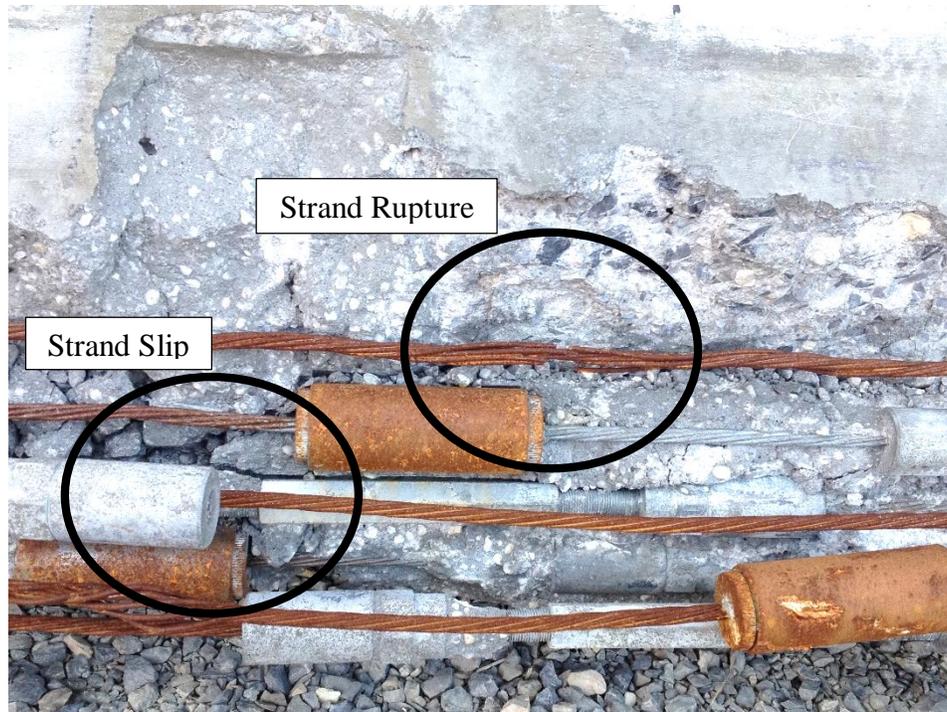
**Figure 88. Test 2 Failed Splice and Ruptured Strand (Photo taken by Mark Jones, used under fair use 2015)**

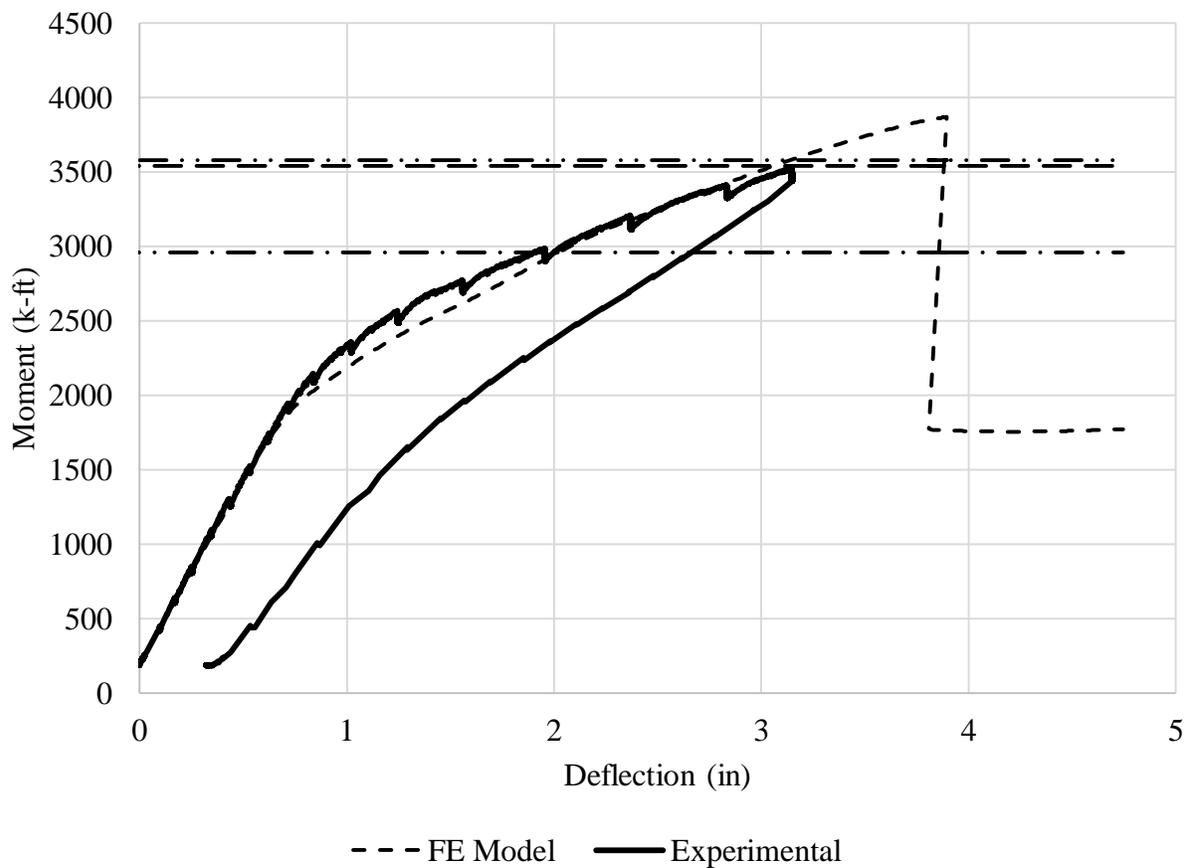
**Figure 89. Test 3 Moment Deflection Behavior**

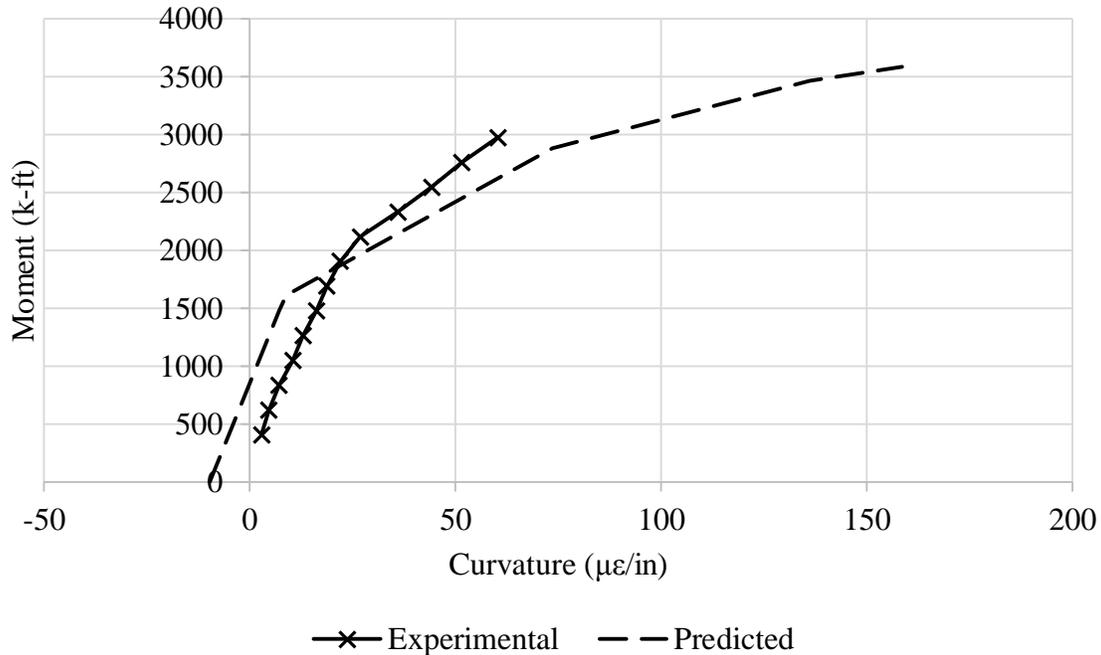
**Figure 90. Test 3 Moment-Curvature Relationship**

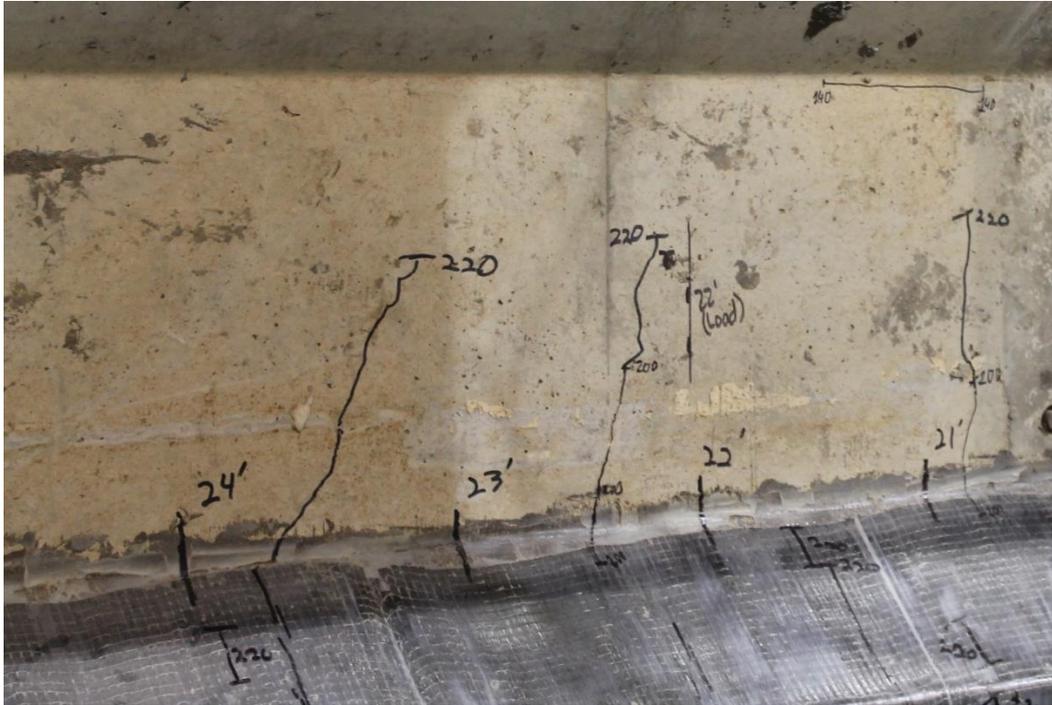
Figure 91. Crack Propagation from FRP into Web (Photo taken by Ioannis Koutromanos, used under fair use 2015)

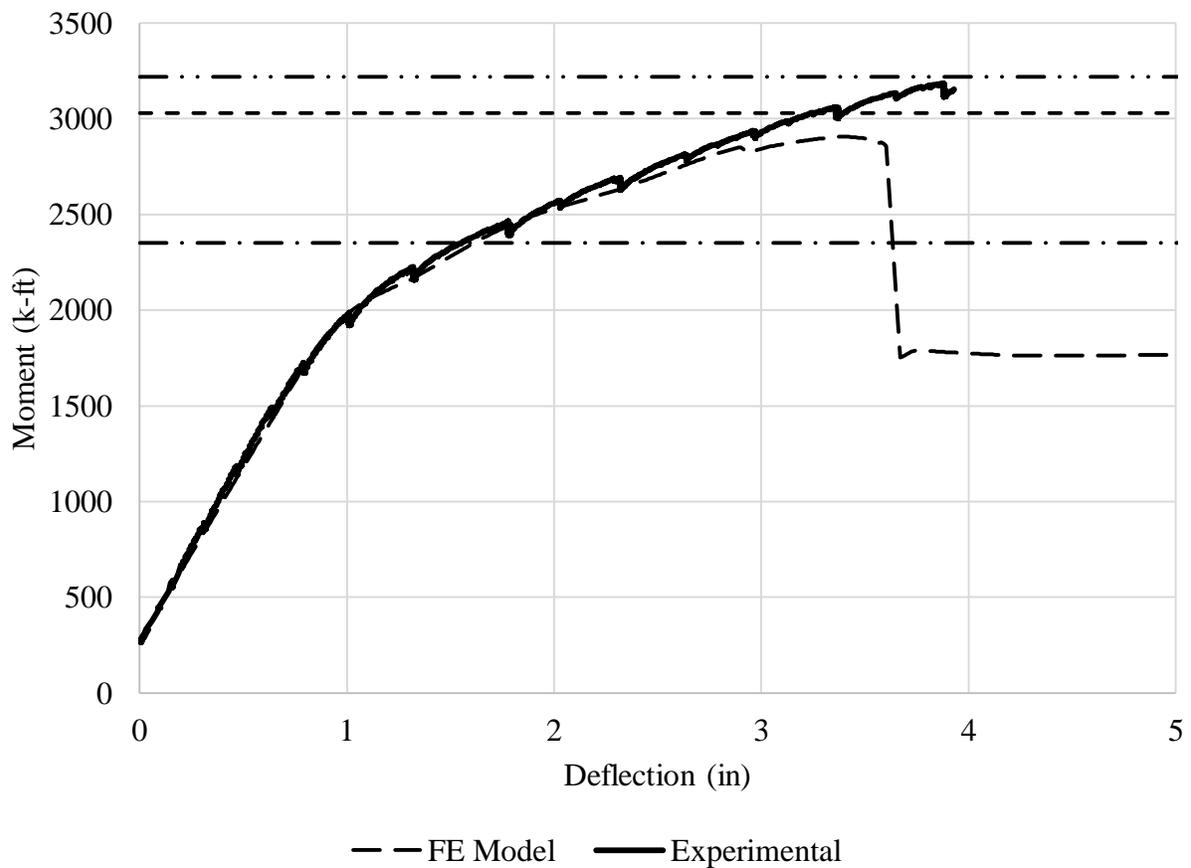
**Figure 92. Test 4, Iteration 1 Moment Deflection Behavior**

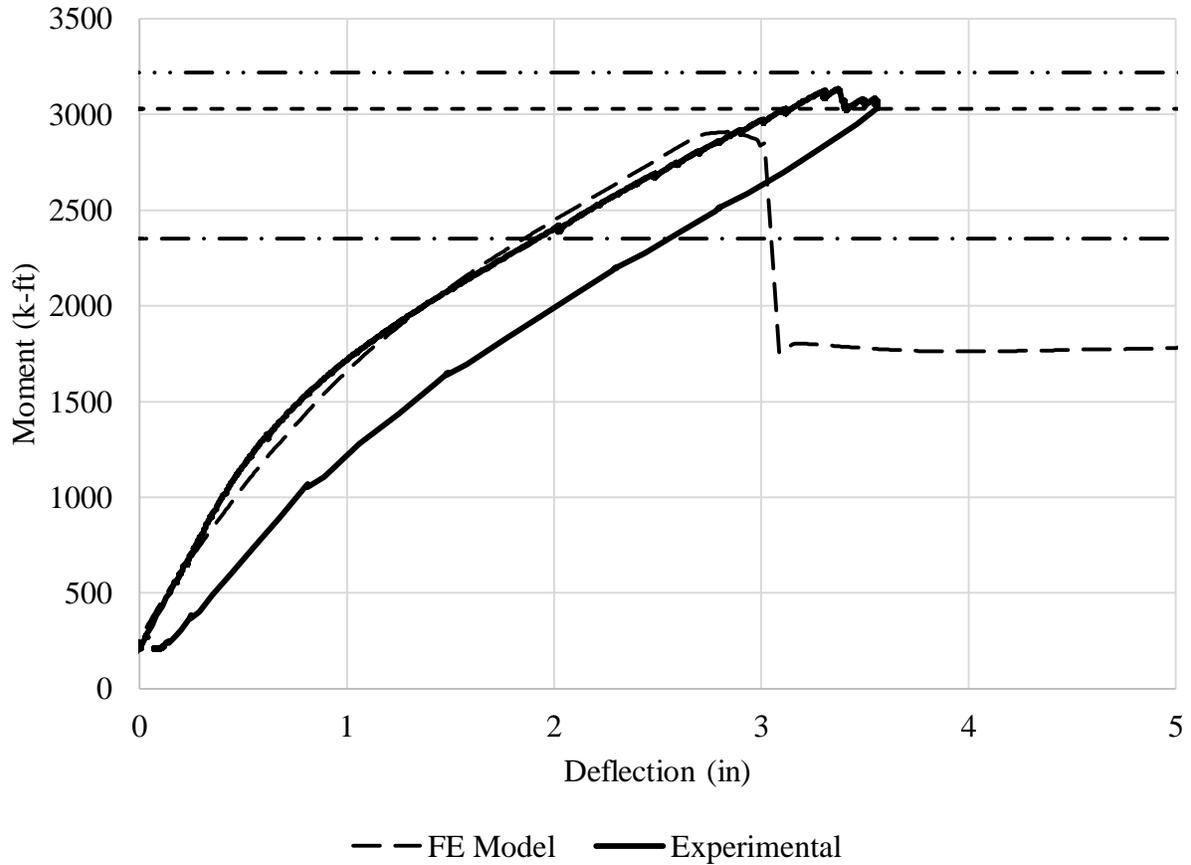
**Figure 93. Test 4, Iteration 2 Moment Deflection Behavior**

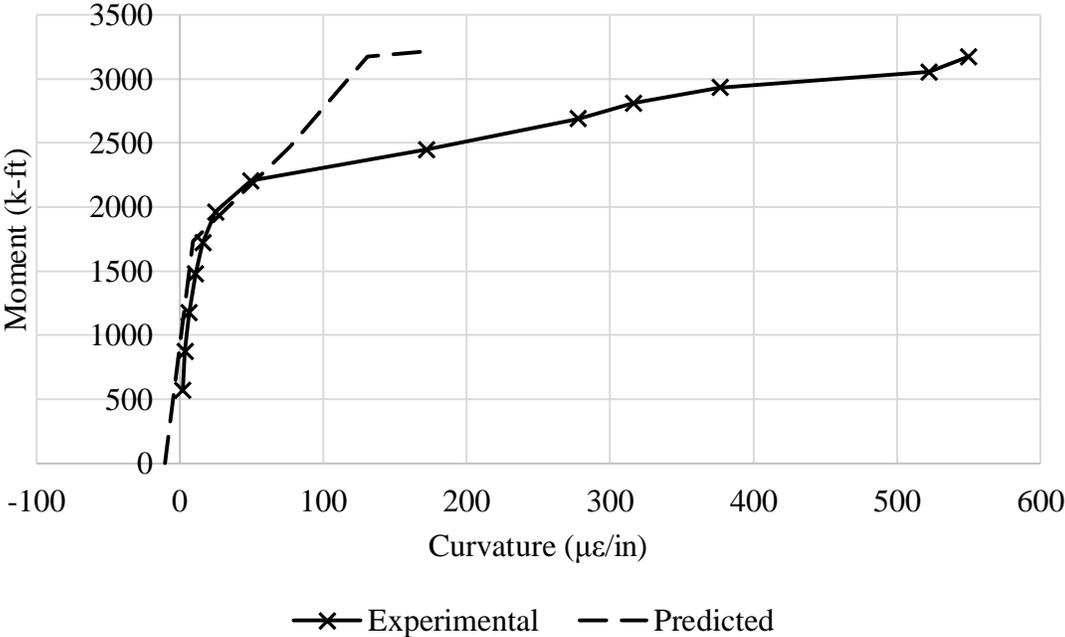
**Figure 94. Test 4 Moment-Curvature Relationship**

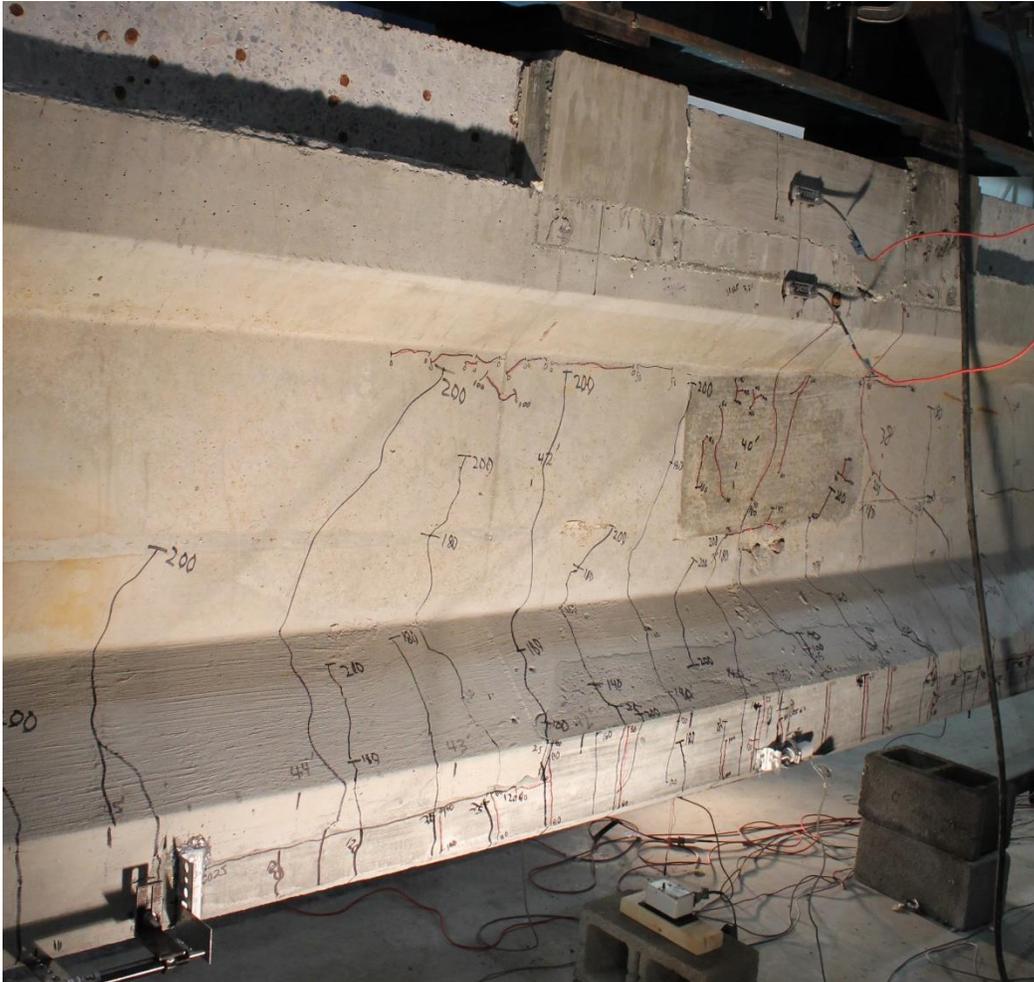
**Figure 95. Cracking Pattern at Load Point at Final Load for Iteration 1 (Photo taken by Ioannis Koutromanos, used under fair use 2015)**

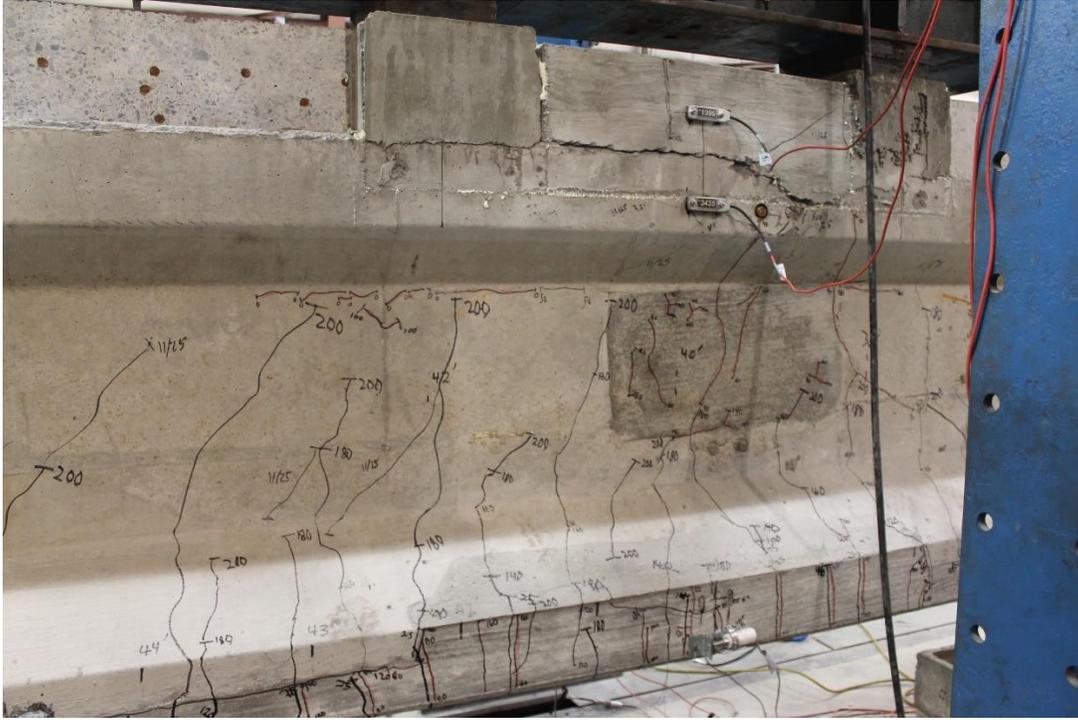
**Figure 96. Cracking Patterns near Maximum Applied Load (Photo taken by Ioannis Koutromanos, used under fair use 2015)**
