REPAIR OF IMPACT-DAMAGED PRESTRESSED BRIDGE GIRDERS USING  
STRAND SPLICES AND FIBER-REINFORCED POLYMER

Thesis submitted to the faculty of the Virginia Polytechnic Institute and State  
University in partial fulfillment of the requirements for the degree of

Keywords: Prestressed concrete repair, flexural tests, FRP, Strand Splices

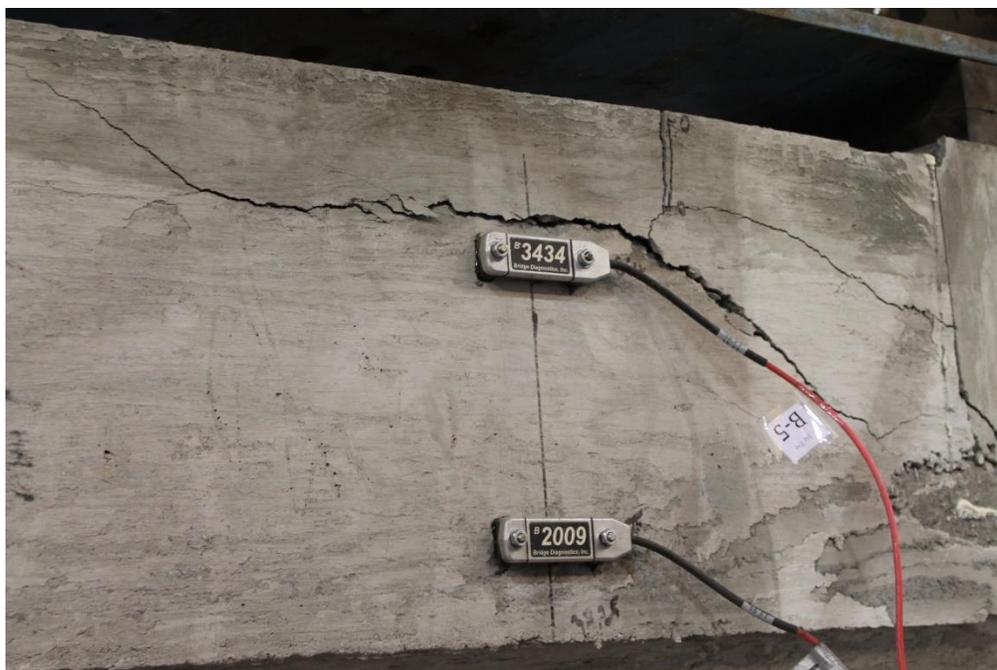
**Figure 97. Flexural Compression Failure in the Deck (Photo taken by Ioannis Koutromanos, used under fair use 2015)**

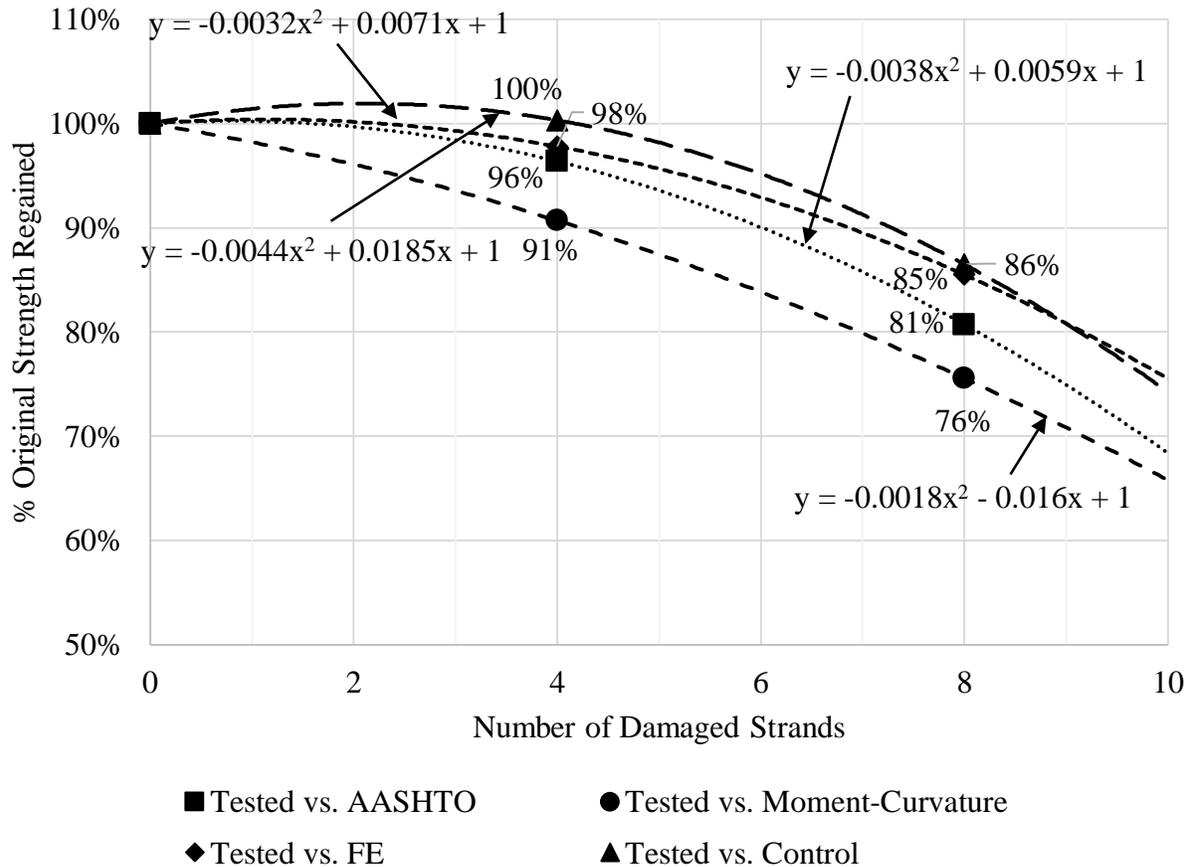
Figure 98. Strand Splice Strength Regenerated Trend Lines

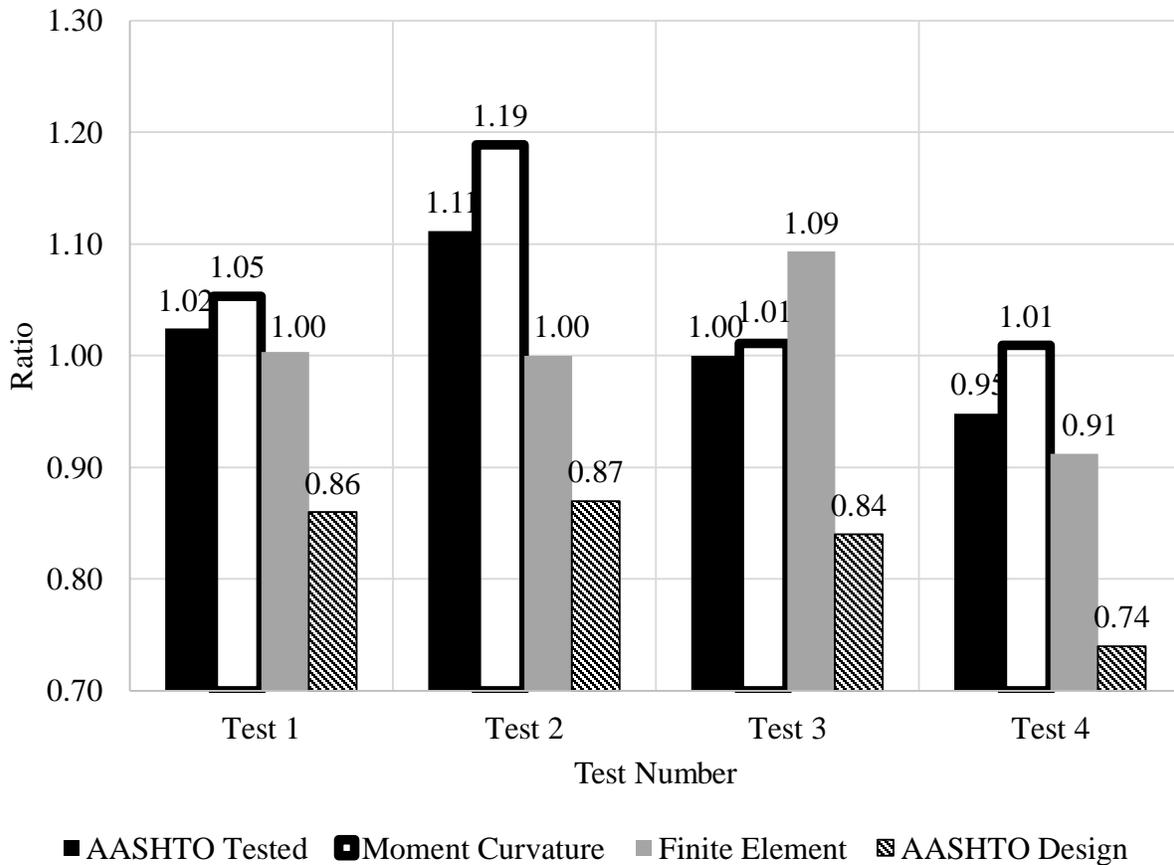
**Figure 99. Nominal to Tested Ratio**

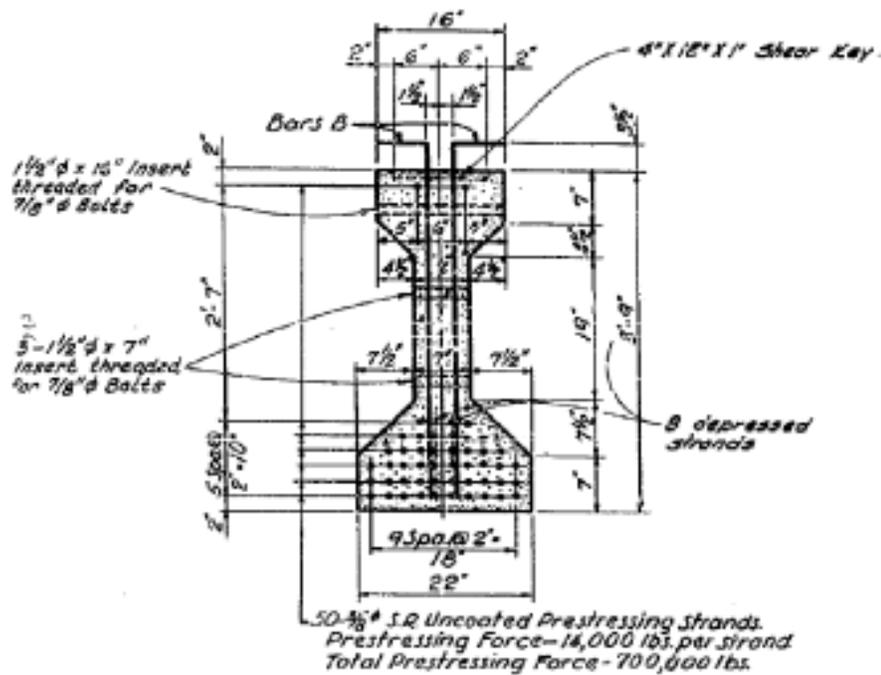
Figure 1 - AASHTO Type III Girder

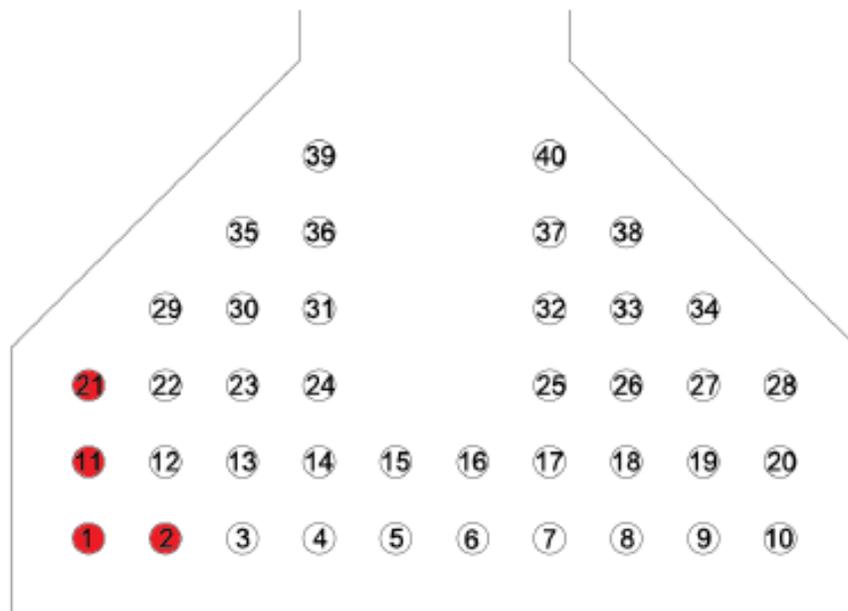
## Damaged Girder - Composite Section Transformed Properties
