# **Long-Term In-Service Evaluation of Two Bridges Designed with Fiber-Reinforced Polymer Girders**

Thesis submitted to the Faculty of the  
Virginia Polytechnic Institute and State University  
in partial fulfillment of the requirements for the degree of

Master of Science  
In  
Civil Engineering

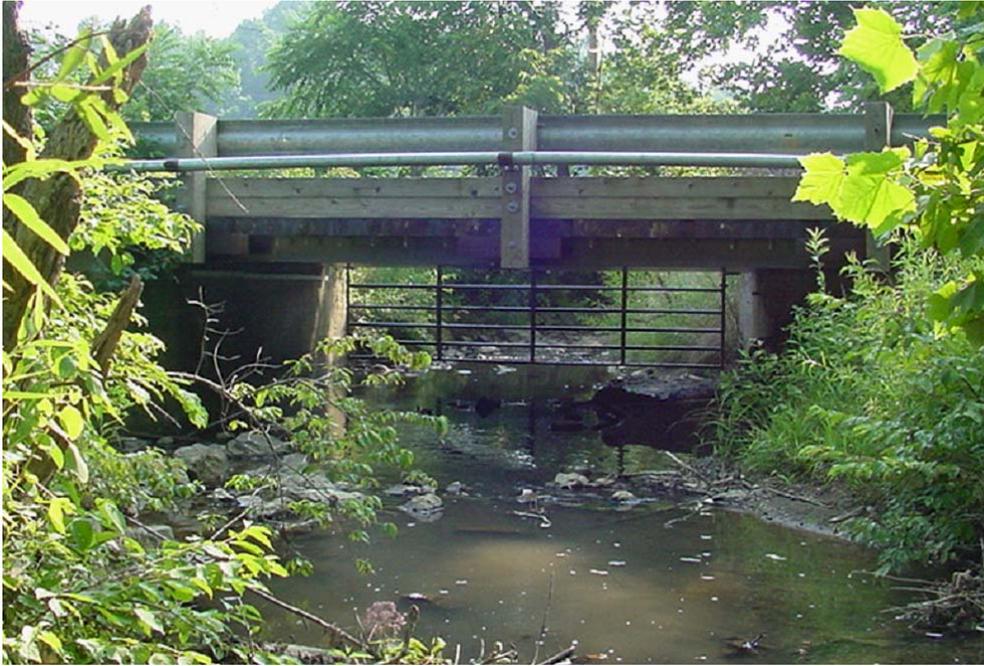
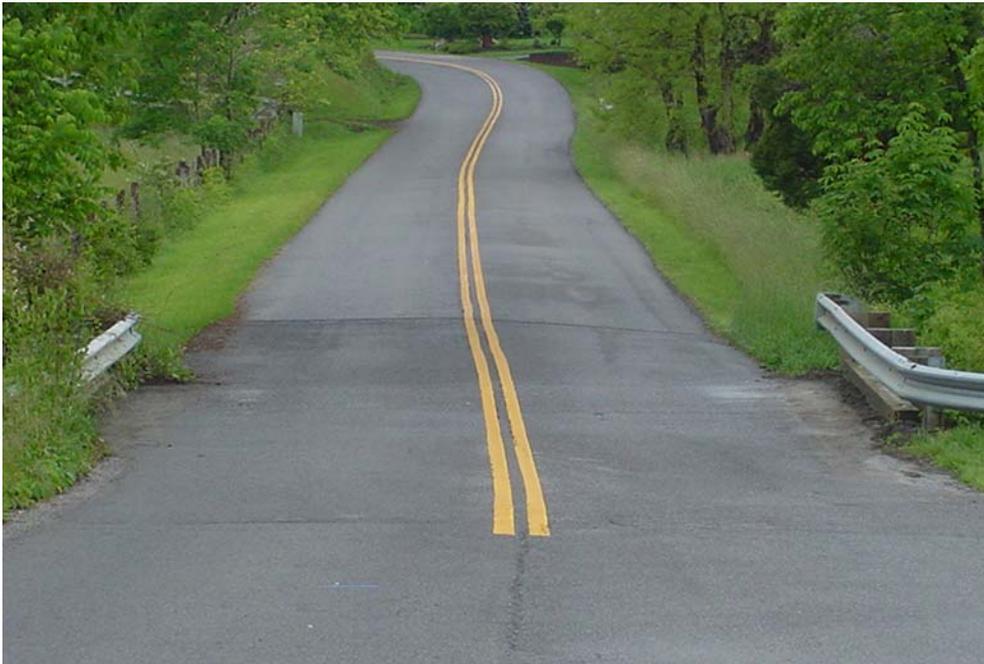
**Figure 1-1.** View of the Toms Creek Bridge looking (a) at the upstream elevation, and (b) toward the northbound approach.

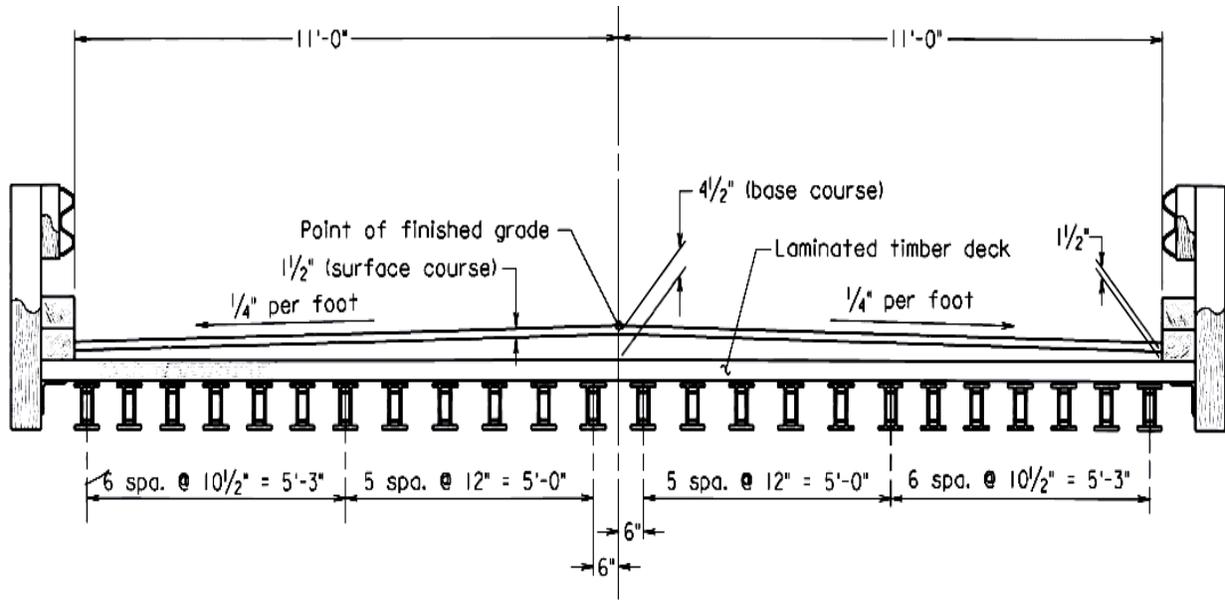
**Figure 1-2.** Toms Creek Bridge cross-section (Neely, 2000).

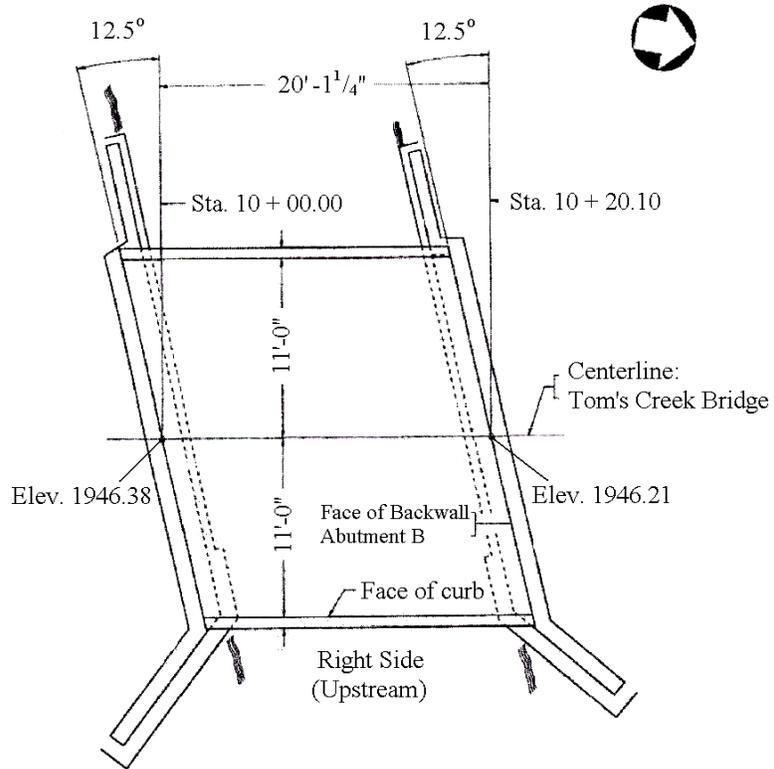
**Figure 1-4.** Plan view of the Toms Creek Bridge (Neely, 2000).

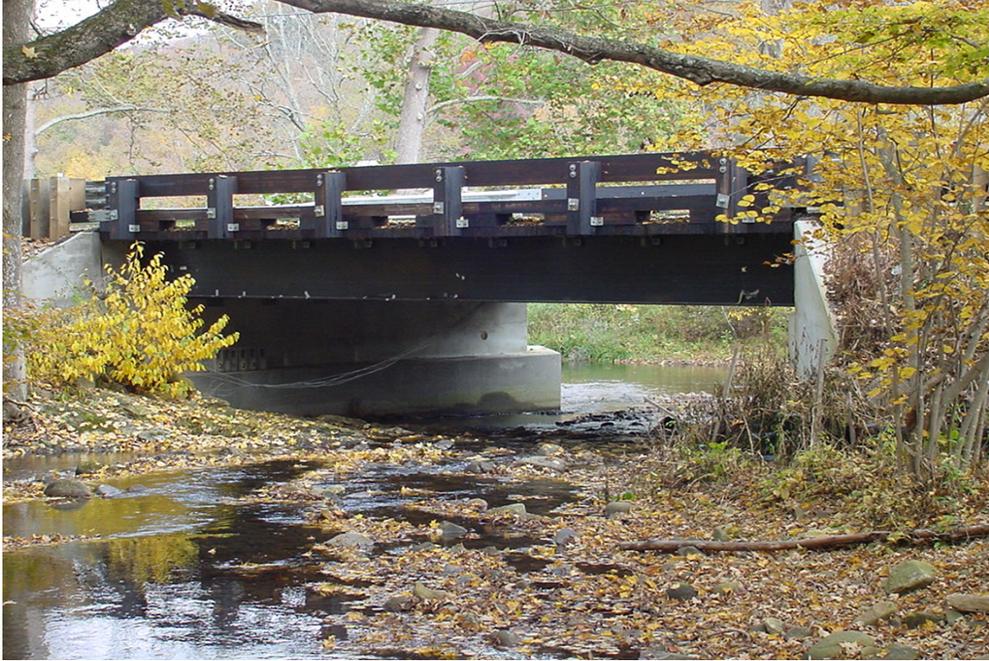
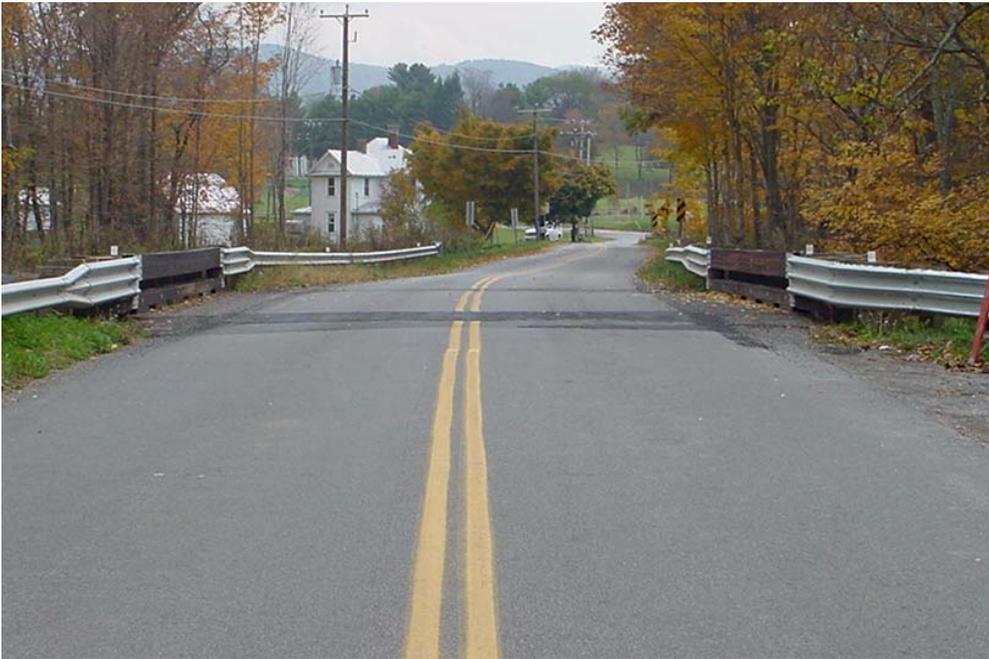
**Figure 1-6.** View of the Route 601 Bridge, looking (a) at the upstream elevation, and (b) toward the eastbound approach.

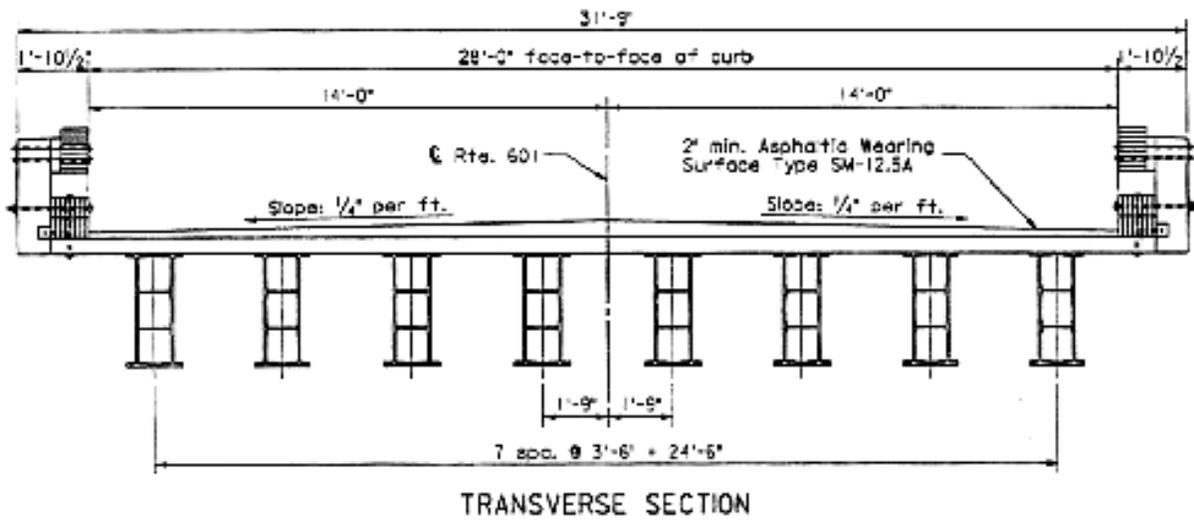
Figure 1-7. Cross-sectional view of the Route 601 Bridge (Restrepo, 2002).

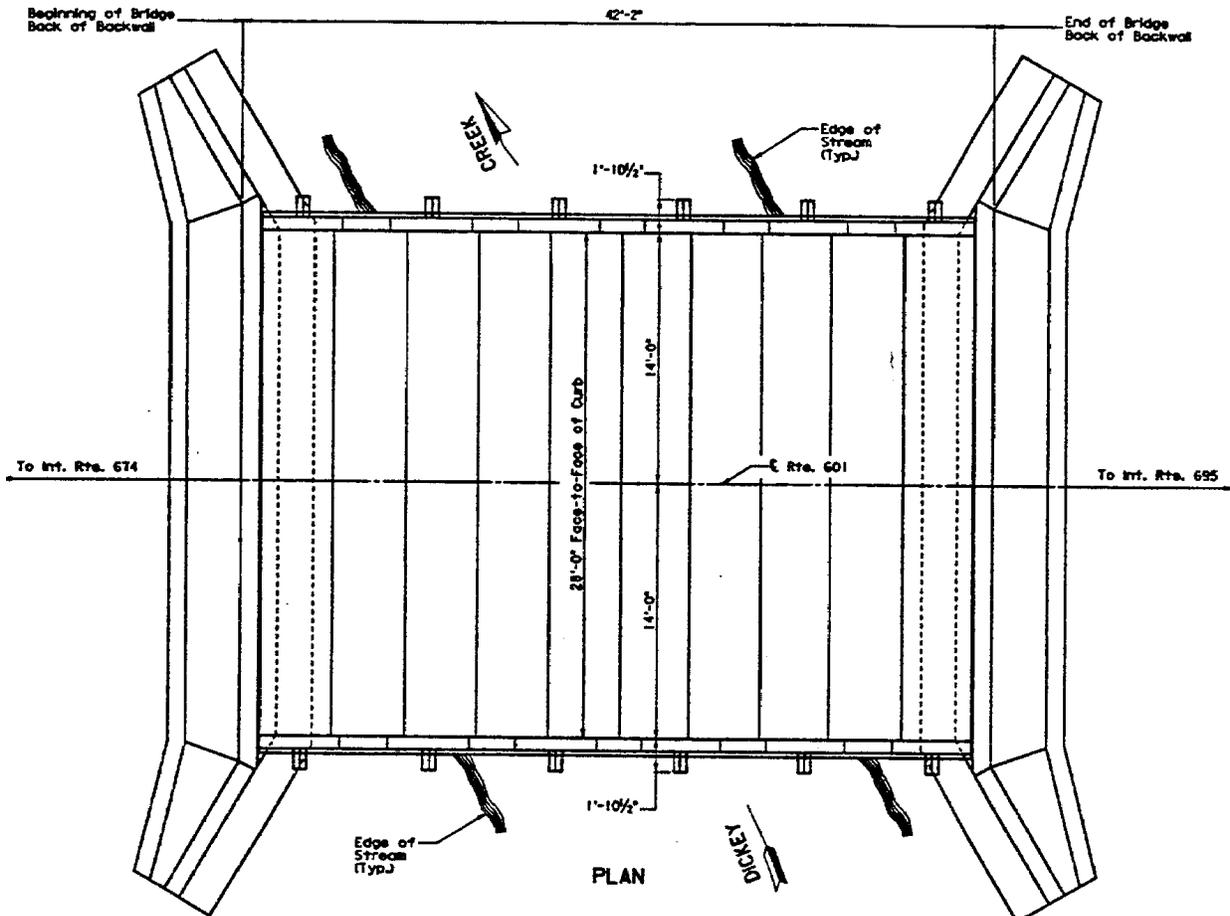
Figure 1-8. Plan view of the Route 601 Bridge (Restrepo, 2002).

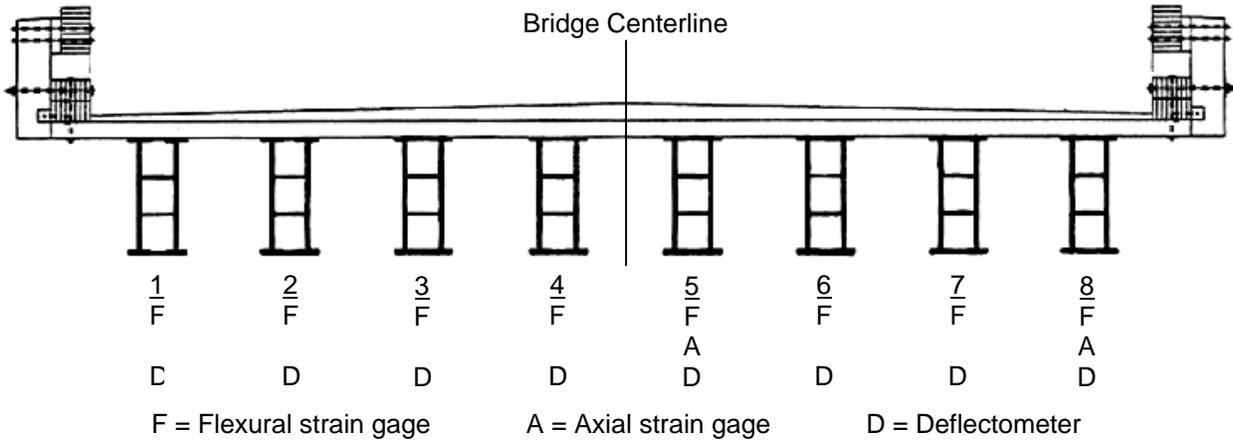
**Figure 2-2.** Instrumentation for the Route 601 Bridge; cross-section is looking in the east direction (Restrepo, 2002).

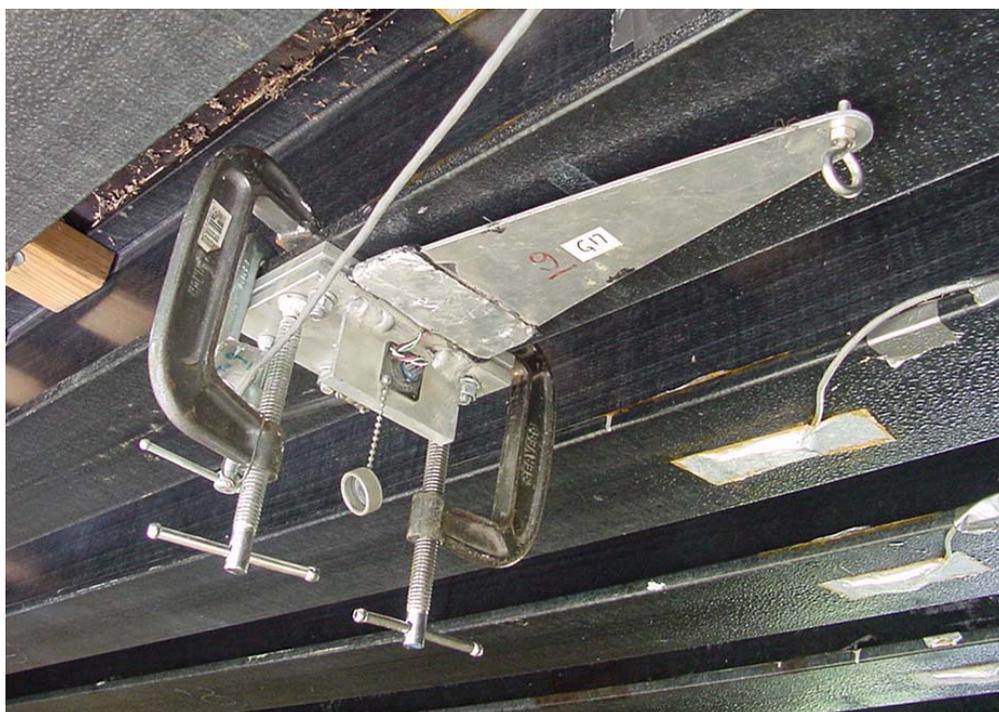
**Figure 2-3.** Deflectometer for the Toms Creek Bridge.

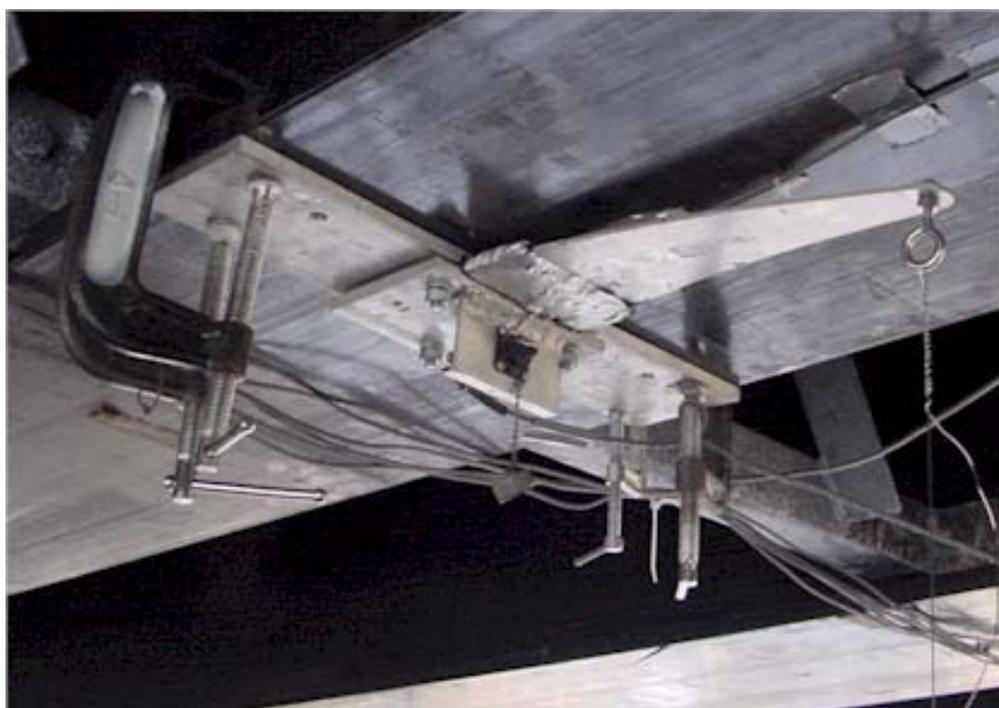
**Figure 2-4.** Deflectometer for the Route 601 Bridge.

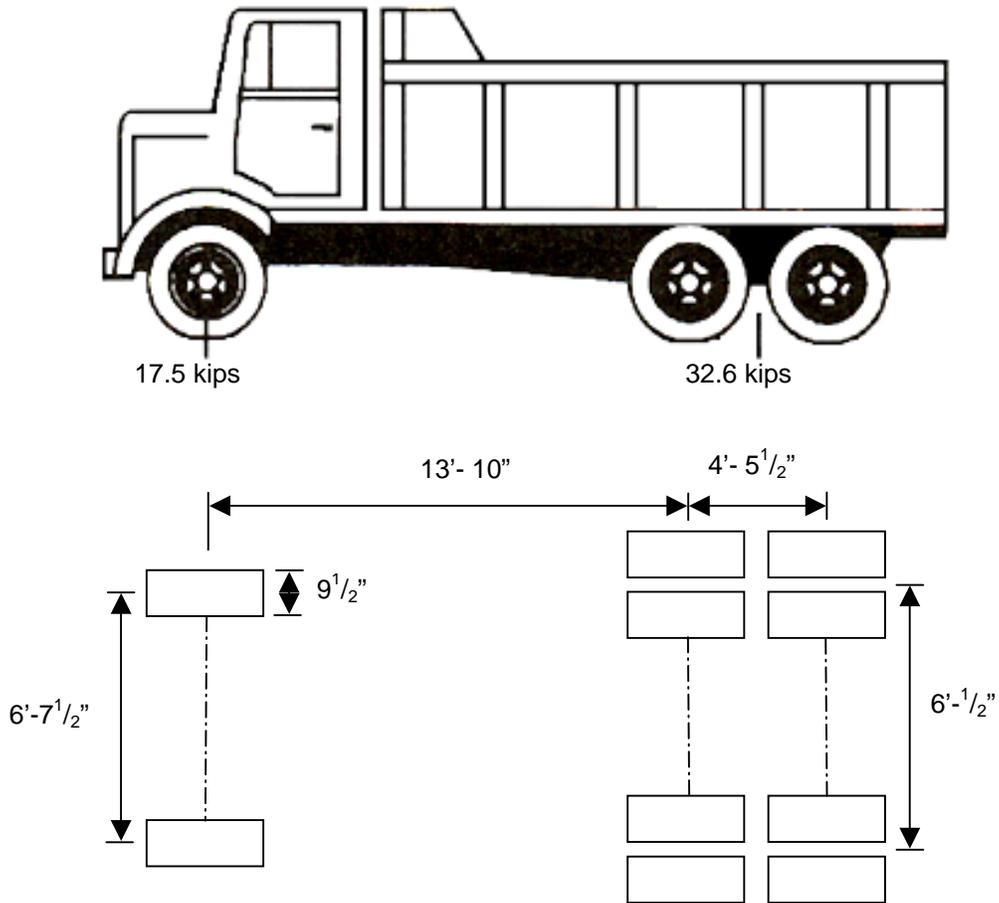
**Figure 2-5.** Sketch showing the dimensions and weight distribution of the VDOT dump truck used for testing the Toms Creek Bridge.

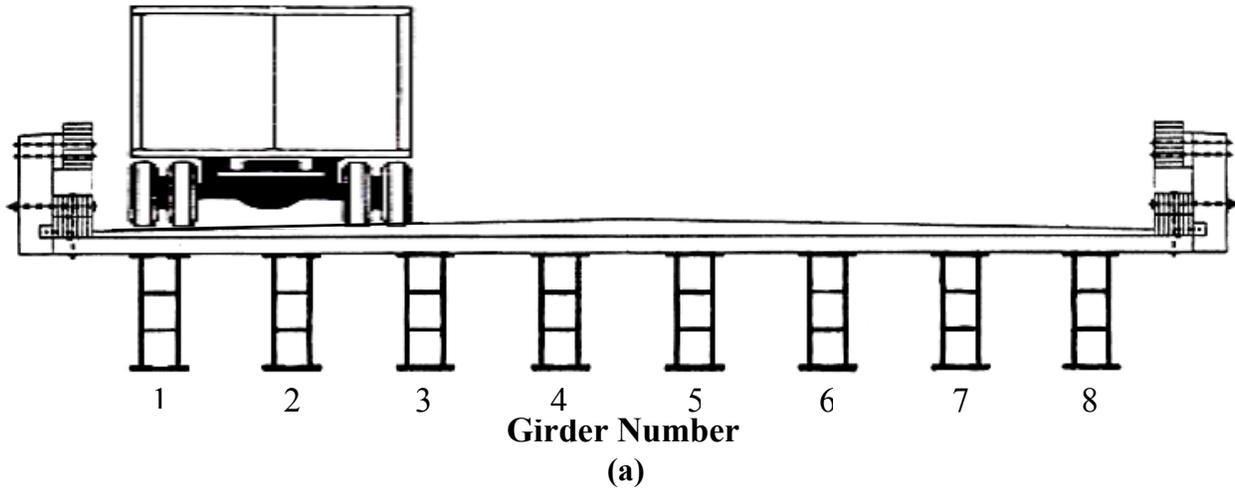
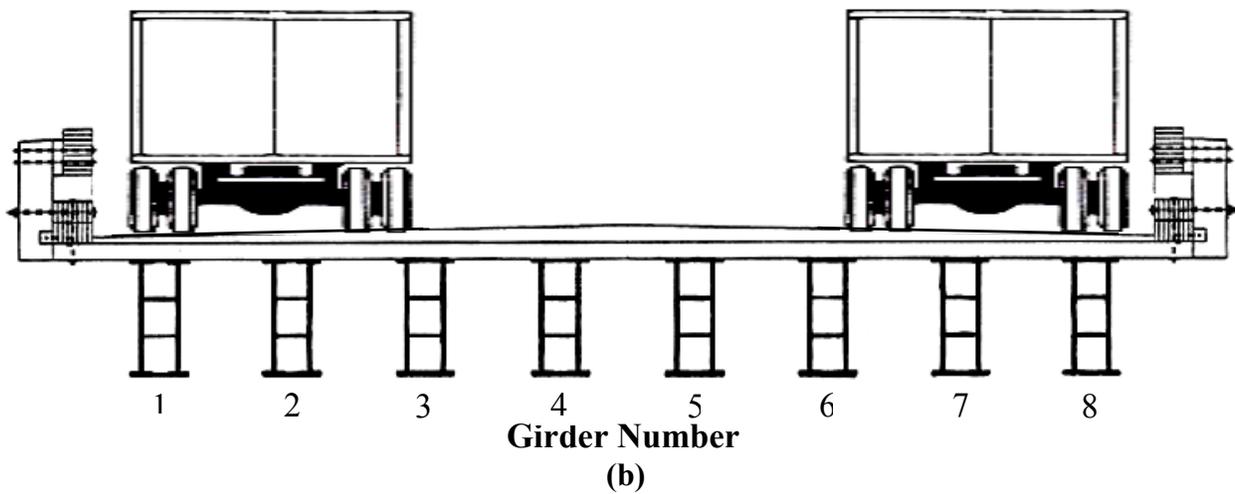
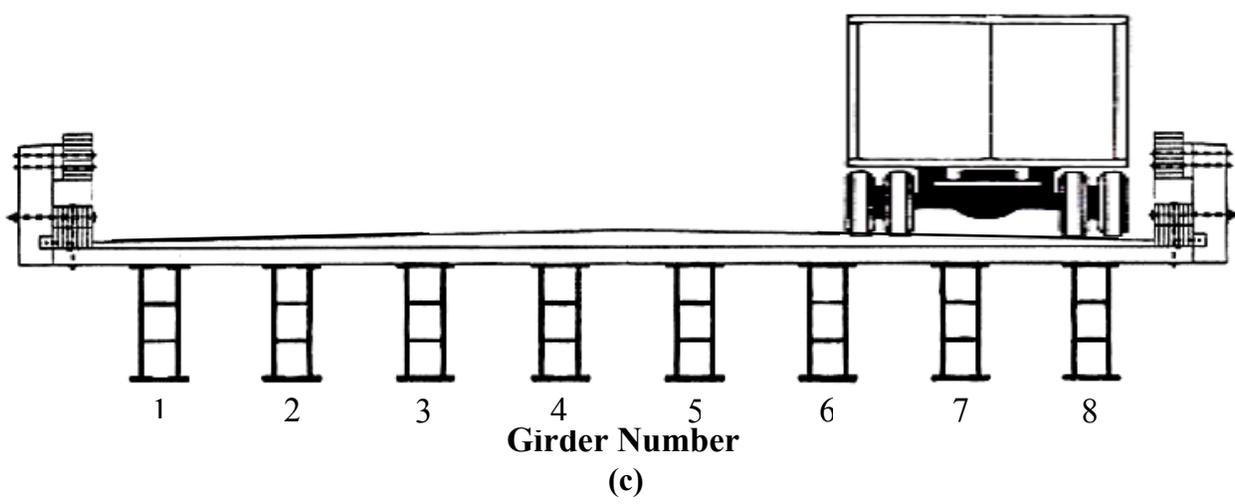
**Figure 2-8.** Exterior truck orientations for the Route 601 Bridge: (a) West Exterior, (b) Multiple-Lane, (c) East Exterior (Restrepo, 2002).

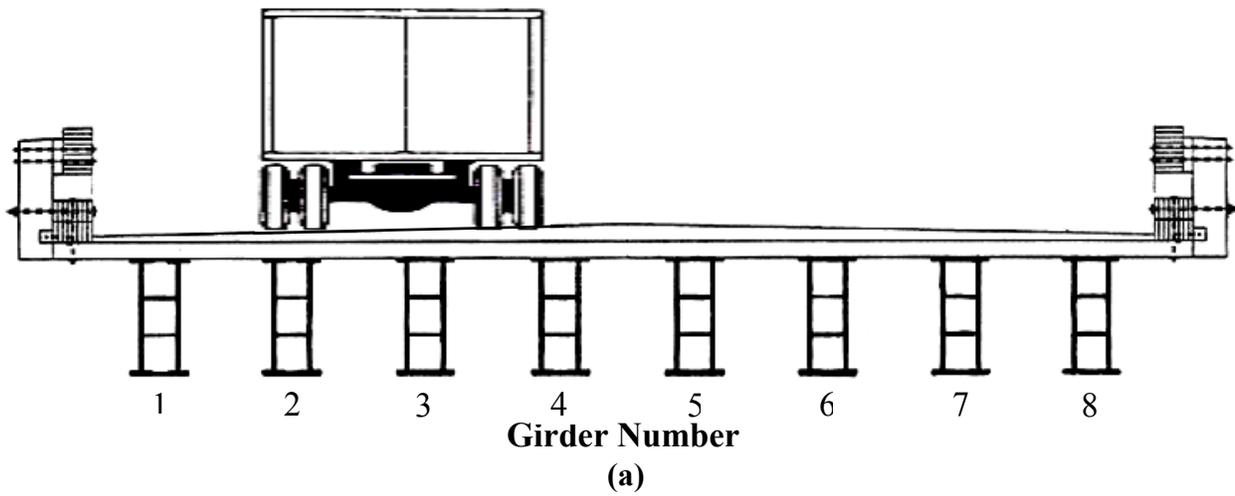
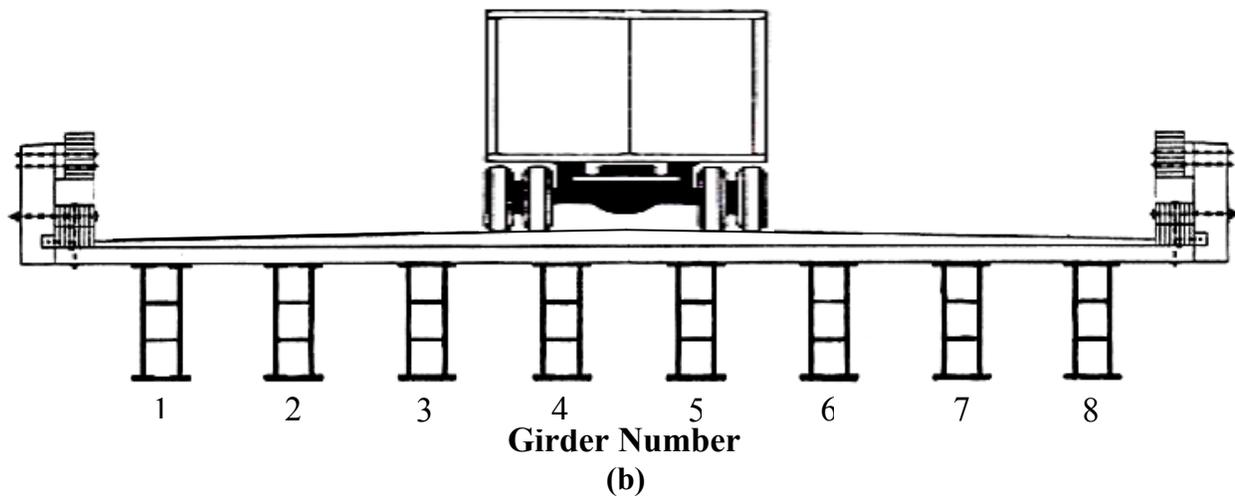
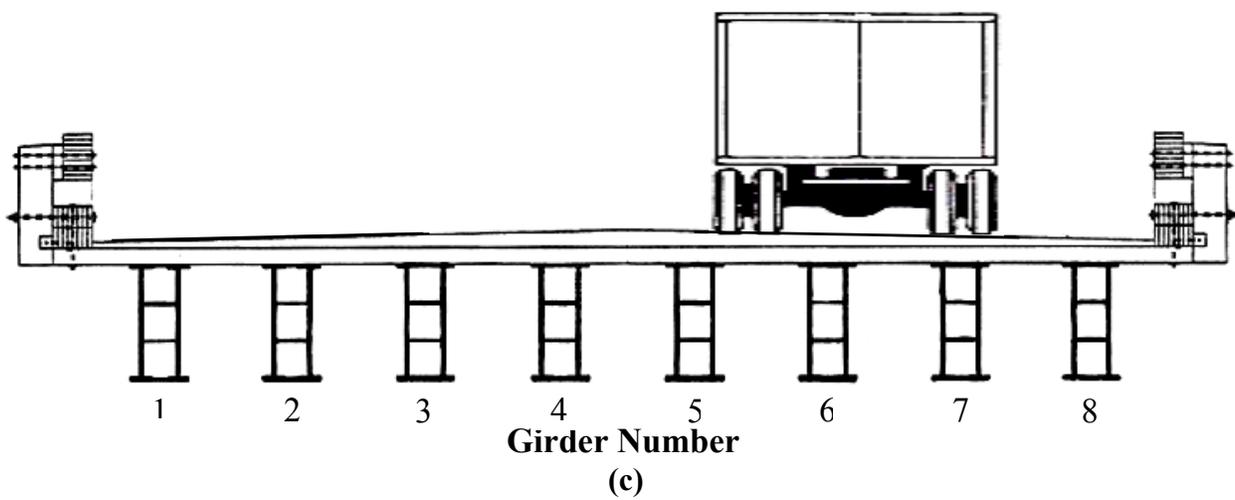
**Figure 2-9.** Interior truck orientations for the Route 601 Bridge:  
 (a) West Interior, (b) Center, (c) East Interior (Restrepo, 2002).

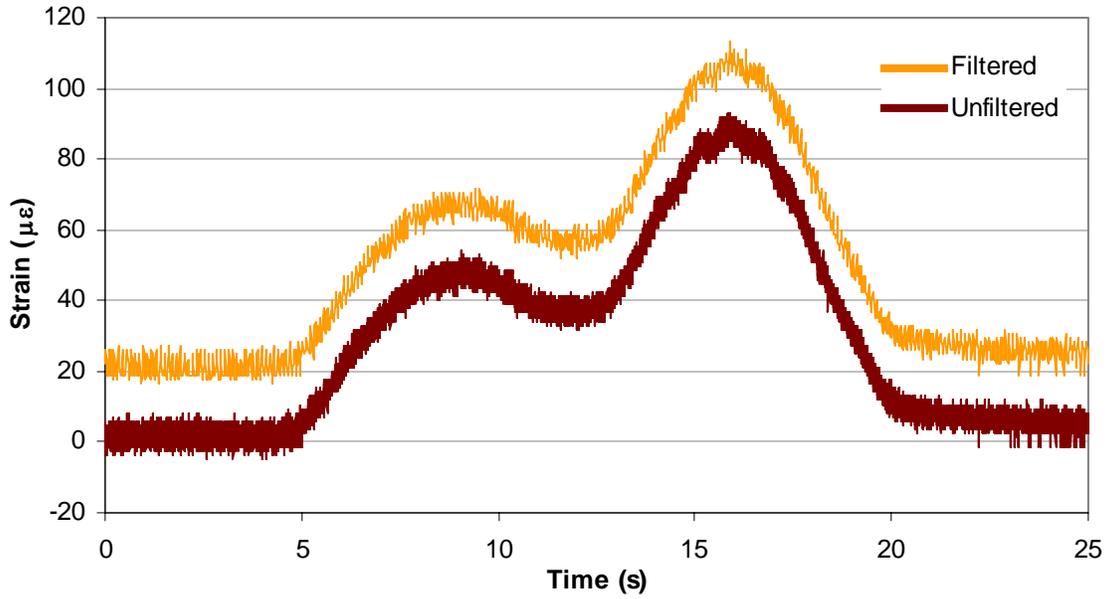
**Figure 2-10.** Typical comparison between filtered and unfiltered data. Data shown is for Girder 16 during a single test of the northbound lane orientation of the Toms Creek Bridge; filtered data was shifted upwards 20  $\mu\epsilon$  for comparison purposes.

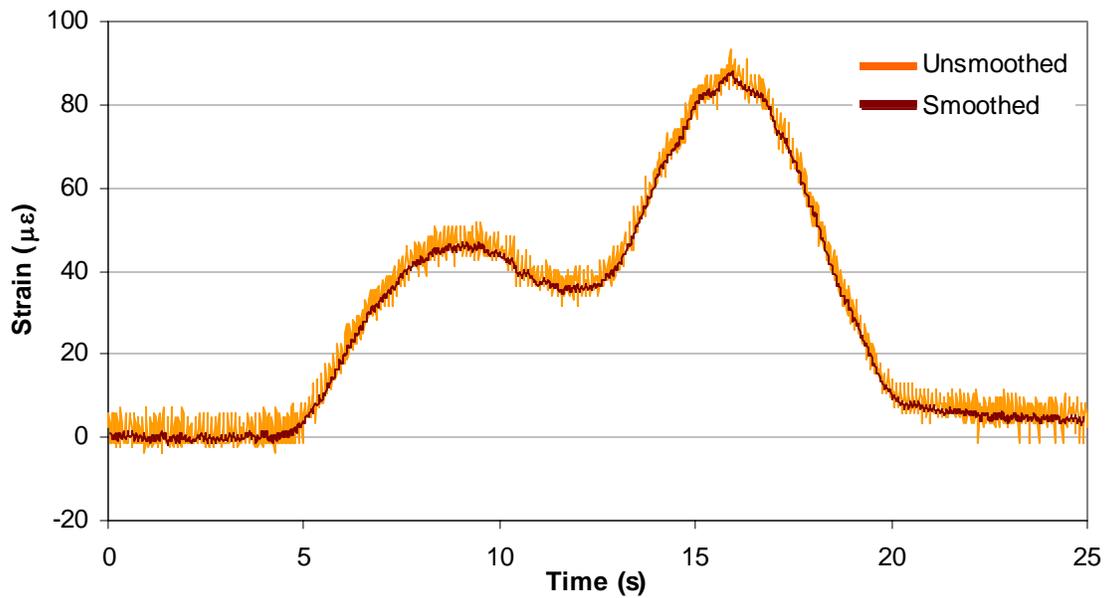
**Figure 2-11.** Typical comparison between smoothed and unsmoothed data. Data shown is for Girder 16 during a single test of the northbound lane orientation of the Toms Creek Bridge; smoothed data has been set to zero.

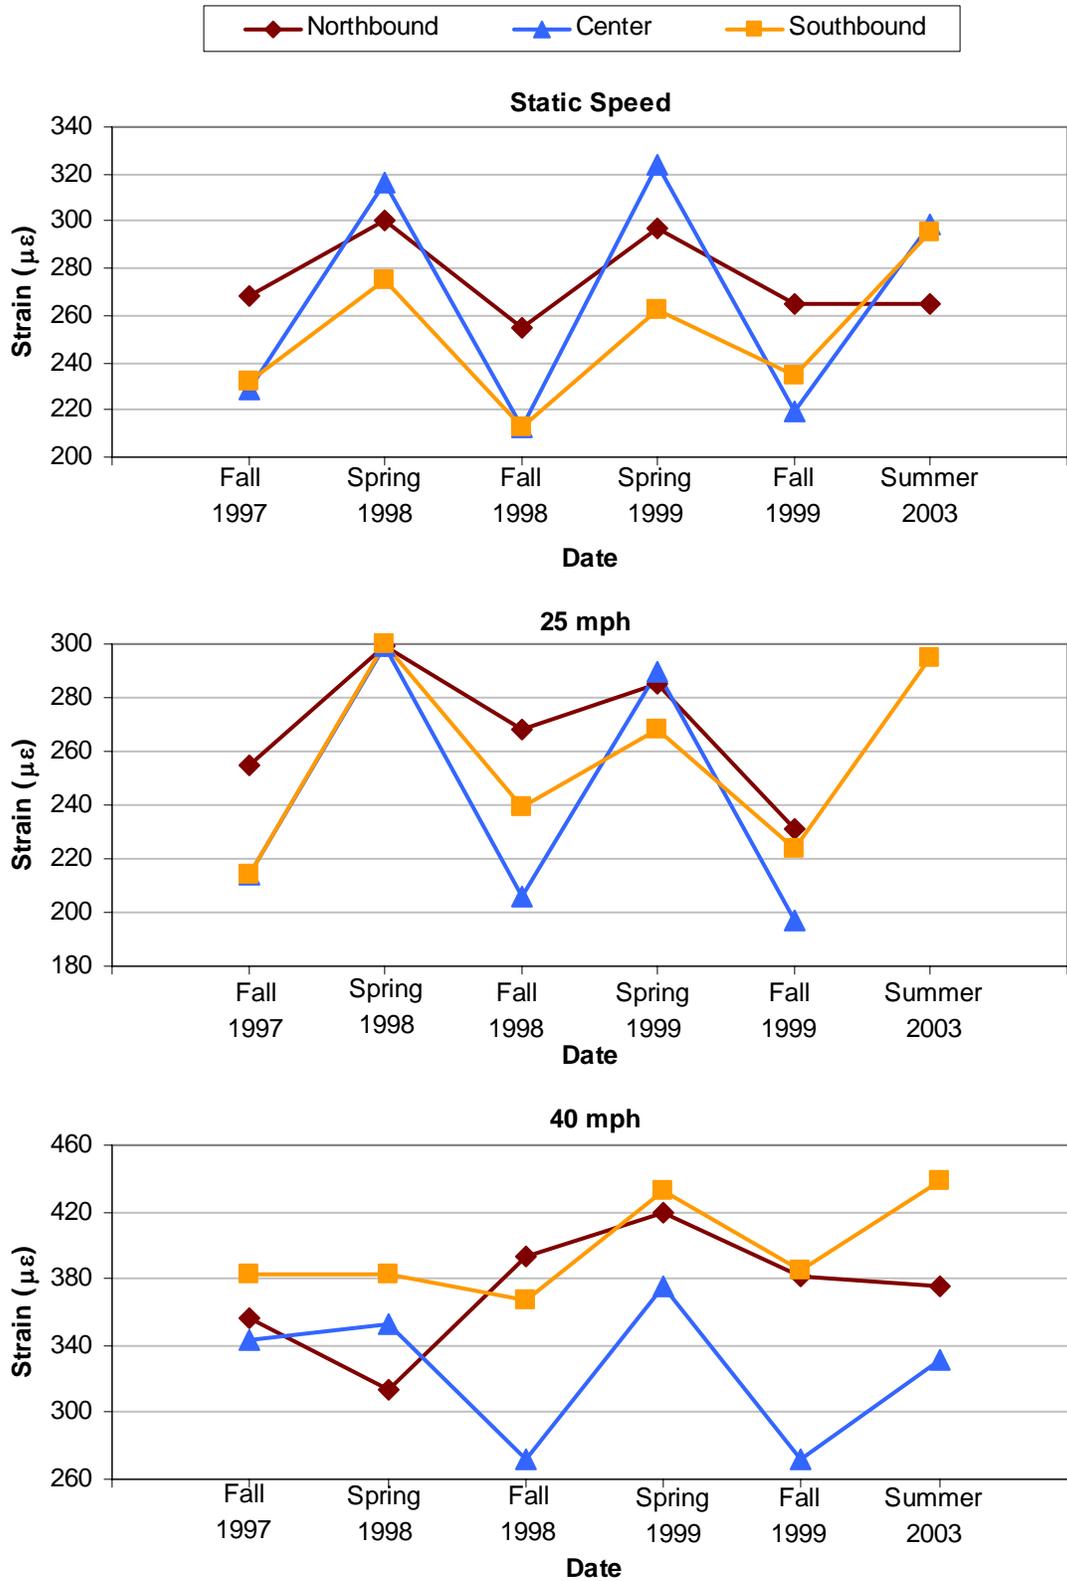
**Figure 3-1.** Average peak strain in the most heavily loaded girder for the different truck orientations and travel speeds in the Toms Creek Bridge.

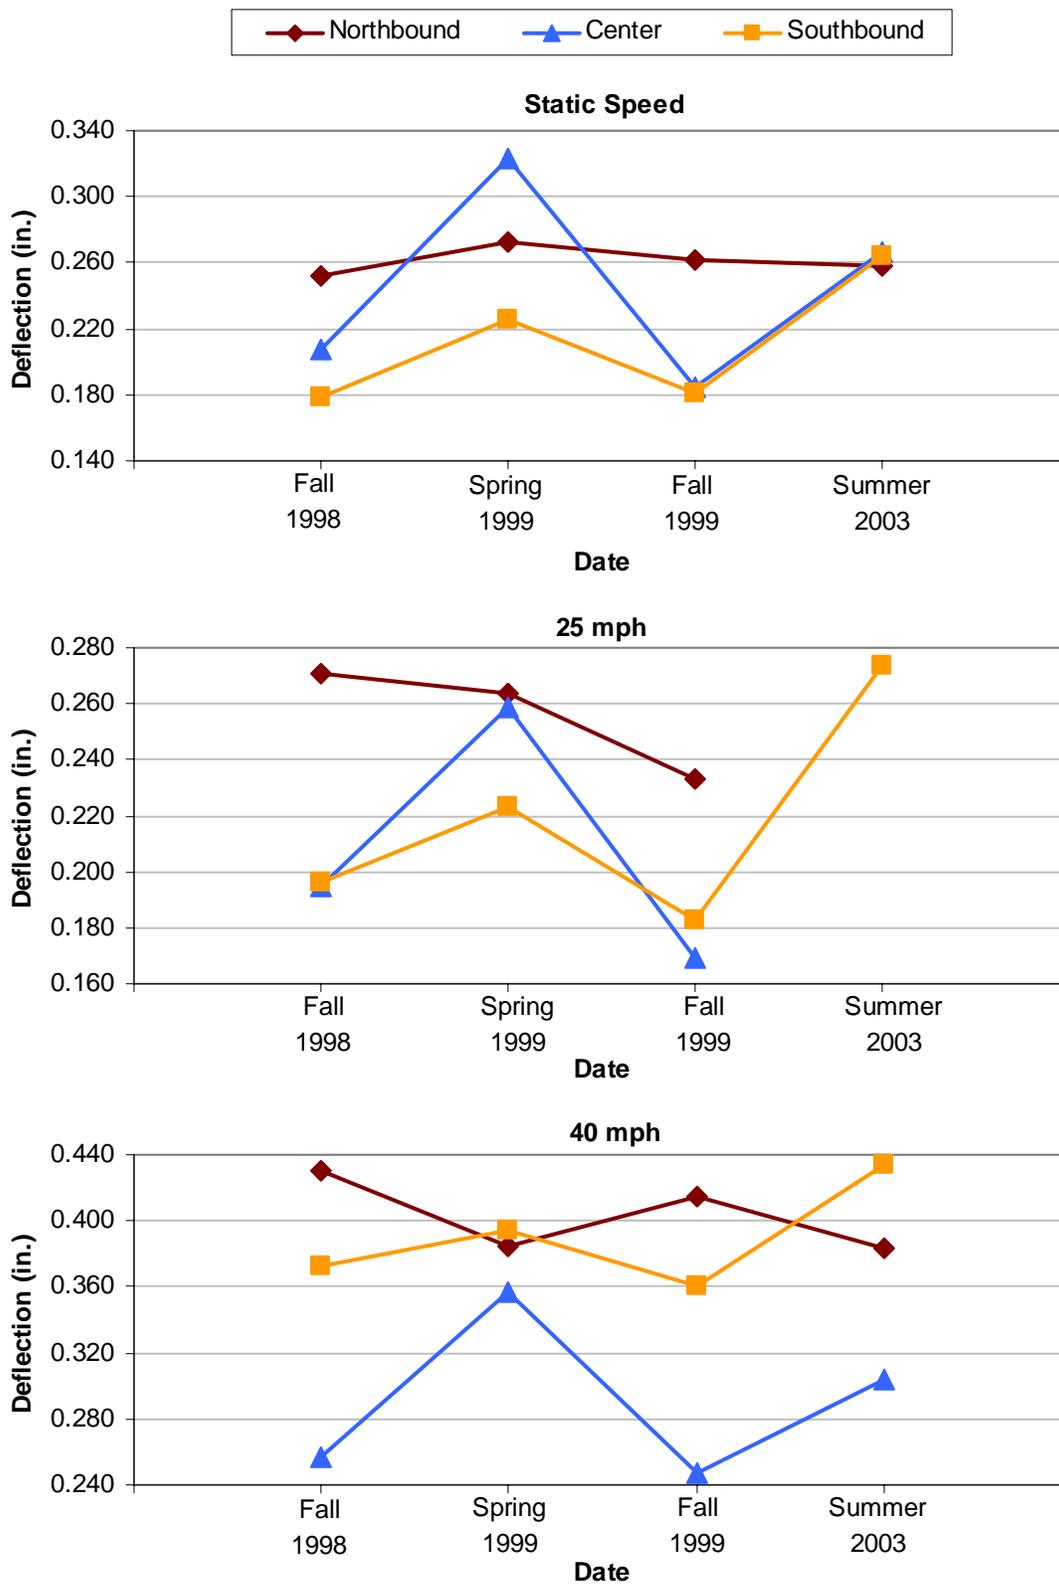
**Figure 3-2.** Average peak deflection in the most heavily loaded girder for the different truck orientations and travel speeds in the Toms Creek Bridge.

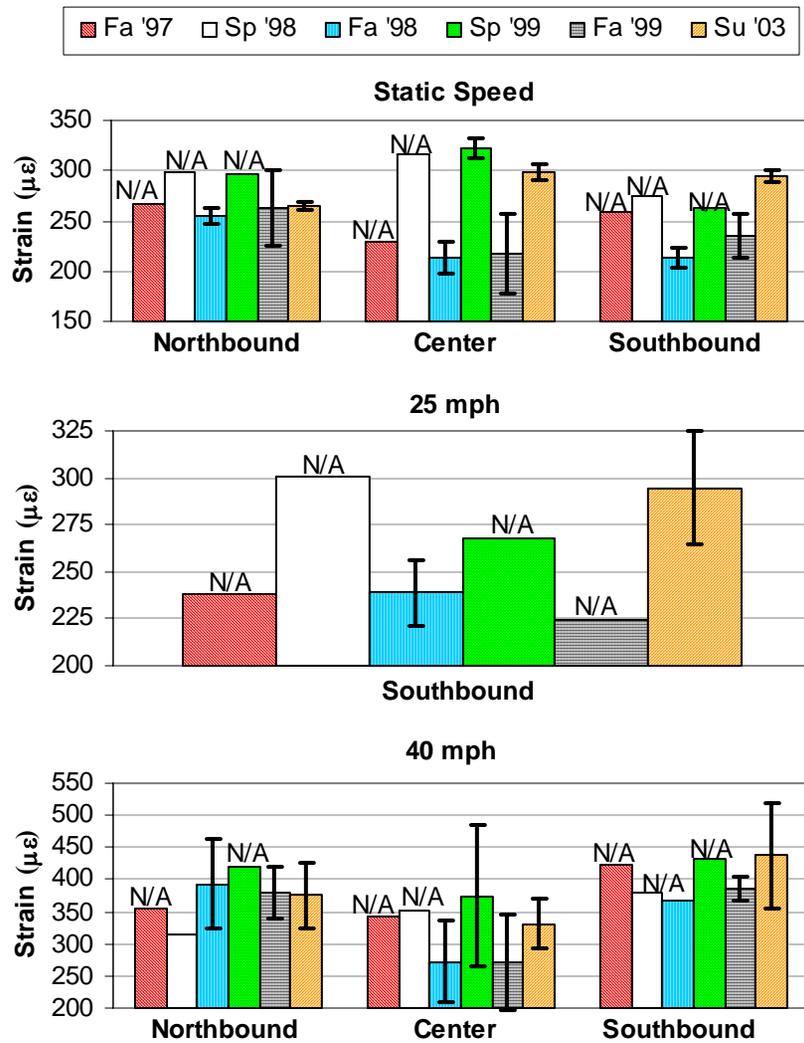
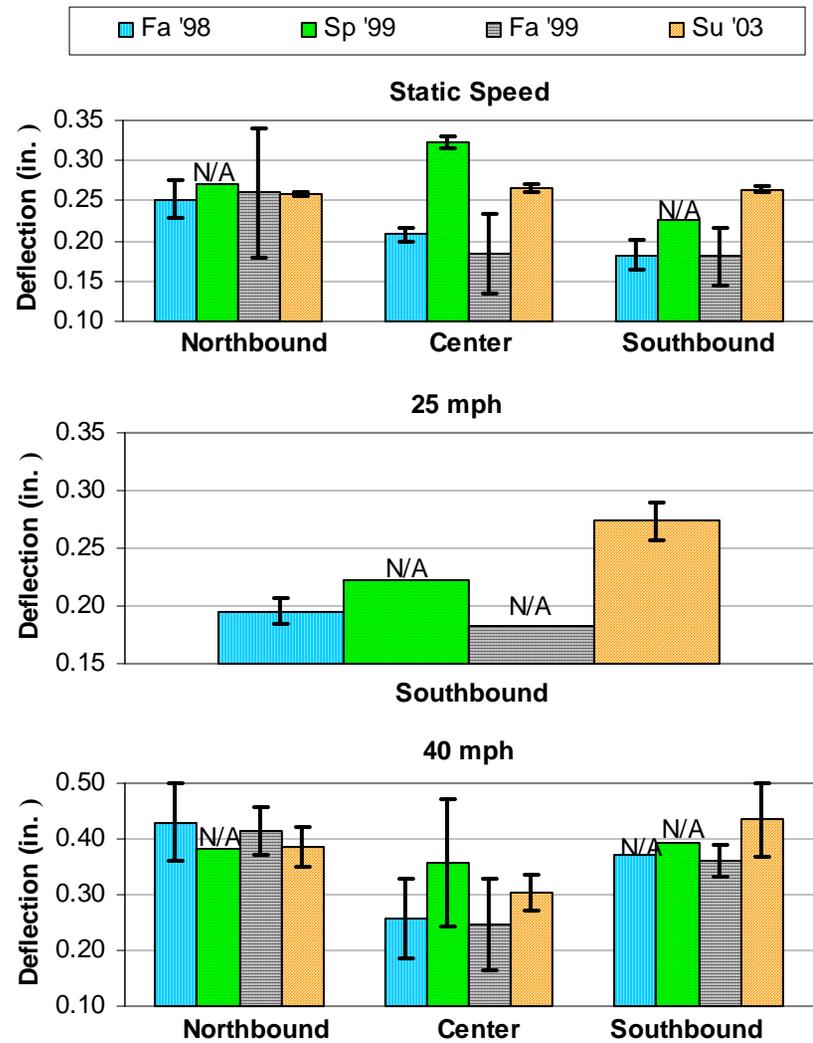
**Figure 3-3.** Error bars for the average peak (a) strain and (b) deflection for the most heavily loaded girder in the Toms Creek Bridge. Data points marked “N/A” do not have enough tests to produce a statistically reliable set of bars; data points without error bars have errors that are too small to appear on the graph.

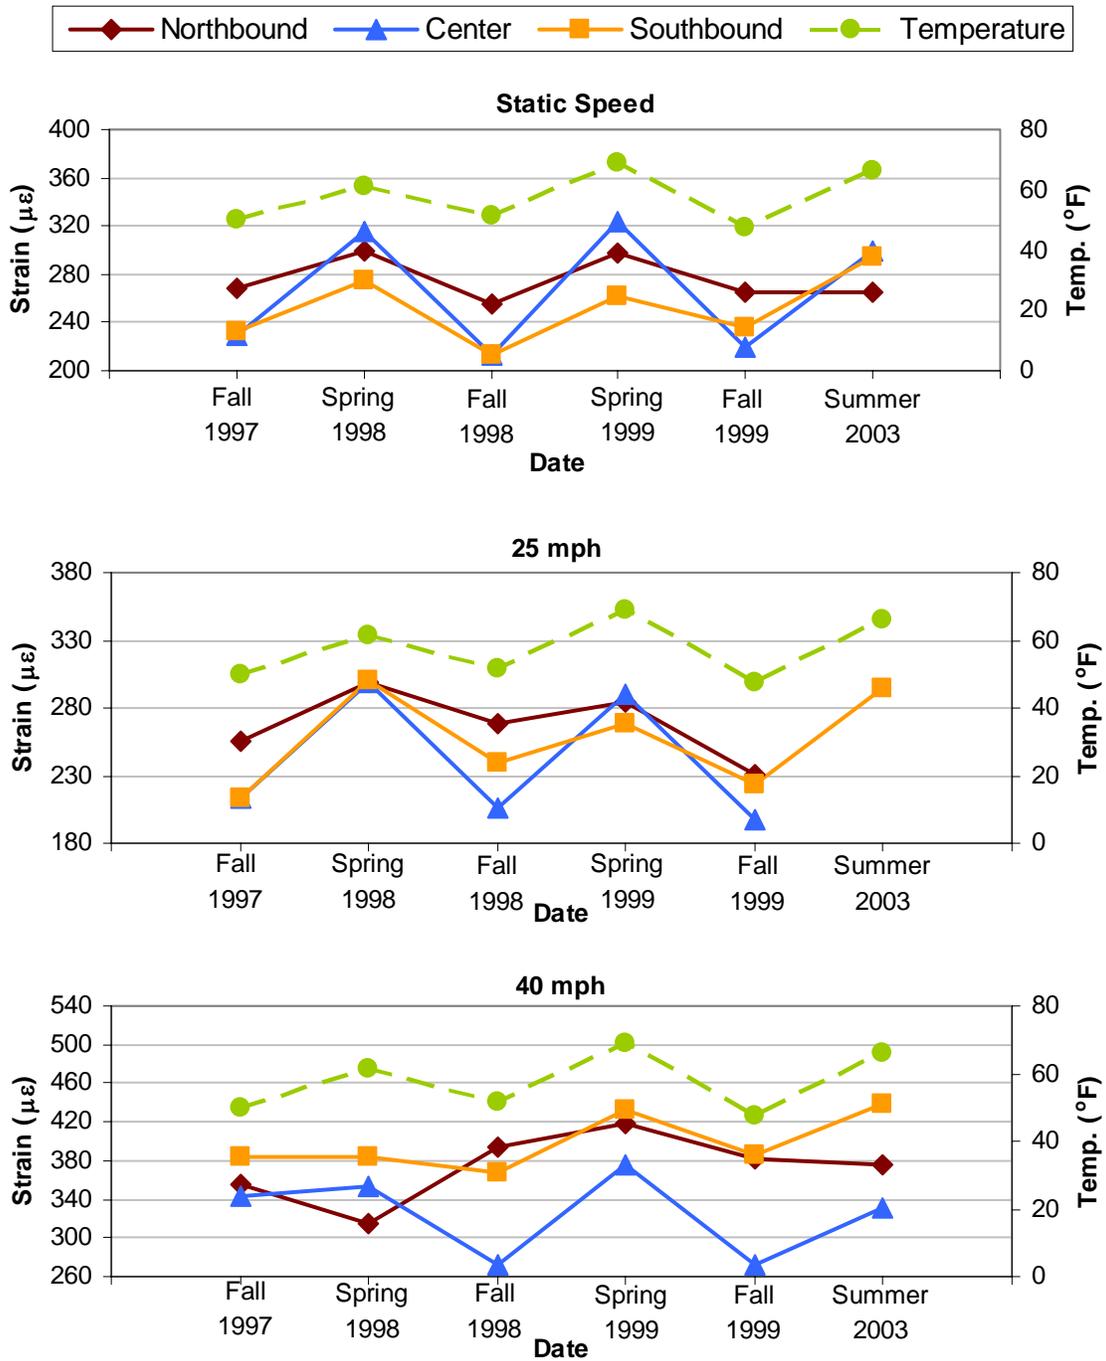
Figure 3-4. Average peak strain shown with the average temperature at the Toms Creek Bridge.

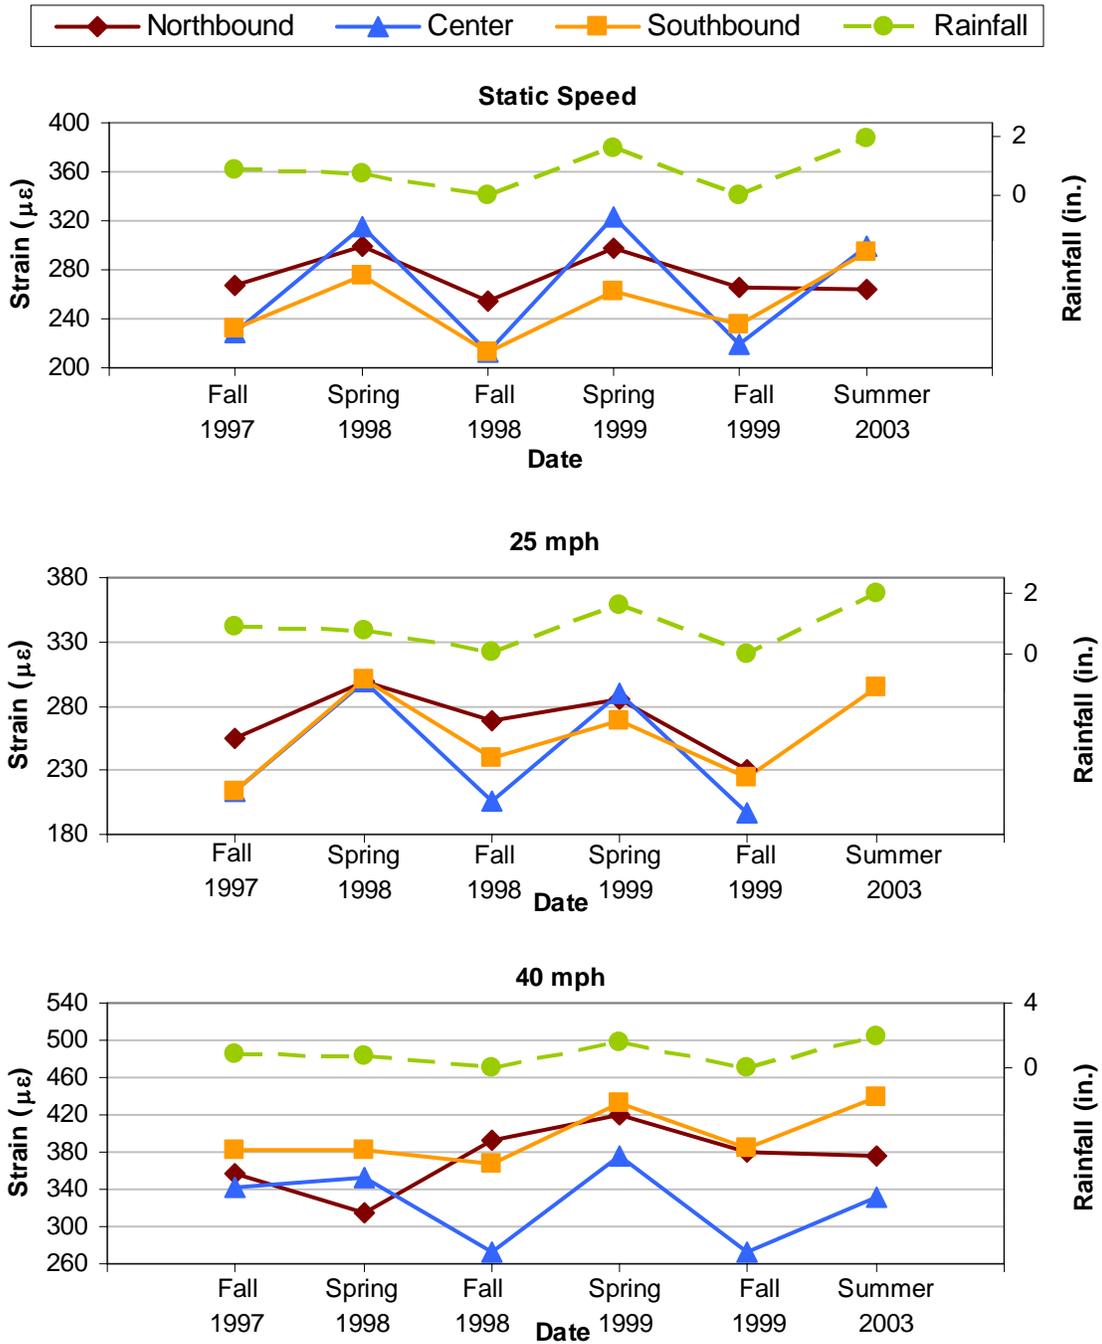
**Figure 3-5.** Average peak strain shown with rainfall at the Toms Creek Bridge. Amount of rainfall is the precipitation over a seven-day period prior to the respective test dates.
