# **Long-Term In-Service Evaluation of Two Bridges Designed with Fiber-Reinforced Polymer Girders**

Thesis submitted to the Faculty of the  
Virginia Polytechnic Institute and State University  
in partial fulfillment of the requirements for the degree of

Master of Science  
In  
Civil Engineering

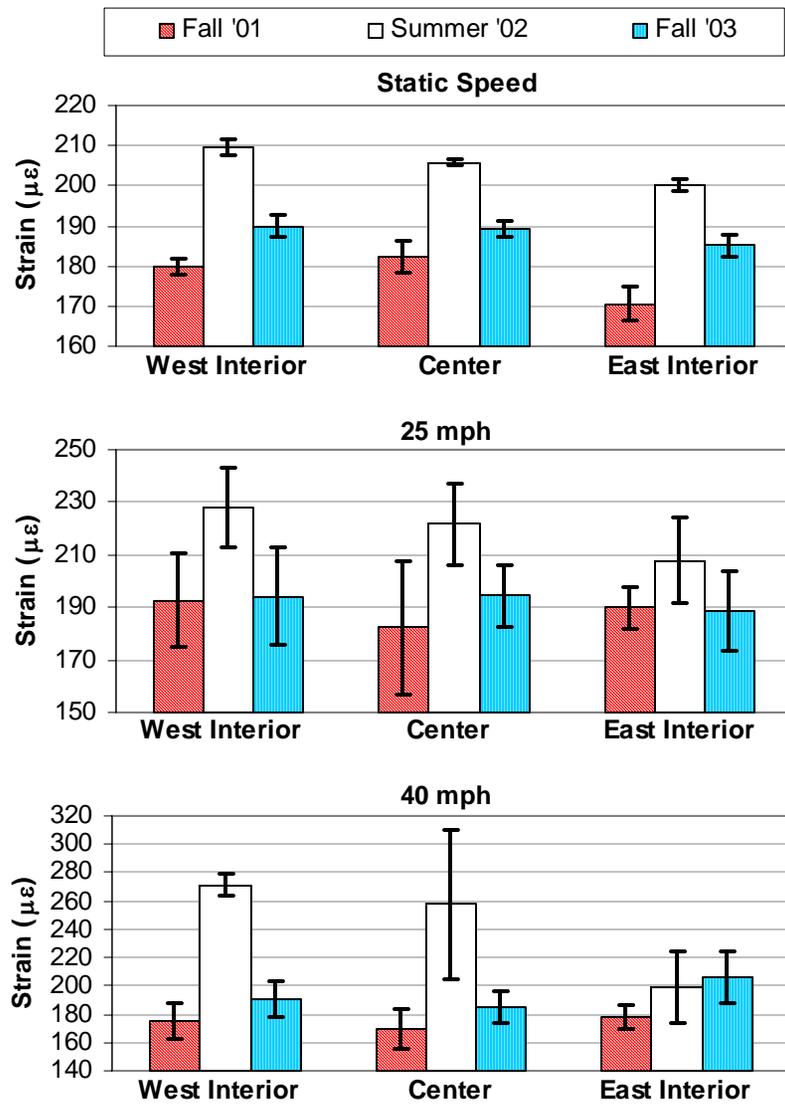
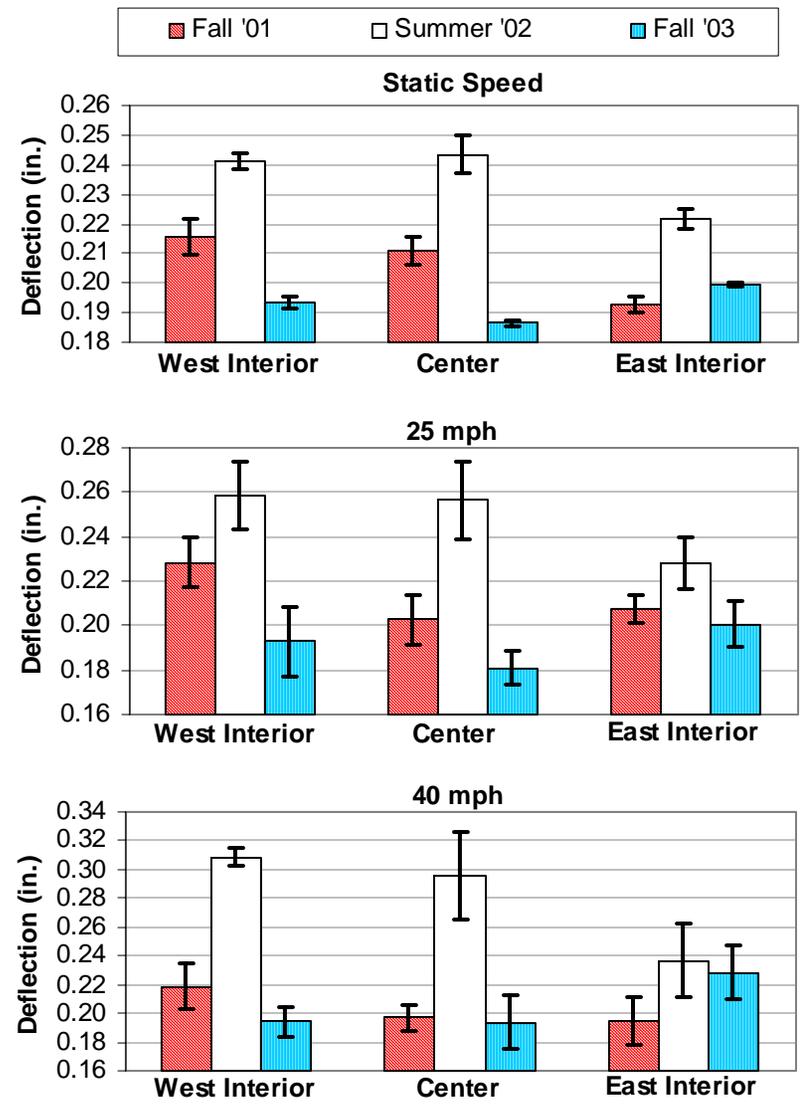
**(a)** **(b)**  
**Figure 3-8.** Error bars for the average peak (a) strain and (b) deflection for the most heavily loaded girder for the interior orientations in the Route 601 Bridge.

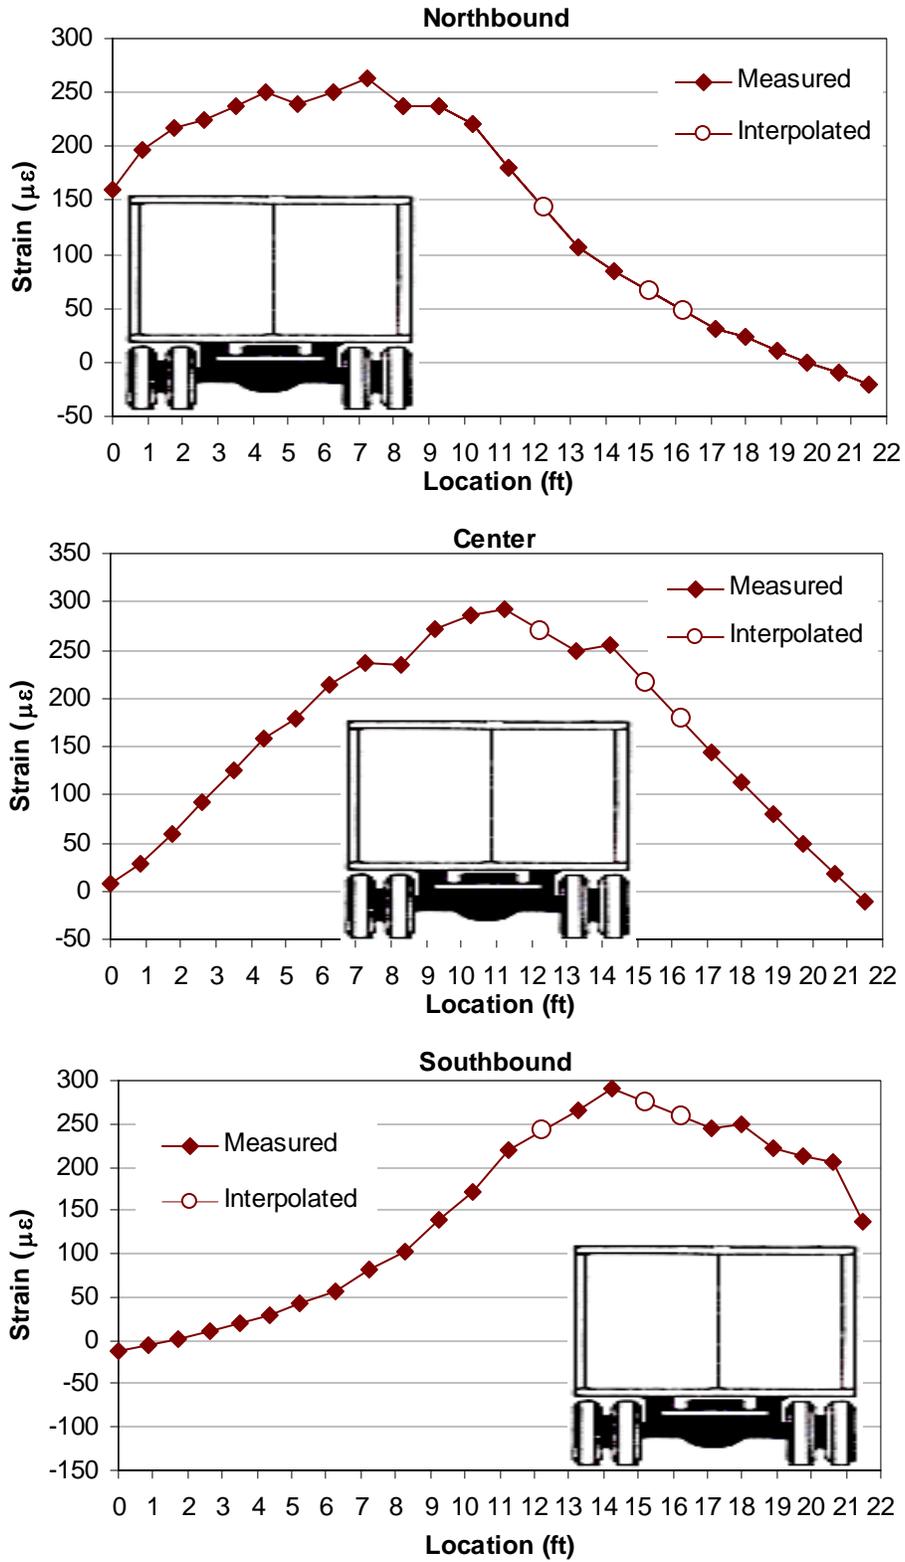
**Figure 4-1.** Typical girder responses to a load truck for the various truck orientations on the Toms Creek Bridge, shown at the time of maximum strain at static speed.

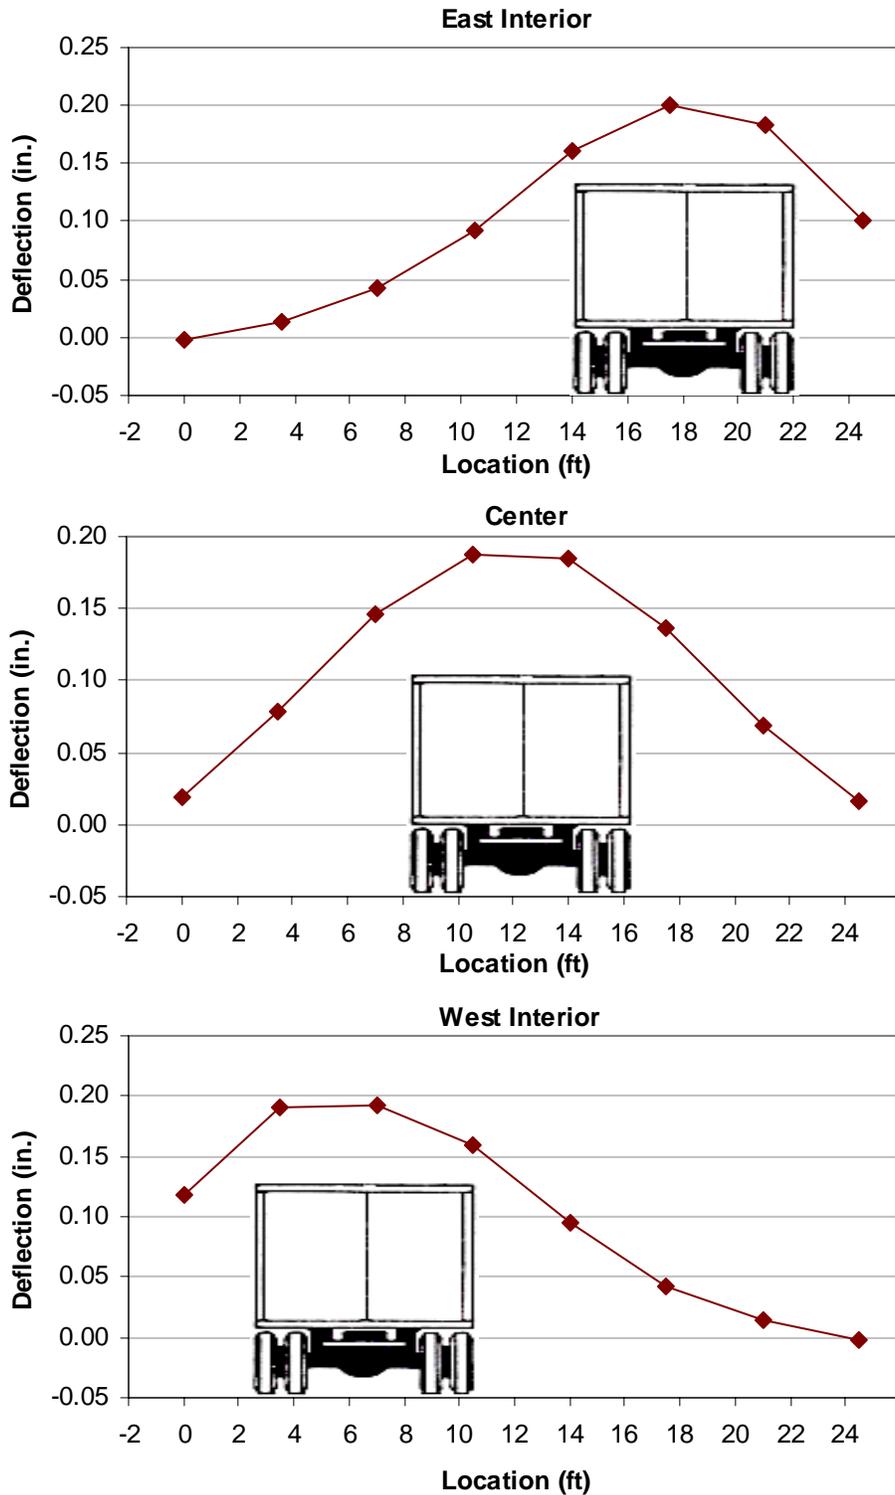
**Figure 4-2.** Typical girder responses to a load truck for the East Interior, Center, and West Interior orientations on the Route 601 Bridge, shown at the time of maximum deflection at static speed.

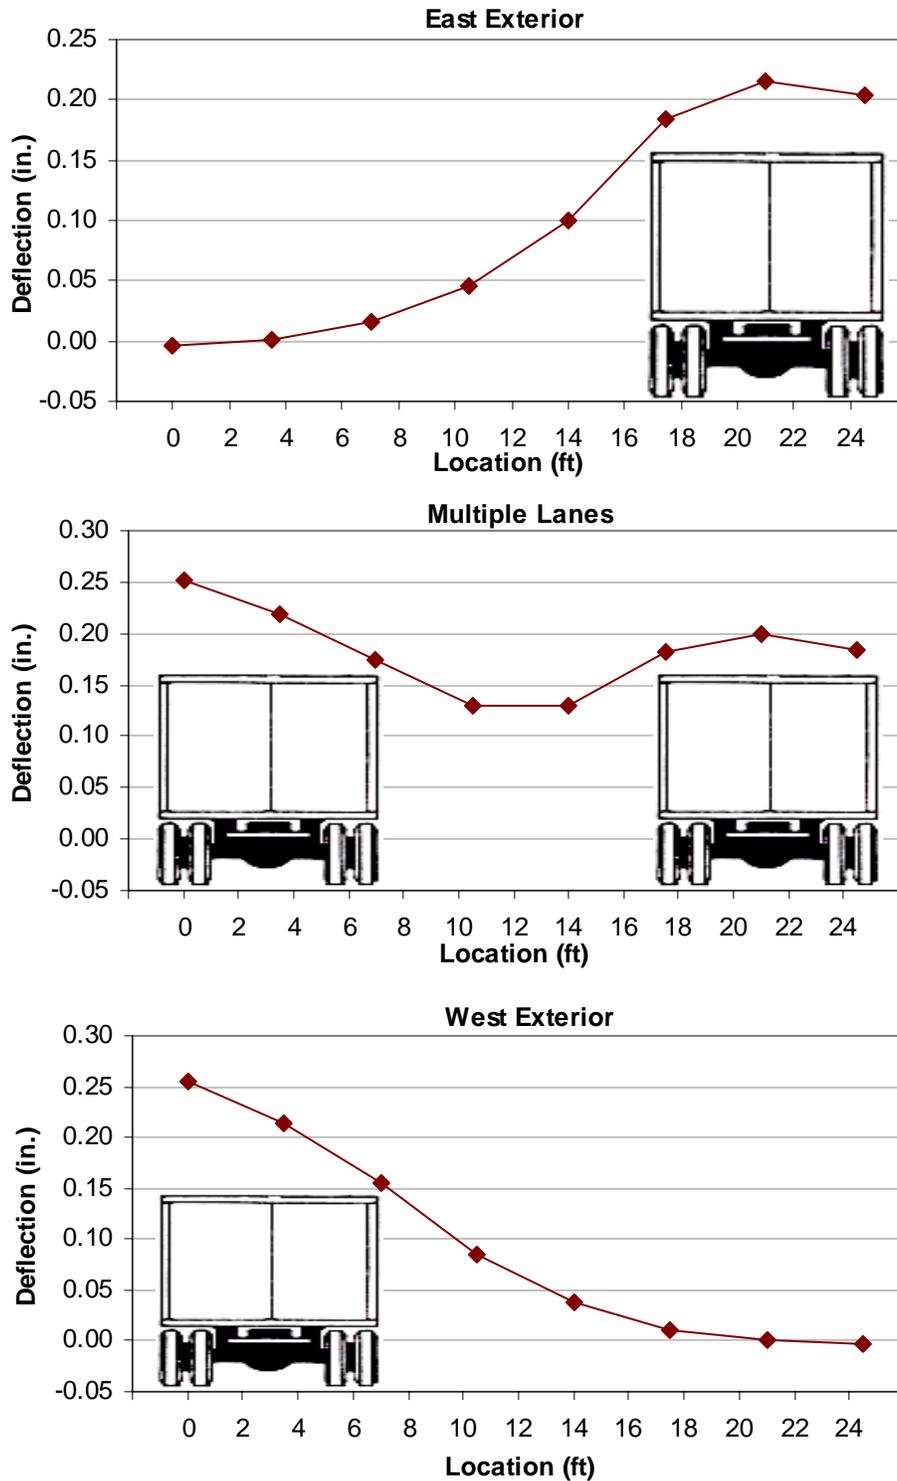
**Figure 4-3.** Typical girder responses to a load truck for the East Exterior, Multiple Lanes, and West Exterior orientations on the Route 601 Bridge, shown at the time of maximum deflection at static speed.

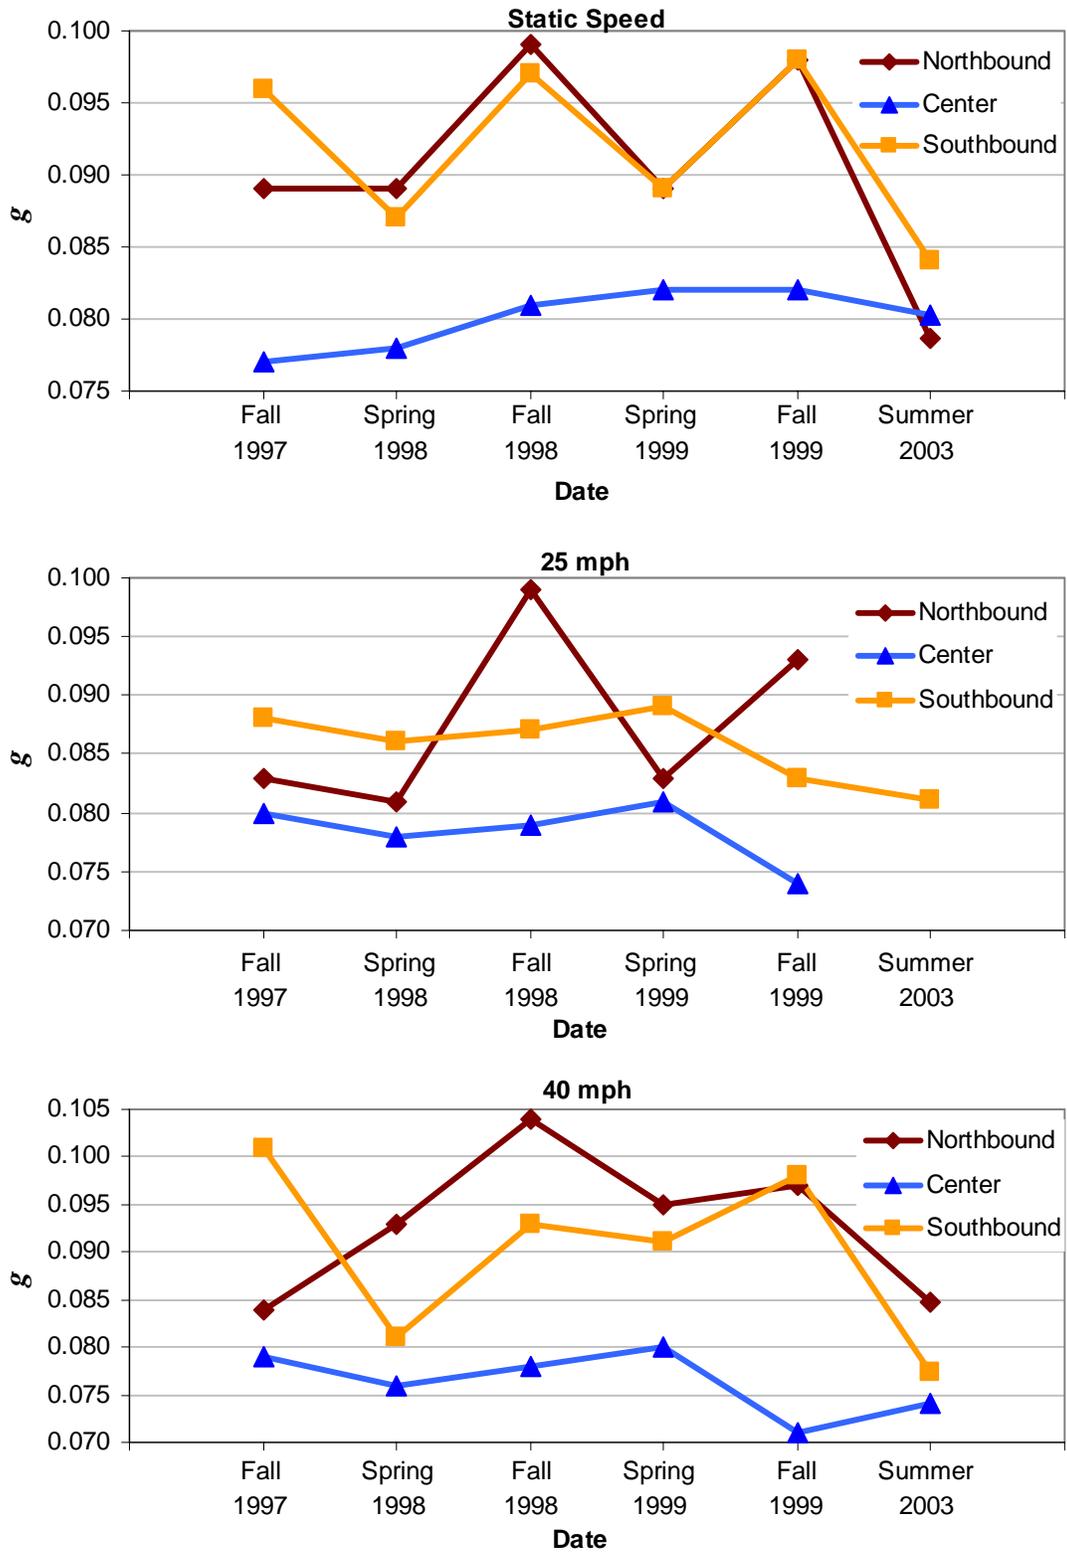
**Figure 4-4.** Average wheel load distributions for the Toms Creek Bridge over time, based on strain measurements at three different speeds.

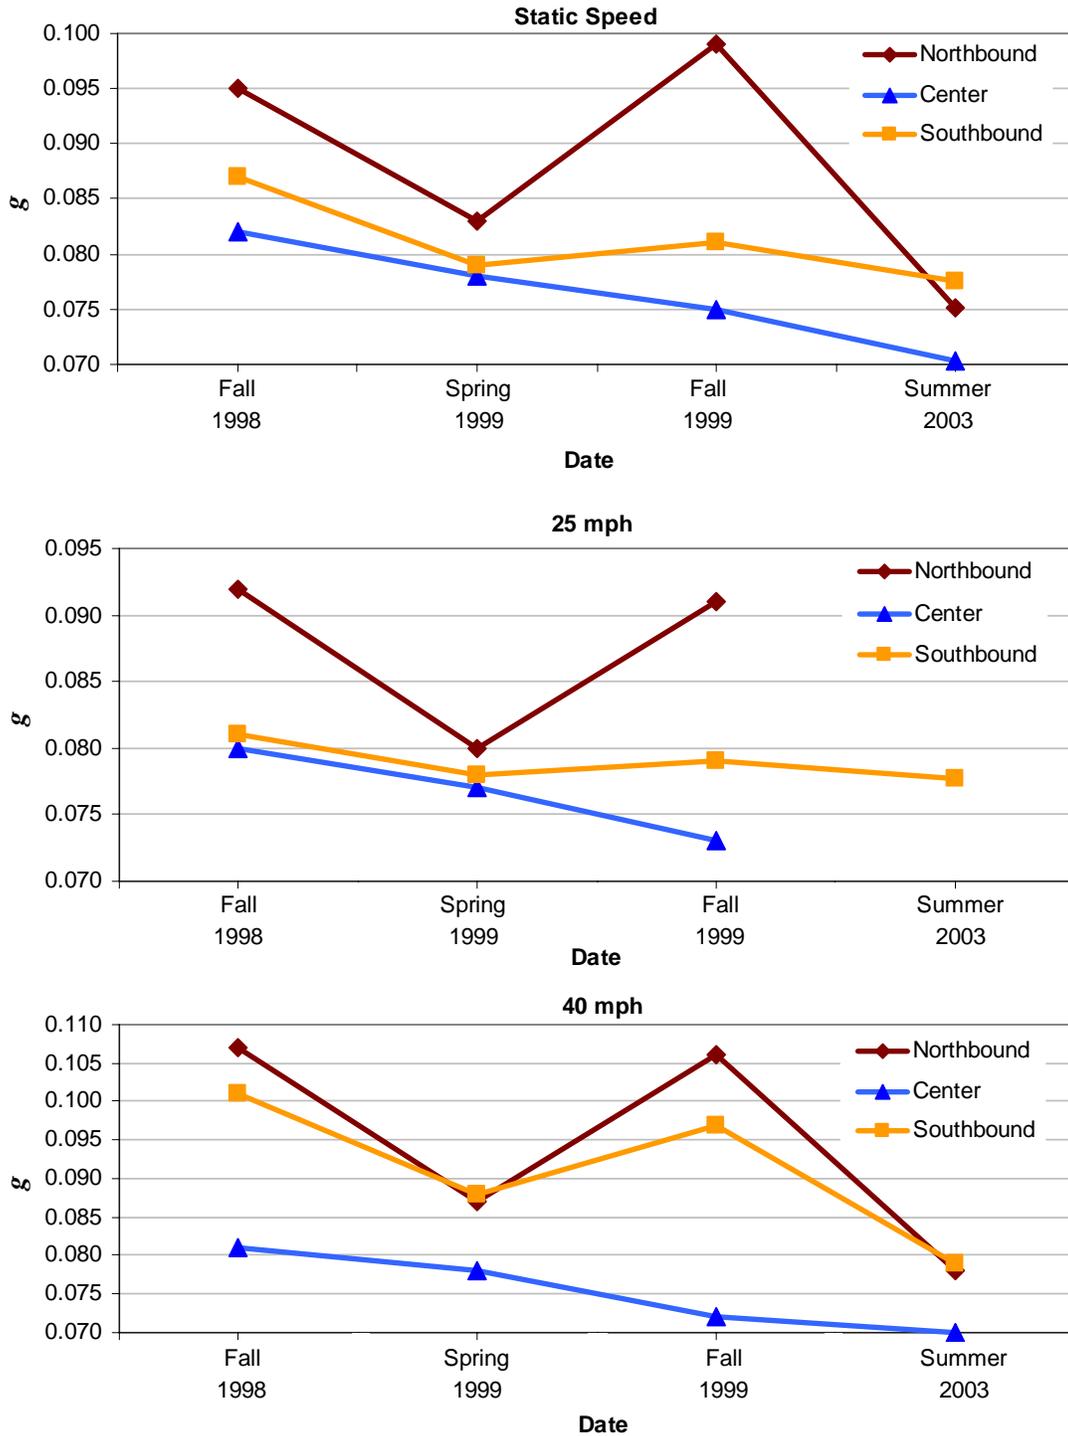
**Figure 4-5.** Average wheel load distributions for the Toms Creek Bridge over time, based on deflection measurements at three different speeds.

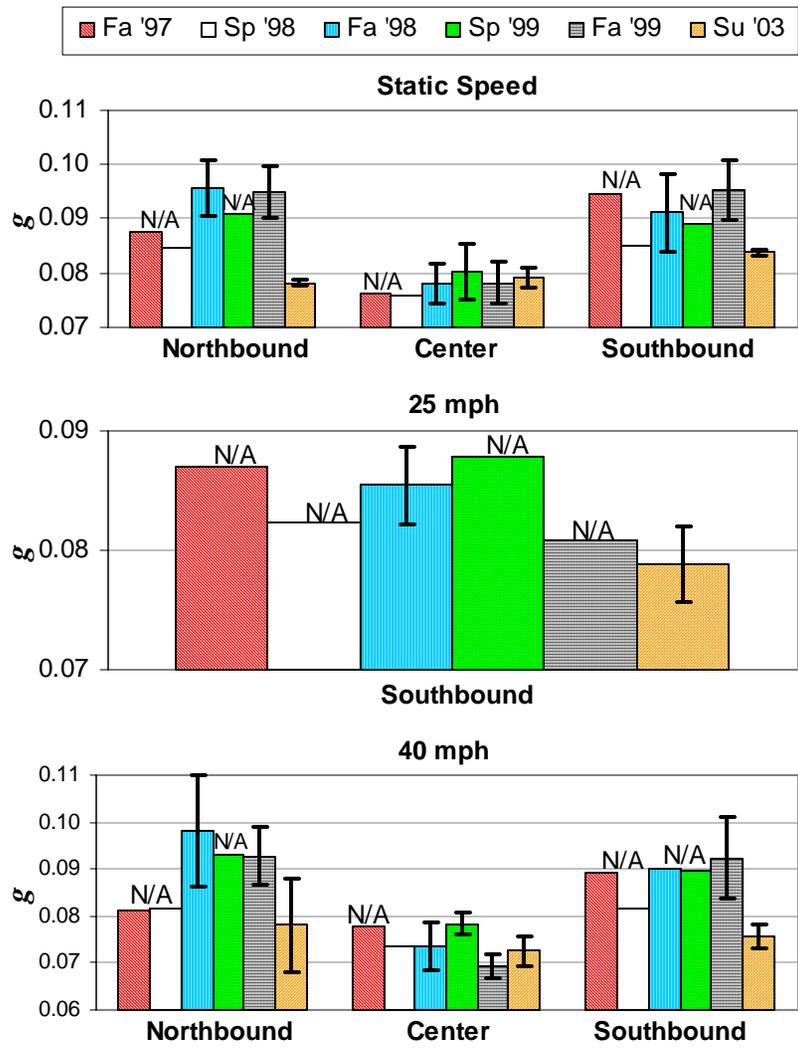
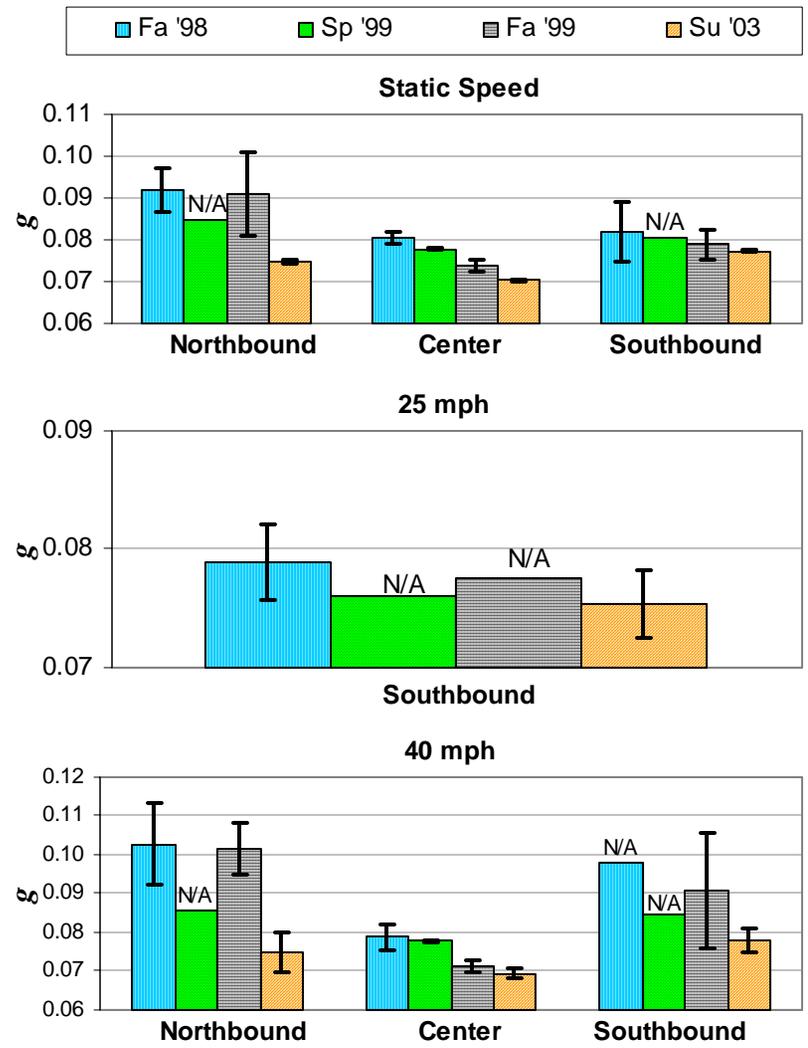
**Figure 4-6.** Error bars for average wheel load distributions in the Toms Creek Bridge, based on (a) strain and (b) deflection measurements. Data points marked “N/A” do not have enough tests to produce a statistically reliable set of bars; data points without error bars have errors that are too small to appear on the graph.

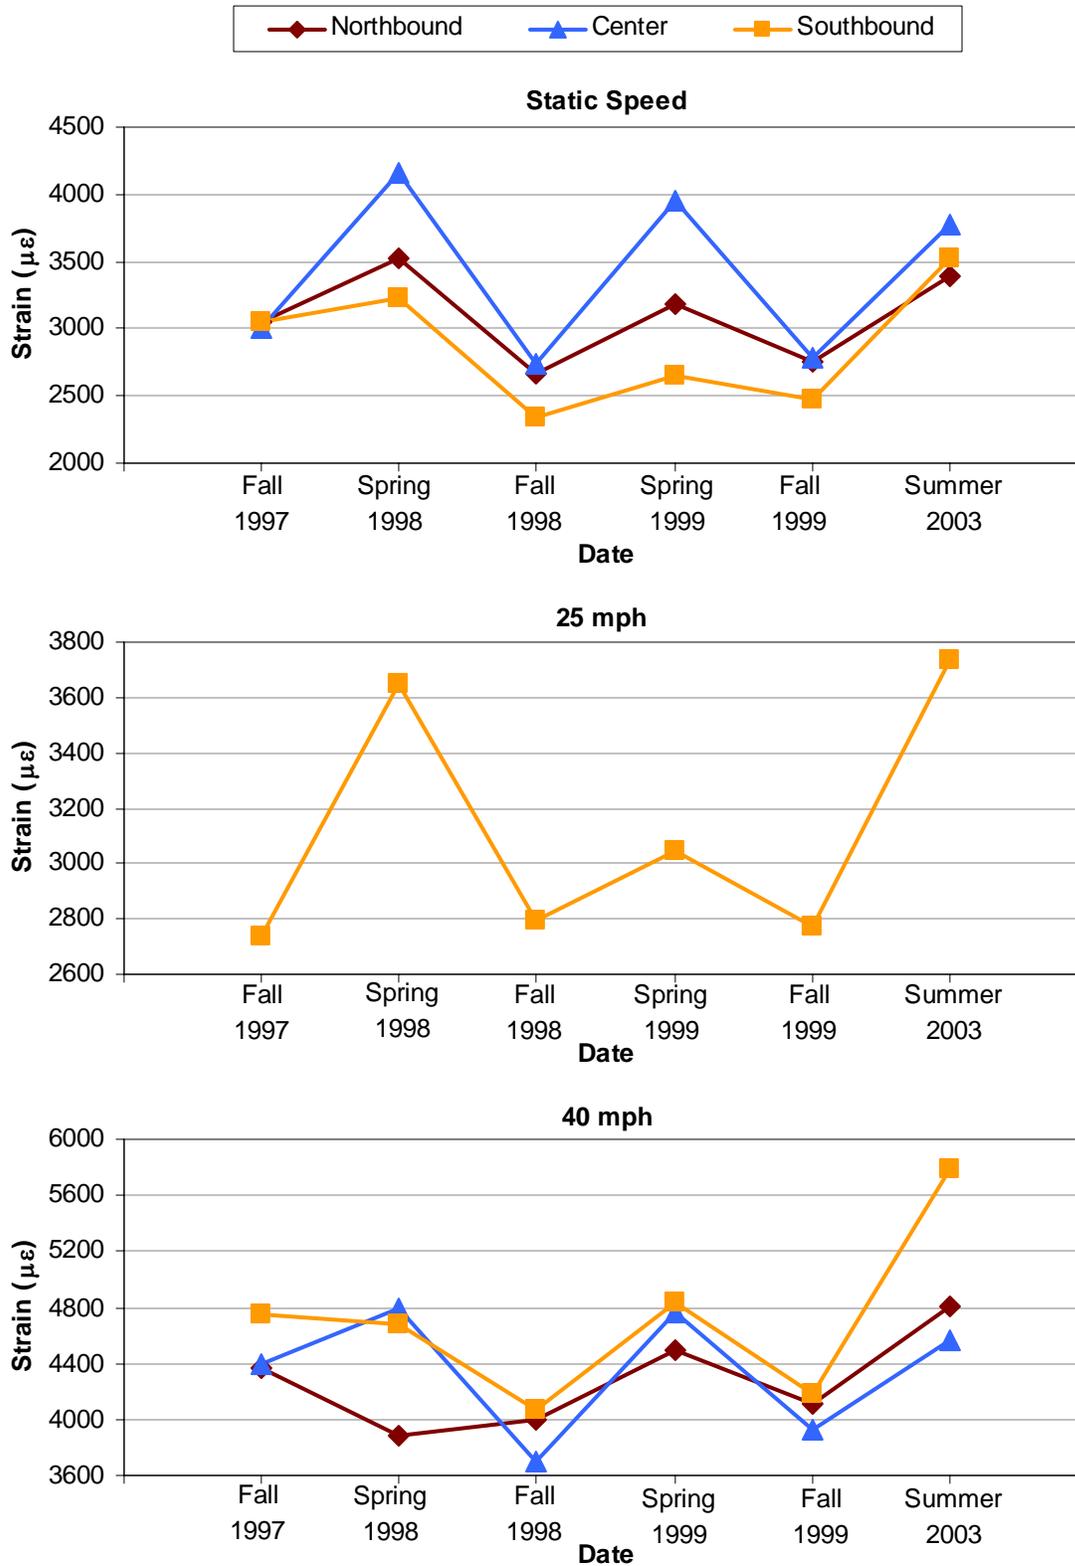
**Figure 4-7.** Average total peak strain in all of the girders for the different truck orientations and travel speeds in the Toms Creek Bridge.

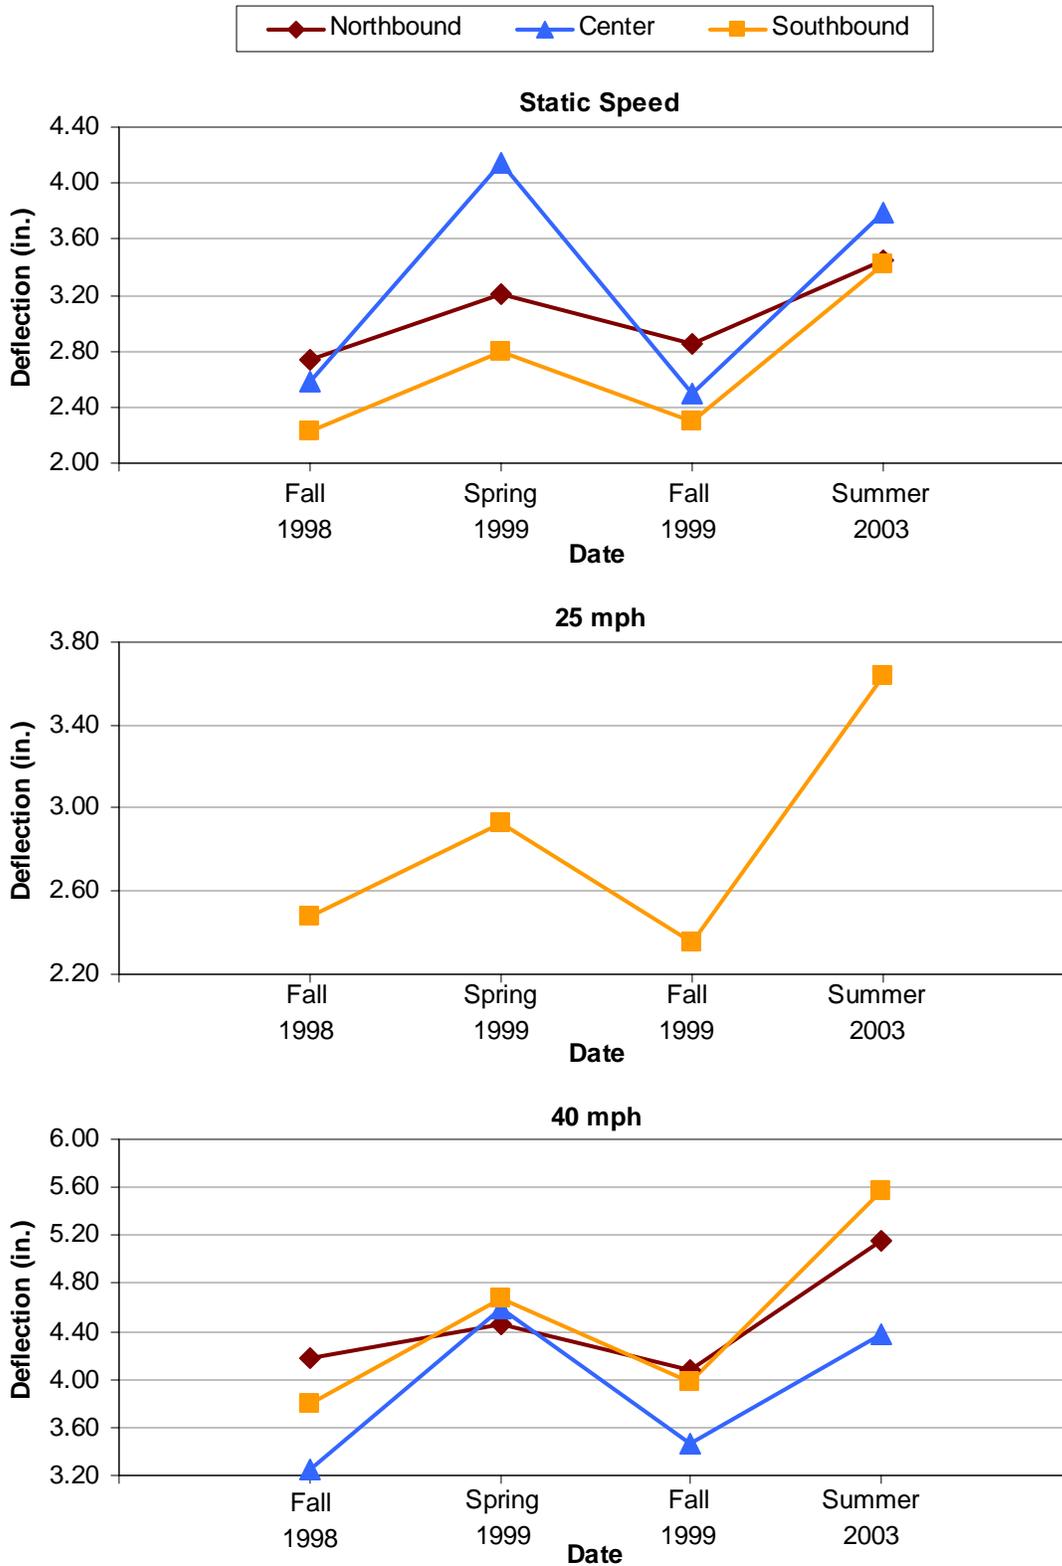
**Figure 4-8.** Average total peak deflection in all of the girders for the different truck orientations and travel speeds in the Toms Creek Bridge.

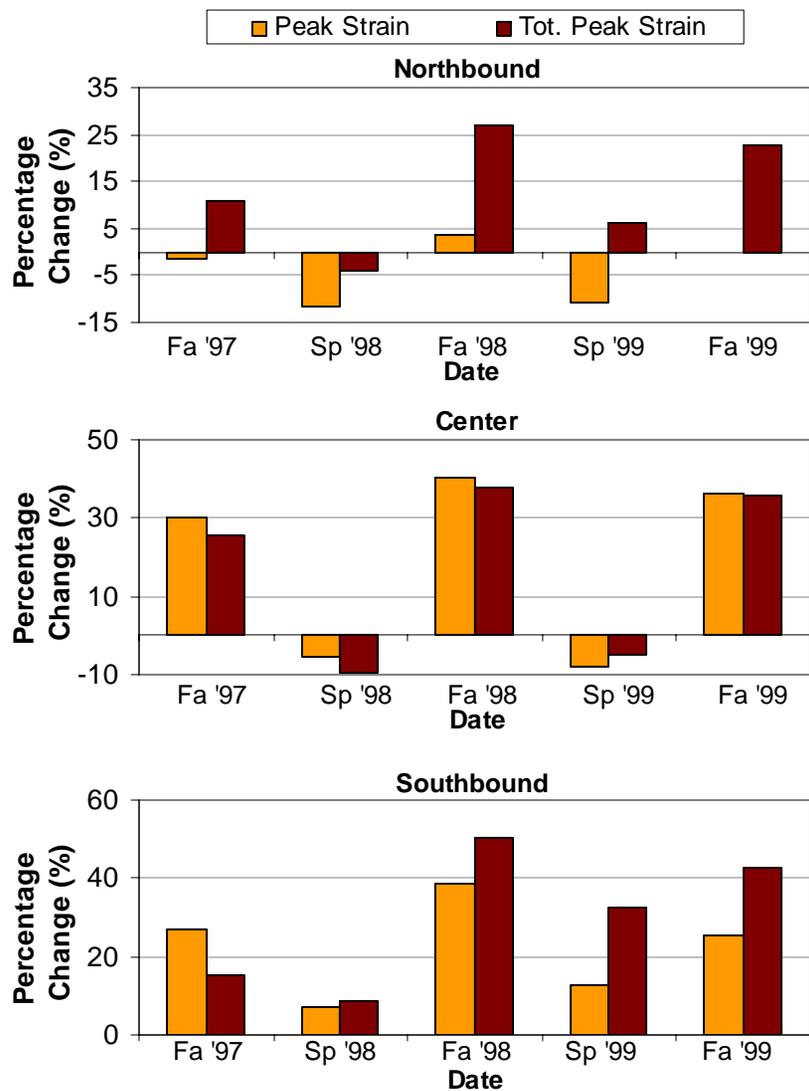
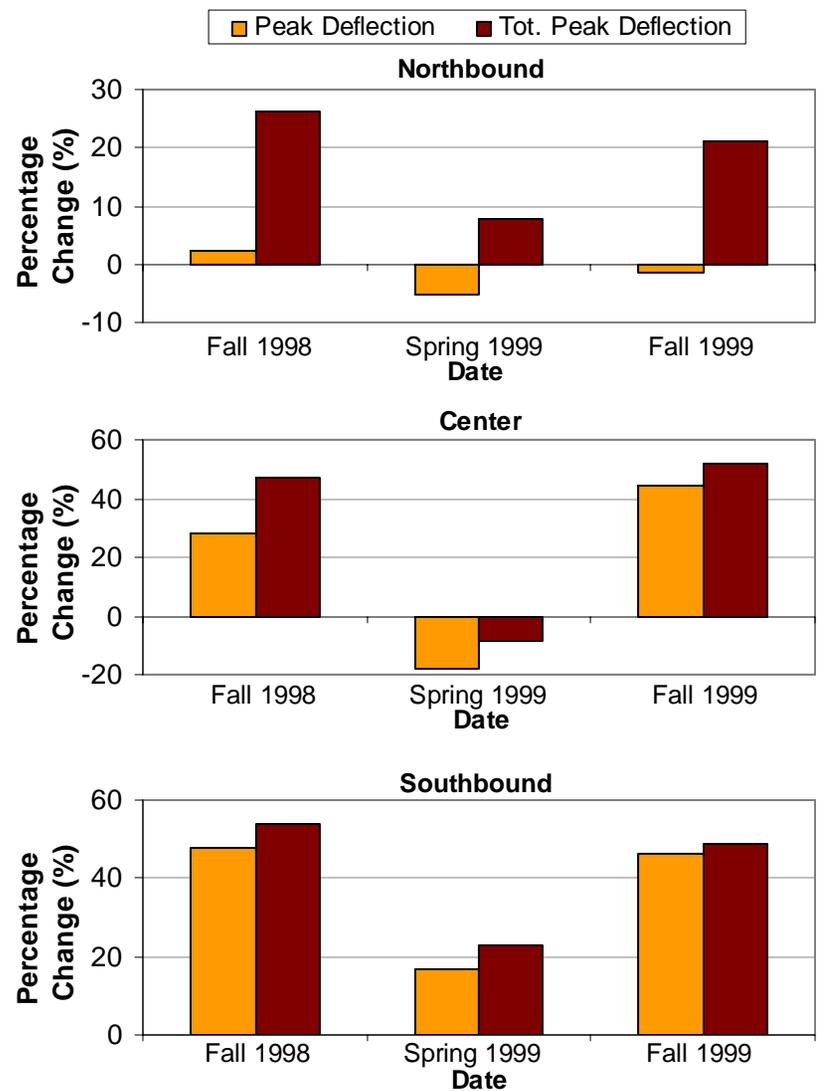
**Figure 4-9.** Percentage change of (a) peak strain versus total peak strain and (b) peak deflection versus total peak deflection from the given test date to the Summer 2003 test for the Toms Creek Bridge in the various truck orientations at static speed.

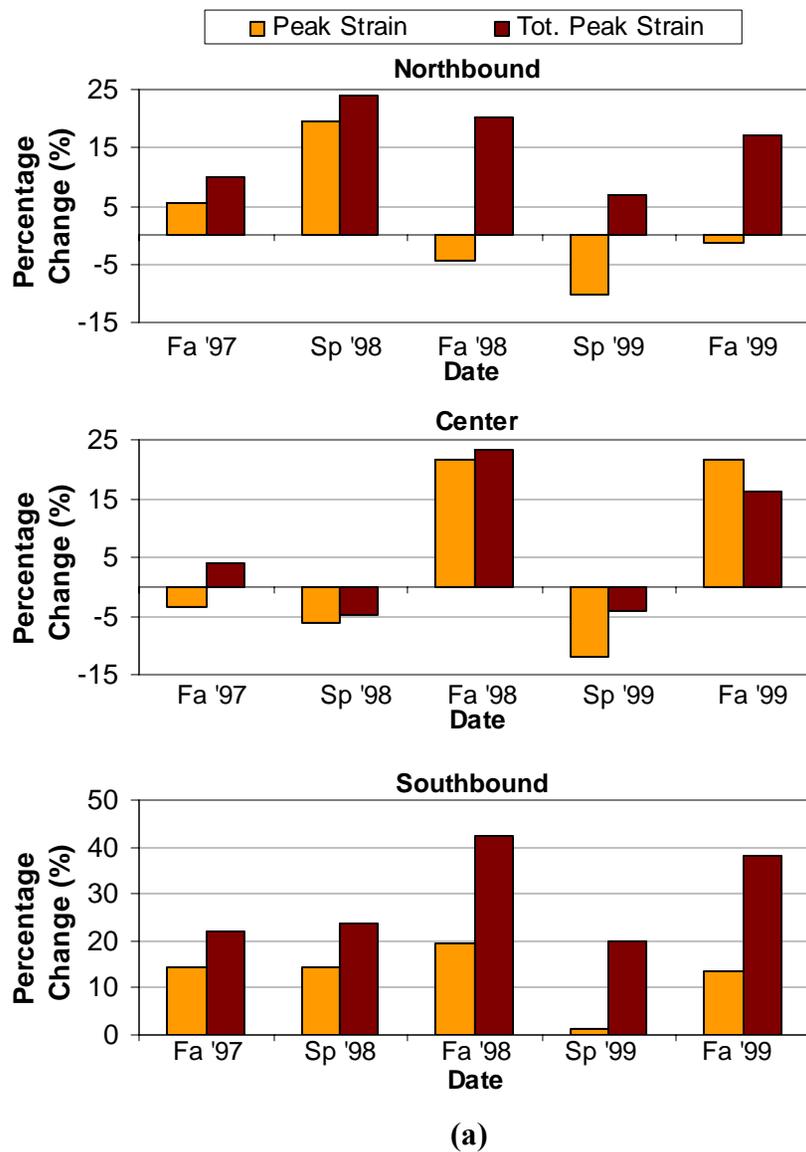
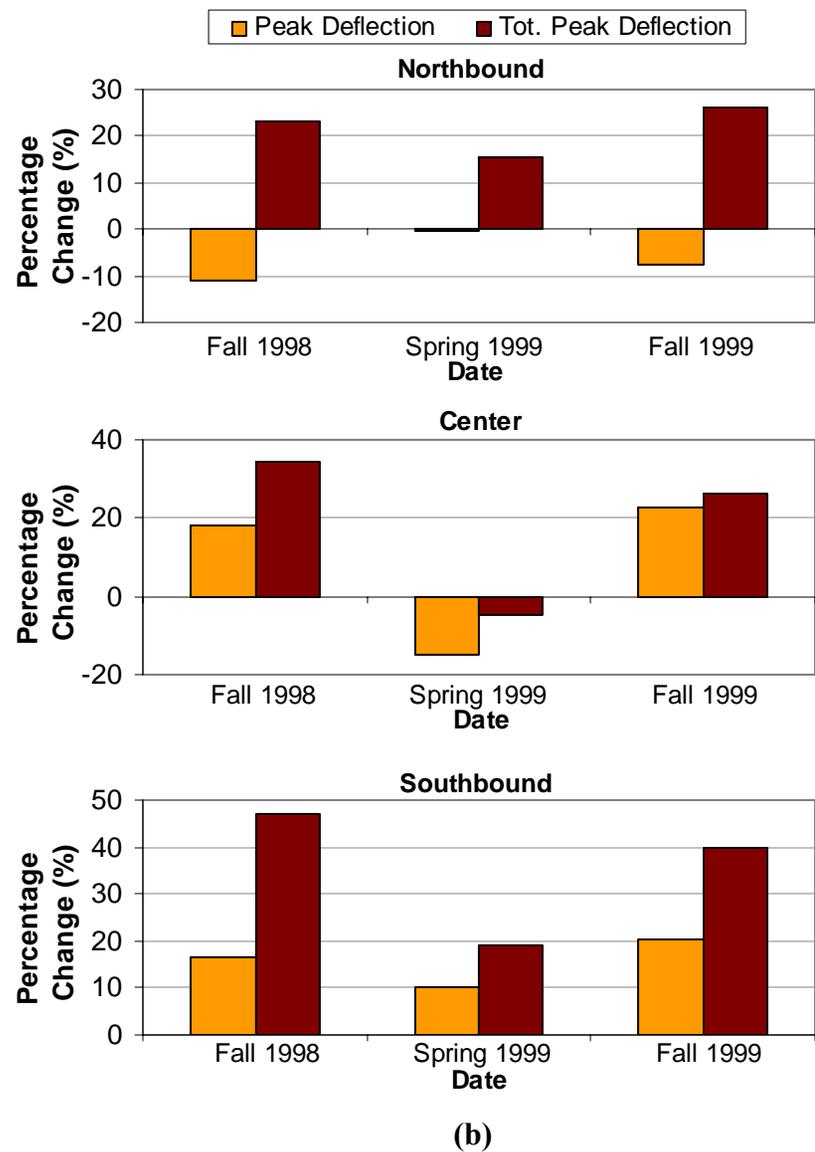
**Figure 4-11.** Percentage change of (a) peak strain versus total peak strain and (b) peak deflection versus total peak deflection from the given test date to the Summer 2003 test for the Toms Creek Bridge in the various truck orientations at 40 mph (64 kph).

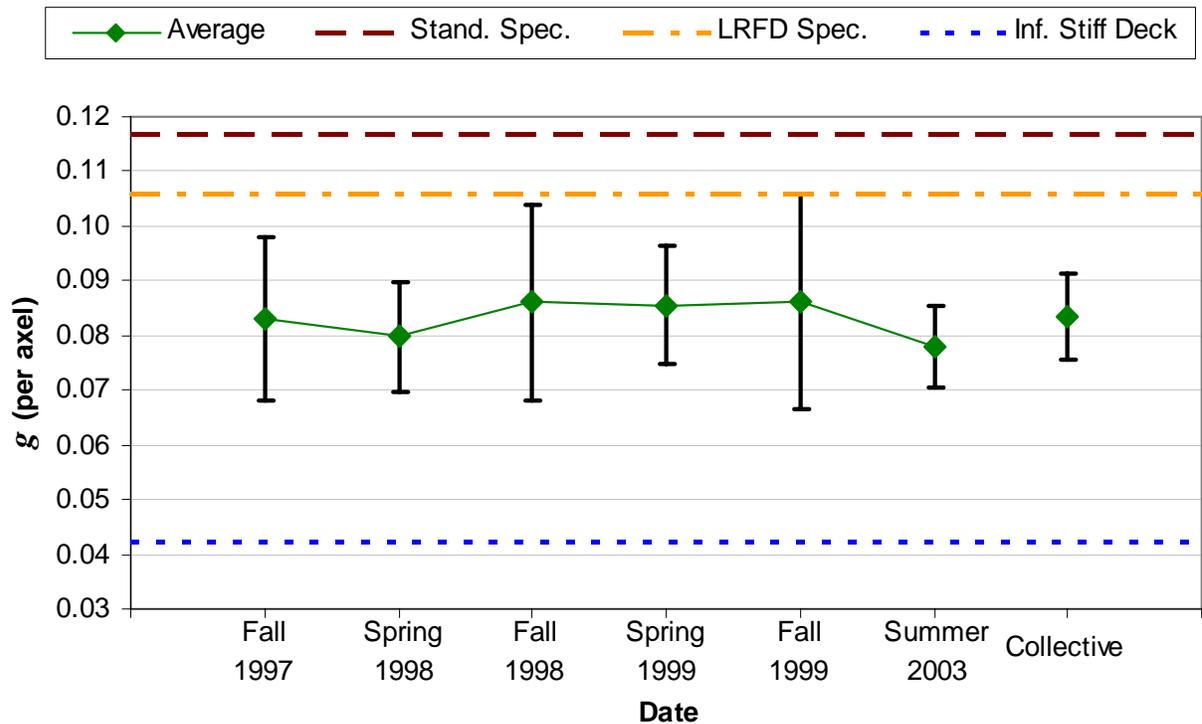
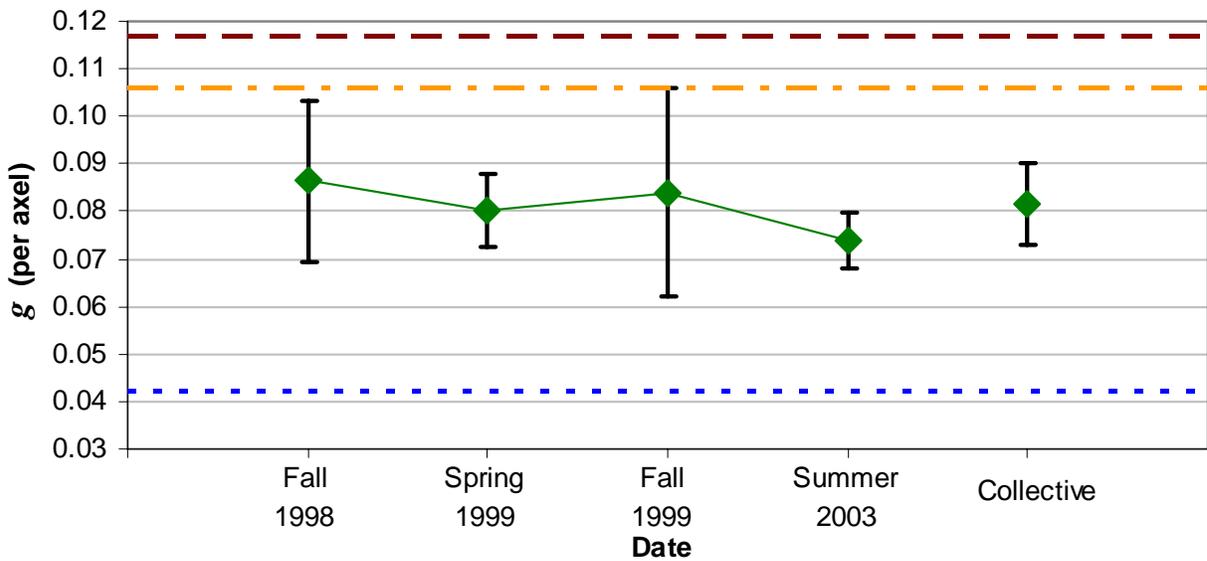
**Figure 4-12.** Comparison of AASHTO *Standard Specifications* and *LRFD Specifications* with the overall results for wheel load distributions in the Toms Creek Bridge, based on (a) strain and (b) deflection. The averages shown here combine the results for all truck orientations and are calculated “per axle.” Error bars are equivalent to  $\pm 2\sigma$ .

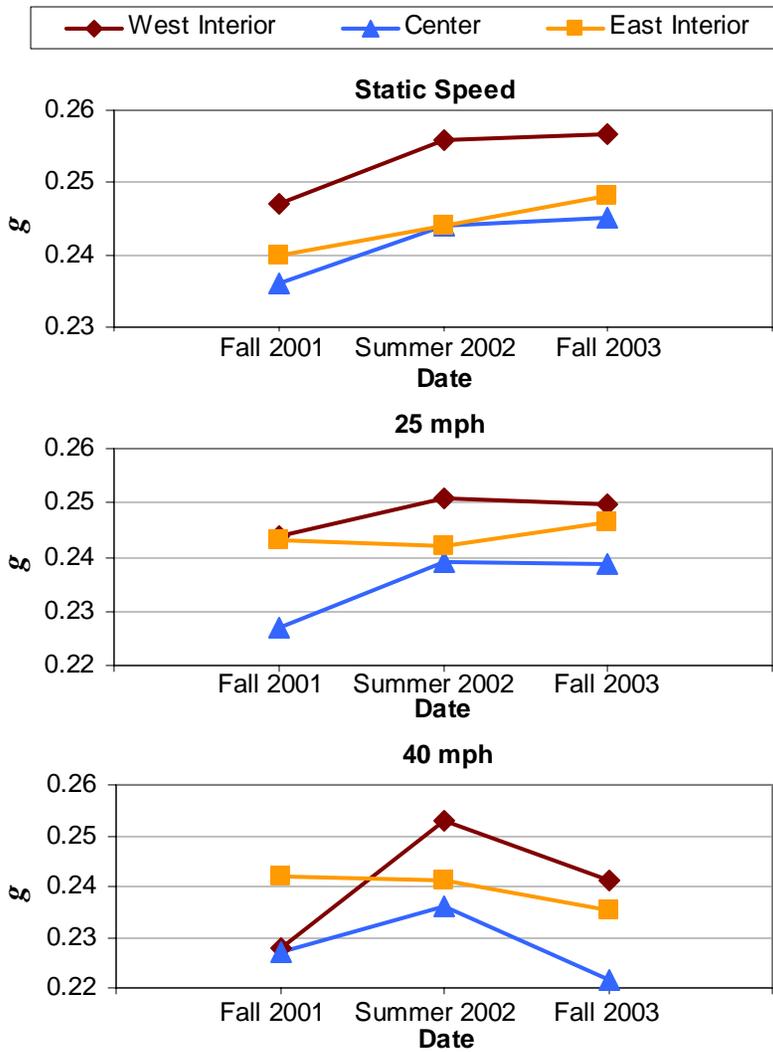
**Figure 4-13.** Average wheel load distributions for the Route 601 Bridge over time for three speeds, based on strain.

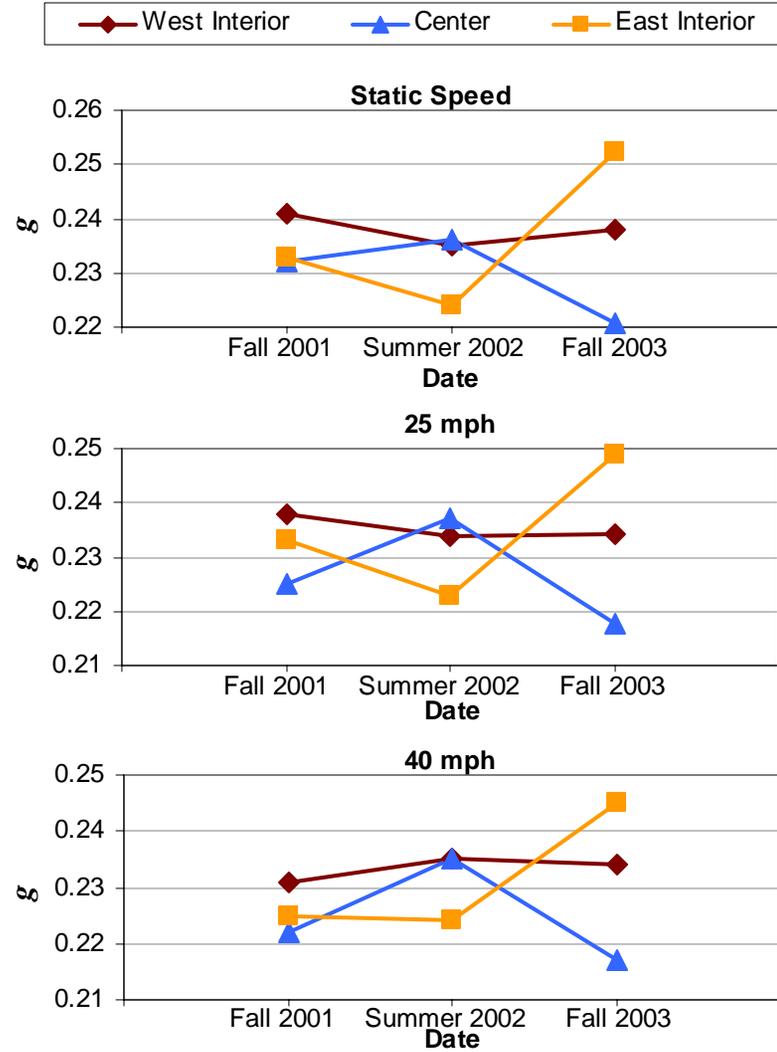
**Figure 4-14.** Average wheel load distributions for the Route 601 Bridge over time for three speeds, based on deflection.

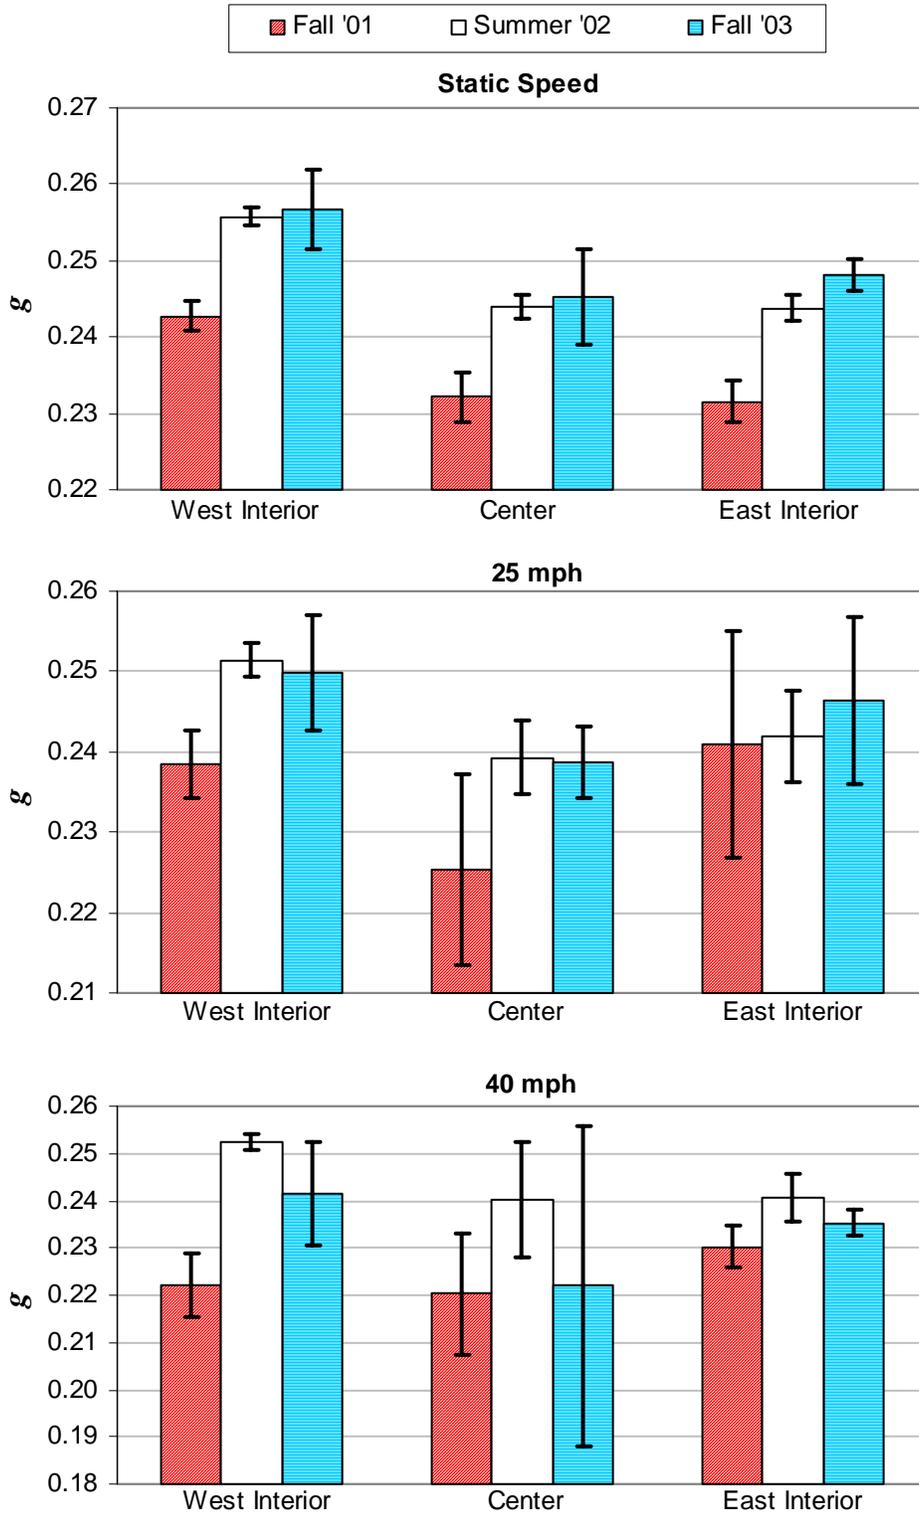
**Figure 4-17.** Error bars for average maximum wheel load distributions at three different speeds of the interior orientations in the Route 601 Bridge, based on strain measurements.
